INCORPORATING DIGITAL DATA INTO RAPID  
GEOMORPHIC ASSESSMENTS

Submitted to the Faculty of the  
Graduate College of the  
Oklahoma State University  
in partial fulfillment of  
the requirements for  
the Degree of  
MASTER OF SCIENCE  
December, 2018

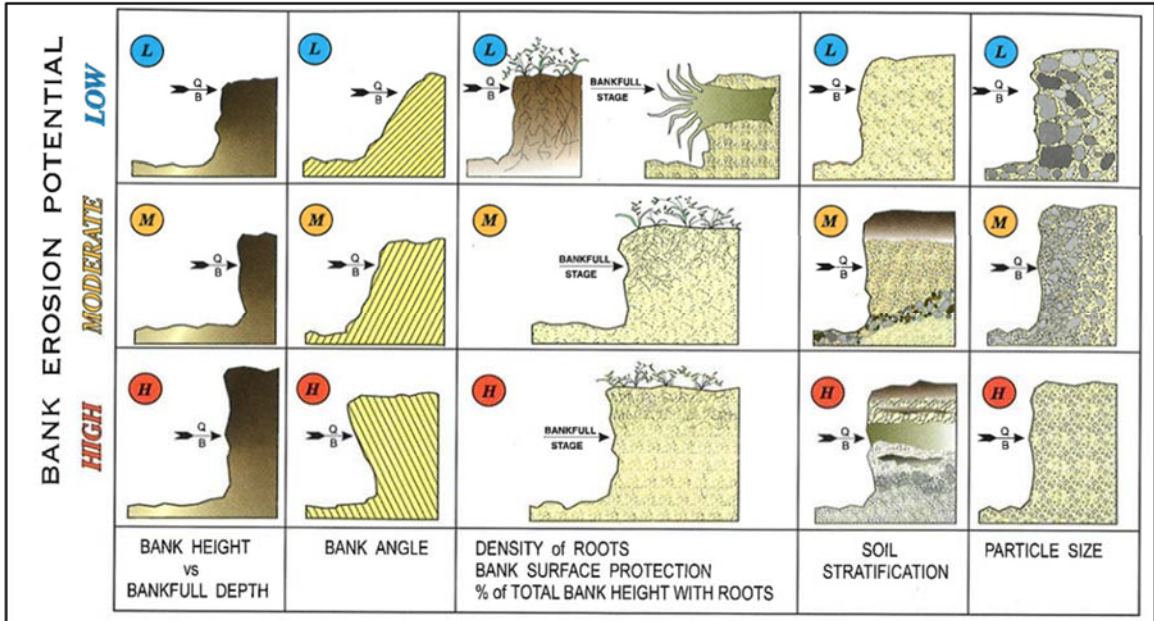
Figure 1: The different erodibility factors considered in the Bank Erosion Hazard Index. Taken from figure 6-25 in Rosgen (1996).

The four BEHI measurements required include bank height, bank face length, bankfull height, and root depth on the bank. These measurements were all performed on the critical bank, the bank that was the most at risk of erosion and failure (i.e., outside of the meander bend). Bank height was measured from the surface of the water to the top of the existing bank, and bankfull height was measured from the surface of the water to the top of the active floodplain. The bank height and bankfull height were used to assess the bank height ratio, the first BEHI metric. The closer this ratio was to one, the lower the risk rating. The rationale behind this metric was that the higher the bank was above the bankfull height, the higher the risk of the lower bank eroding and eventually causing mass wasting (Figure 1).

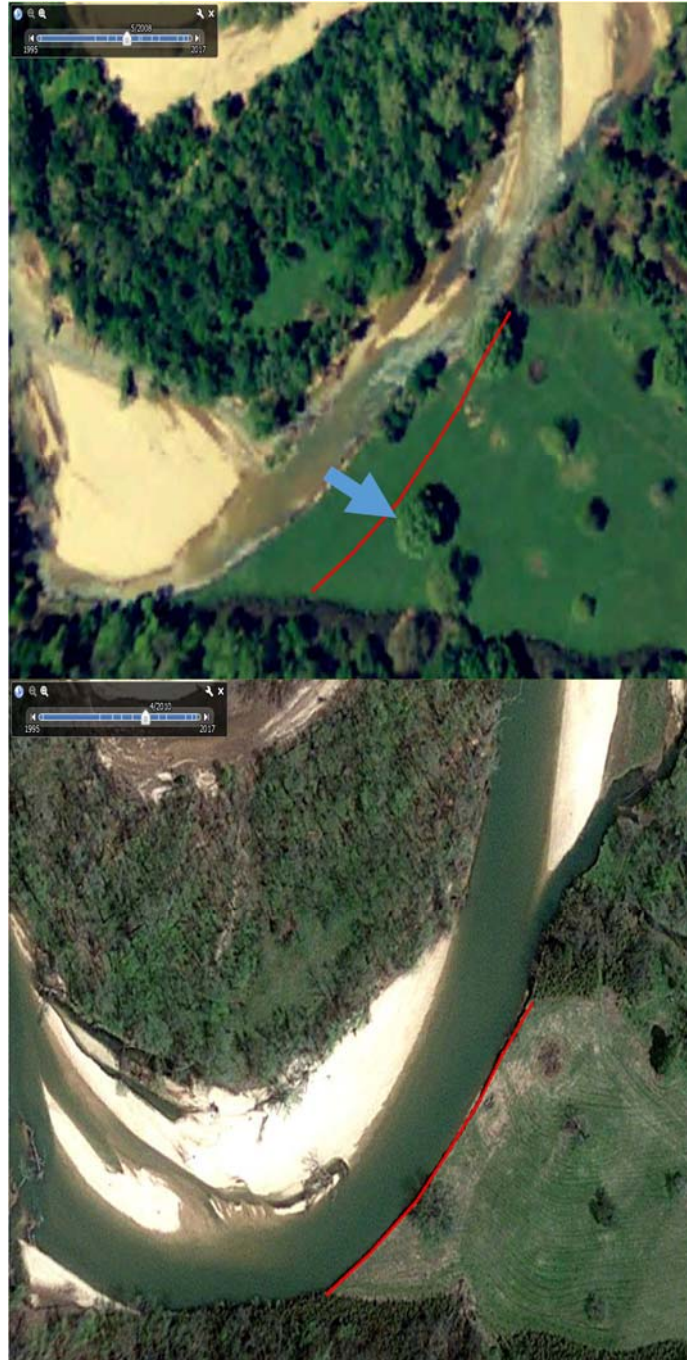
Figure 4: The Google Earth image on the top was taken in 2008, while the picture on the bottom was taken in 2010. The red line indicates the top of the bank in 2010 in both pictures. The blue arrow indicates the direction the channel is going to migrate towards. Google Earth cited the top image from the U. S. Department of Agriculture, Farm Service Agency, and the bottom image as DigitalGlobe.

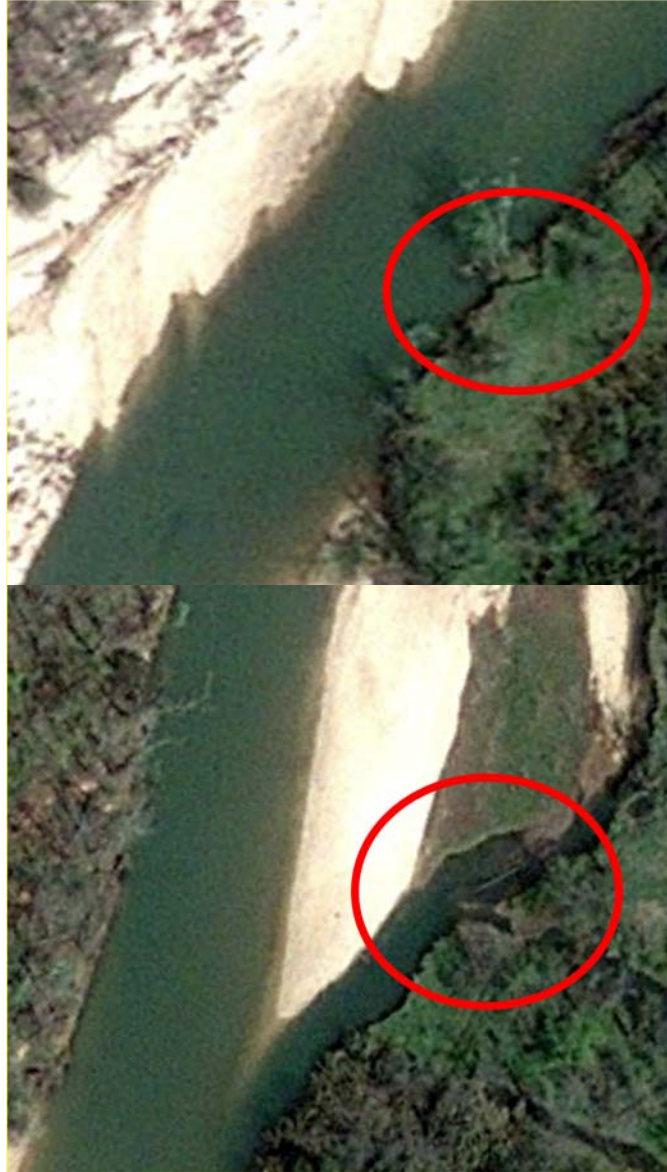
Figure 5: Examples of obvious mass wasting as evidenced by large cracks in the top bank. Google Earth cited both images as coming from DigitalGlobe.

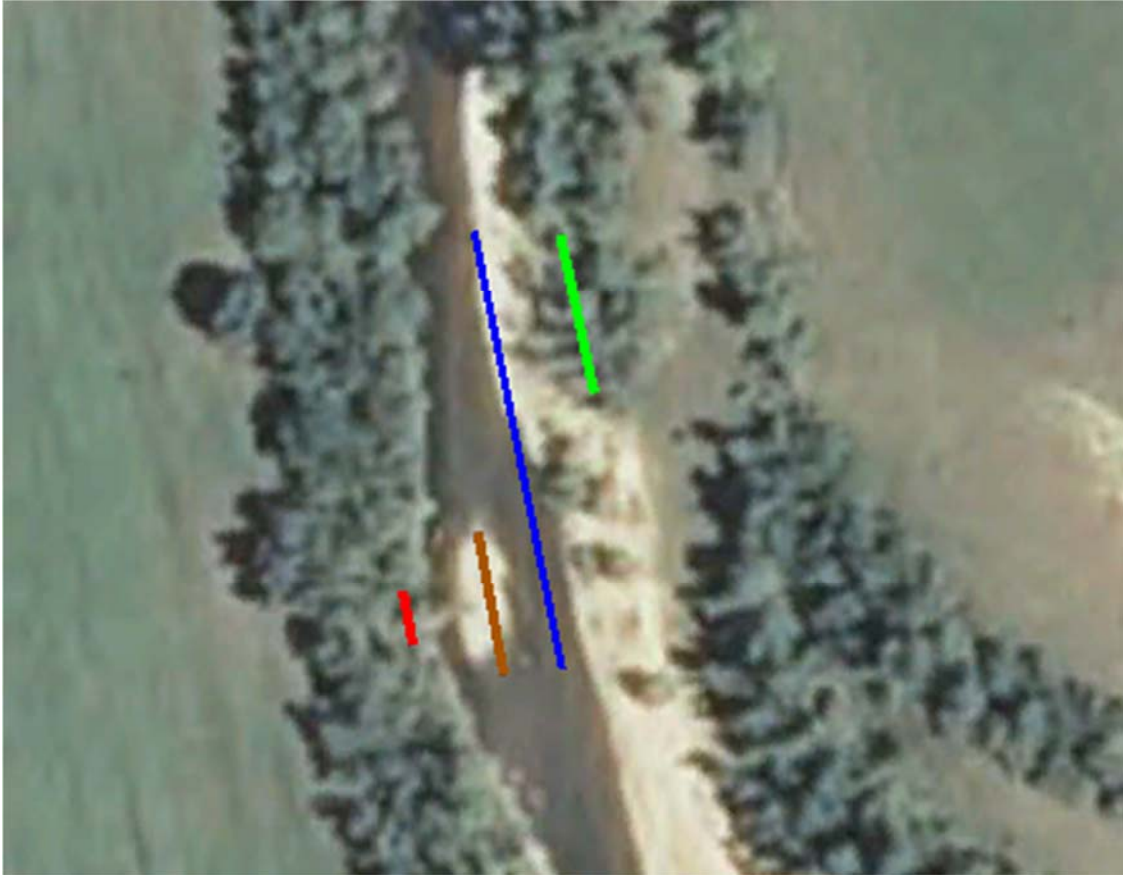
Figure 6: The stream is flowing from the bottom to the top of the image, so that the left bank is on the left side of the image. The blue line represents the reach length, the green line represents woody vegetation that does not make up 100% of the reach. The red line represents bank affected by mass wasting, which is evidenced by a fallen tree visible in a different image. The brown line represents deposition that does not make up 100% of the reach. Google Earth cited the image as coming from the U. S. Department of Agriculture, Farm Service Agency.

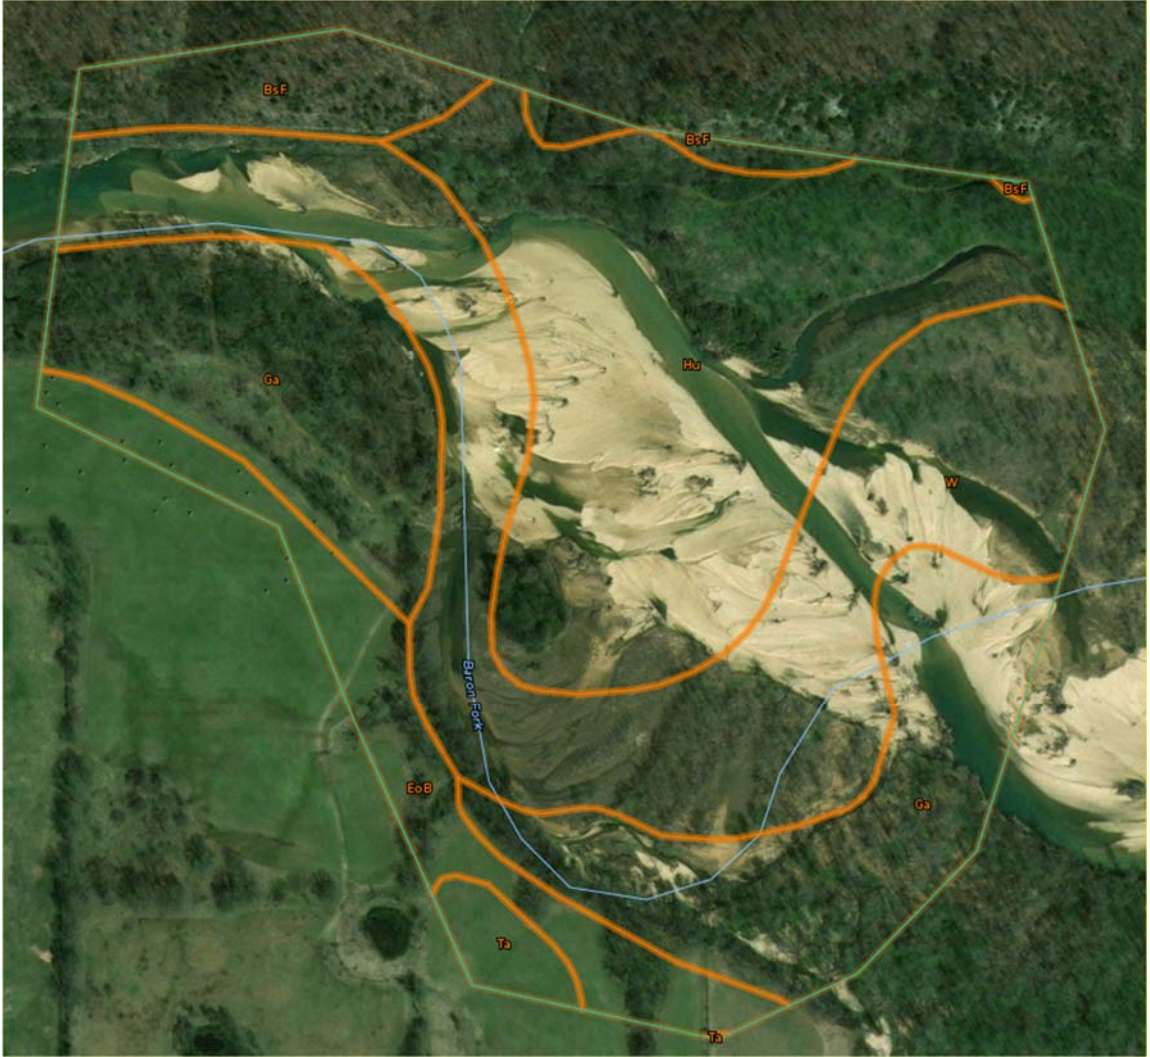
Figure 7: Example of Web Soil Survey map. Note how the stream, denoted by a W in the soil map, does not line up with the course of the stream in the background imagery.

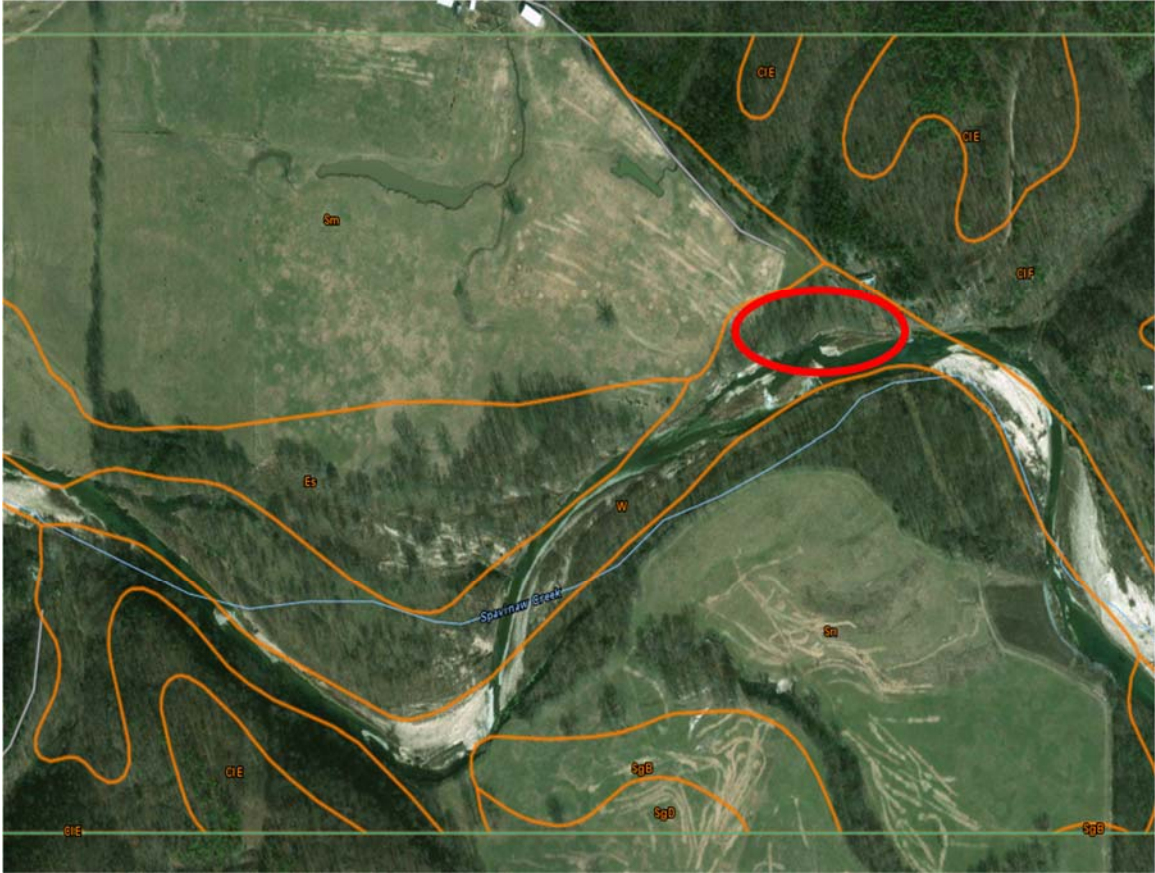
Figure 8: Note the selected streambank that is denoted as water (W) in the soil map. In this case, in deciding between using the Sm or CIF soil types, the Sm soil type was selected based on its closer topographic proximity to the selected bank.

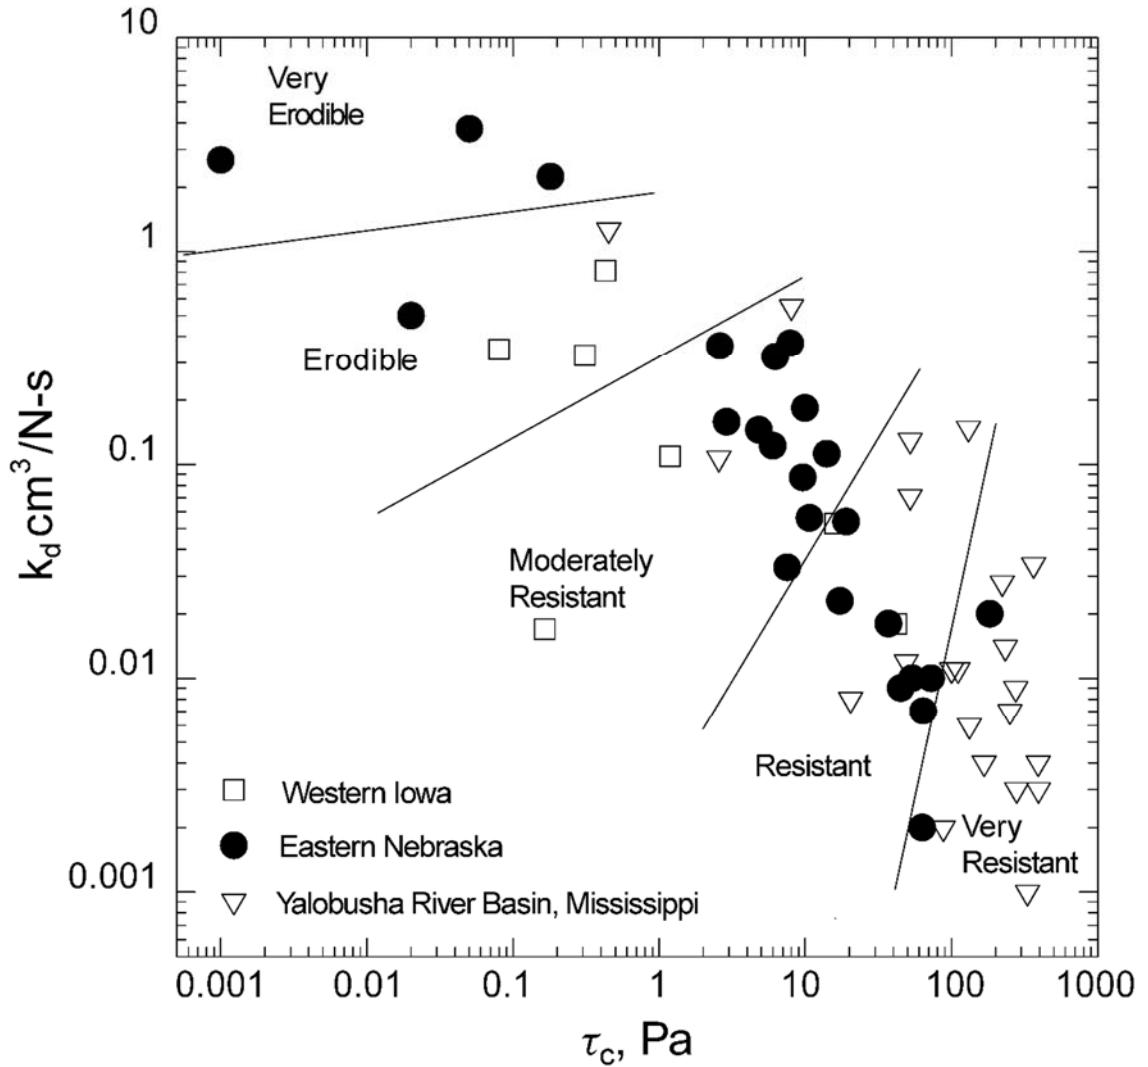
Figure 9: Figure 8 from Hanson and Simon (2001), describing the erodibility classes as defined by the critical shear stress ( $\tau_c$ ) and the erodibility coefficient ( $k_d$ ). Developed for cohesive soils.

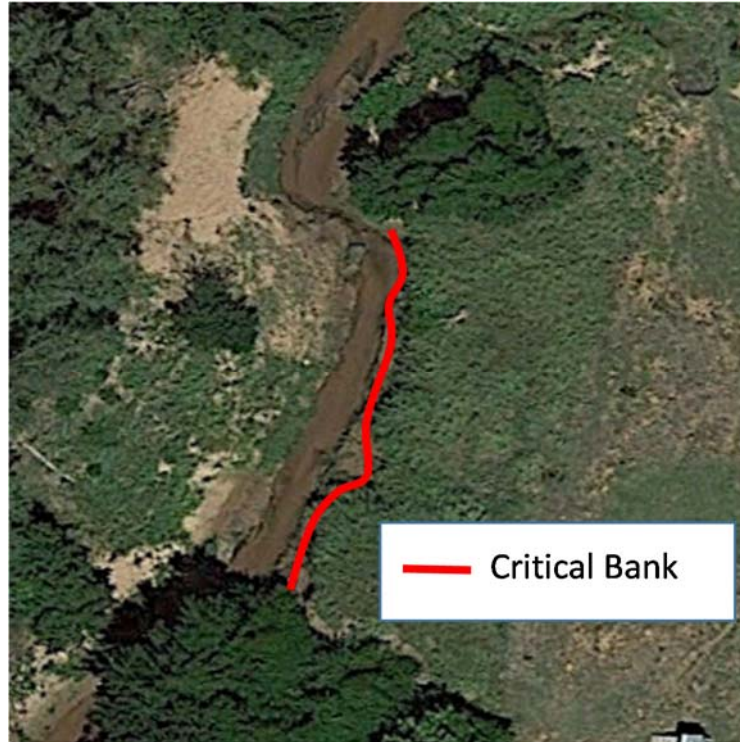
Figure 10: Example of Google Earth vegetation type identified as Vegetated-Grass. Location: WC3. Obtained using Google Earth. Imagery date: 7/26/2015.

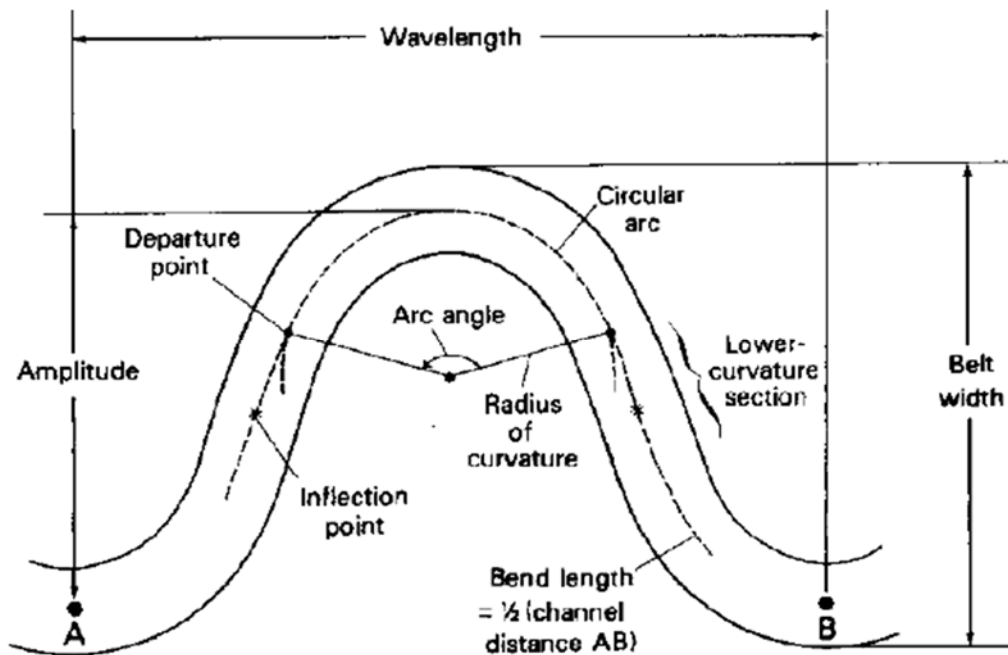
Figure 11: Figure 1 from Williams (1986). Describes meander features and how to measure them.

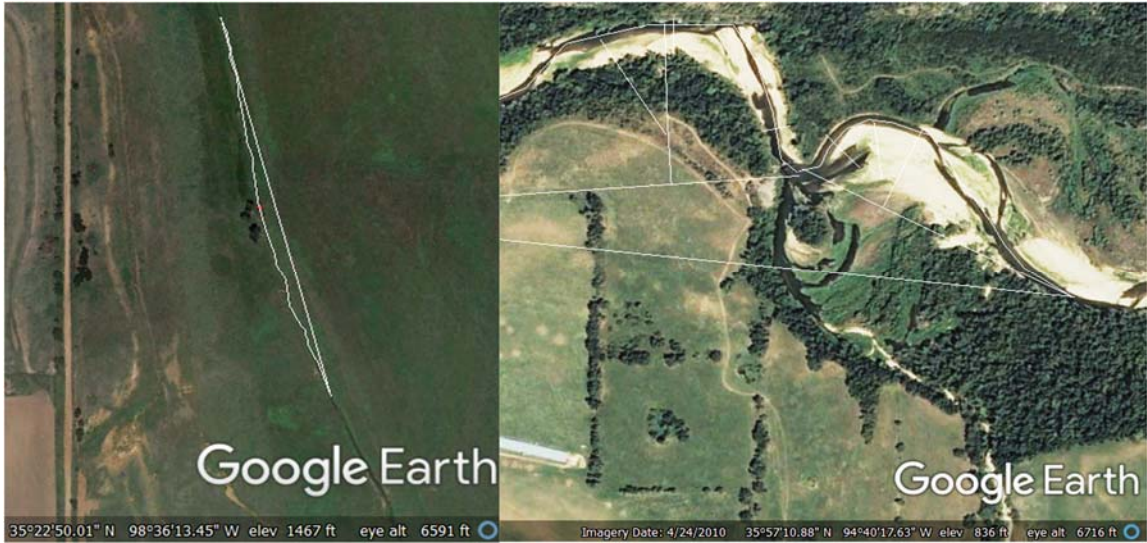
Figure 12: Meander measurements for a site in the Fort Cobb reservoir (left) and from Barren Fork (right). Notice that at a similar eye altitude (in bottom right corner of each picture) there is a significant difference in meandering. Google Earth cited the image on the right as coming from the U. S. Department of Agriculture, Farm Service Agency.

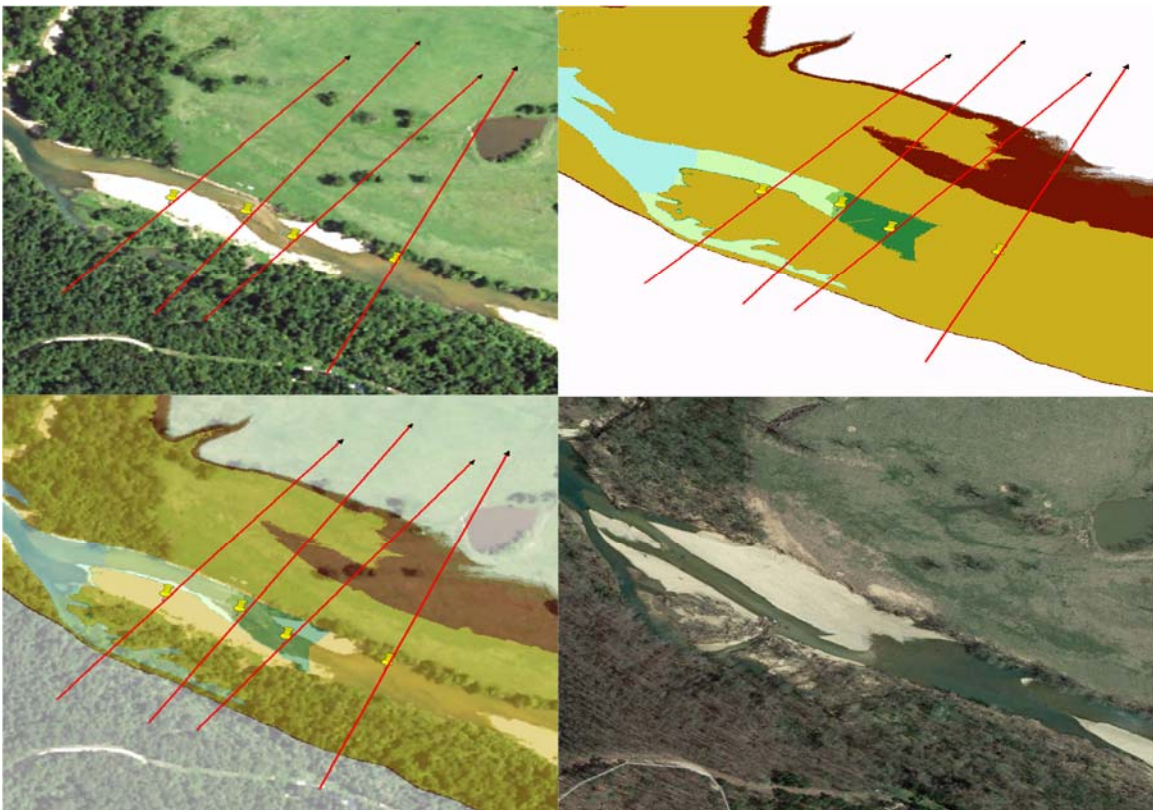
Figure 13: Clockwise from the top left corner: 1) NAIP imagery and the cross sections for Station D. 2) DEM. 3) DEM with NAIP overlaid at 50% transparency. 4) Google Earth image for comparison.

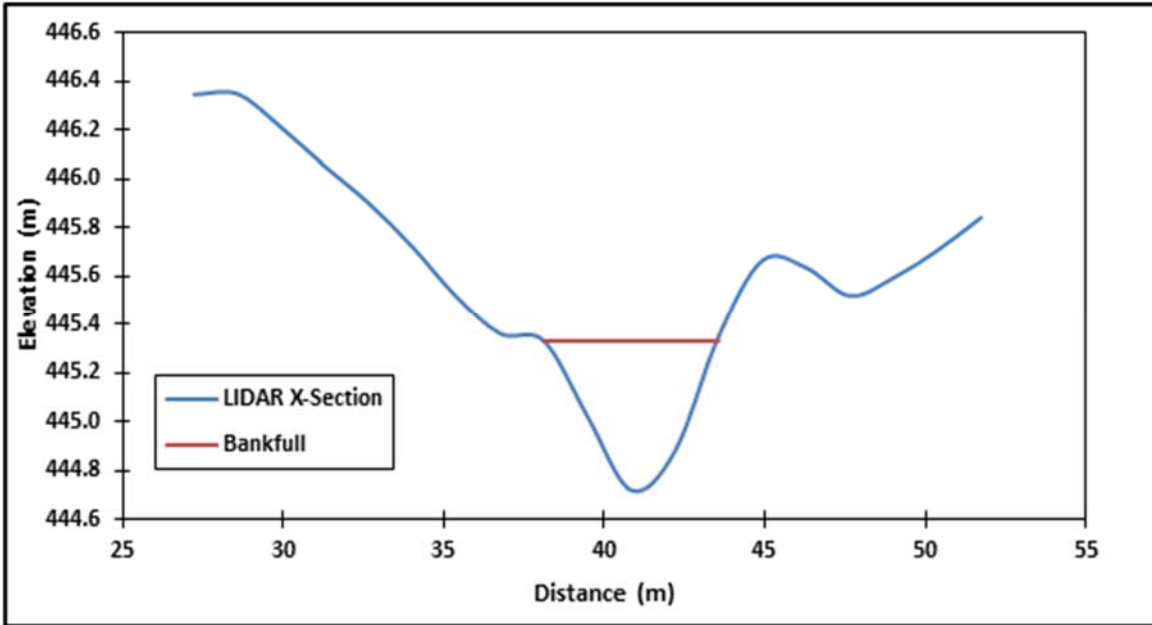
Figure 14: LIDAR cross section from Fivemile, a second order stream, with estimated Bankfull height indicated at the first major change in slope. Cross section taken from the left bank to the right.

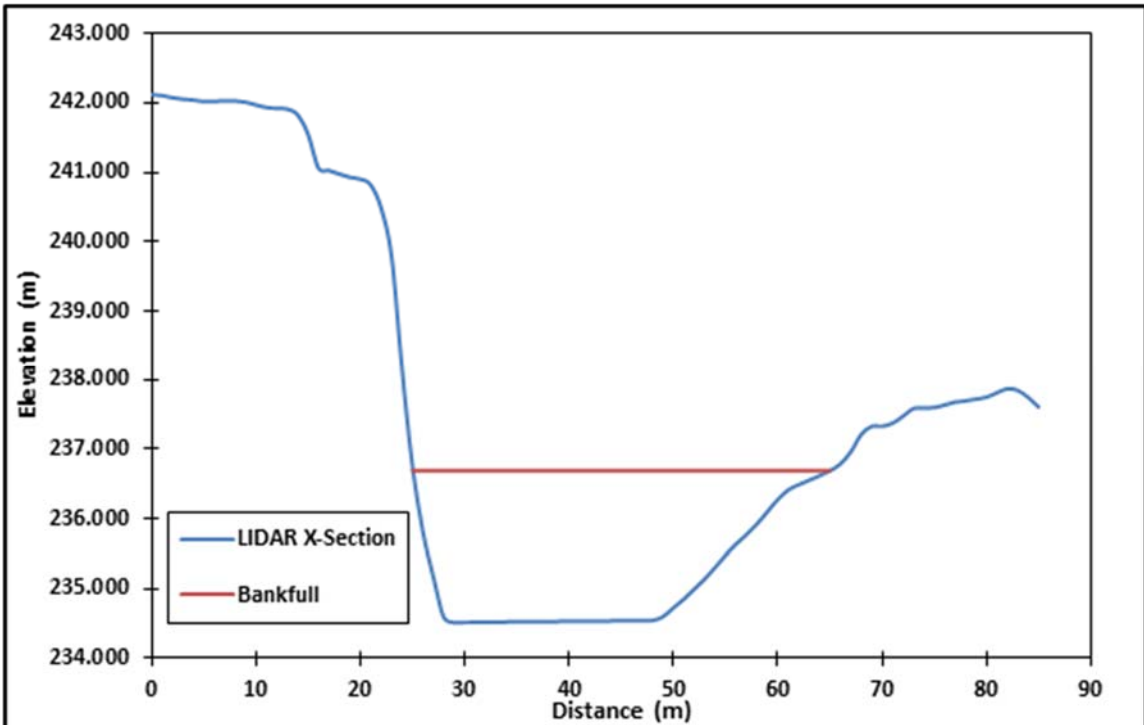
Figure 15: LIDAR cross section from Barren Fork, a fourth order stream, with estimated bankfull depth indicated at the first major change in slope. Cross section taken from the left bank to the right.

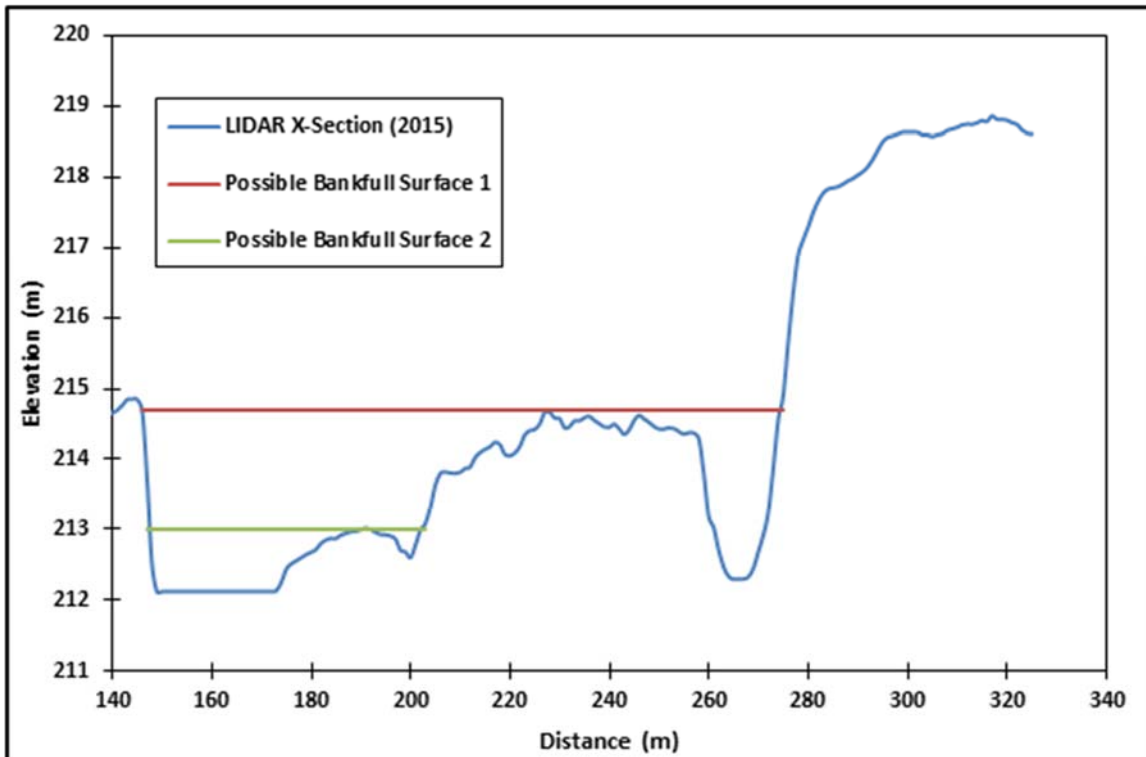
Figure 16: LIDAR cross section with two possible bankfull surfaces. Cross section taken from the left bank to the right.

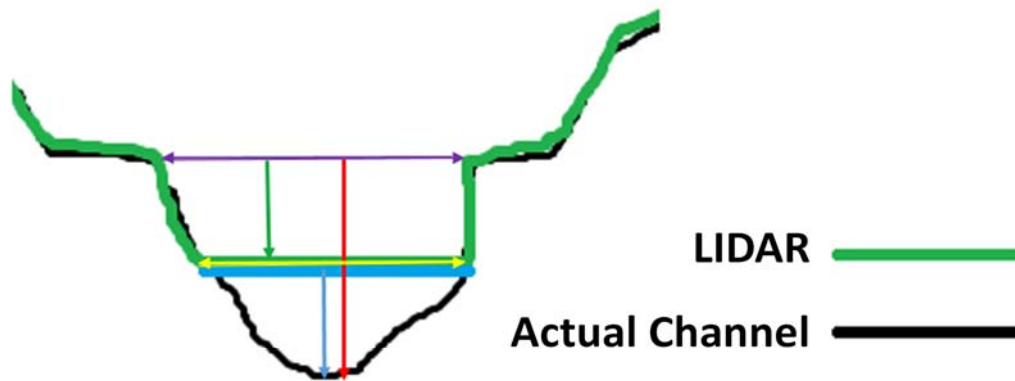
Bankfull Depth:  $D_{Bf} = H_{Bf} + D_f$   
 Bankfull Width:  $W_{Bf}$   
 Baseflow Depth:  $D_f$   
 Bankfull Height:  $H_{Bf}$   
 Base Flow Width:  $W_f$

Figure 17: An Example of how it was assumed LIDAR interacts with an actual channel. The different relevant measurements are identified.

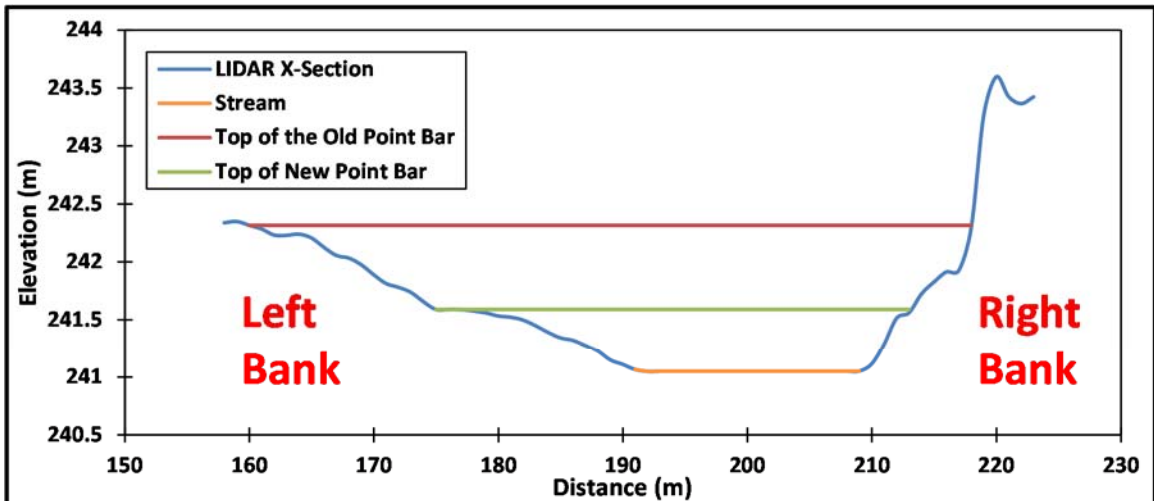
Figure 18: Notice how there is a distinct line in the point bar in the Google Earth Image (taken in 3/20/2016), while the LIDAR cross section captured both this point bar (green line) as well as what appears to be an old, less active point bar (red line). Note the stream is flowing from the top right down, with the left and right banks noted on the image.

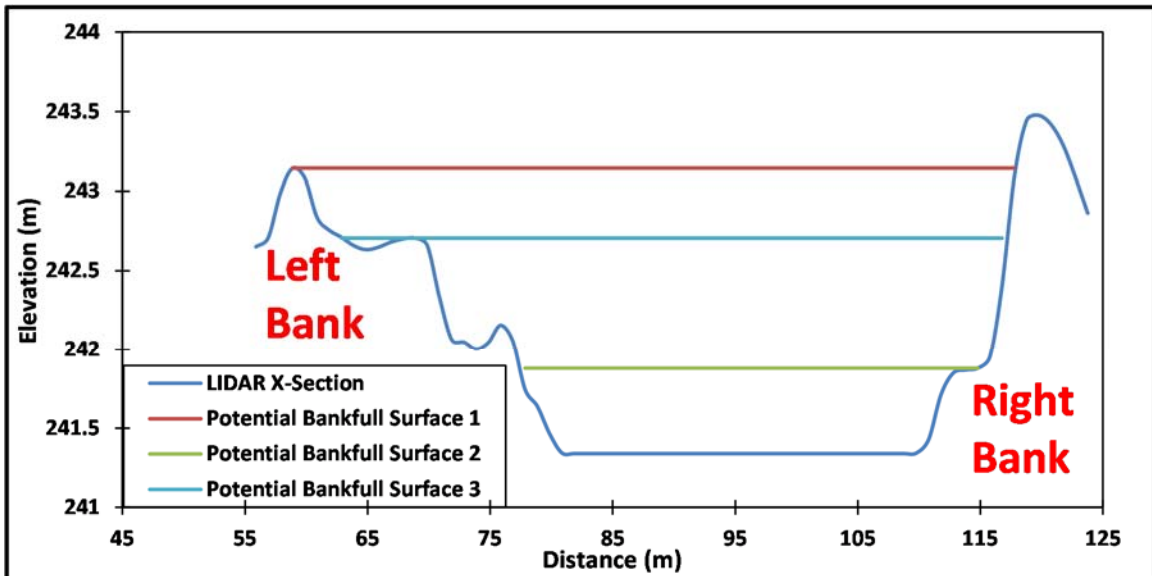
Figure 19: In this example, there were several depositional surfaces and no clear indication of where the top of the apparent point bar was. The light blue line was chosen to represent the bankfull stage as it most closely matched the estimated bankfull in Google Earth.

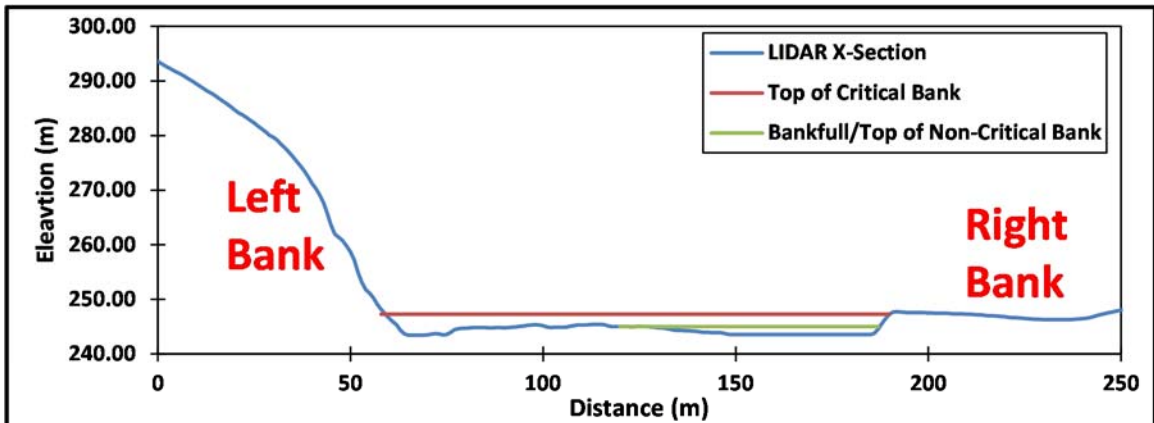
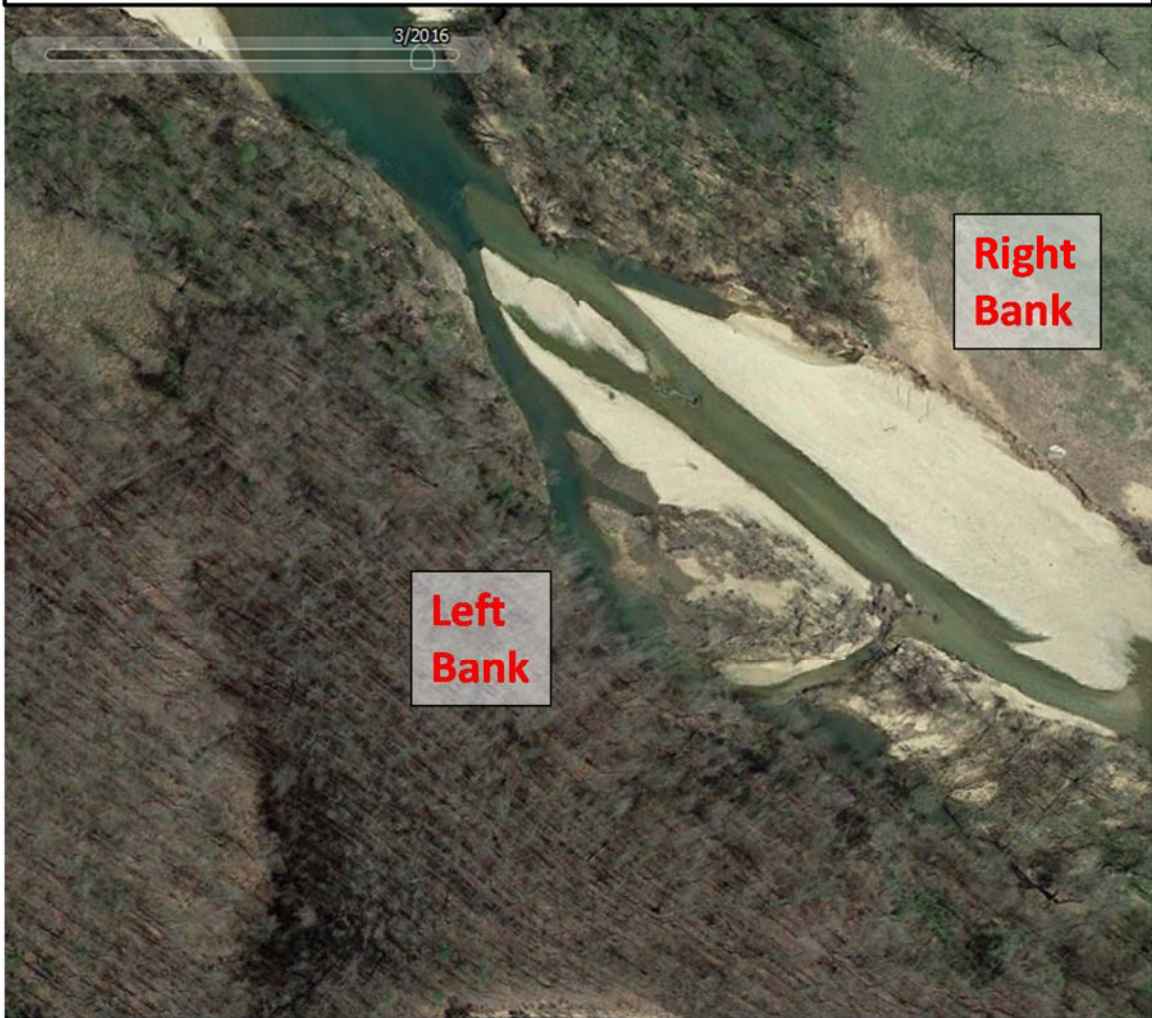
Figure 20: Note the terrace and secondary channel on the left, which can be confirmed in the Google Earth Image. The green line represents the bankfull depth, which also corresponded to the top of the left bank, and the red line indicates the top of the right bank.

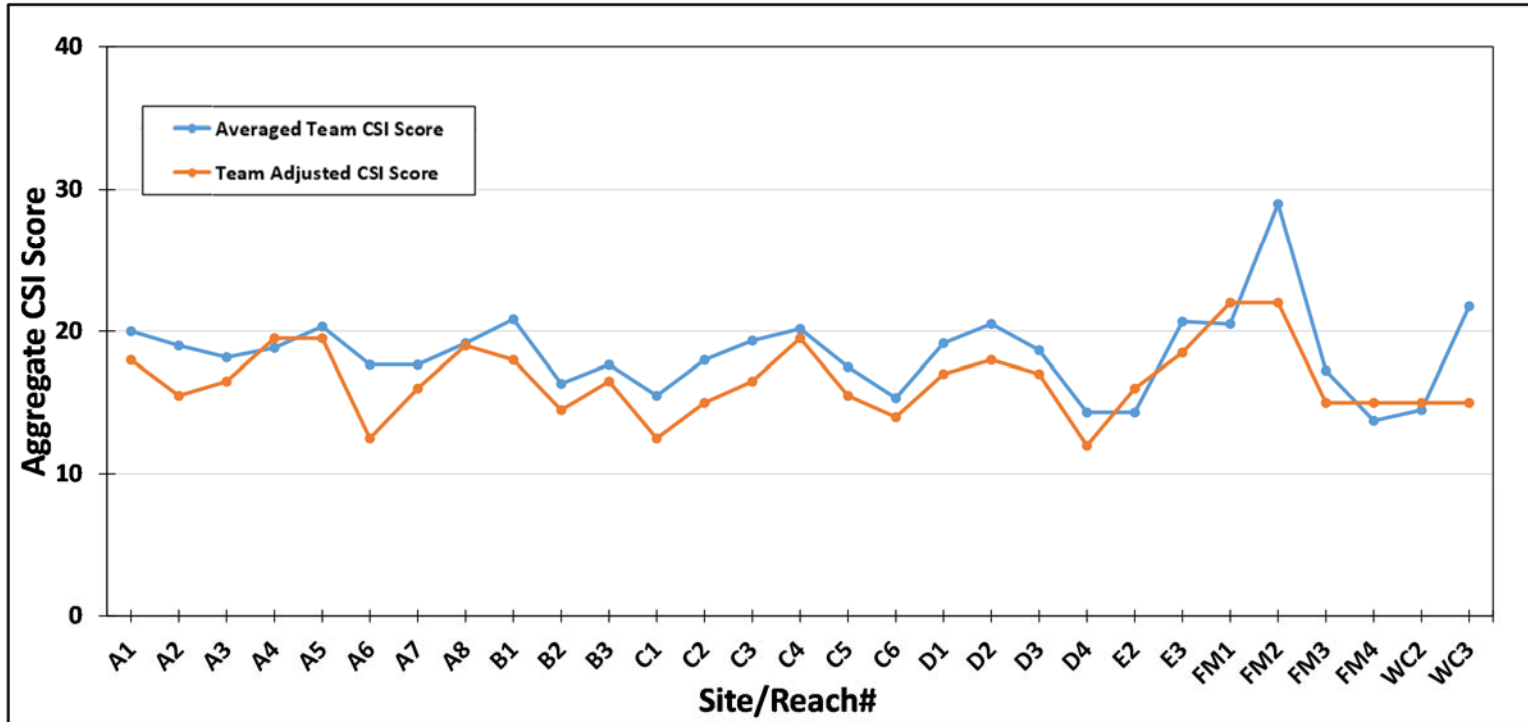
Figure 28: Comparison between the original team adjusted scores and the averaged team score using the development data set (which later are referred to as the historical aggregate score). Note that the final reports for FM1-WC3 sites only reported the final team adjusted stability rank, so an appropriate score was assigned to these points.

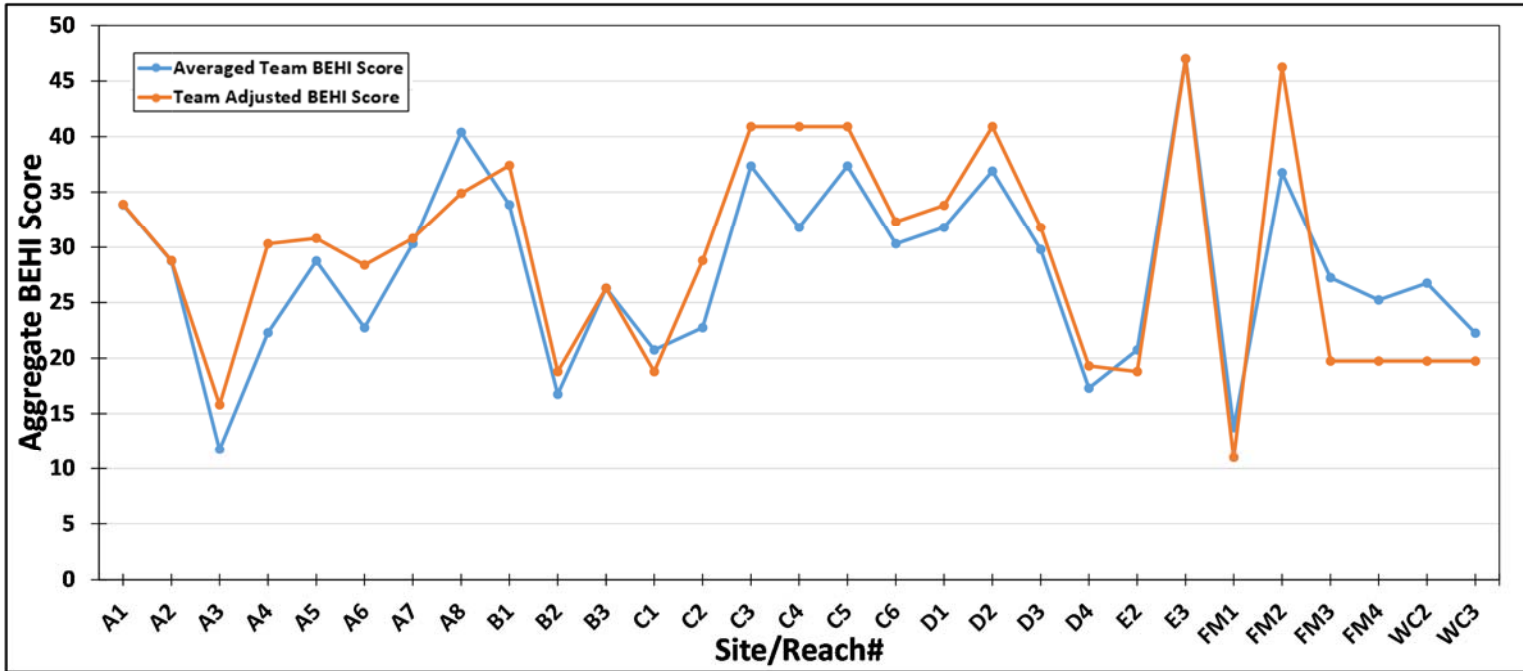
Figure 29: Comparison between the original team adjusted scores and the averaged team score using the development data set (which later are referred to as the historical aggregate score). Note that the final reports for FM1-WC3 sites only reported the final team adjust

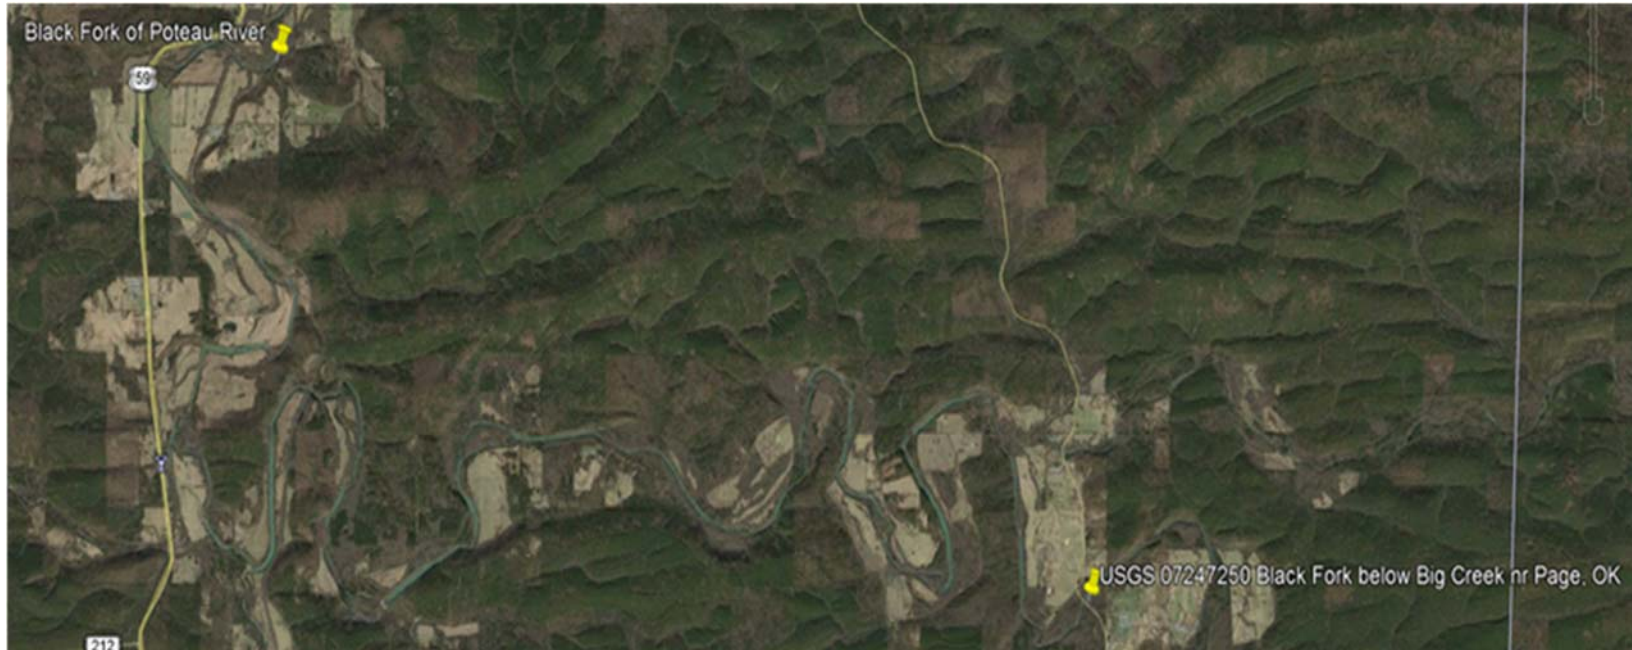
Figure 33: Validation site and stream gage for Black Fork. Imagery was obtained using Google Earth, with eye elevation at 19 km, and imagery date of 3/20/2016.

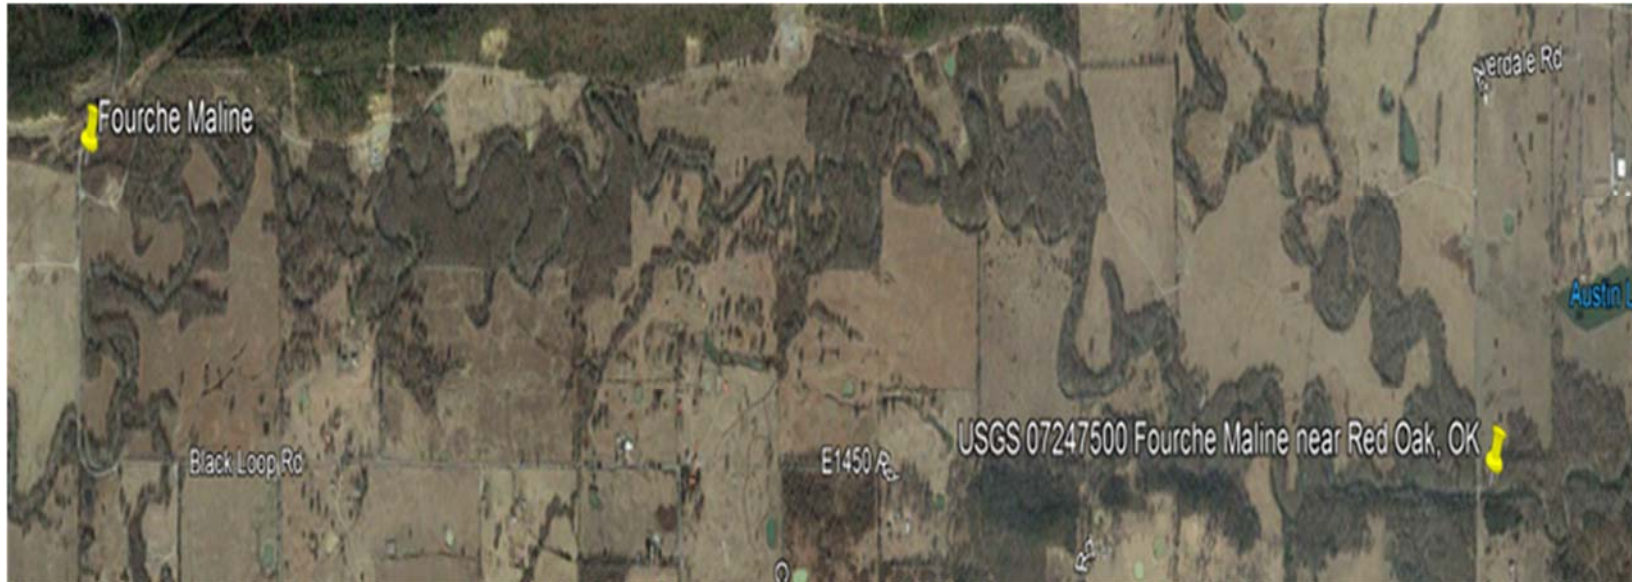
Figure 34: Validation site and stream gage for Fourche Maline. Imagery was obtained using Google Earth, with eye elevation at 189 m, and imagery date of 1/17/2018.

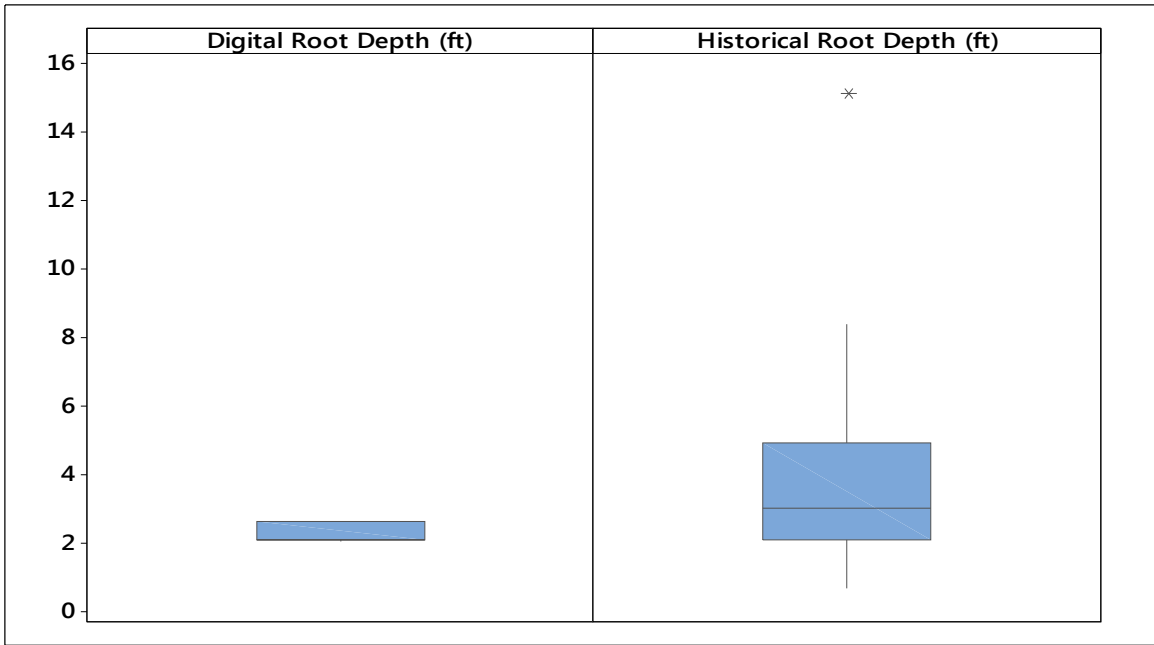
Figure 35: Boxplots of the root depth obtained digitally and the root depth obtained on-site using the development data set.

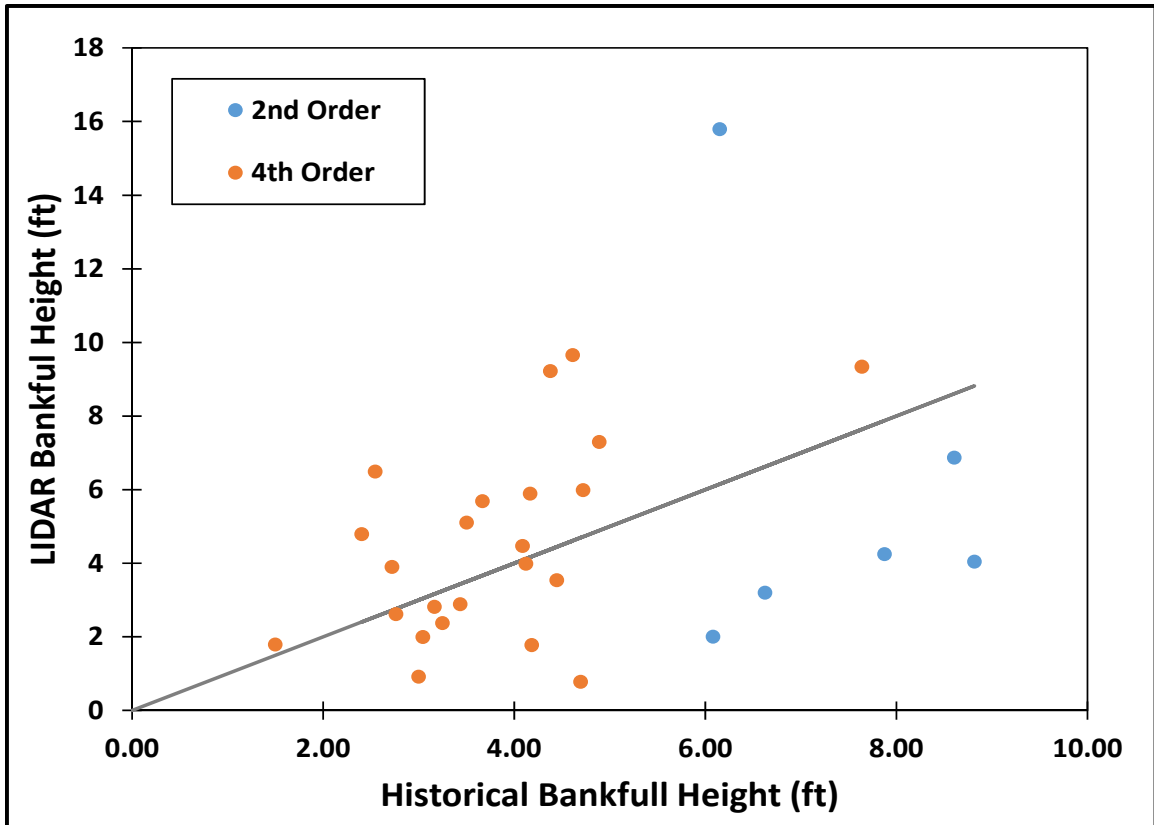
Figure 36: Comparison of bankfull height measured in LIDAR and on-site using the development data set.
