INCORPORATING DIGITAL DATA INTO RAPID  
GEOMORPHIC ASSESSMENTS

Submitted to the Faculty of the  
Graduate College of the  
Oklahoma State University  
in partial fulfillment of  
the requirements for  
the Degree of  
MASTER OF SCIENCE  
December, 2018

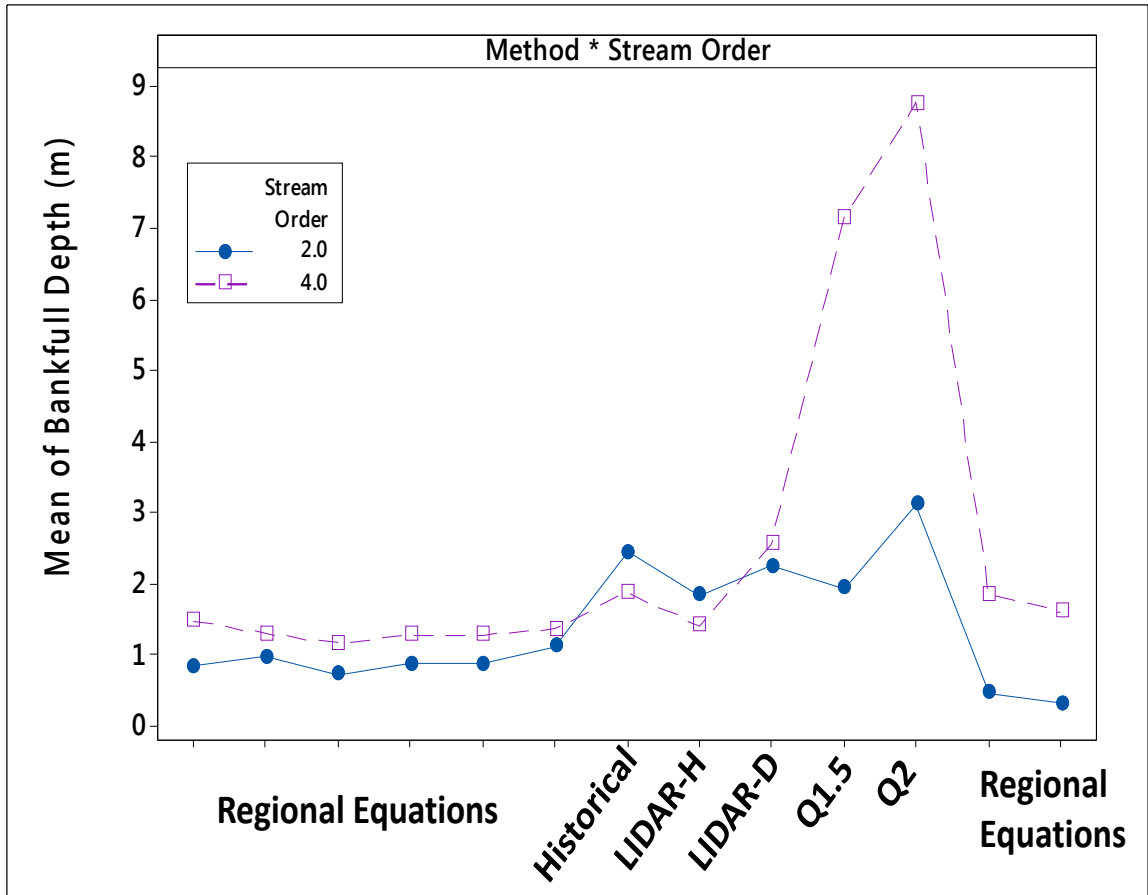
Figure 37: Interaction plot for the Two-Way Analysis of Variance (ANOVA) with Bankfull Depth as the response variable and Method and Stream Order as the treatment variables LIDAR-H refers to the bankfull height measured in LIDAR, LIDAR-D represents the bankfull height measured in LIDAR plus the baseflow depth measured using the LIDAR+StreamGage method.

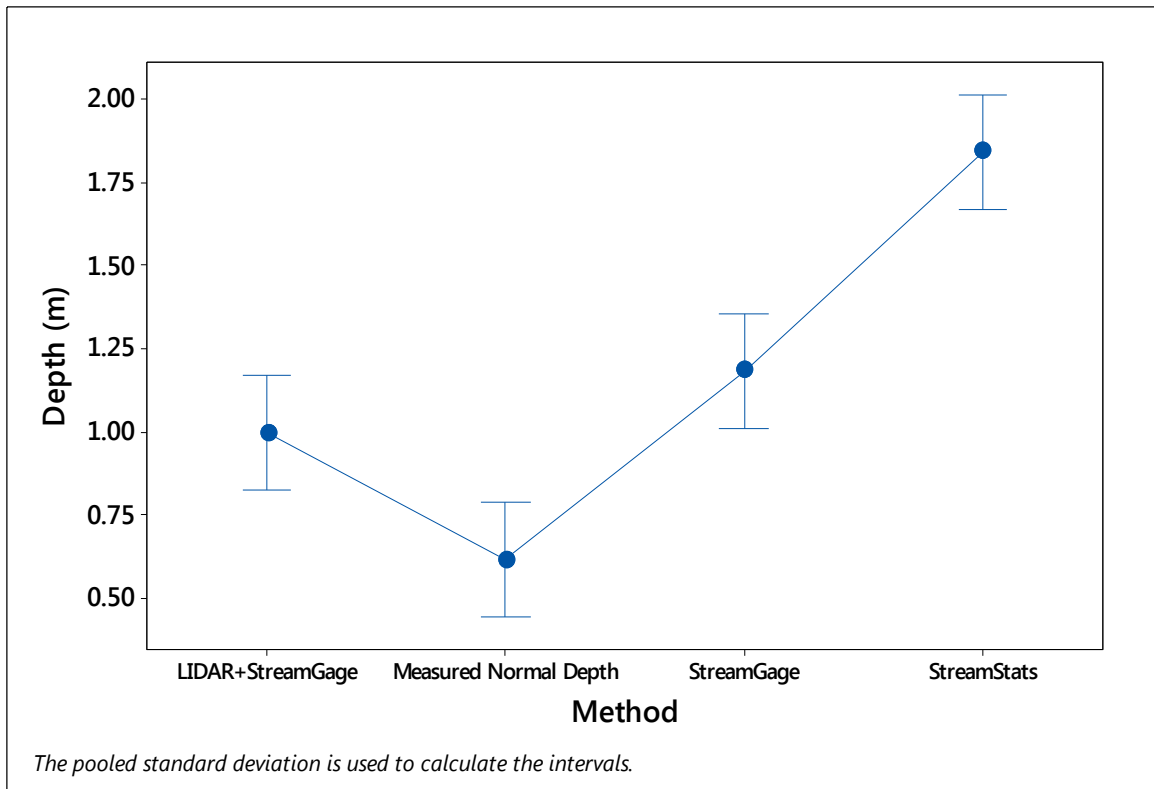
Figure 38: Interval plot comparison between baseflow depth measured on-site (historical), vs. various digital methods using the development data.

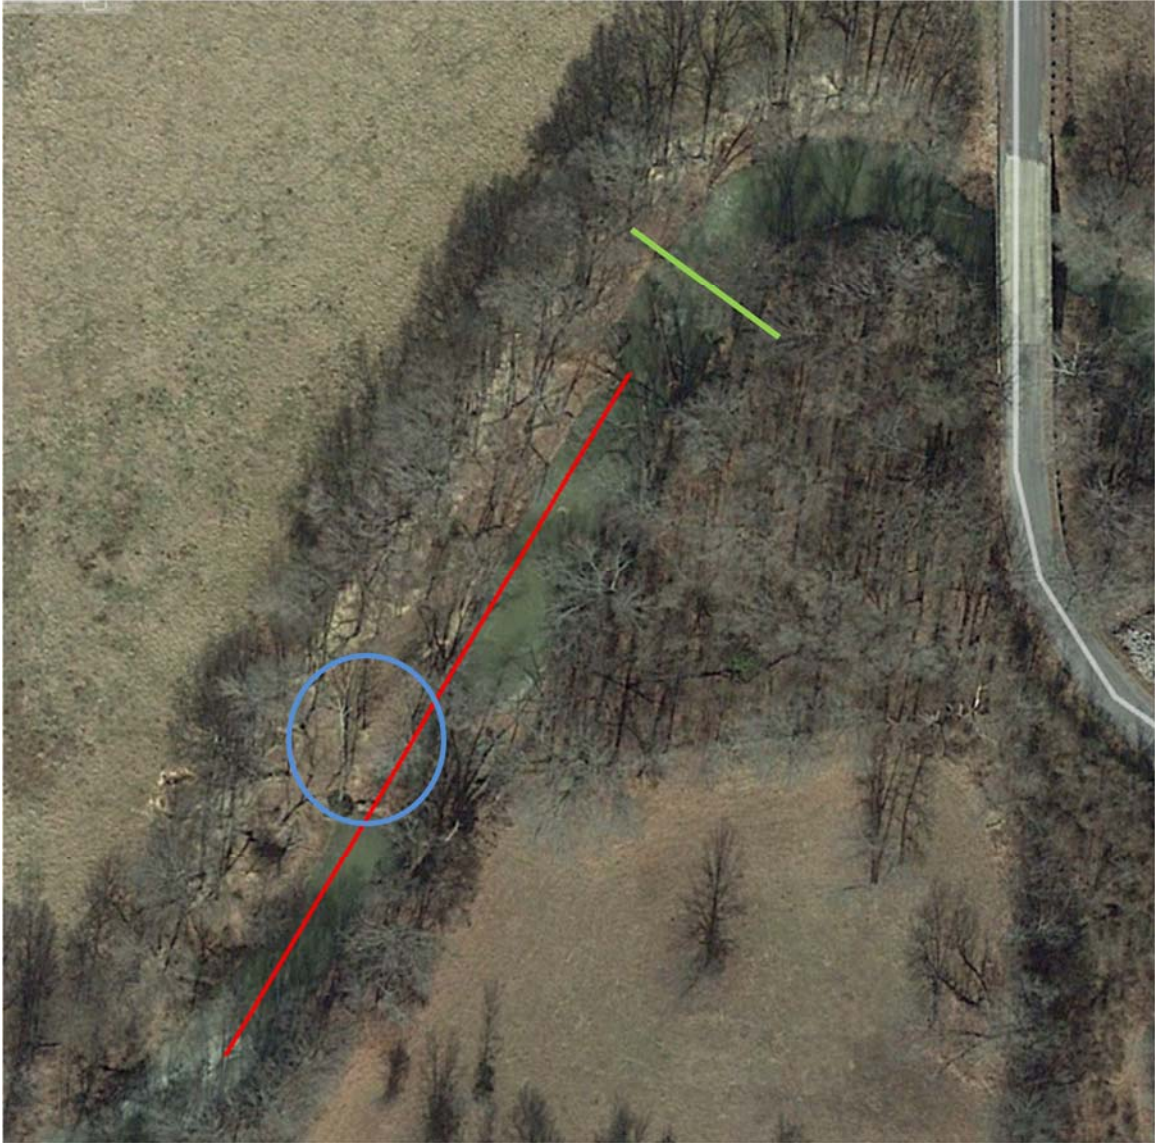
Figure 39: Validation Site\_Fourche Maline - Reach 1. Google Earth image taken 1/17/2018. The red line represents the original reach used in the digital assessment. The circle is highlighting where major slumping was apparent on-site. The green line represents where the on-site assessment was performed.

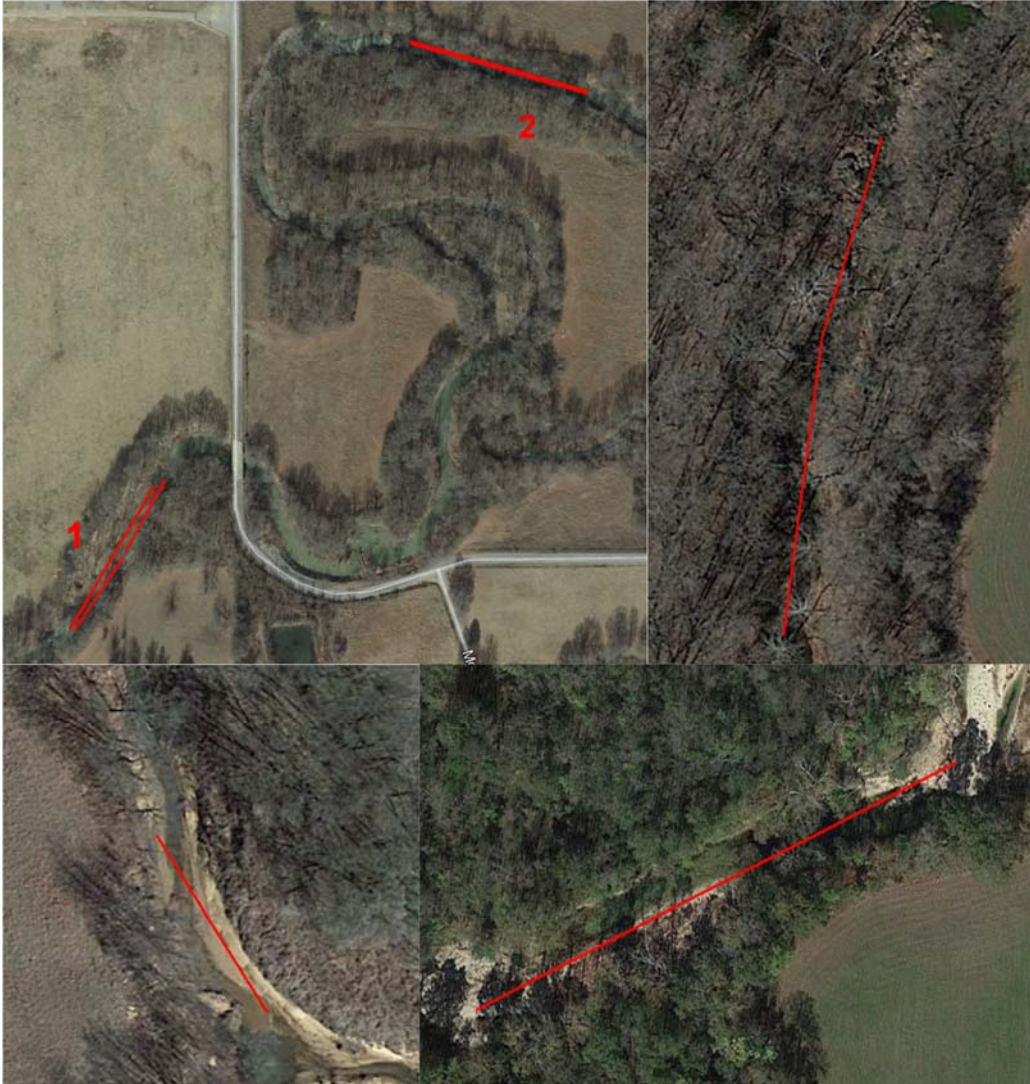
Figure 40: Google Earth images (various imagery dates) of all the validation reaches that failed the digital Channel Stability Index (CSI). Going clockwise starting in the top left corner: Fourche Maline, reach 1 & 2; Feather; Spring, reach 4; Sandy, reach 1. Note how these reaches are relatively straight.

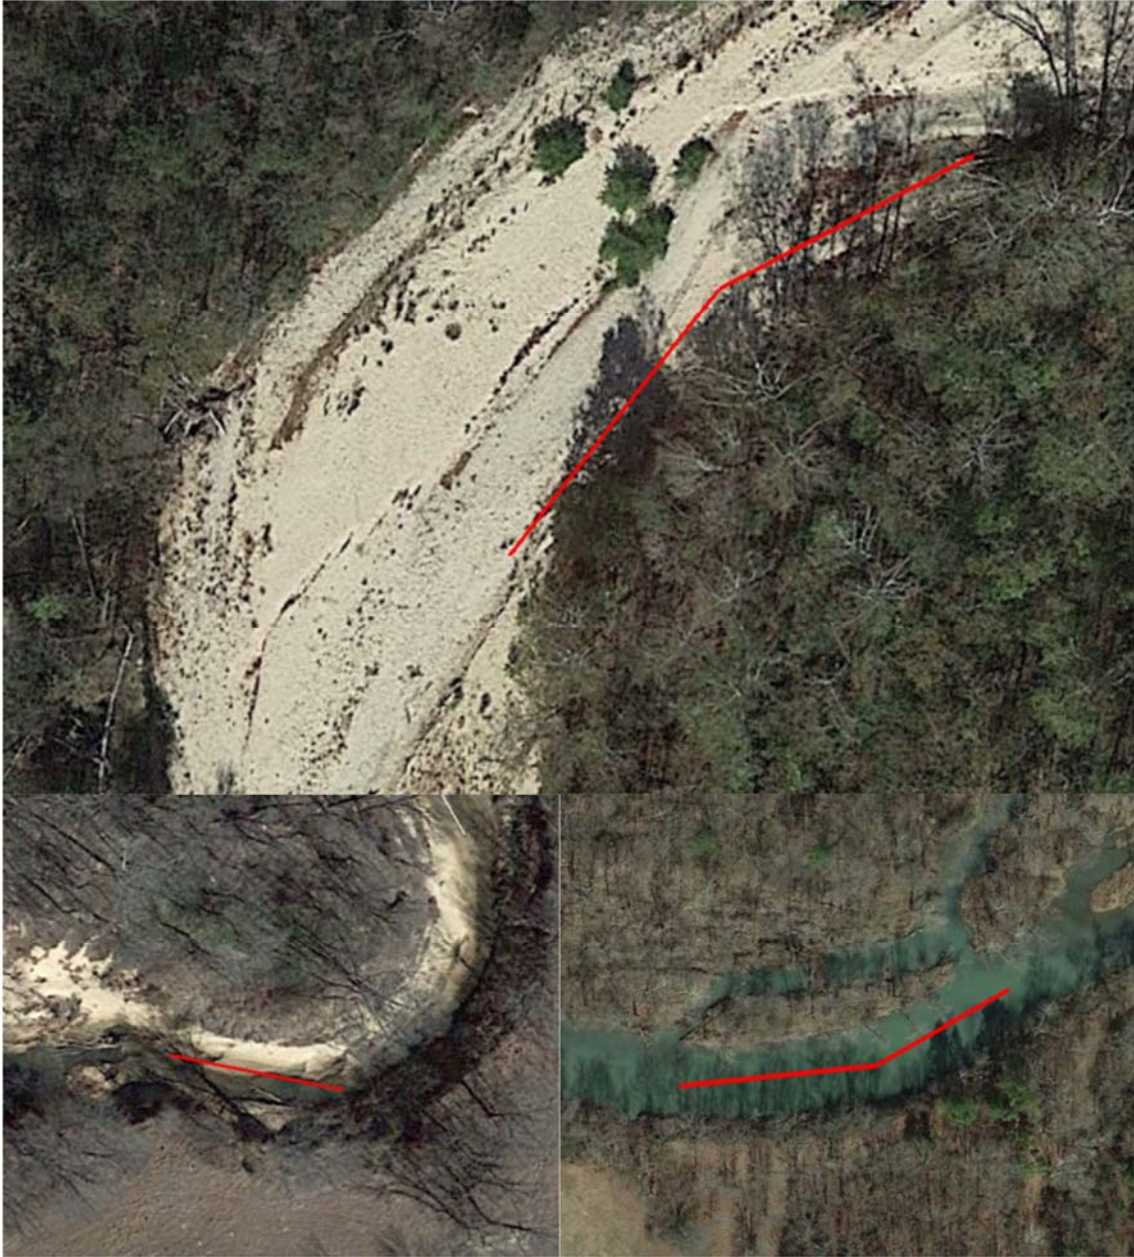
Figure 41: Google Earth images (various imagery dates) of the validation reaches which had a successful digital Channel Stability Index (CSI). Going clockwise and starting from the top: Spring reach 2, Black Fork reach 2, and Sandy reach 5. Note the clear meander present.

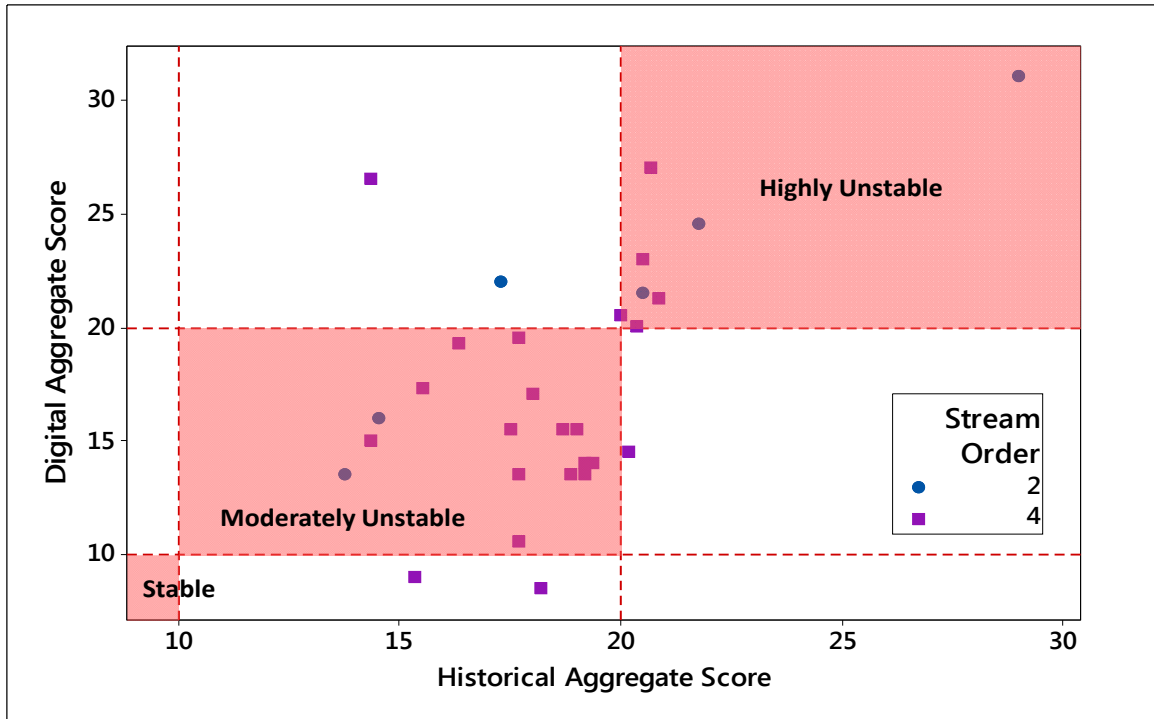
Figure 42: Development Channel Stability Index (CSI) comparing the historical vs the fully digital scores, separated by stream order. Any points that fall inside the shaded box are counted as successful.

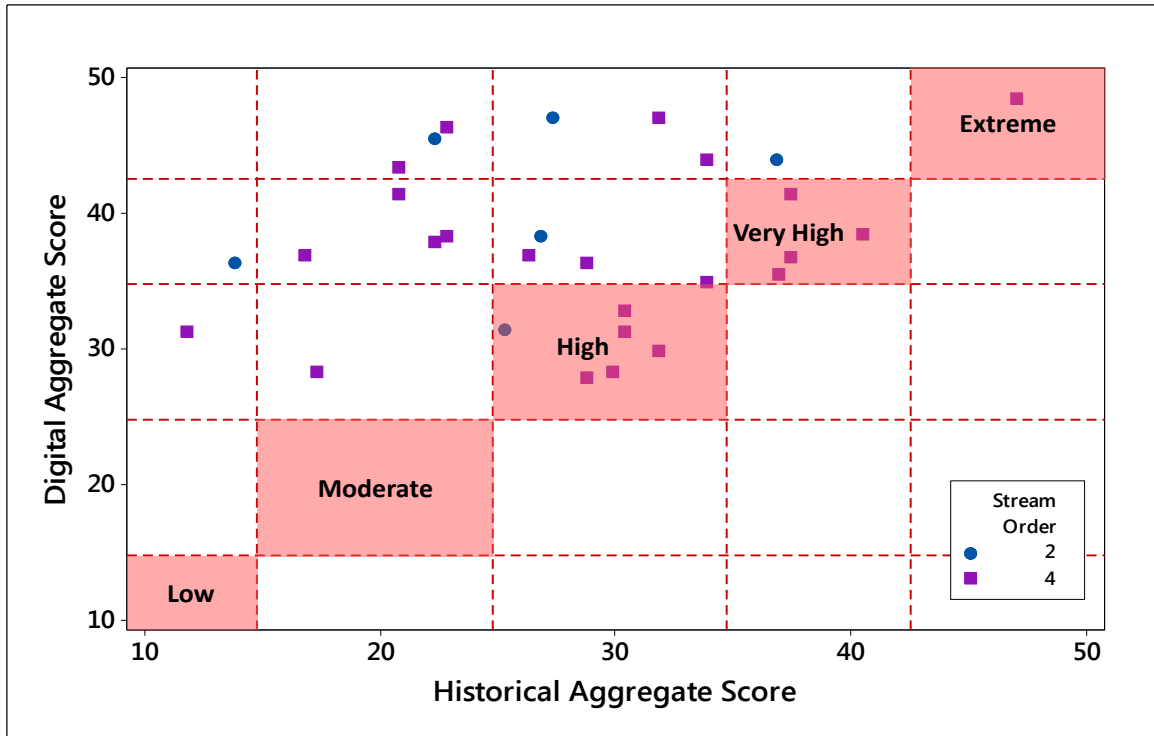
Figure 44: Validation Bank Erosion Hazard Index (BEHI) comparing the on-site vs the fully digital scores, separated by stream order. Any points that fall inside the shaded box are counted as successful.

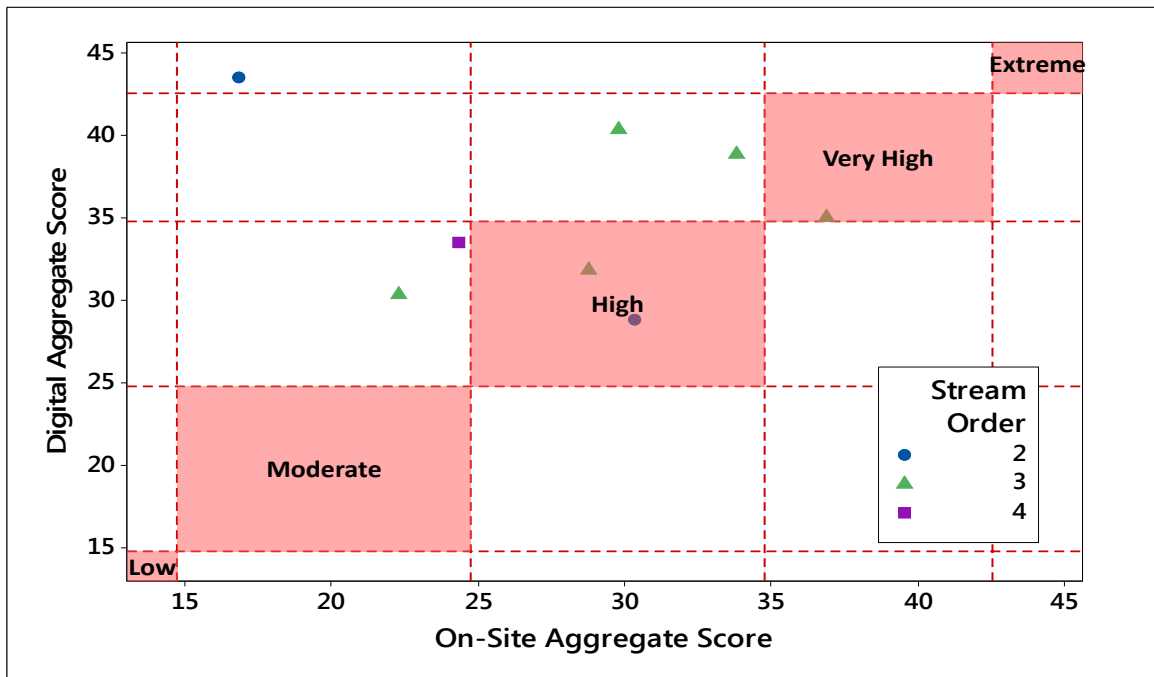
Figure 45: Validation Bank Erosion Hazard Index (BEHI) comparing the on-site vs the fully digital scores, separated by stream order. Any points that fall inside the shaded box are counted as successful.

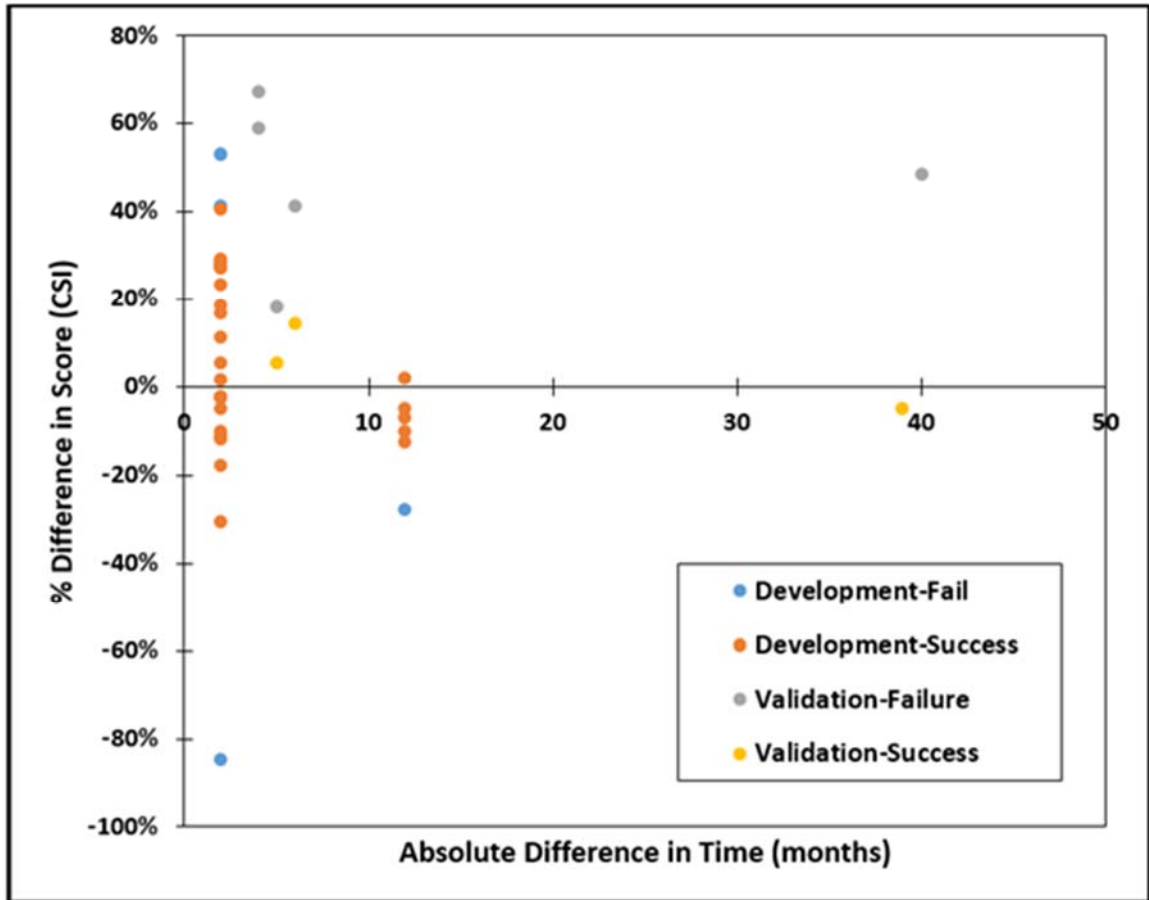
Figure 46: The absolute difference in time between the Google Earth imagery used and the on-site assessment, plotted against the resulting percent difference between the digital Channel Stability Index (CSI) and on-site score. Both development and validation stage data was used.

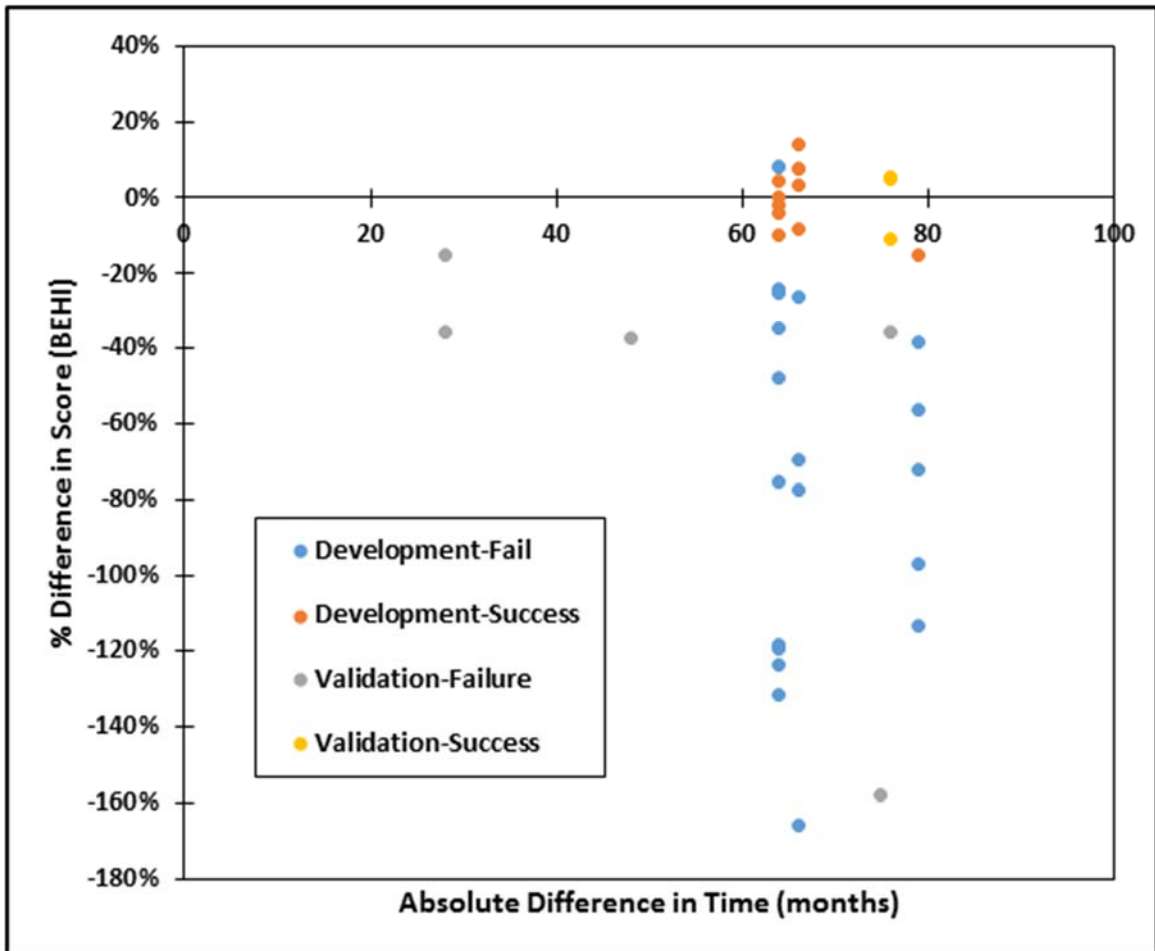
Figure 47: The absolute difference in time between the LIDAR collection date used and the on-site assessment, plotted against the resulting percentage difference between the digital Bank Erosion Hazard Index (BEHI) and on-site score. Both development and validation stage data was used.

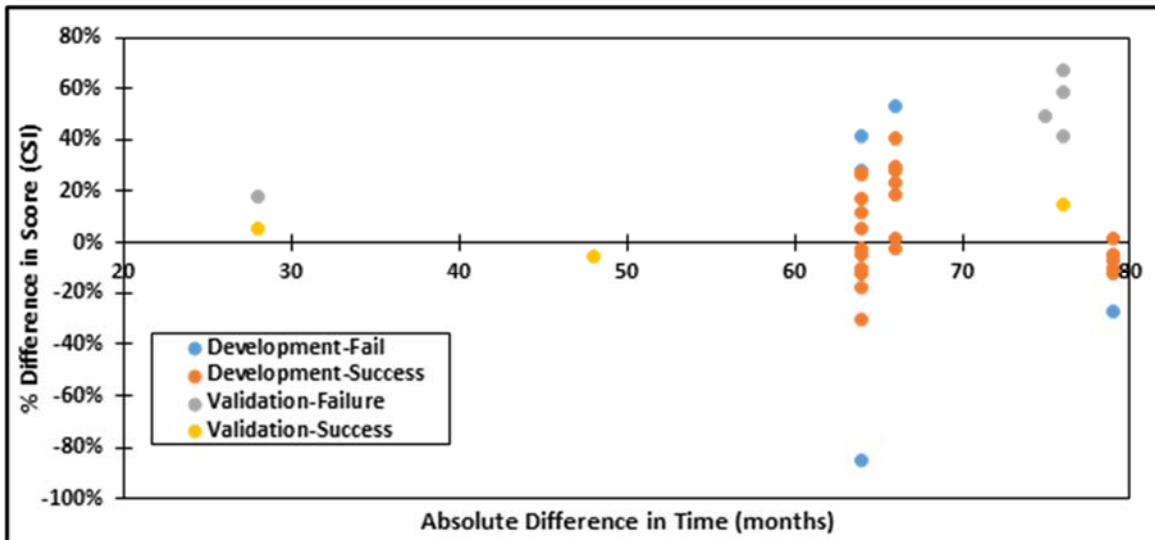
Figure 48: The absolute difference in time between the LIDAR collection date used and the on-site assessment, plotted against the resulting percent difference between the digital Channel Stability Index (CSI) and on-site score. Both development and validation stage data was used.

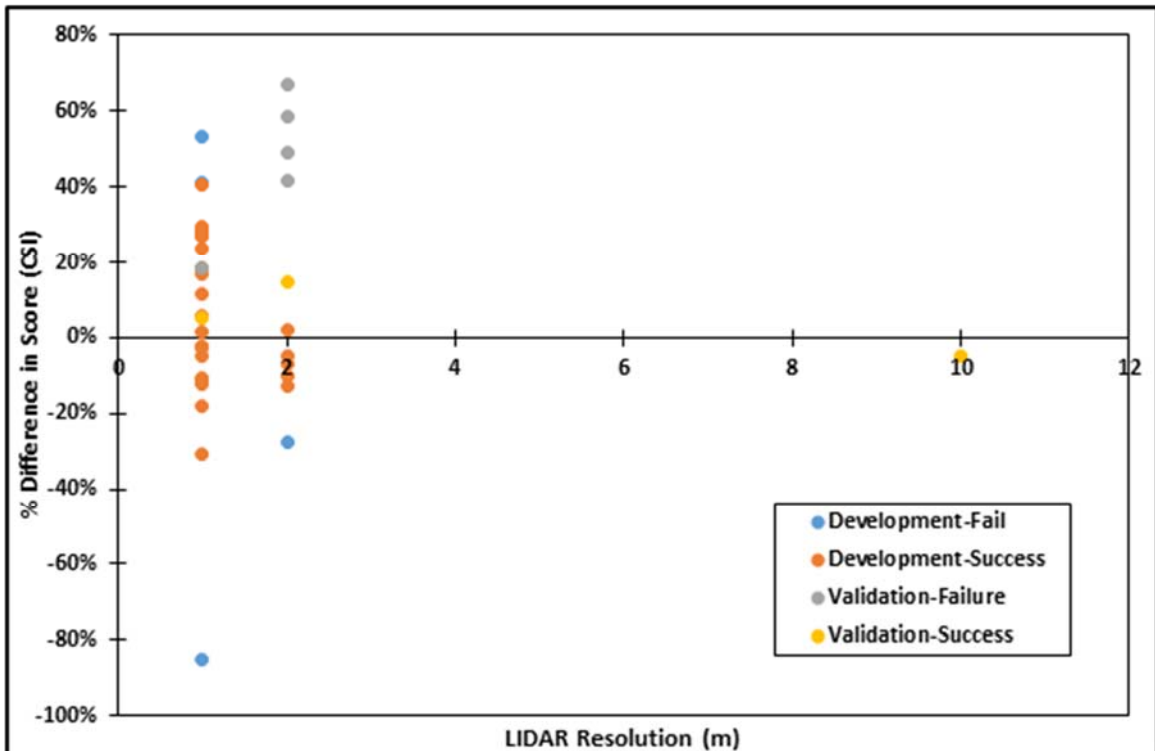
Figure 49: LIDAR resolution used vs. the resulting percent difference between the digital and on-site Channel Stability Index (CSI) on-site score. Both development and validation stage data was used.

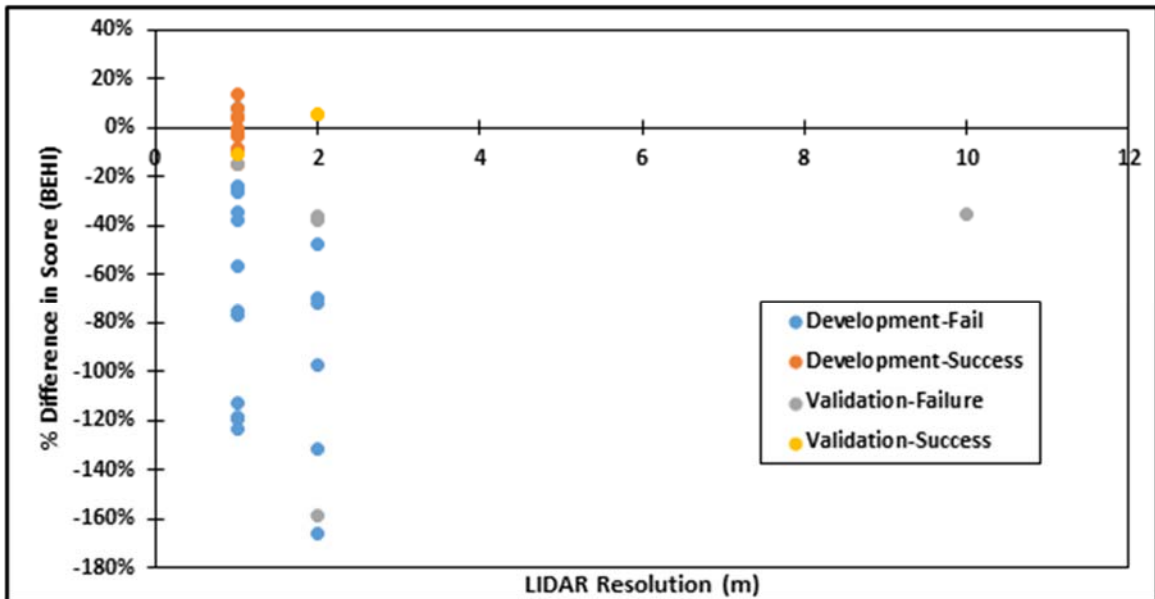
Figure 50: LIDAR resolution used vs. the resulting percent difference between the digital and on-site Bank Erosion Hazard Index score. Both development and validation stage data was used.

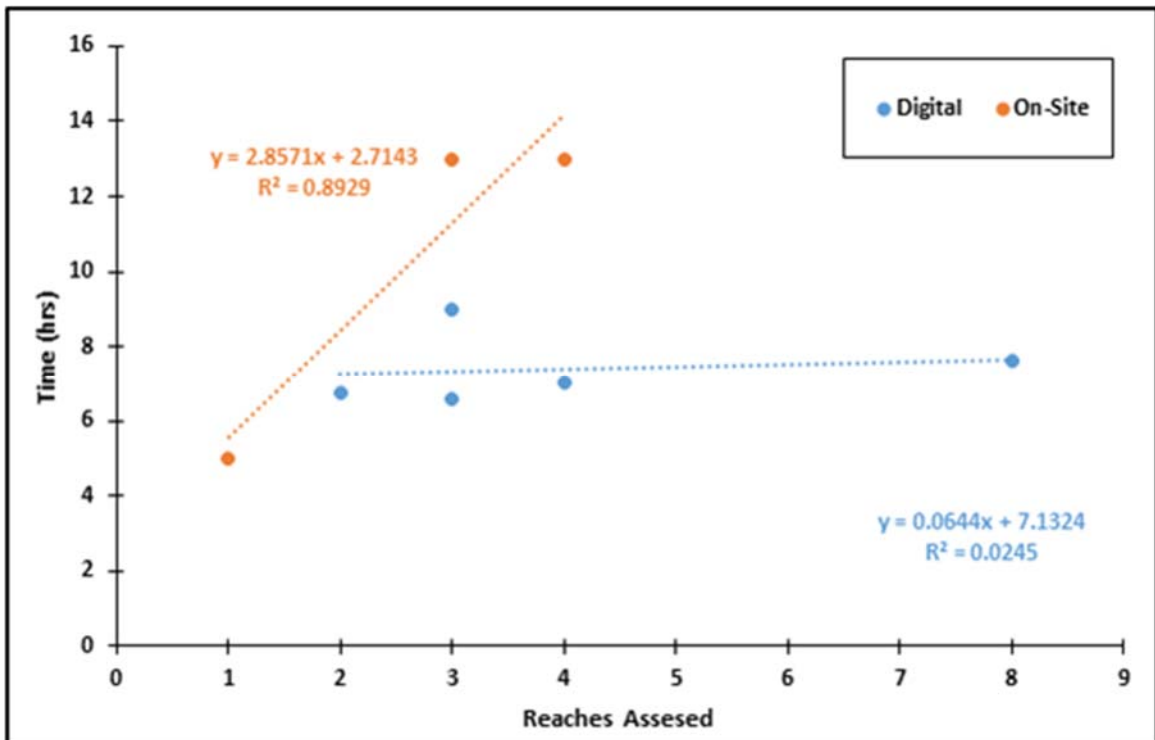
Figure 51: Comparison between the amount of time needed vs the number of validation reaches assessed for the on-site and digital methods.

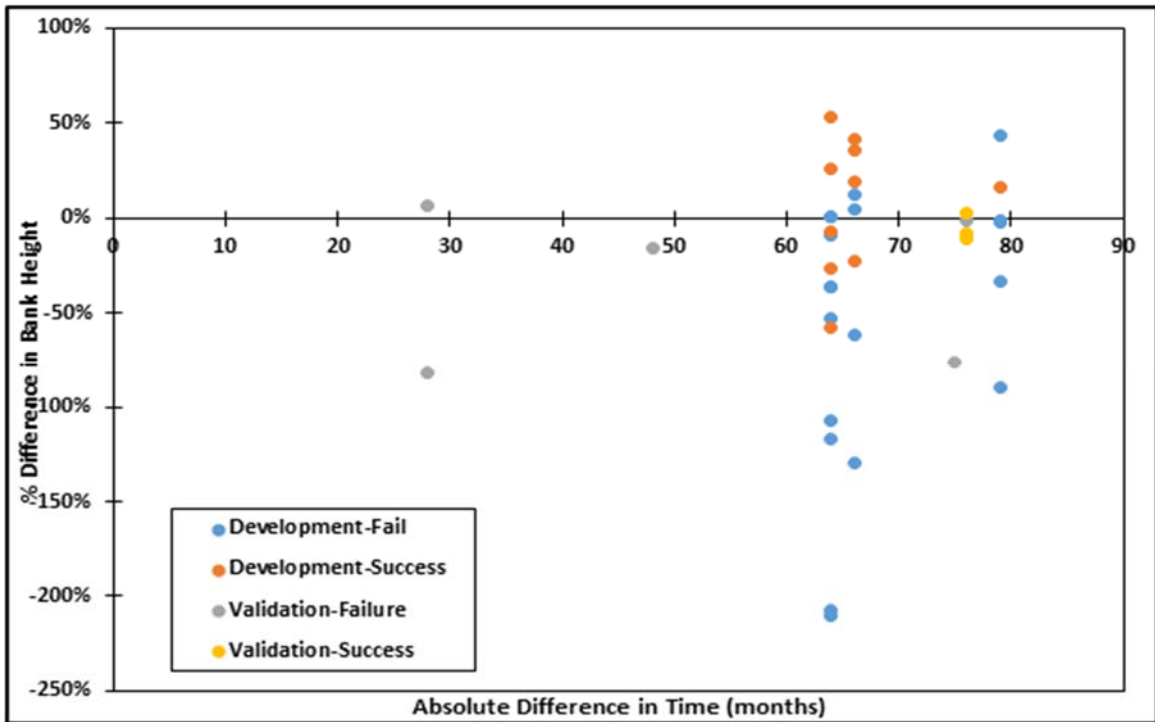
Figure A - 5: The percent difference in bank height when using digital or on-site measurements, graphed against the absolute difference between the times when each was collected.

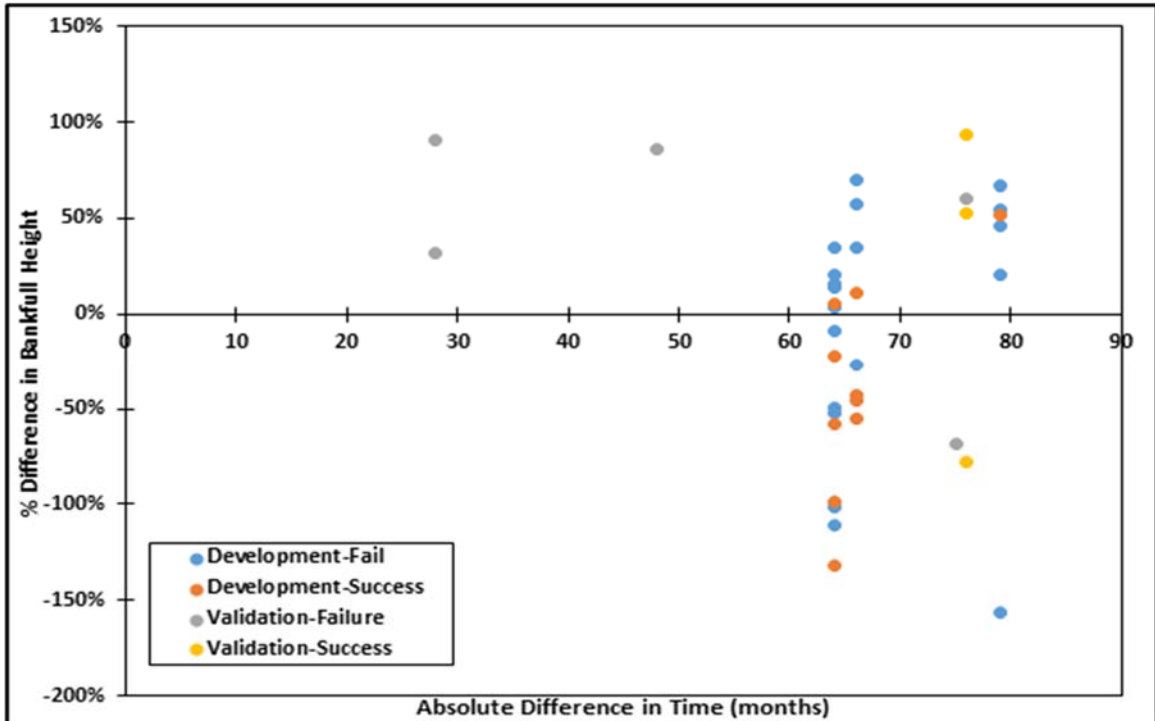
Figure A - 6: The percent difference in bankfull height when using digital or on-site measurements, graphed against the absolute difference between the times when each was collected.

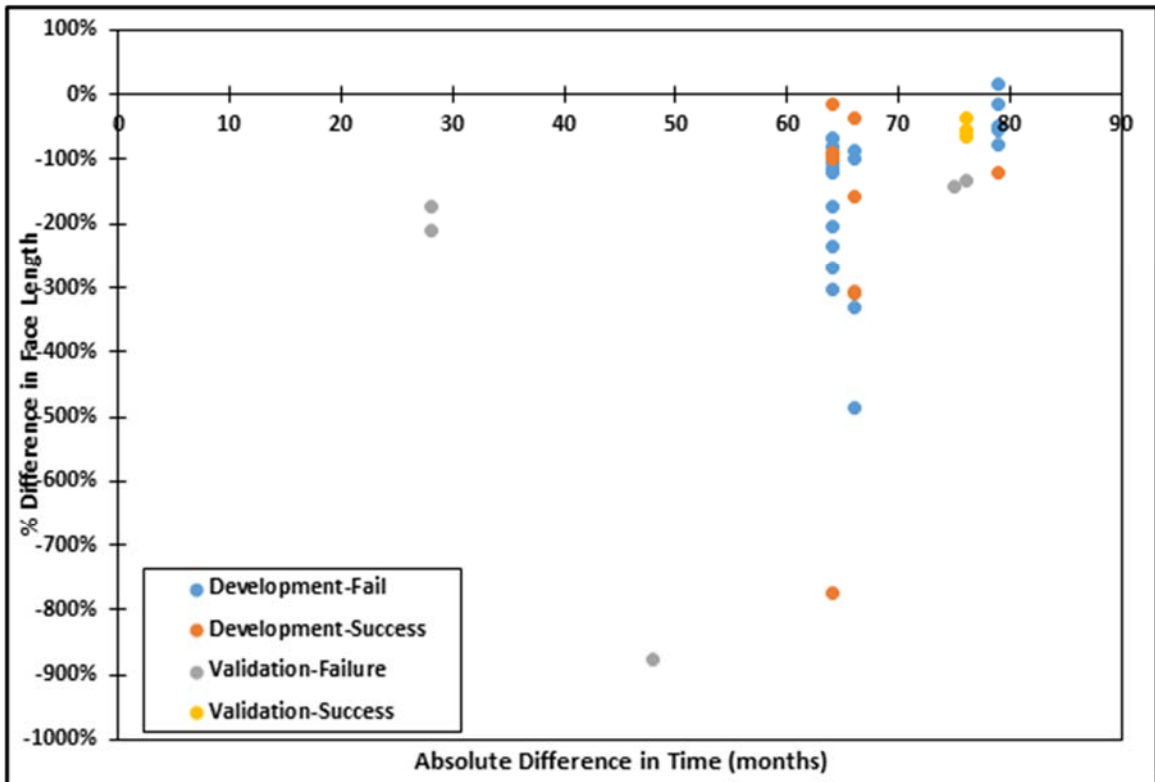
Figure A - 7: The percent difference in face length when using digital or on-site measurements, graphed against the absolute difference between the times when each was collected.

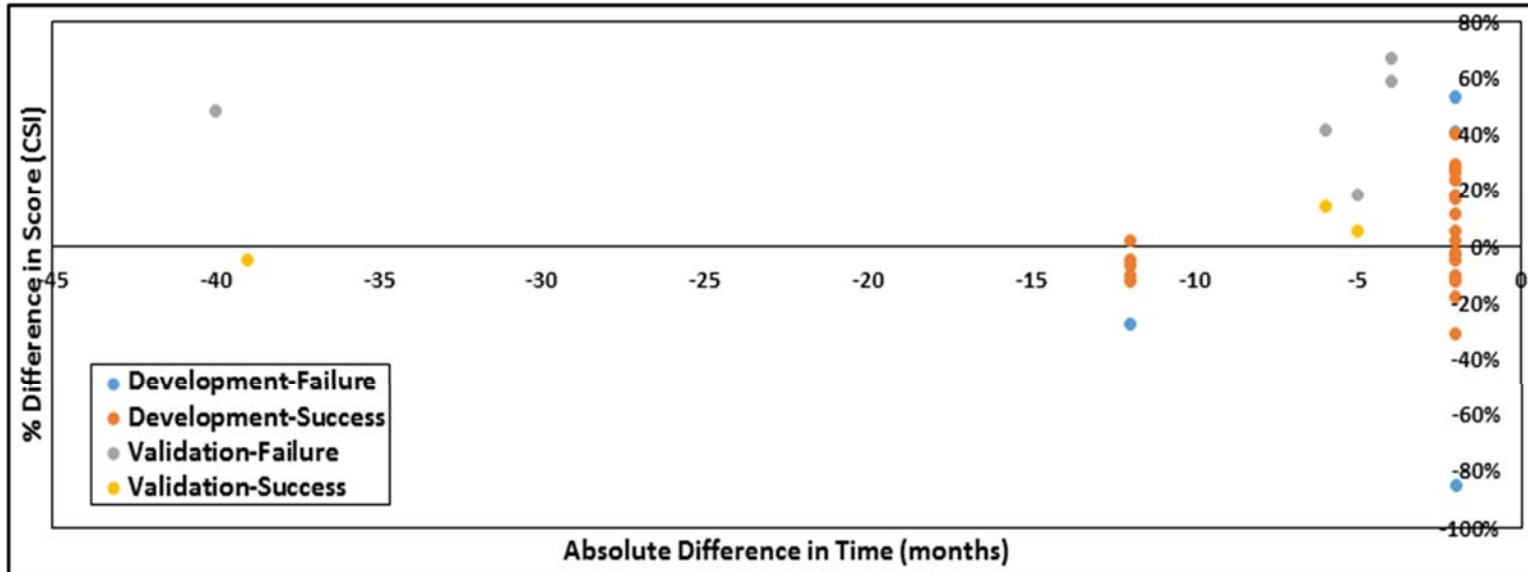
Figure A - 9: Percent difference in score versus the difference in time when the Google Earth imagery and the on-site assessments were collected.
