UNIVERSITY OF OKLAHOMA
GRADUATE COLLEGE

PERFORMANCE OF MULTI-HAZARD-RESISTANT HOLLOW-CORE
FRP-CONCRETE-STEEL COLUMNS WITH HIGH-STRENGTH SCC OR UHPC

A THESIS
SUBMITTED TO THE GRADUATE FACULTY
in partial fulfillment of the requirements for the
Degree of
MASTER OF SCIENCE

By
JACKSON C. MILNER
Norman, Oklahoma
2023

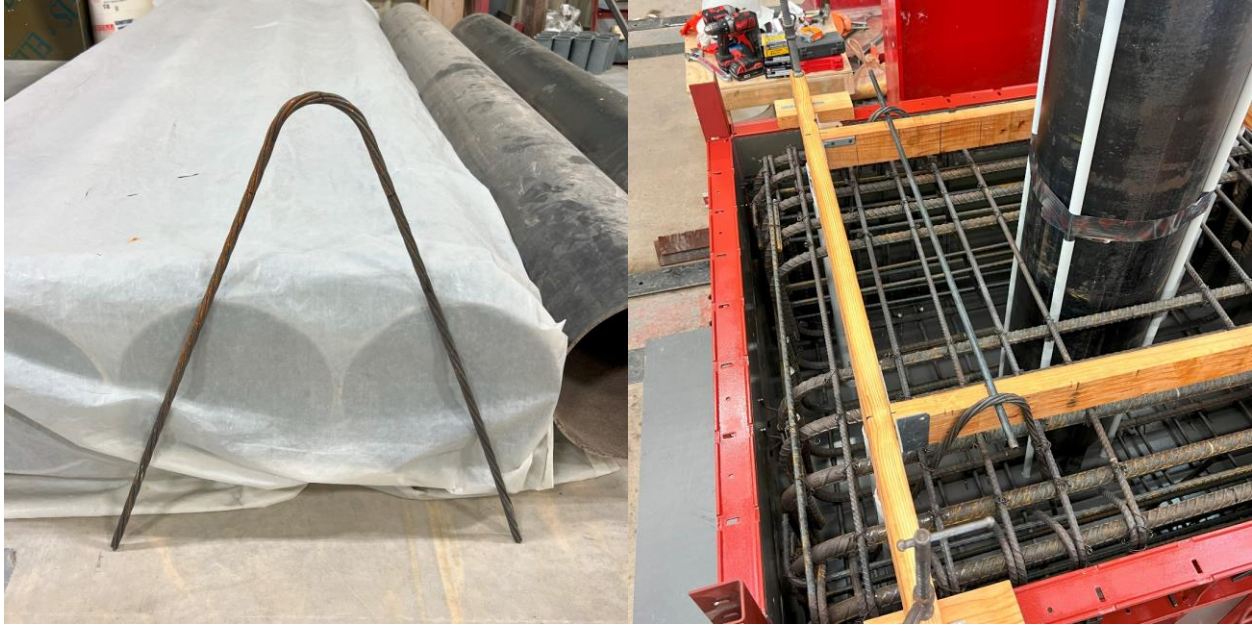
Figure 4-8: Prestressing Strand Lifting Loop, Standard Shape (l) and Typical Location (r)

Prestressing strand loops were implemented to lift and move the column specimens due to commonly being used at precast facilities. The prestressing strand offers high strength and ductility and is also an available waste material around Fears Lab. The strand lifting loops were based on recommendations from the PCI Design Handbook and a PCI Journal: *Industry survey results on the use of prestressing strand lifting loops* (2020). The capacity of each lifting loop was taken as 8 kips based on the recommended capacities for a 0.5-inch diameter strand. However, a 0.5-inch special strand with a larger cross-sectional area was used and therefore had a higher capacity than estimated. The strand lifting loops required a minimum embedment of 24 inches and were extended approximately 6 inches beyond the top of the concrete. The bending radius was approximately 6 inches in an inverted V shape and the ends of the loops were at least 3 inches from the bottom of the formwork. The typical lifting loop and location are shown in Figure 4-8. Four prestressing strand lifting loops were used with one loop in each corner of the concrete base for balance. This resulted in a lifting capacity of 32 kips.

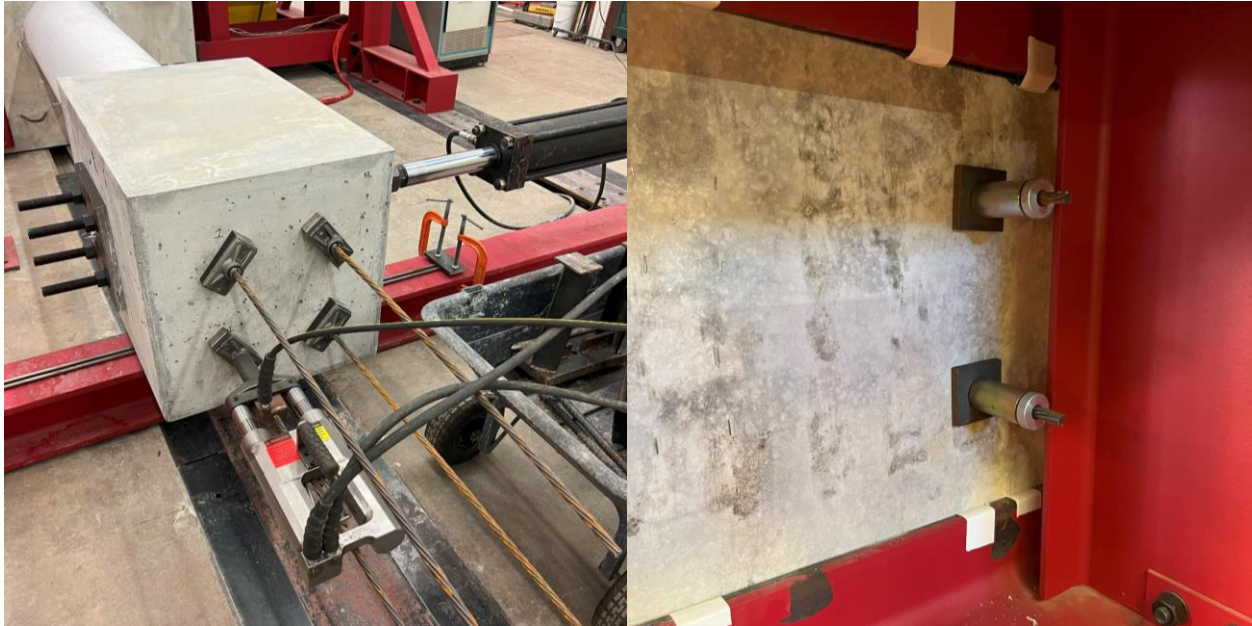
Figure 4-41: Constant Axial Load Application Utilizing Post-Tensioning

post-tensioning was removed in the same order after testing. Large concrete blocks were placed at either end of the column specimen to protect against potential strand failure and deflect any fractured strands. Both anchorage systems are shown below in Figure 4-41.

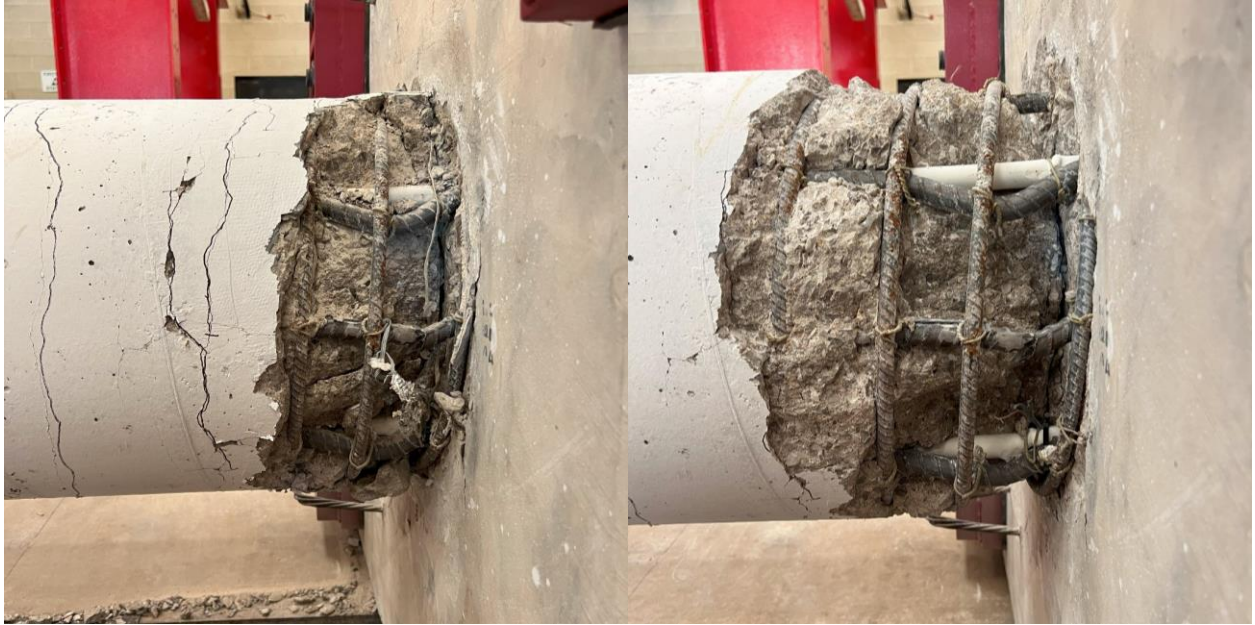
Figure 5-7: RC Column West Side After Testing (l) and Removal of Loose Concrete (r)

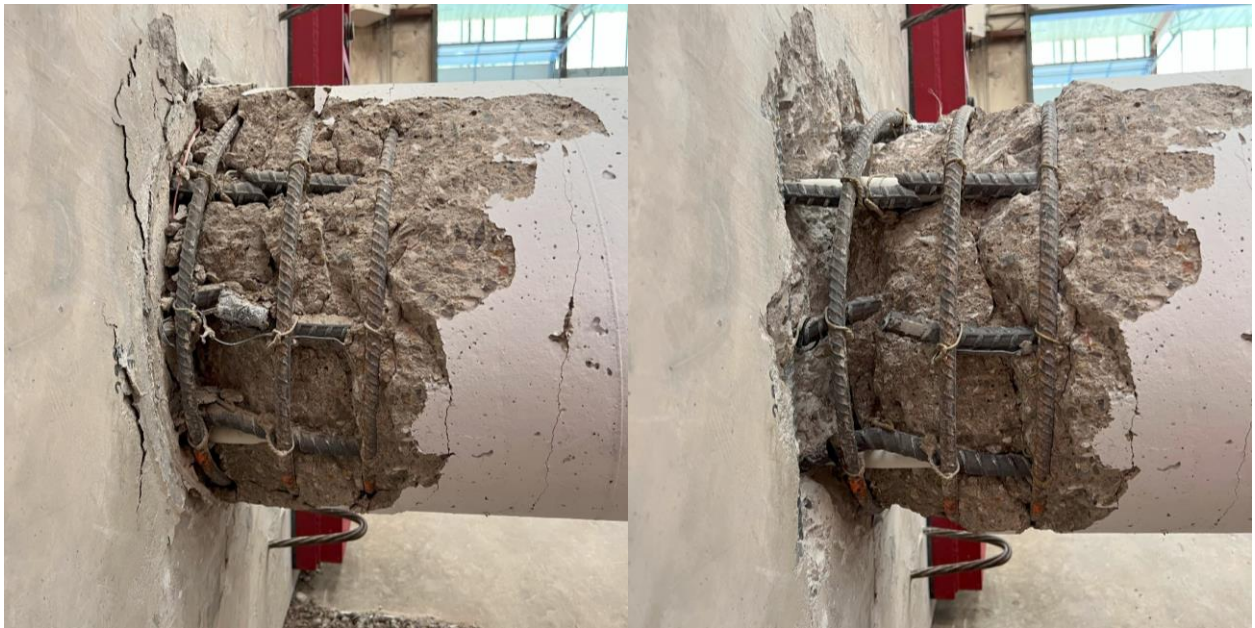
Figure 5-8: RC Column East Side After Testing (l) and Removal of Loose Concrete (r)

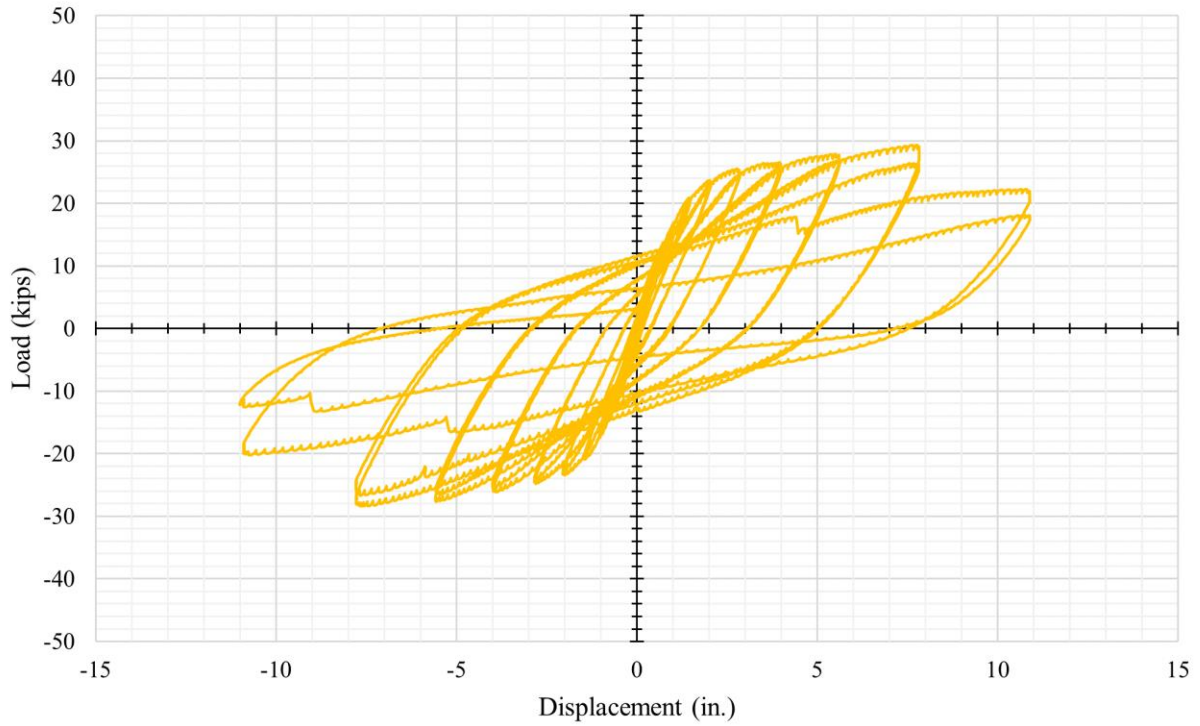
Figure 5-9: RC Column Lateral Load vs. Displacement at Column Head

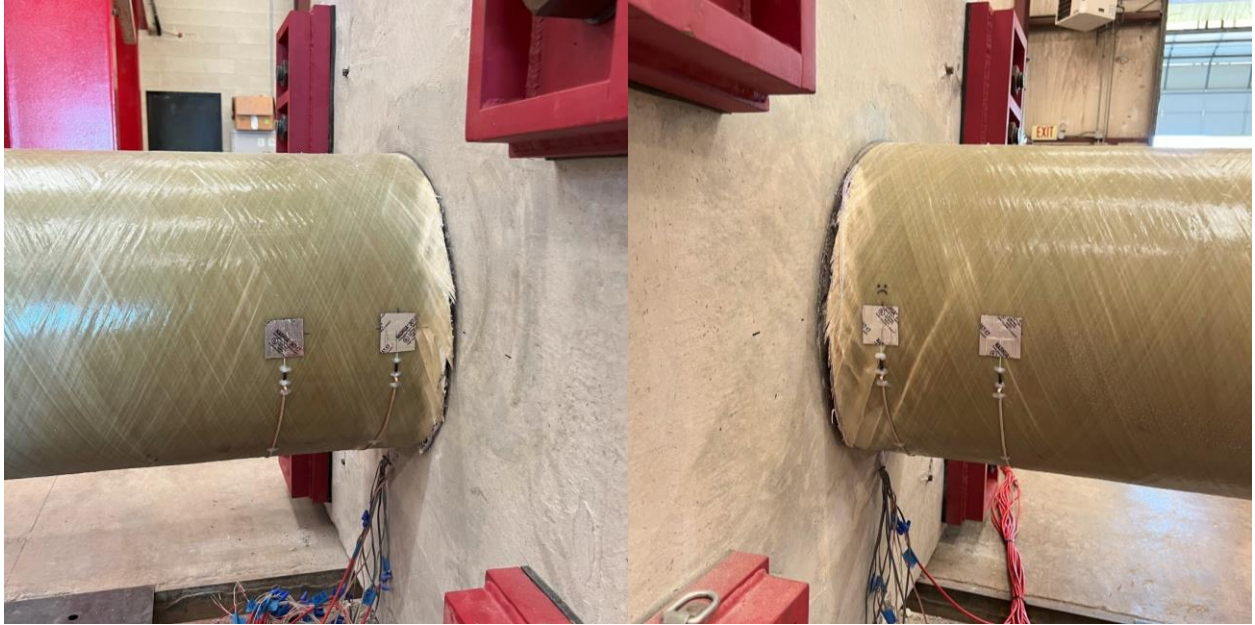
Figure 5-23: HS-SCC 2 GFRP Tube West Side (l) and East Side (r) Damage After Testing

After testing, the lower 15 inches of the GFRP tube was sectioned off, split in half, and removed from the column to reveal the concrete core underneath as shown in Figure 5-24. Next, loose portions of the concrete core were removed so that the damage to the steel tube could be observed. The steel tube was found to have buckled along the extreme fibers of both sides of the column and minor fracturing on both sides. Figure 5-25 illustrates the steel tube damage after concrete removal.

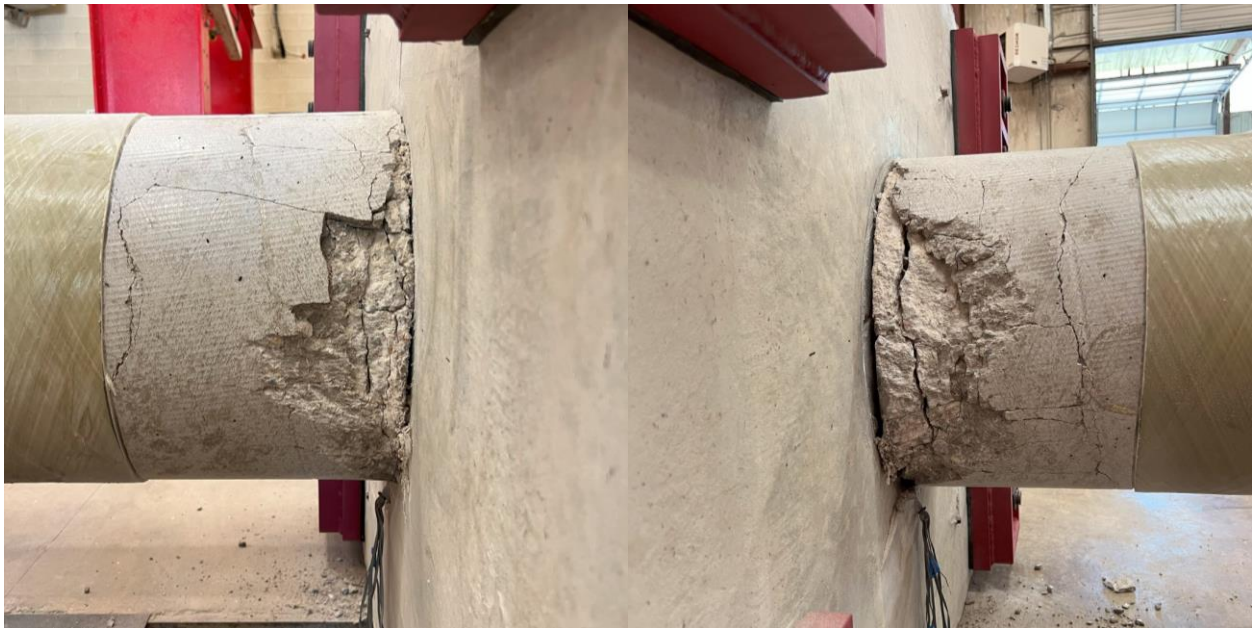
Figure 5-24: HS-SCC 2 Concrete Core After Testing and Light Removal of Concrete

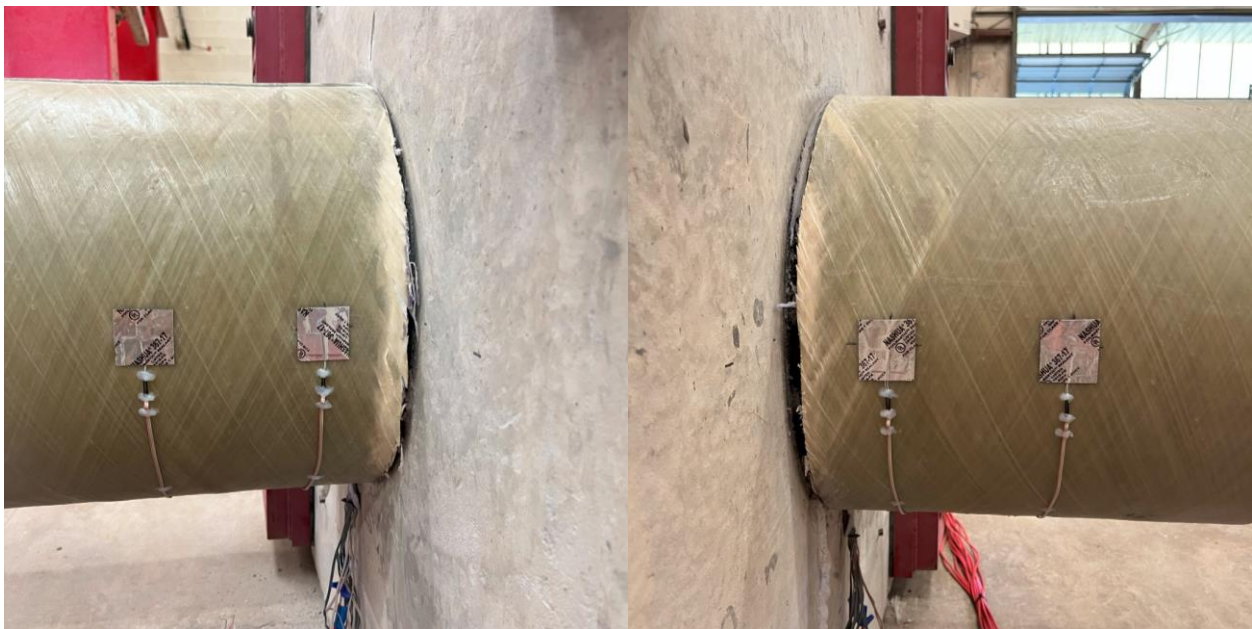
Figure 5-41: UHPC 2 GFRP Tube West Side (l) and East Side (r) Damage After Testing

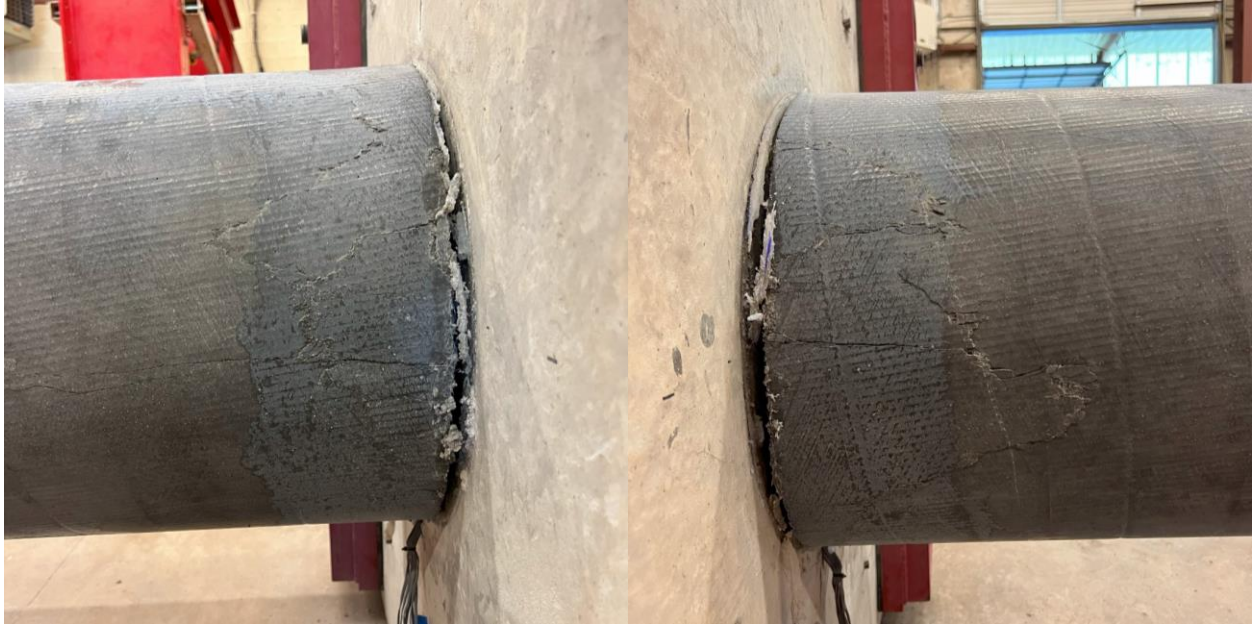
Figure 5-42: UHPC 2 Concrete Core West Side (l) and East Side (r) After Testing

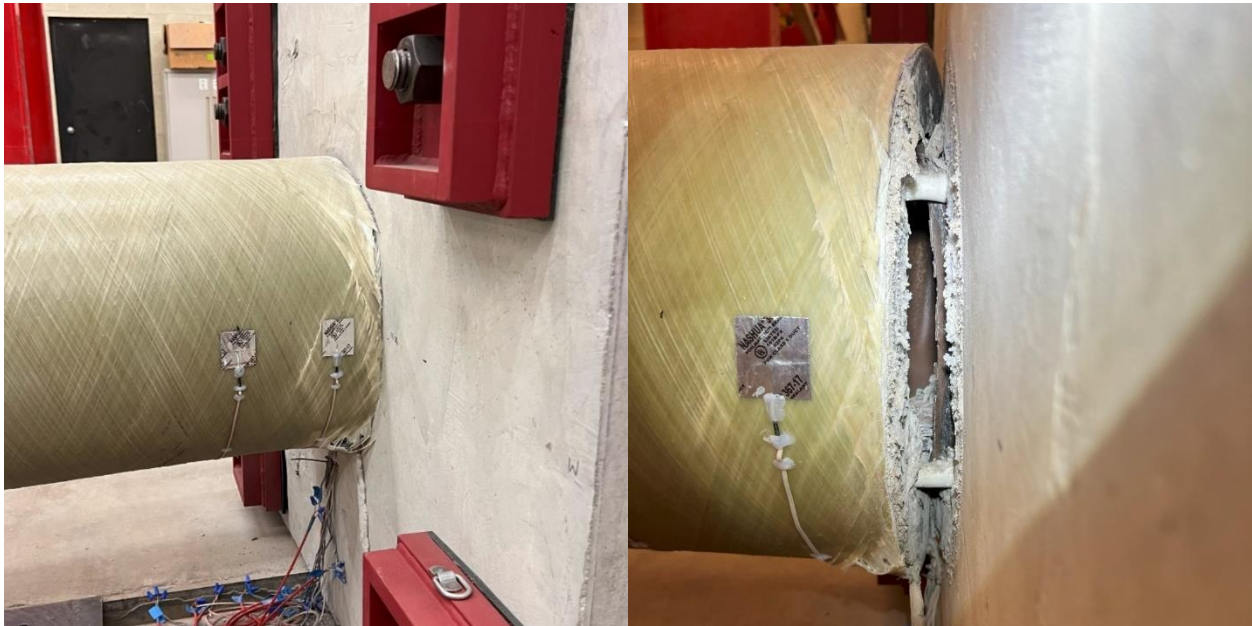
Figure 6-12: HS-SCC 1 GFRP Tube Compression (l) and Fractured Steel Tube (r) During Testing

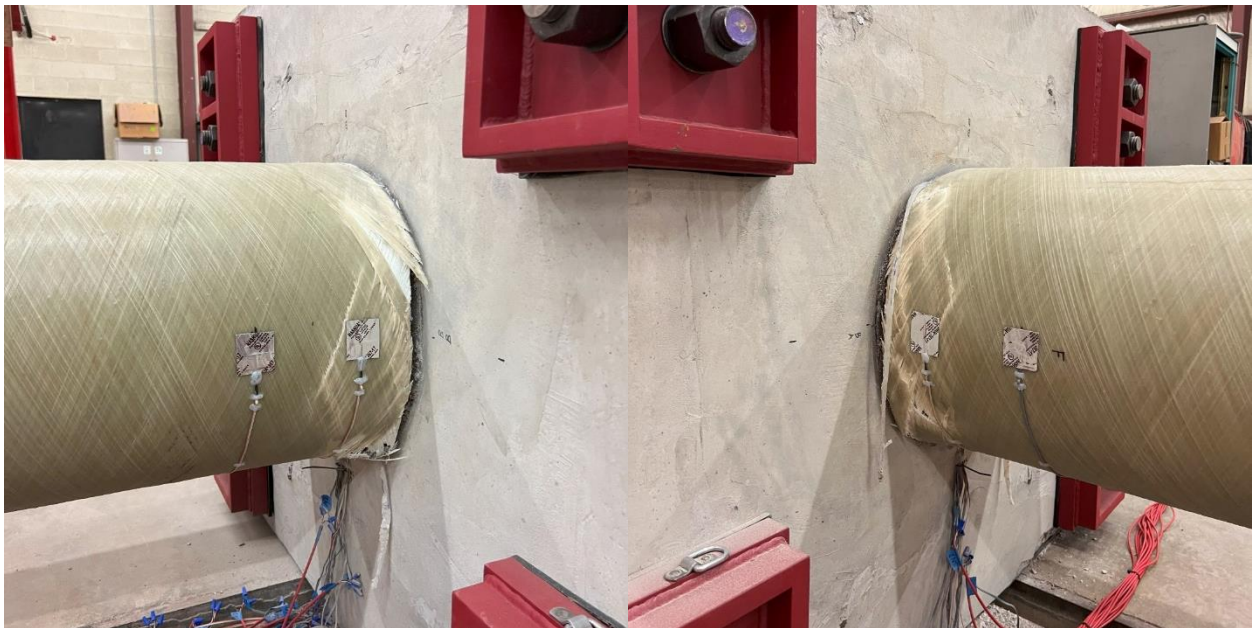
Figure 6-13: HS-SCC 1 GFRP Tube West Side (l) and East Side (r) Damage After Testing

roughly triangular with the most severe damage along the extreme fiber. The concrete core was no longer bonded to the steel tube after testing and was easily removed.

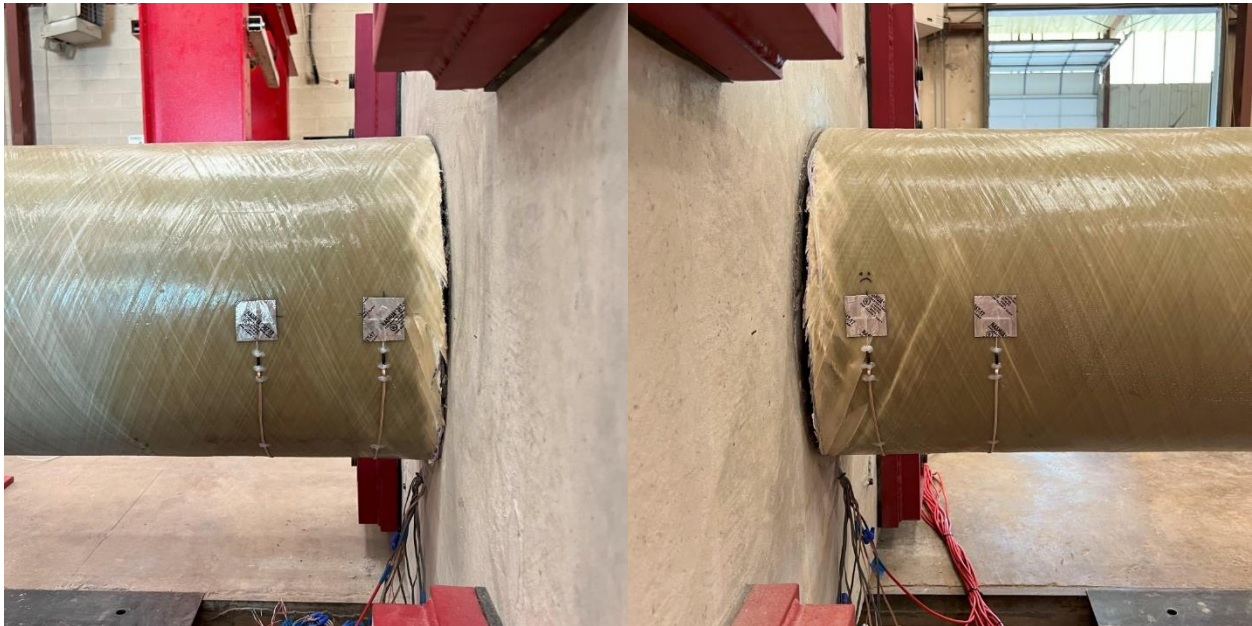
Figure 6-25: HS-SCC 2 GFRP Tube West Side (l) and East Side (r) Damage After Testing

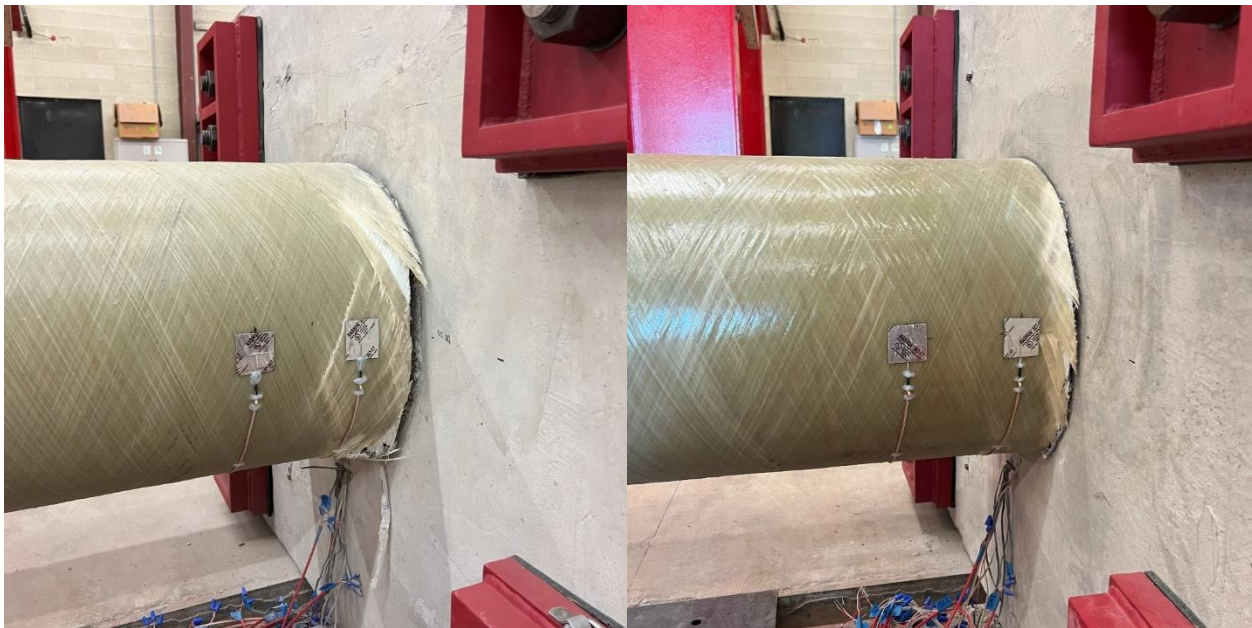
Figure 6-32: Comparing HS-SCC 1 (l) and HS-SCC 2 (r) GFRP Tube Damage After Testing

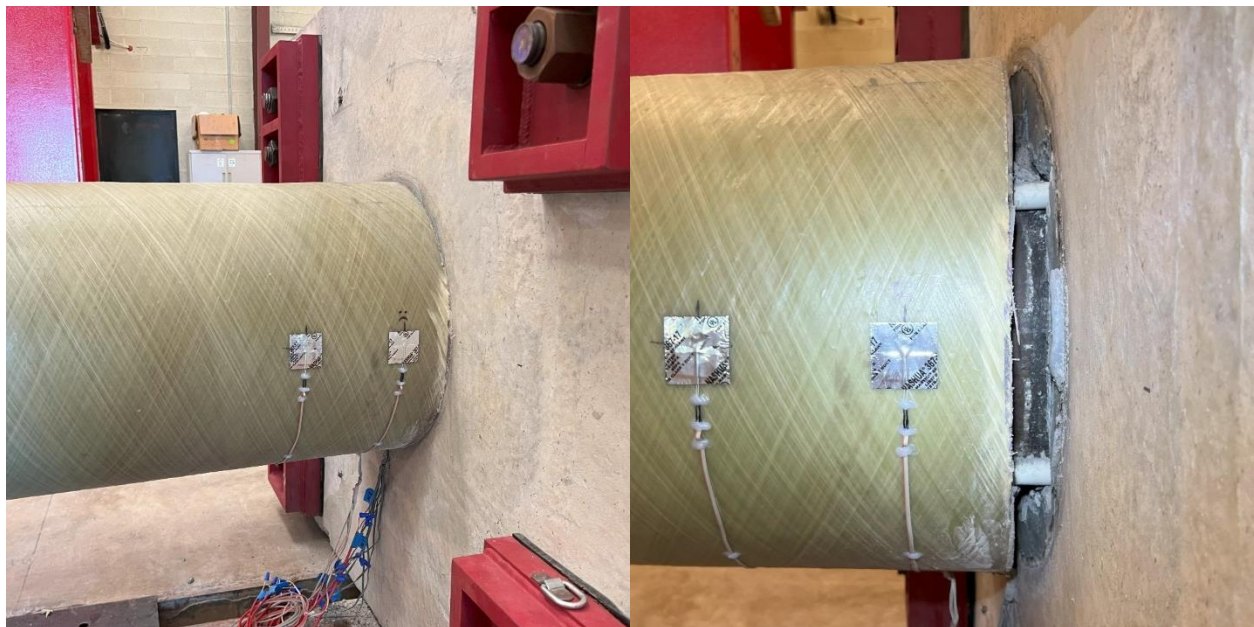
Figure 7-10: UHPC 1 GFRP Tube Compression (l) and Separation (r) During Testing

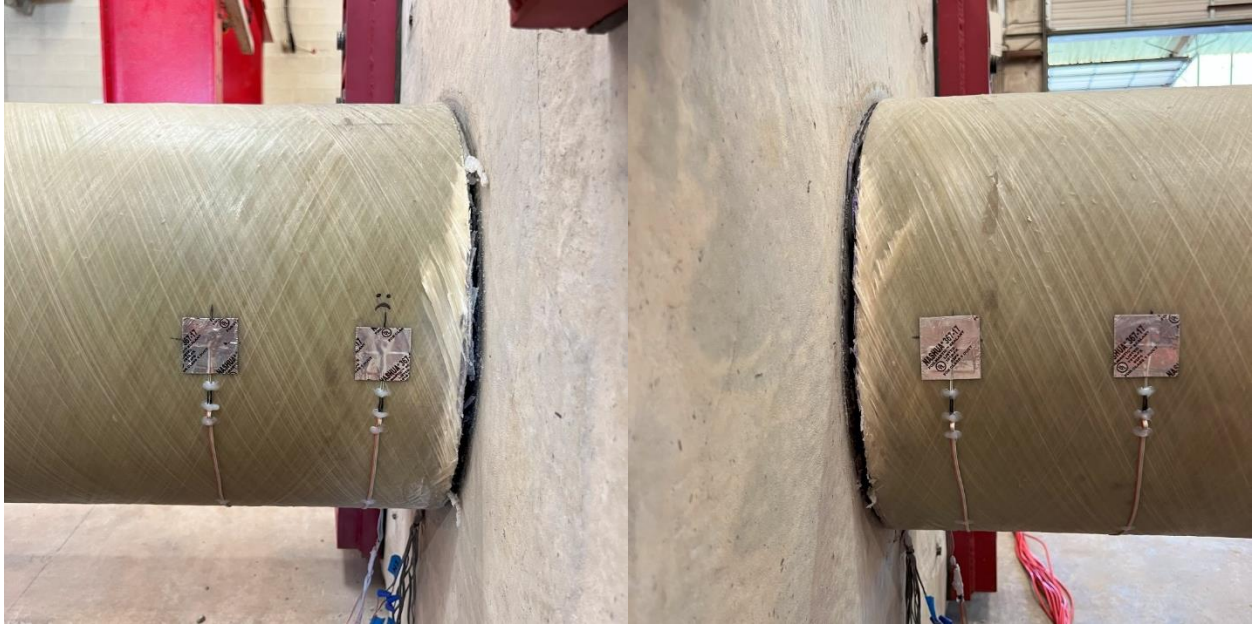
Figure 7-11: UHPC 1 GFRP Tube West Side (l) and East Side (r) Damage After Testing

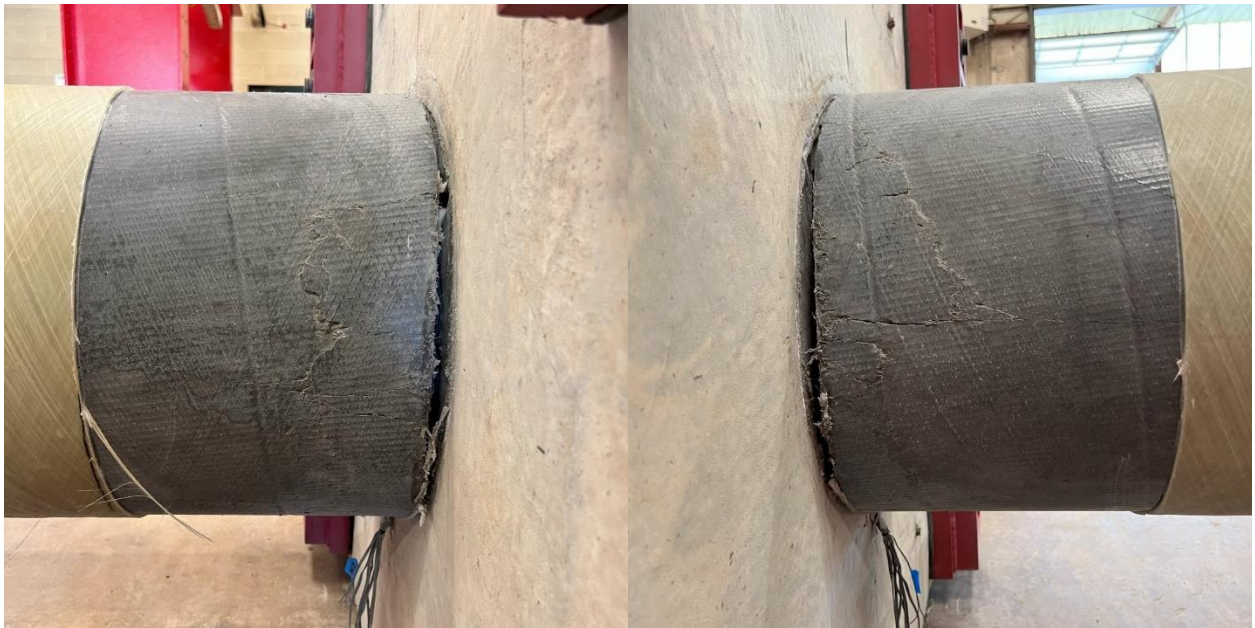
Figure 7-12: UHPC 1 Concrete Core West Side (l) and East Side (r) Damage After Testing

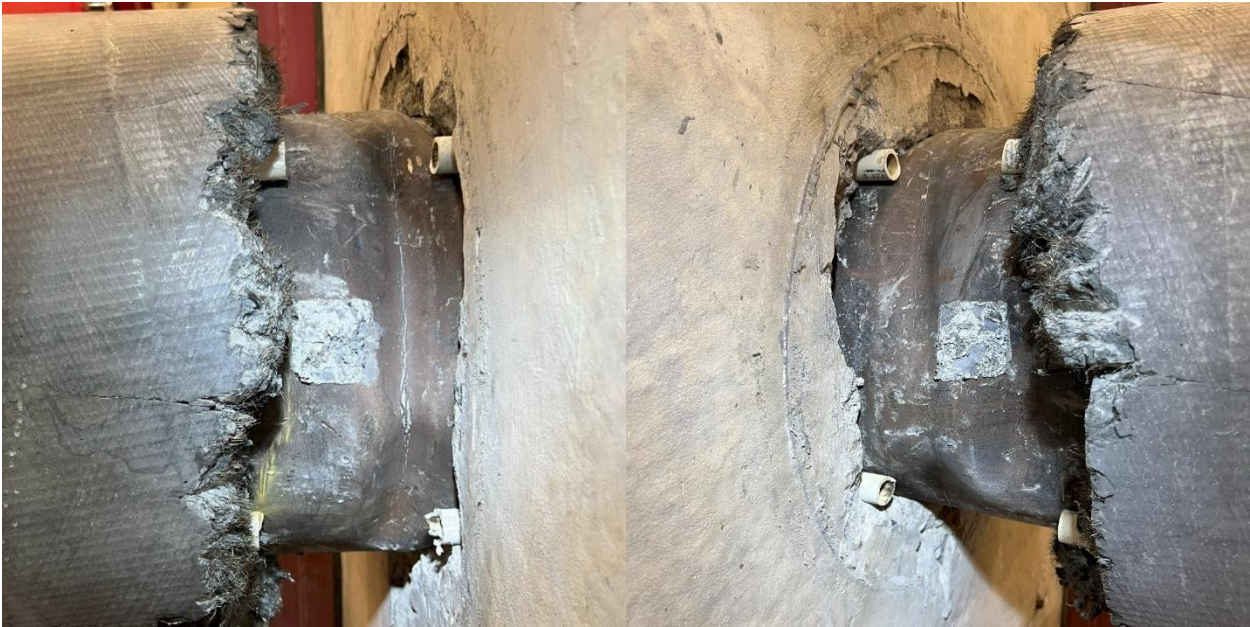
Figure 7-14: UHPC 1 Steel Tube West (l) and East Side (r) Damage After Testing

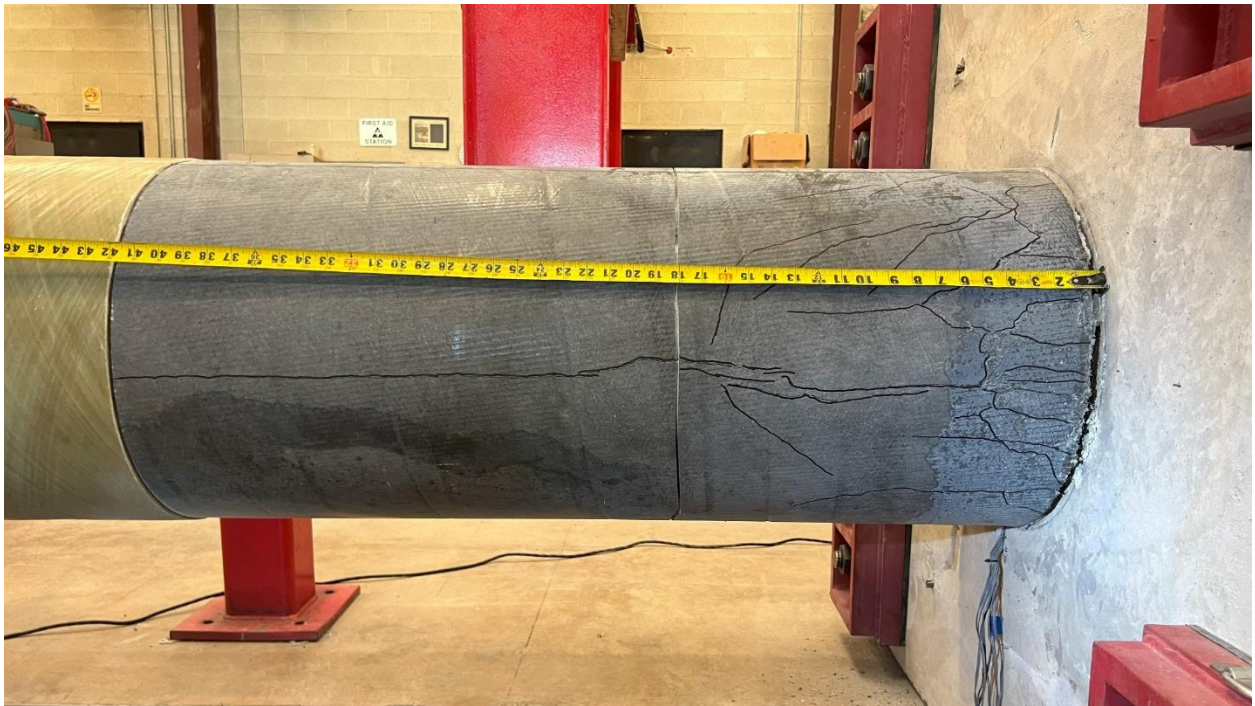
Figure 7-27: UHPC 2 Concrete Core West Side Cracking Along Column Height

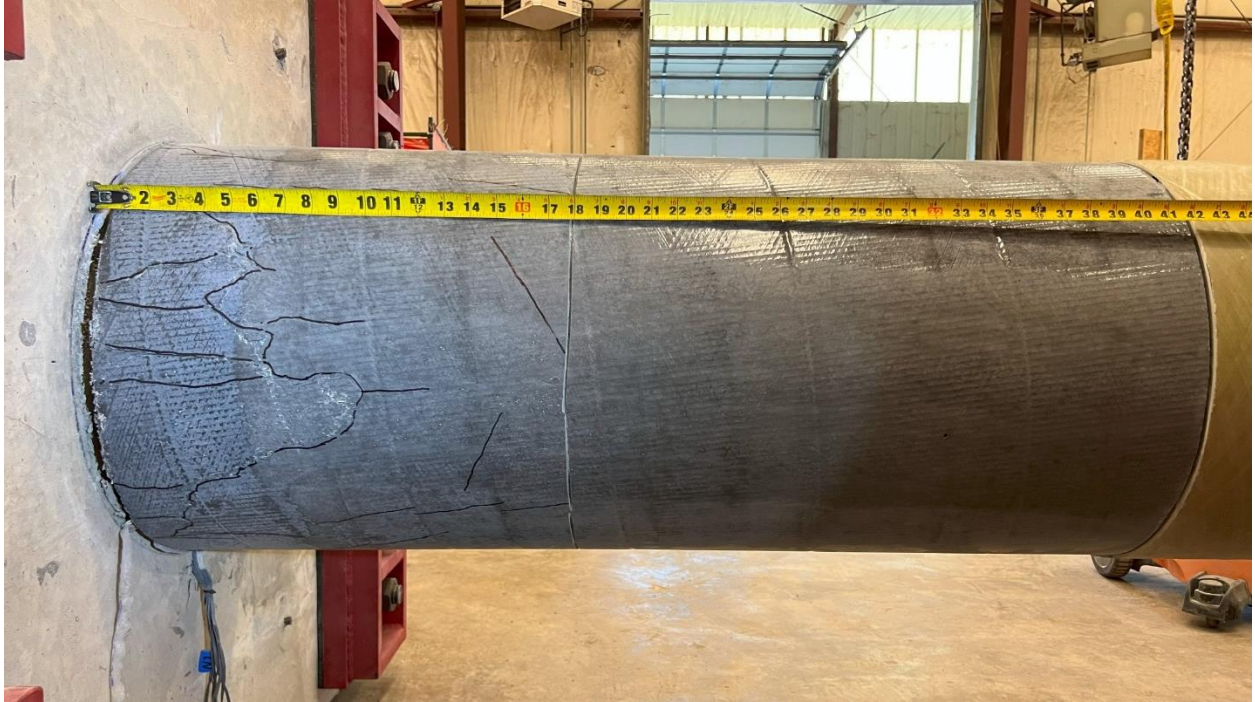
Figure 7-28: UHPC 2 Concrete Core East Side Cracking Along Column Height

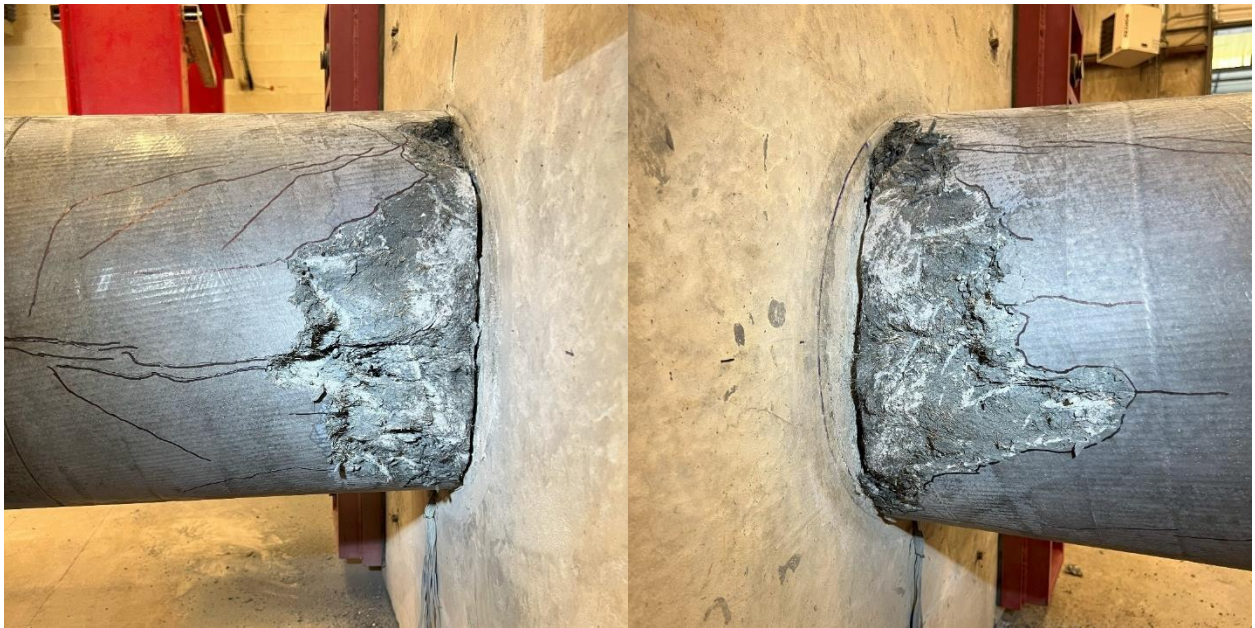
Figure 7-29: UHPC 2 Concrete Core After Testing and Light Concrete Removal

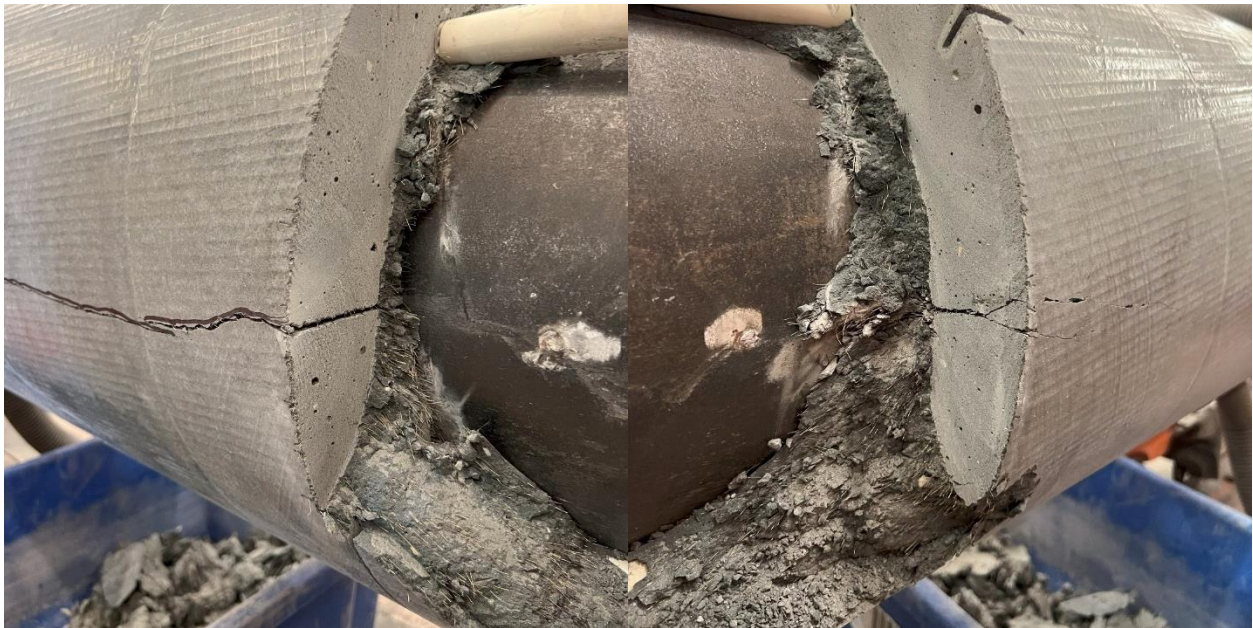
Figure 7-31: UHPC 2 Concrete Core West (l) and East (r) Full-Depth Longitudinal Crack

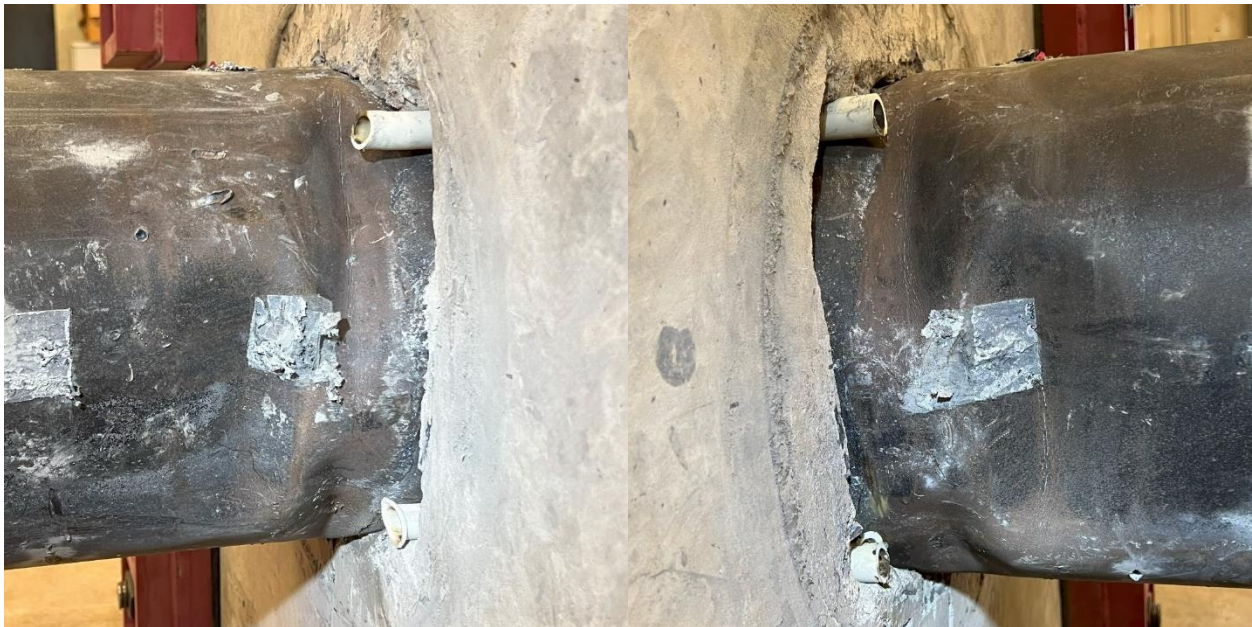
Figure 7-32: UHPC 2 Steel Tube West (l) and East Side (r) Damage After Testing

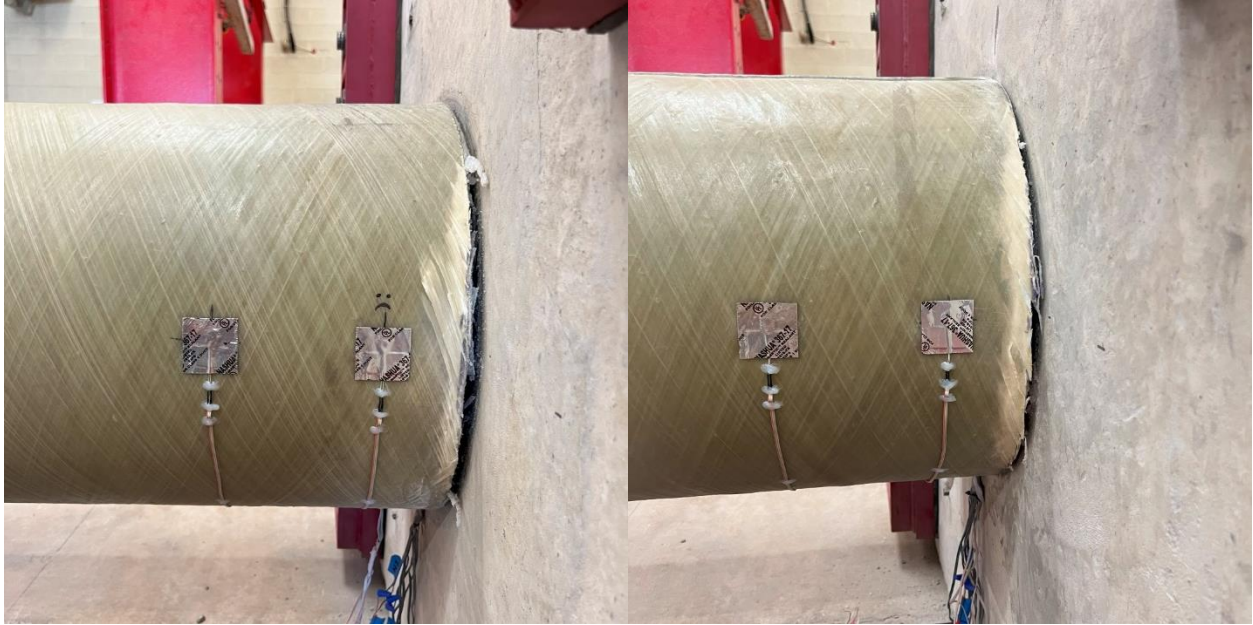
Figure 7-37: Comparing UHPC 1 (l) and UHPC 2 (r) GFRP Tube Damage After Testing

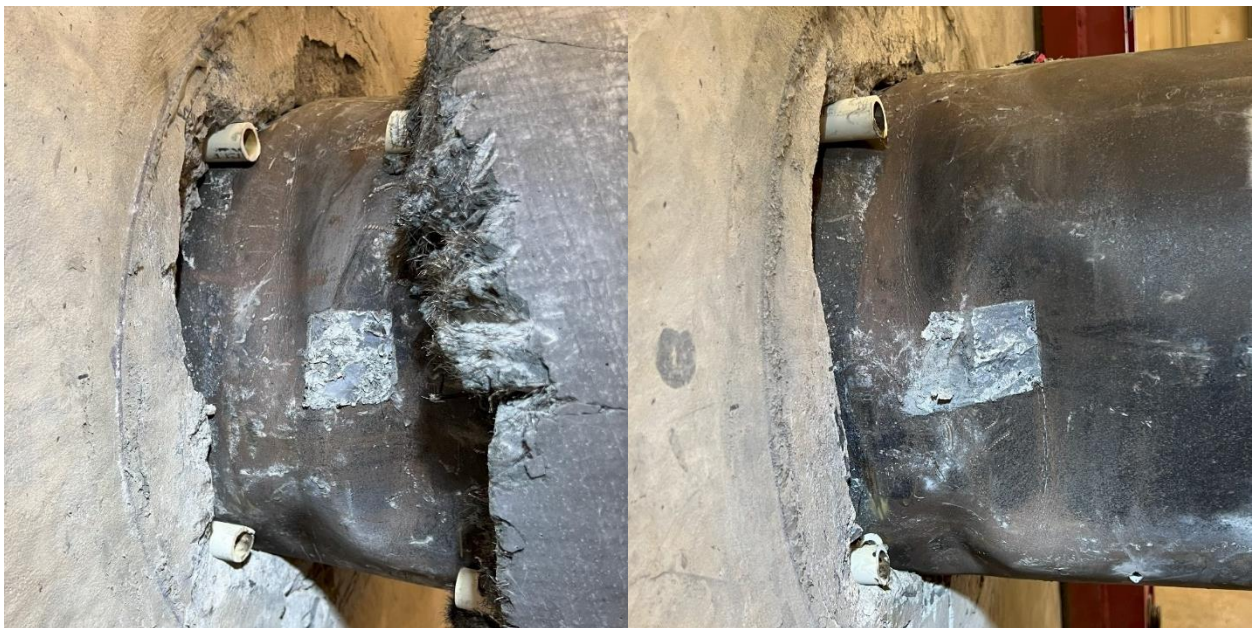
Figure 7-40: Comparing UHPC 1 (l) and UHPC 2 (r) Steel Tube Damage After Testing

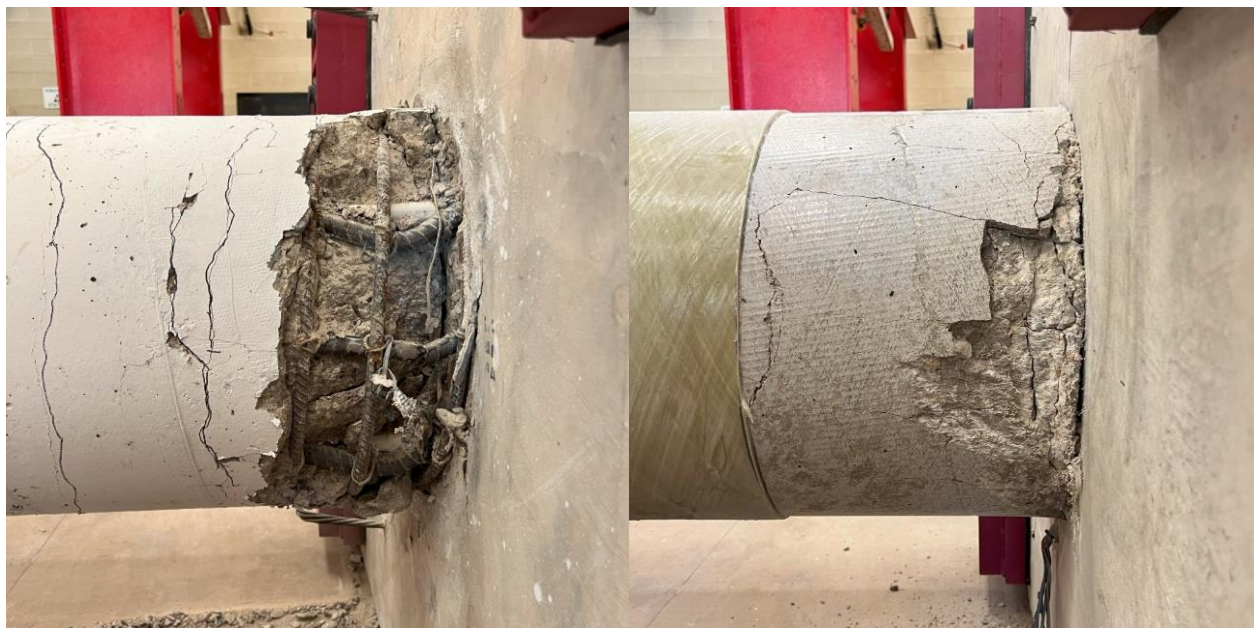
Figure 8-4: Comparing RC (l) and HS-SCC 2 (r) Concrete Core After Testing and Light Removal of Concrete

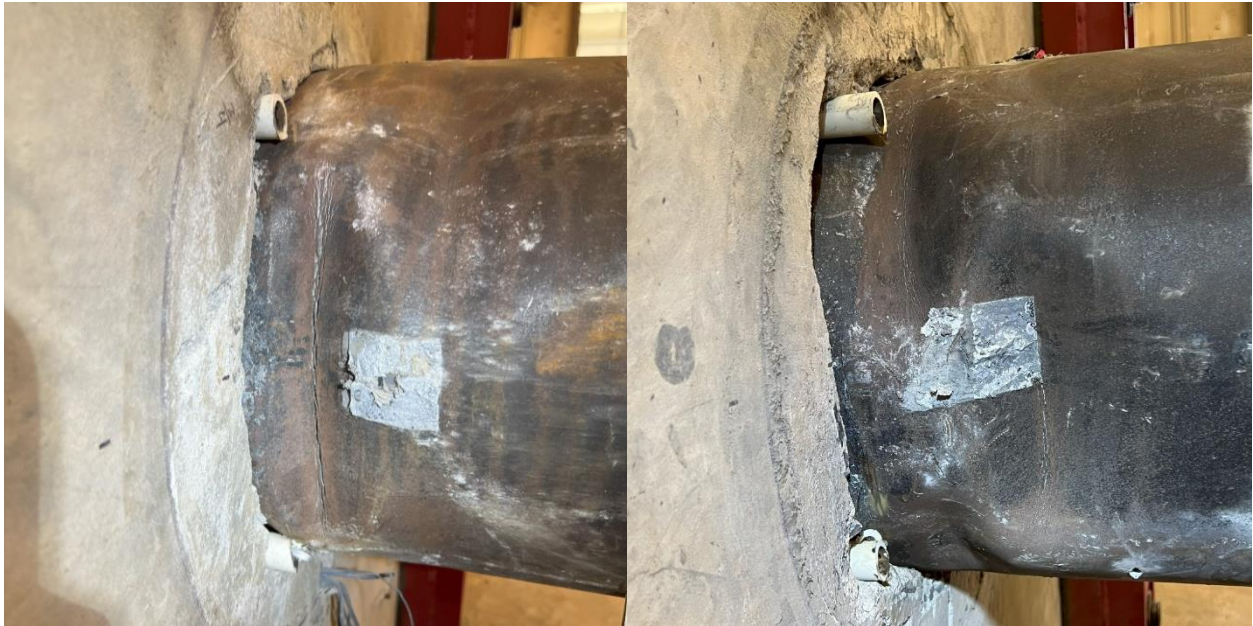
Figure 8-15: Comparing HS-SCC 2 (l) and UHPC 2 (r) Steel Tube East Side After Testing
