EVALUATION OF HOLLOW-CORE-FRP-CONCRETE-STEEL COLUMN AND FOOTING
CONNECTION

A THESIS
SUBMITTED TO THE GRADUATE FACULTY
in partial fulfillment of the requirements for the
Degree of
MASTER OF SCIENCE

By
OMAR YADAK
Norman, Oklahoma

2024

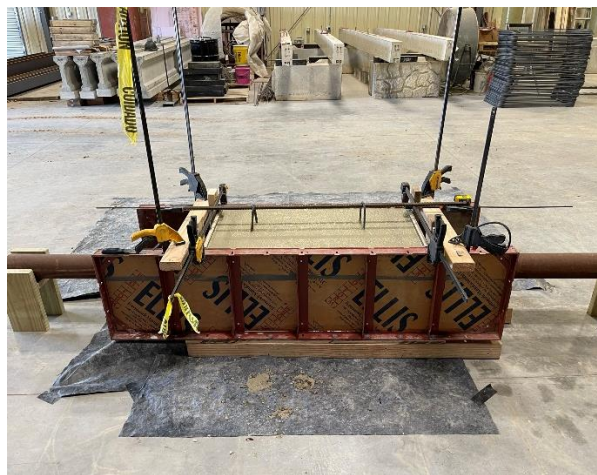
Figure 12. Trial specimen before removing the formwork

The footing portion of the trial specimen was cast horizontally using Rapid Set® cement self-consolidating concrete cast in Fears Laboratory with a compressive strength of 7,200 psi. The 5 in. diameter steel pipe was embedded into the footing a length of $1.6D_i$ from each end, and the steel pipes were extended 4 ft-2 in. from the interface of the footing to result in a moment large enough to ensure the specimen would fail in flexure or due to pullout of the pipe. Figure 12 shows the trial specimen after casting.

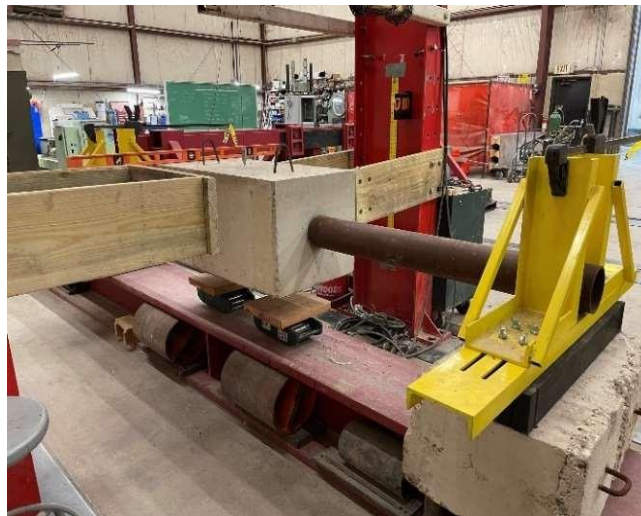
Figure 13. Testing setup for the trial footing-column connection specimen

The specimen was tested with an 11 ft-6 in. simple span with the ends of the pipe placed on steel supports placed on steel reinforced neoprene bearing pads. A vertical load was applied to the midspan of the footing using a hydraulic cylinder, and a wire potentiometer was placed on each side of the specimen at the load point to measure the vertical deflection of the footing. In addition, a linear variable differential transformer (LVDT) was placed on the end of each steel pipe to measure the vertical deflection resulting from the placement of the steel supports on bearing pads. Figure 13 displays the trial specimen in the testing frame.

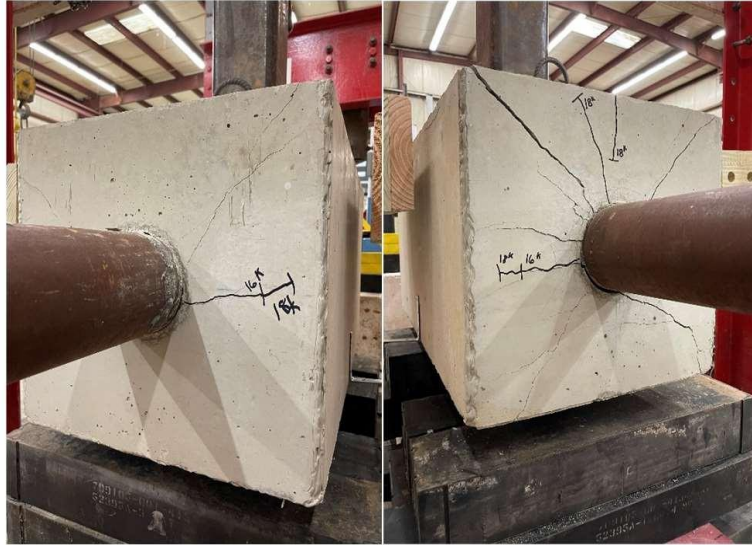
Figure 14. Pullout connection failure from each end of the footing

The specimen failed due to pullout of the steel pipe, as intended, with a failure load of 20 kips. At one end of the footing section, there was a vertical separation of approximately 0.125 in. at the interface between the steel pipe and the concrete, while at the other end, the steel pipe pulled out of the footing directly approximately 0.25 in. Figure 14 presents the pullout failure mechanisms at each end of the footing.

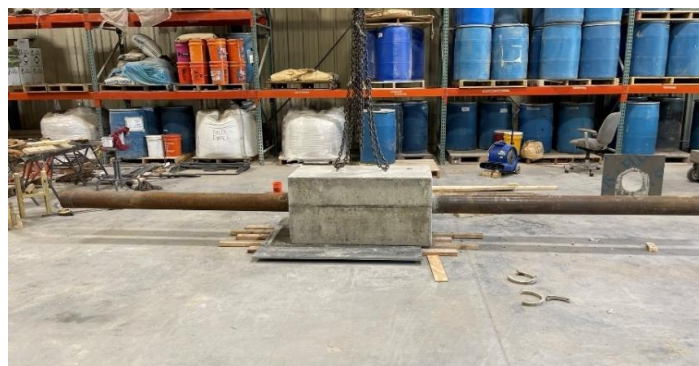
Figure 19. Column footing specimen 1 at 7 days of age

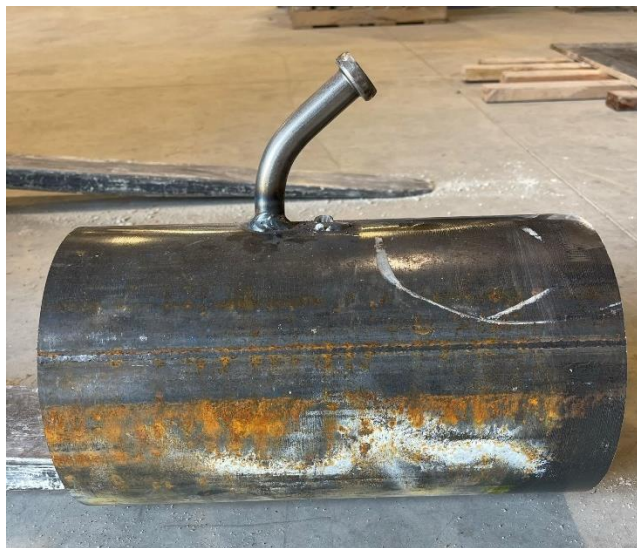
Figure 20. Result of stud bending test

Specimen 6 was cast with shear lugs welded to the embedded end of each steel pipe. The design of the shear lugs in this specimen followed the guidelines outlined in ACI Section 22.9.4 (ACI 318-19), ensuring a sufficient number of studs to prevent pullout failure of the steel pipe. The shear stud chosen had a diameter of 0.75 in. and was 5.25 in. long. Studs were welded to the steel pipe by the Fears Lab technician. The adequacy of the weld connection between the stud and steel pipe was validated by using a simple bend test taking the stud more than 30 degrees from vertical. Figure 20 demonstrates the deformation of the trial shear stud without causing a failure in the connection.

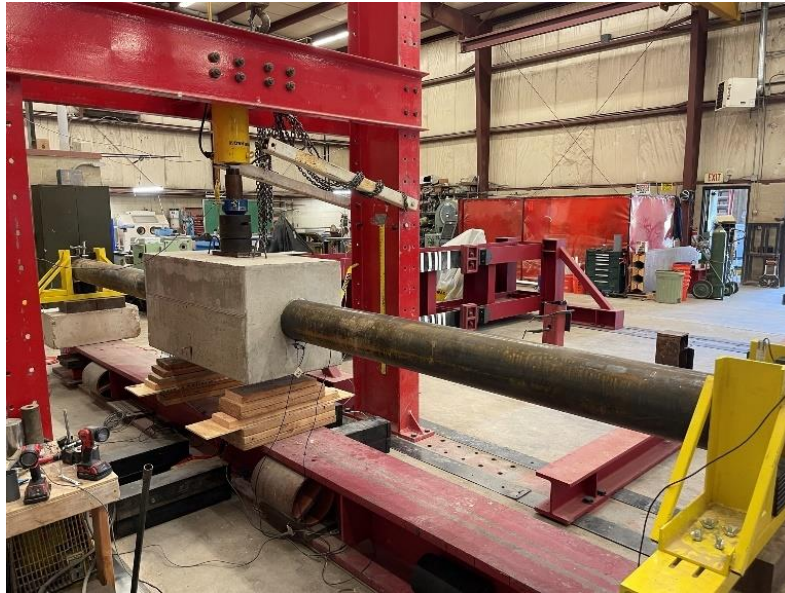
Figure 34. Complete specimen setup before testing

each side of the footing at the midpoint to hook the wire potentiometer for vertical deflection measurements. Figure 34 displays a complete specimen with all instruments placed before testing.

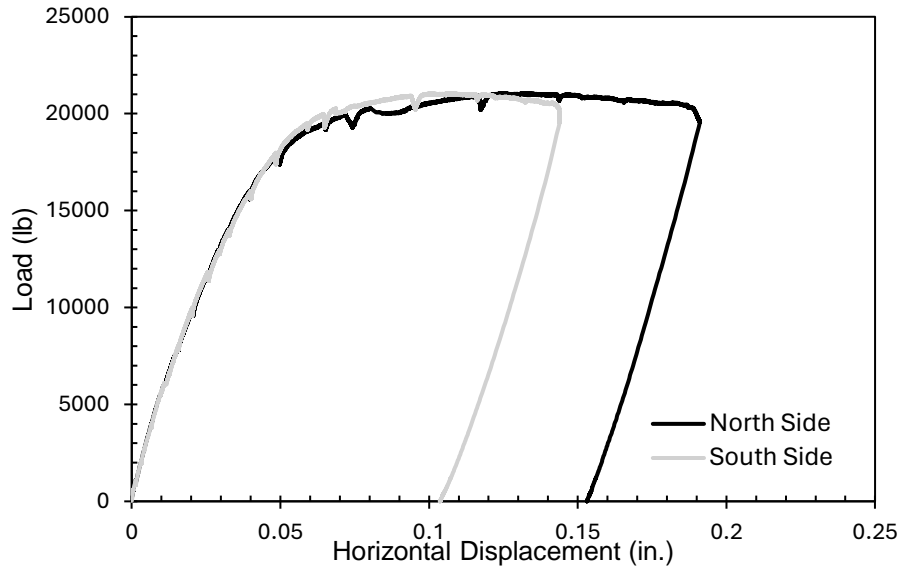
Figure 37. Load vs. tension side horizontal displacement curve for specimen CF-1

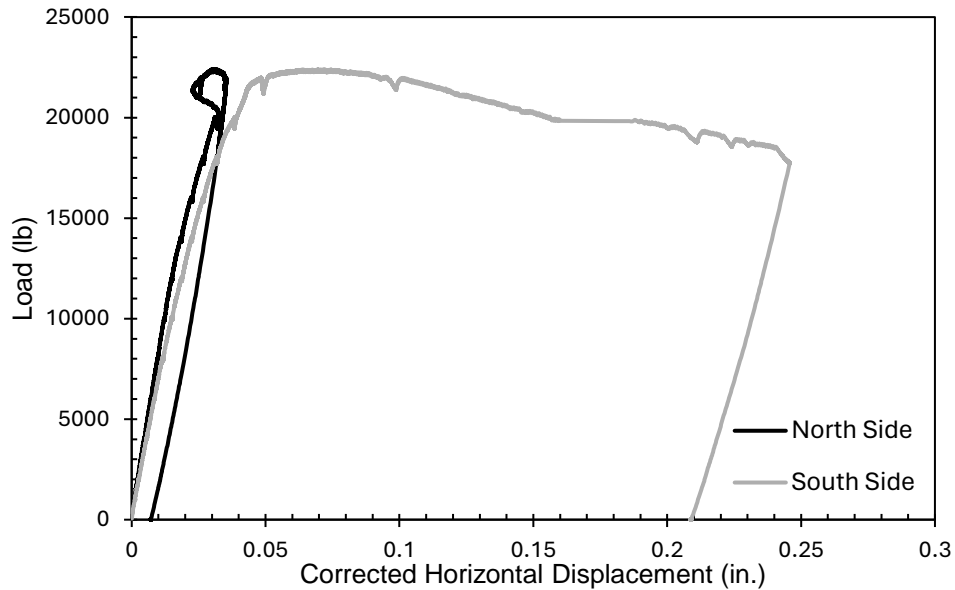
Figure 43. Load vs. corrected horizontal displacement curve for specimen CF-2

Thus, the cleaner original graphs were used to evaluate the failure mechanism instead of the corrected graphs.

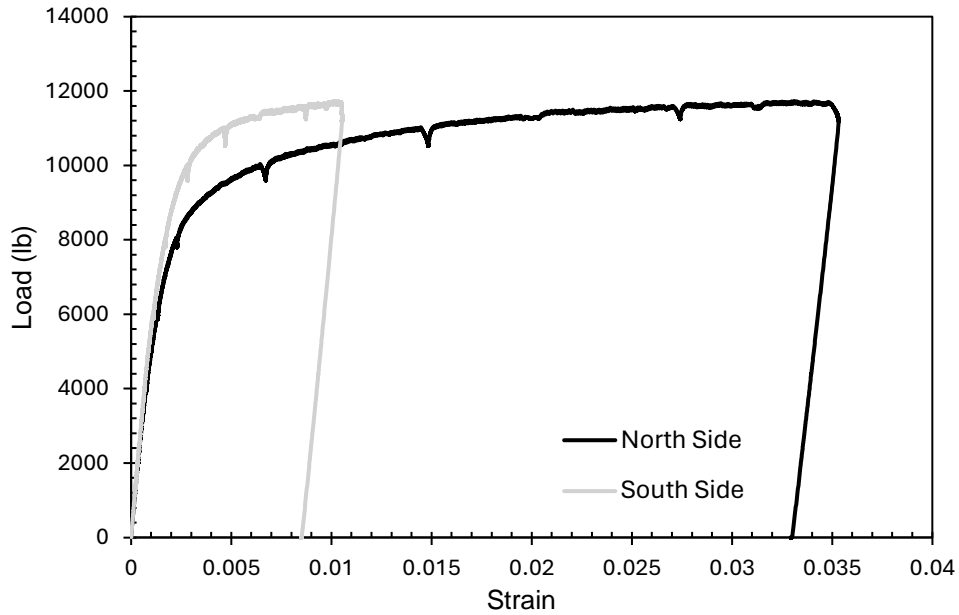
Figure 65. Load vs. strain curve for specimen CF-7

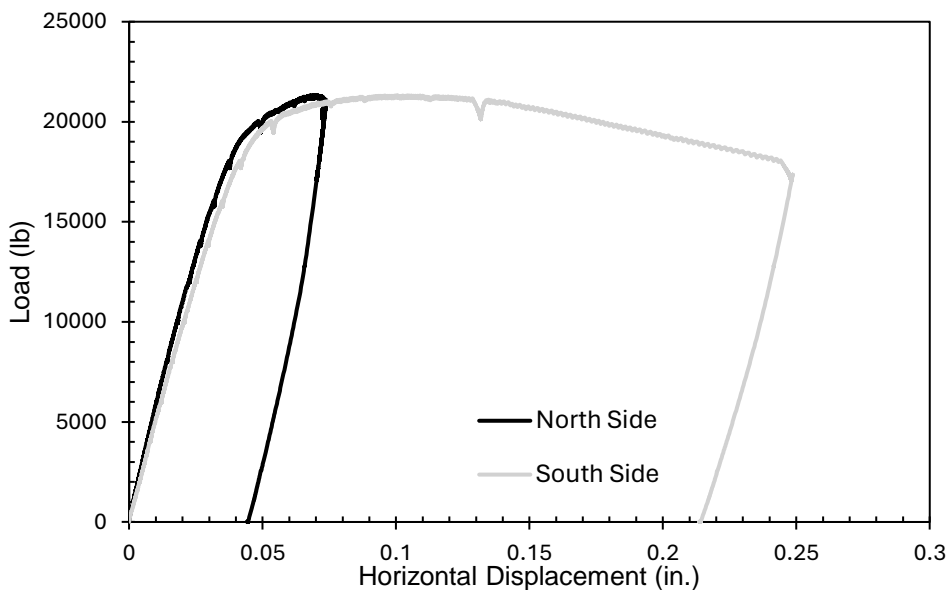
Figure 72. Load vs. horizontal displacement curve for specimen CF-9

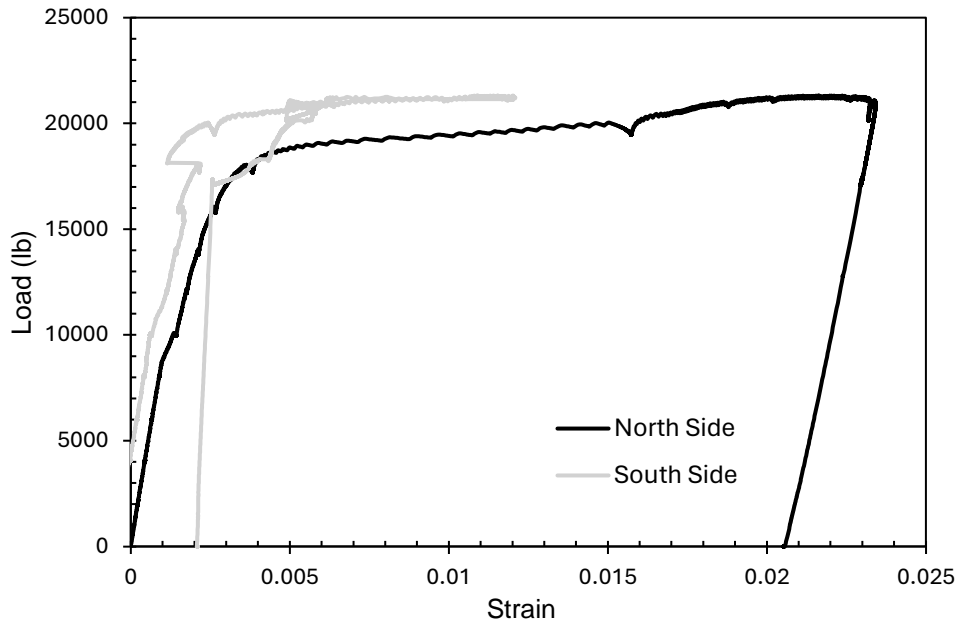
Figure 73. Load vs. strain curve for specimen CF-9

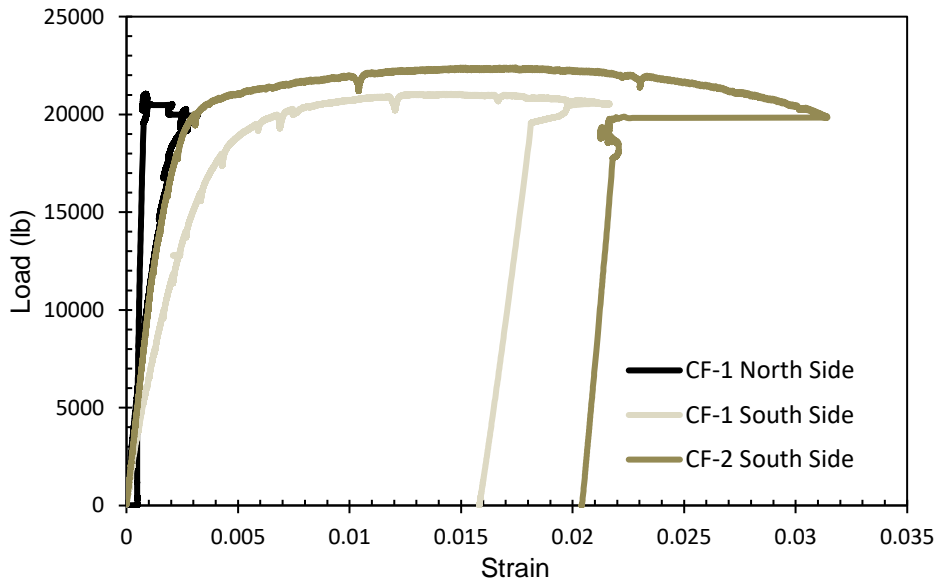
Figure 79. Load vs. strain curves for specimens CF-1 and CF-2
