WATER FLUCTUATION AS A FACTOR IN THE LIFE OF  
THE HIGHER PLANTS OF A 3300 ACRE LAKE IN THE  
PERMIAN RED BEDS OF CENTRAL OKLAHOMA

for the Degree of  
DOCTOR OF PHILOSOPHY

1952

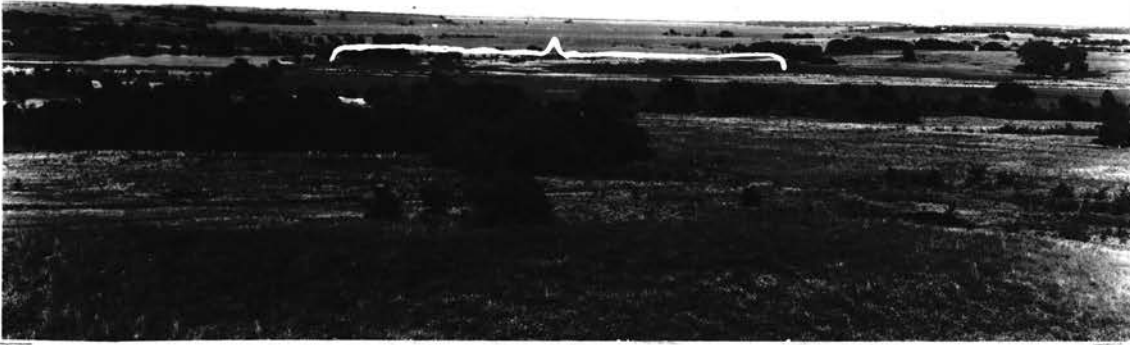
Fig. 1. General View of Lake Carl Blackwell region from the west. Bracket (A) points out a large crop of Polygonum lapathifolium. July 1, 1951.

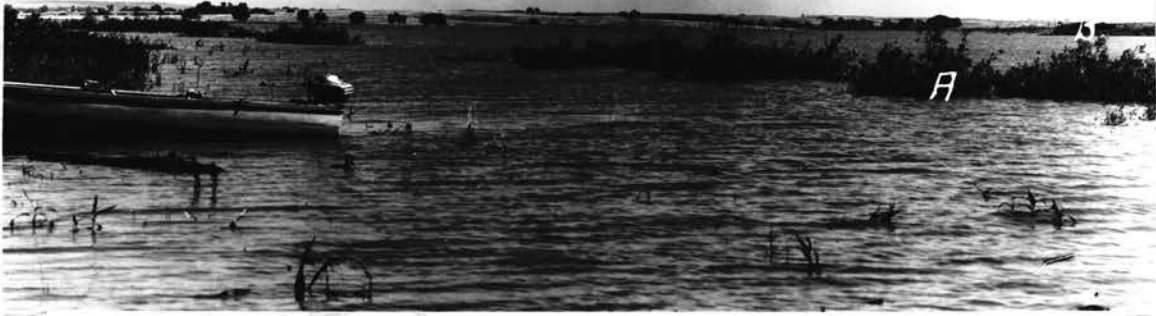
Fig. 2. Showing a comparatively heavy emergent plant population in the semi-protected west side of arm (A) and the absence of plants in relatively open east side of arm (B). Area 9, July 5, 1951.

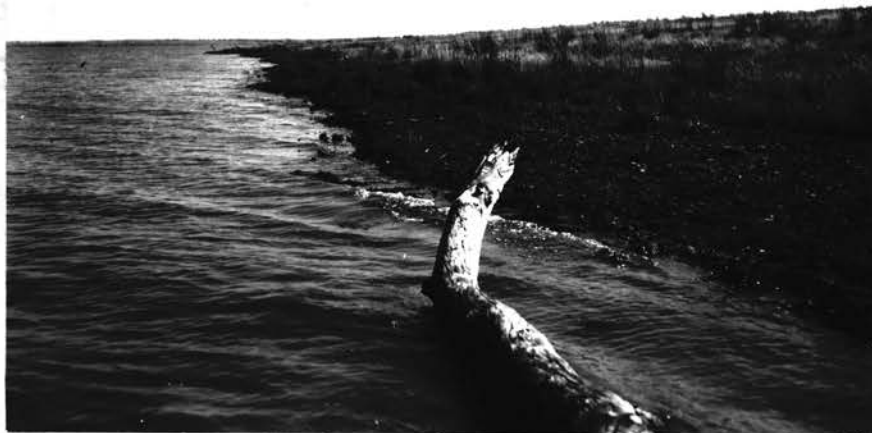
Fig. 3. Showing the absence of emergent aquatic plants in water subjected to shearing wave action. Area 6, August 25, 1951.

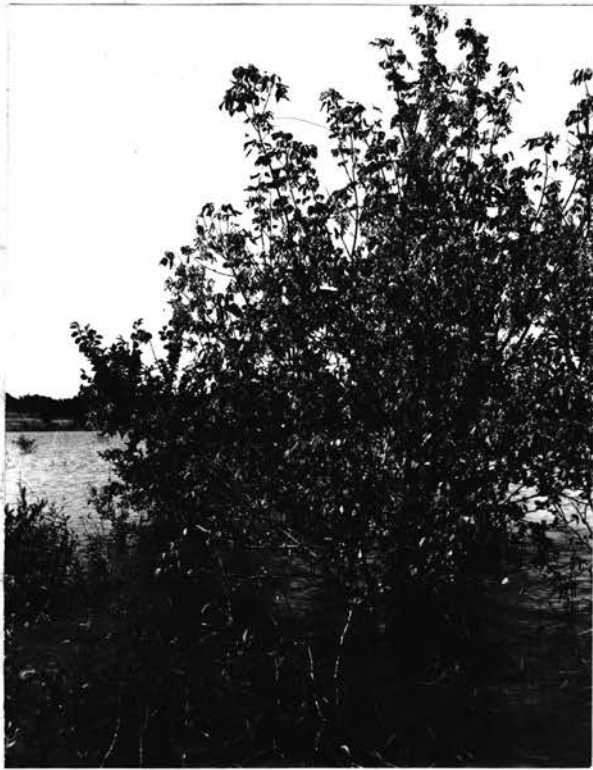
Fig. 7. Acer Negundo L.,  
Box Elder. Showing dis-  
tressed condition after two  
and one half months water  
coverage.- Elev. 941.70',  
Area 13, August 8, 1951.

The Box Elder tree shown in figure 7 began life in 1946. It withstood the short inundations of May and June in 1947 and the shallow inundations of August, September, and part of October in 1950. At the time of the photo, August 8, 1951, the tree showed considerable distress through yellowing of the leaves. Its ability to return to active life was doubted. The photo of the same tree (fig. 8) taken on September 16, 1951 shows almost complete loss of leaves. However the samaras remain, as a last effort of the plant to continue its kind. The cambium layers of plants at, and above the 942.82' level were still viable November 21, 1951, after a continuous shallow water inundation of about six months.

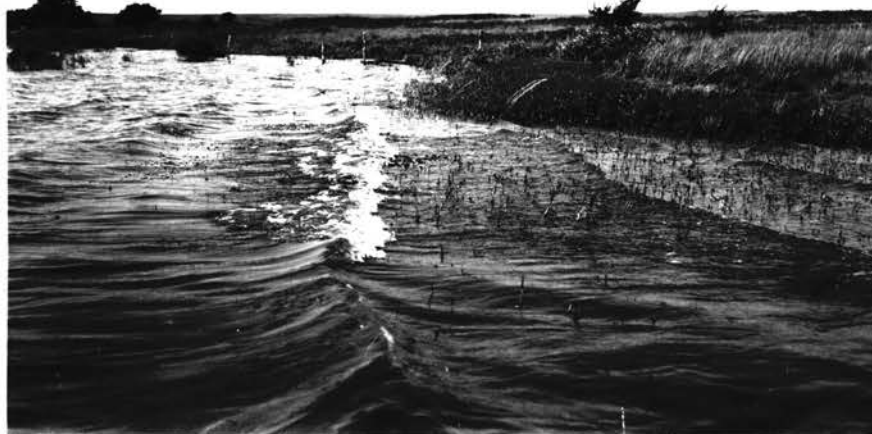
Fig. 9. Ammannia coccinea Rothb., Scarlet Ammannia. Note the plant's resistance to wave action.- Elev. 944.60', 942.05', Area 7, August 28, 1951.

The Scarlet Ammannia, an annual, is limited to the lake's marginal zone of shallow water. The plants sprout in shallow water or water soaked soil. They appear to follow a receding water line and in this manner cover a large area. These plants are very resistant to the erosive forces of wave action as is shown in figure 9. Note that some of the plants are growing in the water soaked soil at the waters edge while others are just

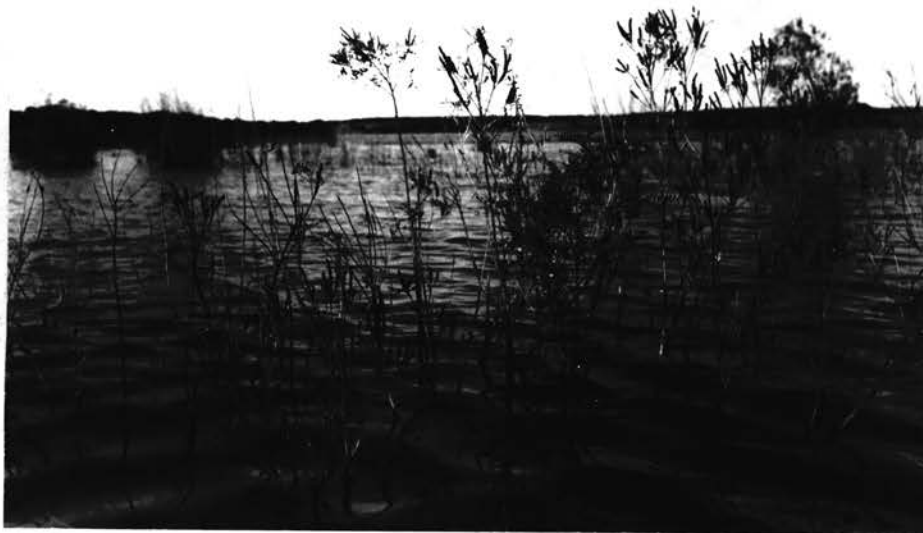
Fig. 11. Amorpha fruticosa L., False Indigo. The False Indigo killed early in shallow water.- Elev. 942.68', Area 13, August 16, 1951.

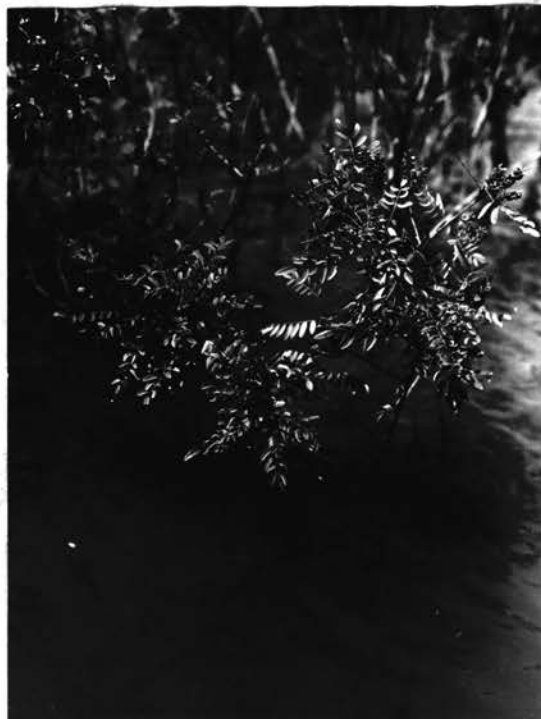
Fig. 12. Amorpha fruticosa L., False Indigo. Prolonged viability was common in deep water.- Elev. 940.25', Area 13, September 16, 1951.

The False Indigo, normally a land plant, shows remarkable resistance to inundation by water. Considerable difference was noted between the rate of the loss of leaves from plants with only their base covered with water and the plants that were almost completely submerged. Figure 11 shows the leafless condition of the plants found in shallow water at the 942.68' level on August 16, 1951. In deeper water, elevation 940.25', with only the upper branches emerged (fig. 12) the leaves remained in a healthy condition until October 1, 1951 the date of the last observation. These plants developed adventitious roots on the

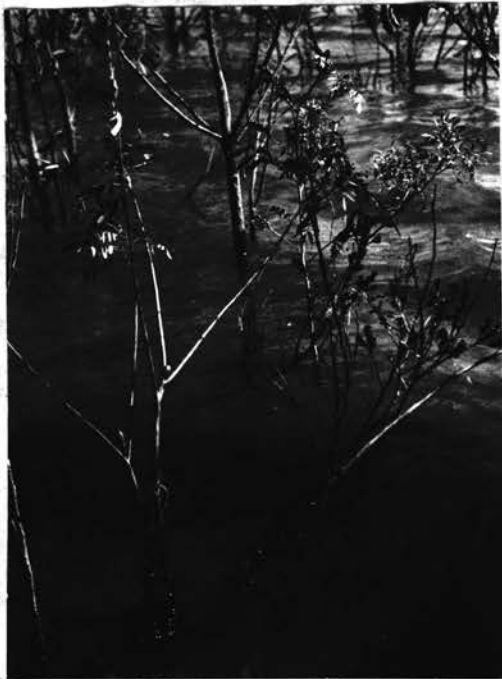
Fig. 13. Amorpha fruticosa L., False Indigo. Plants both in shallow and deep water produced adventitious roots below the water line.- Elev. 940.25', Area 13, October 1, 1951.

tem below the water line (fig. 13). The length and mass of these roots are exhibited in figure 14, photo of the plant after it had been removed from the deeper water. The upper parts of these roots developed chlorophyll. Plants in the shallow water also developed adventitious roots. The large masses of roots developed by plants in deep water may be the explanation for the prolonged viability of the plant.

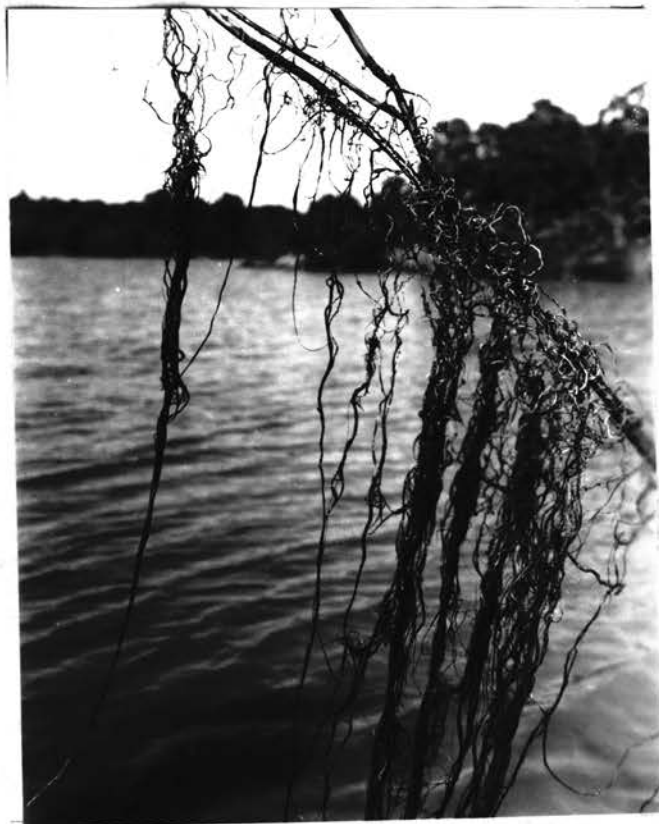
Fig. 14. Amorpha fruticosa L., False Indigo. Plant removed from the water to show mass and length of adventitious roots.- Elev. 940.25', area 13, October 1, 1950.

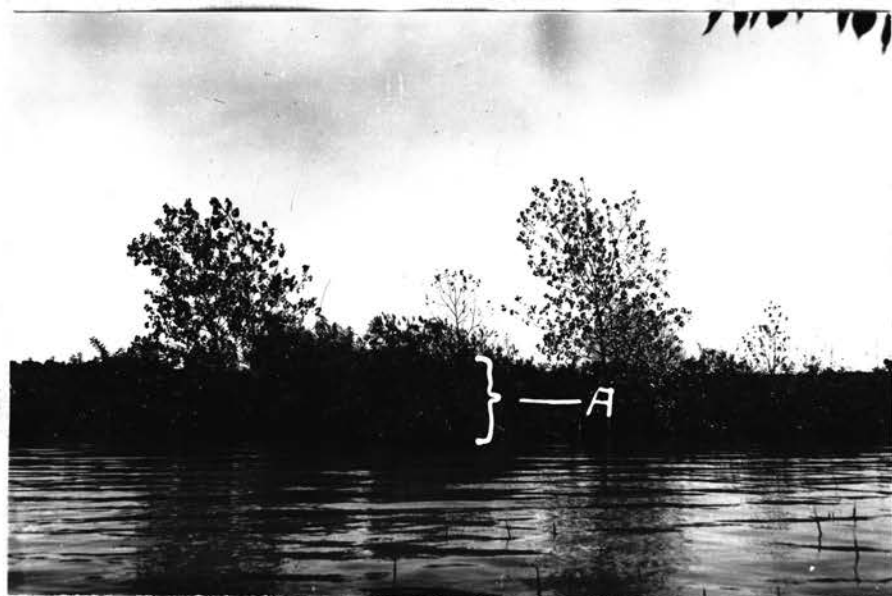
Fig. 15. Cephalanthus occidentalis L., Button Bush. The shrubby mass of Button Bushes (A) produce excellent cover for growing fish.- Elev. 940.68', 939.69', Area 13, August 16, 1951.

The Button Bushes shown in figure 15, A are seven or eight years old. These plants, established during the high waters of 1944 and 1945, survived the low water levels of 1946, 1948 and 1949. During the latter part of 1950 and the early part of 1951 they were inundated continuously for a period of approximately seven months and again from June 15, 1951 to October 1, 1951. Figure 16, A shows the condition of the plants on October 1, 1951. Figure 17 shows the Button Bush at the 940.00' level almost completely covered with water. The flowers of these plants shown by figure 17, A matured into seed and the plants were in a healthy condition when observed August 25, 1951 (fig. 18). These plants produce adventitious roots in a manner similar to that described for Amorpha fruticosa.

The Button Bush is well adapted to the changing conditions of a fluctuating water surface zone. It is a shrubby plant and when not covered with water will furnish excellent cover for upland game. When it is covered with water it can serve as excellent cover for young fish.

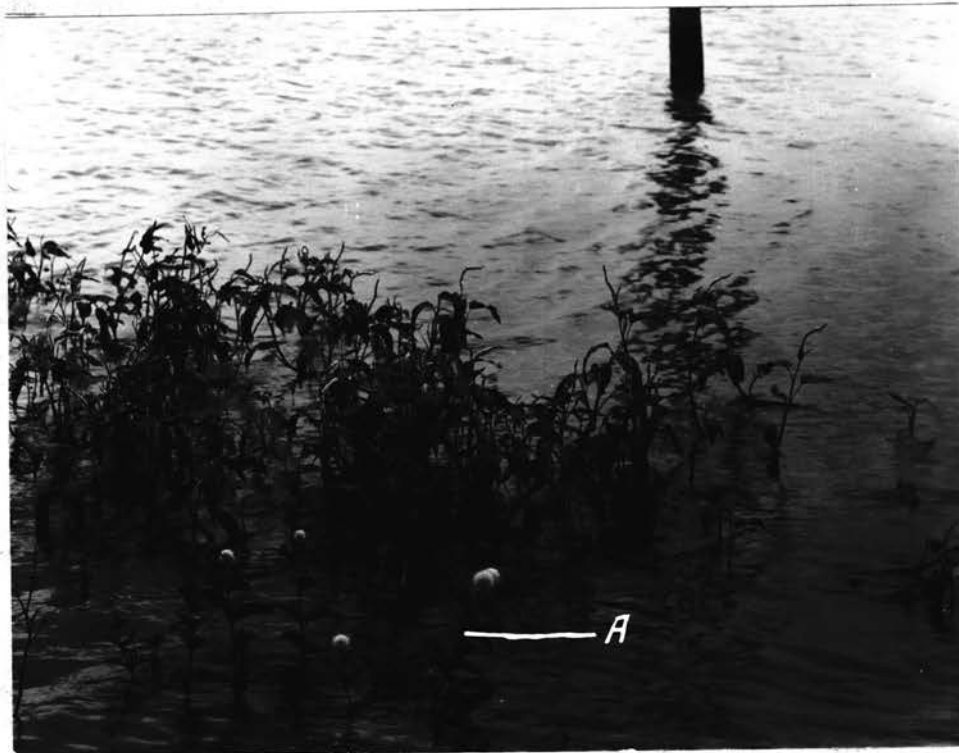
Fig. 17. Cephalanthus occidentalis, Polygonum coccineum  
Study Group. The flowers of the almost completely sub-  
merged Button Bushes (A) matured into seed.- Elev. 940.00',  
Area 1, July 3, 1951.

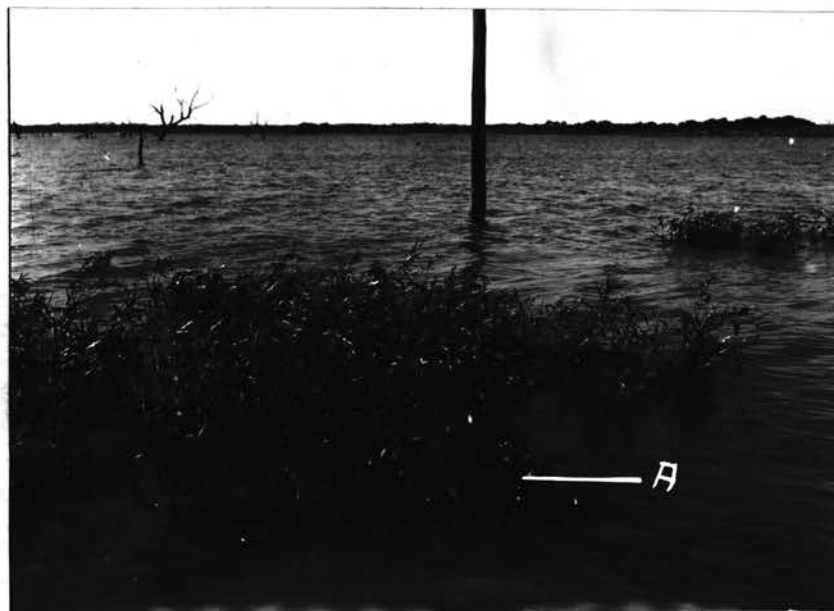
Fig. 18. Cephalanthus occidentalis, Polygonum coccineum  
Study Group. Same group of plants as shown in figure 17.  
The seeds of both plants matured.- elev. 940.00', Area 1,  
August 25, 1951.

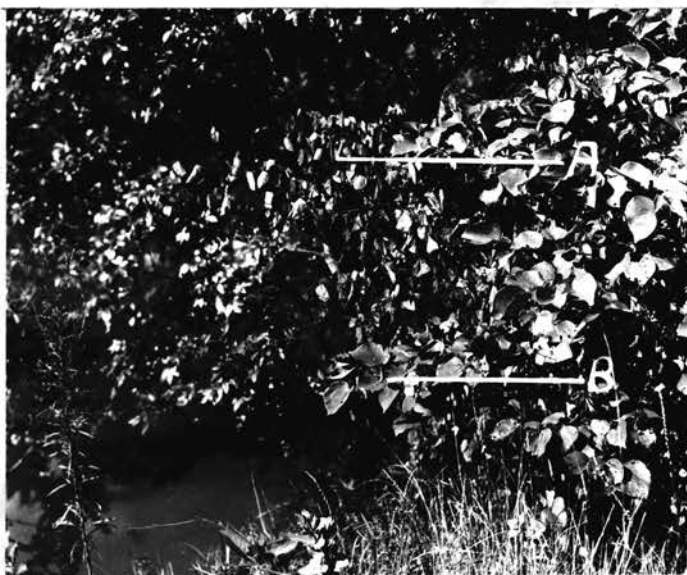
Fig. 20. Cercis canadensis L., Red Bud. The plant at (A) killed with only a few inches of water coverage while plants at (B) lived with its base a few inches above the water line.- Elev. 943.33', Area 2, July 28, 1951.

The Red Bud found only at the high levels of 943.53' and above killed soon after the inundation of its base. On July 8, 1951 after about three weeks of inundation the leaves of the plant had completely lost their green coloration. Figure 20, a photograph taken July 28, 1951 shows the killing effect of inundation of a plant at the 943.33' level. The effect is shown by comparing the drooping leaves (A) of the plant in the water with that of the turgid leaves (B) of the plant with its base above the water line.

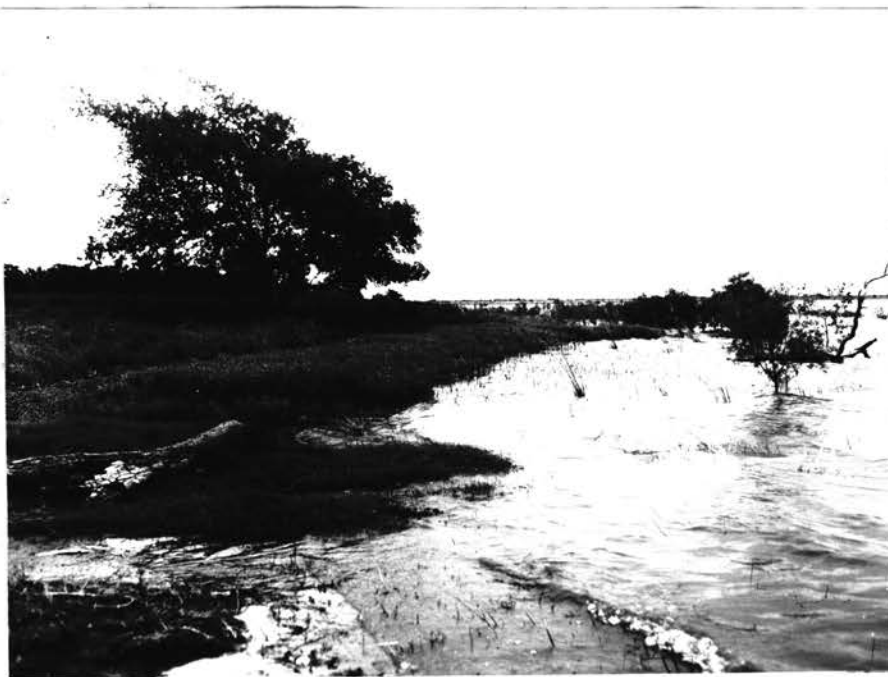
Fig. 22. Cynodon dactylon L., Bermuda Grass. Showing resistance to wave action and water coverage.- Elev. 944.60', 942.65', Area 8, August 22, 1951.

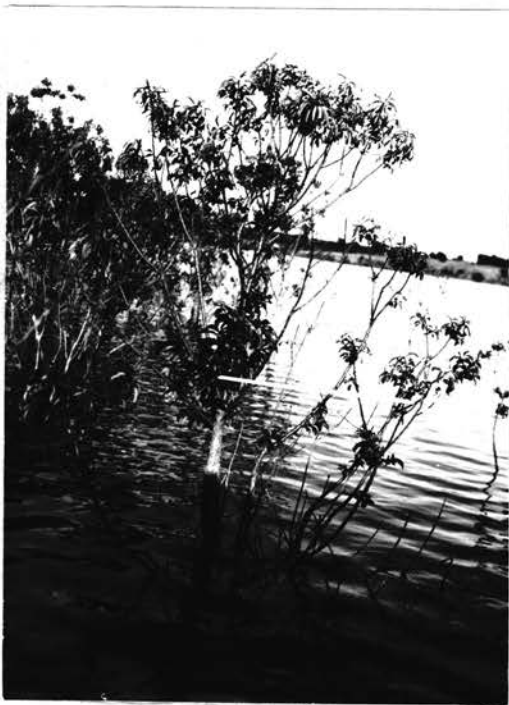
Fig. 23. Diospyros virginiana  
L., Common Persimmon. (A)  
Adventitious sprouts growing  
vigorously a short distance  
above the water line.- Elev.  
938.93', Area 13, August 16,  
1951.

and the Willow showed an inverse killing ratio with the distance of transportation of fluid to the leaves. In the case of the Willow and Cottonwood the leaves farthest from the base began dying first. In the case of the Persimmon all of the leaves gradually lost their viability but at a short distance above the water line new vigorous shoots developed from adventitious buds. Figure 23, A shows the condition of these shoots on August 16, 1951. By September 16, 1951 a large percentage of the original leaves had dropped from the plant and the leaves of the above mentioned shoots (A) of figure 24 had begun to lose their chlorophyll. By October 1, 1951 most of the leaves both from the shoots and the rest of the tree had fallen (fig. 25).

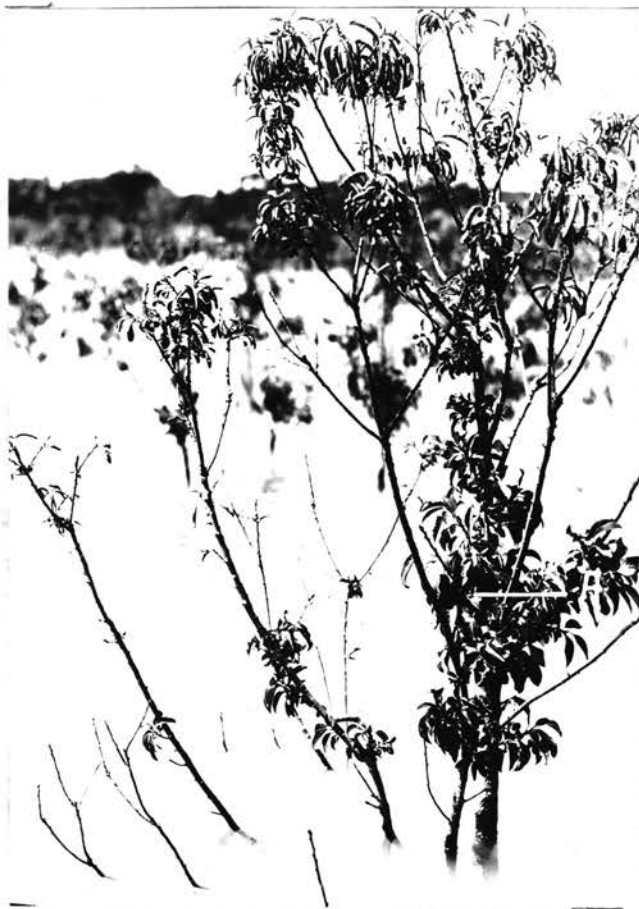
Fig. 24. Diospyros virginiana  
L., Common Persimmon.  
Showing a general distressed  
condition of the plant and  
adventitious sprouts.- Elev.  
938.93', Area 13, September  
16, 1951.

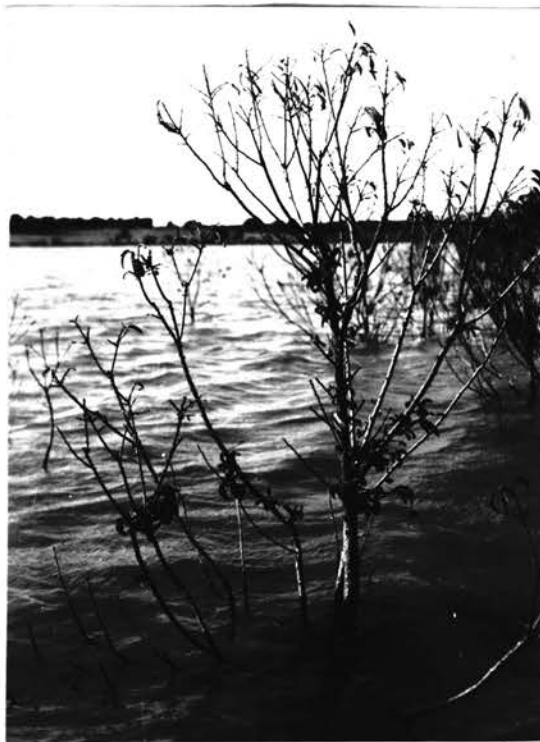
Fig. 25. Diospyros virginiana L., Common Persimmon. Showing complete loss of viability.- Elev. 938.93', Area 13, October 1, 1951.

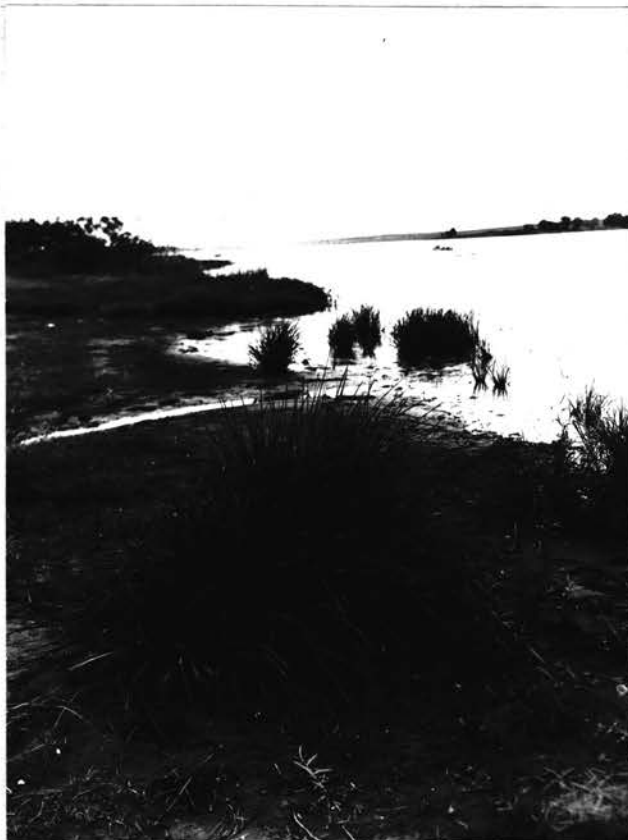
Fig. 26. Echinochloa crusgalli (L.) Beauv., Barnyard-Grass.-  
Elev. 944.60', 943.65', Area 7, August 22, 1951.

Barnyard-Grass, normally a land plant, thrives in the rich moist soil around the edges of our lakes. Once established (fig. 26) it can withstand inundation of its base and continue to maturity in the aquatic habitat (fig. 27).

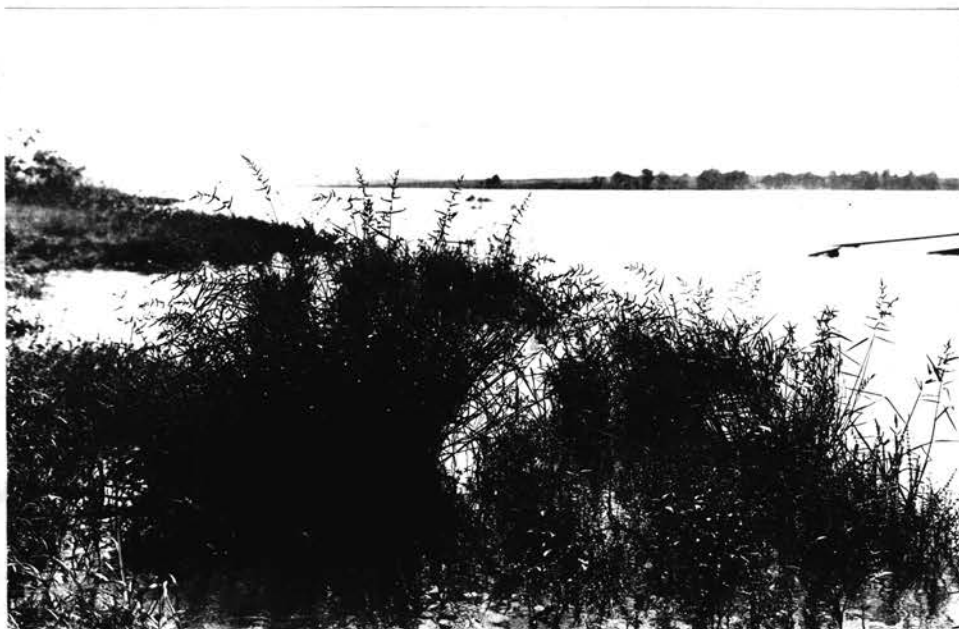
Fig. 27. Echinochloa crusgalli (L.) Beauv., Barnyard-Grass.-  
The same plants shown in figure 26 reach maturity with their  
bases covered with water.- Elev. 944.60', 943.65', Area 7,  
September 18, 1951.

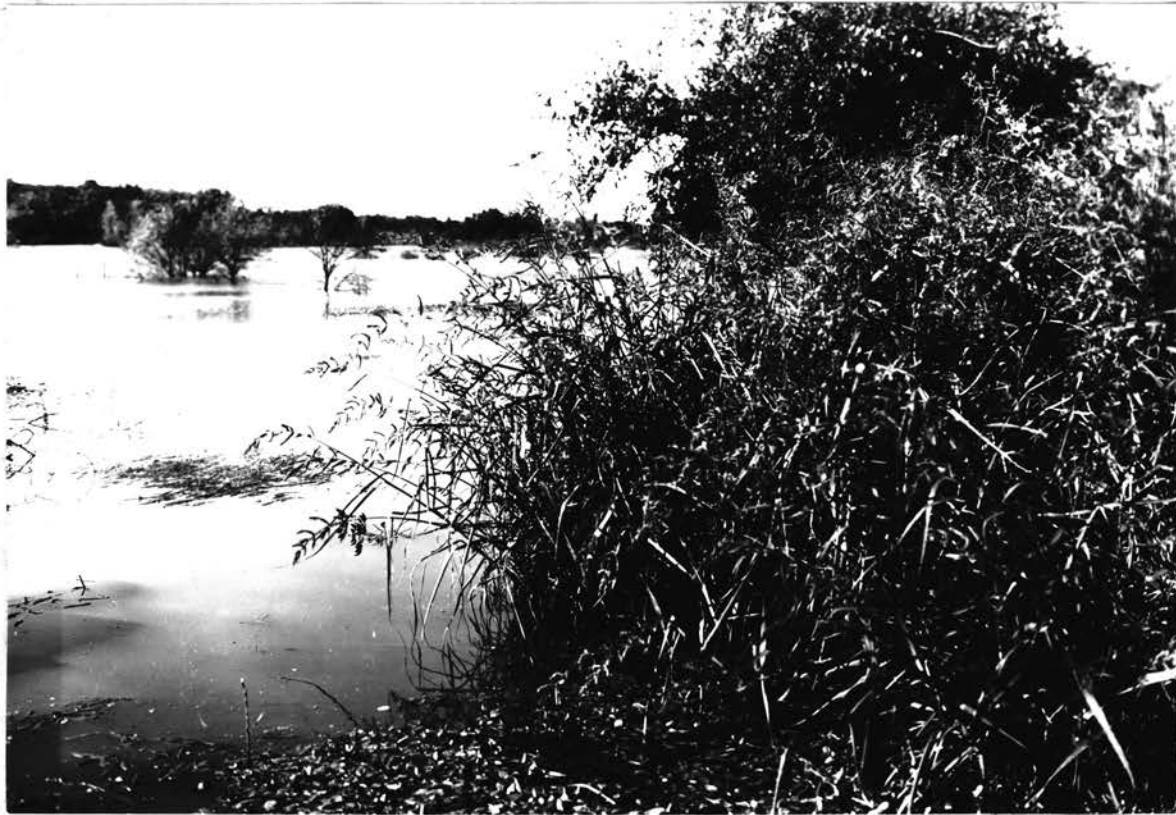
Fig. 28. Echinochloa crusgallica (L.) Beauv., Barnyard-Grass. Illustrating the prolific growth of the plant at or above the water's edge.- Elev. 944.60', 943.67', Area 7, September 16, 1951.

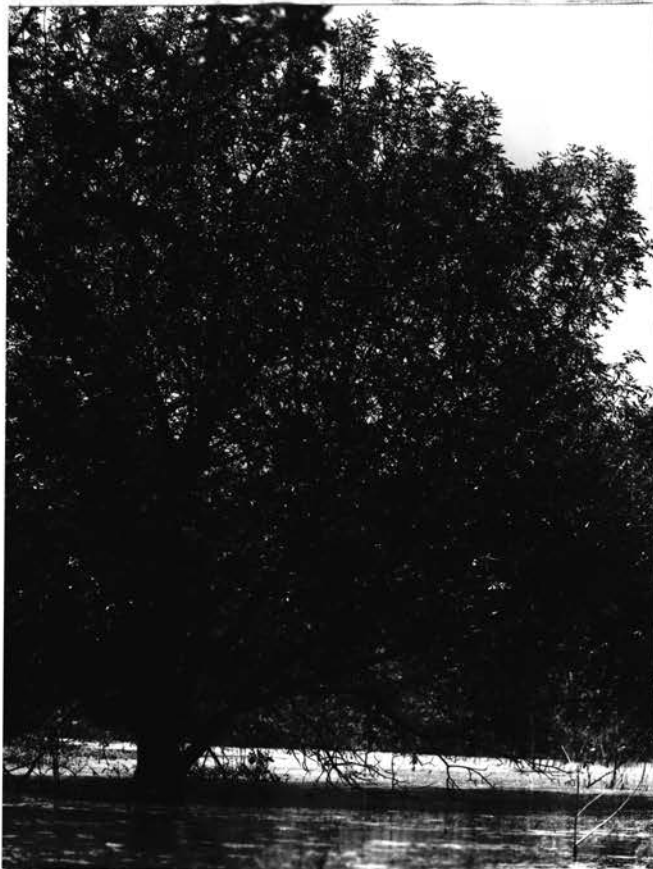
Fig. 30. Fraxinus pennsylvanica Marsh, var. subintegerrima (Vahl) Fern. Green Ash. This tree has withstood inundations of its base throughout the life of the lake.- Elev. 941.09', Area 1, June 23, 1951.

The Green Ash is one of the few original trees that have continued to exist throughout the life of the lake. The tree in figure 30, elevation 941.09', withstood inundations of over two months in 1942, a period of almost two years continuous shallow water inundation in 1943, 1944, and 1945, a short period in 1947, over four months in 1950 and over six months in 1951. It is believed by the author that this tree will live through the winter and again put forth leaves in 1952.

The author recommends this tree for plantings at or near pool levels for use as a shade tree in recreation areas.

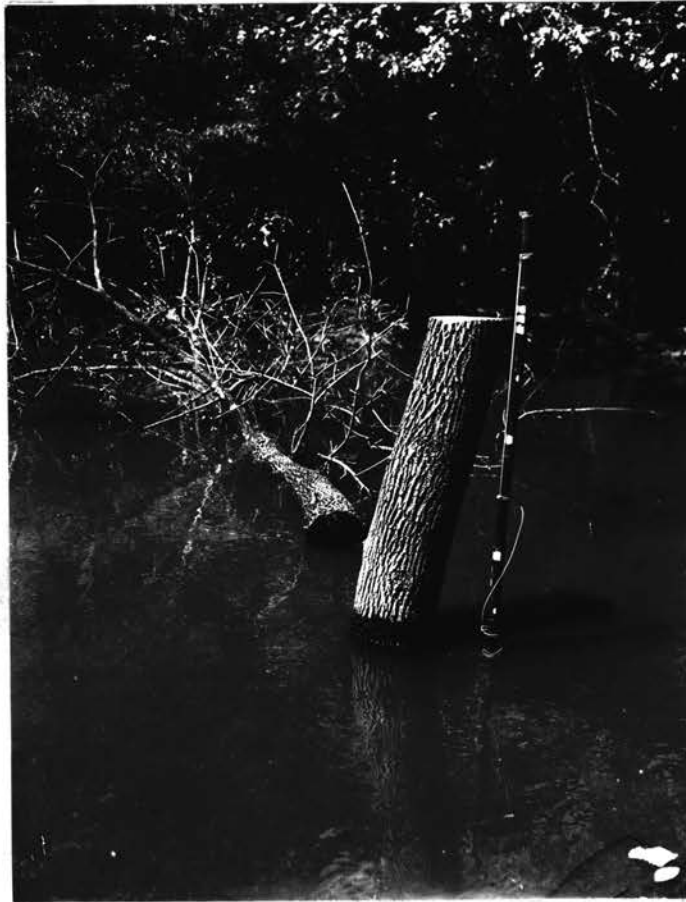
Fig. 32. Fraxinus pennsylvanica Marsh, var. subintegerrima (Vahl) Fern., Green Ash. Showing depth and condition of tree. Note presence of 1951 crop of leaves which remained on the tree after death.- Elev. 937.60', Area 1, August 24, 1951.

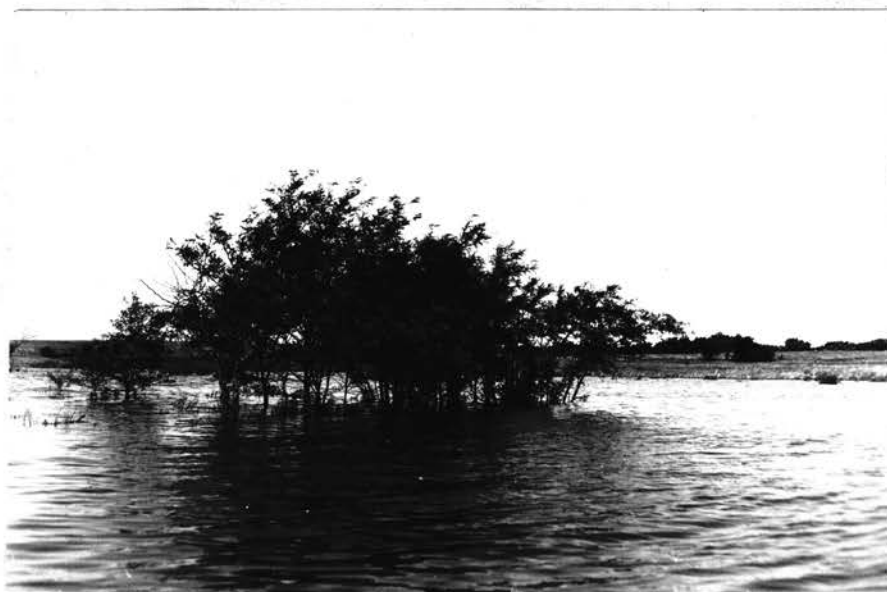
Fig. 33. Gleditsia tricanthos L., Honey Locust. These trees have lived throughout the life of the lake.- Elev. 942.65', 941.15', Area 7, July 8, 1951.

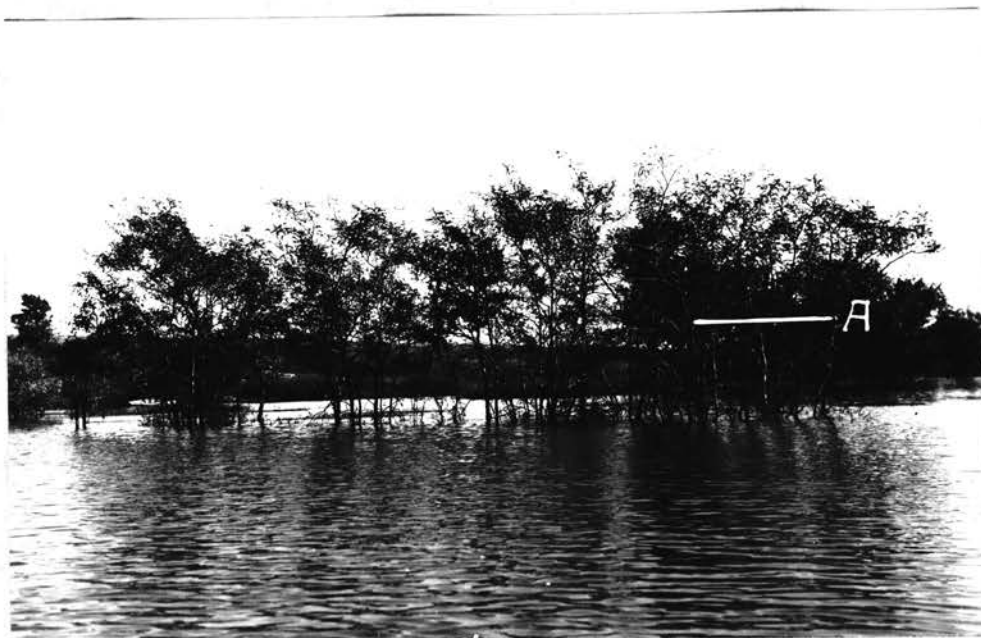
Fig. 34. Gleditsia tricanthos L., Honey Locust. Same group of trees shown in figure 33. Tree shown by (A) killed early at the 941.15' level.- Elev. 942.65', 941.15', Area 7, September 16, 1951.

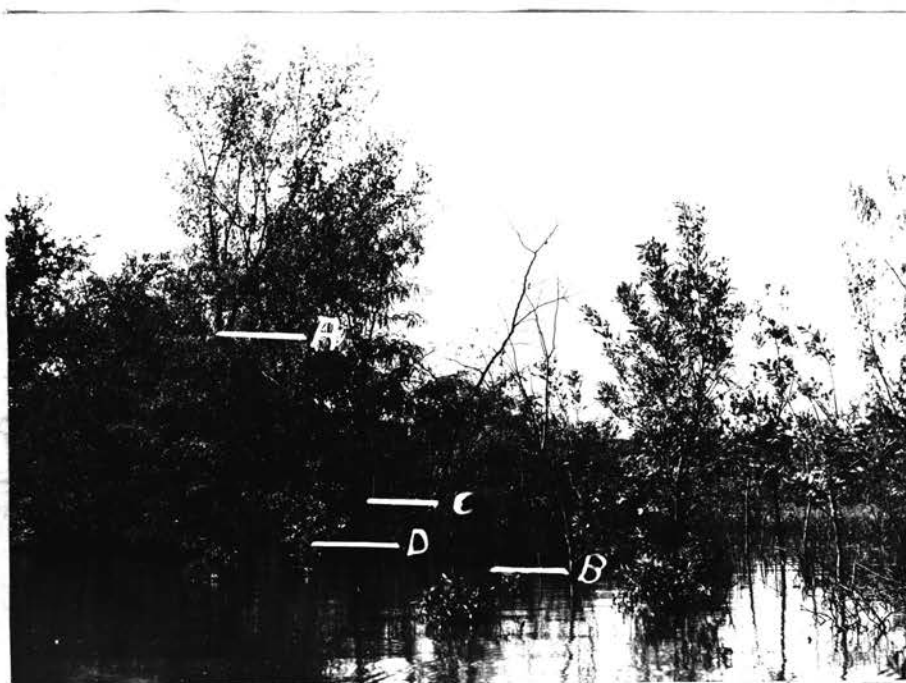
Fig. 36. Same Group shown in figure 35. Note morphological changes.- Elev. 943.31', 942.31', Area 13, September 16, 1951.

Only one Thornless Honey Locust tree was observed and it reacted in the same manner to water inundation as the aforementioned Honey Locust. Figure 35, A shows the plant on August 3, 1951. Figure 36 shows the same tree on September 16, 1951. The cambium layer of this tree was still viable when it was examined on November 21, 1951.

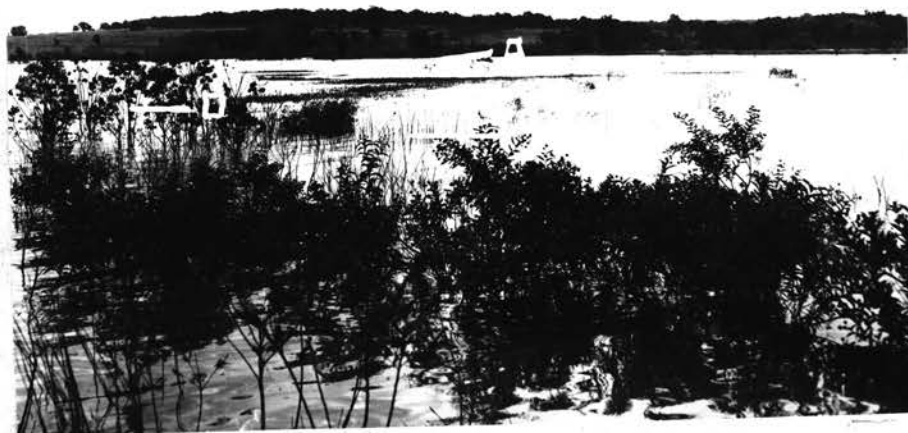
Fig. 38. Study Group of the Semi-open Water of Area 13.  
 Note morphological changes. August 8, 1951.

The Common Persimmon shown in (D) of figure 38 was established after the high waters of 1944 and 1945. The fact that trees six years old were found as low as the 939.91' level shows the Persimmon plant withstood inundations lasting about four months during the growing season of 1947, four months during 1949, eight or more months during 1950 and the early part of 1951, and again over four months in the summer of 1951 before dying. The viability of these plants on August 1, 1951 was considered to be such that they would have renewed their normal activity had they been returned to a land habitat. The above data establishes an inundation killing time for this group of plants of at least four months.

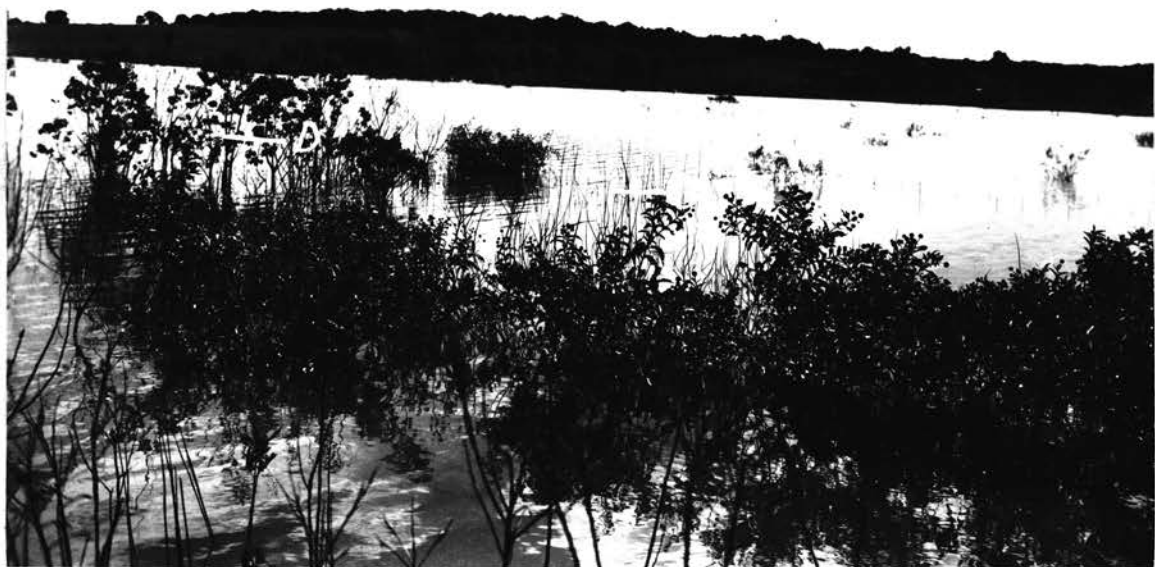
Fig. 39. Study Group of the Semi-open Water of Area 13. Note morphological changes. September 16, 1951.

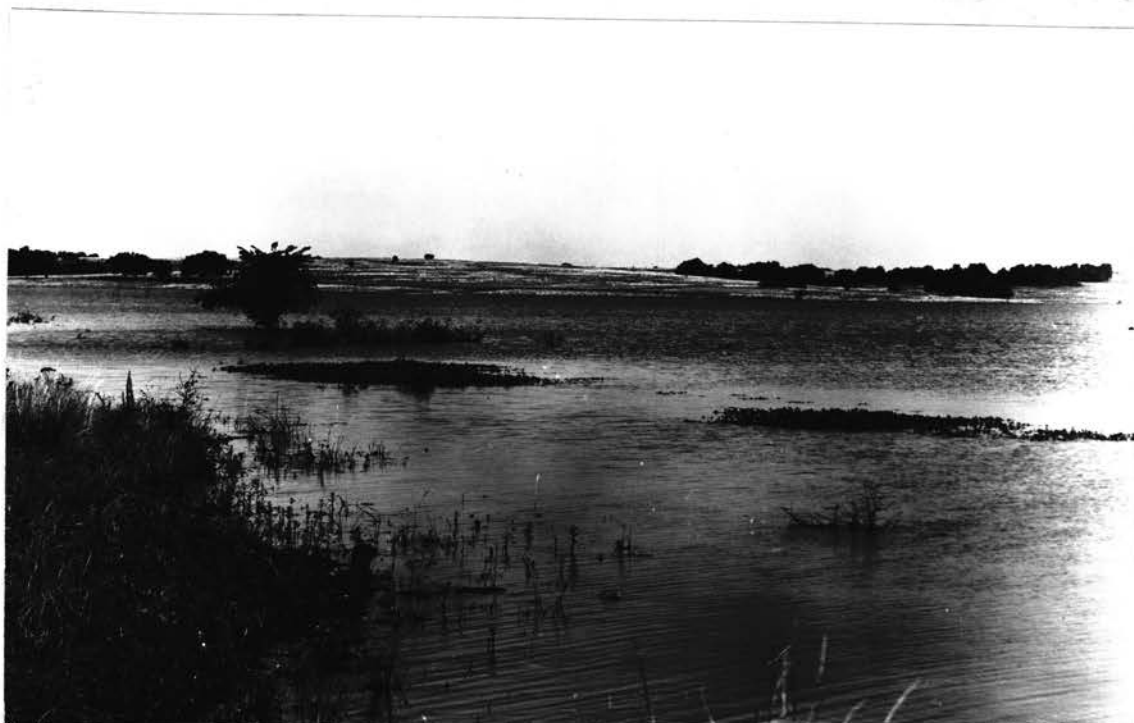
Fig. 40. Jussiaea repens L., Creeping Primrose-Willow. These plants were found to be prevalent only in quiet waters of small inlets.- Elev. 941.50', 940.50', Area 6, July 5, 1951.

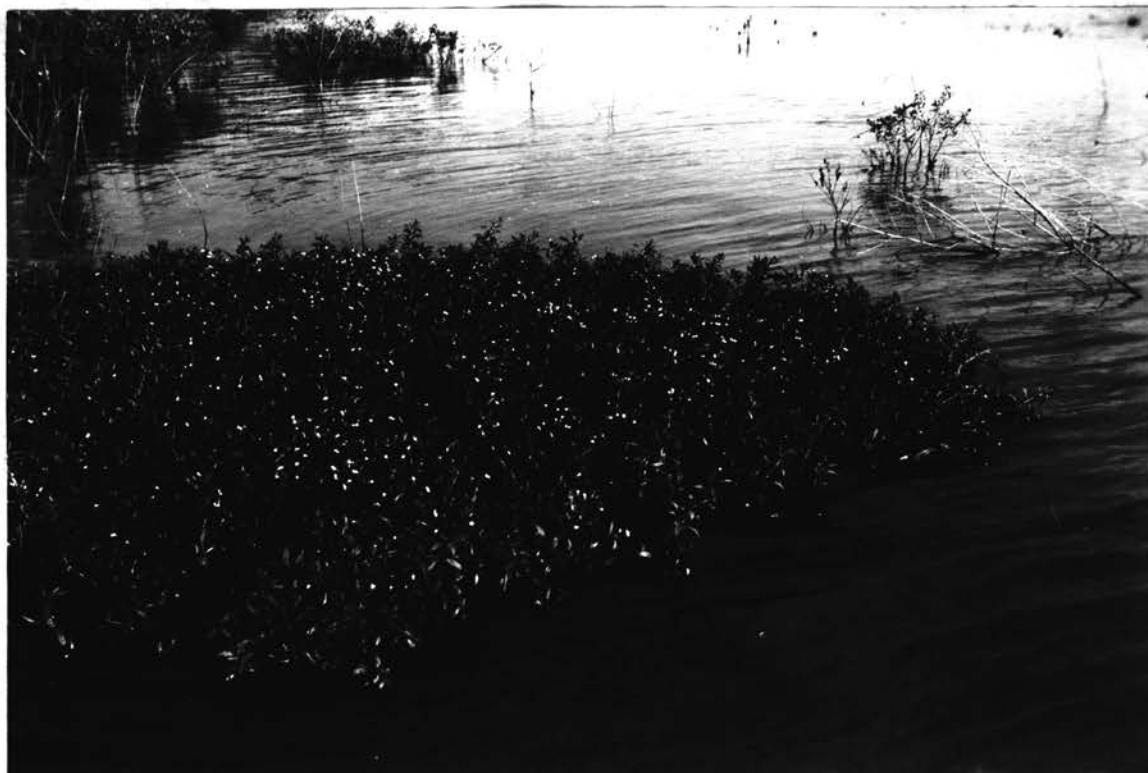
Fig. 41. Justica lanceolata Chapm., Water Willow. The Water Willow spreads from under-water rootstalks.- Elev. 941.60', Area 1, September 18, 1951.

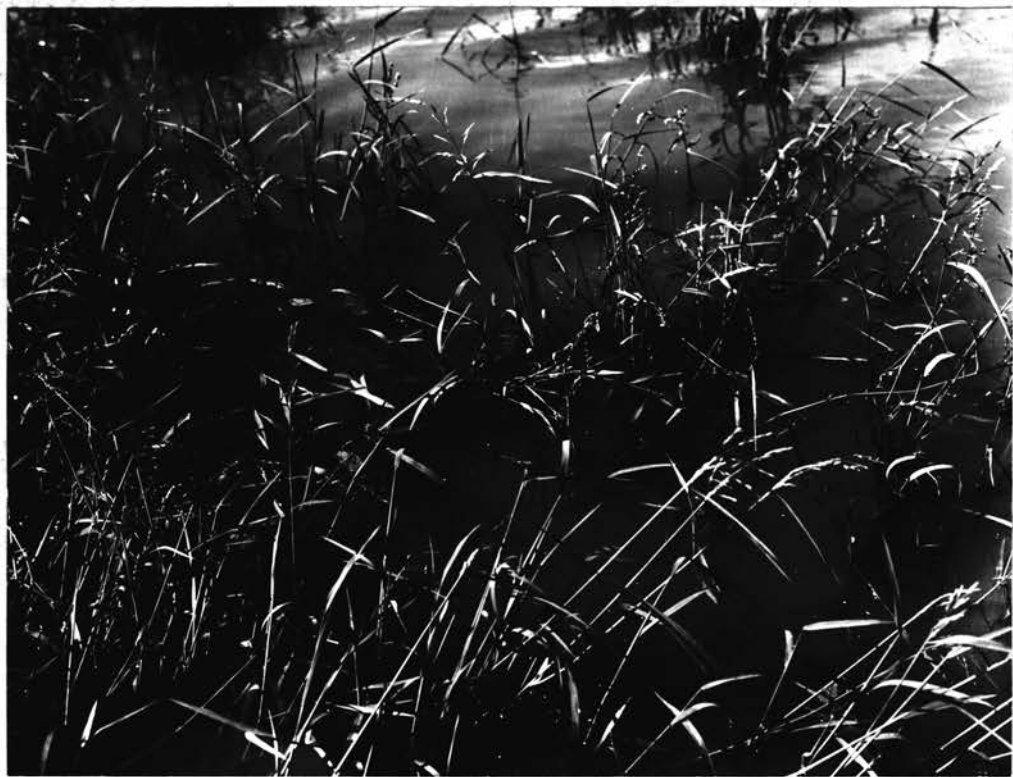
Fig. 42. Leersia oryzoides (L.) S.W., Rice-Cutgrass.  
The Rice-Cutgrass grew to maturity from submerged root-  
stalks.- Elev. 941.79', Area 13, September 26, 1951.

This perennial was first observed in the inundated condition during the high waters of 1951. The plant (fig. 42) at the

941.79' level developed to maturity from rootstalks below the surface of the water. It is believed that this plant will continue to live through the season of 1952 though it remains in the inundated condition.

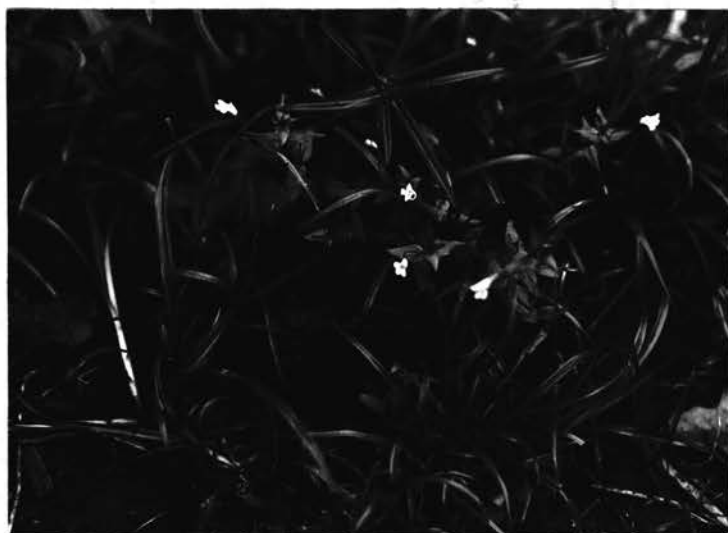
Fig. 44. Lindernia anagallidae (Michx.) Pennel, False Pimpernel. The flowering False Pimpernel survives the competition of Ammannia and Cyperus.- Elev. 944.60', 944.00', Area 10, August 22, 1951.

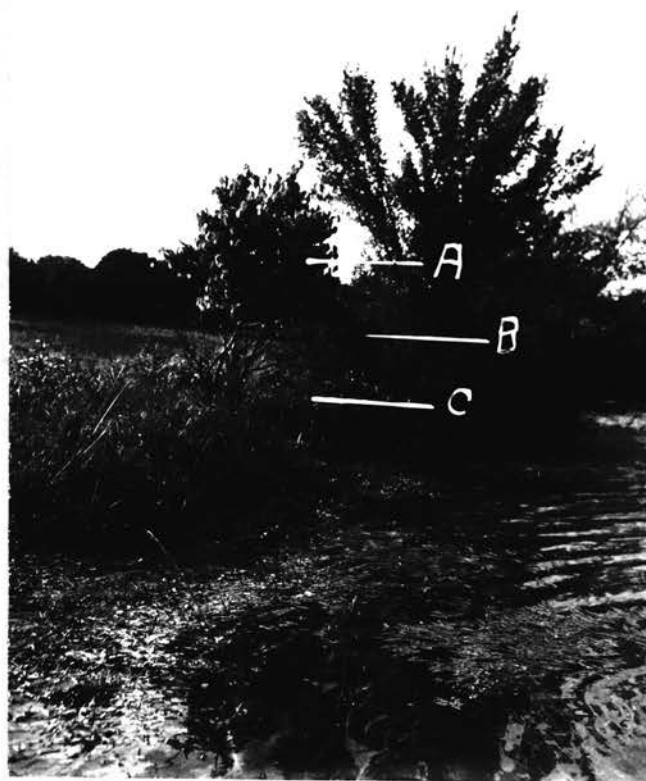
Fig. 46. Plant Study Group. (A) Mulberry, (B) Dogwood, (C) Smilax. Note morphological changes. Area 7, August 22, 1951.

The Common Dogwood on July 8, 1951 after six weeks of water coverage at the 942.54' level showed no apparent ill effects from inundation. Nevertheless, by August 5, 1951 most of the chlorophyll had disappeared from their leaves (fig. 45, B) and by August 22, 1951 most of the leaves had dropped from the plants (fig. 46, B). On the other hand plants at the lower level (941.70') had lost most of the chlorophyll from their leaves before July 28, 1951 (fig. 21).

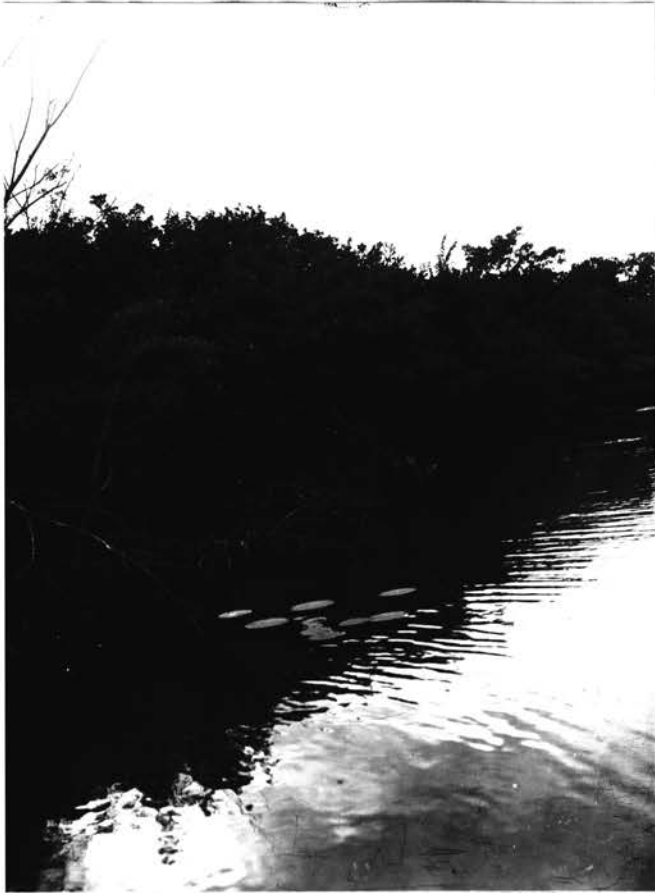
Fig. 48. Nelumbo lutea (Willd.) Pers., Water-Chinquapin, Wonkapin. First leaves of the Water-Chinquapin reach the surface.- Elev. 941.43', 939.93', Area 13, August 8, 1951.

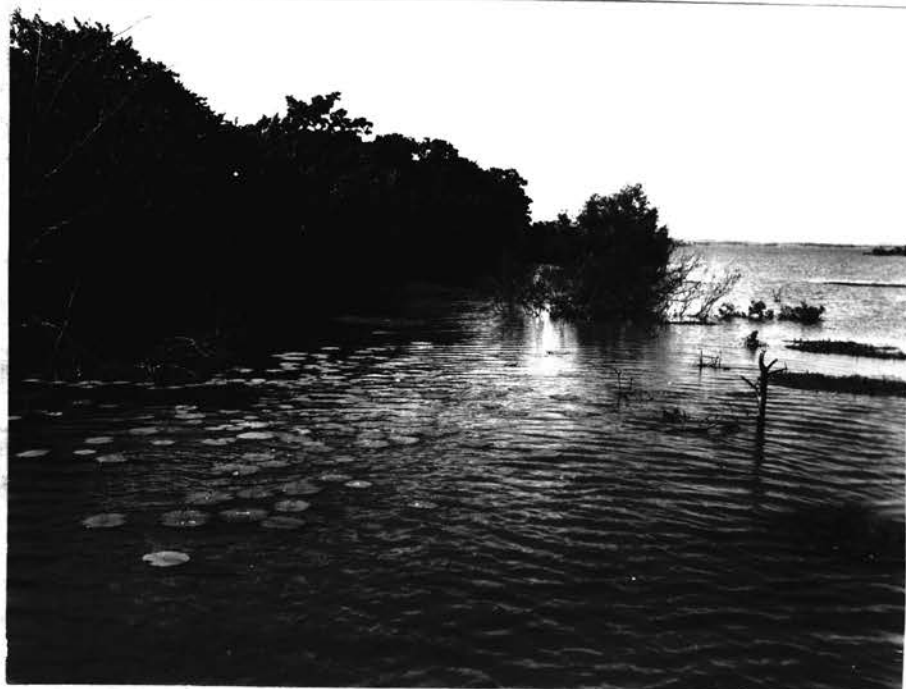
Fig. 49. Nelumbo lutea (Willd.) Pers., Water-Chinquapin, Wonkapin. Same location as figure 48 showing increase in surface leaves.- Elev. 941.43', 939.93', Area 1, October 1, 1951.

The floating leaves of Nelumbo lutea were first noted coming to the water's surface on August 8, 1951 (fig. 48). By October 1, 1951 many of the leaves had reached the surface (fig. 49). It is quite probable that the actively growing leaves of this plant came from rootstocks that established themselves during the high waters of 1944 and 1945. If the supposition is true the plants existed through the dry years of 1946 and 1948.

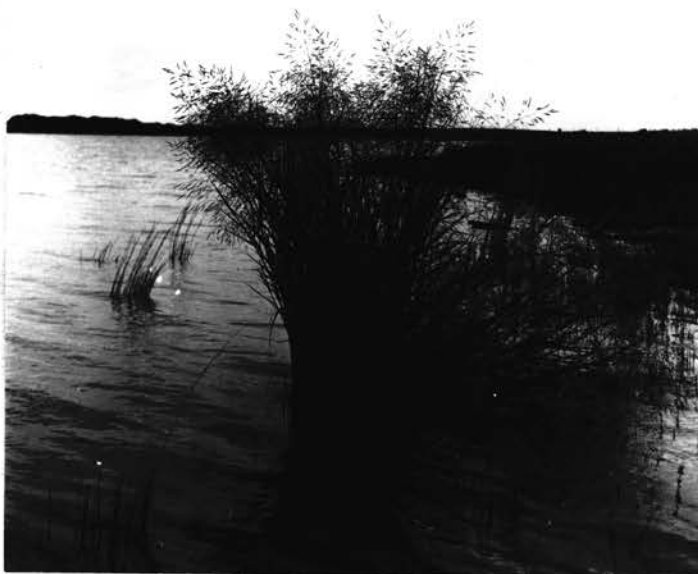
Fig. 50. Panicum virgatum L., Switchgrass. Switchgrass reaches maturity with water covering its base.- Elev. 943.07', Area 7, August 22, 1951.
