WATER FLUCTUATION AS A FACTOR IN THE LIFE OF  
THE HIGHER PLANTS OF A 3300 ACRE LAKE IN THE  
PERMIAN RED BEDS OF CENTRAL OKLAHOMA

for the Degree of  
DOCTOR OF PHILOSOPHY

1952

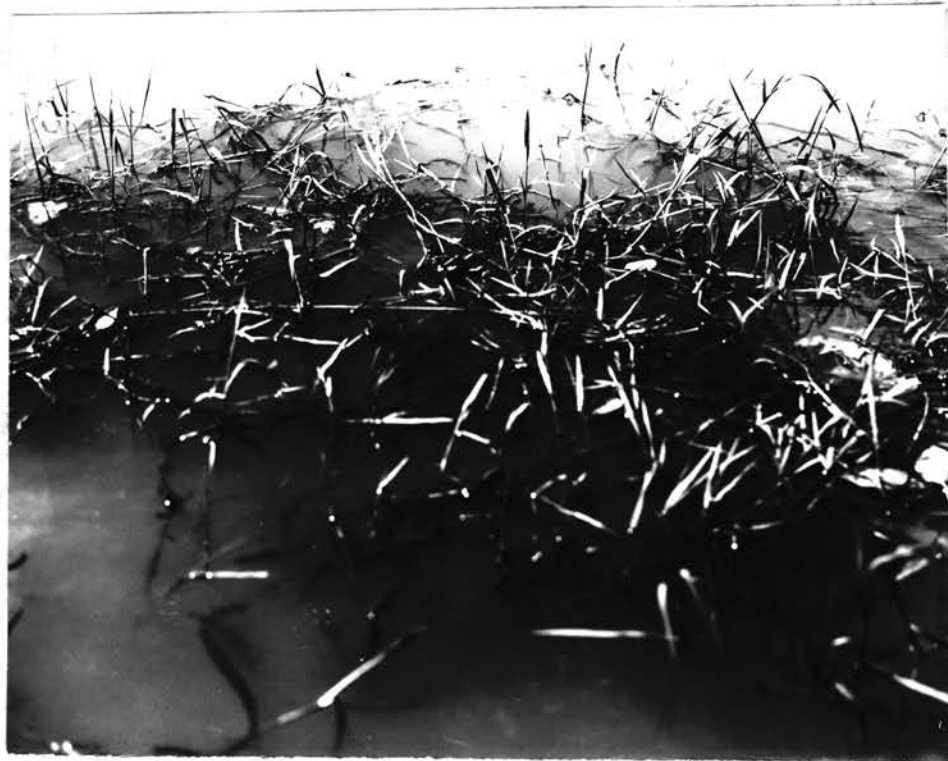
Fig. 51. Paspalum distichum L., Knotgrass. Surface characteristics of the plant after three and half months inundation.- Elev. 939.15', Area 13, August 16, 1951.

Knotgrass was found in the lake as low as the 939.15' level (fig. 51). It continued to exist at this level throughout the summer but did not produce fruit. However plants from the 944.60' level down to the 942.09' level did produce fruit. It is not likely that the plants from the 942.09' level down to the 939.15' level will survive deep water through another year. Even the plants in shallow water may die if they remain submerged.

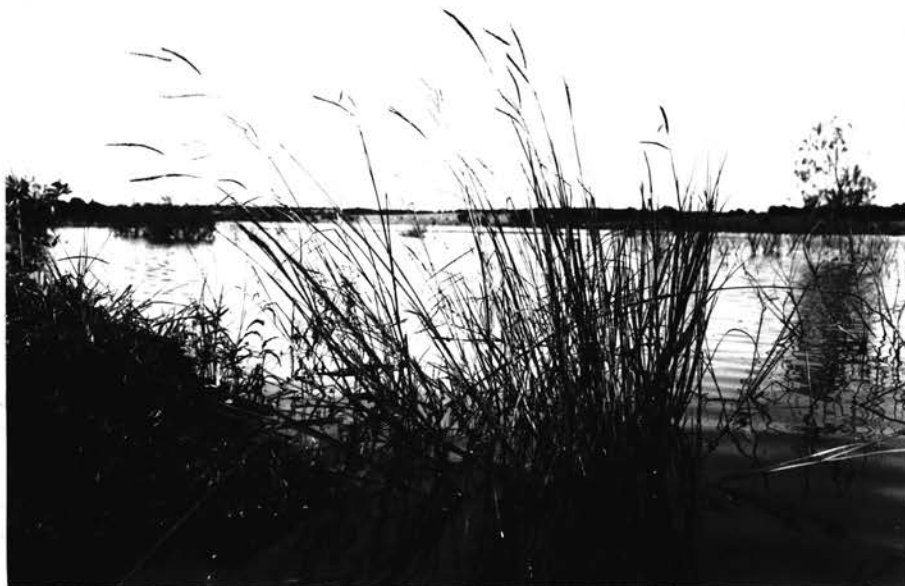
Fig. 52. Paspalum floridanum Michx., Florida Paspalum. Illustrating the ability of the plant to reach maturity after four months inundation of its base.- Elev. 942.68', Area 13, August 16, 1951.

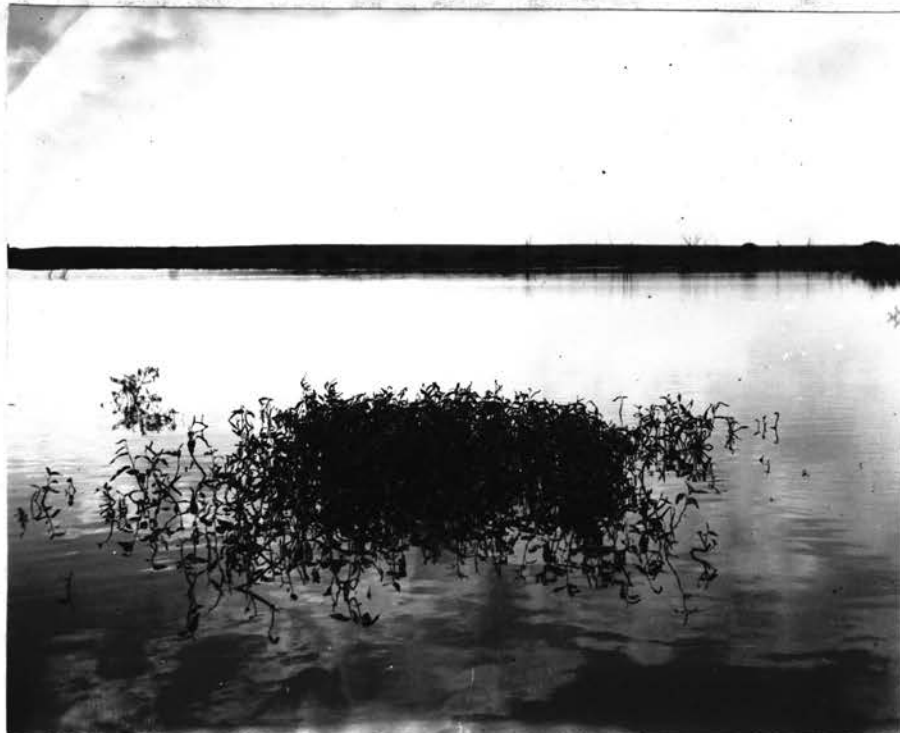
Fig. 53. Polygoneum coccineum Muhl., Water Smartweed. A characteristic group.- Elev. 937.70', Area 2, July 28, 1951.

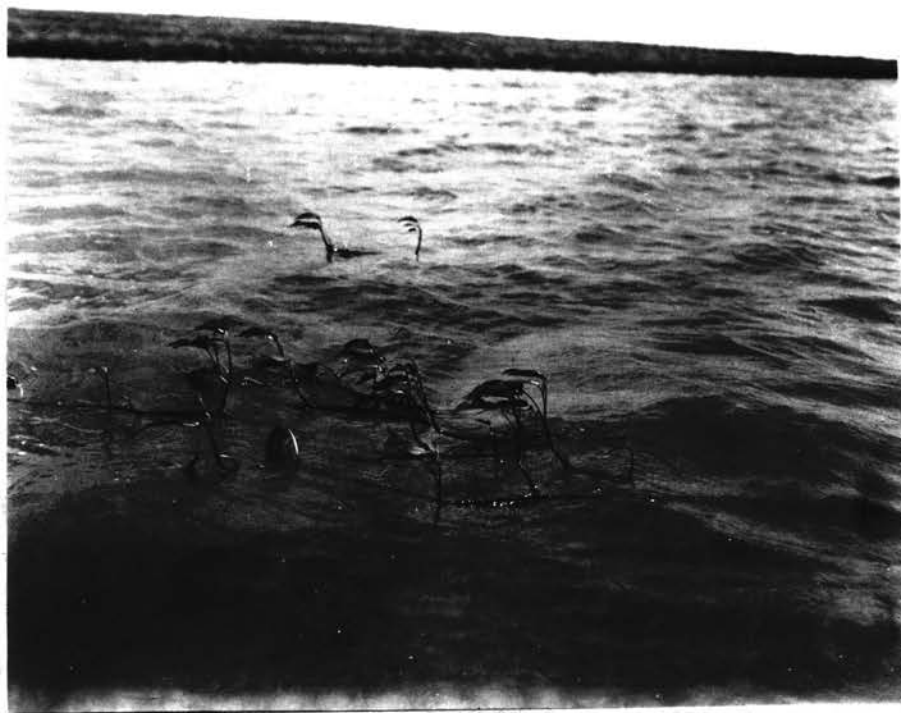
Fig. 54. Polygoneum coccineum Muhl., Water Smartweed. Showing plant modification to meet conditions in a wind swept area.- Elev. 938.10', Area 4, July 9, 1951.

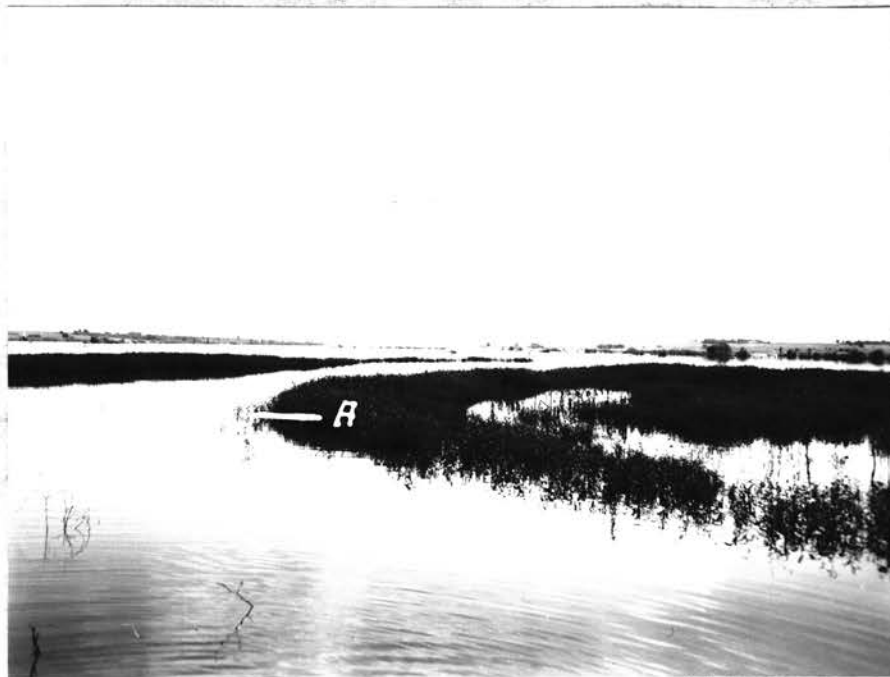
Fig. 55. Polygonum lapathifolium L., Dock-leaved Smartweed. The establishment of plants ceased sharply at the 937.35' level along the edge of the old creek bed.- Elev. 940.35', 939.35', Area 1, July 28, 1951.

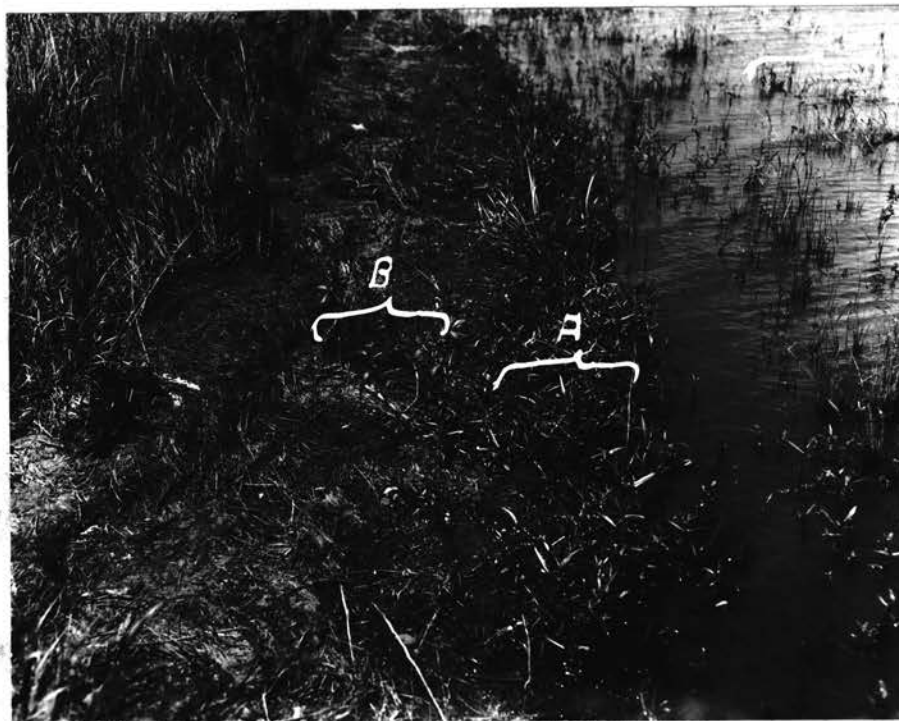
Fig. 56. Shore Line Study Group. Showing areas of seedlings. (A) Ammannia, (B) Cyperus and Polygonum, (D) Potamogeton.- Elev. 944.60', 943.60', Area 7, August 5, 1951.

The American Pondweed was found in abundance at two general levels in the lake, the 940.10' to 938.10' level (fig. 68, A) and the 942.67' to the 941.67' level (fig. 68, B). The graph (fig. 6) shows two high water periods during the past two years. The first rising to the 940.65' level in the midsummer months of 1949; the second rising to the 942.90' level during the late summer months of 1950. The presence of the majority of the plants at these two levels suggest that these plants began their active life in the shallow water areas during these two high water periods. The well established plants of the 940.10' to 938.10' level reached the water's surface about the middle of June while the plants of the 942.67' to 941.67' level did not reach the surface until August. The appearance of the latter group of plants at the surface can be noted by examining area D) of figures 56 and 57.

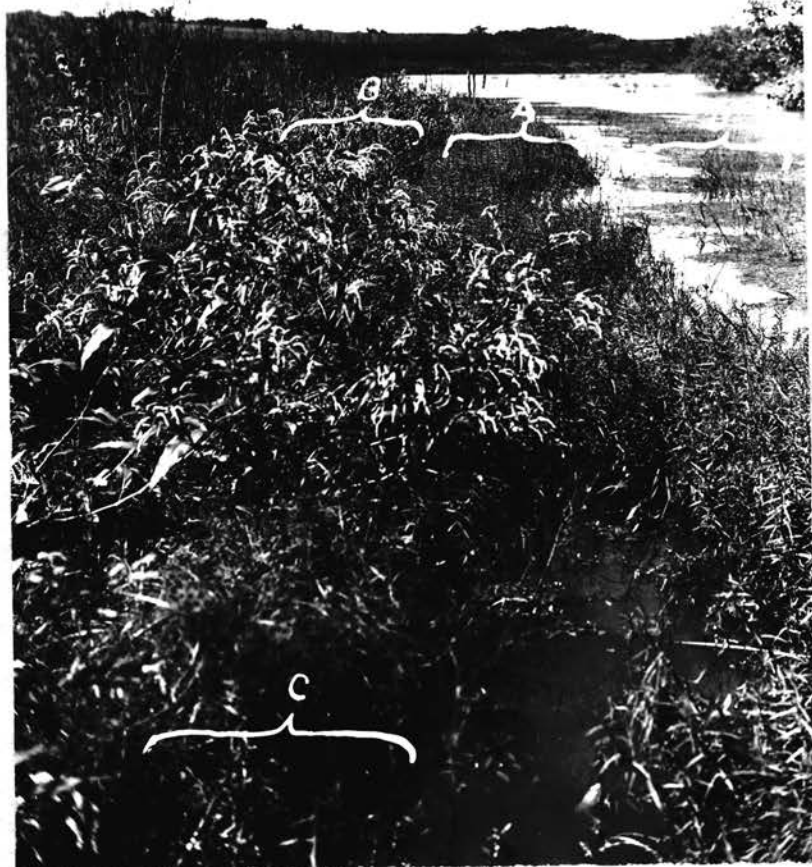
Fig. 57. Shore Line Study Group. Same group as figure 56 showing growth. (A) Ammannia, (B) Polygonum and Cyperus, (C) Cyperus, (D) Potamogeton.— Elev. 944.60', 943.60', Area 7, September 16, 1951.

seeds to germinate before that of the competitive Scarlet ammannia. After the middle of July a rapid drawdown of the water level would allow the two plants to germinate at about the same time and thus even their chances of survival. In either case the plants would have to compete with the larger Polygonums. In figure 10 the narrow zone of Cyperus (C) and Polygonum (D) shows plainly the potency of the ammannia (A) as a competitor. The group shown in this photograph is a result of the slow decrease of the water level beginning about July 15, 1951. A similar plant arrangement can be seen in figure 57.

near the seedlings of the Cyperus and the Polygonum, shown by the bracket (B) figure 57, grew to maturity. Where the stand of Polygonum was heavy the Cyperus plants were stunted or even killed. Where the stand of Polygonum was light the Cyperus grew to maturity (fig. 57, C).

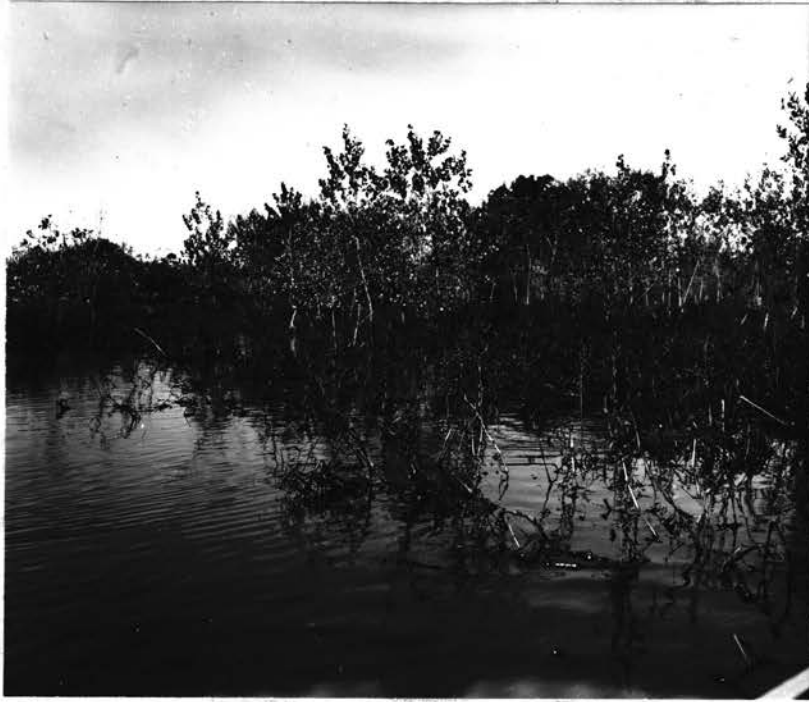
Fig. 58. Plant Study Group. Cottonwood trees in the Polygonum filled water of the old creek bed.- Elev. 944.60', 940.00', Area 1, October 8, 1950.

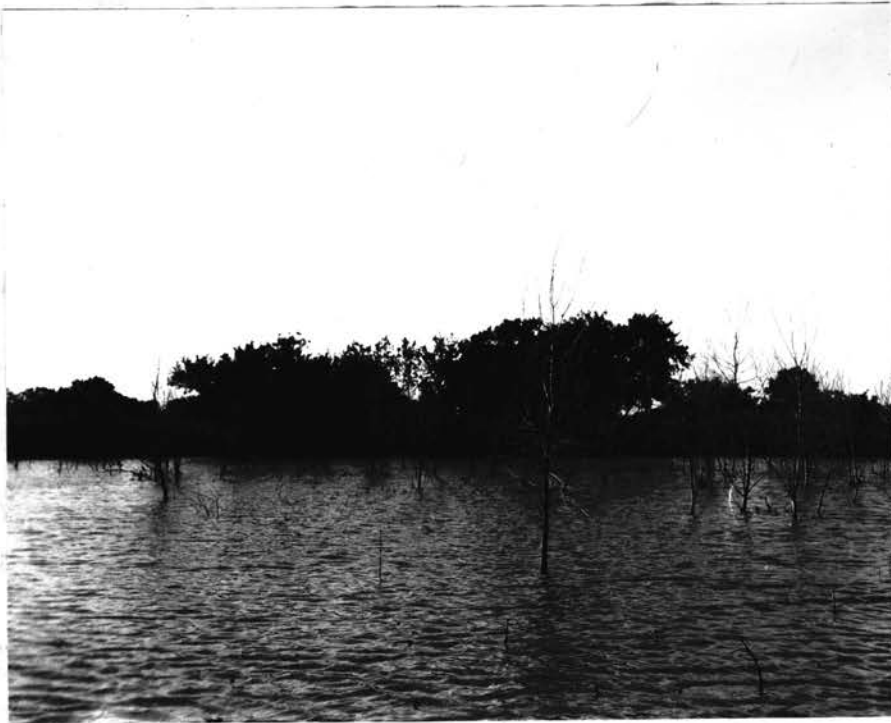
Fig. 59. Plant Study Group. Same group as shown in figure 58 illustrating the early killing of the Cottonwood trees in the quiet detritus filled water.- Elev. 944.60', 940.00', Area 1, August 25, 1951.

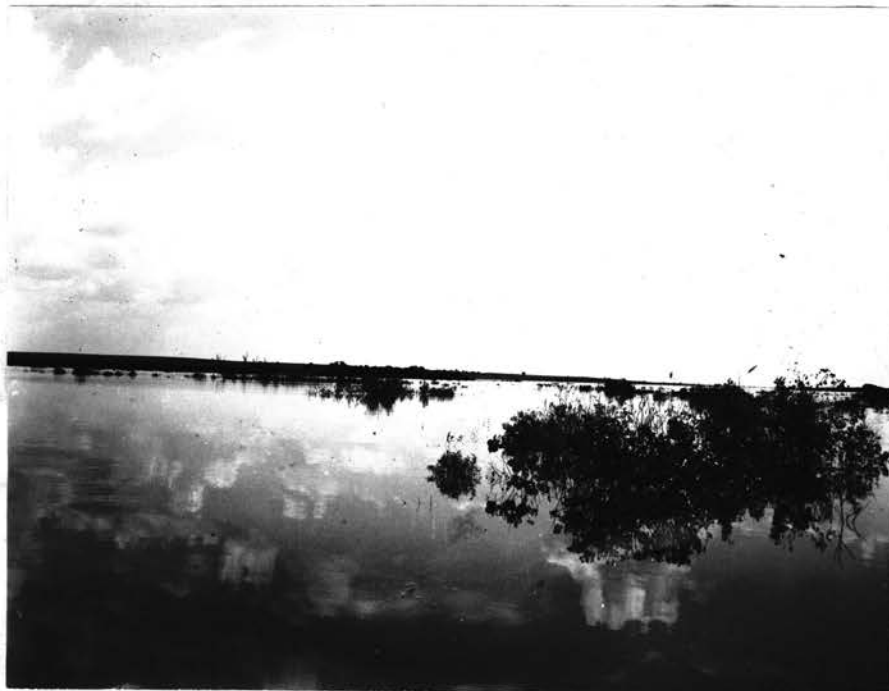
Fig. 61. Populus deltoides and Salix nigra Study Group. Same area as shown in figure 60 showing the prolonged viability of the trees in open water.- Elev. 939.85', 939.35', Area 1, August 25, 1951.

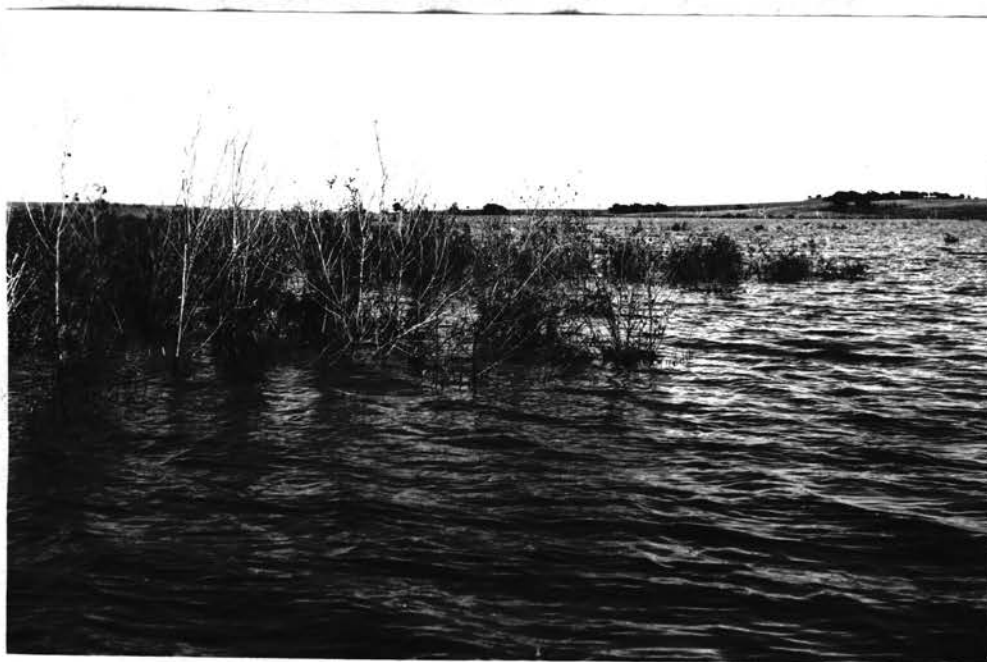
Fig. 62. Populus deltoides Marsh., Cottonwood. Tall two and three year old Cottonwood trees died earlier than the short two and three year old trees.- Elev. 940.09', 939.59', Area 1, September 18, 1951.

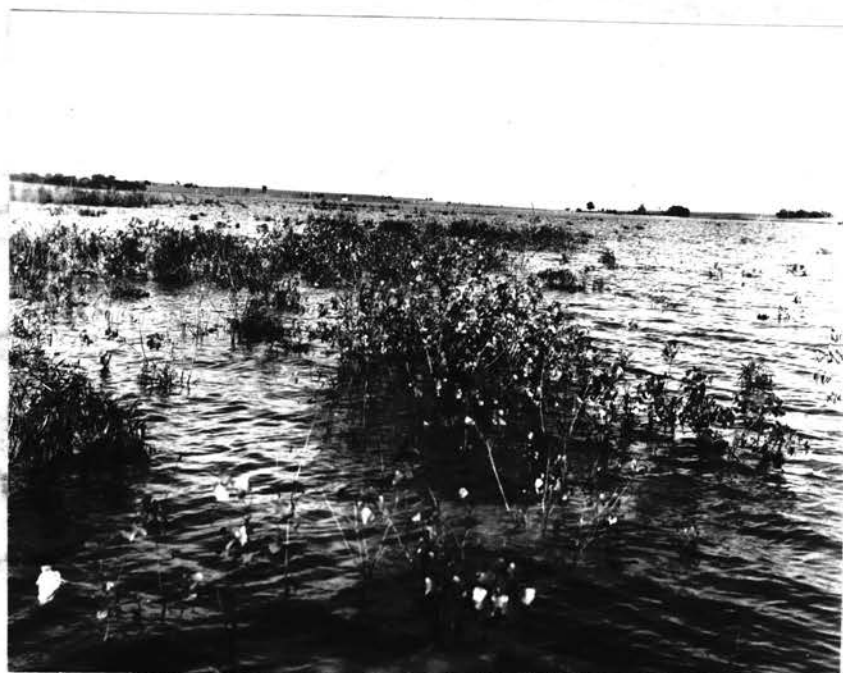
Fig. 63. Populus deltoides Marsh., Cottonwood. Same area as above showing prolonged viability of short two and three year old trees.- Elev. 940.09', 939.59', Area 1, September 18, 1951.

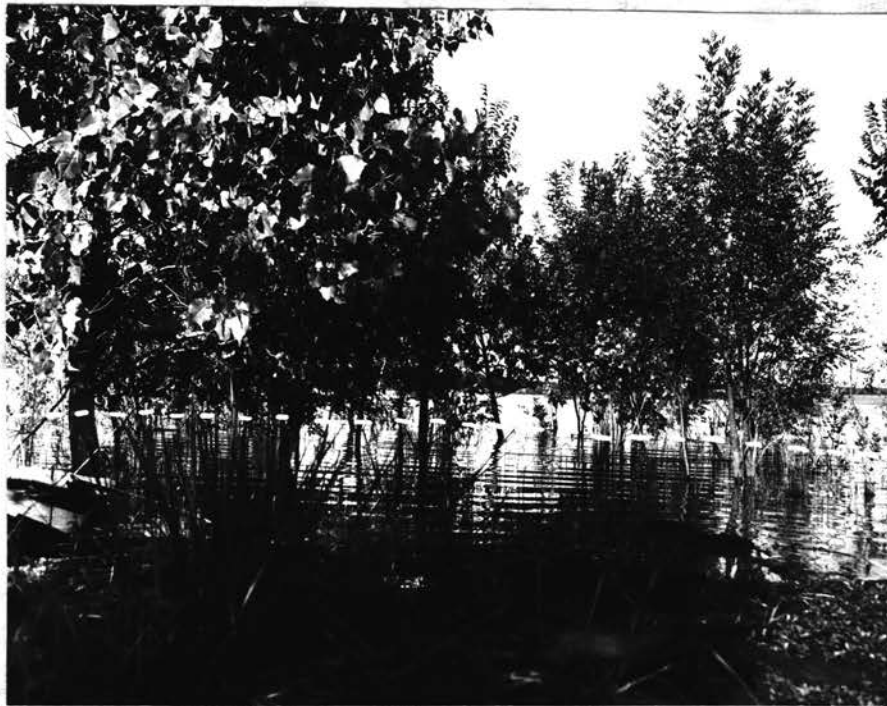
Fig. 64. Six year old Study Group. Dotted line marks limit of establishment at the 940.18' level.- Elev. 944.60', 940.18', Area 13, August 16, 1951.

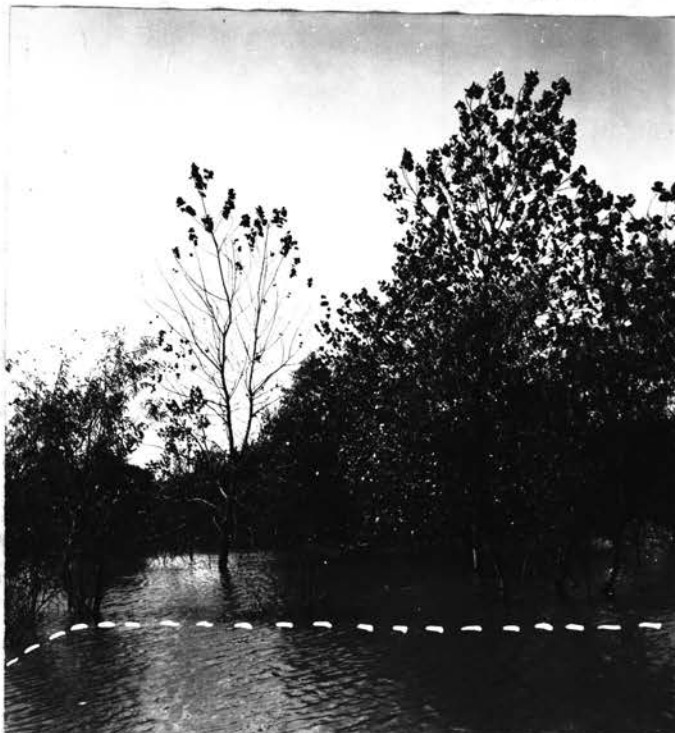
Fig. 65. Six year old Study Group. Same group as figure 64 but taken from the opposite direction.- Elev. 944.60', 940.18', Area 13, October 1, 1951.

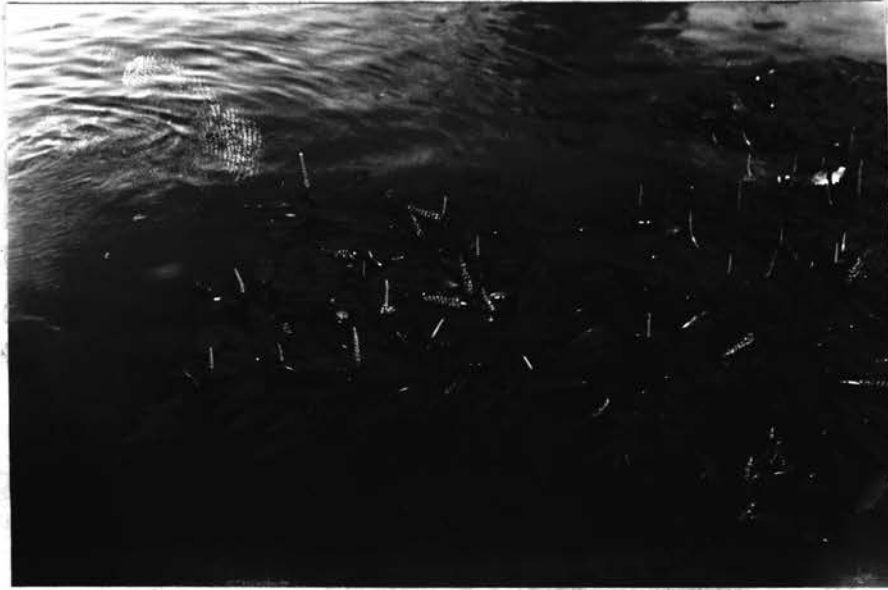
Fig. 67. Potamogeton nodosus Poir, American Pondweed.  
Floating characteristics of leaves and fruiting bodies.  
-Elev. 940.10', 938.10', Area 13, July 9, 1951.

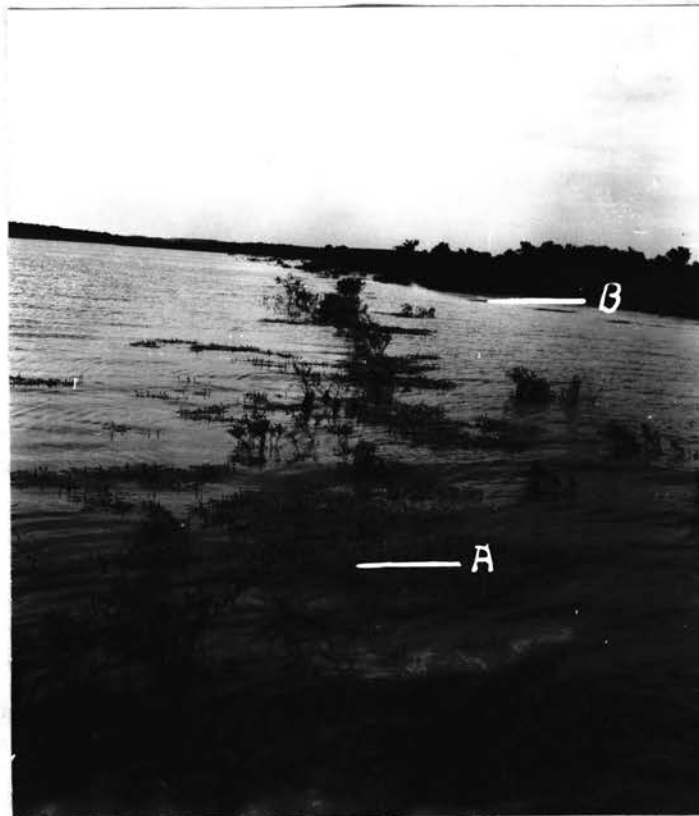
Fig. 68. Potamogeton nodosus Poir, American Pondweed.  
The American Pondweed had established itself at two different levels.- Elev. A; 940.10', 938.10', Elev. B; 942.67', 941.67', Area 7, August 22, 1951.

evels might produce large crops of this plant in a lake once it is seeded. However, more investigation is needed to prove this assumption. The possible use of the American Pondweed should not be overlooked in the fluctuation zone area.

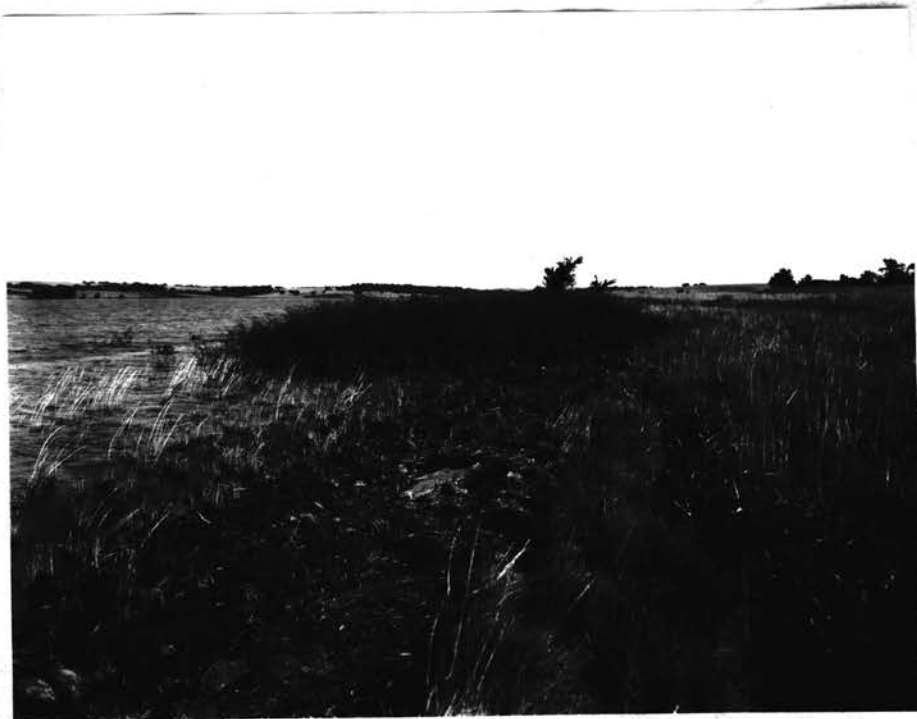
Fig. 69. Prunus angustifolia Marsh., Chickasaw Plum. These Chickasaw Plum trees lived through the high water inundation of the fall of 1945 but were killed quickly by water coverage during the summer months of 1951.- Elev. 944.60', 945.05', August 25, 1951.

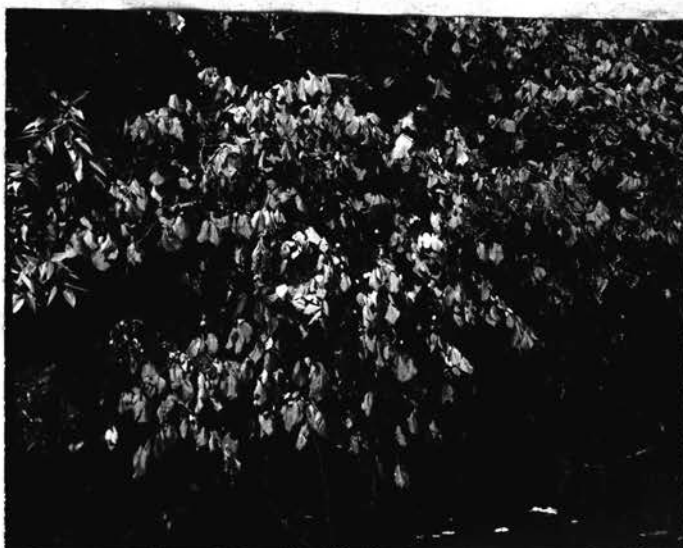
Fig. 70. Prunus americana Marsh, var. lanata, American Wild Plum. Registrating the flaccid condition of the leaves.- Elev. 944.09', Area 2, July 28, 1951.

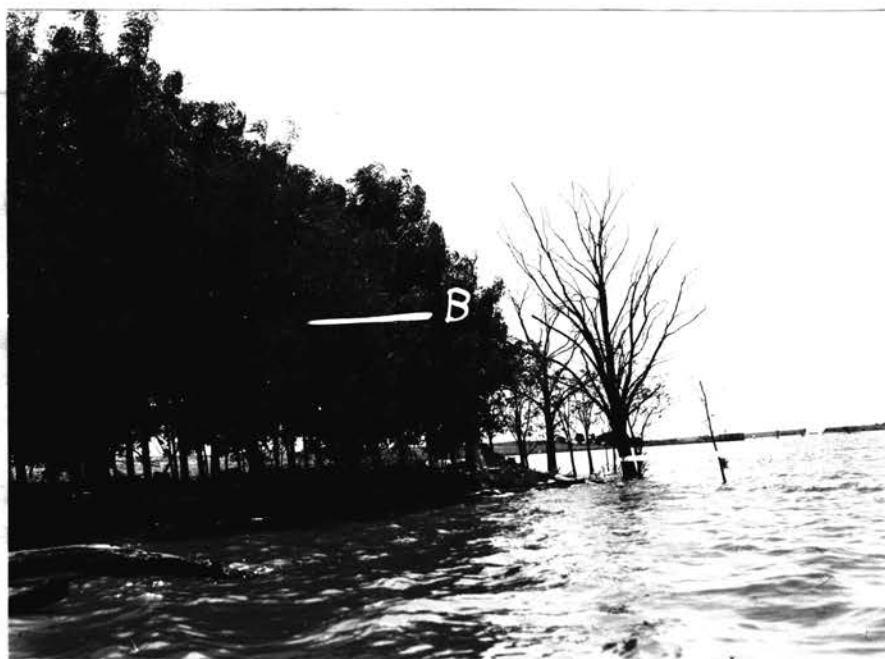
Fig. 75. Robinia Psuedo-Acacia L., Black Locust. The lack of resistance to inundation is shown by the dead tree (A) and the dying tree (B) which is above the water line.- Elev. 944.60', 944.00', Area 3, July 8, 1951.

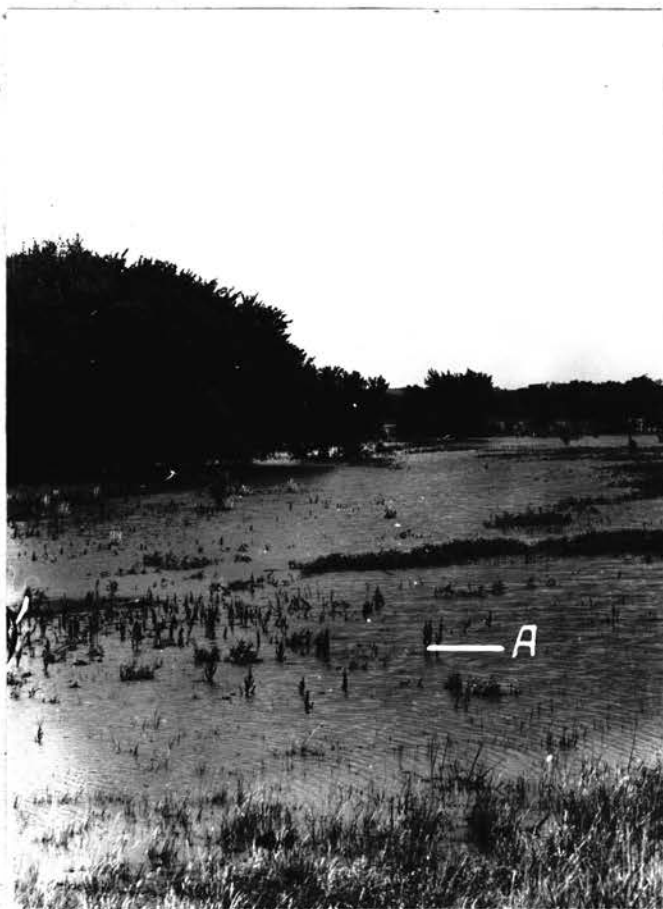
Fig. 76. Rumex crispus L., Yellow Dock. The Yellow Dock soon after inundation.- Elev. 944.60', 942.90', Area 1, July 3, 1951.

Yellow Dock as well as most of the herbaceous upland plants succumbed quickly after inundation. Figure 76, A shows the plant in water at the 942.90' level on July 3, 1951.

e addition of organic matter and nutrients to the water through  
ath and decomposition. This is true of most of the herbaceous  
land plants found in the fluctuation zone.

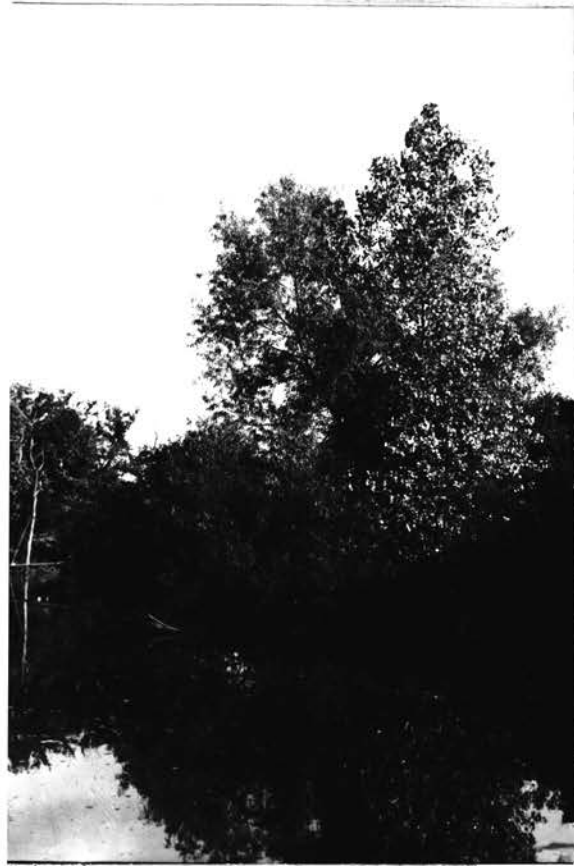
Fig. 77. Plant Study Group.  
Populus deltoides. - Elev. 942.70',  
Salix nigra. - Elev. 940.20', Area  
 2, July 28, 1951.

The Black Willow was found in every section of the lake.  
Its presence in numbers indicates its adaptability to lake shore  
environment. A few trees still exist that were present in the  
old creek bed before the lake was built. Figure 77 shows one of  
these trees at the 940.20' level. This tree withstood inundations  
of its base in 1943, all of 1944 and 1945, a short period in  
1947, 1949, and 1950 and was still alive on October 25, 1951  
(fig. 78). This tree and all of the other trees older than six  
years were found next to a shore possessing a high bank. The  
top of the tree shown in figure 78 started losing its leaves  
long before the leaves near the base. This again suggests as in  
the case of the Cottonwood that the distance of transportation

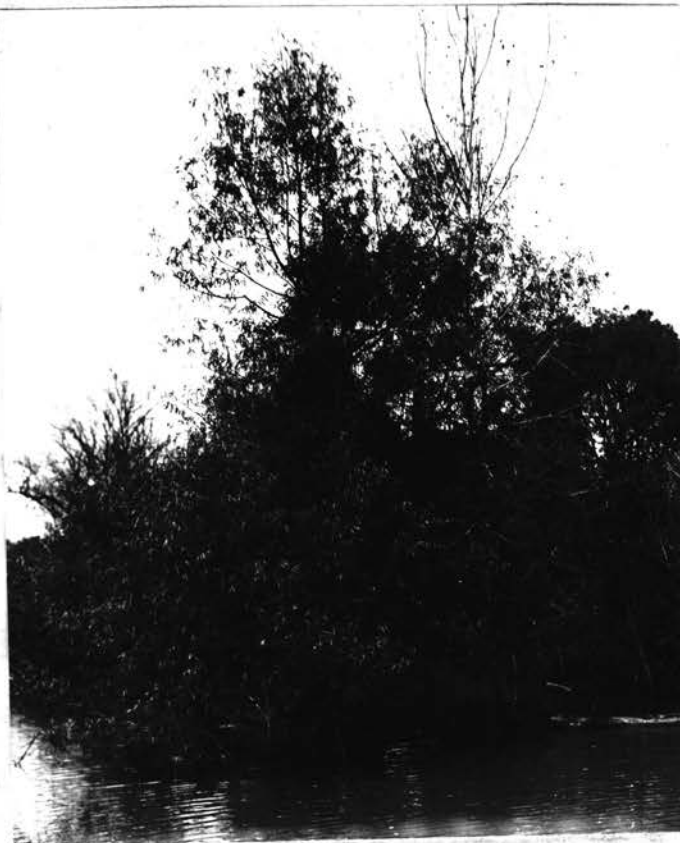
Fig. 78. Plant Study  
 Group. Same group as  
 above. The Cottonwood  
 and the top branches  
 of the Willow died  
 while the lower branches  
 of the Willow remained  
 live. - Populus deltoi-  
des Elev. 942.70', Salix  
nigra Elev. 940.20',  
 Area 2, October 25, 1951.

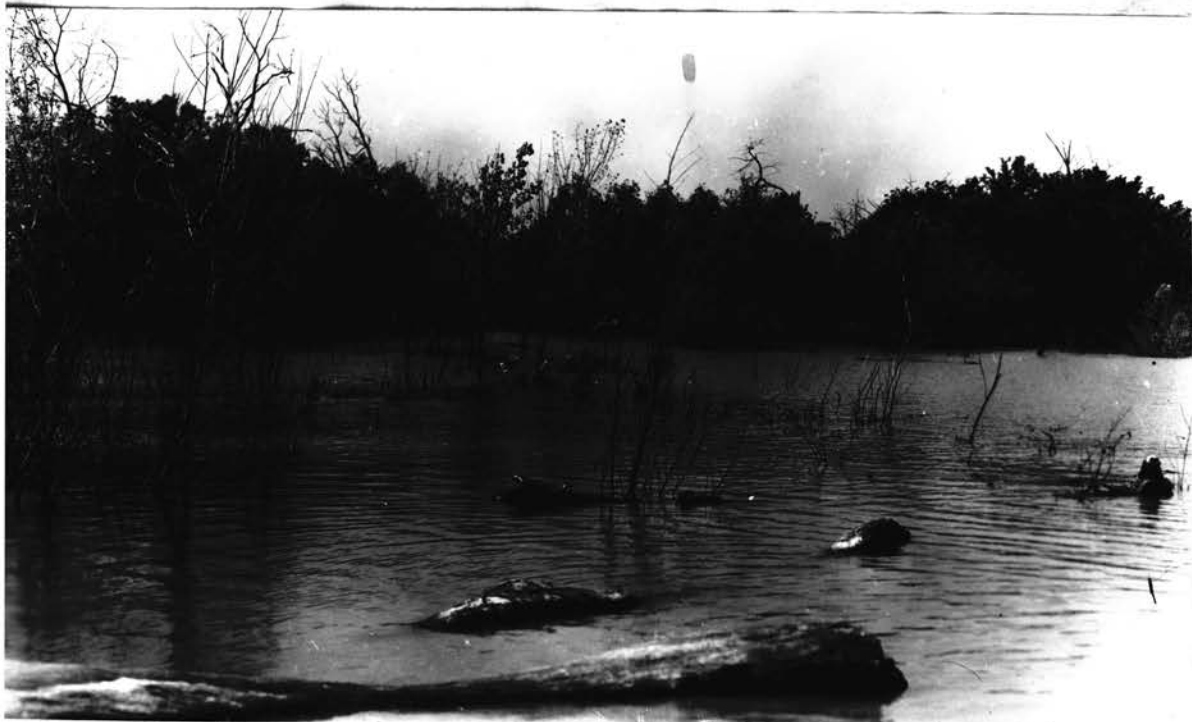
Fig. 79. Salix nigra, Populus deltoides. These trees lived only a short time in the quiet detritus filled waters.- Elev. 944.60', 939.10', Area 1, June 23, 1951.

f water to the leaves might be a killing factor. The tall Willow trees illustrated in figure 80 also showed an earlier discoloration and killing than the shorter trees. The Black Willow as was the case with the Cottonwood tree did not live as long after inundation in the quiet detritus filled waters of the sloughs (fig. 79) as they did in the open waters (fig. 80).

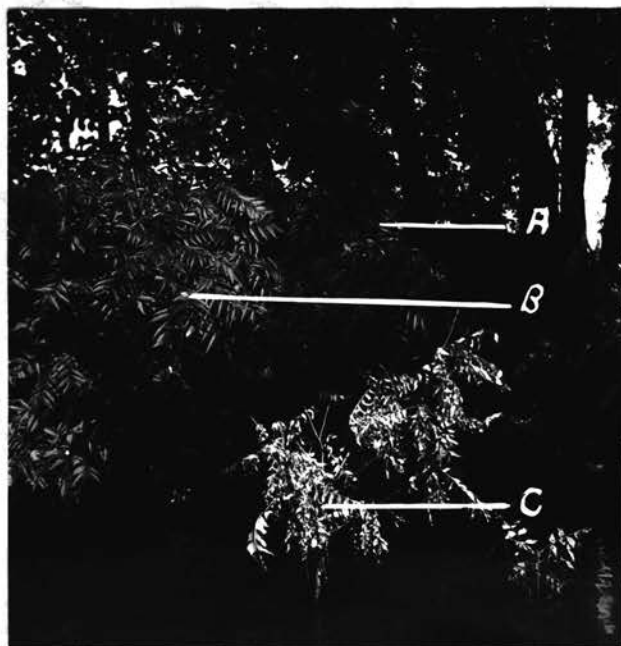
Fig. 80. Salix nigra. Showing prolonged viability of the Black Willow in open water.- Elev. 944.60', 939.10', Area 13, October 1, 1951.

The endurance to inundation of some of the young trees as shown in figure 80 would indicate a rather long inundation killing period time especially in shallow water. The fact that none of the trees older than six years were found in the lake except at the higher levels or near the bank indicates that the killing time is much shorter. The Willow has the ability to put forth adventitious roots from the stem below the water line. These furnish succor to the plants, thus giving a false impression as to killing time. The inundation killing time of this plant will vary considerably with its age and with its location in the lake. Its normal inundation killing period appears to be well over two months and for this reason it is recommended for use as a shade tree at or near pool levels. The young trees when covered with water serve as protection to small fish and add considerably to the esthetic value of a lake.

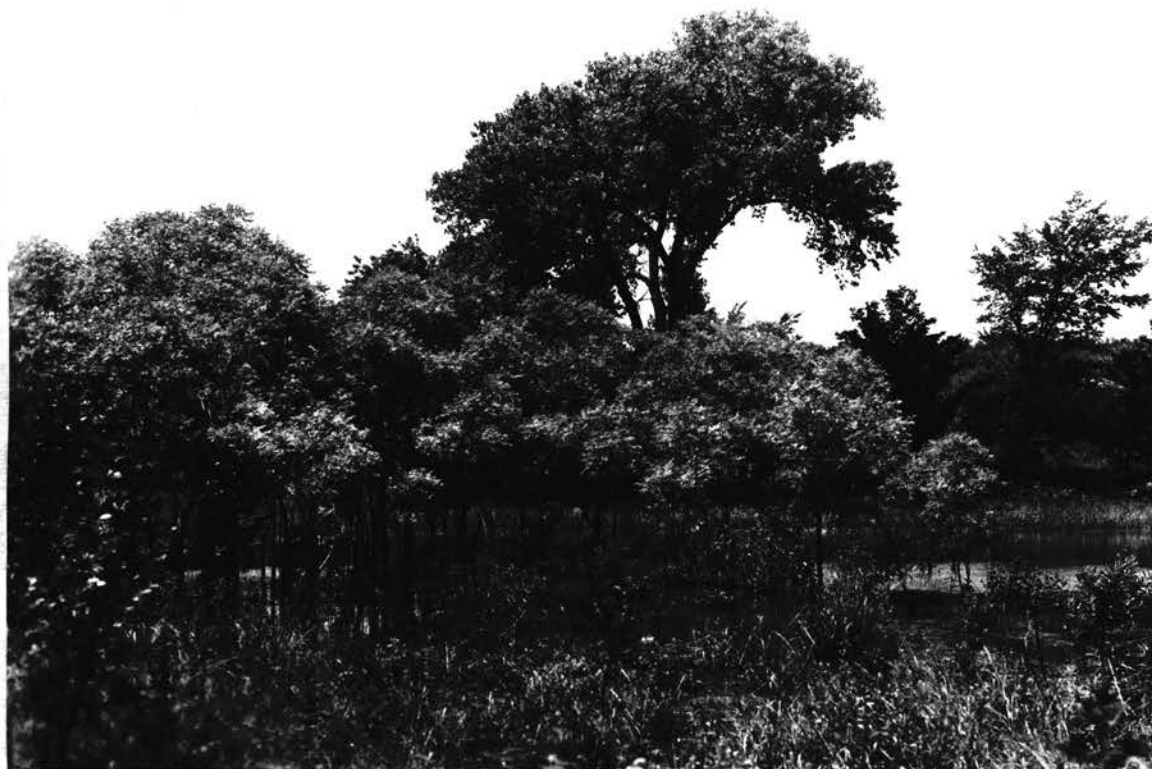
Fig. 82. Sapindus Drummondii, Soapberry. Early discoloration of the leaves was noted in this group of Soapberry trees.- Elev. 943.70', 942.80', Area 1, July 3, 1951.

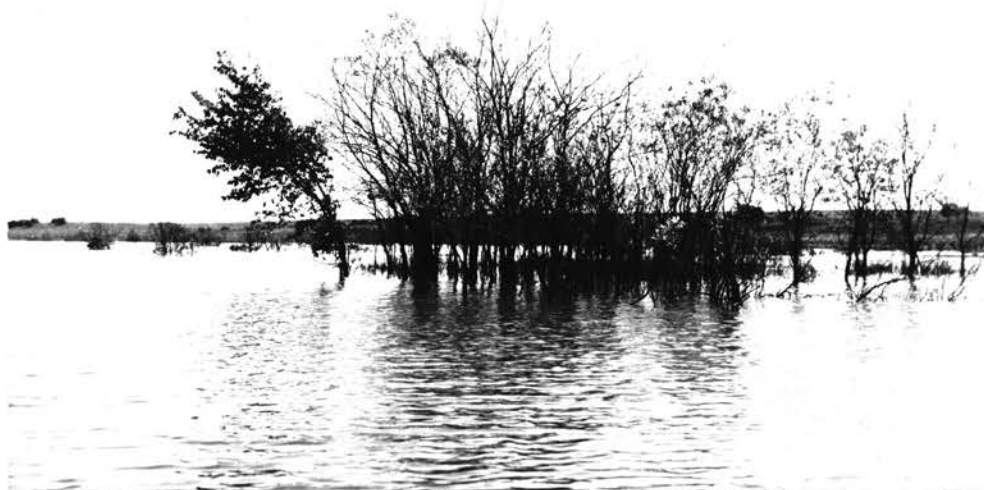
Fig. 84. Sapindus Drummondii, Ulmus americana. Same group as shown in figure 83 illustrating the difference in viability of the American Elm and the Soapberry.- Elev. 943.60', 943.20', Area 7, September 16, 1951.

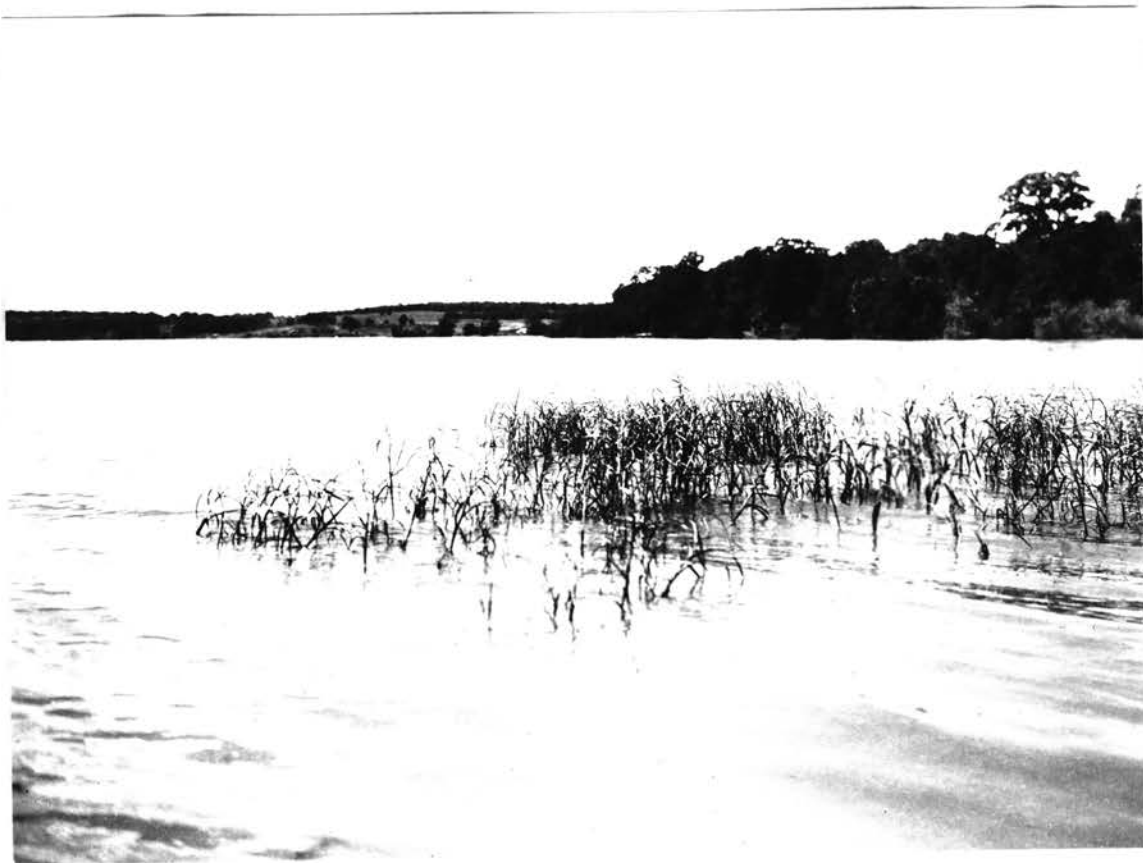
Fig. 85. Scirpus sp. ? General growth characteristics of the plants.- Elev. 940.10', 939.10', Area 13, September 16, 1951.

Scirpus sp. probably introduced by man, was found only in area 13 at the location shown in figure 85. The plant was noted at its present site by the writer while fishing in the lake during the summer months of 1945. Apparently, the plants have persisted in dry soil through the summers of 1946 and 1948.

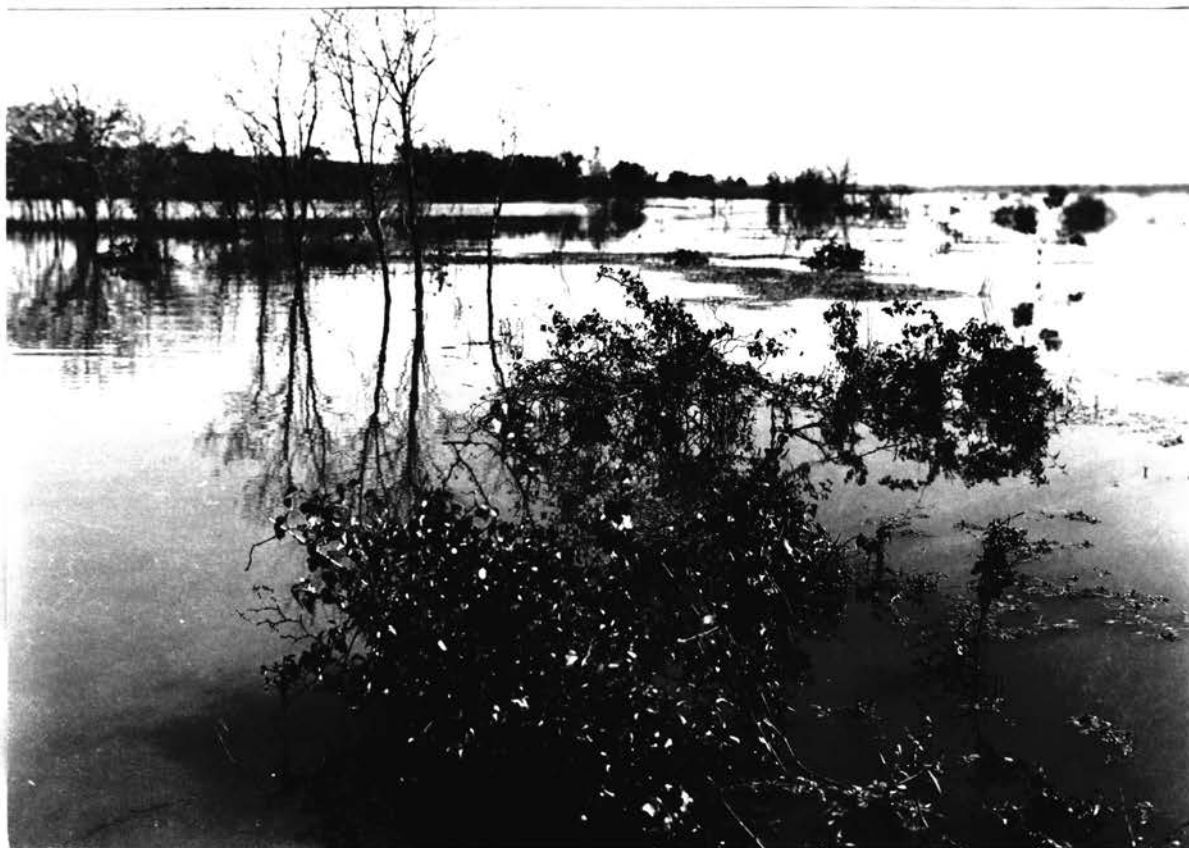
Fig. 86. Smilax Bona-nox L., Greenbrier. This Greenbrier remained visible late in the season.- Elev. 943.20', Area 7, September 16, 1951.

The Greenbrier was found to be quite resistant to inundation. Plants at the 942.79' level, with their bases continually under water remained viable from June 6, 1951 to October 1, 1951 (fig. 85). Others were found that were still viable on October 25, 1951 at the 941.71' level. The Greenbrier (C) of figures 45, 46, and 47 of the, "Plant Study Group, Area 7", shows the plant at the 942.79' level and allows a comparison of its viability with that of the other plants in the group; namely, the Red Mulberry, the Dogwood and the Elm.

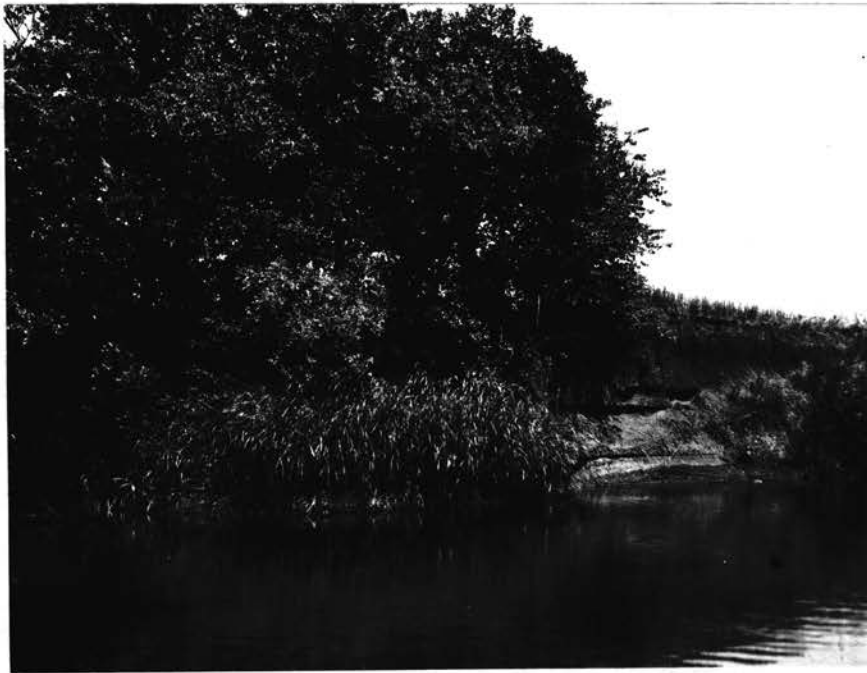
Fig. 87. Sorgum halepense, Johnson Grass. Showing lower limit of growth at the 944.23' level. note the high-water-cut-marks in the old creek bank.- Elev. 944.60', 944.23', Area 1, August 24, 1951.

Figure 32 shows a tree that has continued to exist in the old creek bed of area 1 at the 937.60' level until after the early part of the high water flooding of 1951. The tree was cut to determine its age (43 years). The tree probably would have succumbed before 1951 had not some of its roots been able to reach aerated soil on the creek bank above the level of the water in the creek bed. This tree also survived much higher inundations during the times that flood waters entered the creek. Figure 87 shows flood-water-cut-marks one of which is approxi-

Johnson grass was observed only at one place in the lake ad below the 944.60' level though it is quite prevelant at igher levels. The Johnson grass shown in figure 87 extends ownward to the 944.23' level and forms a definite line at that evel. The line was probably produced by the inflowing waters f the creek which were higher than spillway level.

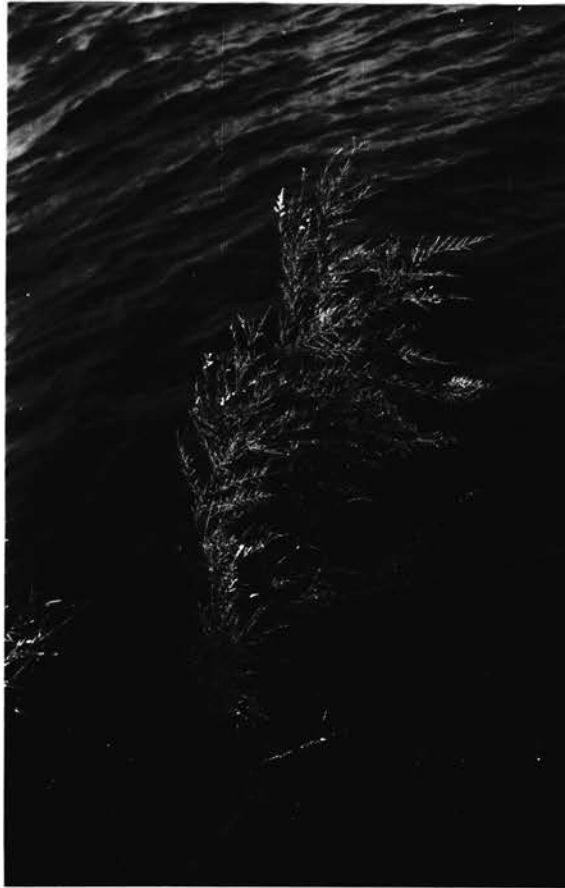
Fig. 88. Tamarix gallica, Salt Cedar. This plant remained viable through the development of adventitious roots just below the water line.- Elev. 940.40', 939.40', Area 11, August 25, 1951.

The Salt Cedar was found between the levels of 940.40' and 39.40' and only in one location (fig. 88). The plants in this rea were in their fifth and sixth years, having started life in 946 and 1947. The plants which started in 1946 lived through ree months inundation in 1947 and 1949, more than seven months i 1950 and more than five months in 1951. Their prolonged via- lity in the long inundation periods of 1950 and 1951 is parti- ly attributed to the plants ability to produce adventitious oots below the surface of the water. The cambium layer of the em below the origin of the adventitious roots died during the
