WATER FLUCTUATION AS A FACTOR IN THE LIFE OF  
THE HIGHER PLANTS OF A 3300 ACRE LAKE IN THE  
PERMIAN RED BEDS OF CENTRAL OKLAHOMA

for the Degree of  
DOCTOR OF PHILOSOPHY

1952

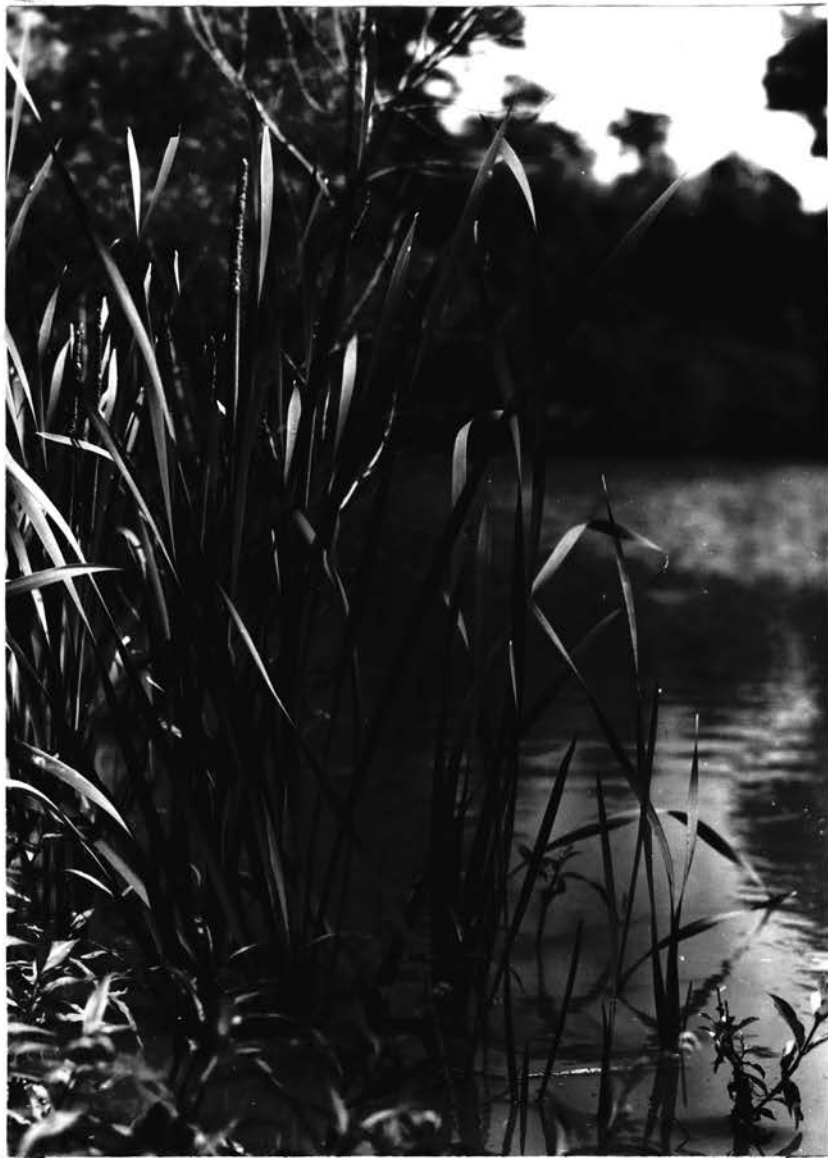
Fig. 90. Typha latifolia, Common Cat-tail. The Common Cat-tails grew vigorously in shallow waters.- Elev. 941.85', 941.35', Area 1, June 23, 1951.

Only the plants found at the higher levels of the fluctuation zone were in a healthy growing condition. Figure 90 shows plants from the 941.85' to the 941.35' level in area 1. The above observation indicates that the plant is probably better suited for use in lakes with a stable rather than a fluctuating water level. The data even suggest that control of water level might be used to kill the plants should they become a nuisance.

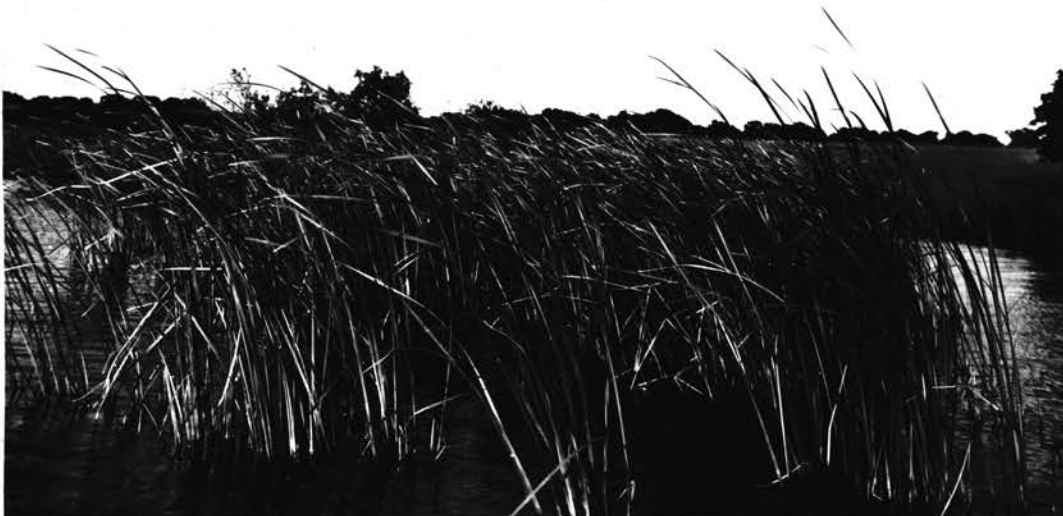
Fig. 91. Typha glauca Godr. ? Cat-tail. These plants failed to produce seed in 1951 but remained viable in the deep waters.- Elev. 938.90', 940.40', Area 7, October 1, 1951.

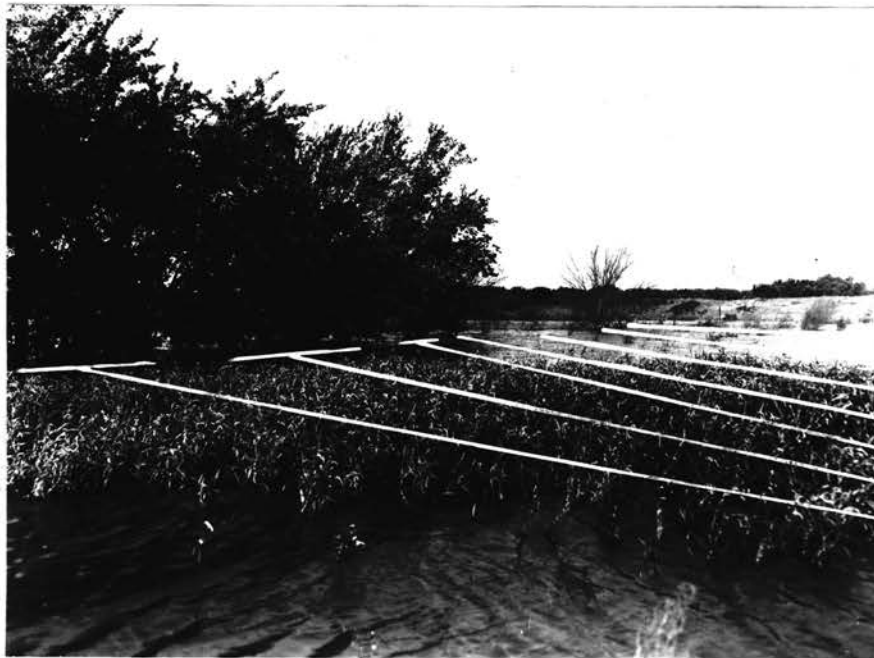
941.02'  
 941.17'  
 941.02'  
 941.32'  
 941.67'  
 942.42'  
 943.17'

Fig. 93. Polygonum lapathifolium, Ulmus americana. Illustrating the growth of P. lapathifolium and the morphological changes in U. americana.- Elev. indicated, Area 7, August 5, 1951.

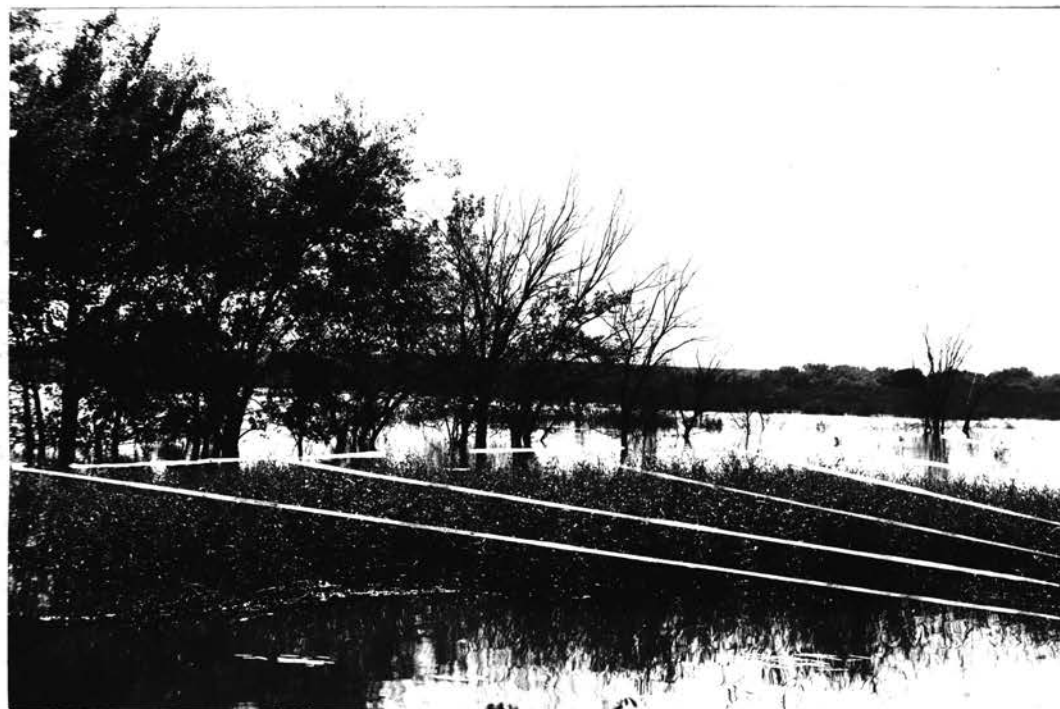
941.02'  
 941.17'  
 941.02'  
 941.32'  
 941.67'  
 942.42'  
 943.17'

Fig. 94. Polygonum lapathifolium, Ulmus americana.  
 Illustrating the growth of P. lapathifolium and the  
 morphological changes in U. americana.- Elev. indi-  
 cated, Area 7, September 14, 1951.

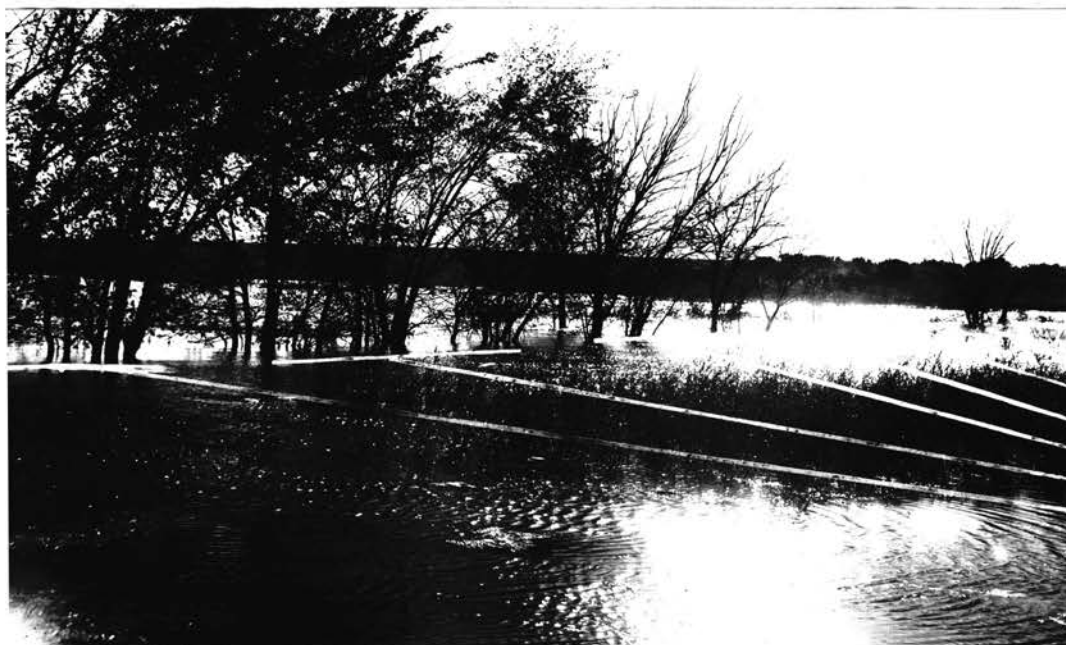
941.02'  
 941.17'  
 941.02'  
 941.32'  
 941.67'  
 942.42'  
 943.17'

Fig. 95. Polygonum lapathifolium, Ulmus americana.  
 Illustrating the growth of P. lapathifolium and the  
 morphological changes taking place in U. americana.  
 -Elev. indicated, Area 7, October 1, 1951.

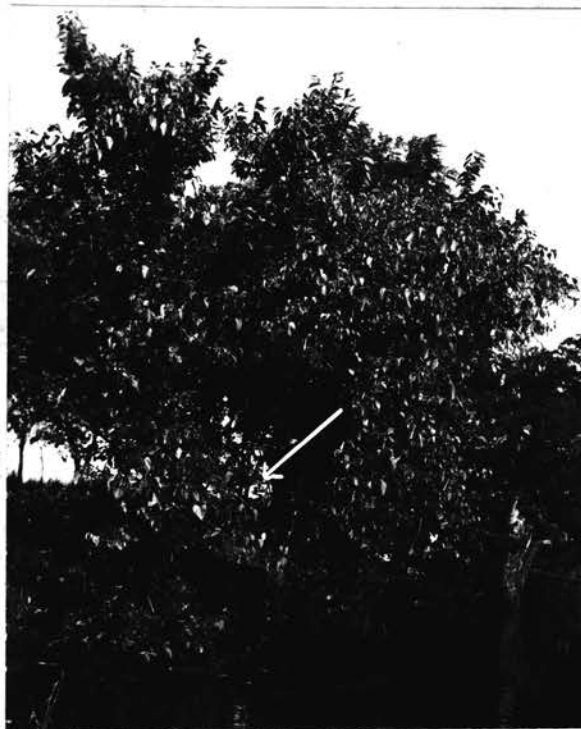
Fig. 96. Vitis sp., Wild Grape.- Elev. 944.60', 940.00', Area 2, July 28, 1951.

Wild Grape plants of this species were found growing along the banks of the creek in area 2 between the levels of 944.60' and 940.00'. They were first observed on July 28, 1951 (fig.96) at which time their viability was considered excellent. They were not again observed until October 25, 1951 (fig. 97) at which time they were about the only plants remaining in a viable condition in the area. However, some of the vines with bases below the 941.71' level had succumbed.
