STREAM FRAGMENTATION AND INFRASTRUCTURE CONDITION IN THE
GREAT PLAINS

A THESIS
SUBMITTED TO THE GRADUATE FACULTY
in partial fulfillment of the requirements for the
Degree of
MASTER OF SCIENCE

By
NATHAN SLEIGHT
Norman, Oklahoma
2017

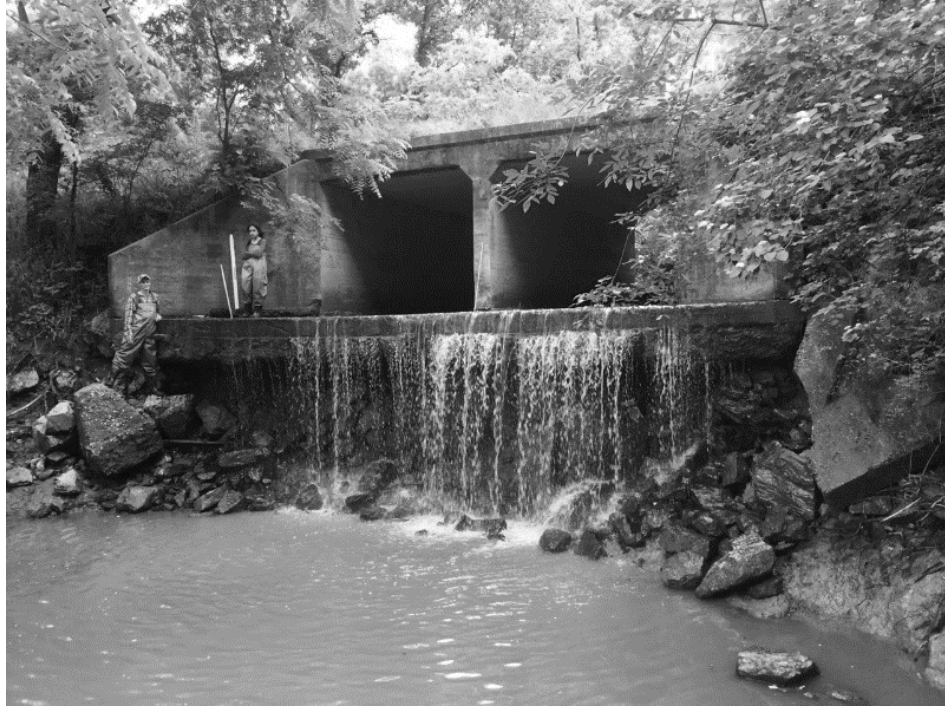
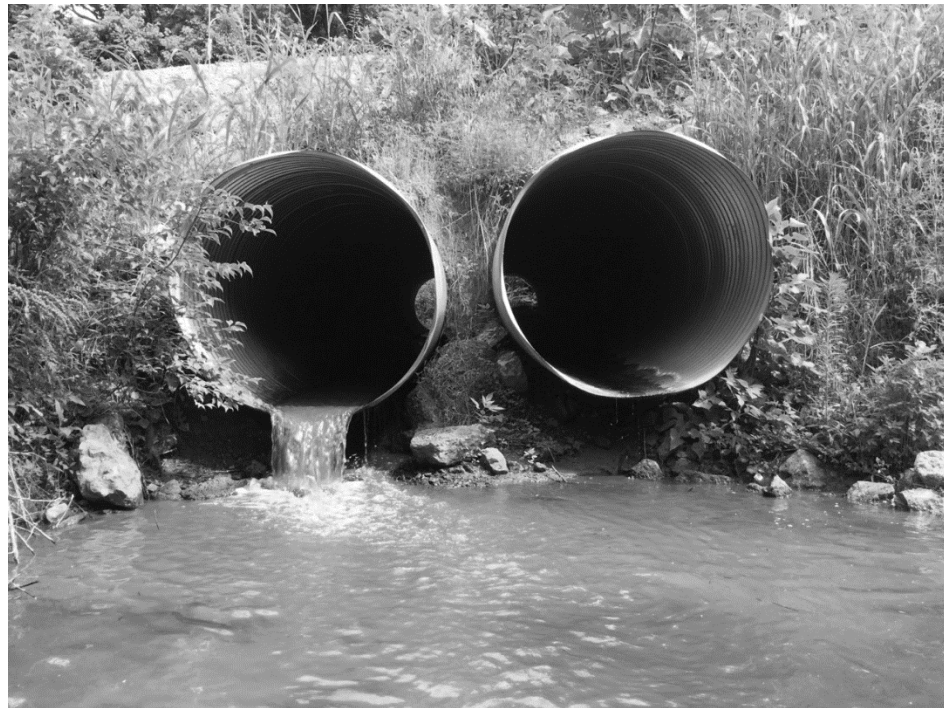
Figure 1. Image a. depicts a box culvert with a significant outlet drop, while image b. shows a round culvert with a significant outlet drop. Both of these barriers are impassable to aquatic life.

Habitat fragmentation and loss threaten biodiversity and ecosystem health on a global scale both aquatic and terrestrial (Perkin et al. 2014; Dudgeon et al. 2006). In the coterminous United States, 85% of large rivers are fragmented by impoundments that divide streams, reduce transport of sediment, prevent fish movement, and alter flow regimes (Perkin and Gido 2011). Although this is a problem throughout the United States, the Great Plains is a region of particular high concern (Gido et al. 2010). Watersheds within the Great Plains have endured substantial land conversion, with more than 90% of land transformed from native prairie to row crop or center pivot agriculture (Gido et al. 2010). The impact is exacerbated by the construction of over 19,000 dams have been built since the 1930's, resulting in habitat loss, degraded water quality, and a loss of aquatic biodiversity (Costigan and Daniels 2012). Fragmented river systems often prevent the movement of numerous aquatic organisms. Fishes are particularly sensitive to stream fragmentation because they are unable to pass across or through most anthropogenic barriers such as road stream crossings (Fig. 1).

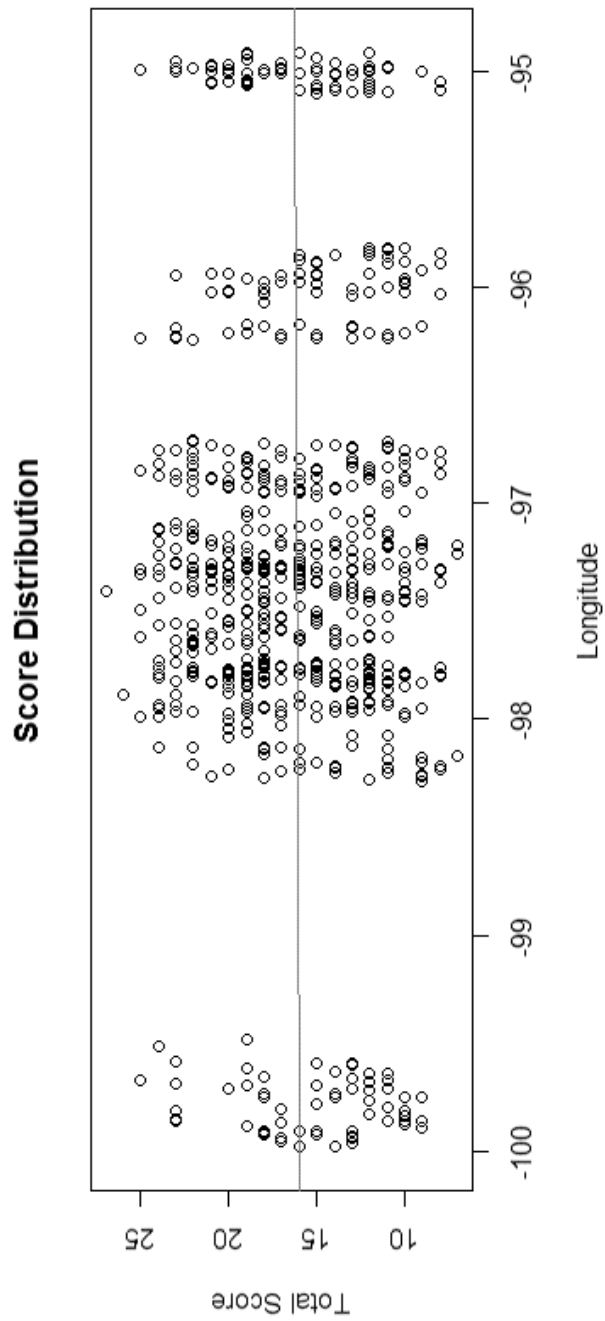
Figure 4. The above plot shows the total index score for each barrier and the longitude at which the structure resides. As shown there is no correlation between location and index score $R^2 = -0.0012$
 $p = 0.7434$

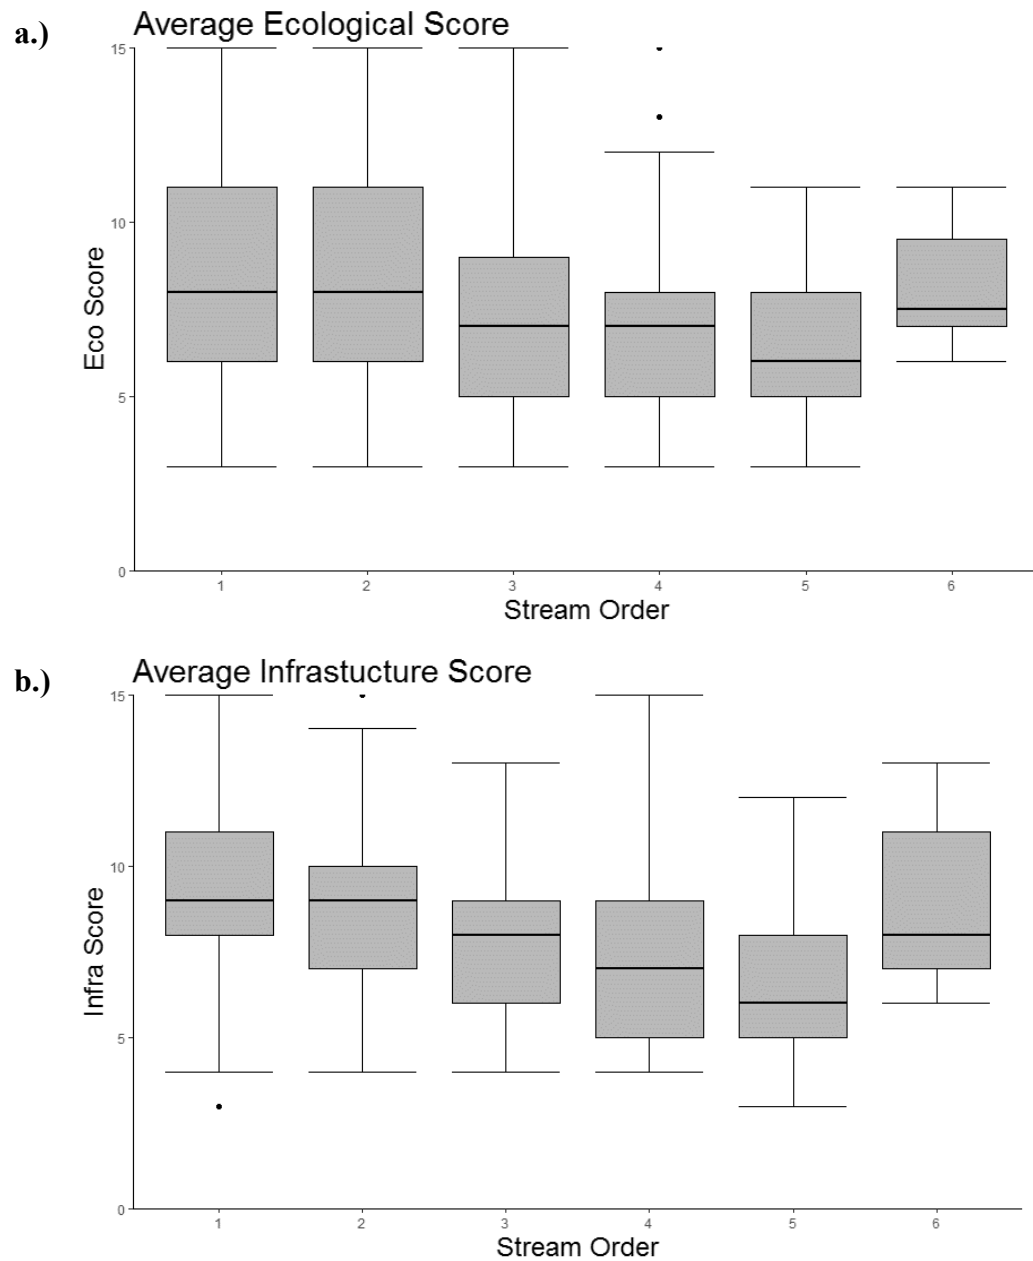
Figure 5. Boxplots showing the distribution of index score for differing stream orders. Figure 4a shows the distribution of the ecological score while figure 4b shows the infrastructure score. Neither of these distributions have any substantial differences in distribution of index score among differing stream orders.
