PERFORMANCE MONITORING AND ANALYSIS OF GEOSYNTHETIC
REINFORCED SOIL INTEGRATED BRIDGE SYSTEMS (GRS-IBS) IN
OKLAHOMA

A THESIS

2017

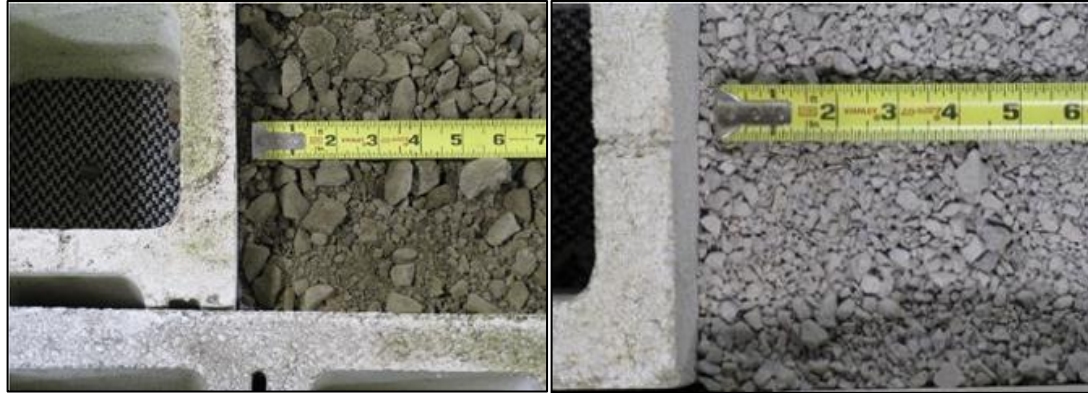
Figure 3: (a) well-graded 21-A gravel; (b) Open-graded AASHTO No. 89 gravel (Adams et al. 2012)

The backfill of the abutments is design to support traffic load in which backfill contributes significantly. Open or well-graded aggregate, (**Figure 3**) or a combination of both can be used as backfill material. Adams et al. (2012) recommends that it is better if the aggregate is angular, which will provide greater shear strength, and that its gradation should allow for optimum compaction, workability, and drainage. Additionally, either aggregate used (**Figure 4**) should be compacted to achieve a minimum of 95% of maximum dry unit weight based on the AASHTO T-99 (Standard Proctor) procedure. It is common practice to use open-graded type rather than well-graded type for the RSF and abutment backfill.

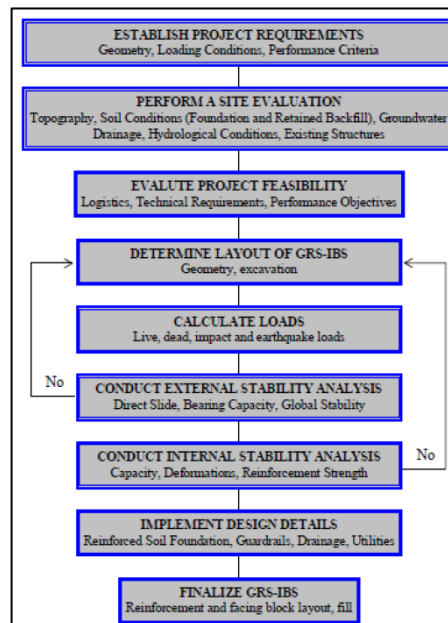
Figure 6: Flowchart of FHWA recommended design steps for GRS-IBS (Adams et al. 2012)

Figure 6 shows the recommended design steps by Adams et al. (2012).

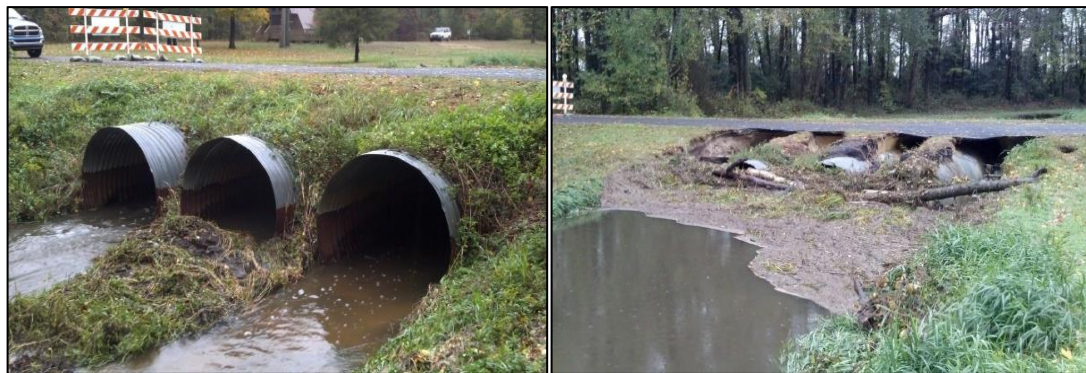
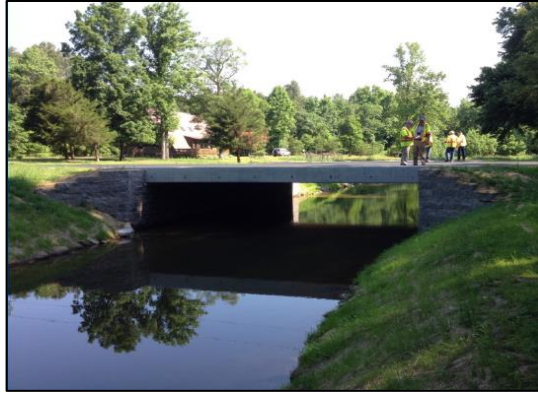
Figure 9: BR 3-140 project in Sussex County, Delaware: (a) Original structure; (b) Original structure after Hurricane Sandy in 2012; (c) New GRS-IBS bridge (Walls 2014)

Delaware reported the construction of two (2) GRS-IBS bridges: (1) BR 3-140 Bridge in Sussex County (**Figure 9**), and (2) BR 1-366 Bridge in Newcastle County (**Figure 10**). BR 1-366 Bridge was constructed in 2013 to replace an existing 77-year-old bridge, with an average daily traffic (ADT) value of 2,094. BR 3-140 in Sussex County was completed on April 11, 2014; a 13-year-old bridge, which was damaged, as result of the culverts being plugged by a large quantity of debris and branches after Hurricane Sandy in 2012.

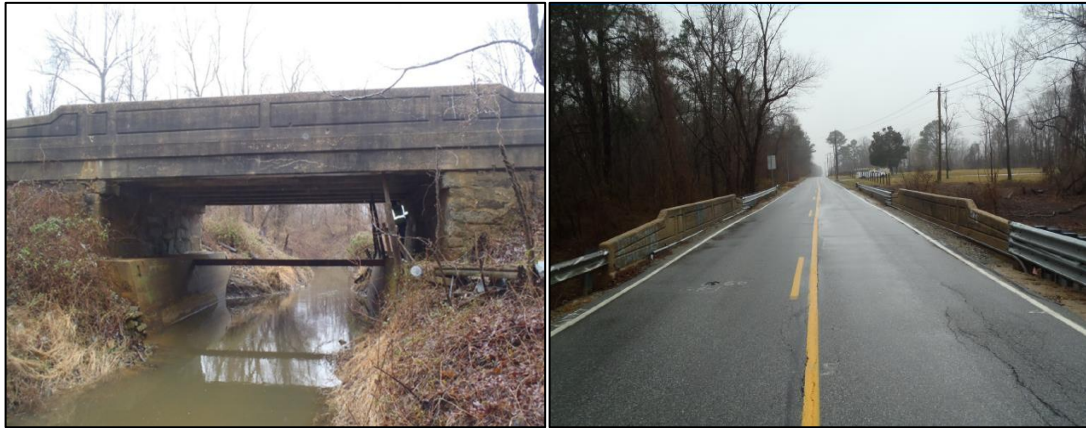
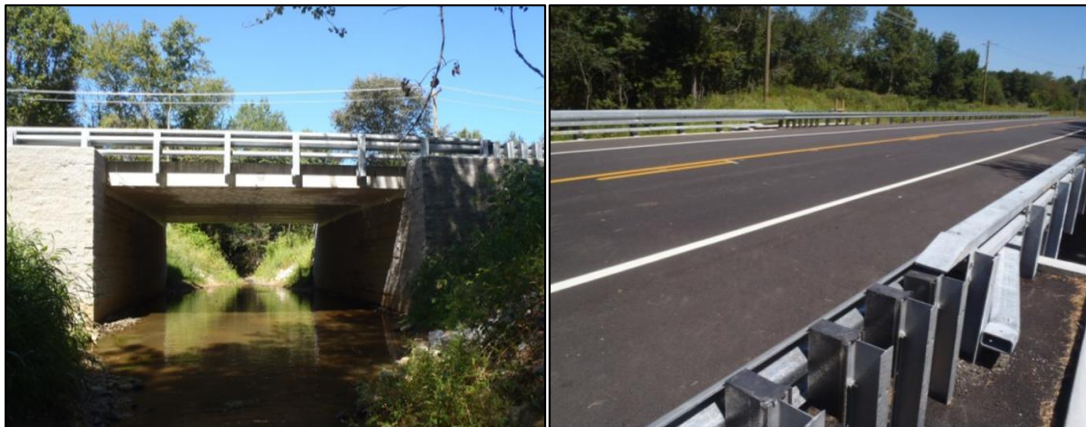
Figure 10: BR 1-366 project in Newcastle County, Delaware: (a) Previous bridge; (b) New GRS-IBS Bridge (Benton 2014)

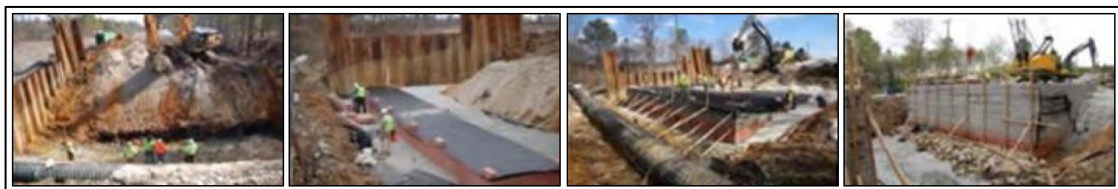
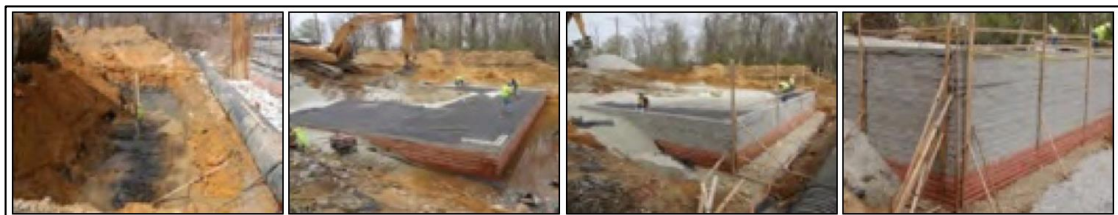
Figure 15: Construction of BR 1-366: (a) East abutment; (b) west abutment (Talebi et al. 2014)

Finally, Talebi et al. (2014) reported excavation and construction procedures in the BR 1-366 project (**Figure 15**). Construction of the east abutment started on March 22, 2013 and was completed in 14 days. Construction of the west abutment started on April 3, 2013 and was completed in 20 days. The entire project was completed in approximately seven (7) weeks, which was comparatively quick for a first-time experience. The construction crew did not include more than five (5) individuals: three (3) to four (4) laborers and one equipment operator. The equipment operator handled the bulldozer to excavate the soil in preparation for the RSF and the GRS abutment, and placement of the GRS fill.

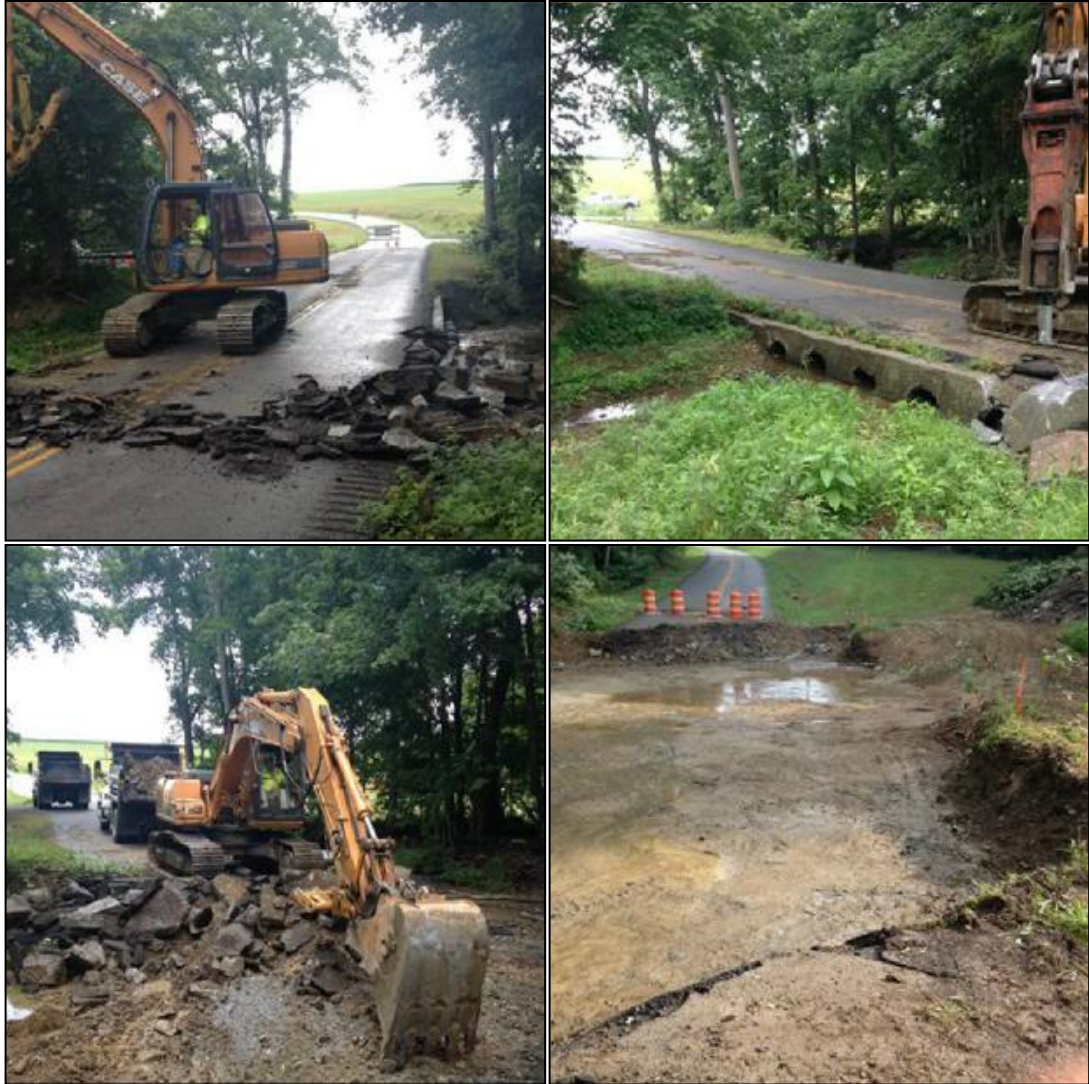
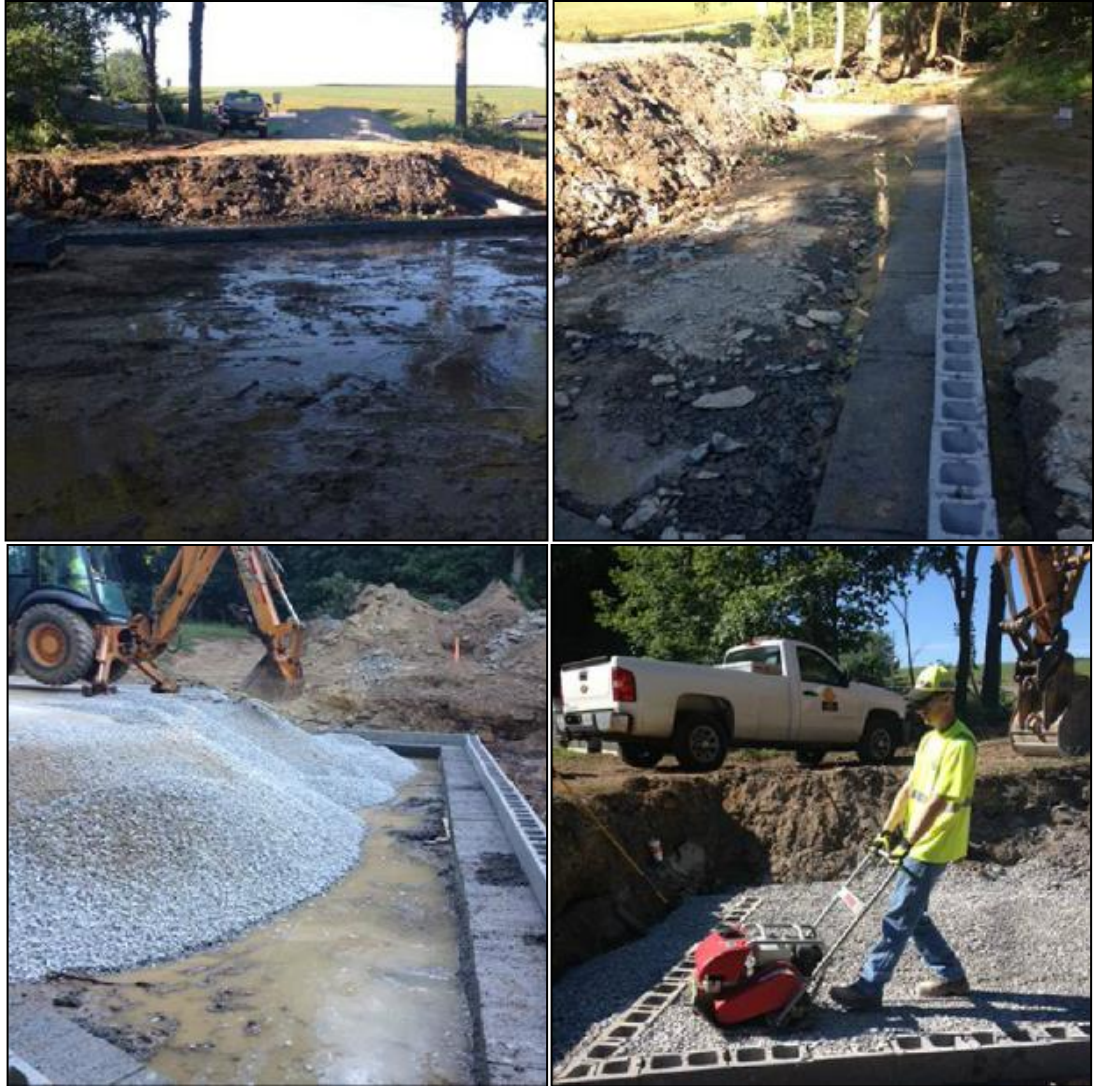
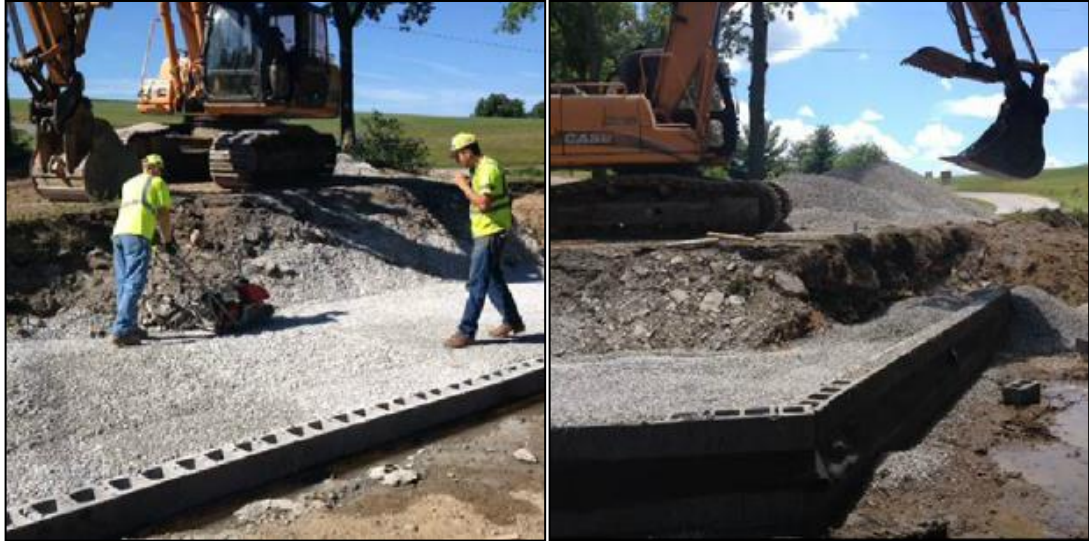
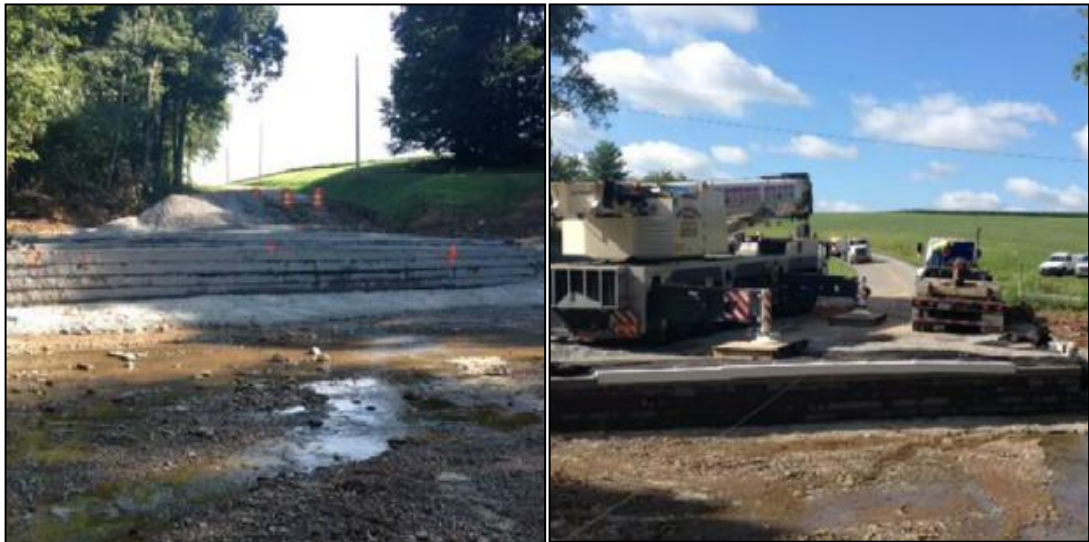
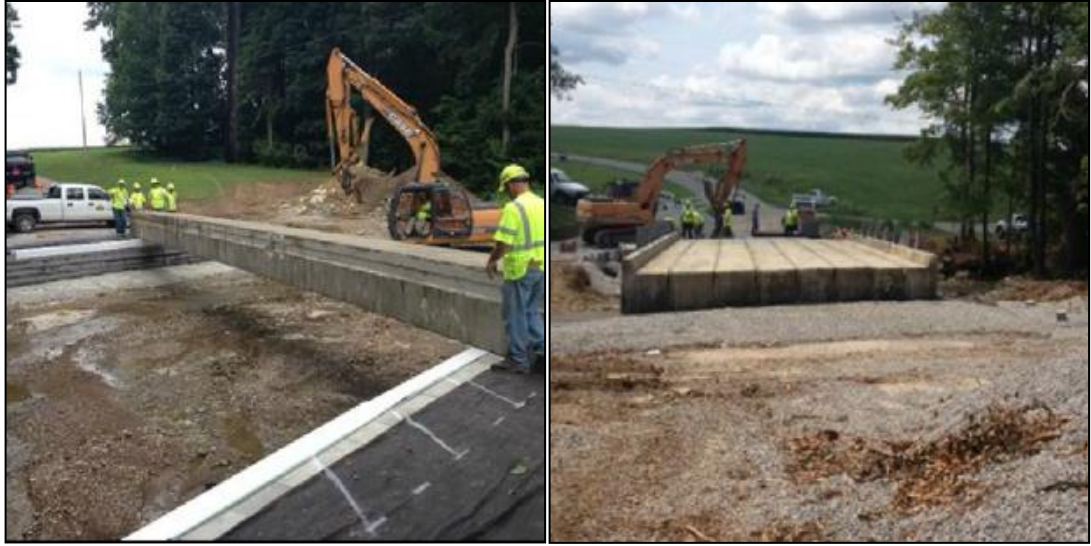
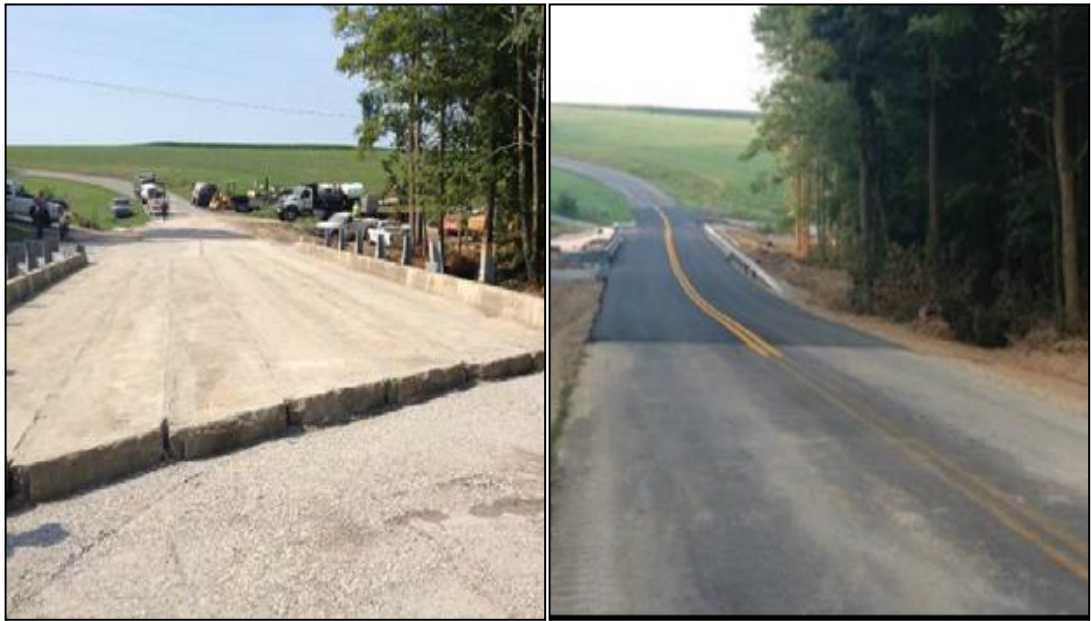
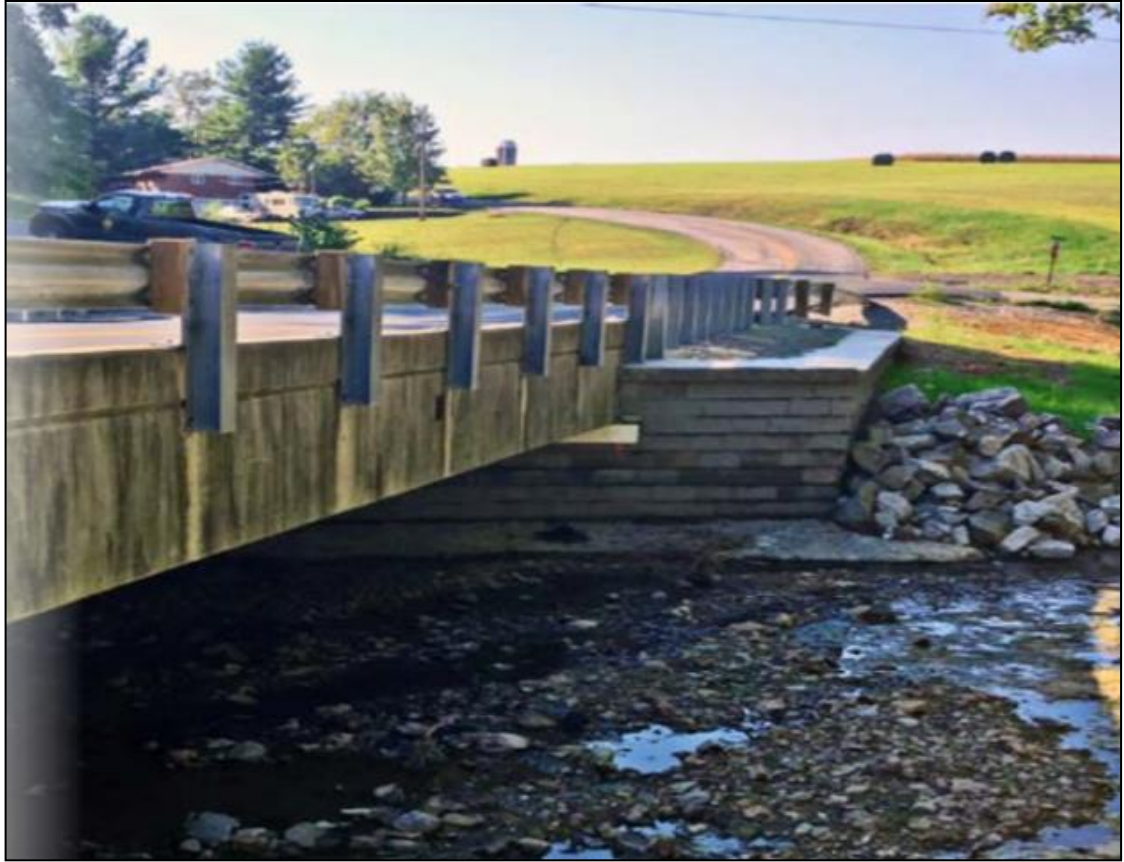
Figure 16: GRS-IBS construction in Palestine road north of Campbellsville in Taylor County, Kentucky: (a) Stage 1: Demolition of old bridge; (b) Stage 2: Placement of first row of CMU blocks; (c) Stage 3: Construction of GRS abutment; (d) Stage 4: Preparation for placement of bridge deck; (e) Stage 5: Placement of bridge deck (f) Stage 6: Finalizing the integrated approach and the roadway surface; (g) New GRS-IBS bridge (Sweger 2014)

The bridge settlement was monitored by the staff, and was found to be negligible. It was determined that the GRS-IBS alternative saved 20% in cost when compared to a conventional solution. **Figure 16** shows the stages of construction of the GRS-IBS. It is important to note that it is essential to have adequate compaction in both the RSF and the GRS abutment, in order to meet strength and performance requirements.

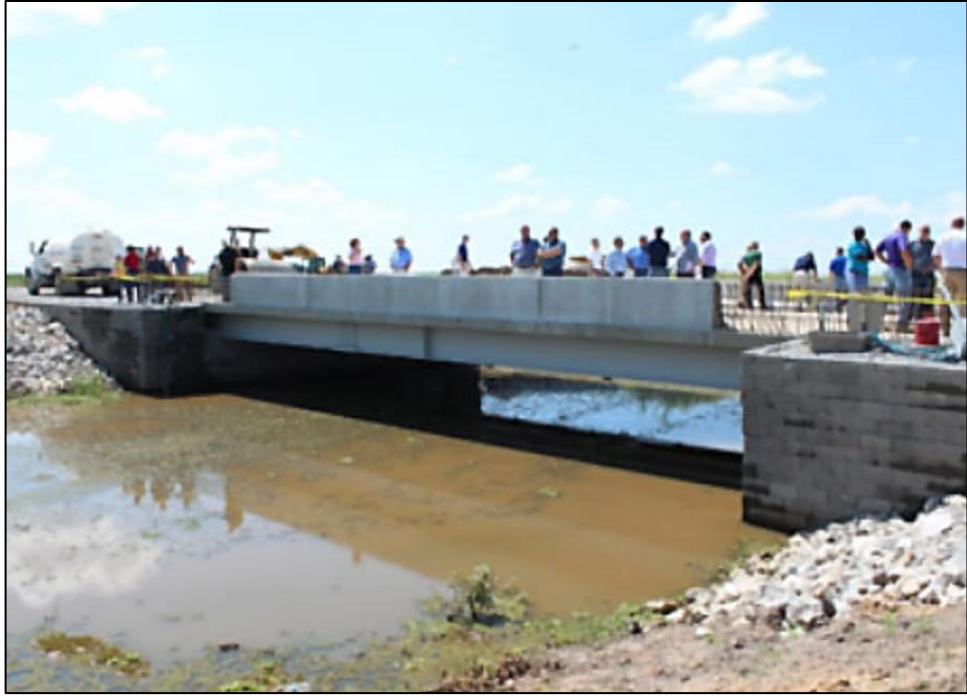
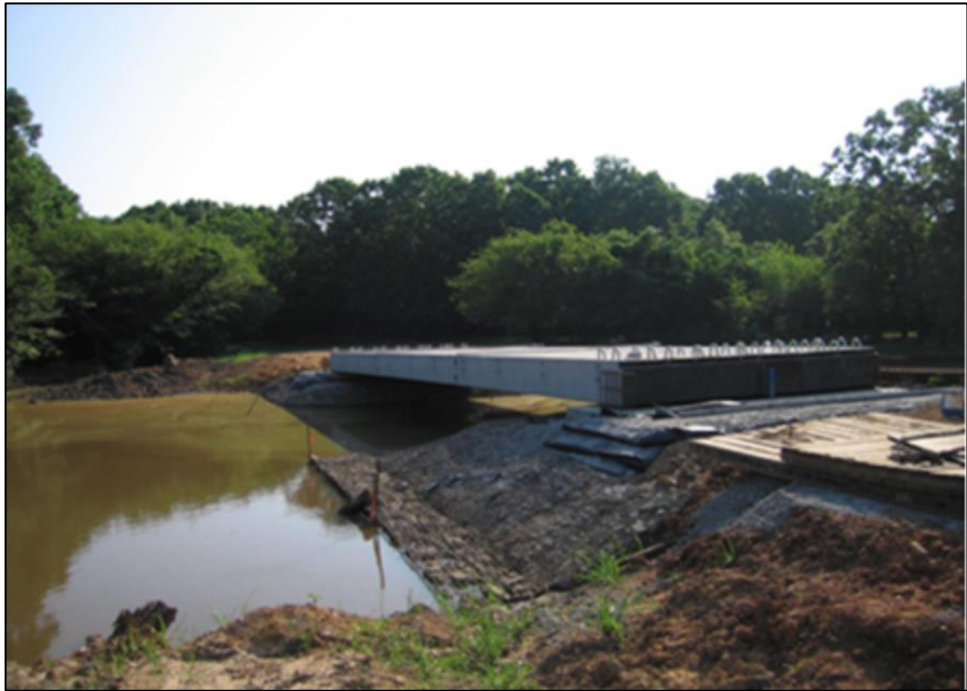
Figure 17: Example GRS-IBS projects, Louisiana (Meunier 2013)

The state of Louisiana has 6 GRS-IBS bridges. This makes it the lead state in number of GRS-IBS bridges for the South-East portion of the country. Out of those six, one was built to handle higher traffic in Saint Bernard County, two bridges were built to replace an old timber trestle bridge in Vermilion County and three bridges in Union County used to replace an old rail car bridge. (**Figure 17**)

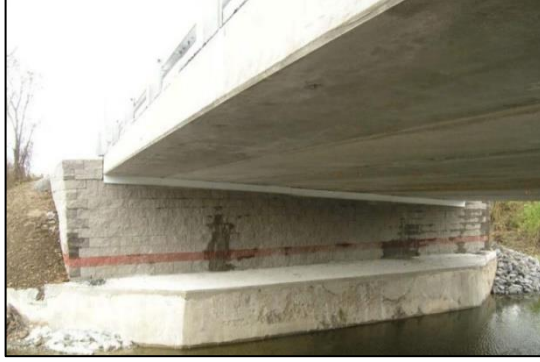
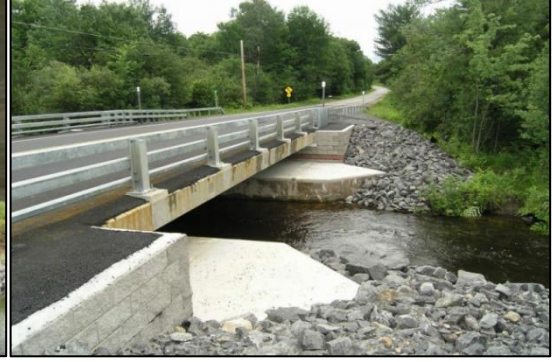
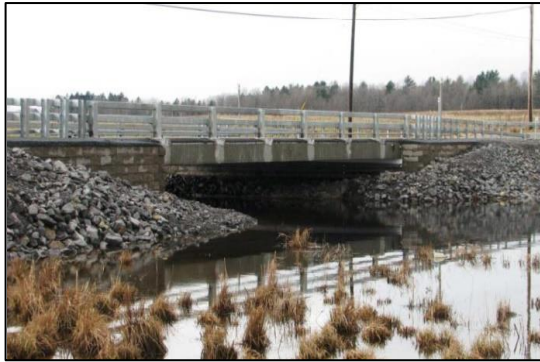
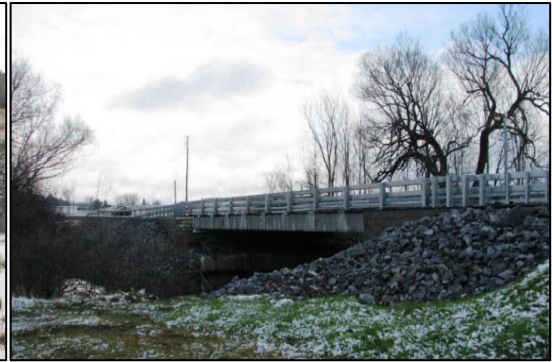
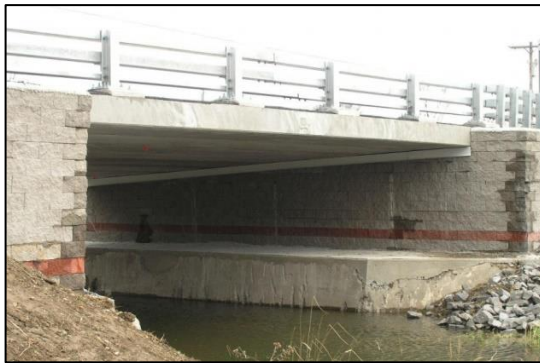
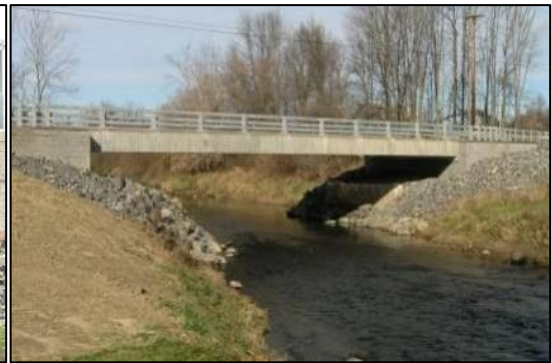
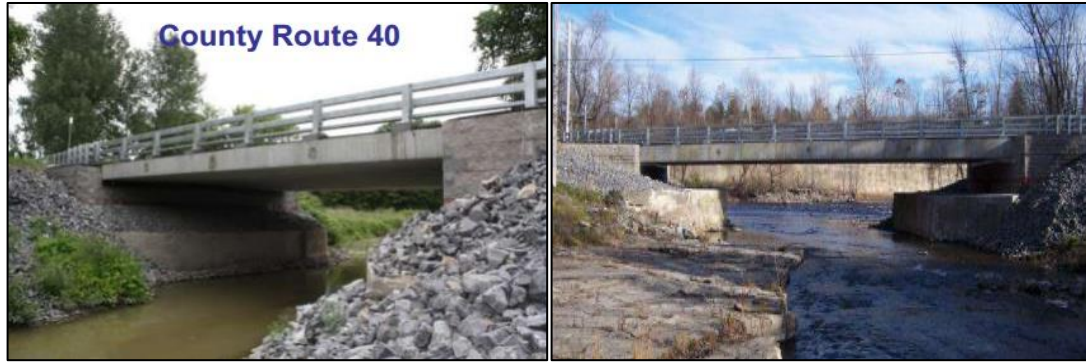
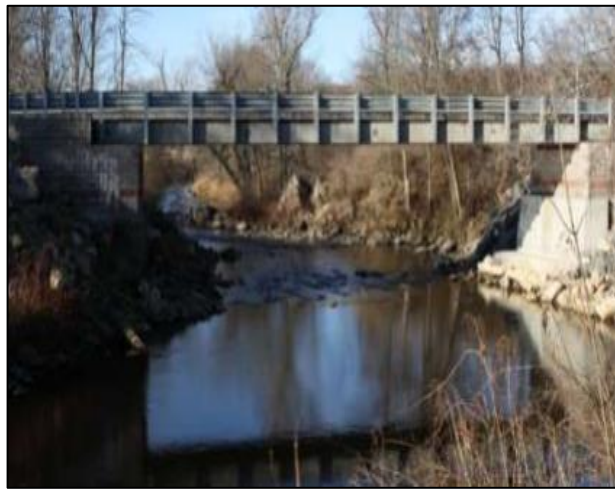
Figure 18: Example GRS-IBS projects in St. Lawrence County, NY: (a) CR 12 Project; (b) CR 24 or Leonard Brook; (c) CR 31 or Brandy Brook; (d) CR 35 or Trout Brook; (e) CR 38 or Plum Brook; (f) CR 25 or Little River; (g) CR 40 or Hutchins Creek; (h) River Road, and (i) Fraser Road or Oswegatchie River (Bogart 2013)

All the GRS-IBS bridges built in St. Lawrence County were single span structures that were shorter than 43 m (140 ft.) of span, making them compliant with the recommendations by Adams et al. (2012). Several conditions were considered when establishing the span of each of these bridges such as hydraulic opening, setback for new abutment location, and bearing area. Of these bridges, the longest one was at Trout Brook with a 28.6 m (94-ft.) span, and the shortest was the CR12 project. Additionally, all the GRS-IBS bridges in this county fell within the advised abutment height by Adams et al. (2012) of 9.5 m (30 ft.) A good example is the CR12 project with an abutment height of 4.6 m (15 ft.) **Figure 18** shows examples of the GRS-IBS bridges built in St. Lawrence County.

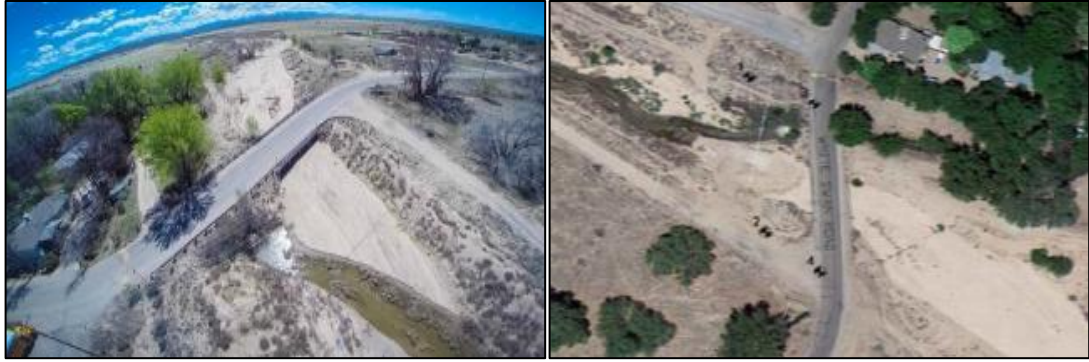
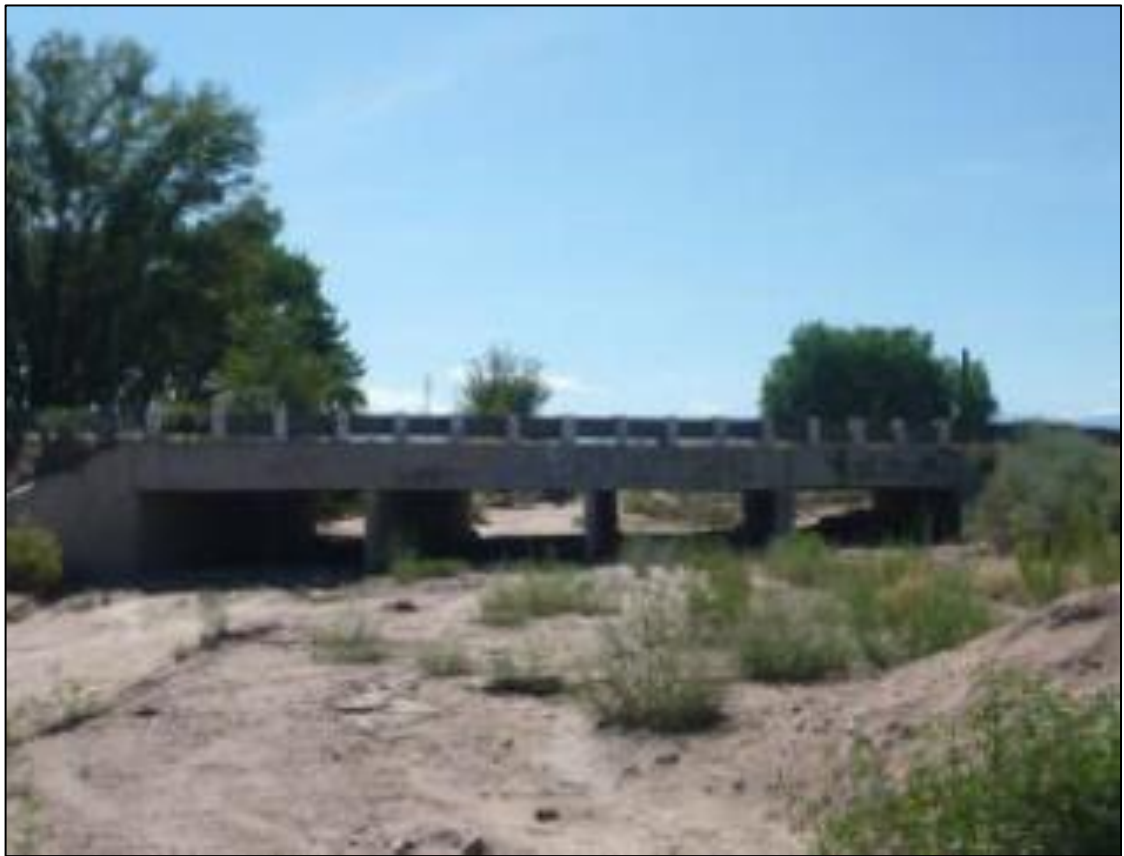
Figure 19: White Swan GRS-IBS Bridge in Ohkay Owingeh Pueblo, New Mexico: (a) Aerial views of the location; (b) Existing bridge prior to the construction (Albert 2015, Peters 2015)

The first GRS-IBS bridge in New Mexico was built 48 km (30 miles) north of Santa Fe by the Ohkay Owingeh Tribe using local labor. This bridge replaced the one shown in **Figure 19**, which suffered from frequent flooding given its skewed angle. Additionally, the sufficiency rate of the bridge was assessed as “fair” with 65.8. For this reason, the local tribal council designed a long-term resolution with a 100-year flooding plan. The project site was located on a major drainage basin close to Arroyo de Chingague. The design used a single span to reduce the amounts of potential sediment deposits. Three main observations can be made considering this project: (1) With proper training, unexperienced crews can complete a GRS-IBS project in a timely and cost efficient manner; (2) Even in dry areas, scour analysis is an important design consideration for GRS-IBS projects; and (3) in cases involving turbid rivers sediment deposits shall be also considered. **Table 11** shows a summary for the GRS-IBS design in New Mexico.

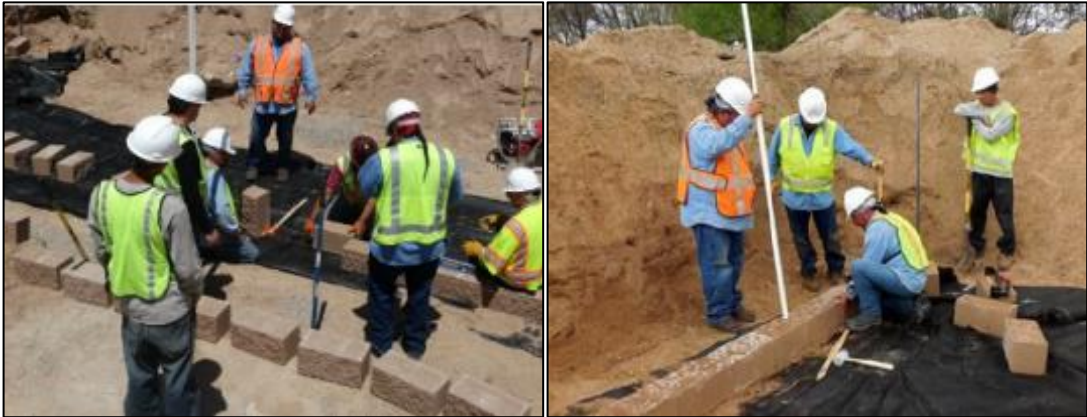
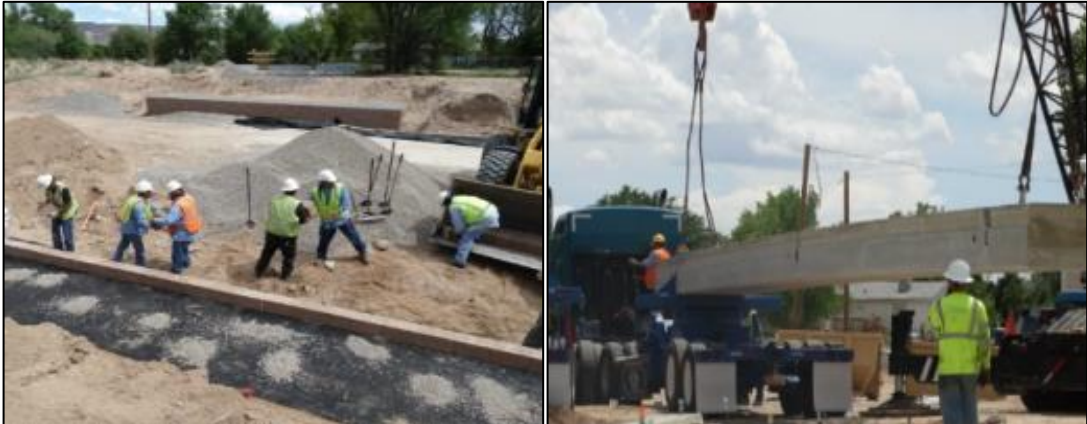
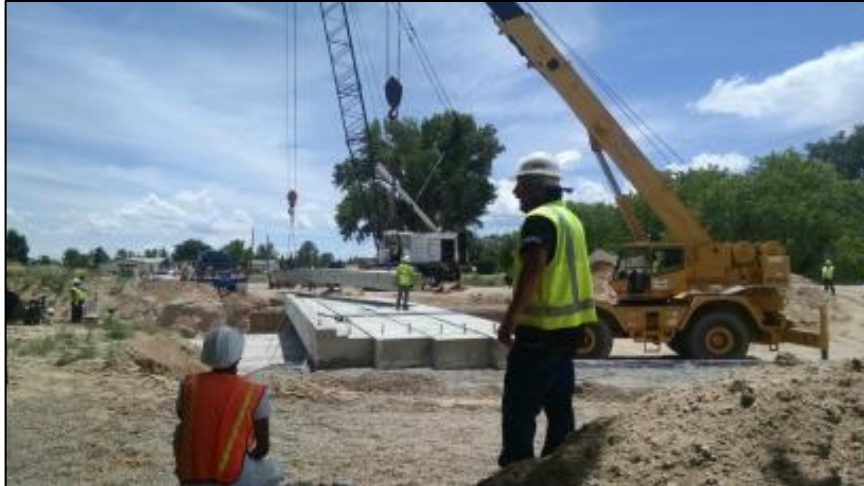
Figure 20: White Swan Bridge during construction in Ohkay Owingeh Pueblo, New Mexico: (a) Abutment construction; (b), (c) Superstructure installation (Albert 2015, Meyer 2015)

The approximate construction time of the GRS-IBS project in New Mexico was 5 weeks, plus a 5-week delay in the delivery of the precast concrete beams for the bridge superstructure. **Figure 20** shows the construction of the GRS-IBS bridge and **Figure 21** shows it completed.

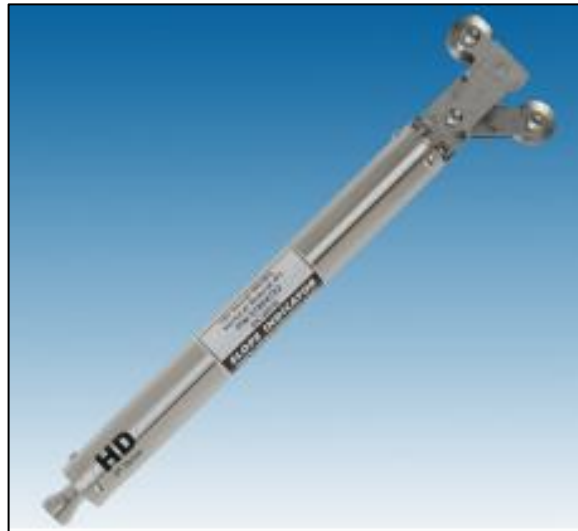
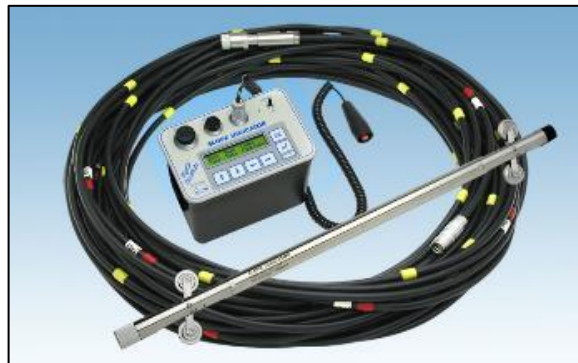
Figure 23: (a) In-Place Incliner (IPI); (b) Inclinometer Probe System (Durham 2014)

In the case of IPI, a series of inclinometers is continually kept inside the casing in each borehole, which makes it possible to provide remote, continuous and real-time sensing (**Figure 23a**). This type of inclinometer is ideal for early failure warning with a resolution of about ± 0.01 mm/m (0.012 in/ft; HMA 2014), but at a comparatively high total cost because the inclinometers have to stay at a fixed location, and therefore cannot be shared across different boreholes.

Manual Slope Inclinometers are used across several boreholes (**Figure 17b**). It is typically used in vertical boreholes with a flexible, grooved casing to guide the inclinometer into the depth of the fill (Abdoun et al. 2008). The cost can be controlled by reducing the number of inclinometers with accuracy of ± 2 mm per 25 m (± 0.0026 in. per 25 ft; HMA 2014). However, this system increases the amount of work necessary to complete the monitoring task. It requires at least one operator to access the site, temporarily install the inclinometer inside a borehole and take measurements. This

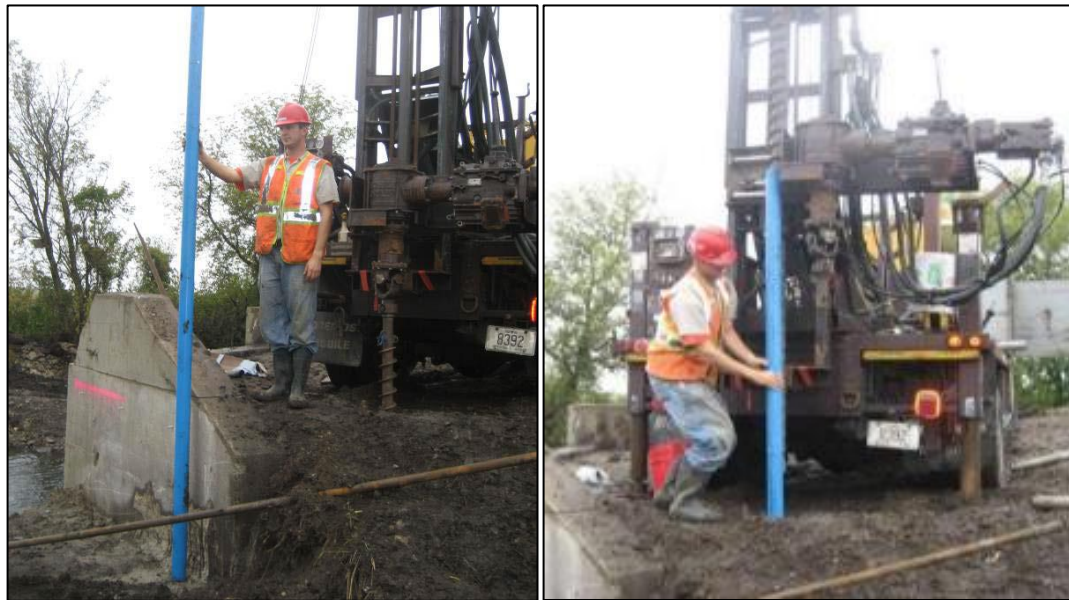
Figure 25: Three 5-foot inclinometer casings snapped together during installation on a bridge abutment in Delaware (Vennapusa 2012)

The 8.48 cm (3.34 in.) diameter inclinometer casing has been reported to be suitable for landslide and long-term monitoring applications (Durham 2013). Additionally, (Vennapusa 2012) listed the steps for the inclinometer installation: (1) Drill a borehole in the abutment, (2) Fill the inclinometer casing with water to overcome buoyancy effects in the hole due to groundwater, (3) Insert the casing into the borehole (**Figure 25**), and (4) Fill the cavity around the casing with sand and cement grout up to the top foot of the cavity (**Figure 25**).

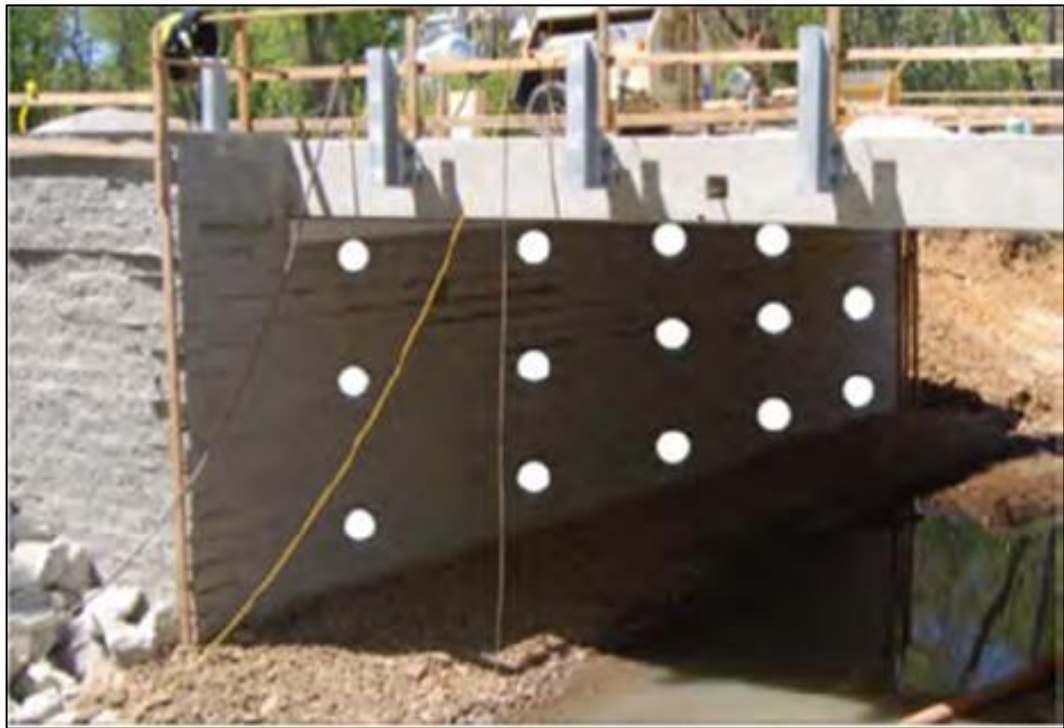
Figure 27: Survey points on the abutment of 1-366 Bridge in Delaware (Talebi et al.2014)

Figure 27 shows the locations of the twenty survey points that Talebi et al. (2014) placed on each abutment, which were spread out at the top, middle, and bottom of the facing wall to measure facing wall deflection during service. However, details such as the precision of the survey equipment or its type (e.g. EDM vs. standard surveying level) were not specified.

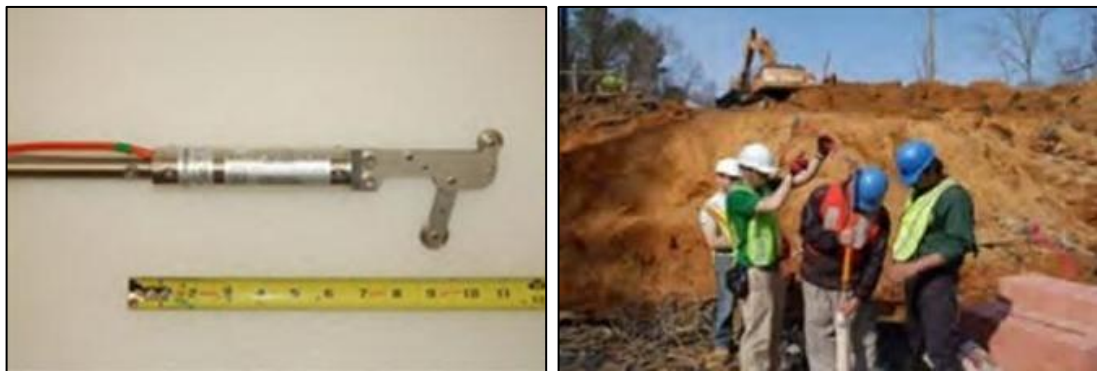
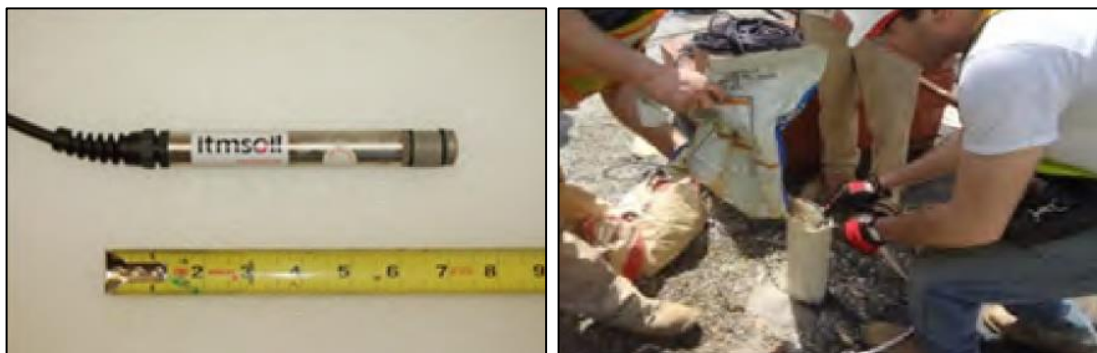
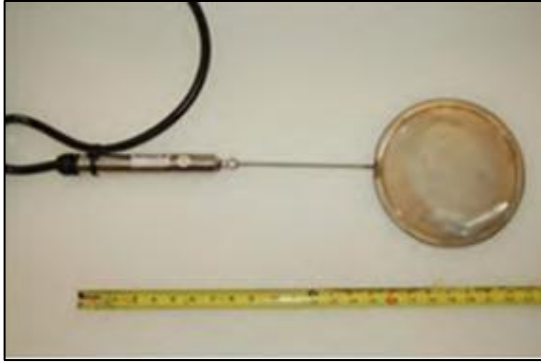
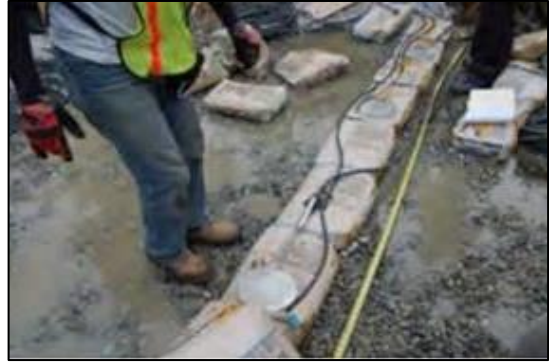
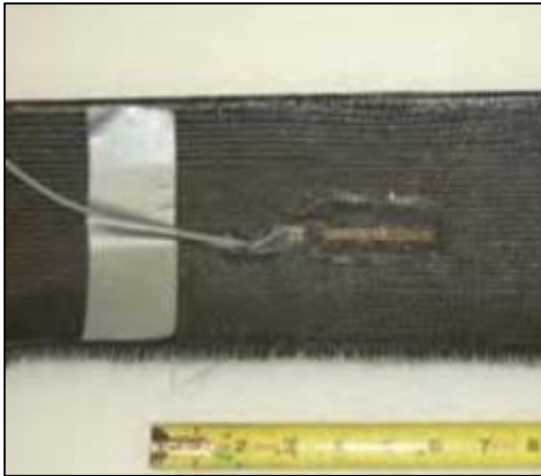
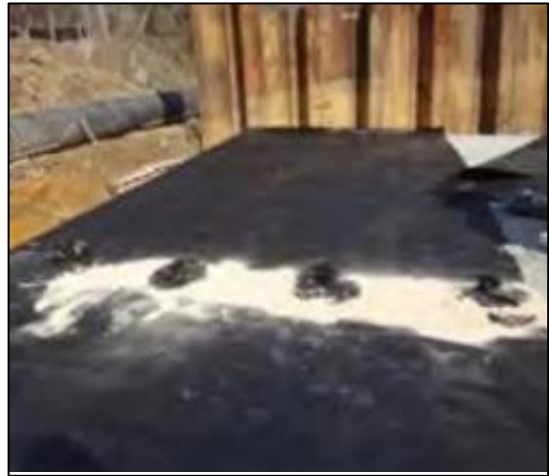
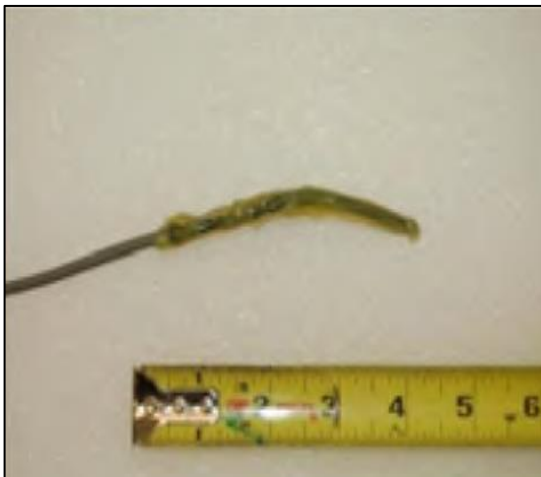
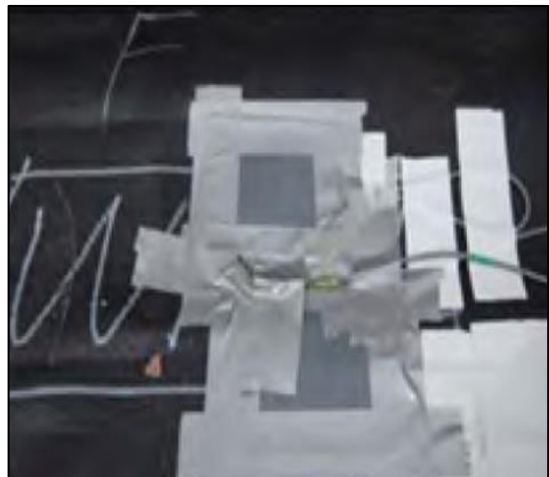
Figure 28: (a) Inclinometers and their site installation at the site in Delaware; (b) Piezometers and their site installation; (c) Pressure cells and their site installation; (d) Strain gauges and their site installation; (e) Thermistors and their site installation; (f) Volumetric moisture content sensors (Talebi et al. 2014)

Figure 28 shows the 1-366 bridge abutment sensors and their installation at the site. Talebi et al. (2014) reported that four inclinometer sensors and three vibrating wire piezometers were installed to measure displacements and pore water pressure in the clay foundation layer during construction and service periods. Eight vibrating wire pressure cells were placed in various locations (i.e. one between the superstructure and the

integration approach, three inside the west abutment, and four under the foundation) to monitor static and instantaneous pressure fluctuations. Strains in the HPG-57 geotextile reinforcement were measured using 50 strain gauges mounted on the geotextile. The strain gauges and pressure cells were covered with sand to protect them against the overlying No. 8 stone backfill material. Twenty-five YSI 55000 thermistors were wired and waterproof sealed in the University of Delaware laboratory prior to field installation, and were placed between the strain gauges to detect temperature and its effect on the measured strains in the woven geotextile. Finally, five MAS-1 volumetric moisture content sensors were placed in the west side abutment to check the moisture content and its effect on strains in the geotextile.

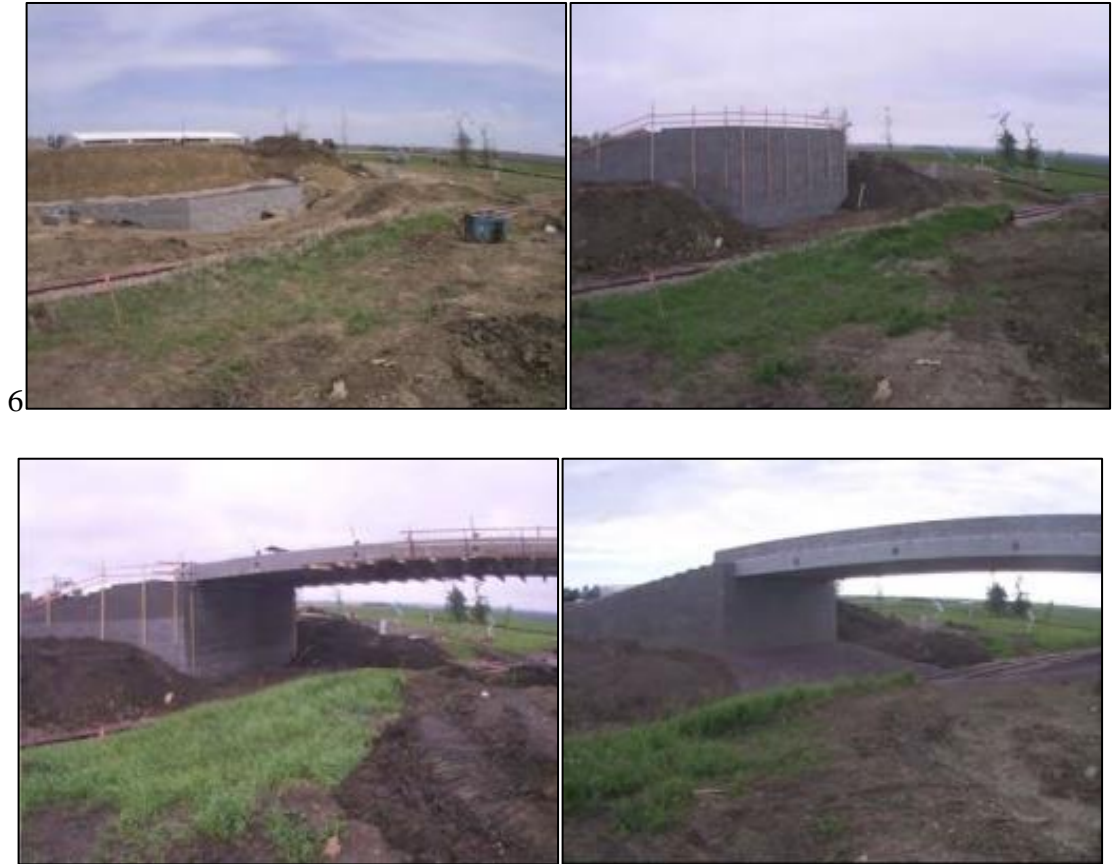
Figure 30: North abutment construction photographs for the CR-55 Bridge in Minnesota (Budge et al. 2014)

The instrumented monitoring for this project was set for three (3) years. **Figure 29** shows the plan view and elevation view of GRS-IBS instrumentation in Rock County Minnesota (**Figure 30**; Budge et al. 2014). **Table 16** shows the summary table for the CR-55 Bridge design features in Minnesota. The monitoring techniques for the bridge abutment are shown in **Table 17** (Budge et al. 2014). Two horizontal Shape Accel Array (SAA) systems were installed at the base of the fill material to measure the vertical position change with respect to a fixed end. Forty-two optical prisms were installed on the facing wall to detect the lateral and vertical movement of the abutment. Two vertical Shape Accel Array systems were placed on the abutments to check movement of the facing wall. Vibrating-wire (VW) earth pressure cells (EPC) were mounted at the base of the abutment to check backfill pressures acting on the foundation soils. Since this area has been experiencing large temperature variations, a weather station was installed to measure the temperature and solar radiation.
