PERFORMANCE MONITORING AND ANALYSIS OF GEOSYNTHETIC
REINFORCED SOIL INTEGRATED BRIDGE SYSTEMS (GRS-IBS) IN
OKLAHOMA

A THESIS

2017

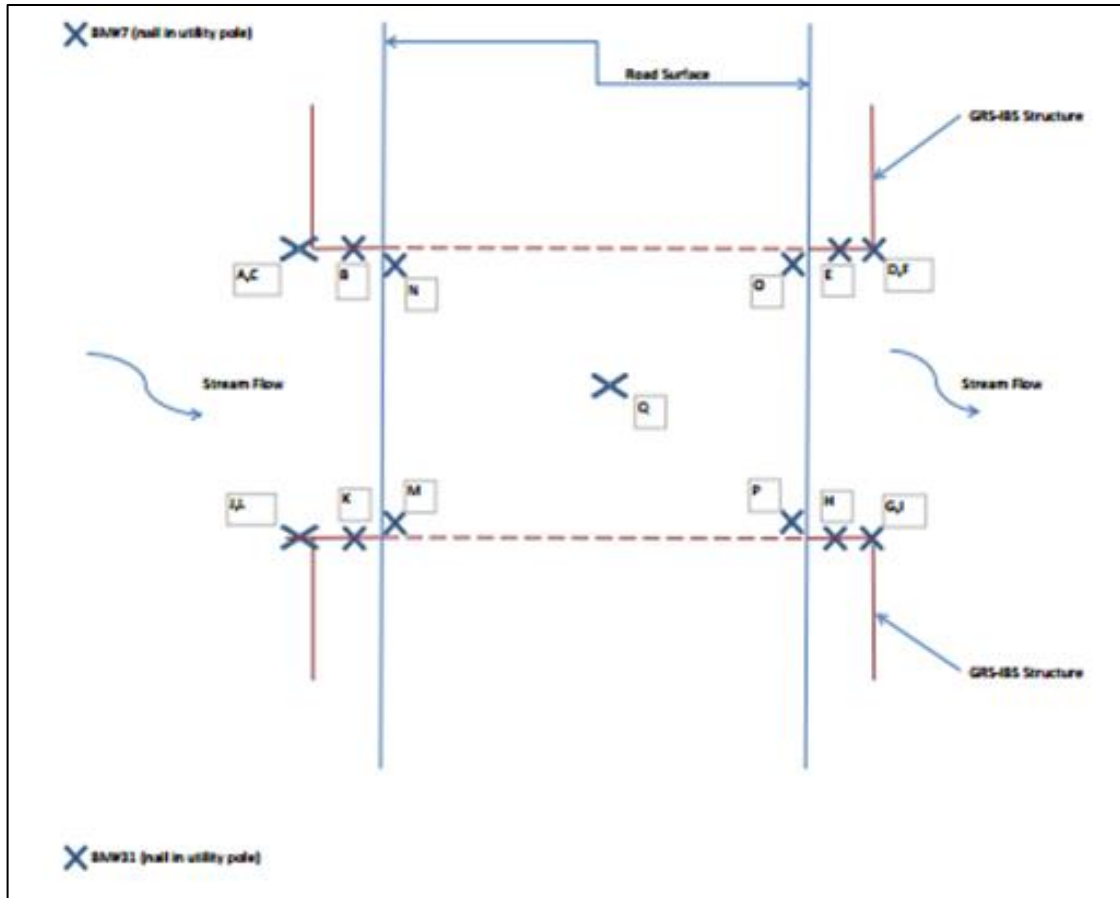
Figure 32: Surveying points for Mount Pleasant Road GRS bridge (Albert 2011)

Point	Elevation (ft)					Description
	10/20/2011	12/7/2011	2/3/2012	4/13/2012	7/23/2012	
A	993.85	993.85	993.81	993.82	993.83	NE Top of GRS Block Row
B		996.09	996.09	996.08	996.08	Ne Top of Cap
C		994.16	994.16	994.16	994.15	NE Top of Sill Plate
D	993.82	993.81	993.77	993.78	993.82	SE Top of GRS Block Row
E		996.07	996.03	996.06	996.06	SE Top of Cap
F		994.14	994.15	994.15	994.14	SE Top of Sill Plate
G	993.87	993.87	993.83	993.84	993.86	SW Top of GRS Block Row
H		996.11	996.09	996.10	996.09	SW Top of Cap
I		994.20	994.20	994.21	994.19	SW Top of Sill Plate
J	993.88	993.89	993.85	993.87	993.87	NW Top of GRS Block Row
K		996.12	996.11	996.11	996.12	NW Top of Cap
L		994.21	994.21	994.20	994.19	NW Top of Sill Plate
M		996.38	996.36	996.36	996.35	NW Top of Deck
N		996.35	996.32	996.32	996.32	NE Top of Deck
O		996.34	996.32	996.31	996.32	SE Top of Deck
P		996.36	996.36	996.36	996.36	SW Top of Deck
Q		996.41	996.41	996.41	996.40	Center of Deck

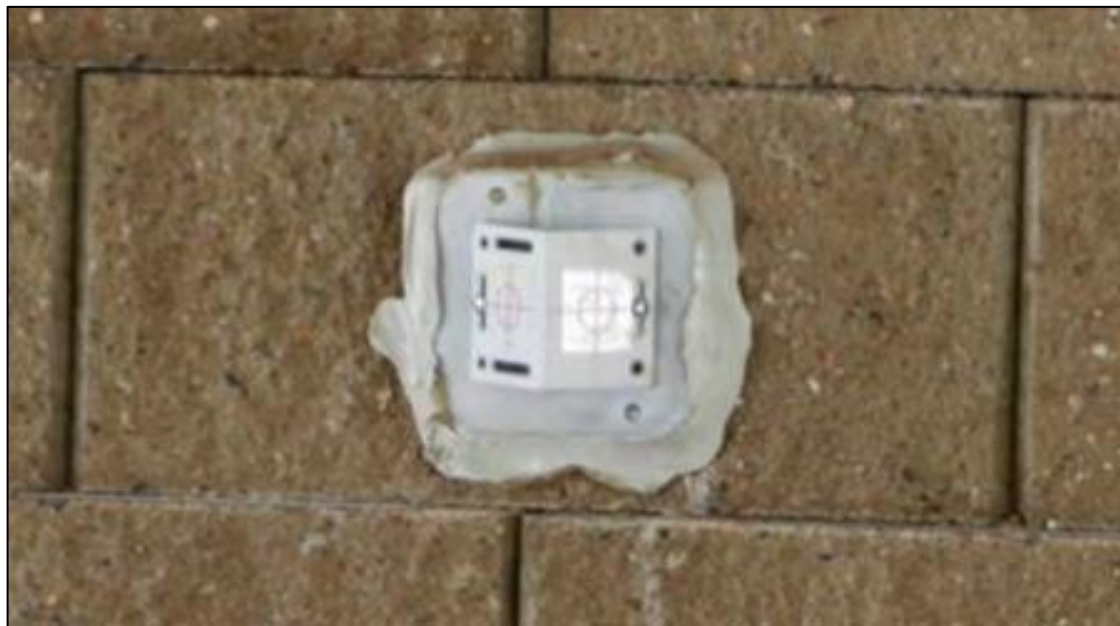
Figure 34: Surveying reflective target installed on abutment wall for STH 40 Bloomer Bridge (Garnier-Villarreal et al. 2014)

Garnier-Villarreal et al. (2014) reported that for the STH 40 Bloomer Bridge the monitoring program included: (1) Foundation, (2) Abutment walls, (3) Deck, (4) Roads, and (5) creek erosion. Standard survey level and rod system with a precision range of ± 3.1 mm (0.12 in.) was used to monitor the deformation of STH 40 Bloomer Bridge caused by environmental and service loads. **Figure 33** shows a sketch of the surveying layout with a photograph of the survey target as shown in **Figure 34**.

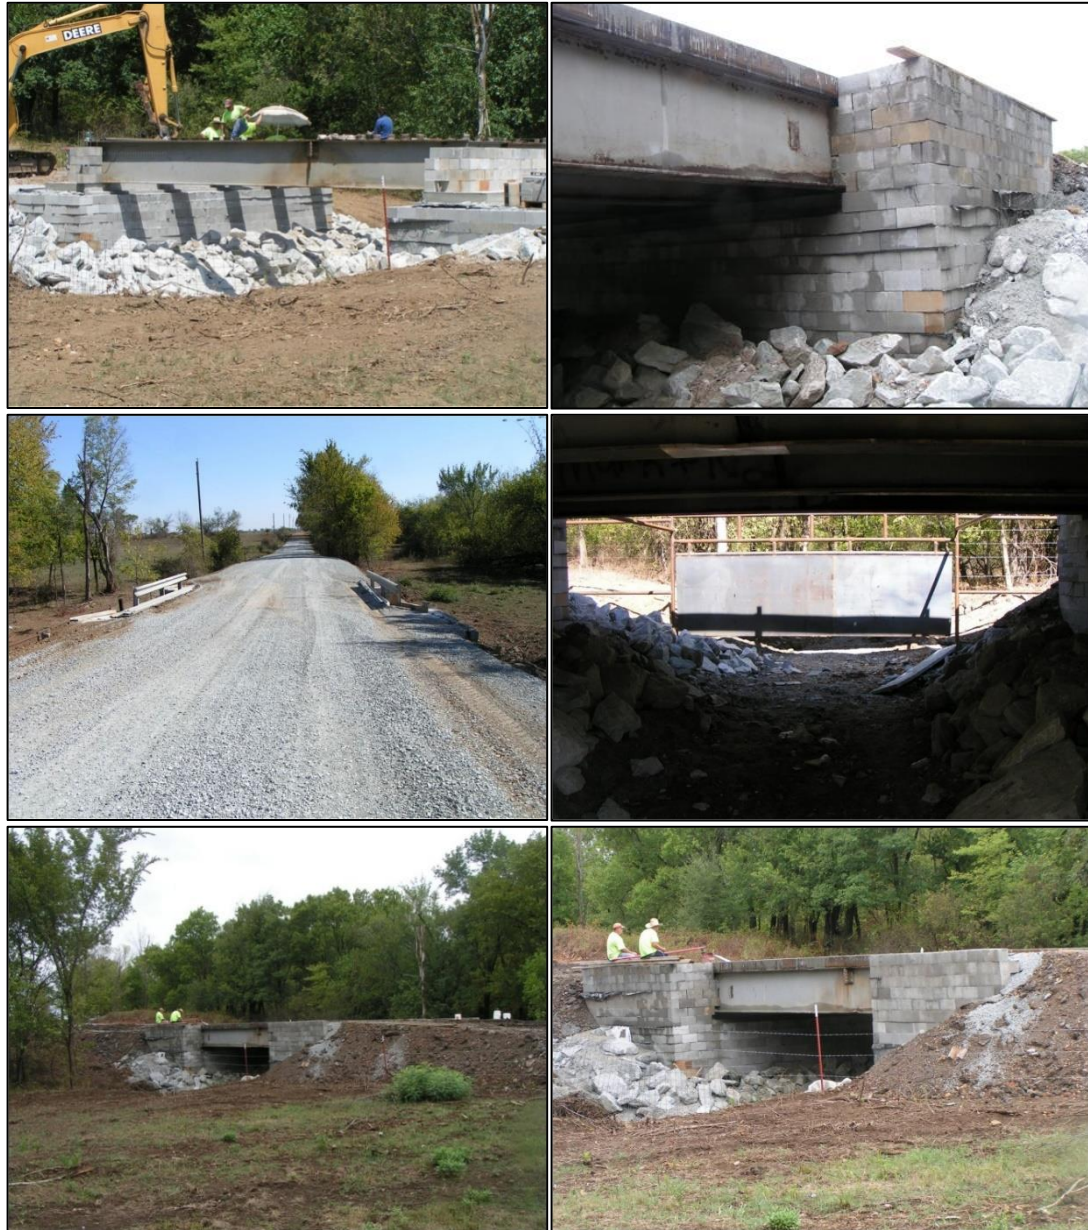
Figure 47: First GRS-IBS Bridge in Ottawa County, Oklahoma, built in 2013

In 2013, the first GRS-IBS bridge was constructed in Oklahoma (**Figure 47**). This bridge was built using county staff under the direction of Mr. Russell Earl. Since this bridge was the first GRS-IBS bridge in Oklahoma, there were some issues related to the abutments leaning profiles in the facing blocks (**Figure 48**). However, this issued appeared to be primarily cosmetic and the bridge to date has been reported with no sign of settlement. Also, Sheffert (2013) reported that the learning curve was very steep and

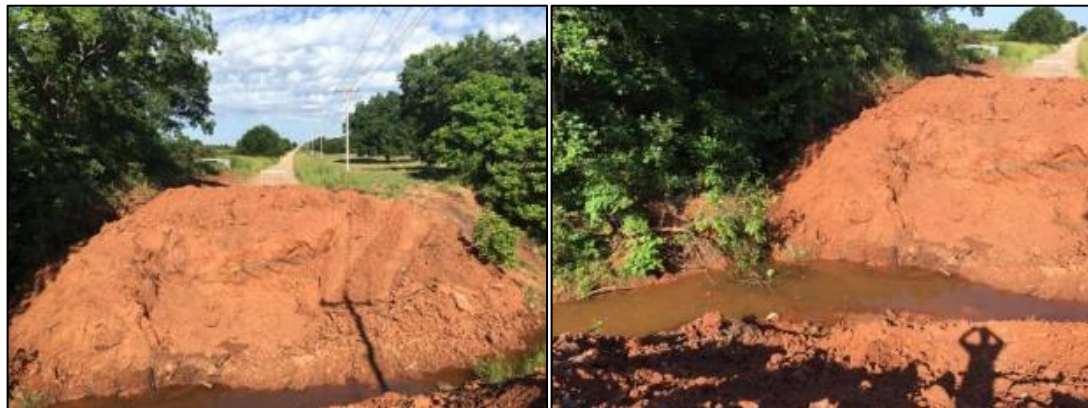
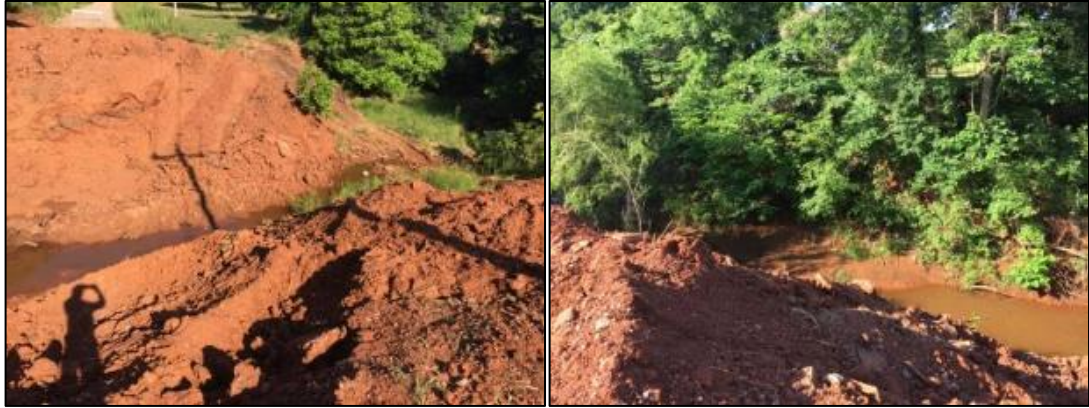
Figure 51: Yates Bridge site after demolition of old bridge and excavation for new GRS abutments

In early June 2016, the construction of the bridge started. Pictures of the site after demolition of the old bridge and excavation for the abutments of a new GRS bridge are shown in **Figure 51**. **Figure 52** shows construction of east abutment including its reinforced soil foundation (RSF). The construction challenges included the increase of the stability of the back-slope in a sandy loam soil and so that the crew could access the bottom of the abutment with the track-hoe. Thus, it was decided to use a much milder 2:1 slope instead of the 1:1 slope shown in Adams et al. (2012) standard details. Additionally, the first layer of reinforcement underneath the GRS abutment was overlain with a new layer of geotextile due to its contamination with silt deposits because of flooding of the site for two days (**Figure 53**). **Figure 54** shows construction of the concrete deck and **Figure 55** shows design drawings used in the project.

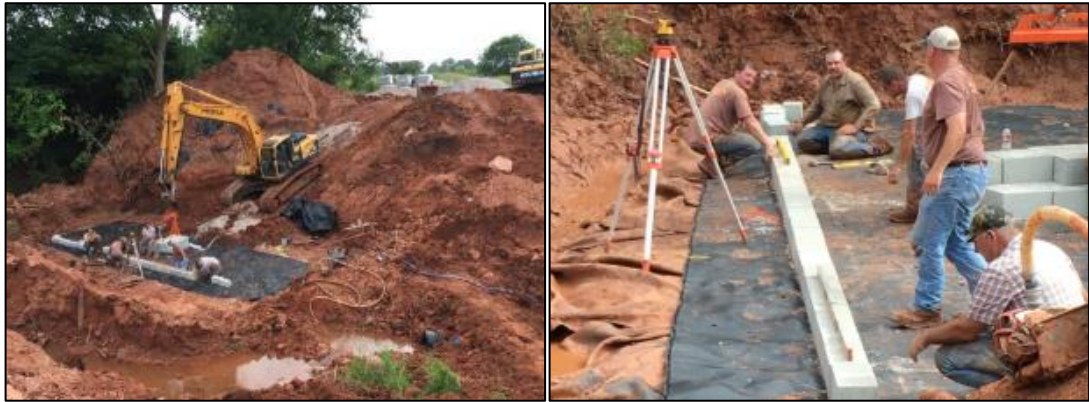
Figure 52: Placement of the first row of CMU blocks (Yates Bridge, 7/11/2016)

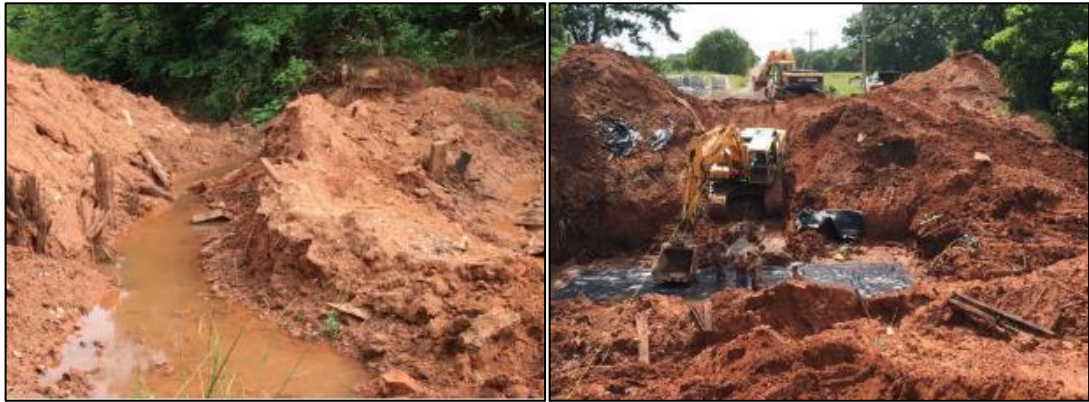
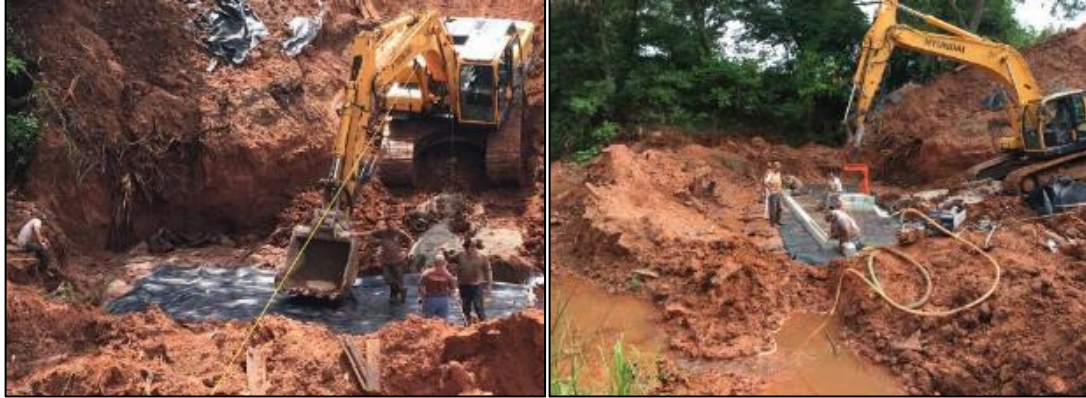
Figure 53: Pumping of flood water out of the GRS abutment site, and placement of a new reinforcement layer on the top of the RSF

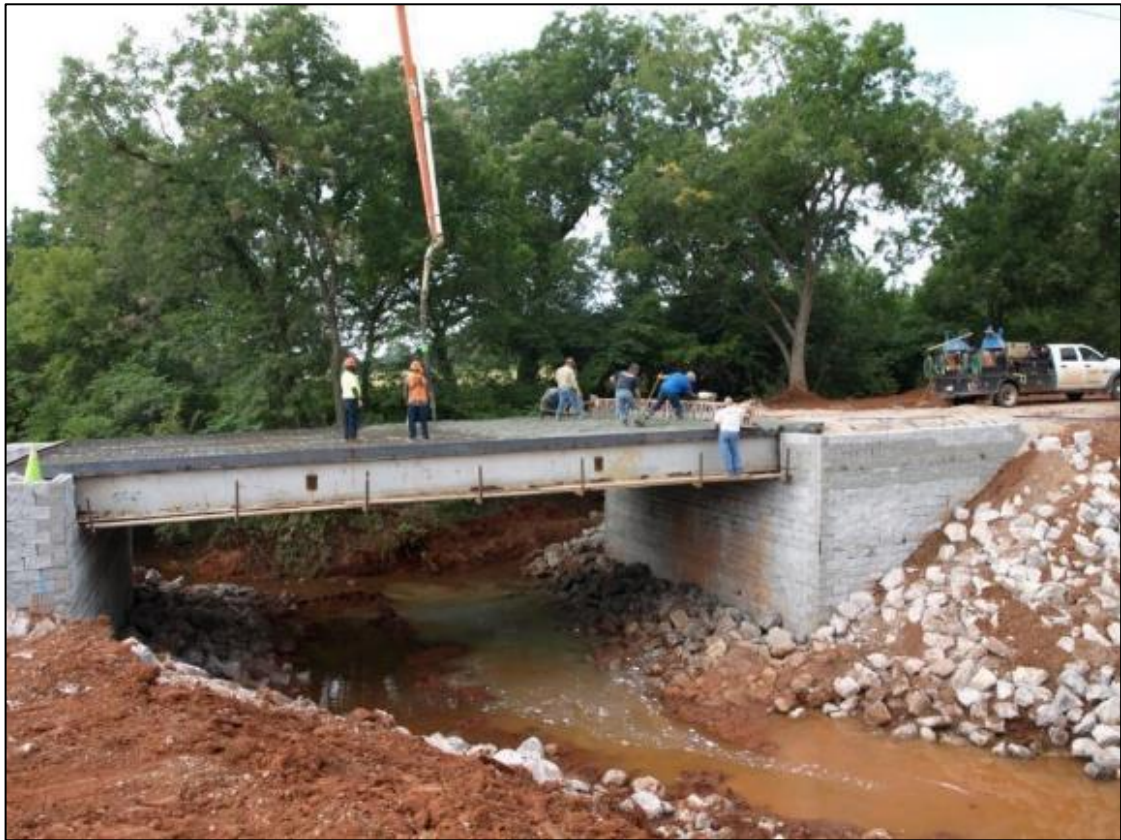
Figure 54: Construction of concrete deck at Yates Bridge, Lincoln County, OK
(Photograph courtesy of Mr. Tom Simpson, PE)

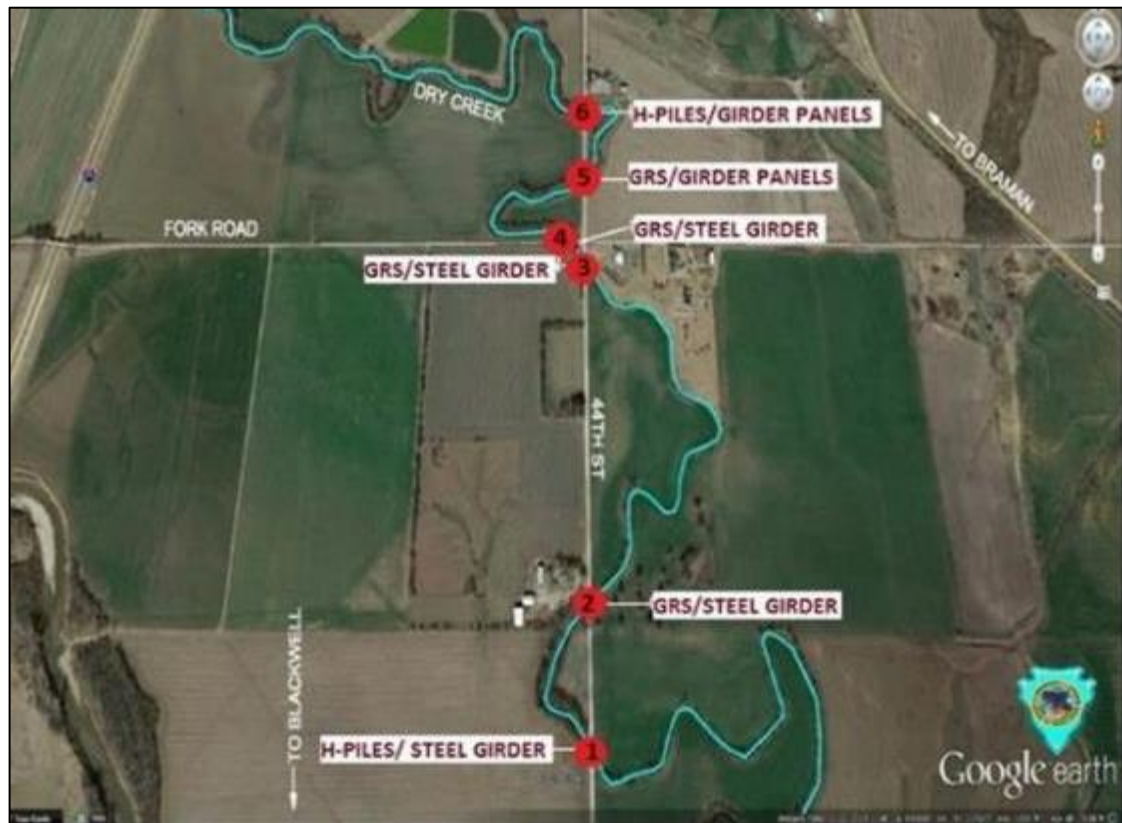
Figure 59: Locations of GRS-IBS bridges in Kay County

During the period between April 2014 and February 2015, four (4) GRS-IBS bridges and two (2) conventional bridges were constructed to replace six (6) bridges over Dry Creek near Blackwell, in Kay County, OK (**Figure 58**). All of them were built within a one-mile segment of the 44th St., which provided a unique opportunity for a side-by-side comparison as reported by Ngo (2016). Their performance was compared with one another for essentially the same geotechnical, climatic, traffic and construction conditions. In addition to the aforementioned conditions, this section reports the weather data, local seismicity and traffic count. The bridges are numbered as shown in **Table 29** and **Figure 59** for ease of reference in this study.

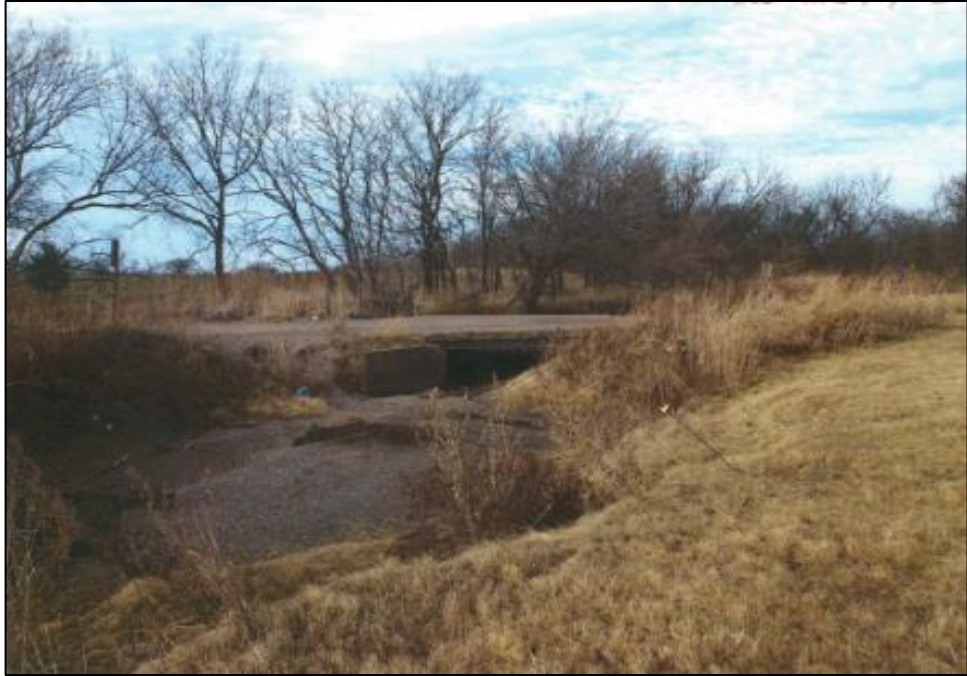
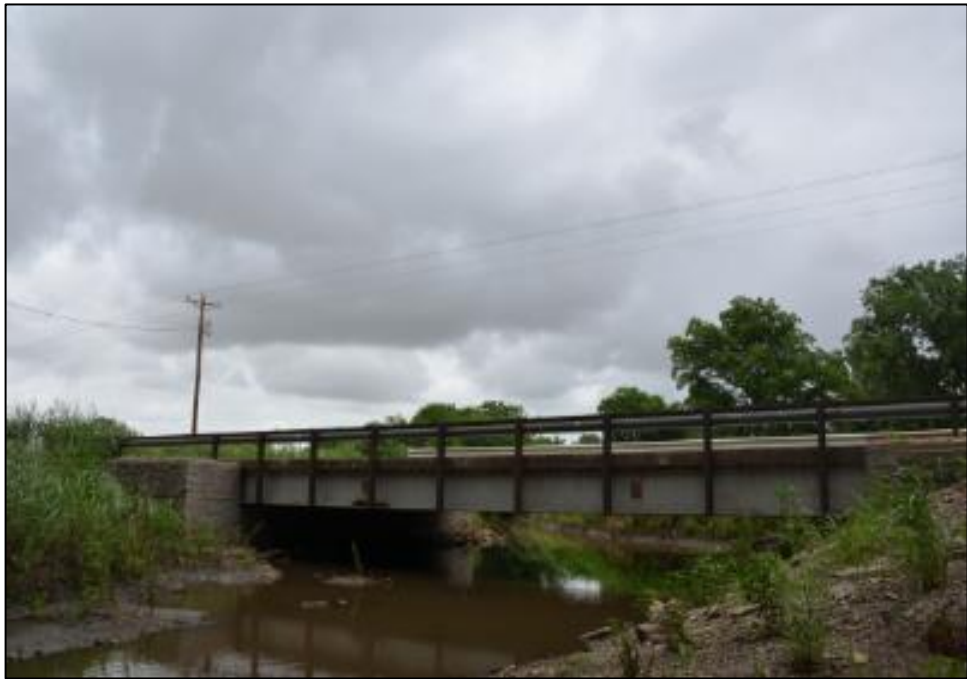
Figure 60: (a) Old and (b) New Bridge No. 2 (Photographs Courtesy of Mr. Tom Simpson, PE)

Figure 60 through **Figure 63** show side-by-side comparisons between the old and new (GRS-IBS) bridges (Bridges Nos. 2 through 5) in Kay County.

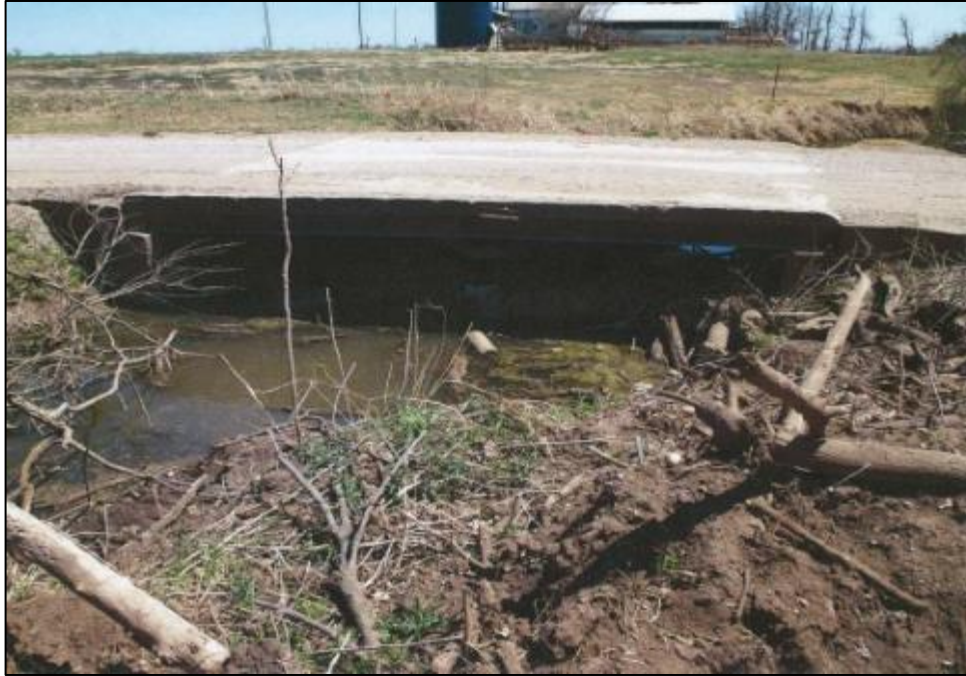
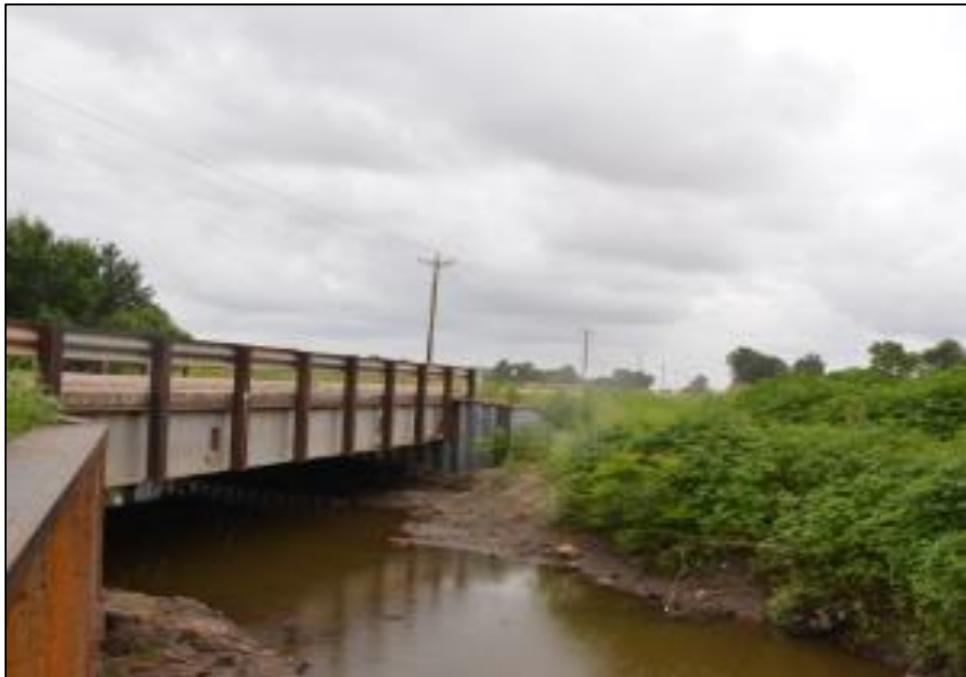
Figure 61: (a) Old and (b) New Bridge No. 3 (Photographs Courtesy of Mr. Tom Simpson, PE)

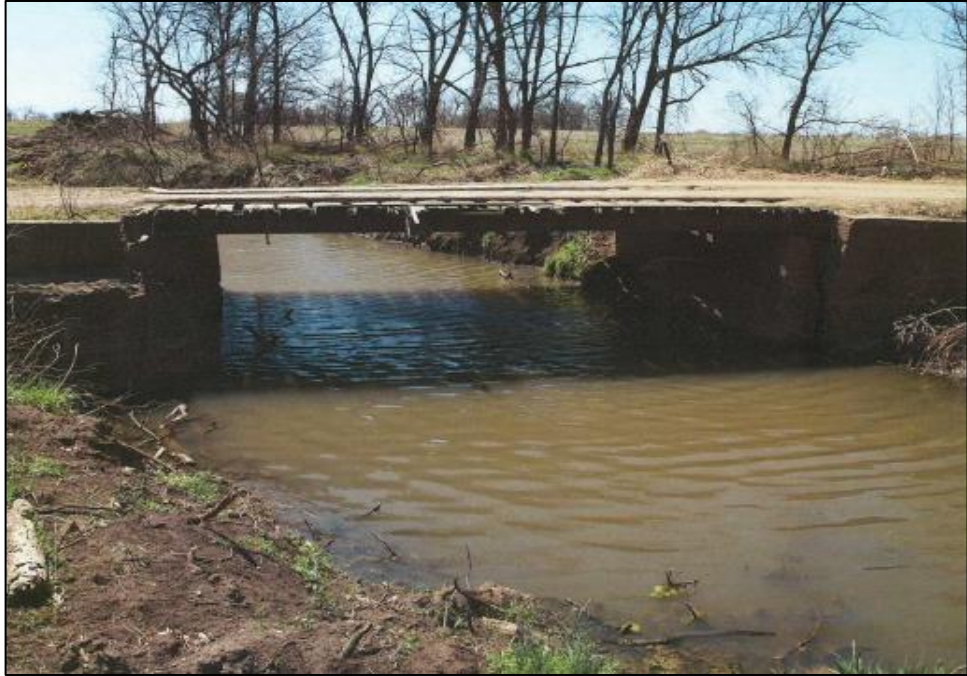
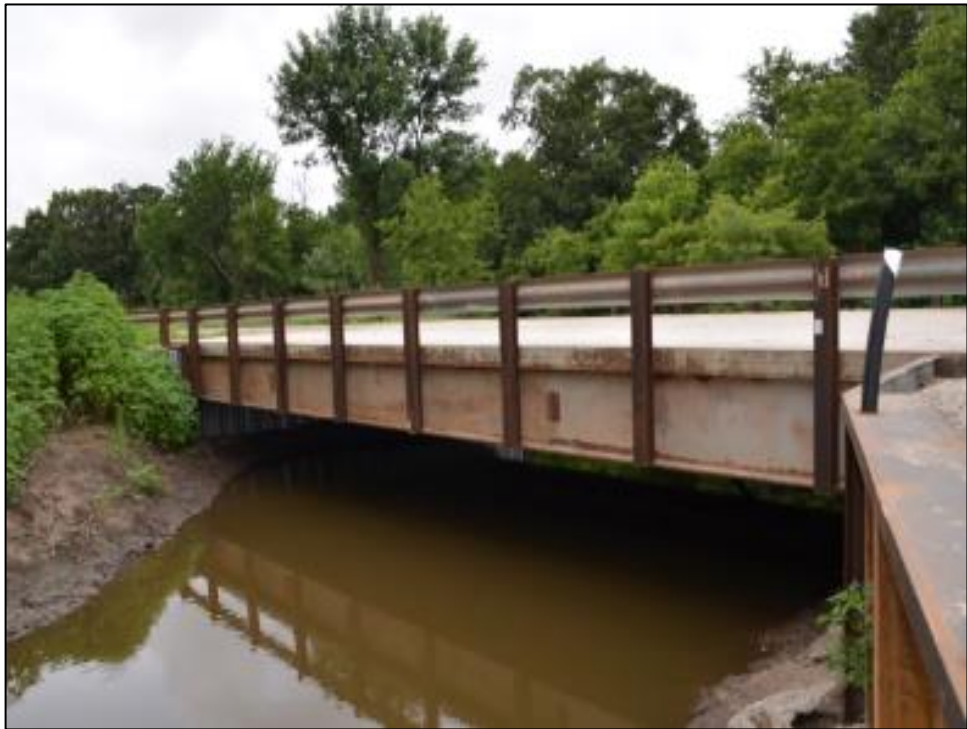
Figure 62: (a) Old and (b) New Bridge No. 4 (Photographs Courtesy of Mr. Tom Simpson, PE)

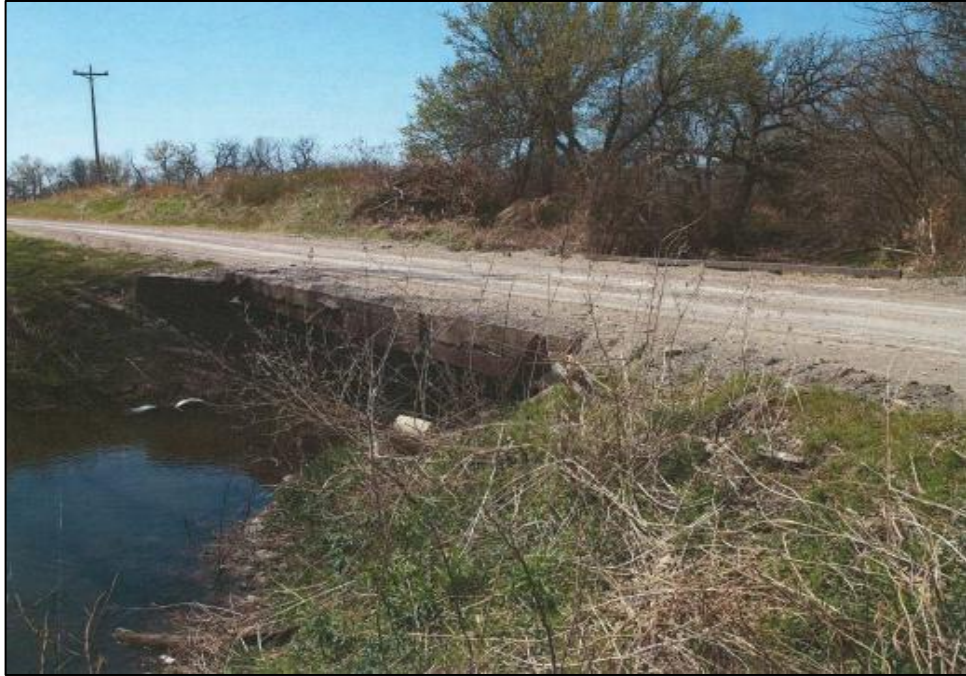
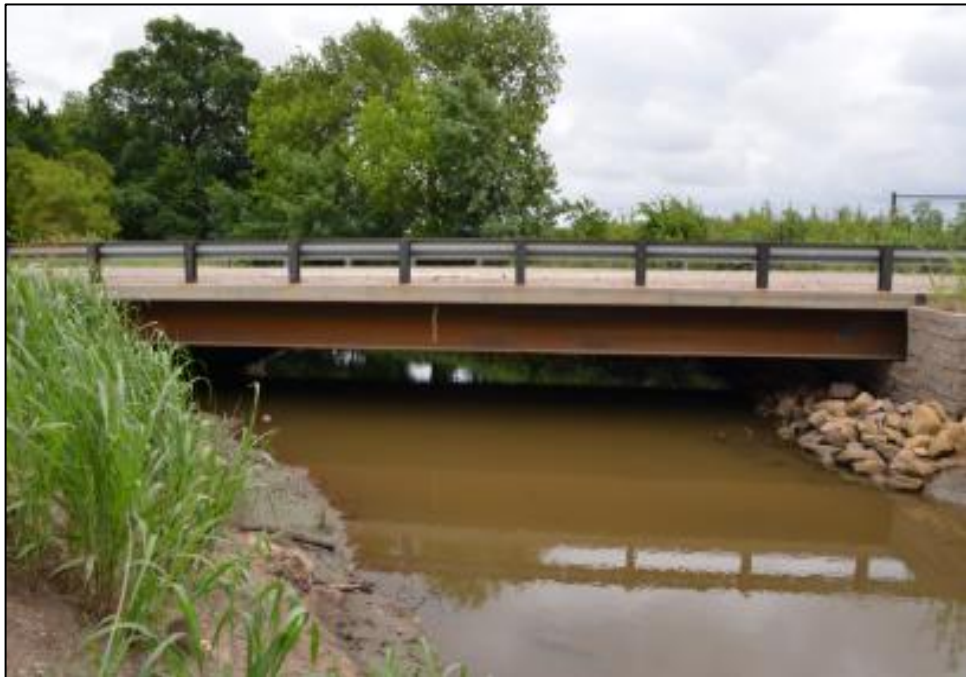
Figure 63: (a) Old and (b) New Bridge No. 5 (Photographs Courtesy of Mr. Tom Simpson, PE)

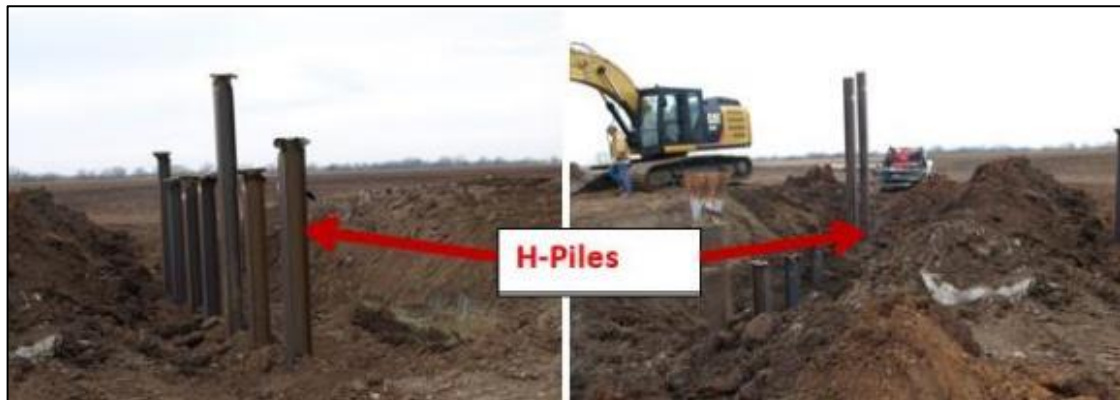
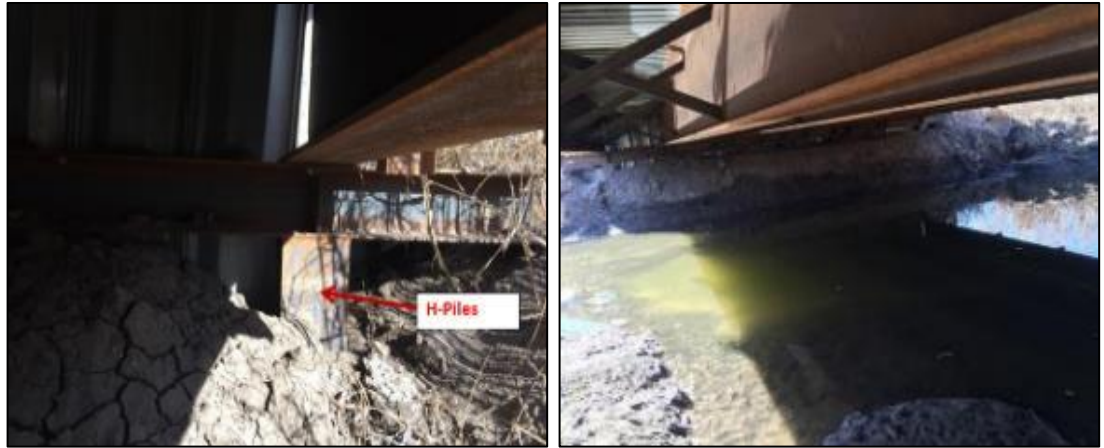
Figure 70: Bridge No. 1 - conventional abutment support with H-Piles driven to bedrock

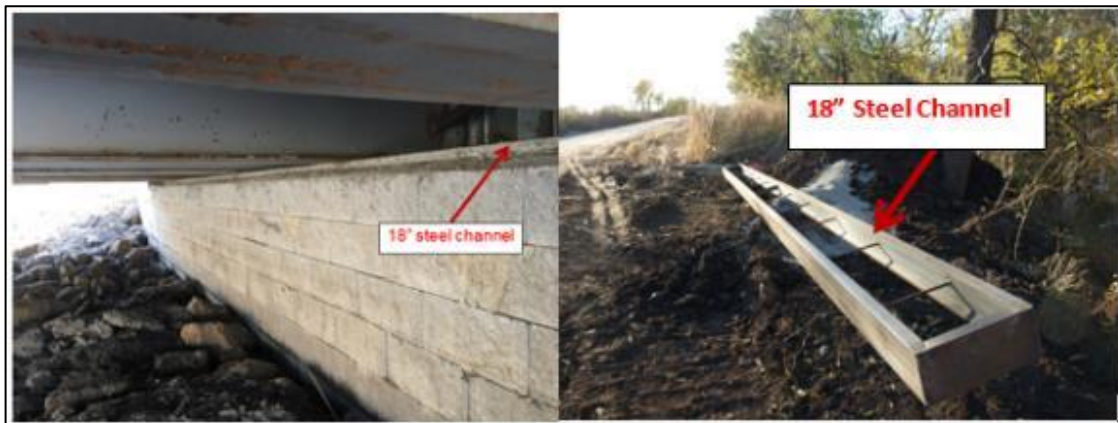
Figure 71: Bridge No. 2 - GRS-IBS with an 18 in.-wide concrete-filled steel channel as the bearing pad for the steel girders

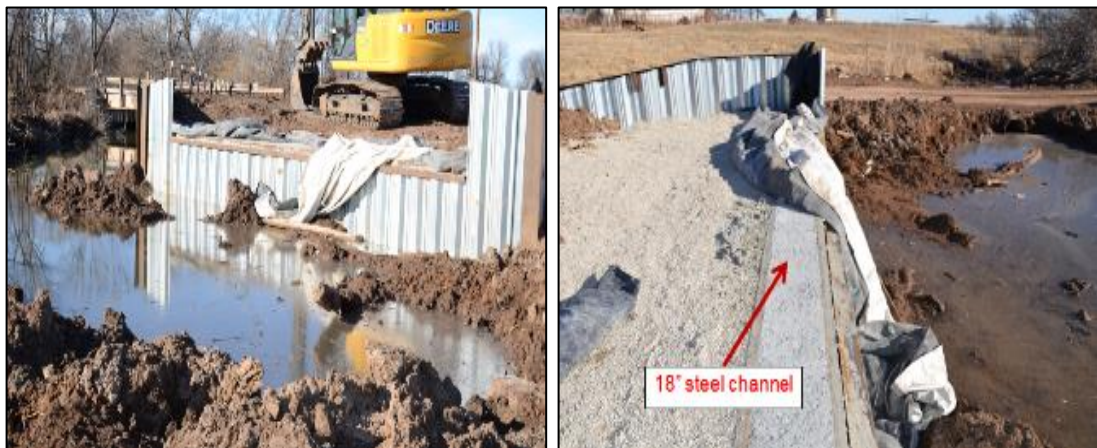
Figure 72: Bridge No. 3 - GRS-IBS under construction with sheet pile facing

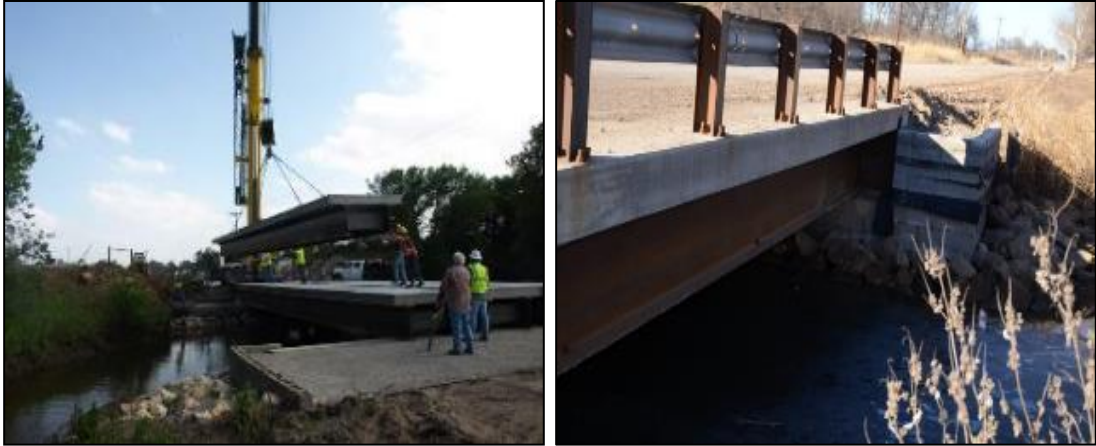
Figure 73: Bridge No. 5 - GRS-IBS with concrete block facing (geotextile reinforcement needs to be trimmed)

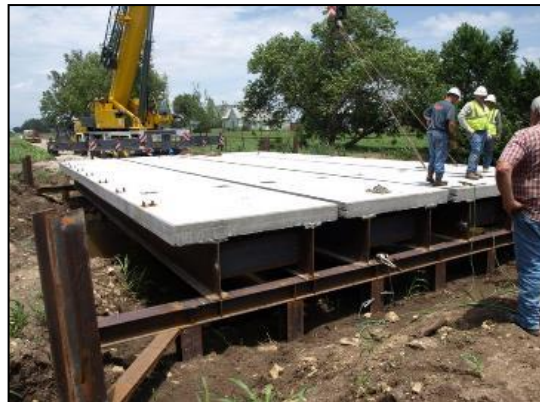
Figure 74: Bridge No. 6 - Bridge on conventional pile support under construction

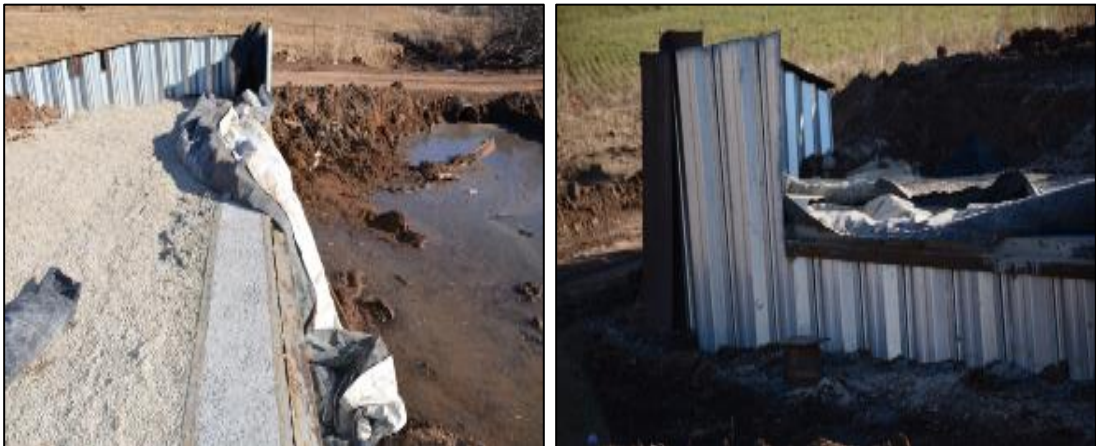
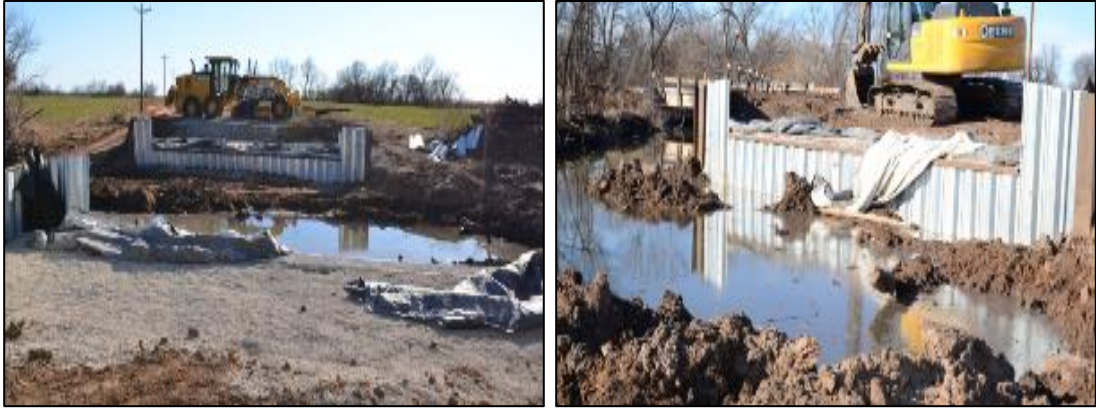
Figure 75: A GRS-IBS (Bridge No. 3) under construction near Blackwell in Kay County with sheet piling for the abutment facing

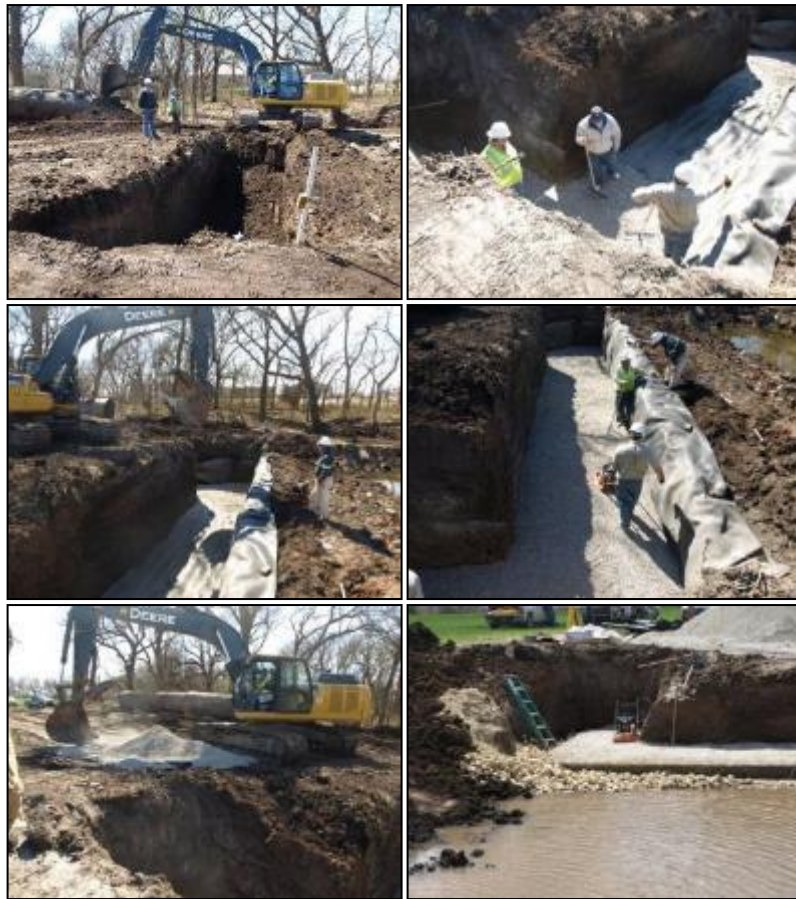
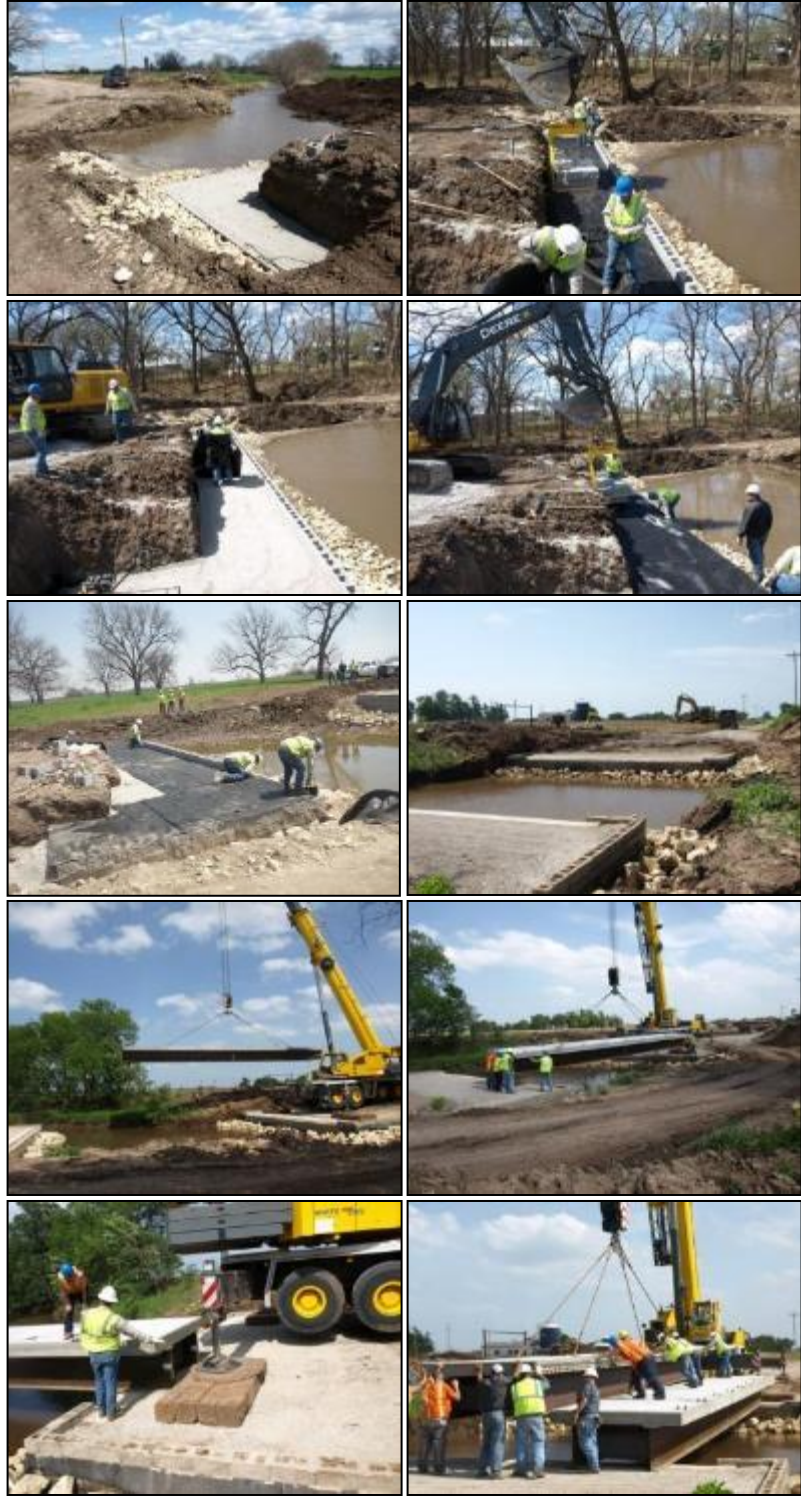
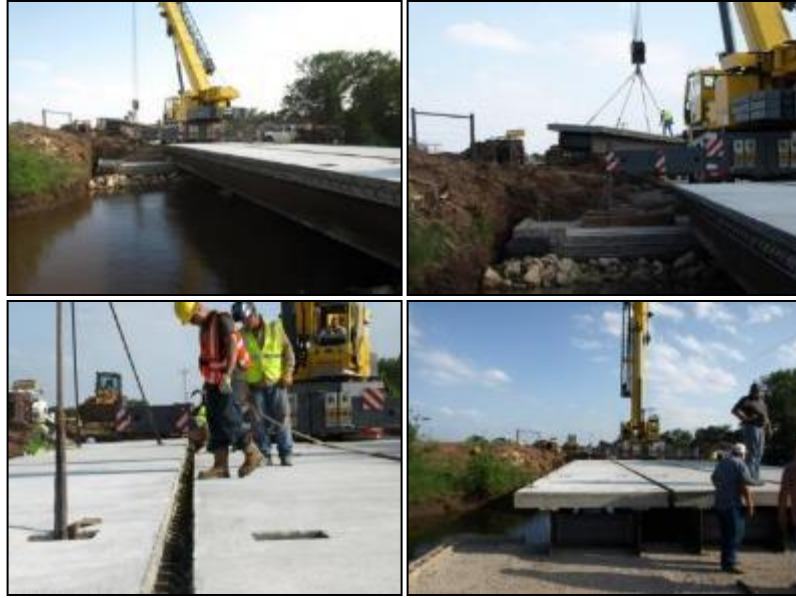
Figure 76: Different stages of GRS-IBS construction near Blackwell in Kay County, OK (photographs courtesy of Mr. Tom Simpson, PE)

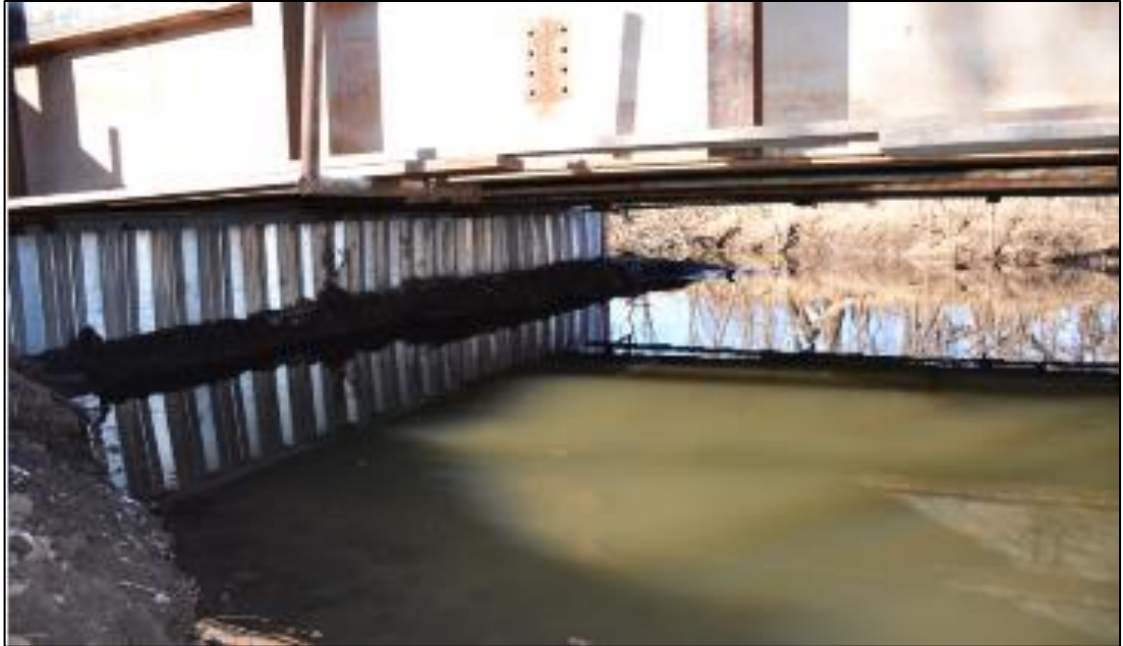
Figure 78: Completed Bridge No. 5 bridge (GRS-IBS) with sheet pile abutment facing

Additional photographs of completed Bridges No. 3 (GRS-IBS with sheet pile abutment facing), Bridge No. 5 (GRS-IBS with CMU blocks facing) and No. 6 (Conventional bridge abutments on H-piles driven to the bedrock but with sheet pile facing) are shown in **Figure 77** through **Figure 80**, respectively. The 22° skew in Bridge No. 3 is indicated with a red circle in **Figure 77**. In Bridge No. 5 (**Figure 79**), box beams were originally planned for the superstructure in the design. However, 7-inch concrete beams overlaid with steel girders from a 50-year-old bridge from the I-40 Crosstown project in Oklahoma City were ultimately used in its construction.

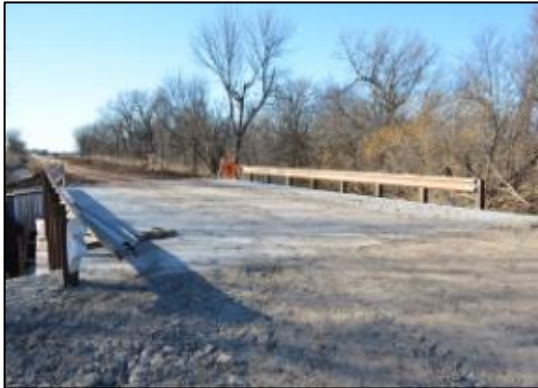
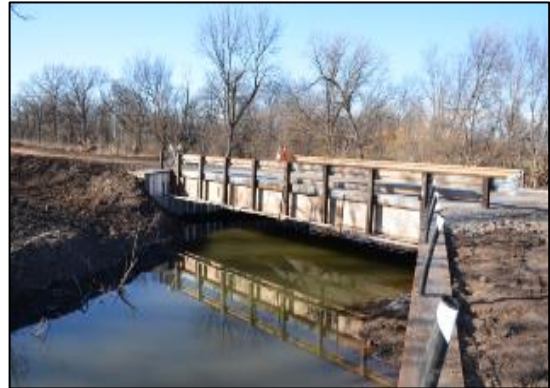
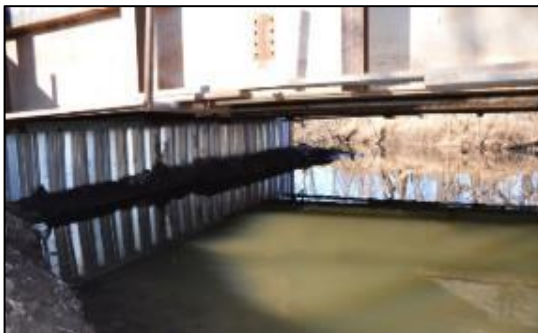
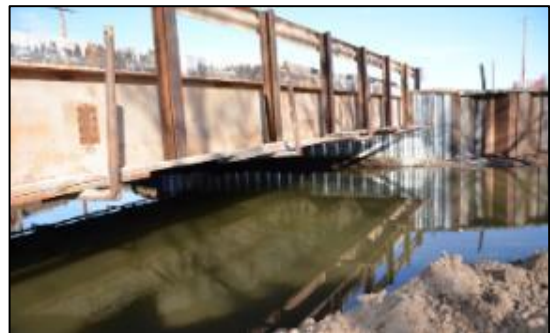
Figure 79: Completed Bridge No. 5 bridge (GRS-IBS) with sheet pile abutment facing

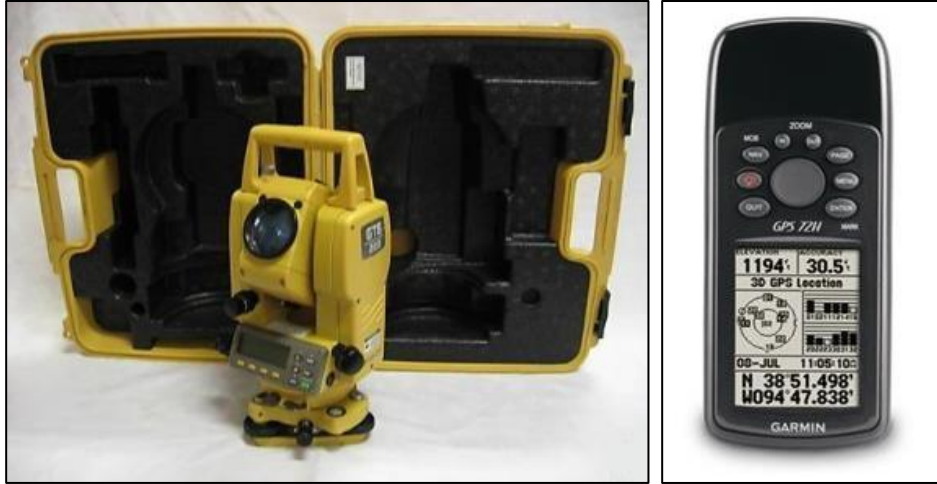
Figure 85: (a) Total Station Topcon GTS-211D used in this study to survey and monitor the deformations of GRS-IBS and conventional bridges; (b) GPS Garmin - 72H

As reported by Ngo (2016), a three-week TST training program was offered by Dr. Russel Dutnell on the University of Oklahoma campus. The training included a closed-loop survey near the CEC engineering building. The TST used was a Topcon GTS-211D model shown in **Figure 85a**. Also, the accuracy of each mode of operation is given in **Table 35**. *Fine Mode* with the accuracy of 1 mm (0.003 ft.) was used to survey the GRS-IBS abutments and comparable conventional bridges in Kay County.

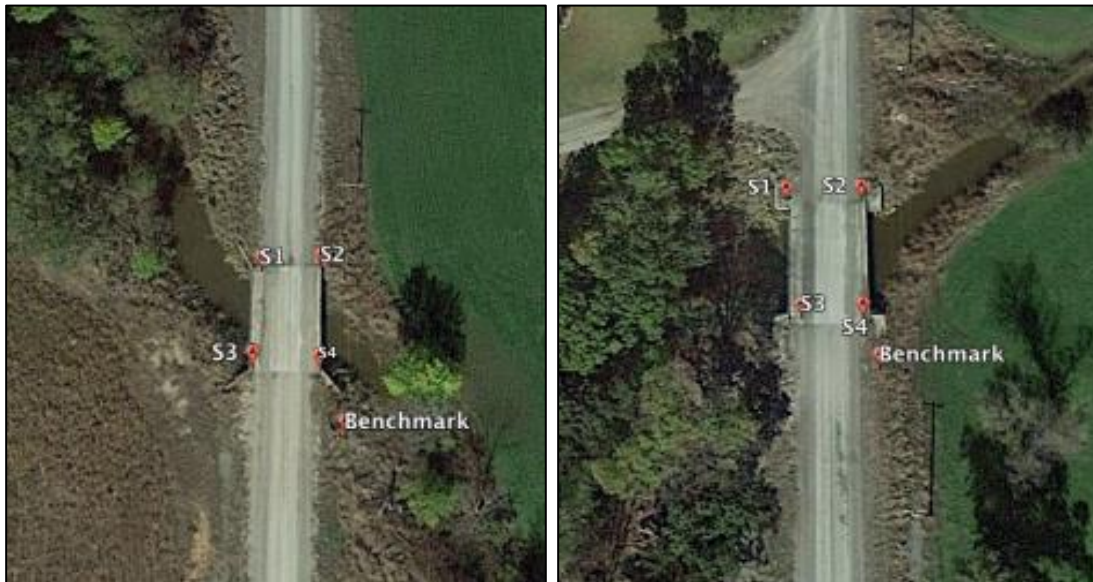
Figure 86: Bridges Nos. 1 & 2 with pilot survey points

Subsequent to the survey training period, a pilot surveying set was performed to Bridge No. 2 in Kay County, OK. One provisional benchmark and control point were installed on the shoulders of the road outside of the approach embankment. A GPS Garmin -72H was used initially to obtain the coordinates of the benchmark and the control points (**Figure 85b**). However, the accuracy of this GPS device is approximately 5 ft. Therefore, the coordinates determined in this preliminary stage (**Table 36**) were used only to help locate the reference points in the subsequent visits to the site. After the training, provisional survey points listed in **Table 37** were monitored as a pilot test (**Figure 86**).
