PERFORMANCE MONITORING AND ANALYSIS OF GEOSYNTHETIC
REINFORCED SOIL INTEGRATED BRIDGE SYSTEMS (GRS-IBS) IN
OKLAHOMA

A THESIS

2017

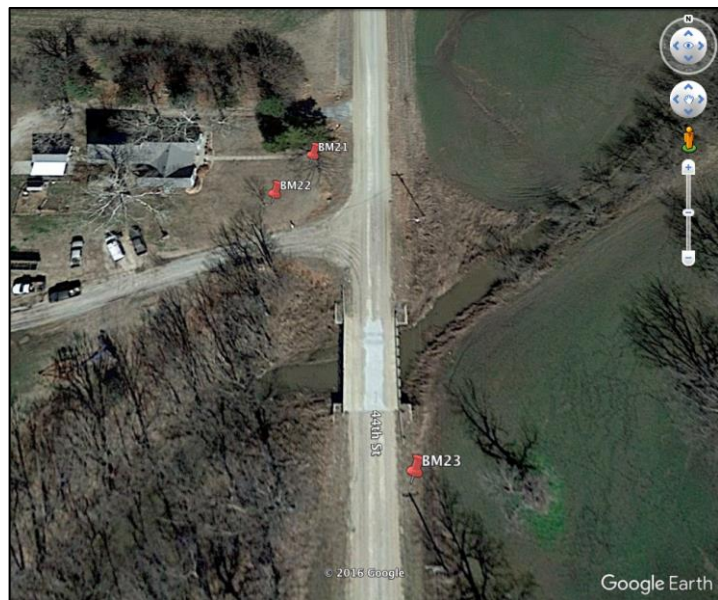
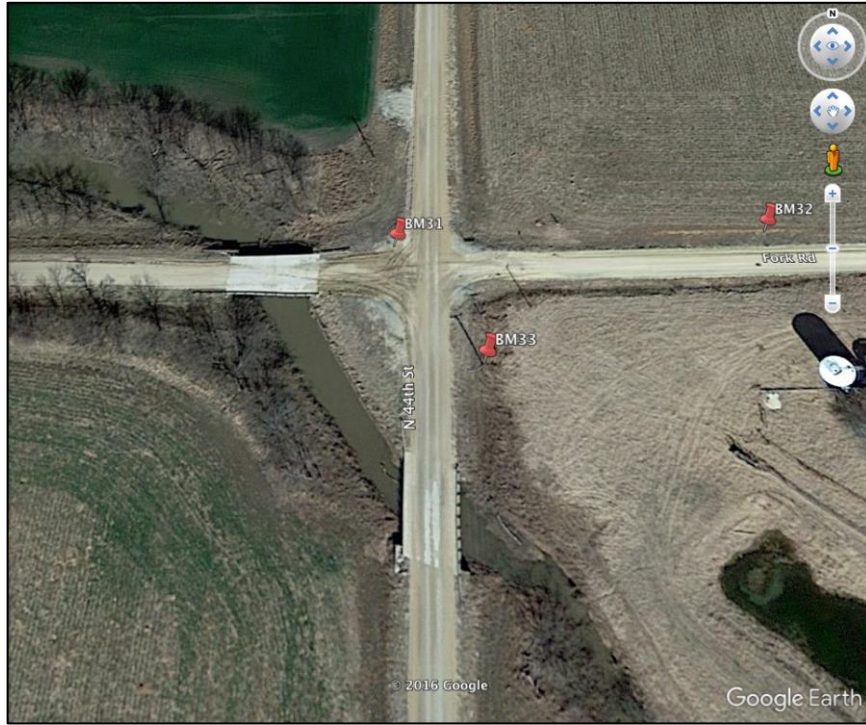
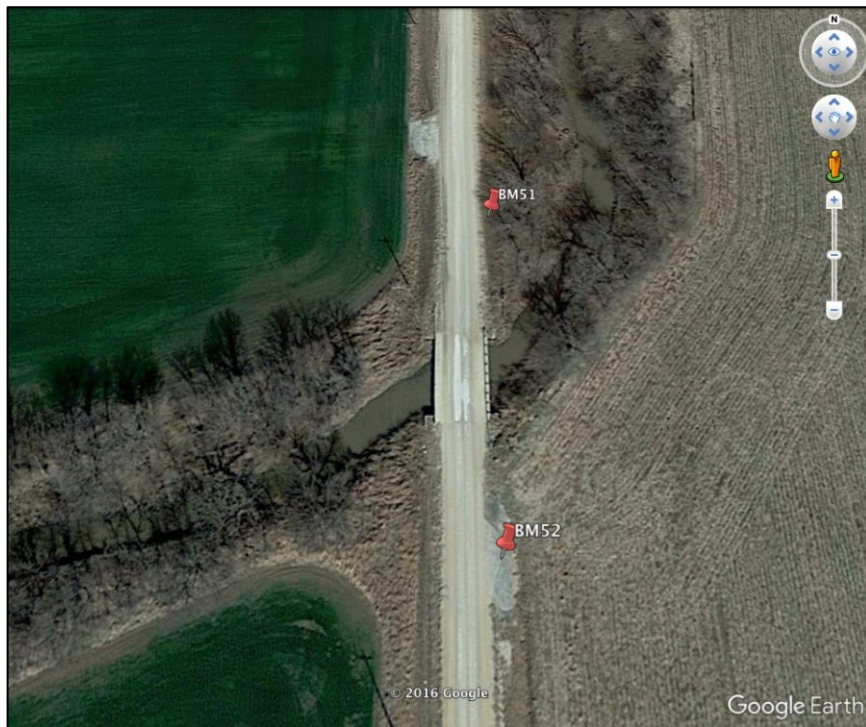
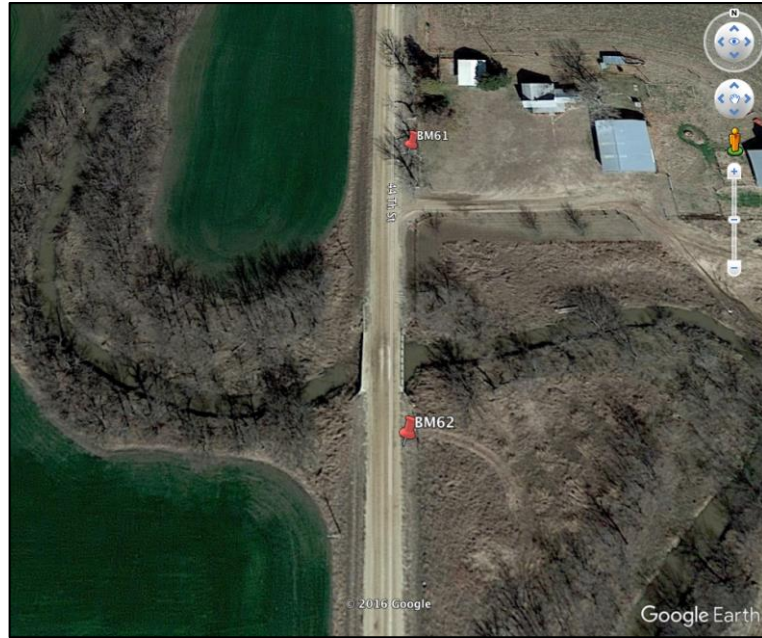
Figure 89: Locations of the benchmarks: (a) Bridge No. 1; (b) Bridge No. 2; (c) Bridge No.3 and Bridge No. 4; (d) Bridge No. 5; (e) Bridge No. 6 (Google Earth 2016)

Ngo (2016) and Hatami et al. (2016) reported the benchmark installation process which can be summarized by the following steps: (1) A 53-cm deep (21-inch deep), 20 cm (8 in.) diameter hole was dug at a higher terrain location near the bridges, (2) A 76 cm-long (30 inch-long), ½ in-dia. rebar was placed in the hole, (3) Water was carefully added to concrete mix to obtain a desired strength of > 13,800 KPa (2,000 psi) for the benchmark concrete cylinder in the ground, (4) Concrete was poured in the hole around the benchmark rebar and it was tamped to expel the air bubbles, and (5) The top surface of the concrete was leveled and completed with a benchmark cap. **Table 39** shows the coordinates of installed benchmarks and control points used to survey the Kay County bridges in this study. The locations of these points were chosen so that they fall within 10 m (33 ft.) from the centerline of the road on either side because the right-of-way on most county roads is 20 m (66 ft.) wide (Simpson 2015). Also, **Figure 89** depicts the locations of the installed benchmarks which are labeled as BMXY for ease of reference where:

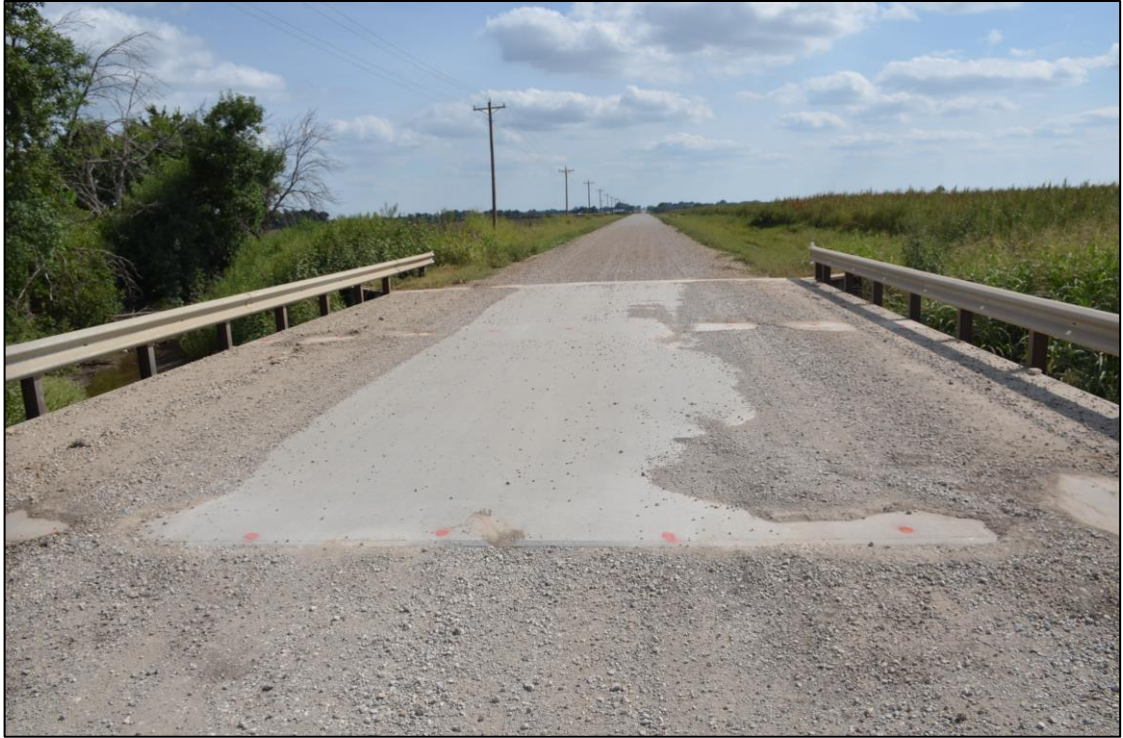
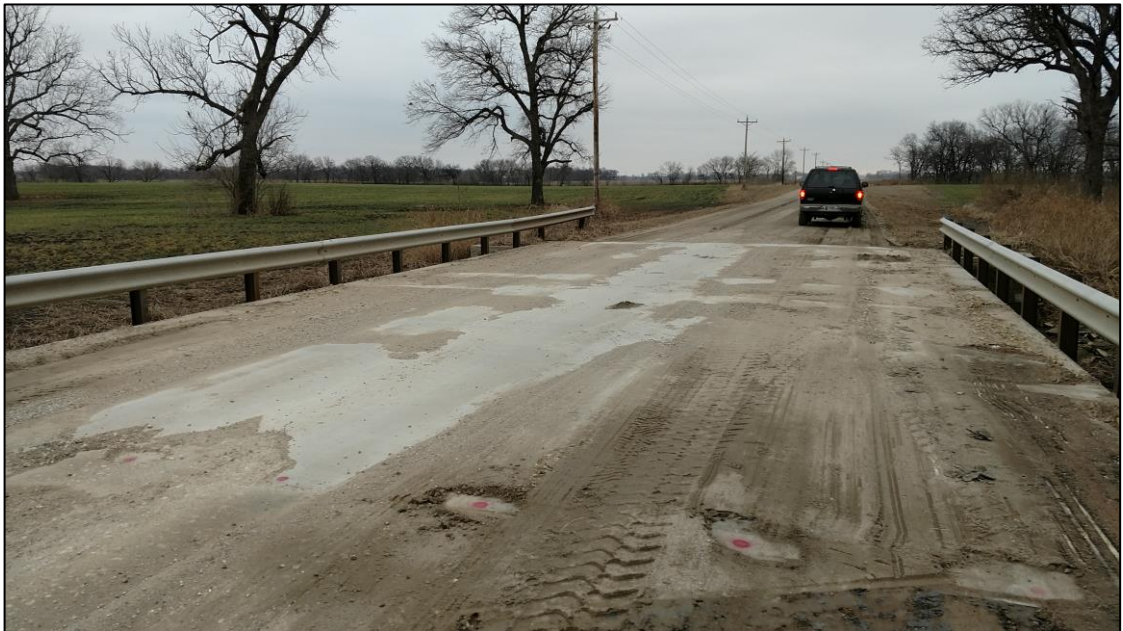
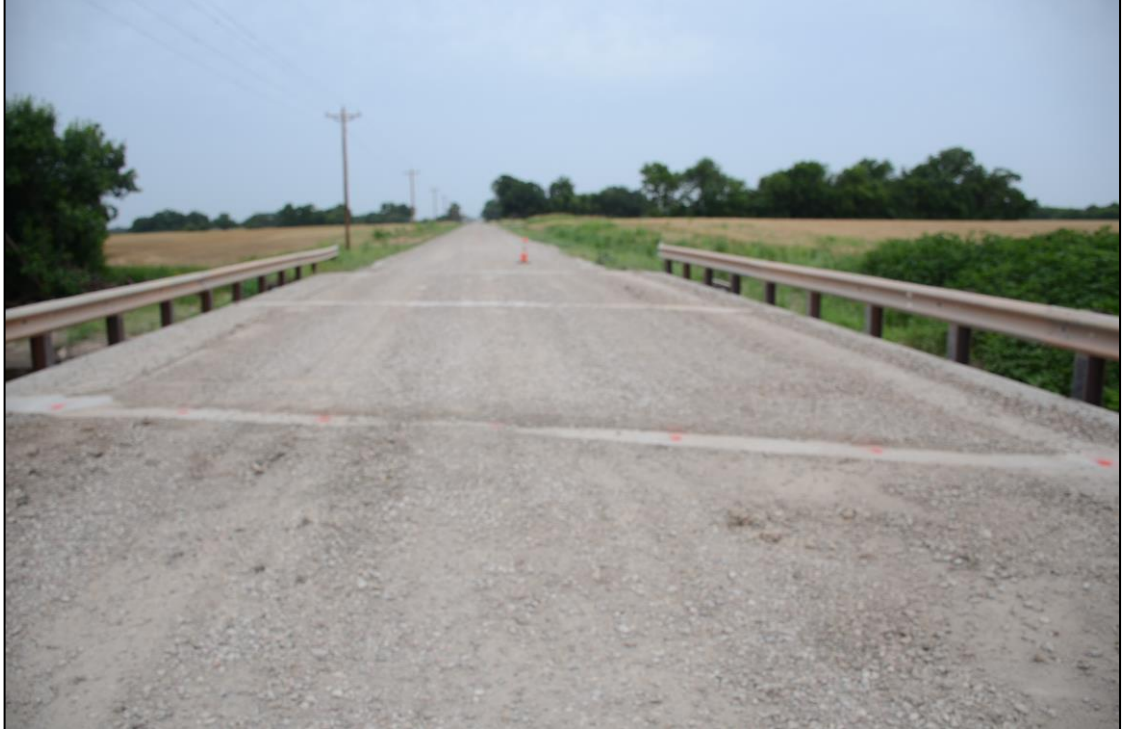
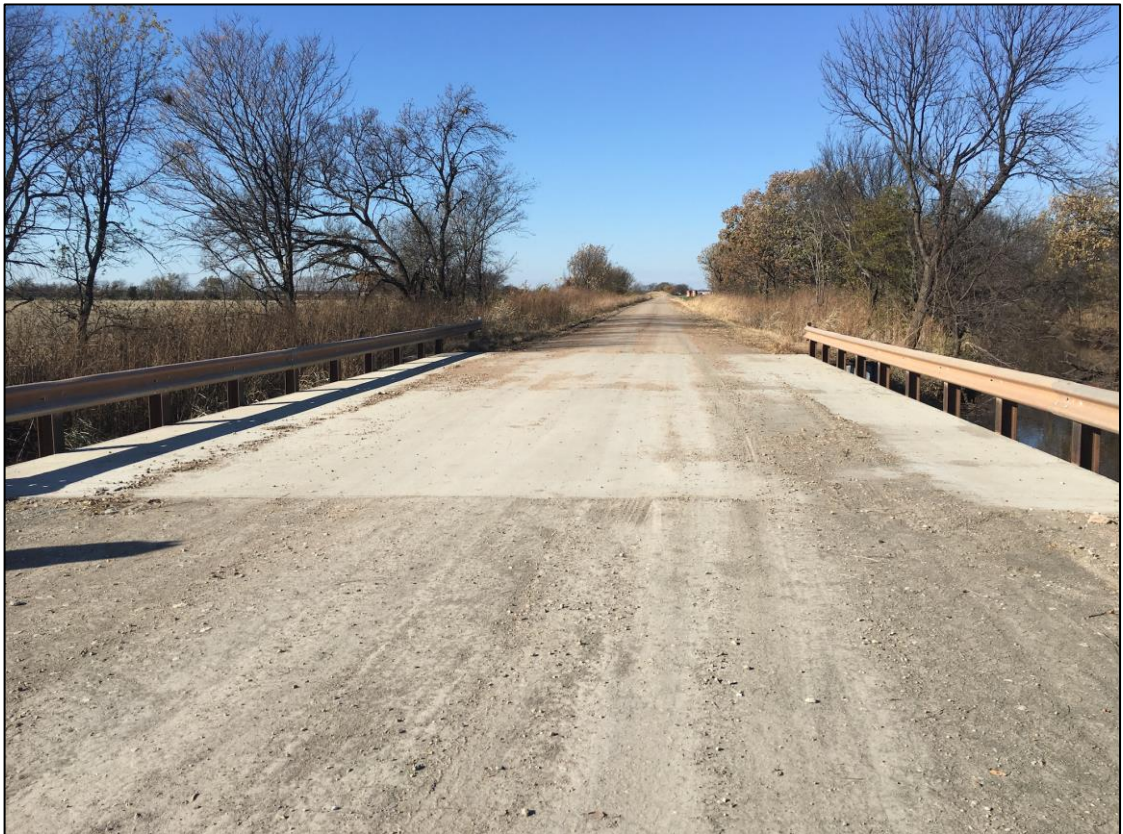
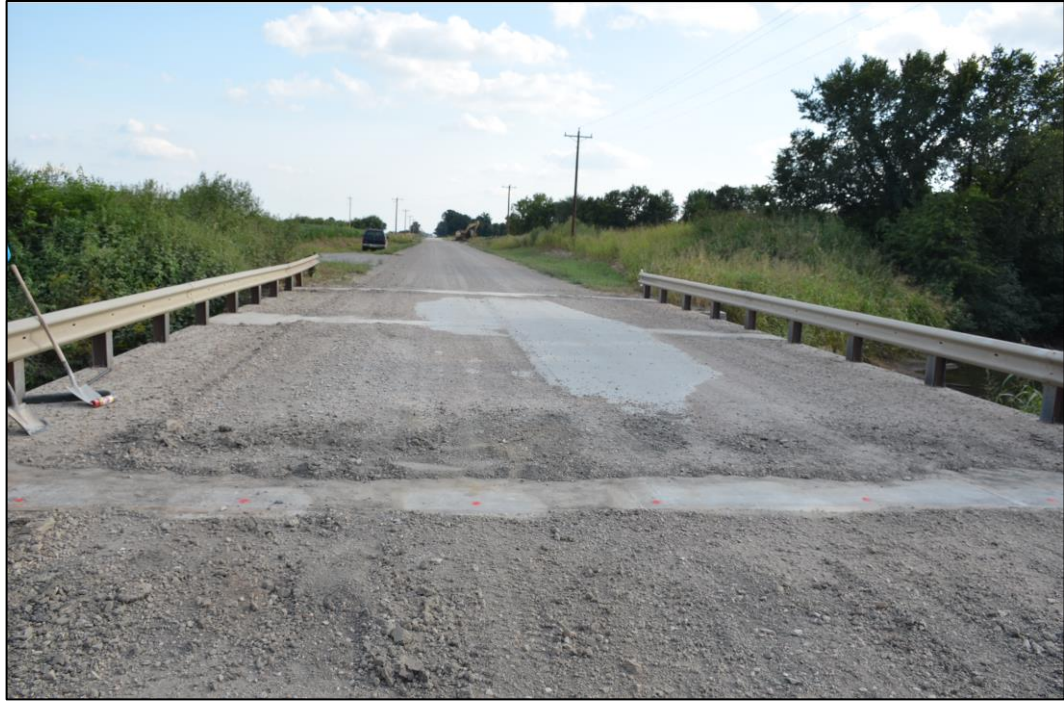
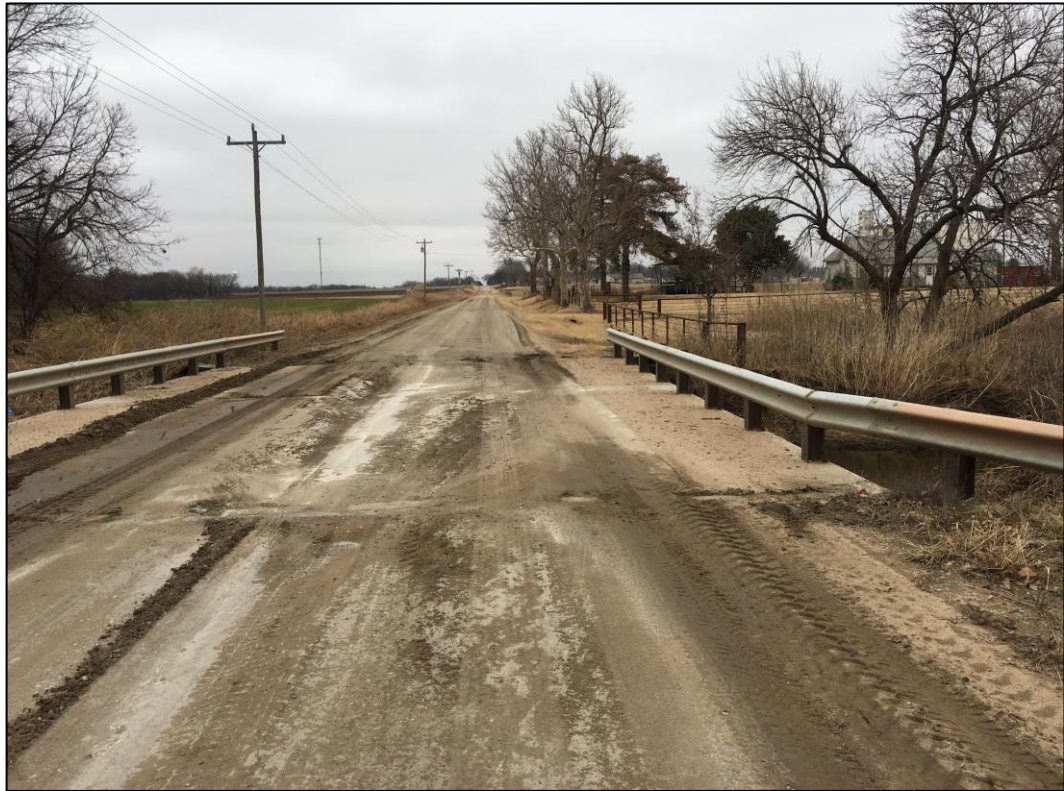
Figure 91: Marked control points: (a) Bridge No. 1; (b) Bridge No. 2; (c) Bridge No.3;
(d) Bridge No.4; (e) Bridge No. 5;(f) Bridge No.6

Figure 91 shows the marked control points for all bridges.
