UNDERSTANDING ULTIMATE SHEAR BEHAVIOR OF PRESTRESSED
CONCRETE GIRDER BRIDGES AS A SYSTEM THROUGH EXPERIMENTAL
TESTING AND ANALYTICAL METHODS

A DISSERTATION
SUBMITTED TO THE GRADUATE FACULTY
in partial fulfillment of the requirements for the
Degree of
DOCTOR OF PHILOSOPHY

By
CAMERON DAVID MURRAY
Norman, Oklahoma
2017

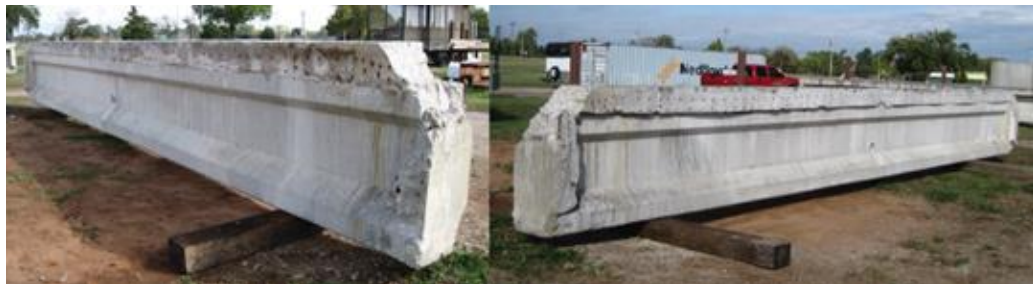
Figure 14: Two views of girder A showing details of condition on October 8, 2013

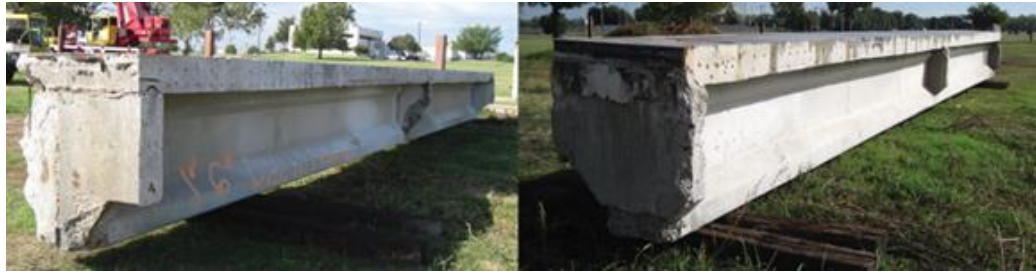
Figure 15: Two views of girder C showing details of condition on October 8, 2013

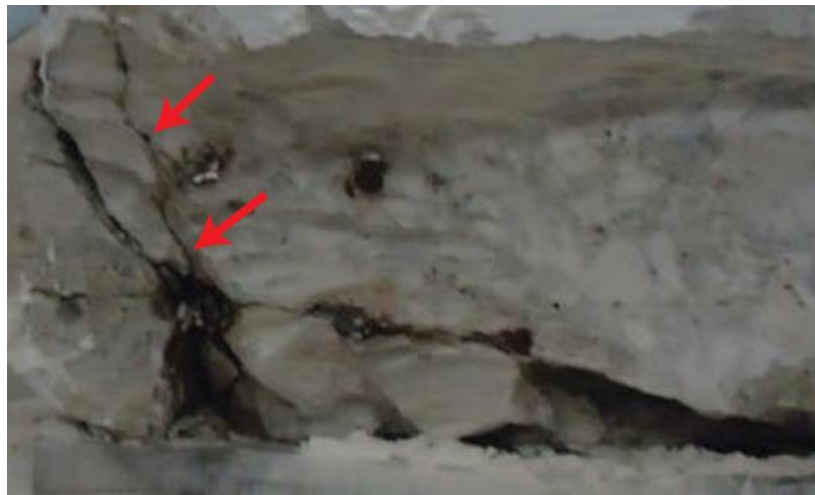
Figure 39: Spalling and cracking at girder end initiated by corrosion cracks

concrete to spall off of the bottom flange (Figure 39). At this point the test had to be stopped so the LVDTs on the strands at that end could be repositioned. The LVDTs monitoring strand slip and bearing deflection were mounted to the sides of the bottom flange on this end of the girder, so spalling caused these instruments to move and no longer provide accurate readings. The spalling behavior ceased at a load of 110 kips, so it appears there were no bearing issues outside of the initial spalling due to the weakened concrete surrounding the corroded strands.

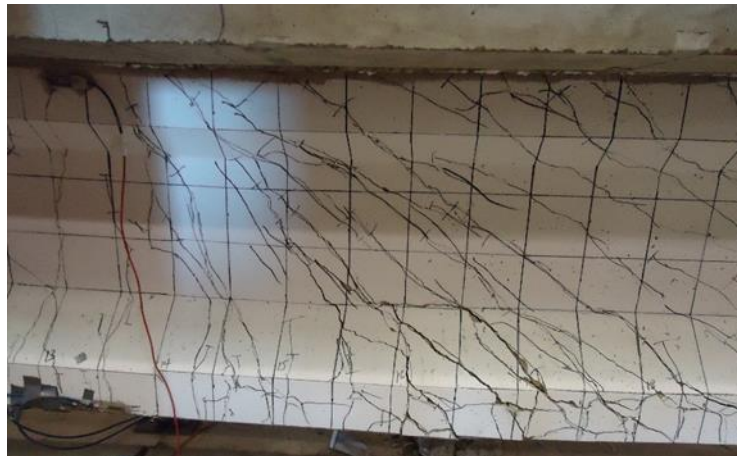
Figure 41: Test C1 failure, note large shear cracks and horizontal cracks in bottom flange

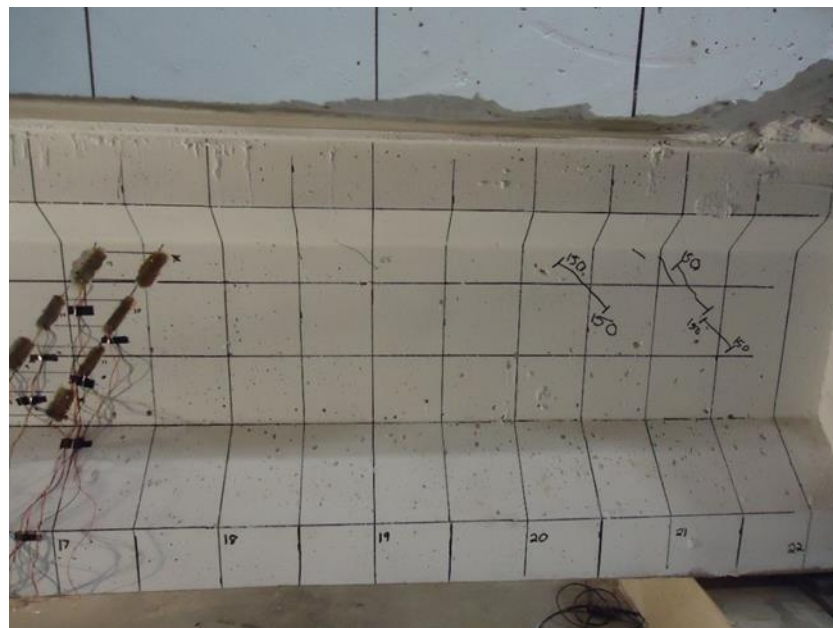
Figure 48: Initial cracking in test C2

themselves more horizontally, along the level of the strands (indicating some potential bond issues). An overview of the cracking from test C2 is shown in Figure 49. Load was increased up to 301 kips at which point a leak in the hydraulic actuator used to apply load caused the test to be halted. Load was removed from the girder until the hydraulic system could be topped up with fluid. After the hydraulics were corrected, load was applied continuously until ultimate failure occurred at a load of 297 kips. As in previous tests, the girder failed when the forces in the deck overlay were too large, causing the overlay to delaminate and crush. The compressive forces during this test were so large that the top flange crushed and compression steel in the top flange and the deck buckled (Figure 51 and Figure 52). This failure type could be described as compression-shear or a flexural failure. Compression-shear is caused by shear cracks entering the compression flange followed by a compression failure (Ross et al., 2011).

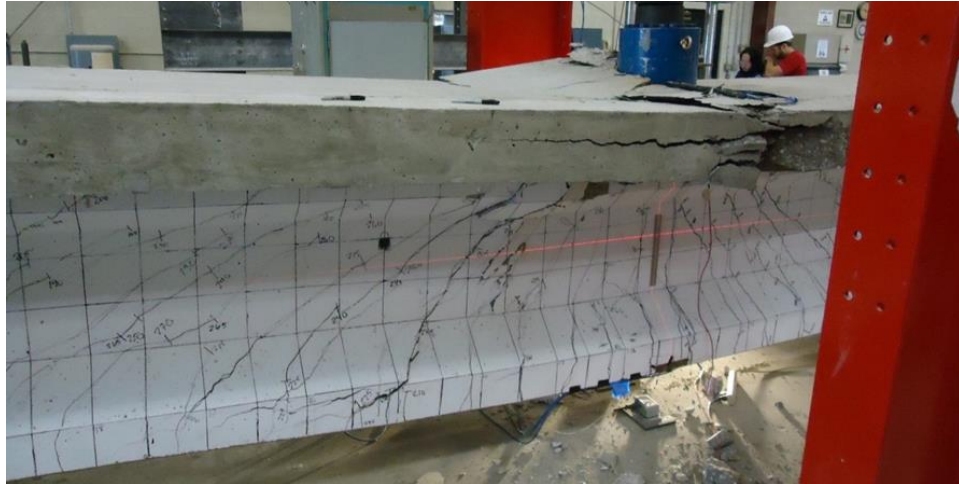
Figure 50: Test C2 failure, showing a large shear crack in the center of the image that entered the top flange where a compression failure occurred

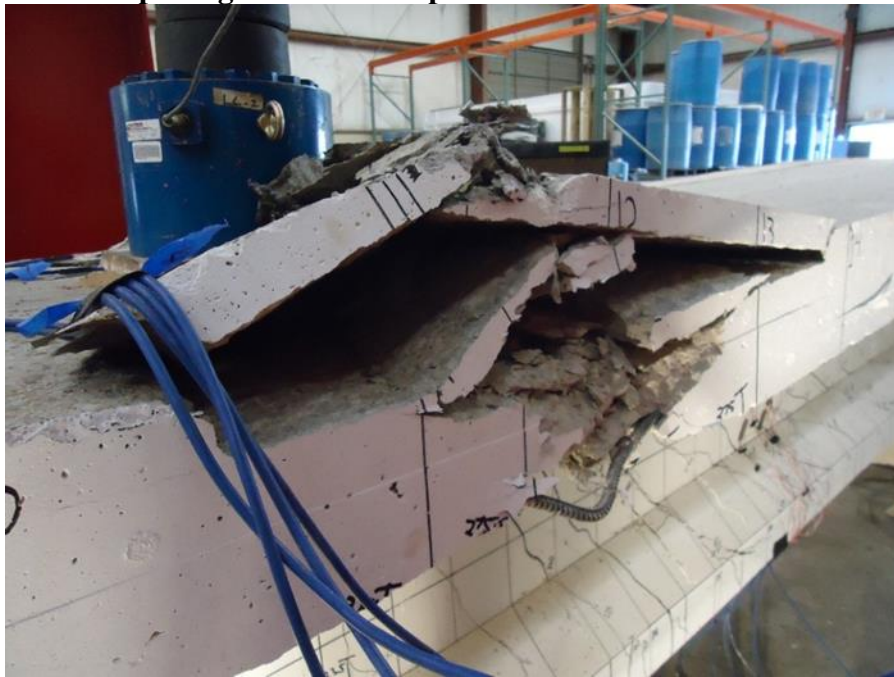
Figure 51: Crushing in girder deck and buckling of reinforcing steel

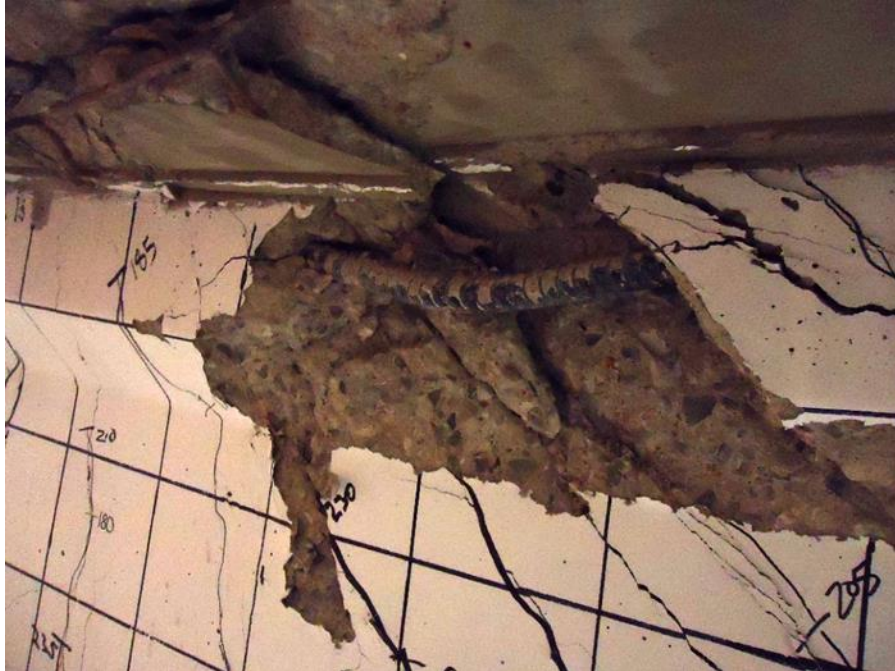
Figure 52: Buckling of compression steel in girder flange and failed deck concrete

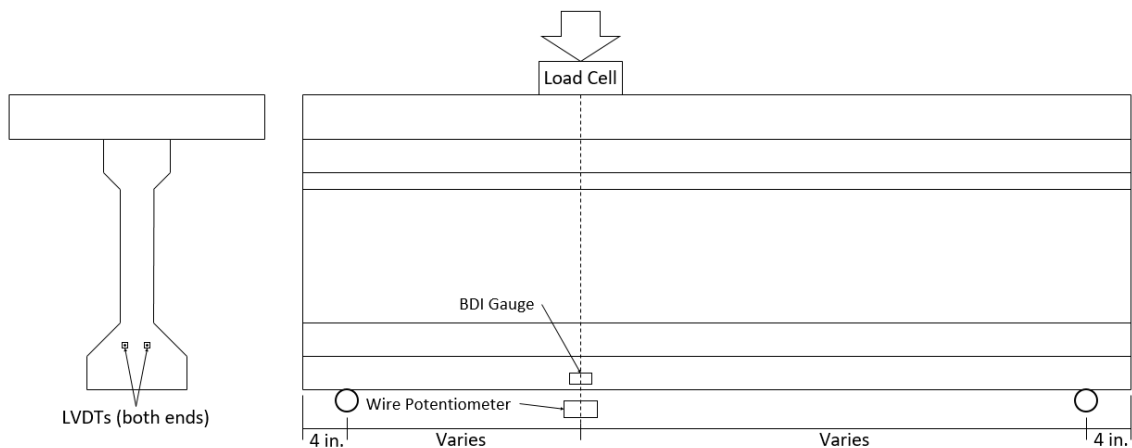
Figure 66: Scale section test setup

each specimen is shown in Figure 66. The load location was varied in these tests to match a/d ratios from the full-scale tests. Applied load was measured using a 100 kip capacity load cell placed beneath the load point, deflection was measured using two wire potentiometers placed beneath the load point, and LVDTs were placed on the strands at both ends to monitor any strand slip during the tests. A BDI strain gauge was placed on the bottom flange under the load point to measure the tensile strain during loading. Load was applied in 5 kip increments until cracking occurred, and at 2 kip increments after cracking. Cracks were marked on the west side of the girder after each load increment. The girders were simply supported on steel rollers and load was applied through a steel plate placed on a bed of sand to limit the effect of imperfections in the girder surface. In all tests, the supports were placed 4 in. from each end for a total span length of 17 ft 4 in.

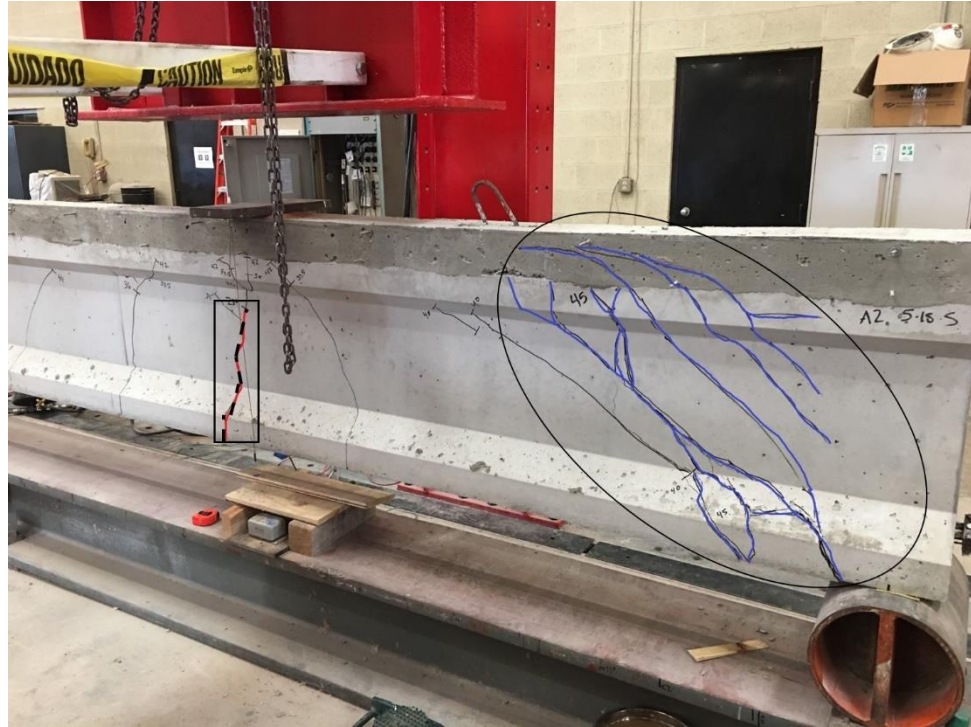
Figure 90: Cracking during test A2s, initial flexural crack (boxed) and shear cracks (circled) shown

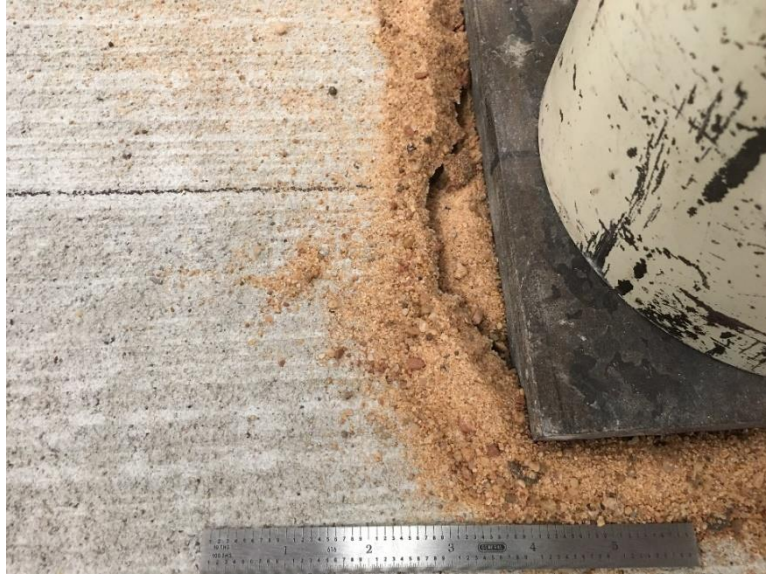
Figure 105: Punching shear failure in slab at load point

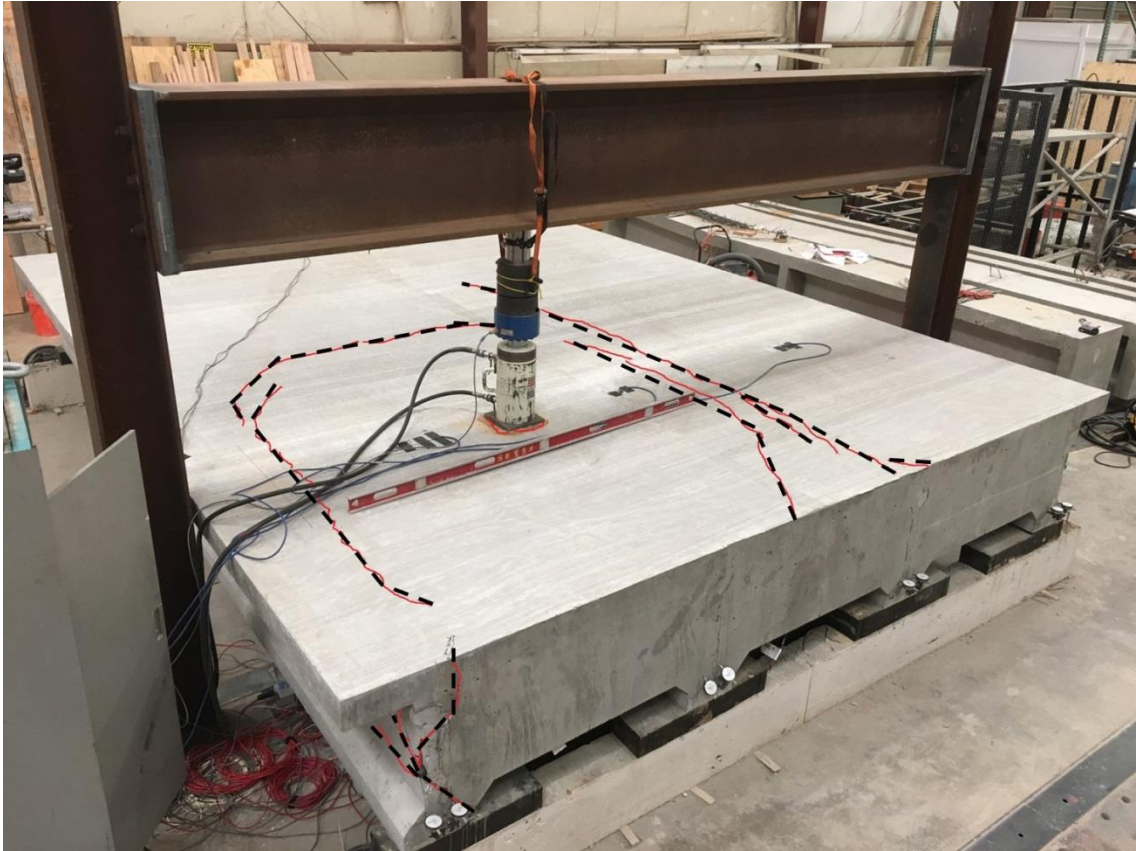
Figure 110: Cracking in scaled bridge section slab at failure (highlighted in red and black for clarity)
