STAINLESS STEEL REINFORCEMENT AS A REPLACEMENT FOR EPOXY COATED STEEL IN BRIDGE DECKS

FINAL PROJECT REPORT – FHWA-OK-13-08
ODOT SP&R ITEM NUMBER 2231

TECHNICAL REPORT DOCUMENTATION PAGE

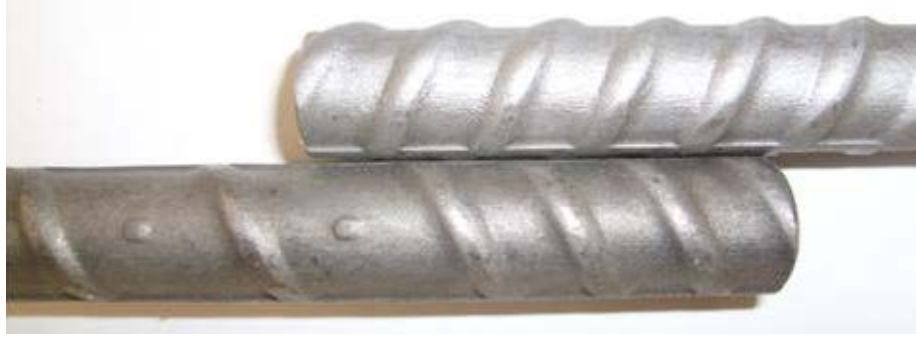
Repickling was performed at the University of Kansas. The procedure consisted of submerging the bars in a solution of 25% nitric acid and 5% hydrofluoric acid for thirty minutes at room temperature (72° F). The bars were then removed from the solution and rinsed thoroughly with distilled water, producing a bright, shiny surface on the metal. Figure 1 shows 2304 bars in the as-received and repickled conditions.

Figure 1: 2304 duplex stainless steel bars in the as-received (left) and repickled (right) conditions

The stainless steel clad bars, conventional reinforcement, and ECR were inspected upon arrival and found to be in good condition. The 2304 bars arrived with a dark and mottled appearance, possibly due to incomplete pickling. As a result, some tests were performed on the 2304 stainless steel bars in both the as-received condition and after repickling.

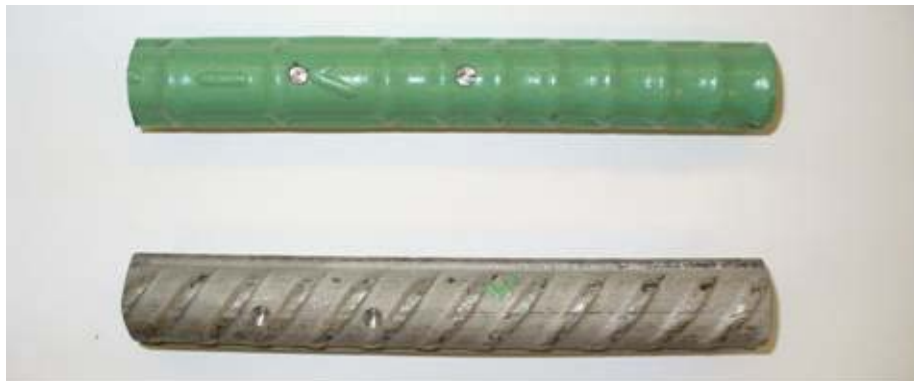
For the rapid macrocell specimens, two holes were placed on each side of a bar, for a total of four holes, exposing 0.83% of the submerged bar area. The holes were located approximately 1 in. from the bottom end of the bar with the second spaced 1 in. from the first hole. For the bench-scale specimens, the number of holes varied based on steel type. The coating on selected ECR specimens was penetrated with five evenly spaced holes on both the top and bottom sides of the bar, exposing 0.5% of the bar area. Selected stainless steel clad specimens had two evenly spaced holes drilled on the top and bottom sides of the bar, exposing 0.2% of the bar area. The reduced number of holes was chosen to reflect the cladding's increased resistance to damage compared to ECR. Holes were drilled to a depth so as to expose the underlying conventional steel. For the rapid macrocell specimens, holes were located approximately 1.5 in. and 2.5 in. from the bottom end of the bar. The exact spacing of the holes varied slightly to avoid drilling at deformations, as shown in Figure 2.

Figure 2: Rapid macrocell specimens, ECR and NX-SCR™ stainless steel clad bars with holes in the coating (0.83% exposed area)

The coating on most ECR bars and the cladding on some of the NX-SCR™ bars were penetrated using a 1/8-in. diameter four-flute drill bit to simulate damage that may occur in the field. The number and spacing of the drilled holes varied between the rapid macrocell specimens and bench-scale specimens.

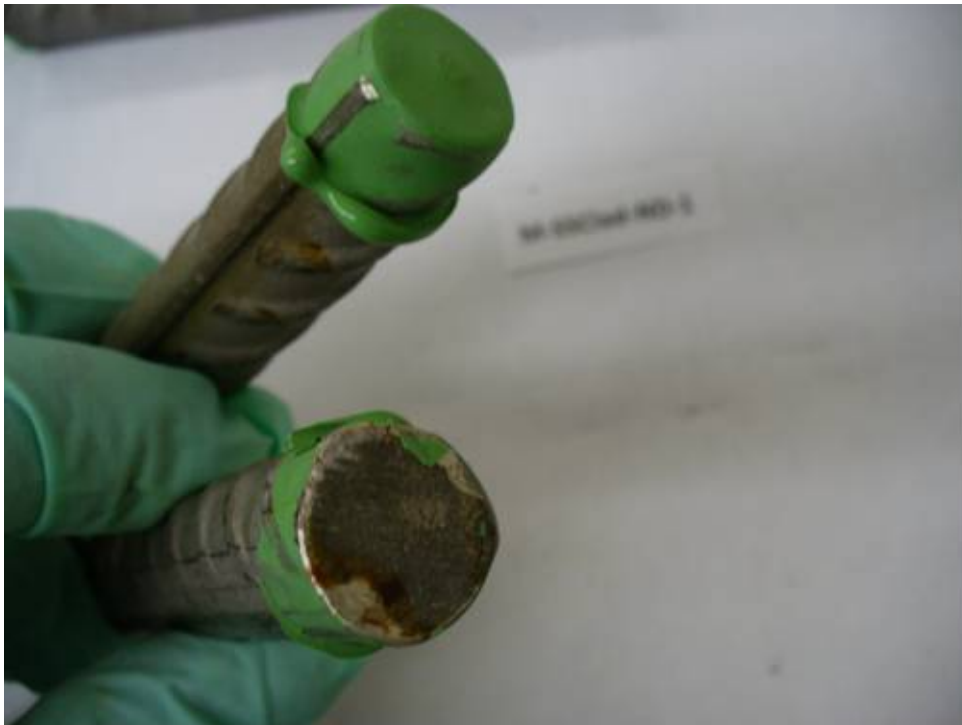
Figure 27: Bar end with protective cap removed at end of rapid macrocell test, NX-SCR™ stainless steel clad (cathodes)

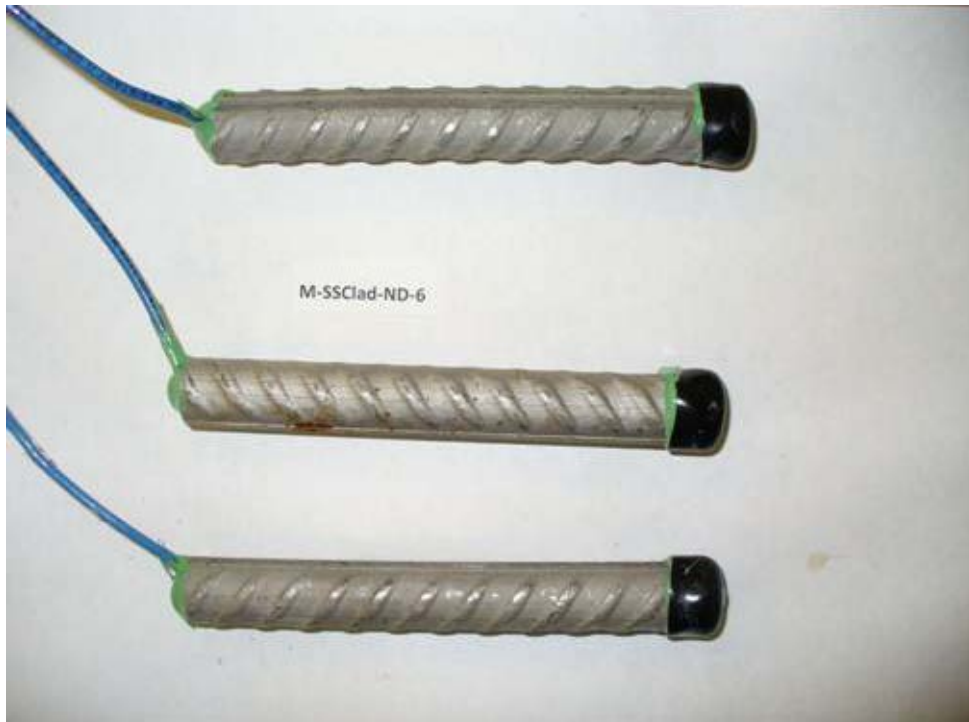
Figure 28a: Photograph of specimen 6 upon completion of the rapid evaluation test, NX-SCR™ stainless steel clad (anode on top, cathode on bottom)

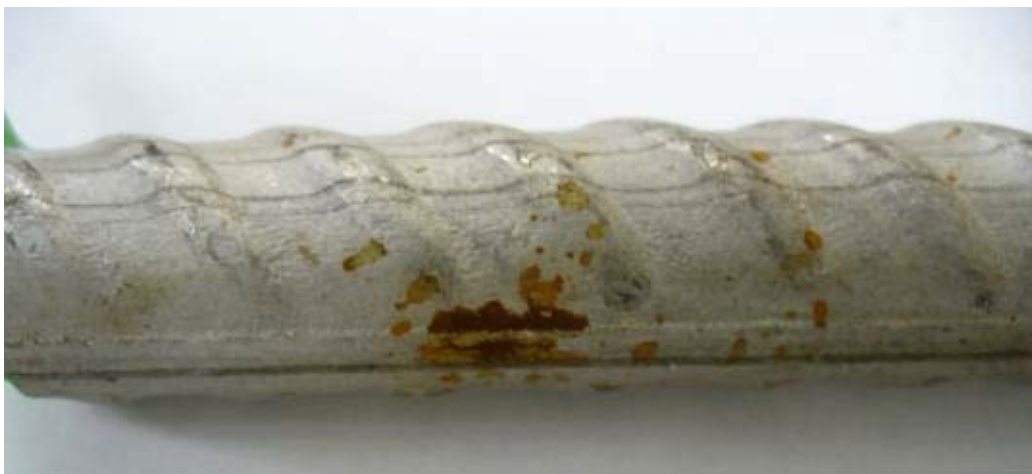
Figure 28b: Photograph of specimen 6 upon completion of the rapid evaluation test, NX-SCR™ stainless steel clad (close-up of cathode)

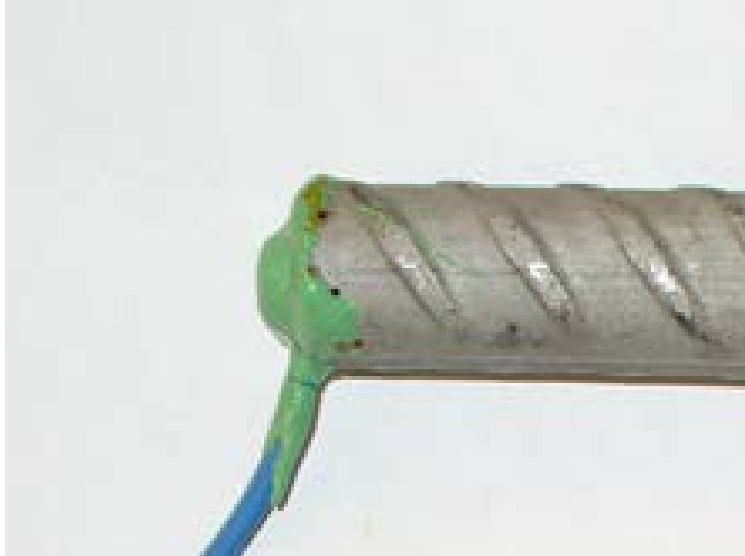
Figure 28c: Photograph of specimen 6 upon completion of the rapid evaluation test, NX-SCR™ stainless steel clad showing corrosion at electrical connection

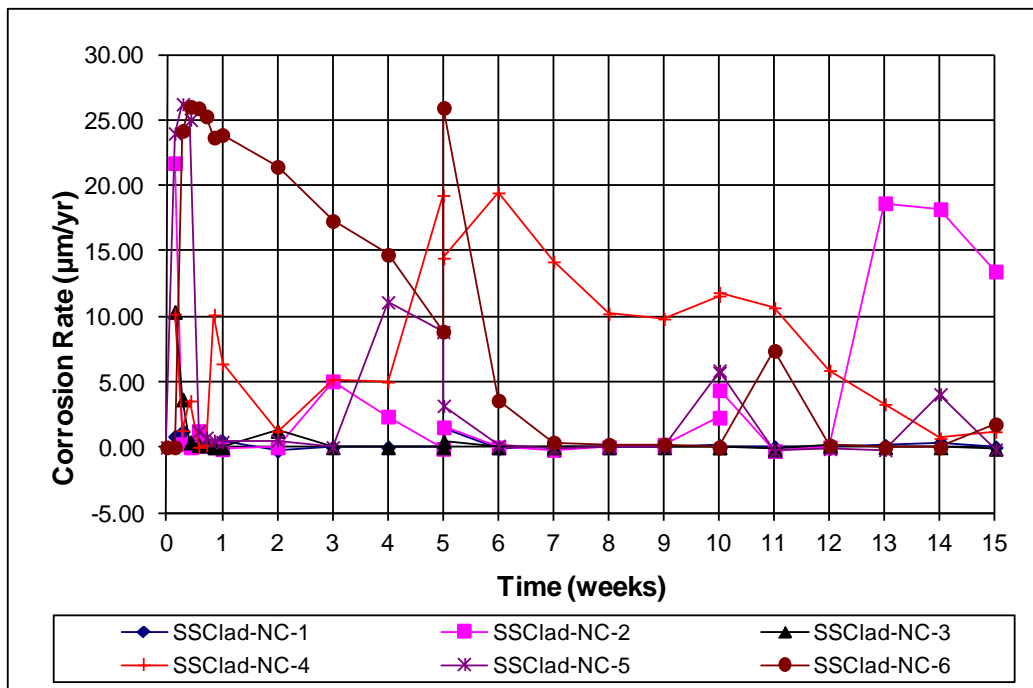
Individual corrosion rates are shown for the uncapped stainless steel clad bars in Figure 29. Corrosion rates were highest in week 1, reaching values in excess of 25 $\mu\text{m}/\text{yr}$. Although the individual corrosion rates of the specimens was rather high due to the exposed conventional steel core of the NX-SCR™ stainless steel clad bars, the individual corrosion rates were much lower than the conventional reinforcement. Upon autopsy of the bars, it was discovered that a significant amount of corrosion was present at the location of the uncapped bar ends, as shown in Figure 30.

Figure 29: Macrocell individual corrosion rates of uncapped NX-SCR™ stainless steel clad bars, specimens 1-6

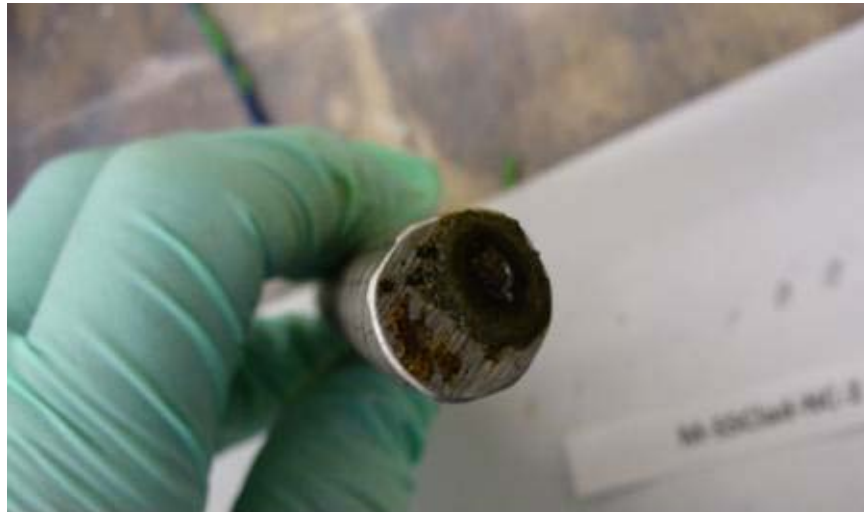
Figure 30: Uncapped bar end upon autopsy, NX-SCR™ stainless steel clad bar

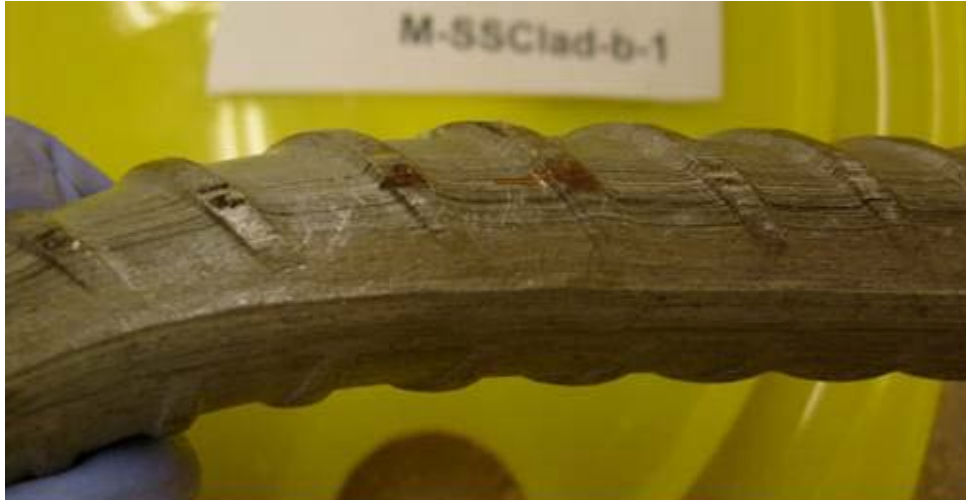
The corrosion rates for the individual bent NX-SCR™ stainless steel clad (SSClad) bars are shown in Figure 31. The individual corrosion rates ranged from +0.40 to $-0.47 \mu\text{m/yr}$, satisfying the maximum value of $+0.50 \mu\text{m/yr}$ in accordance with ASTM A955. Minimal corrosion staining was observed on the bent stainless steel clad bars, possibly due to damage caused by the bending operation. A typical specimen is shown in Figure 32.

Figure 32: Corrosion staining on bent section upon autopsy, bent NX-SCR™ stainless steel clad bar (close-up)

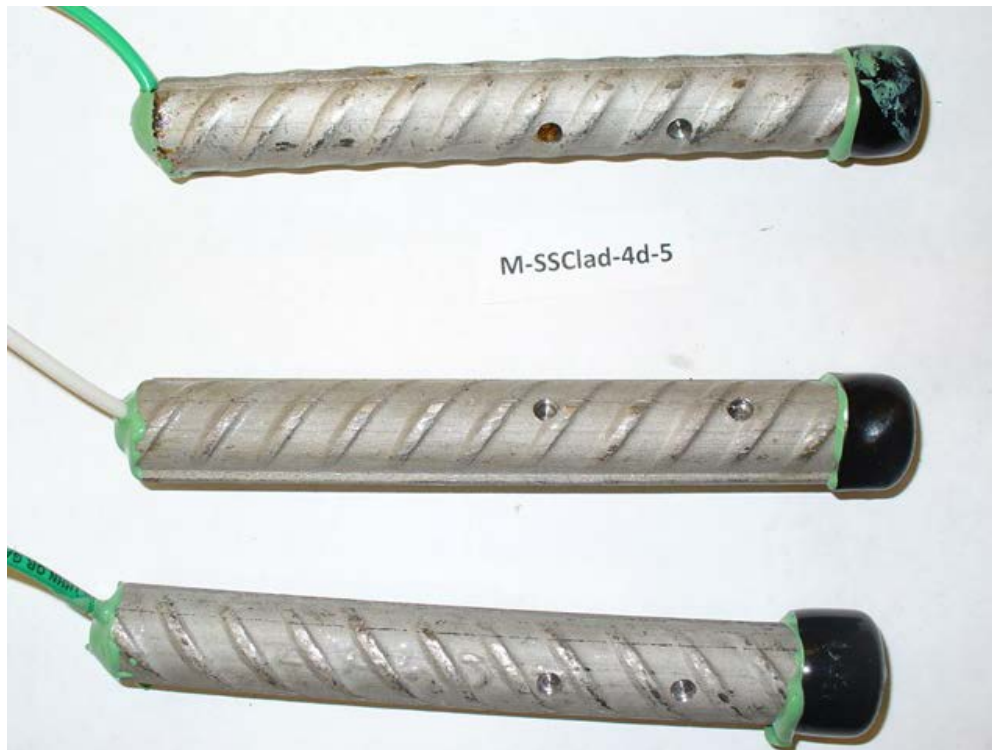
Figure 34: Photograph of specimen SSClad-4h-5 upon completion of the rapid evaluation test, NX-SCR™ stainless steel clad with four holes through the cladding (anode on top, cathode on bottom)

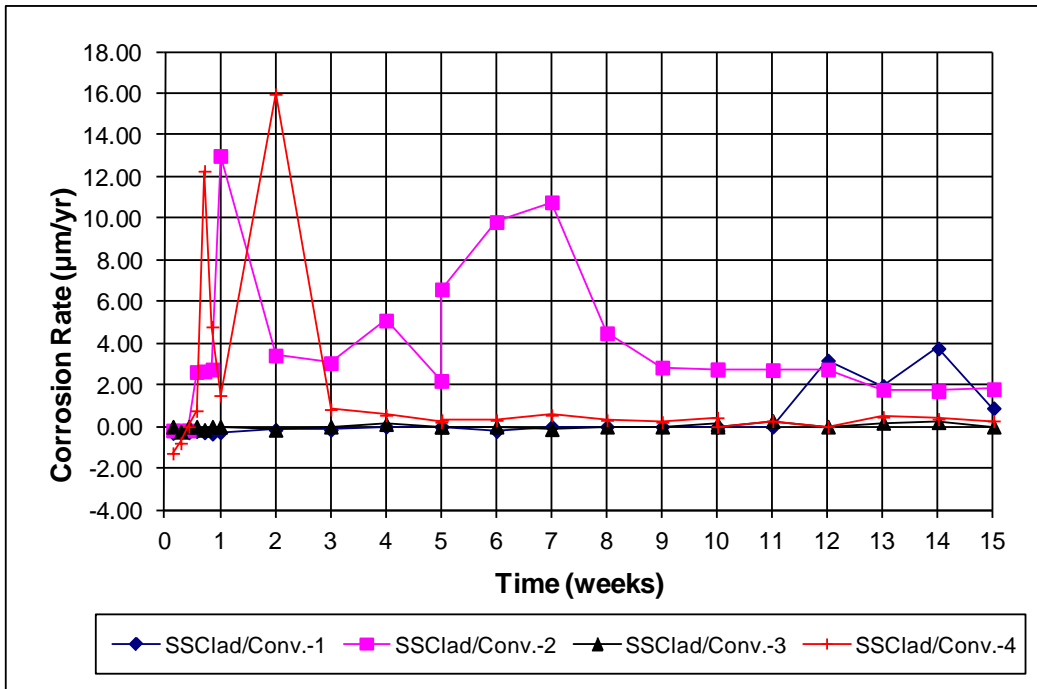
Figure 35b: Macrocell individual corrosion rate of mixed NX-SCR™ stainless steel clad bars (anode/cathode), specimens 1-6 (different scale)

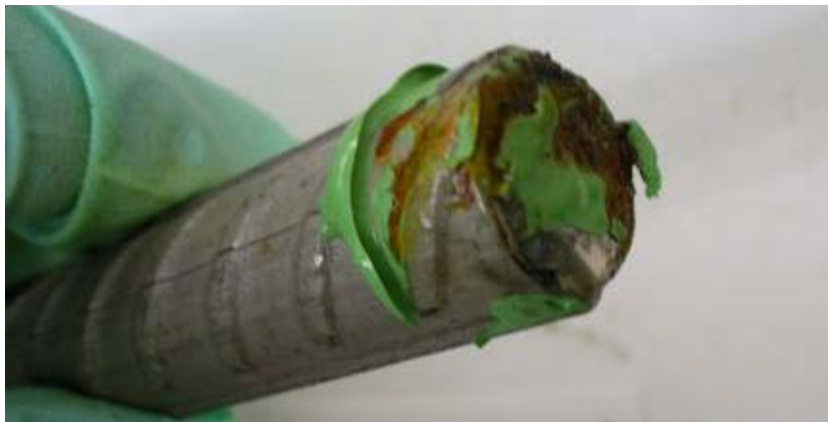
corrosion rate during testing. Specimen SSClad/Conv.-2 had a corrosion rate of approximately 3 $\mu\text{m}/\text{yr}$ during most of the test, with a spike in corrosion rate at week 7 to approximately 10 $\mu\text{m}/\text{yr}$. Because this specimen experienced such a high corrosion rate, it was thought that the protective cap on the end of this stainless steel clad bar may have been ineffective. As a result, an additional mixed SSClad/Conv. reinforcement specimen was tested (SSClad/Conv.-4), but it also exhibited a high corrosion rate. Upon autopsy of specimen SSClad/Conv.-2, a significant amount of corrosion was discovered underneath the protective cap (Figure 36) indicating that the cap rather than the bar failed. Specimen SSClad/Conv.-4 and SSClad/Conv.-1 also exhibited a small amount of corrosion under the cap, suggesting that the corrosion observed for those specimens was also caused by a failure of the cap. All specimens that exhibited corrosion rates greater than 0.5 $\mu\text{m}/\text{yr}$ later exhibited corrosion under the cap. The nonstandard bar size resulted in a poor cap fit and a higher than normal failure rate. Since the corrosion was due to the failure of the cap and not the cladding, this should not be interpreted as the bars failing ASTM A955.

Figure 36: Corrosion under protective cap at end of evaluation, NX-SCR™ stainless steel clad bar, Specimen 2 (close-up)

Figures 51 and 52 show the mixed specimens containing stainless steel clad and conventional specimens. As was the case with the Conv./2304 specimens, the specimens containing conventional steel as the anode and stainless steel clad bars as the cathode showed significant corrosion products on the anode bar, while the cathode bars had no corrosion products (Figure 51). There was slight staining on the cathode bars of those specimens containing stainless steel clad bars as the anode and conventional steel as the cathode (Figure 52). Some of these specimens did, however, show staining under the cap of the stainless steel bar (Figure 36).

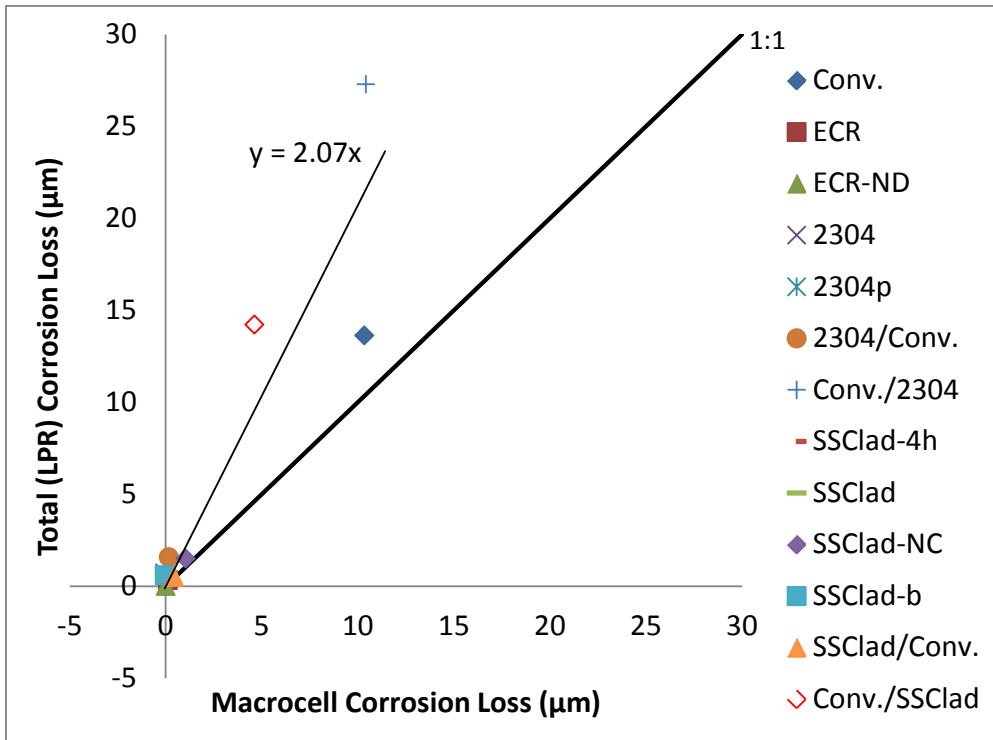
Figure 37a: Rapid macrocell test-comparison between corrosion loss (µm) from macrocell and total corrosion loss readings

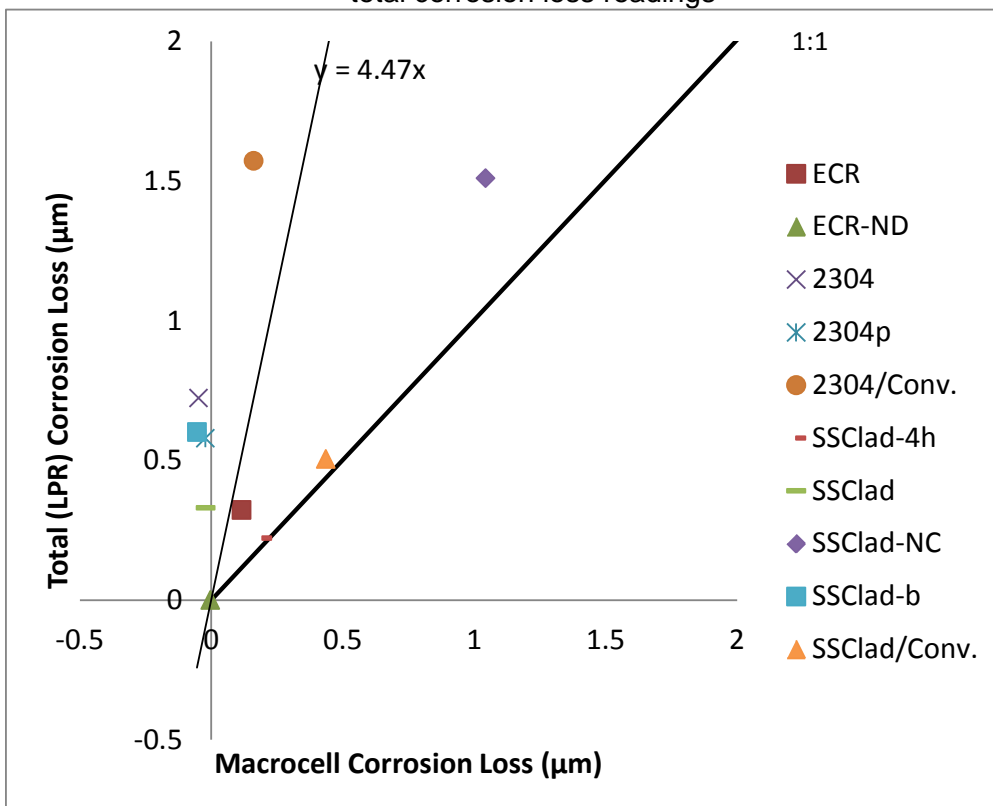
Figure 37b: Rapid macrocell test-comparison between corrosion loss (µm) from macrocell and total corrosion loss readings (different scale)

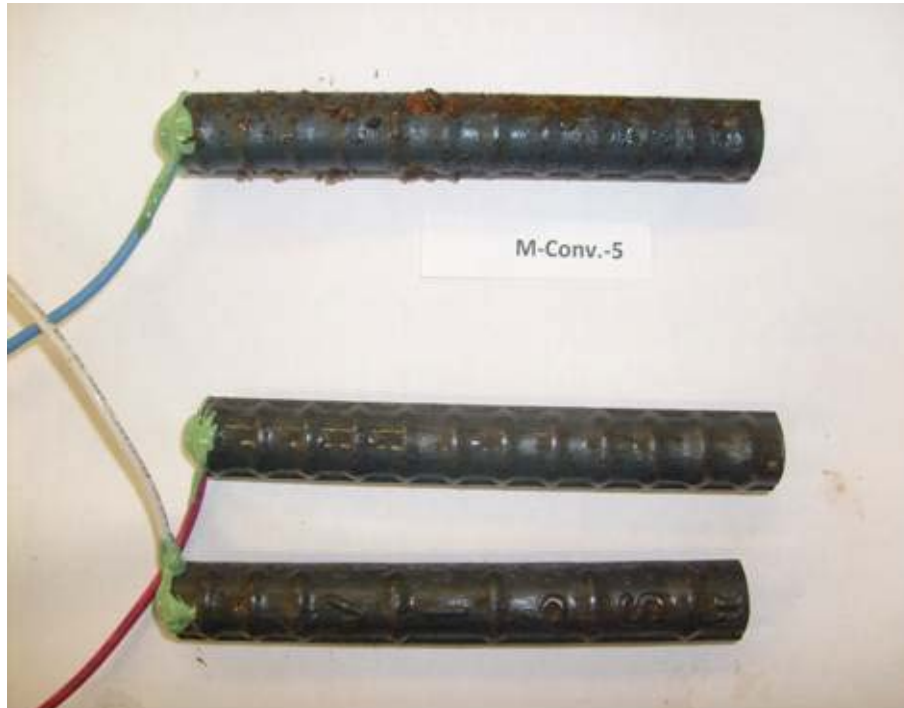
Figure 38 shows a specimen with conventional reinforcement upon completion of the rapid macrocell test. As can be seen, the anode bar had corrosion products along the length of the bar, while the cathode bars did not exhibit corrosion products.

Figure 38: Rapid macrocell specimen upon completion of test, conventional steel (anode on top, cathode on bottom)

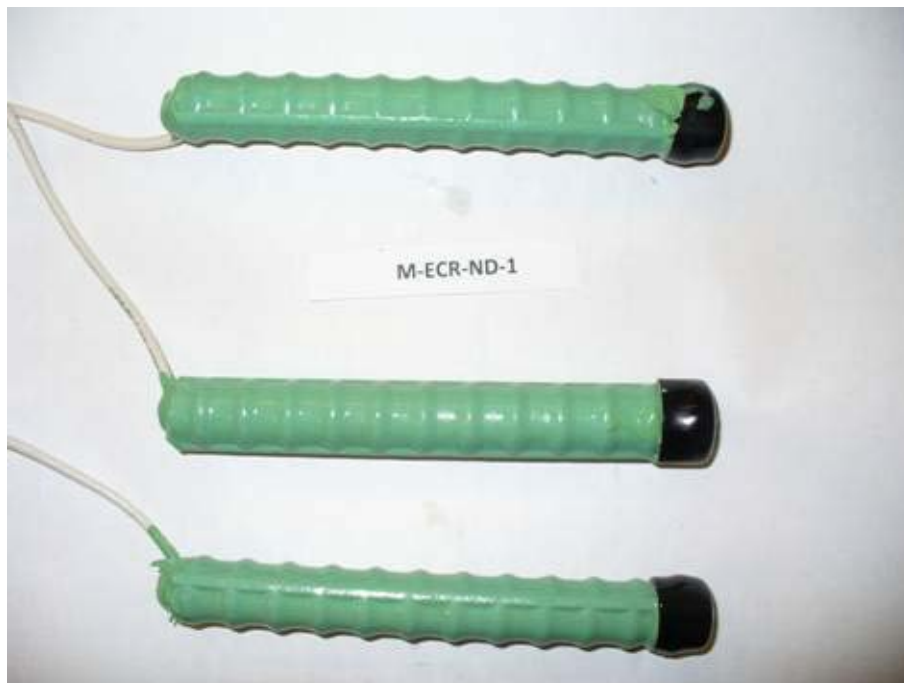
Figure 39 shows an undamaged ECR specimen upon completion of the test. These specimens performed very well and did not exhibit any corrosion or disbondment of the epoxy coating. The ECR specimens with penetrations in the coating did, however, experience some disbondment, as shown in Figure 40.

Figure 39: Rapid macrocell specimen upon completion of test, undamaged ECR (anode on top, cathode on bottom)

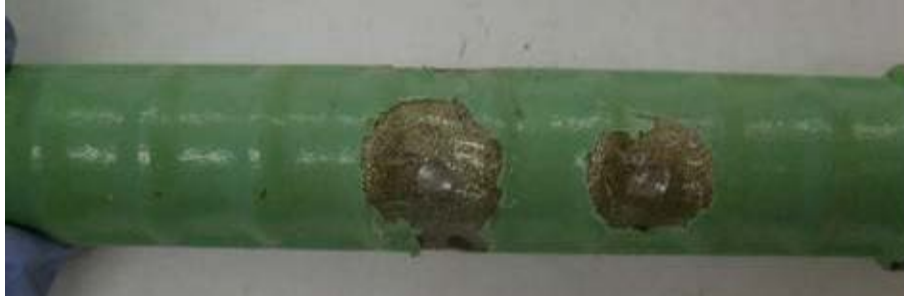
Figure 40: Rapid macrocell specimen upon completion of test, ECR (close-up of damage site after disbondment test)

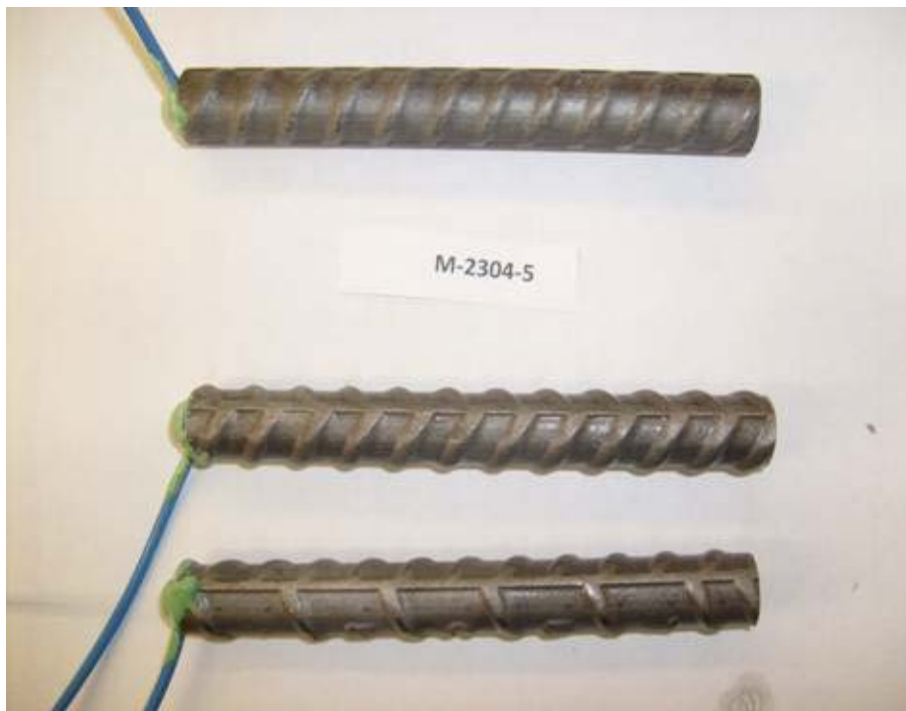
Figures 41 and 42 show the 2304 and 2304-p specimens, respectively, upon completion of the test. Figure 41 is representative of the as-received 2304 specimens that passed the rapid macrocell test. The specimens that failed the test were discussed earlier (Figure 23).

Figure 41: Rapid macrocell specimen upon completion of test, 2304 stainless steel (anode on top, cathode on bottom)

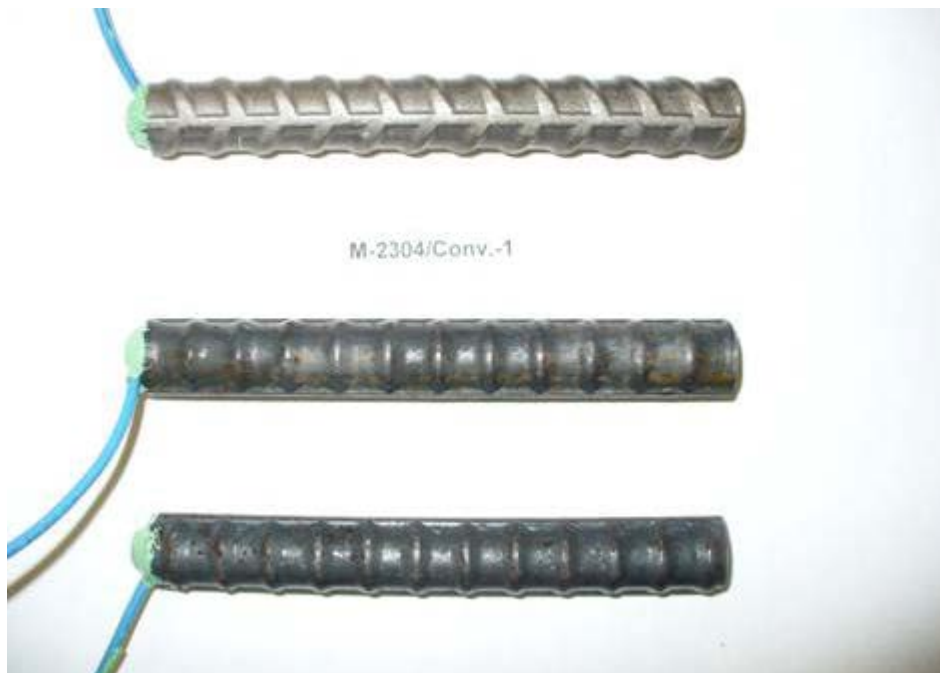
Figures 43 and 44 show the mixed specimens containing 2304 stainless steel and conventional steel. As shown in Figure 44, the specimens with conventional steel as the anode bar show significant corrosion product on the anode bar. The cathode bars in both cases show no significant corrosion products.

Figure 43: Rapid macrocell specimen upon completion of test, mixed 2304/conventional steel (anode on top, cathode on bottom)

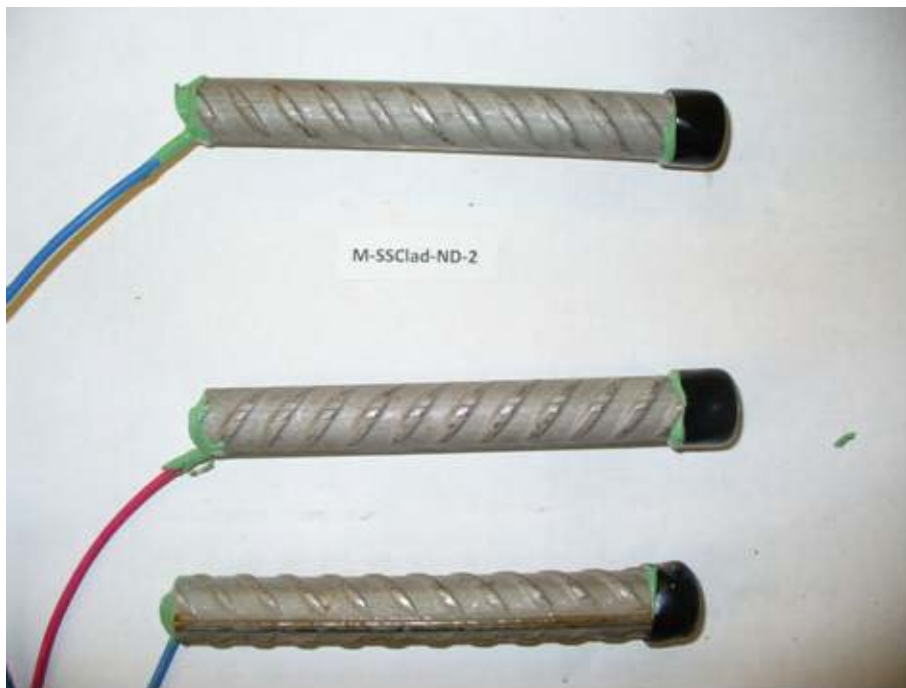
The undamaged stainless steel clad specimens upon completion of the test can be seen in Figures 45 and 46. Figure 46 shows the end of the specimen after removal of the cap. As can be seen, there is no corrosion product under the cap.

Figure 45: Rapid macrocell specimen upon completion of test, undamaged stainless steel clad reinforcement (anode on top, cathode on bottom)

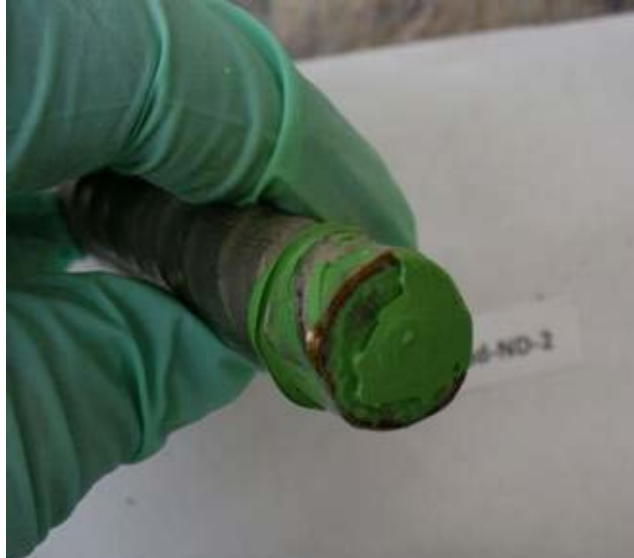
Figure 46: Rapid macrocell specimen upon completion of test, undamaged stainless steel clad reinforcement (close-up of bar end after cap has been removed)

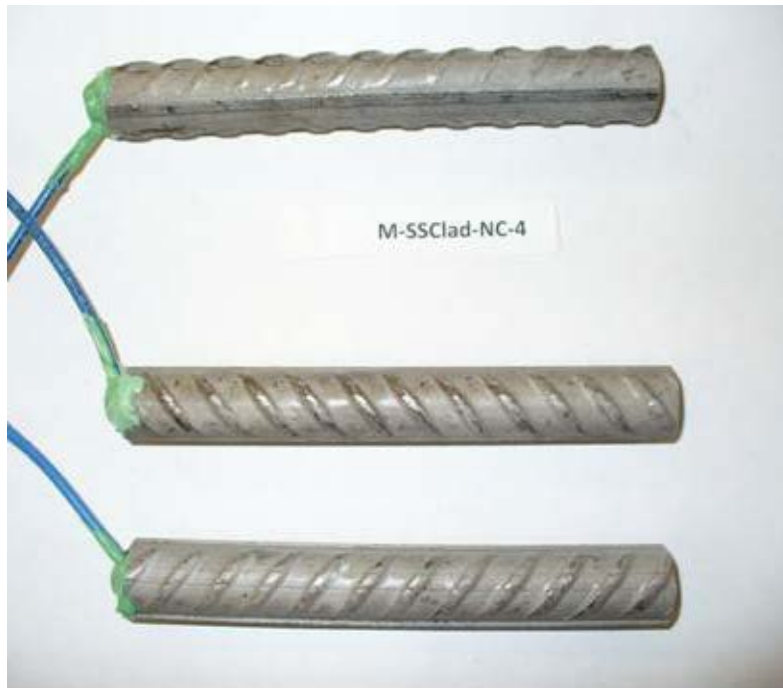
Figures 48 and 49 show the uncapped stainless steel specimens. These specimens showed signs of corrosion at the ends where the conventional core was exposed (Figure 49).

Figure 48: Rapid macrocell specimen upon completion of test, uncapped stainless steel clad reinforcement (anode on top, cathode on bottom)

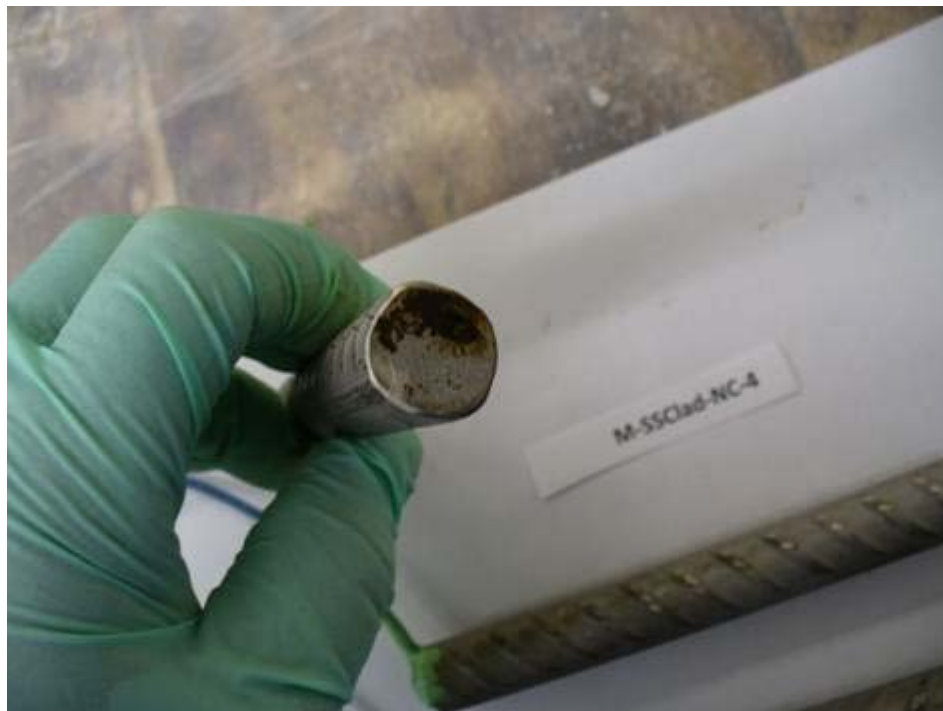
Figure 49: Rapid macrocell specimen upon completion of test, uncapped stainless steel clad reinforcement (close-up of bar end)

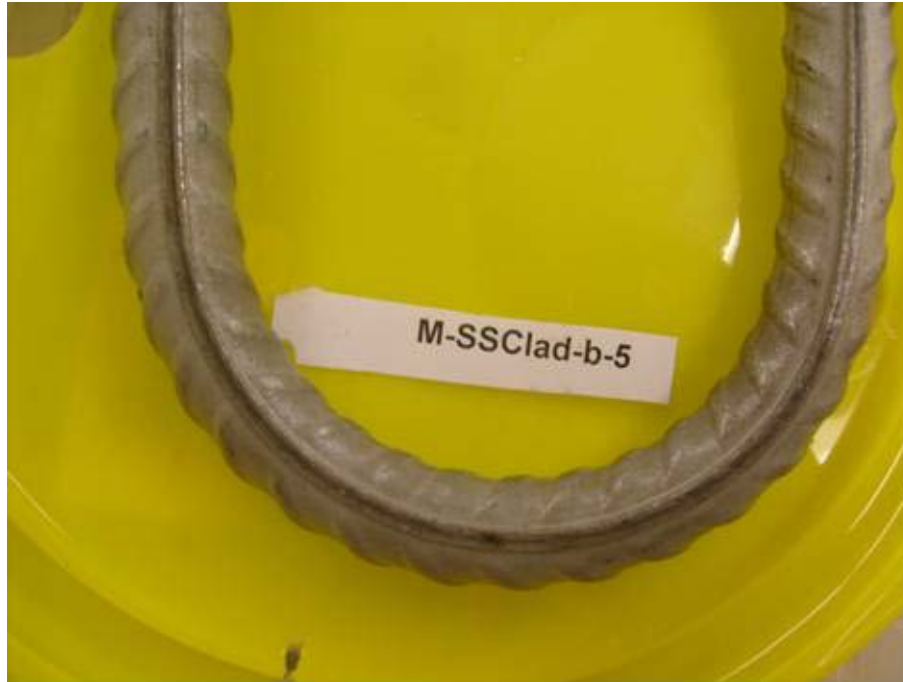
Figure 50 shows a bent stainless steel specimen upon completion of the rapid macrocell test. As discussed earlier, there was minor staining on the bend of most specimens. The corrosion rate of all specimens remained below the limit set by ASTM A955, although bent specimens are not covered by this standard.

Figure 50: Rapid macrocell specimen upon completion of test, bent stainless steel clad reinforcement (anode)

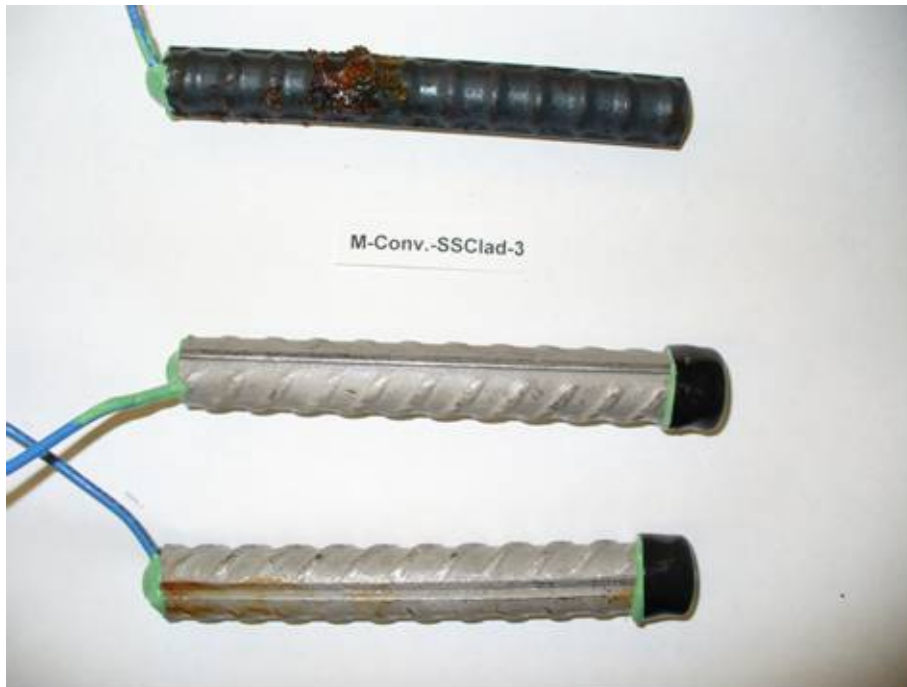
Figure 51: Rapid macrocell specimen upon completion of test, mixed conventional/stainless steel clad reinforcement (anode on top, cathode on bottom)

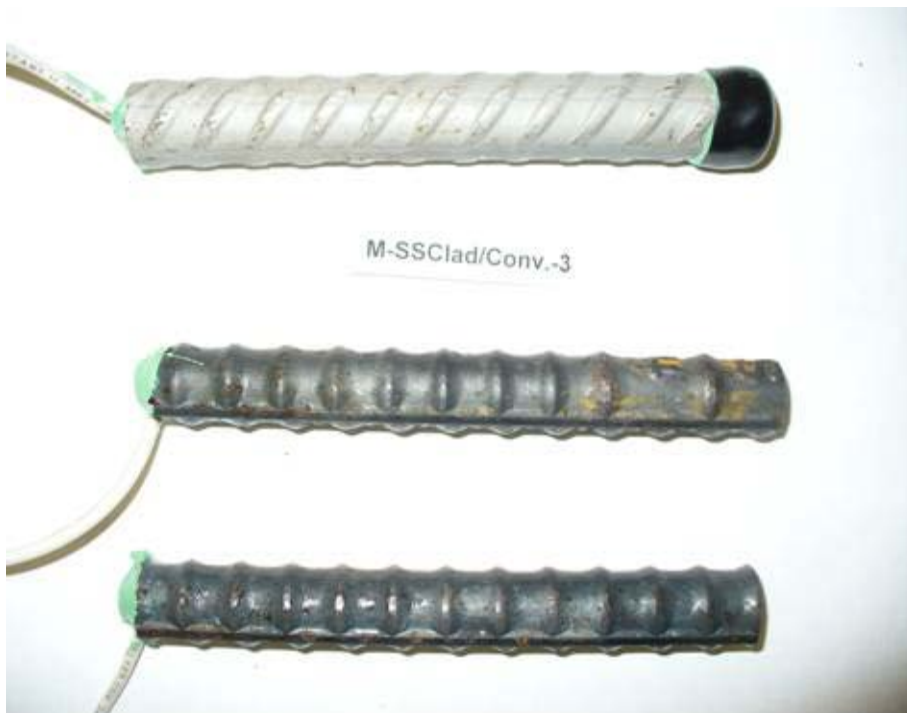
Figure 52: Rapid macrocell specimen upon completion of test, mixed stainless steel clad/conventional steel (anode on top, cathode on bottom)

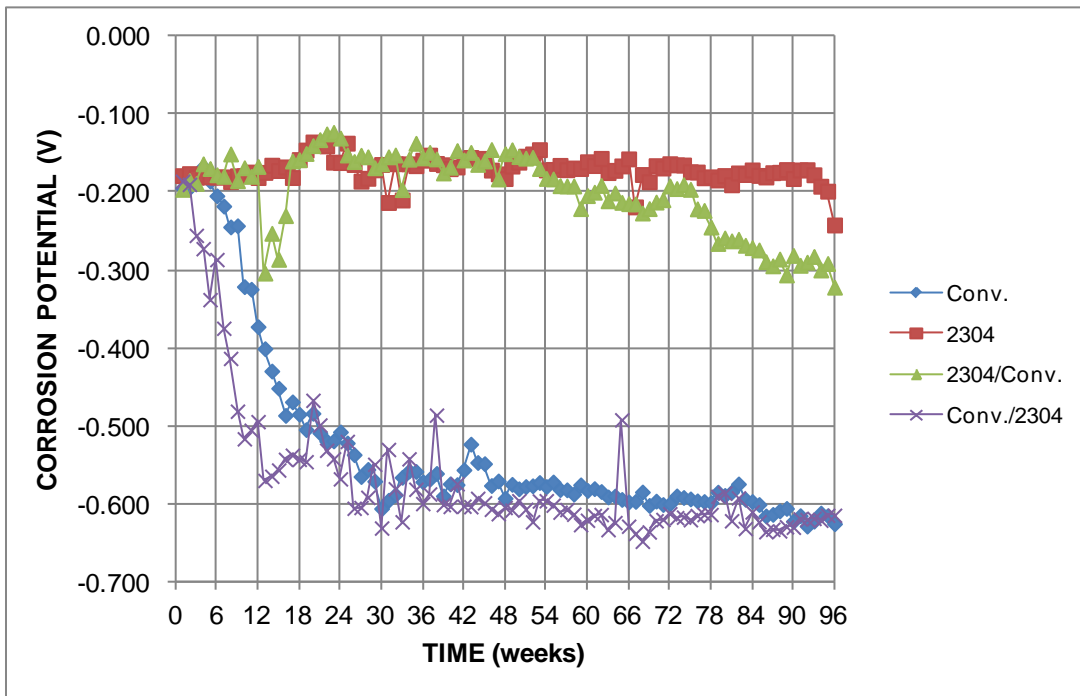
Figure 57b: Average top-mat potentials with respect to CSE for Southern Exposure specimens with conventional and 2304 stainless steel reinforcement

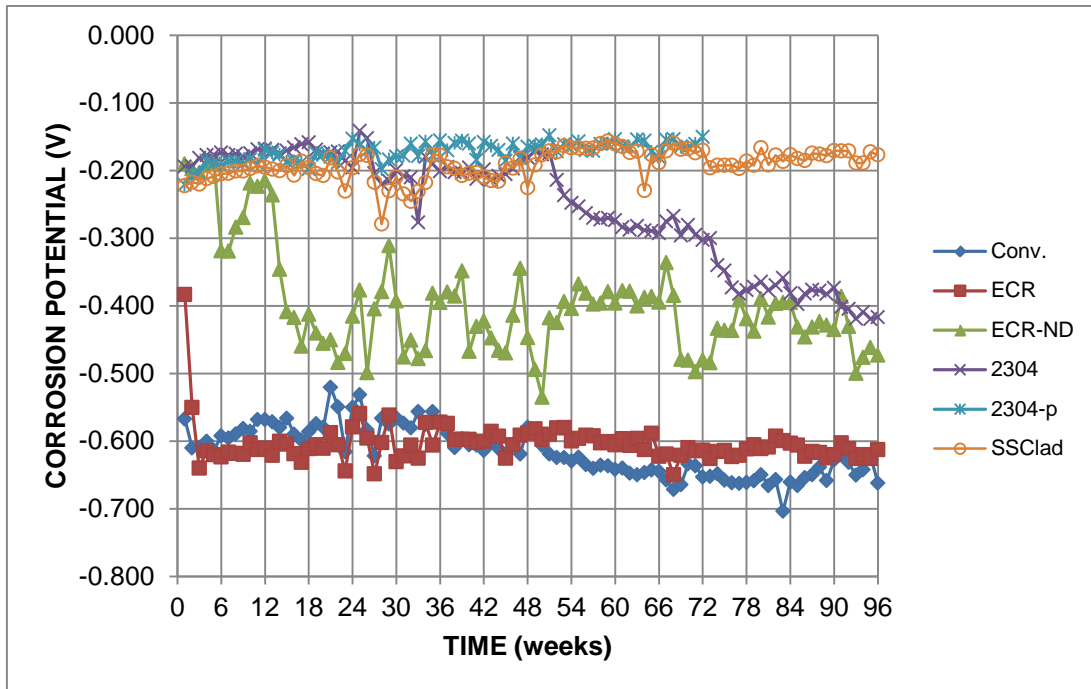
Figure 58: Average top-mat potentials with respect to CSE for cracked beam specimens

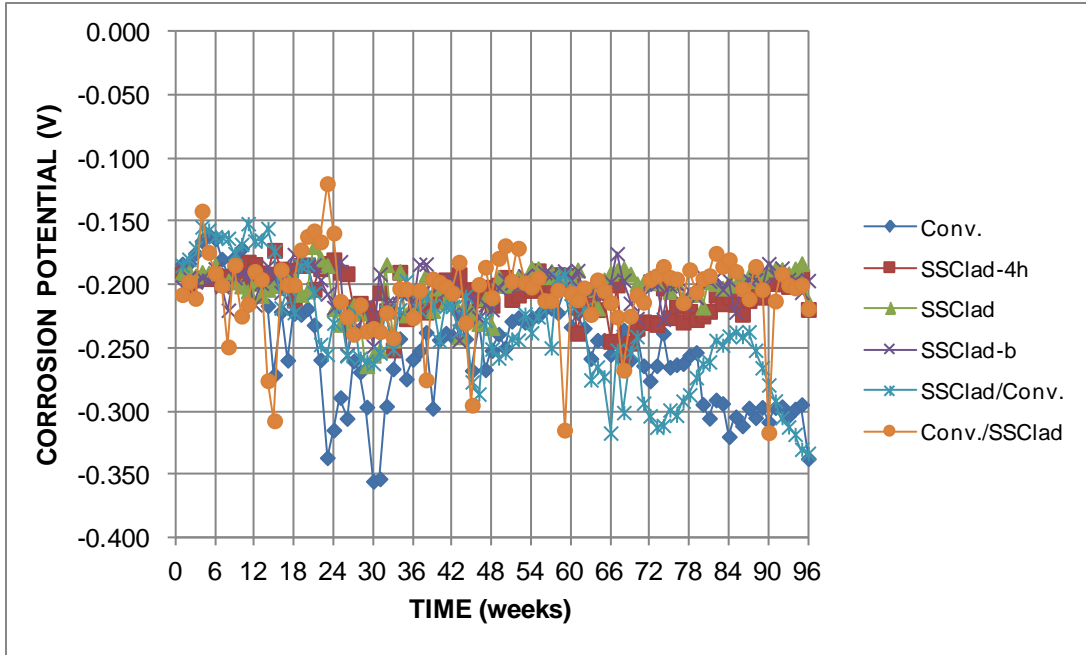
Figure 59c: Average bottom-mat potentials with respect to CSE Southern Exposure specimens with conventional and stainless steel clad reinforcement

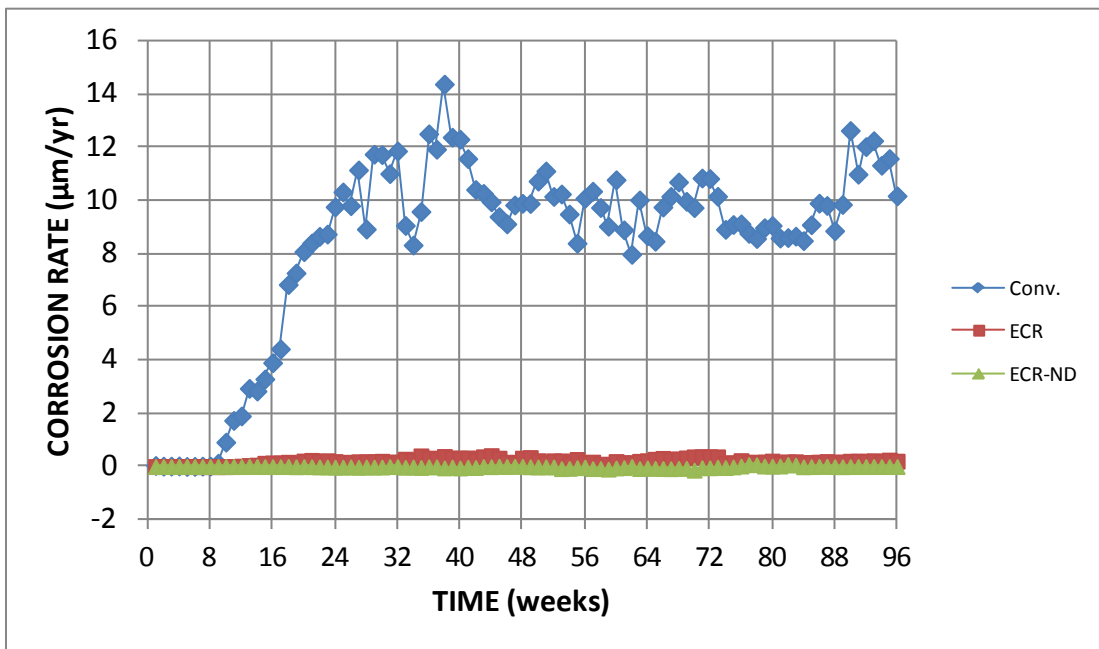
Figure 61a: Average corrosion rates of conventional, ECR, and undamaged ECR Southern Exposure specimens

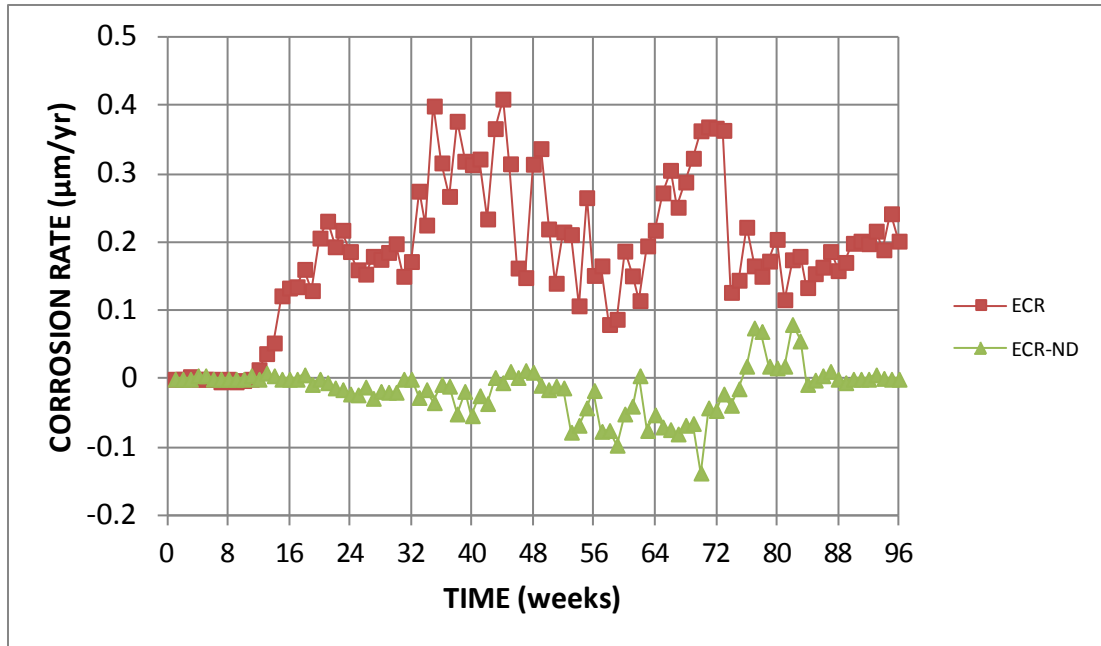
Figure 61b: Average corrosion rates of ECR and undamaged ECR Southern Exposure specimens (different scale)

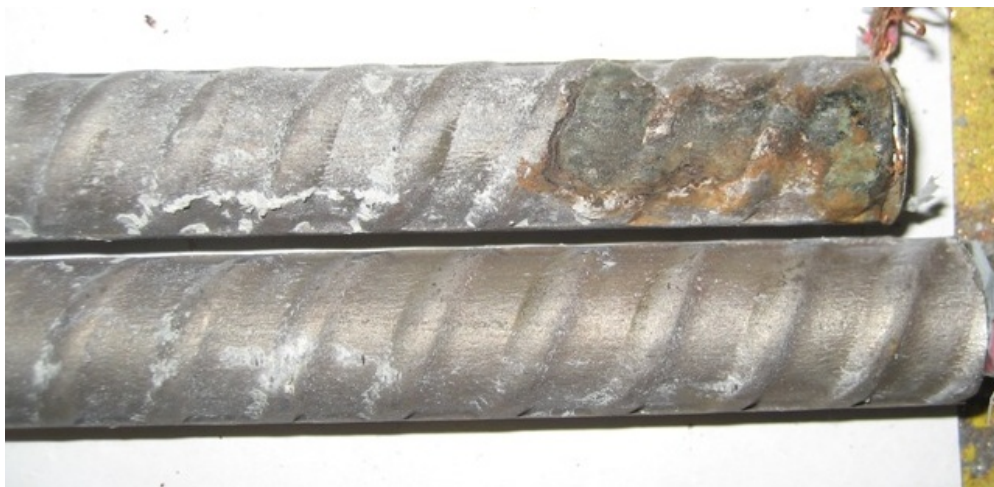
Specimens 2, 3, 5, and 6 initiated corrosion at weeks 75, 96, 98, and 116, respectively. Figures 65a and 65b show specimen 2 after autopsy. Both the top and bottom bars show signs of corrosion near the ends. Specimens 4, 5, and 6 are still undergoing testing and have not been autopsied.

Figure 65a: Top bars of specimen SE-2304-2 after autopsy showing signs of corrosion near the end of the bar

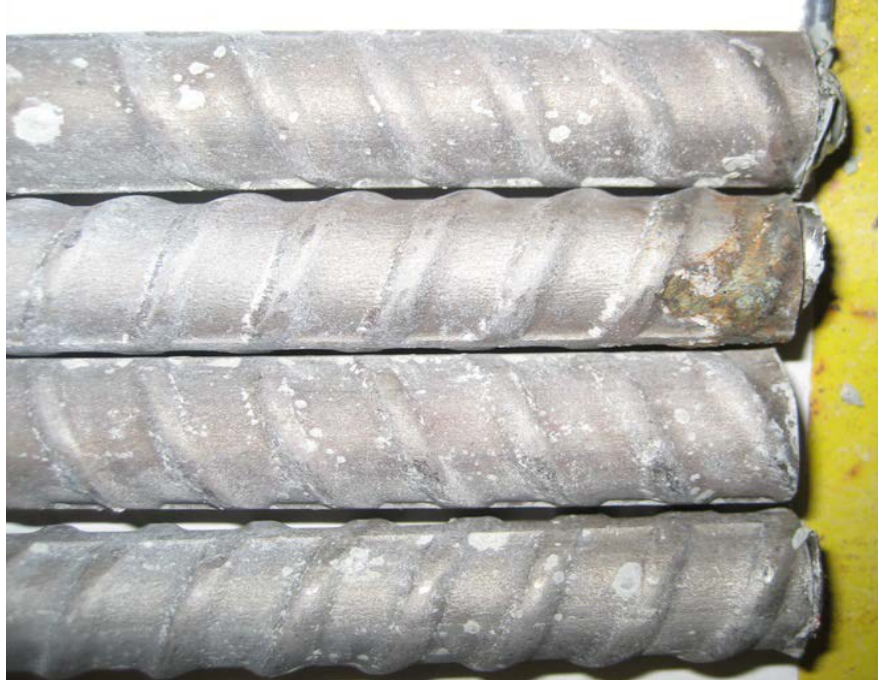
Figure 65b: Bottom bars of specimen SE-2304-2 after autopsy showing signs of corrosion near the end of the bar
