STAINLESS STEEL REINFORCEMENT AS A REPLACEMENT FOR EPOXY COATED STEEL IN BRIDGE DECKS

FINAL PROJECT REPORT – FHWA-OK-13-08
ODOT SP&R ITEM NUMBER 2231

TECHNICAL REPORT DOCUMENTATION PAGE

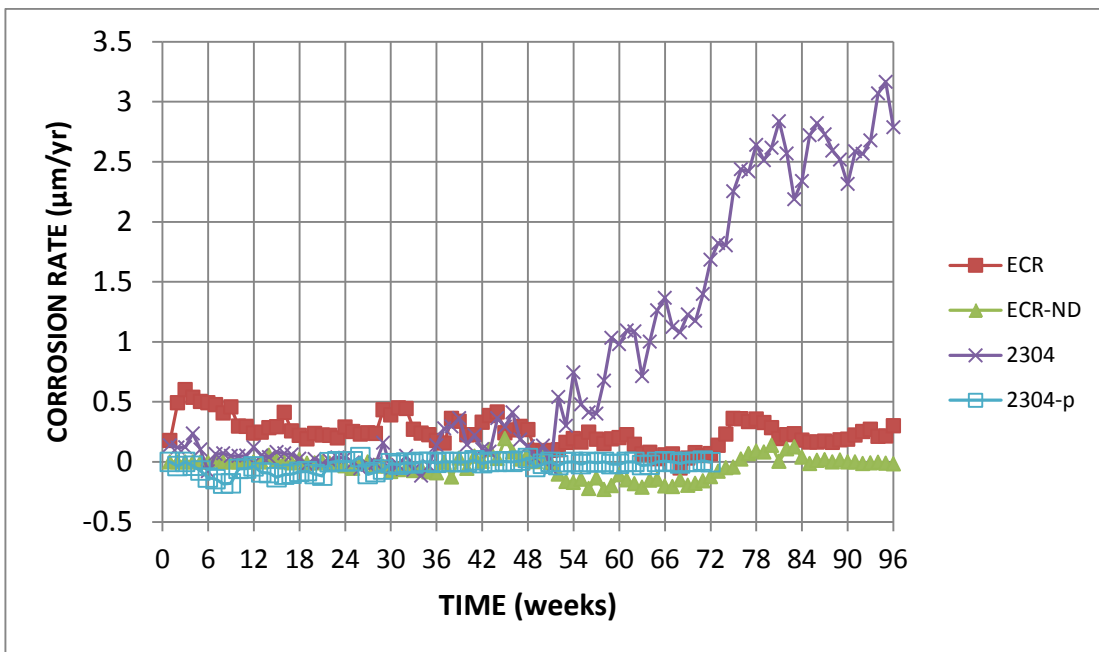
Figure 66b: Average corrosion rate ($\mu\text{m}/\text{yr}$) of cracked beam specimens containing conventional, ECR with ten holes in the coating, undamaged ECR, and 2304 stainless steel (different scale)

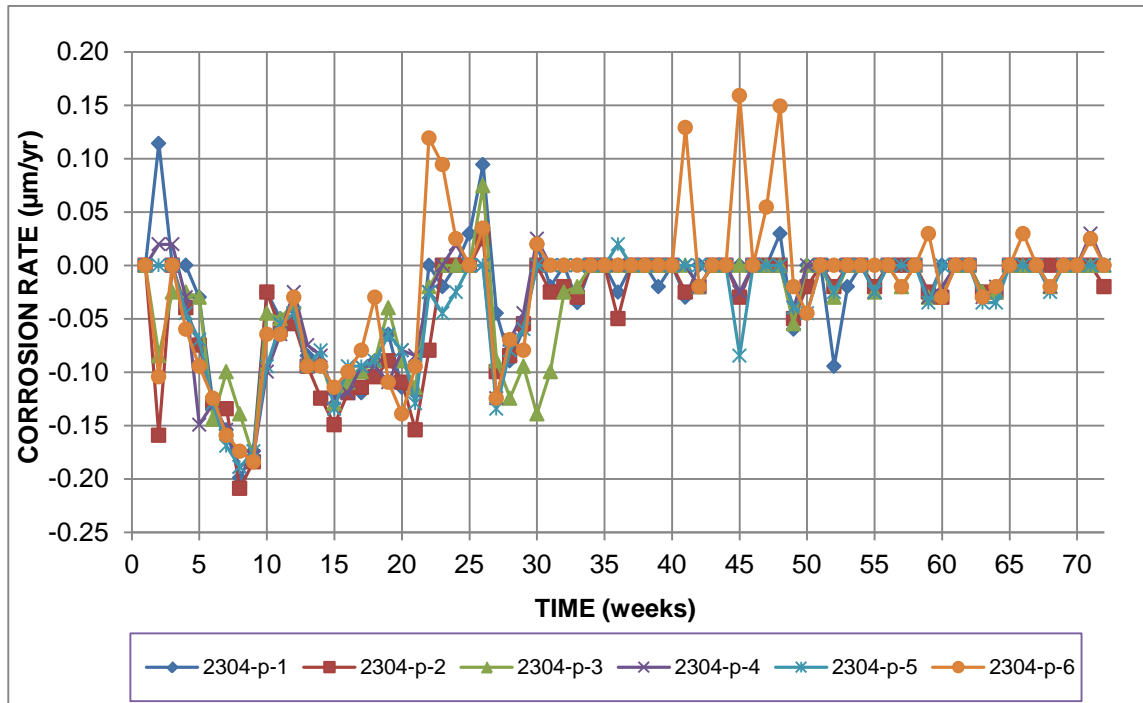
Figure 68: Individual corrosion rates ($\mu\text{m}/\text{yr}$) based on total area for cracked beam specimens with repickled 2304 duplex stainless steel reinforcement

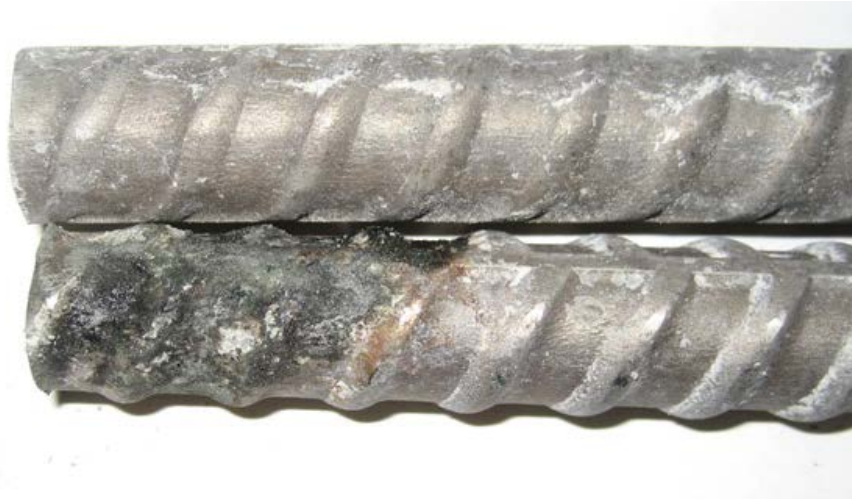
Corrosion products were seen near the ends of the top bars of two of the SE-2304/Conv. specimens (Figure 70). Corrosion products were also seen on one SE-2304/Conv specimen on

Figure 70: Corrosion product on 2304 stainless steel anode bar in 2304/Conv. Southern Exposure specimen 2 after autopsy

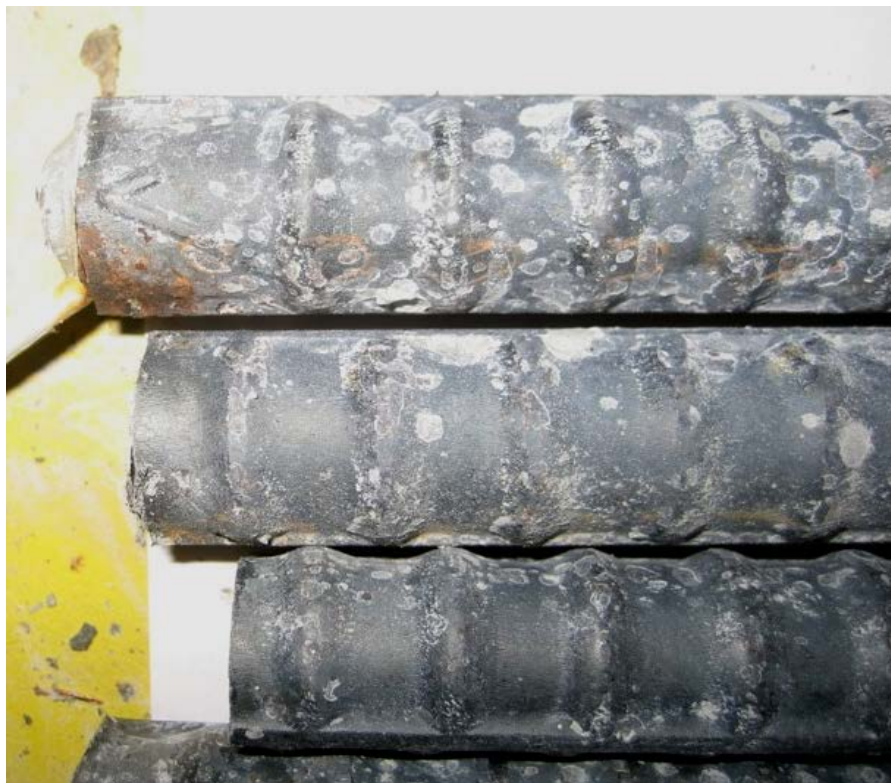
the conventional bars near the ends as shown in Figure 71. One specimen with conventional bars as the anode (SE-Conv/2304-1) showed corrosion near the end of the 2304 cathode bars, as shown in Figure 72. Corrosion products were also observed on cathode bars of specimen SE-Conv/2304-2 (Figure 73), indicating that salt may have reached the bar via the electrical connection.

Figure 71: Corrosion on conventional cathode bar in 2304/Conv. Southern Exposure specimen 1 after autopsy

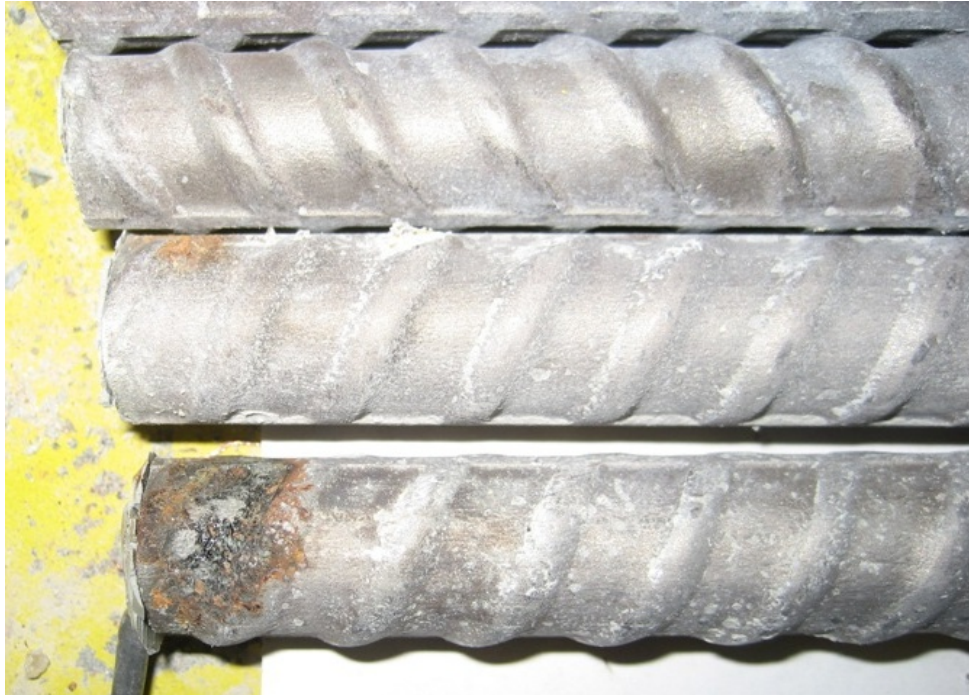
Figure 72: Cathode of 2304 stainless steel, mixed conventional/2304 steel Southern Exposure specimen 1 after autopsy

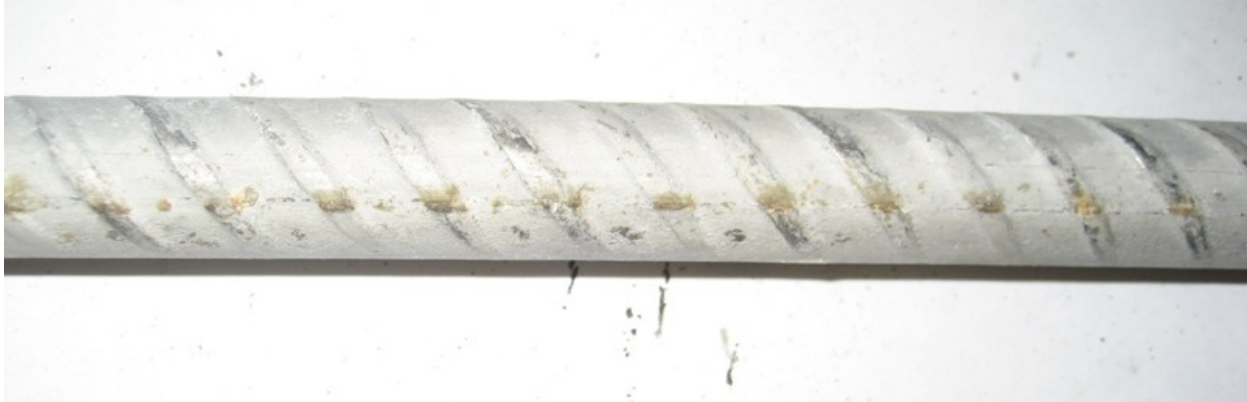
Figure 77a: CB-SSClad-1 top bar upon completion of test showing corrosion on deformations

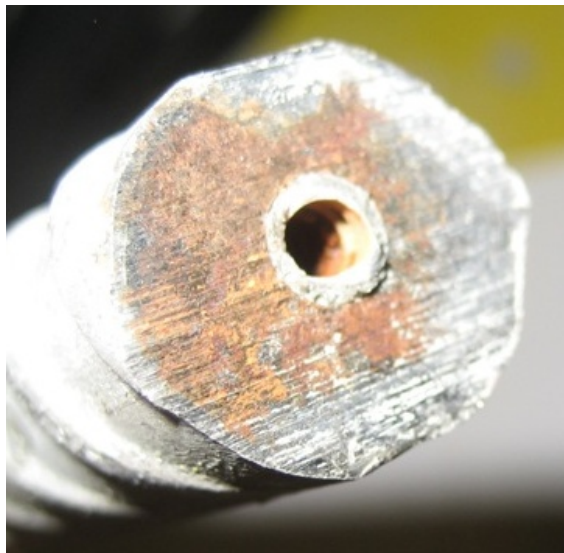
Figure 77b: Corrosion at the end of specimen CB-SSClad-1 upon completion of test

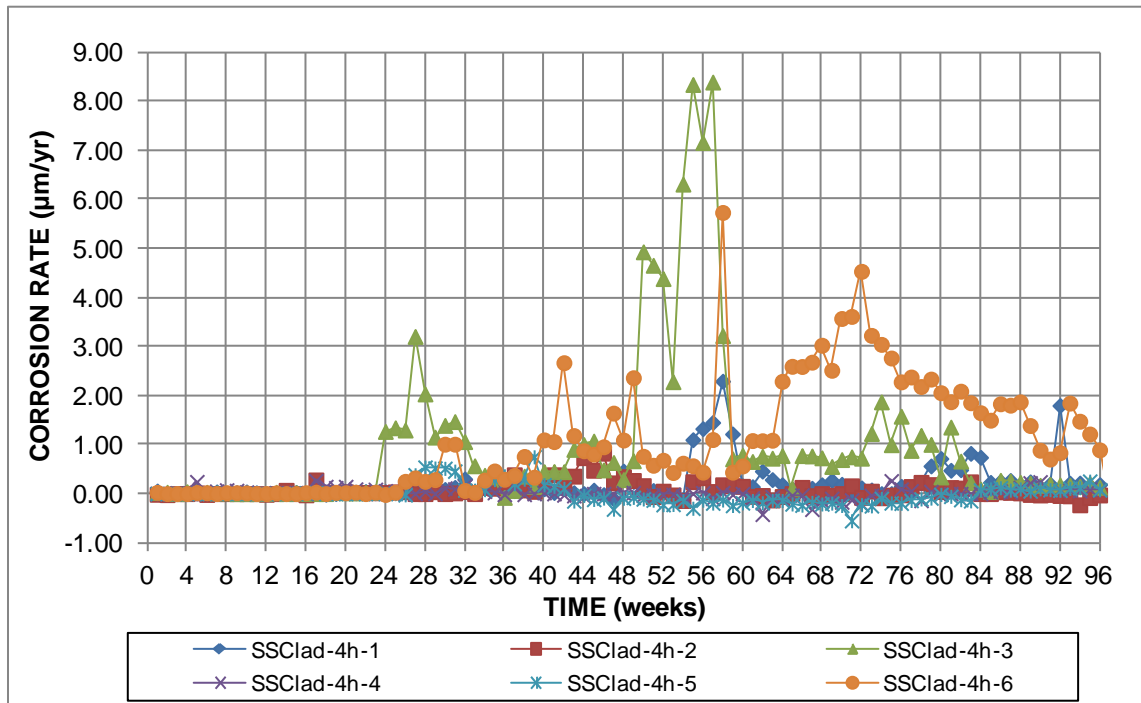
Figure 78b: Individual corrosion rates for Southern Exposure specimens containing NX-SCR™ stainless steel clad bar with four holes through the cladding

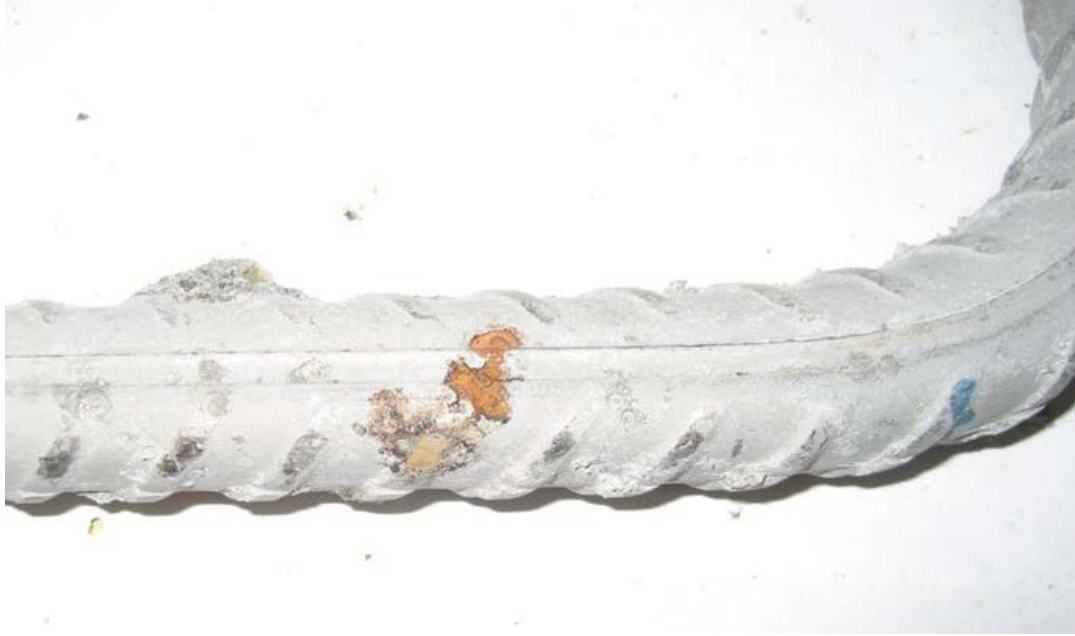
Figure 80a: Corrosion staining on SSClad-b-2 upon autopsy, bent NX-SCR™ stainless steel clad bar (close-up)

The corrosion rates for the individual bent NX-SCR™ stainless steel clad (SSClad) Southern Exposure specimens are shown in Figure 79. For most specimens, the individual corrosion rates remained near zero. However, specimens SSClad-b-2 and SSClad-b-3 initiated corrosion at weeks 36 and 71, respectively. The highest corrosion rate was experienced by SSClad-b-2, reaching 2 µm/yr at week 44. Although no visible penetration of the cladding was noted at the time of bending, the transverse ribs were visibly flattened by the rolling pin, and both specimens exhibited corrosion products at the flattened regions (Figure 80a), suggesting that the cladding was penetrated or torn during the bending operation. Other specimens did not initiate corrosion; however, the potential for damage indicates clad reinforcement should be fabricated using the same precautions used for ECR. Corrosion products were also observed on the end of the conventional core of one cathode bar of SSClad-b-2 (Figure 80b). This would tend to slightly decrease the measured macrocell corrosion rate of the specimen.

Figure 100 shows bars from a Southern Exposure specimen containing bent SSCLad reinforcement after autopsy. As discussed earlier, bars from two specimens displayed corrosion products near the bend (Figure 80a). The rest of the specimens showed no signs of corrosion. However, because of the potential for damage, it is recommended that the SSCLad bars be

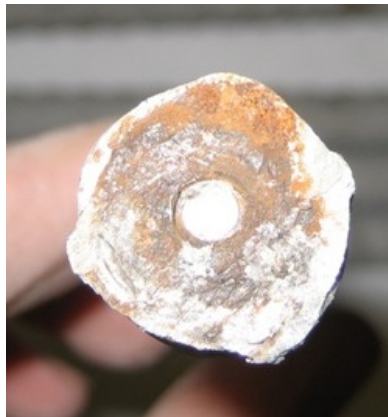
Figure 80b: Corrosion on end of SE-SSClad-b-2 cathode bar

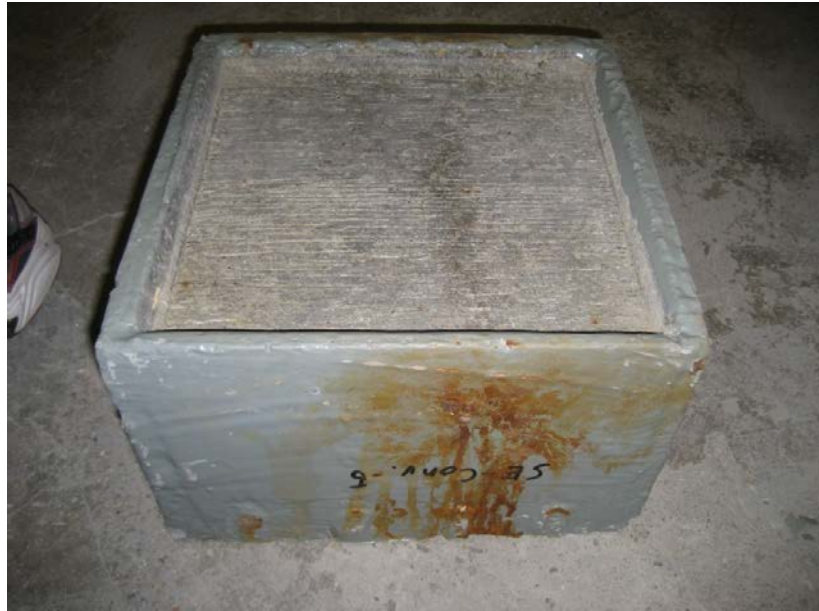
Figures 86a and 86b show a typical Southern Exposure specimen containing conventional reinforcement (Conv.) upon completion of the test. The photograph in Figure 86a, taken before autopsy, shows staining on the outer surface of the specimen. Figure 86b, taken after autopsy, shows the two top bars with significant corrosion product along the length of the bars.

Figure 86a: Staining on outside of Southern Exposure specimen 5 with conventional steel in the top mat

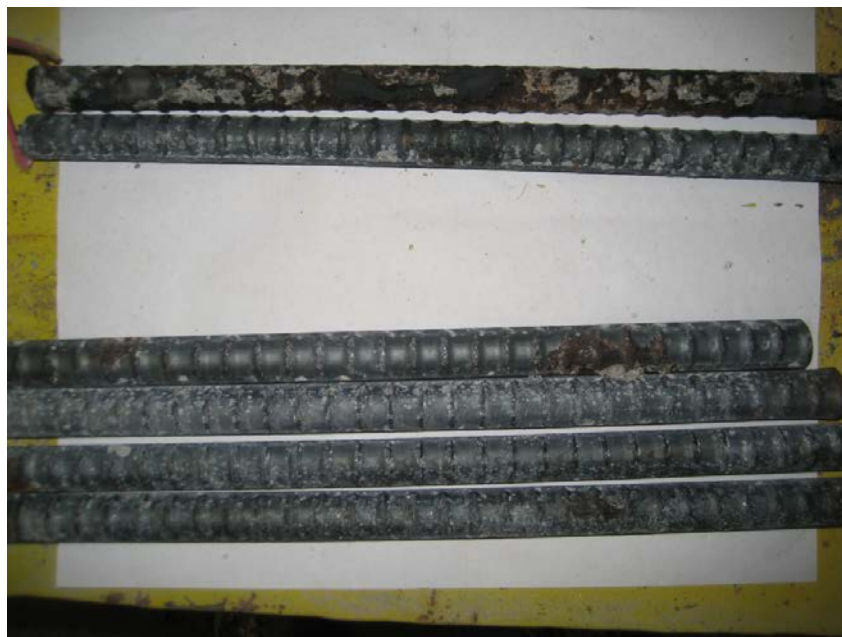
Figure 86b: Bars from Southern Exposure specimen 2 containing conventional reinforcement after autopsy

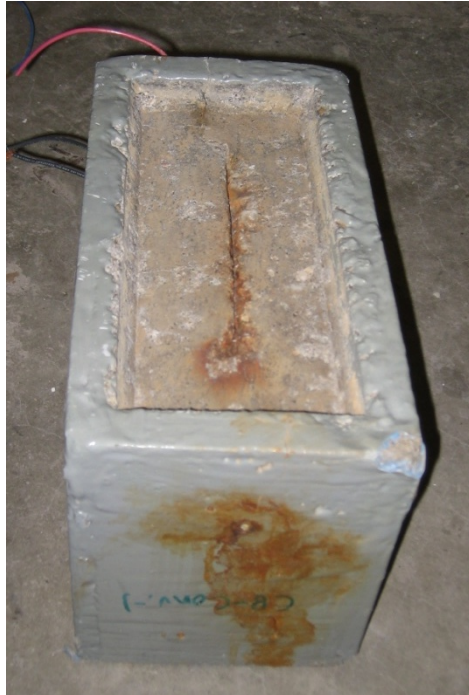
Figures 87a and 87b show a typical cracked beam specimen containing conventional reinforcement (Conv.) before and after autopsy, respectively. As with the Southern Exposure specimen shown in Figure 86, the top bar exhibits significant corrosion along the length of the bar.

Figure 87a: Staining of cracked beam specimen 1 containing conventional reinforcement

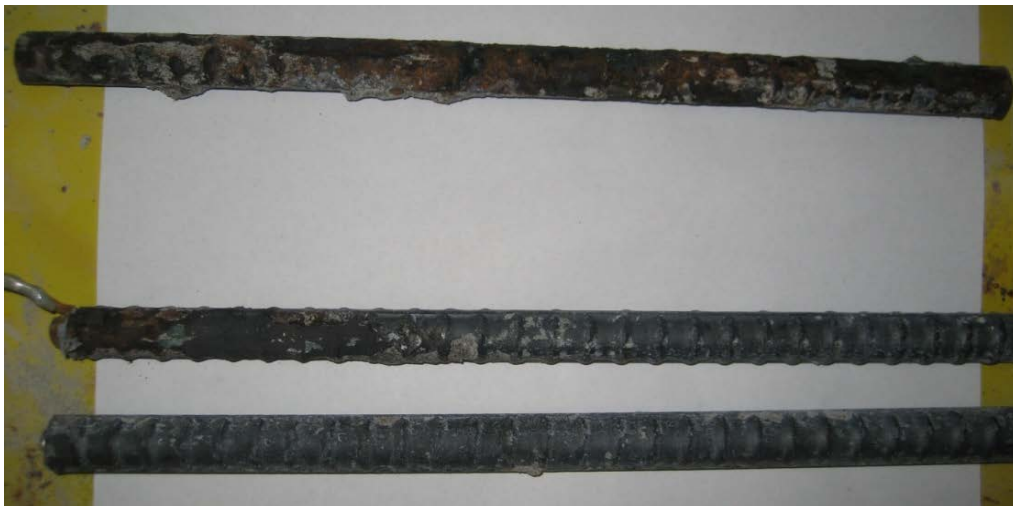
Figure 87b: Bars from cracked beam specimen 1 containing conventional reinforcement after autopsy

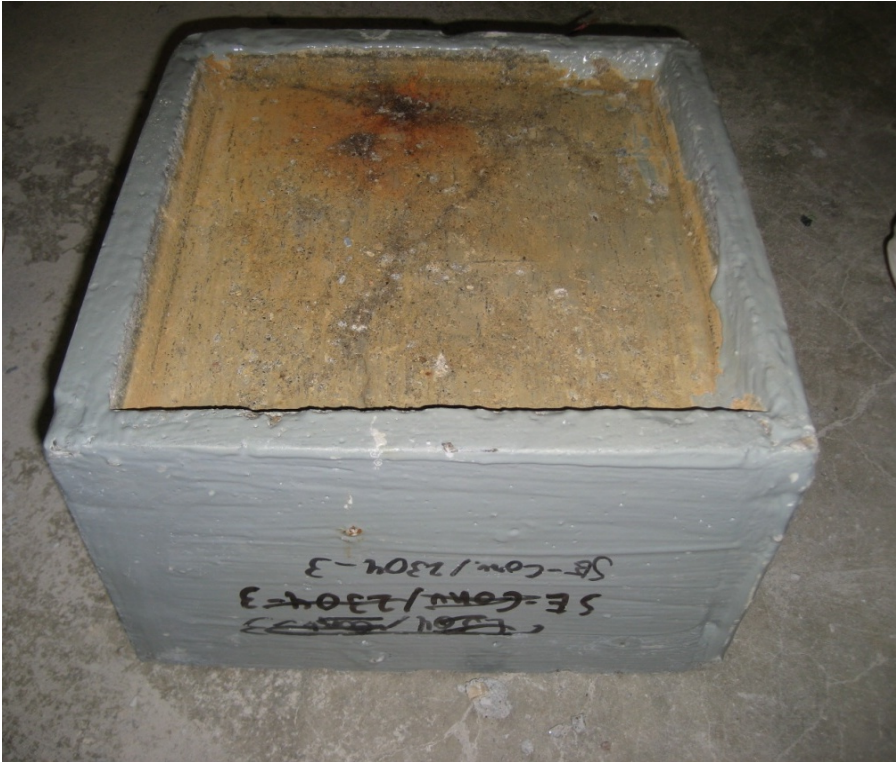
A Southern Exposure specimen with conventional steel as the anode and 2304 stainless steel as the cathode is shown in Figures 88 and 89. Figure 88a shows staining on the top surface of the specimen as well as cracking caused by the corrosion of the top bars. Figures

Figure 88a: Staining on Southern Exposure specimen 3 containing mixed Conv./2304 (anode/cathode)

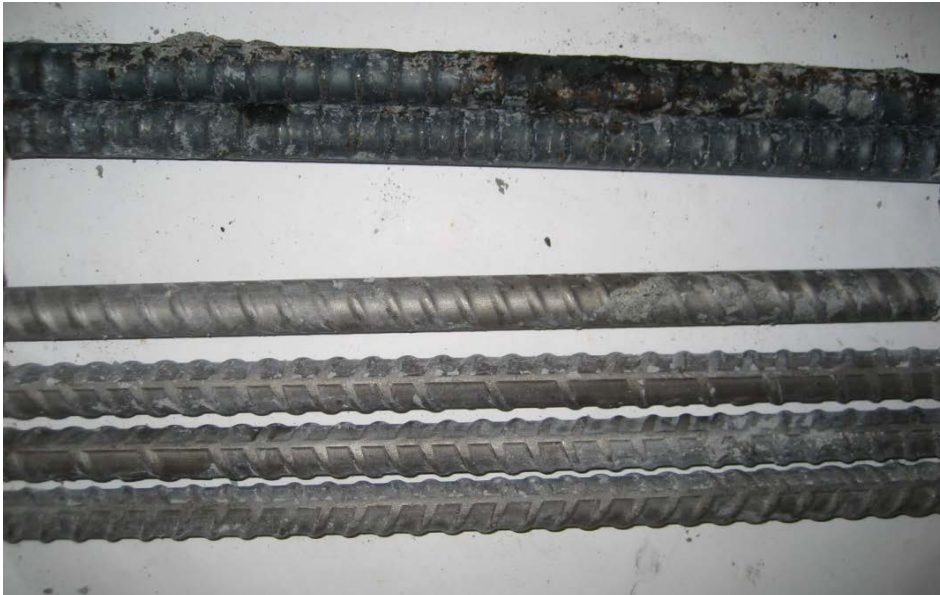
88b and 88c show the bars after being removed from the concrete. It can be seen that the top (conventional) bars show significant corrosion products. One Conv./2304 specimen also exhibited staining on the stainless steel cathode bar, as shown in Figure 89.

Figure 88b: Bars from Southern Exposure specimen 3 containing conventional reinforcement as the anode and 2304 stainless steel as the cathode after autopsy

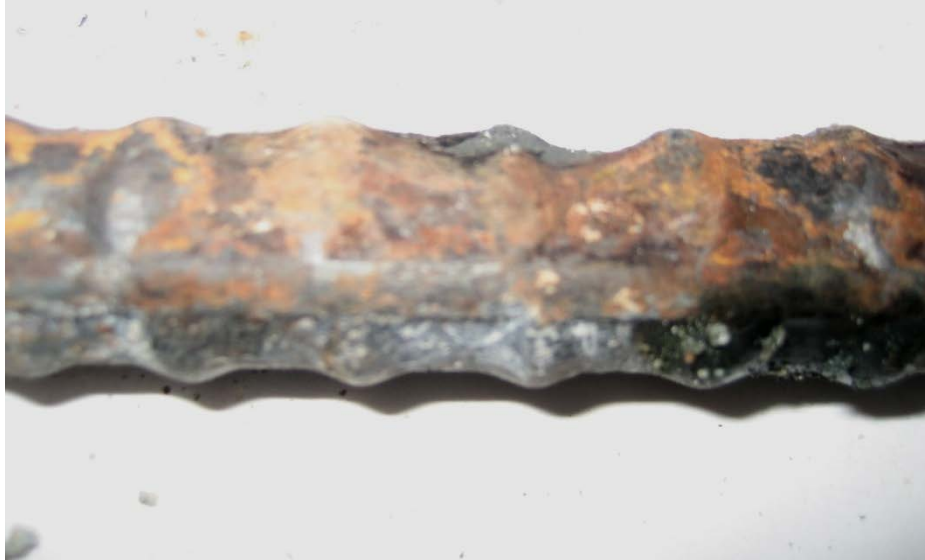
Figure 88c: Close up of conventional top bar in Southern Exposure specimen 3 containing conventional reinforcement as the anode and 2304 stainless steel as the cathode after autopsy

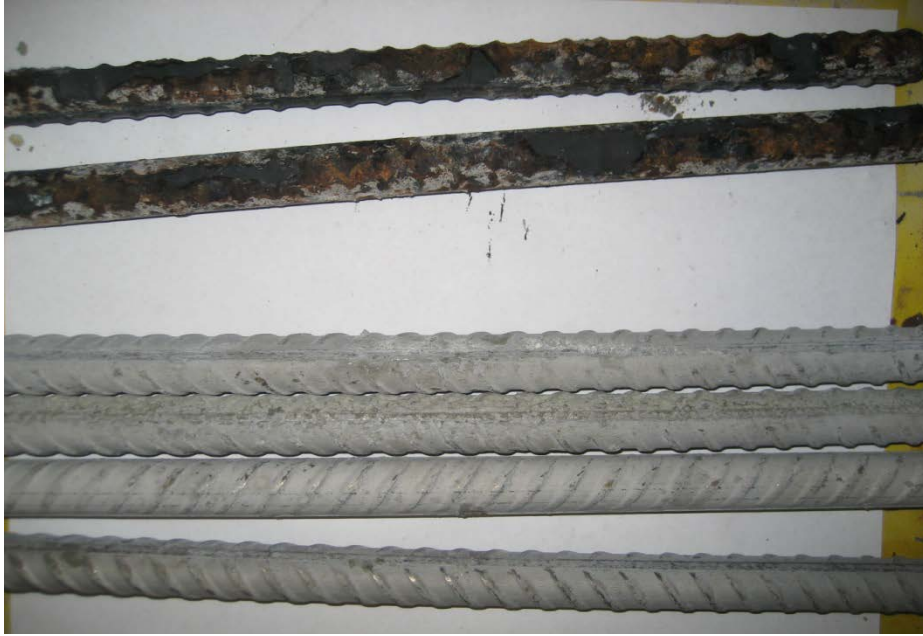
Figure 90 shows a typical Southern Exposure specimen with conventional steel as the anode and stainless steel clad reinforcement as the cathode after autopsy. As with all other specimens containing conventional steel in the top mat, the top bars exhibit significant corrosion products along the length of the beam.

Figure 90: Bars from Southern exposure specimen 1 containing conventional reinforcement as the anode and stainless steel clad reinforcement as the cathode after autopsy

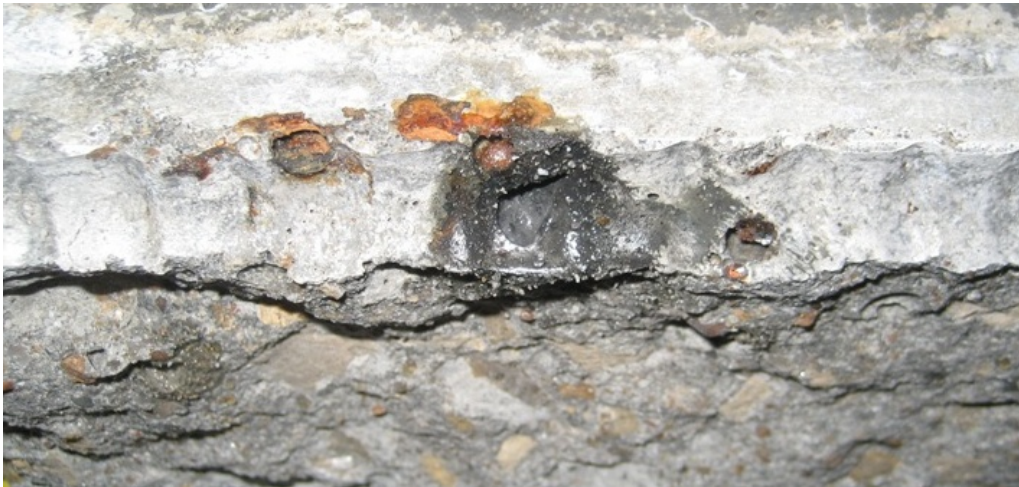
Figure 91: Staining on inside of Southern Exposure specimen 3 containing epoxy-coated reinforcement with penetrations in the epoxy.

Figure 91 shows staining on the inside of a Southern Exposure specimen containing ECR. Figure 92 shows total disbondment of the top bar.

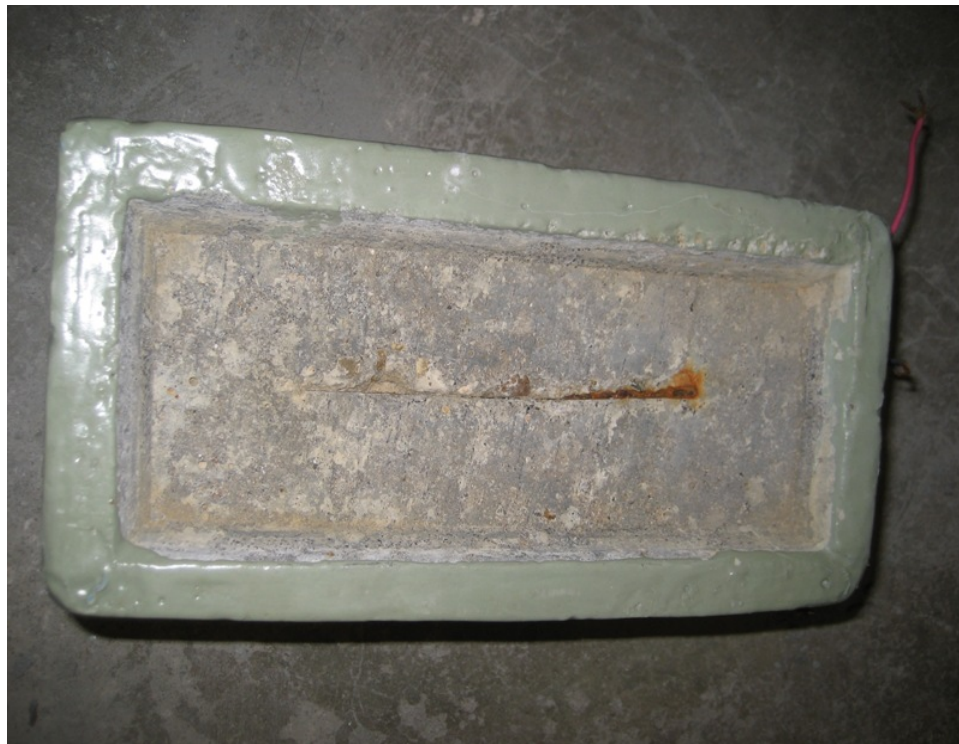
Figure 93a: Staining in the crack of cracked beam specimen 5 containing 2304 stainless steel

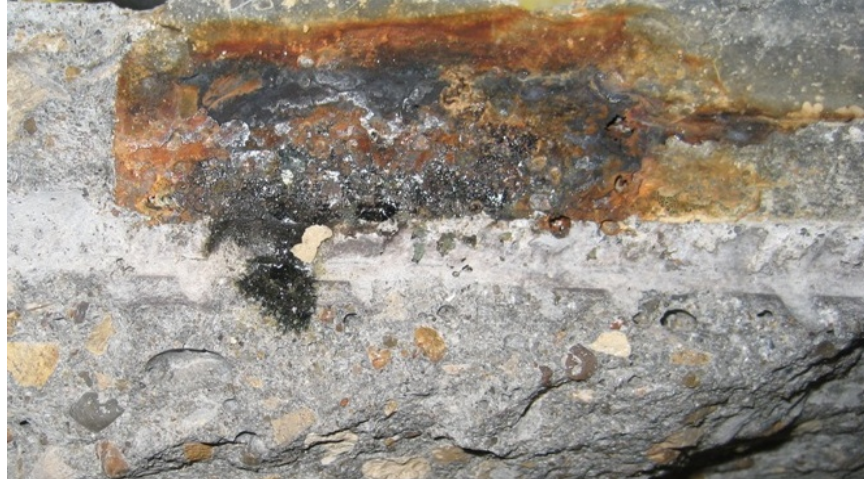
Figure 93 shows staining both in the crack of a 2304 cracked beam specimen (Figure 93a) and also on the inside of the specimen after autopsy (Figure 93b).

Figure 93b: Staining on inside of cracked beam specimen 1 containing 2304 stainless steel

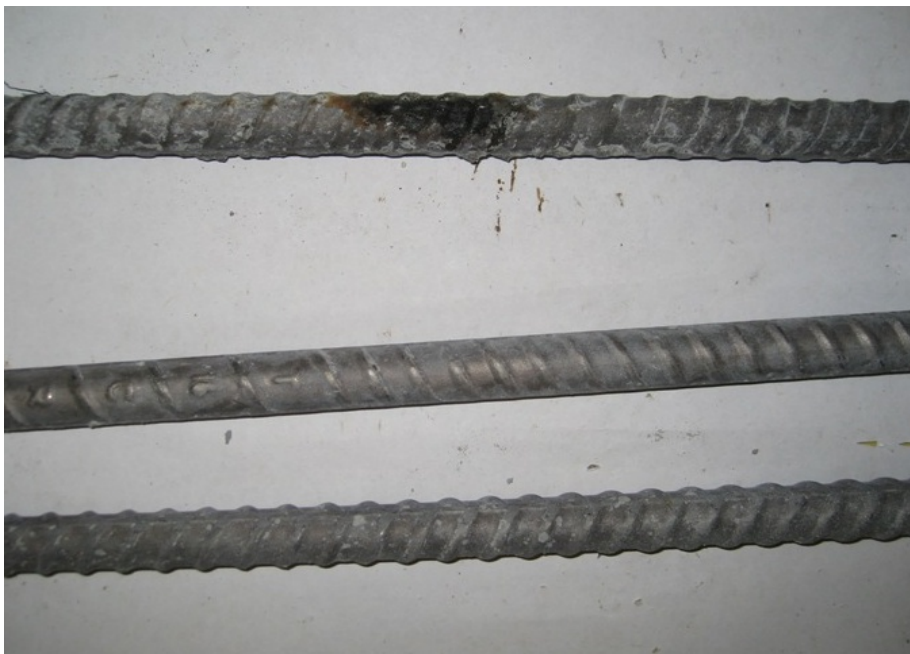
Corrosion products can be seen on the top bar of a 2304 cracked beam specimen (Figure 94a). There is evidence of corrosion at the end as well as in the middle of the bar (Figures 94b and 93c).

Figure 94a: Bars from cracked beam specimen 1 containing 2304 stainless steel after autopsy

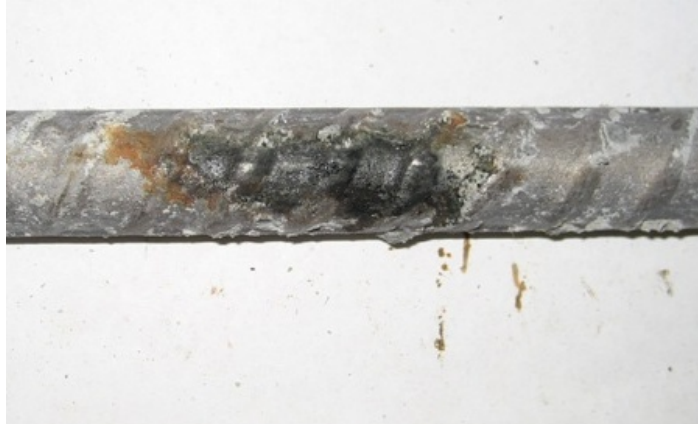
Figure 94b: Top bar from cracked beam specimen 1 containing 2304 stainless steel after autopsy, showing corrosion product on top bar (close up)

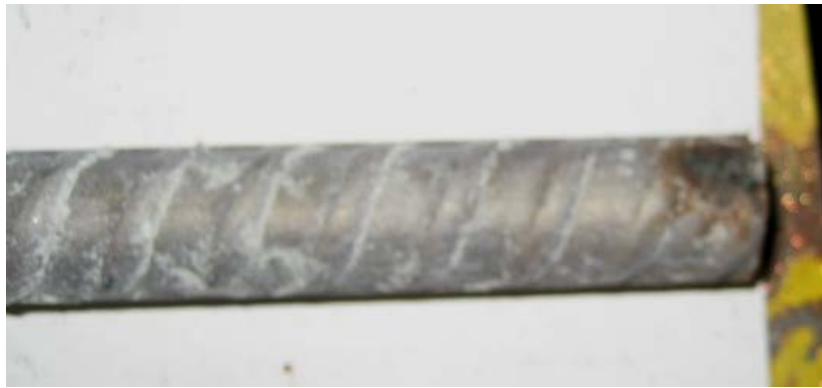
Figure 94c: Top bar from cracked beam specimen 2 containing 2304 stainless steel after autopsy, showing corrosion product near the end of the top bar (close up)

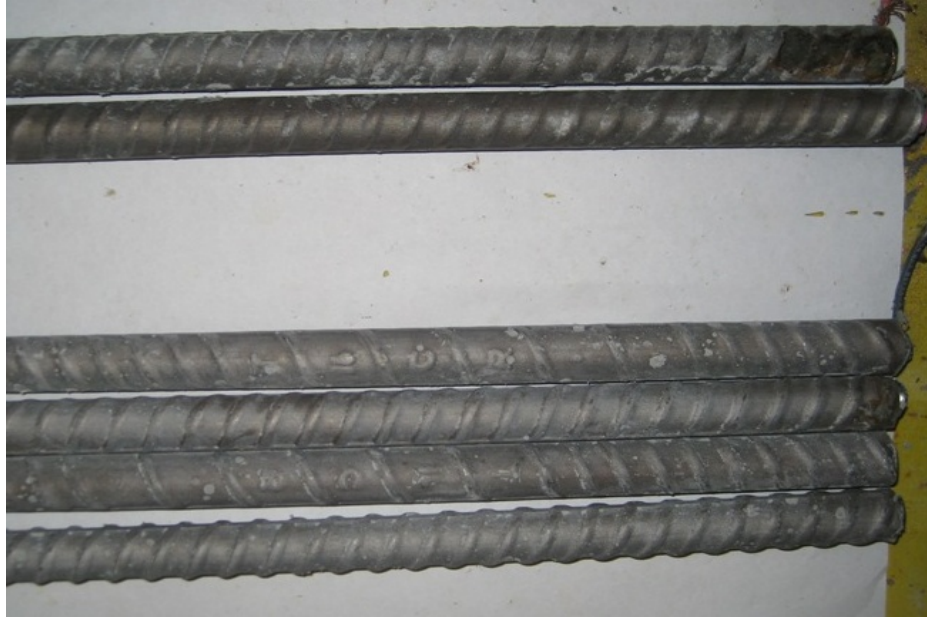
There were also corrosion products on the end of one top bar in a Southern Exposure 2304 specimen as shown in Figure 95.

Figure 95: Bars from Southern Exposure specimen 2 containing 2304 stainless steel after autopsy

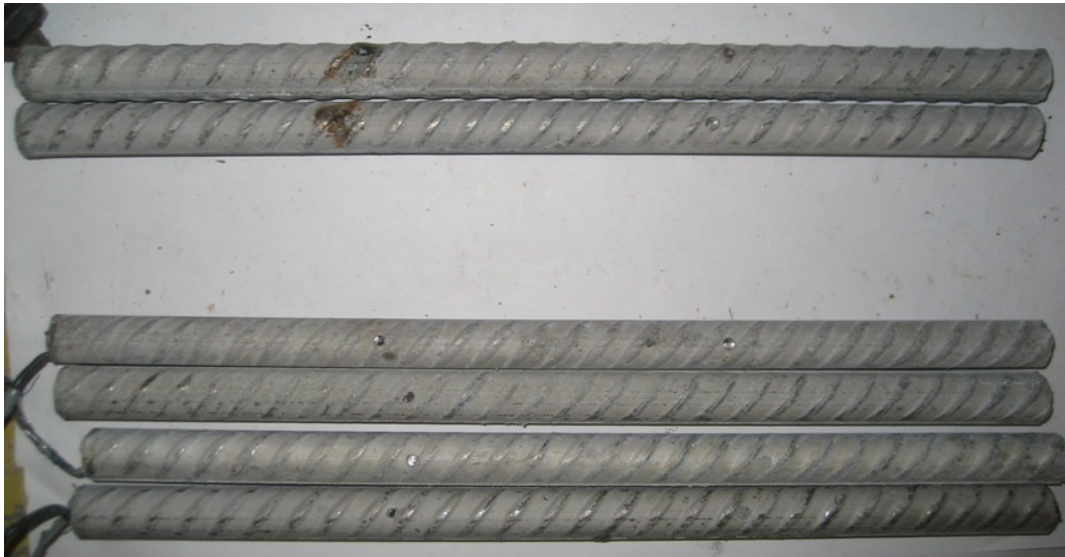
Figure 97 shows bars from a typical SSClad specimen with four holes through the cladding after autopsy. There are corrosion products at some of the holes on the top bars as well as slight corrosion products in the holes on the bottom bars (Figure 97c). There were also corrosion products observed on the exposed ends of the both the top and bottom bars. A cut

Figure 97a: Bars from Southern Exposure specimen 5 containing stainless steel clad reinforcement with four holes through the cladding after autopsy

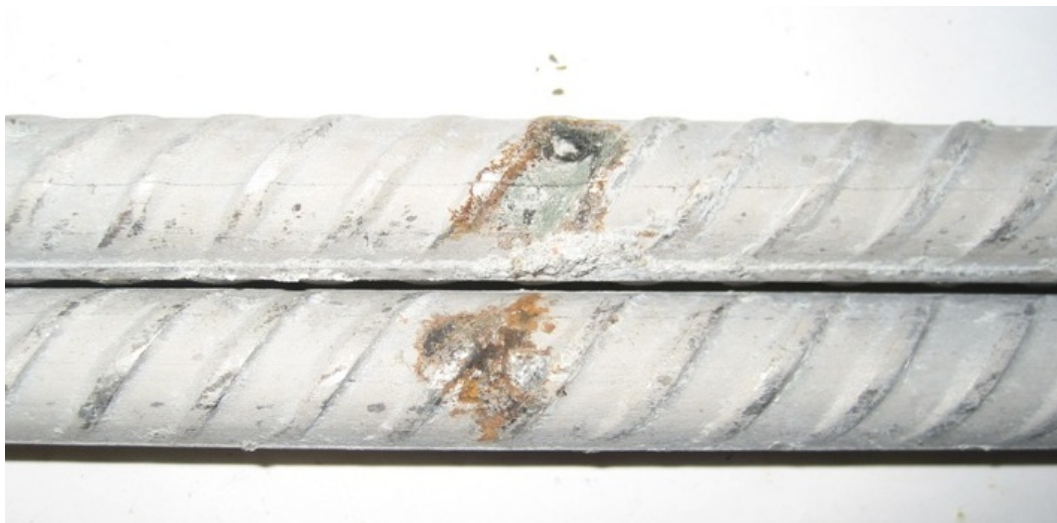
Figure 97b: Top Bars from Southern Exposure specimen 5 containing stainless steel clad reinforcement with holes through the cladding after autopsy, showing corrosion at damage site on top bars (close up)

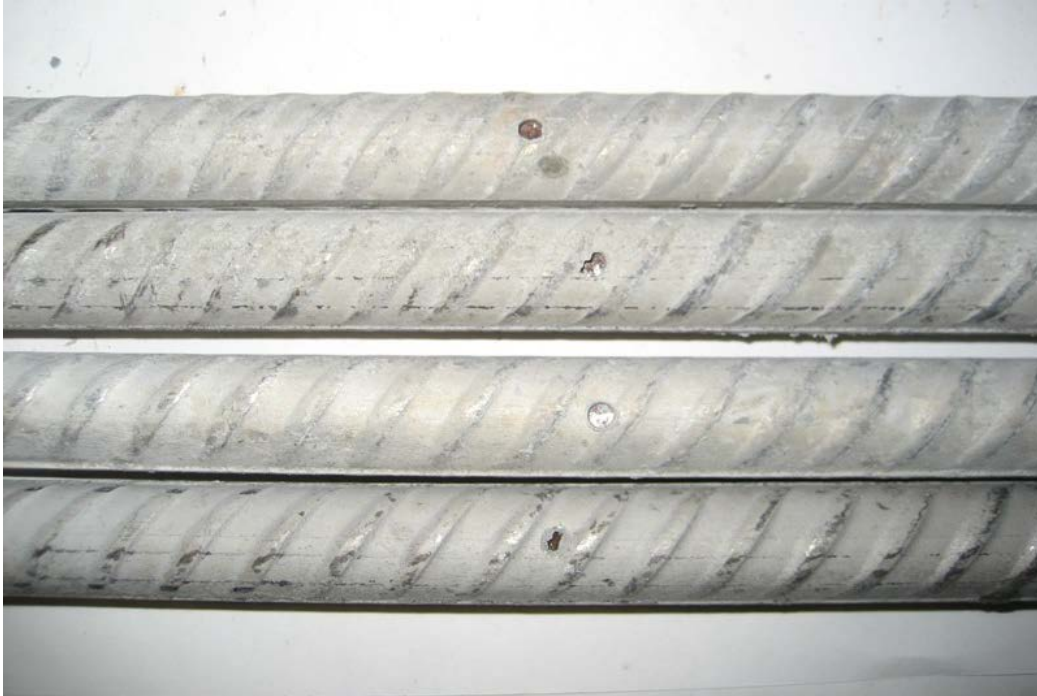
Figure 97c: Bottom bars from Southern Exposure specimen 5 containing stainless steel clad reinforcement with four holes through the cladding after autopsy, showing corrosion at damage site on bottom bars (close up)

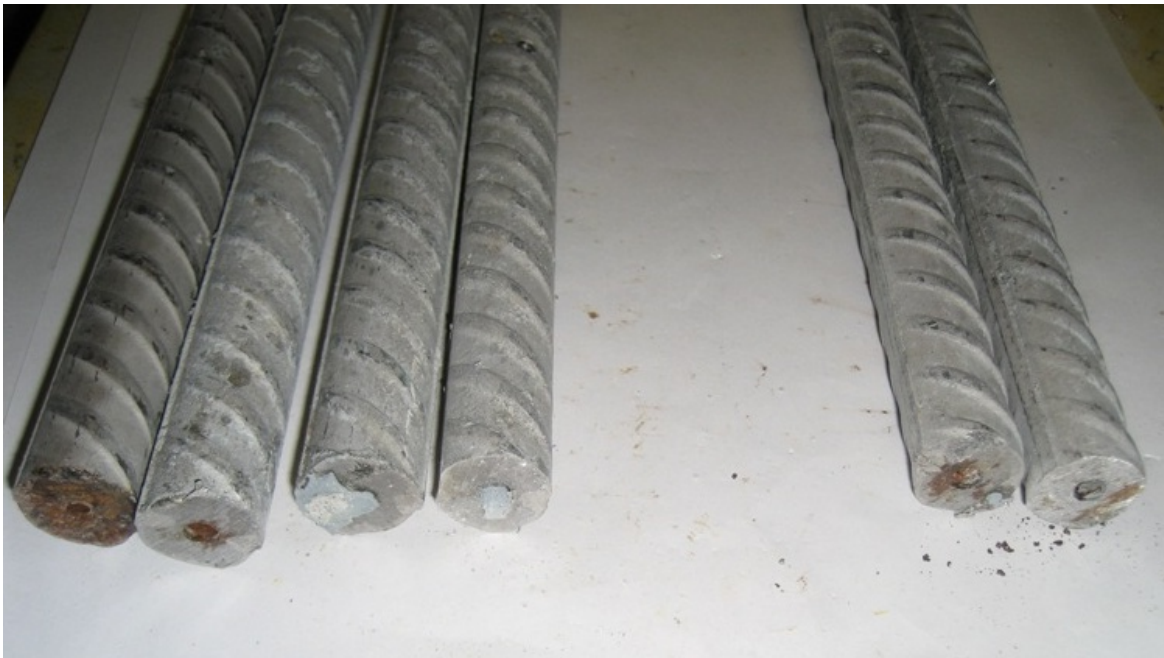
Figure 97d: Bars from Southern Exposure specimen 5 containing stainless steel clad reinforcement with four holes through the cladding after autopsy, showing corrosion at ends of top and bottom bars (close up)

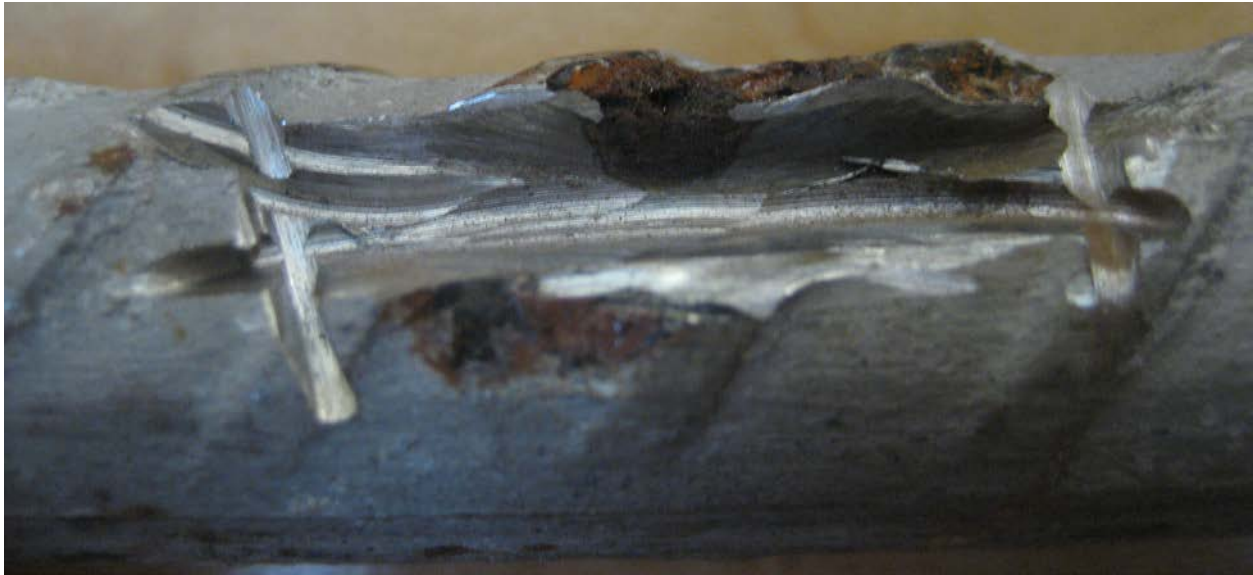
Figure 97e: Bars from Southern Exposure specimen 5 containing stainless steel clad reinforcement with four holes through the cladding after autopsy, showing extent of corrosion underneath the hole

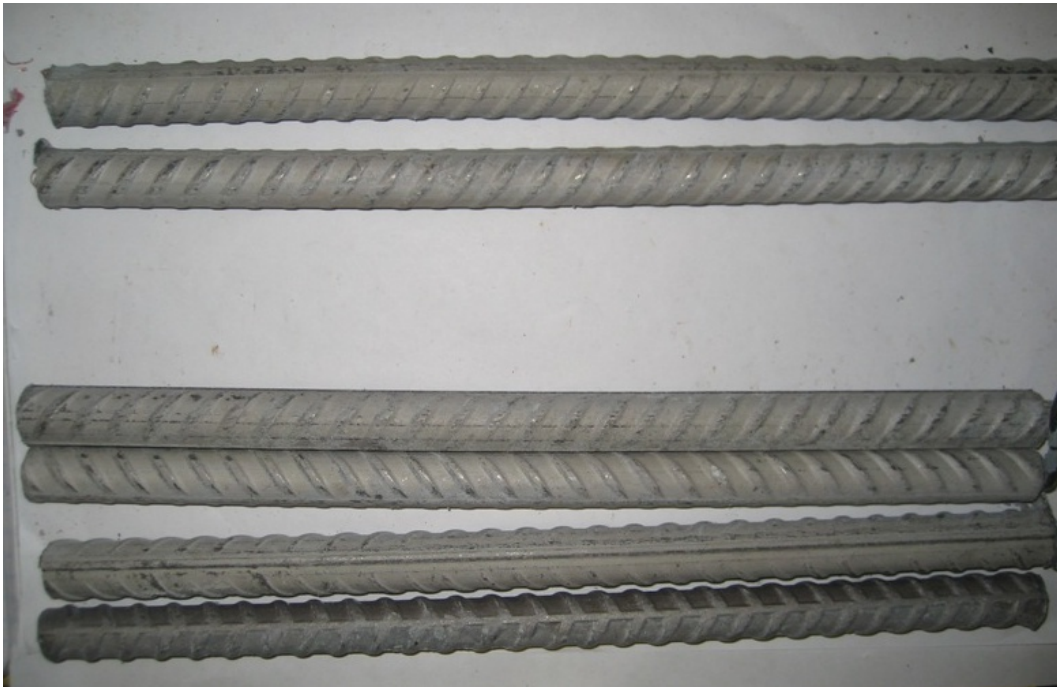
Figure 98a: Bars from Southern Exposure specimen 5 containing undamaged stainless steel clad reinforcement after autopsy

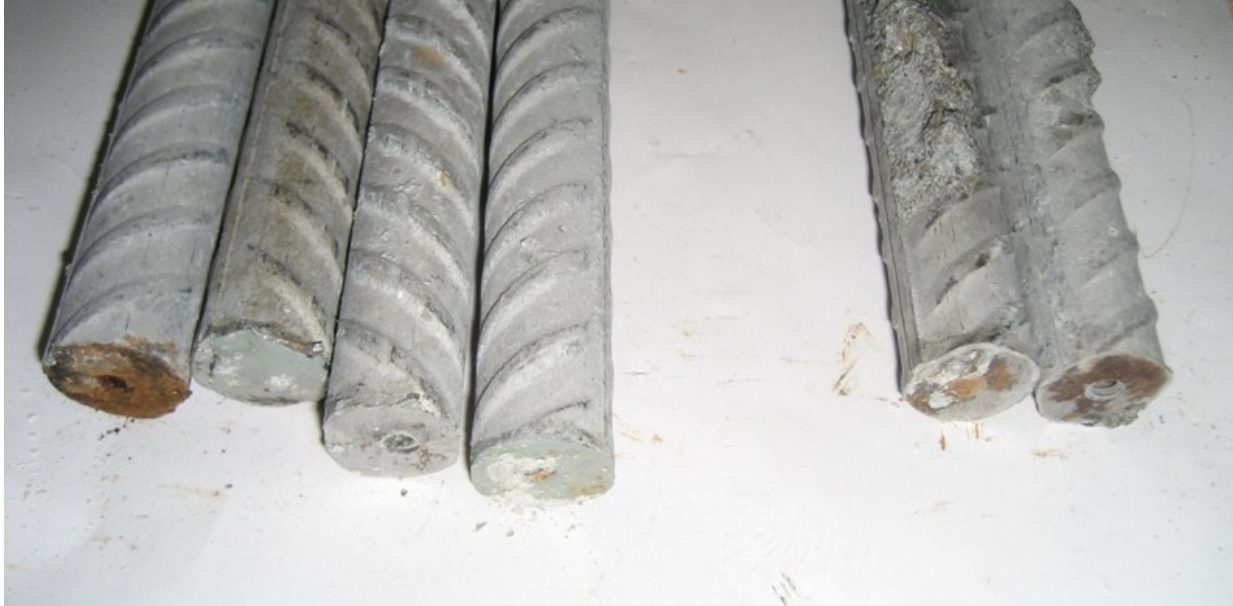
Figure 98b: Bars from Southern Exposure specimen 4 containing undamaged stainless steel clad reinforcement after autopsy, showing corrosion at ends of top and bottom bars (close up)

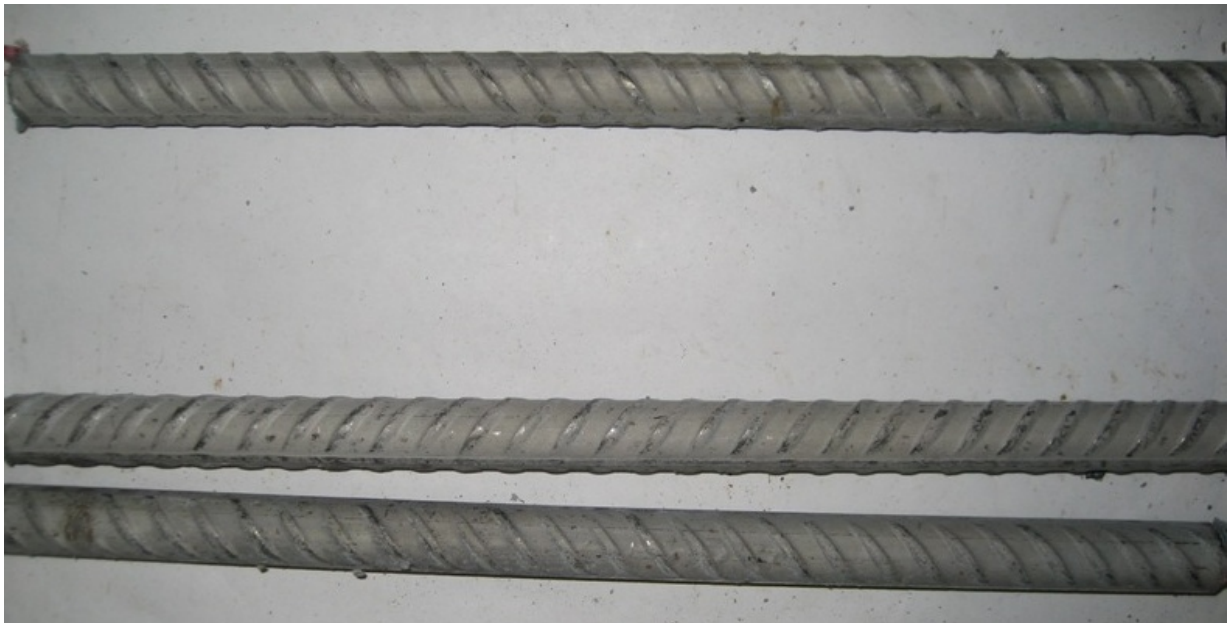
Figure 99: Bars from cracked beam specimen 6 containing undamaged stainless steel clad reinforcement after autopsy

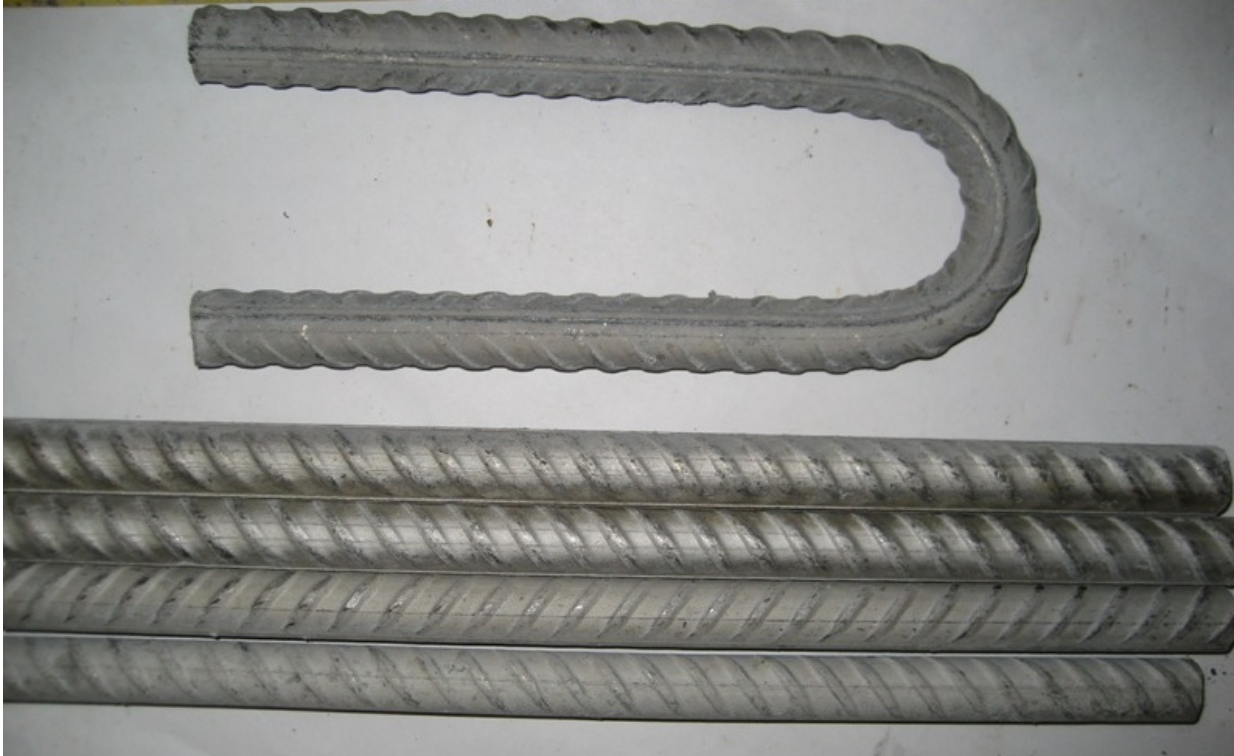
Figure 100: Bars from Southern Exposure specimen 5 containing bent stainless steel clad reinforcement after autopsy
