STAINLESS STEEL REINFORCEMENT AS A REPLACEMENT FOR EPOXY COATED STEEL IN BRIDGE DECKS

FINAL PROJECT REPORT – FHWA-OK-13-08
ODOT SP&R ITEM NUMBER 2231

TECHNICAL REPORT DOCUMENTATION PAGE

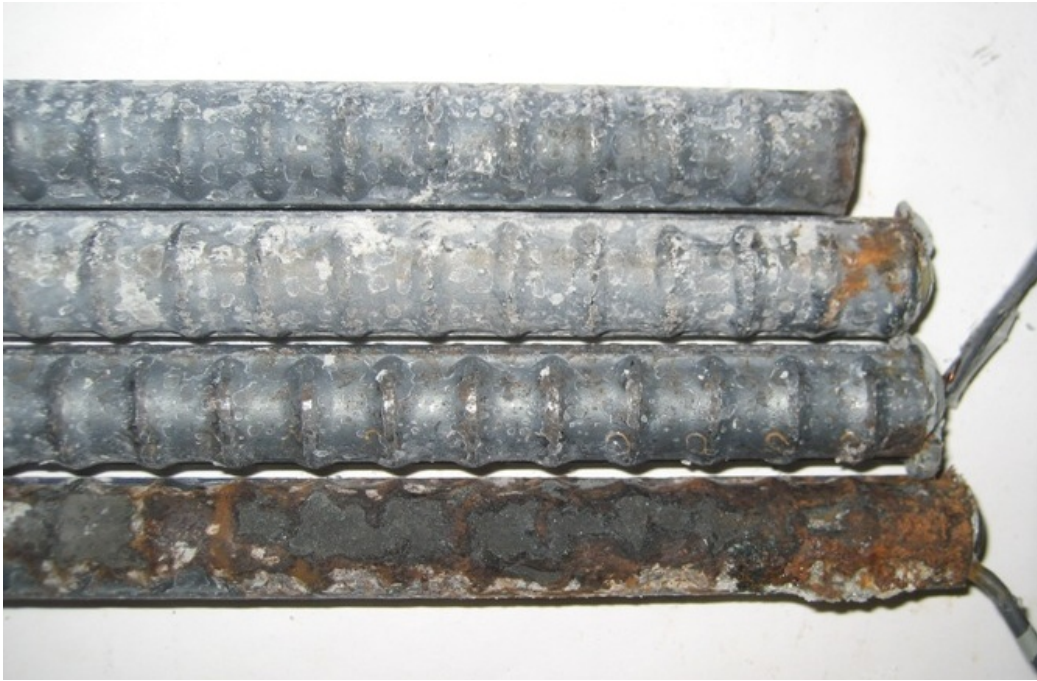
Bars from a Southern Exposure specimen containing stainless steel clad reinforcement as the anode and conventional steel as the cathode are shown in Figure 101. Significant corrosion products were seen on one conventional bottom bar (Figure 101b). There were also corrosion products at the ends of the SSclad bars (Figure 101c).

Figure 101b: Bottom bars from Southern Exposure specimen 3 containing stainless steel clad reinforcement as the anode and conventional steel as the cathode after autopsy

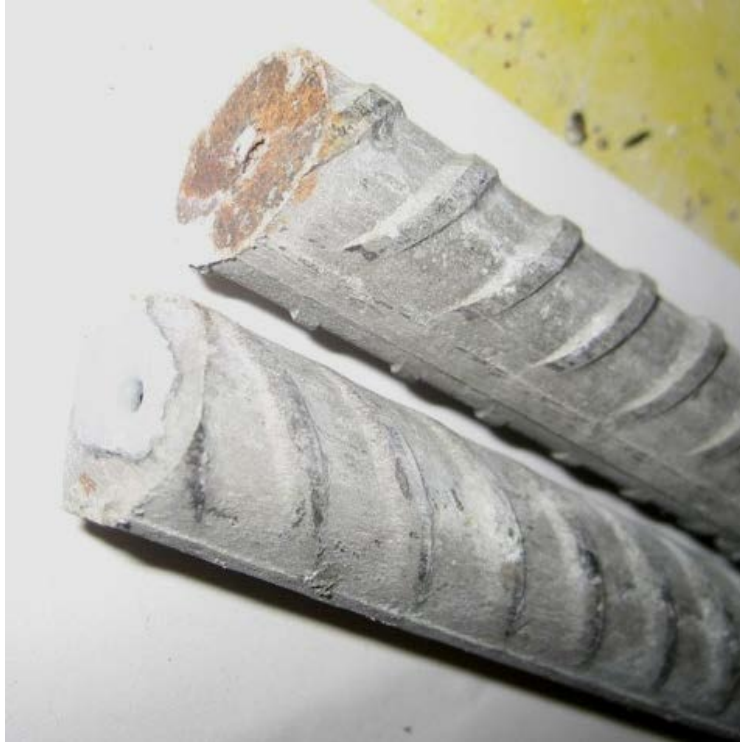
Figure 101c: Top bars from Southern Exposure specimen 2 containing stainless steel clad reinforcement as the anode and conventional steel as the cathode after autopsy, showing corrosion of at ends of top bars (close up)

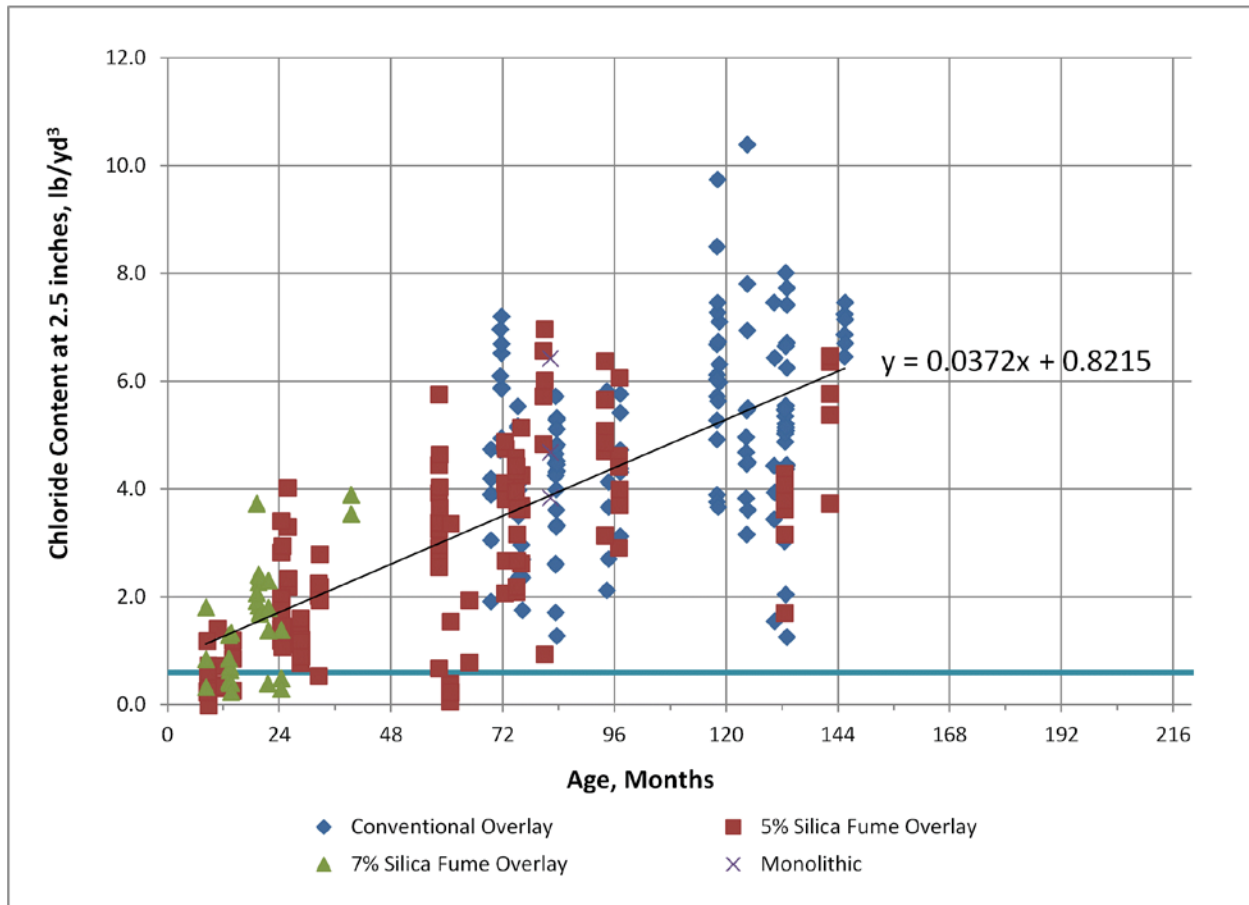
Figure 103: Chloride content taken at cracks interpolated at a depth of 2.5 in. versus age for bridges with an AADT greater than 7,500
