**FINAL REPORT ~ FHWA-OK-21-04**

# **IN-STREAM STRUCTURES INTEGRITY AND CHANNEL STABILITY SURVEY AND EVALUATION**

**School of Civil Engineering and Environmental Science (CEES)  
The University of Oklahoma  
Norman, Oklahoma**

**September 2021**

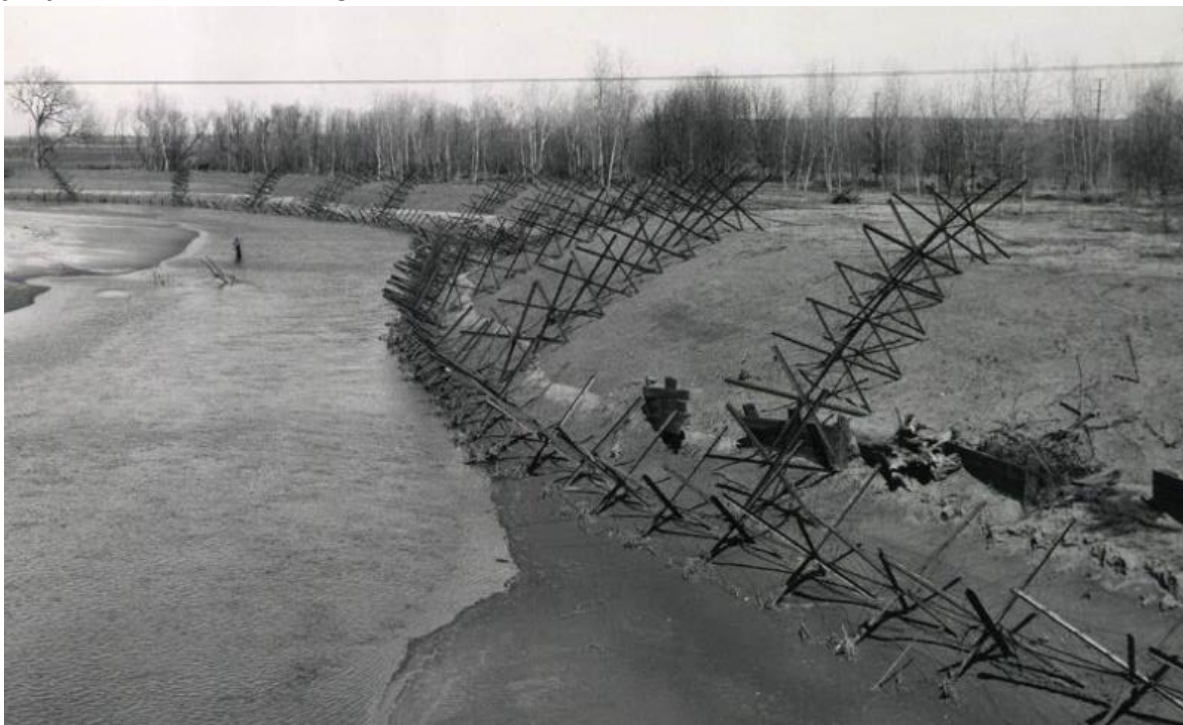
Kellner jetties are permeable structures built to slow the flow of water. They are constructed on streambanks and protrude into the stream to decrease the energy of the water along the streambank and direct it towards to the middle of the stream. The velocity of water is reduced in the Kellner jetty field, allowing sediment to settle out and build up the bank. Thus, Kellner jetties are often used in streams with high sediment loads and relatively low bank slopes. This streambank stabilization method was discovered in the 1920's and was very common in the 1950's and early 1960's (Army Corps of Engineers 1963). Kellner jetties were successful in silty streams with substantial channel scour in New Mexico and Arkansas in the 1950's. They have been found to result in a two-thirds reduction in stream velocity in the jetty field, allowing for the deposition of sediment (Army Corps of Engineers 1963). An example of a Kellner jetty field is shown in Figure 1.

*Figure 1. Example of a Kellner jetty field on the Washita River in Oklahoma, taken in 1950 (Lewis 2020).*

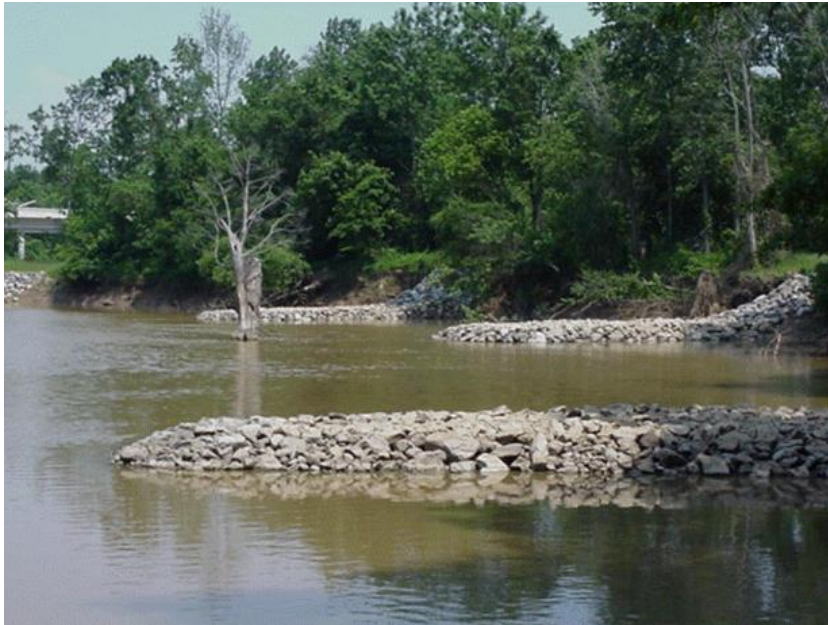
Bendway weirs are transverse, rip-rapped in-stream structures that point inward and slightly upstream (Thornton et al. 2007; Khosronejad et al. 2017). For the purposes of this study, bendway weirs are placed on the outer bank of meanders in a stream and are always placed as multiple weirs in sequence. Their purpose is to deflect high-velocity, near-bed flow away from the outer bank and increase flow resistance near the base of the outer bank (Thornton et al. 2007; Khosronejad et al. 2017). An example of bendway weirs is shown in Figure 5.

*Figure 5: Image of bendway weirs (Thornton et al. 2007).*

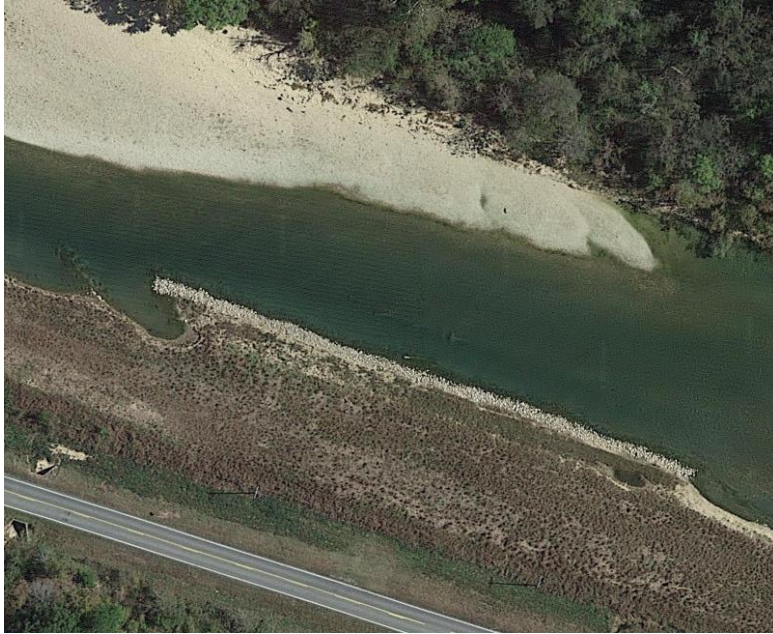
Unlike jetties, pile diversions, and bendway weirs, rock vanes run nearly parallel to the flow of the stream. They allow the stream to flow over the rock structure during higher flows, which makes them less prone to damage from debris in the stream. Because of these factors, rock vanes do not increase the channel roughness and will cause less degradation downstream of the structure (Odgaard and Kennedy 1983). Odgaard and Lee (1984) have developed design criteria based on stream characteristics, hydraulic factors, and stream curvature. Odgaard and Lee (1984) recommend that the ratio of vane height to water depth is between 0.2 and 0.5 at all “erosion-causing flow rates” and that the vanes form an angle of 10-15 degrees with the flow line.

*Figure 10: Aerial photo of rock vane in the Illinois River near Tahlequah, OK (GoogleEarth 2020).*

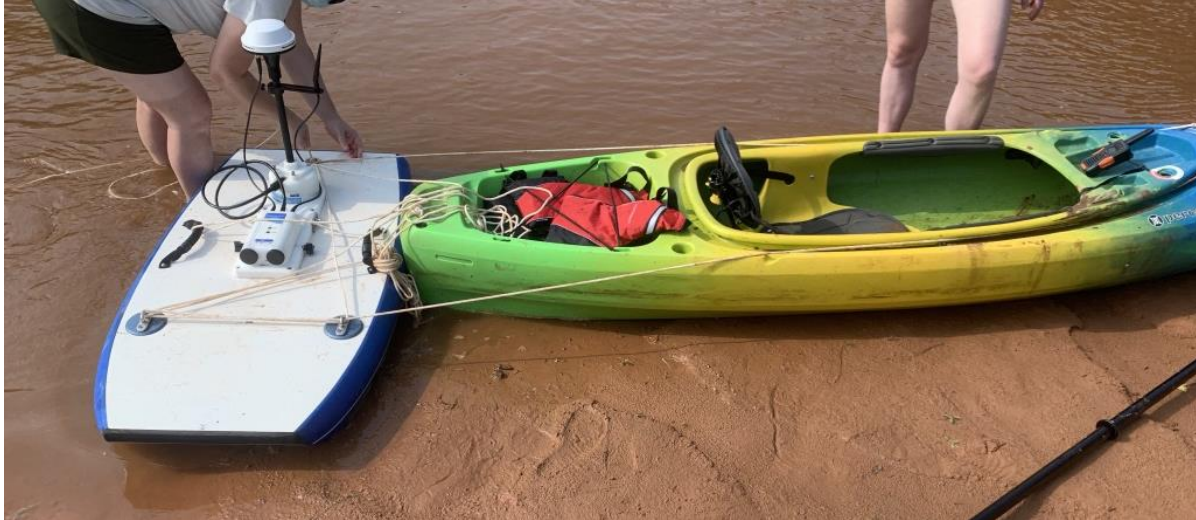
Velocity profiles were collected at each cross section, using an ADCP. Velocity profiles show the stream velocity perpendicular to the cross sectional plane (Rosgen 2014). The ADCP used was a SonTek S5 ADCP, which collects a data point every second as it crosses the stream and contains velocity measurements along the depth of each data point. ADCP data collection methods varied depending on the accessibility of the river. In wadable rivers, a rope was attached to either side of the ADCP, extending bank-to-bank along the cross section of concern, and the ADCP was dragged across the river. In non-wadable streams, the ADCP was attached to the back of a kayak and floated across the cross-section from one bank to the other. A photo of this is shown in Figure 14.

*Figure 14: ADCP attached to back of kayak for cross sections in non-wadable rivers.*
