**FINAL REPORT ~ FHWA-OK-22-04**

# **SHRINKAGE INDUCED DEFORMATIONS IN STEEL BRIDGES MADE COMPOSITE WITH CONCRETE DECK SLABS**

**Civil Engineering and Environmental Science**  
**Oklahoma State University**  
**Stillwater, Oklahoma**

**March 2022**

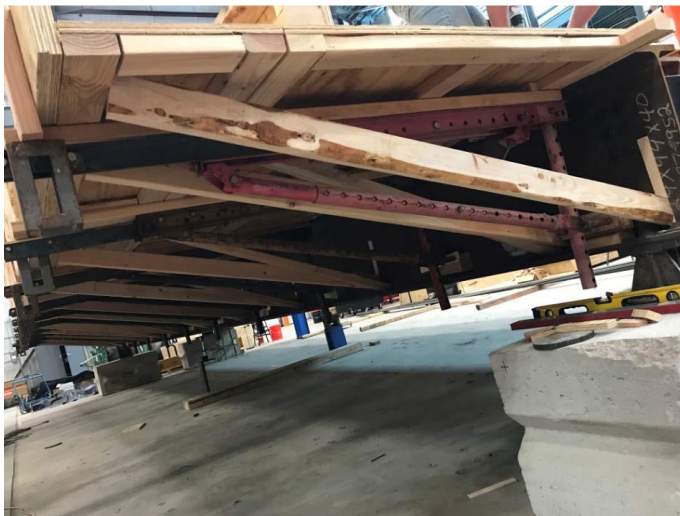
**Figure 4.5: Bracing of formwork for the cantilevers. Additional bracing shims were added to help reduce construction deflections.**
