END-REGION EVALUATION OF HYBRID ULTRA-HIGH-PERFORMANCE  
CONCRETE/CONVENTIONAL CONCRETE PRESTRESSED GIRDERS

A DISSERTATION  
SUBMITTED TO THE GRADUATE FACULTY  
in partial fulfillment of the requirements for the  
Degree of  
DOCTOR OF PHILOSOPHY

By  
JACOB G. CHOATE  
Norman, Oklahoma  
2023

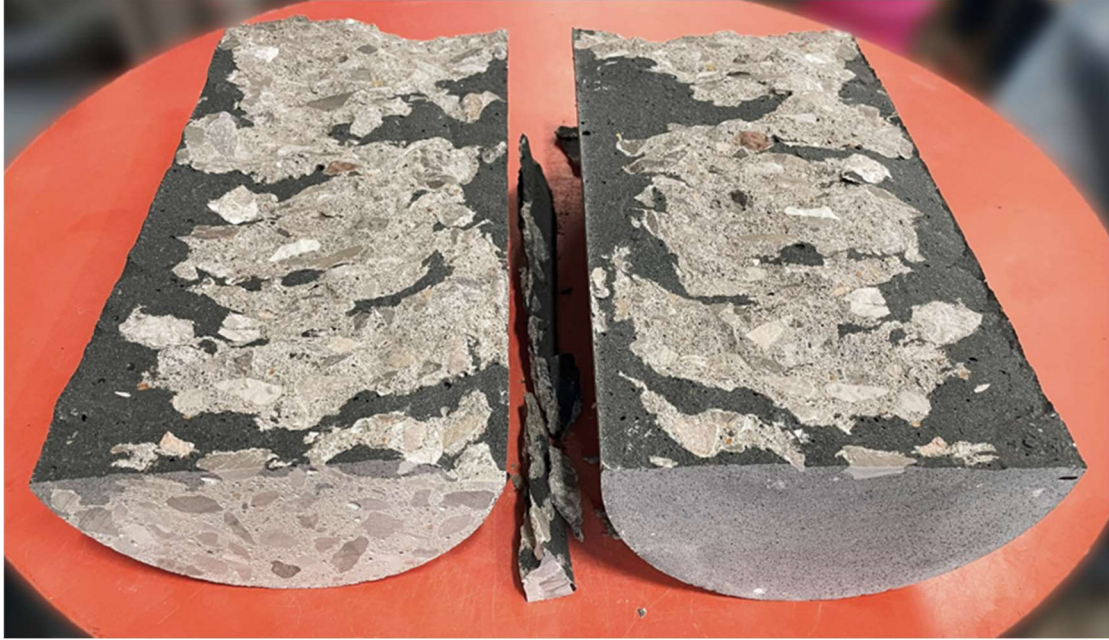
The results from the splitting tensile testing of both sets of BiFluid specimens closely mirrored the splitting tensile strengths exhibited by the monolithic SCC specimens. In the case of all the non-homogenous specimens, failure planes exhibited a consistent trend along the interface of the concretes, positioned just within the SCC section, and occasionally traversing through small segments of UHPC (see Figure 3.4). It was observed that both BiFluid specimens, irrespective of having a linear interface originating from the divider or an irregular interface, showcased comparable strength values. This observation appears to validate the hypothesis that tensile capacity is predominantly influenced by the relatively weaker stratum, in this case the SCC.

**Figure 3.4:** Two halves of tested BiFluid splitting-tensile specimen

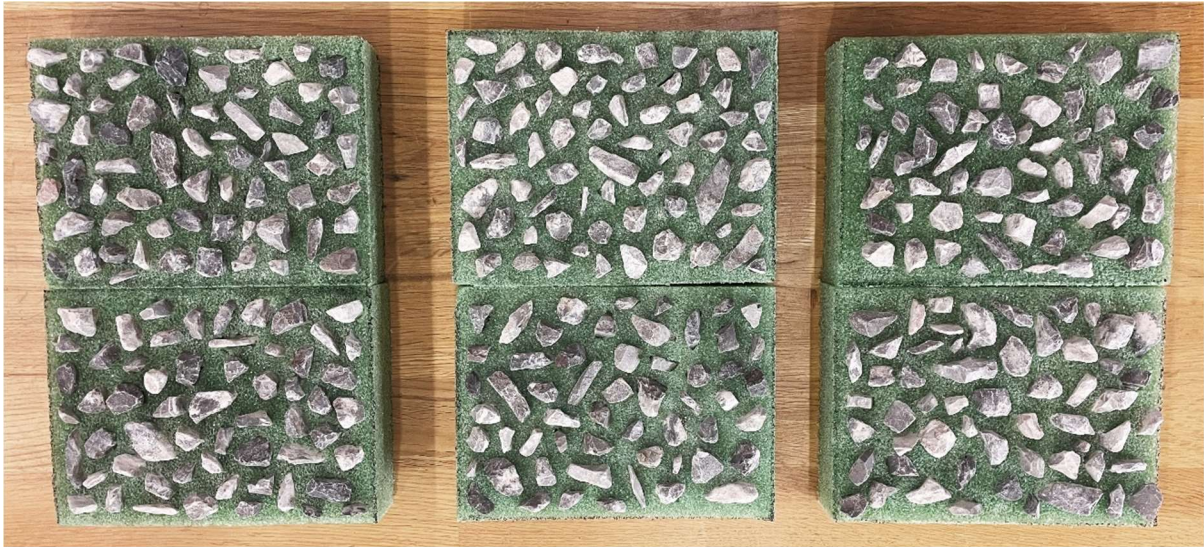
All specimens were cast on their sides with smooth top and bottom testing surfaces created from concrete form-boards. In instances of cold joint interface specimens, the central UHPC section was initially cast with texture molds placed at the interface locations. This approach avoids potential moisture migration issues and the subsequent weakening of UHPC at interface locations. Curing procedures followed a standard procedure, including a minimum of 3 days of moist curing before removing the interface molds. At a later date, the outer SCC sections of cold-joint specimens were cast, along with both sets of BiFluid specimens. With UHPC being cast first, the Exposed Aggregate interface is impossible to achieve through traditional exposure methods due to the absence of coarse aggregate in the UHPC matrix. Instead, crushable foam with partially-depressed pieces of coarse aggregate in the foam were used to simulate an exposed aggregate interface, shown in Figure 3.6. All cold-joint interface textures were placed such that the amplitude of the texture was centered at 2.75 inches from each other (2.625 inches from the outer edges).

**Figure 3.6:** *Exposed aggregate interface molds for direct shear specimens*

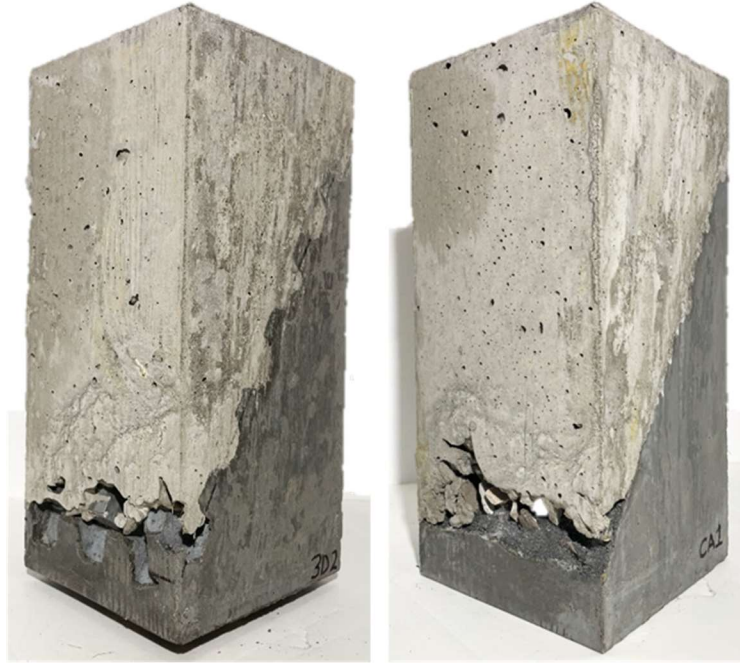
A subset of the cold-joint specimens exhibited a challenge during the SCC casting process within the acute angle of the formwork. This difficulty caused an area of incomplete consolidation in the Exposed Aggregate and 3D Trapezoidal sets despite a 22-inch flow for the SCC, depicted in Figure 3.10. Consequently, it was deduced that the textural protrusions impeded the SCC from achieving full consolidation within this specific section. Additional procedures were taken after testing to document and account for this defect, see Section 3.4.2.

**Figure 3.10:** *Unconsolidated areas of slant shear specimens*

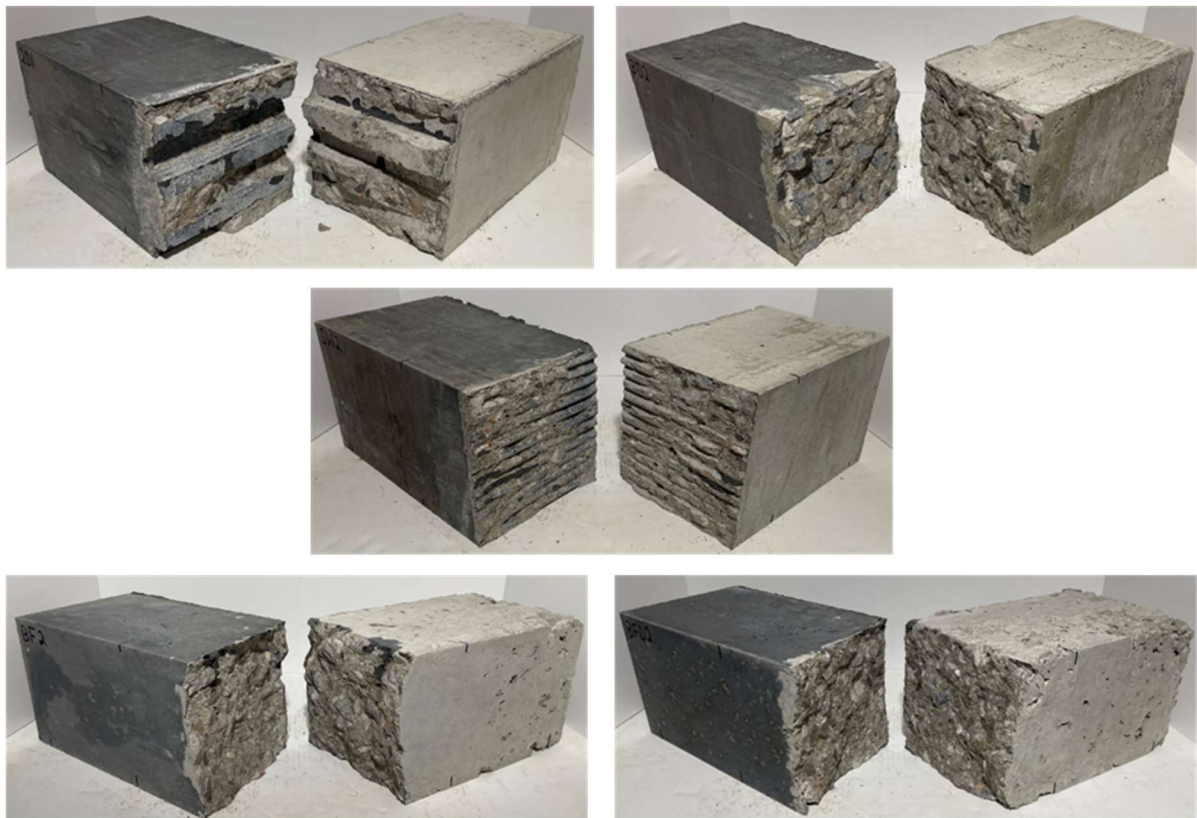
In the context of the BiFluid and BiFluid with Divider sets, the typical failure patterns were characterized by rupture planes within the SCC, near the interface, at approximately one inch from the UHPC section. Conversely, for the cold-joint specimens, failure occurred predominantly at the interface, with small amounts of residual SCC bonded to the UHPC. It was observed that the bonding between the SCC and UHPC predominantly occurred in the recesses or between protrusions of the UHPC surface. Figure 3.12 depicts these details and the representative failure modes for each interface set.

**Figure 3.12:** Typical MOR failures for each interface type<sup>3</sup>

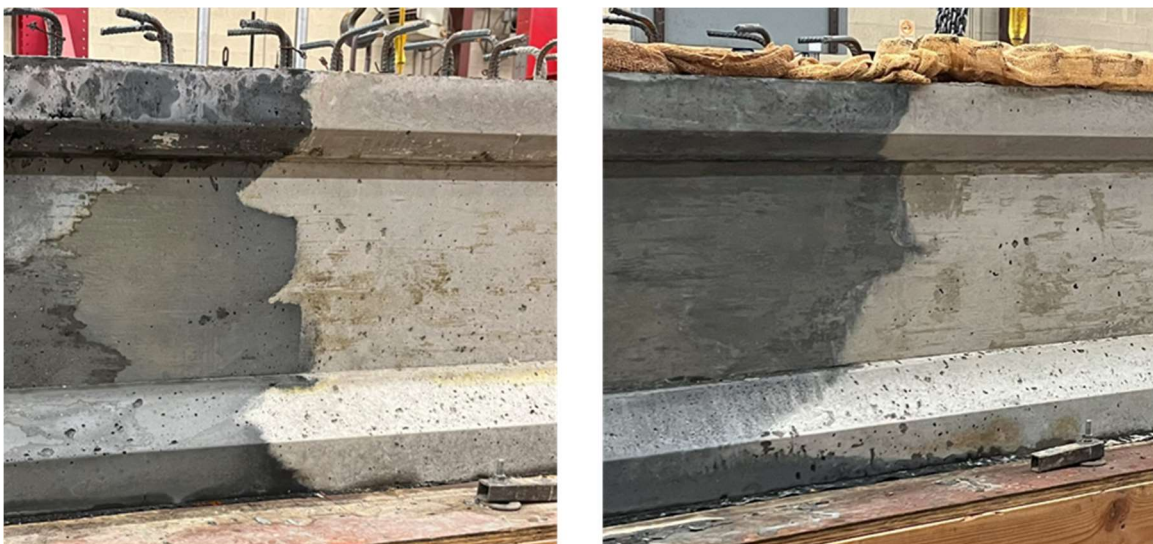
caused challenges in creating uniform contact with the SCC at the interface, resulting in an appearance of SCC extending beyond the interface location in the bottom bell. However, it was evident during casting that the UHPC indeed reached the interface directly beneath the web section, visible on the base of the bottom bell in Figure 4.7. Occasionally, deviations in the fill rate and interface alignment occurred when retrieving additional concrete to add to the forms. The depictions of the resulting interfaces for each of the BiFluid hybrid girders with these alignment details are visible in Figure 4.8.

**Figure 4.8:** Interface alignment of BiFluid girder no. 1 (left) and BiFluid girder no. 3 (right)

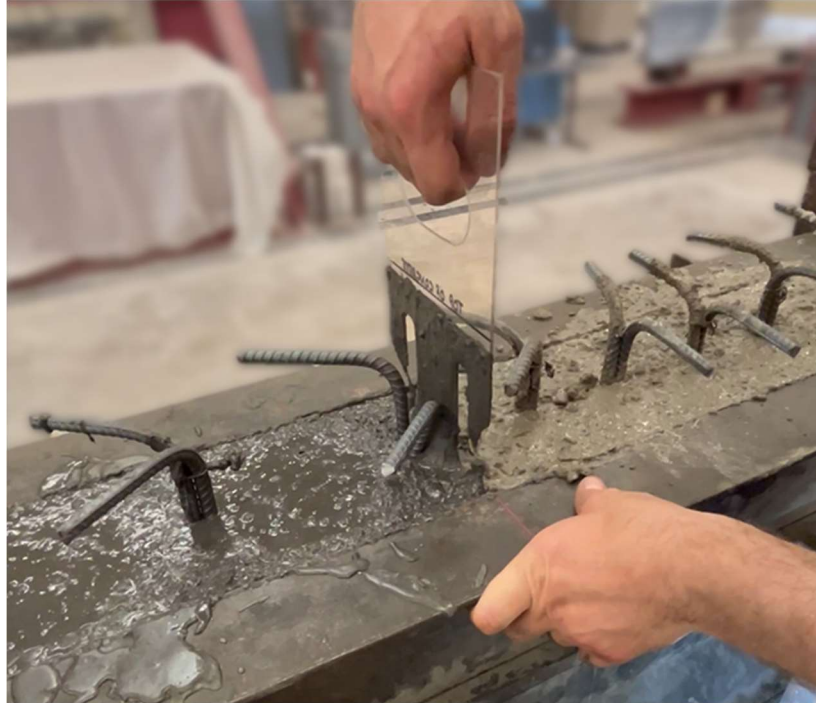
Similar issues concerning concrete passing the interface were also observed during the casting of BiFluid with Divider hybrid girders. Although the divider did facilitate improved placement and alignment of the interface, some of each concrete type passed the interface due to incomplete sealing of the section by the divider. Given the complexity of the girder's cross section and the type of formwork used in this program, a vertically extracted, transparent acrylic interface divider was implemented with a width matching the girder web. For this casting method, the same procedure used for the BiFluid casting was applied, then the divider was removed immediately by gently pulling it upward slowly and out of the concrete, as shown in Figure 4.9. The design for the divider was intended to facilitate vertical alignment of the interface at the web for the full depth of the section. However, due to non-uniformities in the formwork within the web section, openings at the bottom half of the web allowed UHPC to flow past the divider. Correspondingly, the absence of a full divider in the bottom bell gave casting results similar to the BiFluid girders, including the appearance of SCC flowing past the interface.

**Figure 4.9:** Removal of divider immediately after casting the second BiFluid with Divider girder

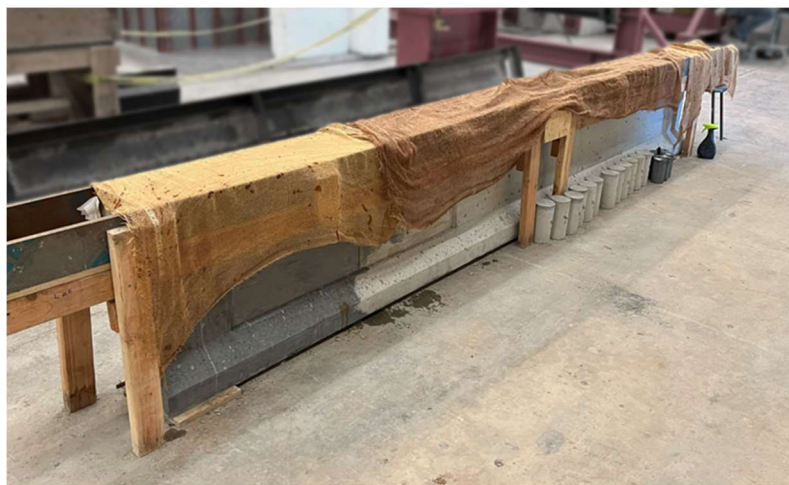
Once each girder section was completed, it was removed from the prestressing bed, and deck reinforcement and formwork were added. Longitudinal reinforcement was tied to the stirrups protruding from the top of the girder, and the deck formwork was assembled. The deck was cast using the same SCC employed for the hybrid girders. Workability of the concrete was not an issue for deck construction; therefore, the decks were cast immediately after the hybrid girders, except for the final hybrid girder deck, which was cast separately. The same curing procedure applied to the girder sections was also implemented for the deck, involving moist curing using wet burlap for three days, as depicted in Figure 4.11.

**Figure 4.11:** Moist curing of deck section of hybrid girder specimen using saturated burlap

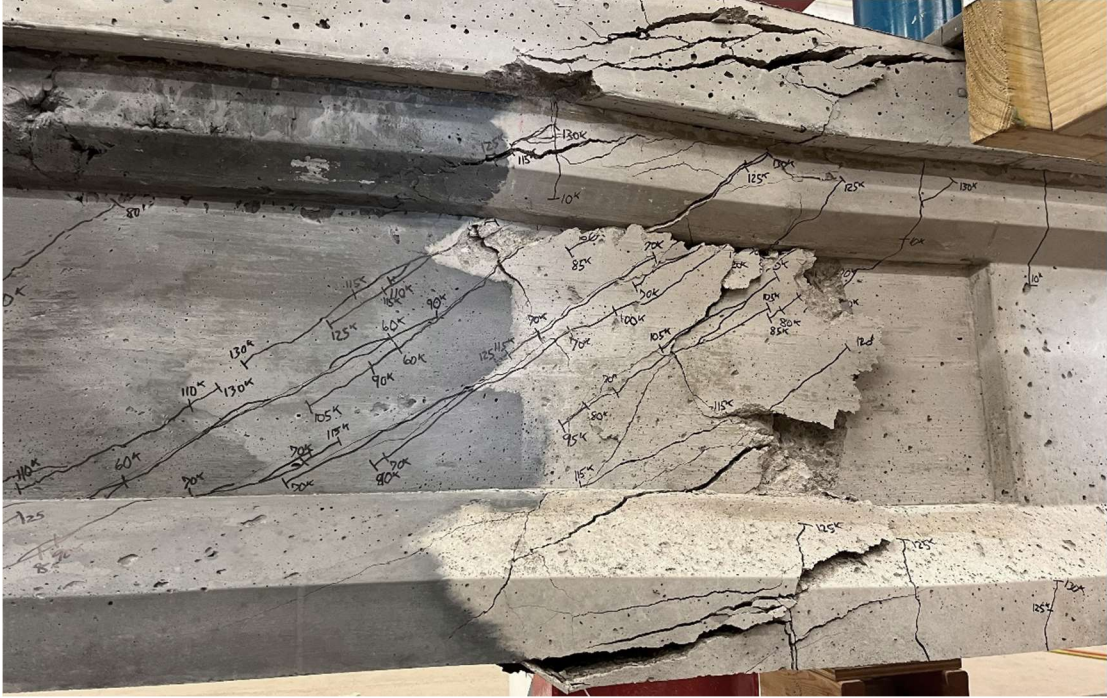
**Figure 4.15:** Failure of BiFluid hybrid girder no. 1

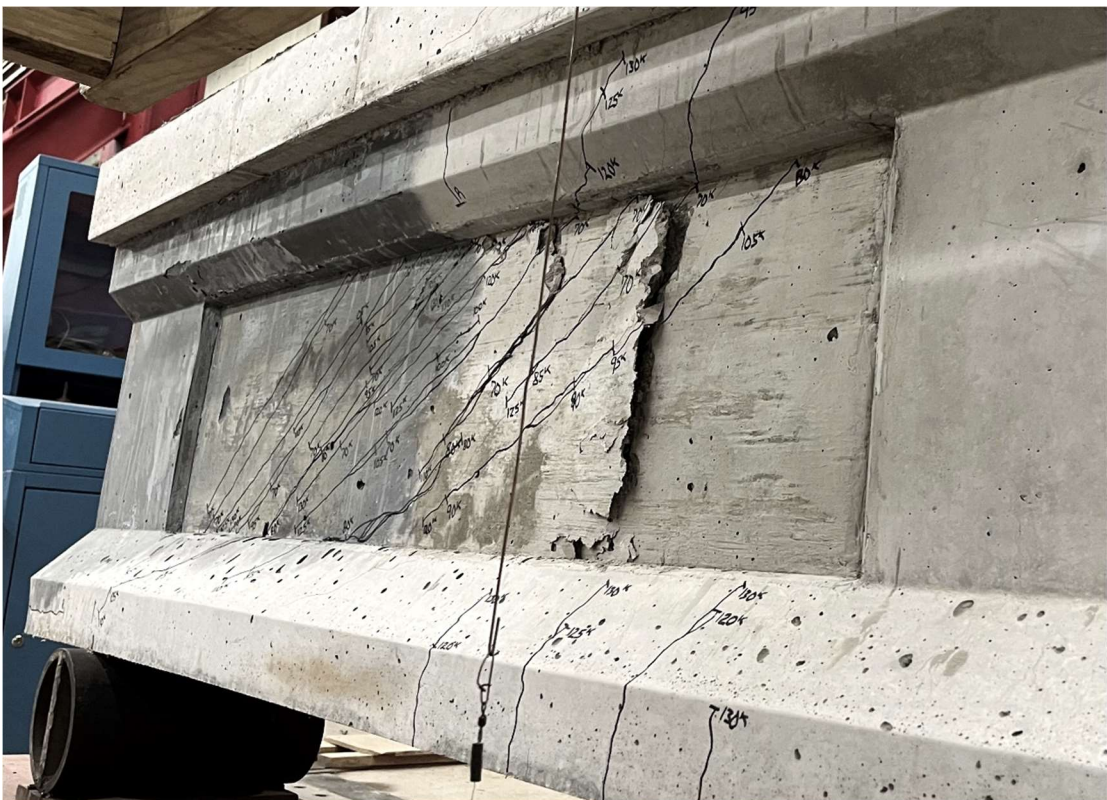
**Figure 4.16:** Failure of BiFluid hybrid girder no. 2

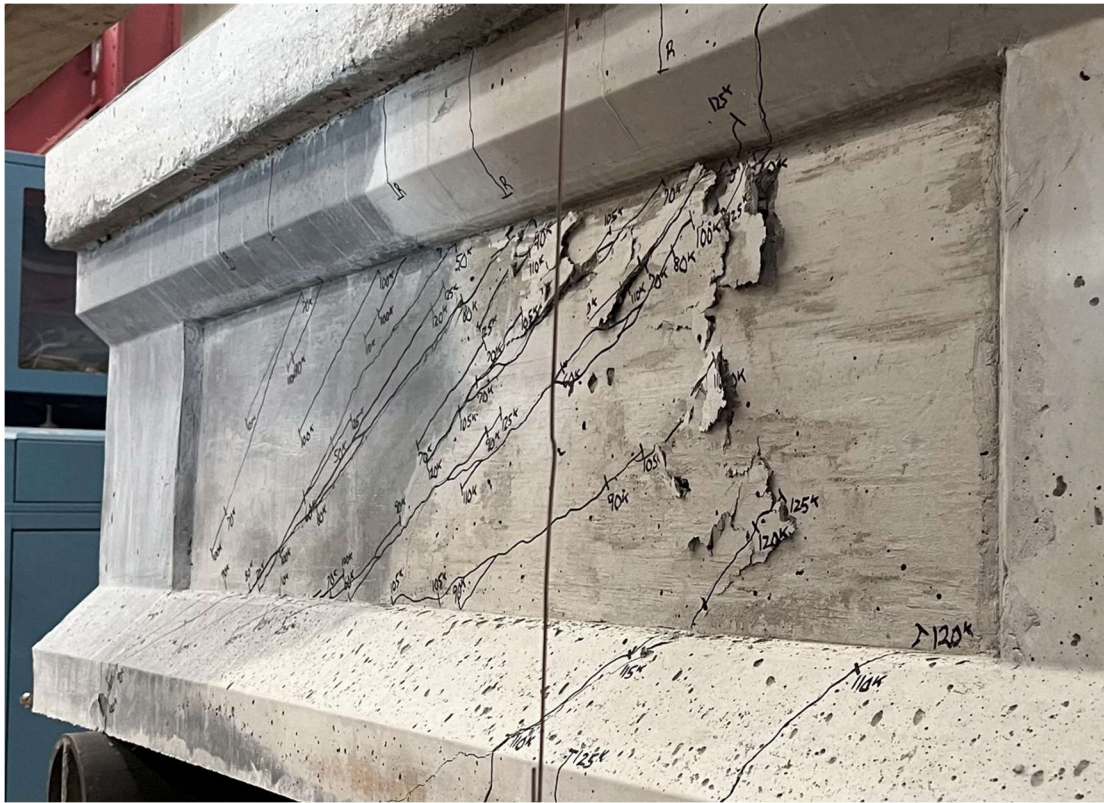
**Figure 4.17: Failure of BiFluid hybrid girder no. 3**

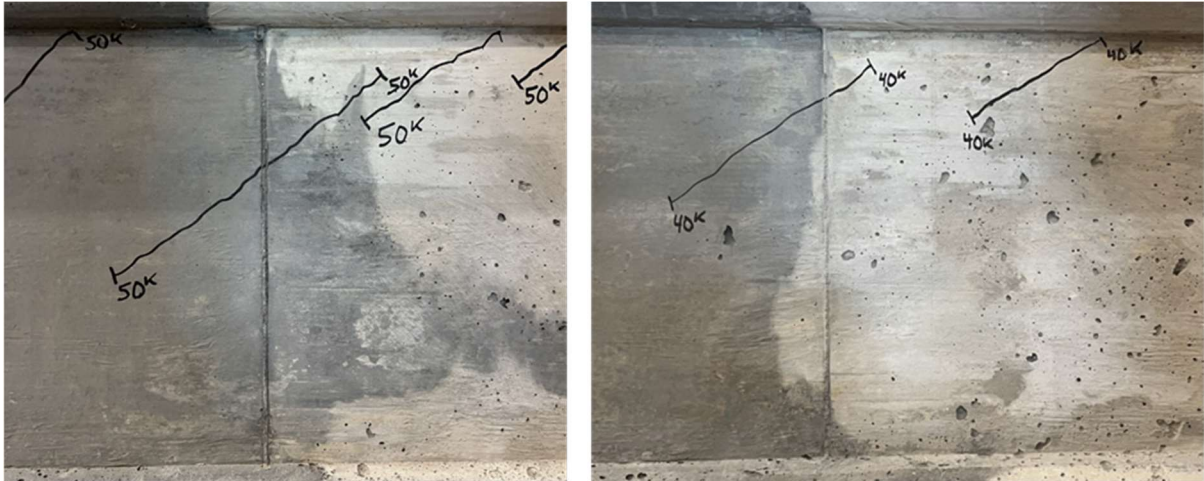
**Figure 4.19:** First cracks to propagate in BiFluid with  
Divider girder no. 1 (left) and no. 2 (right)

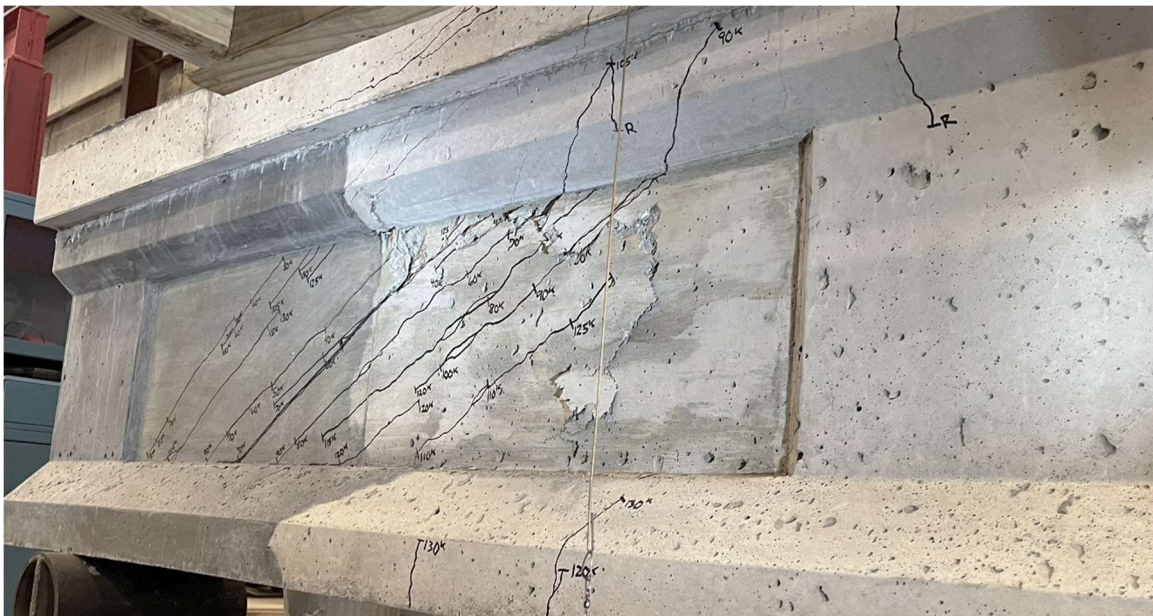
**Figure 4.21:** Failure of BiFluid with Divider hybrid girder no. 2

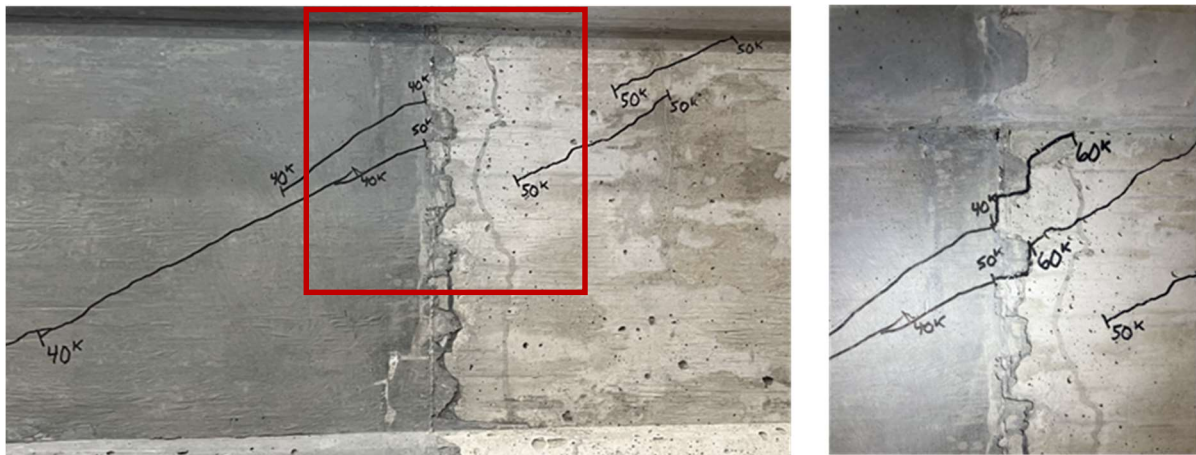
**Figure 4.23:** First cracks to propagate in 2D Trapezoidal hybrid girder no. 1 (left); further crack progression at the interface (right), photo taken of the region outlined in red

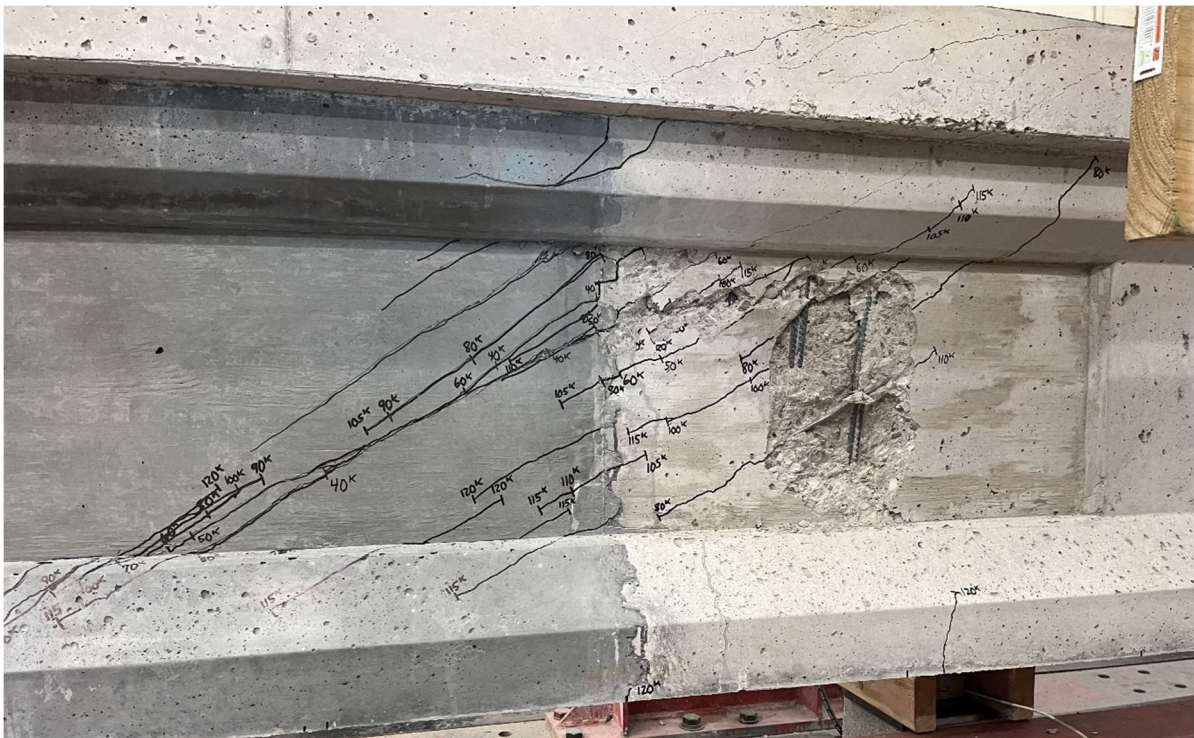
**Figure 4.26:** Failure of 2D textured hybrid girder no. 1

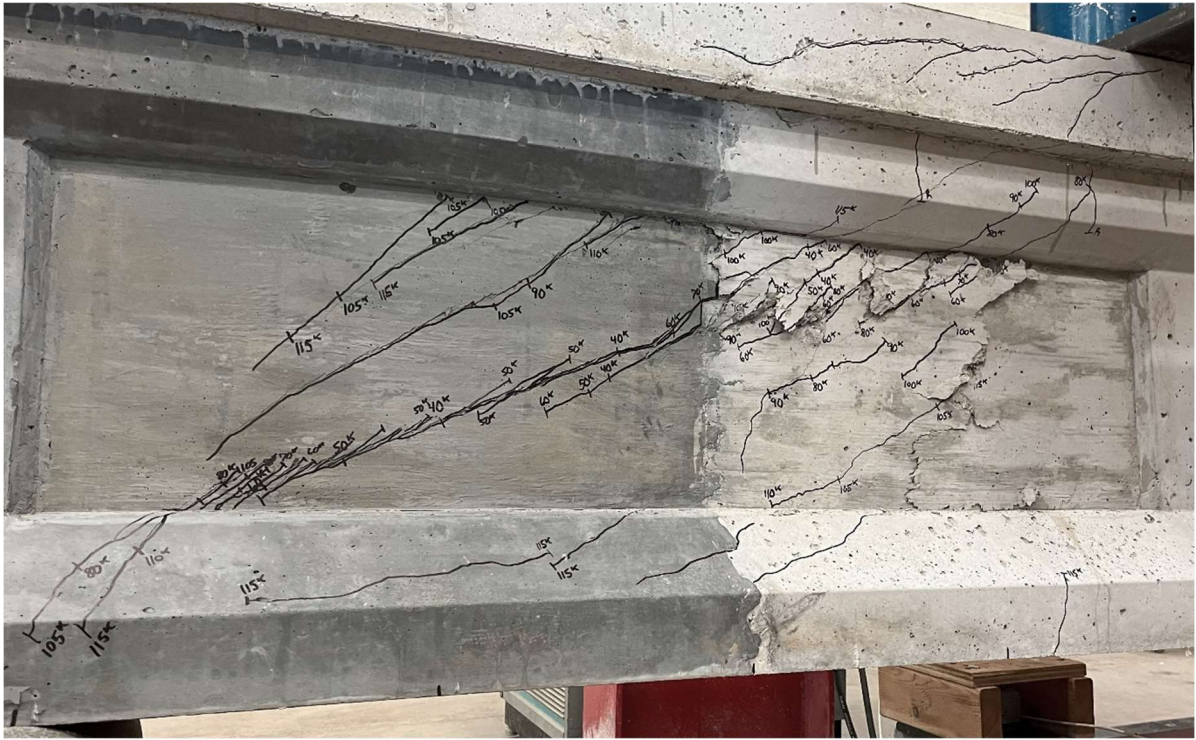
**Figure 4.27:** Failure of 2D textured hybrid girder no. 2

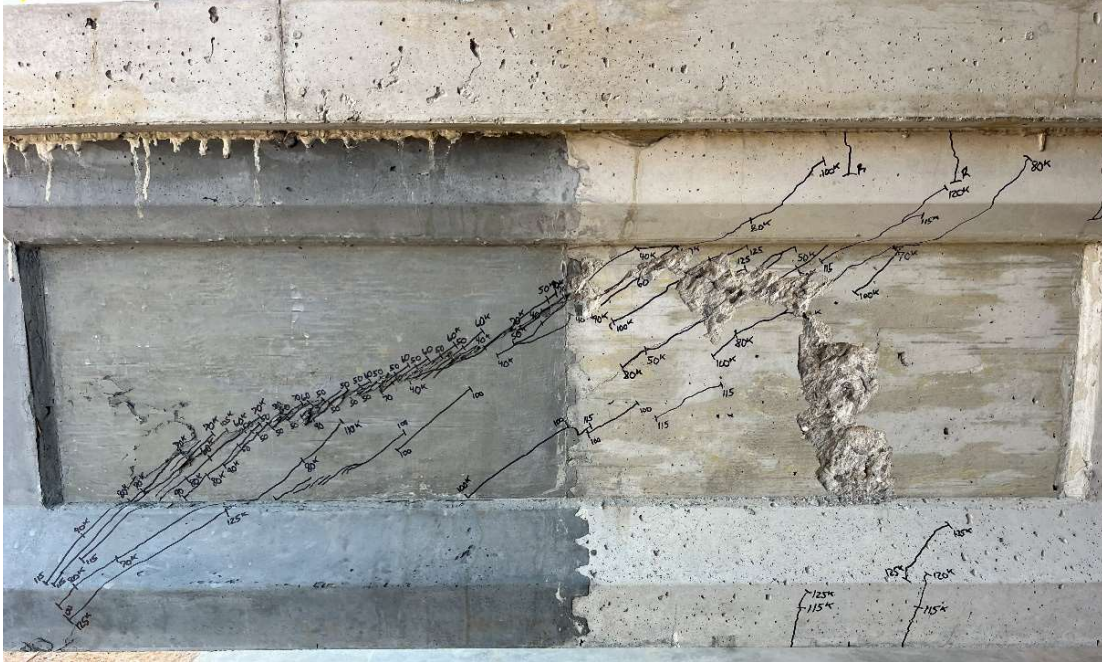
**Figure 4.29: Failure of 3D textured hybrid girder no. 1**

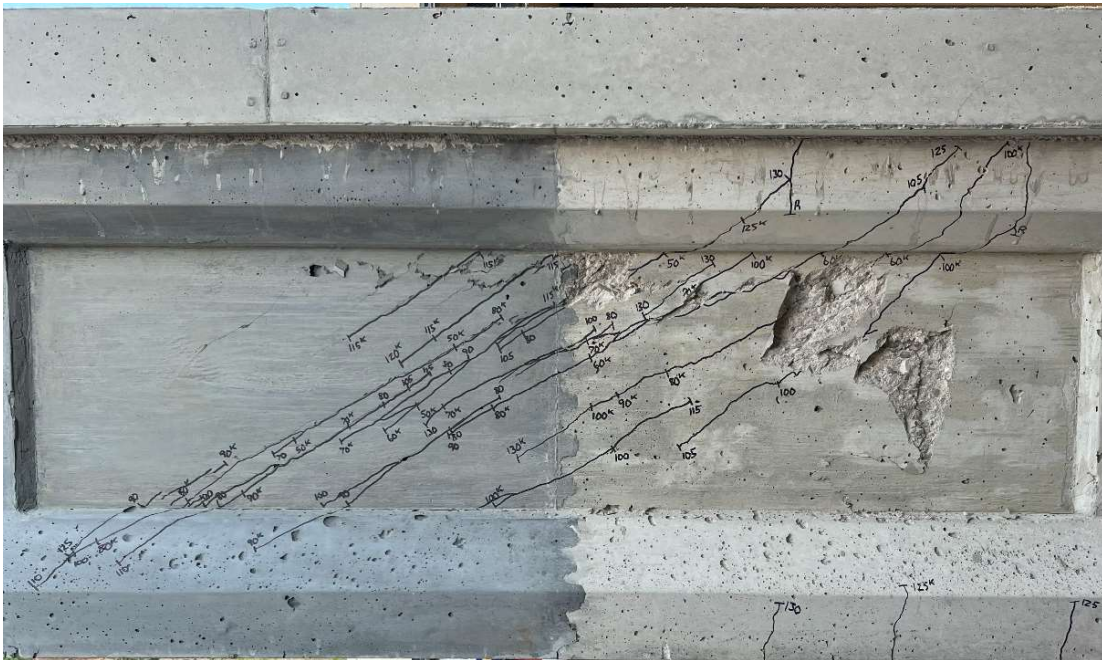
**Figure 4.30: Failure of 3D textured hybrid girder no. 2**

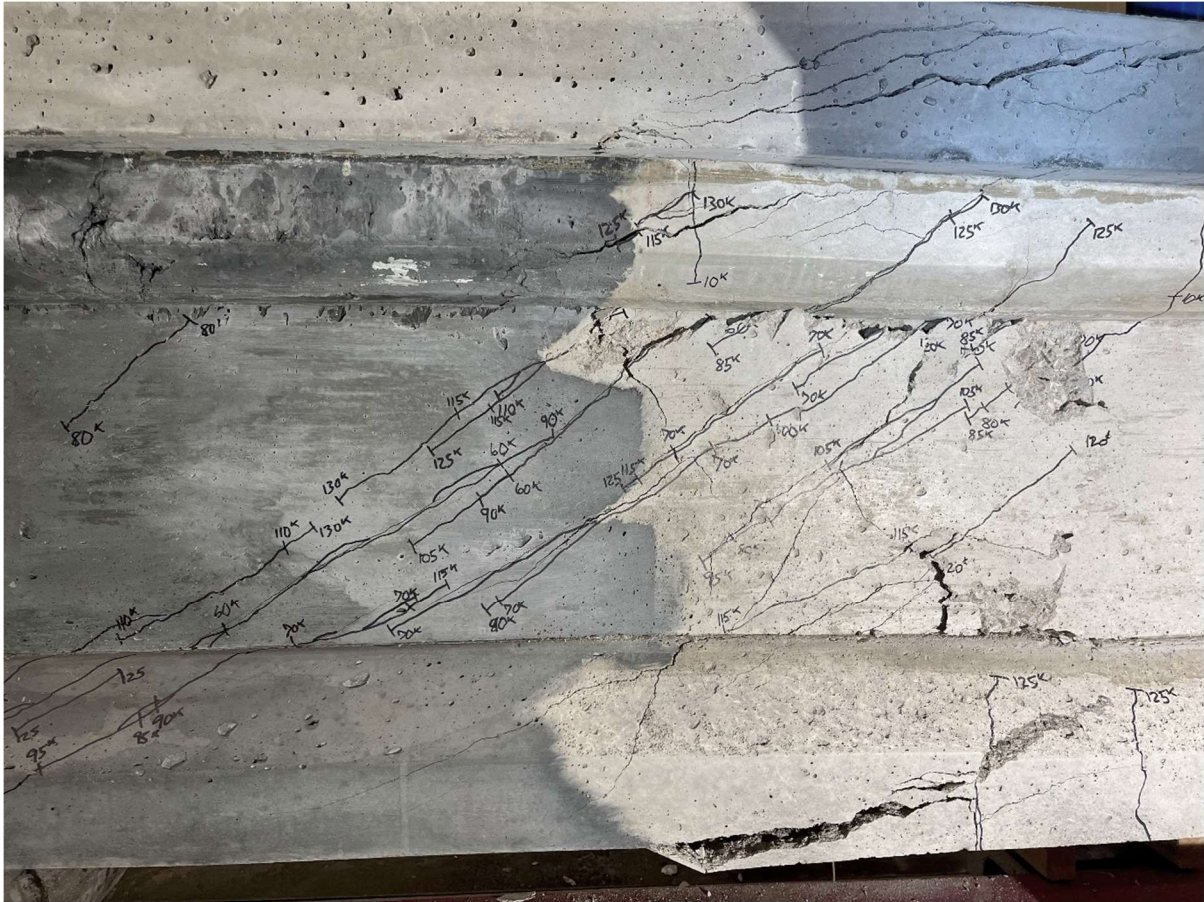
**Figure 6.1:** BiFluid Girder No. 1 cracking in the shear span up to failure

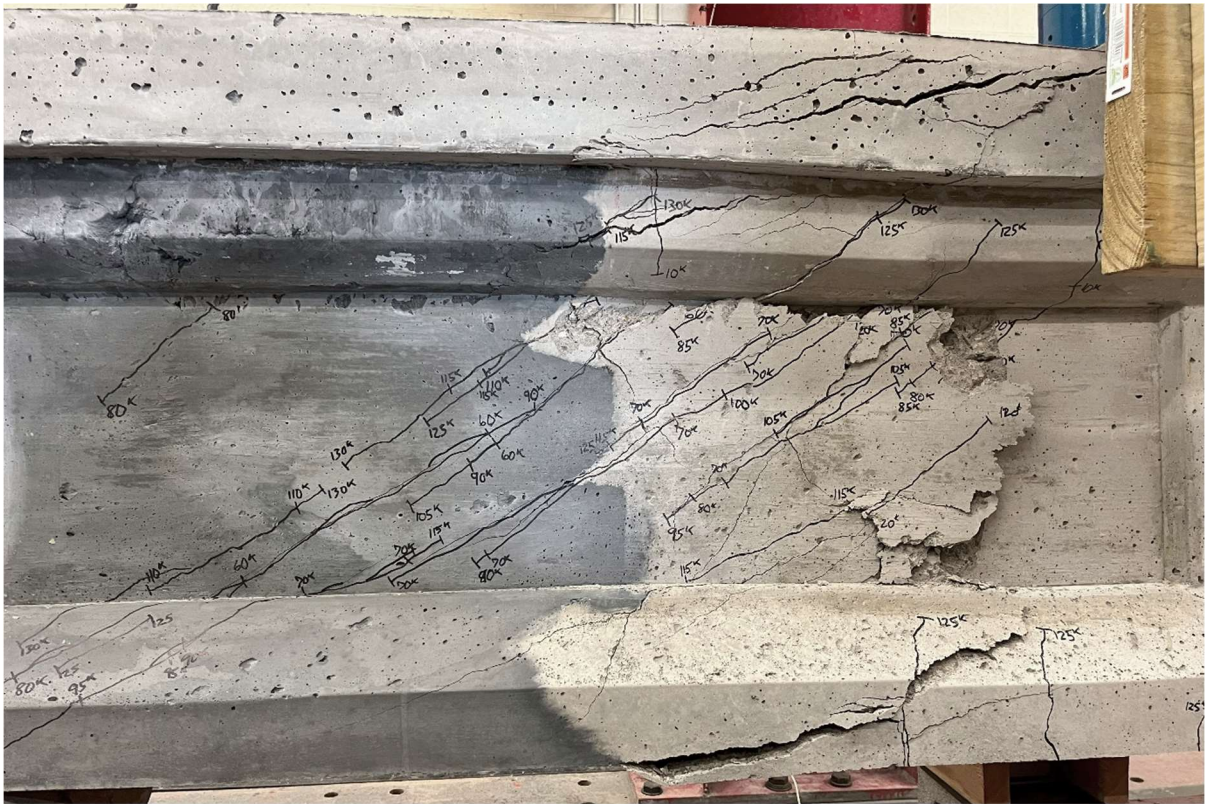
**Figure 6.2:** Post-failure damage observed in BiFluid Girder No. 1

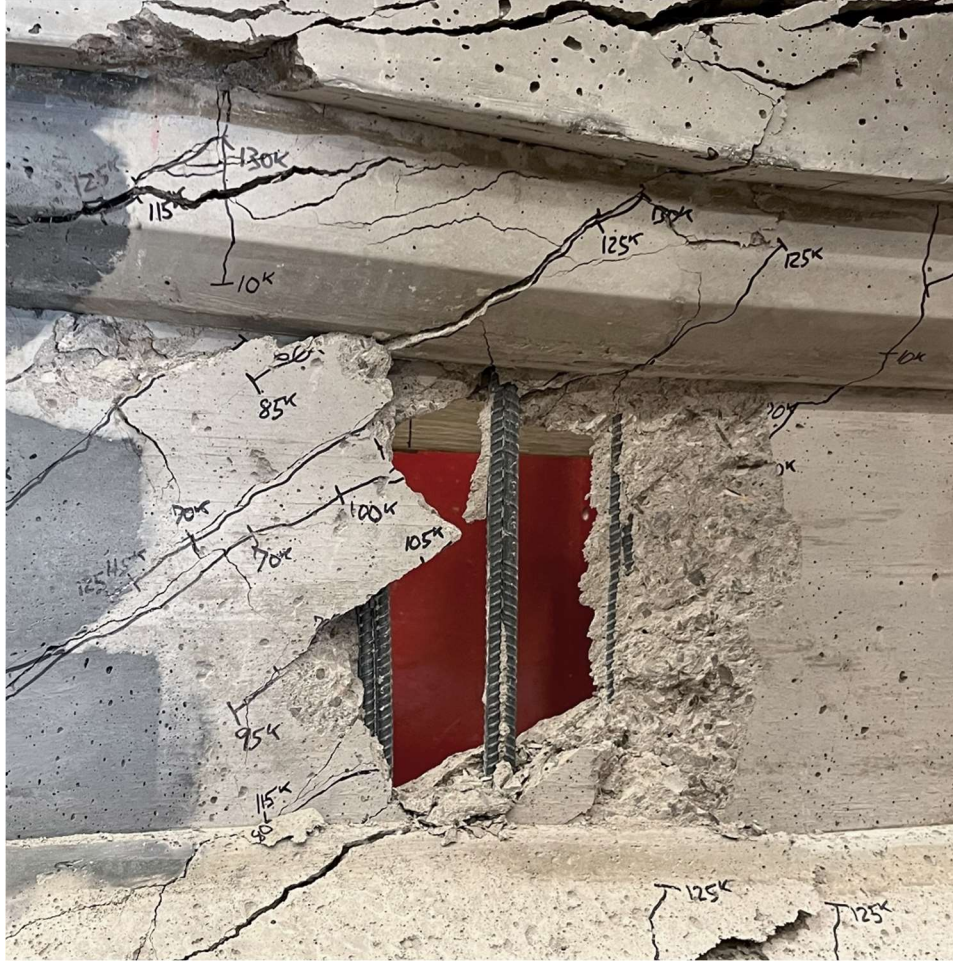
**Figure 6.3:** *BiFluid Girder No. 1 failure after additional displacement featuring a vertical, “V-shaped” failure along the vertical reinforcing in the web.*

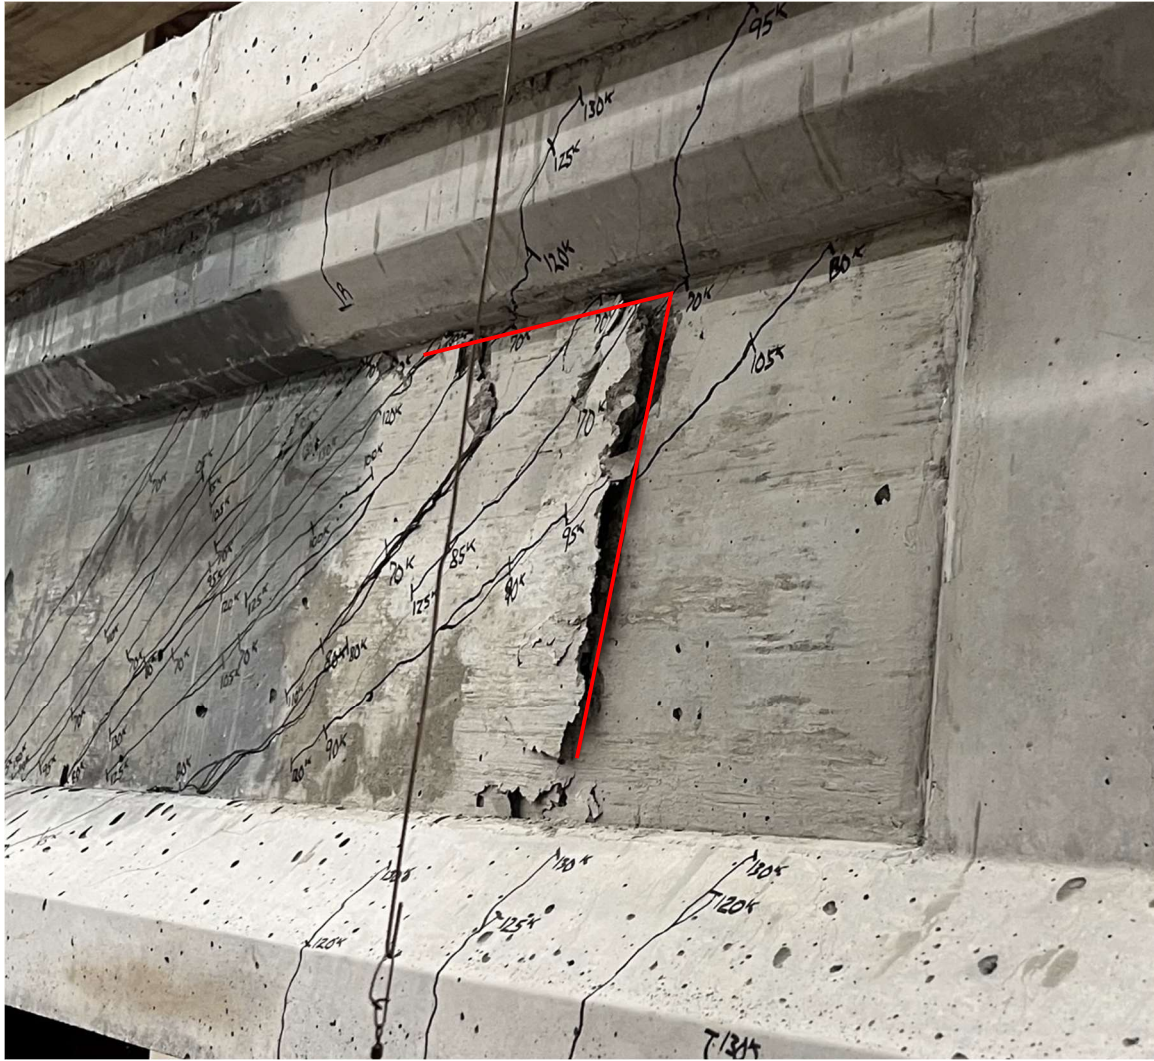
**Figure 6.5:** Highlighted failure path of web failure in BiFluid Girder No. 2

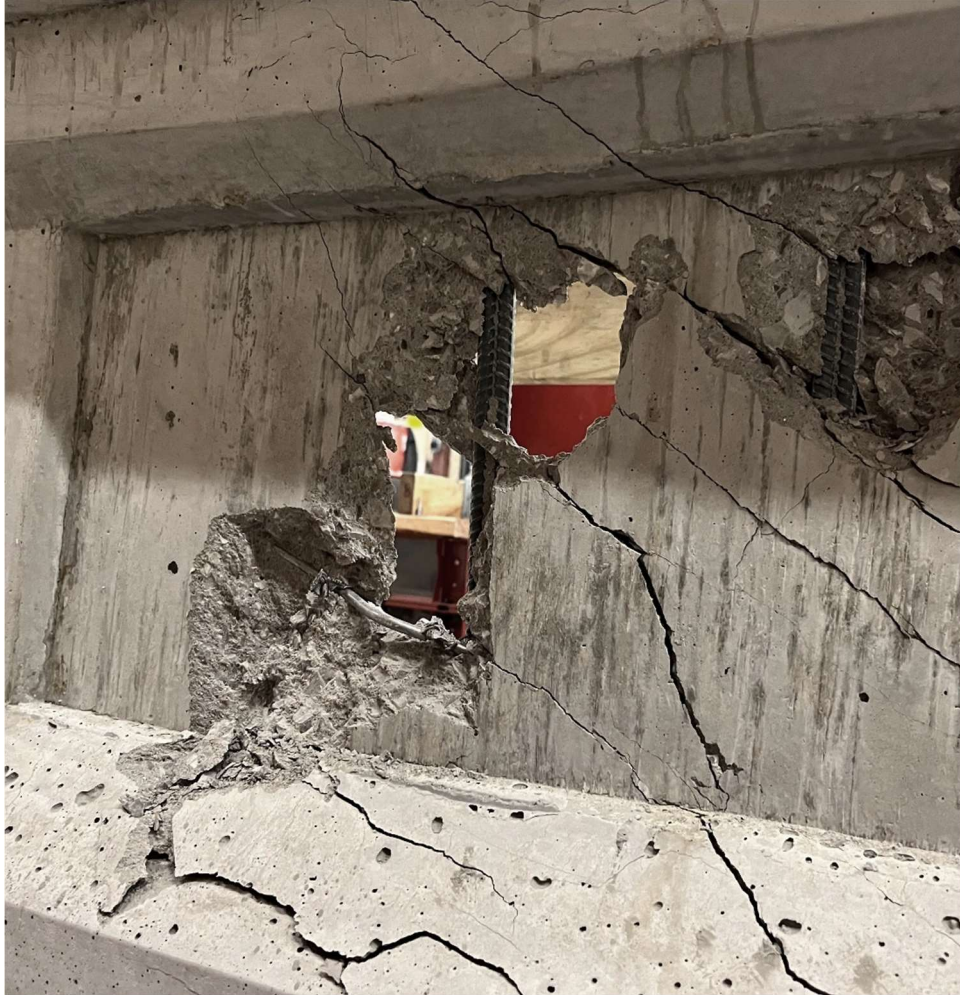
**Figure 6.6:** *Observed, post-testing failure in BiFluid Girder No. 2 on the unmarked face (backside of girder)*

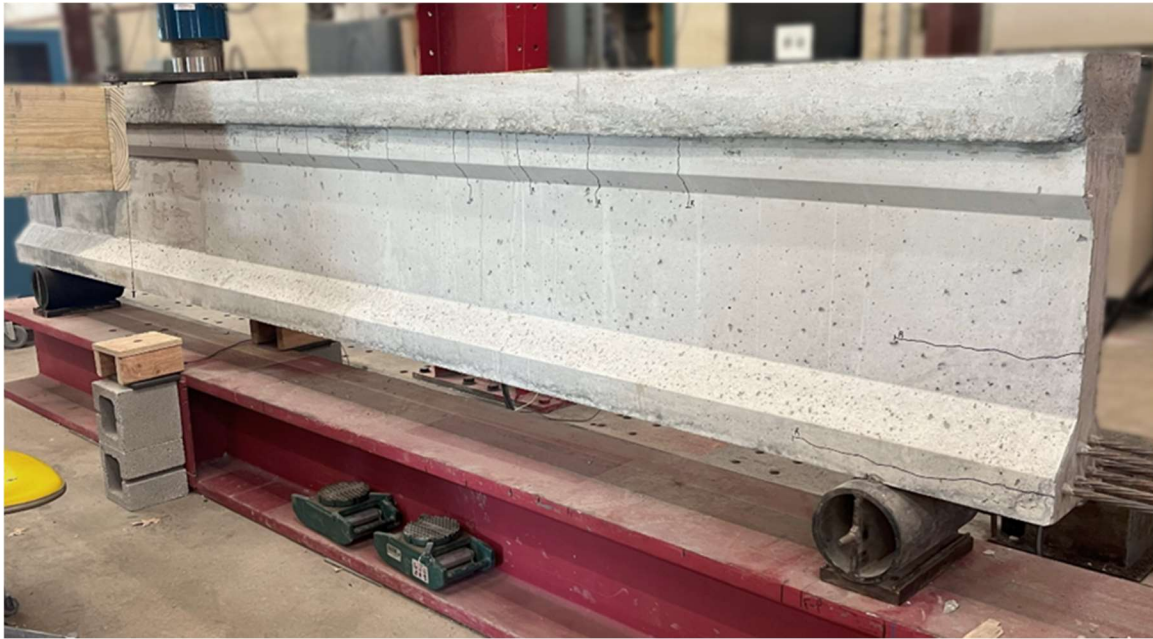
**Figure 6.7:** *Observed cracking due to prestressing forces in BiFluid Girder No. 3*

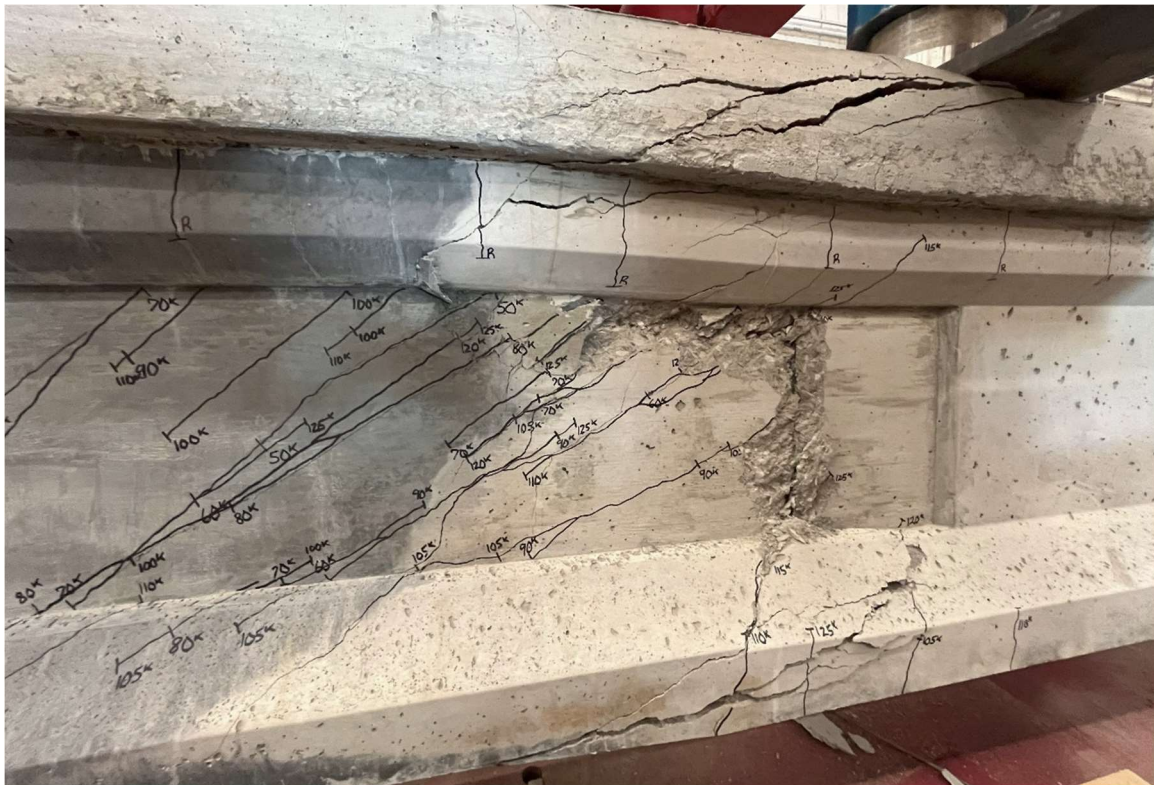
**Figure 6.9:** Observed, post-testing failure in BiFluid Girder No. 3

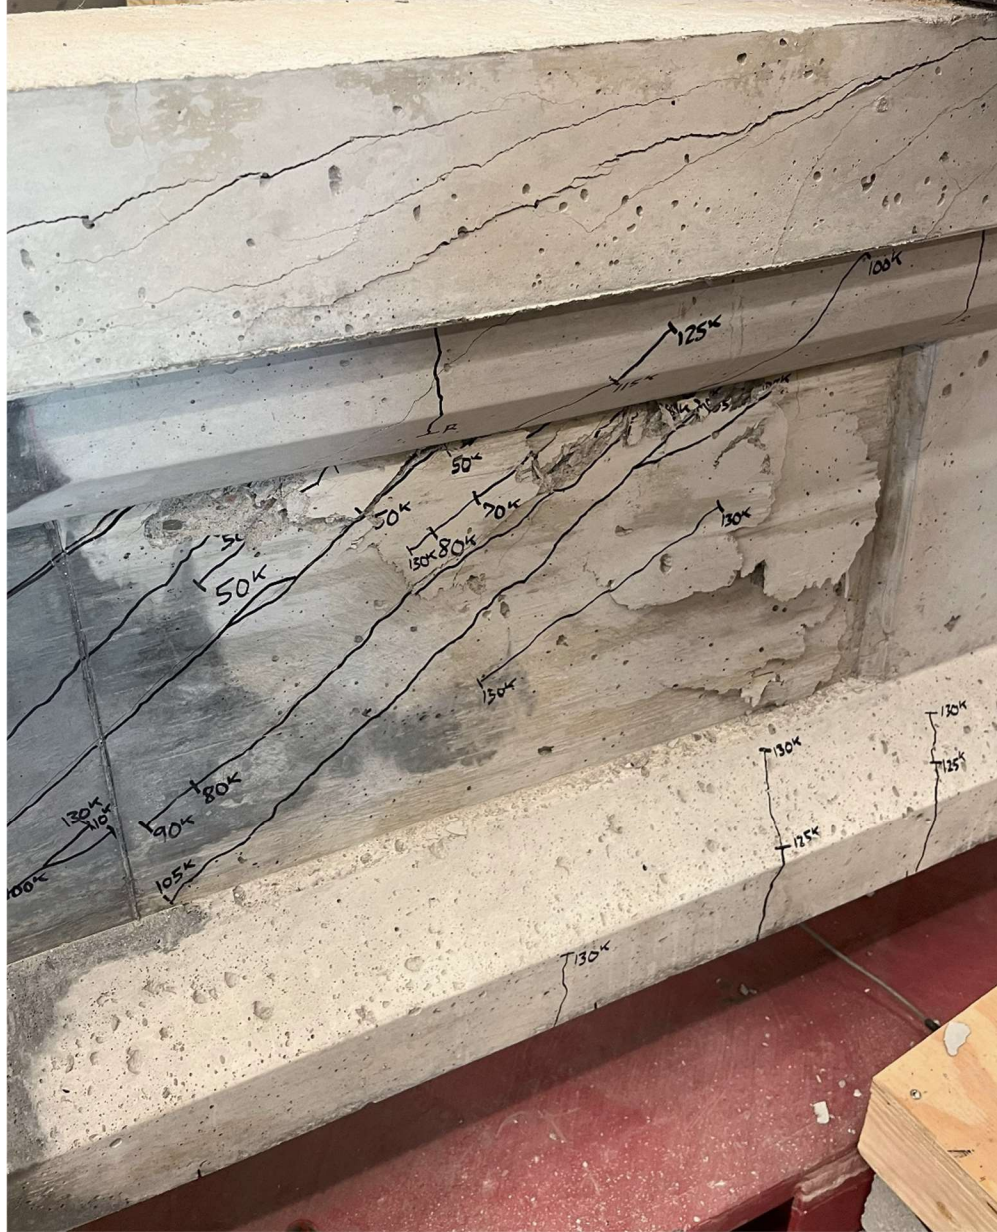
**Figure 6.12:** Observed, post-testing failure in BiFluid with Divider Girder No. 1
