END-REGION EVALUATION OF HYBRID ULTRA-HIGH-PERFORMANCE  
CONCRETE/CONVENTIONAL CONCRETE PRESTRESSED GIRDERS

A DISSERTATION  
SUBMITTED TO THE GRADUATE FACULTY  
in partial fulfillment of the requirements for the  
Degree of  
DOCTOR OF PHILOSOPHY

By  
JACOB G. CHOATE  
Norman, Oklahoma  
2023

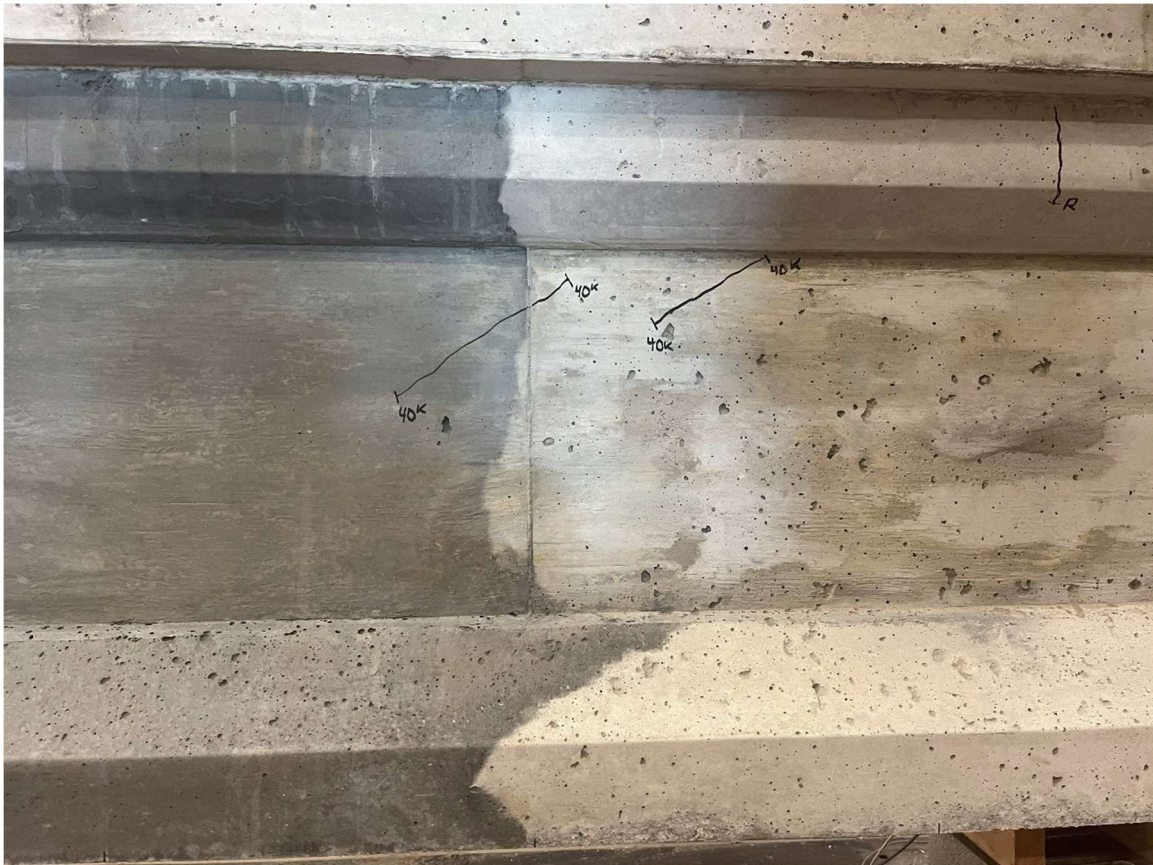
**Figure 6.13:** Initial cracks observed in BiFluid with Divider Girder No. 2

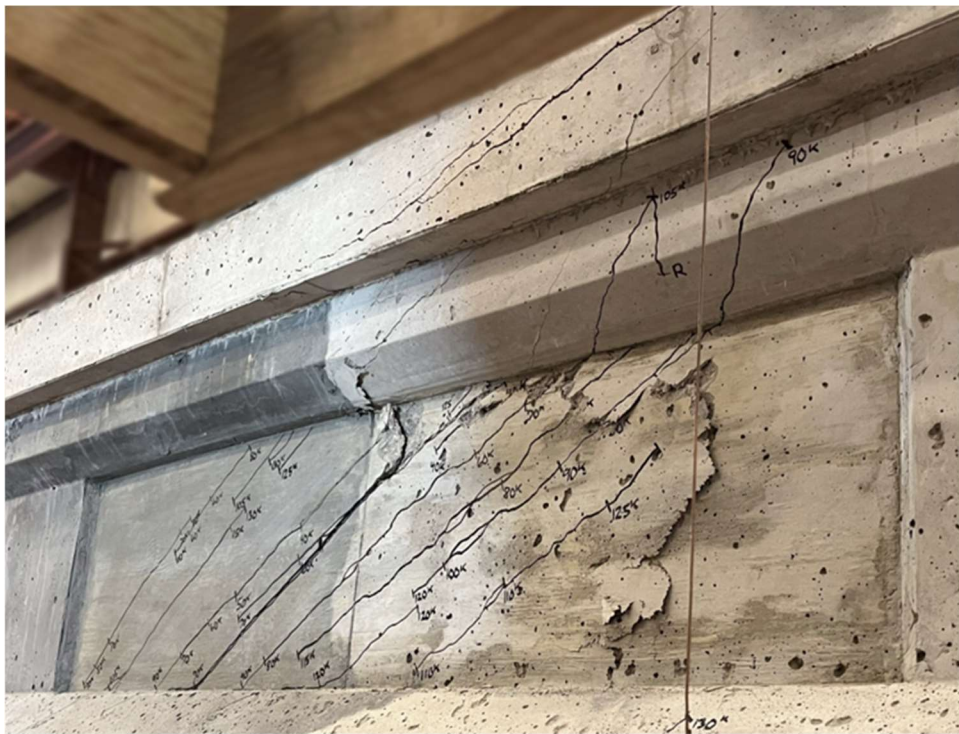
**Figure 6.14:** Observed, post-testing failure in BiFluid with Divider Girder No. 2

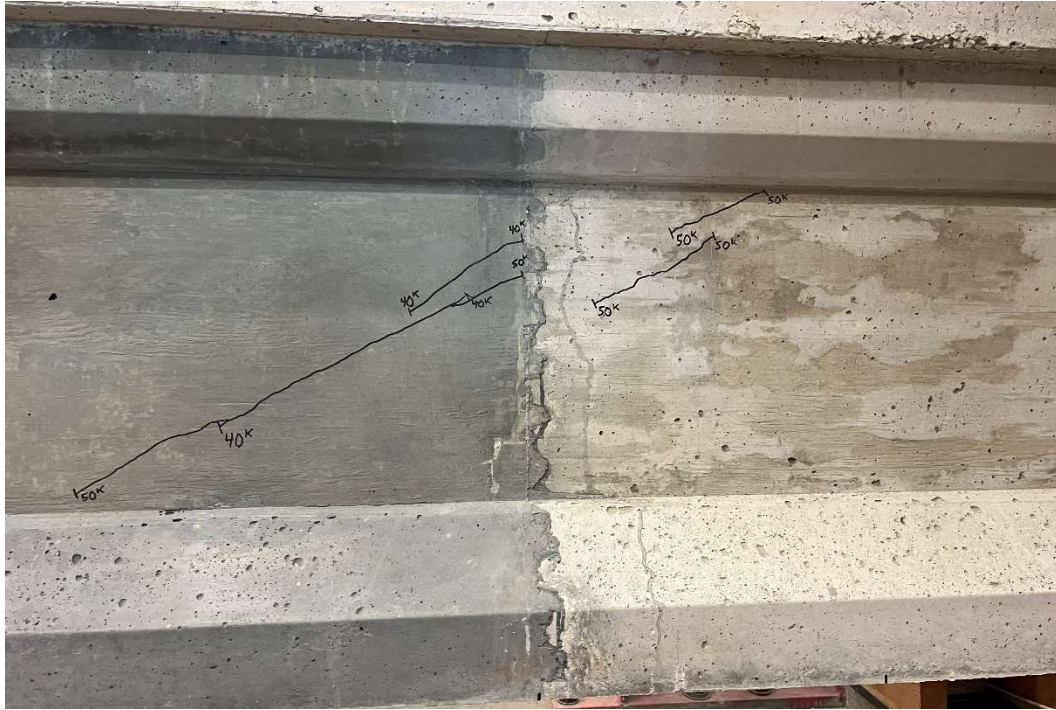
*Figure 6.16: Initial cracks observed in 2D Trapezoidal Girder No. 1*

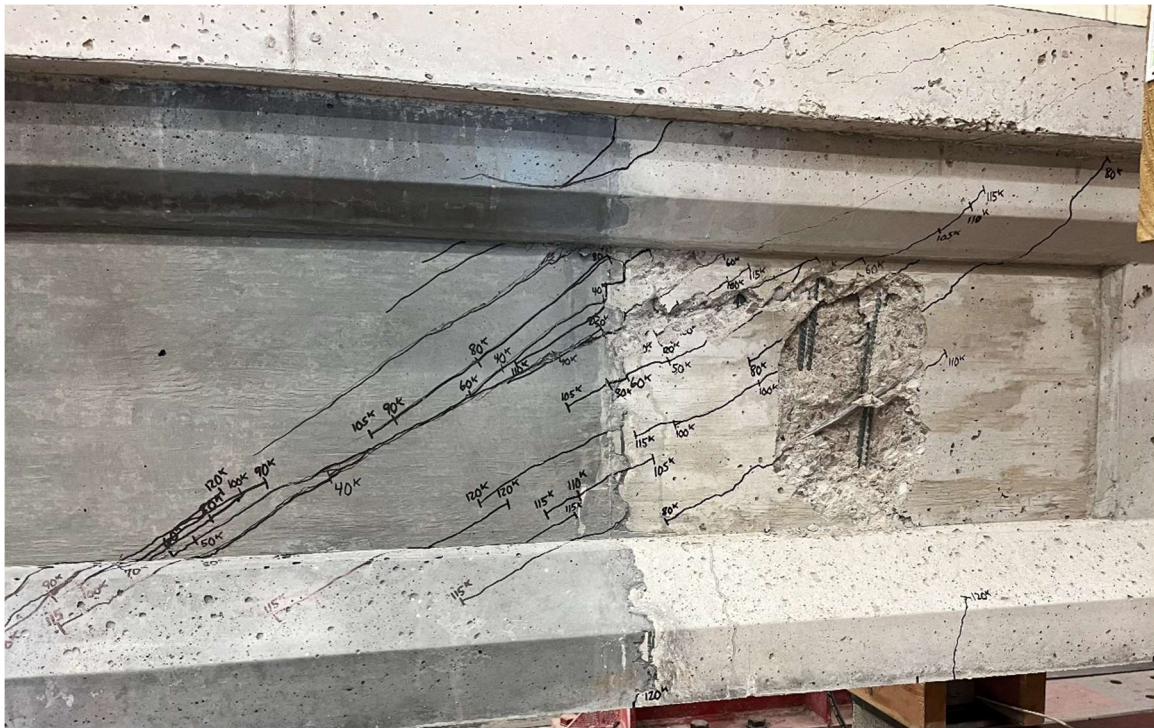
**Figure 6.19:** Observed, post-testing damage in 2D Trapezoidal Girder No. 1

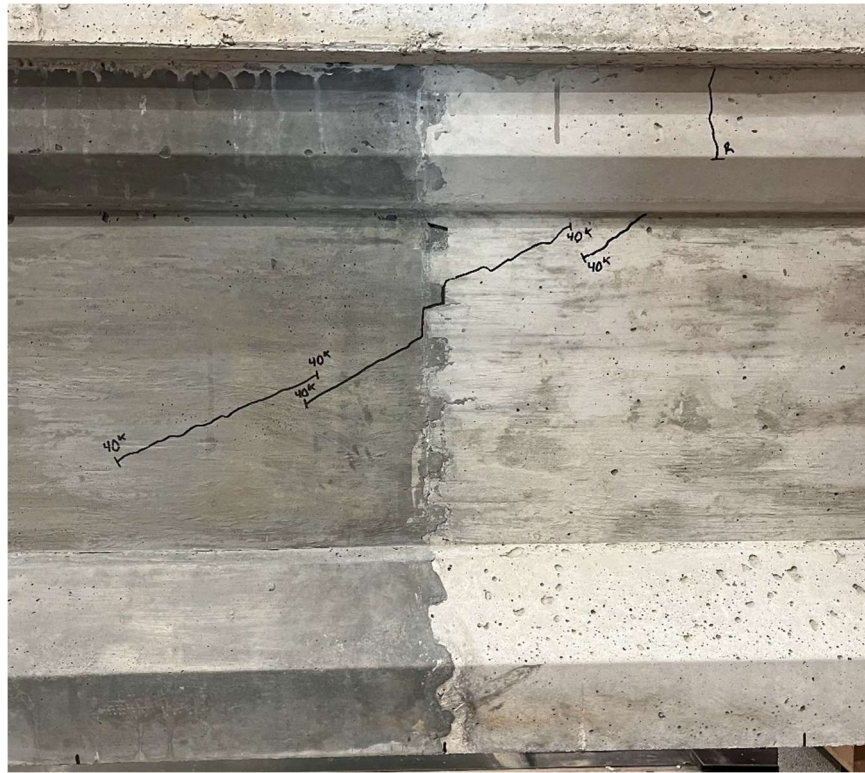
**Figure 6.20:** Initial cracks observed in 2D Trapezoidal Girder No. 2

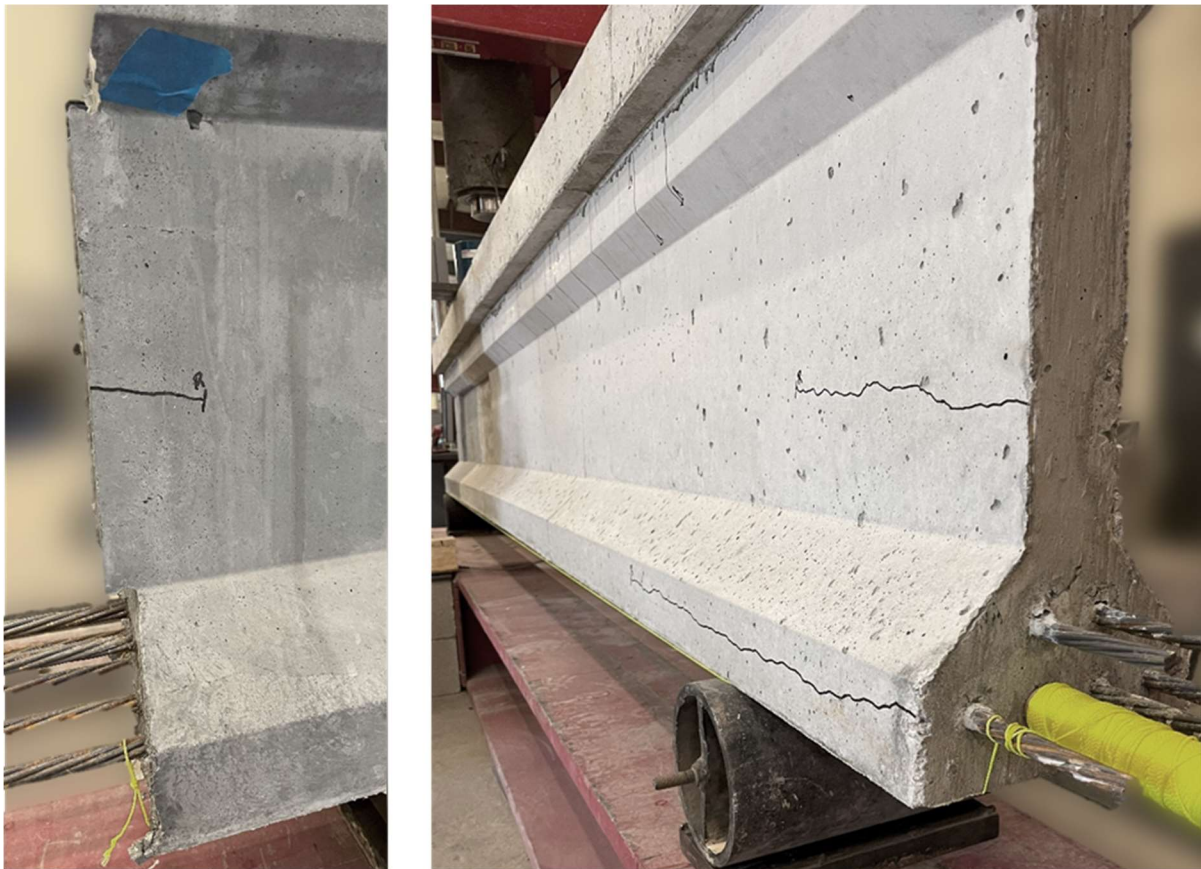
**Figure 6.22:** Observed cracking due to prestressing forces in 3D Trapezoidal Girder No. 1 (UHPC end (left) and SCC end (right))

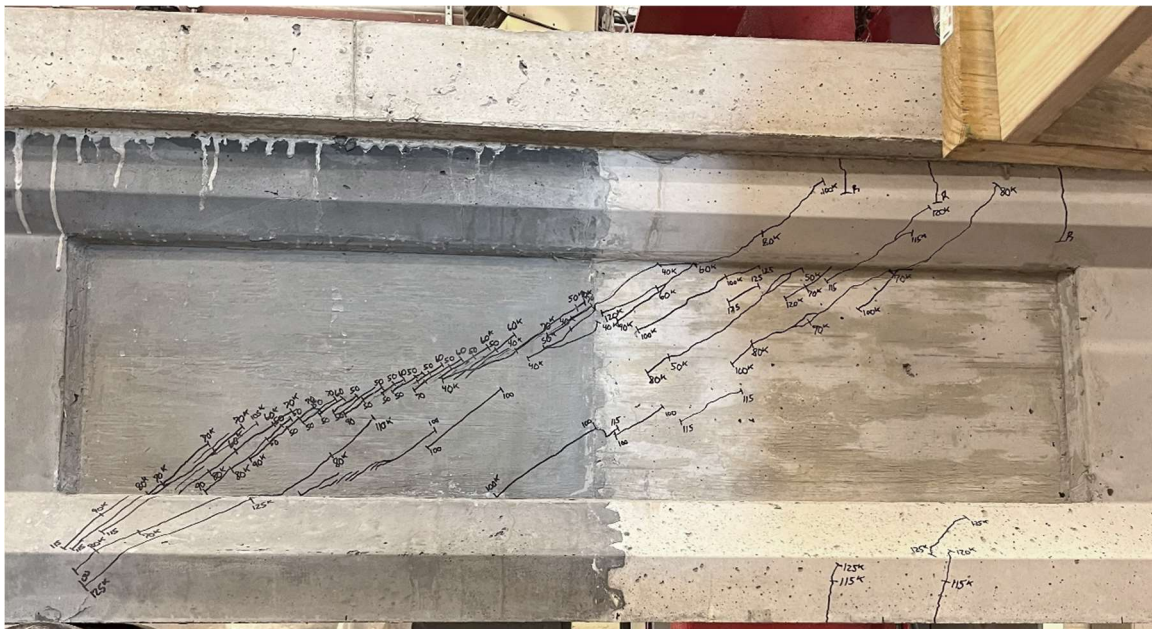
**Figure 6.24:** Crack propagation at 125 kips applied load for 3D Trapezoidal Girder No. 1

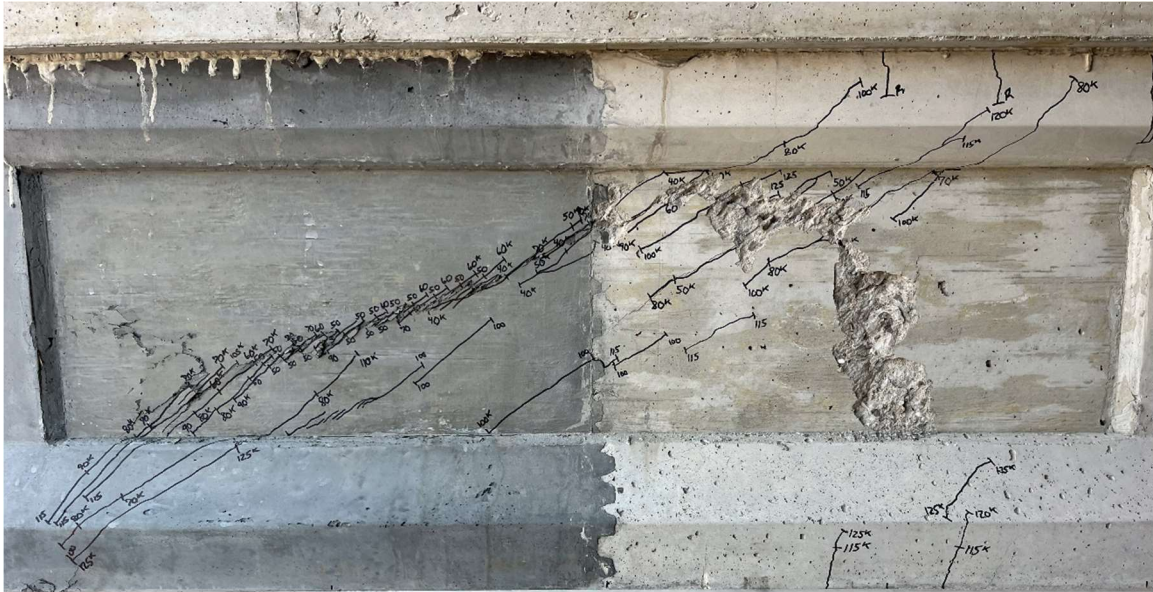
**Figure 6.25:** Observed, post-testing damage in 3D Trapezoidal Girder No. 1

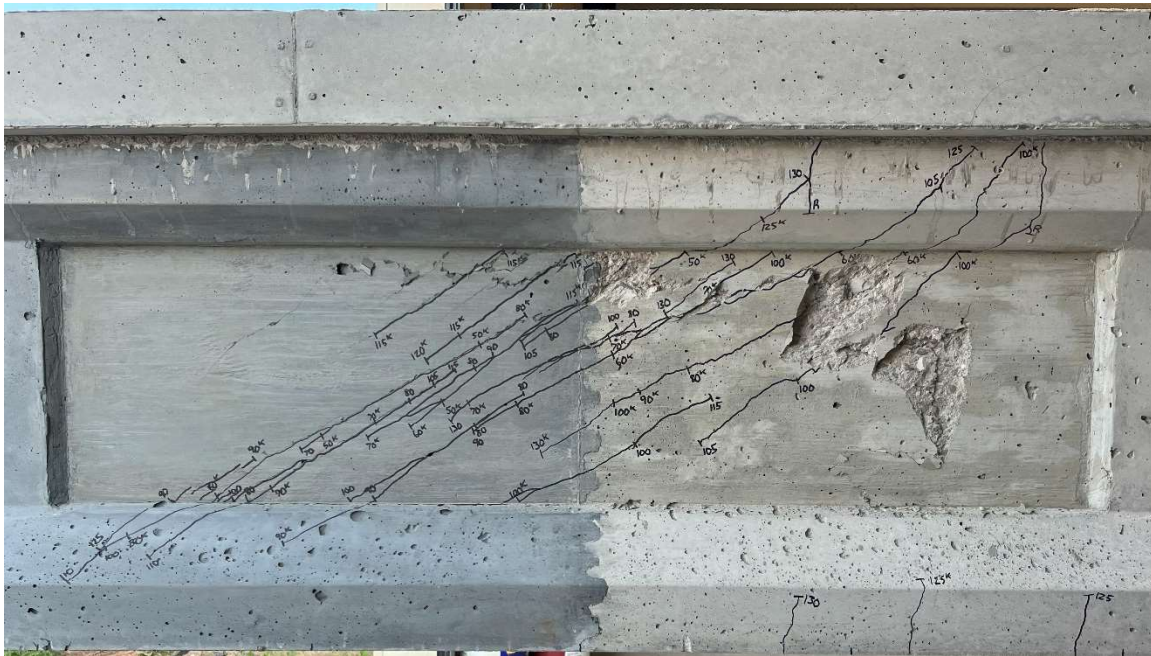
**Figure 6.27:** Observed, post-testing damage in 3D Trapezoidal Girder No. 2

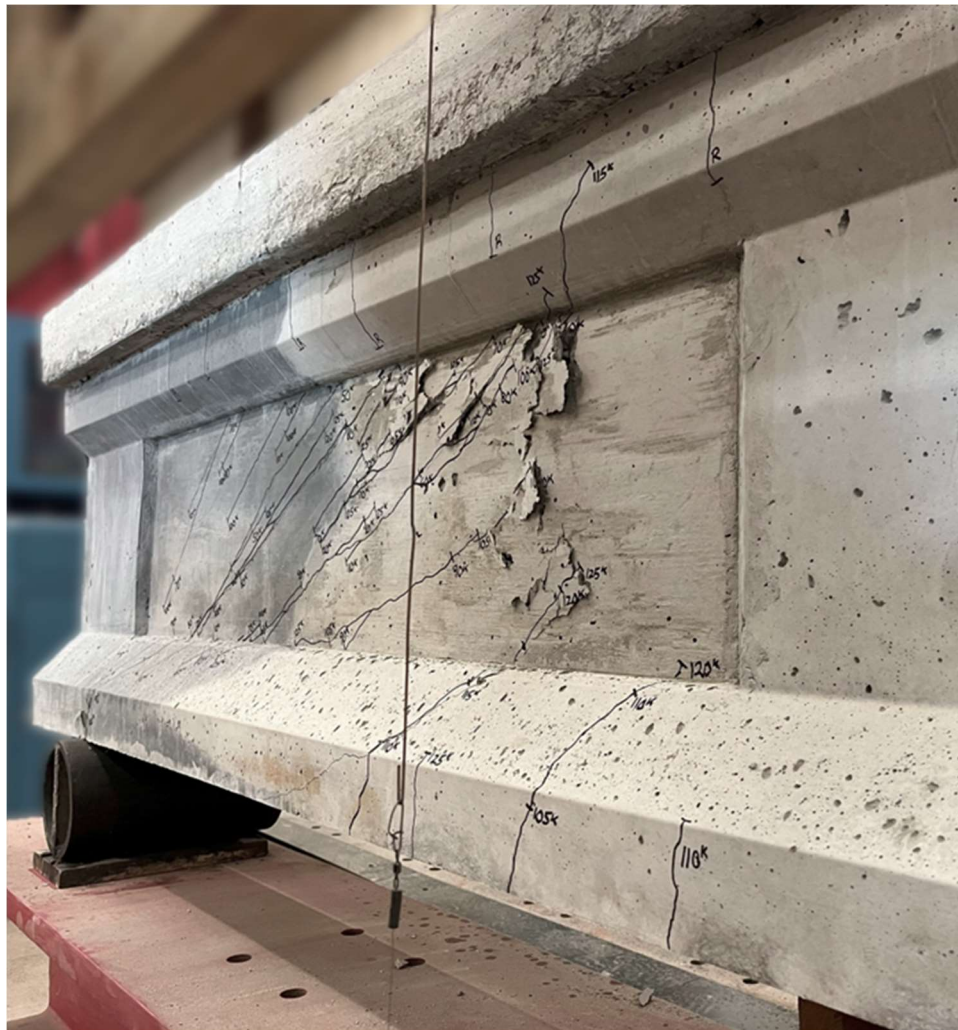
**Figure 6.29:** Representative extents and location of web crushing behavior in hybrid girder specimens<sup>6</sup>
