**FINAL REPORT ~ FHWA-OK-21-03**

# **EVALUATION OF ULTRA-HIGH- PERFORMANCE CONCRETE FOR USE IN BRIDGE CONNECTIONS AND REPAIR**

**School of Civil Engineering and Environmental Science  
The University of Oklahoma  
Norman, Oklahoma**

**February 2020**

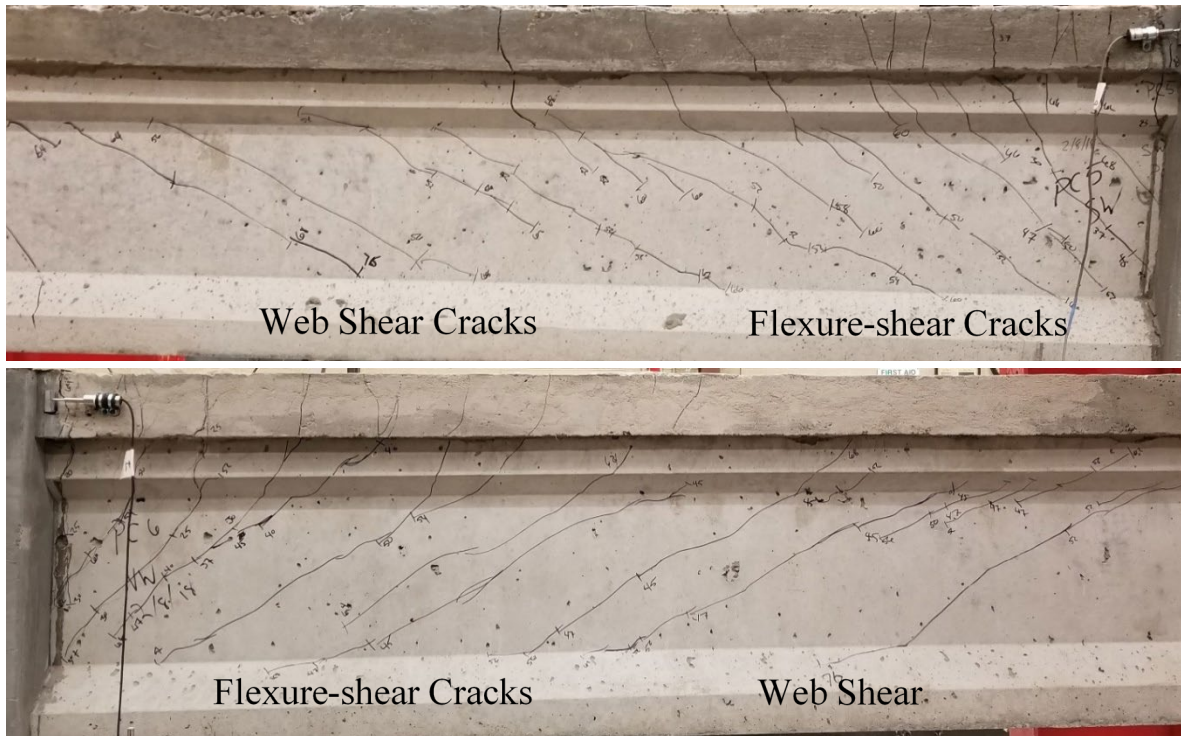
Figure 233. RC1-N girder with flexure-shear cracks and web shear cracks at failure (top) and RC1-S girder with flexure-shear cracks and web shear cracks at failure (bottom)

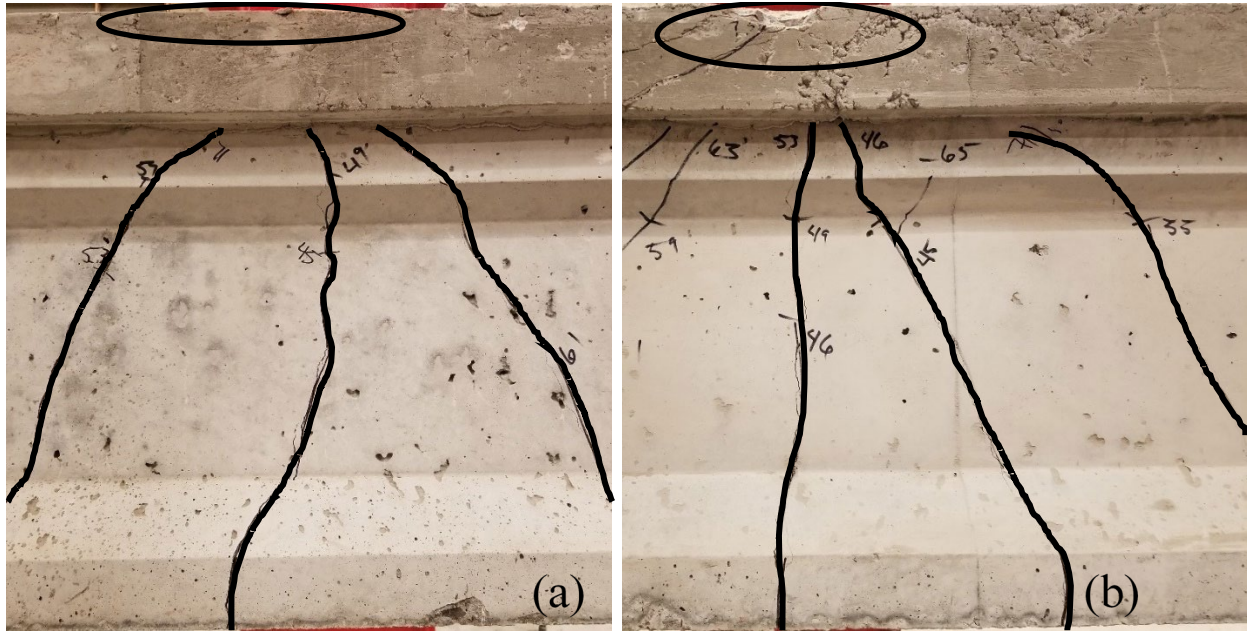
Figure 254. Final flexural cracking under the load point in the RC3-N (a) and RC3-S (b) girders are indicated by dark lines and concrete deck crushing is indicated by dark ovals.

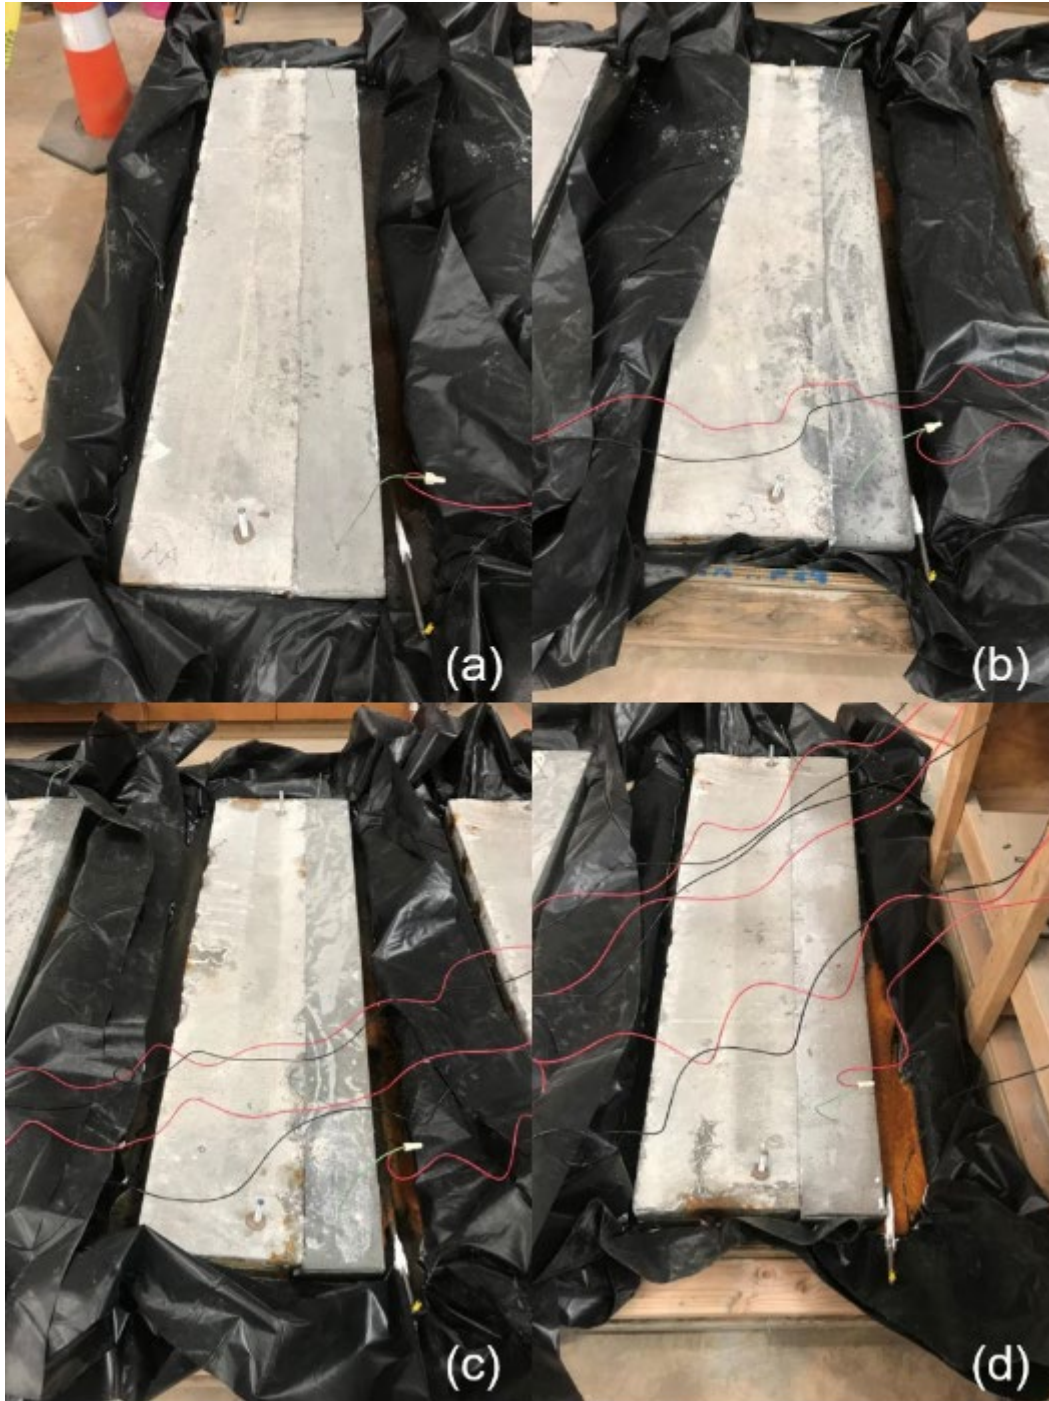
Figure 313. Week 1 update for large-scale corrosion specimens using (a) ODOT AA, (b) J3, (c) Ductal®, and (d) Phoscrete

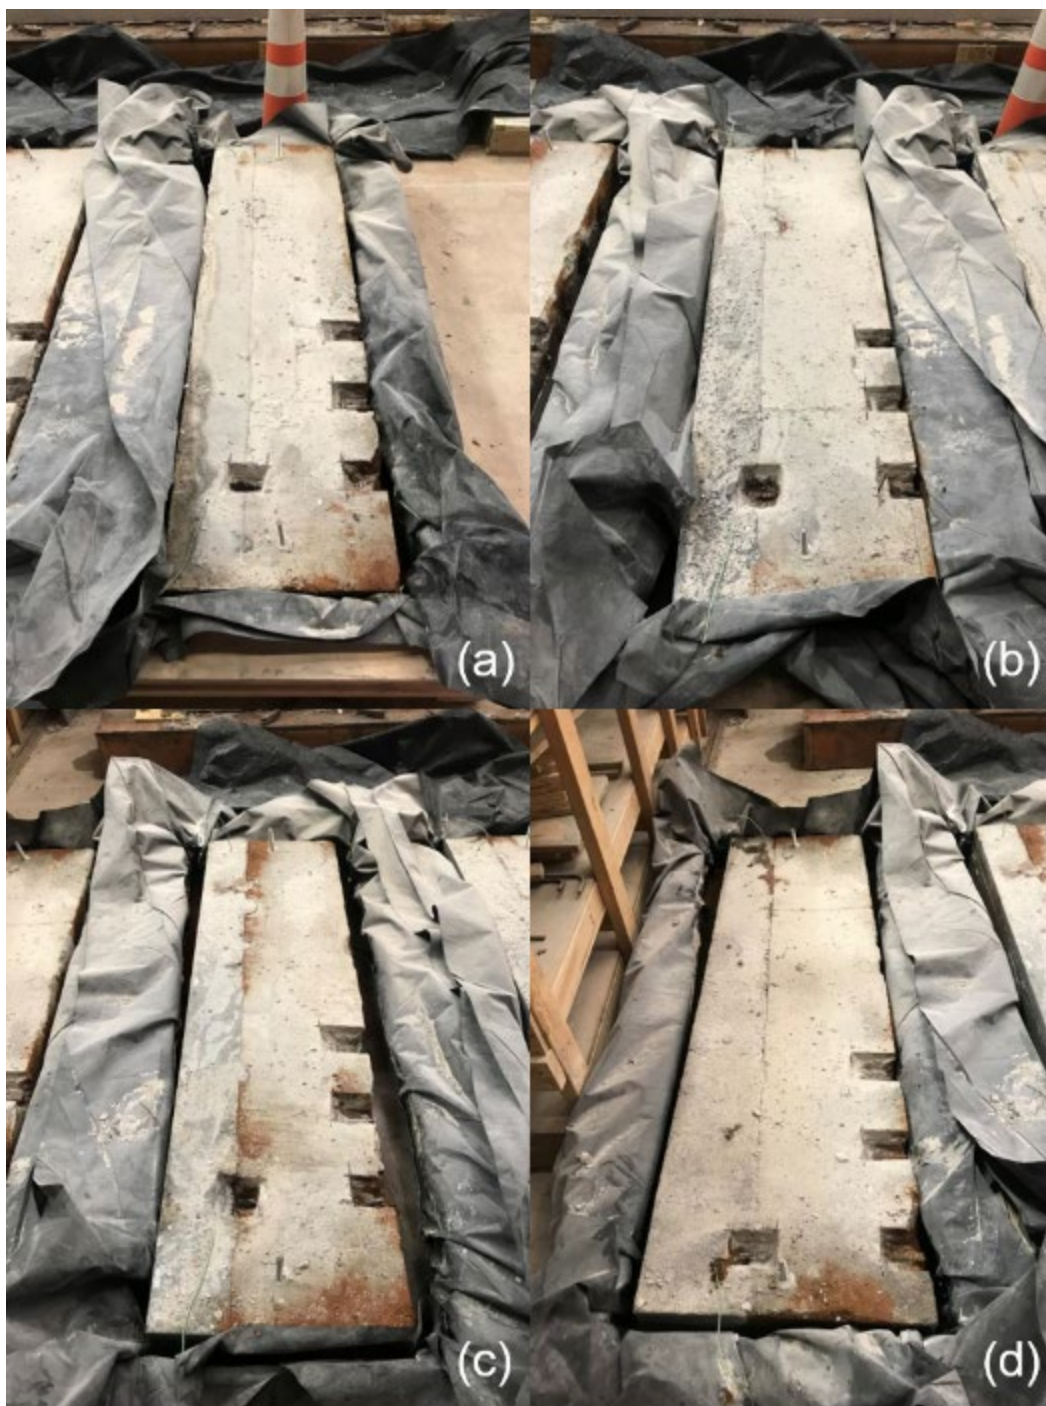
Figure 316. Week 10 update for large-scale corrosion specimens using (a) ODOT AA, (b) J3, (c) Ductal®, and (d) Phoscrete

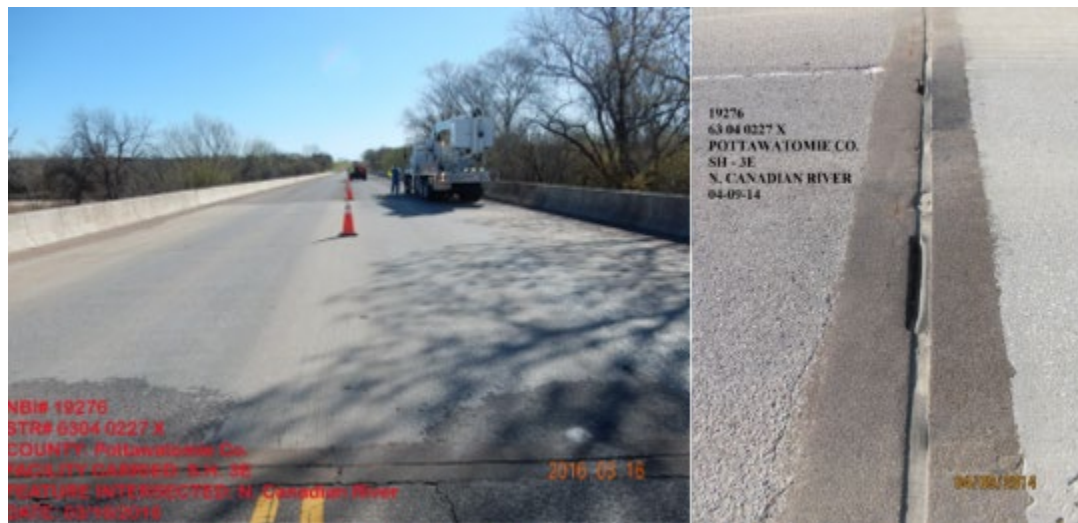
Figure 326. SH-3 bridge over N. Canadian River (left) and expansion joint to be replaced (right)
