FINAL REPORT

REVIBRATION OF CONCRETE FOR BRIDGE DECKS

PROJECT NO. 70-02-2, AGREEMENT NO. 12

OKLAHOMA STATE HIGHWAY DEPARTMENT  
Oklahoma City, Oklahoma

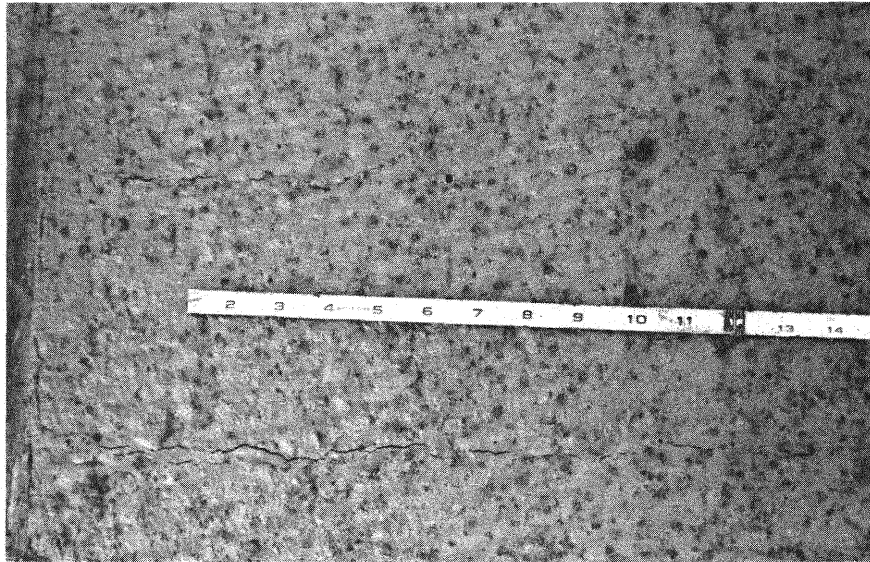
Figure 6 a. Presence of Longitudinal Shrinkage Cracks Before Surface Revibration (RVS-91).

The problem of cracking begins as soon as the concrete has set for a brief time. Shrinkage cracking is often witnessed before finishing begins, and was frequently the case in this project, as may be seen in Figure 6 which also shows chronologically the results of effort on slab RVS.<sup>91</sup>

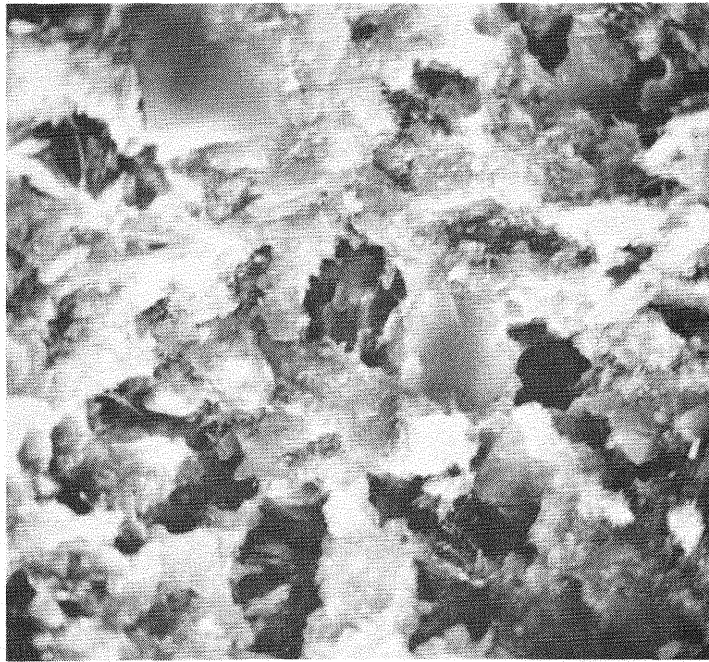
Figure A-13. General View of Fracture Surface of Revibrated Specimen (X-2).

Electron Microscopy Study. The fracture surfaces of eight different specimens were observed in the electron microscope after seven days of water curing, thence, drying at  $110^{\circ}\text{C}$ . Two specimens each were observed from the control series, series X-1, series X-2, and series X-3. Figures A-8 through A-16 are micrographs typical of those taken in this series of tests. Views of the control specimens are given in Figures A-8 through A-11, of specimen X-1 in Figure A-12, of specimen X-2 in Figures A-13, 14 and X-3 in Figures A-15, 16.

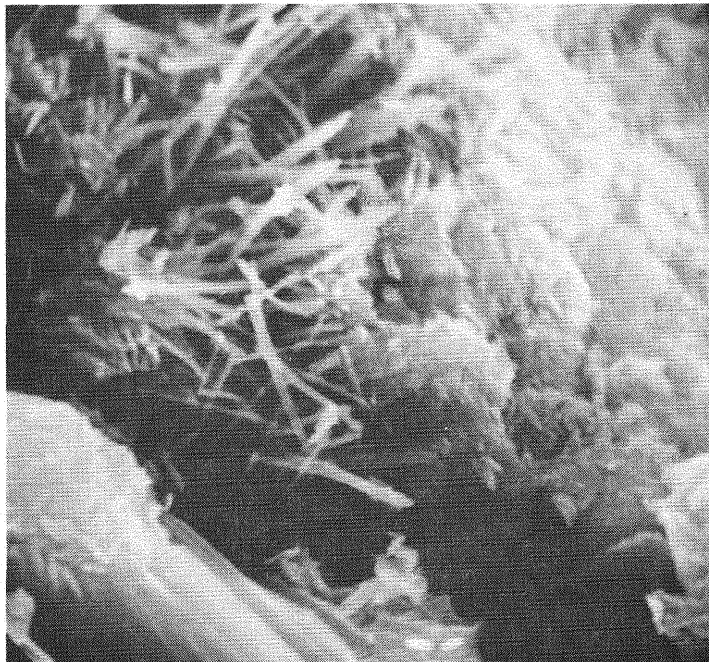
Figure A-14. Calcium Silicate Hydrate in Revibrated Specimen (X-2).

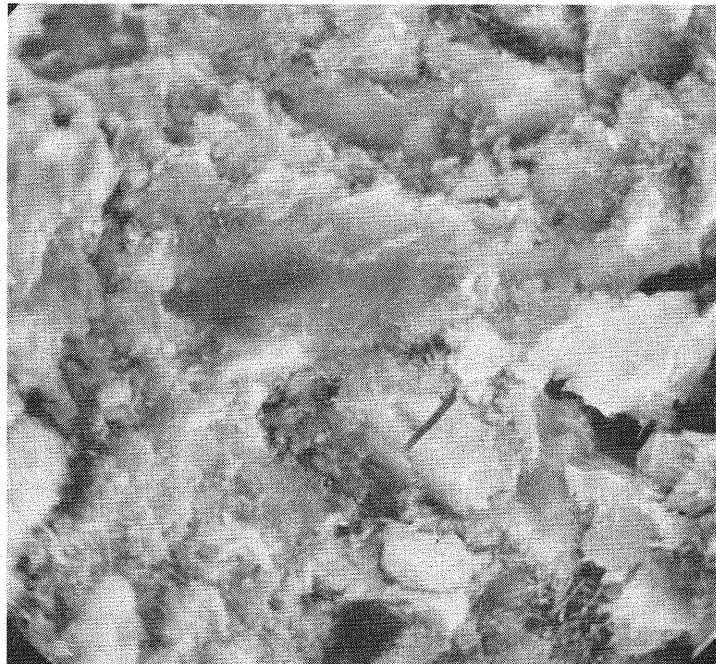
Figure A-15. Fracture Surface of Revibrated Cement Paste After 7 Days of Hydration (X-3).
