EXPERIMENTAL INVESTIGATION OF THE EFFECTS OF EXPOSURE TO PRESSURIZED  
HYDROGEN ON GENERAL USE POLYMER-BASED O-RING SEALS

A DISSERTATION

A DISSERTATION APPROVED FOR THE  
SCHOOL OF AEROSPACE AND MECHANICAL ENGINEERING

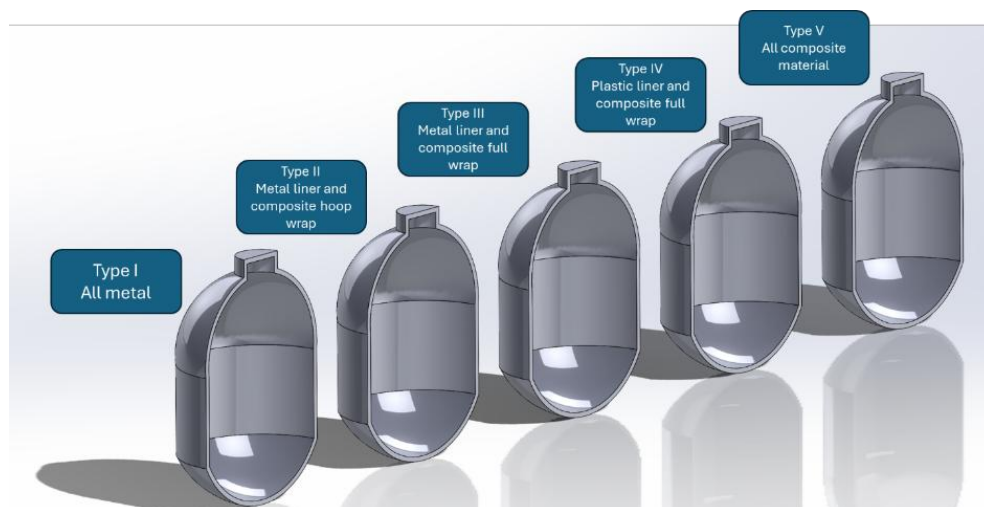
Figure 11: Types of compressed hydrogen gas storage tanks [17].

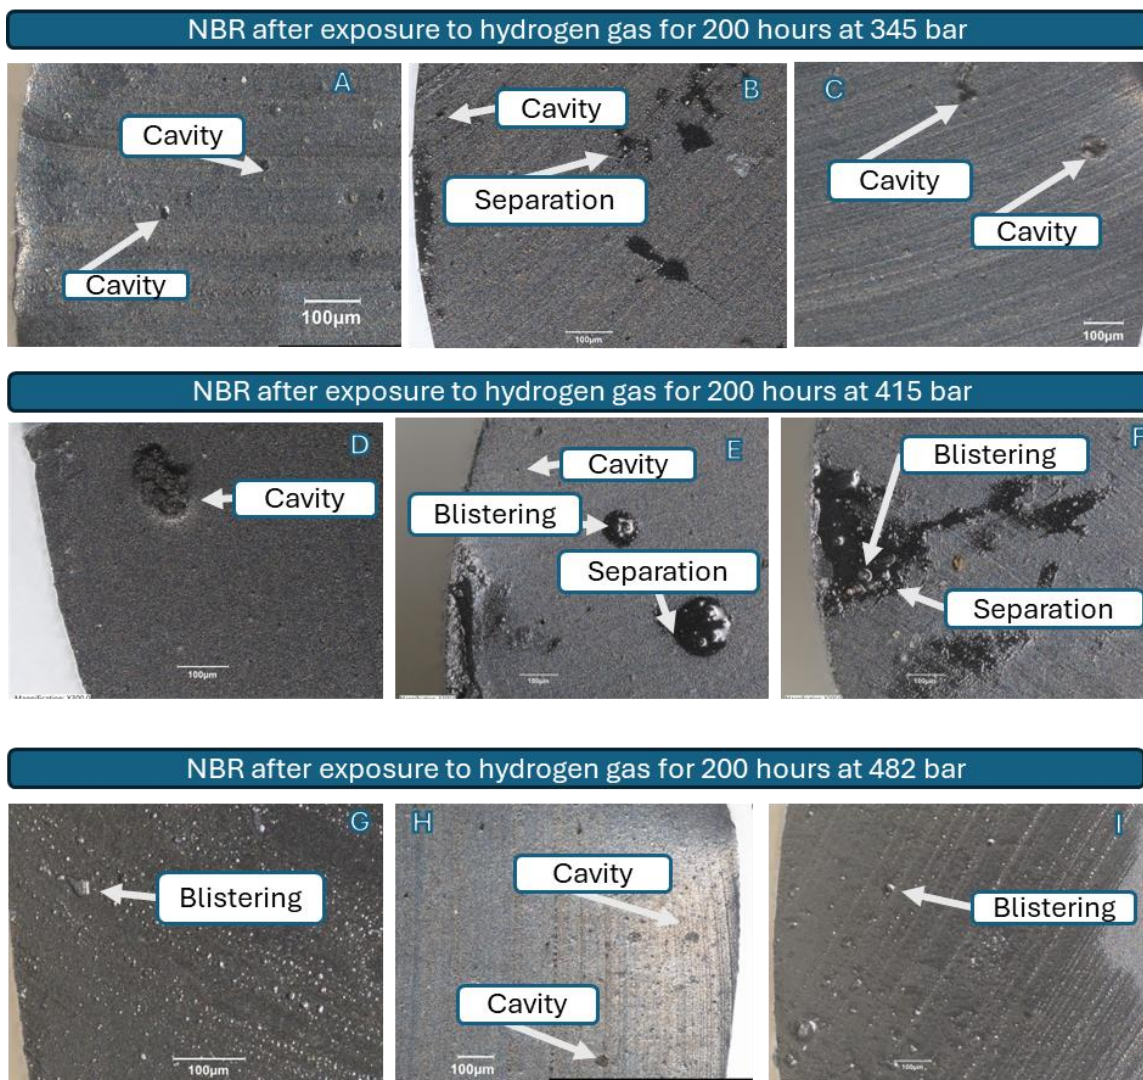
Figure 63: Microscopic images obtained from NBR O-ring samples exposed to hydrogen gas at 345 bar 415 bar and 482 bar respectively highlighting the main defects observed.
