EVALUATION OF FUNCTIONALITY AND SERVICE LIFE OF  
ULTRA-HIGH PERFORMANCE CONCRETE LINK SLAB CONNECTIONS FOR BRIDGES

A THESIS

CLAY REED

2022

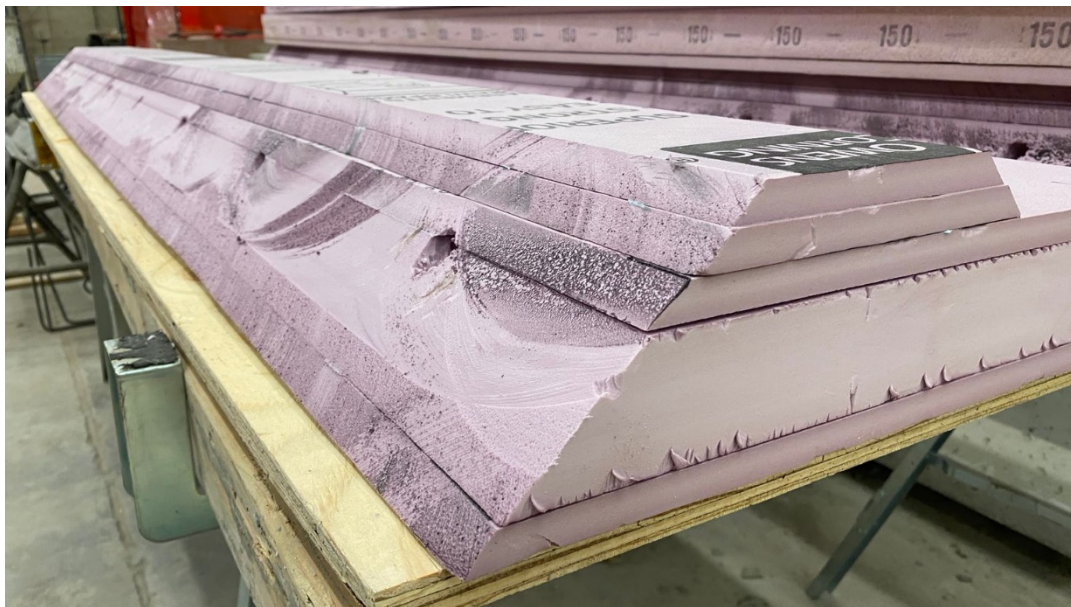
*Figure 3-8: Foam insert with drilled holes for rebar*

To create the connection design, a foam insert was constructed and placed in each section. Each foam section spanned the entire 8 ft. length. Figure 3-6 provides the dimensions for the insert's uniform cross-section, with all non-right angles at 45 degrees. Figures 3-7 and 3-8 show the finished cross-section of one of the inserts. These connection dimensions are based on the NYDOT link slab design reported in the literature review. One insert was placed in each form along one side of the 8 ft. length with the 17 in. side face down and the larger slope facing into the form. The placement was the same for all slab sections. Holes were drilled into the slanted face of the foam to insert rebar extending out of the concrete, which is shown in Figure 3-8.

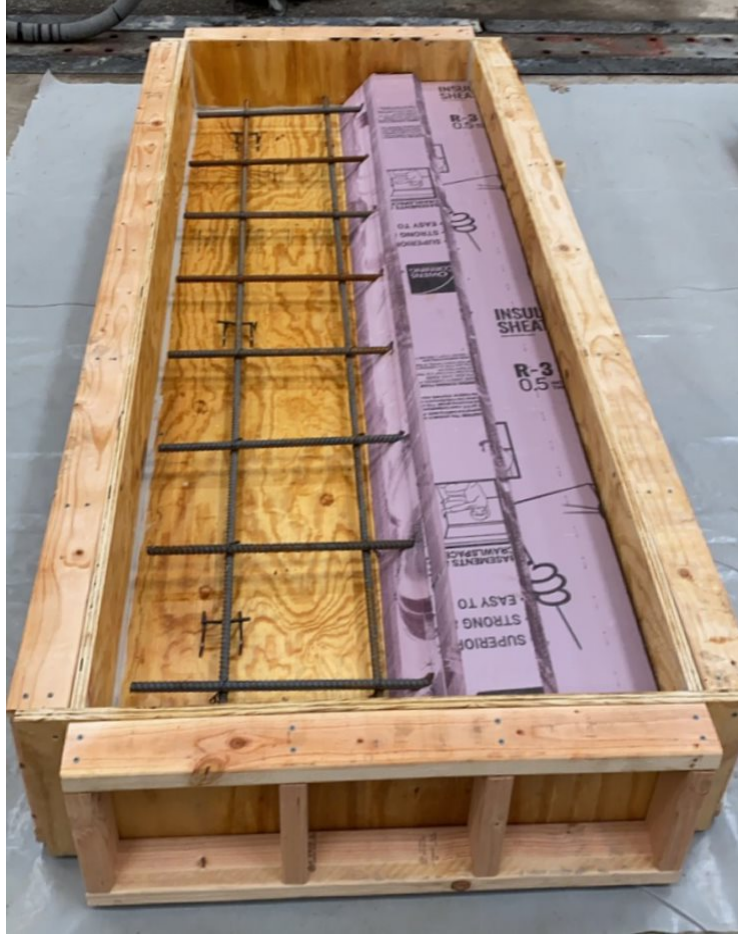
*Figure 3-13: Slab formwork with foam insert and "top" rebar cage layer*

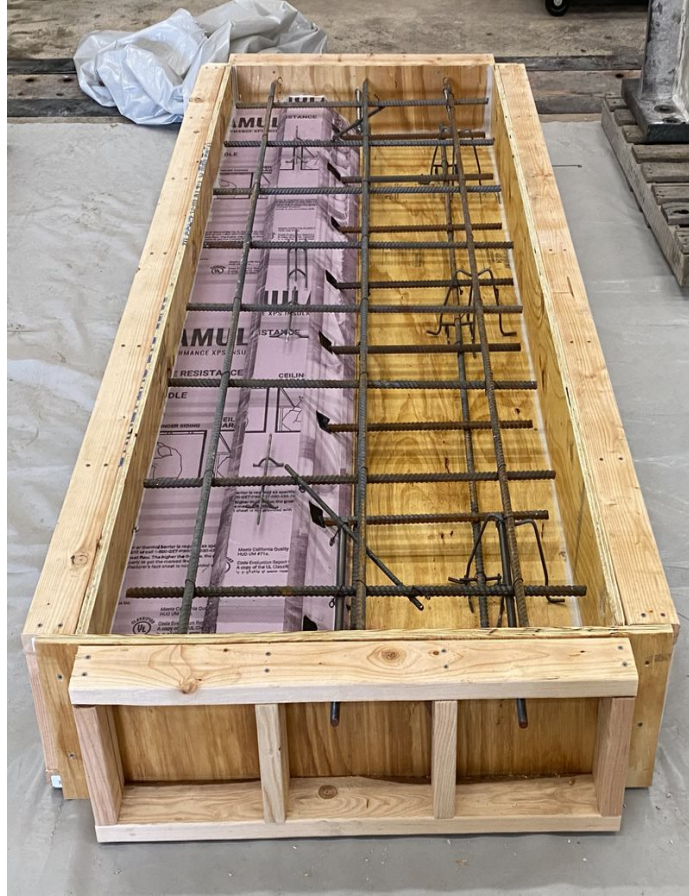
*Figure 3-14: Slab formwork with all rebar, all-thread installed*

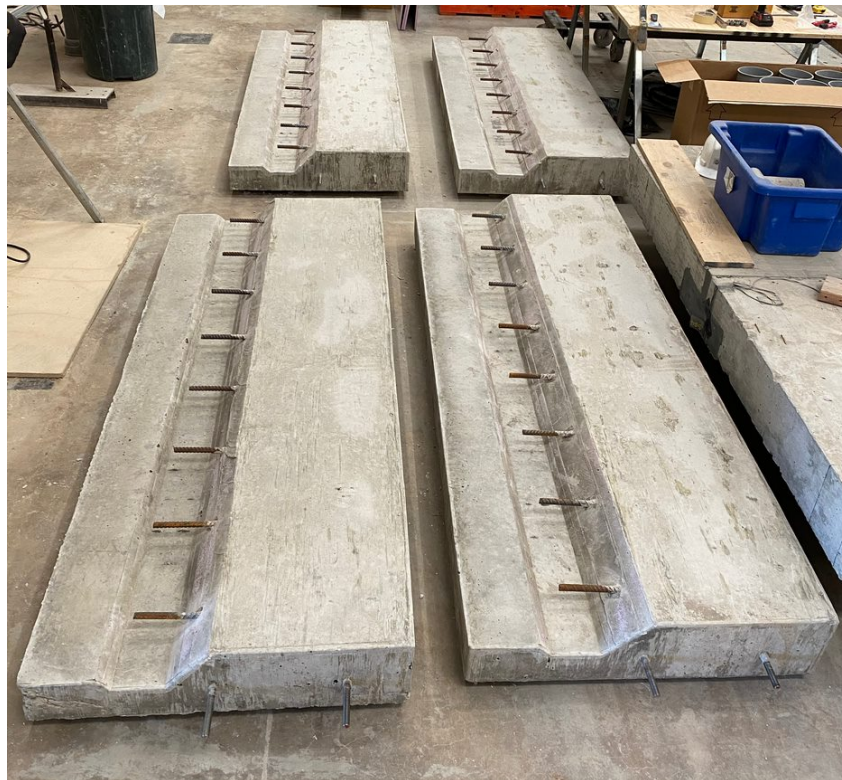
*Figure 3-17: Slab sections with foam removed*

There were two rounds of concrete pours, each producing four slab sections. For each round, all slabs were cast using a Class AA ODOT concrete mix, the state standard for bridge deck construction (for conciseness, this mixture will be referred to as “AA” moving forward). This mixture was provided by a ready-mix concrete supplier for all eight slab sections. Figure 3-15 shows a set of slabs right after casting. All slabs were left in their forms to cure with wetted burlap on the exposed surface for seven days. After seven days, the sections were released from the forms and flipped over to their testing orientation, as shown in Figure 3-16. The foam was stripped from the connection cavity to expose the rebar to be used for splicing (Figure 3-17). The

foam left smoother concrete surfaces than anticipated, so these surfaces were sandblasted prior to placing the link slab concrete. This provided a rough texture to promote a better bond for the connection pour.

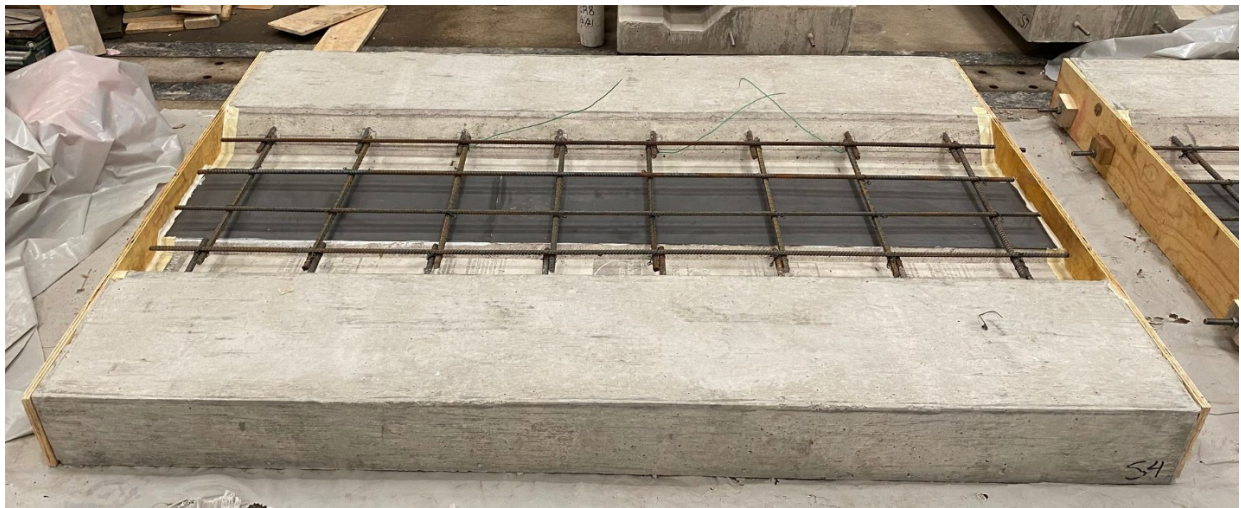
*Figure 3-23: Connection fully prepped for casting*

The exposed rebar of the connected sections was spliced to their mirroring bar with #5 Grade 60 rebar. Each splice was sectioned to have 4 in. of overlap on either side. For each connection, three splicing bars had a copper wire soldered to them in preparation for corrosion testing (Figure 3-20). Transverse #4 Grade 60 rebar was placed and tied above the spliced rebar, spaced 8 in. on center. Dimensions are included in Figures 3-21 and 3-22. The cover was 1.5 in. from the top face based on ACI 318 requirements. Figure 3-23 shows a fully-prepped specimen ready for casting.

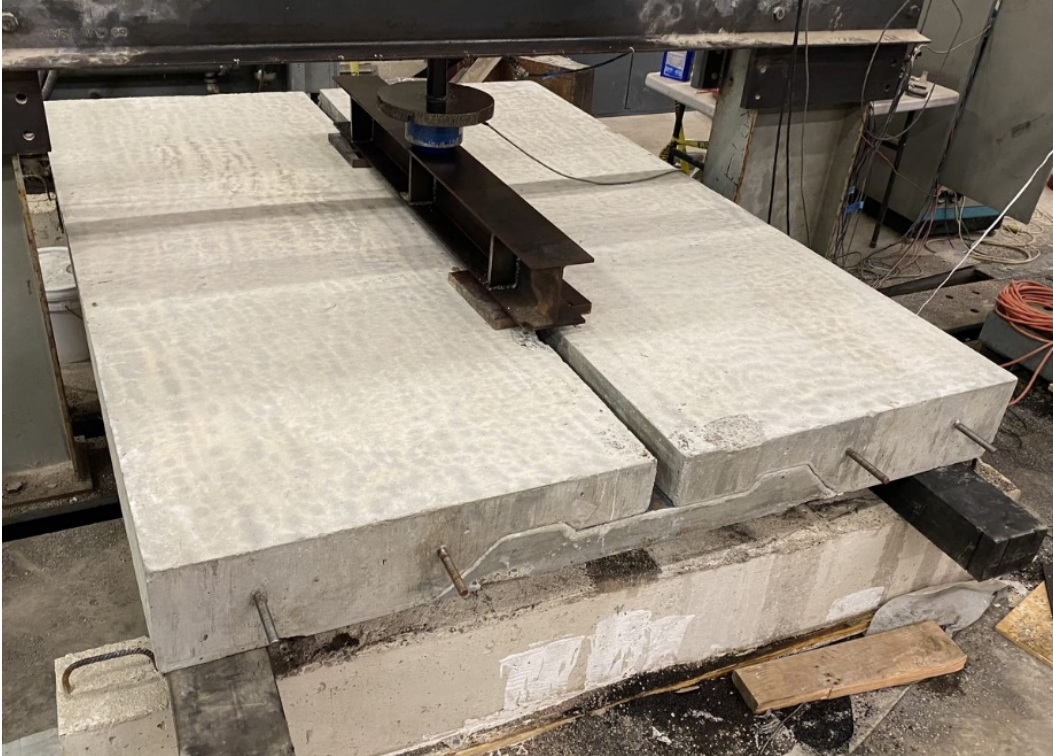
*Figure 3-25: Cyclic load testing setup for tension on link slab surface*

The specimen was placed upside down and loaded to produce tension stresses perpendicular to the joint. This loading was to simulate instances where loads were on the adjacent decks of the connection and no loading was on the link slab. The test loading consisted of 100,000 cycles of 5,000 pounds, which was based on the cracking stress of the link slab for the AA material. The end supports of the specimen during this testing were at the four corners of the specimen.

Loading was applied through a steel beam in the middle of the specimen to distribute loading along the joint. Figure 3-25 shows the testing setup for tension loading. After reaching the cycle count, each specimen was inspected for cracking.

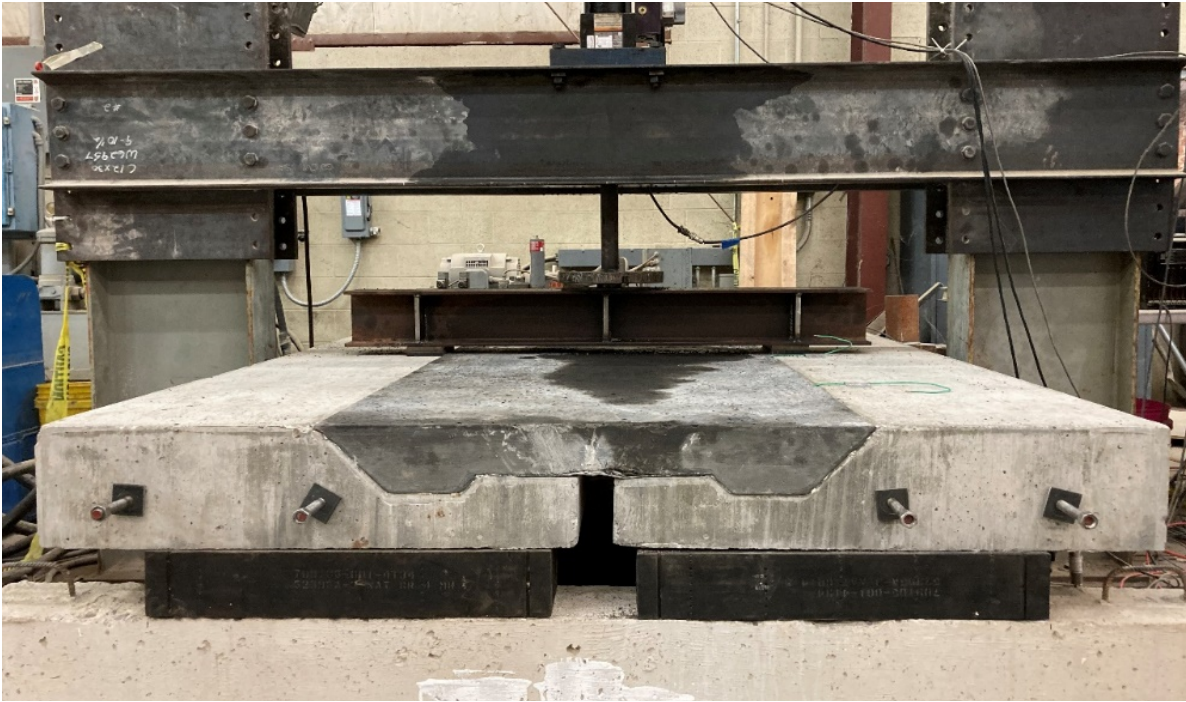
*Figure 3-26: Cyclic load testing setup for compression on link slab surface*

Compression loading applied 20 cycles of 18,000 pounds with the surface face up to simulate traffic loads on the connection. This loading is based on the cracking moment of the AA concrete for the full deck section of 8 in. The end supports of the specimen during testing were along the 6 ft. edge of the specimen. The steel beam was oriented perpendicular to the connection width to promote bending along the connection width. Figure 3-26 shows the testing setup for compression loading. After reaching the cycle count, each specimen was inspected for cracking.

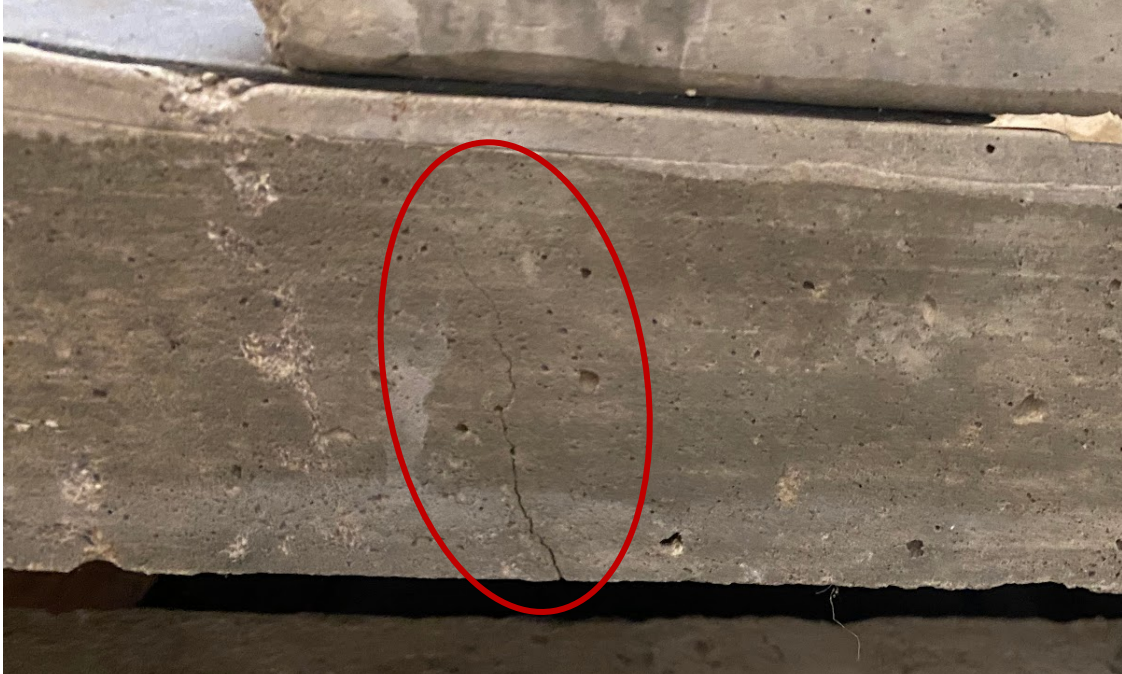
*Figure 3-27: Cracking in AA-L during cyclic loading (annotated)*

While cyclically loaded under tension, the Class AA specimen (AA-L) developed a significant crack near the center of the connection. Figure 3-27 shows the crack as it was observed during testing. No such cracking developed in specimen U-L.

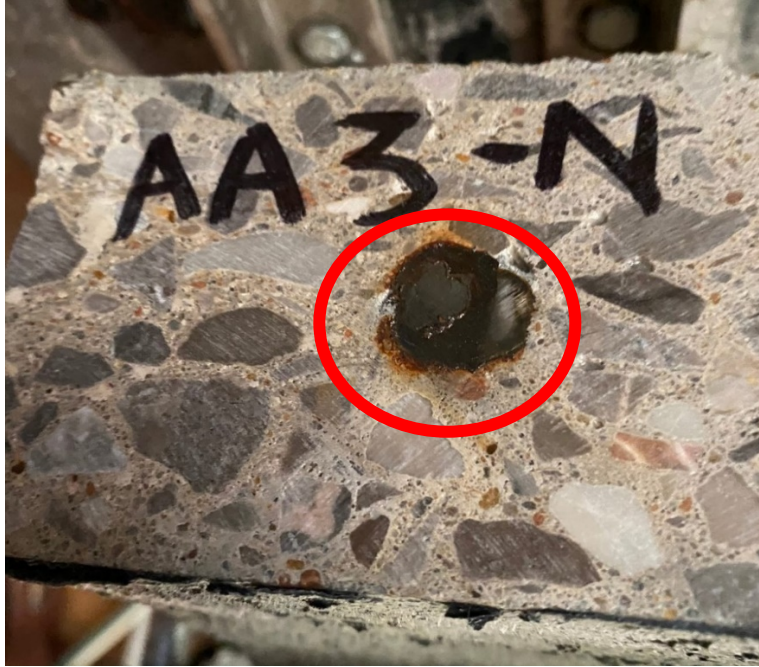
*Figure 4-4: End profile of AA3-N with rebar near center (annotated)*

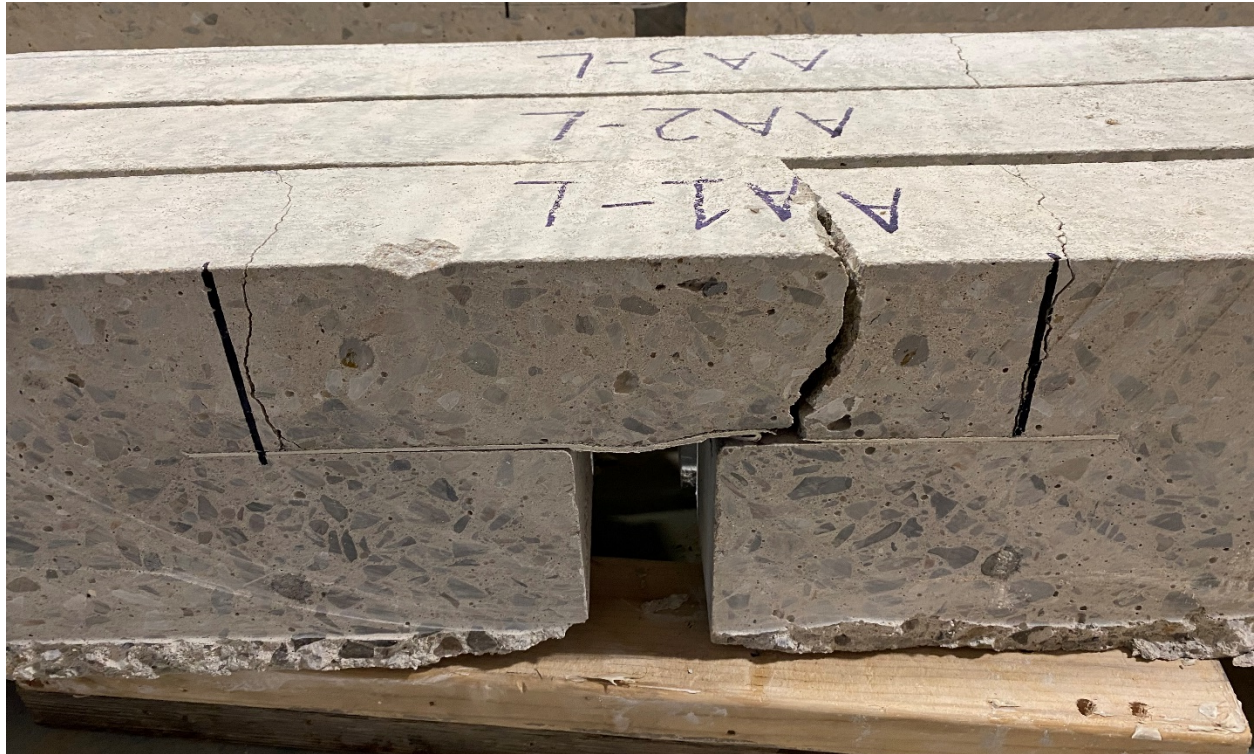
*Figure 4-5: Cracking in AA1-N within 12-inch length denoted with marker*

For connection specimen AA-L, only one freeze-thaw specimen (AA2-L) was able to be cut close to the desired 12-in. length. The parent specimen experienced cracking close to the 2-inch gap of the link slab joint during cyclic loading. This cracking caused the other two freeze-thaw specimens, which did not have rebar running along their lengths, to break into uneven sections shorter than 12 in. An example of the effects of cracking is shown in Figure 4-5. The resulting lengths of each AA-L specimen are as follows: AA1-L is 6 in., AA2-L is 11 in., and AA3-L is 8 in. The cracking would be expected to affect overall durability, both in this research and during service.

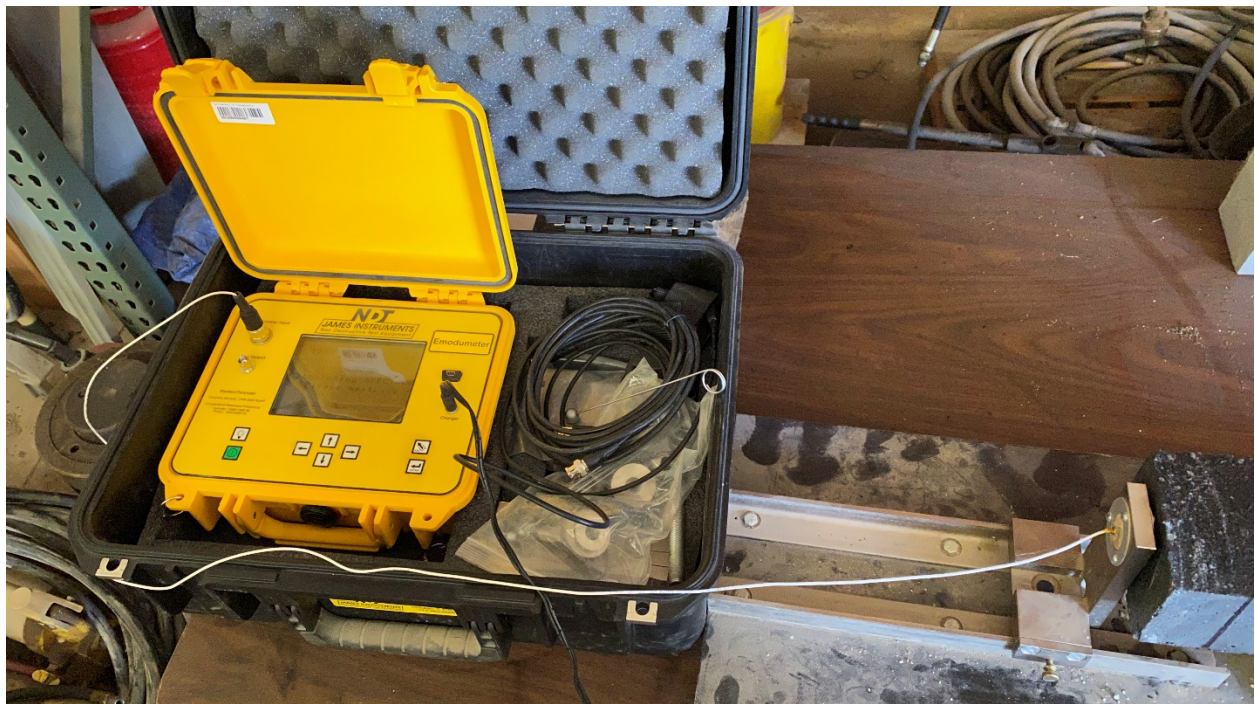
*Figure 4-11: Emodimeter with accelerometer connected (white wire)*

0.55 in. Figure 4-10 shows the striking instrument. On the other end of the specimen, a miniature accelerometer was placed against the center of the face. This sensor was attached to an emodumeter and read the vibrations when the concrete was struck. The emodumeter then determined and provided the resonant frequency of the concrete specimen. This instrument setup is shown in Figure 4-11. Three readings were collected for each specimen per round of testing. The averaged frequency values were used to calculate the specimen's relative dynamic modulus (RDM) of elasticity. The short specimen being tested, AA3-L, had inconsistent readings throughout testing, so five readings were collected per round.

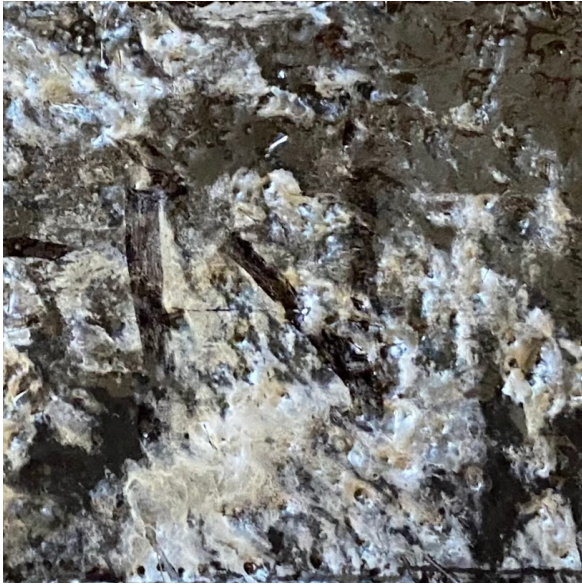
*Figure 4-13: Surface condition at beginning of testing (0 freeze-thaw cycles) for specimens (a) U2-N, (b) U2-L, (c) AA2-N, (d) AA2-L*

Physical changes were observed and recorded during testing. One specimen from each link slab is pictured in Figures 4-13 through 4-15 showing the progression of their surface states from before testing, after 170 cycles, and after 350 cycles when testing concluded. All respective specimens showed similar changes due to testing. Photos for these figures are of the same location of each specimen, as best as could have been achieved with the deterioration of distinguishing marks such as marker labels.

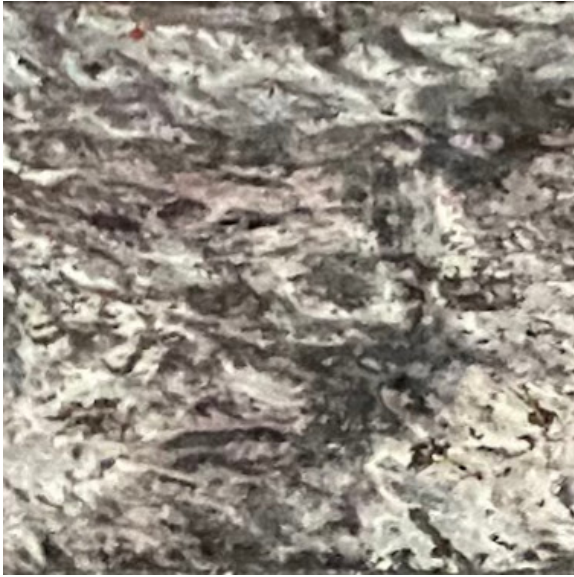
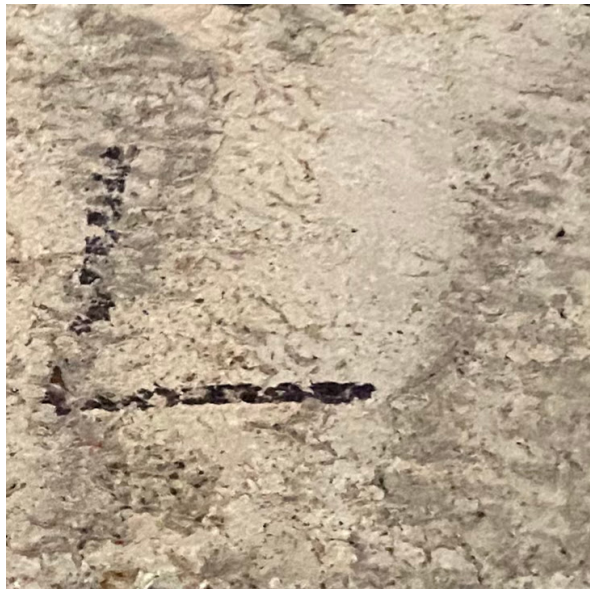
*Figure 4-14: Surface condition at 170 freeze-thaw cycles for specimens (a) U2-N, (b) U2-L, (c) AA2-N, (d) AA2-L*

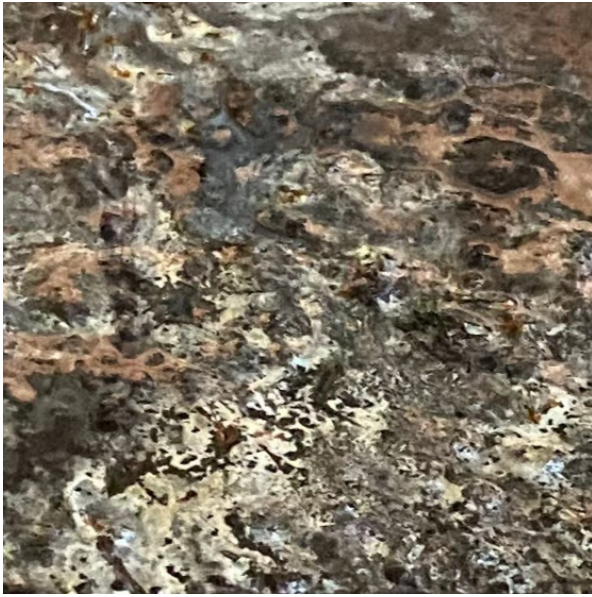
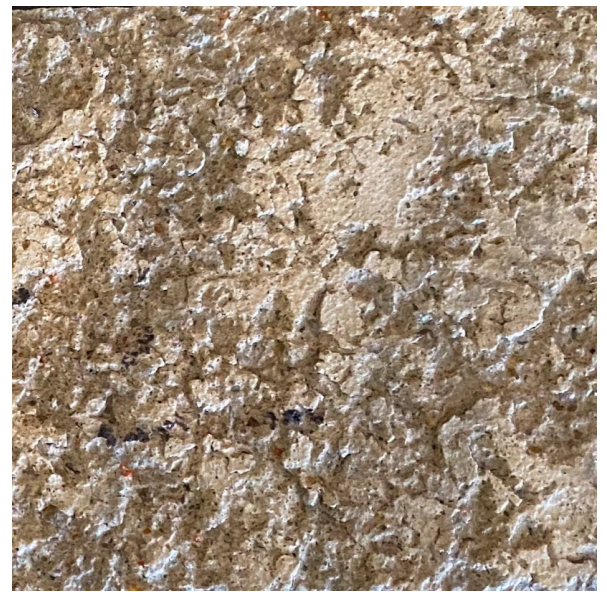
*Figure 4-15: Surface condition at 350 freeze-thaw cycles for specimens (a) U2-N, (b) U2-L, (c) AA2-N, (d) AA2-L*

For the U-L, AA-N, and AA-L specimens, varying degrees of scaling developed on the top surface, with the loaded specimens having the more severe scaling. While AA specimens developed this scaling during testing, U-L specimens had preexisting pockets on their surfaces, as shown in Figure 4-13b. Scaling pieces on the U-L specimens were considerably larger than the AA specimens due to the steel fibers present. Mass was not measured during for this test; any discussion of material loss is based on observations. The finer residue from AA specimens is shown in a testing tray during testing in Figure 4-16. Pronounced pockets on UHPC surfaces indicate material loss as well, but not to the degree observed by AA specimens. Furthermore, AA specimens experienced chipped edges. Figures 4-17 through 4-20 show these affected areas. U-N specimens have little to no observable scaling to its surface, demonstrated in Figure 4-15a, while none of the UHPC specimens showed signs of chipping.

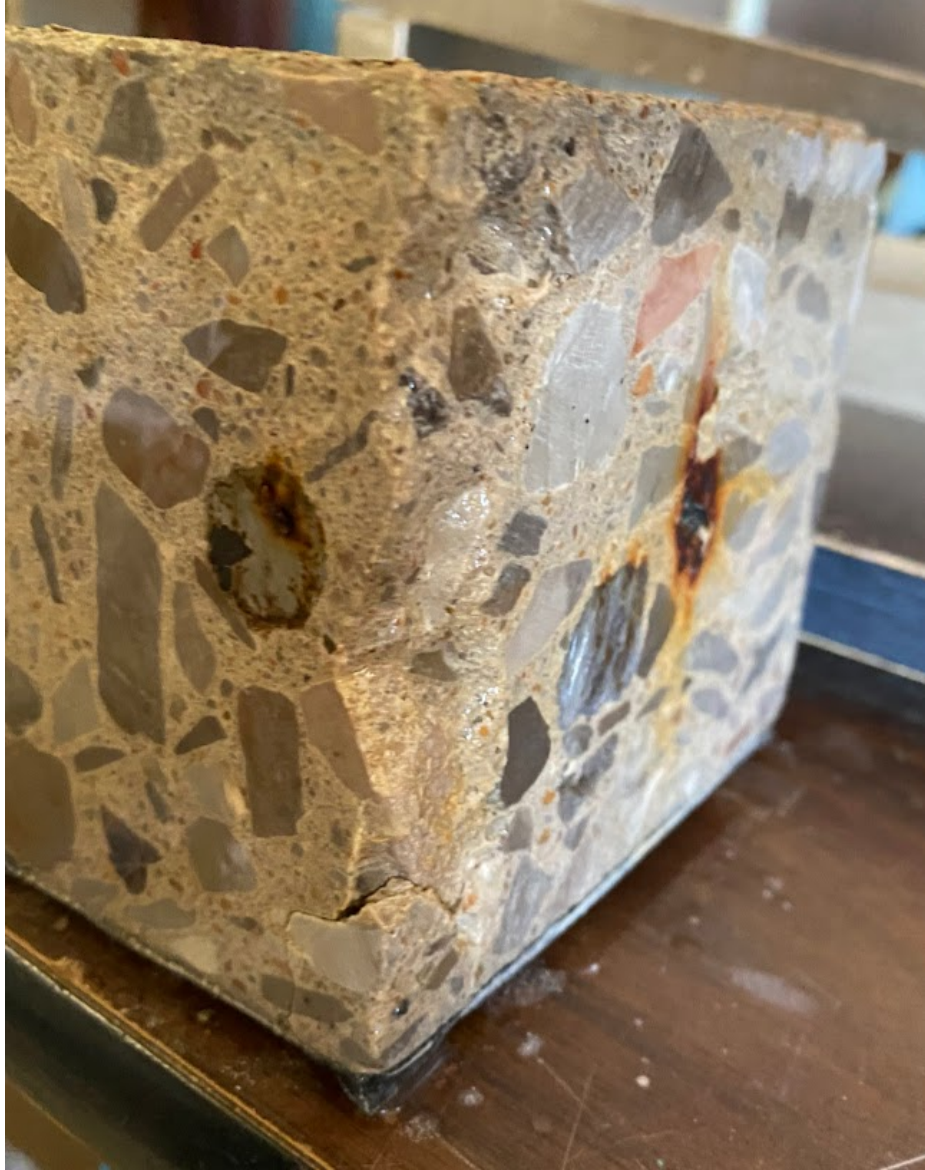
*Figure 4-19: Chipped edges of specimen AA2-L*

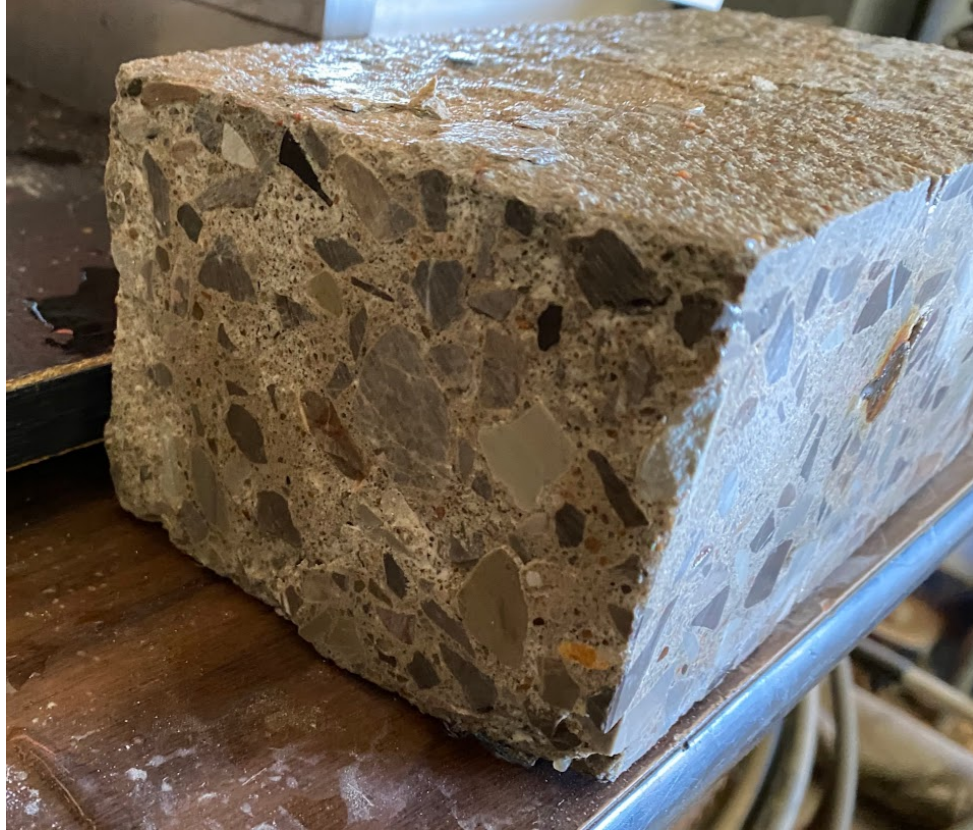
*Figure 4-20: Chipped edges, face of specimen AA3-L*

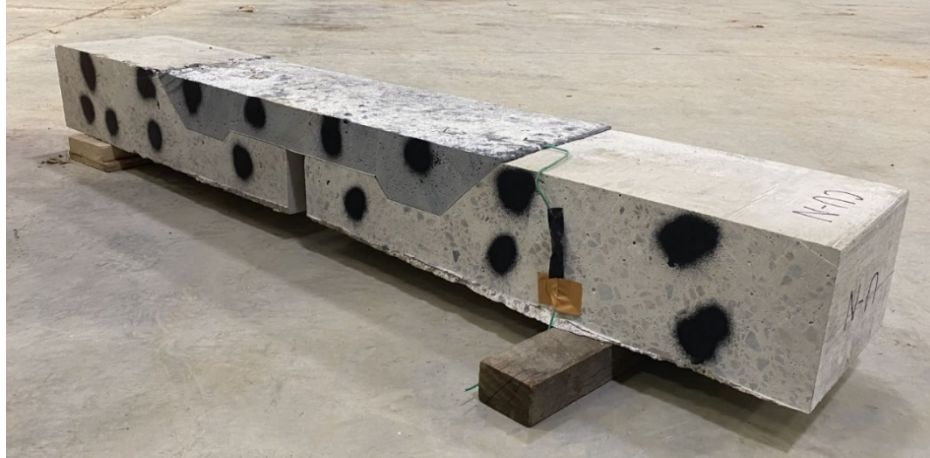
*Figure 5-1: Corrosion specimen CU-N with sealant applied to exposed rebar ends*

One segment from each of the four link slab specimens was subjected to accelerated corrosion testing. All corrosion specimens were sectioned at the same time as the freeze-thaw specimens. Each specimen for corrosion testing measured 1 ft. by 6 ft. in plan and 8 in. in thickness. Each specimen included one of the copper wires previously soldered to the link slab reinforcing cages during specimen fabrication. The ends of the rebar exposed due to sectioning the link slab specimens were coated with a liquid rubber sealant. This covering was applied to simulate an unaltered link slab specimen, as these rebar ends would not be exposed in an actual deck while in service. Figure 5-1 shows a specimen side with the rubber sealant applied. As a reminder, the “C” in a specimen’s label indicates it was subjected to accelerated corrosion testing.

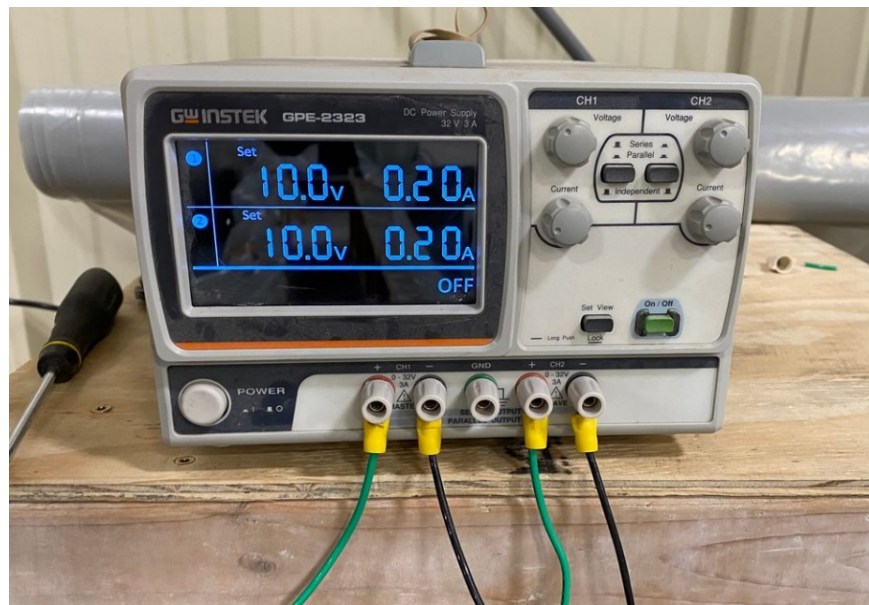
*Figure 5-3: DC power supply with test settings*

Two DC power supplies were utilized to provide the electric current for corrosion testing. One of the power sources is shown in Figure 5-3 along with the set values of 0.2 amps and 10.0 volts.

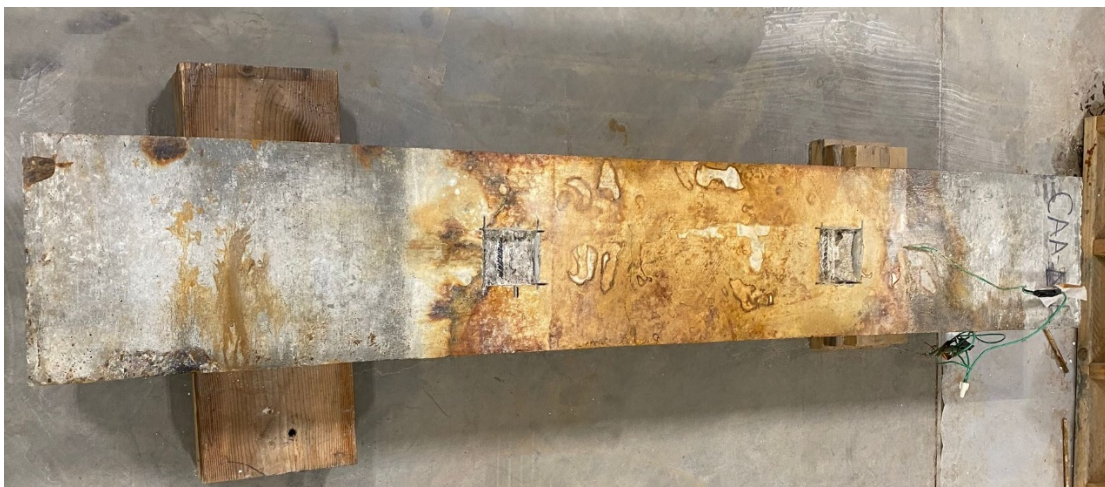
*Figure 5-7: Surface of CAA-L after 37 days of testing, windows cut*

After 5 weeks, specimens were removed from the solution baths, flipped, and windows were cut to observe the state of the reinforcing steel within the link slab connection. Figure 5-7 shows the surface of specimen CAA-L after being flipped over. The rebar and surrounding concrete observed in this specimen are shown in Figures 5-8 and 5-9. Cracking in the connection observed in this specimen are shown in Figures 5-8 and 5-9. Cracking in the connection developed in CAA-L during cyclic loading and is shown in Figure 5-10. Surface cracking raises the potential for the solution to seep into the connection and initiate premature cracking. Similar photographs of all other specimens are provided in Figures 5-11 through 5-20. Cracking was also observed on the surface of CAA-N. The crack coincided with rebar layouts and is corrosion-induced. No cracking was observed in the UHPC corrosion specimens.

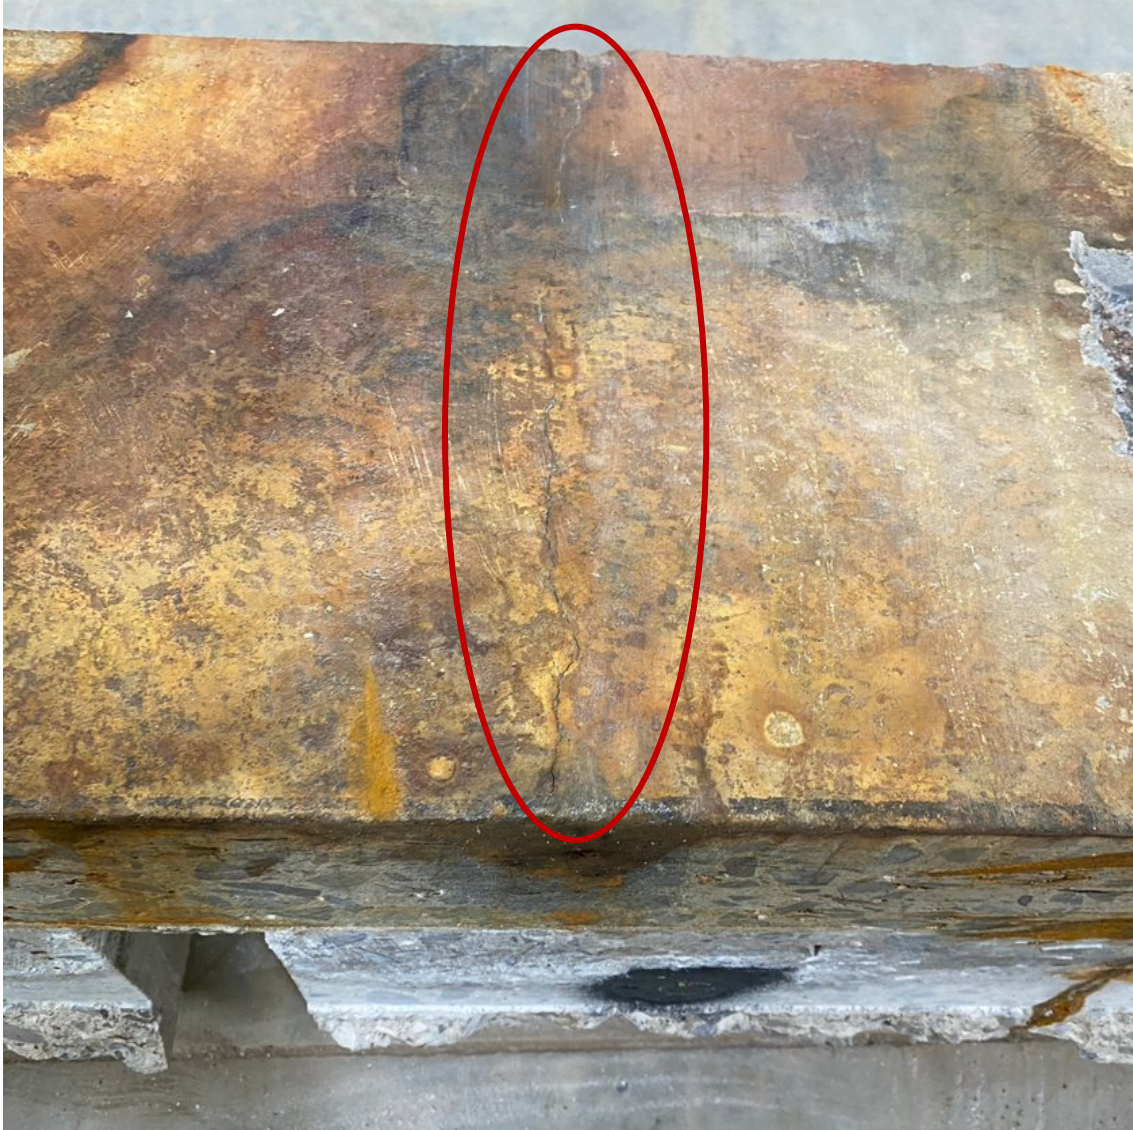
*Figure 5-10: Cracking in specimen CAA-L (present prior to testing, annotated)*

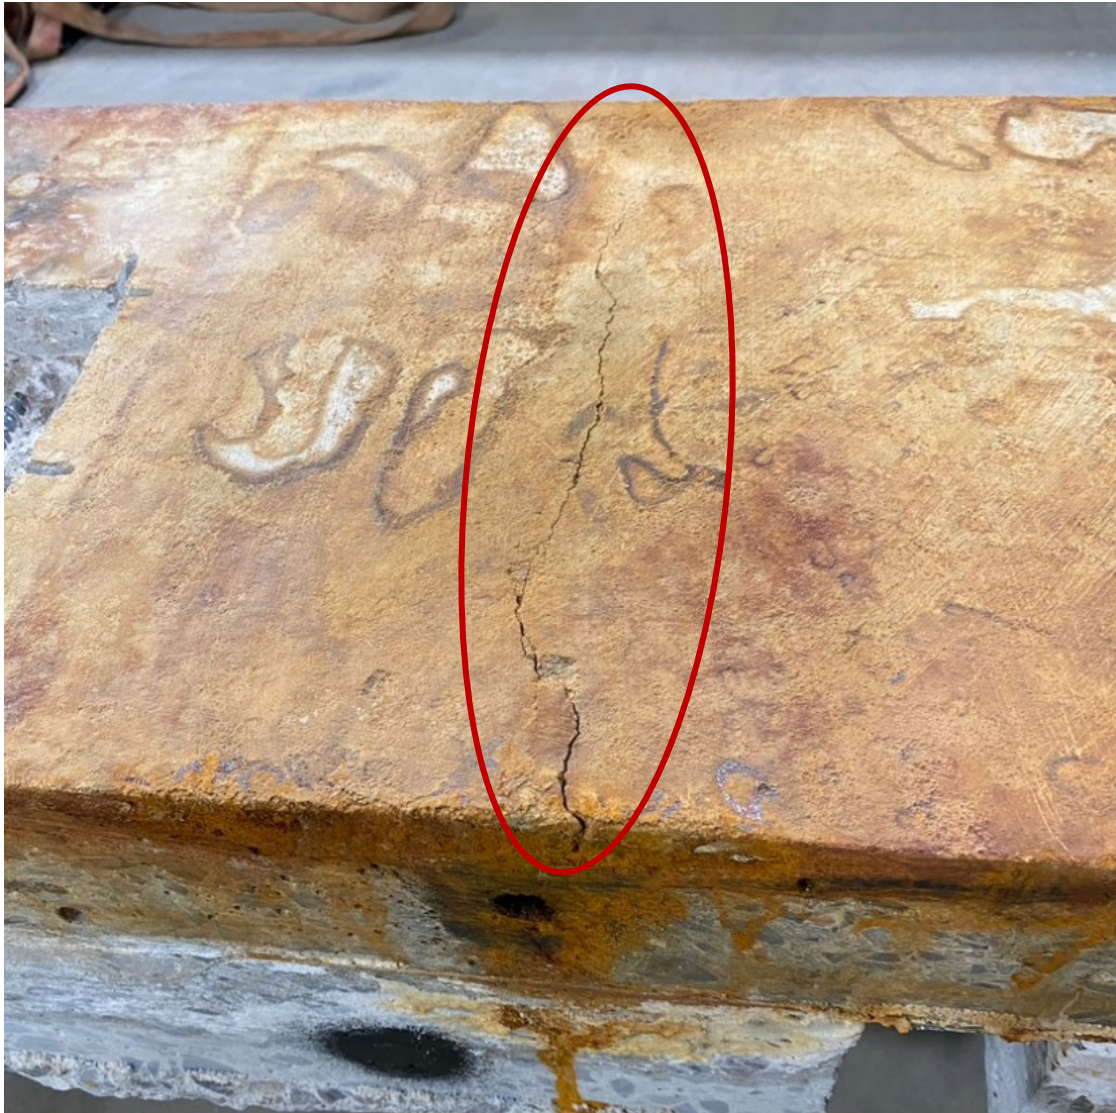
*Figure 5-14: Cracking in specimen CAA-N (annotated)*

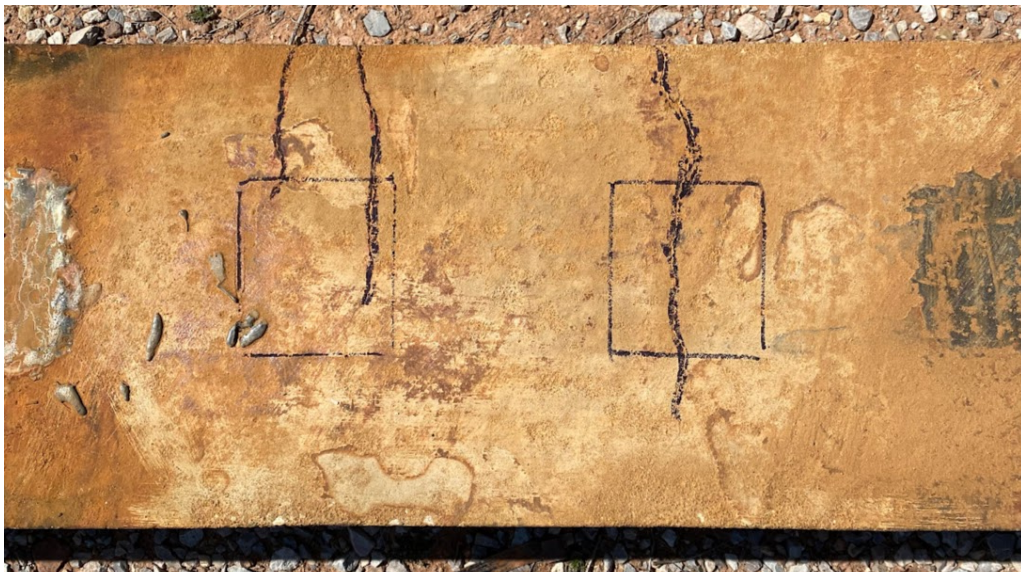
*Figure 5-22: Surface of specimen CAA-L after 65 days of corrosion testing*

After 65 days of total testing time, the state of the connection rebar was observed in the same process conducted at the 37-day checkpoint. Windows were cut for two more segments of rebar in the link slab. Figures 5-22 through 5-27 show the surface and rebar of the AA specimens. Figures 5-28 through 5-33 show the surface and rebar of the UHPC specimens. As with the status of the rebar and surrounding concrete observed at 37 days of corrosion, the status of the rebar in UHPC specimens fared better than Class AA specimens, regardless of whether they were cyclically loaded prior to testing. The Class AA specimens show no signs of corrosion in the rebar and minor signs in the surrounding concrete are seen in CAA-L (Figure 5-23). Cracking observed previously on AA specimens was more pronounced and is annotated in Figures 5-22 and 5-25, indicating further effects of corrosion. No damage was observed at the patched areas of the first set of windows for any specimen.
