**FINAL REPORT ~ FHWA-OK-15-05**

# **EXPECTED LIFE OF SILANE WATER REPELLENT TREATMENTS ON BRIDGE DECKS PHASE 2**

**October 2015**

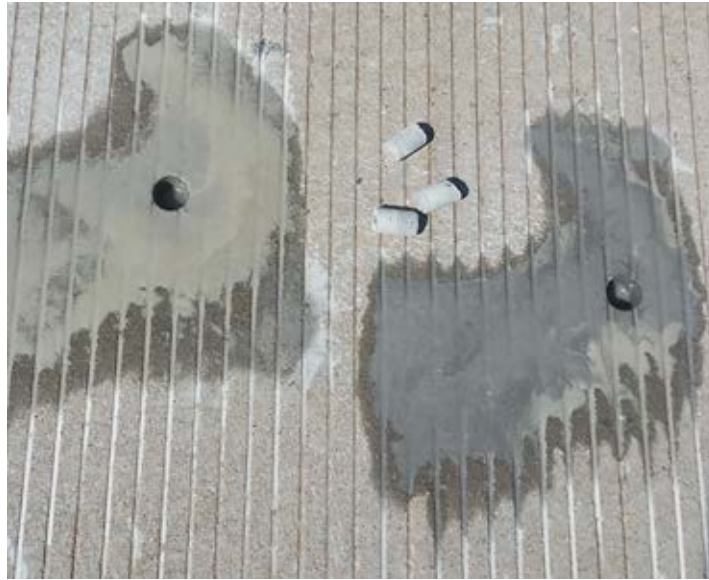
**Figure 1- Example of cores were taken from bridge decks**

Cores that were approximately 3/4" mm in diameter by 1" in height were taken from the driving lane and shoulder of 60 bridge decks (**Fig. 1**). Six cores were taken from each bridge for a total of 360 cores. Three cores were taken from the shoulder and three from the travel lane. These cores were taken at parallel locations so that the amount surface wear could be compared. Cores were taken from areas that were clear of debris, cracks, oil, and salt scaling damage. These cores were collected with a cordless drill. This technique allowed two researchers to sample each bridge in about 1 h. This minimized the requirement for traffic control and allowed more samples to be collected. Since the cores were small, this minimized damage and patching to the
