ROADSIDE DEVELOPMENT AND EROSION CONTROL

Final Report

Causes and Control of Soil Erosion

Oklahoma Highways

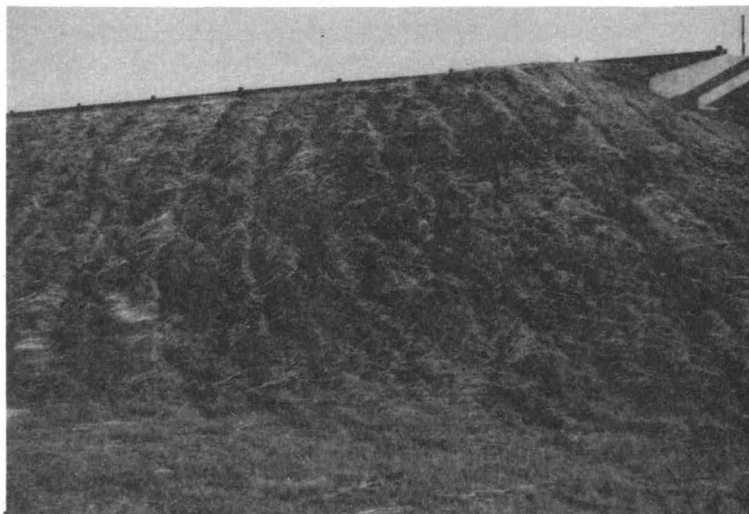
Figure 3. Soil erosion is greatly accelerated by the destruction of grass and the creation of ruts as the mower wheels spin as they ascend or slide in an attempt to stop or turn on the way down.

2. Improper use of maintenance equipment. The operation of mowers particularly, on highly erosive cut and fill slopes is the most destructive force currently acting upon the erosion control vegetative ground cover. The protective vegetative cover is not only destroyed by the improper practice of mowing too short and too frequently, but also by being physically torn from the soil by the shearing action of the tractor sliding as it attempts to traverse the slope generally in a horizontal direction (Figure 2), or from the spinning wheels in ascending the steep slopes, or as they slide in an attempt to stop or turn as they descend (Figure 3).

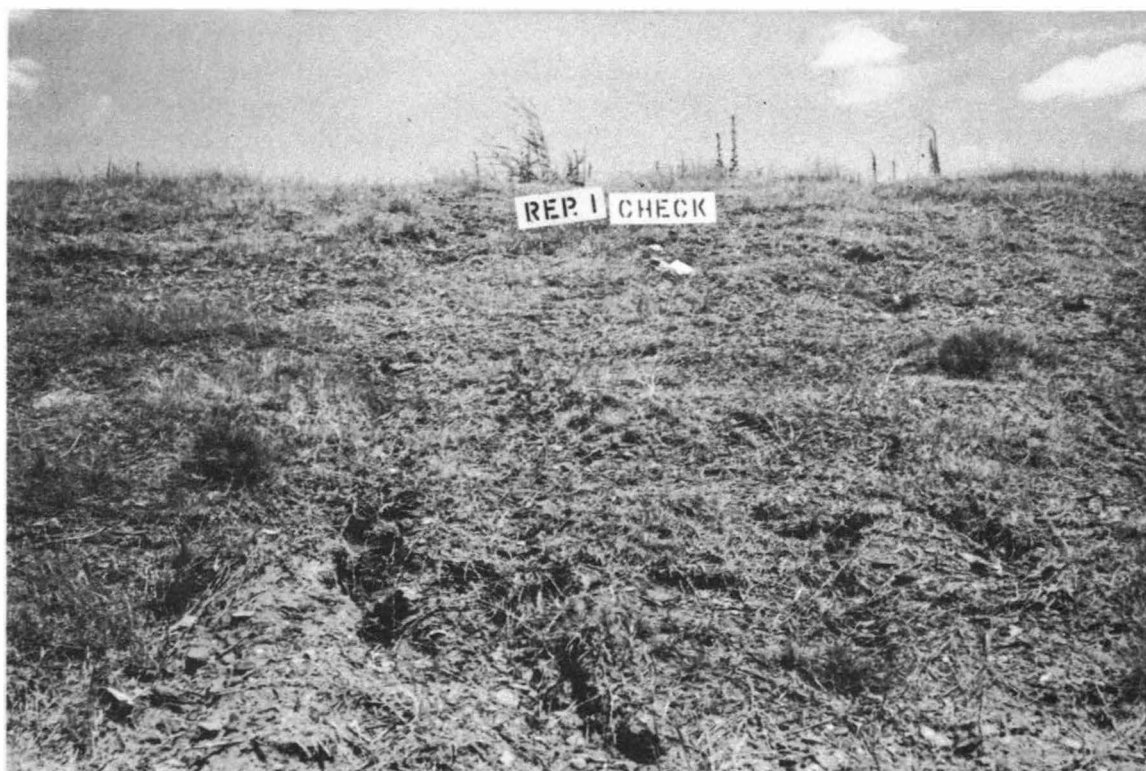
Figure 4. The decline in soil fertility following the successful establishment of a grass, particularly bermuda, results in a thinning or complete loss of the vegetative cover, soil erosion and costly repairs.

3. Decline in soil fertility. Failure to provide maintenance levels of fertilizer to well established bermuda, weeping love, or native grass covers has led to a thinning (Figure 4) or complete destruction of the vegetative cover resulting in certain soil erosion and costly repairs.

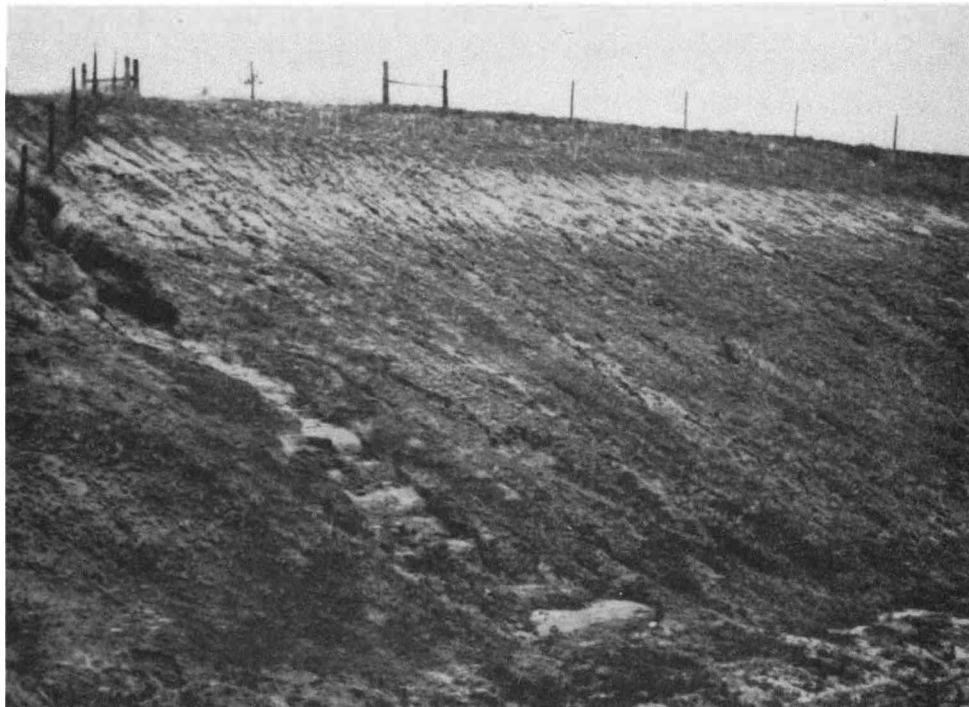
Figure 5. Soil erosion occurs as a result of improper design through omission of a physical barrier along the shoulder to concentrate and remove excess water (top photo), and because of inadequate rights-of-way interceptor ditches could not be constructed on top of cut slopes particularly for the orderly removal of excess water (bottom photo) from terrace outlets, or adjacent watershed.

4. Improper highway design. Failure to acquire adequate rights-of-way for the construction of interceptor ditches on the top of cut slopes particularly, to facilitate the orderly removal of excess water has resulted in serious erosion from water pouring down the slope from terrace outlets or watershed above (Figure 5).

The lack of a physical barrier along the outer side of the shoulder from near the crest of a slope to the bottom for the purpose of concentrating and removing excess water in an orderly fashion has resulted in excessive erosion of fill slopes. Erosion of this type occurs primarily because of superelevation, highway slope is designed to the outside, and the accumulation of gravel on the shoulder that tends to concentrate the runoff water along the dike until a sufficient volume accumulates to break through the gravel ridge and down the fill slope.
