HIGH AMBIENT PRESSURE TESTING APPARATUS AND  
DEMONSTRATION OF USE FOR MATERIAL TESTING

A THESIS

PHILIP M. RESNICK

2023

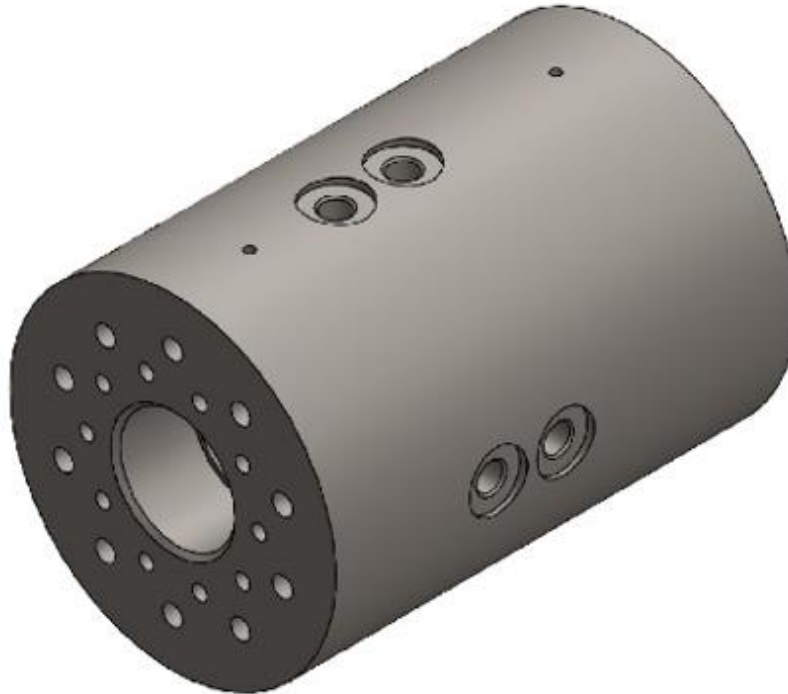
Figure 14: Horizontal Loading Pressure Chamber

in Austempering bulk material. The objective of the new design was to ensure that the stresses imparted on the chamber could be handled better by untreated 4340 to reduce costs while ensuring the chamber safety factor was 2 or greater. The new chamber was to be 2.1875 inches in diameter based on loading simulations using SolidWorks Simulation. Figure 14 shows the new design.

To finalize the design, I obtained a material test report from Bauman Machine for the 8.5-inch billet that was used for the chamber. This manufacturer's testing report, included in Appendix A, showed the forged billet of 4340 had a yield strength of approximately 136 ksi. The clipping of the stresses of the chamber when loaded at 60,000 psi at this value, returned less than 0.25% of the material volume was above this value. Figure 15 and Figure 16 show the locations of the highest stresses returned by the simulations. These locations are at corners of the model and are therefore likely artifacts of the simulation. With the small percentage of volume above the yield

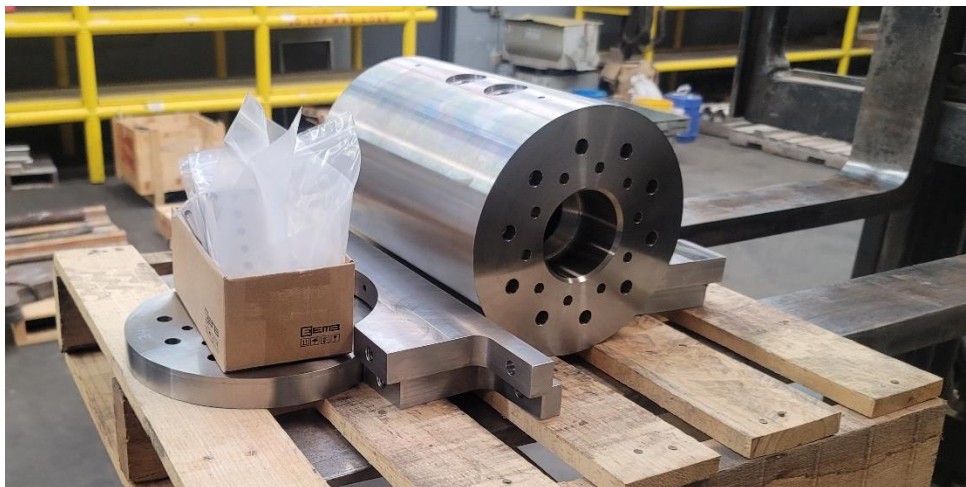
Figure 22: Uncoated Final Pressure Chamber Manufactured Components

Following the completion of the prototype design and drawings, Bauman Machine was hired to produce the Pressure Chamber, Plug, Lid, Mounts, and coupon holder components. The mounts and coupon holder were not fabricated out of 4340 as they would not be subjected to high amounts of stress. Figure 22 shows the components as delivered by Bauman Machine and prior to coating.

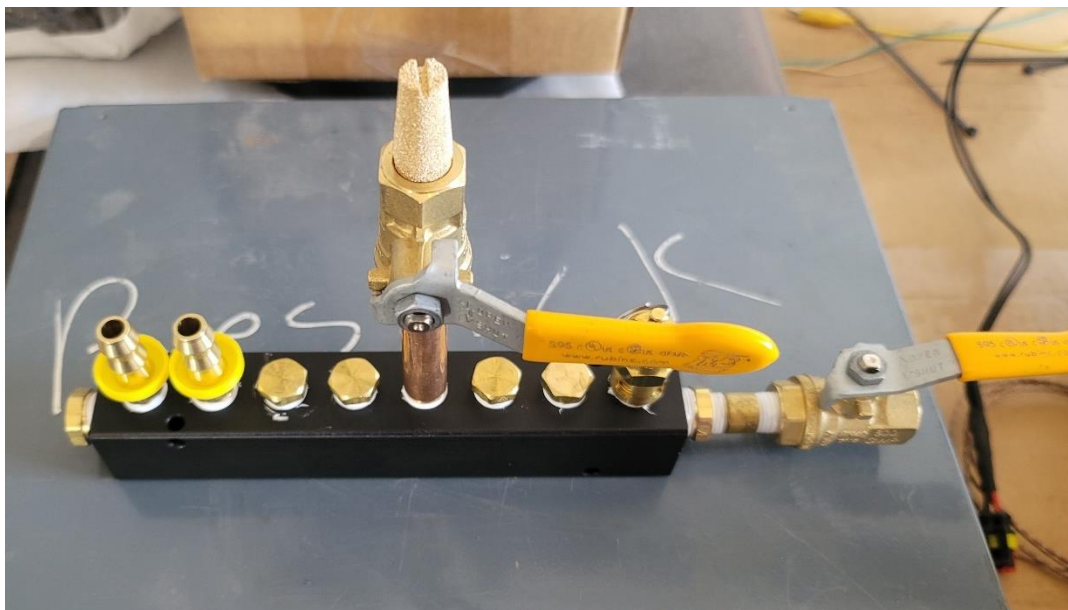
Figure 25: Control Air Distribution Block

The air operated valves, hydrostatic (Sprague) pump, and gas intensifier all required filtered, dry air to operate. The facility's air supply had insufficient air cleaning and. The air-operated valves also had a maximum operating pressure below that of the facility air compressor. To ensure optimal performance, I designed a simple air distribution manifold to clean, dry, and regulate the air. The manifold was to provide overpressure protection by means of a relief valve that would relieve pressure prior to the manifold exceeding the valve's design limit. The pressure regulator selected has an integrated filter, water separator, and regulator to prepare the air. Orifices were used to ensure that the air valves do not operate too quickly which may cause damage. Manual isolation and vent valves allowed for proper ventilation and isolation as necessary. The air pressure was not considered high energy and is therefore safe to operate locally. A COTS distribution block, shown in Figure 25, provided a stable platform to attach the components together and had spare ports for expansion in the future if desired. Figure 26 shows the final schematic of the control air manifold.

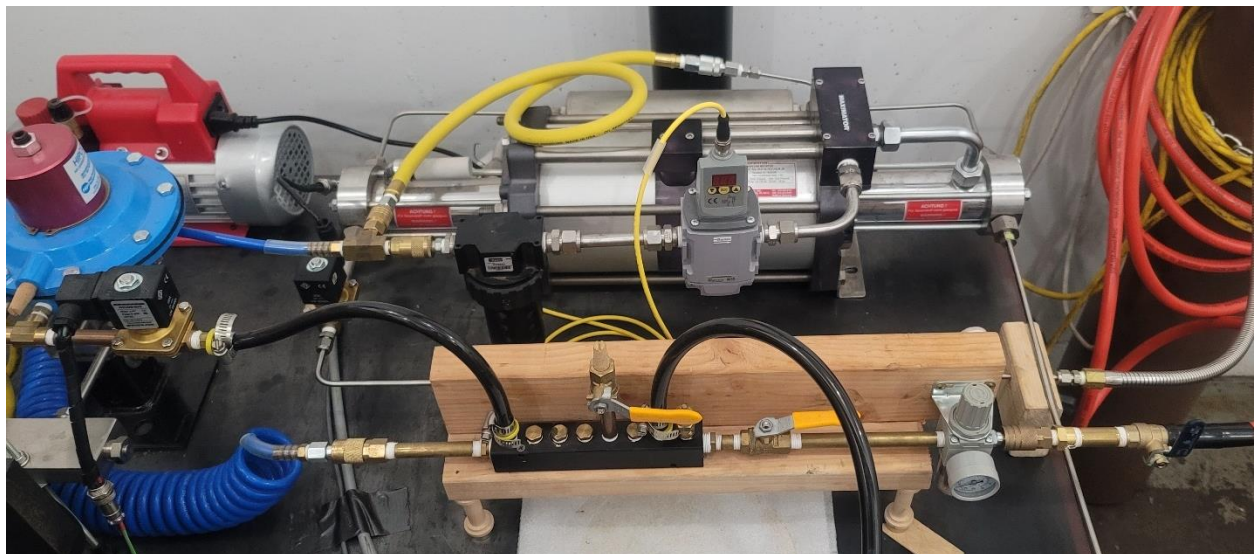
The Control Air Manifold was positioned behind the inlet side of the test stand and is shown in Figure 35. The air manifold was elevated on a wooden structure to provide adequate space for proper function of the automatic water drain valve of the pressure regulator. The blue hose in the photo was for initial Sprague pump and intensifier functional testing but does not provide full air pressure at elevated levels for testing. The Sprague pump and intensifier are connected directly to the building air compressor for actual testing.

Figure 35: As-Built Test Stand Control Air Manifold and Intensifier

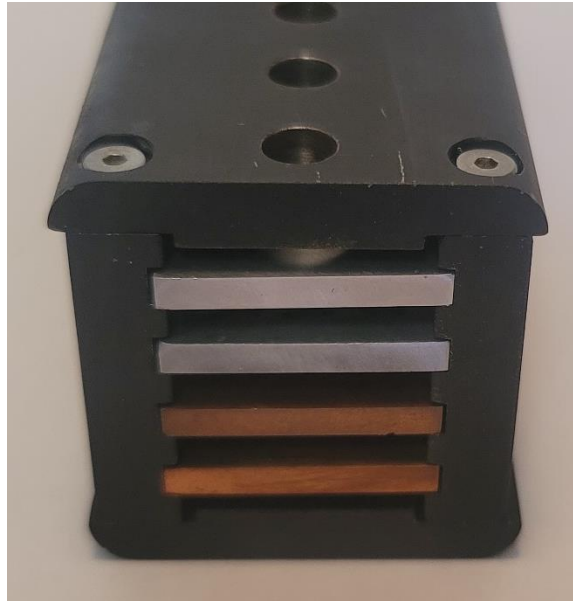
Figure 41: Coupon Holder Loaded with Material Coupons for Testing

For demonstration testing, the coupons were loaded into the holder and supported only by a narrow shelf on the edges. This provided minimum contact between the holder and coupon and

enabled the coupon to move freely. It was possible that the material would deform at pressure if not restrained. Figure 41 shows the coupon loaded with coupons for testing.

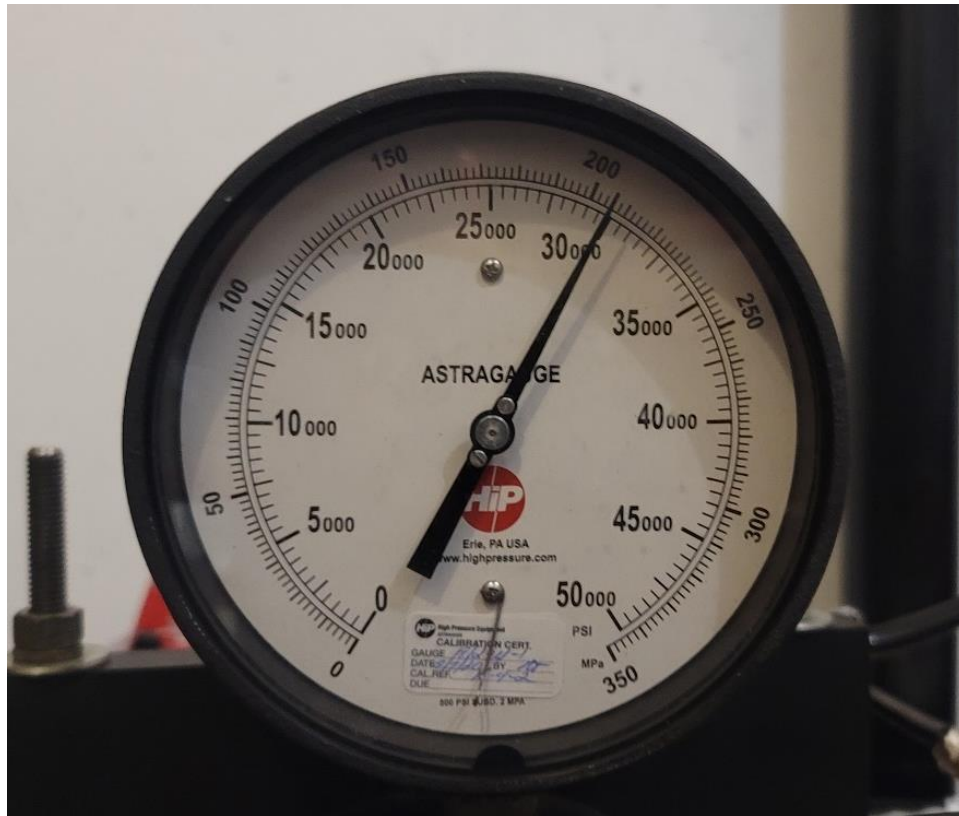
At 30,000 psi, the system was held for 30 minutes to enable small droplets to form from joints as well as for deformation of components to reach an observable amount. I selected a 30-minute hold based on my experience in hydrostatically testing water distribution systems. Figure 42 shows the primary test gauge during this hold.

Figure 42: Proof Pressure Test Primary Pressure Gauge at Test Pressure - 30,000 psi

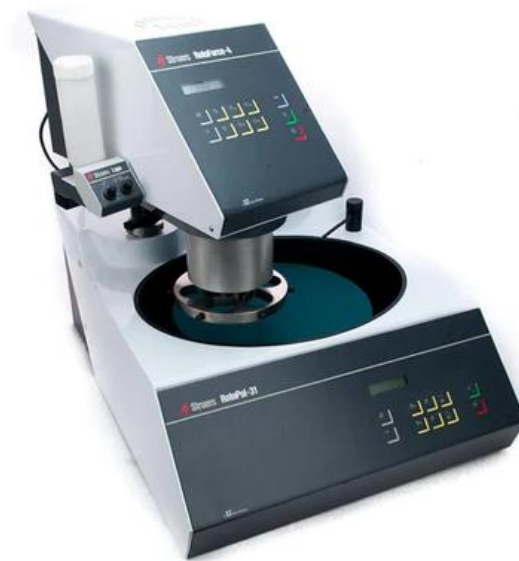
A Struer's TegraPol-31 Auto Polisher was used to polish the pucks using a specific force and duration as dictated by the manufacturer's recommendations for each alloy. Figure 46 shows the polisher.

Figure 46: Struer's TegraPol-31 Auto Polisher - Stock Photo [25]

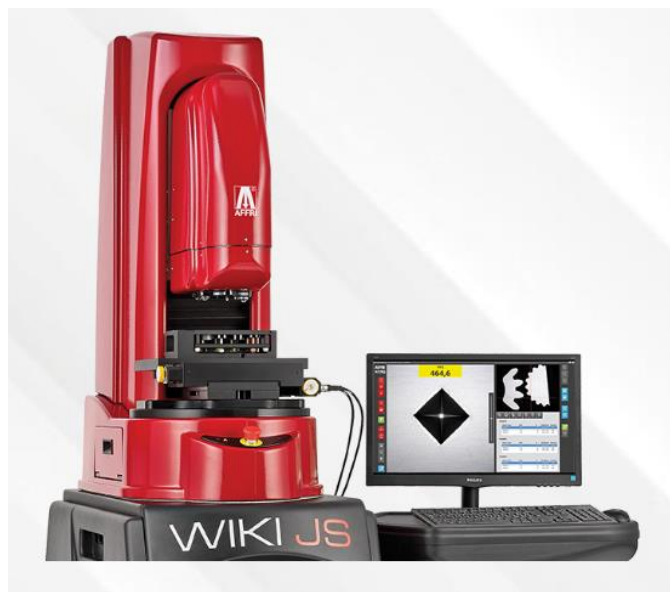
Figure 49: Affri Wiki 200 JS 2 Indenter - Stock Photo [26]

For the microhardness testing, Element Labs utilized a Affri Wiki 200 JS 2 Indenter and Clemex Software. Figure 49 shows the indenter.

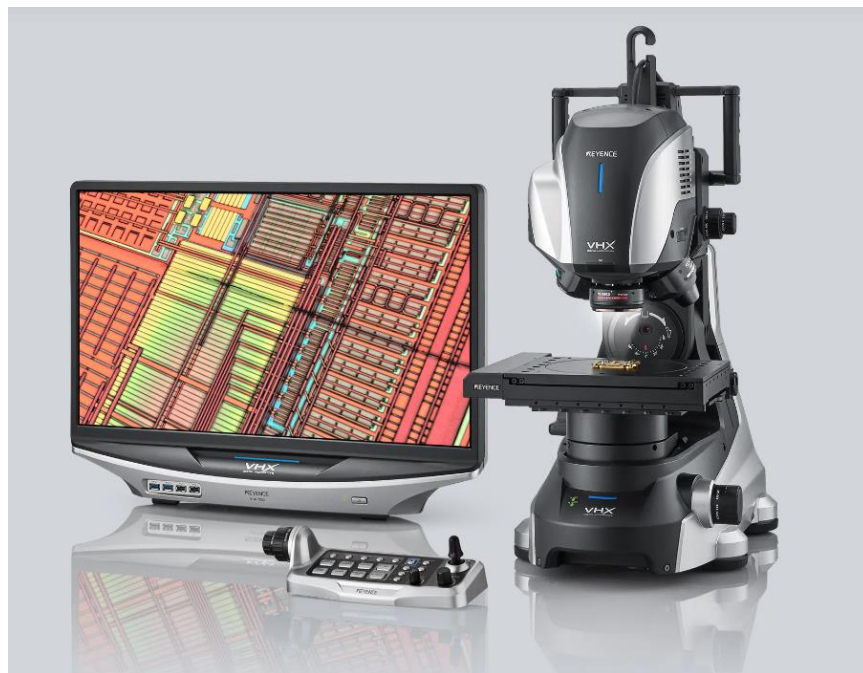
Imaging was performed at the Samuel Roberts Noble Microscopy Lab (SRMNL) on a Keyence VHX-7000 ultramicroscope. The SRMNL houses several different pieces of equipment including Advanced Light - Confocal Microscopes, Scanning Electron Microscopes (SEM), Transmission Electron Microscopes (TEM), and Specimen Preparation Equipment. The VHX-7000 is a fully automated optical digital microscope with magnification from 20x to 6000x. The companion computer setup provides software for detailed picture analysis and comparison at any level. Figure 50 shows the ultramicroscope.

Figure 50: Keyence VHX-7000 Ultramicroscope - Stock Photo [27]

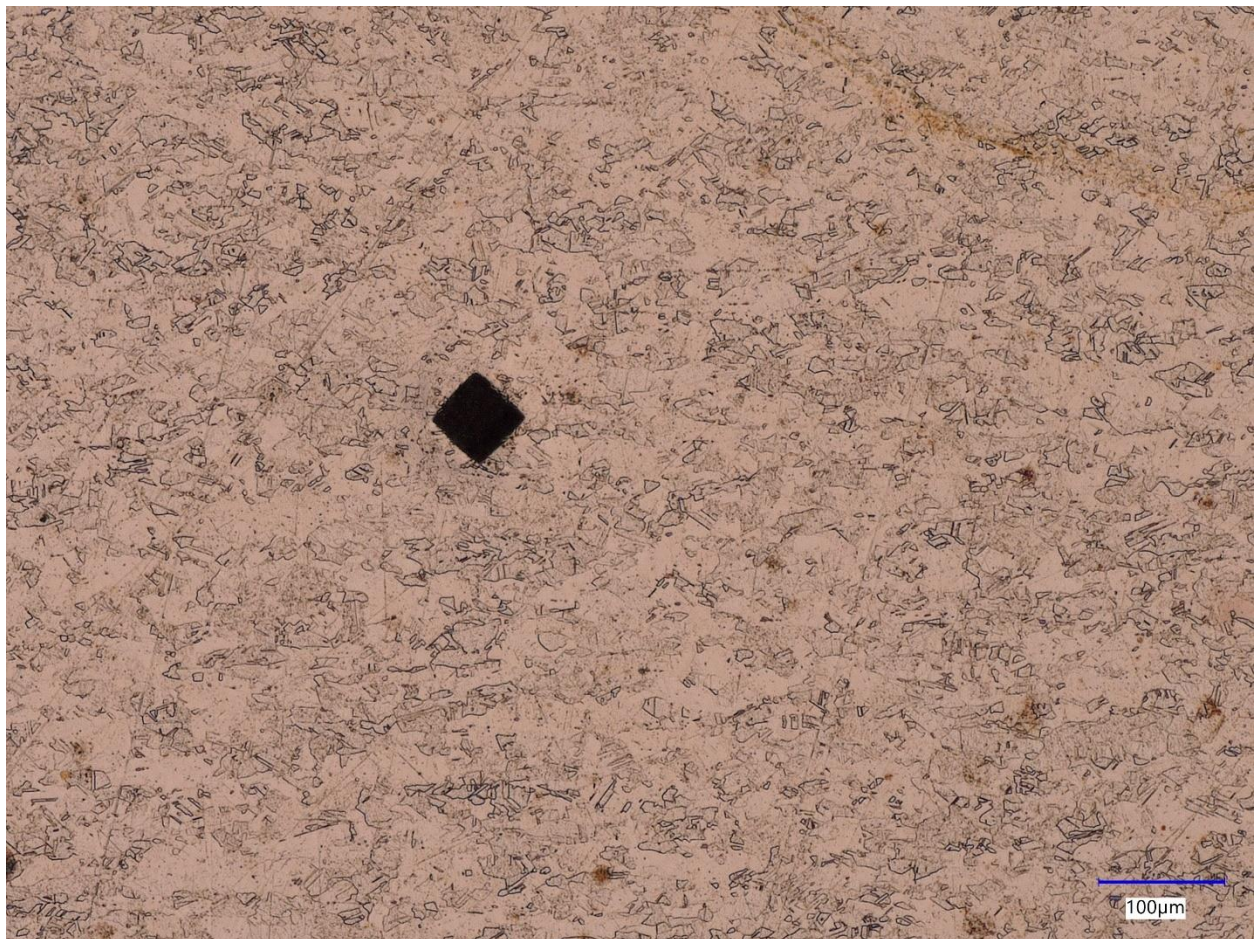
Figure 62: Pretest M1-07 300x Coaxial

Figure 62 shows one of the 110 Multi-Purpose Copper - Annealed (M1) coupons. At 300x magnification, we can easily distinguish the diamond-shaped hardness indentation and see the stain outlining surface features. Using coaxial lighting provided a better view of the stain but did not make the surface topography any clearer it only showed that it exists. Small red splotches on the surface are corrosion or contamination were visible at 300x. As magnification increased, these spots should be avoided or they may obstruct a clear view of the material structure. Very subtle scratches from the polishing process were visible but they were fine enough and few enough that as we increase magnification, we can also find locations of interest where these lines do not exist. The lines and surface corrosion can help locate points of interest, so removing them is not necessarily ideal.

Figure 63 shows a surface that is more densely covered in stained surface features than the surface seen in Figure 62. This was as expected because you would expect more closely packed and smaller grains in a harder material.

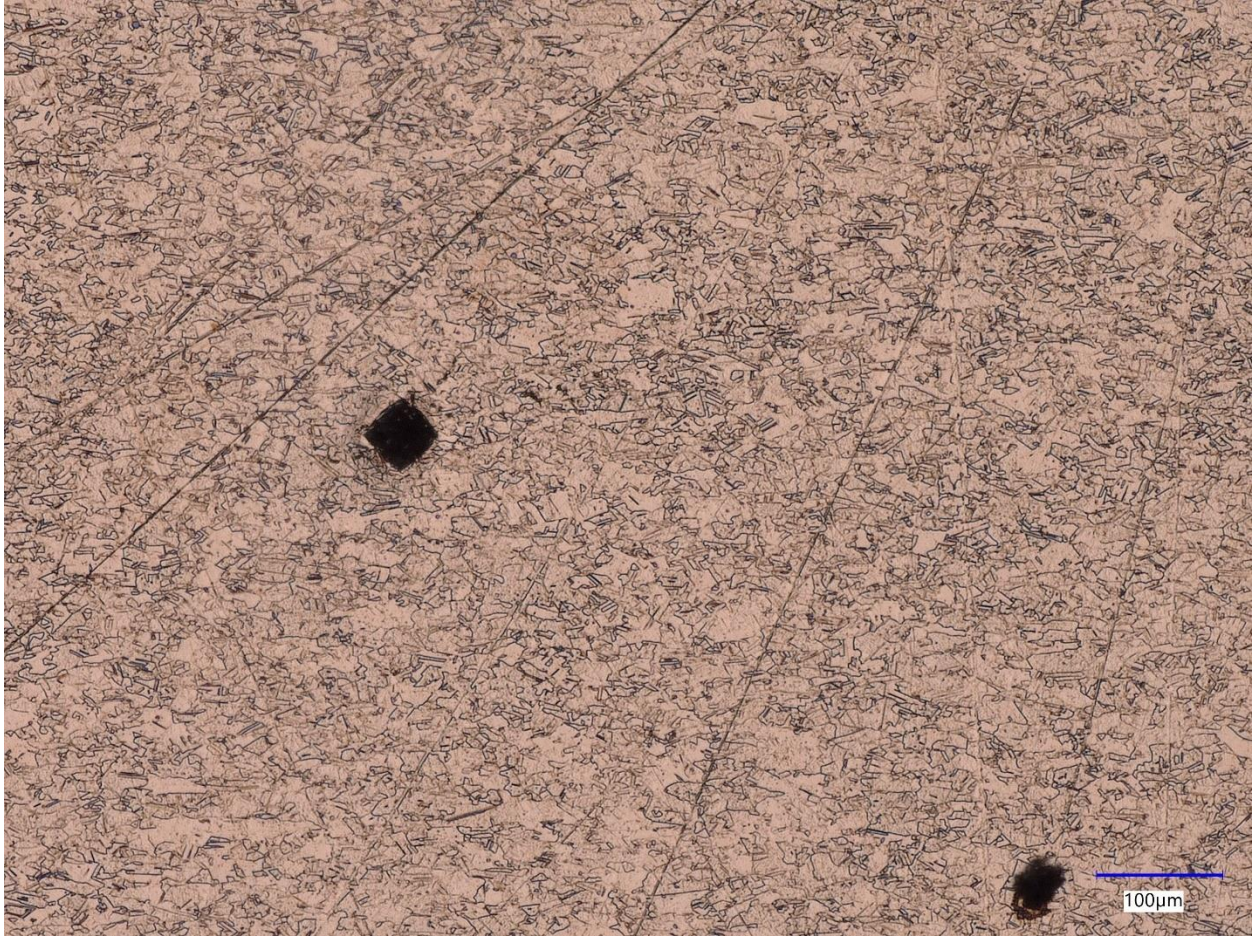
Figure 63: Pretest M2-03 300x Coaxial

Figure 63 shows a 110 Multi-Purpose Copper – 1/2 Hard (M2) coupon at 300x magnification with coaxial light. The polishing lines are more pronounced and run in a similar direction. Grain lines are unlikely to be straight and will travel in multiple directions based on their formation and the material processing techniques. The fact that these are straight and in similar direction these resulted from a polishing process and are a surface characteristic. If we were polishing by hand, once we are finished removing all the lines except those in the same direction at a particular grit, we can rotate the sample 90 degrees and proceed to the next step of polishing until these lines are gone. Going back and forth in that manner ensures that we are polishing the entire surface to a certain level before moving on to another polishing stage.

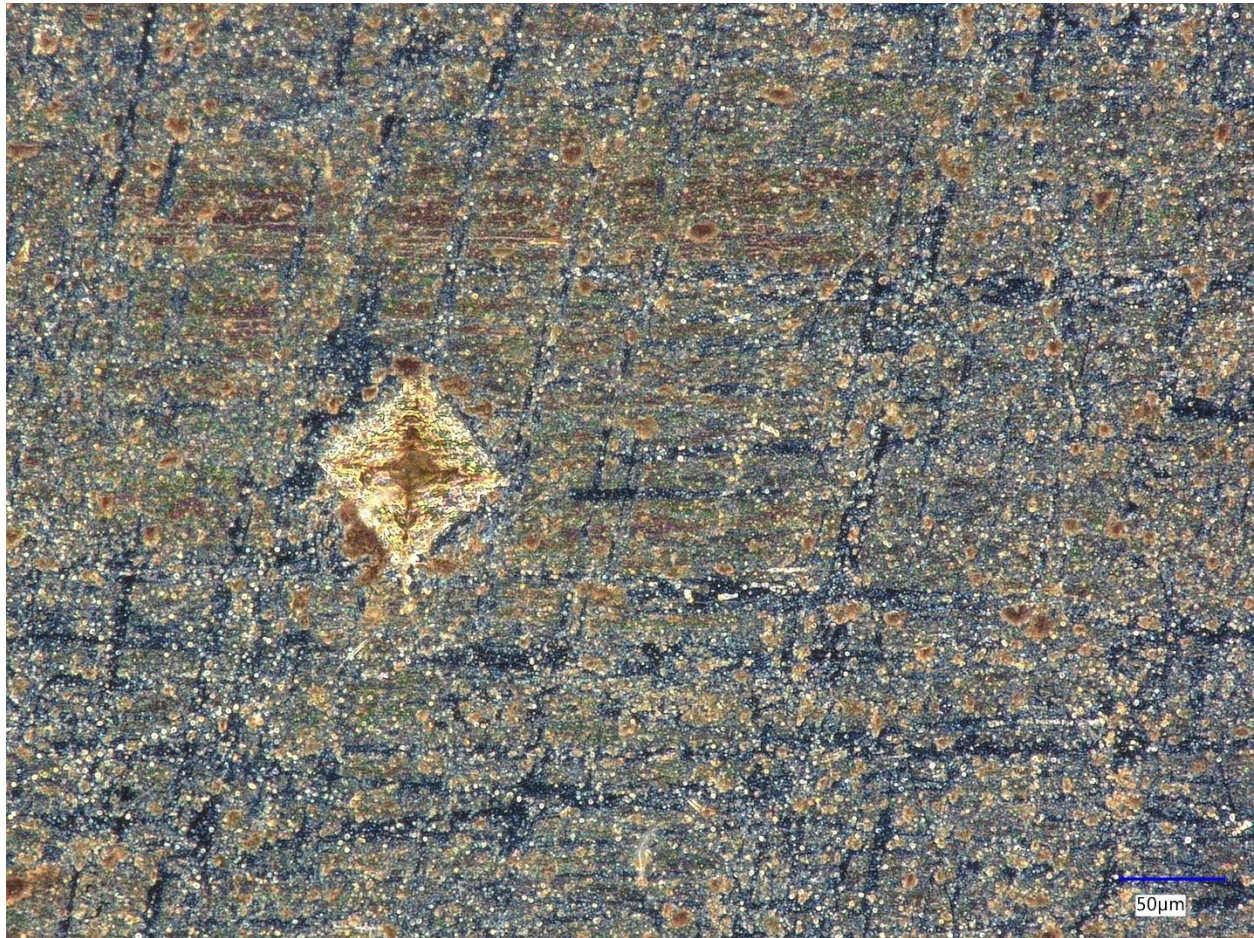
Figure 64: Pretest M5-05 500x Full Ring

Figure 64 shows a 1100-H14 Hardened Easy-to-Form Aluminum (M5) coupons. At 500x magnification and in full ring lighting, we see a clearer picture of the indentation shape and see the high and low spots of the topography. The brown spots on this surface are obstructing the grain structure of the aluminum and are likely residual particles of the polishing compound or excessively reacted areas of the aluminum staining process. 1100 series aluminum is a pure aluminum and very soft. Particles and contamination often embed themselves in the surface unless

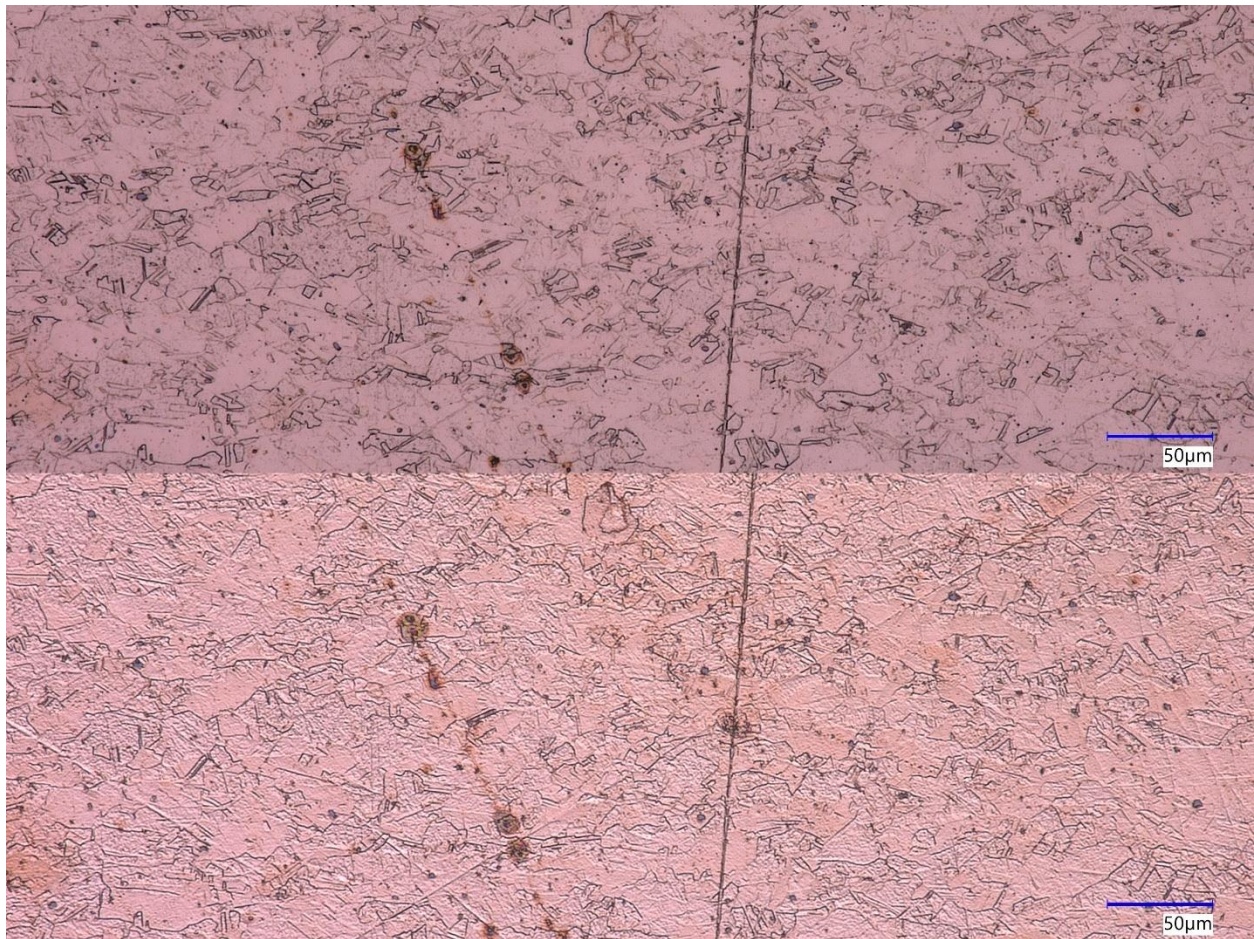
Figure 70: M2-07 Side-by-Side Pre\_Post 500x

Following my pressurization cycle, I repeated the process of capturing individual photos as well as created new split and quad images to assist in comparison. The goal of these posttest images was to capture the exact same locations as the pretest so comparisons can be easily made. Figure 70 shows a pretest and posttest image comparison for a 110 Multi-Purpose Copper – 1/2 Hard (M2) coupon.

We can see in this side-by-side comparison that while the general surface topography did not change, there are indications of some event occurring due to the pressurization cycle. The slightly darker upper section is due to the changes in the brightness settings during imaging and is not a material characteristic. The next section will discuss additional differences.

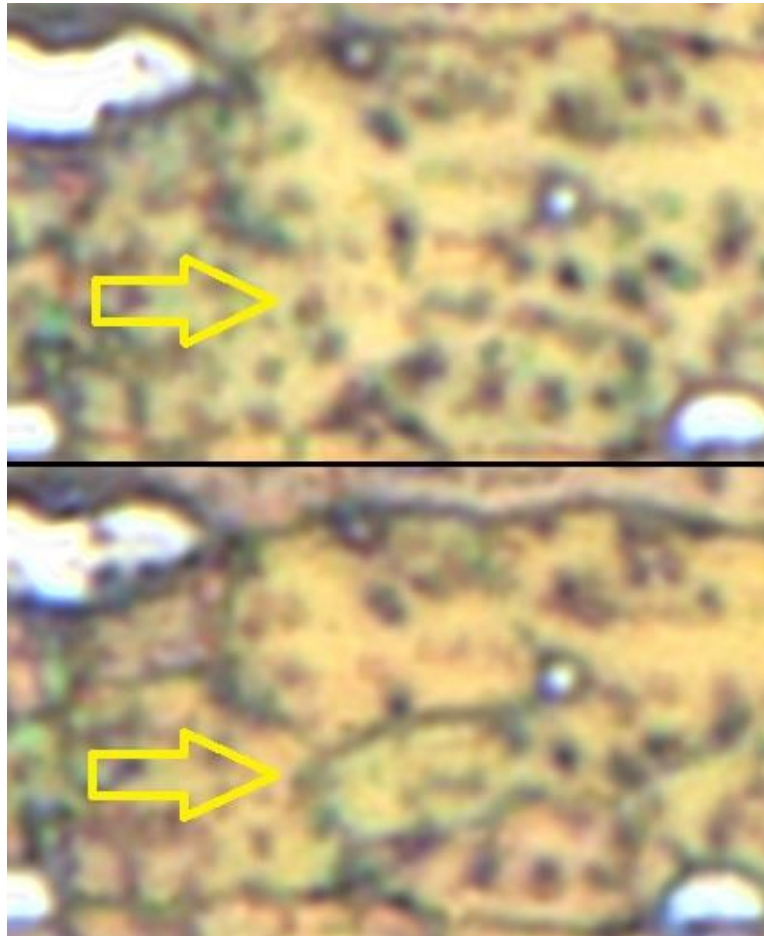
Figure 97: M6-07 Coaxial Comparative Split 4000x Pre\_Post Area 1 Focus

Figure 97 compares the M6-07 coupon, 4000x data focused on the area indicated by the yellow arrow. Like the area on the M6-05 coupon, this area exhibited a color shift and boundary line development.

This image shows a feature line that developed along the upper edge of the newly-formed area, connecting several smaller surface anomalies indicated by black dots. Within this area, the color shifted slightly from a lighter yellow to a tinted green, while the area outside it remained mostly light yellow. To further investigate this area, 3D topography images and surface track lines

Several changes occurred in this area. First, several low valleys in the area disappeared. This could be due to the slight change in angle of the sample between pretest and posttest imaging, which have affected the light, or they could have been caused by movement in the surface material. Future testing should endeavor to maintain a more consistent surface-to-lens orientation to reduce the risk of this being an artifact of the imaging process. Second, as indicated by the curved red line, a ridge formed across the region corresponding to the new boundary line that can be seen in Figure 97. This ridge corresponds to the new feature line that can be seen in the posttest imaging and would indicate that when the material was subjected to pressure, the material was compressed sufficiently to cause plastic deformation resulting in a new updrift. The third change is indicated by the red arrow. Another more pronounced updrift of material appeared on the southern edge of the new grain area. Other updrifts can be seen in other areas of this color map as well. These new features provided a new region on the surface of the coupon and indicated that lasting changes to the physical properties have occurred.

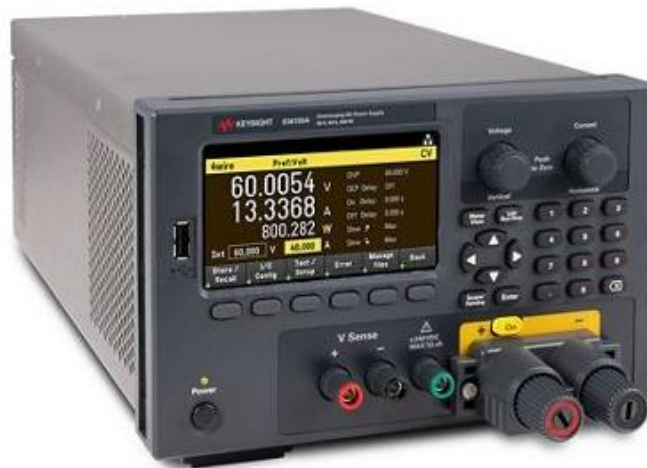
Figure 110: Keysight E36150 Series Autoranging Benchtop Power Supply - Stock Photo [33]

replaced with shielded cable and connectors and then routed to the control panel in such a way that it is not closer than six inches to power circuitry and cables. This will reduce the risk of the signal from the transducer being interfered with by induced voltages. A dedicated 10 VDC, low-noise power supply, like the Keysight E36150 series power supply shown in Figure 110, could be incorporated to provide a known, low-noise power to the transducer. This could also be used temporarily to determine if the current system is the cause of the fluctuation.

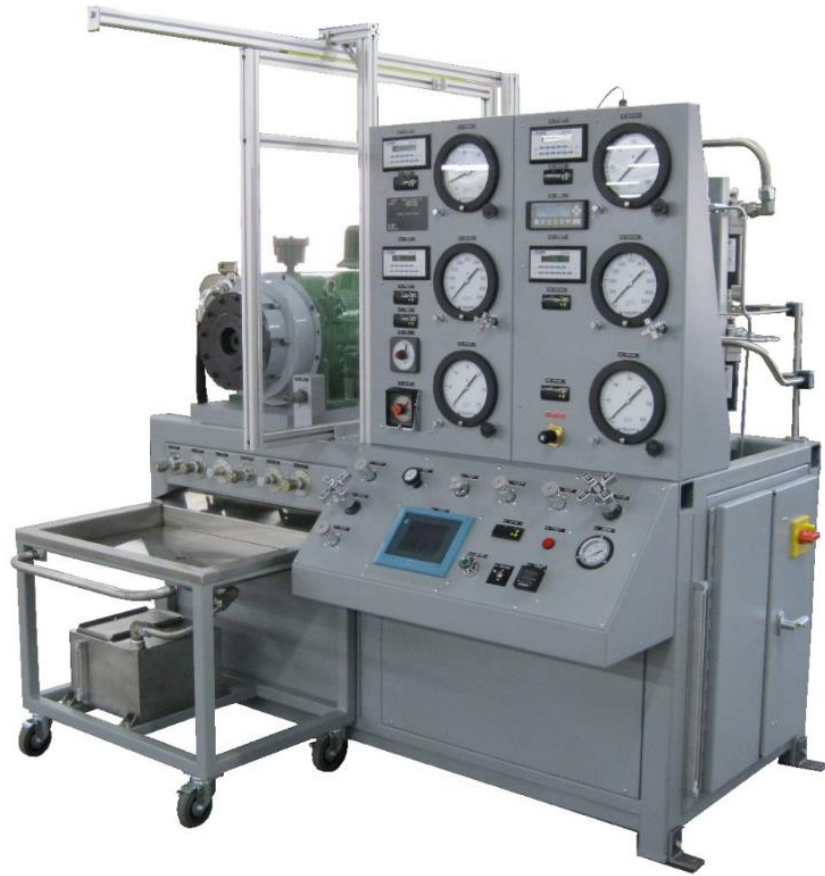
Figure 111: Staley Co. Hydraulic Test Stand Model D39110 – Stock Photo [34]

The current test stand setup has the various subassemblies such as the inlet manifolds, control air manifold, and vent manifold resting independently on the deck of the table. A gauge and valve board could be created to mount these components off the wall, providing better access to the manual valves and viewing angle of the gauges. This would reduce the required deck space and thus shrinking the overall footprint for the test stand. Figure 111 shows an example of a gauge and valve board for a hydraulic test stand. The board for my pressure chamber would not need to be as complicated.
