STRESS WAVE TIMING, A SIMPLISTIC AND COST
EFFECTIVE METHOD TO EVALUATE
DETERIORATED AND REPAIRED
TIMBER BRIDGE PILES

Submitted to the Faculty of the Graduate College
of the Oklahoma State University in
partial fulfillment of the Degree of
MASTER OF SCIENCE
July, 2007

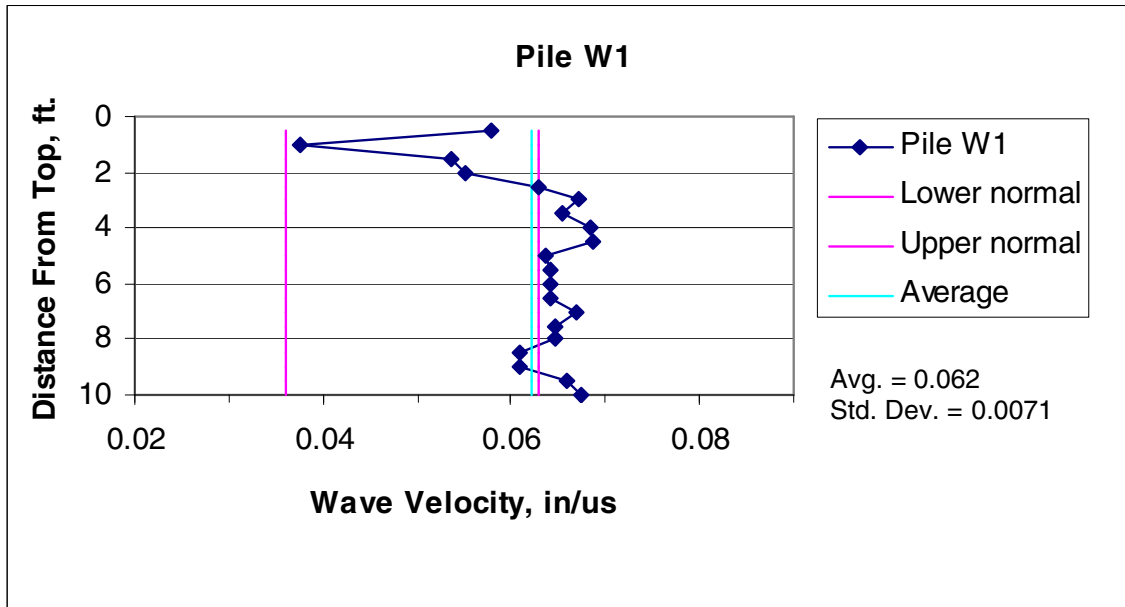
Figure 5.4. Stress Wave Velocity through Timber Pile, W1

Pile W1 appears to be in good shape. The average recorded wave velocity is right at the upper bound for sound wood. If the standard deviation is subtracted from the lowest plotted velocity (at 1' from the top of the pile), the result falls below the lower bounds of normal sound wood ($0.037 - 0.0071 = 0.0299$). However, this point appears to be an anomaly. It was taken where bracing is present, so only the north-south reading was taken. Even though access remained to the east-west data point, the brace made it awkward to take the data reading and human error may have been introduced.

Even if the extreme nature of the velocity at 1ft. is ignored, the top two feet of the pile have generally lower velocities. These lower velocities may indicate a higher degree of wood deterioration. This may be a result of long-term exposure moisture that has permeated the bridge deck. Since the velocity at 1ft. does not appear to be valid, there are no apparent problems in pile W1.

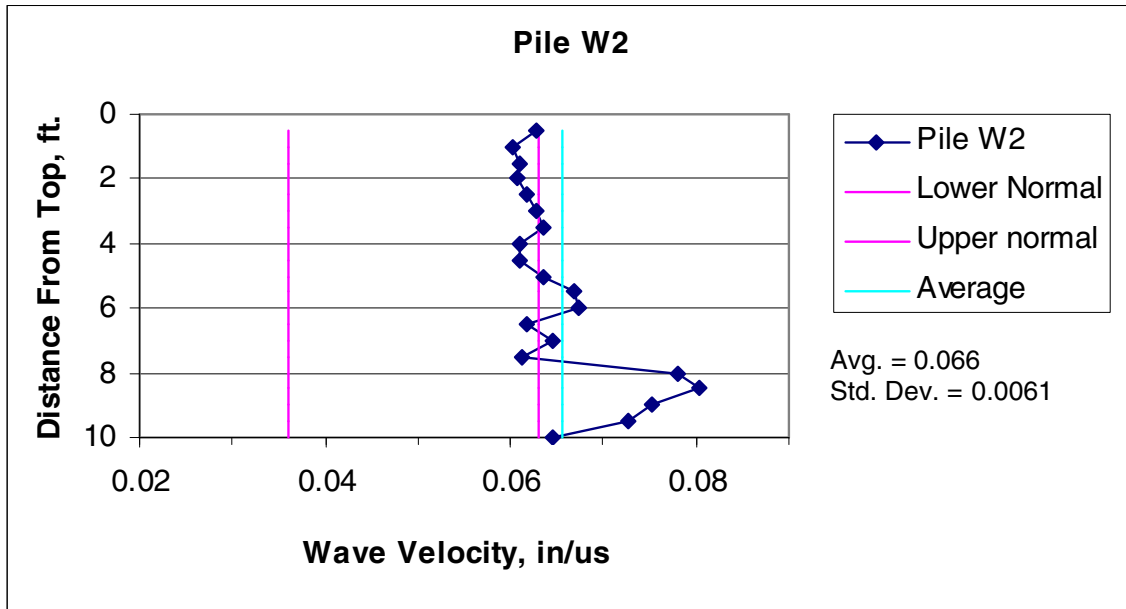
Figure 5.5. Stress Wave Velocity through Timber Pile, W2

Pile W2 appears to be in good condition as well. The average velocity for pile W2 and many of the individual plotted velocities are above the normal upper bound for sound Douglas-fir. If the standard deviation is subtracted from the lowest value (at 1ft. from the top of the pile, the result is still well within the bounds of normal sound wood ($0.060 - 0.0061 = 0.0539$).

Velocities indicate that an area about 1.5ft. long near the bottom of the pile is significantly denser than the rest of the pile. The bottom of the pile could have high long-term moisture exposure through ground contact, which should lead to greater deterioration and decreased density. This may indeed have been the case--if this area of the pile had advanced deterioration, much of it would have been drilled out and replaced with epoxy during the repair operation. If the majority of the cross section now consists of epoxy and aggregate instead of wood, the wave velocities will indeed be higher than those expected for sound wood (Bray and Stanley, 1997). The data do not indicate any problems with pile W2.

The fact that the average velocity is higher than the upper bound expected for sound wood is somewhat surprising. Piles W3 and W6 also exhibit this behavior. This gives rise to the possibility that the sound wave could travel more quickly through the fiberglass/epoxy shell than the wooden pile. It would then be possible that the times recorded were actually the time required for the wave to pass halfway around the pile through the shell, rather than directly through the wooden pile. However, if this were the case, the average velocity should remain consistent for all repaired piles (the fiberglass shell is a more uniform material than the wooden piles; results should vary little regardless of the condition of the pile within the shell). Since the average velocity is higher than the upper bound for sound wood in only 2 of 11 repaired piles, it appears that the waves were indeed passing through the pile and not around it.

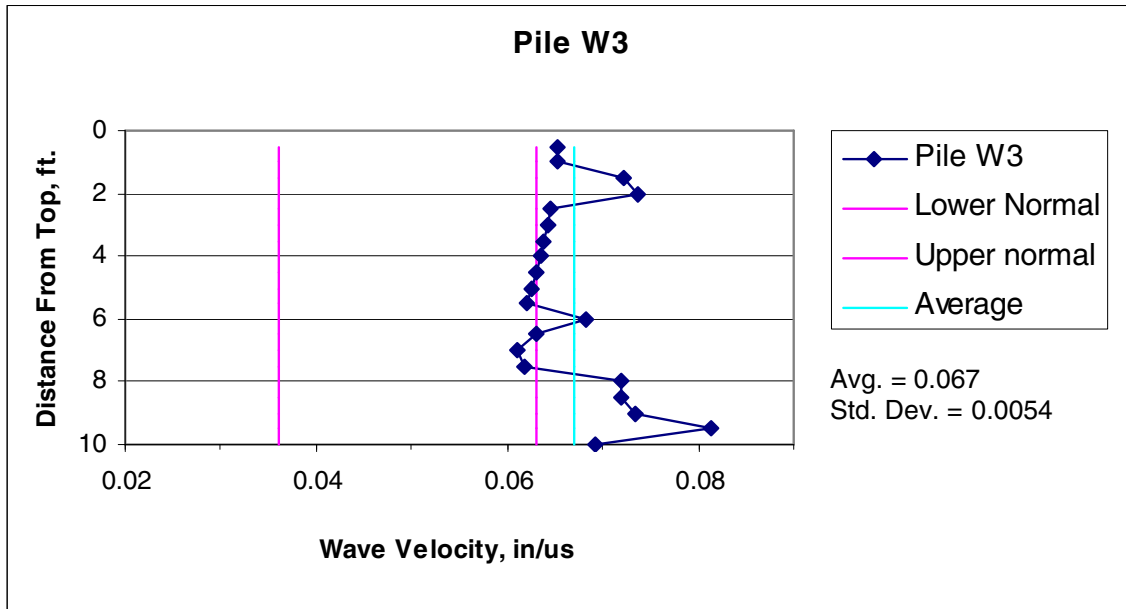
Figure 5.6. Stress Wave Velocity through Timber Pile, W3

Pile W3 is much like pile W2; the average velocity and the majority of individual velocities are actually higher than those predicted for sound wood. As with pile W2, there are localized areas of higher velocities. These areas may be the result of excessive epoxy as previously mentioned, or they could simply indicate local inconsistencies in the pile (such as large knots) which cause an increase in density. Pile W3 appears to be structurally sound.

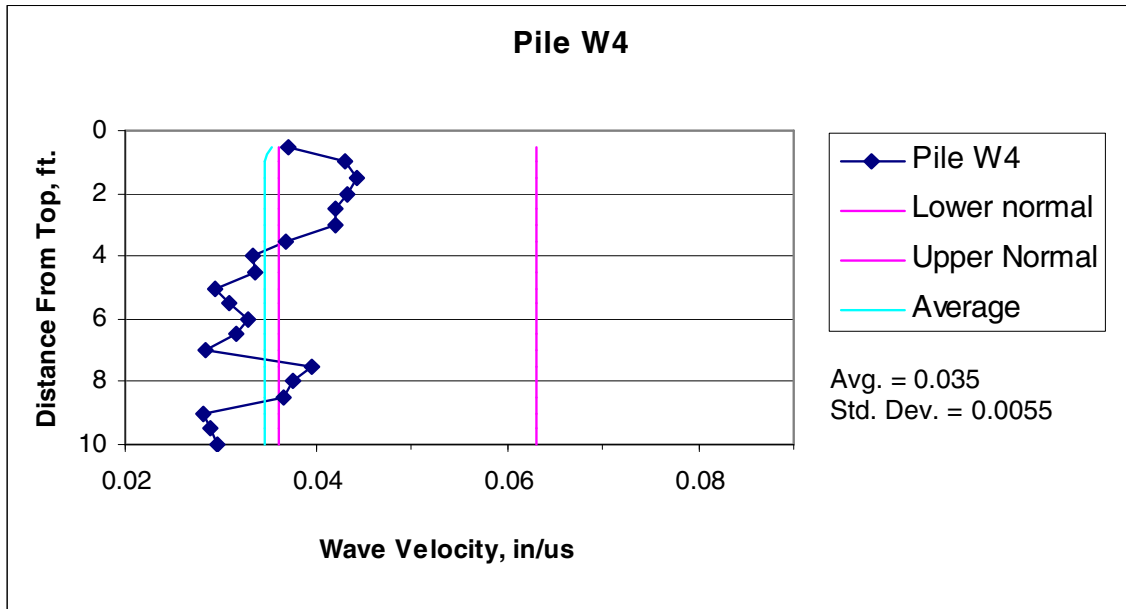
Figure 5.7. Stress Wave Velocity through Timber Pile, W4

Pile W4 was unrepaired (there was no fiberglass and epoxy wrap). The average velocity is below the lower bound for sound wood, and many individual values are well below the lower bound. Pile W4 may well be structurally deficient, and probably should be repaired just like the other eleven piles. The average velocity for the un-repaired pile is approximately half that of the repaired piles. This indicates that the repaired piles may be thoroughly saturated with epoxy, causing the majority of each repaired pile to be much denser than the aged wood present in pile W4.

- Stress wave timing conducted on Cotton County Bridge was adequate to evaluate the repaired timber piles. Some of the piles should be re-examined which are piles W4 and E2. Pile W4 was the only unrepaired pile and had the lowest stress wave velocities. The pile should be repaired before decay progresses.

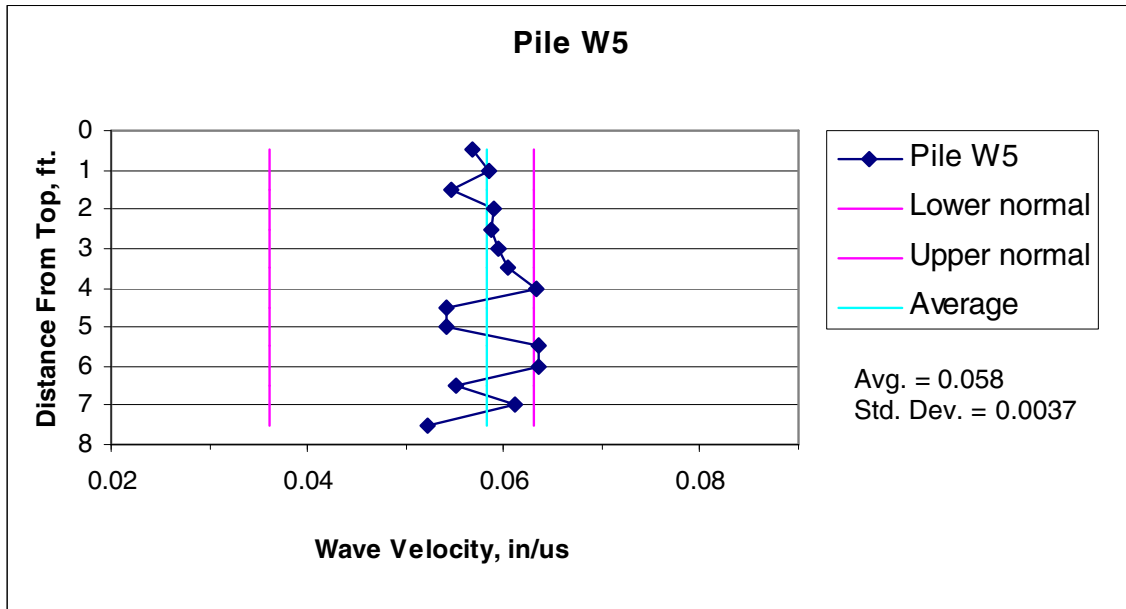
Figure 5.8. Stress Wave Velocity through Timber Pile, W5

Pile W5 yields very reasonable velocities. The average falls nicely within the bounds expected for normal sound wood. No individual velocity minus the standard deviation falls below the lower bound, so there do not appear to be any problem areas within pile W5.

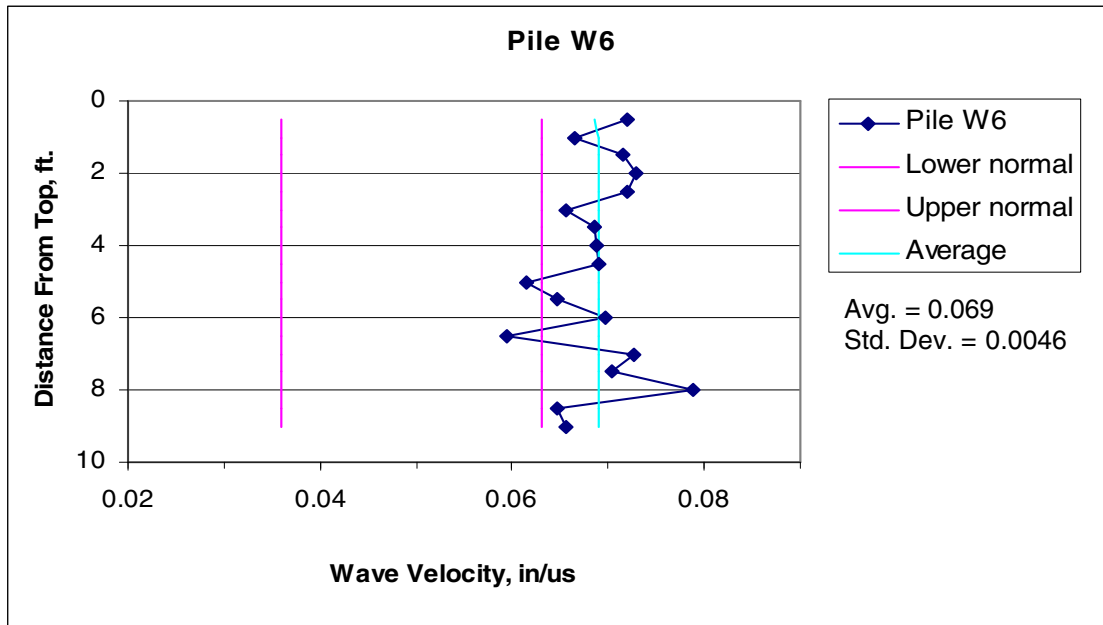
Figure 5.9. Stress Wave Velocity through Timber Pile, W6

Pile W6, like piles W2 and W3, displays an average velocity above the upper bound expected for sound wood. Only two individual values are even low enough to fall within the bounds for sound wood. Pile W6 was likely severely deteriorated before repair, and now contains large amounts of epoxy. It should currently be more than structurally adequate.

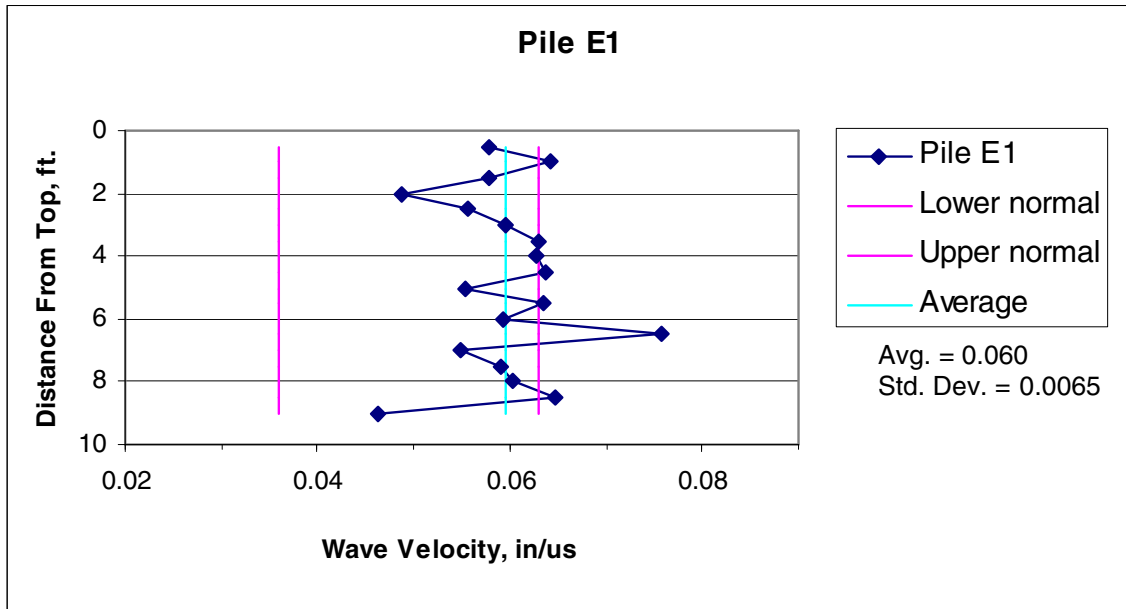
Figure 5.10. Stress Wave Velocity through Timber Pile, E1

The velocities for pile E1 appear to be widely scattered, and E1 does exhibit one of the higher standard deviations. However, the lowest velocity minus the standard deviation yields a value that still falls within the bounds for sound wood ($0.046 - 0.0065 = 0.0395$). The fact that the velocity at 8.5ft. from the top of the pile is so much different than the value just 0.5ft. lower suggests the possibility of an erroneous data point at 9.0ft. Otherwise, the low velocity may be a result of decayed wood that was not fixed during the repair process. The high velocity at 6.5ft. from the top is difficult to explain. However, bracing was present at 5.5ft. and 6.0ft., so the awkward access to data points in those areas could have introduced human error in the data acquisition.

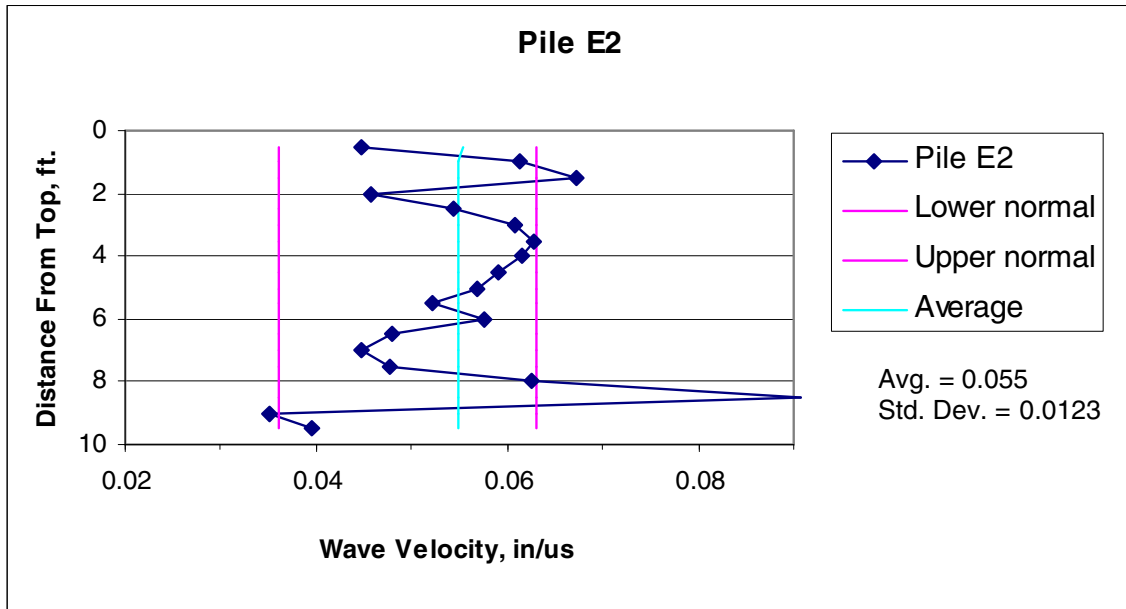
Figure 5.11. Stress Wave Velocity through Timber Pile, E2

Pile E2 shows very erratic results and has the highest standard deviation.

Fluctuations in wave velocities in the top 8ft. of the pile may be a result of any previously mentioned conditions. The bottom three data points appear to be unreliable, as they contain both the highest and lowest velocities at adjacent points. The bottom three data points were also taken where bracing is present. As previously mentioned, human error is more likely near the brace points. Also, the attachment of the brace may cause fluctuations in the data. The bottom three data points are also a major cause of the high standard deviation. If these data points were excluded, the standard deviation would be 0.0074. At that standard deviation, the remaining data indicate that the pile is still sound. However, it might be advisable to re-examine this pile in the near future.

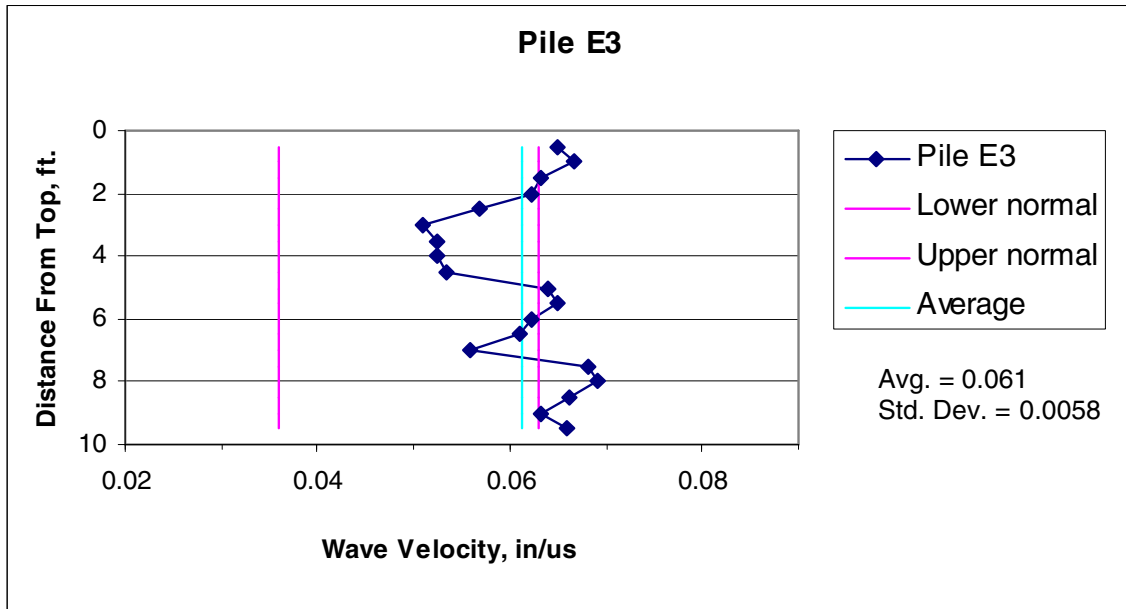
Figure 5.12. Stress Wave Velocity through Timber Pile, E3

Pile E3 also shows scattered data, but the average velocity is near the upper bound expected for sound wood. The lowest value minus the standard deviation is still within the bounds for sound wood ($0.051 - 0.0058 = 0.0452$). This indicates that although some regions are more solid than others, there are not problem areas in pile E3.

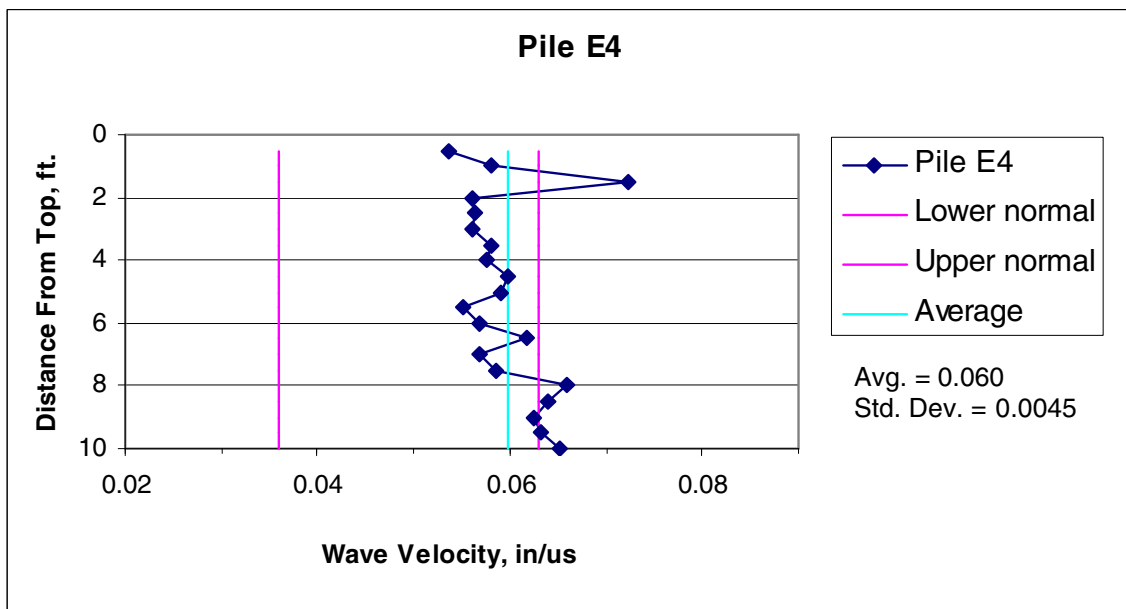
Figure 5.13. Stress Wave Velocity through Timber Pile, E4

Pile E4 exhibits relatively consistent data, with one of the lower standard deviations. Again, the average velocity is near the upper bound expected for normal sound wood. The lowest value minus the standard deviation is still well within the bounds for normal wood ($0.054 - 0.0045 = 0.0495$), which again indicates that there are no problem areas within pile E4. The high velocity at 1.5ft. down from the top likely indicates a locally hard area in the pile, such as a large knot in the cross section. The rest of the velocities generally tend to increase down the pile. This may indicate that the pile originally suffered from steadily worsening decay down its length. After repair, the pile contains steadily increasing epoxy content down its length which accounts for the increasing velocities.

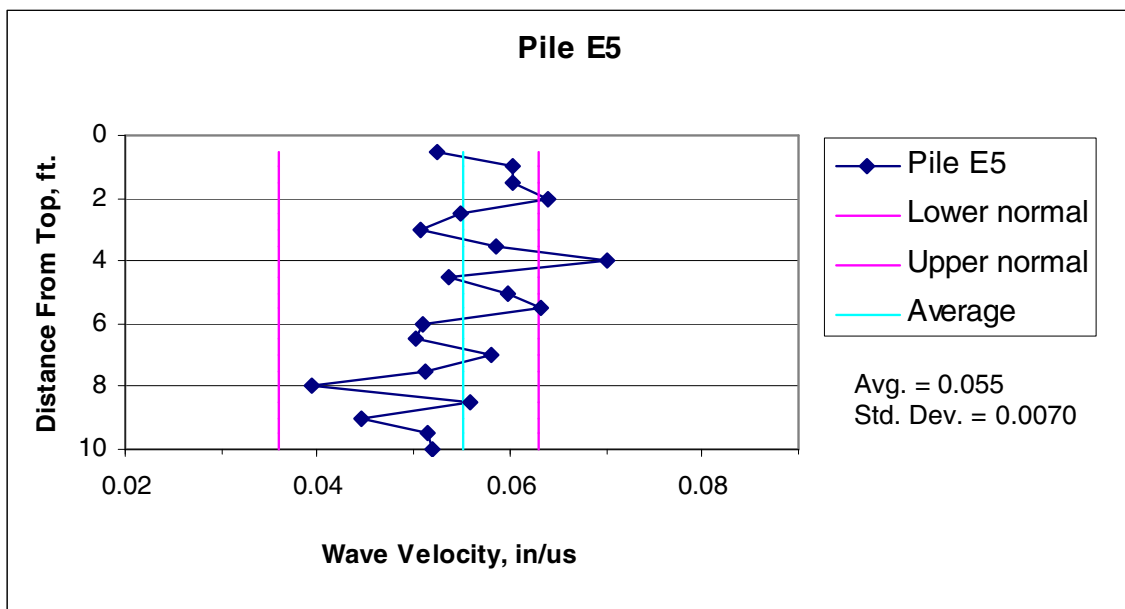
Figure 5.14. Stress Wave Velocity through Timber Pile, E5

Pile E5 exhibits widely scattered data, with one of the higher standard deviations. The average velocity falls within the bounds expected for normal sound wood, but the lowest velocity minus the standard deviation falls below the bounds for sound wood ($0.039 - .0070 = 0.032$). This indicates a point of concern at 8ft. down the pile. This area

of the pile should probably be rechecked at regular intervals to ensure no further deterioration occurs.
