PERFORMANCE OF ULTRA THIN WHITE TOPPING
IN OKLAHOMA

Submitted to the Faculty of the
Graduate College of the
Oklahoma State University
in partial fulfillment of
the requirements for
the Degree of
MASTER OF SCIENCE
July, 2011

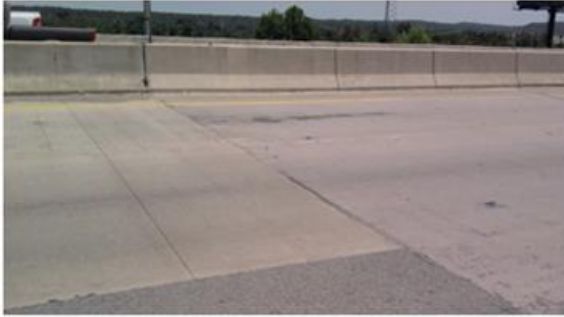
Figure 2.12 – The overlay terminates at a bridge and does not show any distress.

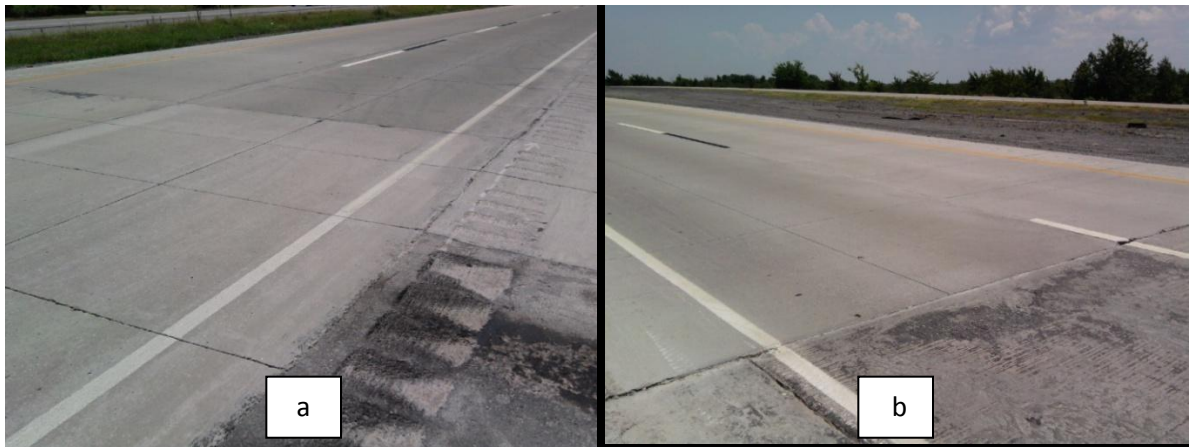
The figures below show the good condition of the overlays. Figures 2.16 a and b show the start

and the end of the south bound overlay. The good condition of the overlays is seen in all the photographs.

Figure 2.16 - Photo a showing start and photo b showing end of the south bound overlay.

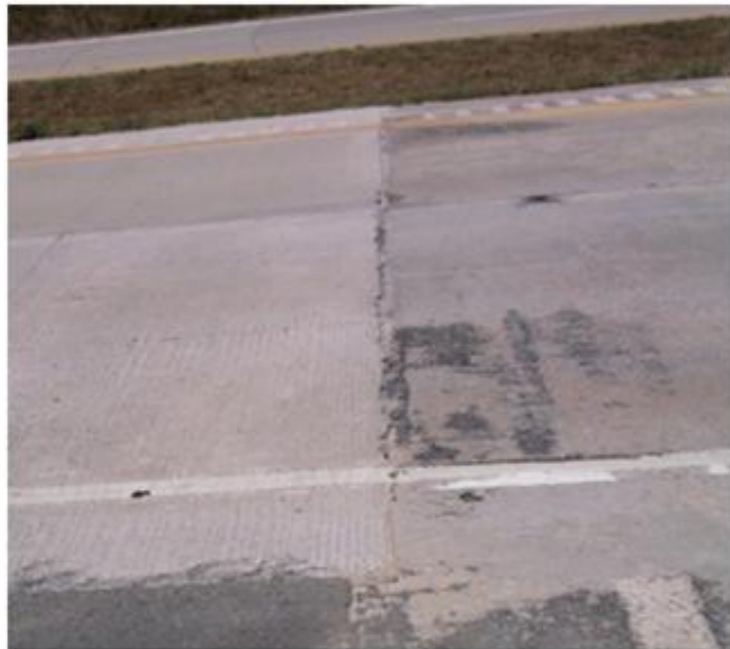
Figure 2.20 – The interface of the overlay and the adjacent pavement is in good condition.

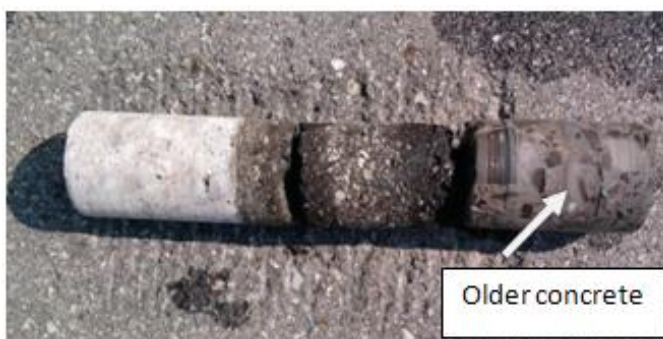
Figure 2.27 – Core from location 9.

Coring on the Chockie Overlay showed that the asphalt that was placed on top of an old concrete layer. The asphalt layer was 8” to 9” in the driving lane and 10” to 12” in the passing lane. The constant depth of the old concrete pavement was 6”. Four cores were taken at the locations 2 and 7 in the passing lane and 3 and 9 in the driving lane as shown in Table 2.11. Figure 2.27 shows the core at location 9.

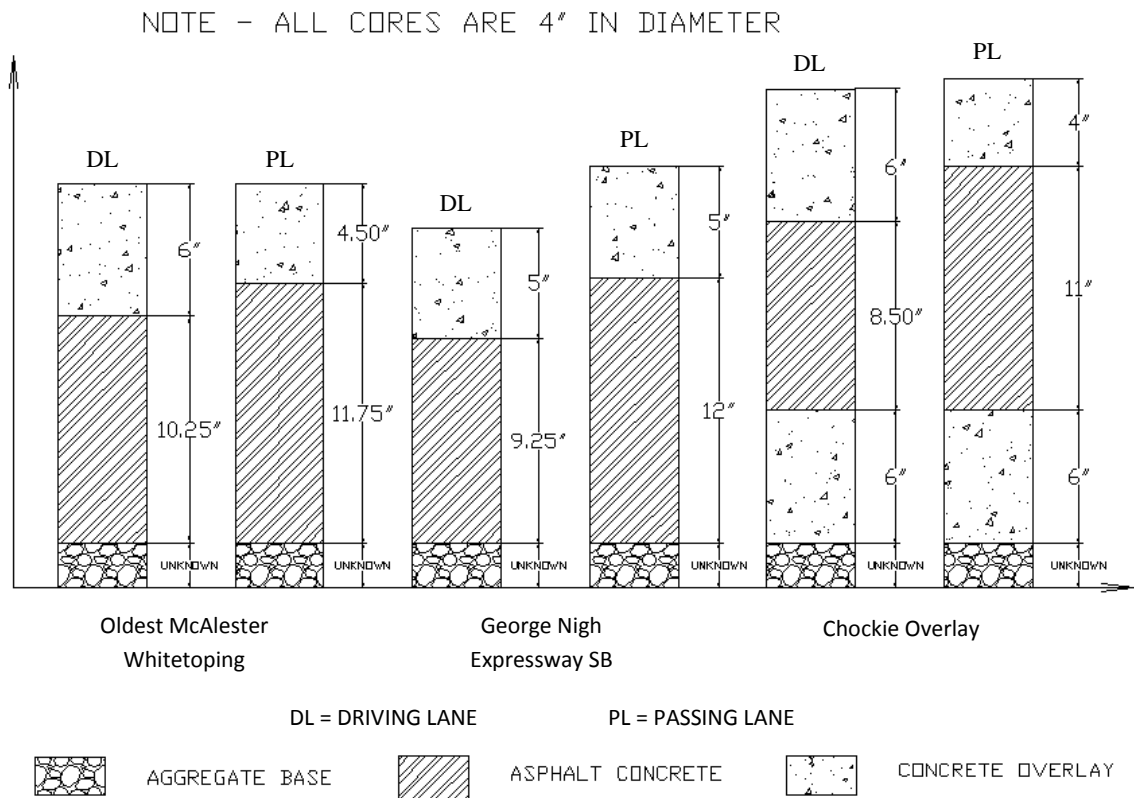
Figure 2.28 shows a comparison of the cores extracted from the overlays. As seen in the figure there is a difference between the overall depth of the material (concrete and asphalt) below each overlay. The George Nigh SB Whitetopping had the least amount of support material when compared to the other overlays but still shows satisfactory performance. It will be interesting to see how this material impacts the long term performance of this overlay compared to the others. The thickness of aggregate base is not included as the coring operations were only carried out from concrete overlay to the end of asphalt layer or to the bottom of the older concrete pavement for the Chockie Overlay.

Figure 2.28 - Details of different cores extracted from Overlay 1, Overlay 2 and Overlay 6 from left to right respectively. The values shown are an average of two core measurements.

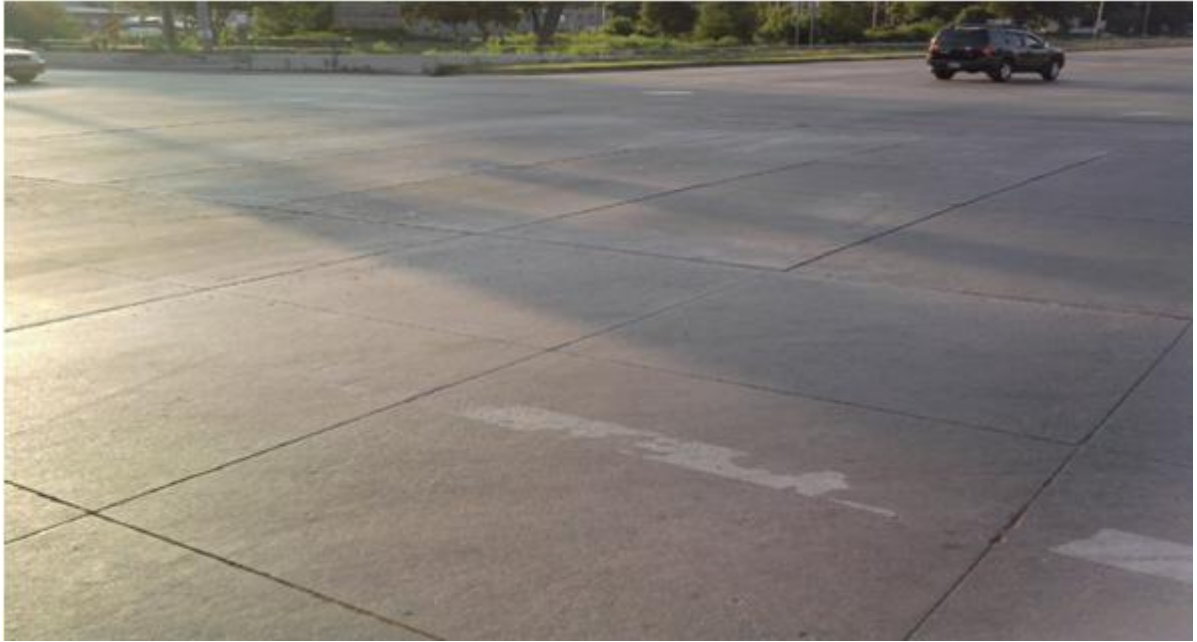
Fig. 2.31 is a photo taken from the edge of the gas station towards the north-west. The panels of the intersection seen in this photo look excellent. There was negligible amount of distress on this side of the intersection. Also the approach from south as shown in Fig. 2.32 does not show any damage. One explanation for this is that there was no elevation difference between the asphalt and concrete overlay. The panels, as seen in Fig. 2.33, on the approach lanes from south to the intersection on US – 177 look in good condition. Again Fig. 2.34 shows the same good conditions of the panels on the approach from the north to the intersection on US – 177. The area shown in Fig. 2.35 is the approach on US – 177 from the north side. Fig. 2.35 supports the hypothesis that if there is no elevation difference between the asphalt pavement and the concrete overlay, the initial panels will show good performance.

Figure 2.31 - Intersection as seen from the edge of gas station towards north-west.

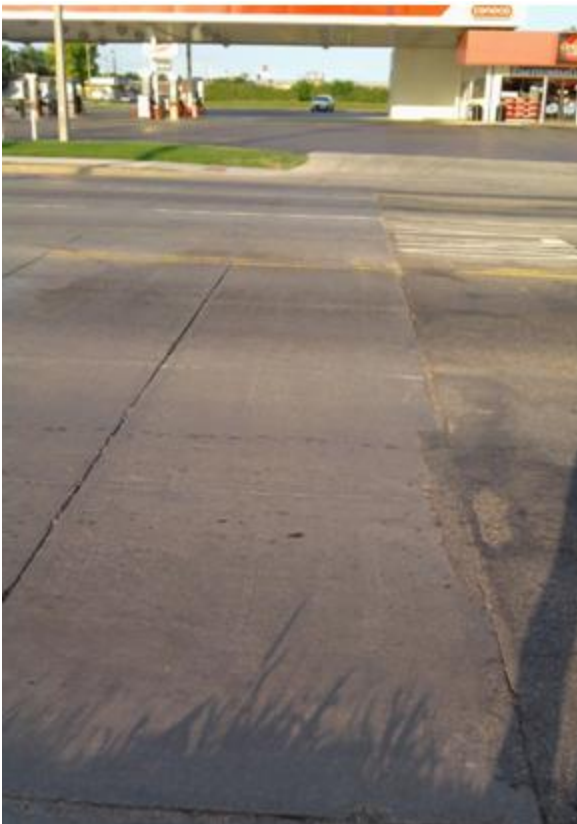
Figure 2.32 - Approach on US 177 from south on showing excellent condition of initial panels.

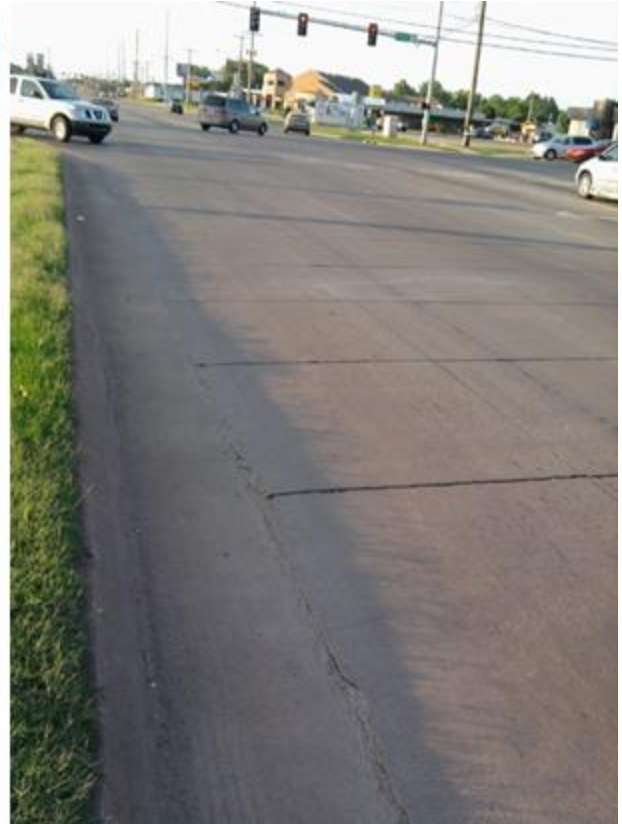
Figure 2.33 - Excellent condition of panels US 177 from the south.

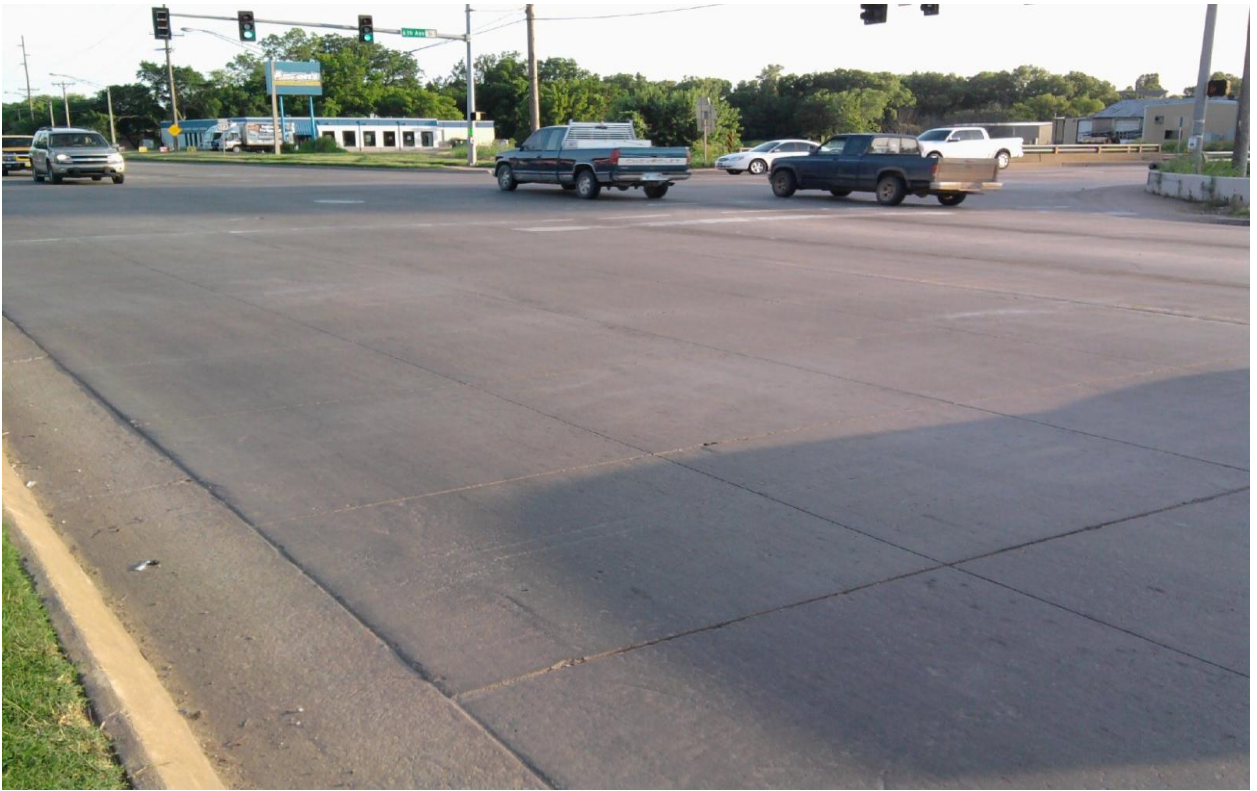
Figure 2.34 - Photo of intersection seen on US 177 towards south-west showing excellent condition of overlay.

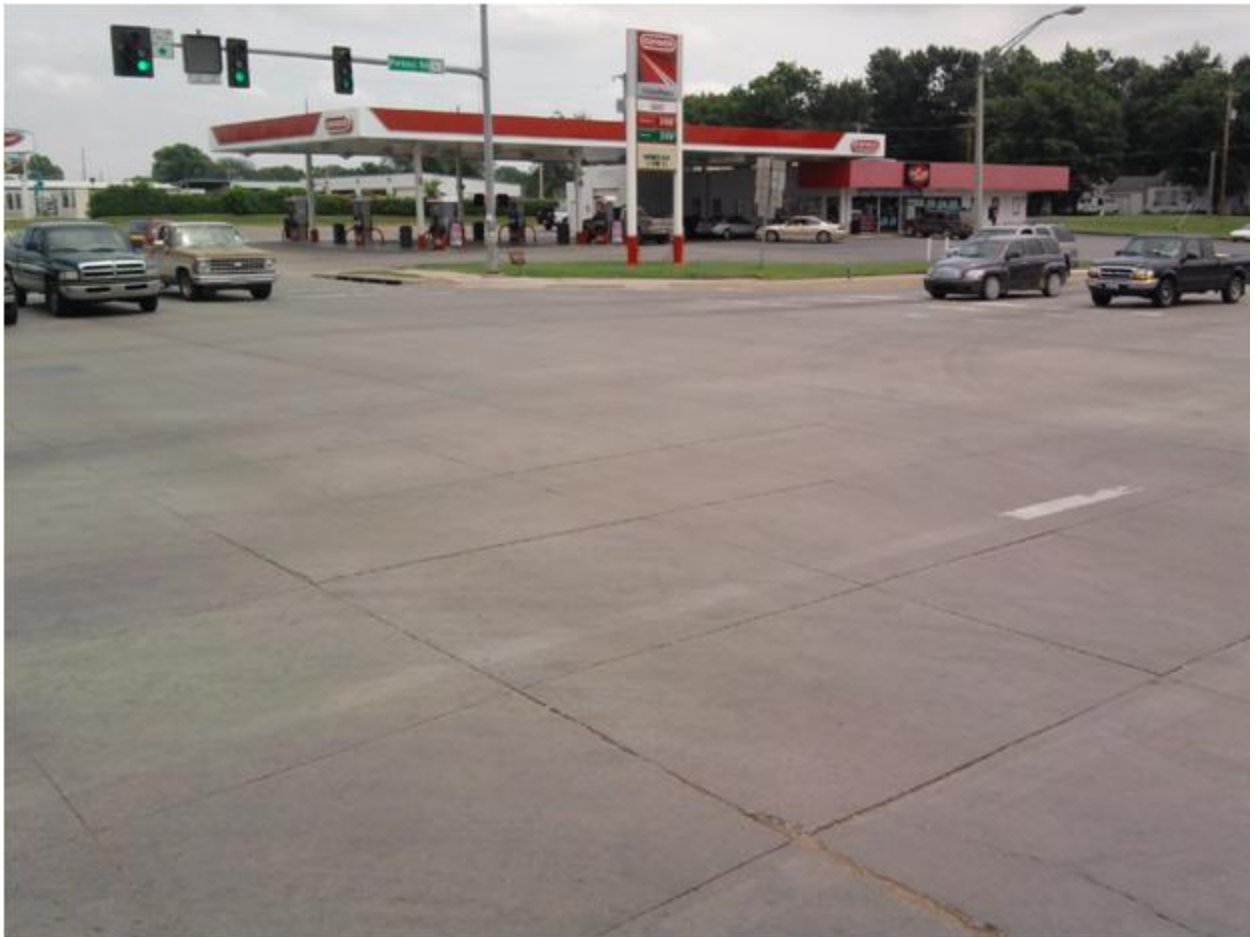
However, overall condition of the overlay in the intersection looked satisfactory as shown in Fig. 2.45.

Figure 2.45 - Overview of the intersection.

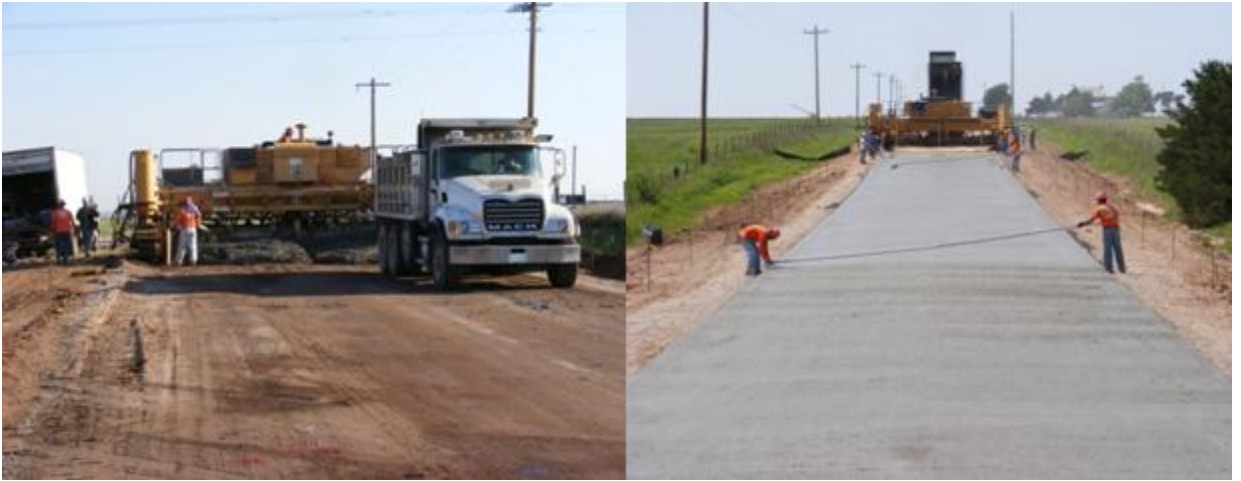
- 3) During the construction the old asphalt pavement surface was not milled and may not have been adequately cleaned. This can be seen in Fig. 2.48. Therefore, it is possible that the asphalt and concrete may not have a good bond. If de-bonding occurs then one would expect a significant decrease in performance for the overlay.

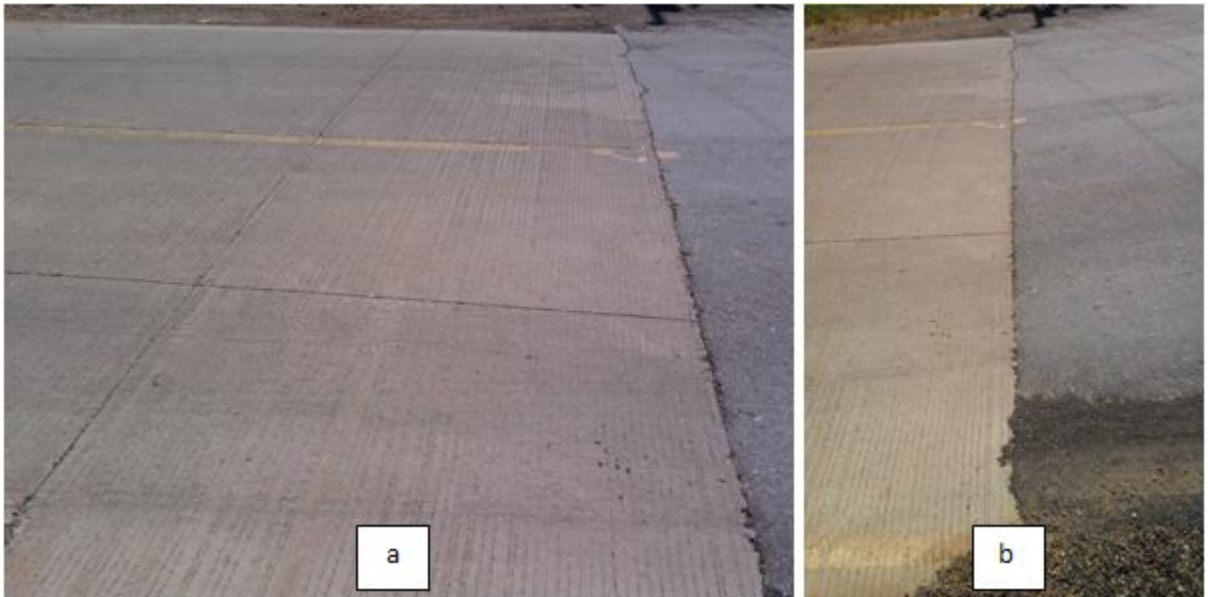
Figs 2.50 & 2.51 show the beginning of the overlay on its south side. The initial panels, which from previous experiences are the most critical, look un-cracked.

Figure 2.50 - Photos a and b show approach panels in un-distressed condition. Elevation difference between leaving asphalt pavement and approaching concrete panels is almost zero.

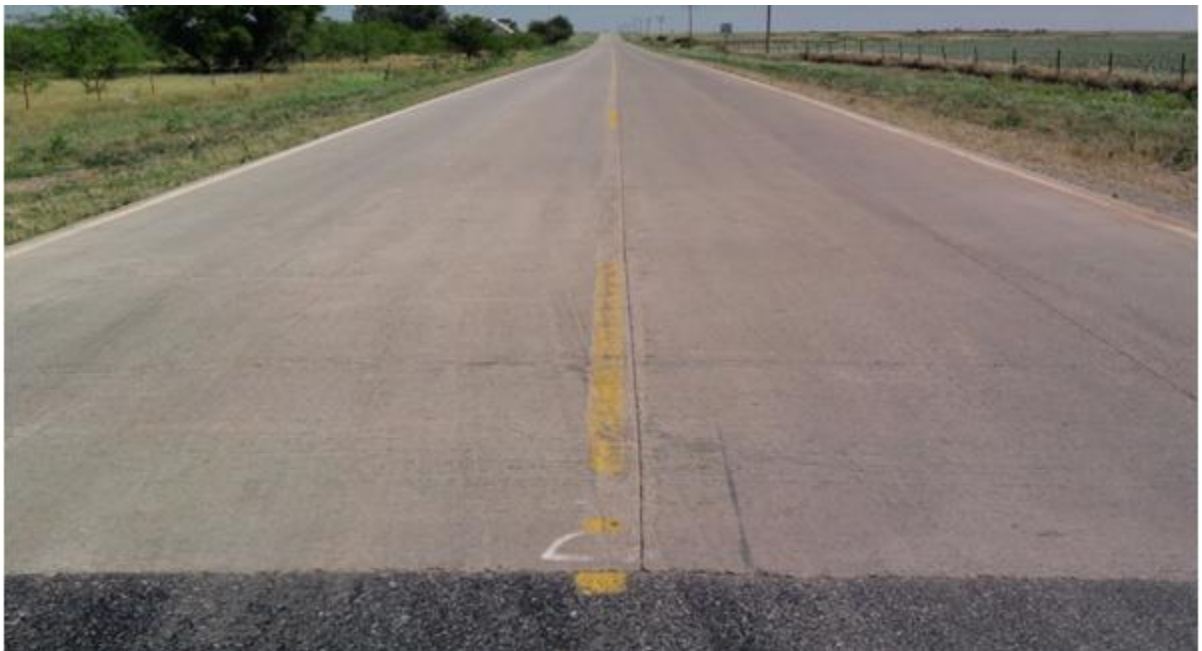
Figure 2.51 - Photo shows the overlay from south direction (looking towards north).

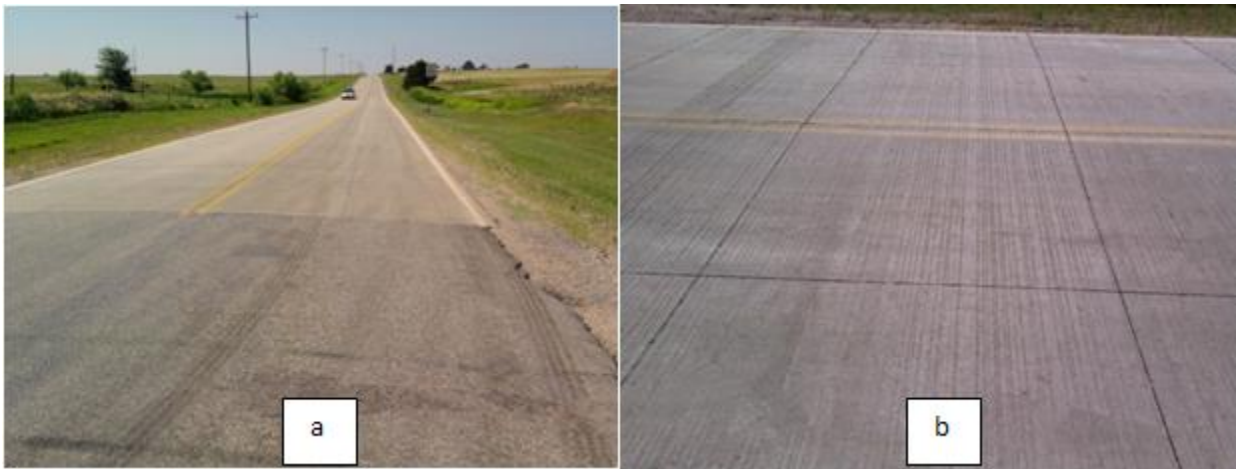
Fig. 2.52 shows the condition of the overlay where it ends on the north side. The elevation difference between concrete and asphalt pavements was thought to be insignificant. The good condition of the initial panels suggests that if the same elevation for approach and leave

pavements is maintained, the initial panels on the overlay are less likely to fail assuming that there is good bond between the concrete and the underlying asphalt.

Figure 2.52 - North end of overlay. Photo a is taken looking towards south direction. Photo b is seven panel series from the end of the overlay.

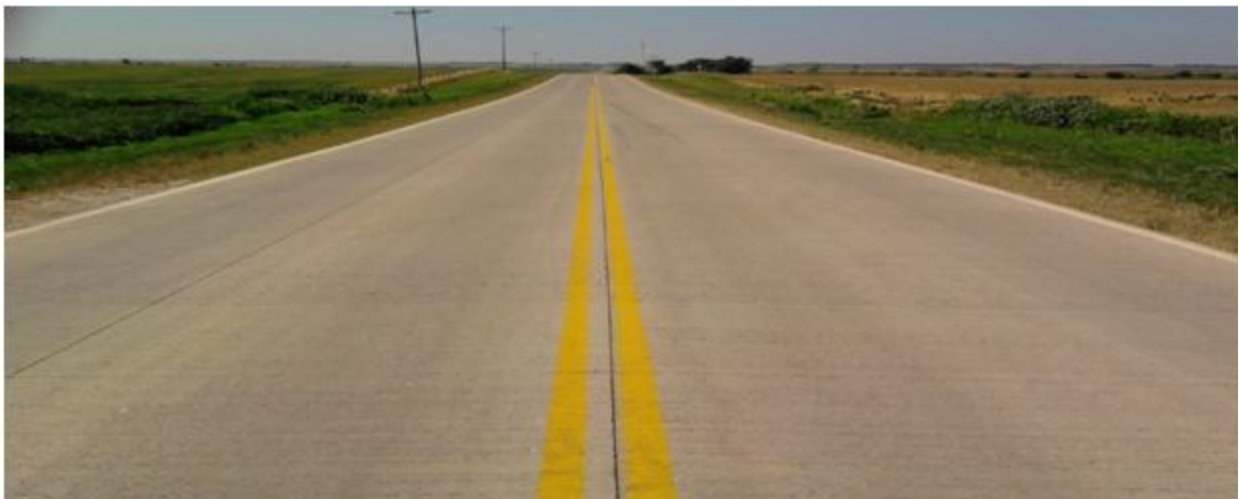
Figure 2.53 - Photo showing the excellent condition of the overlay.

The overall condition of the thin white topping is excellent as shown in Fig. 2.53. The research team did not notice any longitudinal cracks, transverse cracks, fatigue distress or pop outs.
