ASSESSMENT OF CONTINUOUSLY REINFORCED
CONCRETE PAVEMENT DESIGN AND
BEHAVIOR IN OKLAHOMA

Submitted to the Faculty of the
Graduate College of the
Oklahoma State University
in partial fulfillment of
the requirements for
the Degree of
MASTER OF SCIENCE
May, 1999

OKLAHOMA STATE UNIVERSITY

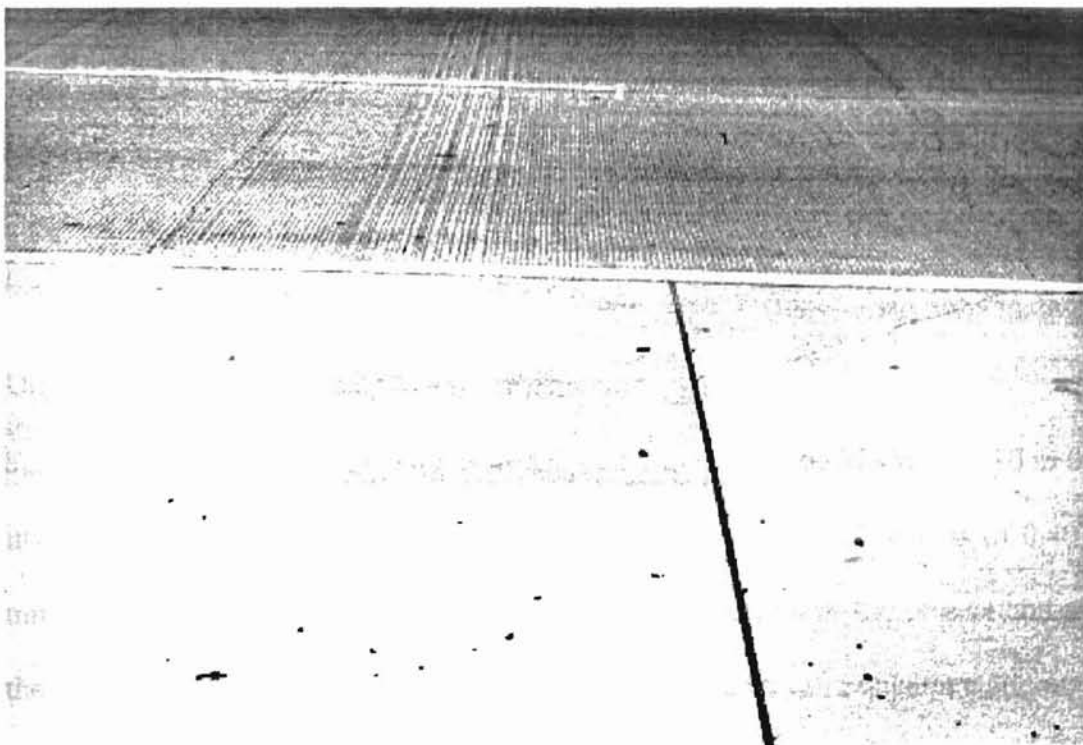
Figure A6. Typical view of SAP-51(392) westbound.

The pavement has transverse crack spacing and Y-cracking similar to the eastbound lanes. Crack widths were slightly wider, about 0.30 to 0.60 mm. There were no longitudinal cracks, no punchouts and no repairs. The Terminal Joints at both ends were not damaged and the ride was excellent. See Figure A6.

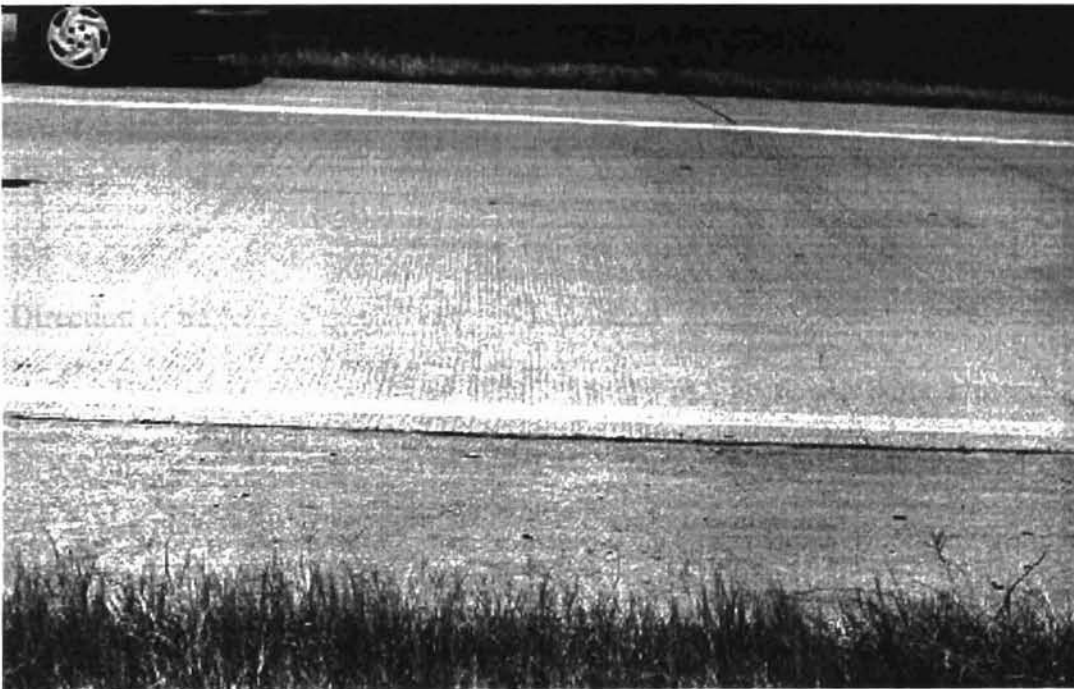
Figure A9. Typical view of MAFEGC-410(35) westbound.

Transverse crack spacings were 1.5 to 2.0 m. Crack widths were 0.30 to 0.50 mm in the first and middle third sections. The last section had crack widths of 0.40 to 0.70 mm. There was light spalling at the cracks in the end third of the project and at one of the construction joints. There were no longitudinal cracks, no punchouts and no repairs. There were areas that had developed some Y-cracking, and a curved crack or two, but no

longitudinal cracks and terminal joints were not damaged. The ride on the CRC was excellent. See Figure A9.

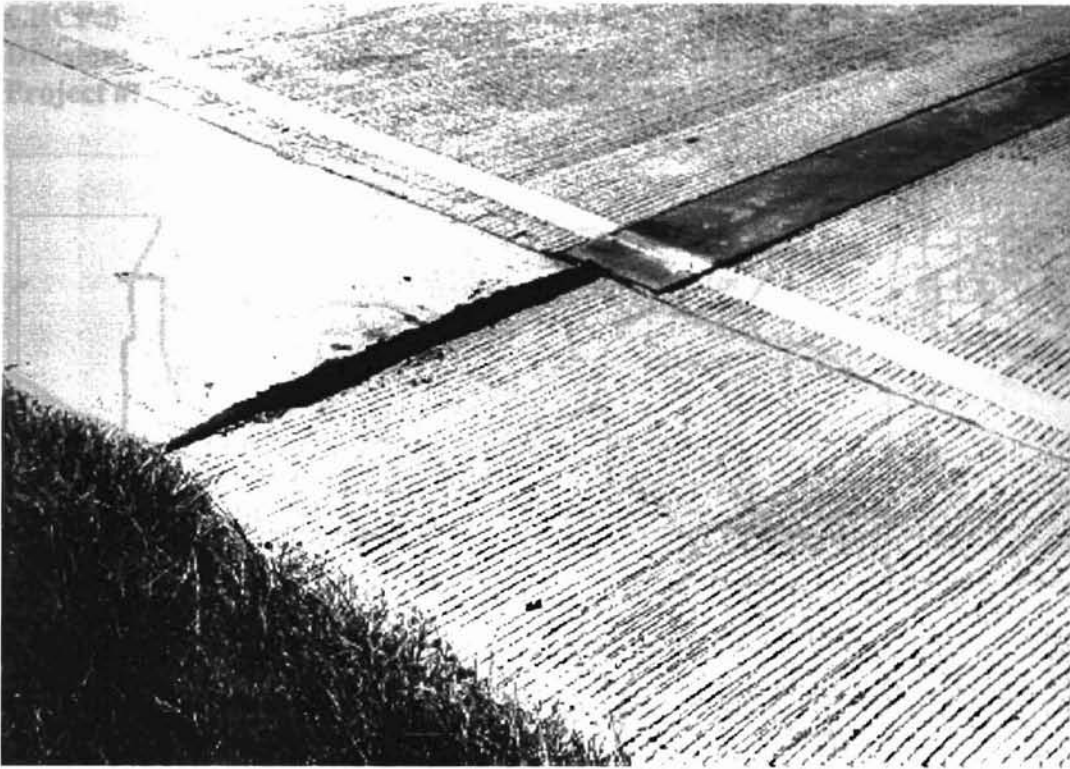
Figure A11. Steel beam at end joint.

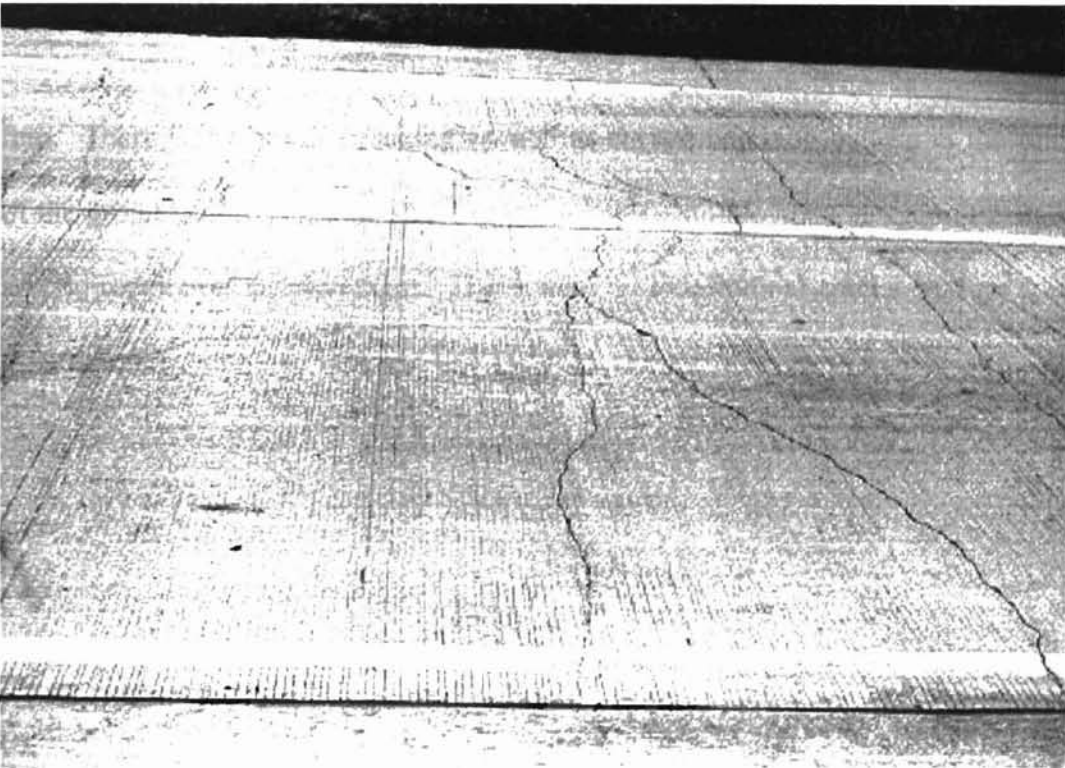
Figure A12. Typical view of MABRF-593(241)

Transverse crack spacings were 1.5 to 2.0 m. There was some clustered cracking in the middle of the project. The crack had slight spalling. There were no repairs, but one punchout of about 0.2 m². The ride on the CRC was excellent. See Figure A12.

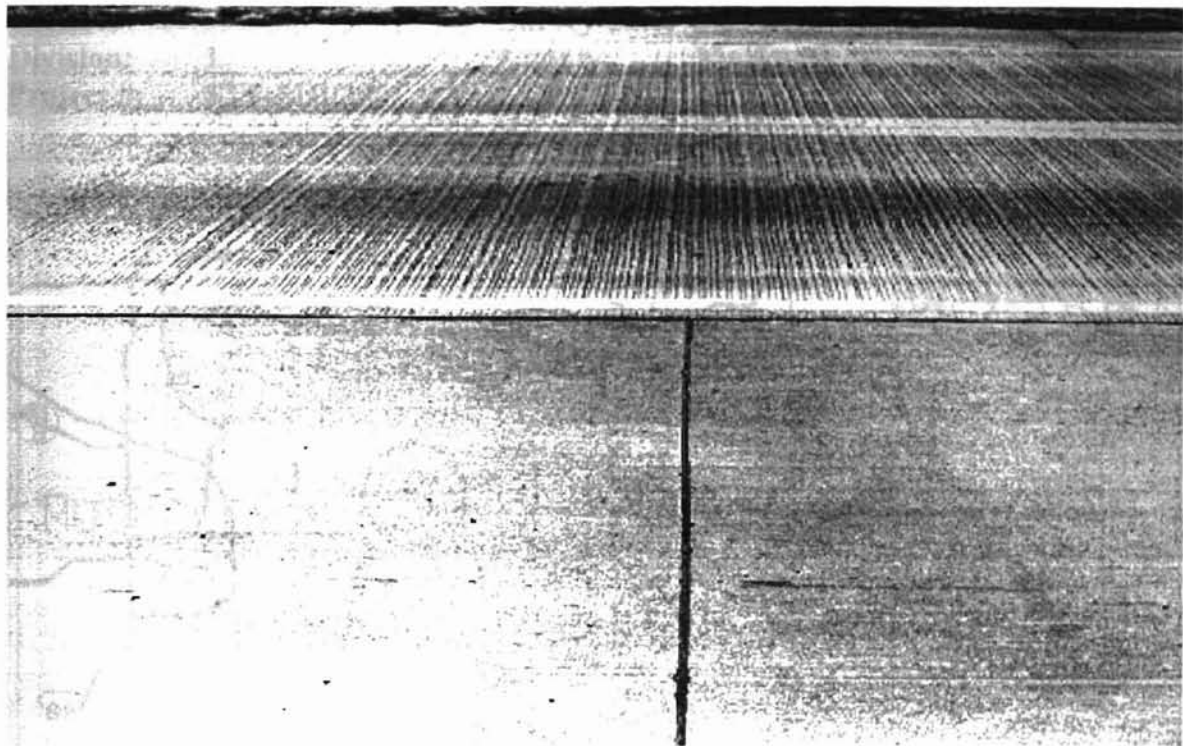
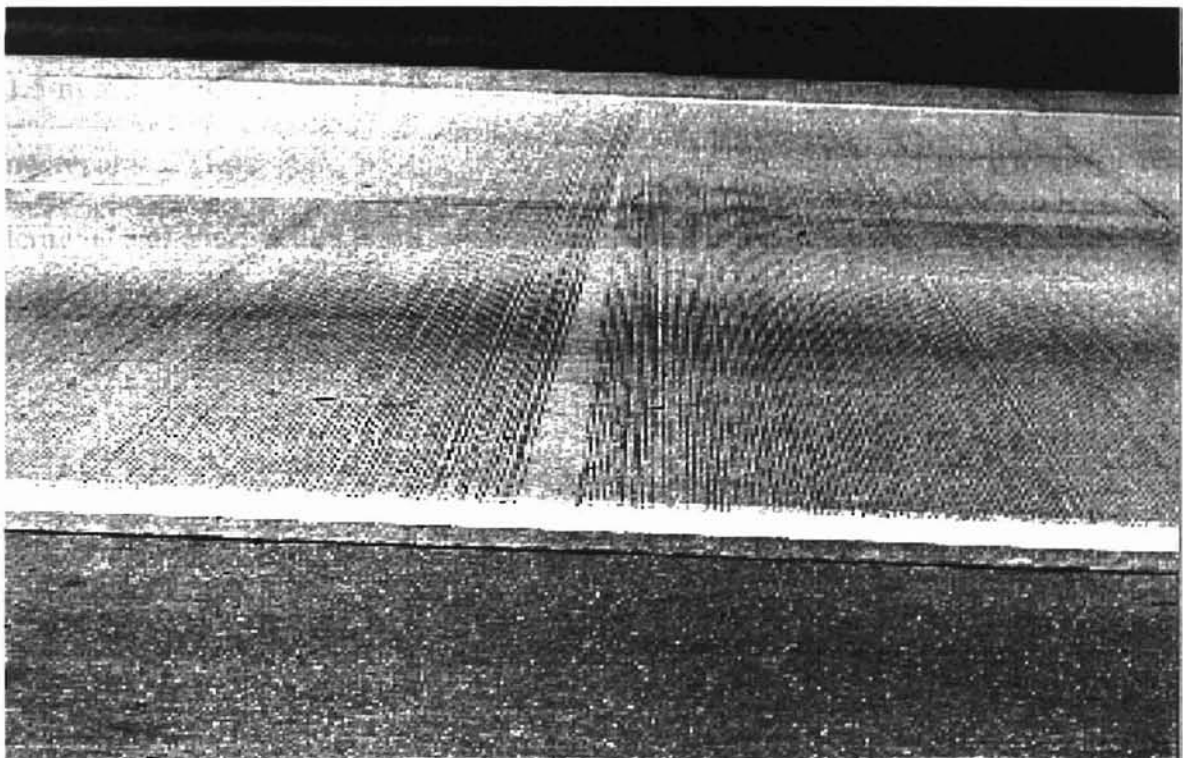
Transverse crack spacings were 0.6 to 1.5 m. The crack widths were 0.25 to 0.60 mm. There was some Y-cracking as well as curved cracking pattern in the middle third of the project. There was no spalling at the cracks, no blowups, no popouts, no punchout and no repairs on the pavement. There were no longitudinal cracks, and no construction joint deterioration. See Figures A14 and A15.

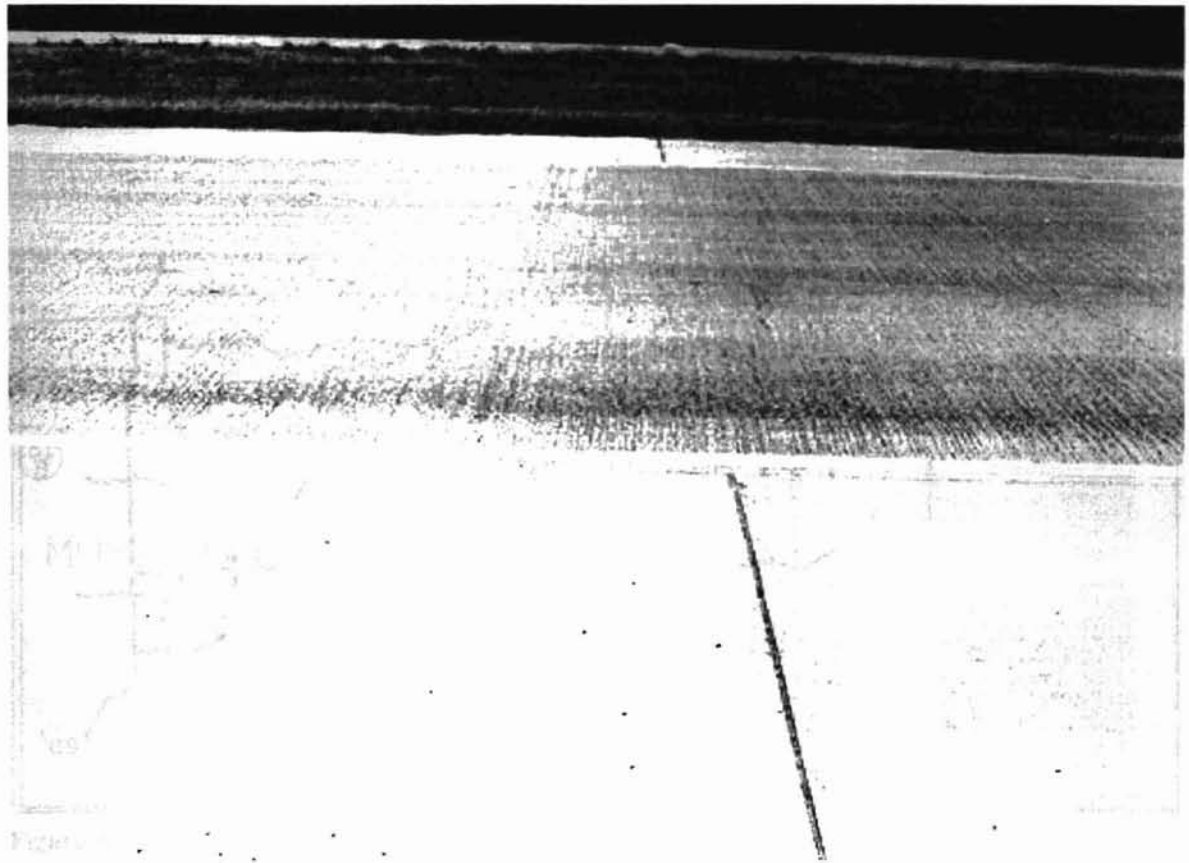
Figure A17. Typical view of STP-51B(36) eastbound

Transverse cracks were generally straight. Crack spacings were between 0.9 to 1.5-m and crack widths were about 0.55 mm. There was no spalling, no punchouts, and no repairs. There were no longitudinal cracks, no blowups, and no popouts. The terminal and construction joints were all good. This is a nice looking project and the feel of the ride on the CRCP was excellent. See Figure A17.

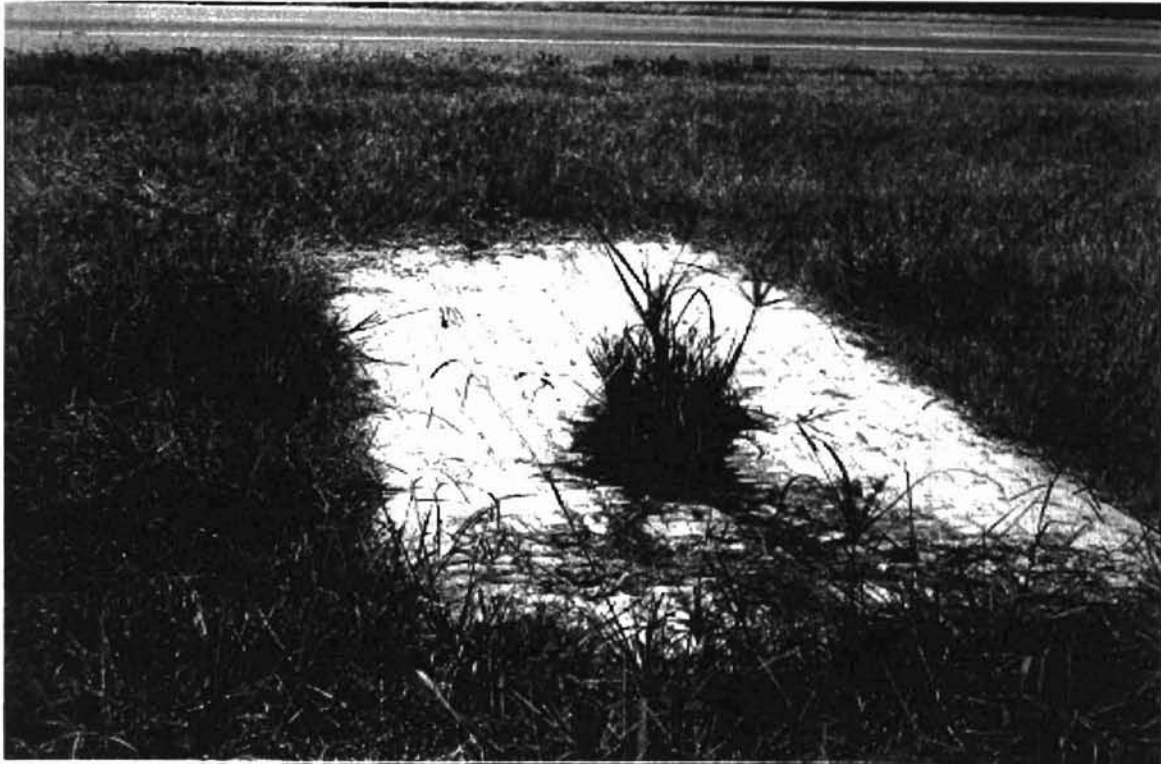
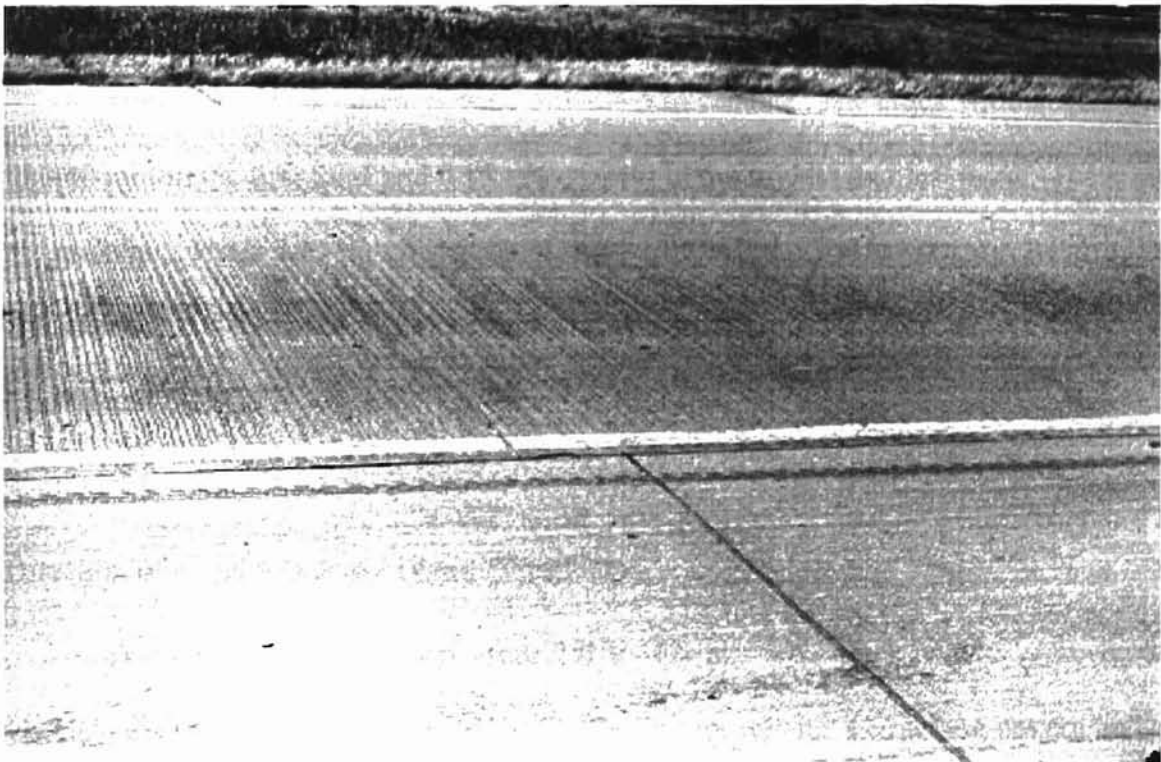
Transverse crack spacings range from 0.6 to 1.5 m. The crack widths were 0.30 to 0.60 mm in the first third of the project and 0.20 to 0.50 mm in the middle third. There were no clustering of cracks, no longitudinal cracks and no punchouts. There was no spalling. The terminal and construction joints had repairs totaling 0.5 m² in area. There was spalling at the east end wide flange. The ride on the CRC was excellent. See Figures A25 and A26 for an underdrain outlet and typical condition of the pavement.

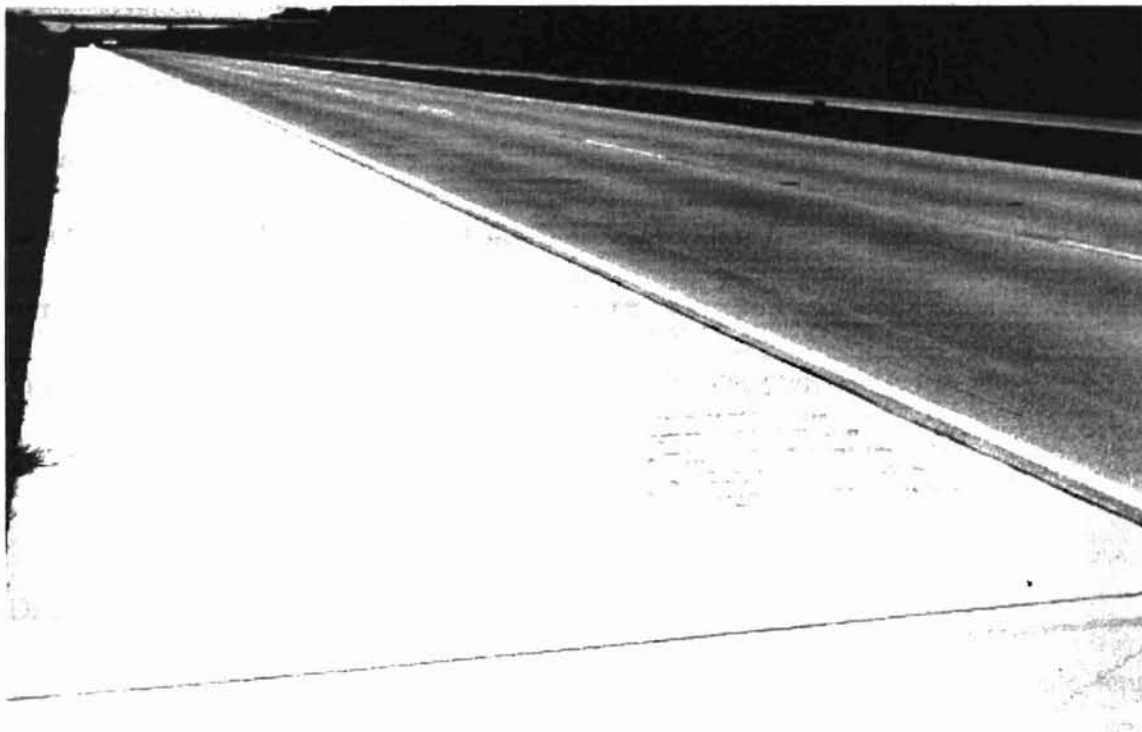
Figure A29. Typical view of IM-40-6(221) westbound.

Transverse crack spacings were 3.0 to 4.5 m. The crack widths were hardly visible – about 0.10 mm for most of the CRCP. There was no Y-cracking pattern and no spalling at the cracks. There were no clustering of cracks observed, no longitudinal

cracks, and no punchouts. The terminal and construction joints were all in good shape. The pavement looks good and the ride was excellent. See Figure A29.

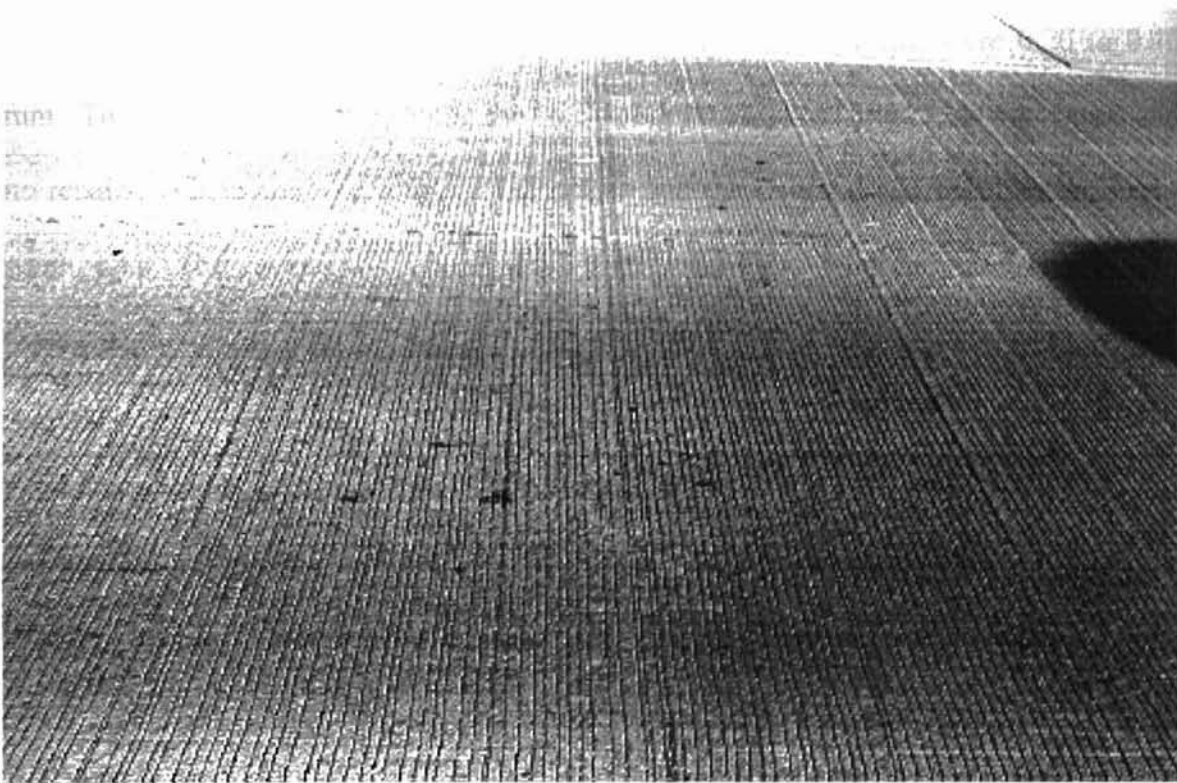
Figure A35. Typical view of MAF-186-(180) southbound.

Transverse crack spacings were 1.5 to 2.0 m for this direction. Crack widths were 0.20 to 0.40 mm. There were no clustered cracks, no spalling, punchouts, and no repairs. There were no longitudinal cracks. See Figure A35.

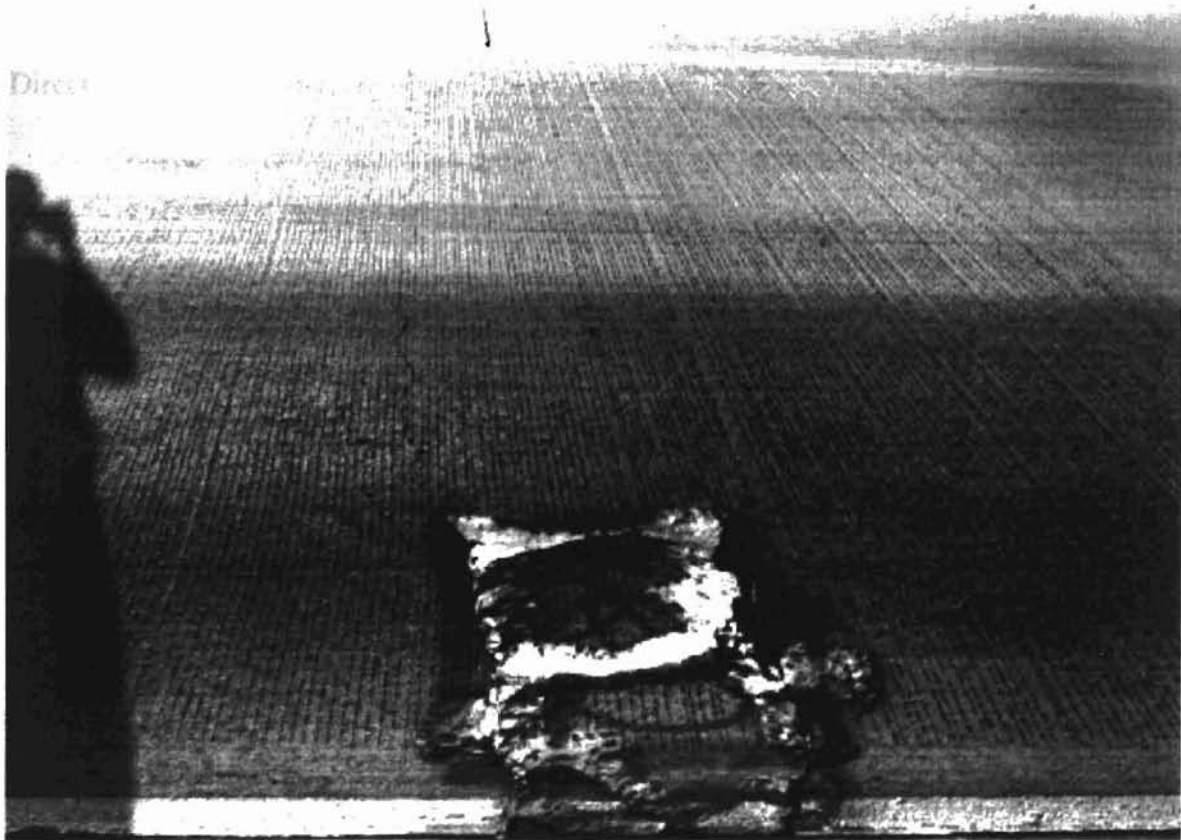
Transverse crack spacings were 1.5 to 2.0 m for this direction. Crack widths were 0.30 to 0.50 mm. There were no clustered cracks, no spalling, but one 0.1 m² punchouts. See Figure A38. There were no longitudinal cracks, no blowups, no popouts, no scaling and no construction joint deterioration.

Figure A38. A punchout in southbound DPIY-204(001).

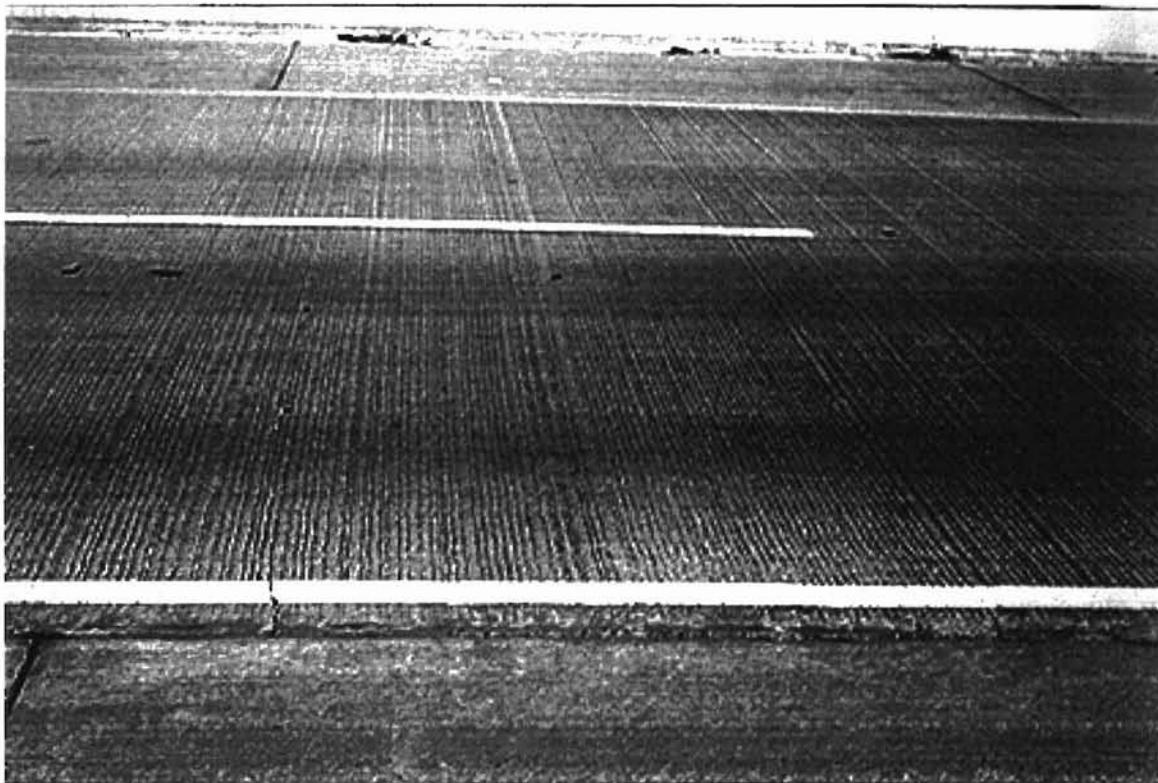
Transverse crack spacings were 0.9 to 1.5 m for this direction. Crack widths were 0.30 to 0.60 mm. There were no clustered cracks, no Y-cracks, no spalling, no punchouts and no repairs. There were no longitudinal cracks. See Figure A41. The terminal and construction joints were all good. The ride on the CRC was excellent.

Figure A41. Typical pavement condition on MAF-186(185) southbound.

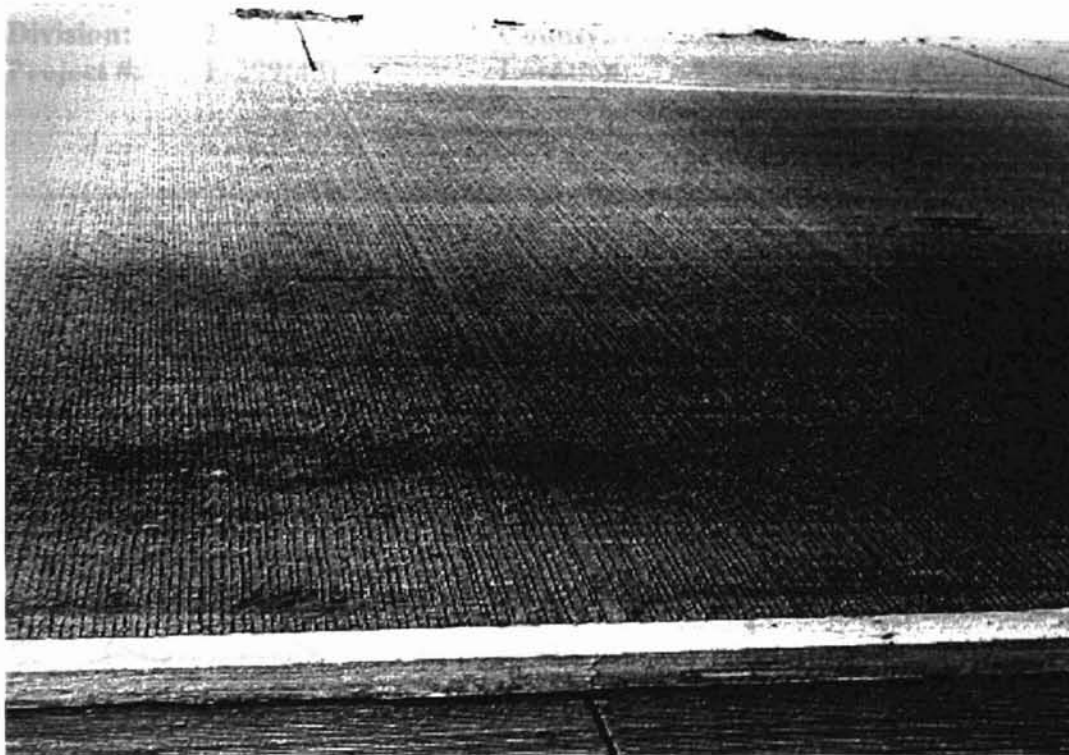
Figure A43. Typical pavement condition on MAF-186(183).

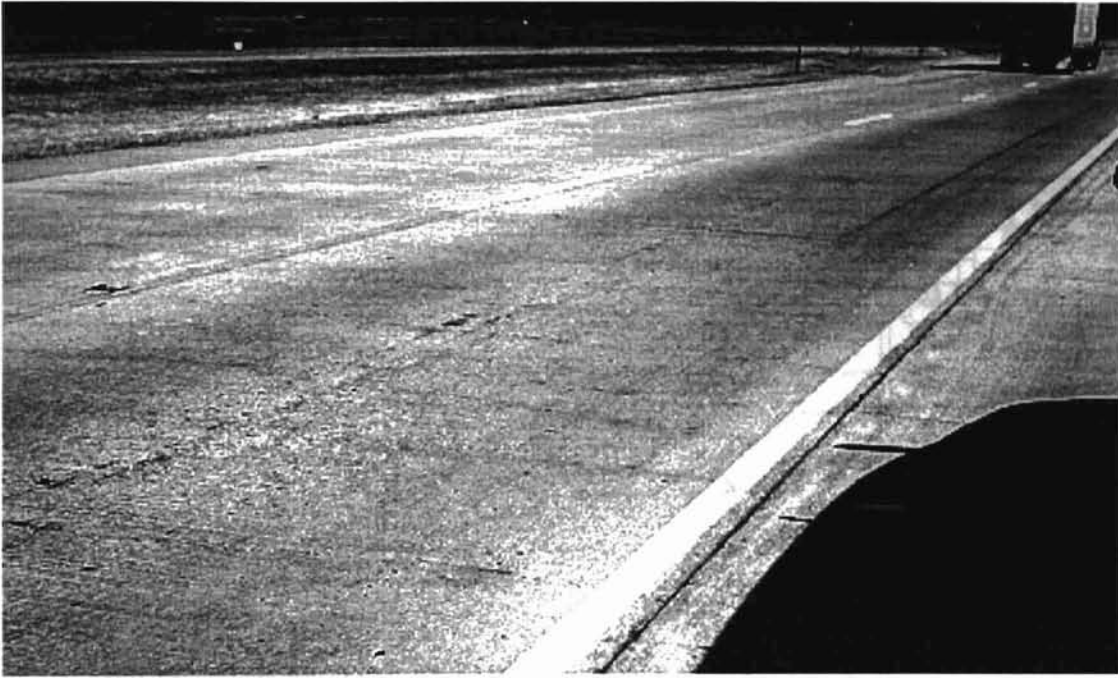
This section was 2.253 km long with transverse cracks at 2.0 to 4.5 m spacings in the first third, and 1.0 to 2.0 m in the rest of the pavement. Crack widths were 0.30 to 0.80 mm in the first third of the way and 0.20 to 0.60 mm in the rest of the section. There were no Y-cracking, no clustering, no spalling, but one punchout of about 1.1 m². See Figure A46.

Figure A46. Typical pavement condition of F-299(45) northbound.

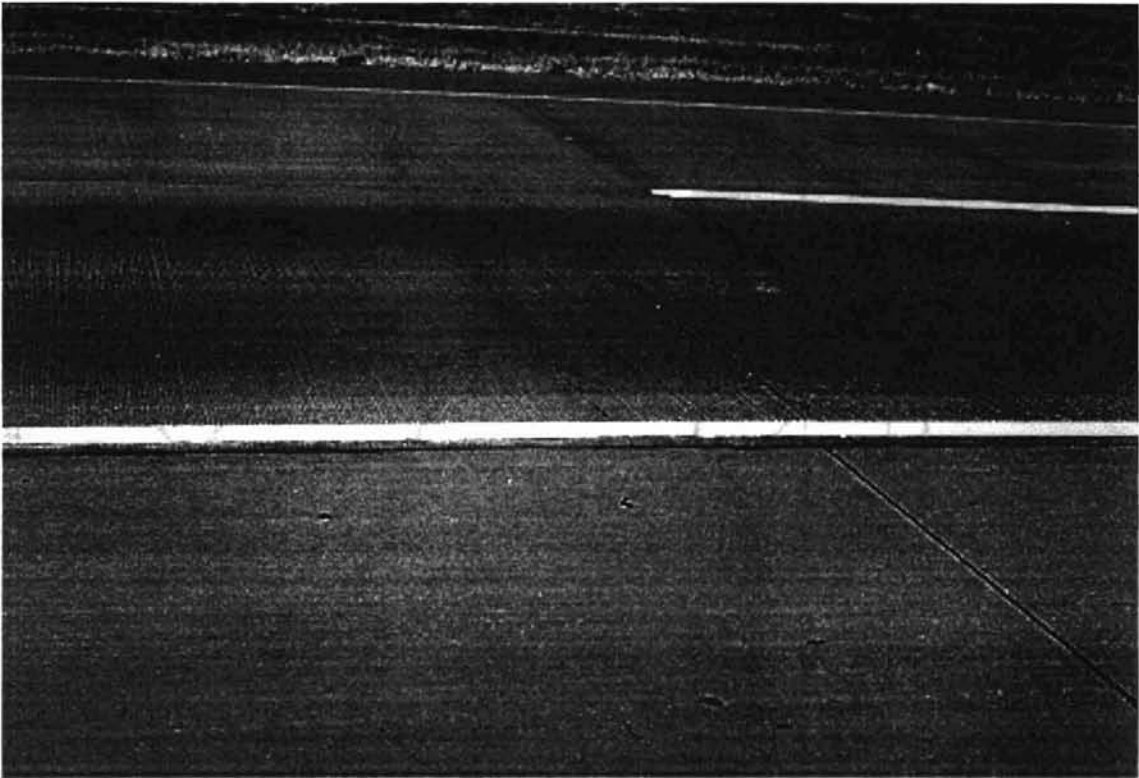
Transverse cracks spacings range from 1.2 to 2.0 m. Crack widths were 0.40 to 0.90 mm at the beginning of the project and wider northwards. There was spalling at the cracks. In general, the northbound lanes has fewer punchouts and repairs per kilometer than the southbound lanes. The length of CRCP in this direction is only 1.77 km. See Figure A49.

Figure A49. Typical pavement condition on F-299(35) northbound.

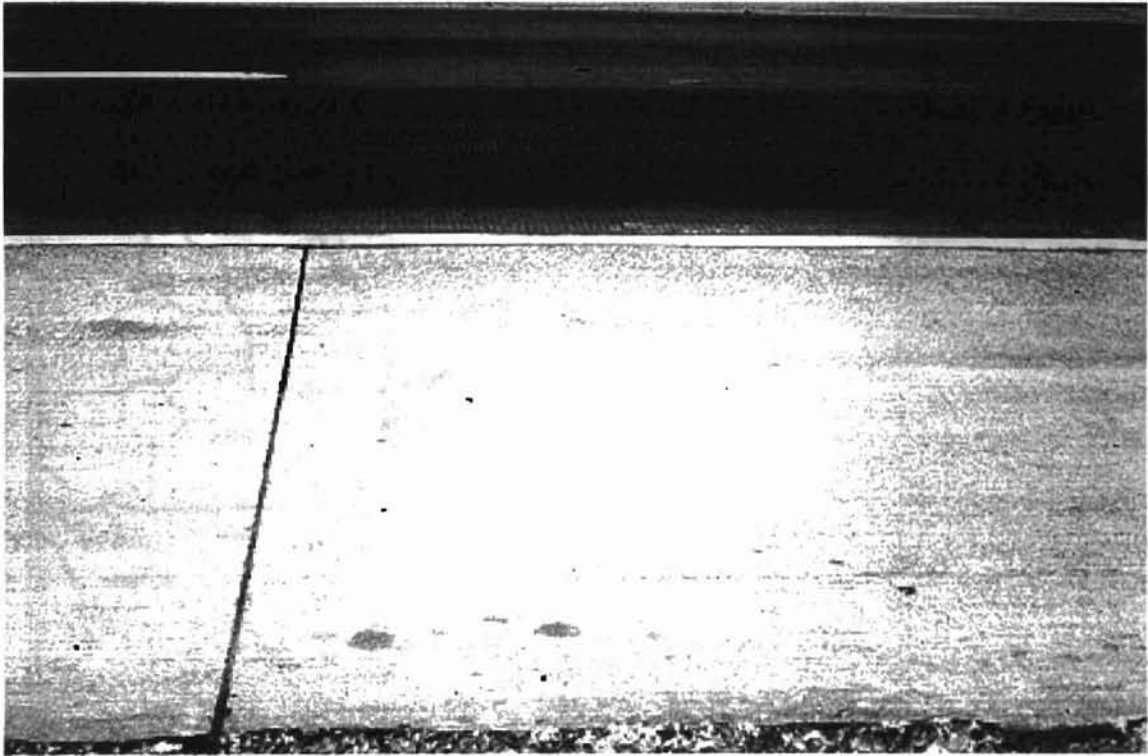
Transverse crack spacings range from 0.6 to 1.5 m. Crack widths were 0.20 to 0.60 mm. There were some Y-cracks and clustering of cracks, but no spalling, no punchouts and no repairs. There were no longitudinal cracks, no scaling, no blowups and no popouts. See Figure A52.

Figure A52. Typical condition of shoulder and pavement of F-299(99) northbound.

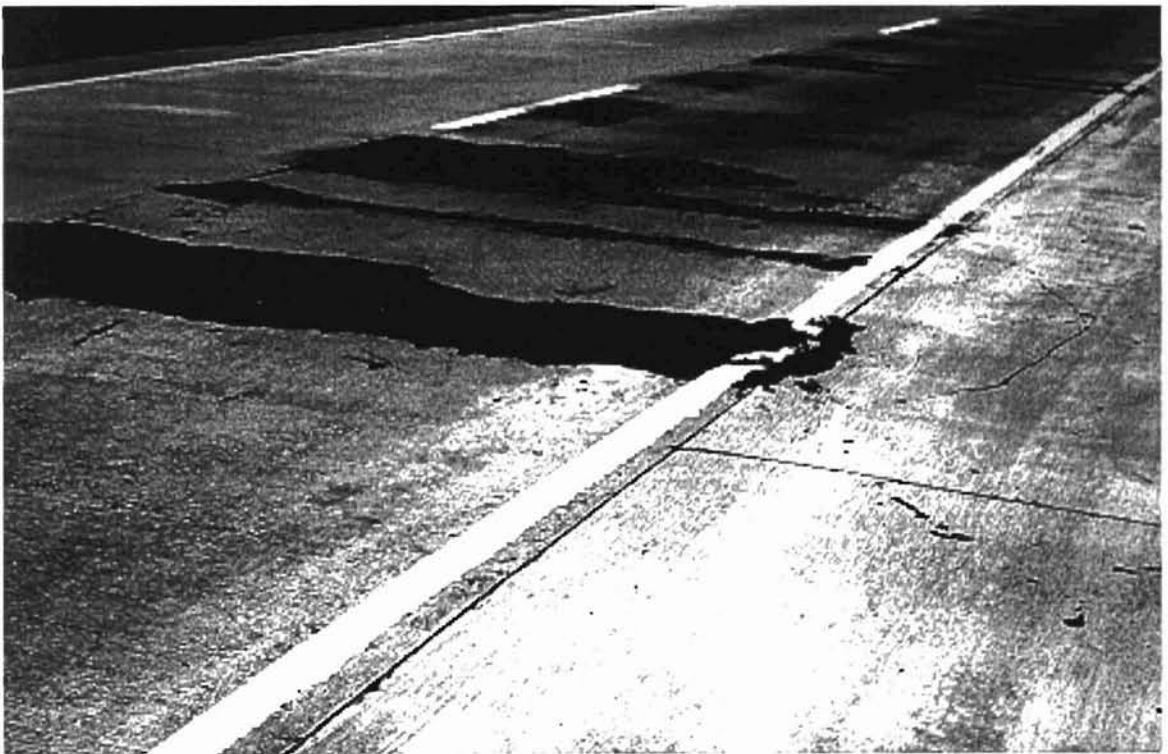
This project has clustered cracks, Y-cracking, longitudinal cracks, spalling, and punchouts and repairs at a staggering one hundred and fifty locations in the 12.7 km section. The number of failures makes this an unusual project. See Figure A56.

Figure A56. Patches on F-219(35) southbound.

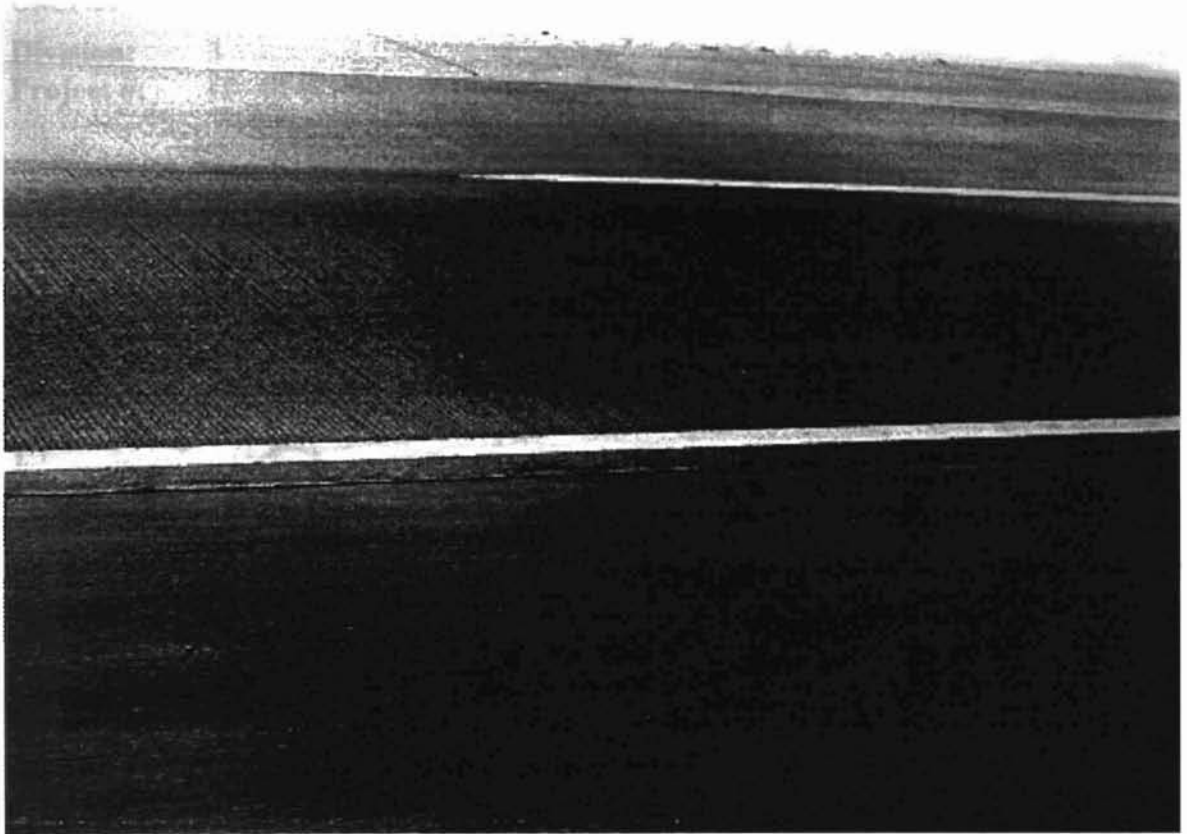
Transverse Cracks were generally straight across the pavement. Crack spacings were around 1.5 m. Crack widths were in the region of 0.40 mm at most locations. There were no spalling along the cracks, no longitudinal cracking, no punchouts, and no repairs on the project. The CRCP provided an excellent riding surface and driver comfort. See Figure A58.

Figure A58. Typical condition of MAF-235 eastbound.

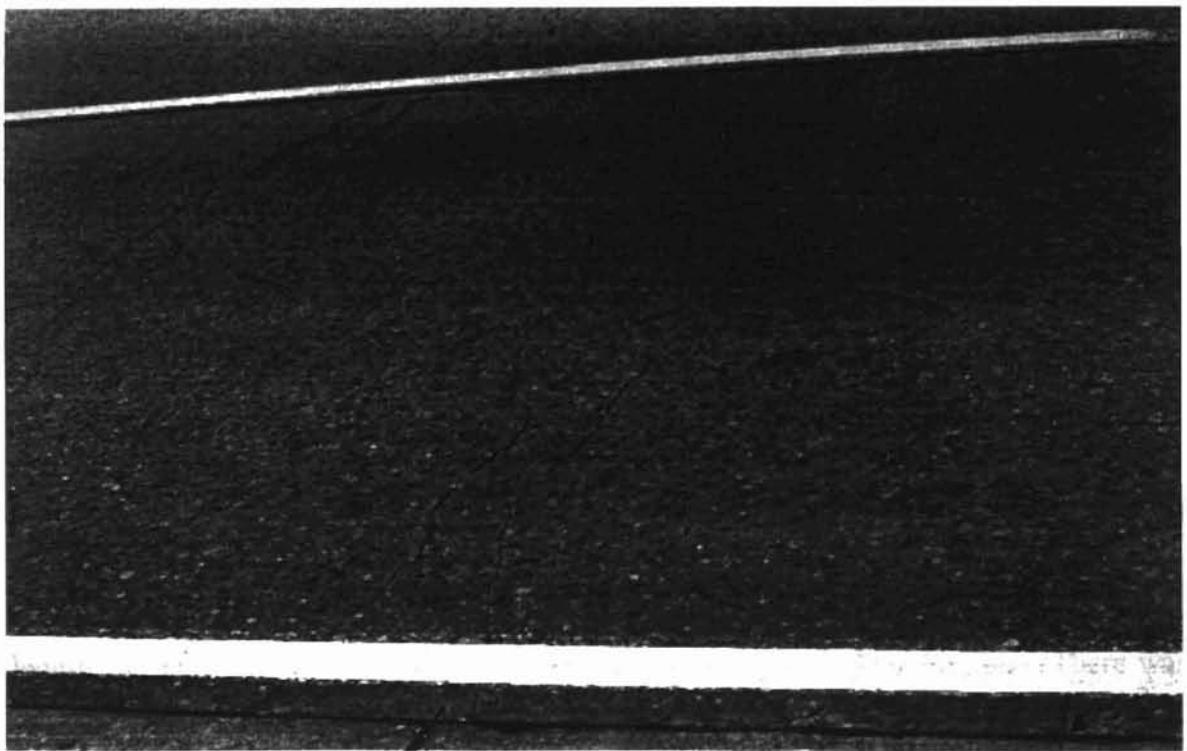
Similar to eastbound lanes. Transverse crack spacings were 0.9 to 1.5 m. The crack widths were 0.40 to 0.80 mm. There were a few Y-cracks. The cracks position did not seem to be influenced by the 15mm wide lines cut in the shoulders. There were no longitudinal cracks. See Figure A59.

Figure A59. Typical condition of MAF-235(009) westbound.

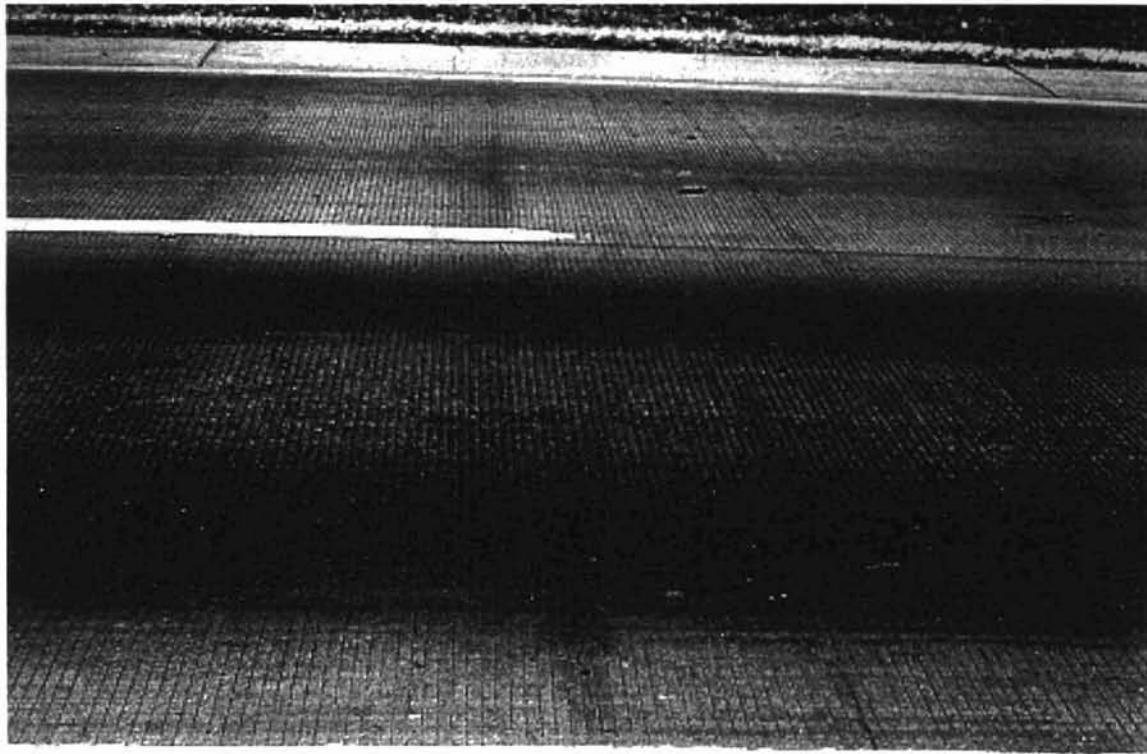
Transverse Cracks were generally straight across the pavement. Crack spacings were 0.3 to 2.0 m centers. Some sections of the pavement have wider transverse crack spacing. Crack widths were in the region of 0.45 to 0.90 mm at most locations. There was some spalling along the cracks. Although there were some Y-cracks, there was no longitudinal cracking, punchouts, and no repairs on the CRCP. The CRCP provided a most excellent riding surface and driver comfort.

A similar pattern of pavement behavior and response to traffic and environment is seen here as it was for the northbound lanes. See Figure 68

Figure A68. Typical pavement condition on F-385(043).

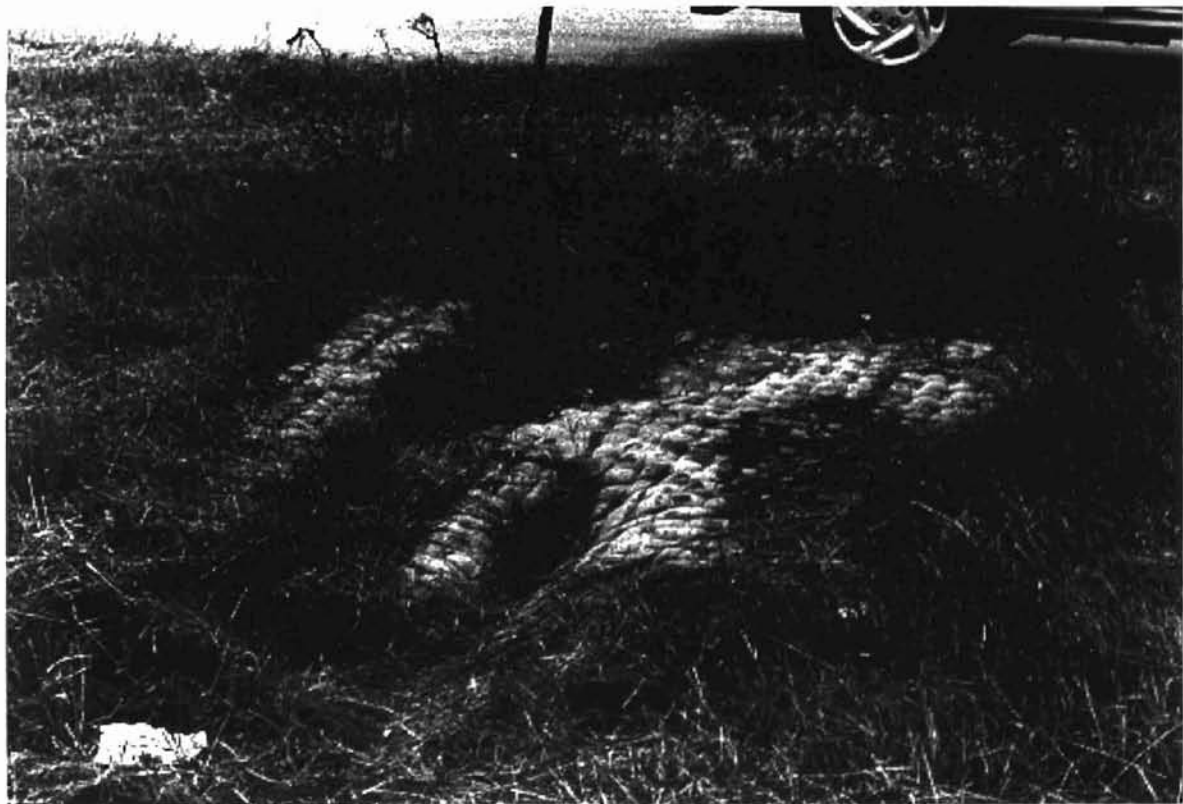
Figure A71. Outlet of drain under pavement.

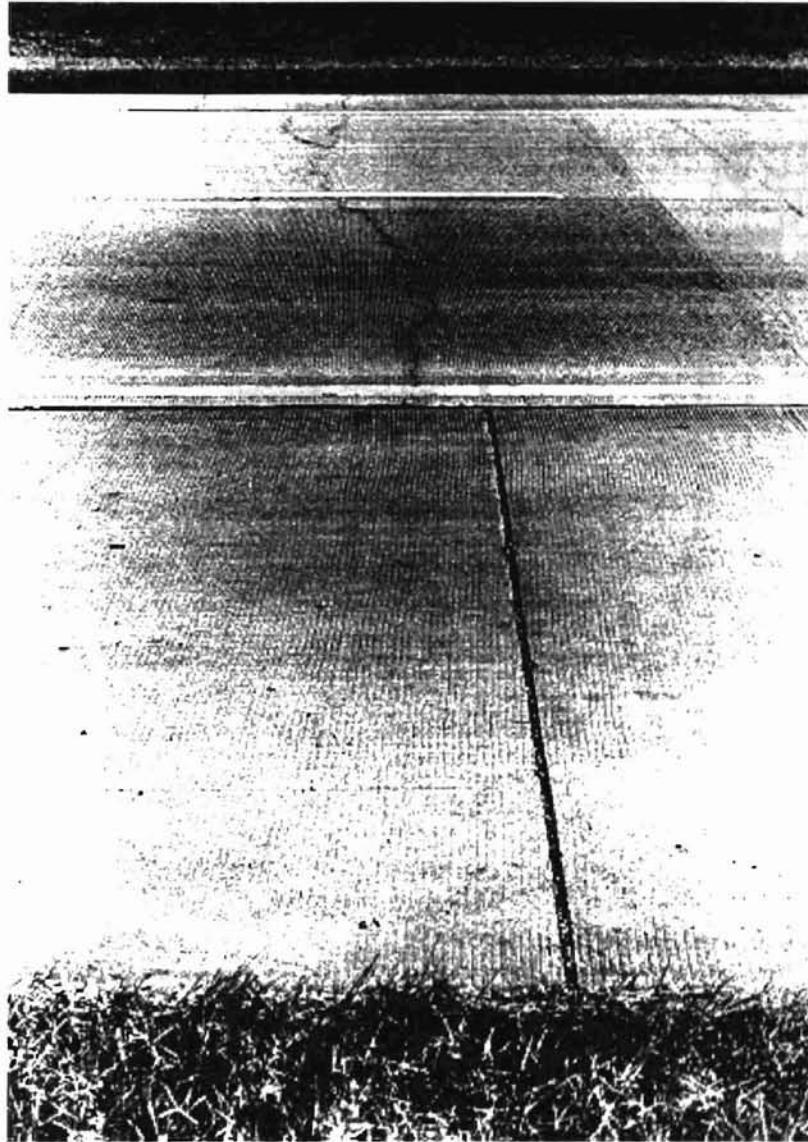
Transverse Cracks were generally straight across the pavement. Crack spacings were 0.3 to 2.0 m centers. Some sections of the pavement have wider transverse crack spacings. Crack widths were in the region of 0.45 to 0.90 mm at most locations. There was a bit of spalling along the cracks. Although there were some Y-cracks, there was no longitudinal cracking, punchouts, and no repairs on the CRCP. The CRCP provided a most excellent riding surface and driver comfort.

Figure A73. Typical pavement condition on MAF-385(054).
