ASSESSMENT OF CONTINUOUSLY REINFORCED
CONCRETE PAVEMENT DESIGN AND
BEHAVIOR IN OKLAHOMA

Submitted to the Faculty of the
Graduate College of the
Oklahoma State University
in partial fulfillment of
the requirements for
the Degree of
MASTER OF SCIENCE
May, 1999

OKLAHOMA STATE UNIVERSITY

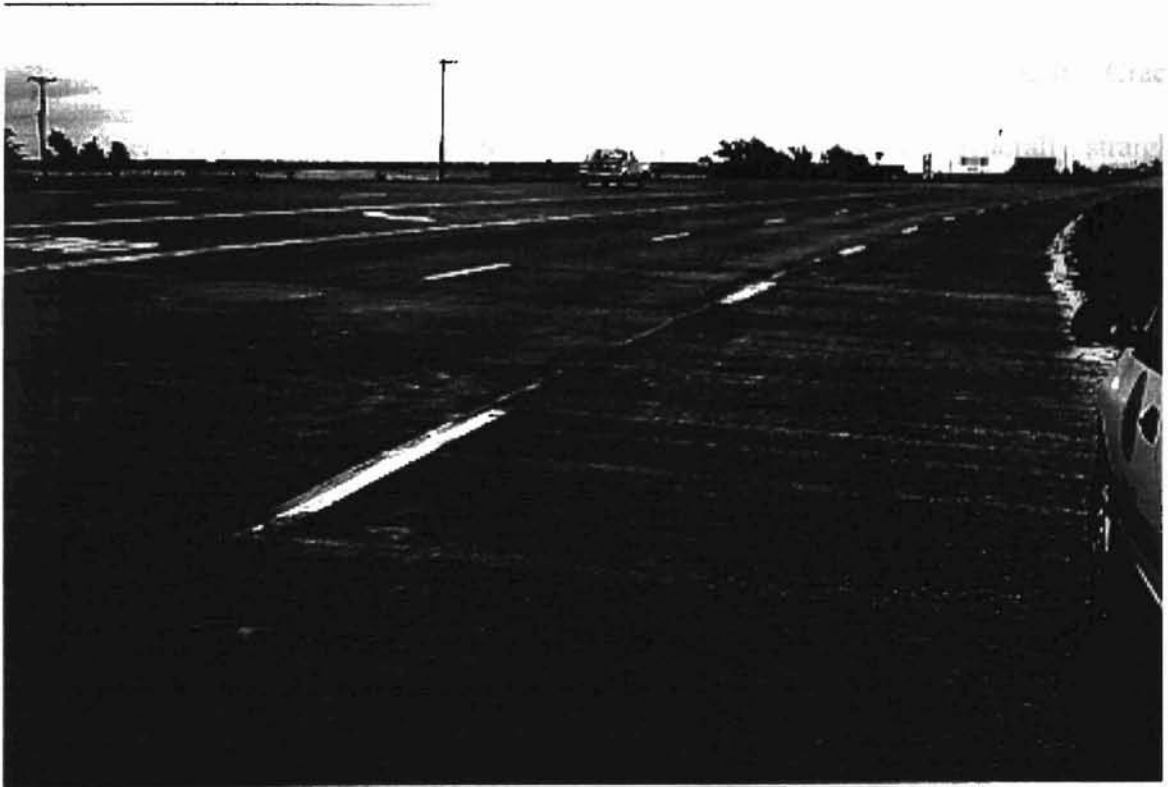
Transverse Cracking has developed at 1.5 m to 2.0 m apart. Crack widths were of the order of 0.20 mm to 0.50 mm. The cracks were generally straight across the pavement. There were some longitudinal cracks in the pavement, but no Y-cracking and no curved cracks, no spalling, no punchouts, and no repairs. The terminal joints were not damaged in any way. Construction joints were all good. The ride was excellent. See Figure A78.

Figure A79. Typical pavement condition of MAF-350(11).

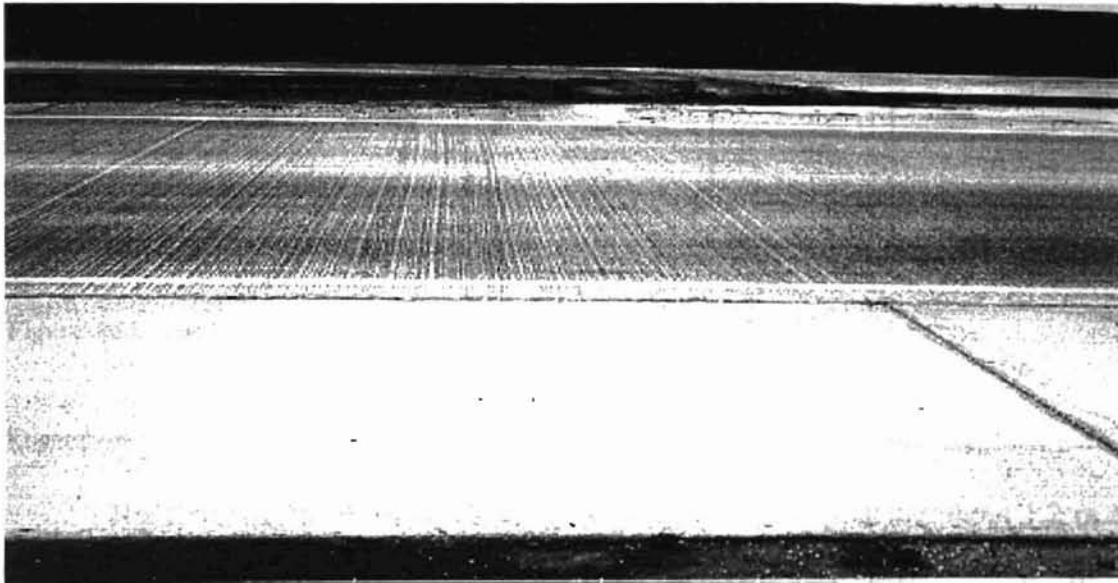
Transverse cracks were at 2.0 m to 4.5 m apart for the whole length. Crack widths were of the order of 0.10 mm to 0.20 mm. The cracks were generally straight across the pavement. There were no clustered cracks, no Y-cracking and no spalling at the cracks.

There were no longitudinal cracks anywhere and no punchouts for the whole length. The terminal joints were not damaged in any way and all construction joints looked good. There were no signs of construction defects. See Figure A81. The ride was excellent.

Figure A81. Typical pavement condition on NH-8N(001) eastbound.

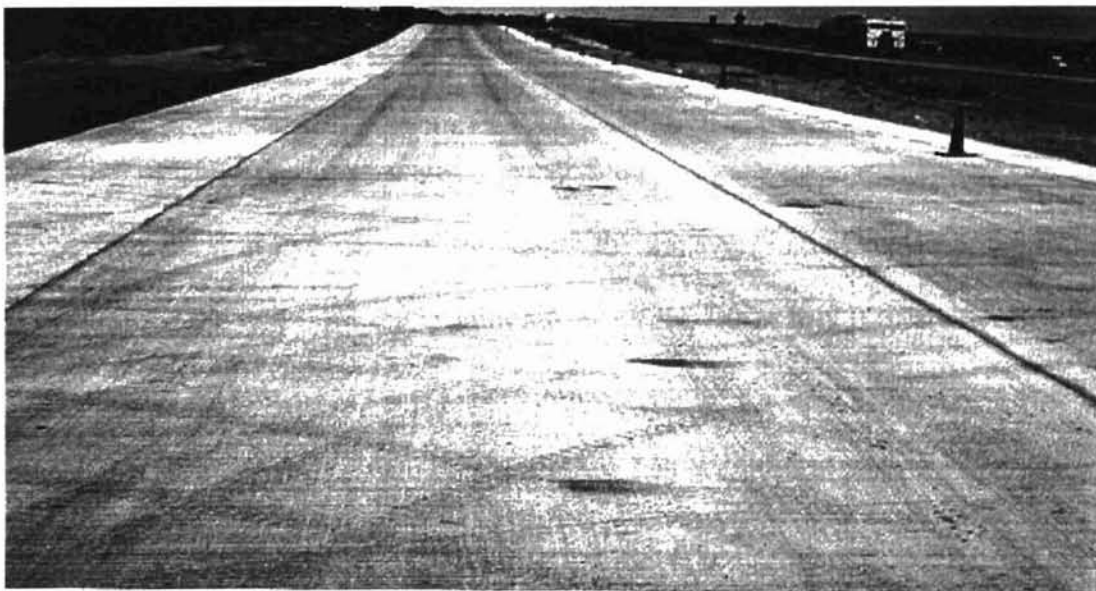
This section is under construction at the time of survey. This pavement has just been completed and not opened to traffic except construction vehicles. See Figure A82. For the length completed, transverse cracks were about 4.5 m apart. Crack widths were about 0.10 mm. Cracks were generally straight across the pavement. There were no clustered cracks, no Y-cracking and no longitudinal cracking.

Figure A82 Westbound NH-8N(001) under construction. Traffic moving in both directions in eastbound lanes.

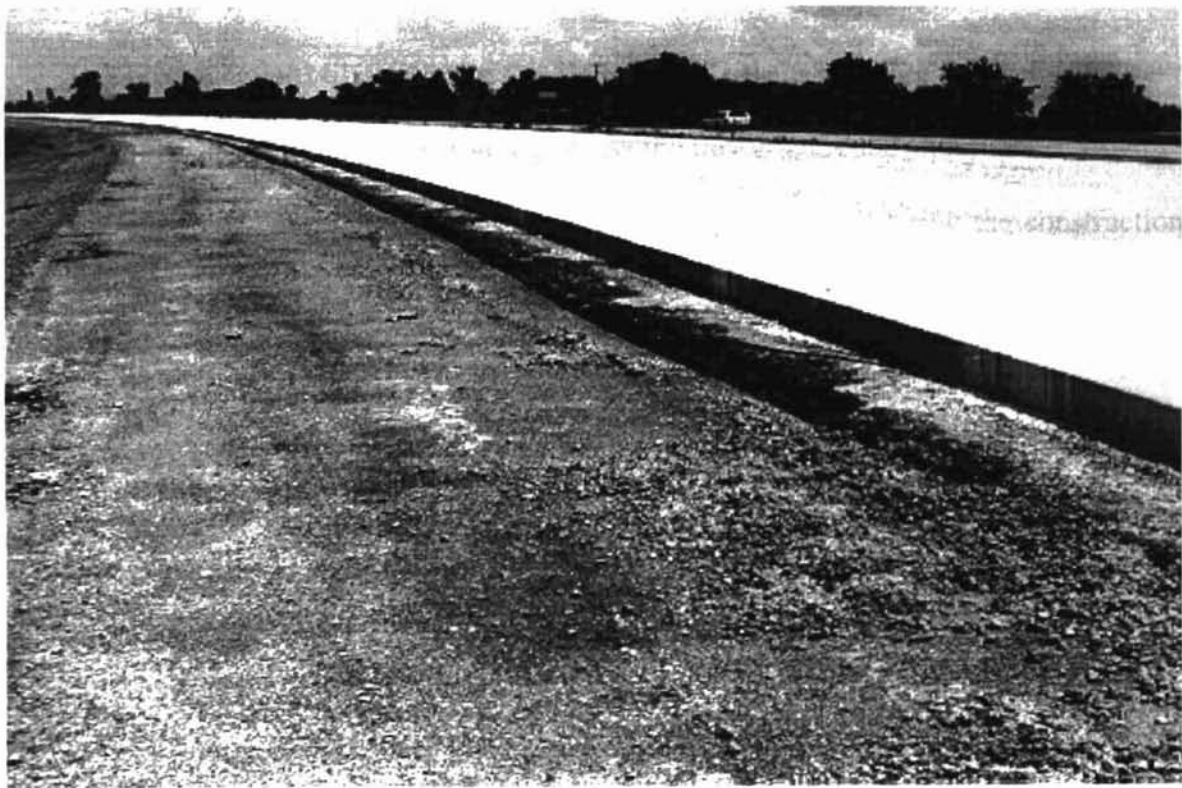
Figure A96. New CRCP constructed at time of survey.

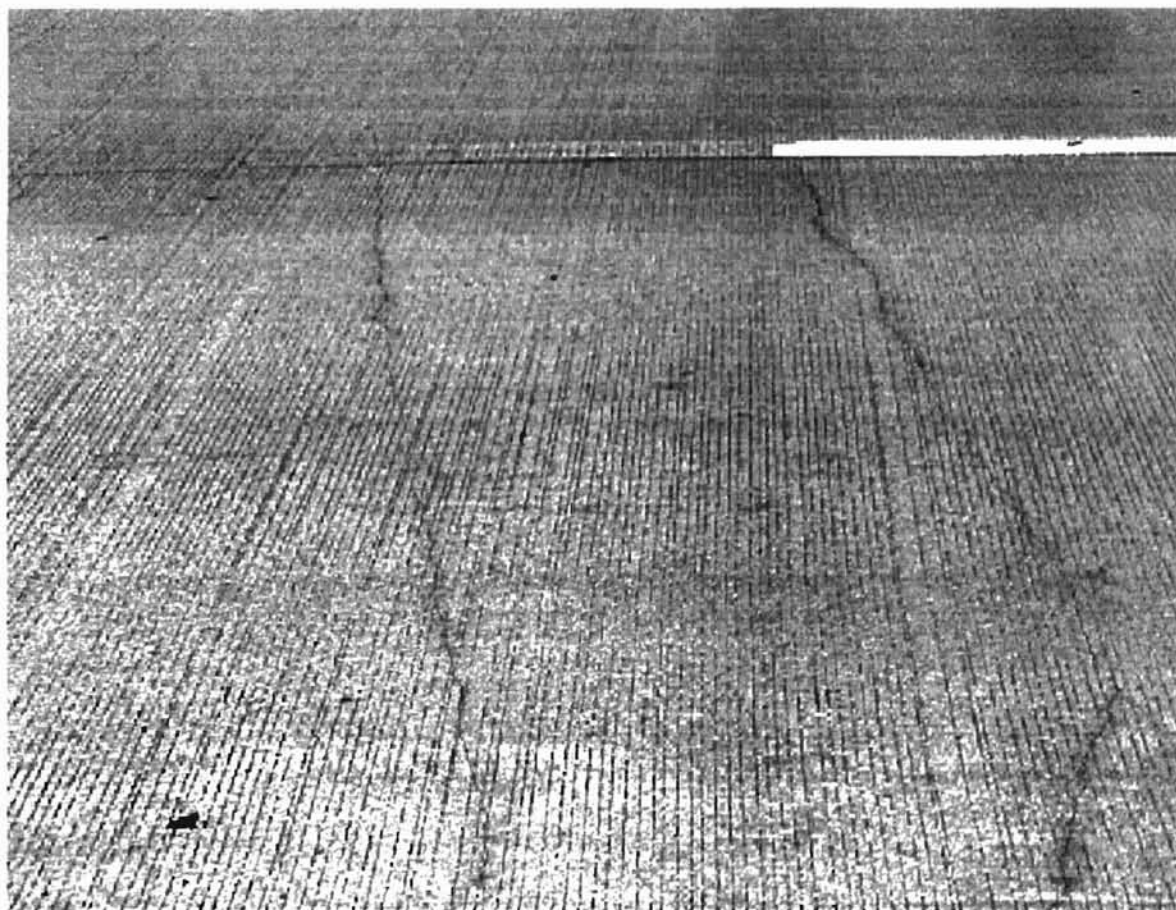
The occasional occurrence of curved cracks in Division 8 is shown in Figure 98. Figure 99 is a typical view of CRCP condition in Division 8.

Figure A98. Typical pavement condition in Division 8.

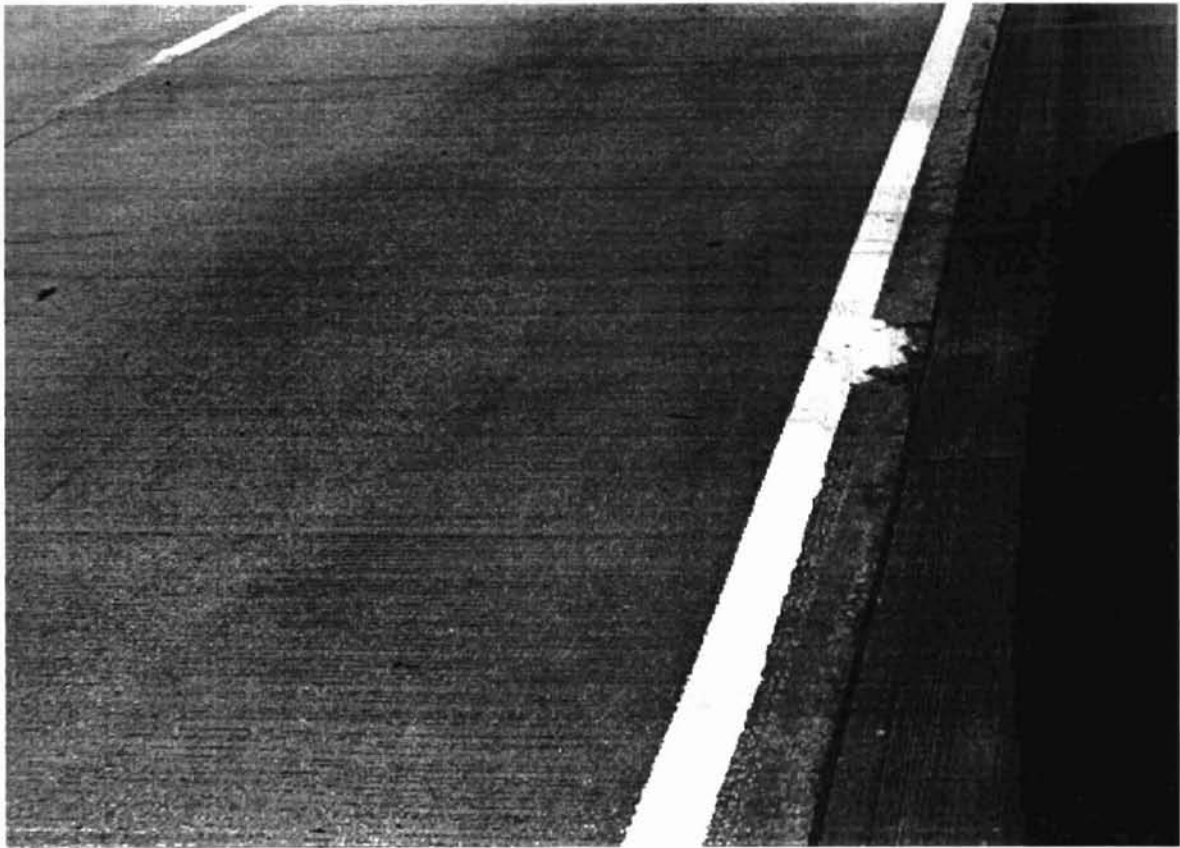
Figure A99. Typical view of transverse cracks in Division 8.

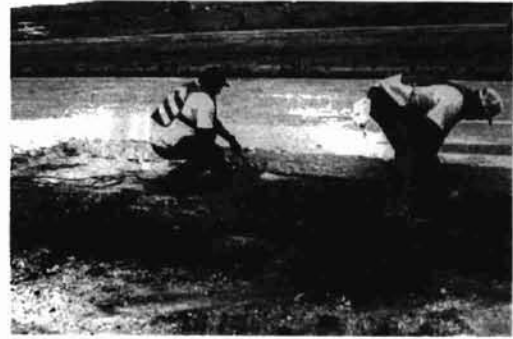
5. Drilling holes for transverse steel

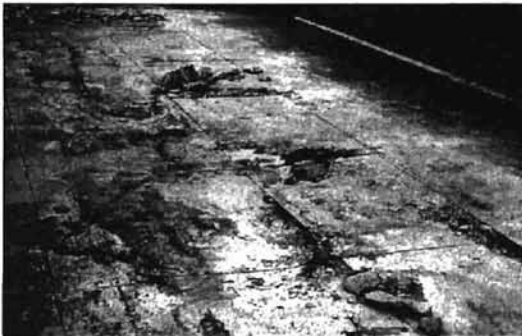
2. Full-depth sawed pavement for removal.

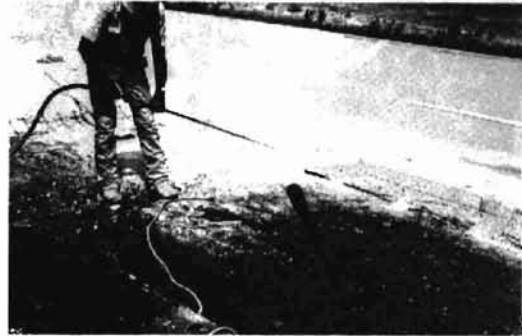
6. Blowing out dust from holes.

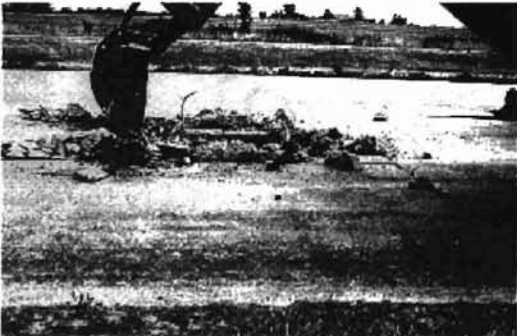
3. Removal of sawed sections.

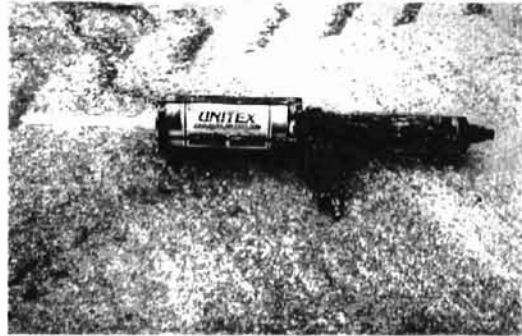
7. Glue gun for epoxy binder.

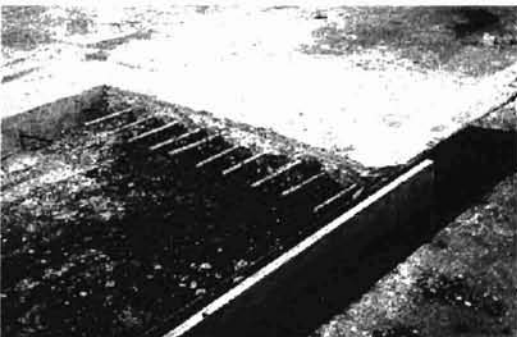
4. 450 mm (18") longitudinal reinforcement exposed.

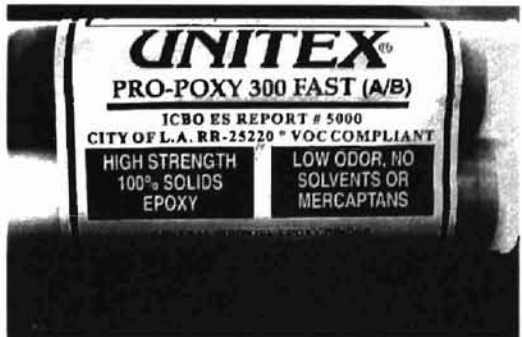
8. Two cylinders containing epoxy compounds.

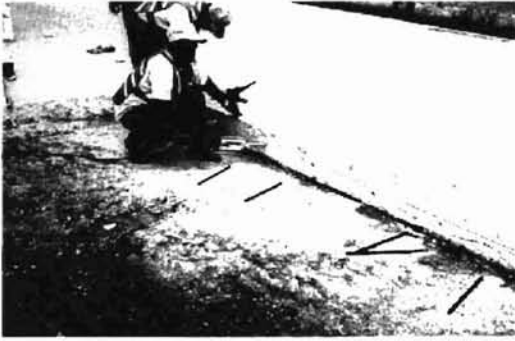
9. Injecting epoxy into holes.

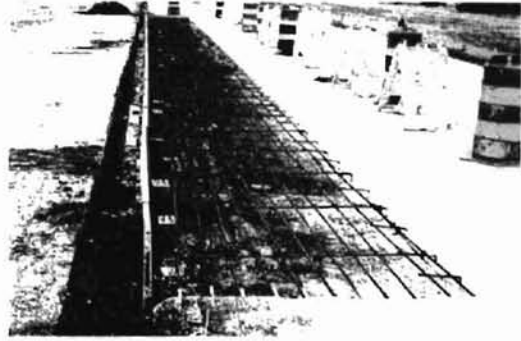
13. All steel installed and ready for concreting.

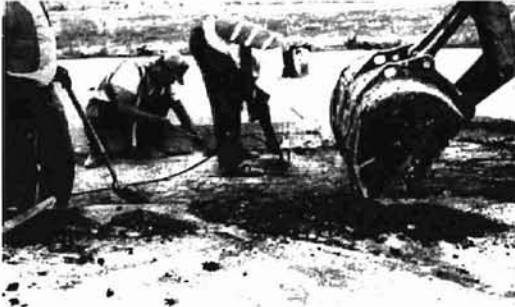
10. Tapping transverse steel into epoxy-injected holes.

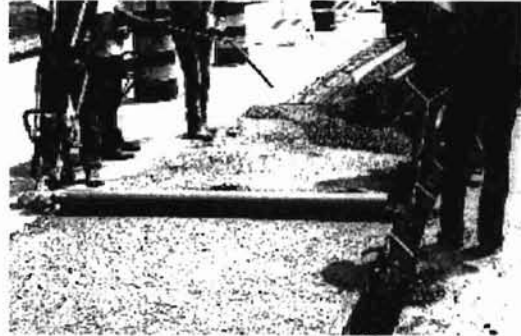
14. Internal vibrator and levelling roller to consolidate and level concrete.

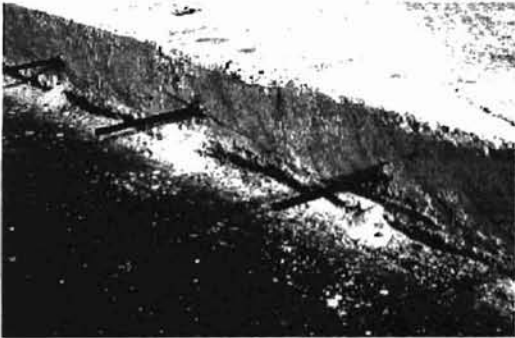
11. Close view of transverse steel installed.

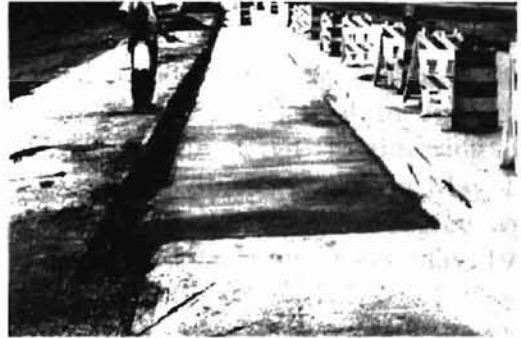
15. Curing concrete.

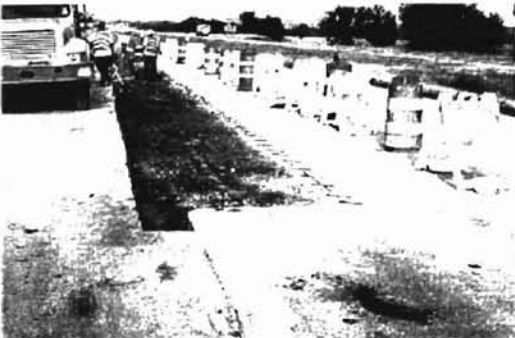
12. Longitudinal and transverse steel ready for connection.

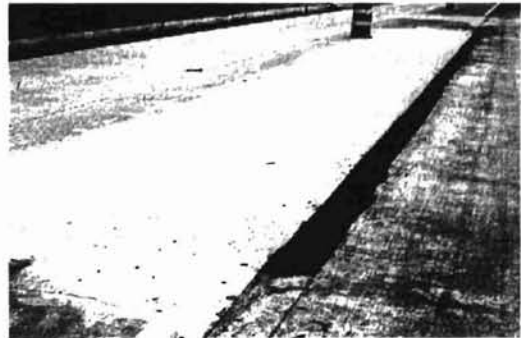
16. Repair completed.
