FACTORS RELATING TO SUBGRADE MOISTURE VARIATIONS
BENEATH OKLAHOMA HIGHWAYS

Submitted to the Faculty of the Graduate College
of the Oklahoma State University
in partial fulfillment of the requirements
for the Degree of
MASTER OF SCIENCE
May, 1970

The School of Civil Engineering at Oklahoma State University is presently engaged in a six-year Subgrade Moisture Variations research project, which began in June, 1964. The project is sponsored by the Oklahoma Department of Highways and the U. S. Department of Transportation, Federal Highway Administration, Bureau of Public Roads.

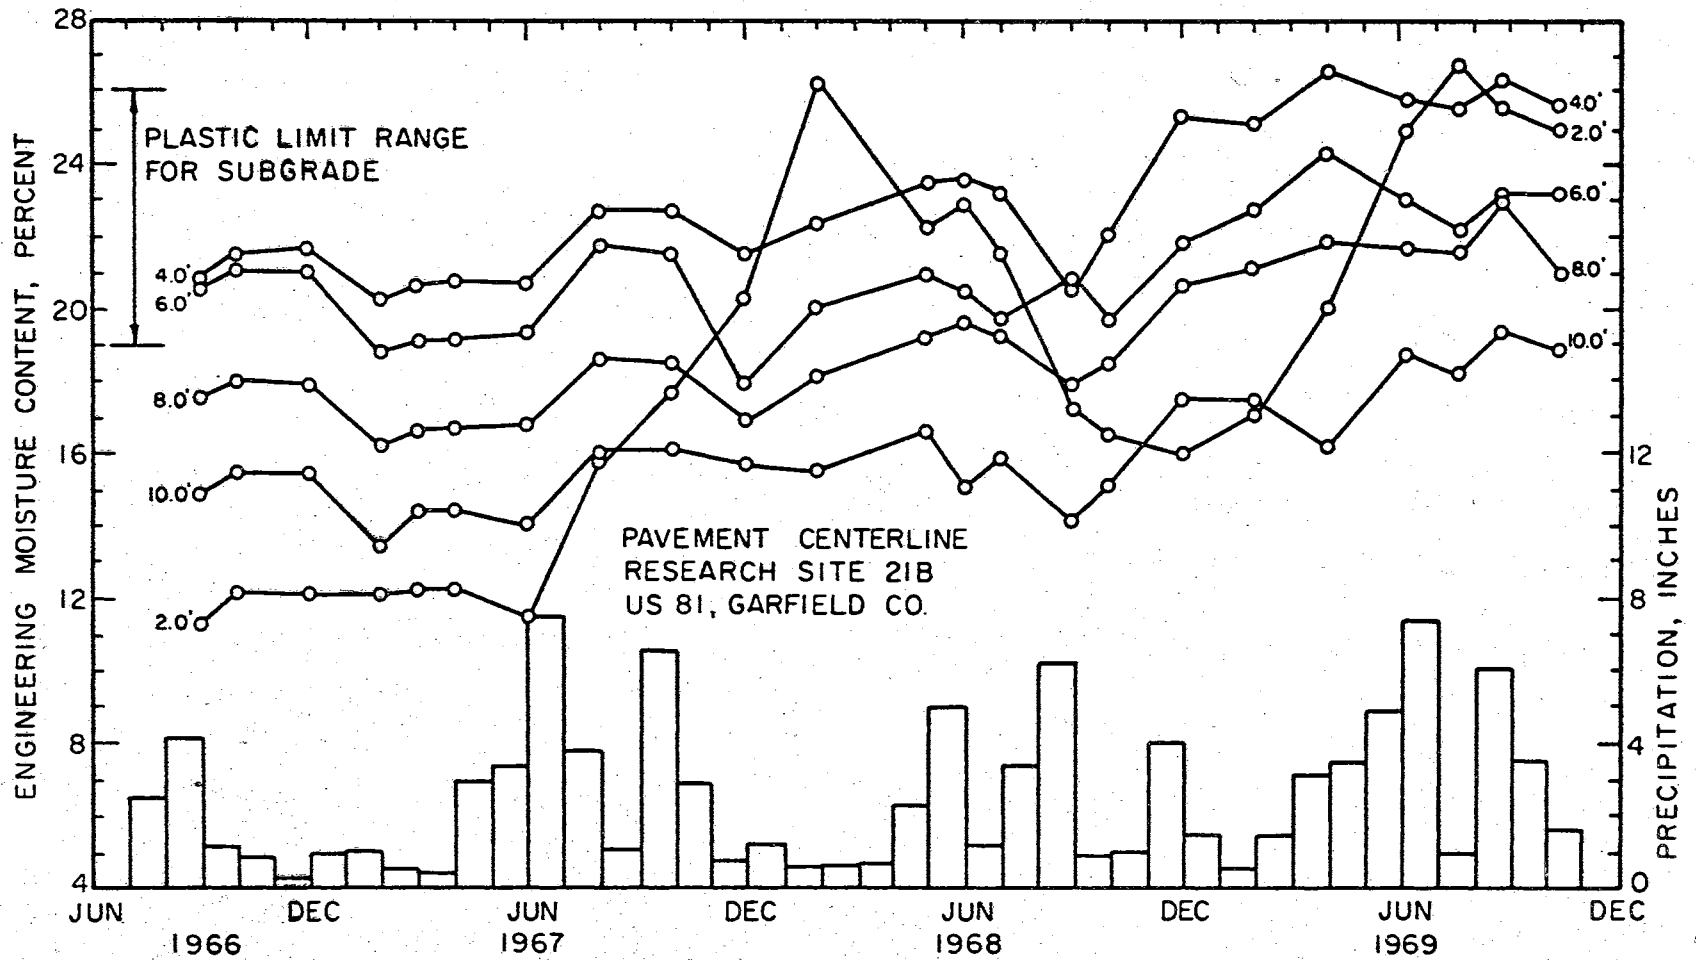
Figure 5.4. Moisture Variations at Selected Levels Beneath Pavement and Rainfall at Site No. 21

a plastic limit of 18-22 percent, lineal shrinkage averages about 10 percent, and the base material is a fine sand cushion. Drainage is rated fair because water stands in the median after rains and shoulder slopes are very gentle. Even though pavement and shoulder ratings are excellent, some shoulder settlement has been noted. The research site was installed in August, 1966, just after the period of drought mentioned previously.

Moisture accumulation is the more predominant mode of subgrade moisture behavior with "cyclic" variations superimposed on the accumulation, as shown in Fig 5.4, a plot of moisture variations under pavement at the site. Monthly rainfall is also shown in Fig 5.4, and the time lag between rainfall is generally six to eight weeks, as noted in previous literature (Ref 1). Moisture contents decrease with depth, except for the 2.0 foot level shown in Fig 5.4. This is indicative of precipitation dependent moisture variation. Because of the geometry of the nuclear probe, the 2.0 foot level means 2.0 feet from the pavement surface to the bottom of the probe, consequently the 2.0 foot level reflects moisture content of the sand cushion. Moisture content fluctuates more in the sand cushion than any other level and moisture variations in the subgrade are generally preceded by a corresponding variation in the sand cushion, which probably acts as a moisture reservoir feeding moisture to the subgrade. Moisture conditions under the shoulders varied at a faster rate, but the general trend was the same as under the pavement, because of the pervious stabilized aggregate base material used under the shoulders.

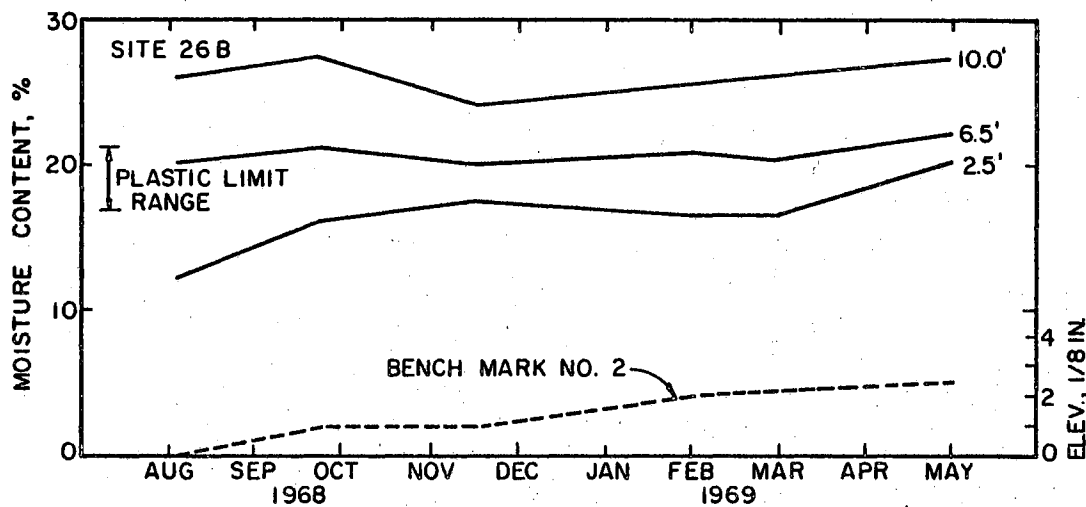
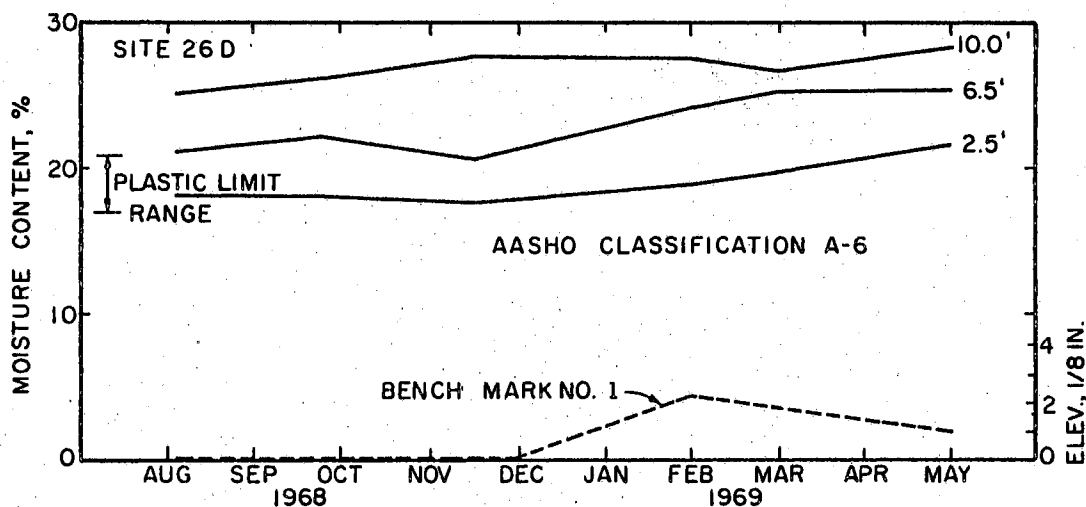
Figure 5.5. Moisture Variations at Selected Levels and Bench Mark Elevations at Site No. 26

Site No. 26 is located in Cleveland County on US 64. The two-lane highway was constructed in 1963 with PCC pavement on a sand base course and improved shoulders over stabilized aggregate base material. A rather uniform A-6 subgrade material exists at the site, and it has a plastic limit range of 18-22% and lineal shrinkage of 10-16%. The research site is located at the beginning of a shallow transition subgrade cross-section. The bench mark in the pavement edge is located to the cut side of the section. Pavement and shoulder ratings have steadily decreased at this site since 1966. Presently, the pavement rating is excellent, but the shoulder rating has dropped to good because of settlement and slight cracking in the shoulder. Figure 5.5 shows a plot of moisture behavior and bench mark readings at Site No. 26. A water table below this site probably exerts the greatest influence on moisture behavior, because moisture content increases with depth and the zone of capillary rise appears to be holding moisture

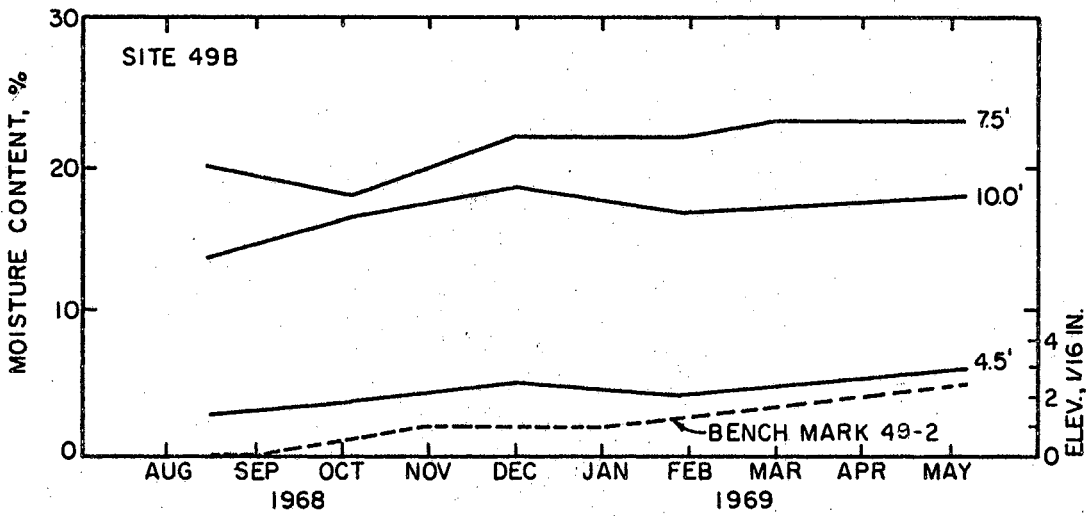
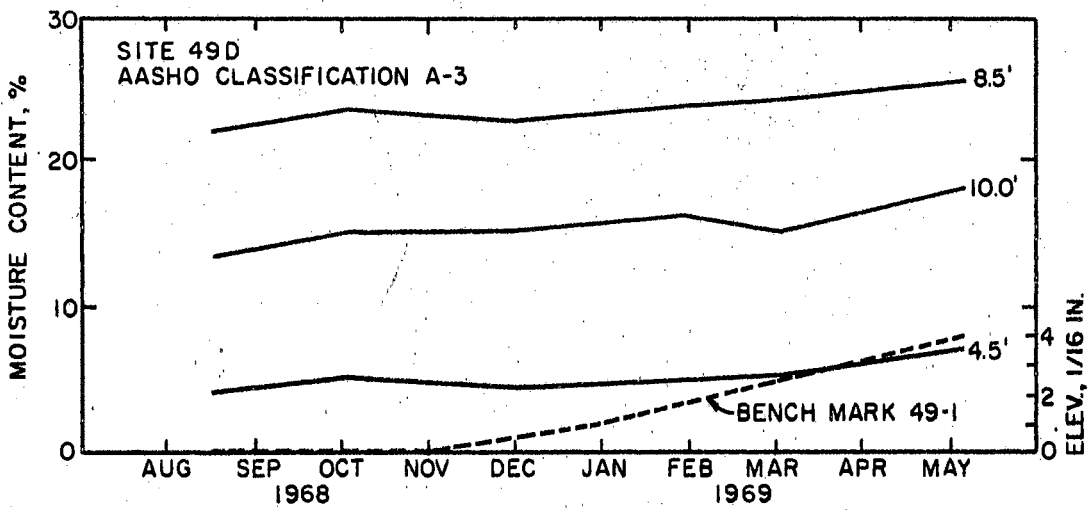
Figure 5.6. Moisture Variations at Selected Levels and Bench Mark Elevations at Site No. 49

The swelling potential of even "good" Oklahoma subgrade soils is illustrated by conditions observed at Site No. 49, located in Payne County on SH 51. The two-lane highway was completed in 1967 and has asphaltic concrete (AC) pavement with improved shoulders on a sand-asphalt base. The research site was installed in 1967, just after surfacing, on a slight cut with downhill grade. The drainage is rated as good. Classification of the subgrade soil by the AASHO system is A-3, a red, clayey sand that exhibits no obtainable Atterberg limits. However, the pavement centerline and edge did heave with increasing moisture content, but to a lesser degree than more plastic subgrades. Moisture behavior and corresponding pavement movements for Site No. 49 are shown in Fig 5.6. Heave at Site No. 49 was the result of an

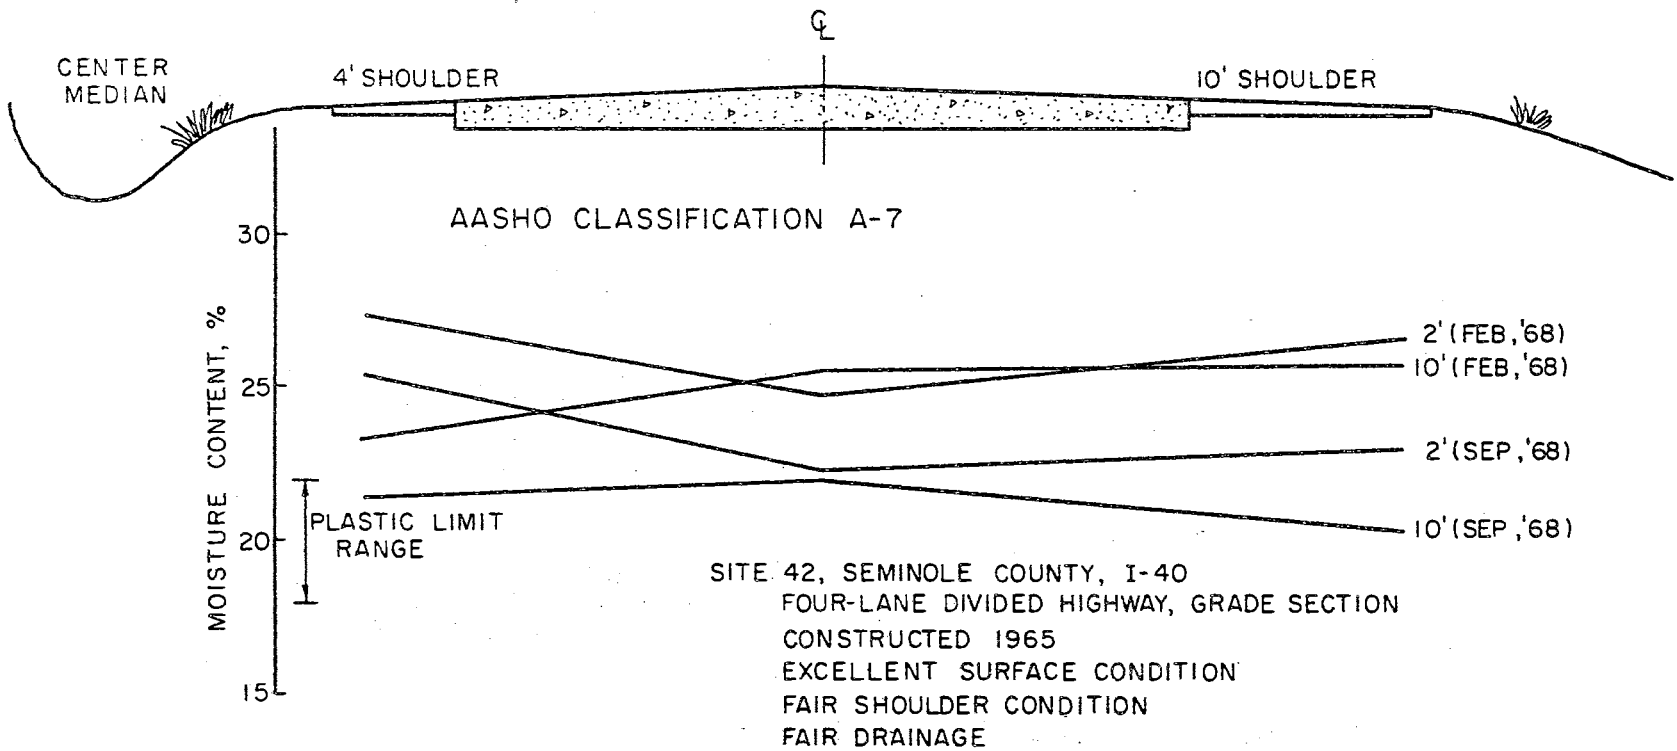
Figure 5.8. Subgrade Moisture Distribution at Site No. 42

The results of lateral swelling are illustrated in Fig 5.7, a photograph of the outside shoulder of I-40 adjacent to Site No. 42 in Seminole County. This four-lane divided highway was constructed in 1965 and has PCC pavement with improved shoulders extending four feet inside and 10 ft outside the pavement, on a uniform A-7 clay subgrade with a plastic limit range of 18-20 percent and lineal shrinkage of 18 percent. The base material is sand-asphalt under the pavement and soil-cement under the shoulders. The outside shoulder has moved laterally away from the pavement, opening the joint between shoulder and pavement approximately one inch. The shoulder surface has also cracked extensively, in both transverse and longitudinal directions. The longitudinal cracks are within three to five feet of the shoulder edge and are probably caused by the wet-dry interface described by Dagg and Russam (Ref 6). A plot of moisture conditions under the highway at Site No. 42 for the wet and dry seasons of the year is shown in Fig 5.8, and seasonal fluctuations under the outside shoulder are more severe than under the inside shoulder or pavement centerline. Divided highways generally exhibit this type of moisture behavior because the median does not drain as well as the outside shoulder, thus most four-lane divided highways have only fair to good drainage.

Tensile stresses in the soil-cement base material, as a result of swelling caused by increased moisture content, probably caused the shoulder cracking shown in Fig 5.7. Observation records and photographs of Site No. 42 indicate the cracks have doubled in extent and number since the summer of 1967, when first observations were made. The new cracks probably caused fluctuations before they were sealed, as shown in Fig 5.9, a plot of moisture variations under the outside shoulder at Site No. 42. It can also be seen in Fig 5.9 that, prior to sealing the cracks in the summer of 1968, moisture content had increased to well above the plastic limit range. After sealing, moisture contents were reduced to an equilibrium value with the moisture content/plastic limit ratio between 1.1 and 1.2. As previously mentioned, greater fluctuations in subgrade moisture content occur under the outside shoulder and this probably resulted in differential movements between the pavement and outside shoulder, causing the new, unsealed cracks shown in Fig 5.7.

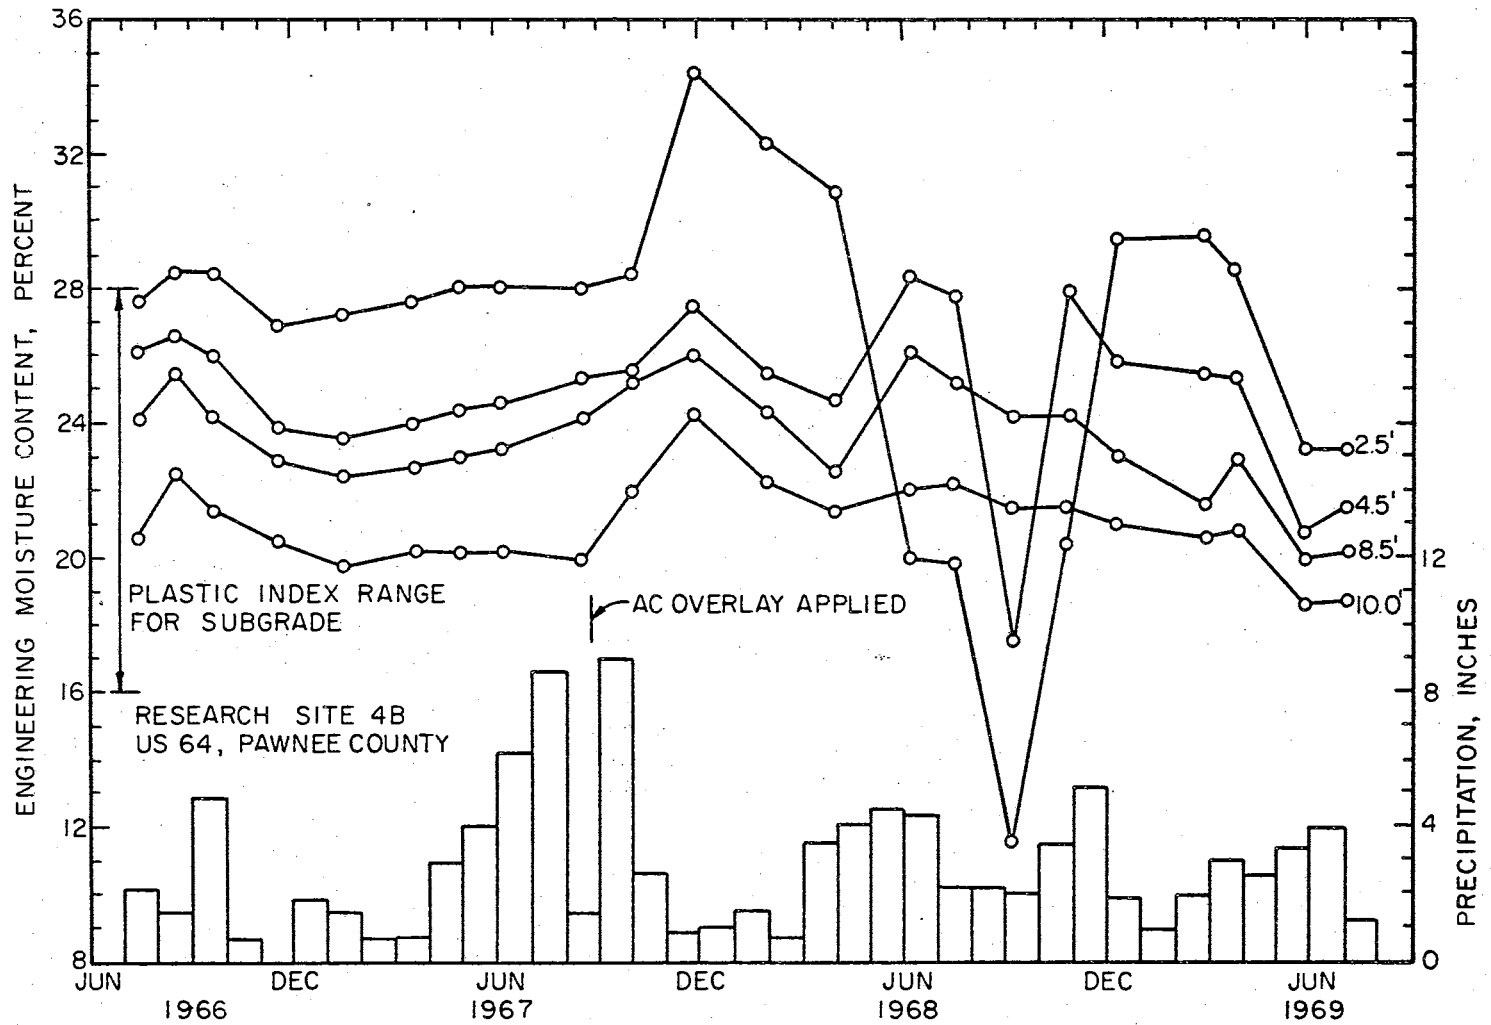
Figure 5.11. Moisture Variations at Selected Levels Beneath Pavement and Rainfall at Site No. 4

Infiltration occurred through cracks in the overlay, as is shown by moisture variations and rainfall at Site No. 4. This two-lane PCC pavement with open shoulders was constructed in 1930, directly on the subgrade, and has been continuously overlaid with AC by Oklahoma Highway Department maintenance forces. No records are available to show when the first overlay was completed. The highway is on grade in a creek-bottom area. The pavement rating increased from poor to good because of a second overlay in 1967, but has decreased steadily since that time. Drainage is rated fair because of gently sloping shoulders.

Figure 5.11 shows moisture variations and rainfall at Site No. 4, installed in July 1966. Moisture contents decrease with depth and some levels are above the subgrade liquid limit. Moisture contents had decreased when the second overlay was applied and heavy precipitation in the winter of 1967-68 caused a sharp increase in moisture contents, particularly at the 2.5 foot level. The bearing capacity was greatly reduced and in the early spring of 1968 the new overlay cracked. Since the old overlay was already cracked, infiltration occurred. Research personnel reported a "thumping" noise whenever traffic crossed the transverse joints before and after the second overlay. Much of the subgrade support was evidently lost long before 1966 when first observations were made. Figure 5.12 shows a photograph of the

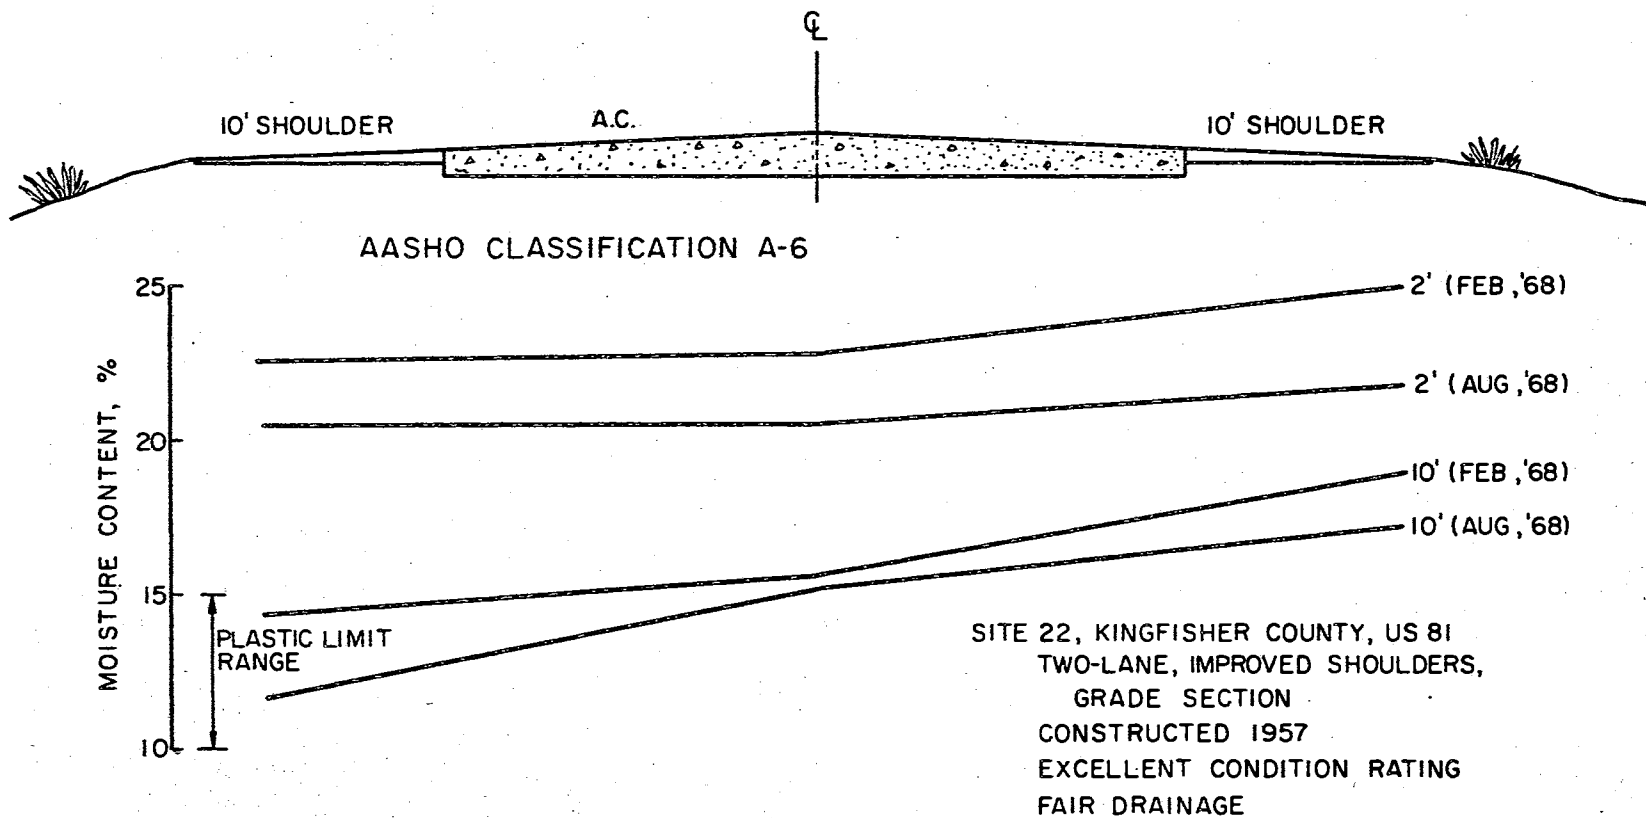
Figure 5.17. Subgrade Moisture Distribution at Site No. 22

Drainage conditions at Site No. 22, on US 81 in Kingfisher County, illustrate the relation of infiltration and verge/shoulder slopes. The two lane AC highway was constructed in 1924 and was overlaid and widened with improved shoulders in 1957 to increase traffic capacity. Stabilized aggregate base material was used under the pavement and shoulders, while the subgrade consists of sandy, A-3 material that has a layer of A-6 clay between the four and five ft levels. Drainage is rated fair because the east verge has a gentle slope and has been noted to remain wet for several days after a rain, while the west verge is on a somewhat steeper slope. The pavement is on grade and is rated excellent. A moisture profile under the pavement is shown in Fig 5.17, where left is to the west. Greater fluctuations under the east or right hand shoulder between the wet and dry seasons of the year were caused by poorer drainage, resulting in more infiltration on the east verge. The steeper verge on the west, or left hand side, provided better drainage and less infiltration. At the shallower 2.0 foot depth, moisture contents under the pavement centerline are between the moisture contents at the shoulder, while at the 10.0 ft depth the centerline moisture content remains almost constant during the wet and dry periods of the year. The previously mentioned clay layer between four and five feet probably acts as a moisture "barrier" and reduces the effects of infiltration from the shoulders, and it

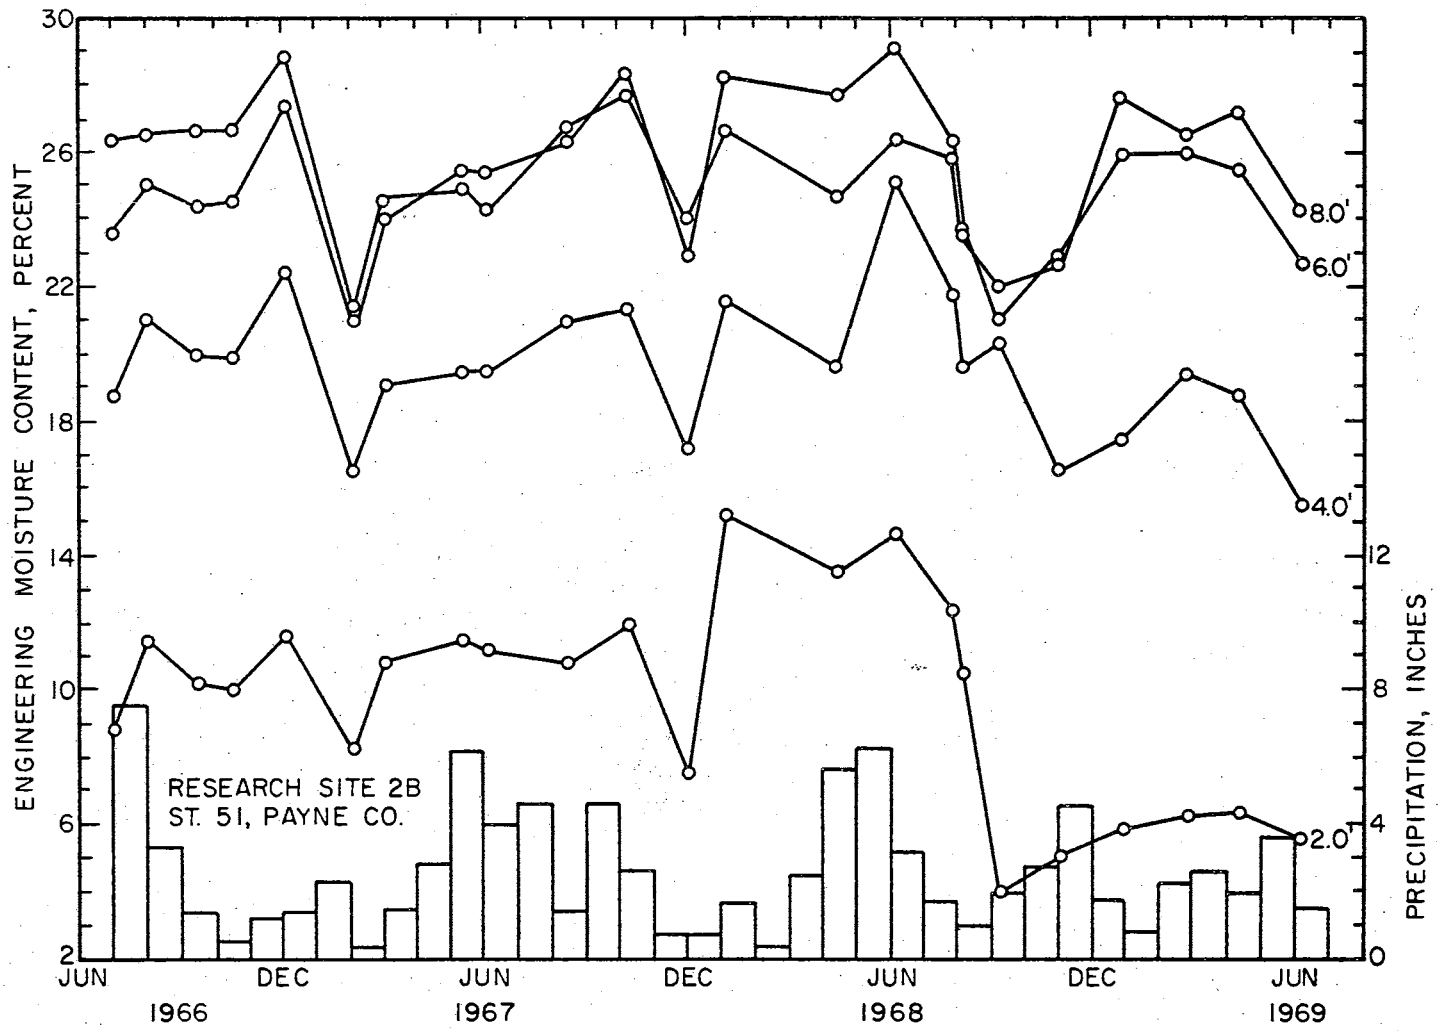
Figure 5.22. Moisture Variations Beneath Pavement at Site No. 2

Site No. 2 is located on SH 51 in Payne County. The two-lane highway was originally constructed in 1930 with open shoulders and PCC pavement on a uniform A-3 sandy soil. In 1955 an overlay was applied and wide shoulders were added to allow for increased traffic. The subgrade has a liquid limit of 20% but no plastic limit or lineal shrinkage. A water table was encountered during site installation in 1966, at a depth of 8 to 10 feet. Moisture variations beneath the pavement are shown in Fig 5.22, along with rainfall for the three-year period of study. Subgrade moisture conditions appear to be influenced by both precipitation and the fluctuating water table. Bench mark data from Site No. 2 indicate heaving with increasing moisture content, but, as at Site No. 49, heaving is generally less than 1/8 inch.

Hair-line cracks in the overlay denote location of transverse and longitudinal joints in the original PCC pavement, and probably allow some infiltration into the subgrade. The reason for good behavior of the overlay at Site No. 2 is the soil type.
