NONDESTRUCTIVE EVALUATION OF OKLAHOMA
STATE UNIVERSITY COLVIN CENTER ANNEX
DECAYED TIMBER ARCHES

Submitted to the Faculty of the
Graduate College of the
Oklahoma State University
in partial fulfillment of
the requirements for
the Degree of
MASTER OF SCIENCE
December, 2001

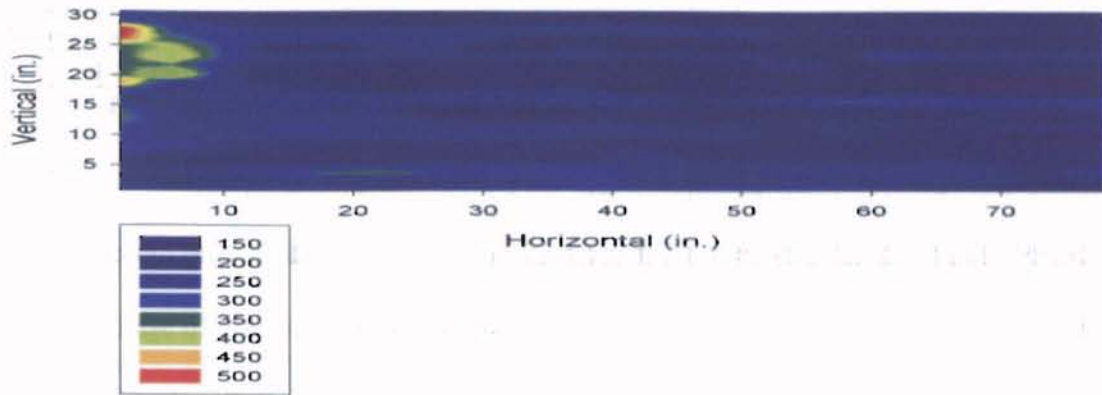
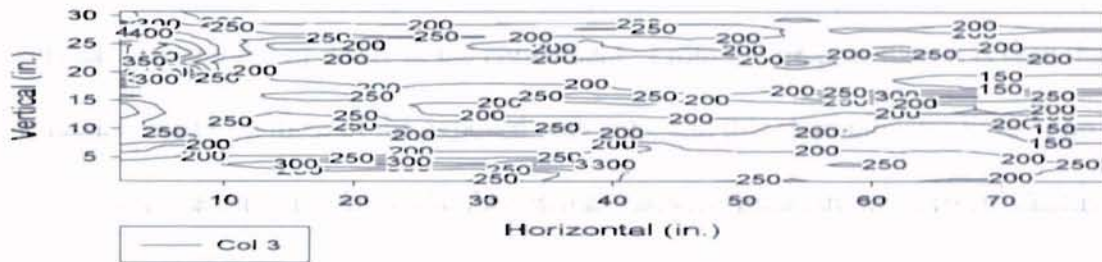
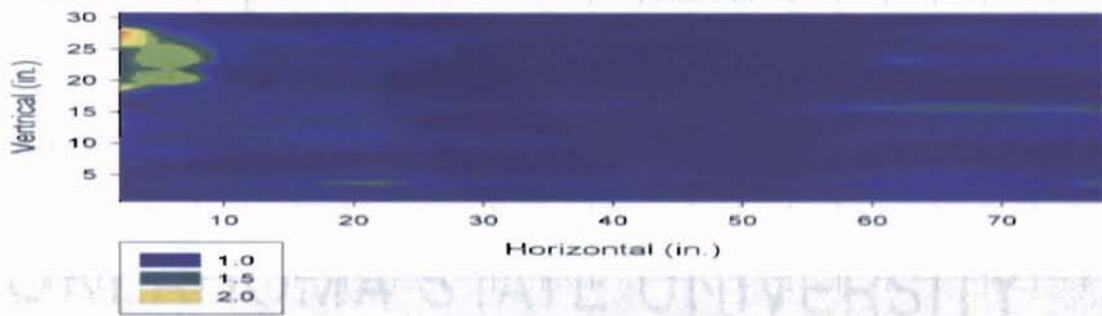
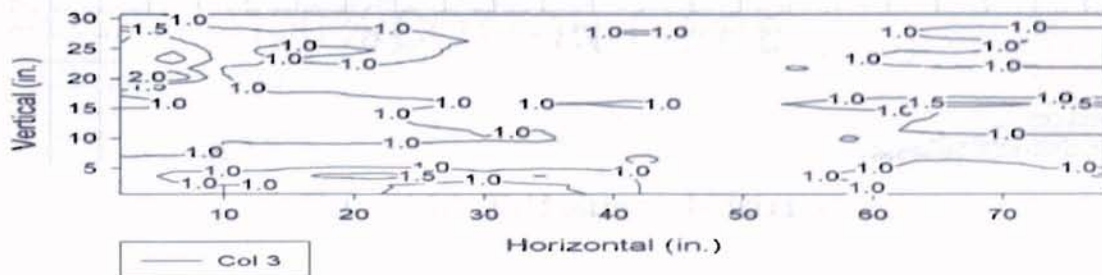
Figure 4.1.2: Glulam 0 Graphs

In Glulam 0, a small amount of decay is present throughout most of the member. In the first eight inches, a pocket of advanced decay exists. This critical area can be seen as completely decomposed areas in the field picture. This advanced area is surrounded by regions of moderate and early decay and should be flagged since the connection between the member and the ground is made in this locale. Throughout the remainder of this component, early to moderate decay is often present, but few areas of concern exist. Lamination O is an exception, though, because moderate decay exists throughout the mid-section of the entire piece up to about 20-inches from the top. This decay is indicated on the color contour diagram as a light blue region just above the 10-inch vertical mark. Sometimes these middle areas of slower travel time indicate a natural knot in the wood, but, in this case, the entire lamination is affected, so decay is most likely present.

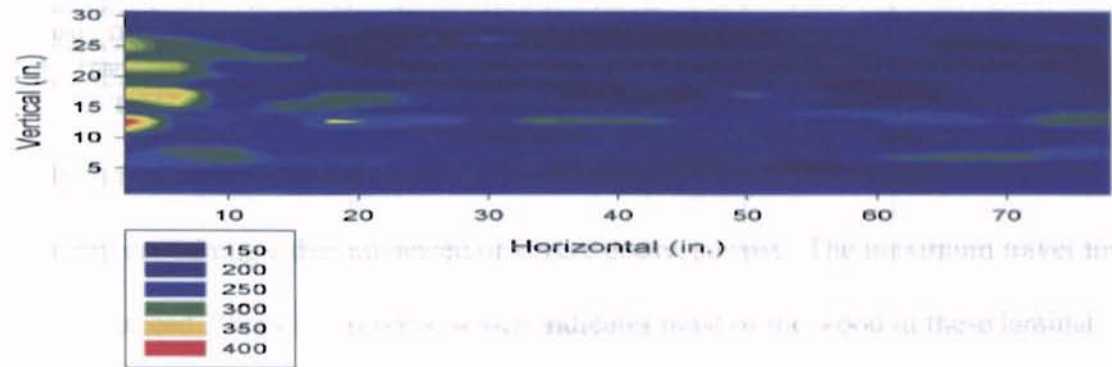
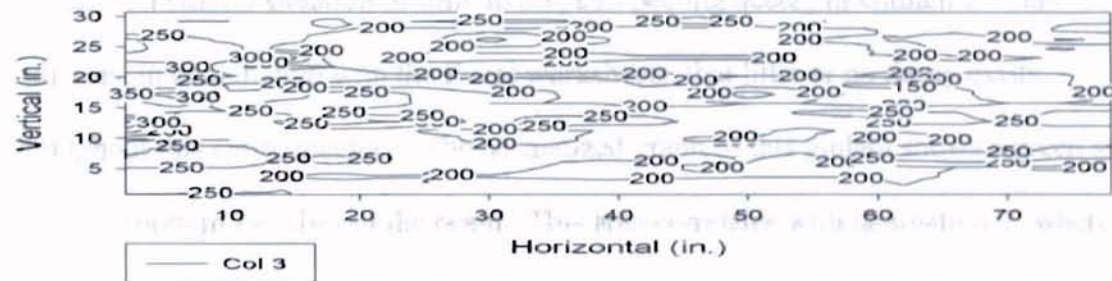
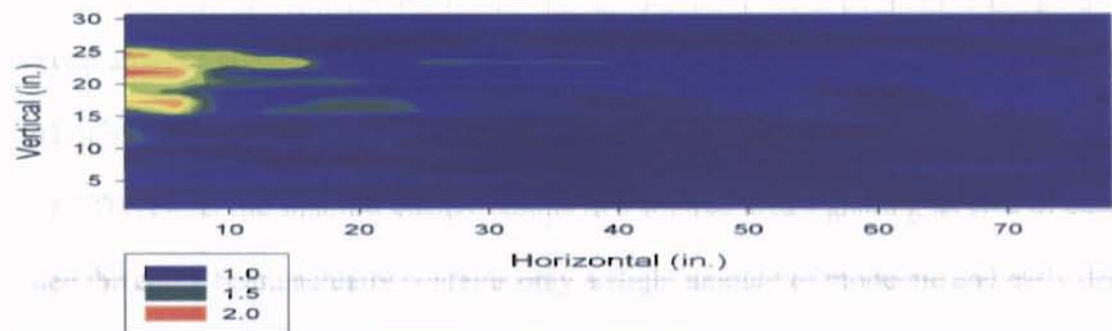
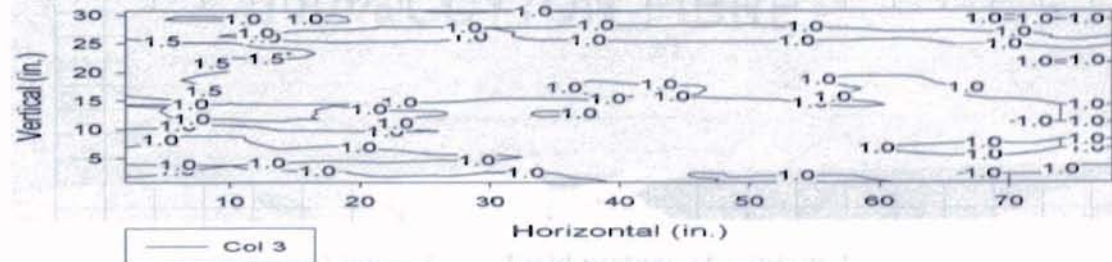
Figure 4.2.2: Glulam 1 Graphs

Glulam 1 seems to have very little decay throughout, with patches of early to moderate decay present only in the top half of the member and not extending much past 16-inches from the base of the arch. No advanced or severe decay exists throughout any of the glulam. The location of this member is such that it is protected on both sides by brick walls. These structures have helped in deterring weather from glulam 1 and have, in turn, decreased the amount of decay in the constituent. From the field picture, it is seen that the paint remains on most of the exposed arch area, and this sign indicates little or no decay, since the paint peeling is the first step to allowing moisture to reach the depths of the beam. The contour diagrams for this member show decay throughout its entirety, which is misleading. The maximum travel times reach only to 400- μ s, which is relatively small, so every little change in travel time is magnified, since there are no large times present.

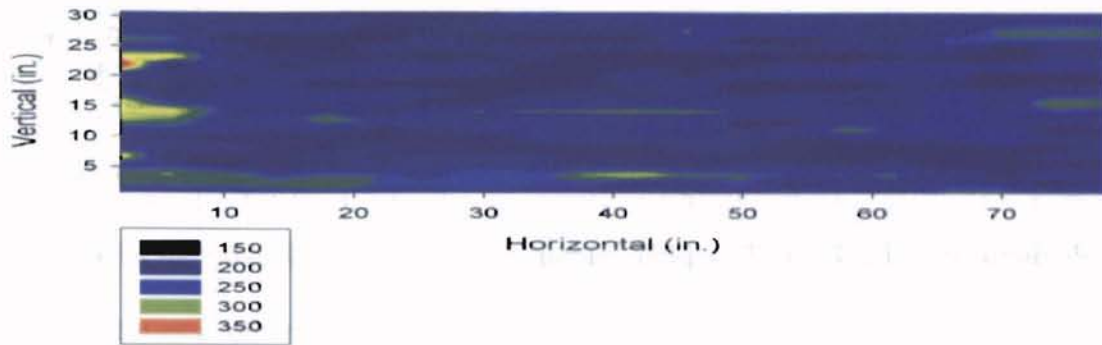
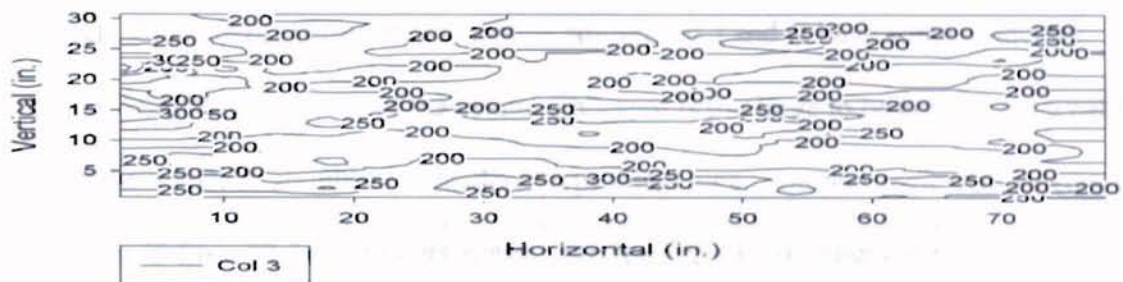
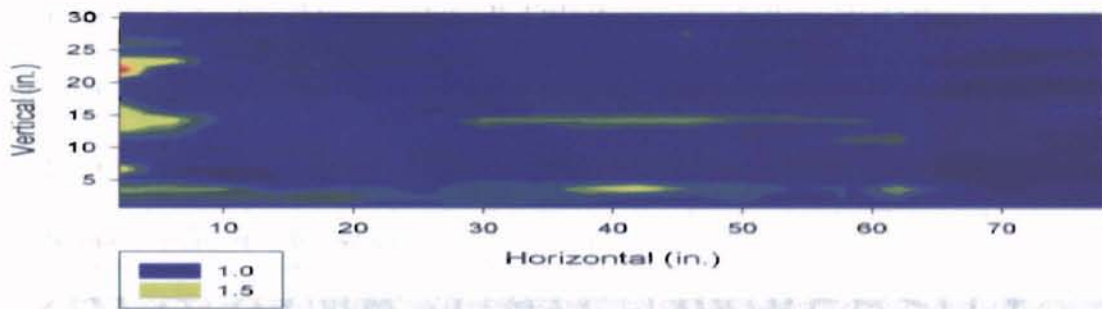
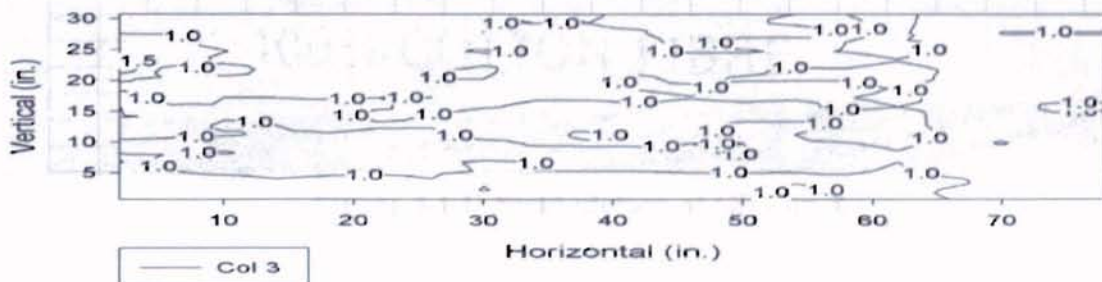
Figure 4.3.2: Glulam 2 Graphs

Early to moderate decay exists throughout areas of Glulam 2, but no major areas of concern, containing either advanced or severe decay, subsist. The maximum travel time did not exceed 300 microseconds, which indicates most of the wood in these laminations is sound. This satisfactory state can be seen in the field picture below. As mentioned in Glulam 1, a similar situation of little to no paint peeling occurs in Glulam 2. This indicates, in conjunction with the Excel worksheets, that little or no decay exists throughout this entire member. The normalized graph of this glulam shows a green area along the bottom 8-inches of the beam. This area correlates with lamination T, where moderate and early decay exist throughout the entire beam. This demonstrates the accuracy of the normalized graphs. Another reason the normalized graph contains several areas of green coloration is because the variance of the time travels is so slight, similar to glulam 1, that the normalized graph has very little change from one area to the next. Therefore, the smallest change results in a colored area signaling an area of decay, when the entire beam actually contains only a slight amount of moderate and early decay.

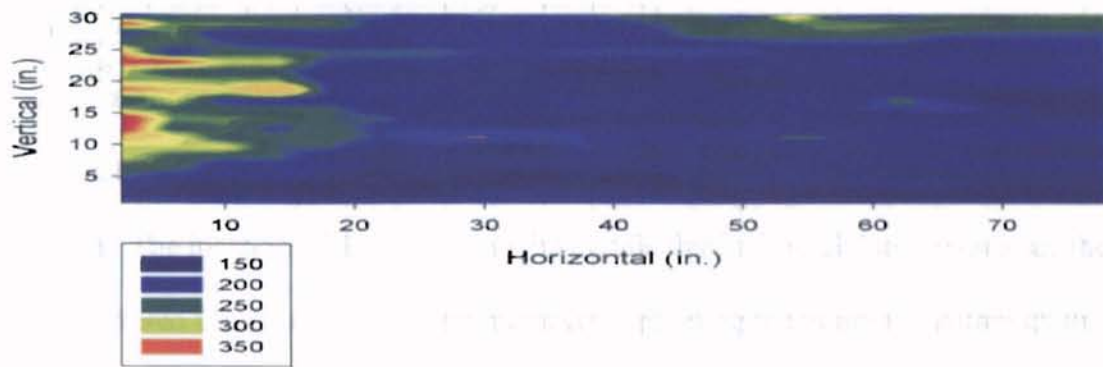
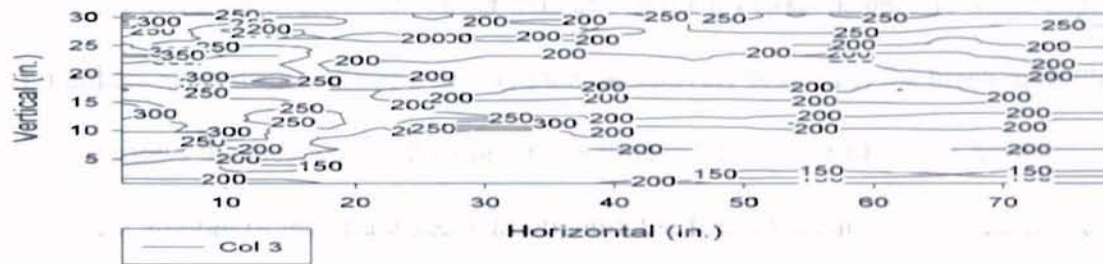
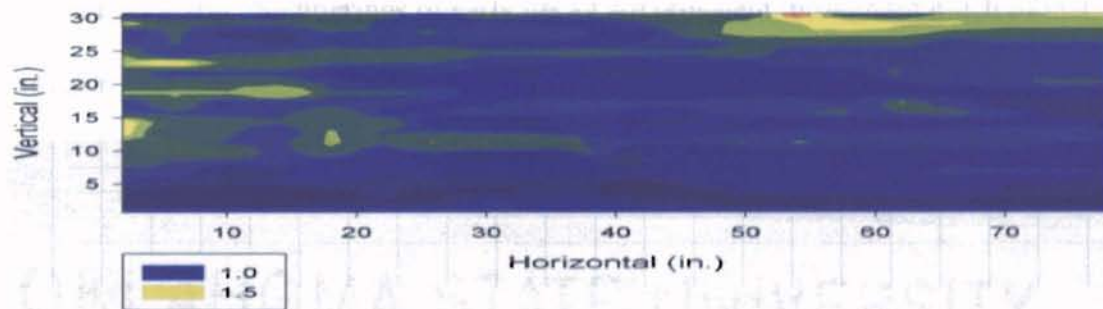
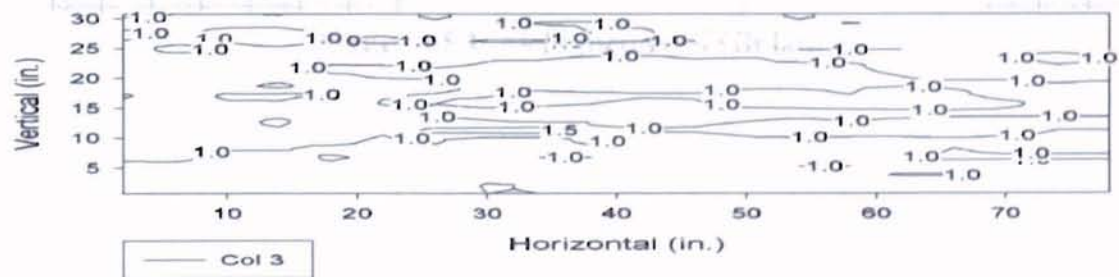
Figure 4.4.2: Glulam 3 Graphs

Glulam 3 has a large concentration of moderate decay in the first 16-inches, although very few of the travel times approach or surpass 350- μ s. This value is comparatively low to travel times in other arches. Yet, the effects of weather and wood grain orientation could be the reason for this difference, which was discussed previously. Throughout this member, some areas of concern do exist. Laminations J and K have some moderate decay existing through most of the beam. This spot is too large to be considered a natural knot in the wood, so should be considered a problem area. Another region of concern is lamination T from 32-inches to 40-inches. Moderate decay is shown in this locale, but due to the relatively small size of the area, a natural knot in the wood is probably the cause of the large travel times. Overall, little decay occurs throughout the expanse of this member, but the first foot is of a primary concern. The graphs below show many areas of high decay, yet, as mentioned above, the travel times are relatively low, and the Excel worksheets indicate otherwise.

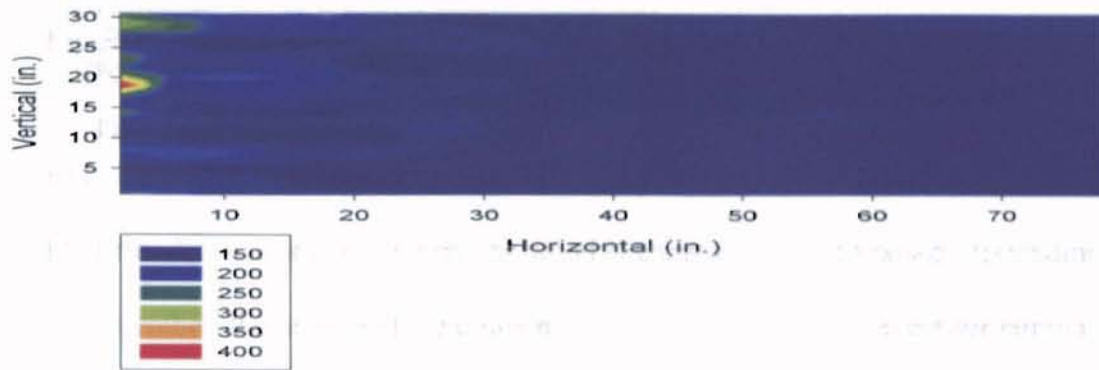
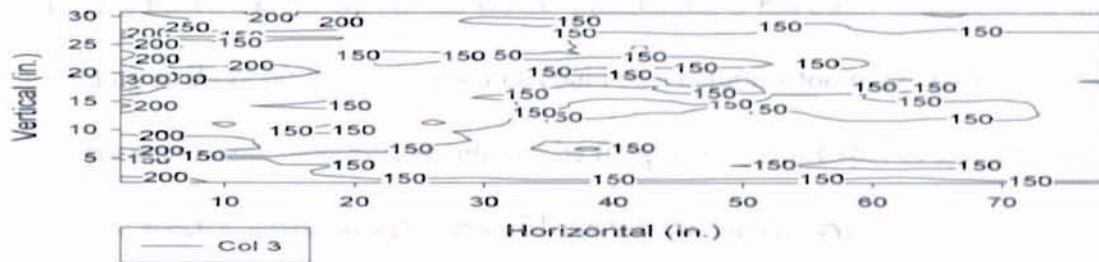
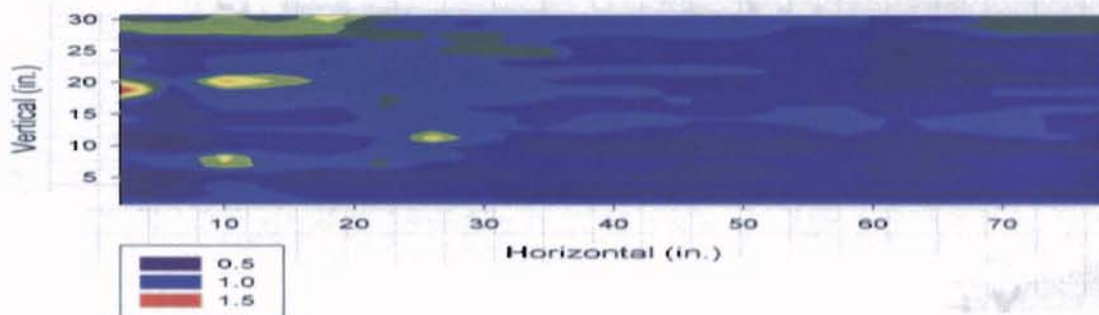
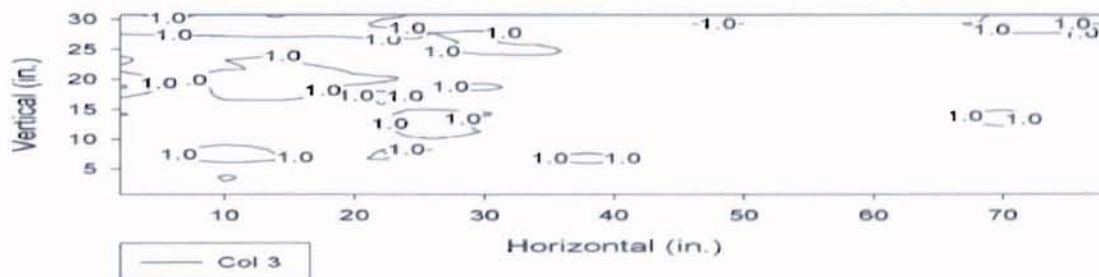
Figure 4.11.2: Glulam 10 Graphs

As found in all others, glulam 10 also has a high concentration of moderate decay in the first 12-inches of the member, with no advanced or severe decay existing throughout the entire member. Beyond this region, a high concentration of early decay with interspersed moderate decay exists throughout the next 16-inches. From this point, only small amounts of early decay exist with no moderate decayed regions. This decay can be seen on the color contour diagram in the left side of the graph. Beyond this area, no coloration other than blue exists, indicating no decay throughout. Once again, the normalized graph is misleading because this graph shows green and dark areas throughout the entire beam, but the highest travel time is 400- μ s, which is relatively low, causing erroneous graph portrayals. Overall, this beam is in good condition, which is apparent in the field picture, Figure 4.11.1. Little paint has peeled off the beam, which is a good indication of little decay.

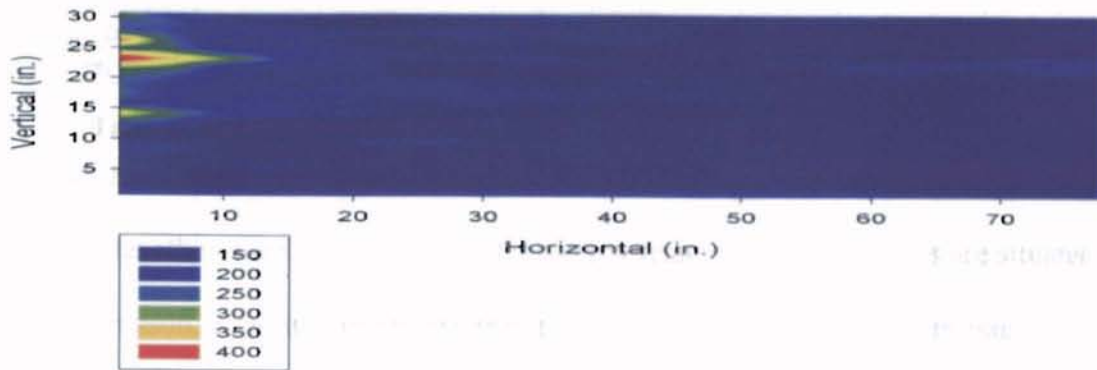
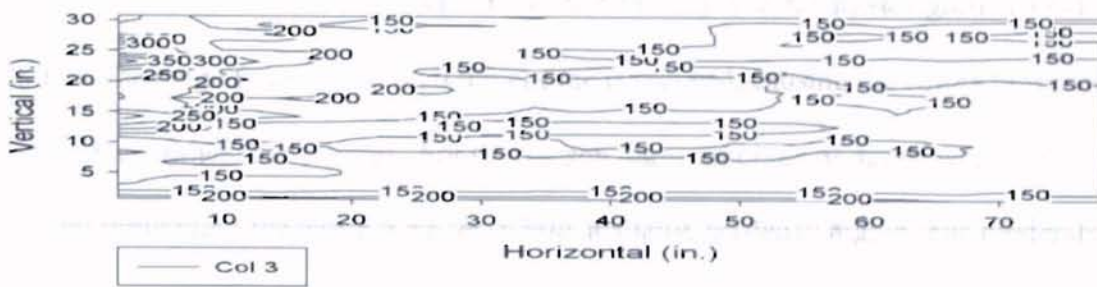
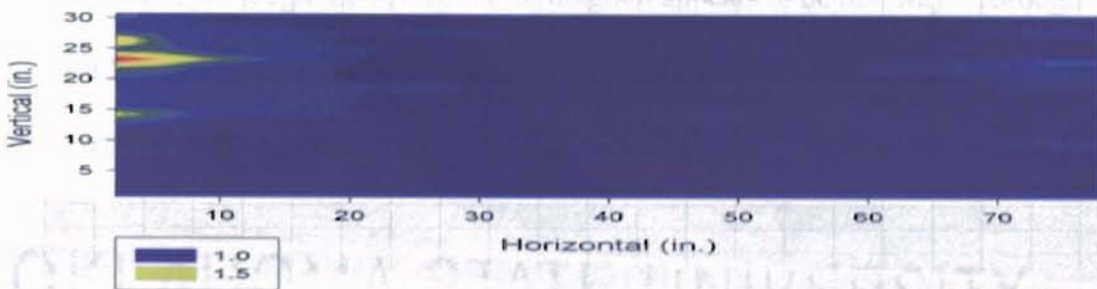
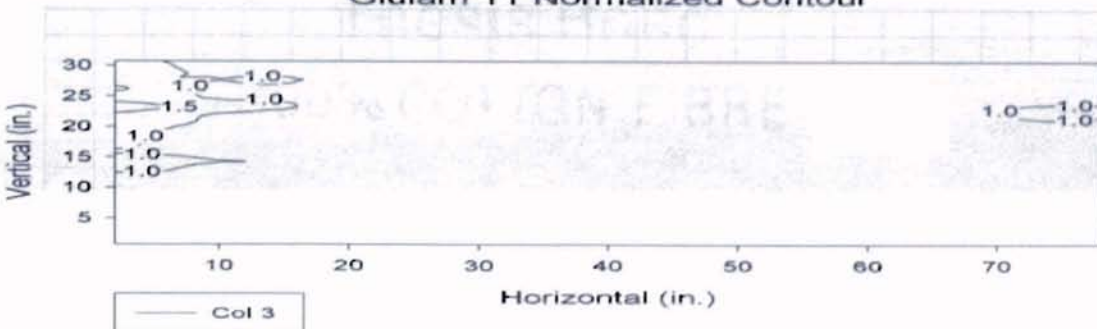
Figure 4.12.2: Glulam 11 Graphs

A large concentration of moderate decay is limited to the first 12-inches of glulam 11. At grid location E1, a hole exists where the wood is completely decomposed. Extending on into the member, the usual early and low moderate decay subsists, except for laminations J and Q. Lamination J has moderate decay throughout the entire first 52-inches, which an area larger than a natural knot in the wood. Lamination Q has decay starting at 52-inches and ending at about 60-inches. This area could be a natural knot in the wood since it is relatively small, and, therefore, should not be flagged as a prime spot of concern. Other than these specific areas, no key areas of decomposition exist beyond the usual scattering of early decay.

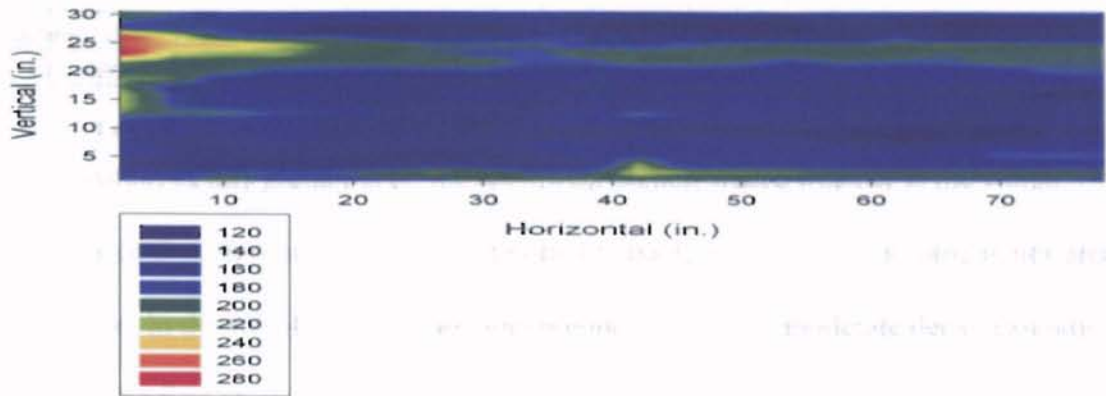
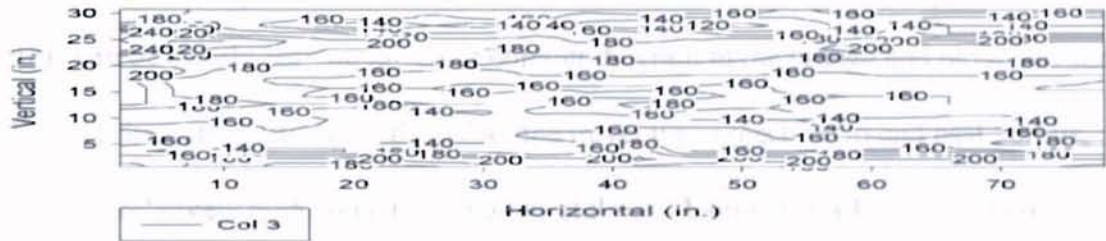
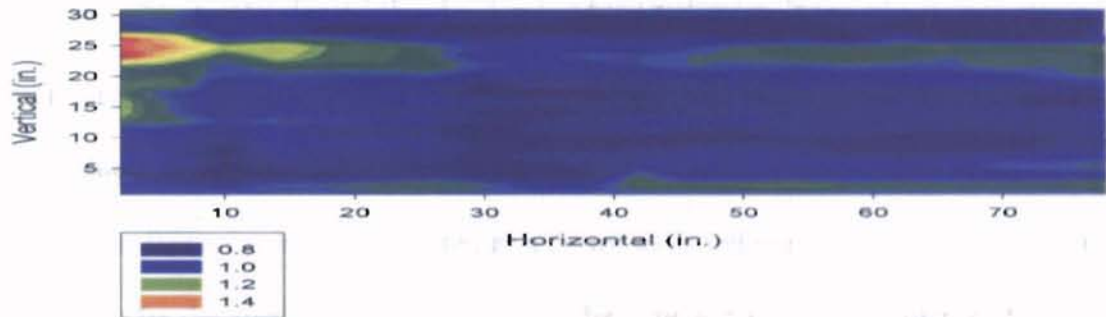
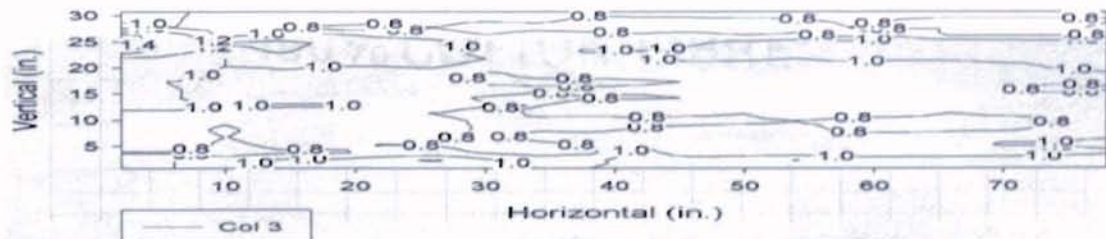
Figure 4.13.2: Glulams 12 Graphs

Glulam 12 is protected on both sides from the environment. One side has a brick wall, and, on the other, the Oklahoma State University tennis courts' bleachers are situated. For this reason, very little decay exists in this member. The color contour diagram is misleading, because the green areas usually represent areas of large decay due to the high travel time. Yet, since all the travel times are relatively low, the most significant being 280- μ s, the range from low to high travel time is reduced, causing the colors to represent lower travel times than normal. For this reason, large amounts of decay seem to be present throughout the entire member, while, actually, no decay higher than moderate exists at all, and only early decay exists past the first 12-inches. This glulam is not one of major concern, although the color contour diagram appears to be that way. Throughout the member, some early decay is present, yet nothing to be concerned about due to the scattered nature of the decay.

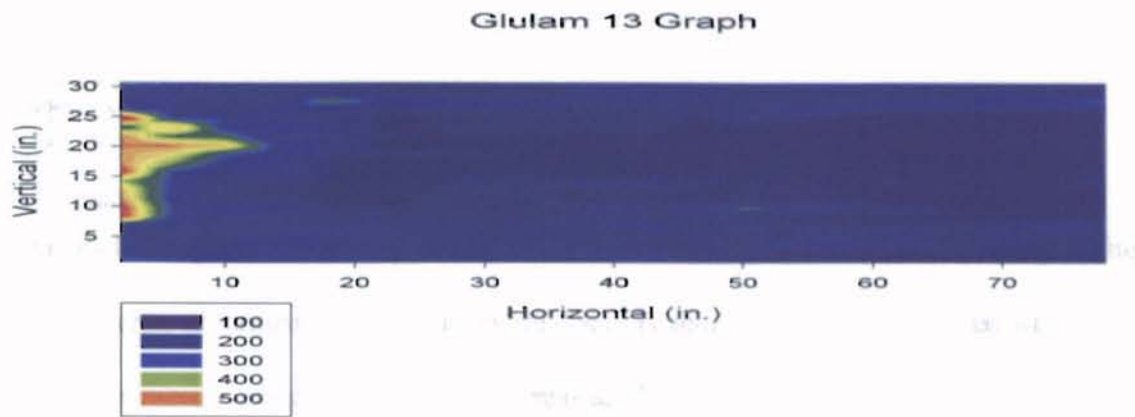
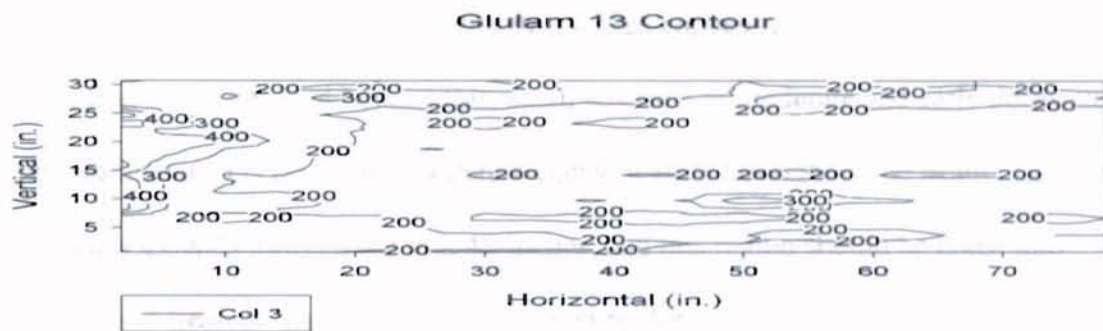
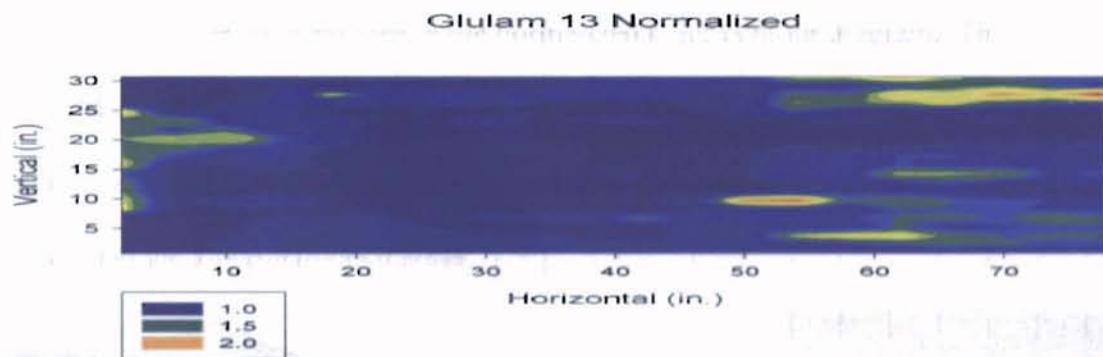
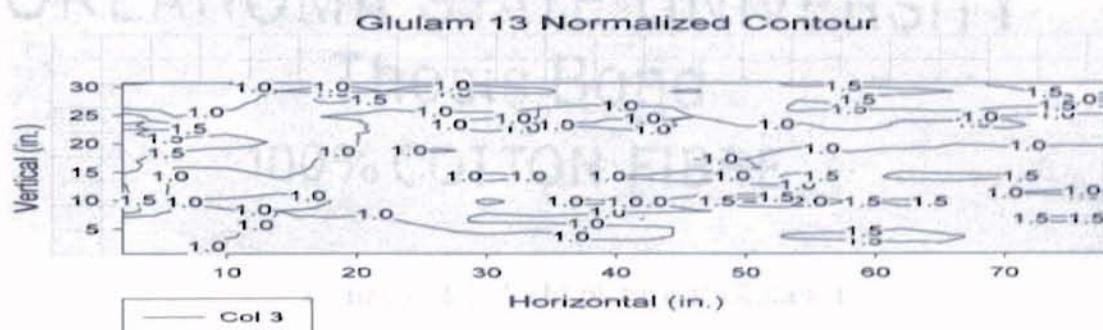
Figure 4.14.2: Glulam 13 Graphs

Because of that, the condition of this member is poor. Glulam 13 has some major areas of concern in the first 4-inches, with a high concentration of moderate decay extending through the first 16-inches of the member. Severe decomposition is located in lamination F, with laminations E and G containing advanced decay, all in the first 4-inches. These areas can be clearly seen on the color contour diagram in the orange and red zones and in the field diagram on the left side. Also, the travel times reach up to and past 500- μ s, which is relatively high compared to other glulams. Laminations E, F, and G contain moderate decay throughout most of the glulam, with this region stopping at 52-inches. In lamination O, at about 50-inches, a small pocket of apparent decay exists, and due to the small nature of the area, this spot could be a natural knot in the wood, but may not be. A light blue area surrounds the green region, which is usually present when decay subsists. Therefore, this area should be treated as a decay spot, and precautions should be taken to treat or to fix the area. Other than these problem areas, nothing more than scattered early decay exists.

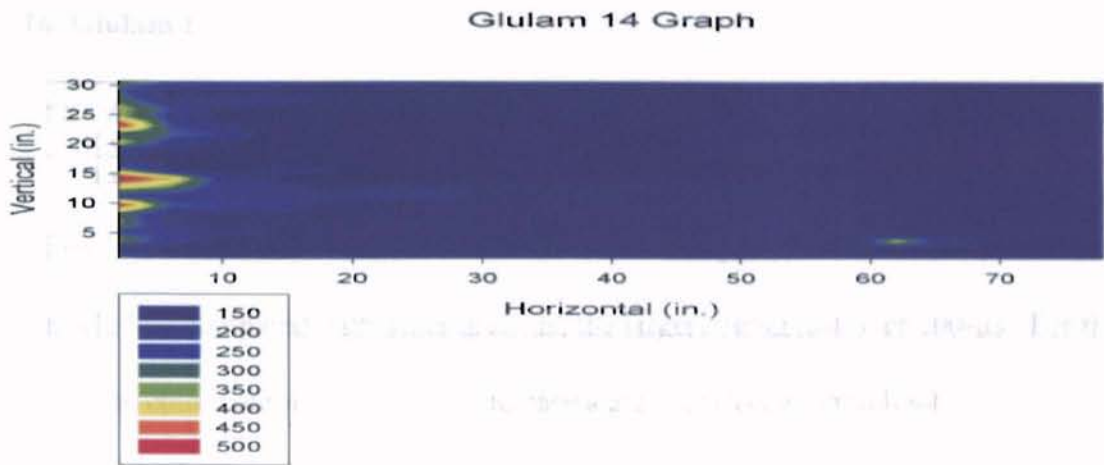
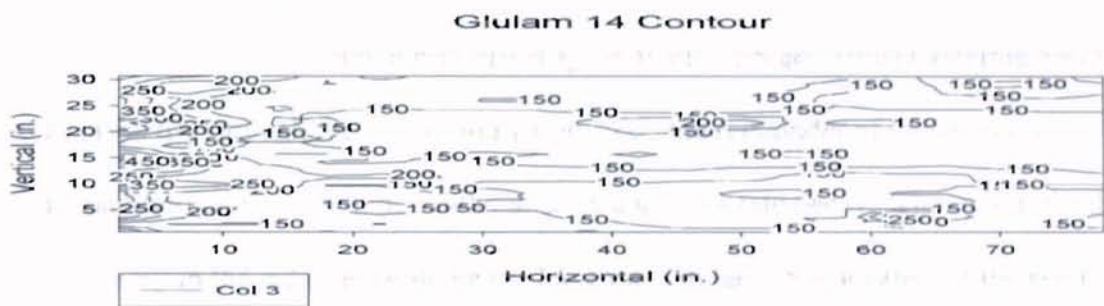
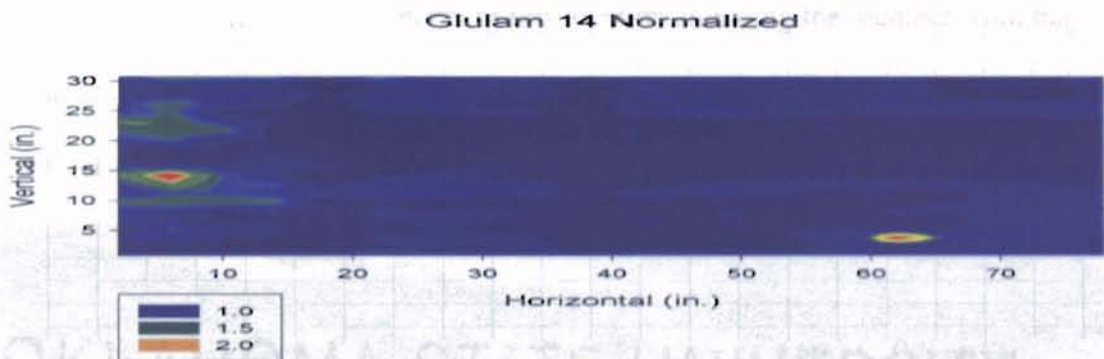
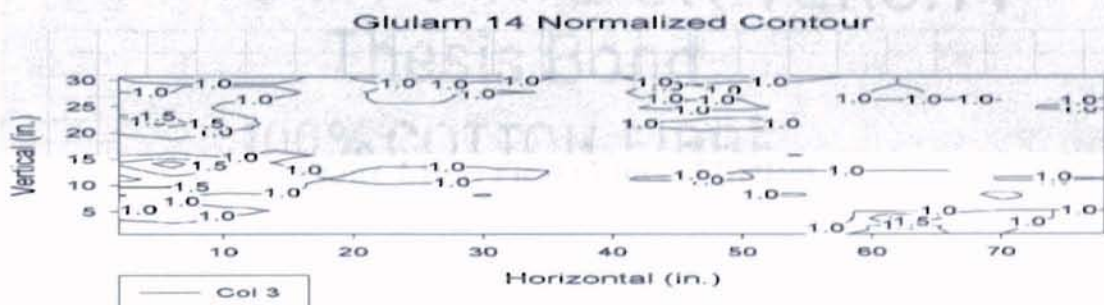
Figure 4.15.2: Glulam 14 Graphs

Glulam 14 contains 4-inches of severe decay in lamination G and advanced decay in the first 4-inches of lamination L. The severe decay is actually completely rotted wood, so a value was merely assigned to it. These areas are indicated with the orange and red hues on the color contour diagram. Besides this, a high concentration of moderate decay exists in the first 12-inches, and beyond this, small amounts of moderate and early decay exist. Yet, laminations G and S have moderate decay in areas throughout the beam. Lamination G's decay extends through the first 48-inches, and this region should be taken into account and treated. Lamination S only contains decay between 60- and 70-inches, which can be seen as a red area in the normalized color contour diagram. This area is most likely a natural knot in the wood, due to the small nature of the apparently decayed region. Past the first 12- or 16-inches, nothing more than scattered early decay exists, other than the aforementioned areas.

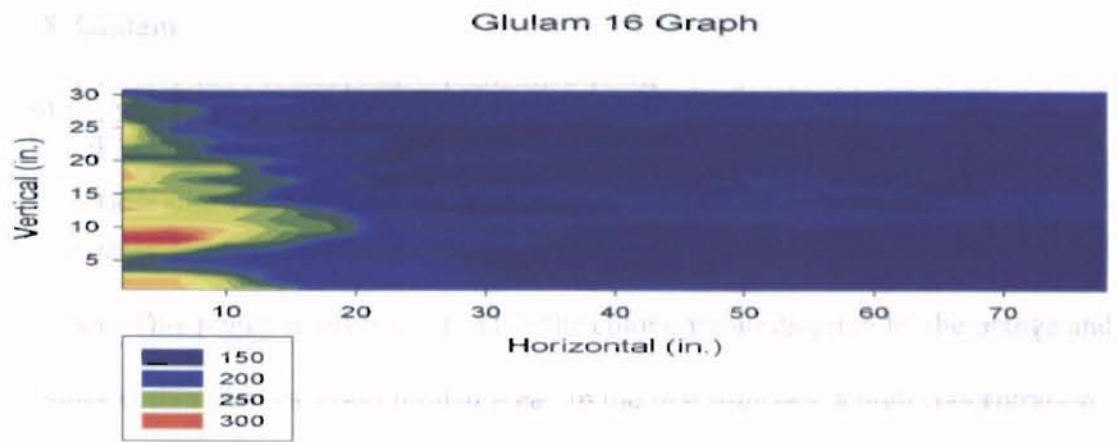
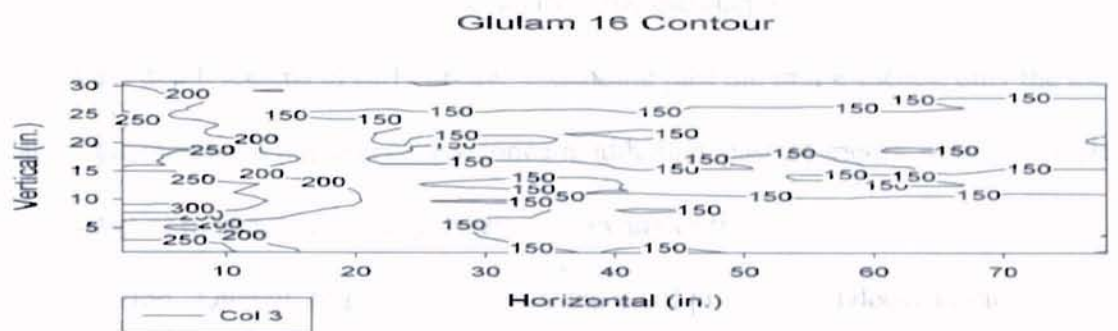
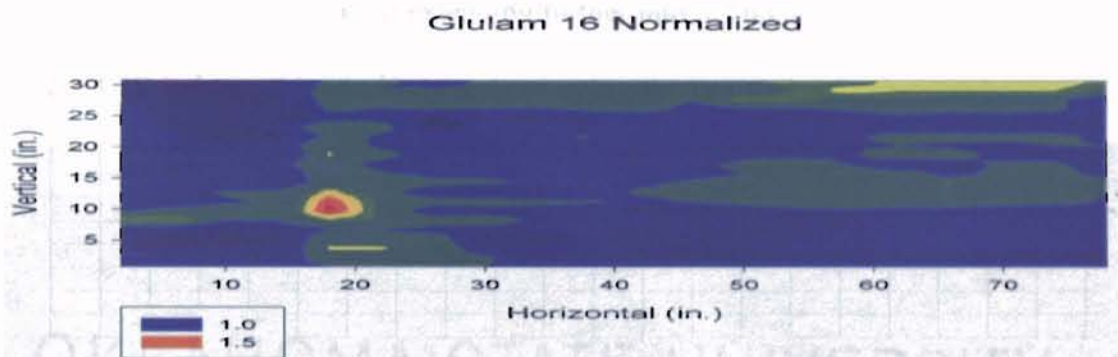
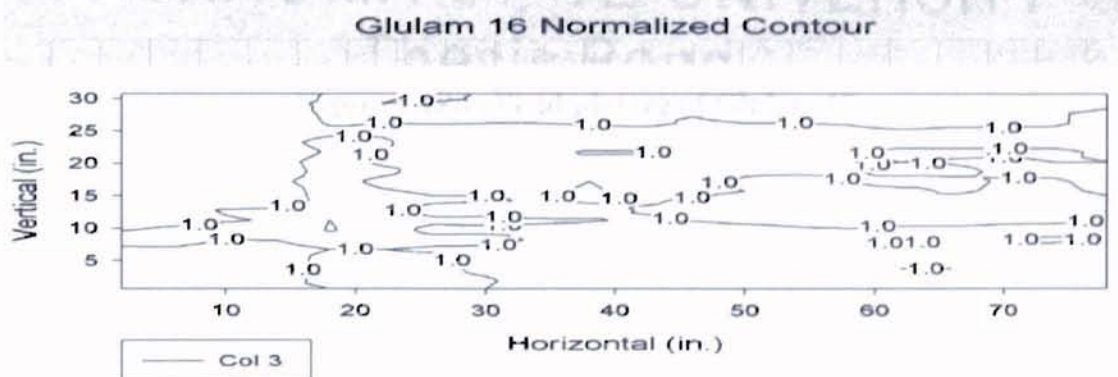
Figure 4.17.2: Glulam 16 Graphs

In glulam 16, moderate decay exist throughout the entire depth of the beam in the first 8-inches, with most of the moderate decay diminishing after the first foot of the member. One spot of concern is the moderate decay extending through 44-inches in lamination T, almost 3-feet of the member, with low moderate and early decay subsiding throughout the remainder of the glulam up to the last foot. Other than these areas of concern, the usual early and low moderate amounts of decay exist throughout the member, but no major regions of decomposition. When looking at the graphs, many areas of decay seem to exist, but the highest travel time is only 300- μ s, which is relatively small, so causes erroneous graph results. The field picture in Figure 4.17.1 seems to show a lot of decay, but this apparition is merely due to paint peeling.

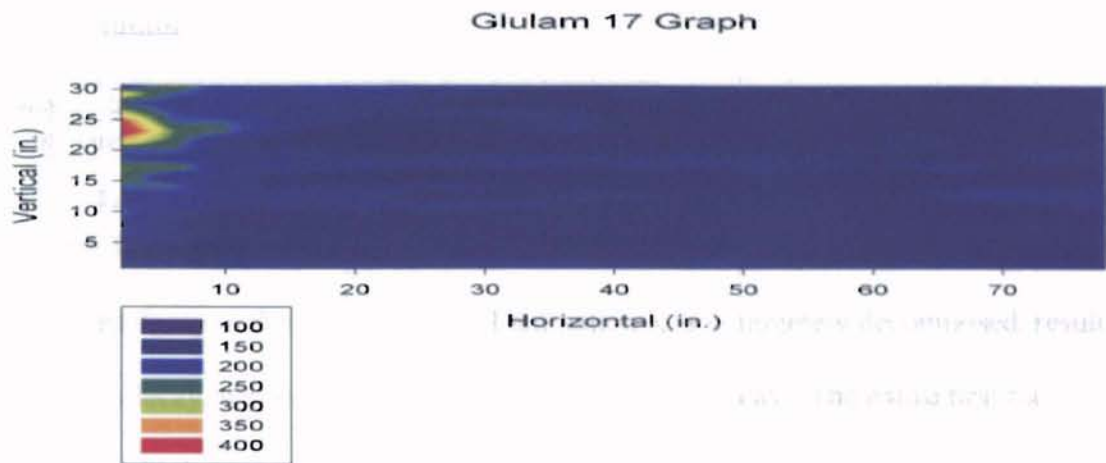
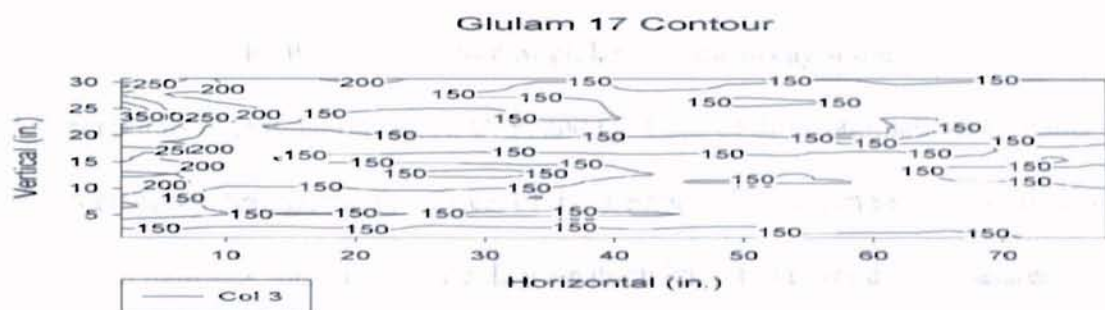
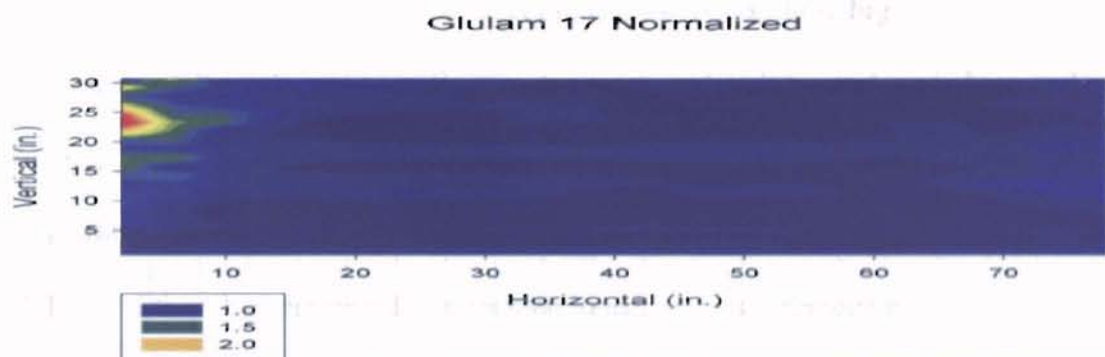
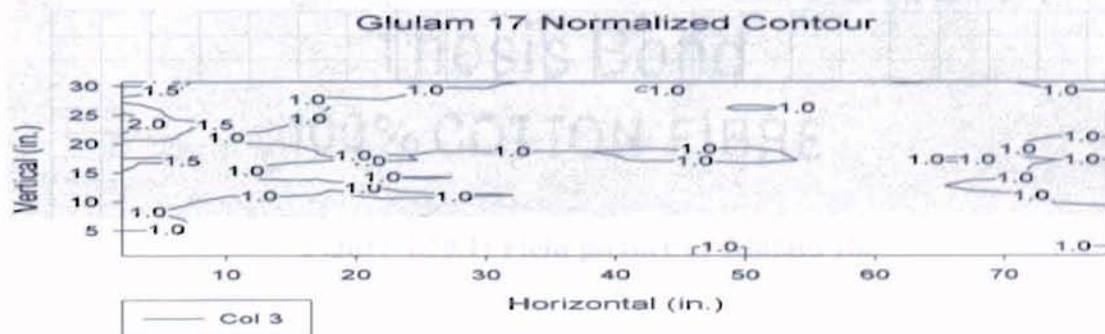
Figure 4.18.2: Glulam 17 Graphs

The primary area of decay in glulam 17 is in the top 10-inches of the first 2-feet of the member. This region is made apparent in the color contour diagram by the orange and red hues within that one concentrated area. In the first 8-inches, a high concentration of moderate decay exists throughout the depth of the member, but in this glulam, the bottom half of the depth lessens to early decay. Extending past the first 8-inches, only the top half of the member's depth is of any concern, although, past 24-inches, only miniscule scatterings of moderate and early decay exist in any of the member, both of little apprehension. Overall, this glulam follows the usual problems of decay in the first foot, with little or no decomposition extending further into the member. The field picture in Figure 4.18.1 shows this result.

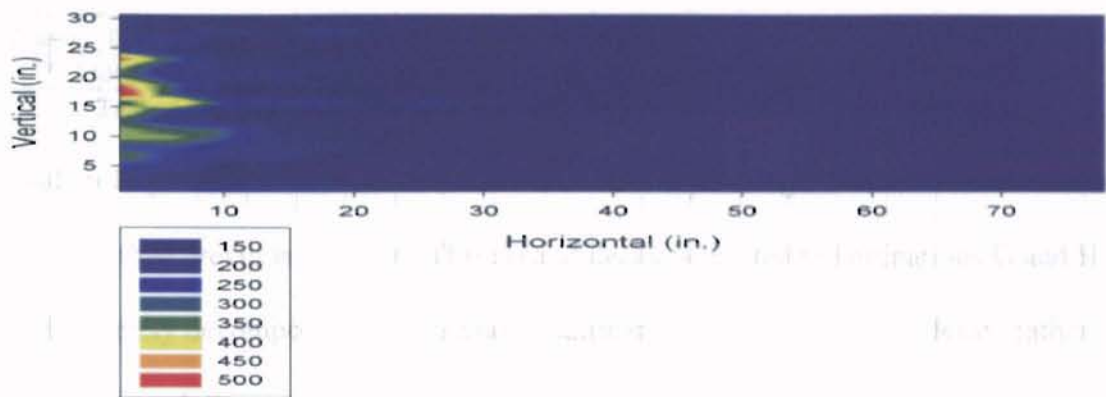
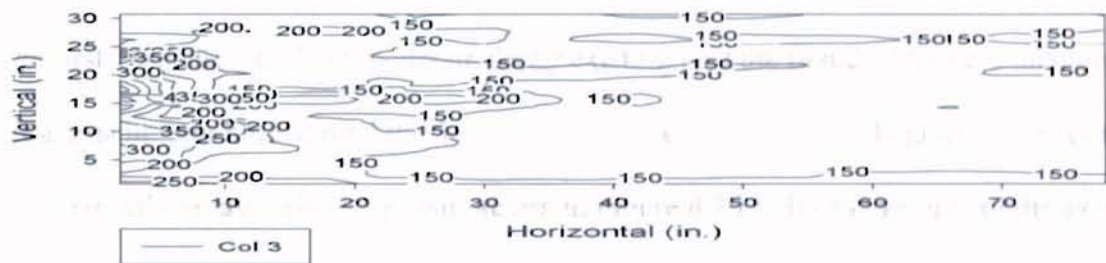
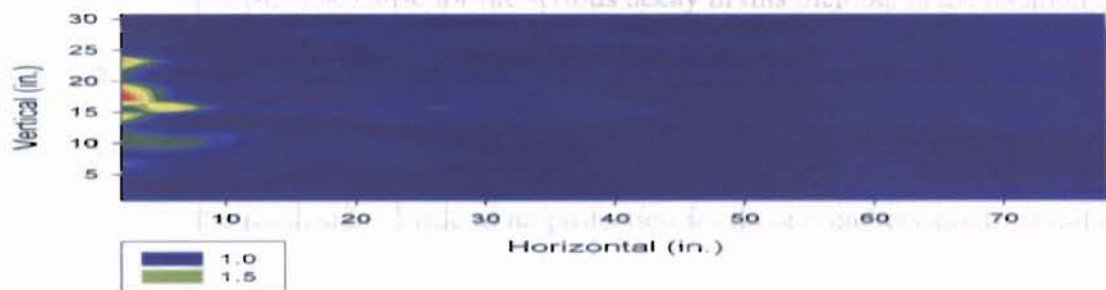
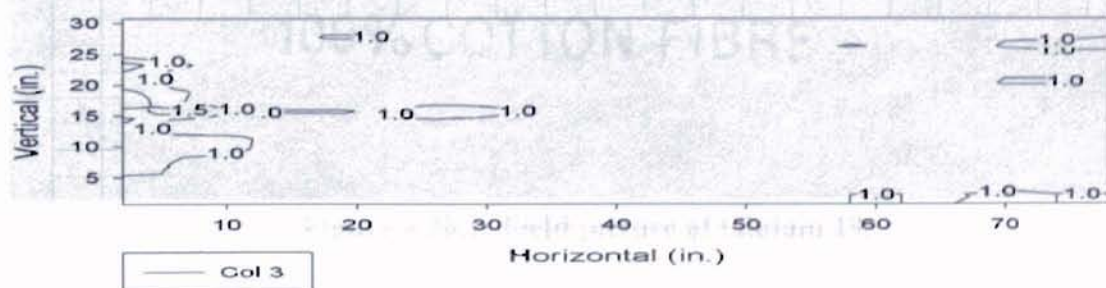
Figure 4.19.2: Glulam 18 Graphs

Glulam 18 contains a high concentration of moderate decay, with areas of severe and advanced decay in the first 4-inches. Lamination K is completely decomposed, resulting in severe decay, while lamination J contains advanced decay. The entire first foot contains a high concentration of moderate decay, with a few exceptions in the top half of the member's depth. Past the first foot of glulam 18, the decay somewhat subsides, with the exceptions of laminations K, N, O, P, and Q. Each of these laminations contains moderate decay through the first 2-feet of the member. The largeness, and continuity of the region indicates something more than a natural knot in the wood, so measures should be taken at this spot to avoid further decomposition. All of these high decay areas are easily seen on the color contour diagram in orange, red, yellow, and green hues and on the field picture in Figure 4.19.1. Primary emphasis should be placed on these laminations, especially since the decay is extending further than previously mentioned glulams. Other than the specific areas mentioned, no major regions of concern exist.

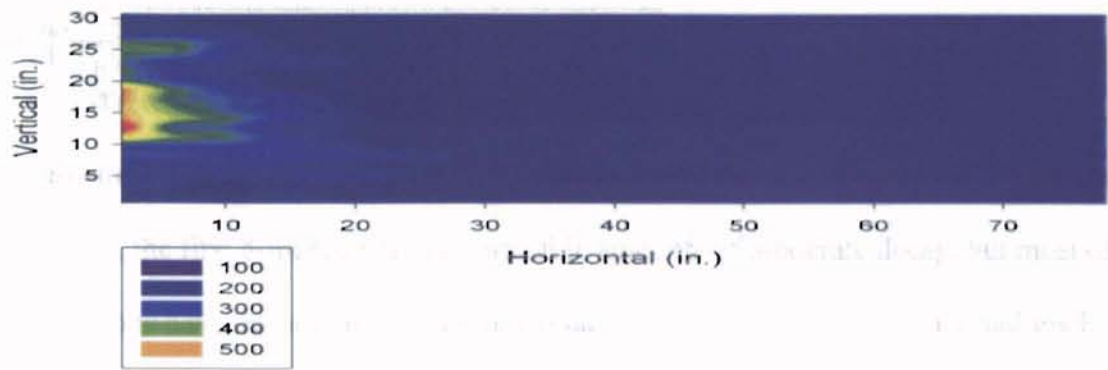
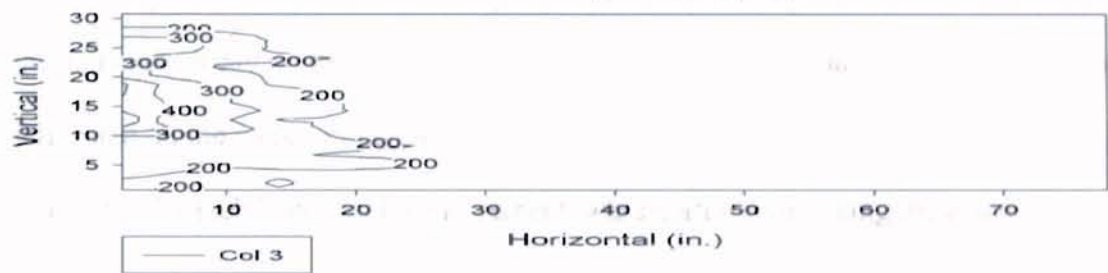
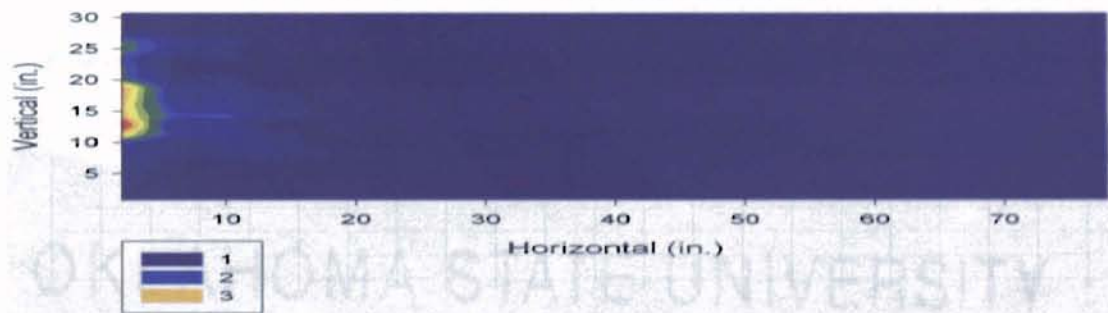
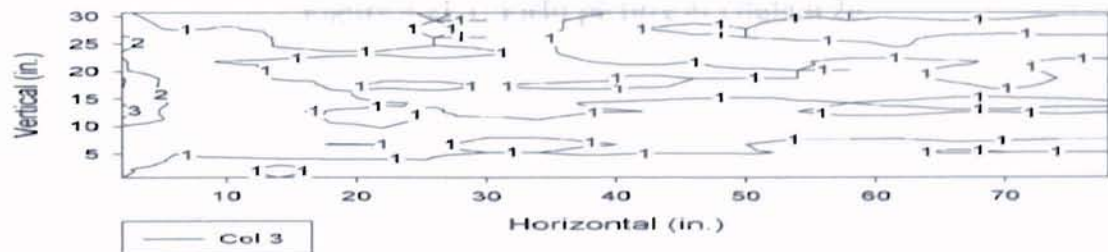
Figure 4.20.2: Glulam 19 Graphs

Glulam 19 possesses more severe and advanced decay through the first 4-inches of the member than previous glulams. This area of decay is limited to laminations G and H with severely decomposed pockets and to lamination M with advanced decay, rather than spread through the entire depth of the member, with total decomposition occurring in spots G1 and H1. Past this region, a high concentration of moderate decay exists through the first 16-inches, with no moderate decay existing past the first 2-feet of the member. The area in light blue around the 5-inch mark on the color contour diagram indicates this lamination's decay. Also, the field picture in Figure 4.20.1 shows this area of decay as rotted wood on the left side of the picture. Other than the above-mentioned areas, no major concerns exist. The cause for the serious decay in this member is the location of the arch. A pattern has developed with the decay being more prevalent in the middle third of the glulams, such as glulams 4 through 8 on the south side and glulams 17 through 20 on the north side. Little to no protection for these members exists, resulting in more decay.
