NONDESTRUCTIVE EVALUATION OF OKLAHOMA
STATE UNIVERSITY COLVIN CENTER ANNEX
DECAYED TIMBER ARCHES

Submitted to the Faculty of the
Graduate College of the
Oklahoma State University
in partial fulfillment of
the requirements for
the Degree of
MASTER OF SCIENCE
December, 2001

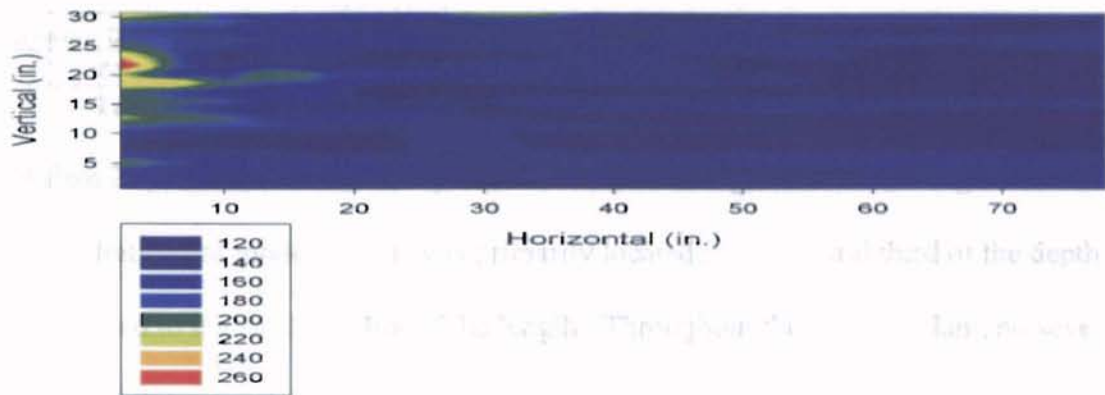
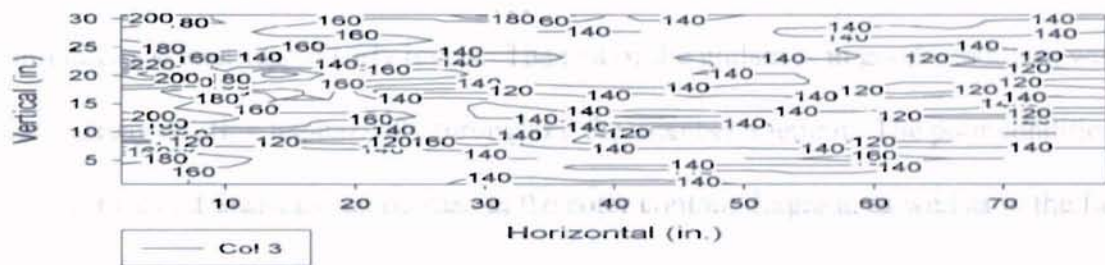
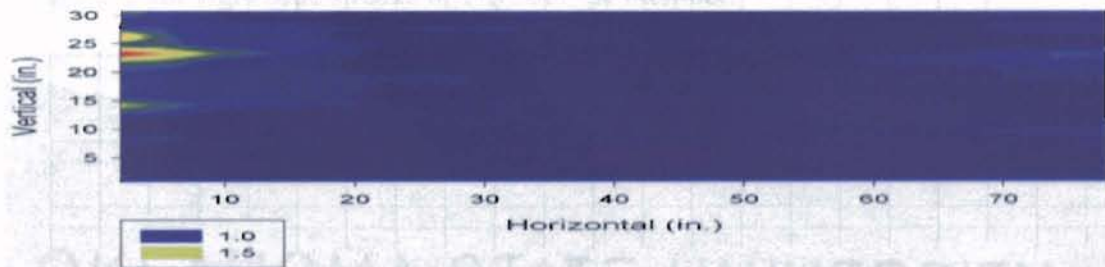
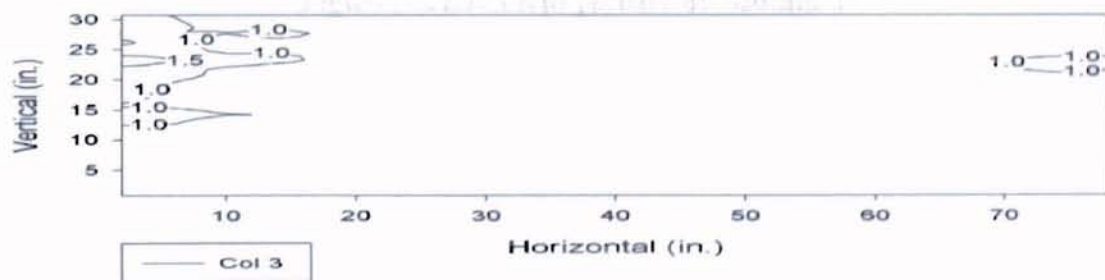
Figure 4.21.2: Glulam 20 Graphs

In glulam 20, decay does not persist through the entire depth of the member at any point. Actually, the first 8-inches have considerable amounts of moderate decay, but most of the laminations have decomposition limited to laminations F through M. Laminations F through I have moderate and early decay ranging from the ground connection up to 5-feet. This region is the largest amount of decay in the entire member. Lamination M also has moderate decay up to 3-feet of the member. These problematic areas are somewhat delineated on the contour diagram, but not fully. Also, lamination A has a green area around the 30-inch horizontal measurement, which, after referencing the excel worksheets, indicates moderate decay. The remainder of the member does not have any prime concern areas outside of the usual early decay, which can be seen in the field picture in Figure 4.21.1 in the good quality of the paint.

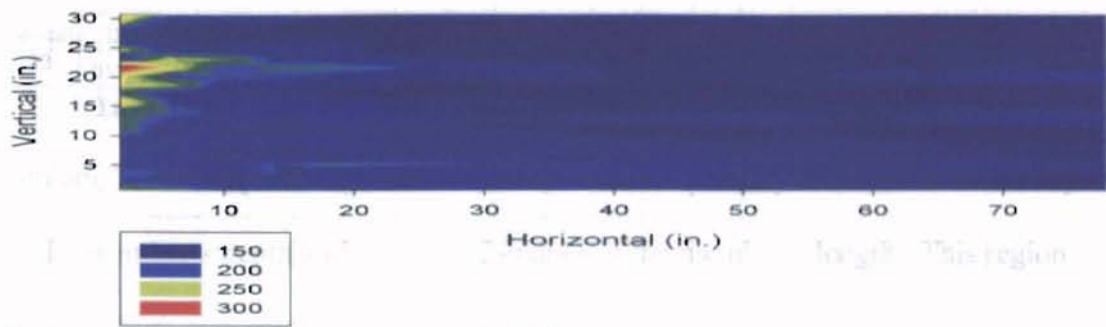
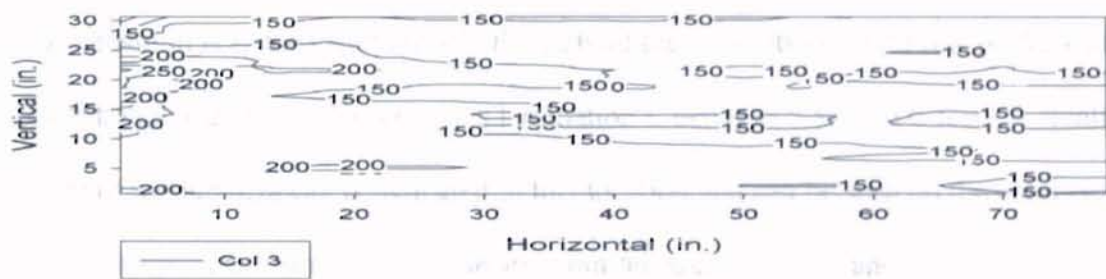
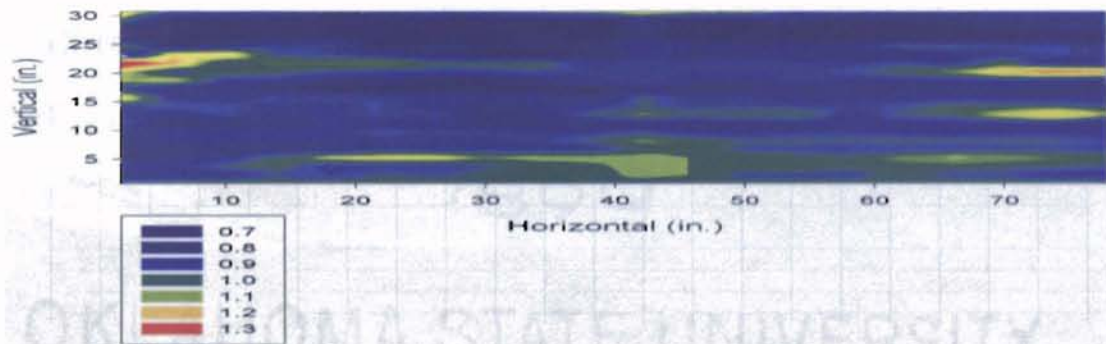
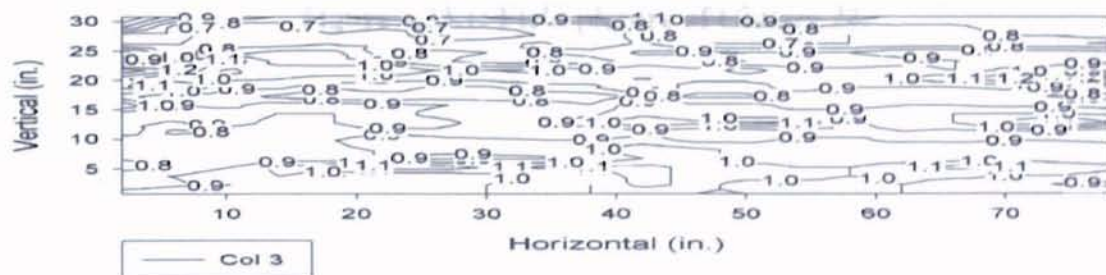
Figure 4.22.2: Glulam 21 Graphs

Glulam 21 follows a similar decay structure as previous glulams in that high concentrations of moderate decay is primarily located in the central third of the depth, and limited to the first 8-inches of the length. Throughout the entire glulam, no severe or advanced decay exists, and the only crucial laminations are G and T. Moderate decay is present in this component through 3-feet of the member's length. From here, decay diminishes scatterings of early levels. The rest of the glulam is in good condition, with early decay existing haphazardly throughout the member's length. The poor condition of the beam's first 8-inches can be seen in the color contour diagram, as well as in the field picture in Figure 4.22.1. Also, the extended decay can be seen in the regular contour diagram in the light blue streaks throughout the member.

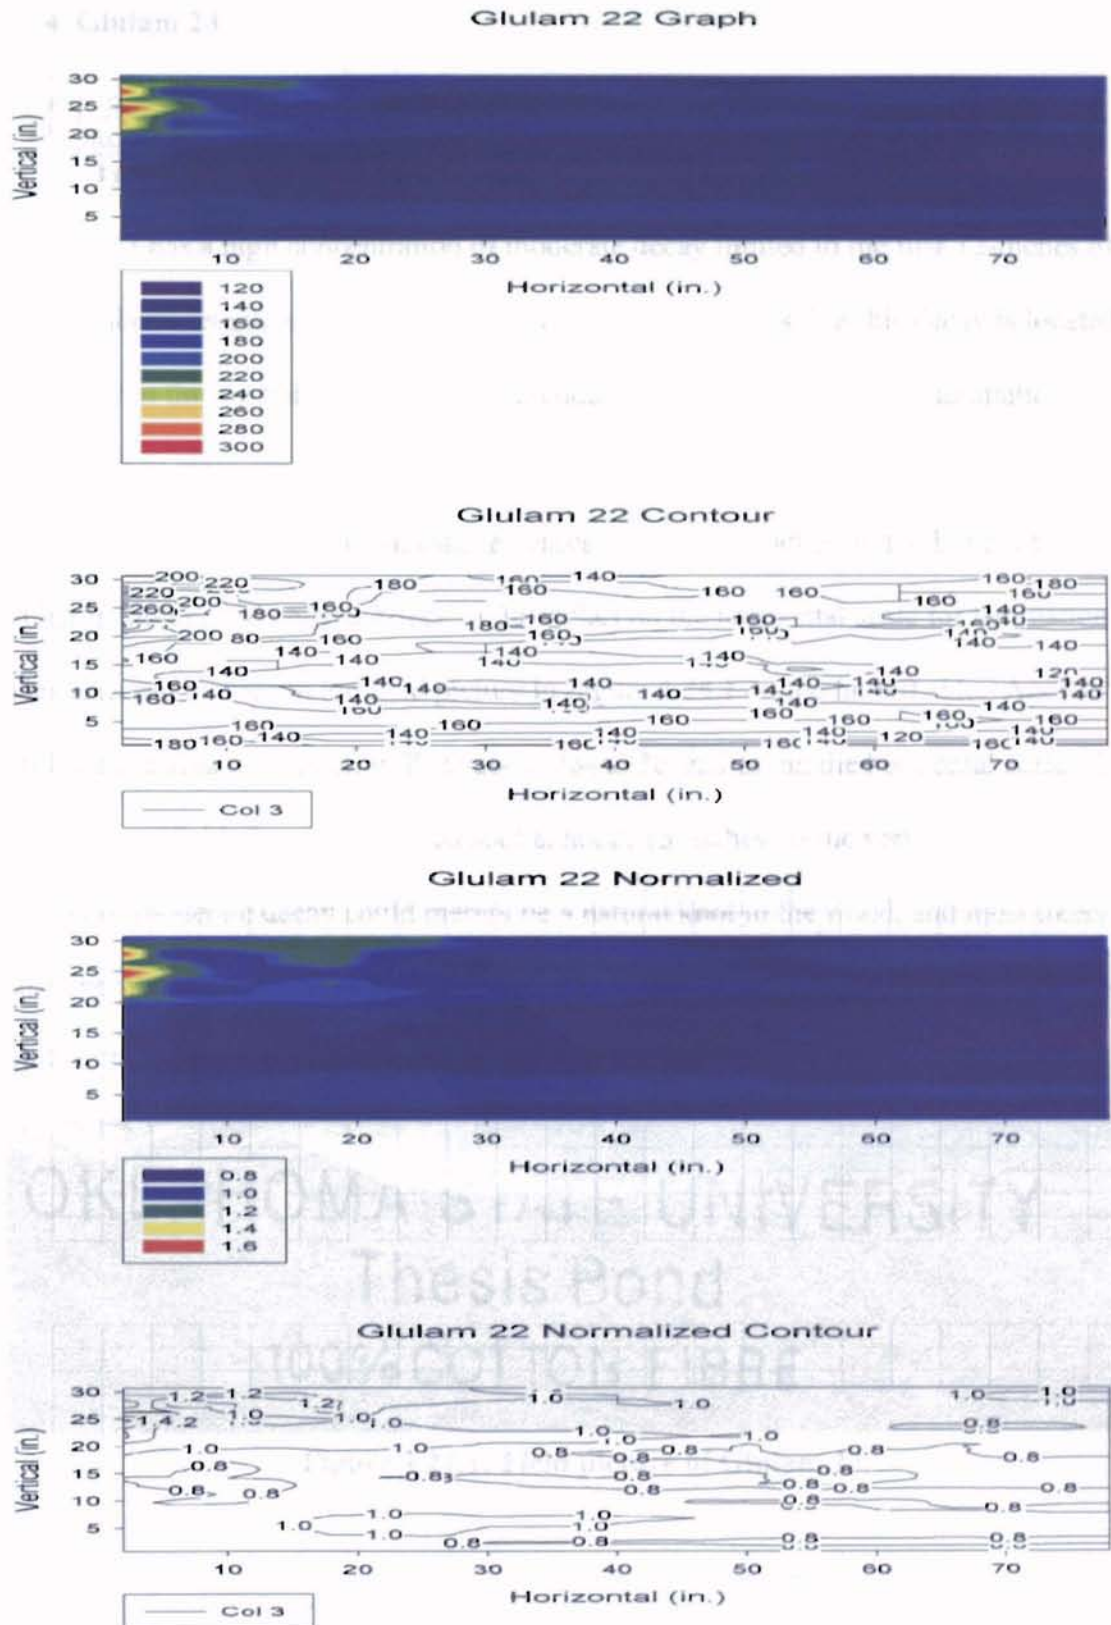
Figure 4.23.2: Glulam 22 Graphs

Glulam 22 has very little amounts of decay, with the primary area limited to the top third of the member's depth and the first 12-inches of the member's length. This region contains high concentrations of moderate decay, which is expected in trend with the other glulams. Yet, beyond this area, no decay exists above early, and most of that decomposition is spaced sporadically throughout the laminations, with few pockets of concentrated decay. One exception is lamination L between 5 ½- and 6-feet. A small pocket of moderate decay is indicated in this location and can be seen on the color contour diagram as a small, light blue area; but the area could be, and most likely is, a natural knot in the wood. Other than these limited regions of decay, glulam 22 is in excellent condition, despite what is indicated in the field picture in Figure 4.23.1. The peeling paint is misleading, since little decay actually occurs.

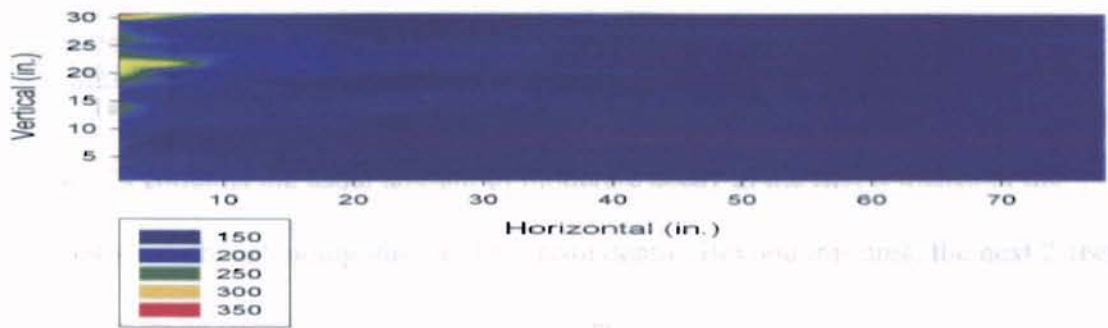
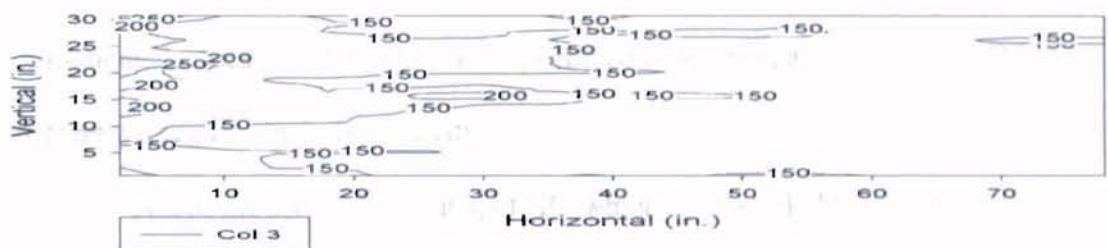
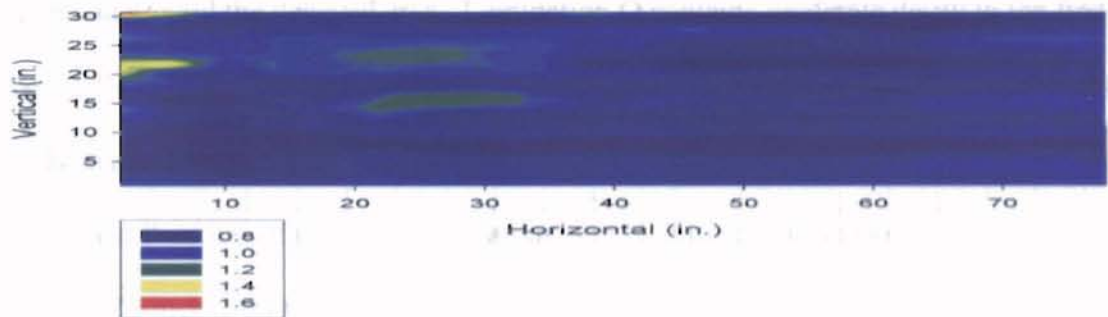
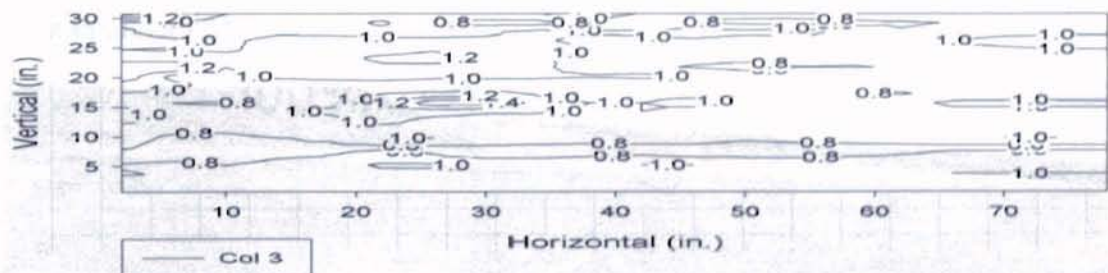
Figure 4.24.2: Glulam 23 Graphs

Glulam 23 has a high concentration of moderate decay limited to the first 12-inches of the member's length, similar to previously discussed glulams, but this decay is located primarily in the top half of the beam. Extending further into individual laminations F and G, the decay areas can be seen as a light blue coloring, between 20- and 30-inches on the vertical scale. Yet, this decomposition ceases at about 20-inches on the horizontal scale in lamination F, and ends at 3-feet, or 36-inches on the horizontal scale for lamination G. This area can be seen in the field picture in Figure 4.24.1 on the far left side. Another problematic area is lamination K, at about 28- to 36-inches, on the horizontal scale. This area is identifiable by a small green spot at about 15-inches on the vertical scale. This pocket of moderate decay could merely be a natural knot in the wood, and most likely is since no major decay exists around the region. Other than these flawed areas mentioned, glulam 23 is in good condition and is easily treatable.

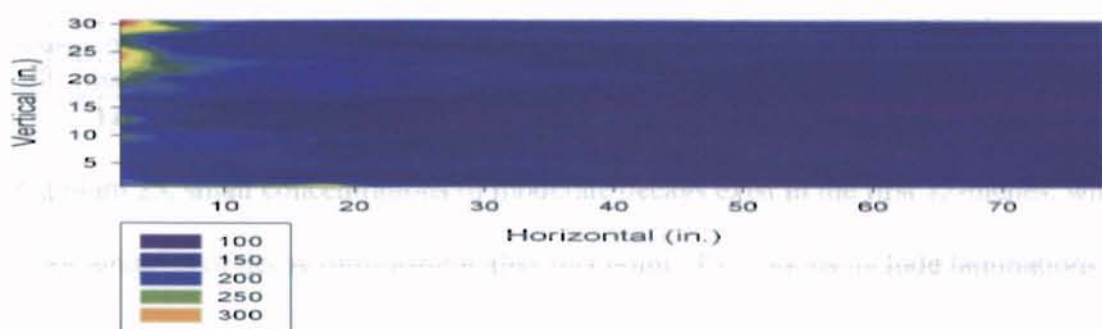
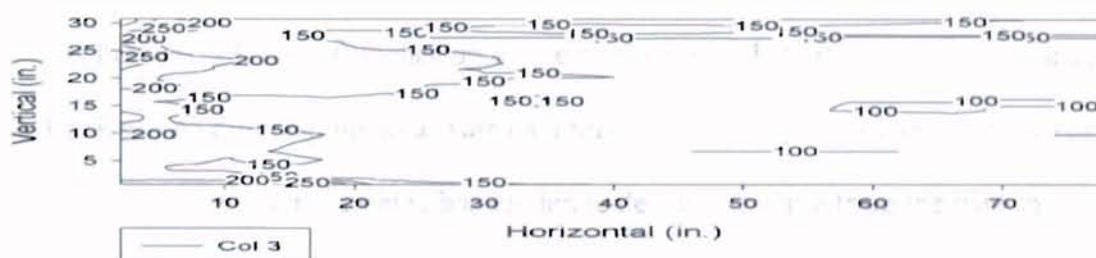
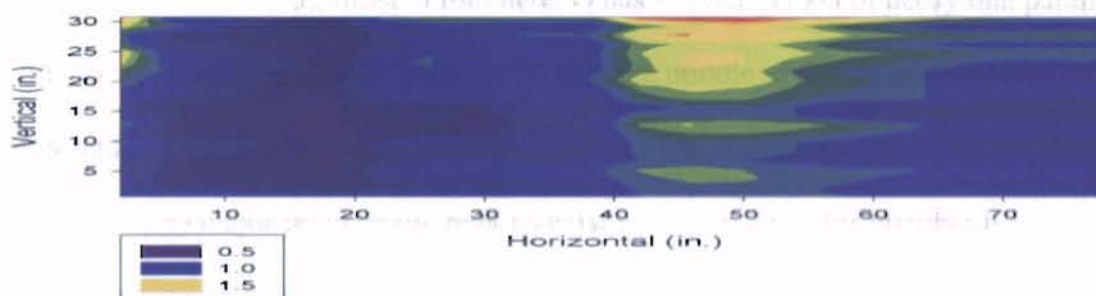
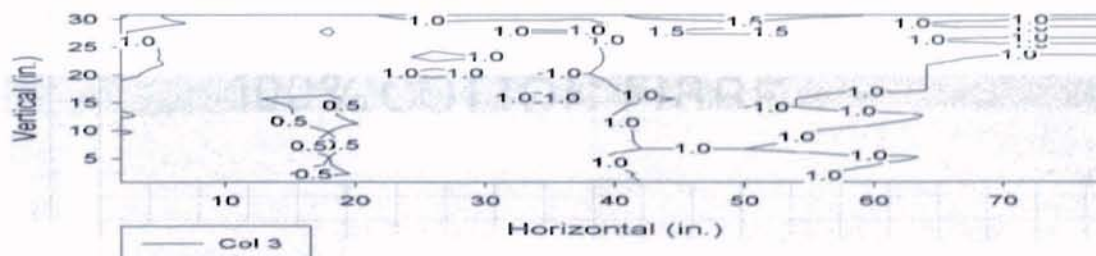
Figure 4.25.2: Glulam 24 Graphs

Glulam 24 contains the usual amount of moderate decay in the first 8-inches of the member's length, extending through the entire depth. Beyond this area, the next 2-feet contain sporadic concentrations of moderate decay. Lamination U contains moderate decay in the first 2-feet of the member. This bottom lamination is a primary support component, so decay in this area needs special consideration and treatment. Other problematic regions include laminations K and O. Lamination K has an indication of randomly placed moderate decay at spot K9, which is most likely a natural knot in the wood due to the small nature of the area. Also, the decay does not slowly dissipate into the wood around the decayed area. Lamination O contains moderate decay in the first 3-feet of the member's length, which then diminishes to early decay for another foot. None of these areas can be seen well on the color contour diagram or the field picture outside of the first 8-inches of decay, except lamination U. Green and orange hues can be seen in the first 20-inches on the horizontal scale at the bottom of the member, which indicate the above-mentioned decay. Other than these problem areas, no major regions of concern exist in glulam 24.
