IMPLEMENTING FIBER-REINFORCED, SELF-CONSOLIDATING  
CONCRETE AS A REPAIR MATERIAL FOR AASHTO PRESTRESSED  
CONCRETE GIRDERS

A THESIS

JACOB G. CHOATE  
Norman, Oklahoma  
2018

A THESIS APPROVED FOR THE  
SCHOOL OF CIVIL ENGINEERING AND ENVIRONMENTAL SCIENCE

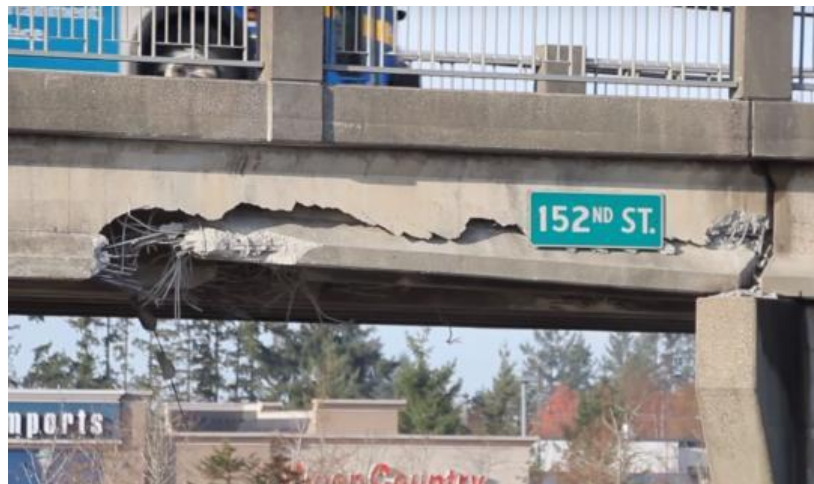
bridges whose life span has exceeded the intended service life of the structure or have been subject of an extreme loading condition. Alternatively, impact damage occurs as a result of an object, often a vehicle, striking the structure. The result of an impact damage is unique in that it is often instantaneous, and the damage resembles an explosive failure, which is exemplified in Figure 1.1.

**Figure 1.1 Impact Damaged, Prestressed Concrete Bridge (Greenizan, 2017)**

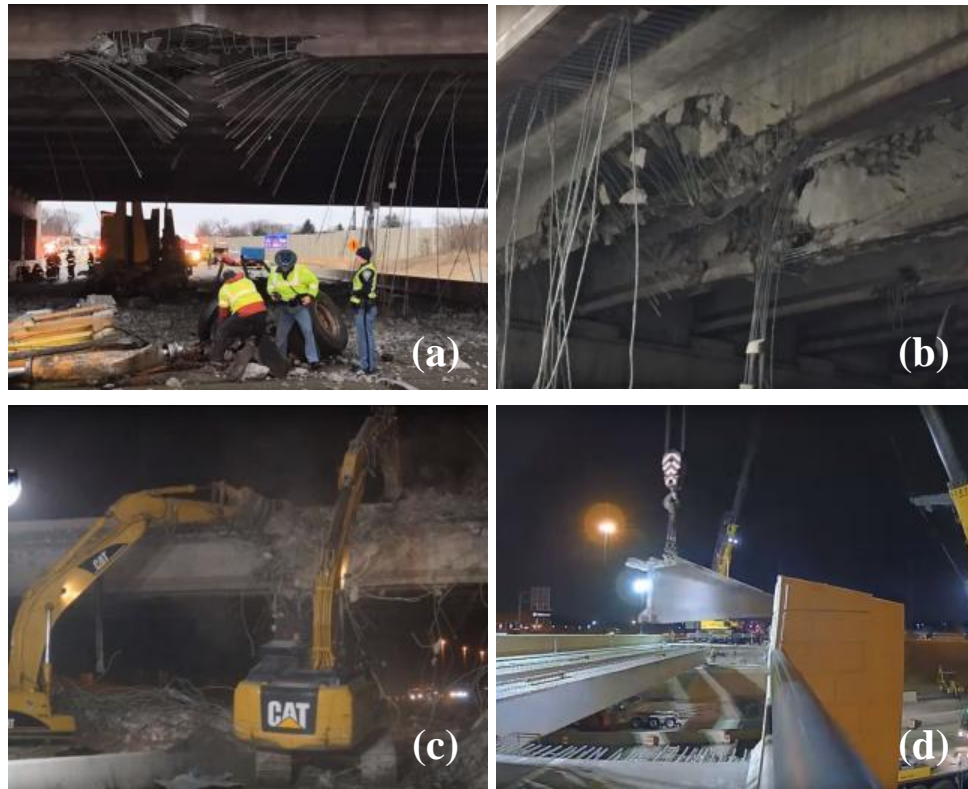
When these bridges face structural issues with their superstructure, often the member in question is replaced rather than repaired, like the 2017 Rockville Road Bridge project in Indiana. This overpass was struck by a mobile car-crusher that severely damaged four of the bridges fourteen girders. Since the bridge crossed a busy interstate highway, fixing the damaged structure was of high priority and the project turnaround was expedited. The solution was to remove the four damaged girders and deck then replace them with a new structure. Figure 1.2 shows the repair project at different points in the process. The Indiana Department of Transportation estimated the total cost of the project from impact to opening to be beyond \$1.2 million (INDOT, 2017). Repairs can offer a more desirable economic solution when compared to alternatives such as replacement and implementing additional structural components.

**Figure 1.2 Impact Damage Replacement Project in 2017; (a) Initial Impact Cleanup; (b) Damage to Interior Girders; (c) Damaged Girder Removal; (d) Installation of Replacment Superstructure (INDOT, 2017)**

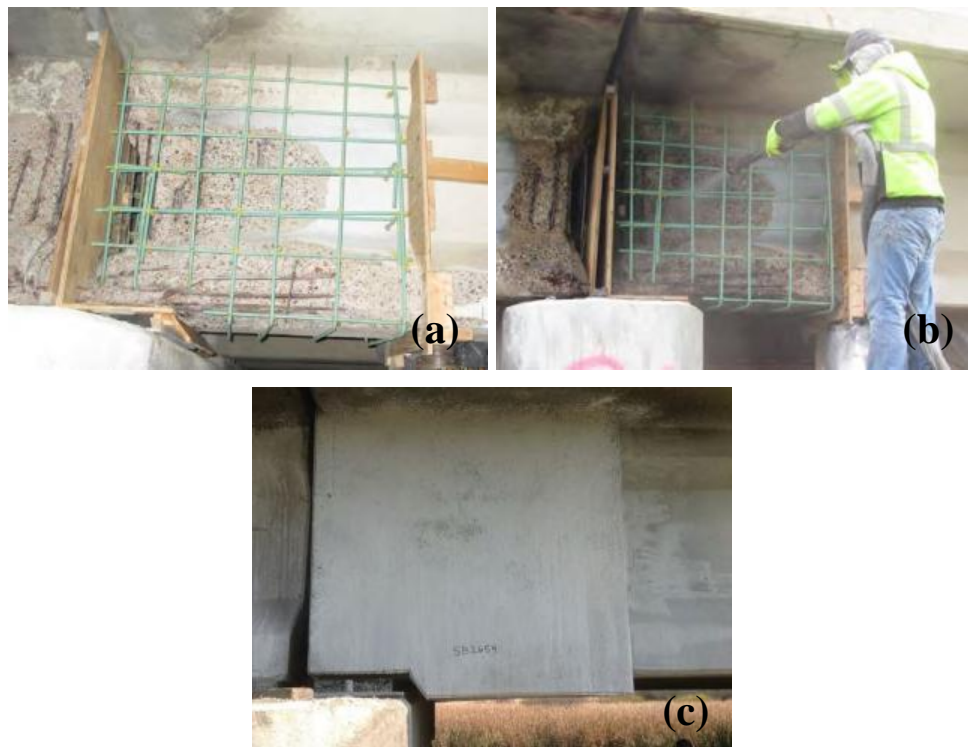
**Figure 2.1 University of Minnesota Shotcrete Repair Project; (a) Added Repair Reinforcing; (b) Shotcrete Application; (c) Completed In Situ Repair (Shield, 2018)**

In a study conducted by the University of Minnesota, severely deteriorated bridge girders were repaired, removed, and tested along with identical, undamaged girders from the same bridge. The corroded girders were repaired in situ by adding reinforcement around the damage, then applying shotcrete as shown in Figure 2.1. All four girders were extracted (two repaired and two undamaged, unrepaired), then taken to the University of Minnesota for shear testing. Testing revealed that the repair was able to restore the capacity of the damaged girders to that of the undamaged, unrepaired girders. Moreover, the repair was able to be performed without affecting traffic and at a significantly

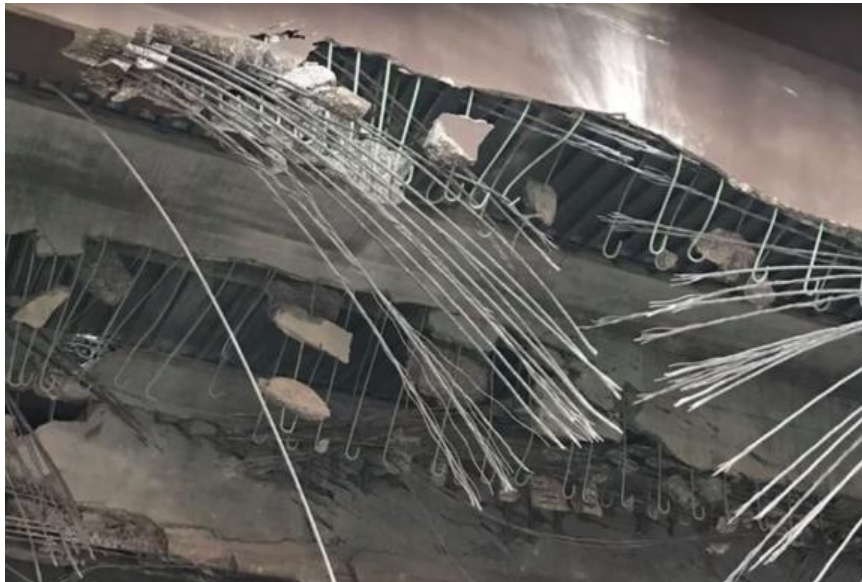
a mobile car-crusher traveling on the interstate below the bridge, caused four of the bridge's 125-foot-long girders to suffer catastrophic localized damage. Due to the necessity of the bridge and the high volume of traffic, the project was dubbed a "high-priority bridge repair." The existing four damaged girders and the deck they supported were removed, replacement girders were installed, and a new deck was cast in place of the old. The project lasted nearly five months and the total project cost was reported to exceed \$1.2 million in cost from initial impact to reopening (INDOT, 2017). When comparing the costs between this replacement and the previously mentioned shotcrete repair, the replacement was astronomically higher than that of the repair. This is true for nearly all repairs when compared to replacements. Figure 2.2 illustrates the destruction from the impact of the Rockville Road bridge.

**Figure 2.2 Rockville Road Bridge Damage (INDOT, 2017)**

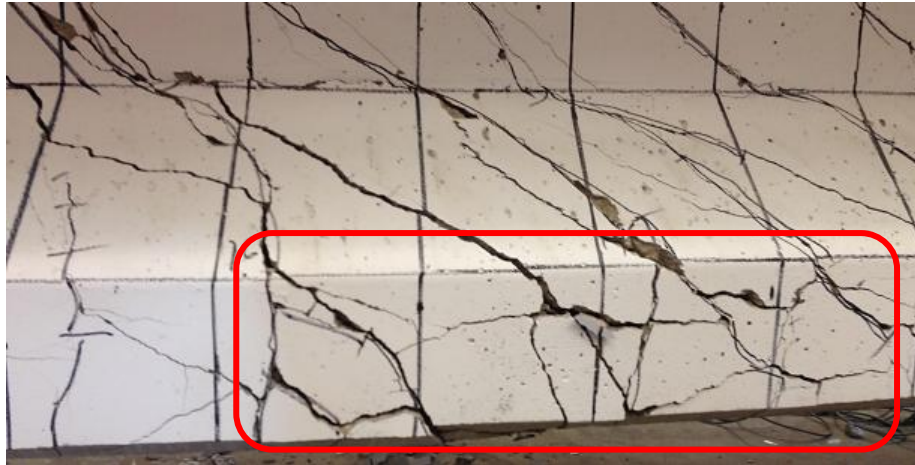
recorded next to the perpendicular line. Spalling behavior began at 90 kips of applied load where the girder bears on the southernmost support and continued until the loading reached 110 kips. It was noted that the extent of the corrosion accompanied by the bearing force was causation for cracks formed before testing to reopen and small sections of concrete to spall off the bottom bell of the girder. Web-shear cracking was first recorded at 160 kips of applied load and the initial propagation of flexural cracks were logged at 195 kips. At this load point, cracking in the bottom bell began to progress in a manner that suggests a bond-shear failure was occurring, an example of which is shown in Figure 4.5. This progress continued to 260 kips of load where the cracks were observed to follow the length of the straight strands in the bottom bell. Beyond the 300 kip load increment, the girder began to display signs of plastic deformation. Murray described the performance just before failure as increased deflection per load complemented by further spread of shear cracking in the bottom bell. This shear cracking is believed to be the source for the ultimate failure by contributing to debonding of the prestressing strands leading to compressive failure of the concrete in the deck at an applied load of 318 kips. The compressive failure in the deck led to partial delamination of the 2-inch-thick wearing layer on the topside of the deck, and the result is shown in Figure 4.6. Figure 4.7 shows the full extent of the damaged received during test C1.

**Figure 4.5 Shear & Horizontal Cracking in the Bottom Bell**

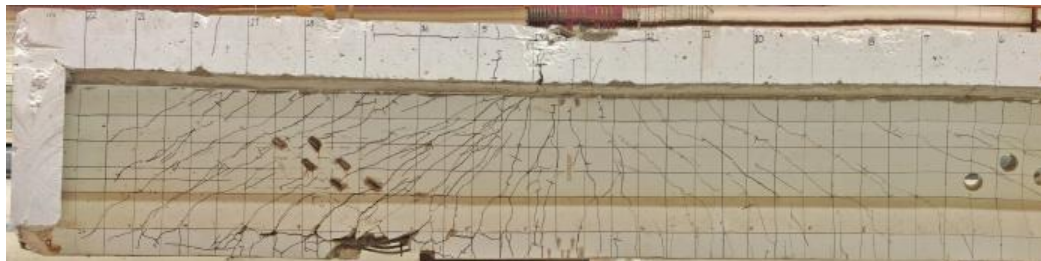
**Figure 4.7 East Elevation of Damage Received During Test C1**

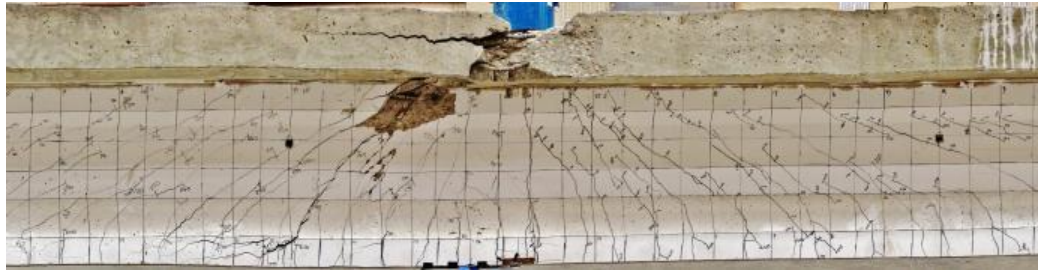
The second test (C2) featured a loading location at the quarter-span of the original girder length. This location was predetermined to be the critical section for shear, although, with an  $a/d$  ratio of 3.83, flexural failure was anticipated to be a controlling factor. Cracking was initially recorded at 150 kips of load in the form of web shear cracks at a location approximately 2 feet from the north support. Flexure cracks first propagated at a load of 160 kips and continued to develop until reaching the deck at a load of 190 kips, roughly. Shear cracks in the web started to expand into the bottom flange forming flexure-shear cracks at 195 kips of applied load. A number of these cracks began to traverse laterally, in the direction of the strands as more load was applied, suggesting bond failure along the tendons. Figure 4.8 illustrates the various types of cracking behaviors in test C2. Load was continuously applied until ultimate failure at which the compressive forces in the deck caused the longitudinal steel to buckle (Figure 4.9), the two-inch overlay to delaminate, and the deck itself to buckle. Murray noted this as either a compression-shear failure, which is the result of shear cracks entering the compressive zone leading to failure by compression, or simply a flexural failure. The extent of the damage caused by test C2 is shown in Figure 4.10.

**Figure 4.10 West Elevation of Damage Received During Test C2**

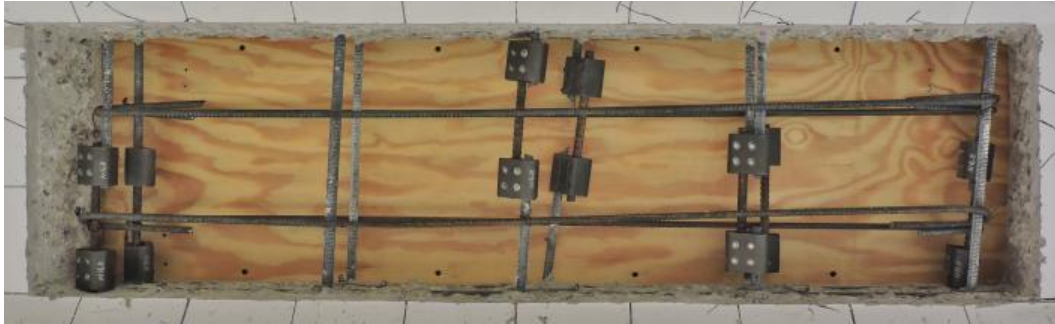
**Figure 5.3 Core-Sampled Web Replacement Reinforcing**

The existing shear stirrups were constructed using Gr. 40, No. 4, deformed steel bars and the splicing steel was of the same type and grade. The splicing bars were connected to the existing reinforcing using BARSPLICE™ couplers specifically sized for the reinforcing bars being used. Figure 5.3 shows the installed couplers for the repair. Additionally, the couplers are designed to meet the ASTM requirements for bar splicing. Before these couplers were fully secured, they were test fit to allow for the maximum distance between splicing materials and the surface of the formwork. The couplers' tightening mechanism featured snap-off bolts that sheared off once the bolts were tightened to the

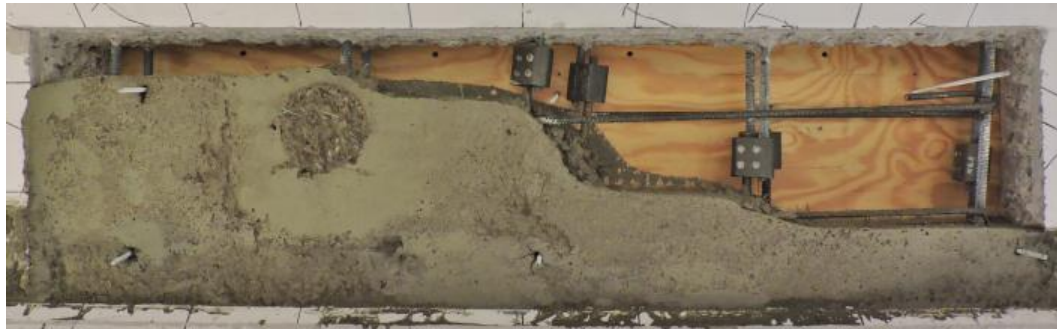
the aggregate and cementitious paste. This became more evident when transferring the mix to the dispensing bucket and when adding it to the formwork. The quicker set time and segregation caused the aggregates and the fibers to collect at the bottom of the bucket and clogged the fill neck despite trying to consolidate the mix using a tamping rod. It was decided to abandon this mix and try again. As a result, the remaining concrete was disposed of and the formwork removed and cleaned. Figure 5.5 shows how much the form was able to be filled. Any concrete material in the form and fill neck was removed and the surface was cleaned with a wet towel and compressed air. It is believed that multiple factors played into the failure of the mix: extreme temperatures, unanticipated leaking of ice water into the aggregate buckets, abnormal absorption by the aggregates in those buckets, but the most likely cause was the use of a different high-range water reducer than used in previous mixes.

**Figure 5.5 Extent of Flow for First Pour of Core-Sampled Web**

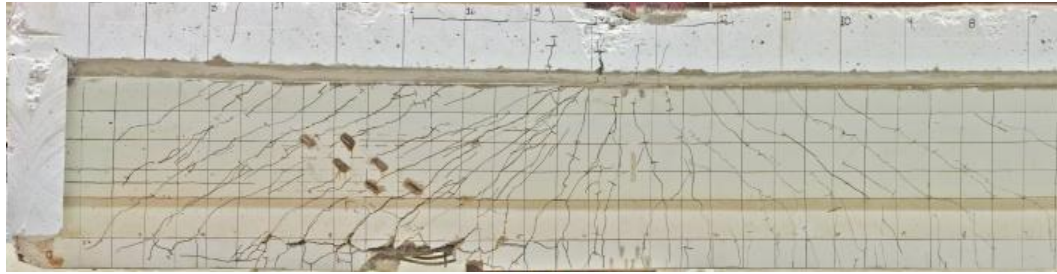
Once surveying and documenting of the initial, failed state of the girder was completed, shown in Figure 5.7, preparation started for the south end to be repaired. Using the survey data, an extent of concrete was designated for demolition and repair. The original extent measured 8 feet from the southern face of the girder and one foot perpendicular from the bottom face of the girder. The aim in doing so was to maintain an area defined by 6 inch increments of the preexisting grid mapped on the girder in previous testing and to reduce the number of irregular shapes in the repair section. This area to be demolished encapsulated the entire bottom bell of the girder for the 8-foot section.

However, due to the presence of large cracks at the intersection of the eight foot marker from the end of the girder and one foot boundary from the base of the girder, the area was expanded to include these cracks in the repair section. Expanded boundaries of the repair were moved to 8 feet, 2 inches from the southern face of the girder and the top boundary was raised from one foot to 1 foot, 3 inches only from the 6 foot mark from the southern face until the 8 foot, 2 inch boundary. The southern face of the girder features an 8-inch-thick diaphragm that was cast onto the member during its original installation within the bridge structure. When the 10-inch-thick deck addition was fabricated in Murray's study, the addition did not extend fully to the end of the girder. Rather, the addition was cast up to 8 inches shy of the end of the girder. The missing 8 inches of deck on

**Figure 5.7 South End Damage From Original Testing**

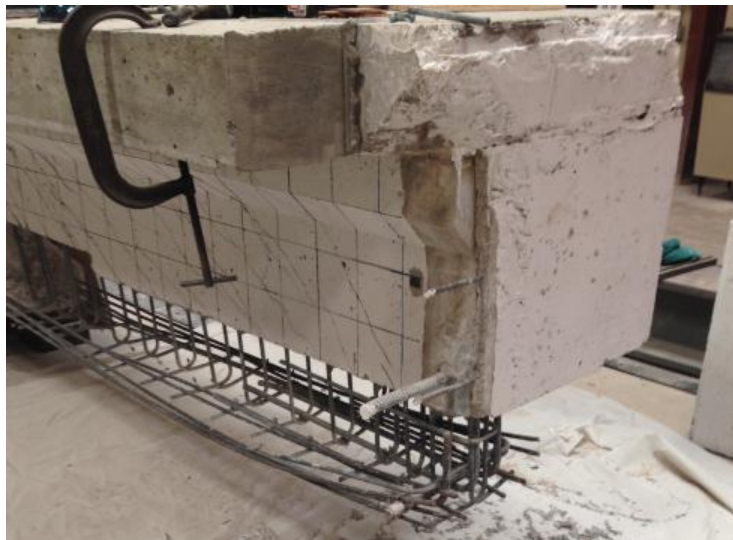
**Figure 5.8 South End With Damaged Concrete Removed**

the west side was utilized as the planned fill hole for the FR-SCC repair material. Since the diaphragm was cast onto the girder post-installation with no roughening of the interface between the girder and diaphragm, removal of the west side of the diaphragm was achieved with relative ease in comparison to the concrete on the girder itself. In order to provide for a better bond to the surface of the girder and west-side deck extension, the surfaces were roughened using a hammer-drill. An illustration of the final, fully demolished South end is shown in Figure 5.8.

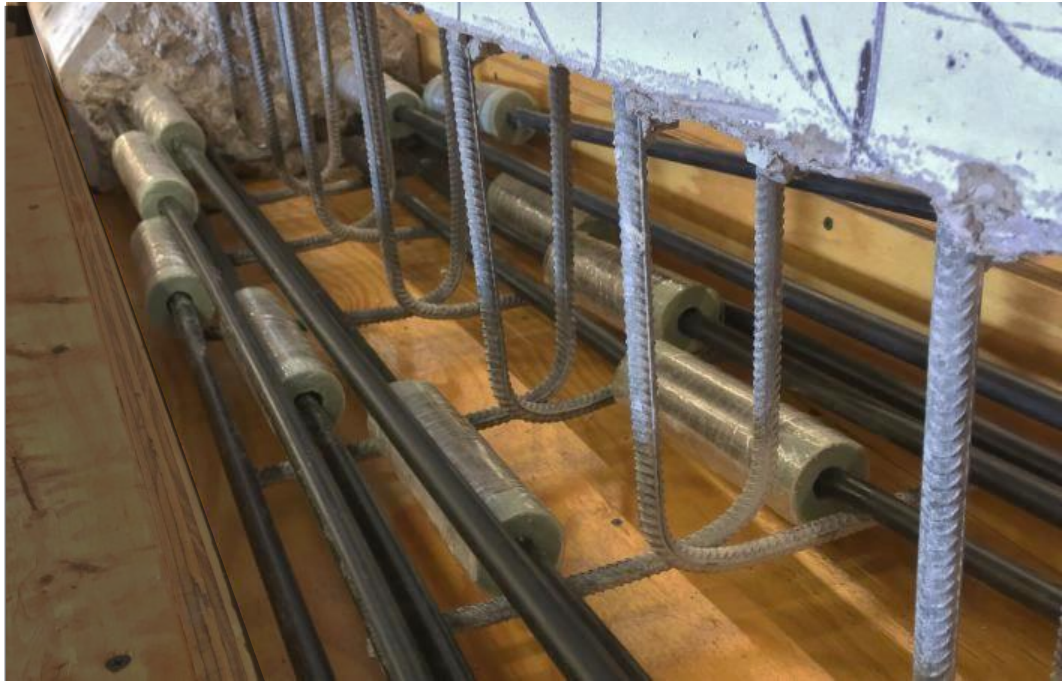
**Figure 5.10 Assembled Post-Tensioning Splice Chucks**

existing strands. Furthermore, the ends of the strands showed signs of corrosion to the extent that they would have been inadequate for restressing. As a result, the existing strands were cut to a shorter length, within the repair section, and new strands were connected using Sure-Lock® 1/2 inch splice chucks. Due to limited availability, the replacing tendons are 1/2 inch special as opposed to the existing, 1/2 inch tendons in the girder. Splice locations depended on the layout and fitment of the splice chucks with their housings; by staggering the splice chucks, all ten strands were able to be spliced within the bottom bell of the repair volume, which is shown in Figure 5.10. Existing tendons were cut at a dimension that allowed for them to protrude 1/2 inch beyond the wedges within the splice chuck (Figure 5.11). The remaining lengths of exposed existing and replacement strands were coated in a thin layer of automotive grease, then sleeved with a 1/2 inch plastic irrigation line. This grease-and-sleeve arrangement, shown in Figure 5.12, is similar to monostrand post-tensioning tendons and allows for movement during the post-tensioning stage.

A special housing was created using a clear, acrylic sheet and foam cutouts to permit movement of the splice chucks during tensioning. Construction of the housings began with forming the acrylic sheets to a cylindrical shape by heating them in a uniform manner, minimizing warping. A 2-inch-diameter PVC pipe was used as the template for molding the curvature of the sheets. Once cooled, a splice chuck was placed in the now cylindrical, acrylic sheet, and the sheet was clasped tight around the chuck and secured by wrapping it with clear

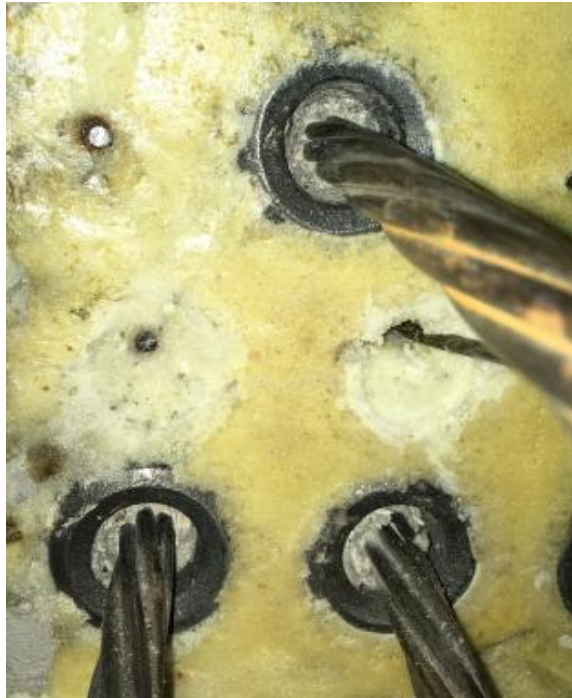
Upon removal of the formwork of the south end, it was observed that some of the FR-SCC repair material had seeped into the holes of the anchor plates through which the strand passes (Figure 5.18). This volume is the conical region where the wedges would set for post-tensioning; thus, it was important for this location to be cleared of obstructions, allowing for proper seating of the wedges.

**Figure 5.18 Anchor Plates After Casting the South End Repair**

To remove the excess concrete, a hammer and various small chisels and picks were used to break away some of the existing concrete. In an effort to expedite the clearing of the anchor plates, an alternative approach was conceived that included prying the anchor plates away from the concrete to better remove the excess concrete. In doing so, concrete was spalled off the bearing area for the only two anchor plates removed, shown in Figure 5.19. It was decided to cease progress with this approach and instead utilize a high-velocity pressure washer to clean-out the remaining concrete in the anchor plates.

Once the excess concrete was removed, a mixture of mortar was used to patch the spalled concrete behind the two anchor plates removed previously. This mixture included sand, Type III portland cement, hydrated lime, and water. The material mix ratio was three parts sand, one part cement, one-fifth part hydrated lime, and one-third part water. The mixing method closely followed the ASTM recommended procedure for test specimens in the lab (ASTM C192). All materials excluding water were mixed together, thoroughly. Water was added to the mixture and hand mixed for 3 minutes. The mixture was allowed to rest for 3 minutes while water was brushed on the application area of the girder, then mixed again for 2 minutes. The mortar was applied by hand initially and spread with a putty knife. Immediately, the anchor plates were pressed against the girder and tapped with a rubber mallet to provide for consolidation of the mortar. The plates were clamped in-place and allowed to cure for 7 days until post-tensioning was performed on the section.

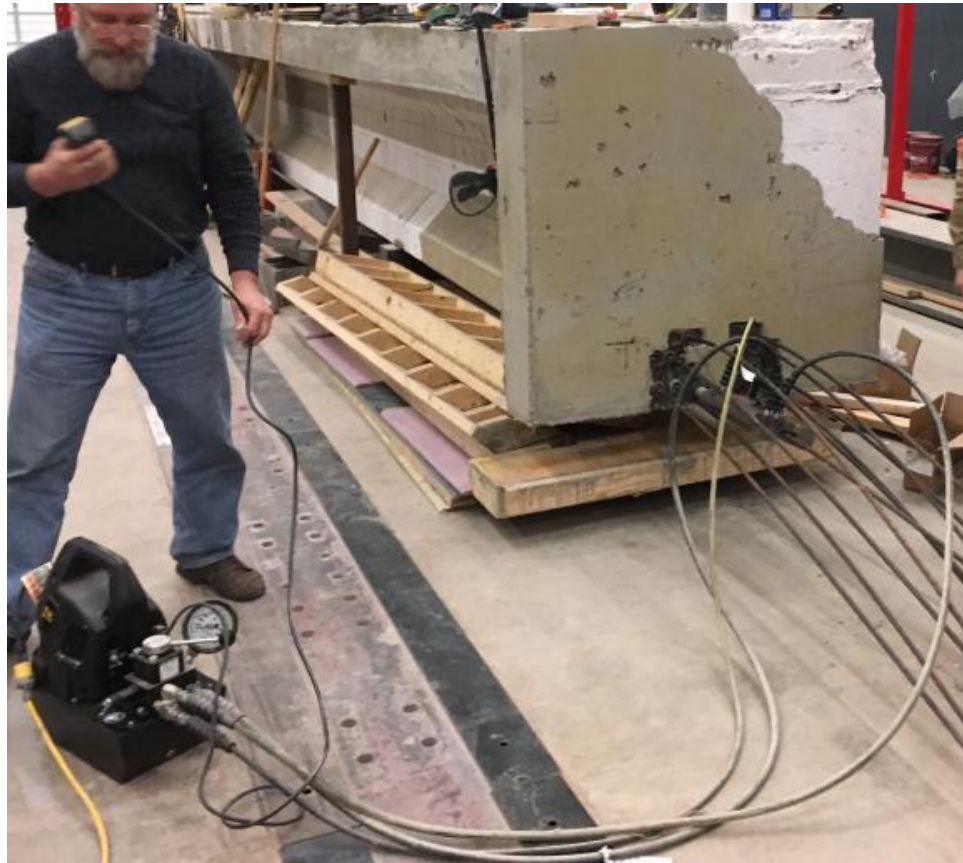
**Figure 5.21 Post-Tensioning Strand Stressing**

Post-tensioning was performed by stressing individual strands up to the originally specified 28.8 kip load per the ODOT construction documents. In doing so, the inner most strands were stressed first, alternating from each strand group on each side until the outermost strands were the last to be tensioned. Figure 5.20 illustrates the pattern in which the strands were tensioned, and Figure 5.21 shows the tensioning setup. Stressing was achieved by using a monostrand post-tensioning jack manufactured by Precision-Hayes International that was attached to a motorized, hydraulic pump featuring a pressure gauge. A load calibration test was conducted with the same equipment before post-tensioning to determine the gauge reading that coincides with a 28.8 kip force in the strands. Since the monostrand jack includes a power-seating device, very minimal seating losses occurred and all strands were successfully re-tensioned. The strand tensioner achieves re-tensioning by pushing against the anchor plate and pulling the strand. Once fully tensioned, a second internal cylinder seats the wedges in place, approximately maintaining the desired strand force of 28.8 kips.

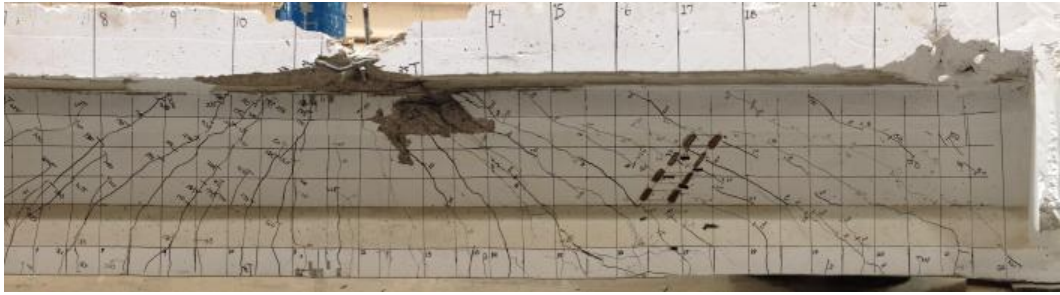
In the best interest of safety, major demolition of concrete did not start until the south end was cast and the strands re-tensioned. Upon initial surveying of the north end (Figure 5.22), the beam did not appear to have significant damage and that the repair would have been limited to the deck and bottom bell where horizontal cracks showed signs of possible debonding. However, during the demolition, it was discovered that beyond the surface, the north end had major damage to the concrete that extended from the top of the deck to the bottom bell. The concrete in this zone was loose enough that portions of it fell off without agitation. This damage, as illustrated in Figure 5.23, followed a 45-degree angle extending from the load point diagonally down to the north support (the closest support to the load point). As a result, the demolition area was expanded to where the southern boundary for the girder was along the 11 foot gridline (measured from the midpoint of the girder) and the southernmost boundary for the deck was four inches north of the 10 foot gridline. The northern boundary for the deck was along the 16 foot gridline as well as the top bell portion of the girder. The northern boundary for the web of the girder coincided with the 16.5 foot gridline and the bottom bell boundary was 18 inches to the north of that at the 18 foot gridline. Figure 5.24 shows the full extent of the concrete demolition.

**Figure 5.22 North End Damage from Original Testing**

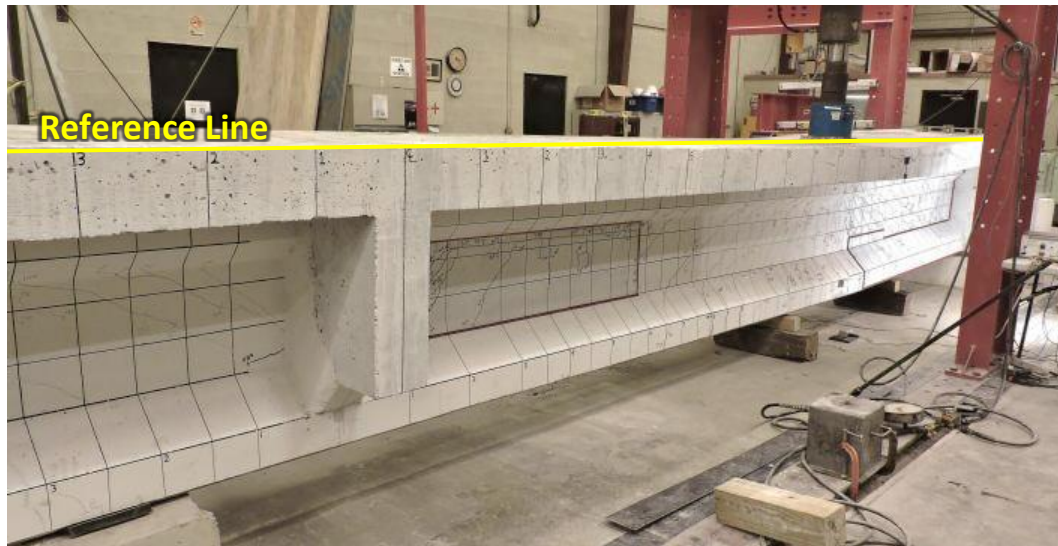
The maximum load, as mentioned previously, reached 249 kips at approximately 2 and 1/4 inches of average deflection, and load was continuously applied without actually increasing, until the maximum average deflection reached 2 and 5/8 inches under the same applied force. Testing was concluded at this deflection, as it seemed apparent that because the deck was not crushing, the strands were yielding. The vertical crack at the interface of the repair continued to grow, as discussed previously, confirming the elongation of the strands. The repair zone had several web-shear cracks that spread down, into the bottom bell, but did not fully extend to the bottom of the repair. Accordingly, it follows that the failure mechanism was purely flexural. Figure 6.8 shows the fully deflected state of the girder at the peak of testing.

**Figure 6.8 South End Test at Maximum Deflection**

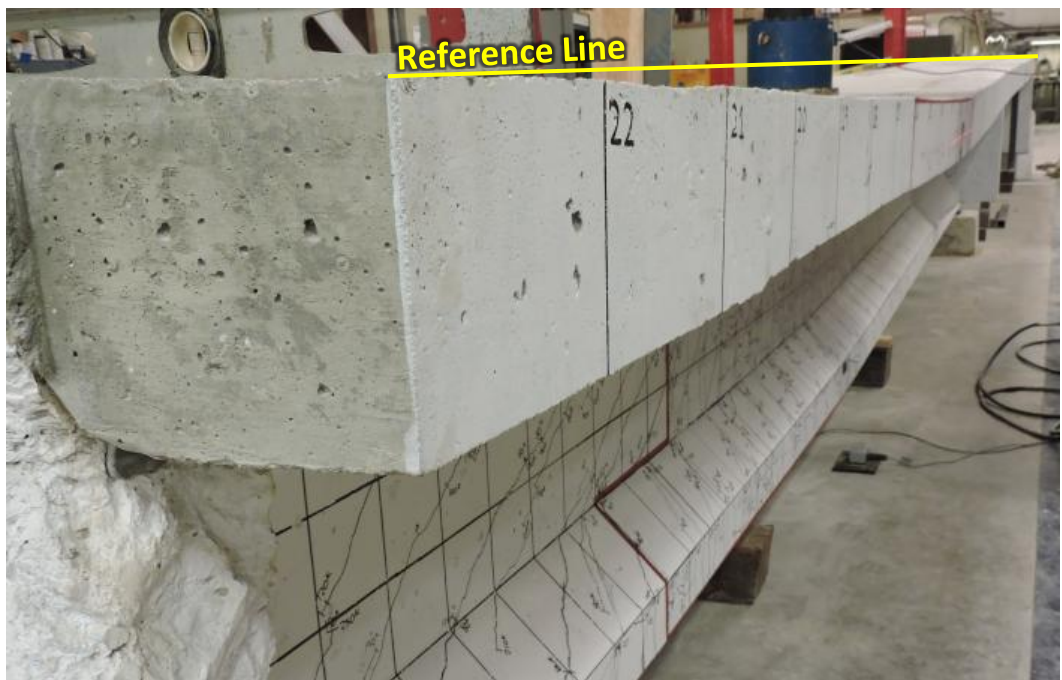
**Figure 6.15 North End Test at Maximum Deflection**

Under the maximum load able to be sustained by the girder, the deflection at the load point was 2 and 5/8 inches and continued to deflect under the same 249 kip load until the deflection reached approximately 3 and 1/8 inches of maximum deflection. After deflecting this additional 1/2 inch without an increase in resistance, the test was stopped and load was removed. Just as with the south end test, this end showed no signs of crushing in the deck and no signs of direct shear failure. Thus, it follows that the failure mechanism was flexural in nature. Within the repair zone most, if not all, of the cracks began as vertical, flexural cracks that, under increasing load, began to reorient themselves towards the load point as shown in Figure 6.14. Figure 6.15 shows the fully deflected girder during testing.

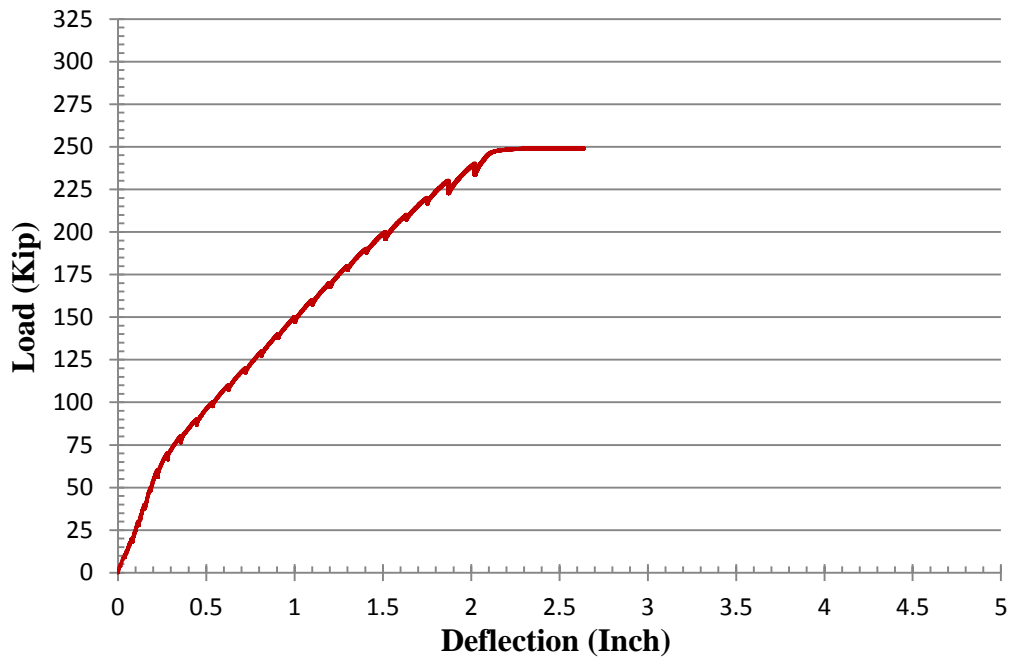
**Figure 6.16 Load-Deflection Plot South End Repair Test**

The load-deflection plots for both the south end and north end repair are shown in Figure 6.16 and Figure 6.17, respectively. The maximum loads for both tests was 249 kips with slightly different maximum deflections. A summary of the results are presented in Table 6.2 and post-repair testing elevations are provided in Appendix C.

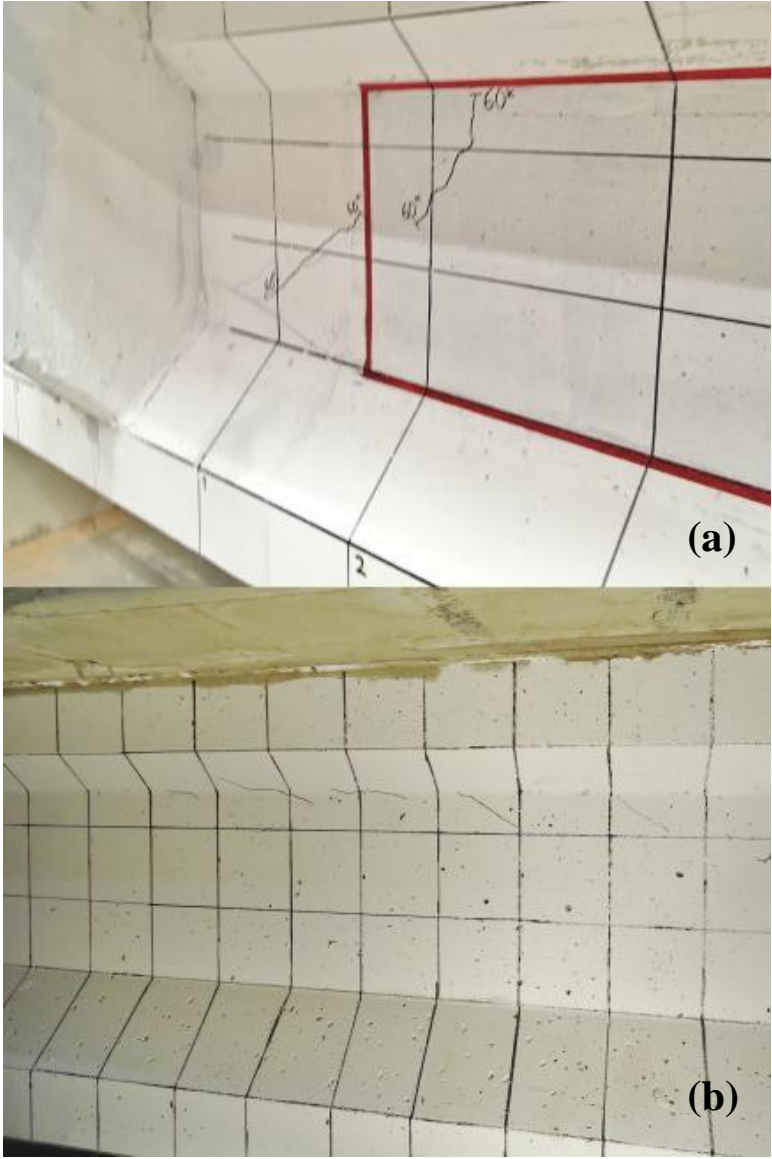
**Figure 7.1 (a) First Cracks For South End Repair Beam Test (60 kips, West View); (b) First Cracks For Murray’s “C1” Testing (160 kips, East View, Courtesy of Cameron Murray)**

Loading for both tests was applied in a series of 10 kip increments until failure. Negating the spalling at the south end support that occurred at 90 kips of applied load, the first cracks for the original testing of the south end appeared at 160 kips. The first sign of cracking for the repaired beam was difficult to pinpoint since there were pre-existing cracks outside of the repair zone, however, existing cracks first expanded into the repair zone at 60 kips, or approximately 38% of the cracking load in Murray's testing. First cracks for both tests appeared near the base of the top bell, just south of the middle diaphragm in the girder (Figure 7.1).

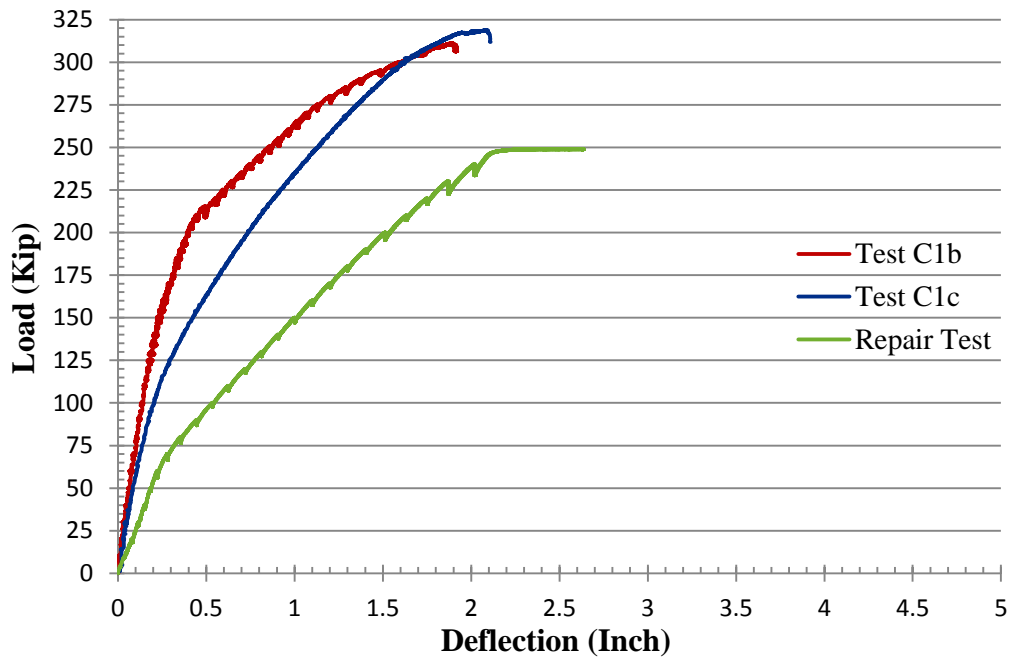
**Figure 7.2 Load vs. Deflection Plot of Original and Repair Testing of South End of Girder**

With each iteration of testing, the toughness of the girder dropped and the slope of the load-deflection plot became more horizontal, which correlates to a decreasing stiffness, shown in Figure 7.2. That is to say, the stiffness for test “C1b” is higher than that of test “C1c” as well as the repair test. Thus, the toughness for test “C1b” is the highest, then “C1c,” and the repair test with the lowest toughness as well as the lowest stiffness.

bridge girder with a composite deck. During the south end repair test, a crack at the vertical interface between the repair concrete and the existing concrete formed at the cracking load, which was just south of the applied load. According to Figure 7.2, this is the point in the loading that the load-deflection plot changes slope, and proceeds to increase linearly as load is applied. When taking into account that this linear stiffness continues until failure and that the crack that appeared at the vertical interface of the repair and existing concrete widened throughout testing, it is clear that the strength of the strands were key to the overall capacity, i.e., the strands were responsible for taking the full tension force of the internal moment; that with the increase in load, the strands were elongating, elastically, until they reached their elastic limit and began undergoing plastic elongation. This can be supported by calculating the stress in the strands from the maximum load attained from the test and using the strain compatibility method equations along with stress/strain relationships.

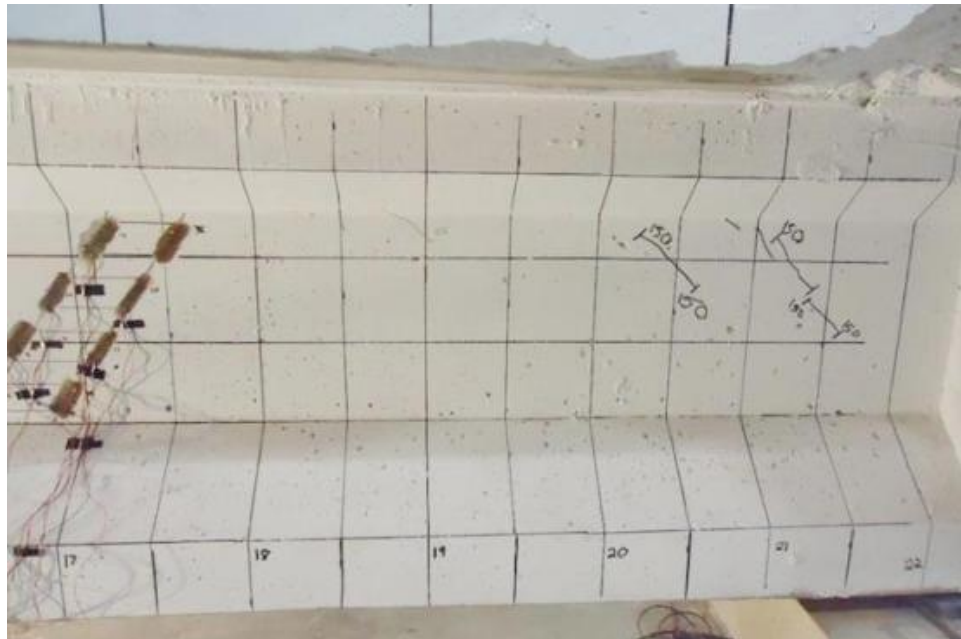
**Figure 7.3 First Cracks for Murray's North End Testing (150 kips, East View, Courtesy of Cameron Murray)**

(approximately 16% of the maximum load of the repair test), equating to about 27% of the cracking load for the original testing. These cracks were flexural, located in the bottom bell of the repair section and the first cracks for Murray's tests appeared as web-shear cracks near the northern support as shown in Figure 7.3.

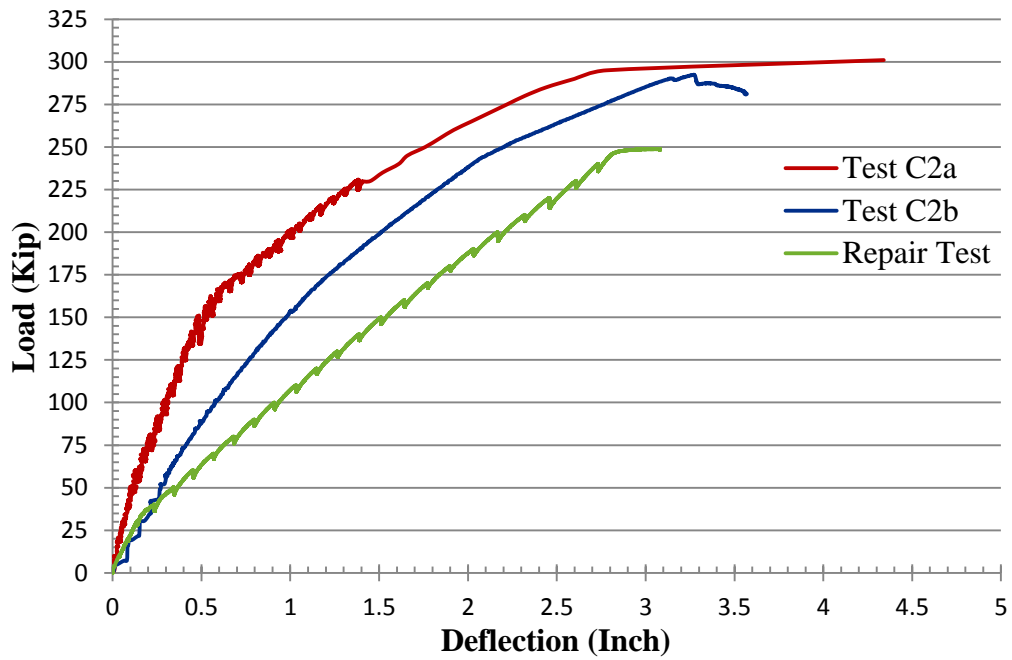
**Figure 7.5 Load vs. Deflection Plot of Original and Repair Testing of North End of Girder**

Analogous to the south end testing, Figure 7.5 illustrates that with each progression of testing, the stiffness and toughness of the girder decreases. Test “C2a” exhibited the highest stiffness and, thus, the dominating value of toughness; the repair test matched the stiffness of test “C2b” until the cracking load, at which point the stiffness changed to a linear plot much like the repair testing for the south end repair. It should be noted that both repair tests, north and south, attained their maximum load at approximately the same deflection as each end’s original testing that was conducted by Murray. The comparative testing results for the north end are given in Table 7.2 and a plot of the extent of cracking for the original and repair testing are presented in the Appendix. The values in Table 7.2 are derived from a simply supported arrangement, neglecting the influence of the overhanging portion of the girder.

Similarly to the load-deflection plot for the south end repair, the north end repair test features a clear change in slope at the cracking load, shown in Figure 7.5. The plot also shows that before this stiffness change, the slope of the plot for the repair test closely aligns with the slope of the "C2b" test plot. After the stiffness change, the plot increases linearly until failure much like the repair test for the south end. This leads to suggest that when the cracks propagated, the strands debonded from the concrete creating a similar resisting internal moment to
