BRIDGE STEEL COATINGS TOLERANT OF MINIMAL SURFACE PREPARATION

**Construction Report
June 1996**

**Kimberly L. Gordon
Research Project Manager**

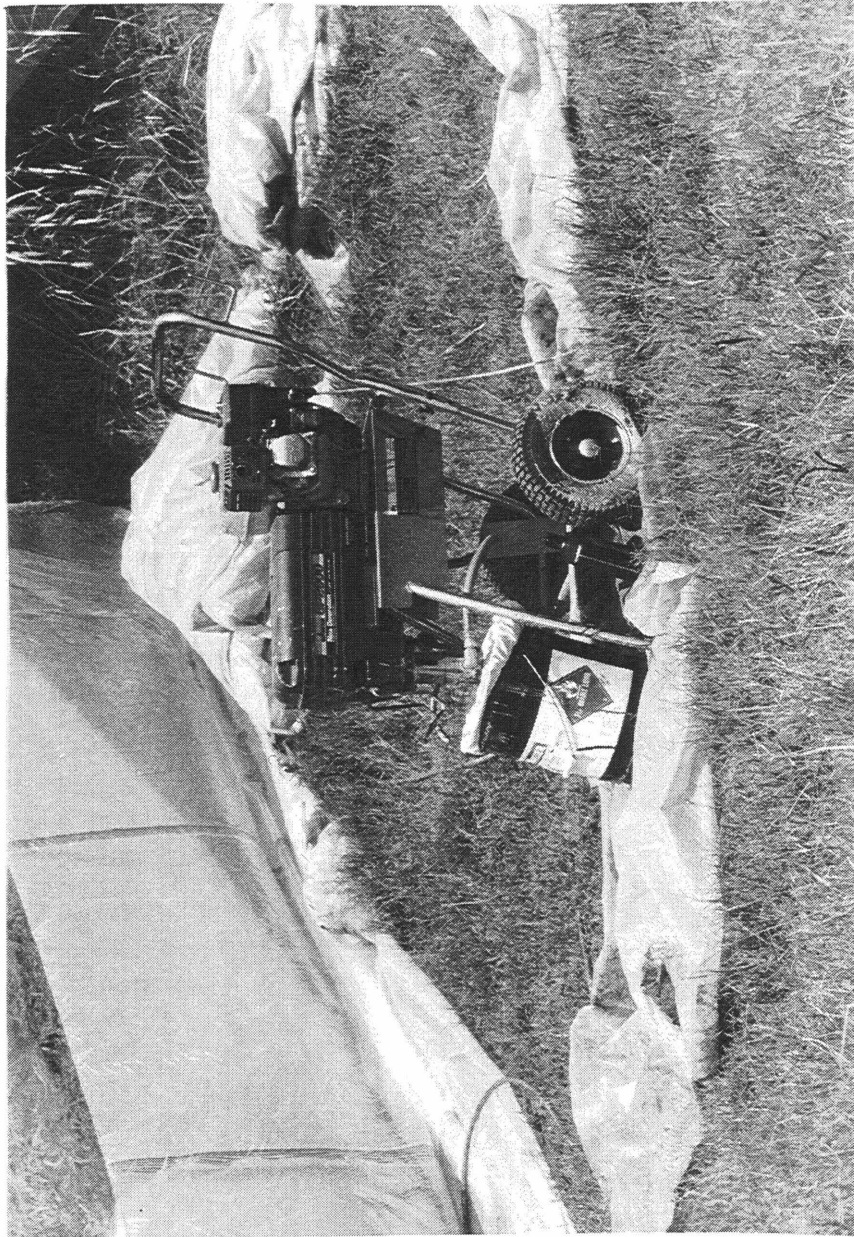
Figure 4. Airless Spray Equipment

Scaffolds and ladders were used as an aid when painting areas that were not easily accessible from the ground. The flanges were painted first by hand with brushes or rollers. The beams were then painted using an airless spray setup shown in Figure 4. The tip sizes used to paint the steel beams were within the range specified by the manufacturer listed in Table 5. Blank spaces left in the table indicate that no tip size was listed in the information available at the time that this report was written. The manufacturer's recommended dry film thickness is also listed in this table. Exceptions to these values are noted in the text.

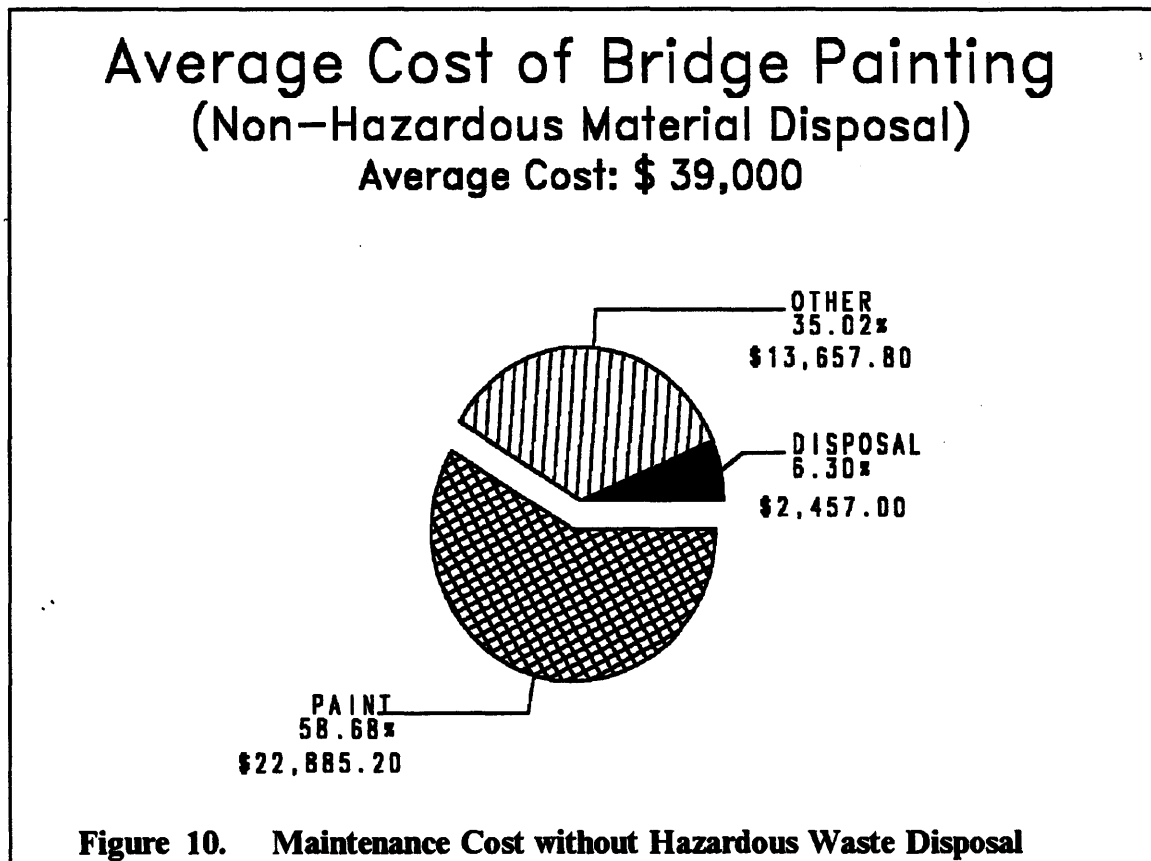
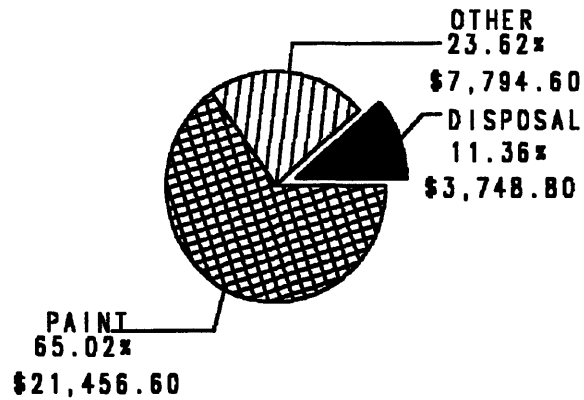
Figure 11. Maintenance Cost with Hazardous Waste Disposal

The percentage of money used in each facet of maintenance is shown in Figure 10. Figure 11 shows the same cost analysis for the control bridge.

Cost of Control Bridge Painting (Hazardous Material Disposal) Cost: \$ 33,000

Disposal includes: disposal, collection,
treatment and blasting of hazardous
materials.
