# ESTABLISHMENT OF UNDERDRAIN MAINTENANCE PROCEDURES

<b>1. REPORT NO.</b> FHWA/OK 95(04)	<b>2. GOVERNMENT ACCESSION NO.</b>	<b>3. RECIPIENT'S CATALOG NO.</b>	
<b>4. TITLE AND SUBTITLE</b> ESTABLISHMENT OF UNDERDRAIN MAINTENANCE PROCEDURES		<b>5. REPORT DATE</b> May 1995	
		<b>6. PERFORMING ORGANIZATION CODE</b>	
<b>7. AUTHOR(S)</b> Steven Sawyer, Project Manager		<b>8. PERFORMING ORGANIZATION REPORT</b>	
		<b>10. WORK UNIT NO.</b>	
<b>9. PERFORMING ORGANIZATION ADDRESS</b> Oklahoma Department of Transportation Research & Development Division 200 Northeast 21st Street, Room 2A2 Oklahoma City, OK 73105		<b>11. CONTRACT OR GRANT NO.</b> Item 2183	
		<b>13. TYPE OF REPORT AND PERIOD COVERED</b> Final Report May 1991 to May 1995	
<b>12. SPONSORING AGENCY NAME AND ADDRESS</b>  Oklahoma Department of Transportation 200 Northeast 21st Street Oklahoma City, Ok 73105		<b>14. SPONSORING AGENCY CODE</b>	
		<b>15. SUPPLEMENTARY NOTES</b>	
<b>16. ABSTRACT</b> Project #2183 analyzed the condition of underdrains and developed a method of classifying, maintaining, and, when necessary, replacing underdrain outlets.  The project encompassed every region of Oklahoma and many different climates and ge

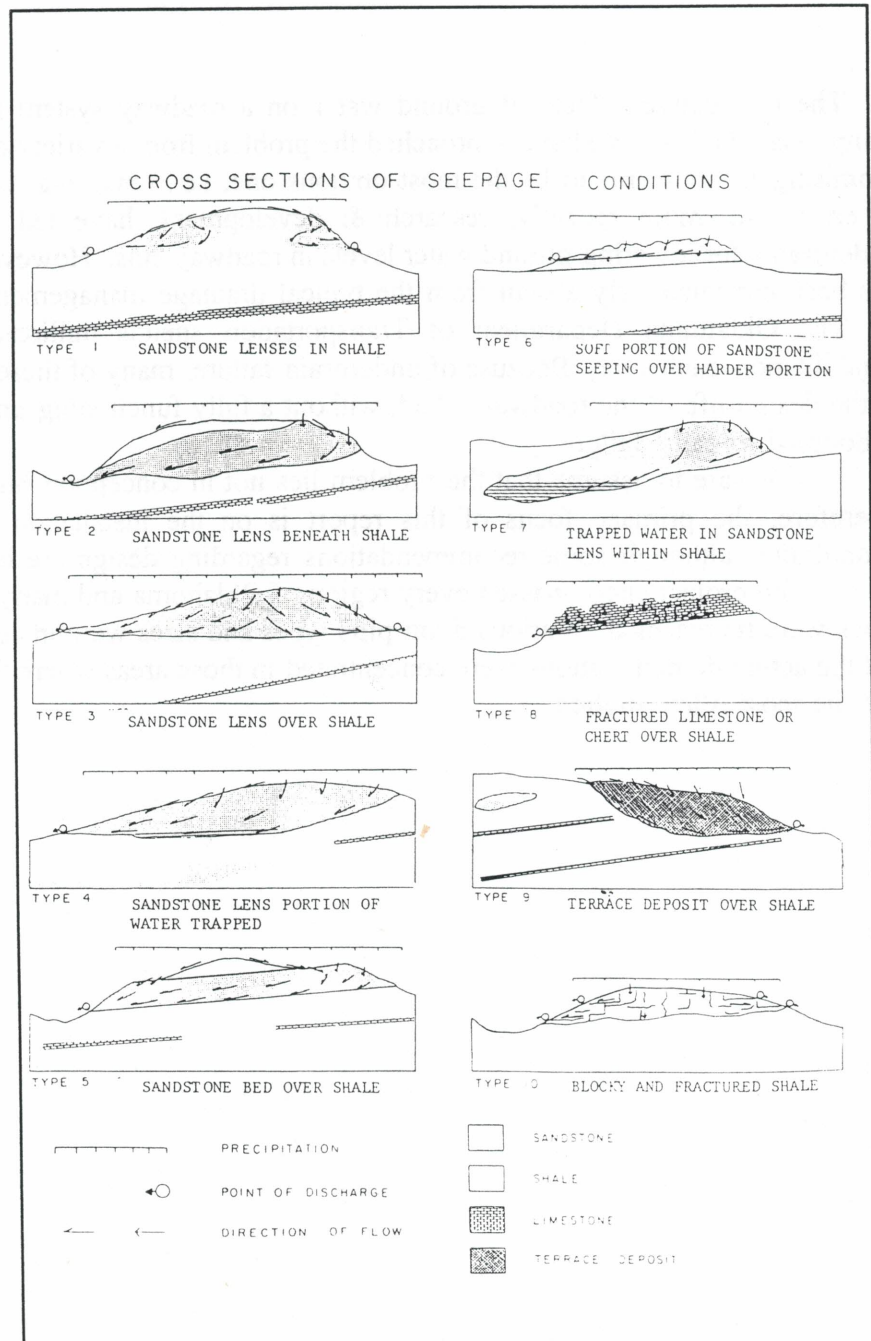
Figure 1 Geological conditions.

The presence of ground water in a roadway system can stem from a variety of geological conditions. Ten of the more commonly encountered seepage conditions are represented by the cross sections illustrated in Figure 1.

These conditions are comprised of a porous, permeable layer of material overlying a denser, less permeable layer. In Oklahoma, the geology ranges from predominately Pennsylvanian in the east, characterized by thick layers of hardened sandstone and limestone, to predominately Permian in the west, characterized by red clay and soft sandstone. (4)

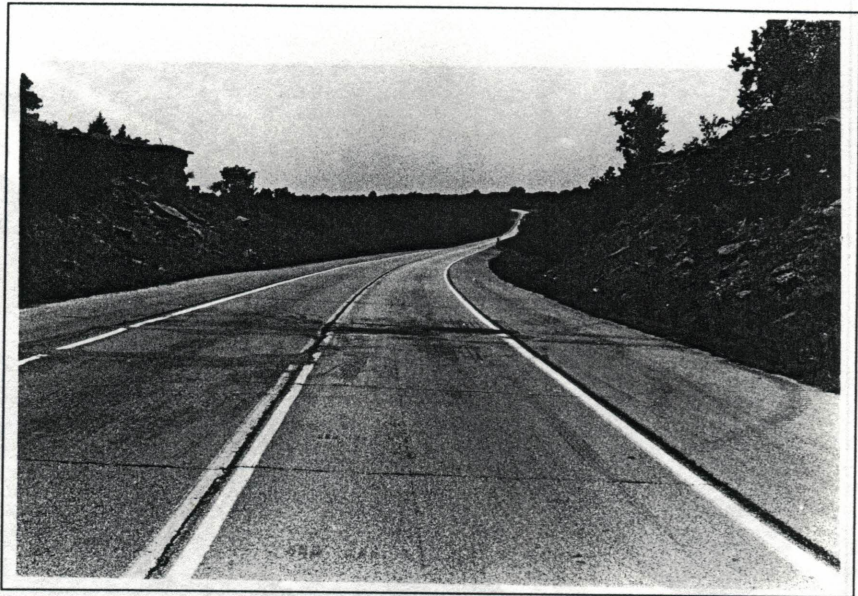
Figure 2 *Cut section.*

The most likely place to encounter a problem with ground water is in a *cut section* - that portion of a roadway which is designed to pass *through*, rather than over or around an area of relatively high elevation. (Figure 2)

When a cut section passes through the upper level of a water table, the water can permeate the sub-base, base, and in some cases, the pavement itself.

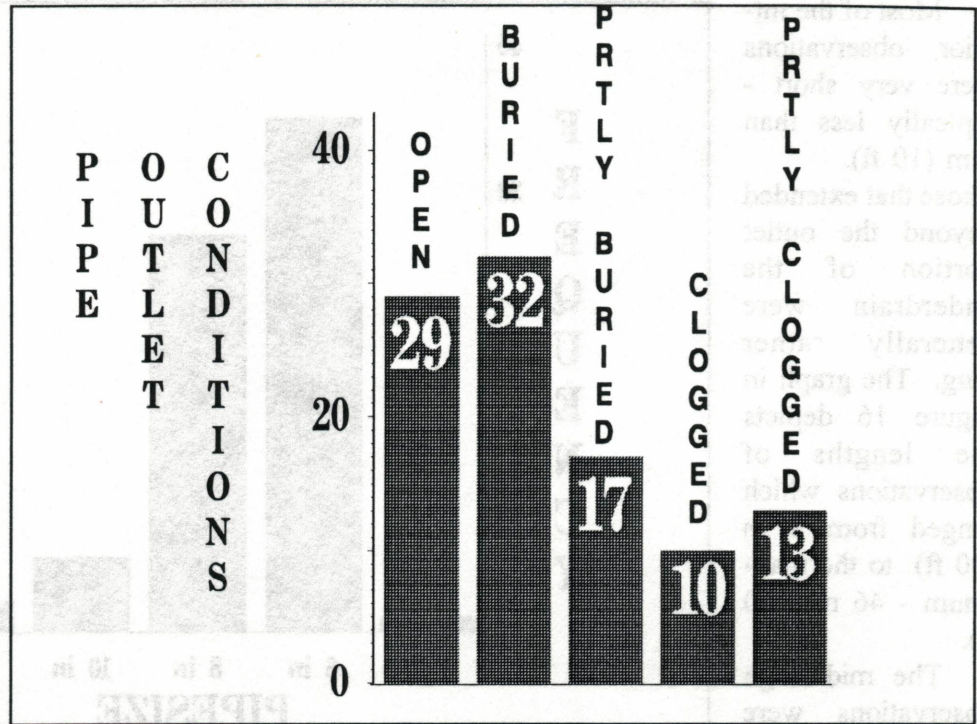
Figure 13 Frequency of outlet conditions.

An outlet's condition fell into one of five categories:

The chart in Figure 13 shows the frequency of each condition.

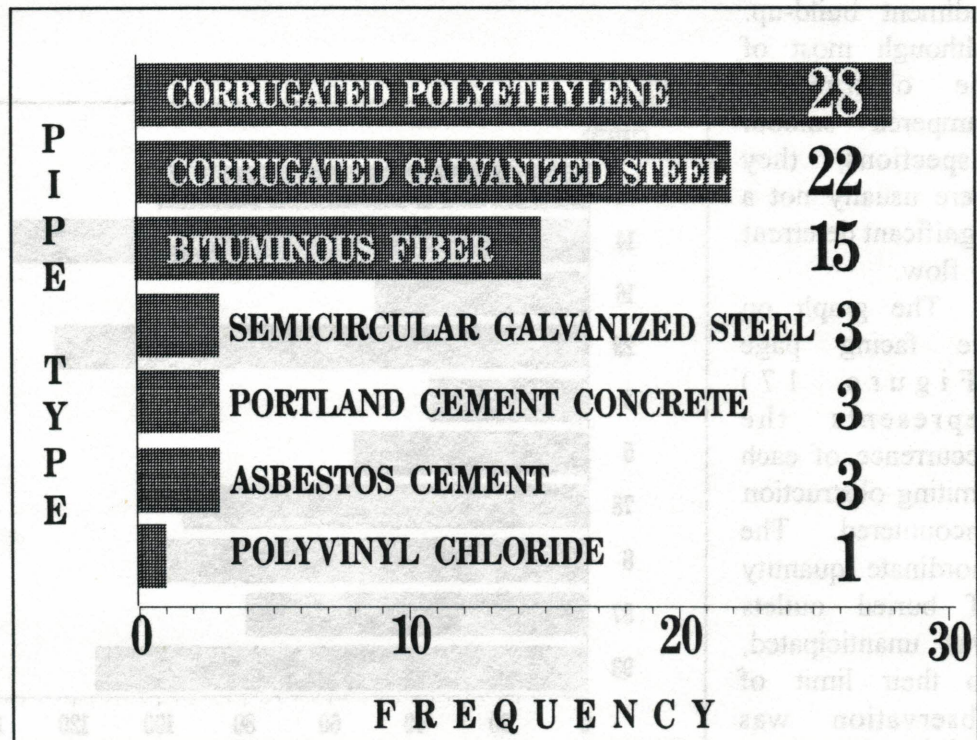
Figure 14 Pipe types.

The apportionment of pipe types was more true to prediction. The majority were of the types stipulated in the 1988 standard specifications, CGMP or HDPE. The distribution of all types found is represented by the graph in Figure 14.

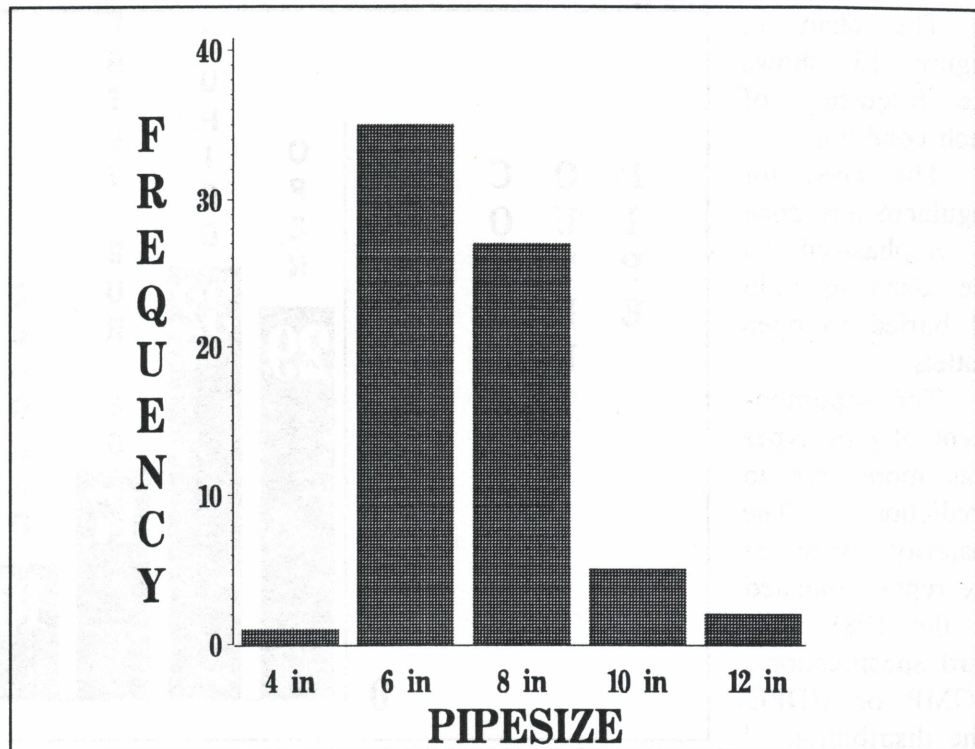
Figure 15 Frequency of pipe sizes.

The majority of underdrain pipe sizes were 15 cm (6 in) and 20 cm (8 in), as indicated by the graph in figure 15 on the following page.

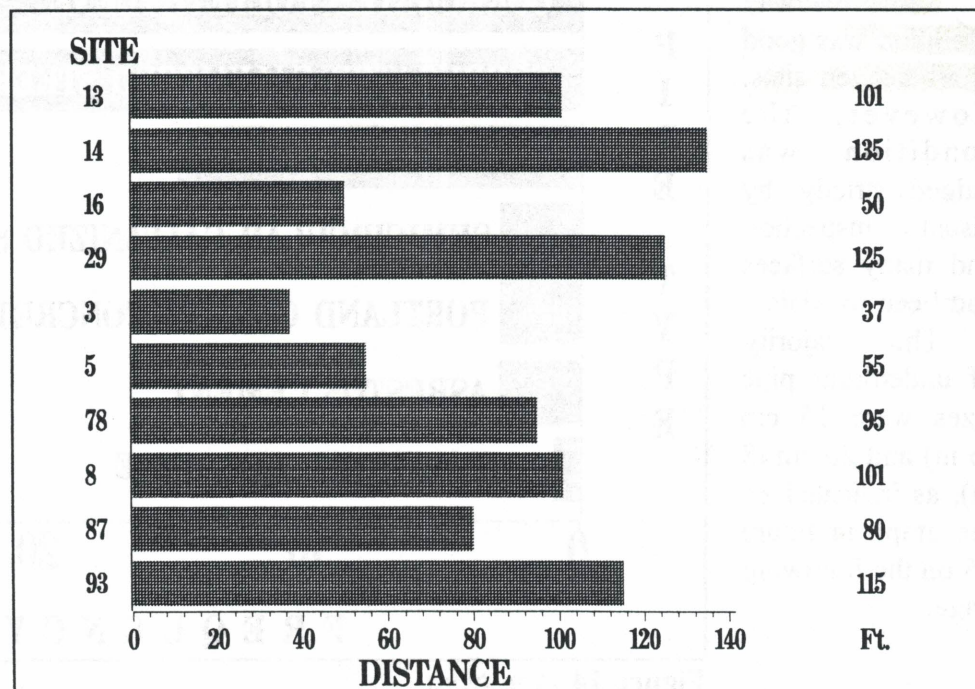
Figure 16 Observations beyond 30 feet.

Most of the interior observations were very short - typically less than 3 m (10 ft).

Those that extended beyond the outlet portion of the underdrain were generally rather long. The graph in Figure 16 depicts the lengths of observations which ranged from 9 m (30 ft) to the maximum - 46 m (150 ft).

The mid-range observations were generally limited by sediment build-up. Although most of the obstructions hampered smooth inspections, they were usually not a significant deterrent to flow.

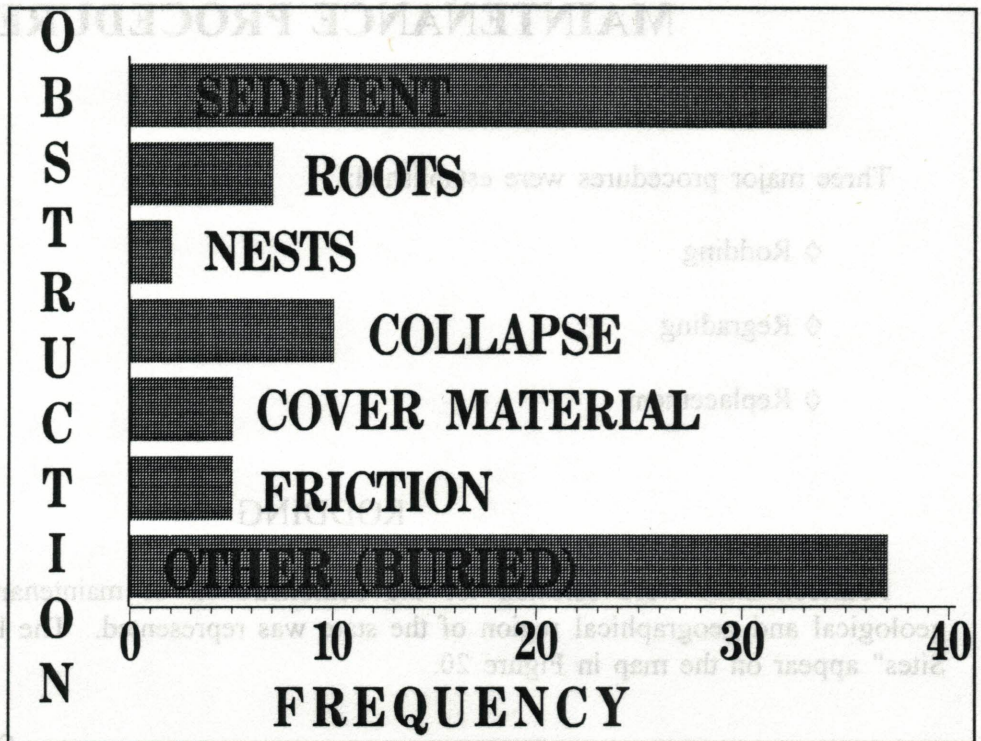
Figure 17 Limiting obstructions.

The graph on the facing page (Figure 17) represents the occurrence of each limiting obstruction encountered. The inordinate quantity of buried outlets was unanticipated, so their limit of observation was logged with OTHER.

The conditions of twenty-nine of the buried outlets remain unknown because they were not exhumed.

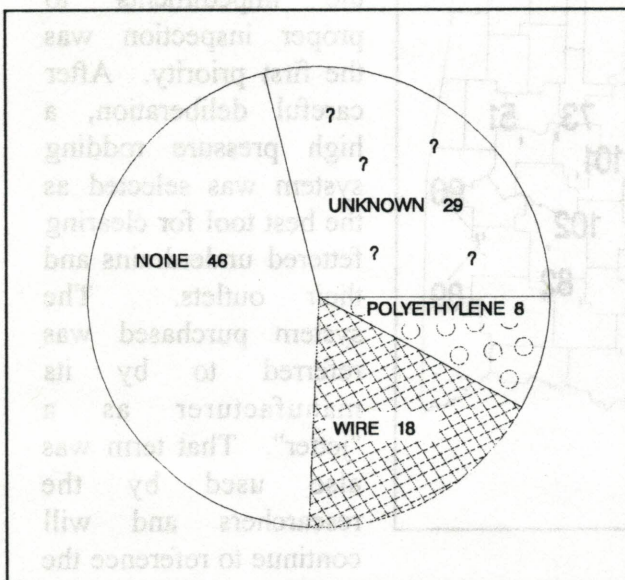
Figure 18 Rodent screen types.

Rodent screens were present at twenty-six sites. The total apportionment of screen types is illustrated in Figure 18.

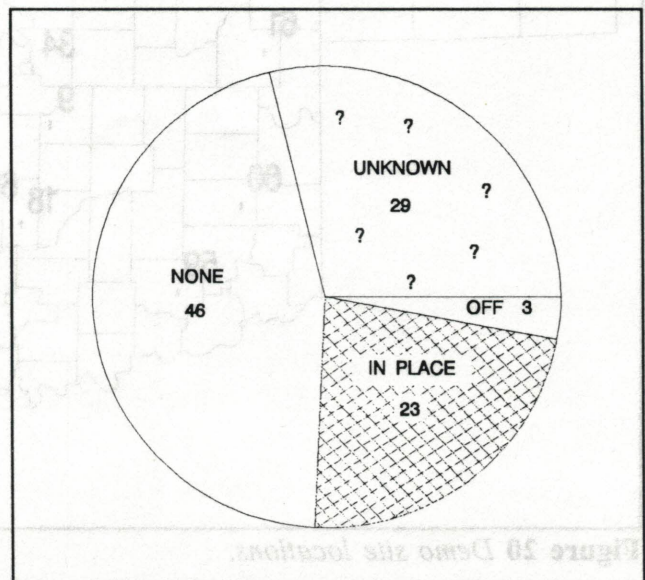
Figure 19 Condition of rodent screens.

Of the twenty-six rodent screens found, only three had been detached from the outlet. The remaining screens were secure. (Figure 19)

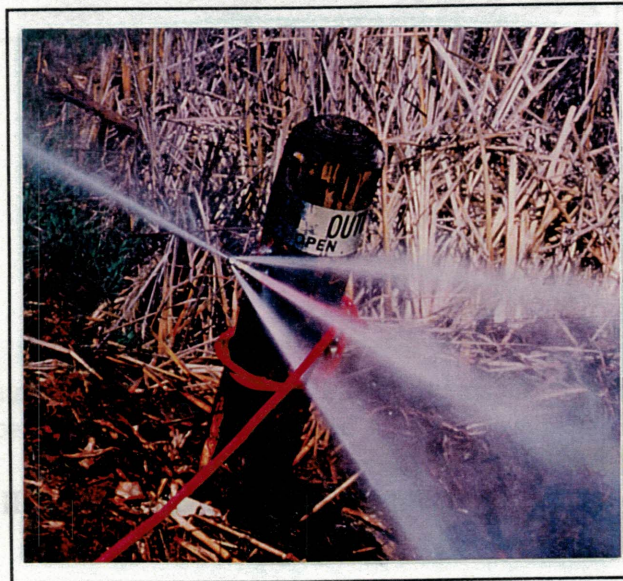
**Figure 22** Jetting action of a thruster head.

The jetting action of the most often used thruster head is pictured in Figure 22. One stream thrusts forward to loosen sediment and/or cut through roots while the rearward streams wash out debris and propel

the hose through the pipe. The operator swabs the pipe with an oscillating motion until the obstructing material is carried to the outlet opening. (Figure 23)

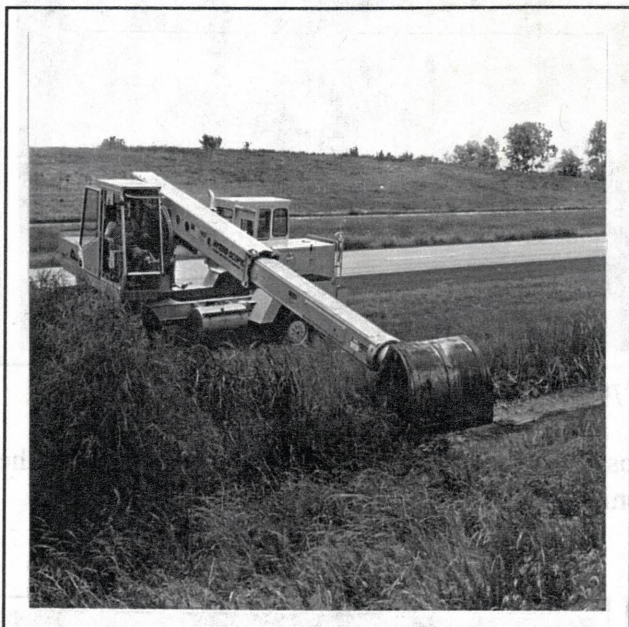
**Figure 24** Hydraulic excavator.

At sites where the outlet was buried, the ditch was regraded and the outlet opening uncovered. For most situations, the consummate implement for regrading is a truck mounted multi-purpose excavator with a hydraulic telescoping boom. (Figure 24) Its versatility allows access to the outlet in many different ditch configurations and a skilled operator can leave the sight in finished condition. (Figure 25) The shape and slope of the regraded ditch was generally left to the discretion of the equipment operator. However, it is recommended that only experienced and highly skilled operators be allowed to make such on-site judgements. If an operator has any doubts about the outcome, the ditch should be surveyed and staked.
