Video inspection of wells in open loop ground source heat pump systems in Norway.

Sondre Gjengedal, Randi K. Ramstad, Bernt Olav Hilmo, Bjørn Frengstad

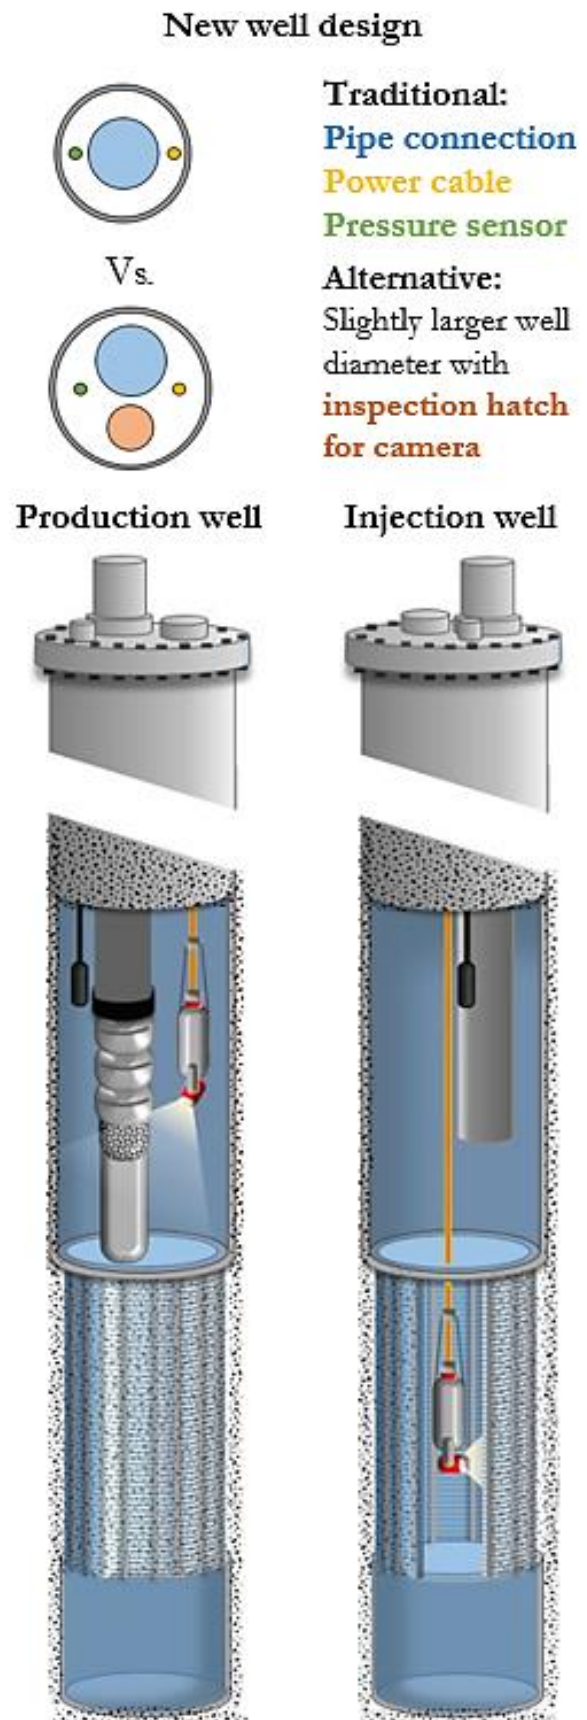
Figure 2 The traditional well design does not have space for a video camera. An alternative design that allows for real-time video inspection can reduce the over-all cost of fault detection.

If the well designs include enough space for a video camera while the pump and pipes are operating, the time needed and the over-all cost of the inspection is greatly reduced. A possible alternative would be to increase the well diameter sufficiently to give space for a camera along the side of the pump or injection pipe. An inspection “hatch” next

to the pipe connections is a potential technique. By installing the pump and injection pipe slightly off-center, the additional well diameter needed for the camera might be minimized (figure 2). The video inspection can then be conducted during normal system operations and the actual well behaviors are observed live on the monitor while groundwater flows through the system. The increased installation cost due to a larger well diameter will be more than outweighed by the benefits of regular monitoring of the well conditions during the lifetime of the wells. In addition, a larger screen diameter would in most cases improve the well characteristics.
