**FIELD PERFORMANCE  
EVALUATION  
OF  
SELF-LEVELLING SEALANTS  
DOW CORNING 888-SL AND 890-SL**

Gary G. Williams, P.E.  
Research Project Manager

Research & Development Division  
200 N.E. 21st Street, Room 2A2  
Oklahoma City, Oklahoma 73105

April, 1995

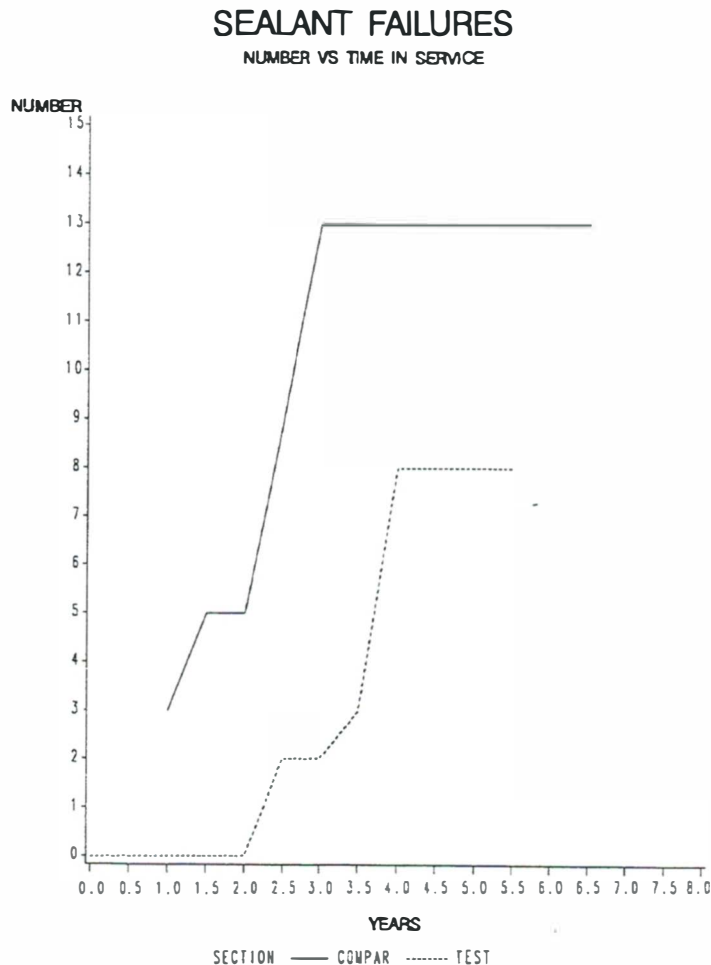
**Figure 5. Failures vs. Time, Test Section and Comparison Section 1.**

On the date of the final survey of this location (5-11-94) eight sealant failures had occurred. Of these, two were cohesion failures. The cohesion failures had the appearance of holes (approximately 1/4 inch diameter) through the sealant down to the backer rod. Six adhesion failures were also observed. All were located in the outside edge line joint. Adhesion failures were one inch and two inches long. The adhesion failures began to appear when the sealant had been in service for 3.5 years. Two of the adhesion failures were located where thermoplastic striping crossed the sealed joint.

By the end of the evaluation period, 13 failures were observed in this section. Nine of these were adhesion failures. Six of the failures were located in the outside edge line joint. The remainder were randomly located in the transverse joints on the shoulders. There were also four cohesion failures, which appeared as (1/4 - 3/8 inch diameter) holes through the sealant. The holes extended down to the backer rod.

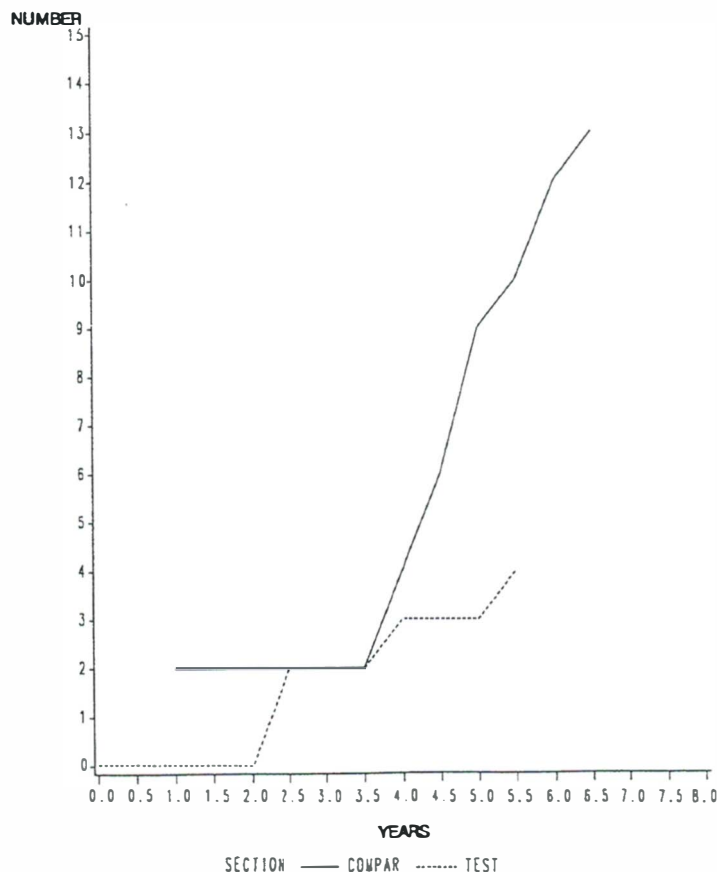
Figure 6. Failures vs. Time. Test Section and Comparison Section 2.

This section was last surveyed on May 11, 1994. At that time, four failures were observed (Two adhesion and two cohesion failures). All failures were located in the outside edge line joint.

Of 13 failures observed during the last survey, 10 were adhesion failures. The majority of the adhesion failures were located in the edge line joints. Nine of these failures were located in the outside edge line joint, with one in the inside joint. Lengths of adhesion failures ranged from one inch (2.54 cm) to one foot (30.48 cm).

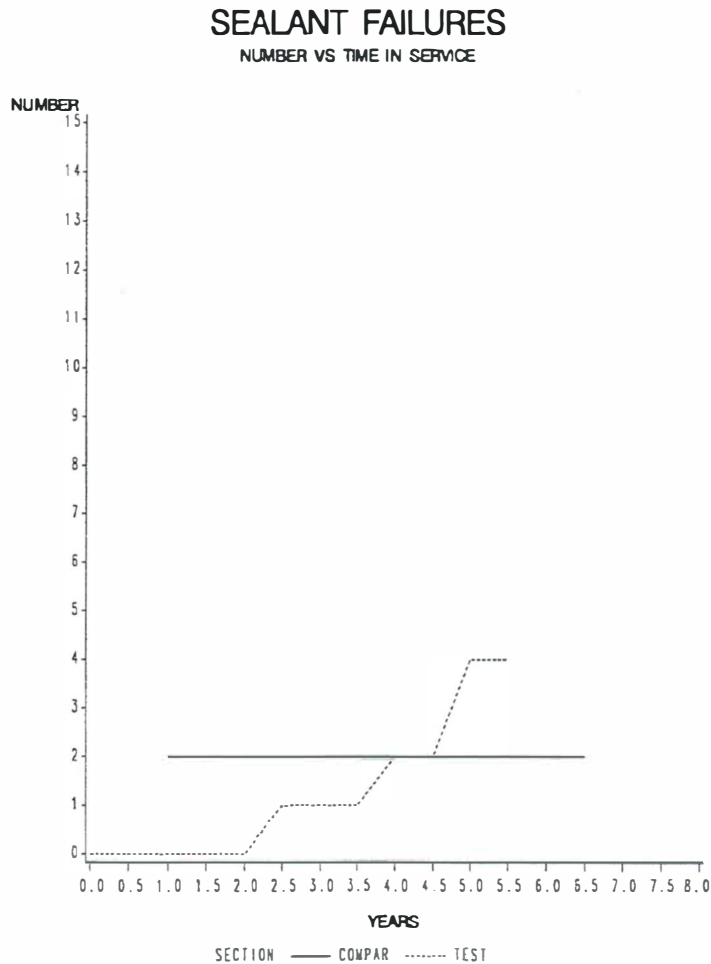
Figure 7. Failures vs. Time, Test and Comparison Sections 3.

Four failures had occurred in this section by the date of the final survey (May 11, 1994). Three of these were adhesion failures of the sealant in the edge line joint. All were approximately two inches long. In one localized area, there were three holes (each approximately 1/4 inch diameter) within one foot of each other.

Only two cohesion failures were noted in this section by the time of the final survey (May 11, 1994). These had the appearance of holes (approximately 1/2 inch diameter) through the sealant, down to the backer rod. Both failures were located in intersections of edge line joints and transverse joints in shoulders.

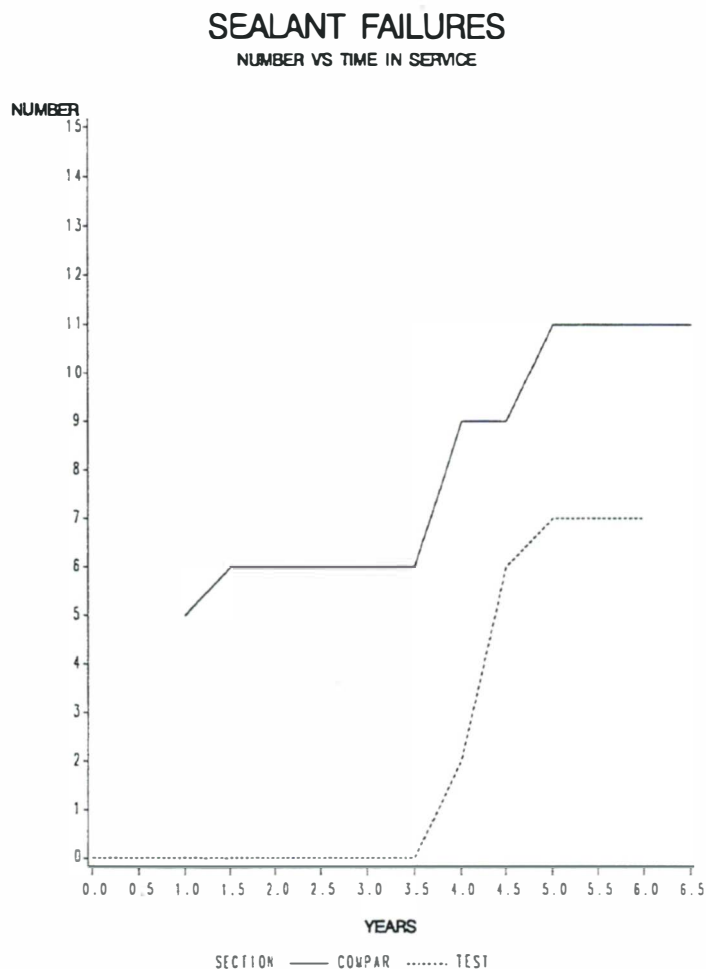
Figure 10. Failures vs. Time, Test Section and Comparison Section 1.

At the time of the final survey on this project (June 3, 1994), this section had seven adhesion failures (no other types of failure observed). Lengths of failures ranged from one inch to six inches. Four of these had failed on both sides of the sealant. This allowed the sealant to drop down into the joint in the failed area (Figure 13). All of the failures in this section were in locations where thermoplastic striping crossed a sealed joint (Figure 14). The failures were first observed when the sealant had been in service three and one half years.

Eleven failures had occurred in this section by the time of the final survey. Five of these were cohesion failures, appearing as 3/8 inch (0.9525 cm) diameter holes through the sealant). All of the failures of this type occurred at the intersection of transverse joints and longitudinal edge line joint. One failure was a three-inch-long cohesion failure that had the appearance of a split in the sealant. The other three were adhesion failures occurring where thermoplastic striping crossed joints (Figure 15).

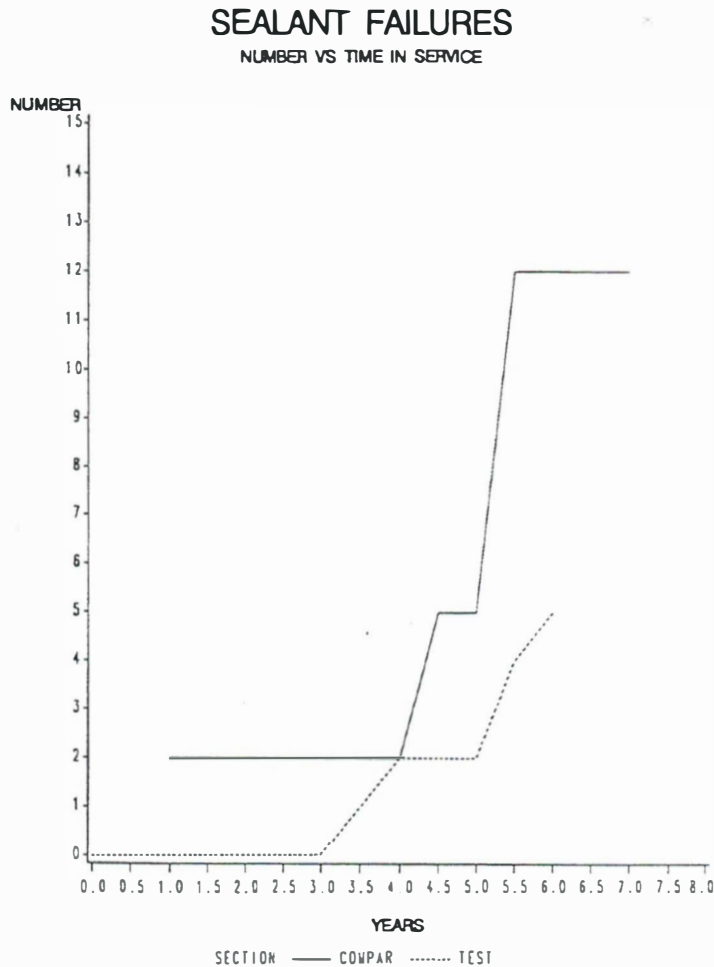
Figure 11. Failures vs. Time, Test Section and Comparison Section 2.

During the final survey (May 11, 1994), five failures were located in this section. Four of these were cohesion failures appearing as "holes" (approximately 1/2 inch diameter). The one adhesion failure was located where thermoplastic striping crossed a transverse joint.

The final survey noted twelve failures in this section. Nine of these were adhesion failures occurring where thermoplastic striping crossed transverse joints. The remaining failures were an adhesion failure (not located at a stripe) and two 1/2 inch diameter holes (cohesion failures) through the sealant.

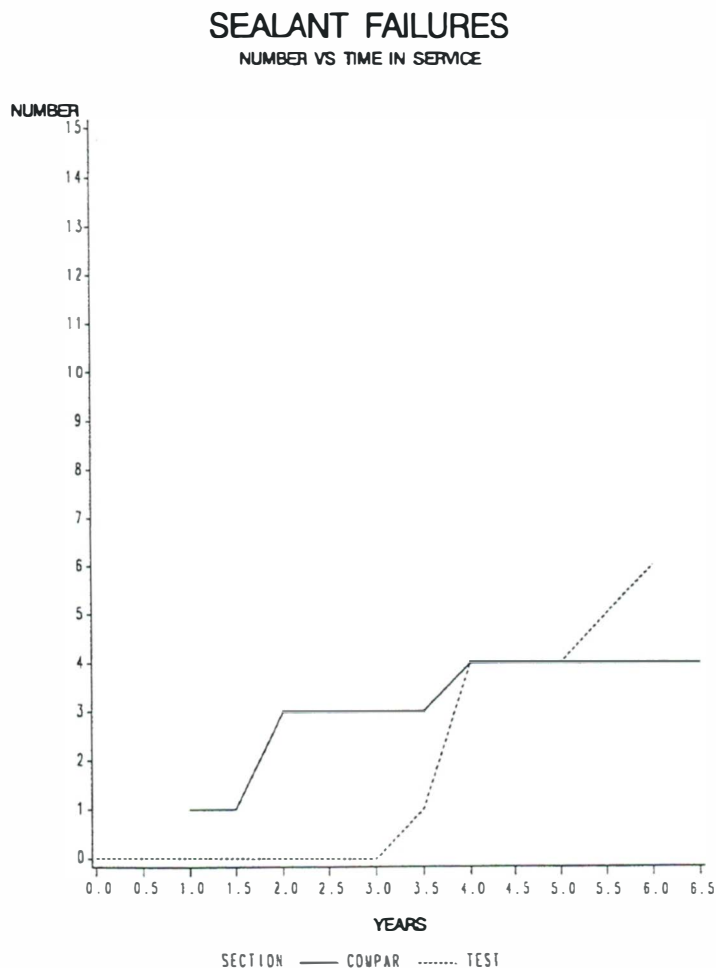
Figure 12. Failures vs. Time, Test Section and Comparison Section 3.

During the final survey (May 11, 1994), a total of six failures were noted in this section. Of these, four were cohesion failures appearing as 3/8 inch (0.9525 cm) diameter holes through the sealant. The holes extended down to the backer rod (Figure 16). The remaining two were adhesion failures. One was located where thermoplastic striping crossed a transverse joint. The other was located in the outside wheel path.

All four of the failures in this section were cohesion type, appearing as 3/8 inch (0.9525 cm) diameter holes. The holes extended down to the backer rod. Three of the failures were located at intersections of transverse and longitudinal joints. The remaining failure was located where thermoplastic striping crossed a transverse joint.

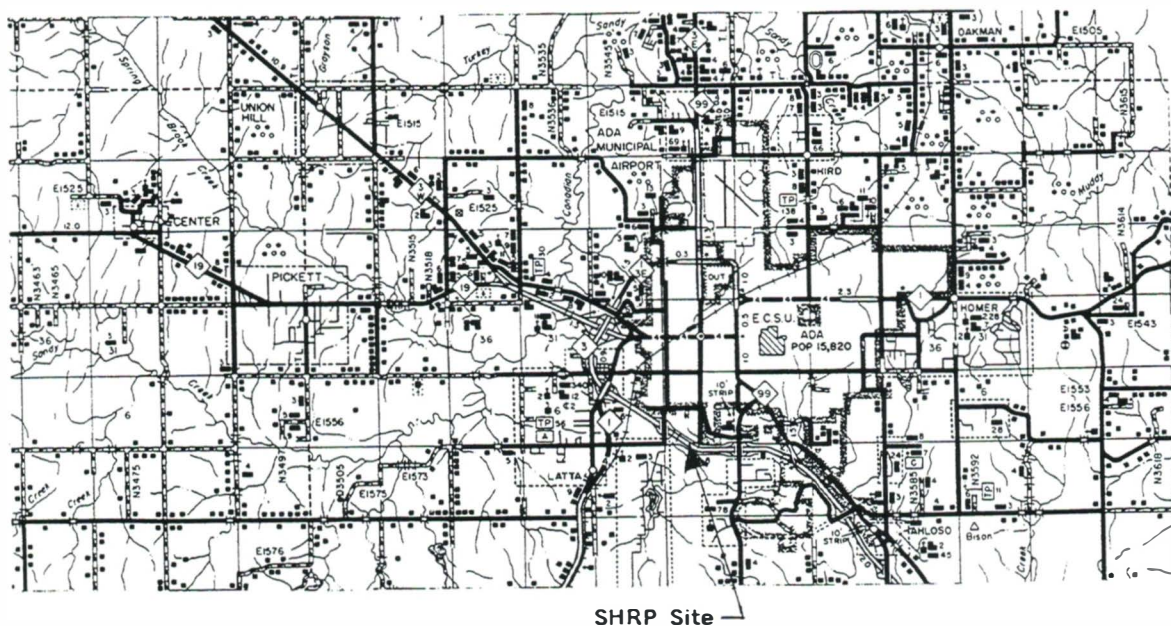
Figure 25. S.H. 3 SHRP Site.

Prior to the demonstration, the the original joint sealant was removed by sawing it out of the joints. The joints were then cleaned by sandblasting. Removal of the old sealant and joint cleaning was done by ODOT Maintenance Forces. It is difficult to completely remove old sealant in this manner. In numerous locations, small amounts of the old sealant remained on the joints. The saw cut between the roadway and the shoulder varied in width from 1/2 inch (1.27 cm) to 2 inches (5.08 cm) (Figure 26). Also, the elevation of the shoulder varied from being flush with the roadway to as much as 1 inch (2.54 cm) below it. (Figure 27). Most of the failures at this location were related to these conditions.

The majority of the failures (17 out of a total of 19) were considered to be related to site conditions described above. The number of failures observed in each survey since installation is summarized in Table 2.

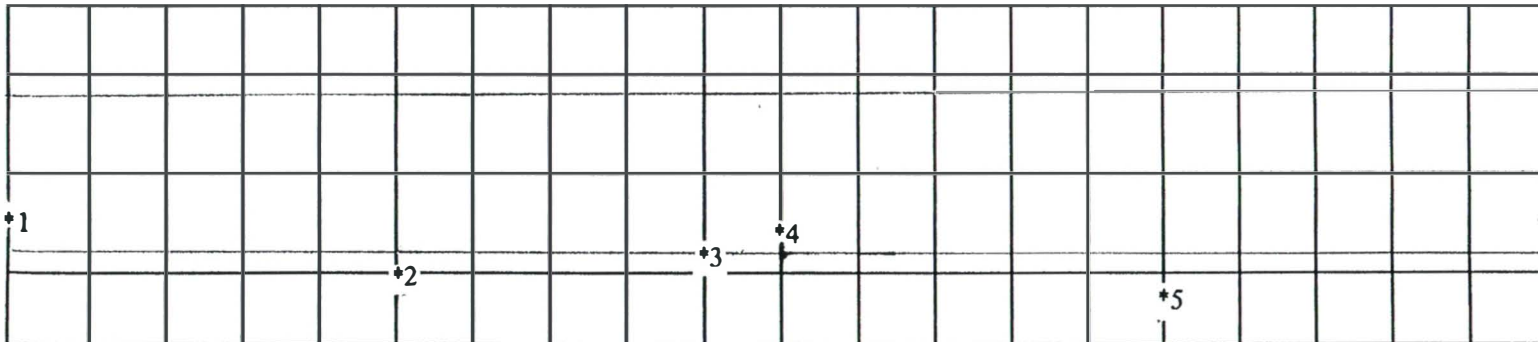
Test Section 2.

\* Location of Failure.

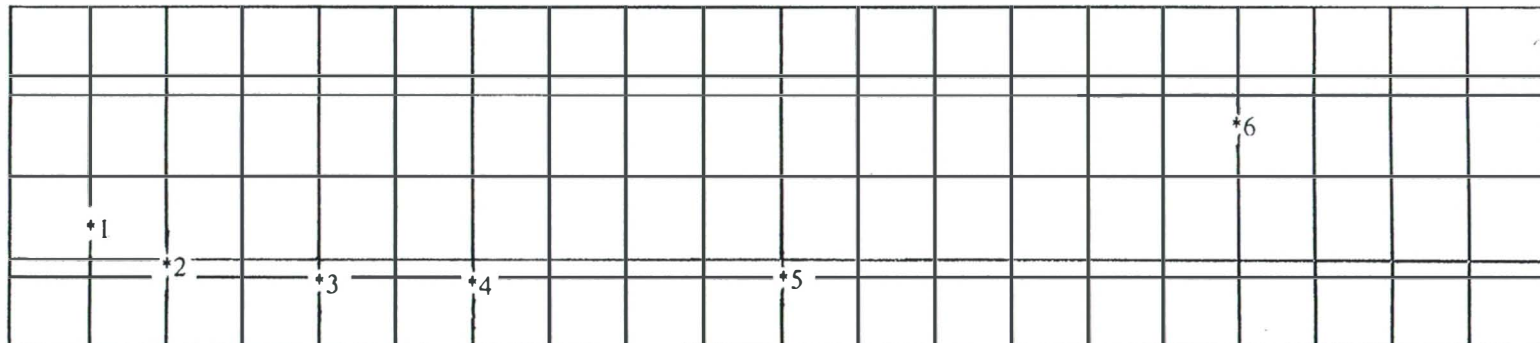
Test Section 3.

\* Location of Failure.

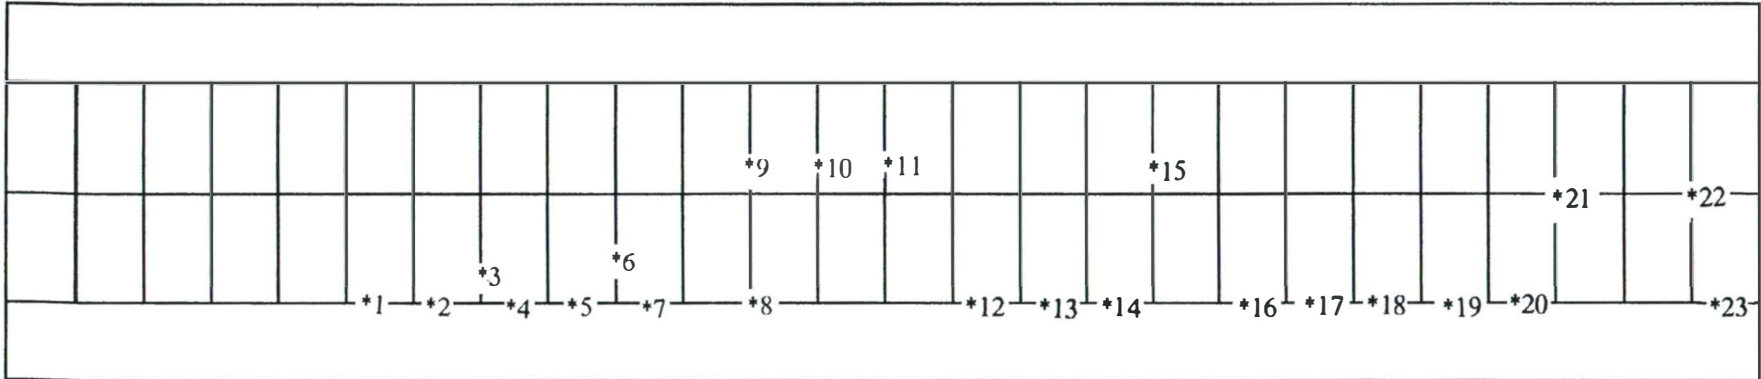
\* Location of Failure.
