Final Report O.R.A. 157-622

# EFFECTIVENESS OF RIVERBANK PROTECTION AND RIVER CONTROL IN OKLAHOMA

By  
Jimmy F. Harp, PhD  
Professor  
and  
Mathew Thomas  
Research Assistant

August 15, 1989

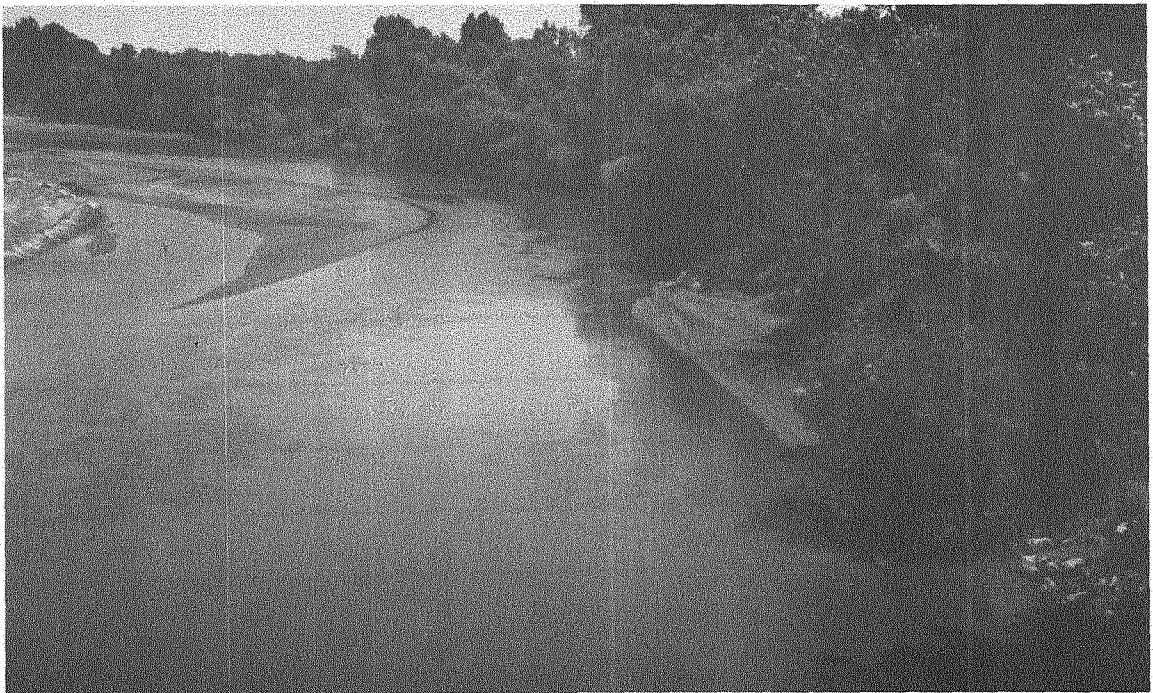
FIGURE 31b

RIVER FLOW AGAINST THE EASTERN EMBANKMENT

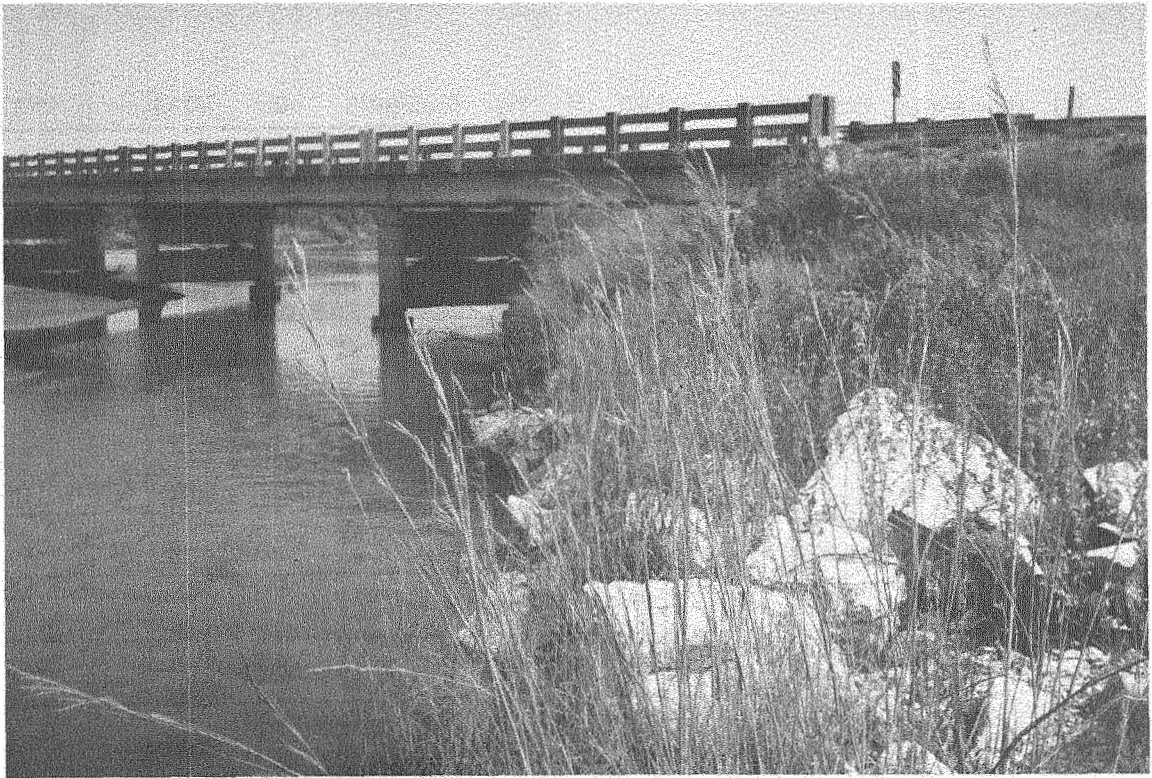
FIGURE 37a

View of Bridge Abutment with Riprap

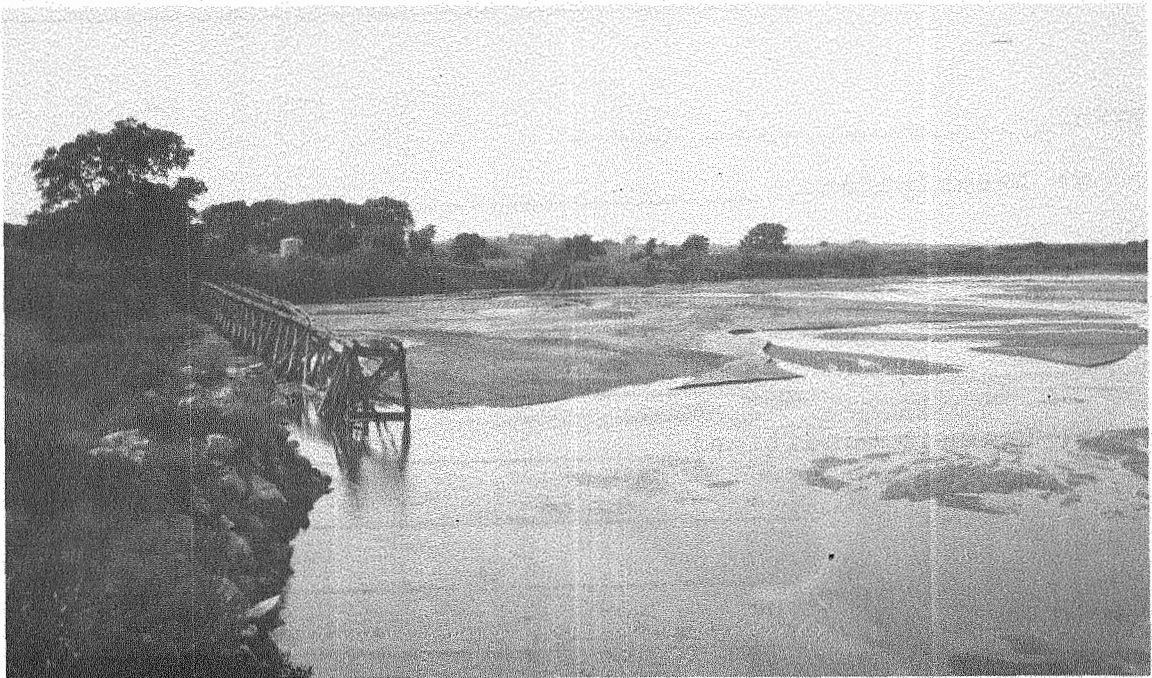
FIGURE 37b

b) Present Condition: MOST OF THE DIVERSIONS NEED REPAIR. THEY HAVE  
PERFORMED EXCELLENTLY IN DIVERTING FLOW AND INDUCING DEPOSITION.  
THE RIVER IS CUTTING BEHIND THE FIRST PILE DIVERSION. MOST OF  
THEM NEED REPAIR. SAND DEPOSITION NOT ENOUGH TO ENCOURAGE  
VEGETAL GROWTH.

View of the Pile Diversion Field

For now, increased attention should be focused on the river action at the southern bank. In the event of a major flood, the river may erode the southern bank extensively, given the present conditions. The pile diversions should be repaired or an alternative river training technique should be looked into. As an observation, the present bridge structure is likely scheduled for replacement in the next decade or so. Consideration should be given to moving the bridge site downstream. This would also correct the highway alignment.

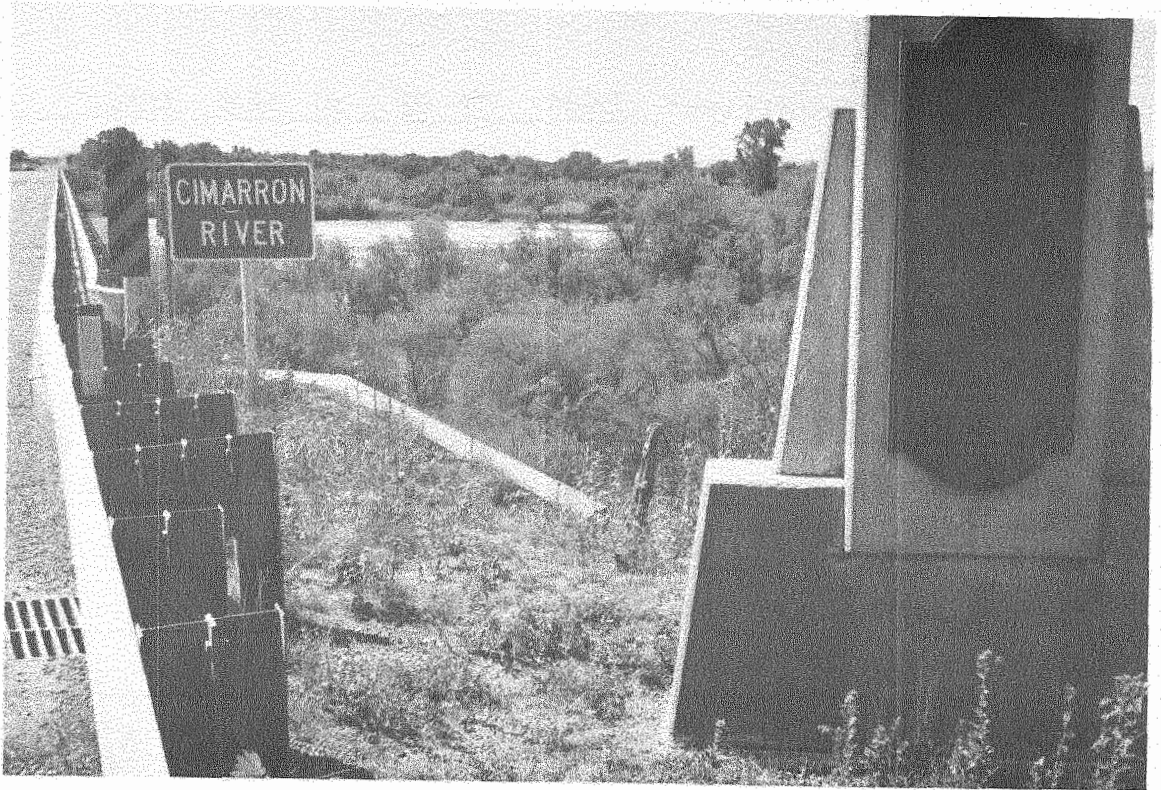
FIGURE 40a

View of Bridge Site

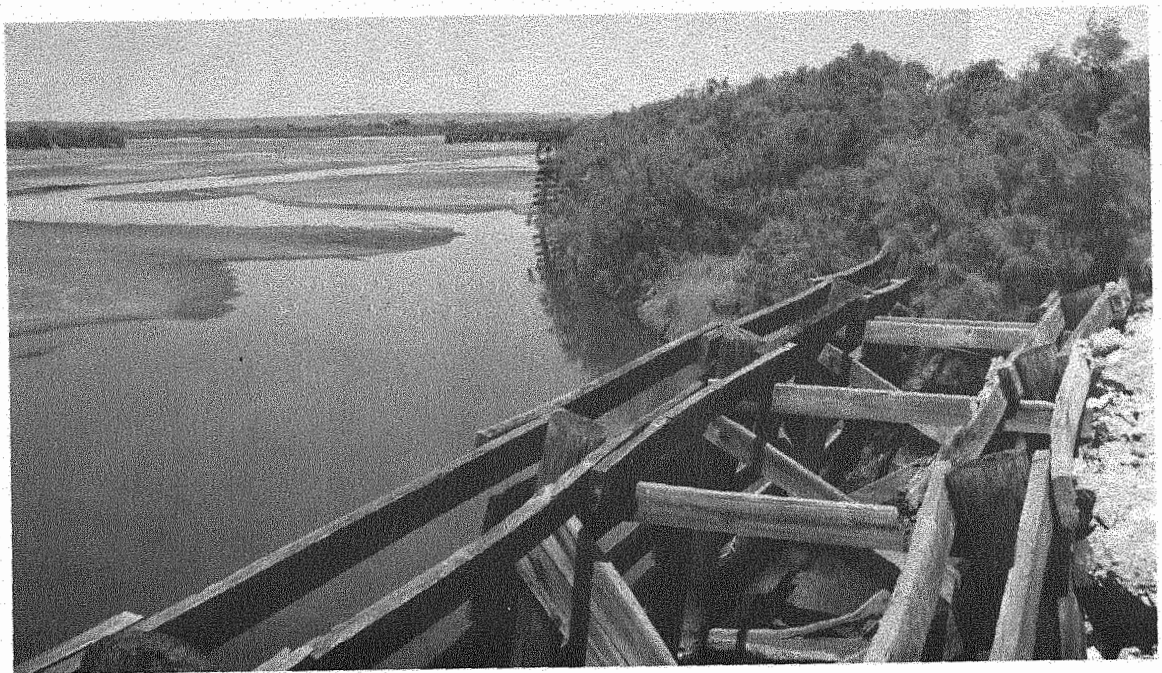
FIGURE 40d

Bank Building Process in between Pile Diversions

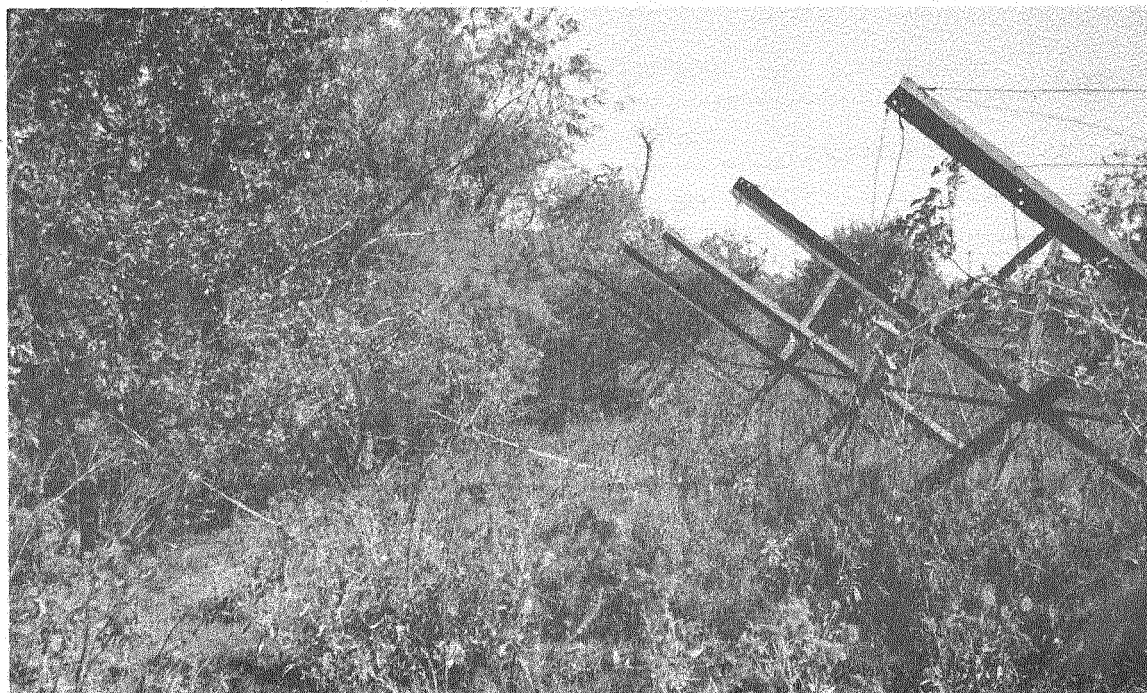
FIGURE 49b

View of Kellner Jetty Field

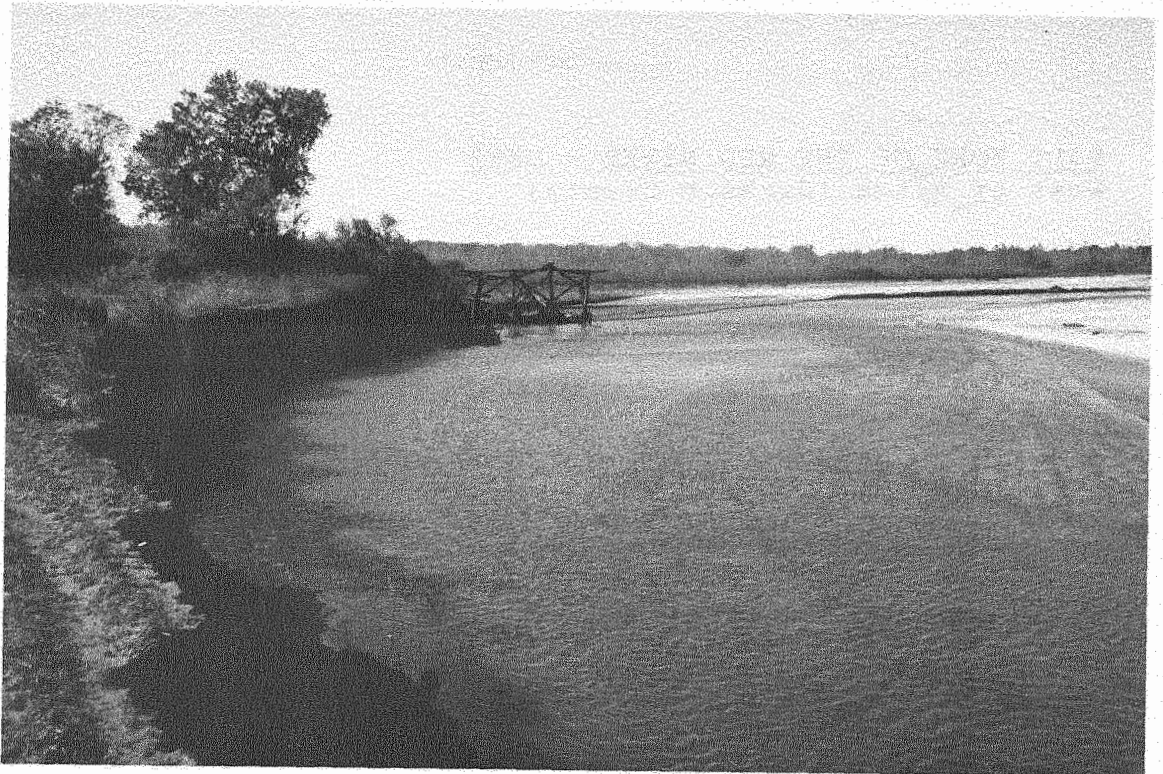
FIGURE 49c

View of Eroding South Bank (Upstream)

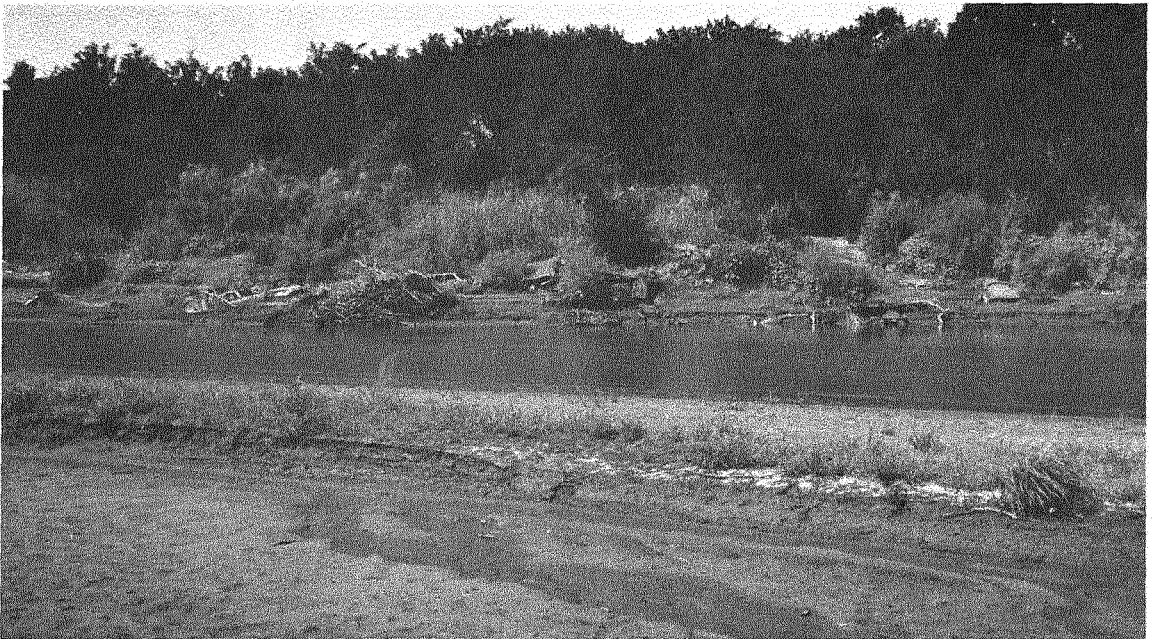
FIGURE 61e

Car Bodies Used as an Erosion Control Measure

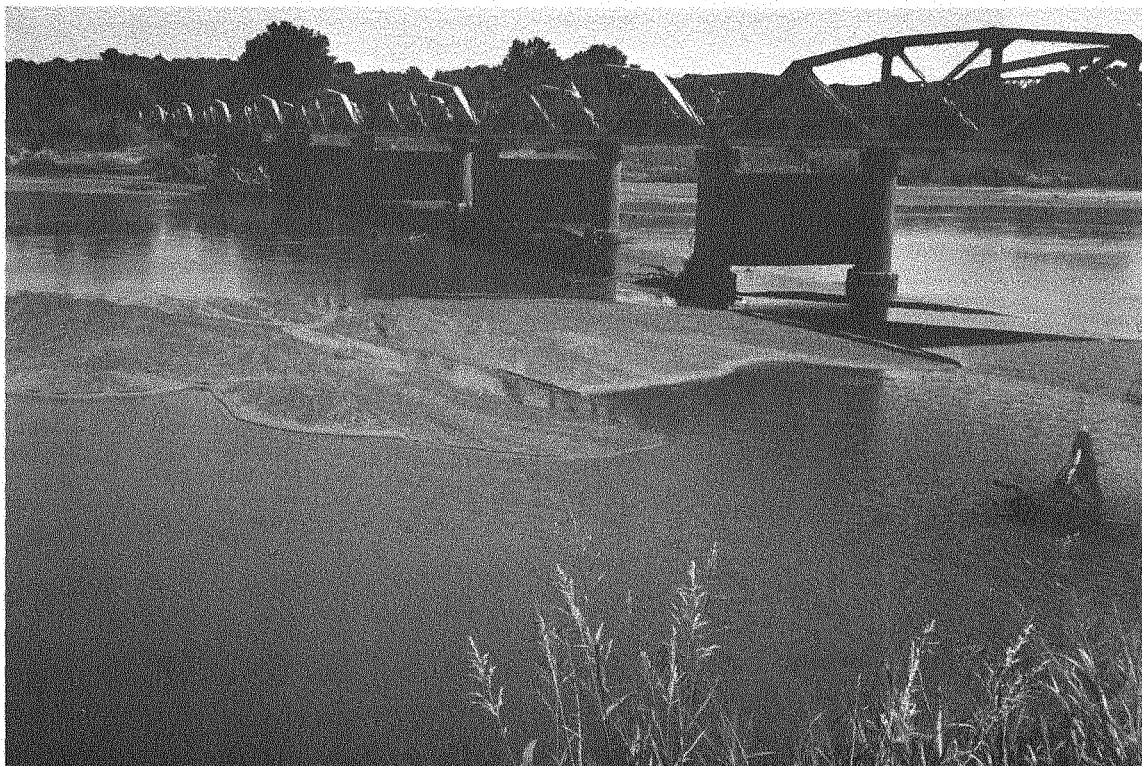
FIGURE 64a

Log Jams on Bridge Piers

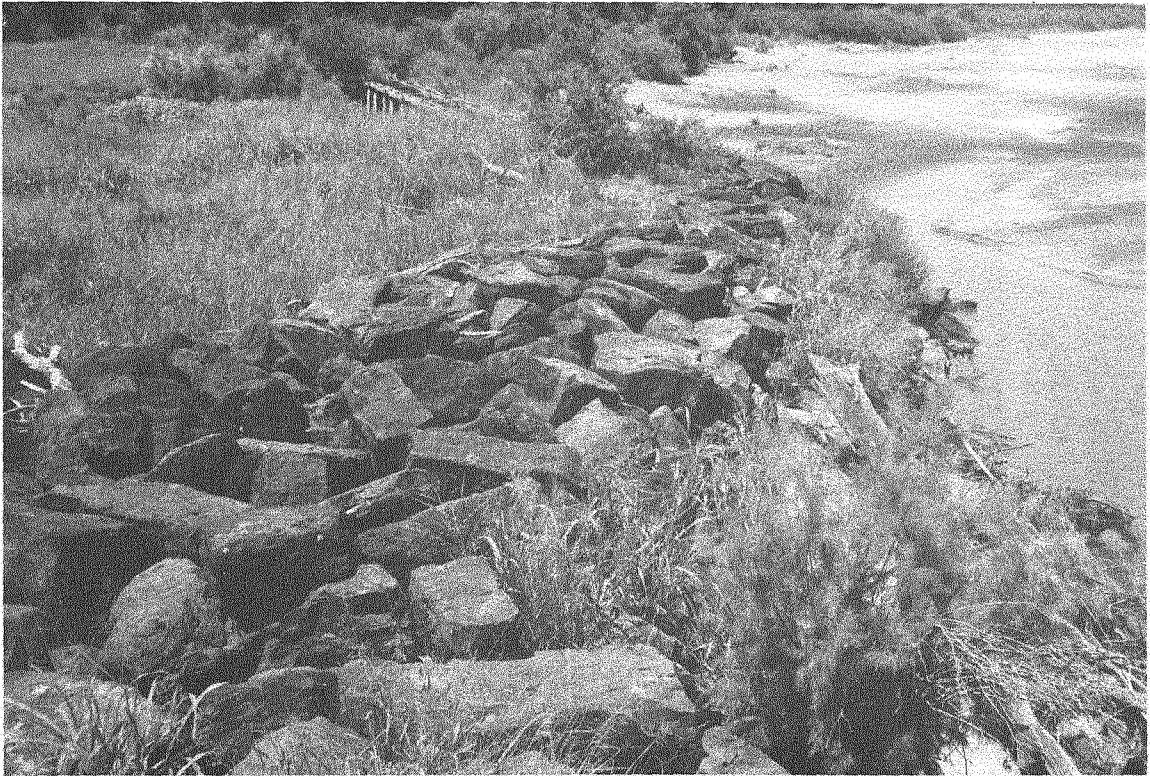
FIGURE 64c

Riprap on the Southern Abutment

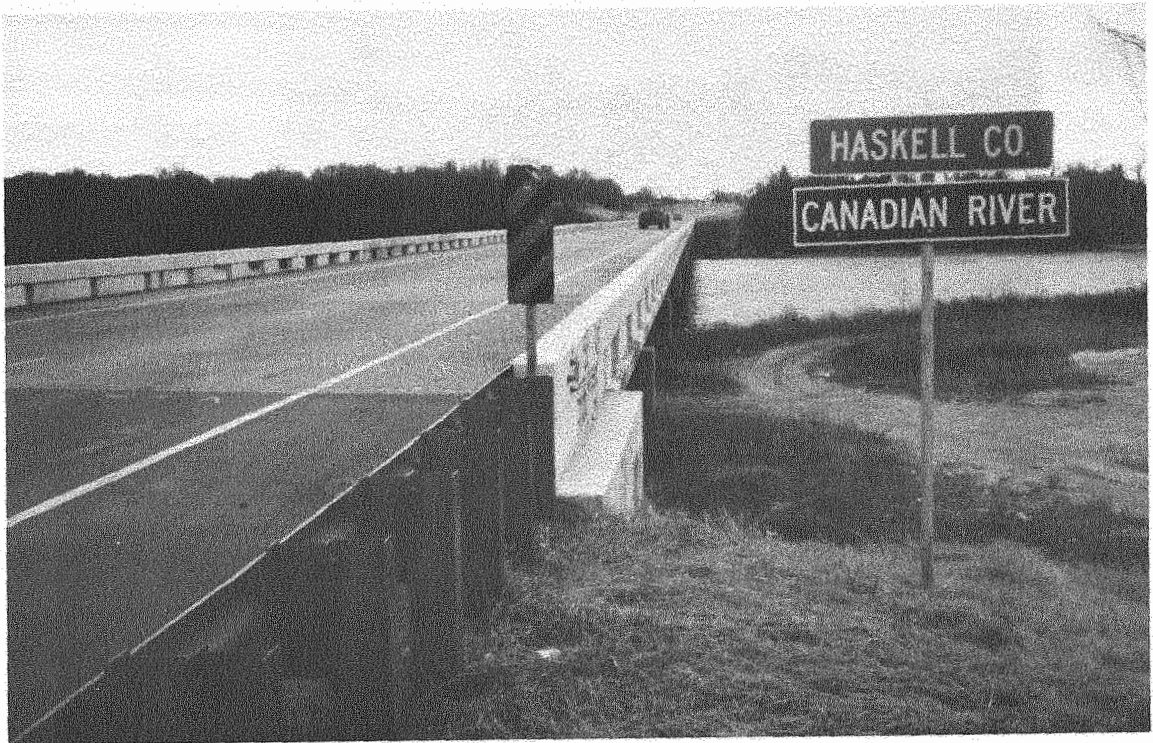
FIGURE 73a

View of the Bridge Site

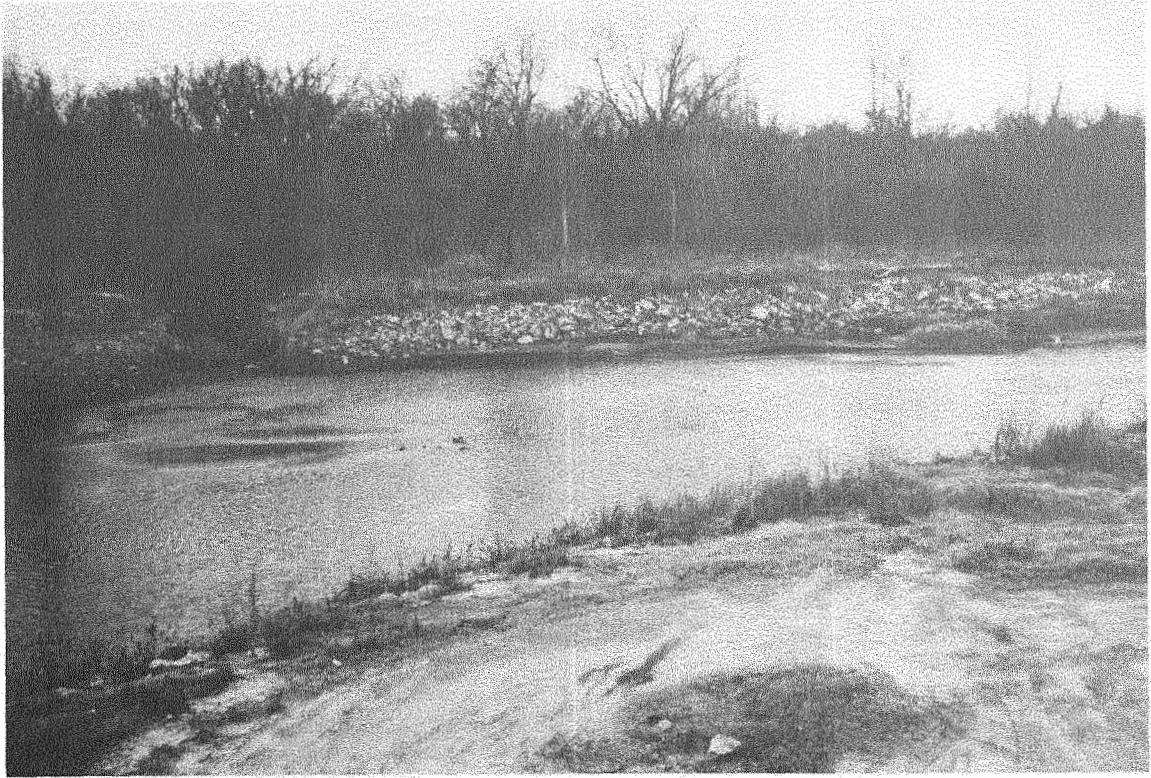
FIGURE 73c

SPECIAL NOTES: THE RIPRAP IS IN FAIRLY GOOD CONDITION.

Riprap on the Upstream Bank

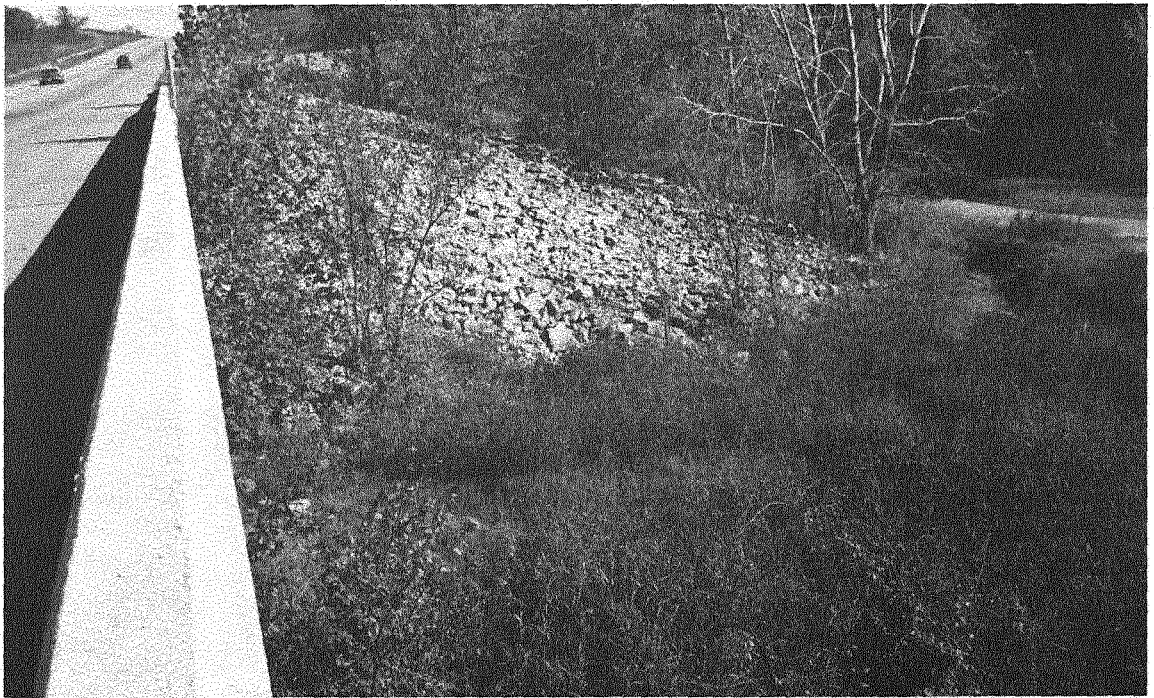
FIGURE 76a

Riprap At Bridge Abutment

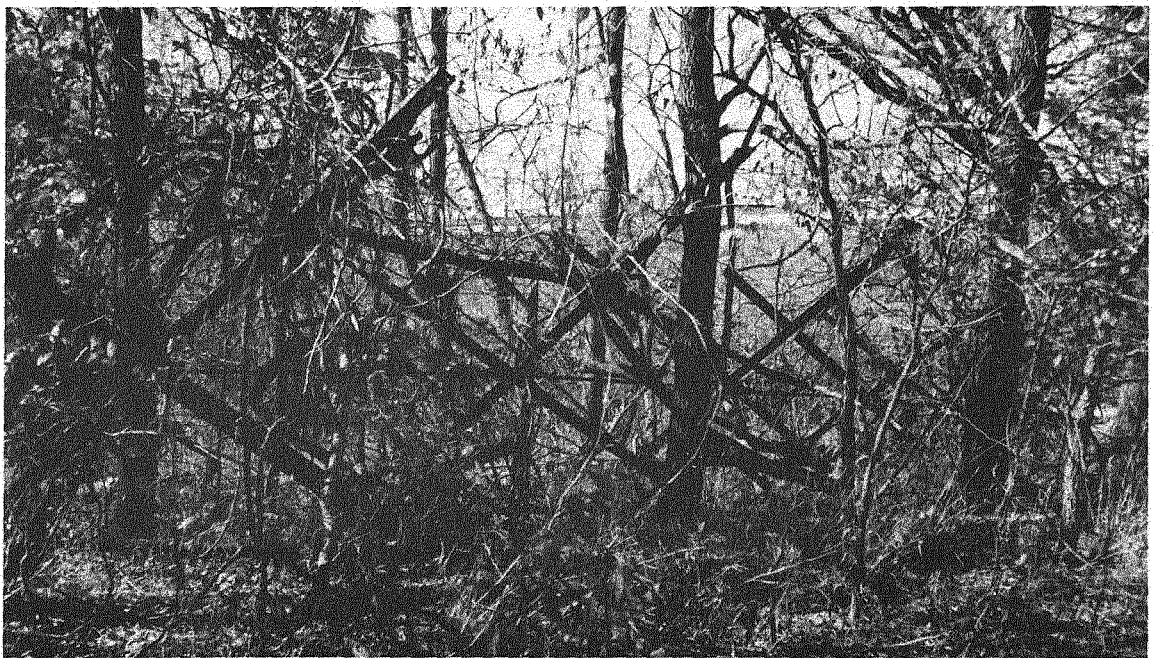
FIGURE 76b

Overgrown Kellner Jetty Field

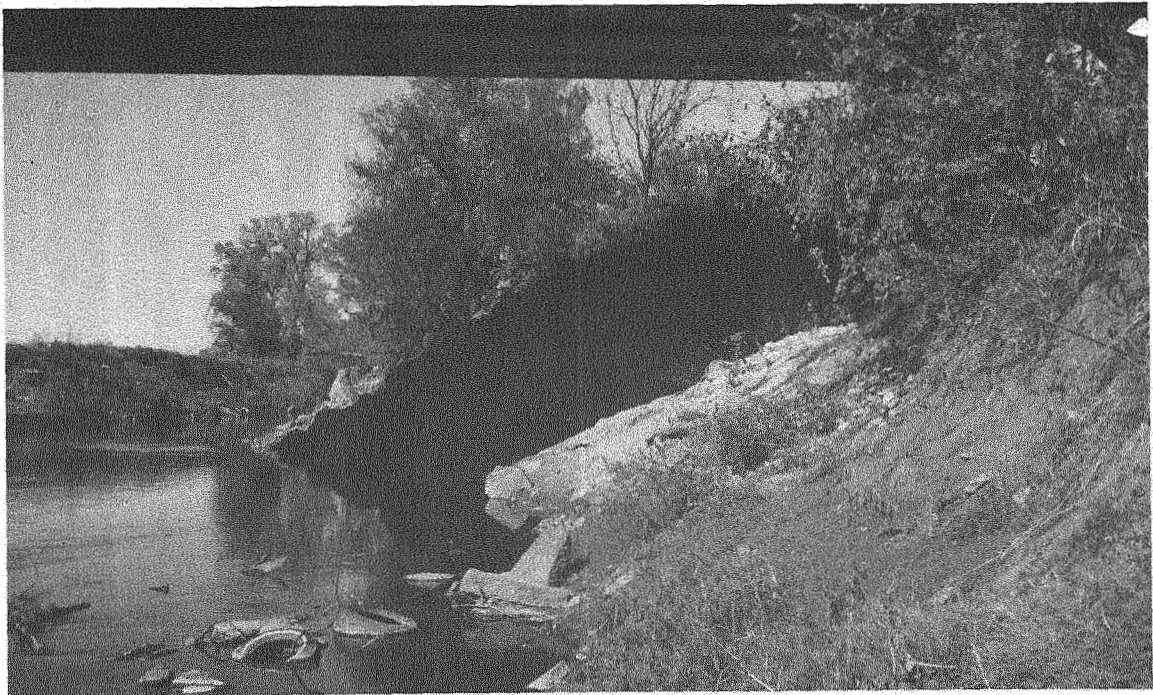
FIGURE 76d

Remnants of Old Bridge

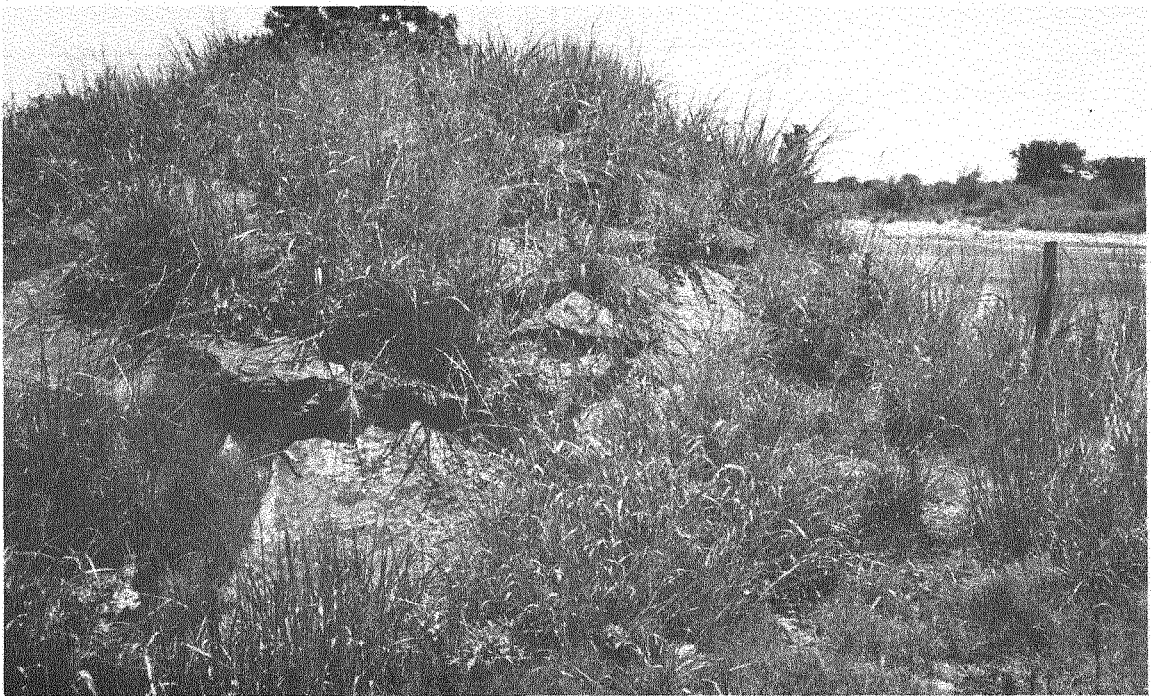
FIGURE 79b

Dike with a Facing of Riprap

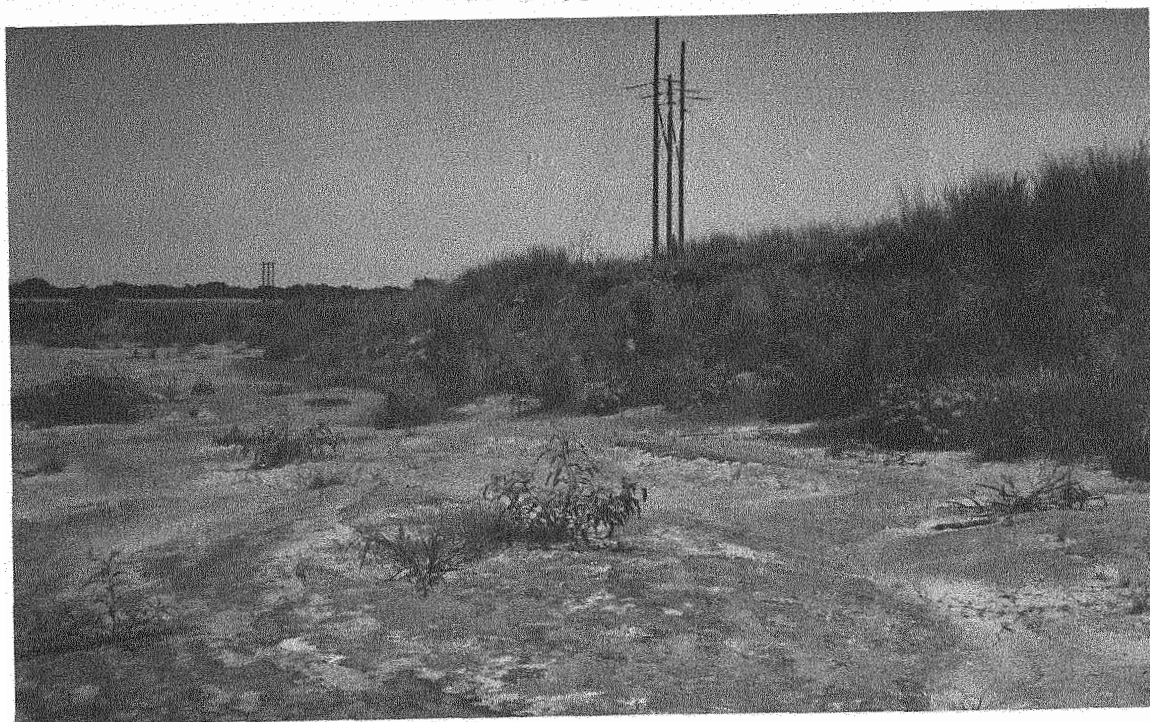
FIGURE 79d

a) Description: CONSTRUCTED IN 1989 TO EXTENDING FROM THE  
BRIDGE STRUCTURE TO THE OLD RAYFIELD JETTY FIELD  
TO PROTECT THE SOUTHERN BANK.

Location of Newly Installed Jetty Field

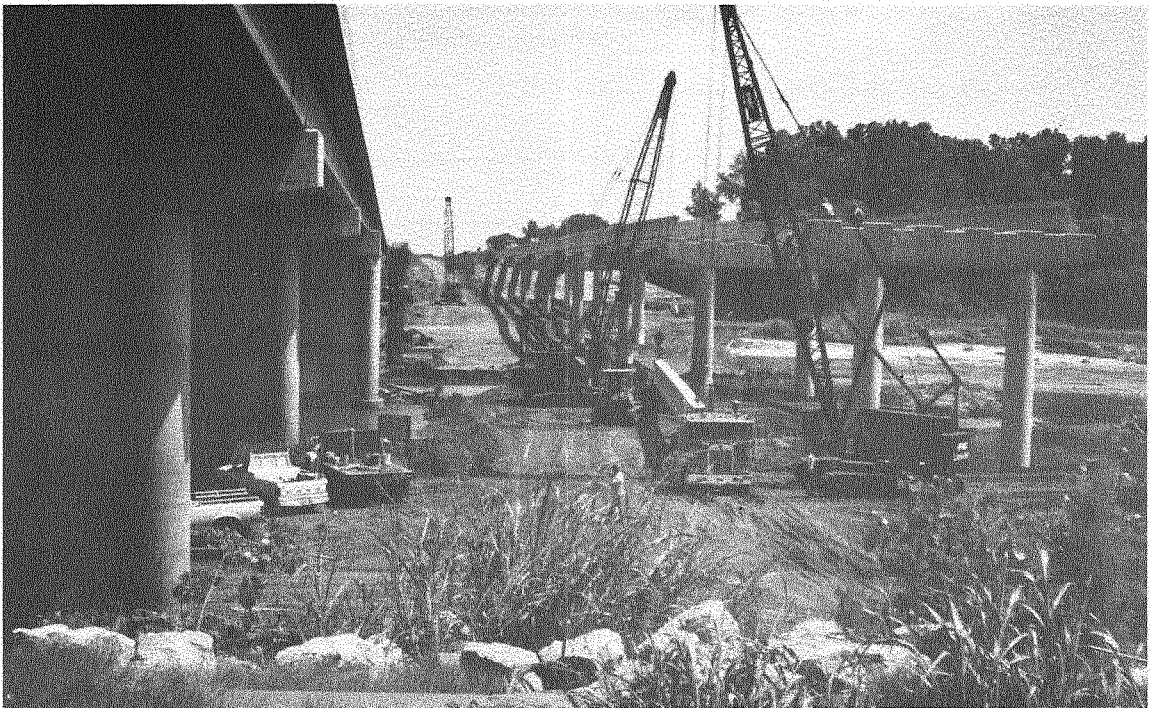
FIGURE 82b

New Bridge Under Construction

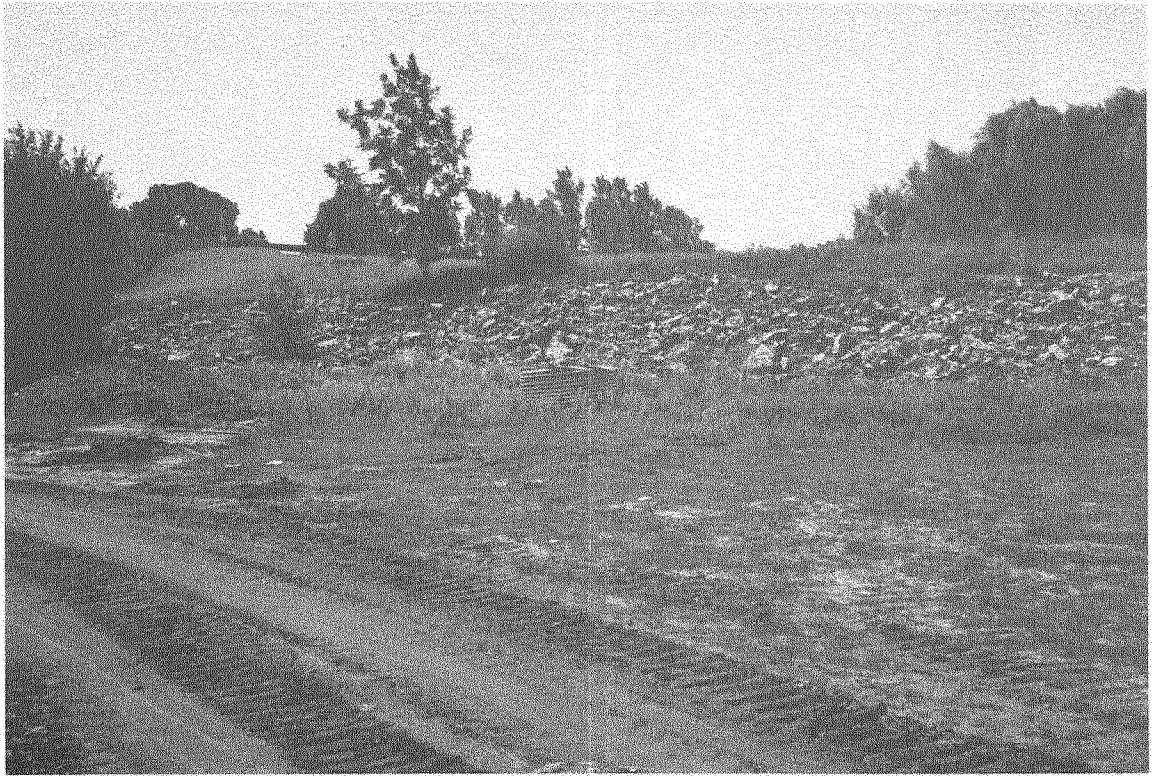
FIGURE 82e

Riprap on Abutment

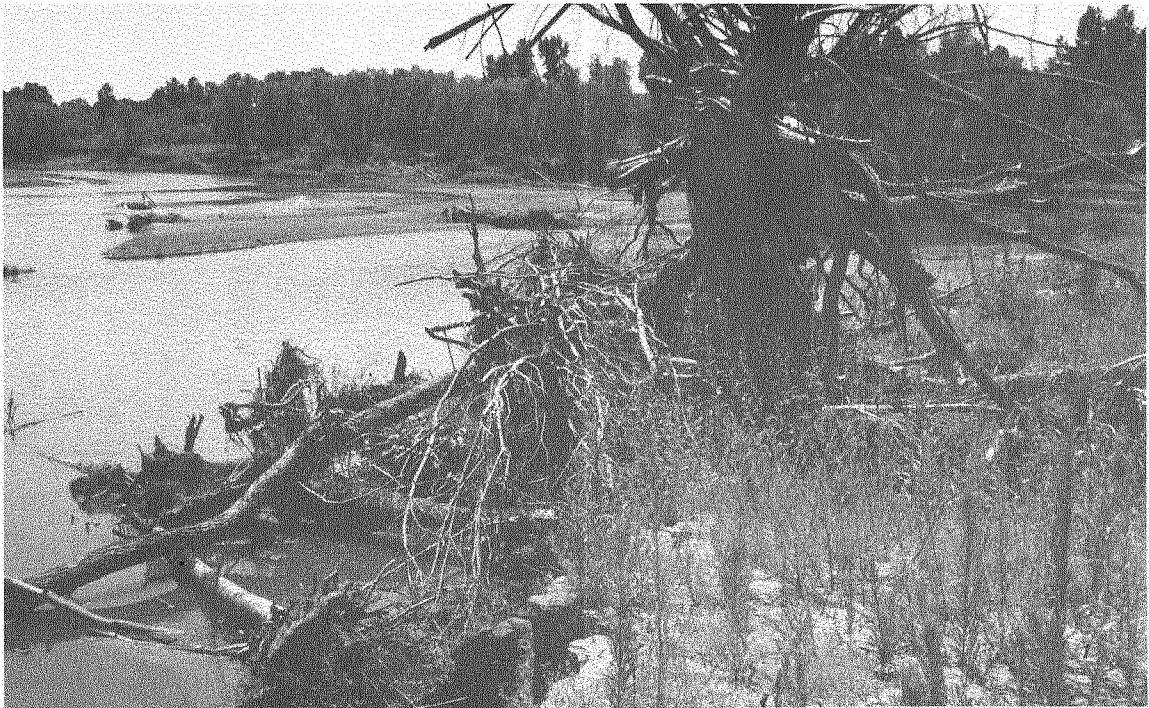
FIGURE 82f

Erosion of Upstream Banks

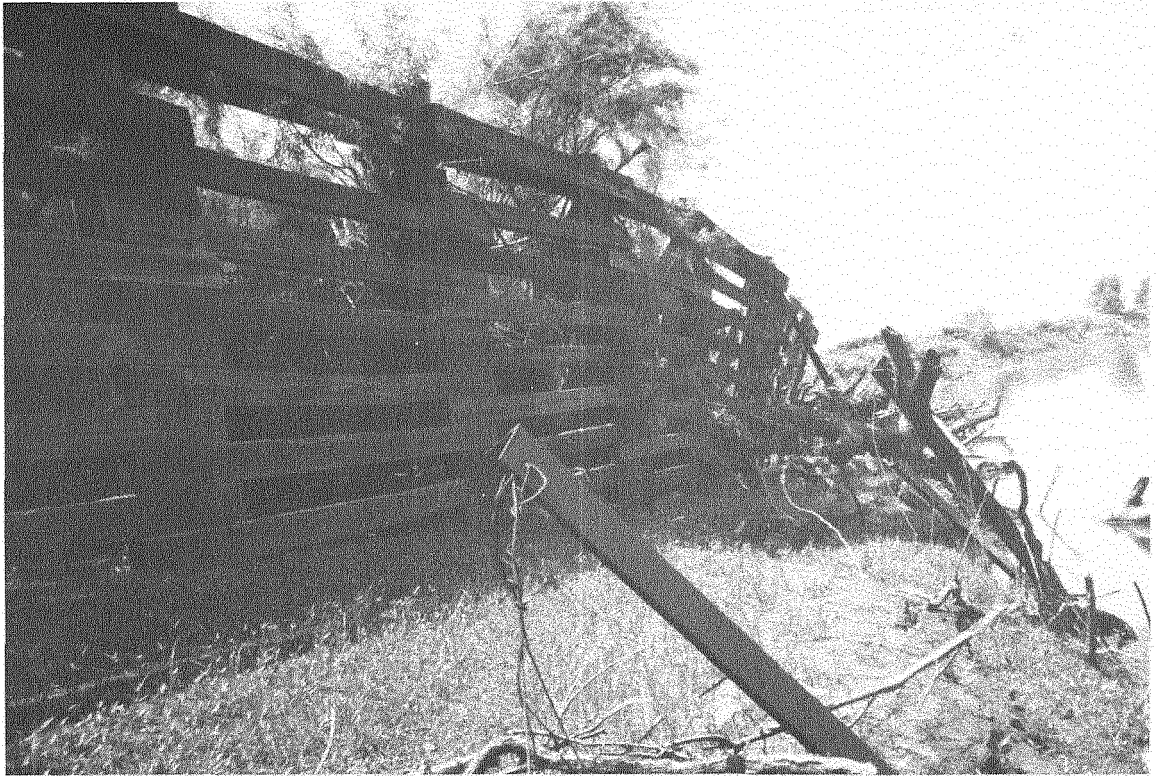
FIGURE 88c

b) Present Condition: THE DIVERSION IS STEEL IN PLACE, BUT HAS SHOW  
SIGNS OF DECAY AND NEEDS SOME LOST SURFACE  
PLANKING. THE DIVERSION IS IN NEED OF REPAIR  
OR ALTERNATIVE REPLACEMENT.

Closeup of Pile Diversion

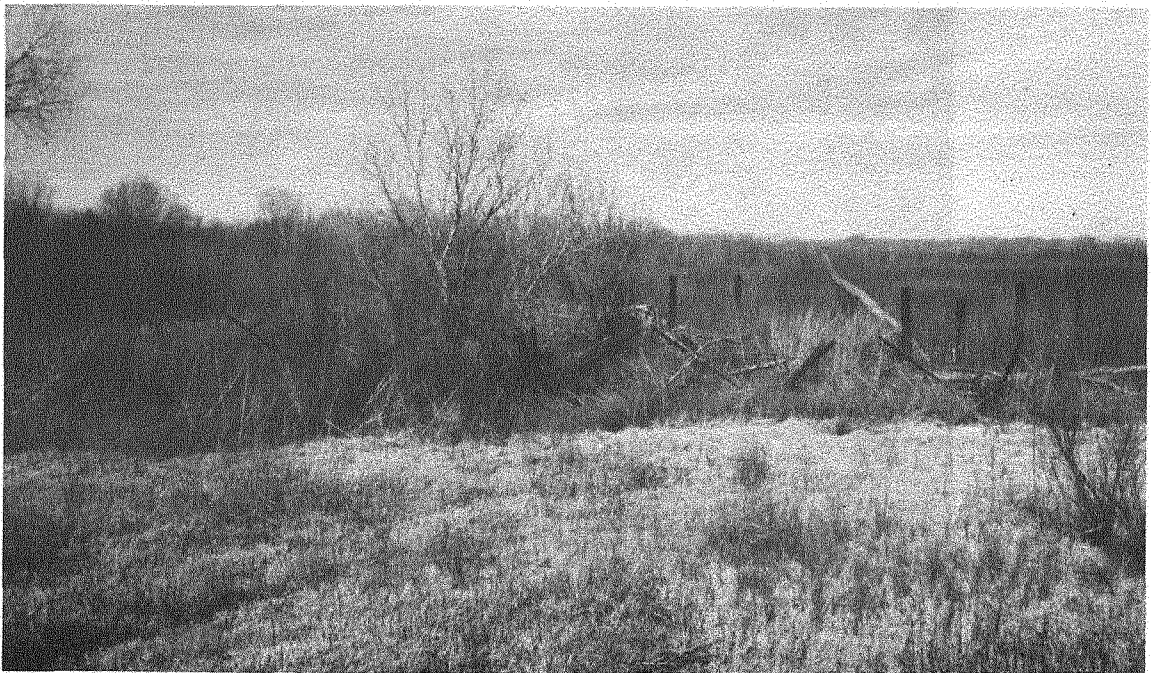
FIGURE 91d

a) Description: THESE STRUCTURES ARE MOSTLY DAMAGED  
WITH VERY FEW OF THEM STILL STANDING.

Kellner Jetty Field
