SCHOOL OF  
CIVIL ENGINEERING  
OKLAHOMA STATE UNIVERSITY

FATIGUE DAMAGE TO STEEL  
BRIDGE DIAPHRAGMS,

Report No. FHWA/OK 89(10)

State Study No. 2156

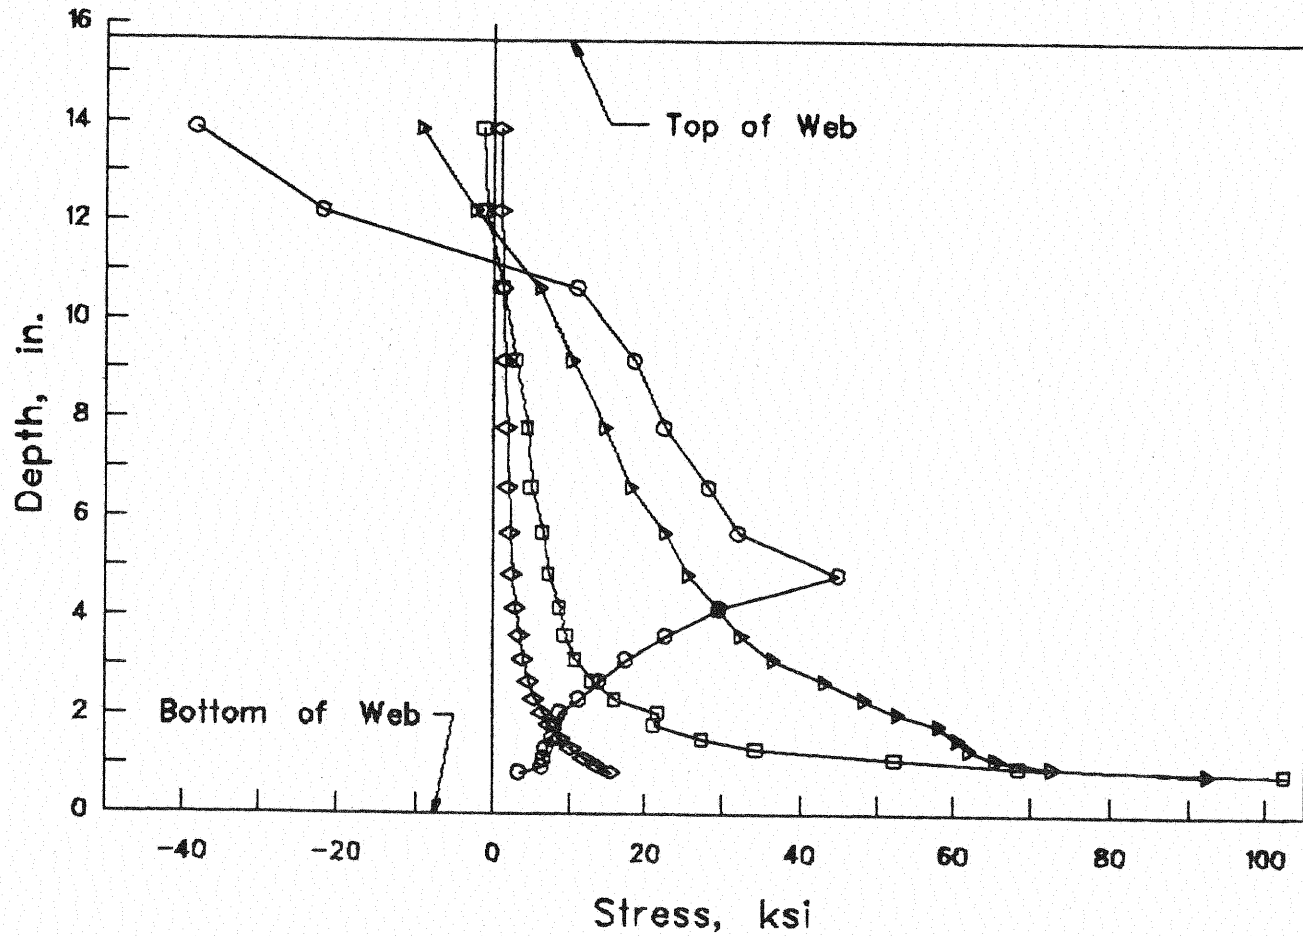
Figure 22. Stress Along Crack Line From Finite Element Analysis

Stresses calculated along the crack line for the four analytical models are shown in Figure 22. In examining this figure, recall that the moments applied to the models are ten times greater than the moments calculated from the grid analysis. Also recognize that the analysis is an elastic analysis; calculated stresses are not restricted by a plastic limit. The sole purpose of this figure is to show how the stress distribution in the vicinity of the cope changes as diaphragm modifications are applied.

As seen in Figure 22, all modifications succeed in reducing stress at the cope. The tapered cope provides only a slight reduction while the uncoped diaphragm and the diaphragm with bolts removed from the connection provide significant reductions. Removing the cope from the bottom flange leads to a relatively uniform stress distribution, while removing bolts from the bottom of the connection causes the peak stress to shift up away from the cope.

The results of the analyses indicate that the most effective way of reducing stress in the diaphragm at the connection is to install an uncoped diaphragm. In the uncoped diaphragm, there are no points of high stress concentration. Removing bolts from the bottom half of the diaphragm-to-girder connection is also effective in reducing stress at the cope, but results in a high stress in the center portion of the web. Tapering the cope reduces stress at the bottom of the diaphragm, but to a much lesser degree than the other two modifications.

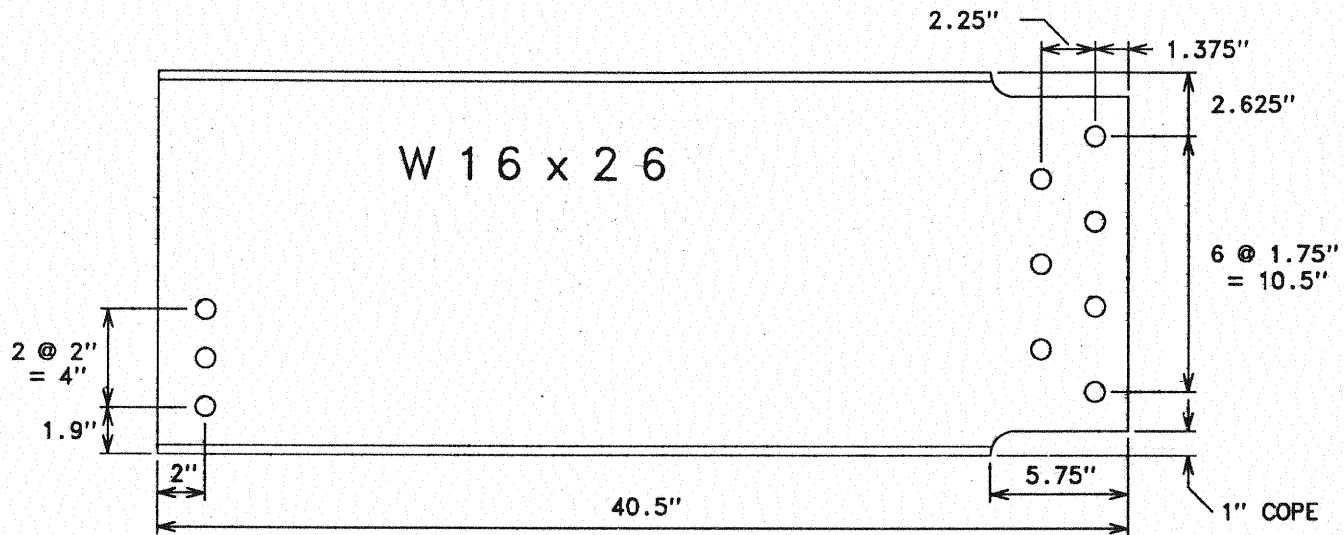
Figure 23. Test Specimen for Original Detail

Original Detail. The first tests were conducted on the original connection detail. To verify that the load and support systems were producing the strain gradient anticipated for a composite beam loaded in bending, the first laboratory diaphragm was instrumented with three strain rosettes as shown in Figure 29. Strains measured at gages 2, 5, and 8 for a 30-kip load are plotted in Figure 30. As expected, longitudinal strain reaches a tensile maximum at the bottom of the beam and decreases toward the top of the beam.

The original detail was tested under cyclic loads at a variety of stress ranges. The data obtained are shown in Table 2, and a plot is shown in Figure 32. A line fit to the data using the least squares method is also shown on the plot. Data for tests discontinued without initiating noticeable cracks are indicated by an arrow attached to the data point and are not included in the regression analysis. The 90% confidence limit lines shown on the plot indicate there is a 90% probability that future values would fall within the limits. The detail can be placed in a specific stress

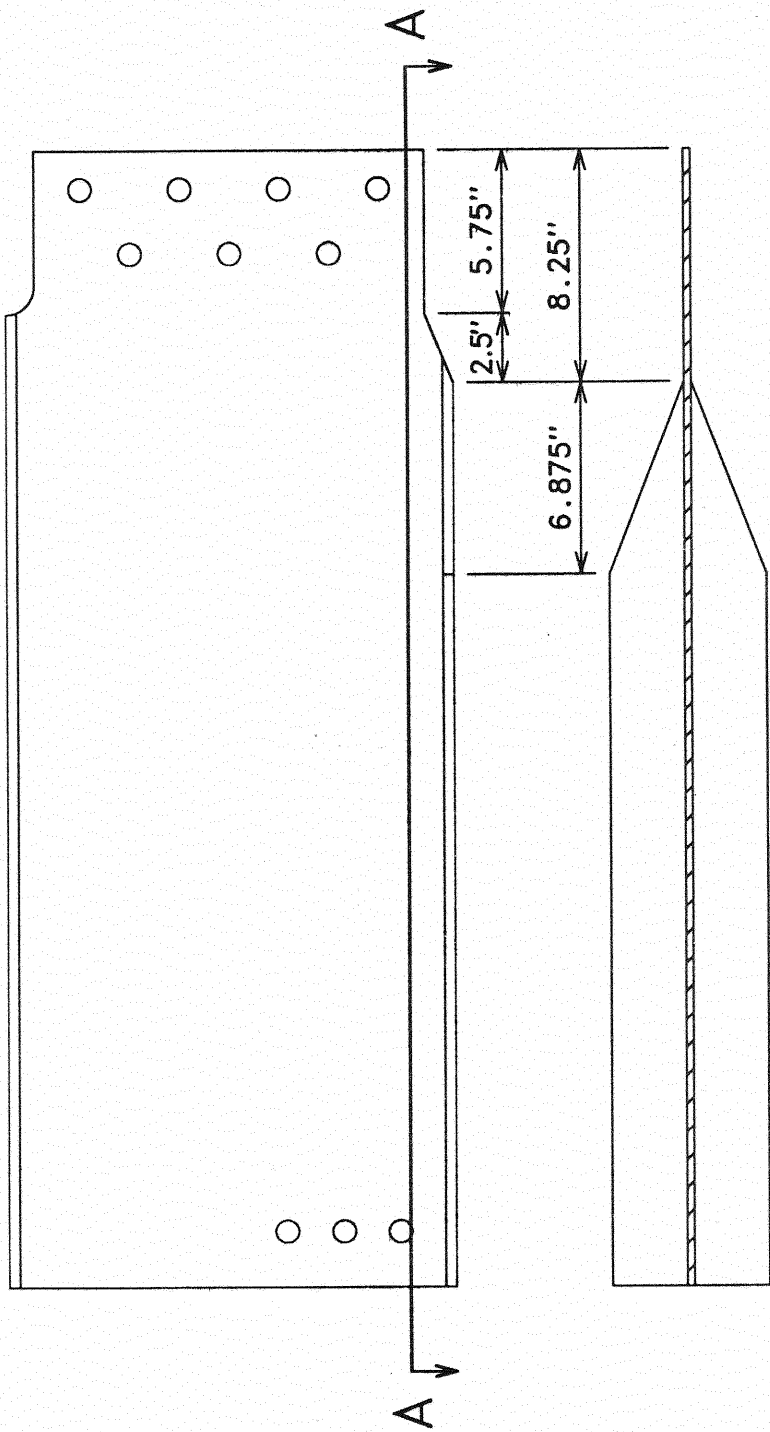
Figure 24. Tapered Cope Detail

Tapered Cope. The fatigue life of the tapered cope detail was very dependent on how carefully cutting and grinding procedures were carried out. As can be seen in Table 3 and Figure 35, the two tapered cope specimens exhibited significantly different fatigue lives. One test resulted in a substantial increase over the life of the original detail while the other resulted in only a minimal increase. A failed specimen is shown in Figure 36. Cracks in these specimens originated at rough spots on the tapered surface and grew into approximately the same shape as on the original detail.

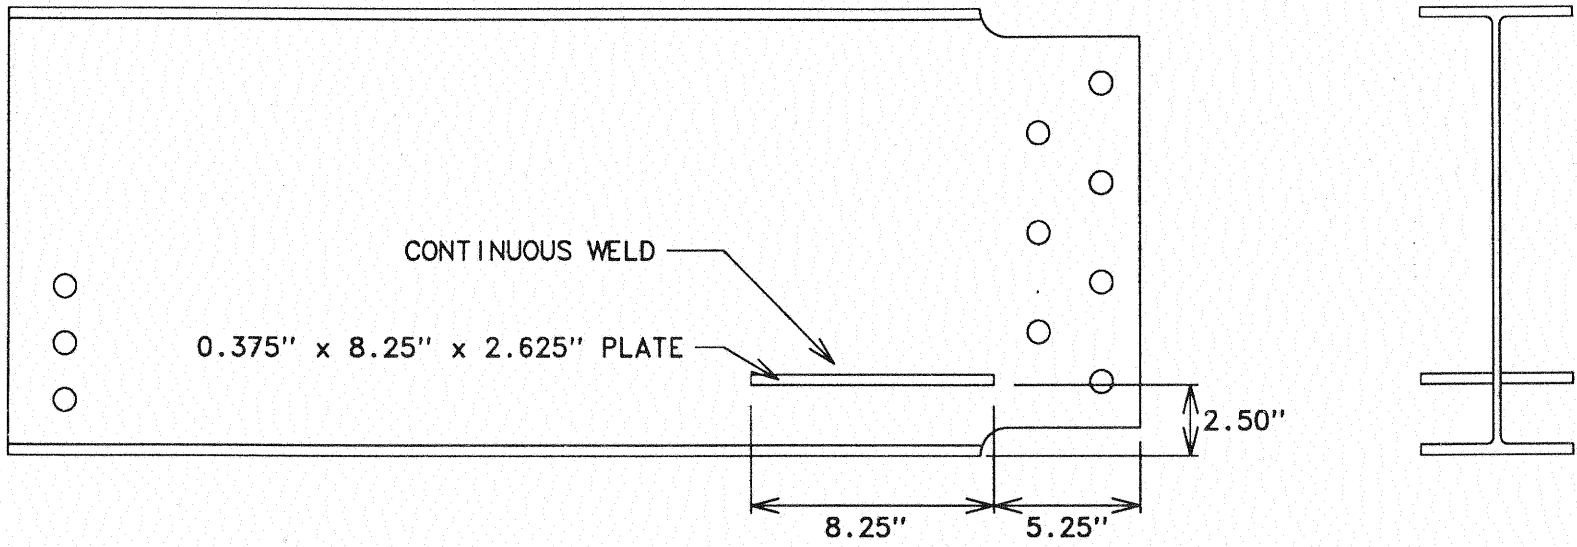
Figure 25. Auxiliary Flange Detail

Tests with the auxiliary flange were conducted on specimens having fatigue cracks which had propagated approximately 3/4 in. prior to any modifications being performed. A 1/2-in. diameter hole was drilled at the end of the crack to help retard crack growth. This hole size was selected to match the size used in Reference [4]. The auxiliary flange was then welded in place above the drilled hole.

As can be seen in Table 3 and Figure 35, the modification did increase average specimen fatigue life, but there is a great deal of scatter in the data. In both tests, a short period of no growth after the modification was followed by propagation around the end of the auxiliary flange. A failed specimen is shown in Figure 39. The fact that the crack easily propagated around the auxiliary flange is an indication that the flange does not extend far enough ahead of the cope to be effective.

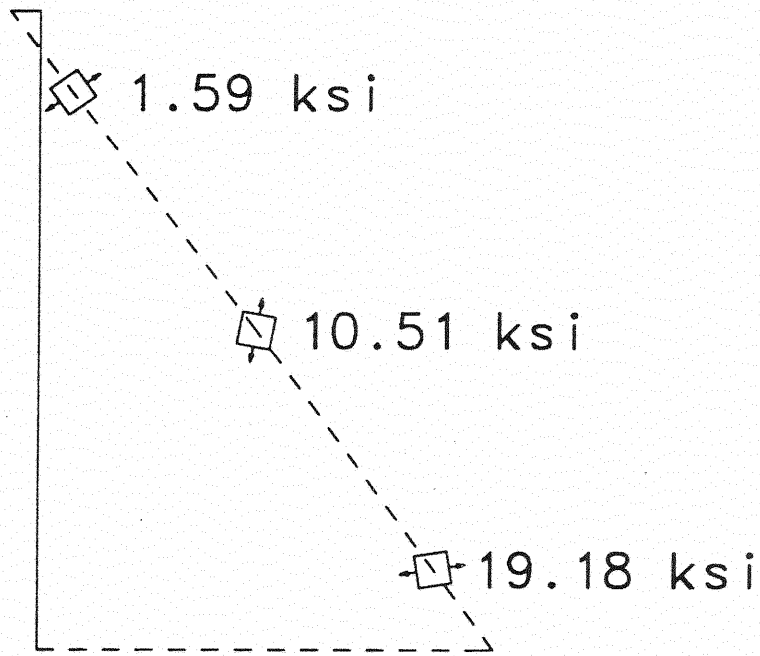
Figure 31. Principal Stresses Near Cope

The rosette data were also used to determine the magnitude and direction of principal stresses at gage locations. Principal stress elements are shown in Figure 31. The important observation to be made from this figure is that the maximum tensile stress is oriented perpendicular to the anticipated crack plane.

Failed specimens are shown in Figure 34. Specimens were considered to have failed when the crack had grown through half the web. It was found that very few cycles relative to the total number of cycles applied were necessary to propagate the crack from the web centerline through the upper half of the web. Stopping the tests when the cracks reached the web centerline was necessary to prevent the specimens from becoming so flexible that they would impact on the load frame during cycling. An important observation to be made from Figure 34 is that the crack shape is very similar to shapes observed on the bridge and that the crack plane is approximately perpendicular to the direction of the maximum principal tensile stress shown in Figure 31.

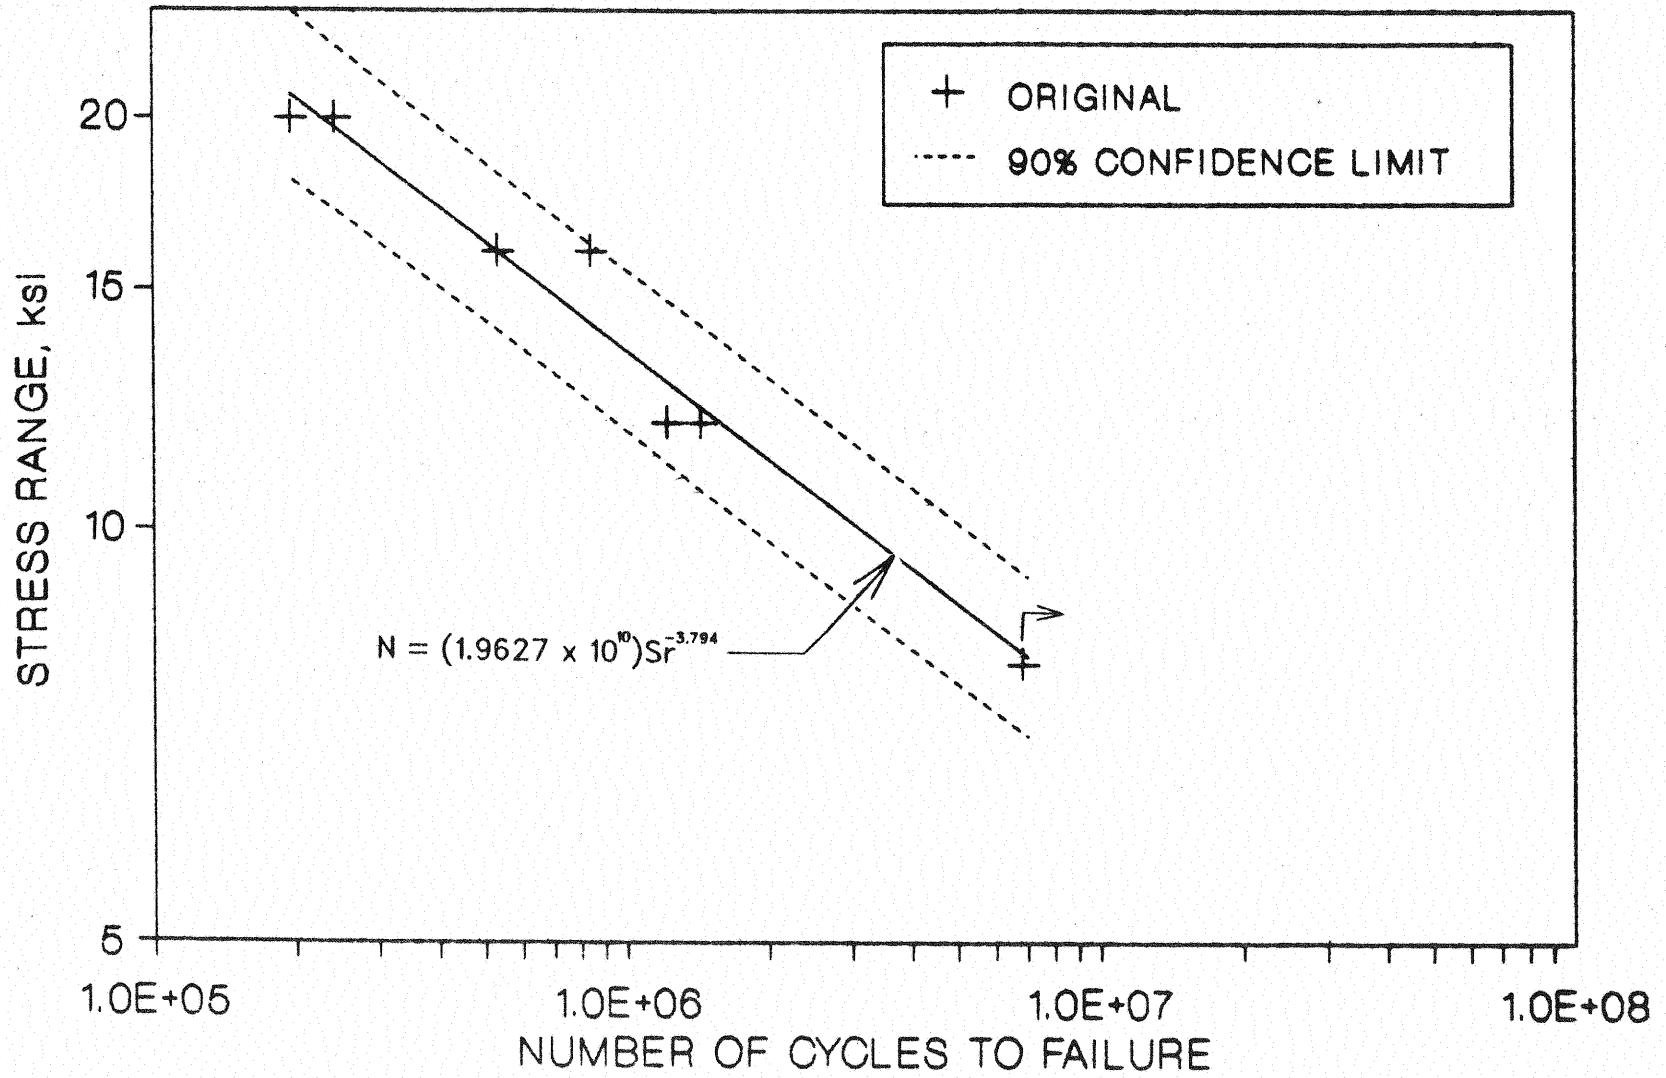
Figure 32. Fatigue Life of Original Detail

Stress Range, KSI	Number of Cycles to Failure
20	195160 240740
16	529660 835220
12	1213240 1431580
8	6824790* 6824790*

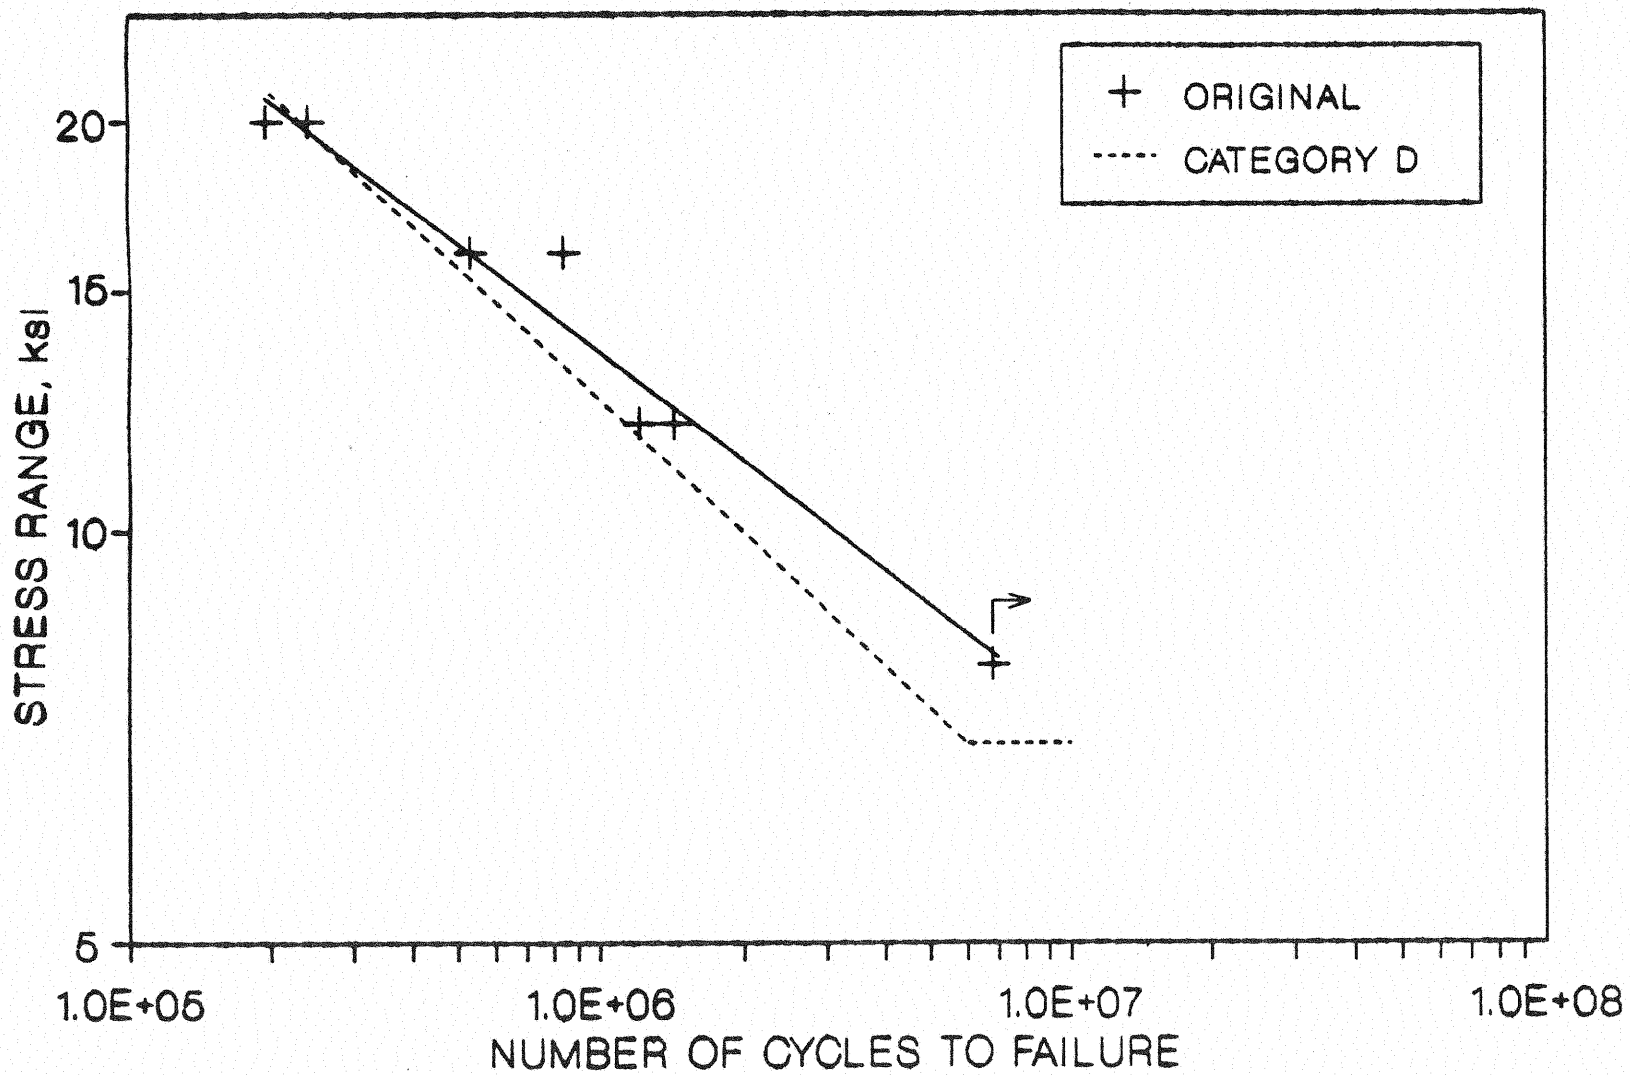
Figure 33. Fatigue Life of Original Detail Compared to a Category D Detail

category as discussed in Reference [3]. The fatigue data are replotted in Figure 33 with the corresponding stress category superimposed.

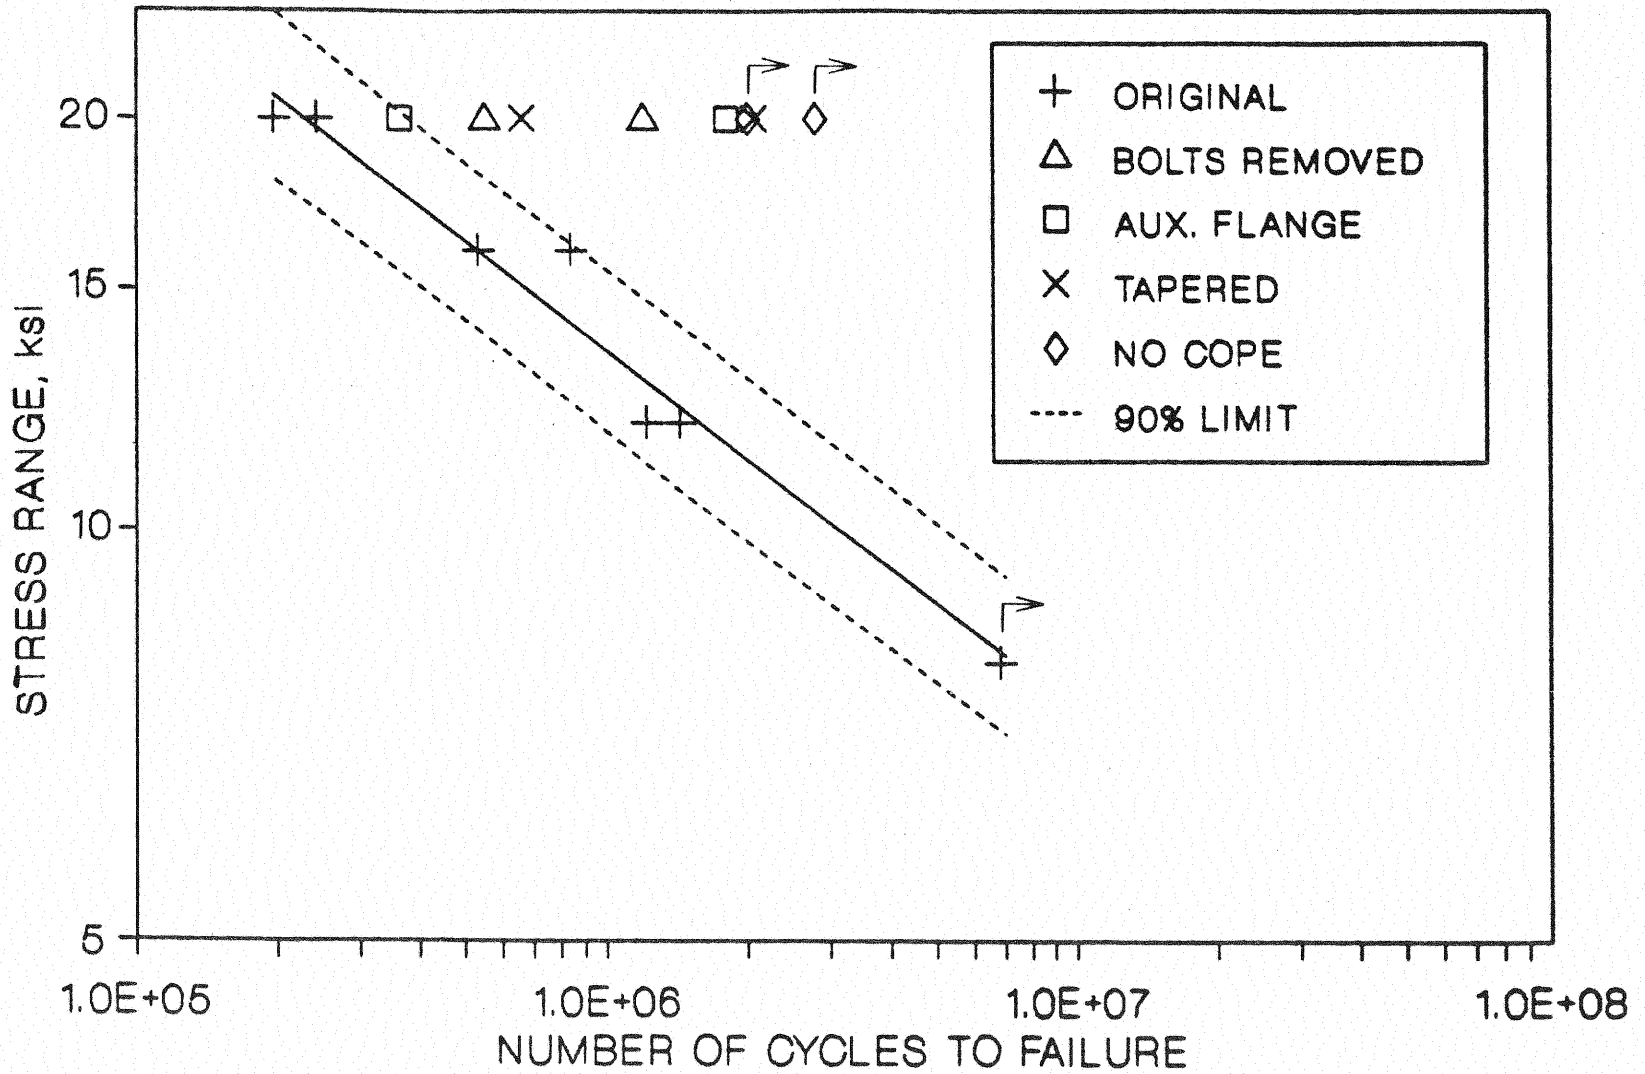
Figure 35. Fatigue Life of All Specimens

No Cope in Bottom Flange. Two specimens were tested at the 20 ksi stress range. Data are recorded in Table 2 and plotted in Figure 35. Both specimens withstood over two million load cycles with no sign of fatigue damage. The data points plot well beyond the upper 90% confidence limit for the original detail, indicating that a significant improvement in fatigue life has been achieved.

Fatigue data are recorded in Table 3 and plotted in Figure 35. Data points for the two specimens tested plot beyond the upper 90% confidence limit for the original detail, indicating the modification is effective at increasing the diaphragm fatigue life. Average fatigue life for this detail is slightly less than for the tapered cope, but scatter in the tapered cope data is greater. Neither this detail nor the tapered cope is as effective at increasing fatigue life as is the uncoped detail.

It is recommended that for uncracked diaphragms and for diaphragms with cracks shorter than one inch, the bottom two bolts in the diaphragm-to-girder connection be removed. This recommendation is based on the effectiveness of this modification to increase fatigue life--even for diaphragms containing small cracks--and the relative ease with which this modification can be accomplished. Diaphragms containing cracks longer than one inch should be removed and replaced with diaphragms not coped at the bottom

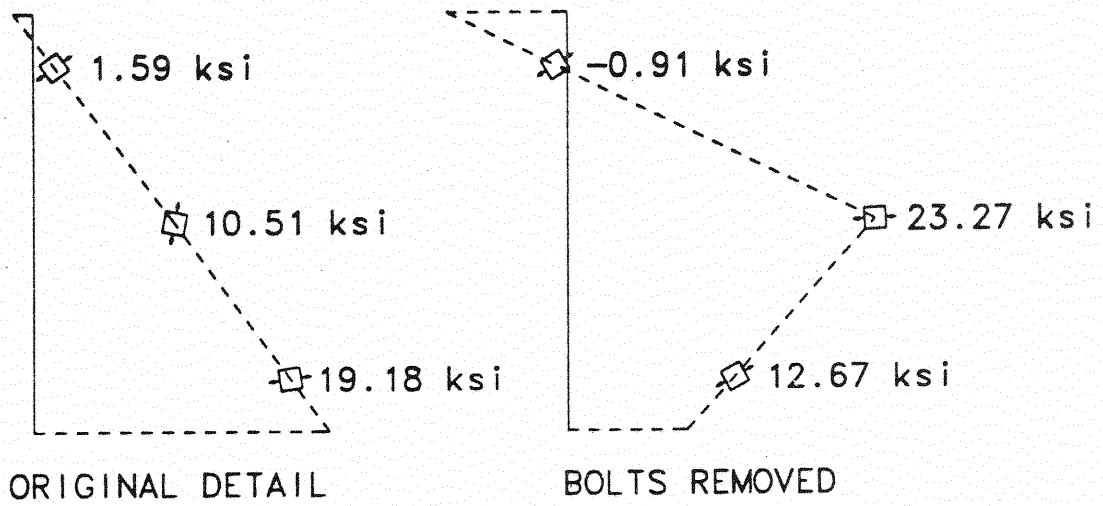
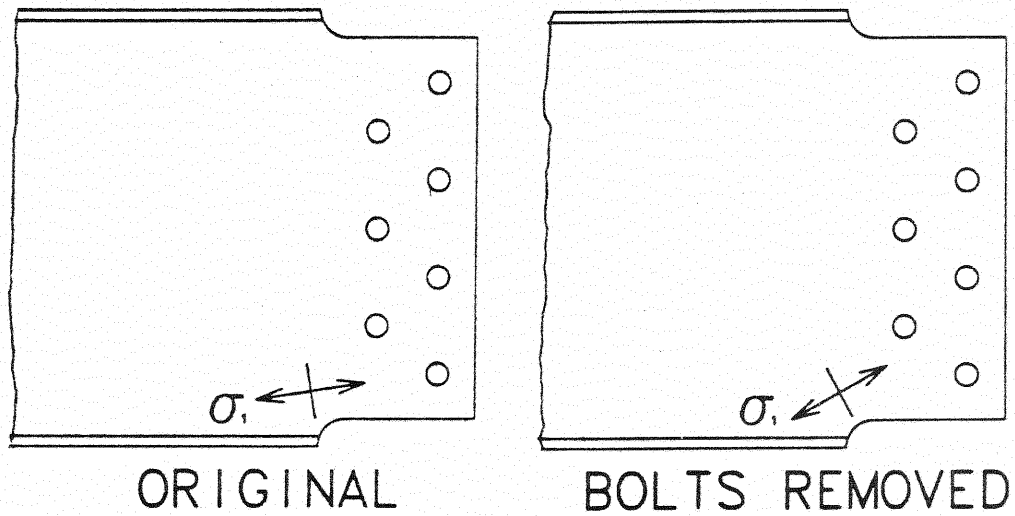
Figure 37. Comparison of Stresses in Original Detail to Stresses With Bolts Removed

Bottom Bolts Removed. Removal of the two lowest bolts relieves the stress at the lower cope, but still leaves the connection with sufficient capacity to carry the wheel loads of an HS20 truck. (Calculations are shown in Appendix B.) In Figure 37, the magnitude and direction of principal stresses in the diaphragm when all bolts are in place are compared to the stresses when the lowest two bolts are removed. Strains with bolts removed were measured using the same beam described in the discussion of the original detail. The shape of the measured stress distribution is in agreement with results of the finite element analysis shown in Figure 22.
