PORTLAND CEMENT CONCRETE

PAVEMENT RESTORATION

FINAL REPORT

Under
Demonstration Project No. 69

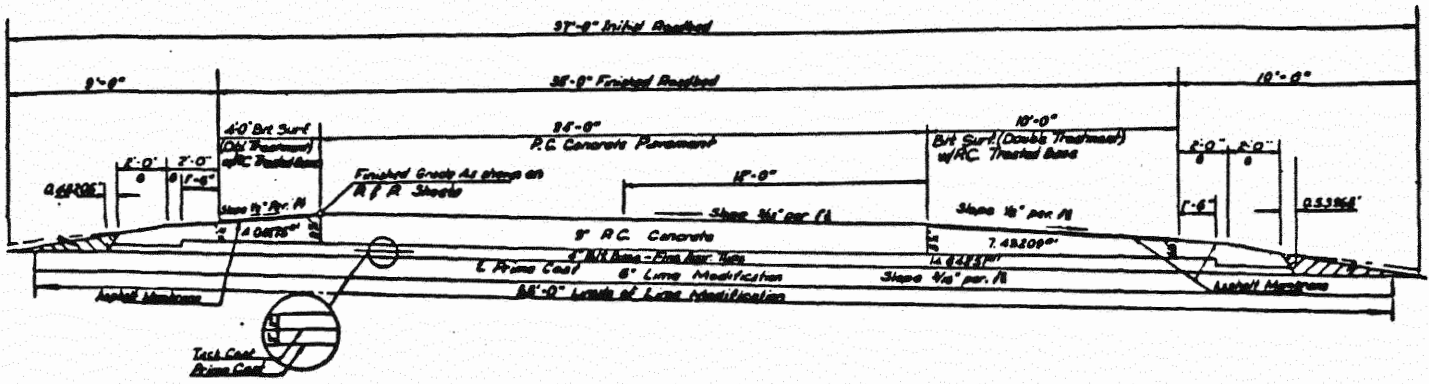
Preliminary investigation of these areas, including fault measurements and deflection readings, resulted in the selection of a 2,400 foot section on eastbound I-40, between Yukon and El Reno. This section, originally built in 1969, consists of a 9 inch plain PCC pavement with sawed joints every 15 feet on a 4 inch fine aggregate bituminous base (FABB). The top 6 inches of the subgrade had been modified with lime. The typical section of the roadway is illustrated in Figure 1.

Figure 1. Typical section of I-40 test section.

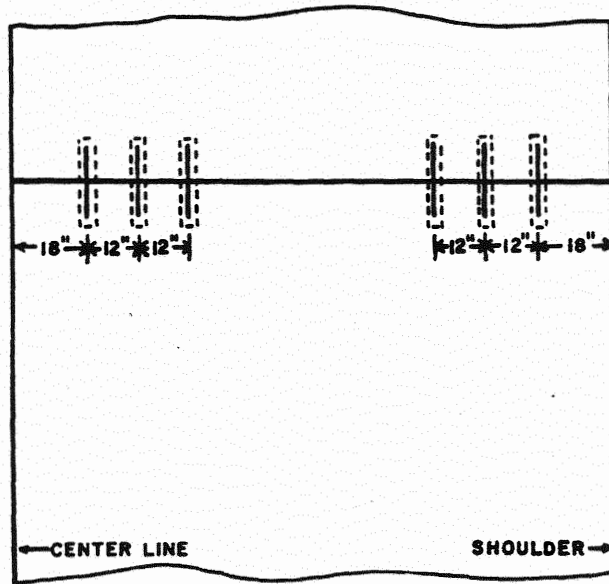
Two types of load transfer devices, dowel bars and double-v's, were retrofitted on six consecutive joints each for demonstration and evaluation purposes. Three dowel bars were installed in each wheel path of the outside lane, 6 per joint, as shown in Figure 5. Three double-v load transfer devices were installed per joint, one in the inside wheel path and two in the outside wheel path as shown in Figure 6.

Figure 5. Placement of dowel bars for load transfer.

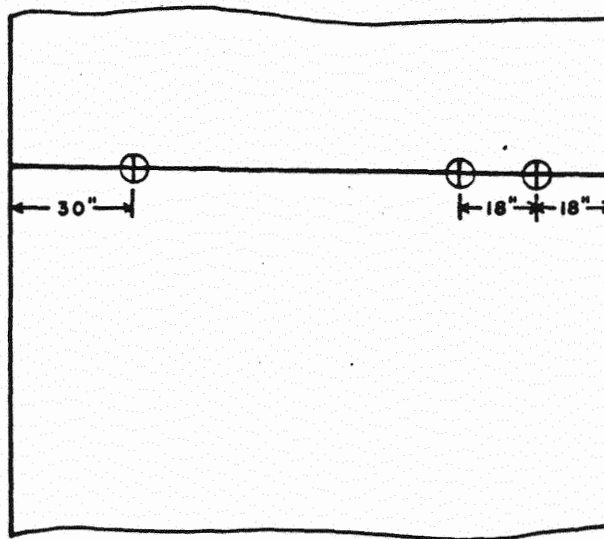
Figure 6. Placement of Double-v devices for load transfer.
