OKLAHOMA DEPARTMENT OF TRANSPORTATION

# PRECOATED MEMBRANES

March , 1986

PRECOATED MEMBRANES

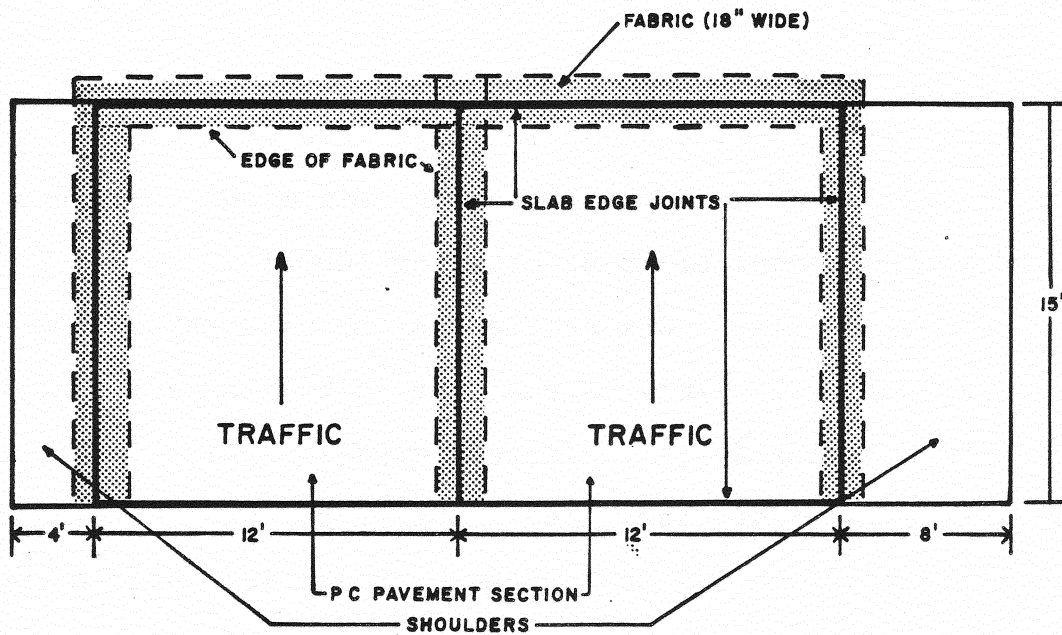
Figure 2. Plan view of Bituthene installation over the PCC joints.

On the southbound lanes, all the transverse joints were covered with 1.5 ft (0.5 m) wide Bituthene. The longitudinal joints on the outside shoulder, the centerline joint and 180 ft (54.9 m) of joint on the inside shoulder also were covered with 1.5 ft (0.5 m) wide Bituthene. See Figures 2 and 3. Two random cracks within the test section were covered with 3 ft (0.9 m) wide Bituthene and the remaining cracks were covered with 1.5 ft (0.5 m) wide Bituthene. See Figure 4.

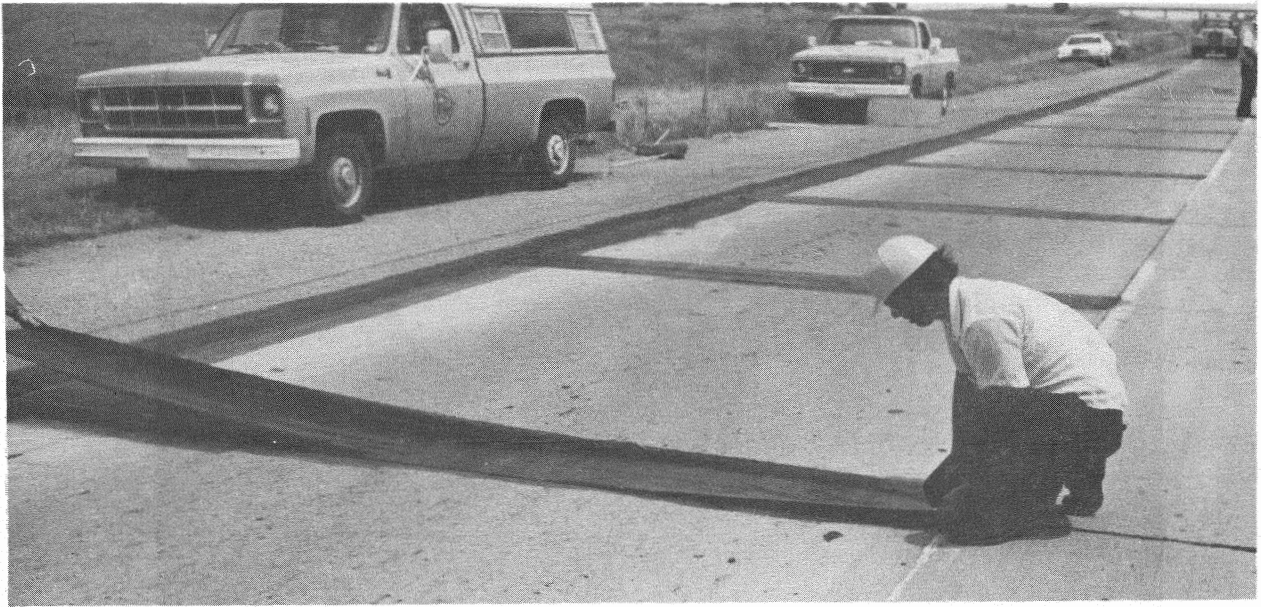
Figure 6. All the transverse, centerline and outside longitudinal joints were covered with 1.5 ft wide Bituthene on the northbound lanes.

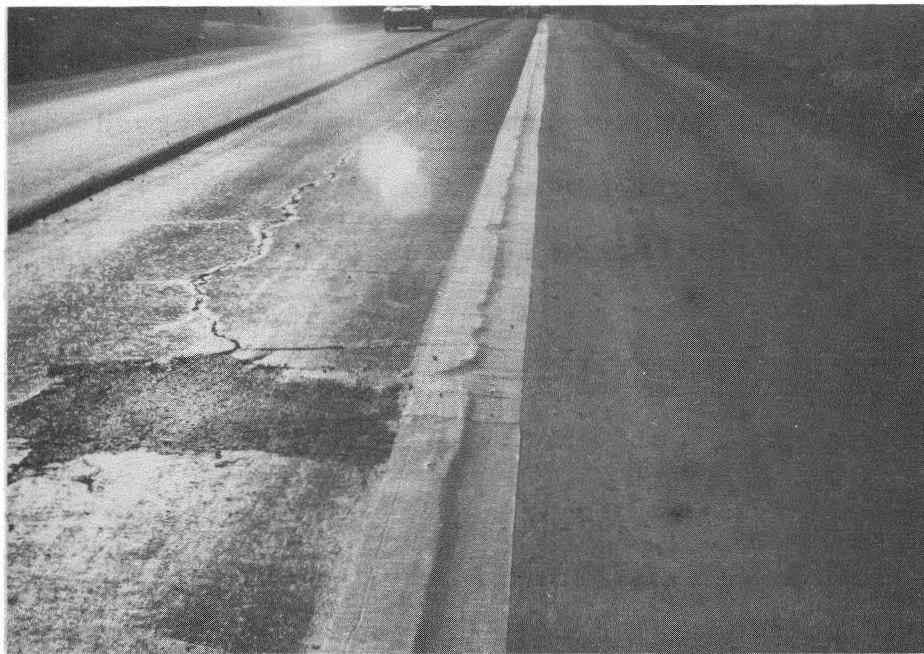
Polyguard was applied over the longitudinal joints on July 25, 1978 using SS-1 emulsion as a prime coat. It was installed by a two-man contractor crew. The membrane was centered over the pavement edge joint between the existing PCC pavement and the FABB widening in the treated sections 1, 2 and 3. See Figure 3.

Figure 3. Polyguard strip membrane installed over the longitudinal edge joint between the PCC slab and AC widening section.

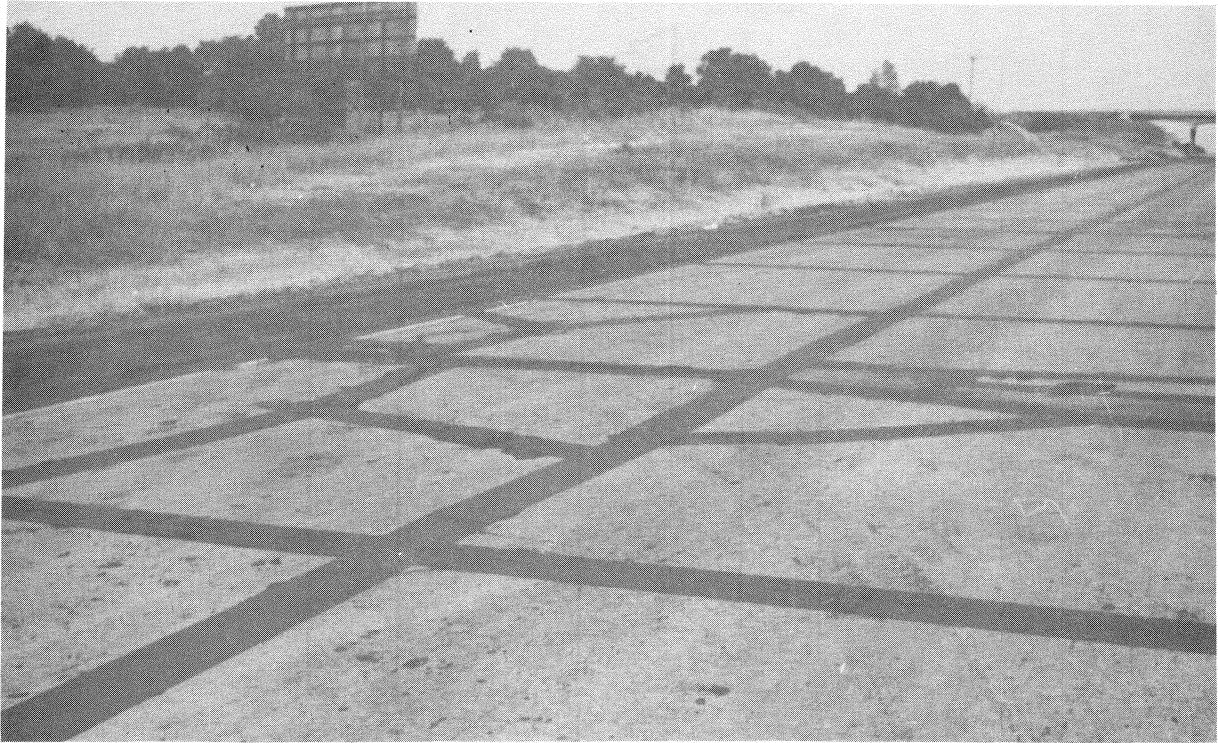
**Figure 2.** Petrotac installed over the transverse, and longitudinal joints, and diagonal cracks in PC concrete pavement.

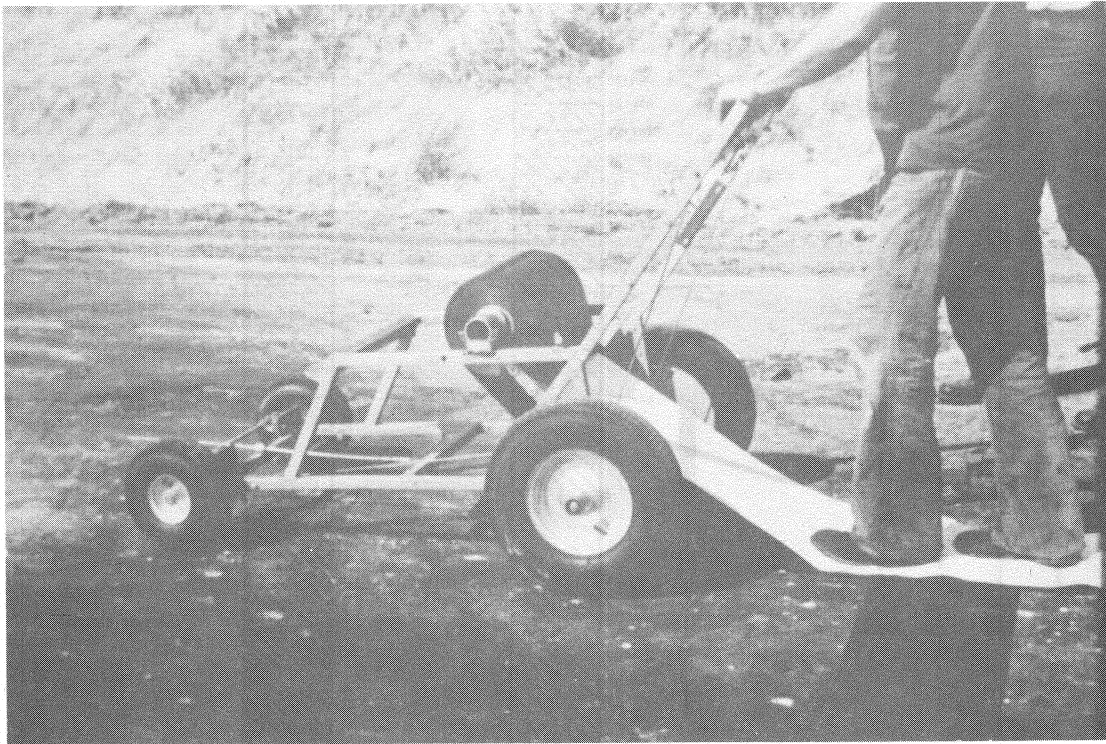
**Figure 3.** A special laydown machine was used to install the Petrotac over the longitudinal joints.

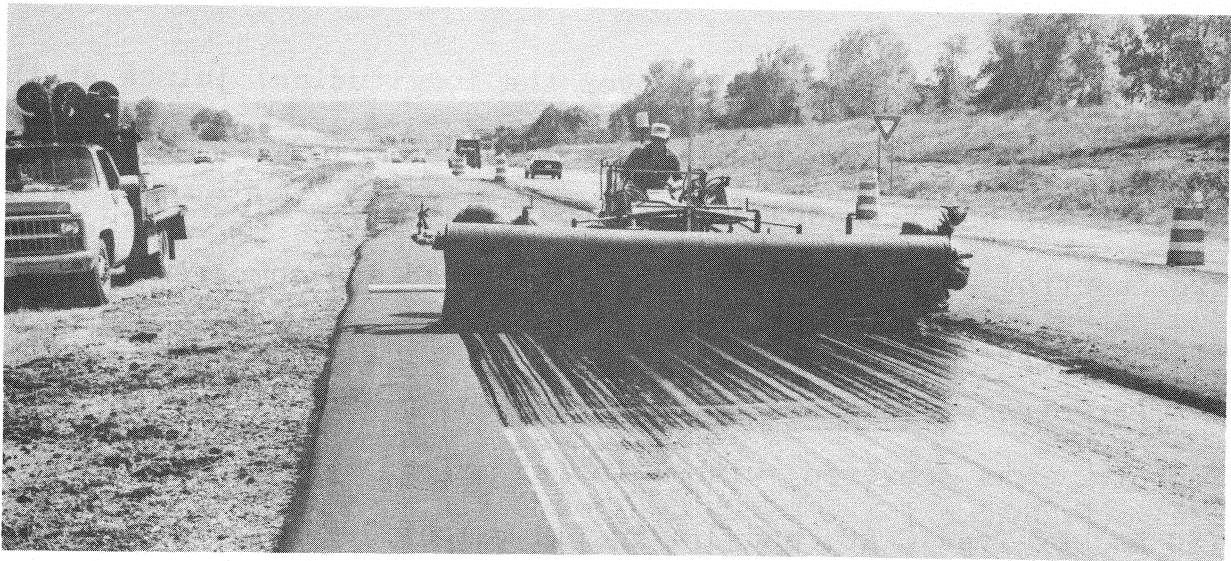
Figure 4. Petromat was applied over the Type D AC.

Petromat then was installed over the Type D AC using AC-3 (85-100 penetration) as a tack coat. See Figure 4. The tack coat application ranged from 0.22 gal/yd<sup>2</sup> (1.0 l/m<sup>2</sup>) to 0.29 gal/yd<sup>2</sup> (1.3 l/m<sup>2</sup>). The speed of the laydown machine was about 5 mi/hr (8 km/hr). Petromat was covered with 2 in (50 mm) of Type C AC and 3/4 in (19 mm) of OGFSC.

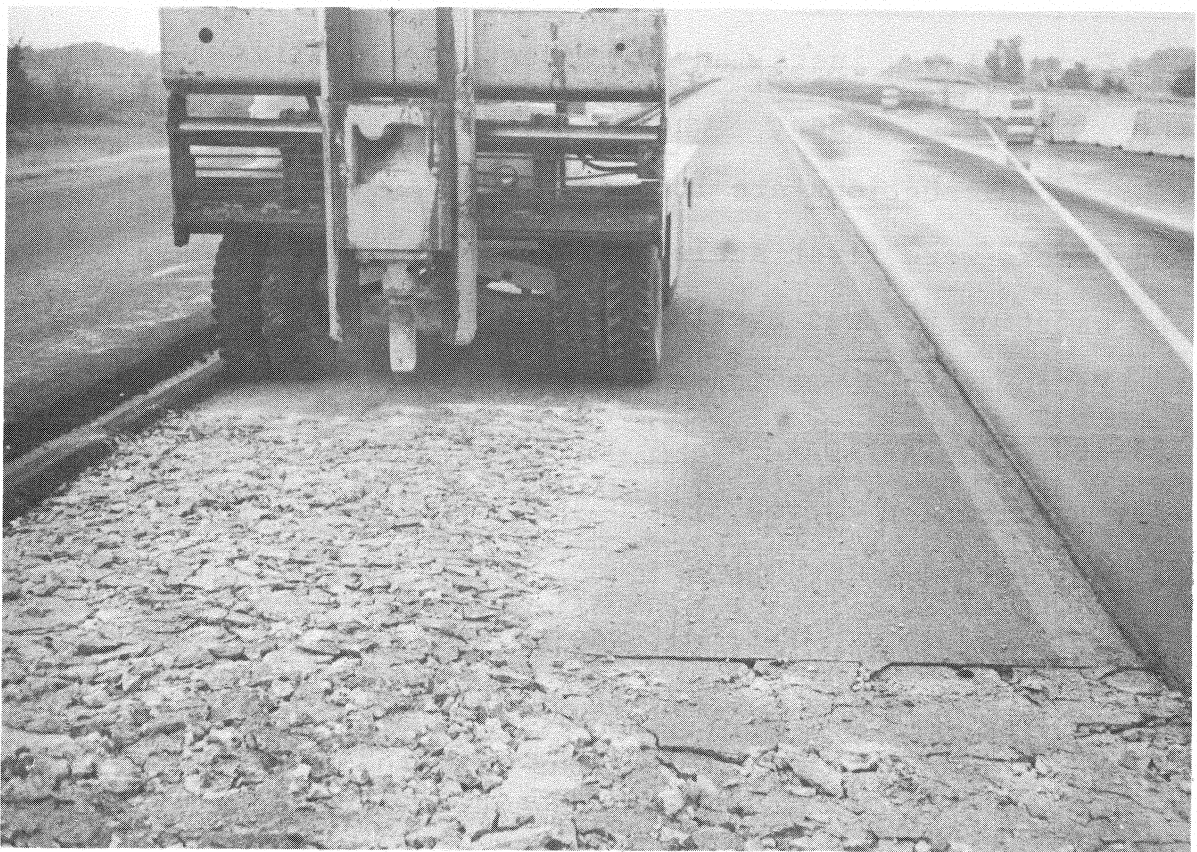
Figure 5. The existing slabs were cracked with a pile driver type pavement breaker where removal or seating was desired.

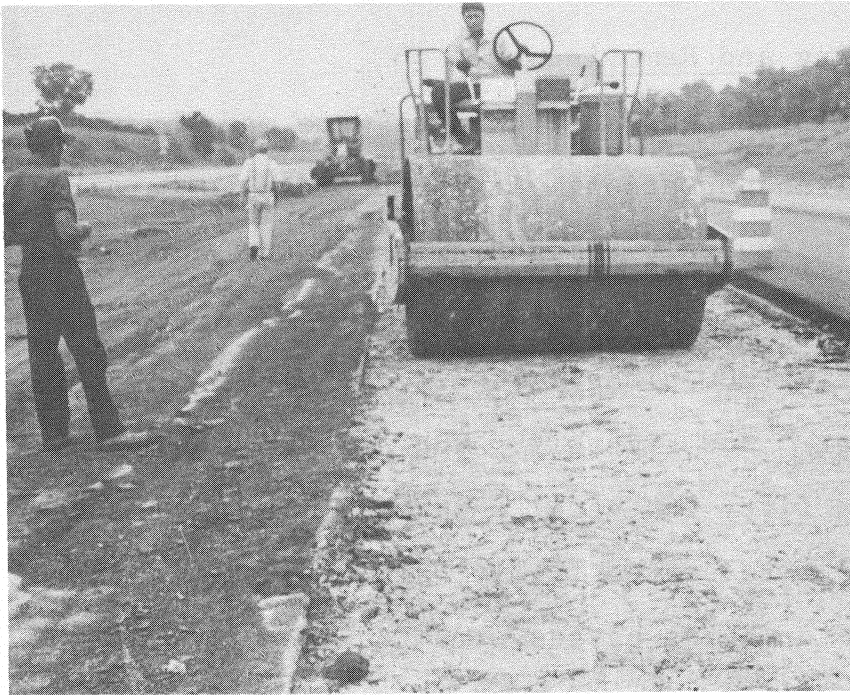
Figure 6. The cracked pavement was rolled with a steel wheeled roller to ensure seating.

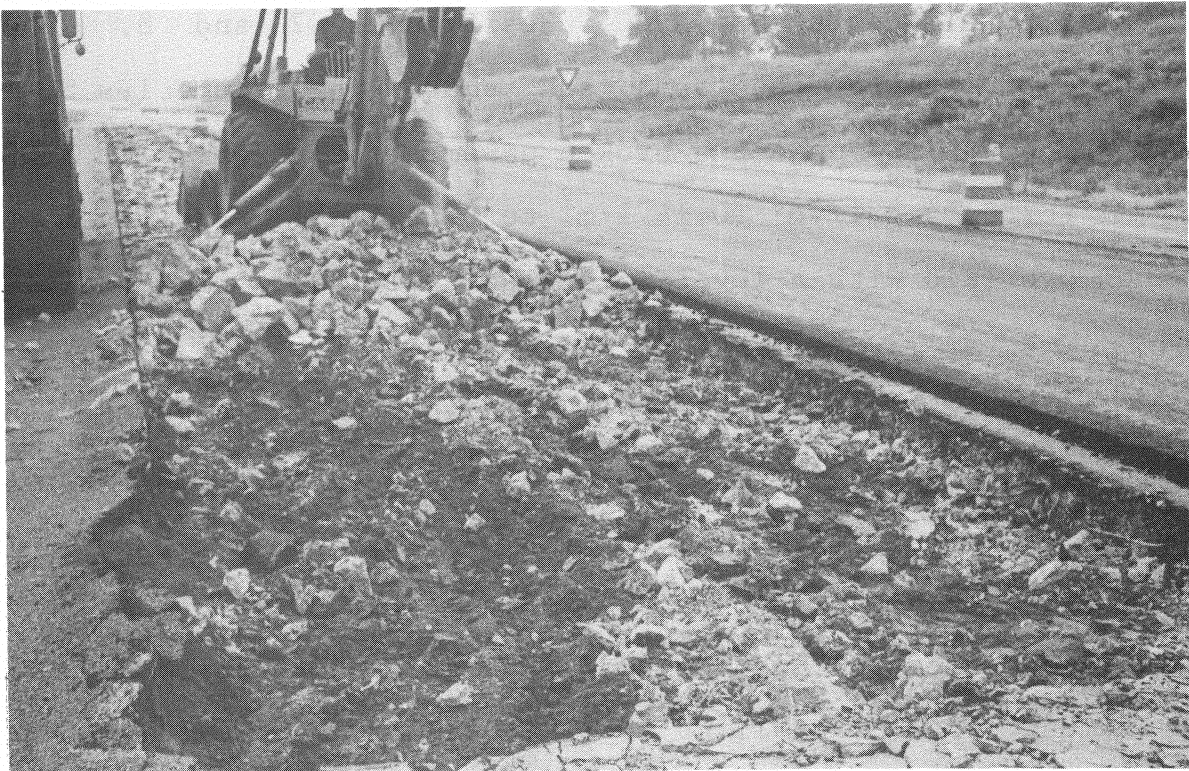
Figure 7. Soft subgrade sections were removed and replaced with AC.

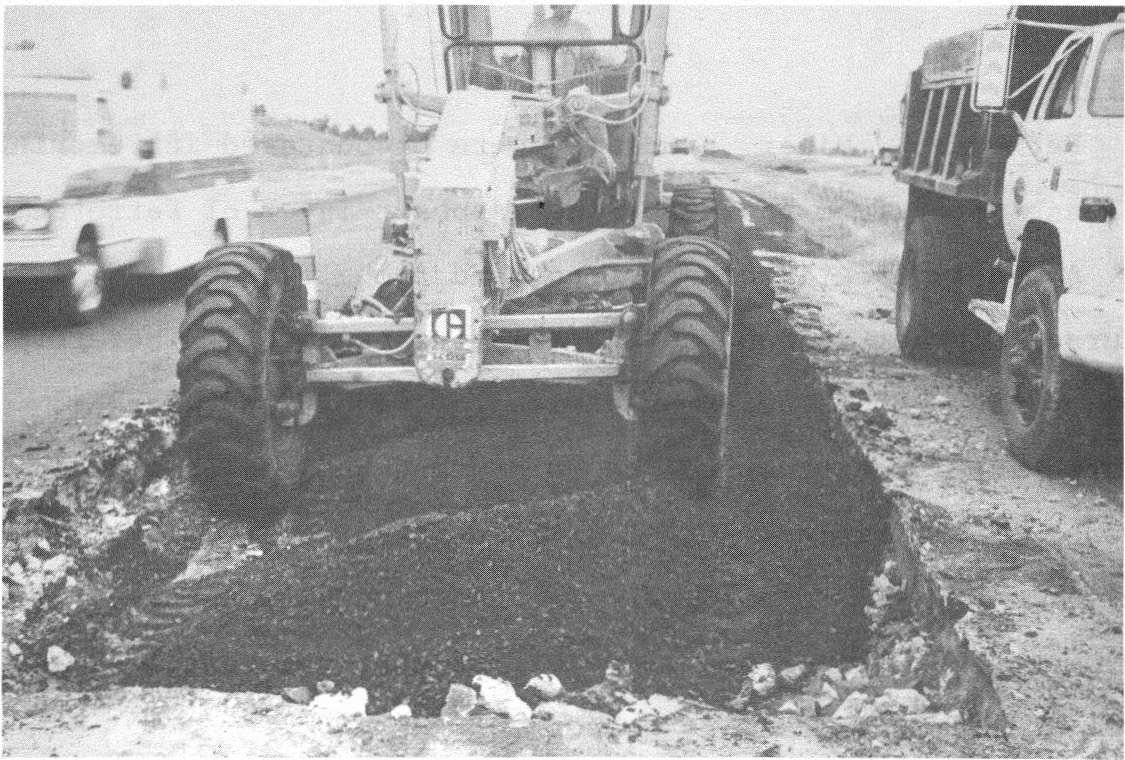
Figure 8. A PCC pavement section. It was removed and patched with full depth Type A AC mix.
