REPORT ON OPERATION OF 60 KV TRANSMISSION SYSTEM IN THE FORT WORTH AREA 1940 - 45

Submitted to the Department of Electrical Engineering Oklahoma Agricultural and Mechanical College In Partial Fulfillment of the Requirements For the Professional Degree of Electrical Engineer 1948

Prepared by Texas Electric Service Company Power Department April, 1945

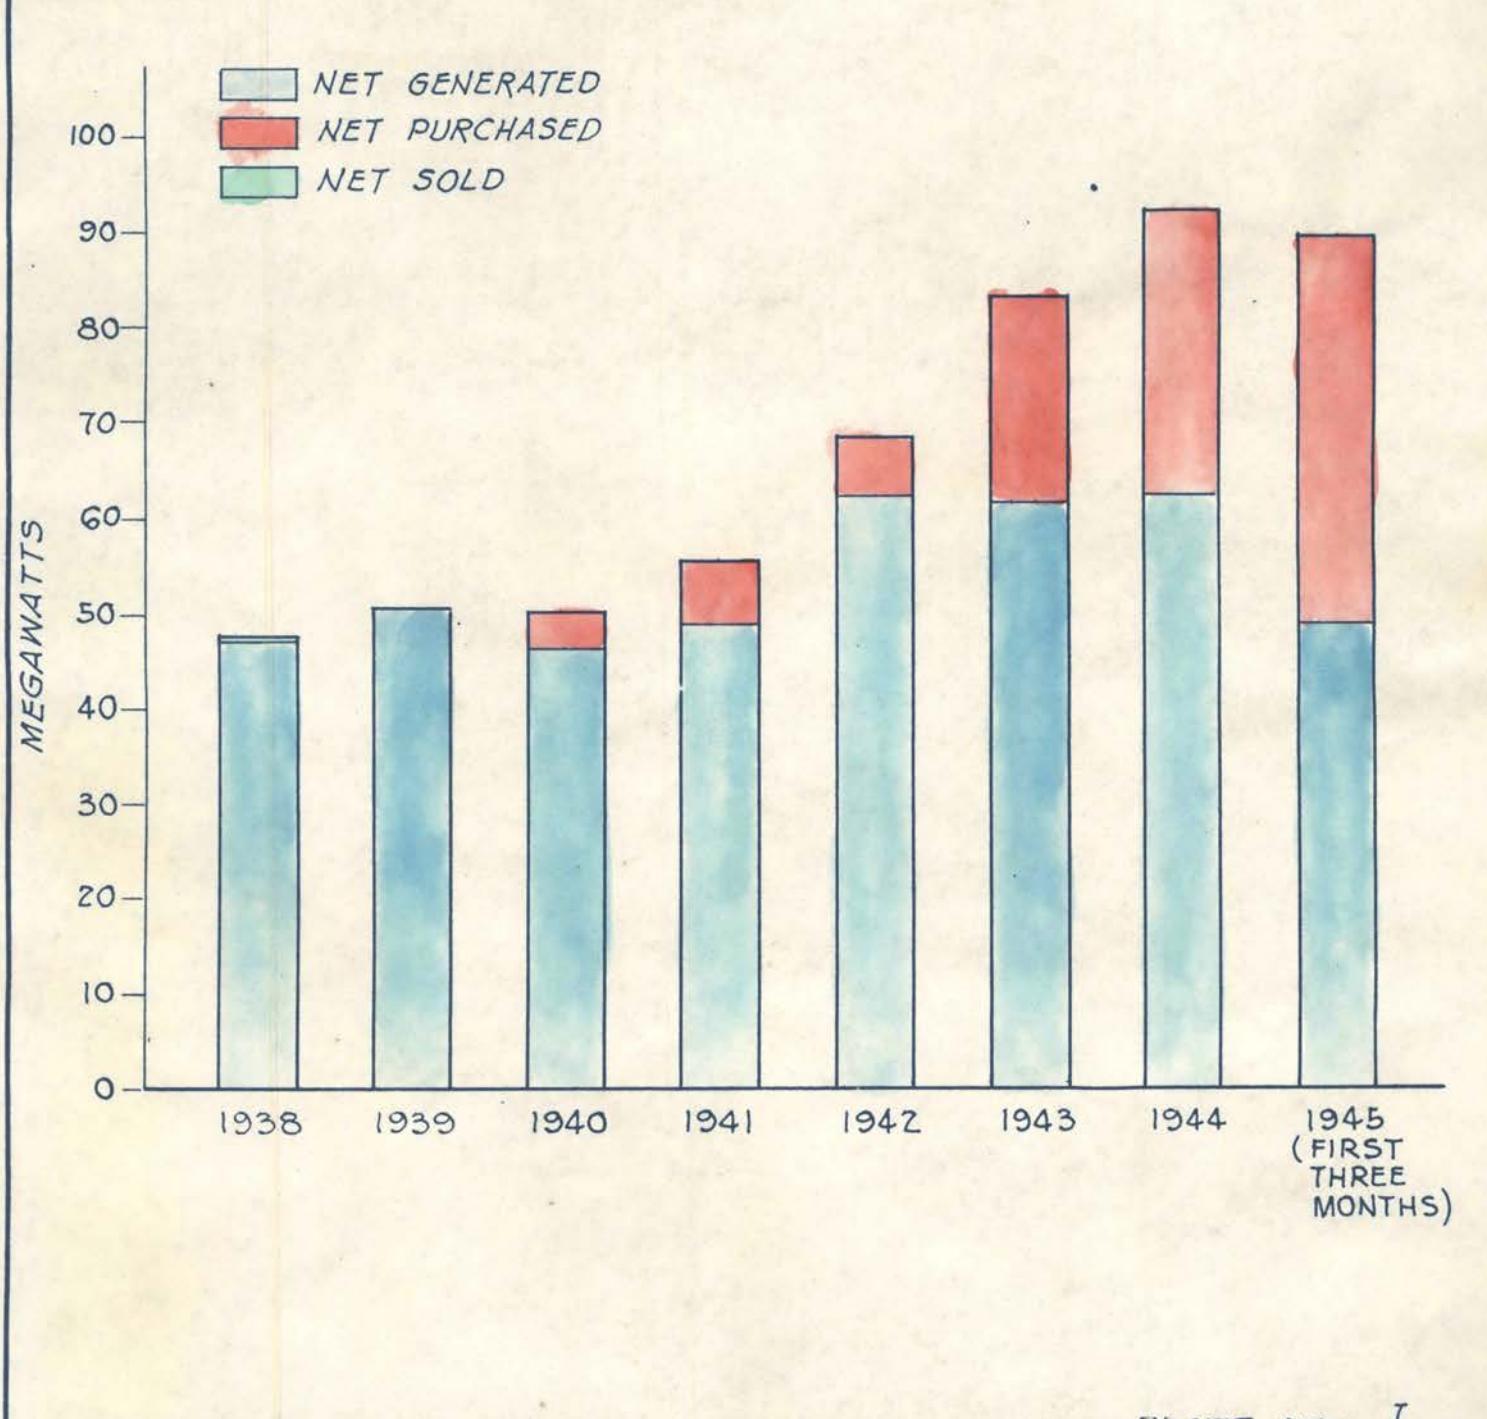
PLATE NO. _I

This plate shows graphically the gradual change in the Fort Worth area annual load peaks from 1938 to April 1, 1945.

The green part of the graph shows that in 1938 there was a surplus of capacity to be sold even on the peak. In 1939 the peak equalled the capacity, but since that time there has been a growing shortage even with the Handley addition in 1942. PEAK NET CONSUMED COMPOSED OF NET GENERATED AT SAME HOUR AND NET INTERCHANGE.

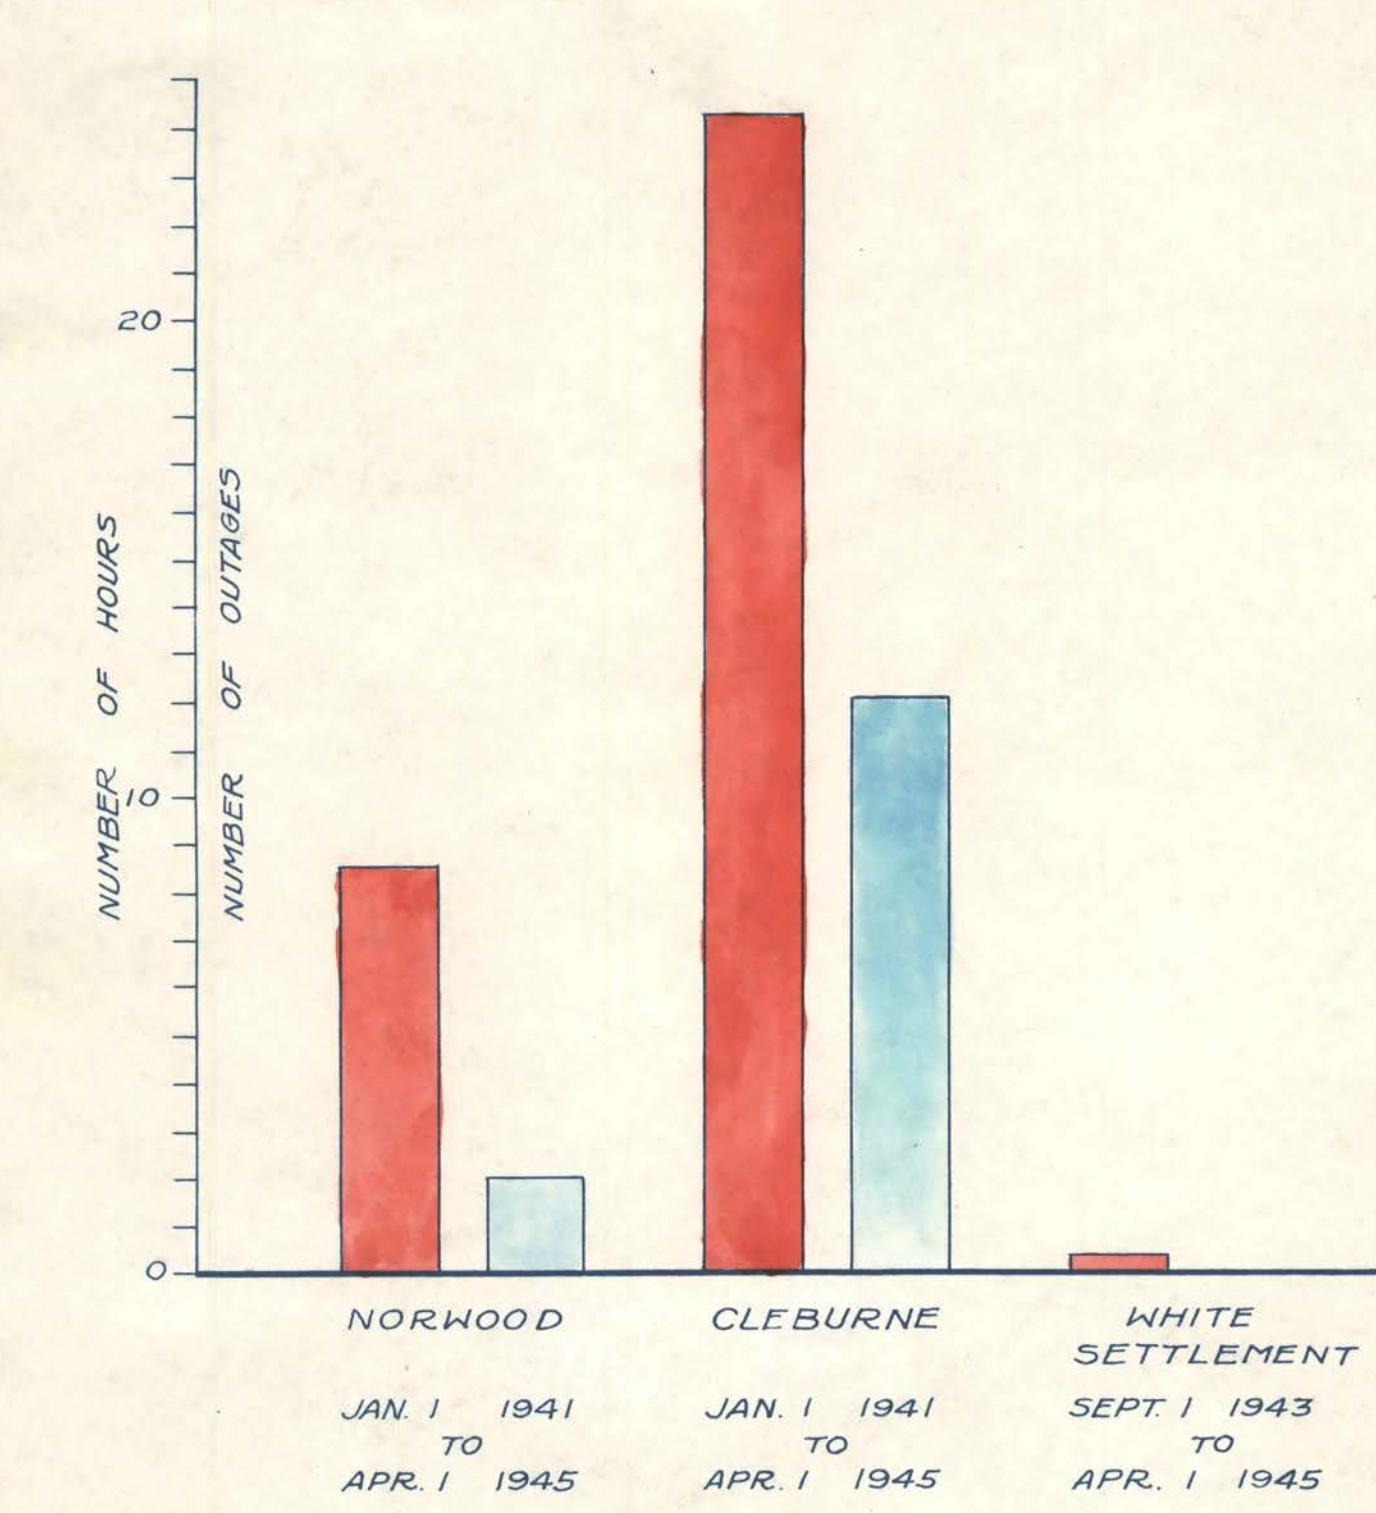
PLATE NO. _I

A short section of this line has insulated wire. However, only one of the 12 prolonged interruptions was caused by conductor failure in the insulated section.

The greater part of the Norwood line outage was due to a conductor failure as a result of a gunshot conductor. COMPARISON TOTAL OUTAGES FORT WORTH 60 KV LINES DUE TO LINE TROUBLES

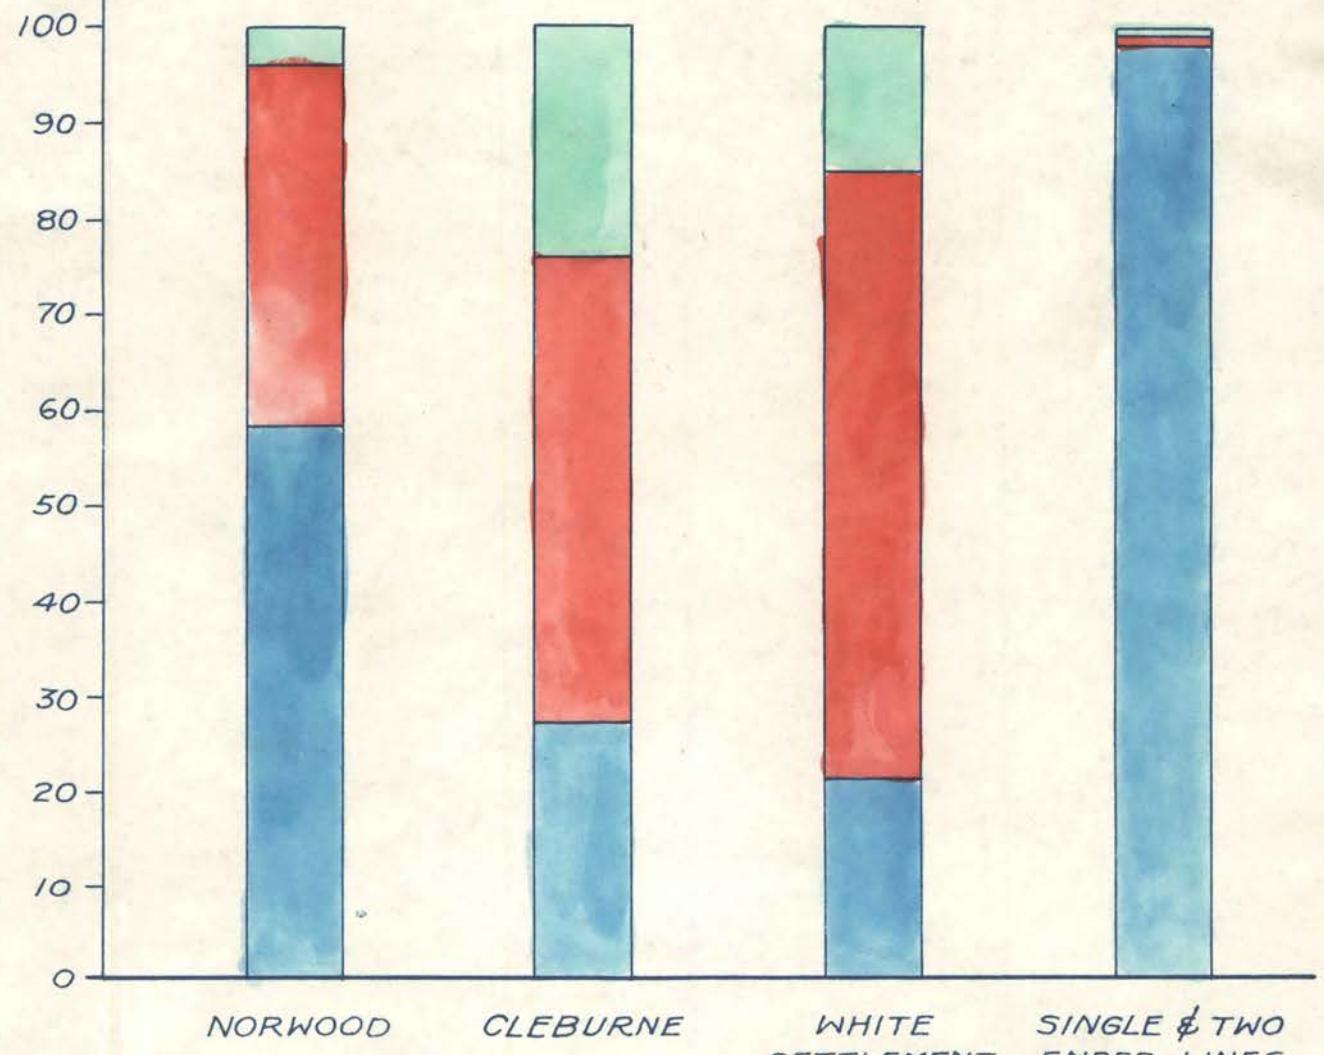
PLATE NO. I

Comparison is made here of questionable, incorrect, and correct operation of the three 60 kv lines and other high voltage lines over the TESCO system.

This chart is made up from tabulations to be found at the latter part of the Operating Record section. COMPARATIVE SWITCH OPERATION FORT WORTH GO KV LINES WITH OTHER GO KV LINES FOR ISOLATING FAULTS
