FINAL REPORT ~ FHWA-OK-13-09

APPLIED APPROACH SLAB SETTLEMENT RESEARCH, DESIGN/CONSTRUCTION

SCHOOL OF CIVIL ENGINEERING AND
ENVIRONMENTAL SCIENCE

August 2013

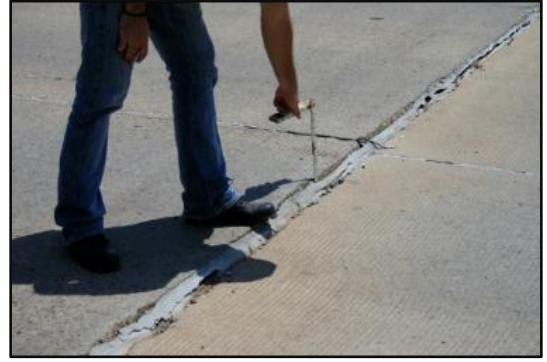
Examples of common problems are seen in Figure 4.4. A large gap can be seen between the wing wall, moving outwards, and the approach slab on Tecumseh Road over I-35. The developing bump on S.H. 6 over West Elk Creek has pulled the seal between pavement slabs apart. A concrete surface channel designed to carry water away from the embankment on S.H. 11 over I-35 failed and collapsed into a 3' deep void beneath the channel.

(b) Vertical separation destroys seal

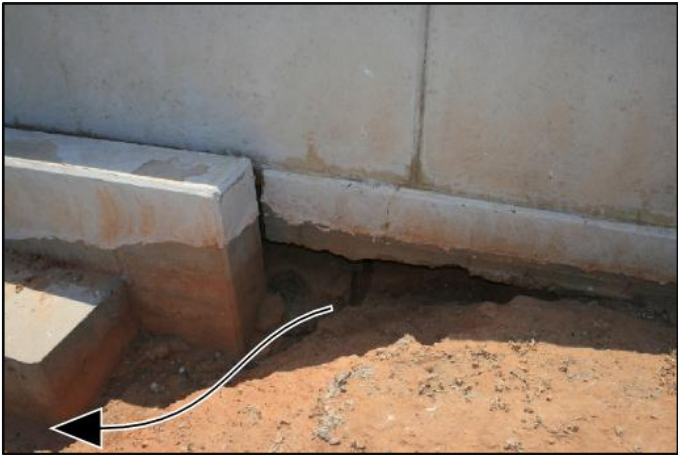
Once voids were present under the approach slab, soil was able to flow laterally directly from beneath the approach slab, as seen at S.H. 6 over Sadler Creek in Figure 4.7. An example of a void under the approach slab is shown at S.H. 59 A over Big Creek in Figure 4.8. An example of an under-abutment void is shown at U.S. 177 over Salt Fork, Bridge B in Figure 4.9.

Figure 4.7 Soil flowing laterally from beneath approach slab

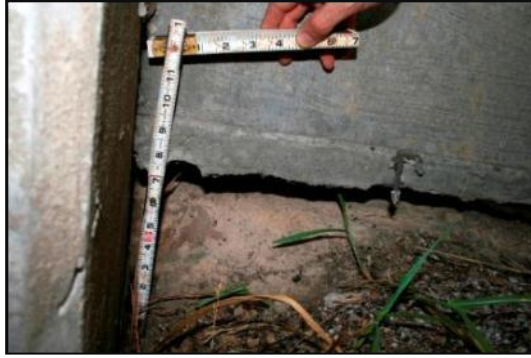
Figure 4.8 A 7" void under approach slab

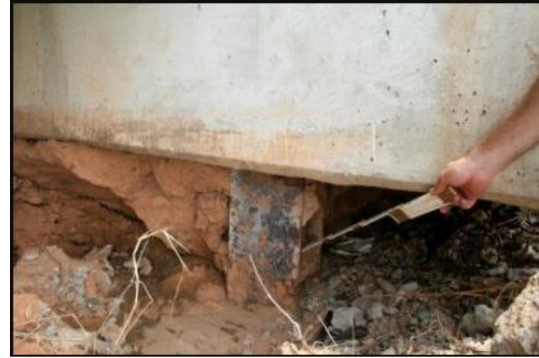
Figure 4.9 A 1' 9" void under abutment

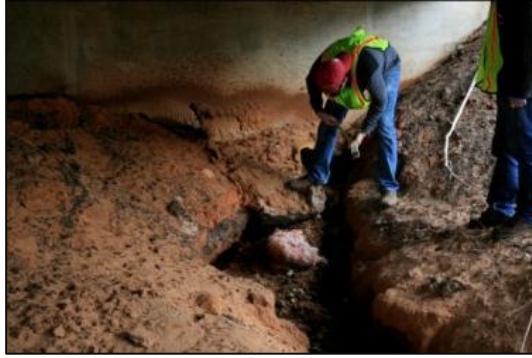
Erosion under the abutment was a common observation during Level I investigations. Four bridges in Caddo County, S.H. 152 over Lake Creek, S.H. 152 over Lake Creek Overflow, S.H. 152 over Willow Creek and S.H. 9 over Running Creek experienced this problem. No underdrain was specified at these locations. An erosion channel at S.H. 152 extending from beneath the abutment to Lake Creek is shown in Figure 4.11 and Figure 4.12.

Figure 4.11 Erosion channel under abutment at S.H. 152 over Lake Creek

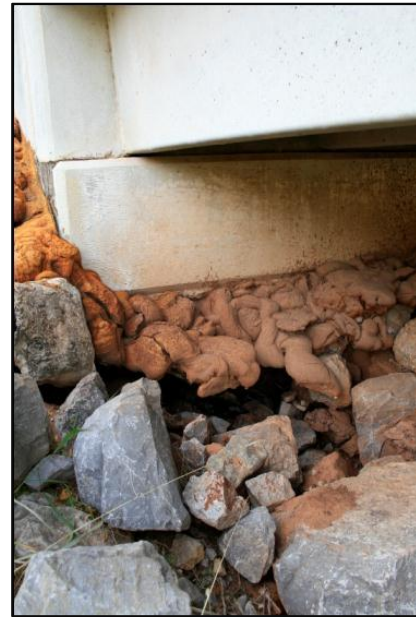
A similar channel was observed at S.H. 152 over Willow Creek and is shown in Figure 4.13. Expanding foam maintenance was used beneath S.H. 9 over Running Creek, but the erosion continued and a void is present even below the foam as seen in Figure 4.14. An example of erosion beneath the abutment is presented in Figure 4.15.

Figure 4.14 Void and maintenance under abutment at S.H. 9 over Running Creek

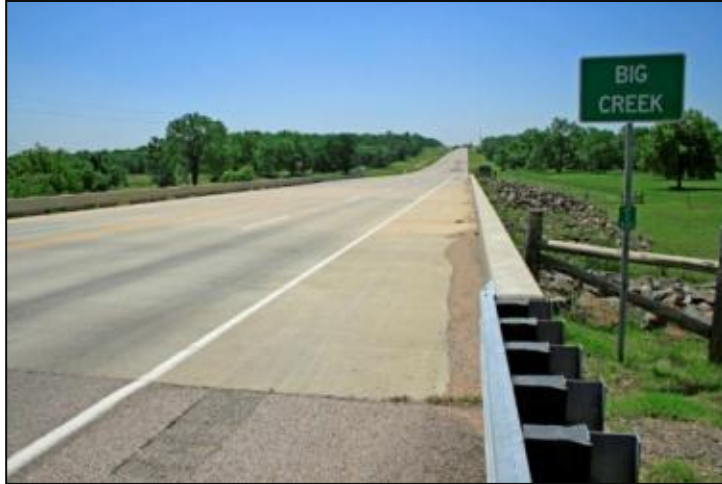
Figure 4.16 The driving surface is smooth on S.H. 3W over Big Creek

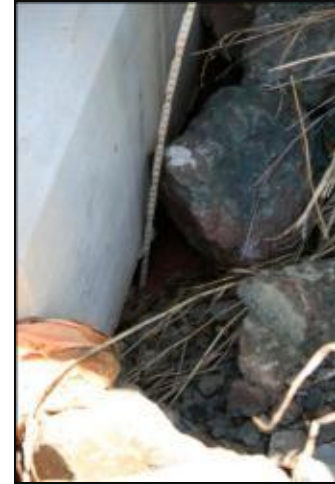
State Highway 3W over Big Creek is a conventional abutment bridge with an underdrain design fairly similar to the 1999 standard. The major difference is that, instead of having a filter sand layer and a coarse pipe underdrain material layer, there is only 2' of filter sand surrounding the pipe. Also, the top of the filter material is level with the bottom of the abutment. The approach performance at this site is acceptable. No bump was observed, and the surface structure was in good shape when the team visited on May 21st, 2011, as seen in Figure 4.16. There was however, a void developing under the abutment, as seen in Figure 4.17. The underdrain design for this site is shown in Figure 4.18.

Figure 4.17 Void forming beneath abutment at S.H. 3W over Big Creek

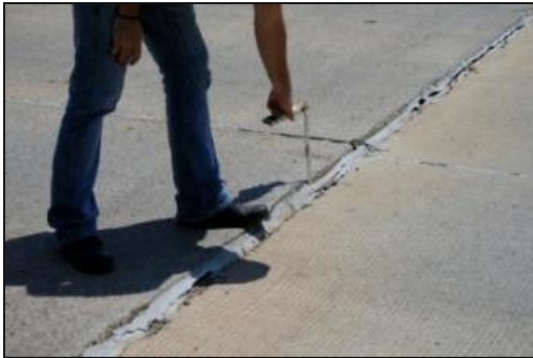
S.H. 6 over West Elk Creek features a design somewhat similar to the 1999 standard for integral bridges. The most significant difference is that granular backfill, as opposed to CLSM, is specified. The driving surface at this site is rough. A 3" bump was measured between the bridge and the north approach. Voids up to 4" were measured both under the approach slab and

Figure 4.19 A 3" bump

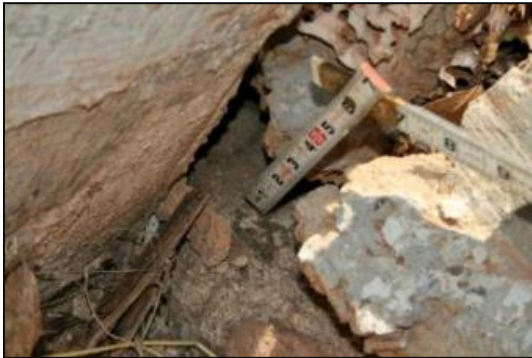
Figure 4.21 4" void beneath the approach slab

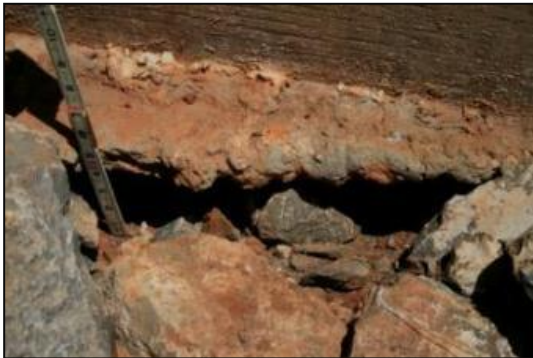
Figure 4.20 4" void beneath the abutment

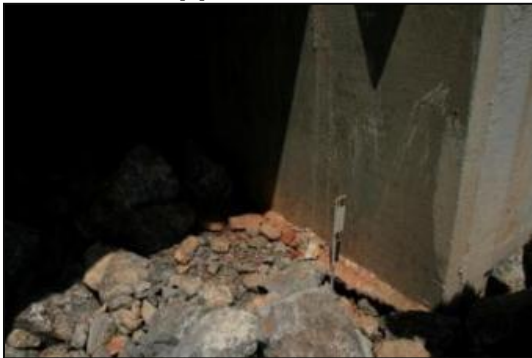
4.22 Void beneath north abutment

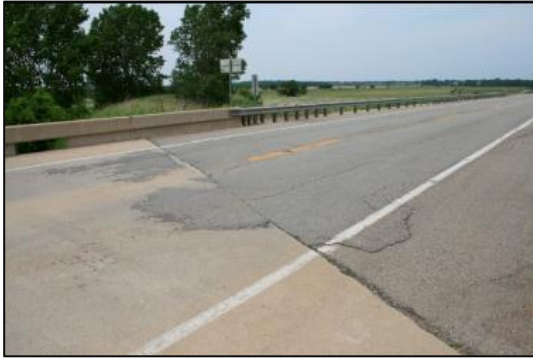
U.S. 177 over the Salt Fork consists of three bridges, each with different embankment construction techniques. Embankment A-2 was constructed using typical construction practices. A bump developed at this approach and the asphalt is cracked. Erosion was observed beneath the abutment. Figure 4.24 shows the approach A-2 and Figure 4.25 shows the observed erosion. The underdrain design is shown in Figure 4.26.

Figure 4.24 US 177 Approach A-2

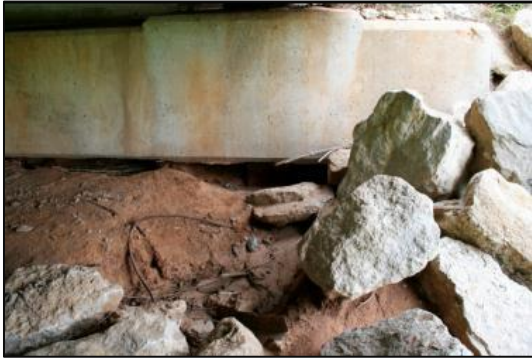
Figure 4.25 Erosion under the abutment on US 177 Embankment A-2

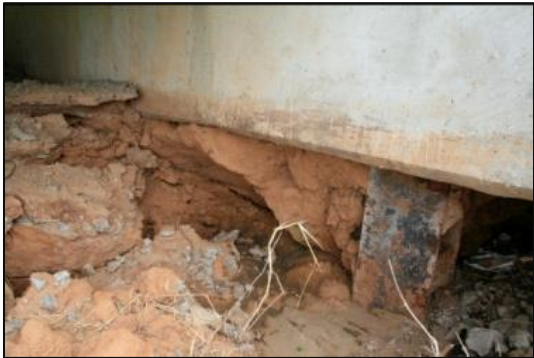
Embankment B-1 utilized geotextile reinforcement. A 2” bump was measured at this location, as seen in Figure 4.27. Substantial erosion under the

Figure 4.28 Erosion beneath abutment at U.S. 177 over Salt Fork, Embankment B-2

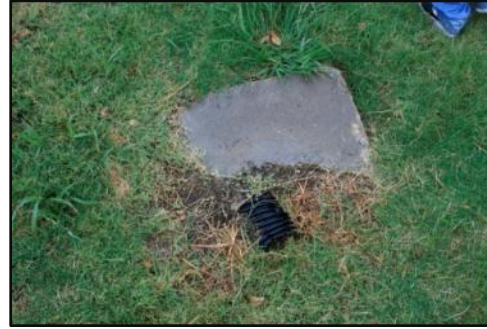
In many locations, the outlet drain is buried or crushed. The underdrain is useless if water cannot flow out of the outlet. Water becoming trapped in the embankment could have detrimental effects on the embankment performance. In Moore, bridges carrying 19th St. over I-35 and I-35 over Main Street have drains which are buried and blocked. No significant erosion was observed at either bridge, but the embankments were observed to have settled, as shown in Figure 4.36.

(c) The outlet at I-35 over Main St. is almost completely buried

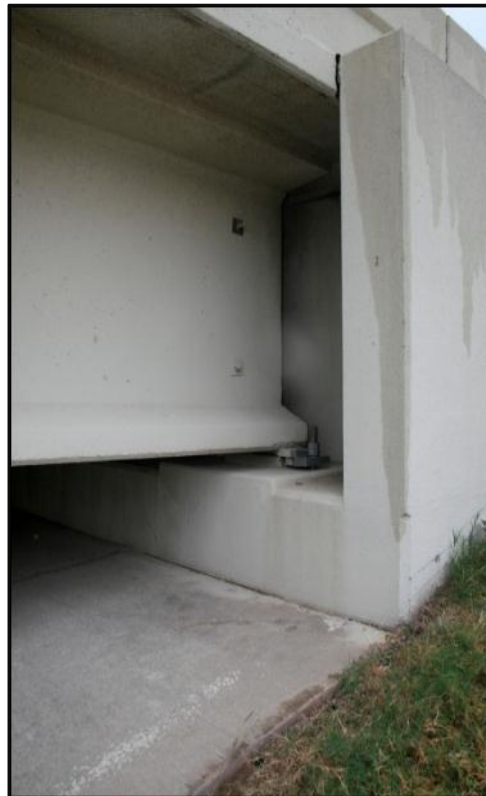
(b) Blue lines on the wing-wall indicate the original soil level and the settlement of the embankment relative to the structure at 19th St. over I-35

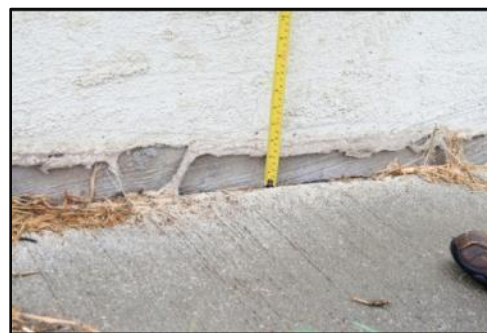
(d) 2" of embankment settlement is measured between the embankment and wing-wall at I-35 over Main St.

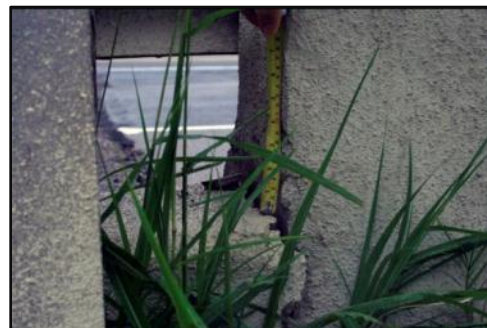
(e) 2" vertical separation is measured between the pavement and bridge interface at I-35 over Main St.

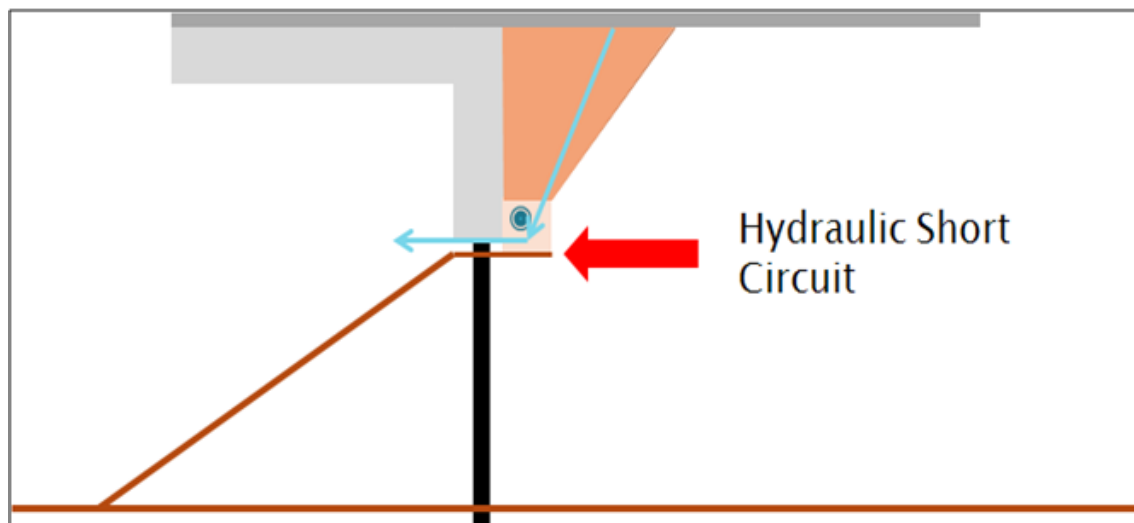
One of the most significant observations of this study is the amount of erosion occurring under abutments. This likely is contributing to significant loss of backfill and approach slab settlement. These observations led to a careful scrutiny of the backfill drainage design details for abutments, which resulted in an important finding. That is, basically some of the design details, such as those similar to the standard detail for integral abutment bridges in Figure 4.10, allow for a hydraulic short circuit to develop beneath the abutment. Thus, water in the backfill can largely bypass the drainage pipe and exit beneath the abutment causing large amounts of erosion over time. Figure 4.37 provides a schematic of the problem. The problem is that the proper function of the drainage system in Figure 4.10 requires that the contact between the bottom of the abutment and the underlying soil remains water tight so that water will be contained in the drain and exit via the pipe. Since the abutment is supported on piles it will generally not settle. However, any small amount of settlement of the soil beneath the abutment, which is highly likely in most cases, will cause a gap to open up and allow water to bypass the drain. Even if the embankment soil does not settle, it is unlikely that this contact is water tight and eventually water will begin to flow through this interface and cause erosion. Over time, extensive erosion can occur as observed at many sites.

Figure 4.37 Schematic Cross-Section View of Hydraulic Short Circuit that Can Develop in the Abutment Drainage System

A modification to this design is needed to introduce a water stop at the interface of the abutment and underlying soil. Figure 4.30 shows an example of a conventional abutment design where a water stop appears to have worked

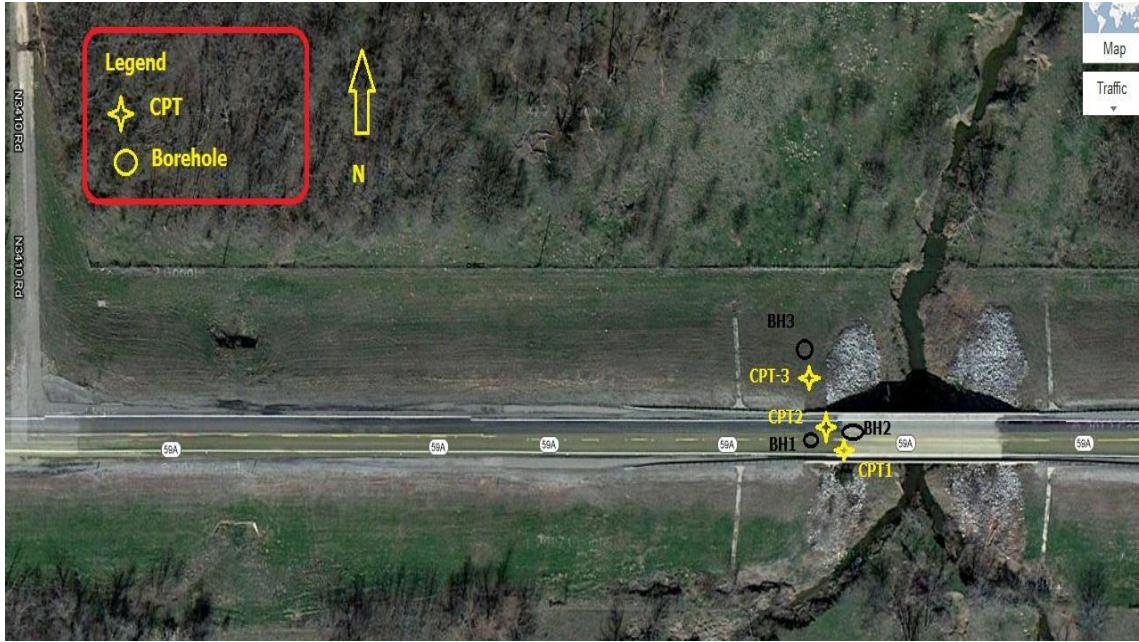
Figure 5.1 Sounding Locations for SH-59A over Big Creek

Three test borings and three cone soundings were conducted, both on and off the west embankment as shown in Figure 5.1. Test boring logs and tabulated soil properties are contained in Appendices B and C, respectively. Soil properties and interpreted soil profiles are shown in Figure 5.2 and results of

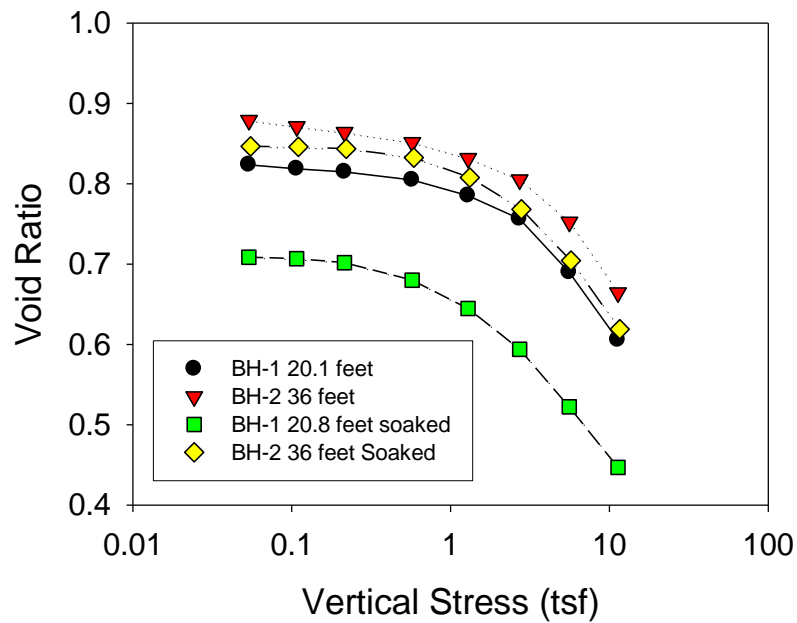
Figure 5.4 Oedometer Test Results - SH-59A over Big Creek

The most noteworthy observation from the subsurface investigation was the significant thickness of relatively compressible clay beneath this site. Oedometer results from four tests on representative samples from the clay layers are shown in Figure 5.4 and Table 5.2. Overconsolidation ratios (OCRs) shown in the table indicate the soil is generally lightly to moderately overconsolidated, consistent with normalized undrained shear strength mentioned above. Values of compression index (c_c) and recompression index (c_r) are generally lower than expected based on popular empirical correlations such as that proposed by Skempton (1944) and Kulhawy and Mayne (1990); however, results from two tests are consistent with values observed by one of the authors for several sites in Oklahoma (as shown in Figures 5.5 and 5.6). Interestingly, compression indices from the higher PI layer at a depth of 36 ft.

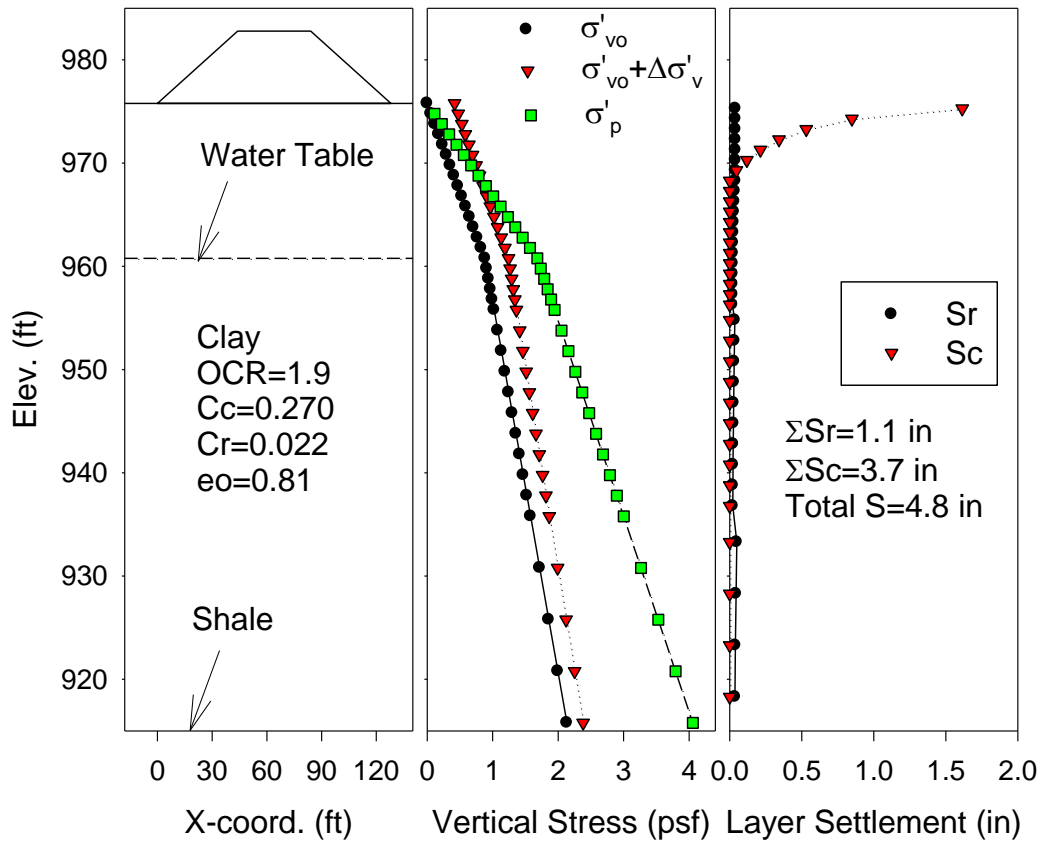
Figure 5.8 Results of Settlement Analysis - SH-59A over Big Creek

Settlement analysis based on the average results for parameters shown in Table 5.2 was conducted. Since oedometer data indicated relatively similar properties at different depths, a uniform clay layer with constant OCR was assumed. The embankment dimensions estimated from project plans and assumed stratigraphy are shown on Figure 5.7. Calculated total settlement based on average properties was 4.8 inches as shown in Figure 5.8, and consisted of 3.7 inches of virgin compression and 1.1 inches of recompression. Results of the settlement analysis shown in Figure 5.8 reveal that a significant amount (78%) of the total settlement is due to virgin compression while 22% is attributed to recompression in soil immediately beneath the embankment. This observation emphasizes the importance of having high quality estimates of settlement properties, especially preconsolidation stress, for soil immediately beneath the embankment where loading is the greatest. If a significant clay crust (weathered layer) had developed, expected settlements would be less. Using the range of settlement parameters in Table 5.2 gives a range of possible total settlements from 2.8 to 8.2 inches. Settlement predictions are consistent with the magnitude of observed settlements and are likely a primary cause of the approach slab settlement problem for SH-59A over Big Creek. In addition, as noted previously in this report, voids were observed under the slab indicating some erosion may also be contributing to the observed settlements.

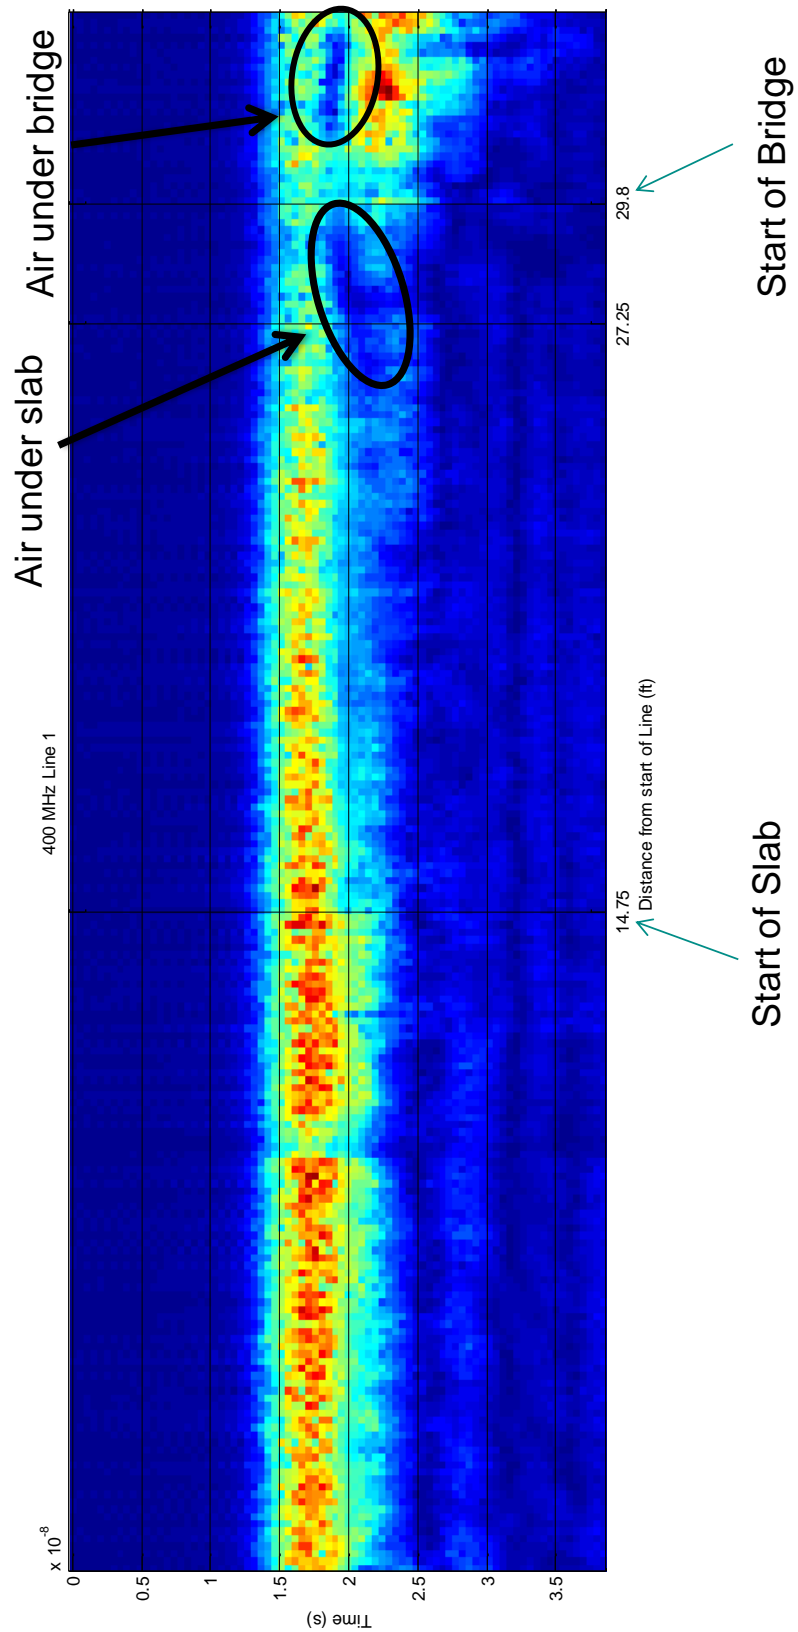
Figure 5.10 Results and Interpretation of GPR Along a Line on the West Approach Slab in the Eastbound Lane – 400MHz Antenna

In Figure 5.9 a photograph of the Portable GPR in use is shown. Figure 5.10 presents the results along one line of the GPR survey and interpretation based on the 400MHz data. Based on this initial work the following conclusions were made:

- Perturbation of waveform over void can be used for detection and approximate extent, but poor resolution.
- A higher frequency antenna (1-1.6GHz) is recommended for better resolution and characterization of the voids.
 - A large contrast between concrete and air as reflected on the 400MHz waveform should give a distinct reflection on higher frequency data.

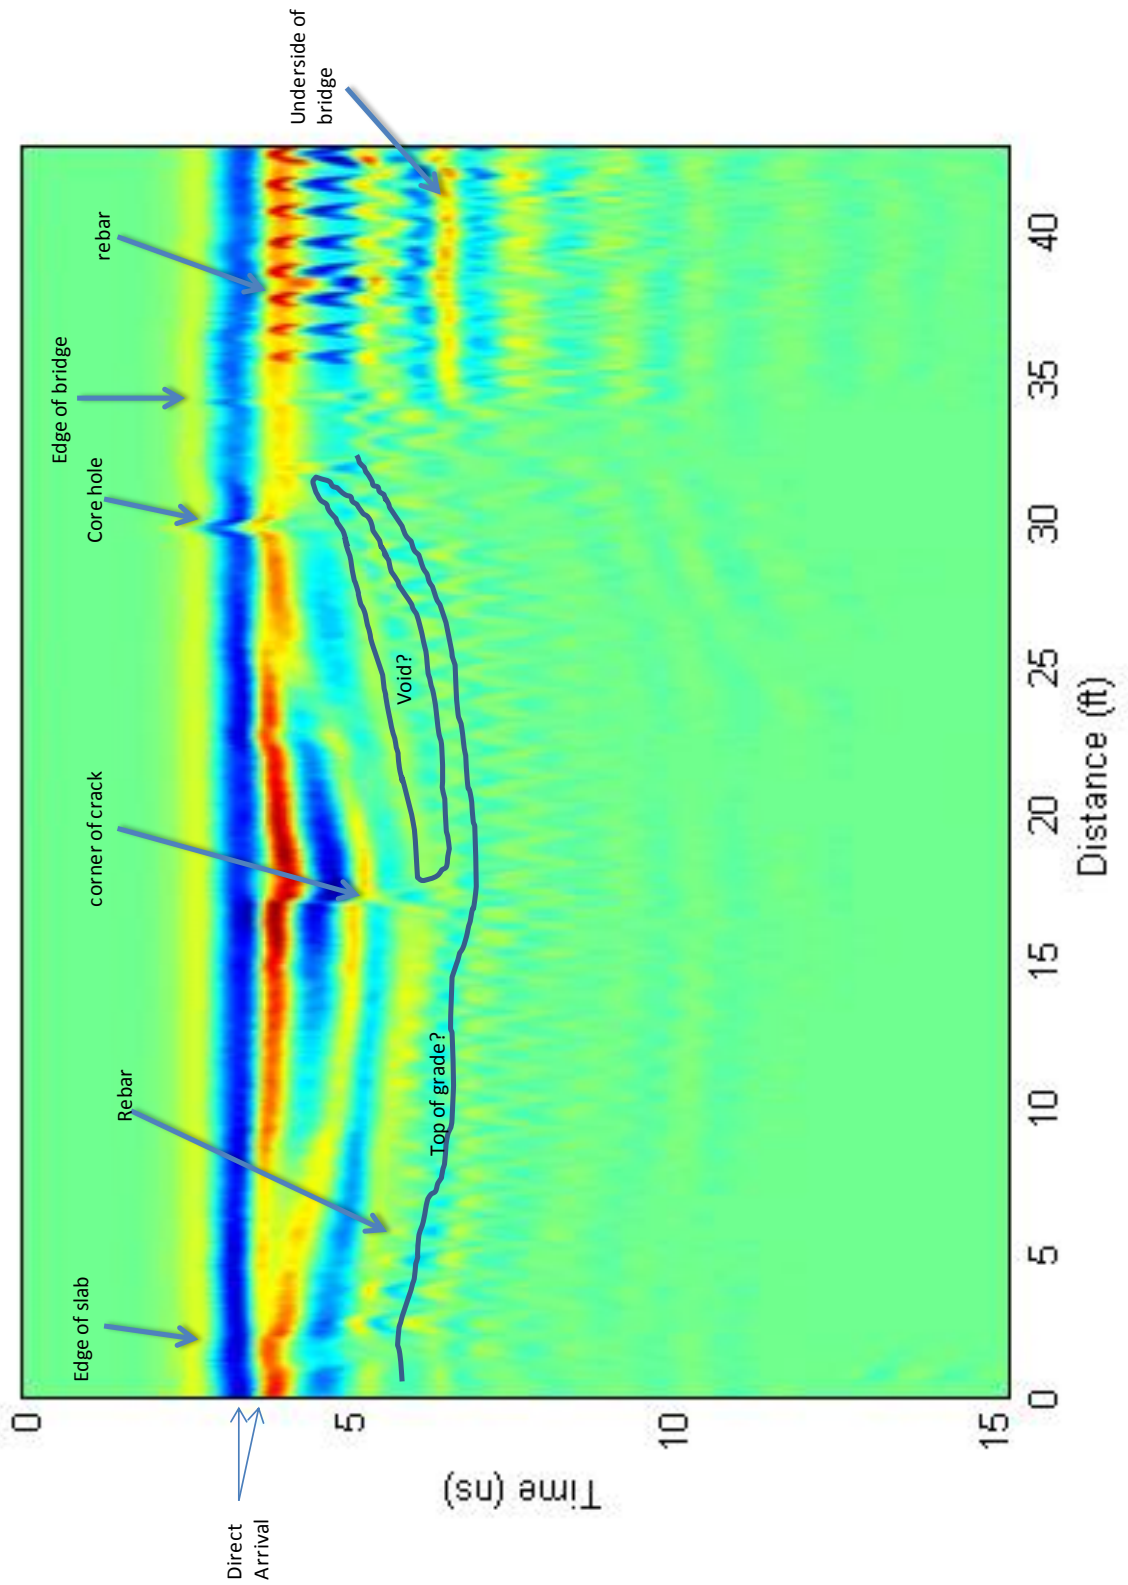
Figure 5.11 Results and Interpretation of GPR Along a Line on the East Approach Slab in the Westbound Lane – 1.3 GHz Antenna

Following the initial work using the 400MHz antenna, a 1.3 GHz antenna was obtained and used at the same site for comparison. While data interpretation is continuing, the preliminary results reveal stronger reflections from discontinuities in the pavement and greater potential for detecting voids. Results and interpretation from the higher frequency antenna are shown Figure 5.11. These preliminary results indicate the GPR may be a valuable tool for void detection under slabs, as well as other uses.

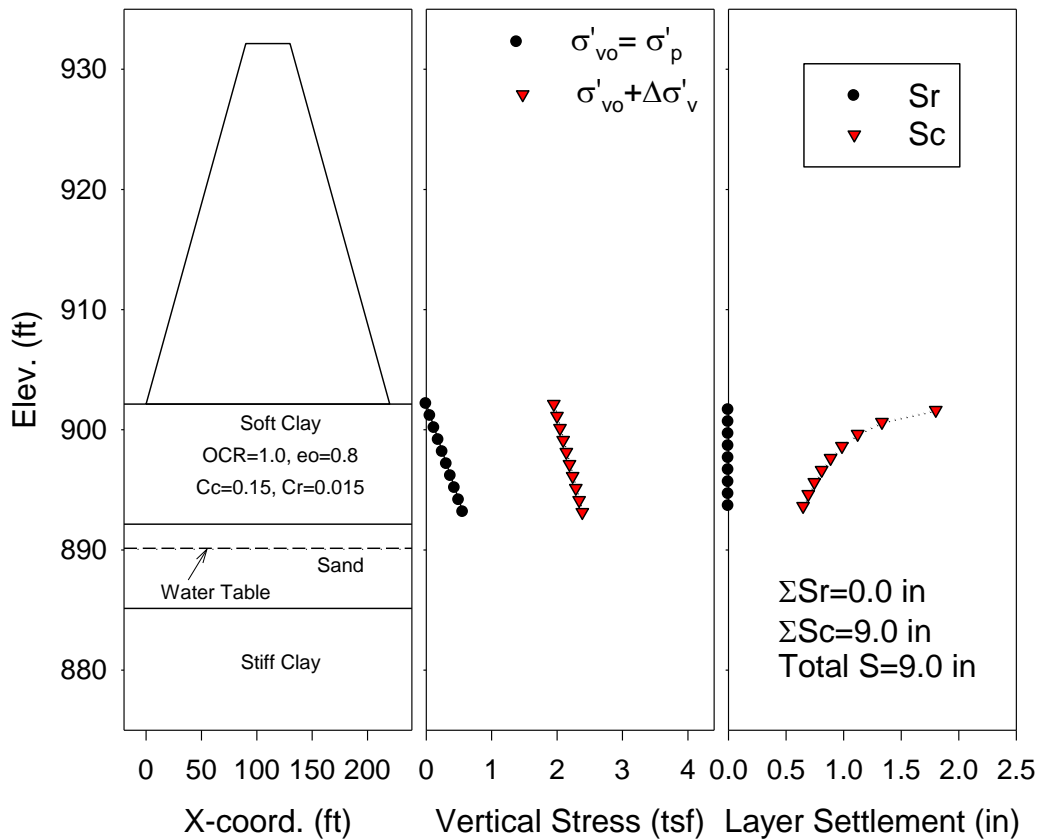
Figure 5.19 Results of Settlement Analysis – US-177 over Salt Fork, South Embankment

analysis was on the south embankment where significant clay layers were detected. In addition, the south embankment was about twice as high as the north embankment. Test borings for the south embankment reveal about 8 feet of granular backfill, mostly fine sand behind the abutments underlain by about 24 feet of red to dark brown sandy clay that primarily makes up the embankment fill. Plasticity indices in the clayey fill range from 12 to 24 with an average around 18, and sand contents range from 61% to 86%. Cone data in Figure 5.15 reveal the soil below the fill varies from sand to clay at the south embankment. The cone data from the CPT-6 test on the west side of the embankment (off the embankment) reveal a strong layer of sand in the soils at elevations below the embankment fill. On the other hand, CPT-7 on the east side of the embankment (off the embankment) reveals a soft layer of clayey soil for the same elevations. This is of particular concern since soft clays are highly compressible and can settle significantly. Below this variable zone, both CPT-6 and CPT-7 indicate a 6-foot layer of sand followed by about 10 feet of stiff clay to the termination depth.

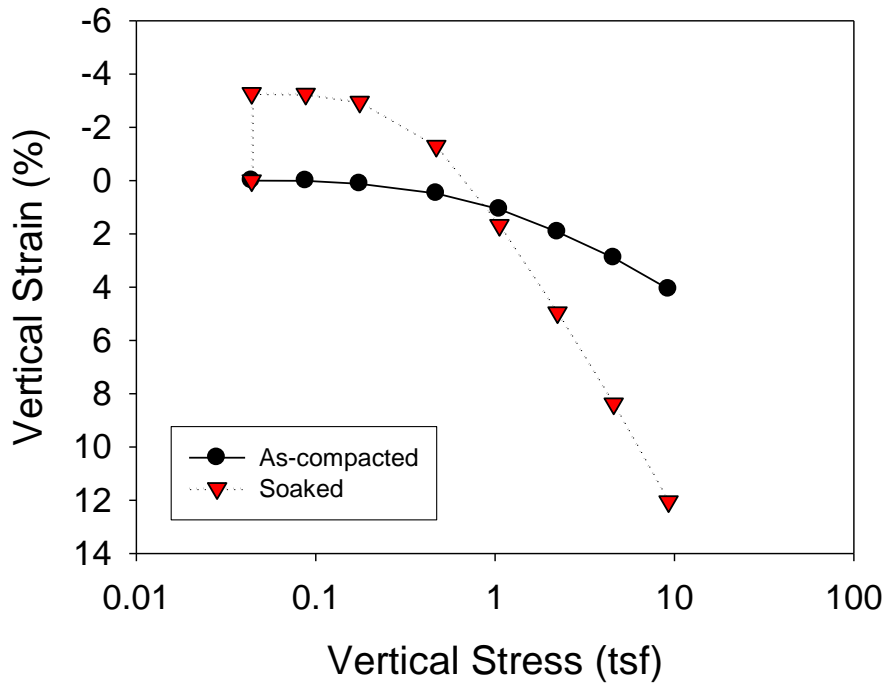
Figure 5.20 Double-Oedometer Results – US-177 over Salt Fork: BH-1, 13-18 feet

In addition to the settlement of foundation layers, compression of the fill material may have contributed to the overall settlement of the bridge approach slabs. Figure 5.20 shows double-oedometer data for a composite sample of embankment fill soil taken from 15 to 18 feet in Boring BH-1. Two samples were compacted to a relative compaction of approximately 97% and a moisture content 2 percentage points dry of optimum (approximate $w=13.2\%$) based on the standard Proctor curve shown in Figure 5.21. This soil state is meant to represent the average compacted condition dry of optimum but within specifications. In Figure 5.20, the soil exhibits a significant tendency for swelling

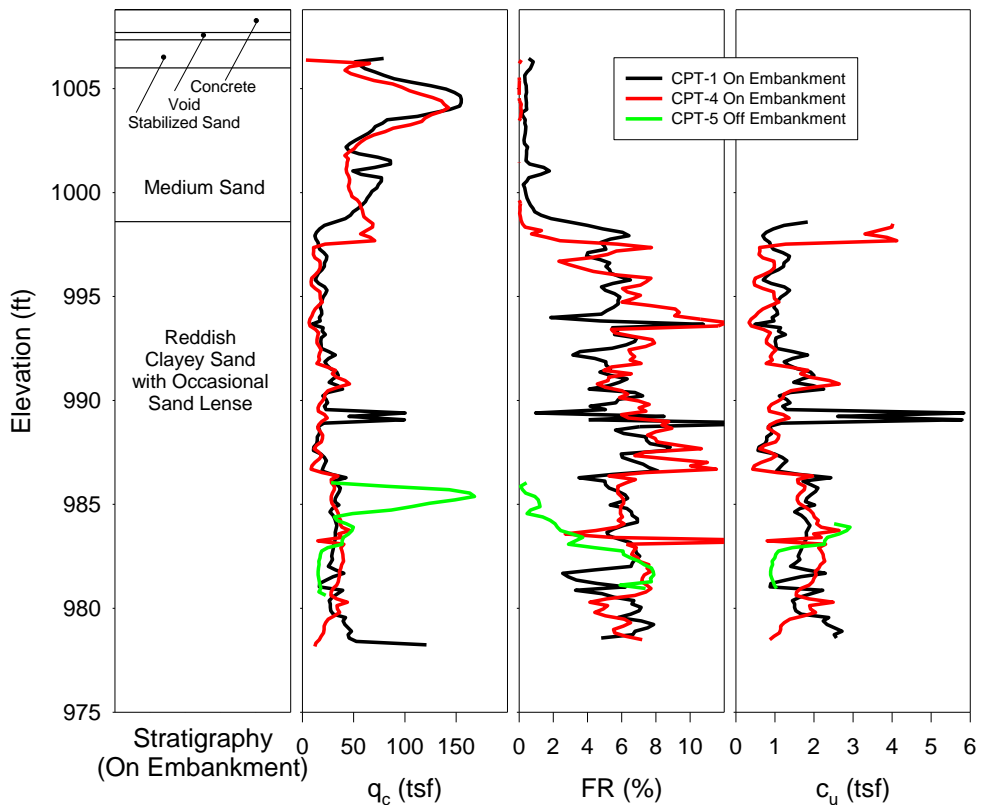
Figure 5.37 Cone Soundings for East Embankment – SH-1 over SH-99

Test boring and CPT sounding locations are shown in Figure 5.34. Soil properties and interpreted stratigraphy are presented in Figures 5.35 and 5.36 for the east and west embankments, respectively. Interpreted stratigraphy is based on results of test borings and CPT profiles shown in Figures 5.37 and 5.38. Based on the project drawings and subsurface profiles it appears the embankment soils consist of medium sand backfill behind the abutments and clayey sand for the remainder of fill. Based on project drawings it appears the embankment soils are about 10 feet thick on the west side and nearly 20 feet thick on the east side. Natural soils are quite variable below the west embankment and made up of clayey sand although weathered layers of sandstone, shale and limestone were encountered. Natural soils below the east embankment appear more uniform and consist of primarily of clayey sand. It appears based on the borings and CPT profiles for the east embankment that the natural soils are at least 13 feet thick. Results of CPT-1 show an increase in tip resistance at about 13 feet, which may indicate the beginning of the weathered rock zone. However, the CPT-4 sounding did not yet encounter rock at this depth as shown in Figure 5.37.

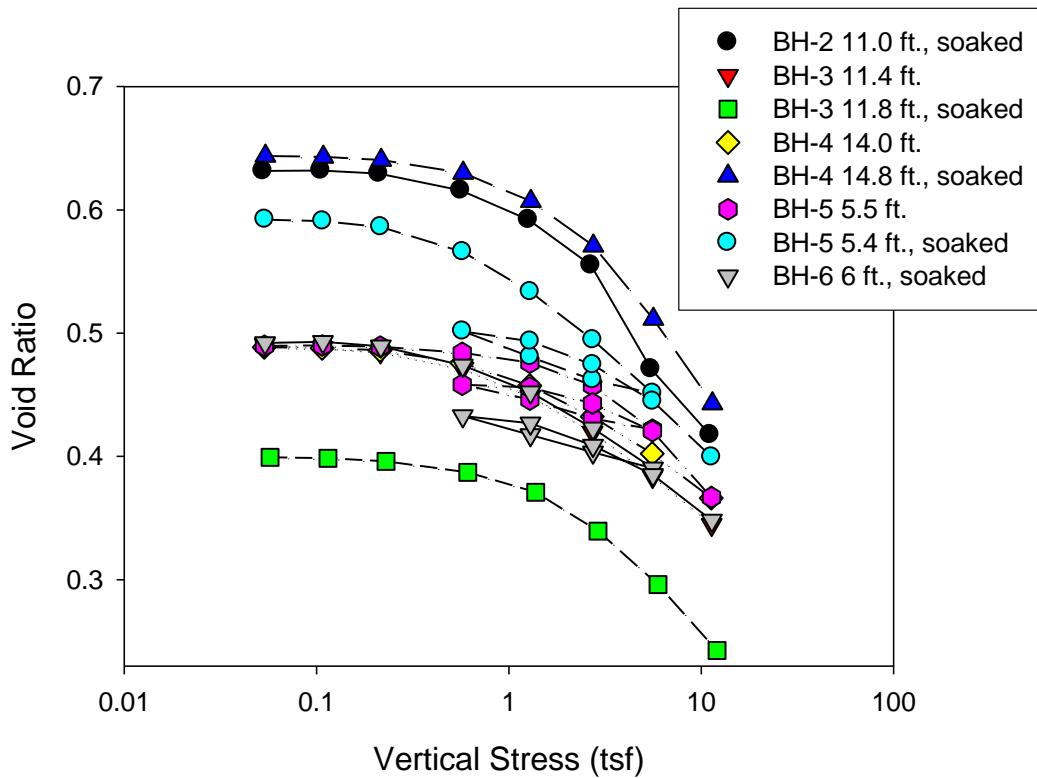
Figure 5.39 Oedometer Test Results – SH-1 over SH-99

Based on the preceding discussion, for the purpose of analyzing the settlement of the foundation soil a thickness of 15 feet was assumed below the east embankment. Consolidation test results are presented in Table 5.9 and Figure 5.39. The assumed embankment geometry and soil properties used in the analysis are shown in Figures 5.40 and Figures 5.41. Settlement parameters used for the analysis, shown in Figure 5.41, are based on the average values representing natural soils below the embankments corresponding to borings BH-4, BH-5, and BH-6 in Table 5.9. These parameters are consistent with other Oklahoma soils as shown in Figures 5.5 and 5.6, although recompression parameters for the higher PI soils are higher than noted for other sites. It should be noted the higher recompression indices were obtained from unload-reload curves for these particular higher PI soils.

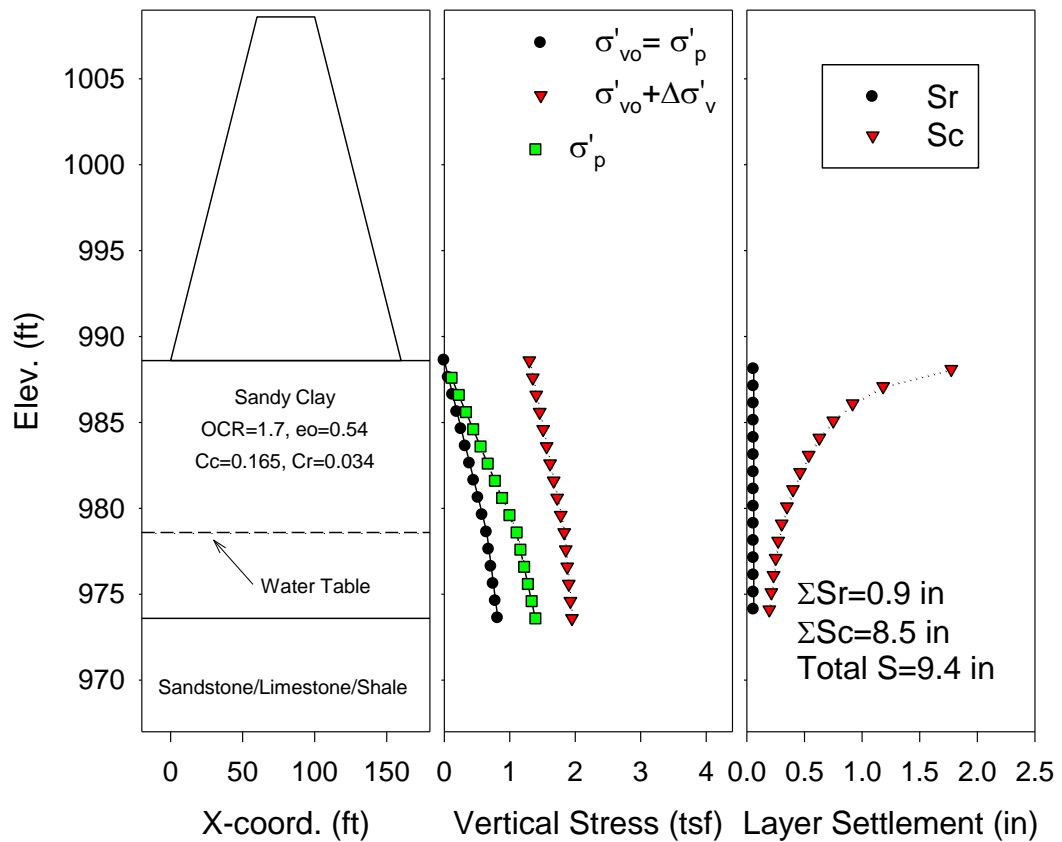
Figure 5.41 Results of Settlement Analysis – SH-1 over SH-99

Results of the settlement analysis predict a total settlement of 9.4 inches, being mostly due to virgin compression. Estimates of wetting-induced compression settlement based indicate a possible collapse settlement of about 0.4 inches for complete wetting of a 20-foot thick embankment. Wetting-induced compression was calculated based on the double-oedometer results shown in Figure 5.42 for a sample compacted to about 97% relative compaction and 2 percentage points dry of the OMC based on the standard compaction curve shown in Figure 5.43. Since wetting-induced collapse is only expected to occur in the lowest 5 feet of the embankment and collapse strains in the corresponding stress range are relatively small, predicted collapse settlements are relatively low for this fill. Results of the settlement analysis suggest the
