CRITICAL CORROSION PIT DEPTH FOR FATIGUE
CRACK INITIATION IN 2024-T3, 6061-T6 AND
7075-T6 ALUMINUM ALLOYS

Submitted to the Faculty of the
Graduate College of the
Oklahoma State University
in partial fulfillment of
the requirements for
the Degree of
MASTER OF SCIENCE
December, 2006

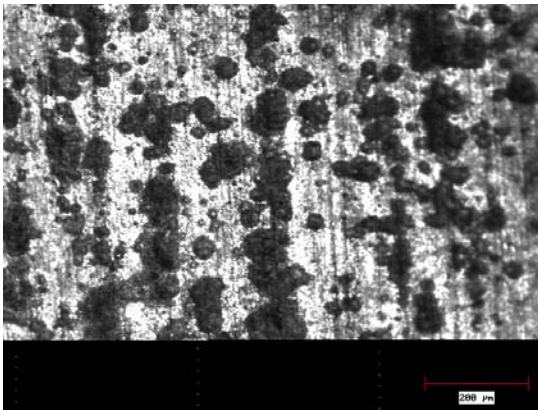
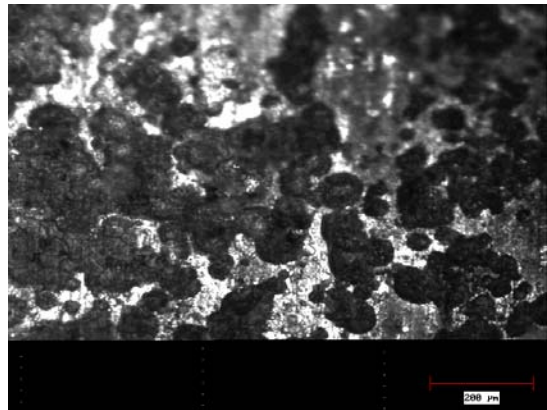
As seen in Figure 38 and 39, the 2024-T3 specimens displayed threshold pitting at the 200/1 ratio during the 30 min and 60 min tests. At the 50/1 hydrogen peroxide ratio, the pitting is very well formed and easily generated within a 30 min window. The other two alloys were much more resistant to pitting. The 7075 specimens in Figure 40 and 41 displayed essentially no pitting up to the 50/1 ratio, just a slight appearance of general corrosion. The 6061-T6 specimens, Figures 42 and 43, appeared slightly less resistant to corrosion than the 7075-T6; forming light pits at the 200/1 ratio but the heavier pits occurred best at the 50/1 ratio and the appearance was more akin to fields of light pits that began to coalesce into larger pitted areas. Further corrosion rate tests were done with 6061 and 7075 at lower ratios (40/1, 30/1 and 15/1) of hydrogen peroxide as shown in Figure 44 - 46; overall the best concentration was in the 40/1 to 30/1 range; the 15/1 ratio

Figure 39 – 2024-T3, 60 minute exposure, at ratios of NaCl solution to H₂O₂ hydrogen peroxide (200x). Vibrant pitting is obvious with increasing H₂O₂. Note the elongation of the pitting in the sheet rolled direction (vertical).

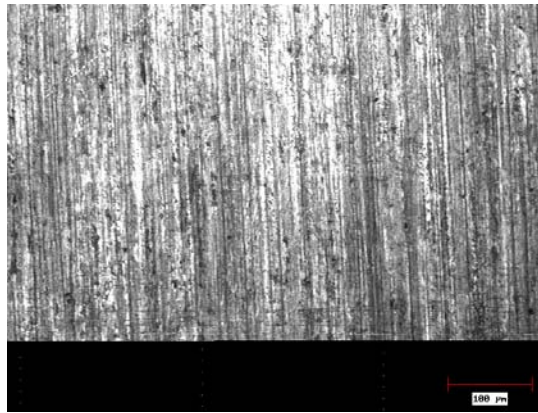
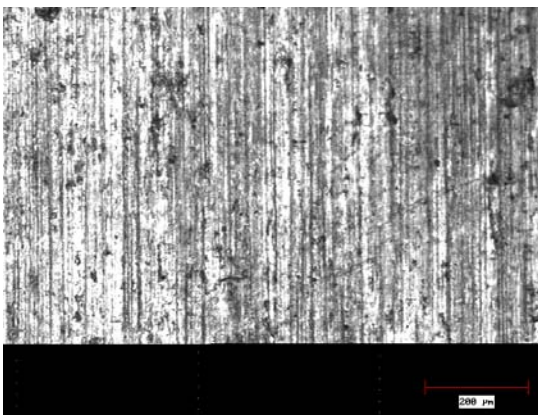
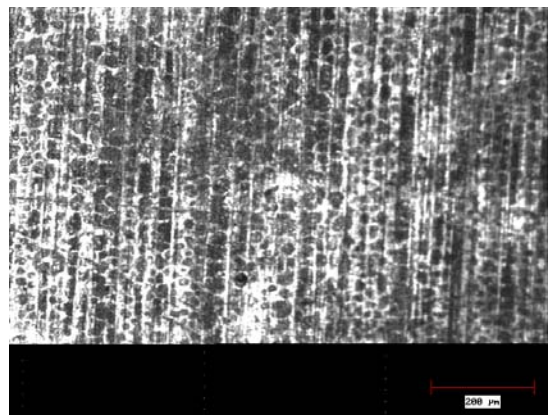
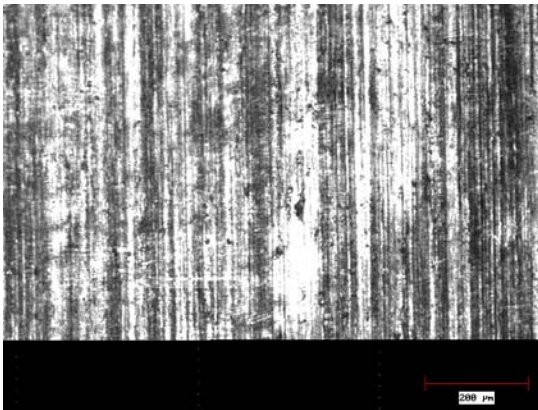
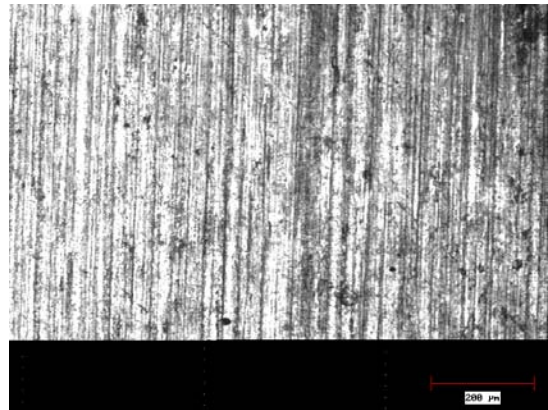
Figure 40 – 7075-T6, 30 minute exposure, at ratios of NaCl solution to H₂O₂ hydrogen peroxide (200x). Pitting is virtually nonexistent.

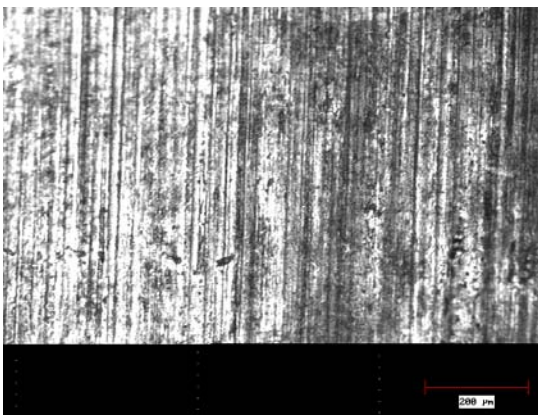
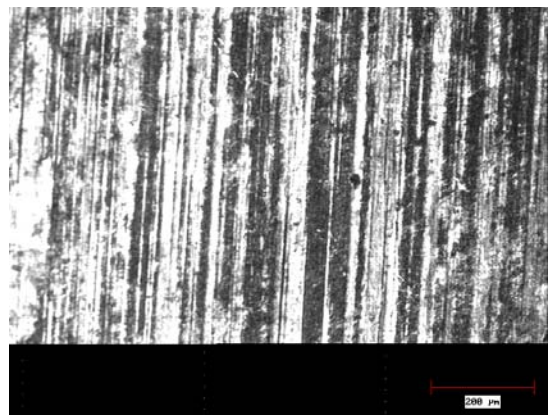
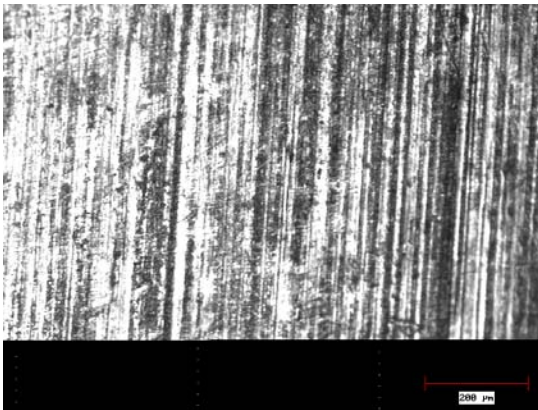
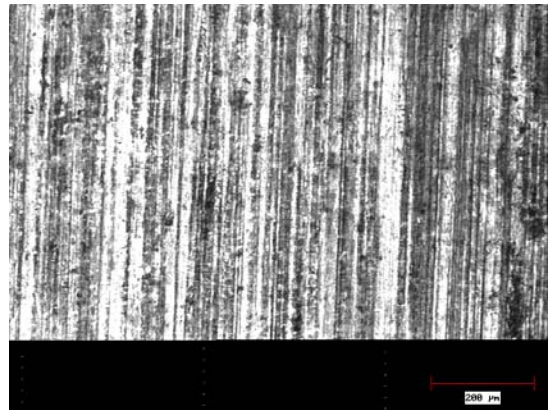
Figure 41 - 7075-T6, 60 minute exposure, at ratios of NaCl solution to H₂O₂ hydrogen peroxide (200x). Pitting is virtually nonexistent, slight general corrosion noted.

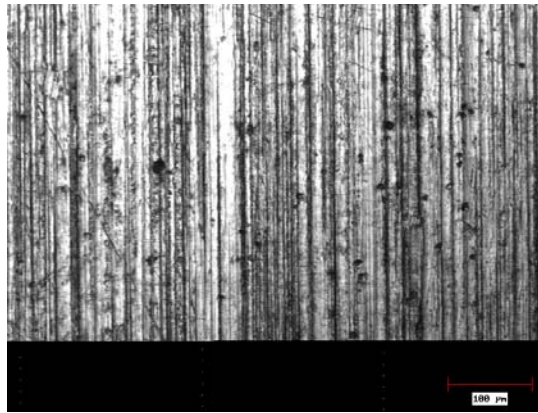
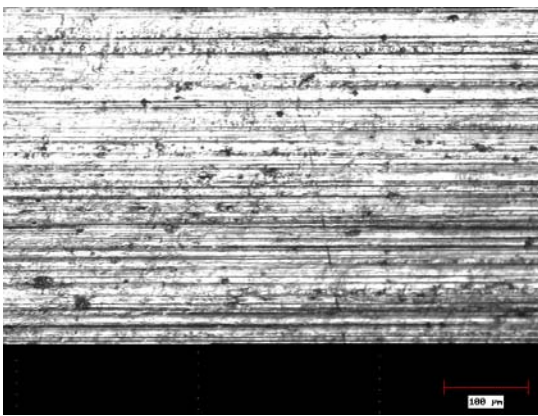
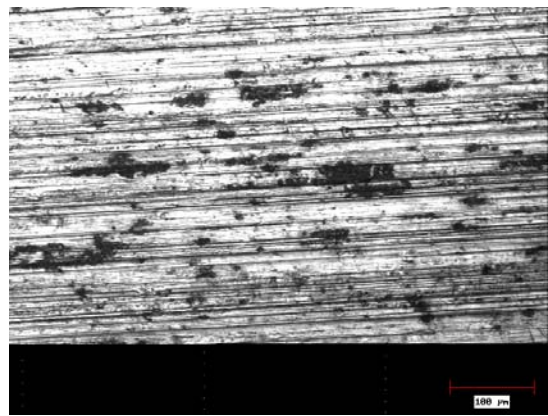
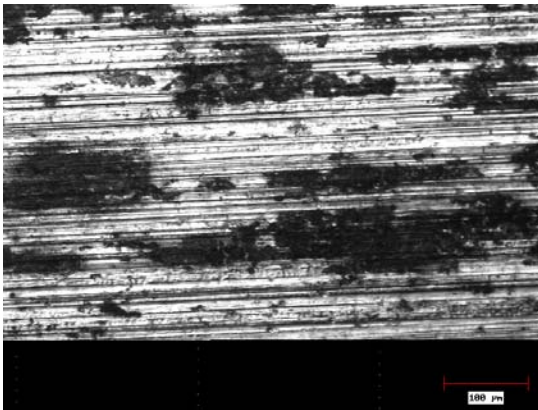
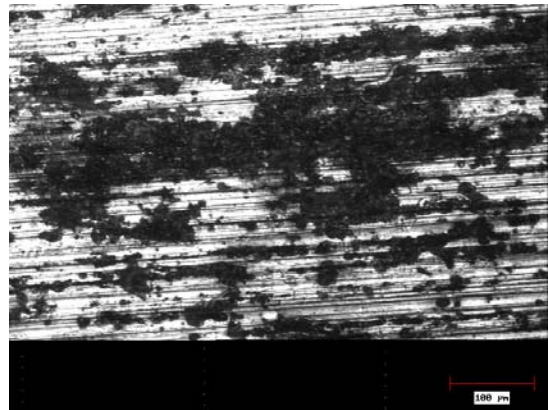
Figure 42 – 6061-T6, 30 minute exposure, at ratios of NaCl solution to H₂O₂ hydrogen peroxide (200x); pitting is steadily increasing as ratio is lowered. The larger dark regions as seen in (c) and (d) are pits merging into fields or groups. Note the elongation of the pitting in the sheet rolled direction (horizontal). (photos C-019 through C-022)

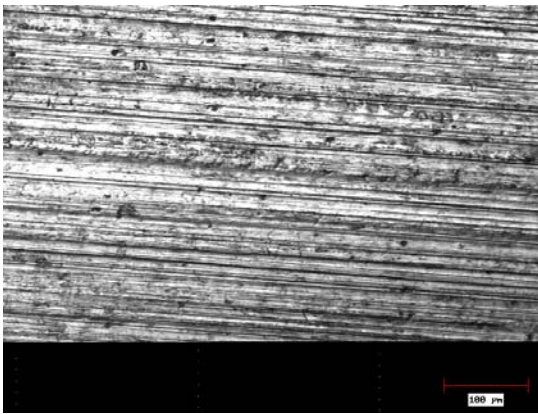
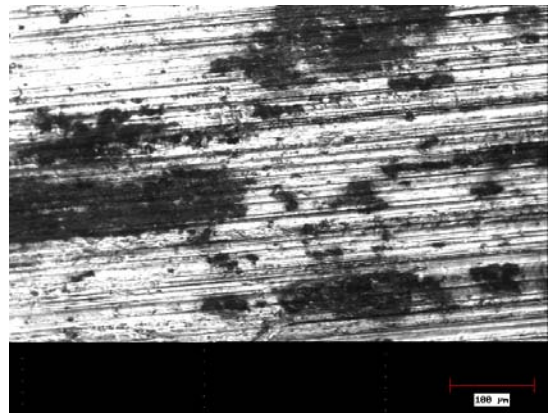
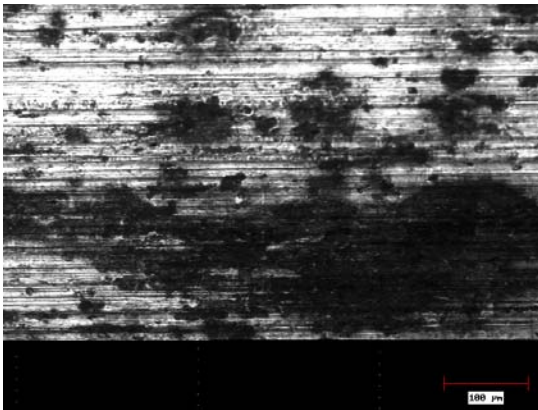
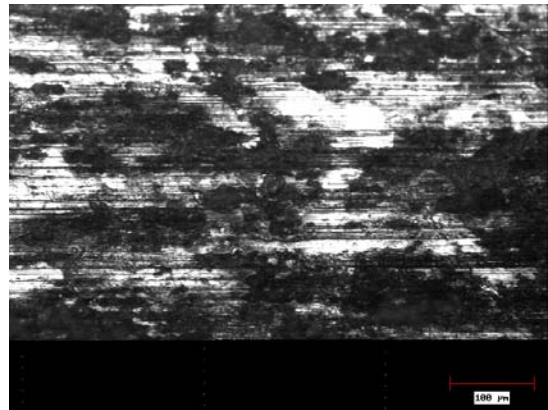
Figure 43 – 6061-T6, 60 minute exposure, at ratios of NaCl solution to H₂O₂ hydrogen peroxide (200x); further pitting as exposure time increases. The larger dark regions appear to be single pits merging into fields or groups. Note the elongation of the pitting in the sheet rolled direction (horizontal). (photos C-023 through C-026)

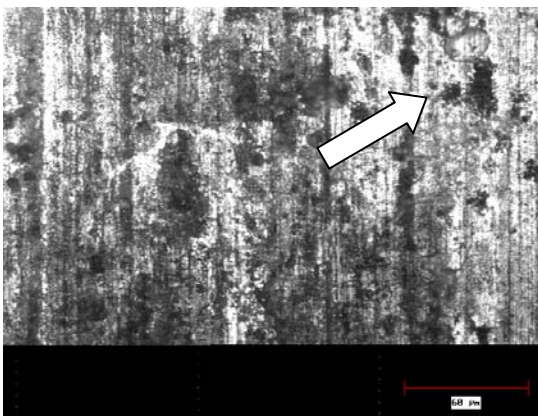
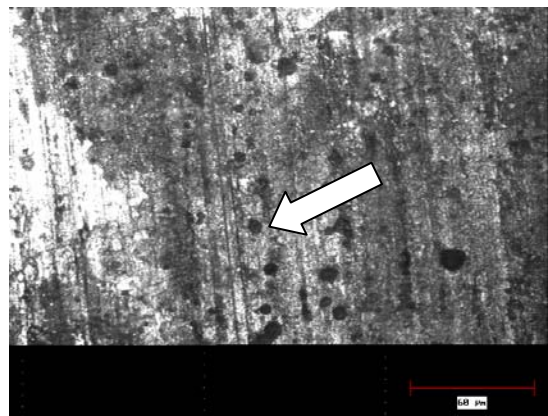
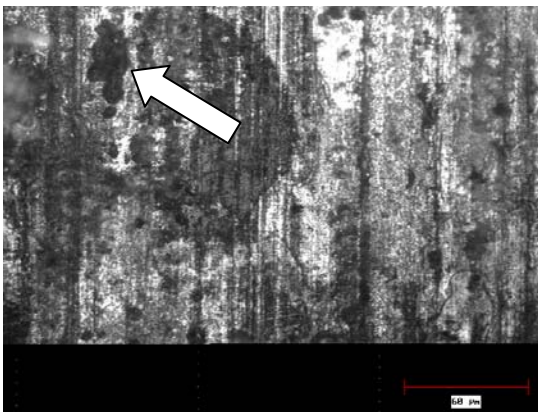
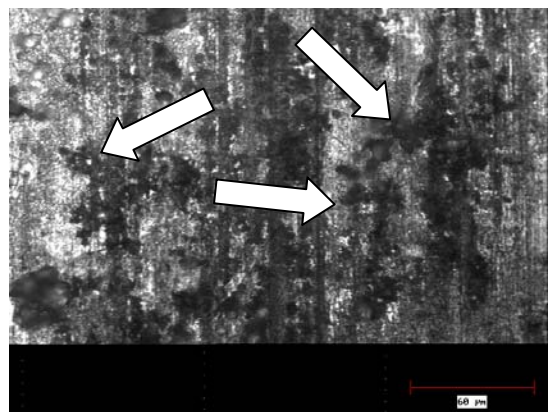
Figure 44 – 7075-T6 exposure to ratios of 3.5% NaCl solution to H₂O₂ hydrogen peroxide (500x). as indicated by arrows, pitting is becoming evident at higher levels of H₂O₂.

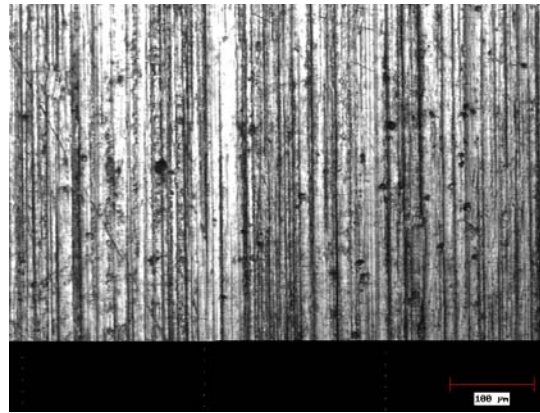
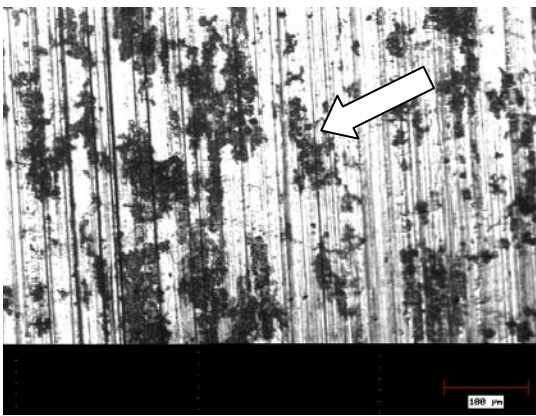
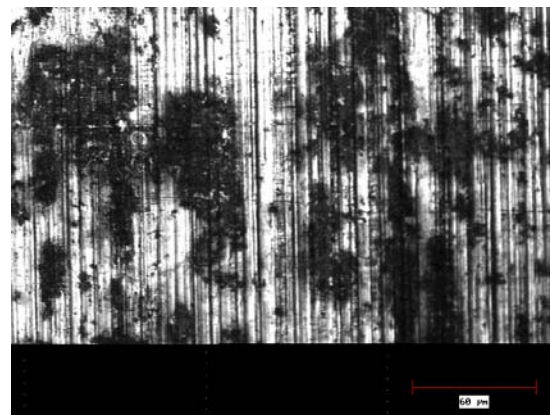
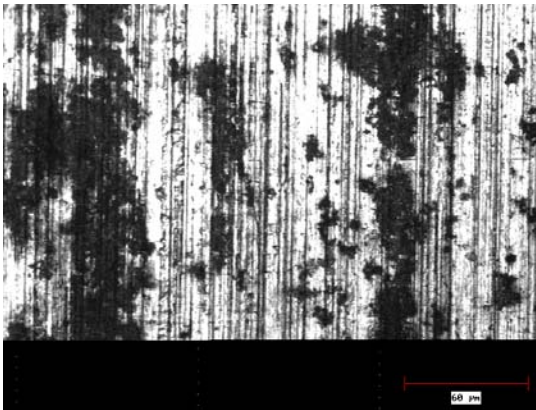
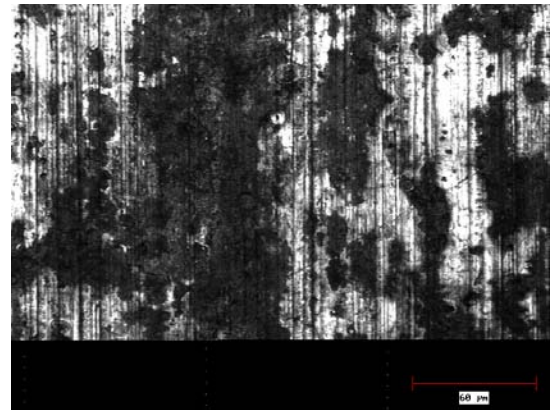
Figure 45 – 6061-T6 exposure to ratios of 3.5% NaCl solution to H₂O₂ hydrogen peroxide (200x). Pitting is becoming evident at 30/1 ratio of H₂O₂ at the 15 minute exposure as shown in (a); as exposure time increases the pits coalesce into the larger dark regions. Note the elongation of the pitting in the sheet rolled direction (vertical).

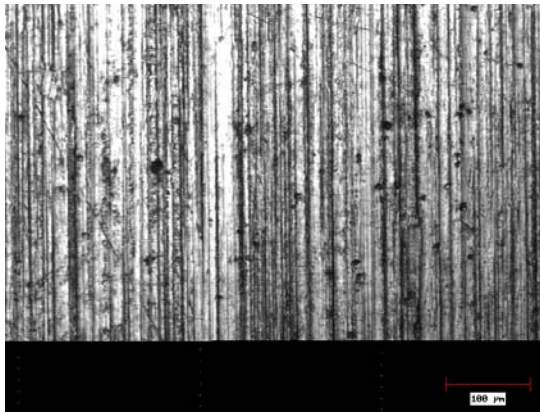
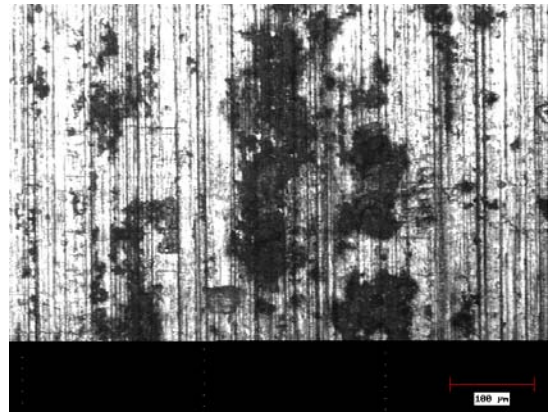
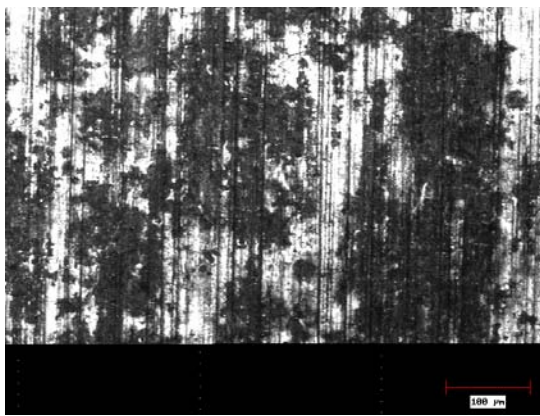
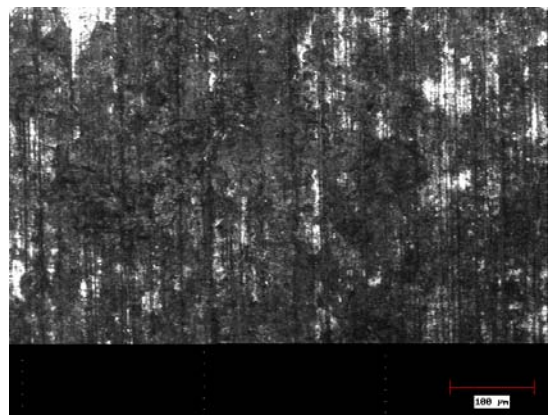
Figure 46 – 6061-T6 exposure to ratios of 3.5% NaCl solution to H₂O₂ hydrogen peroxide (200x). Pitting is becoming evident at 60/1 and 30/1 ratios of H₂O₂ within the desired 60 min test window. Corrosion at the 15/1 ratio is becoming excessive as individual pits are coalescing into large fields and appears more like general corrosion than pitting. Note the elongation of the pitting in the sheet rolled direction (vertical).

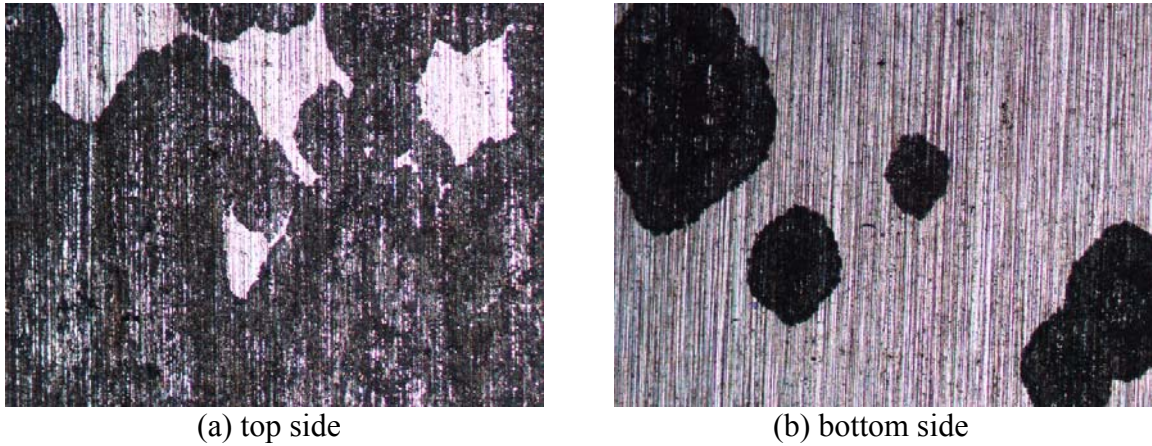
Figure 47 – 2024-T3 corrosion each side of sheet, 3.5% NaCl at 30/1 ratio H_2O_2 . Note the significant difference between the corrosion rates of the top and bottom. (photos CR-007/-008)

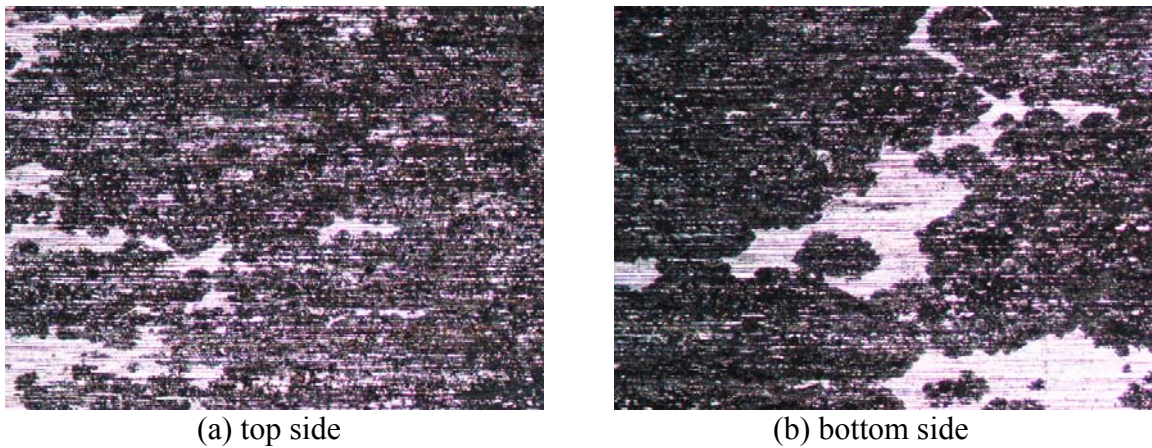
Figure 48 – 2024-T3 laser cut corrosion each side of sheet, 3.5% NaCl at 30/1 ratio H_2O_2 . Slight difference between the corrosion rates of the top and bottom. (photos CR-009/-010)

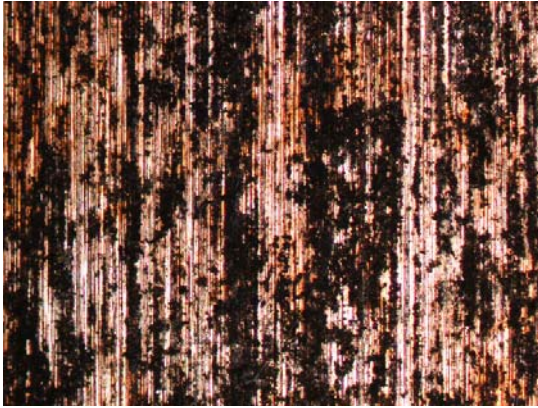
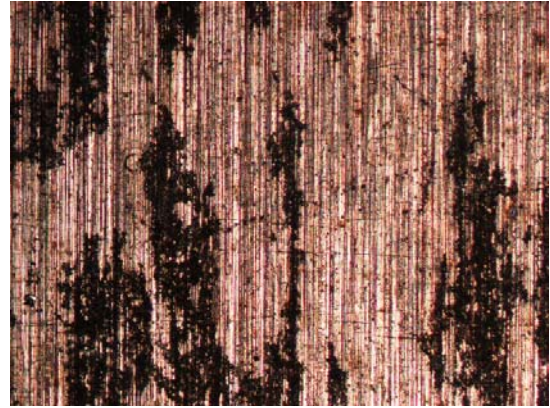
Figure 49 – 6061-T6 corrosion each side of sheet, 3.5% NaCl at 15/1 ratio H_2O_2 . Notice the significant difference between the corrosion rates of the top and bottom sides. (photos CR-001/002)

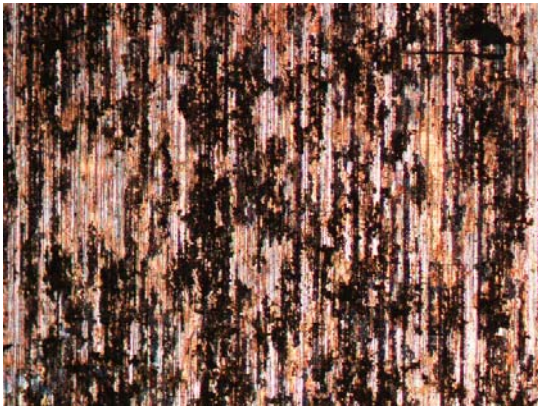
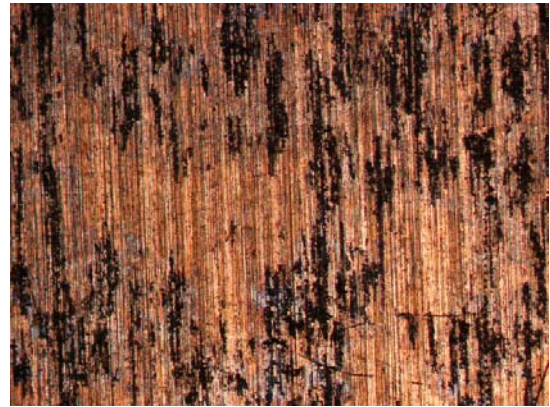
Figure 50 – 7075-T6 corrosion each side of sheet, 3.5% NaCl at 15/1 ratio H_2O_2 . Notice the significant difference between the corrosion rates of the top and bottom sides (photos CR-003/-004)

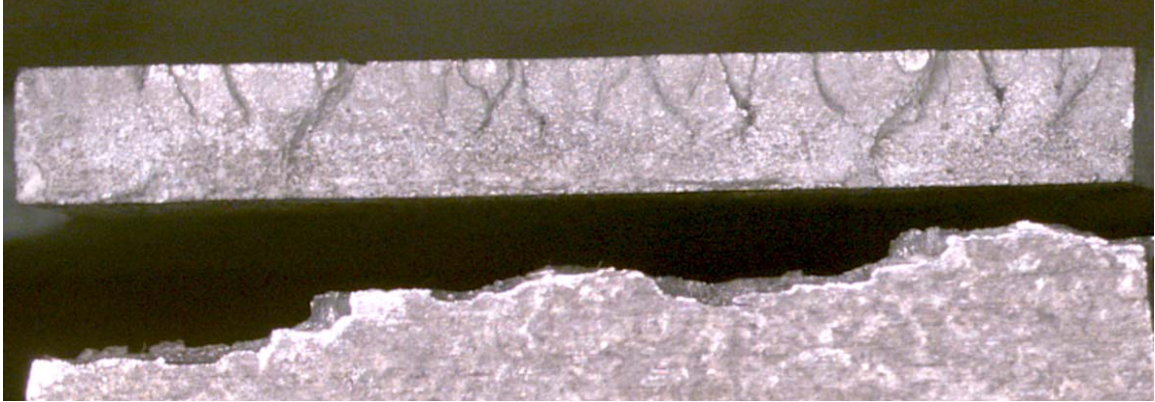
Figure 51 – Specimen T-1, 2024-T3 corroded during cyclic loading, exposed to 15/1 ratio 3.5% NaCl solution to H₂O₂ hydrogen peroxide, deflection = 17 mm (uncalibrated), N_f = 22300 cycles. The 15/1 ratio resulted in a high rate of corrosion and overrode any link to accelerated corrosion under cyclic loading conditions; pursuing threshold pitting would need to be accomplished at a much lower hydrogen peroxide ratio. Note approximately 20 ratchet marks; it appears there may be individual cracks that traversed much of the cross-section before linkage. (photo # TPS-003)
