**FINAL REPORT ~ FHWA-OK-22-02**

# **A SYSTEMS APPROACH FOR DESIGN, CONSTRUCTION, AND MAINTENANCE OF BRIDGES AND ADJACENT ROADWAYS**

**School of Civil Engineering and Environmental Science (CEES)**  
**The University of Oklahoma**  
**Norman, Oklahoma**

**January 2022**

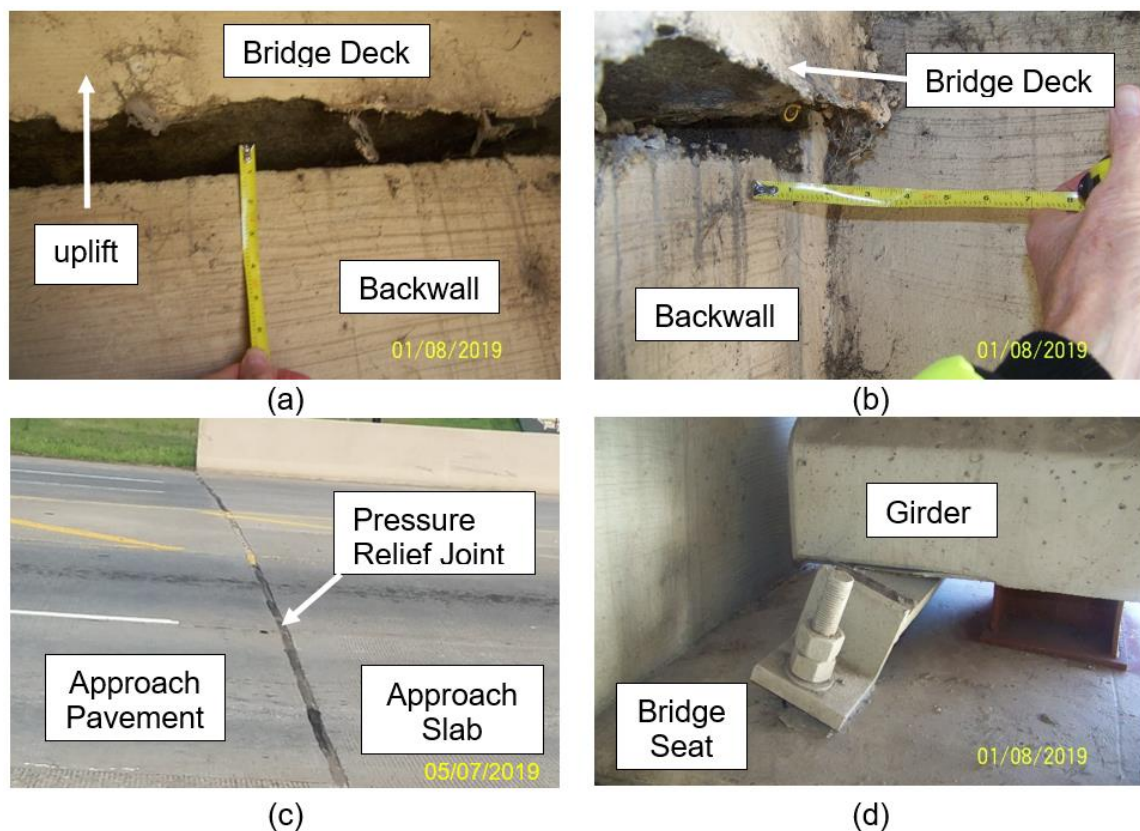
**Figure 24. Shields Boulevard over I-40: (a) deck uplift, (b) deck movement, (c) uncompressed relief joint, (d) rotated bearings**

Sometime prior to 2019 it was discovered that the southernmost bridge span had moved north by approximately 3 inches. Interestingly the pressure relief joint located at the end of the south approach slab had not compressed. In addition, the span had lifted approximately 1 inch at the abutment. It appears the span was being compressed by the pavement south of the bridge. Photographs provided by ODOT showing the deck movement at the abutment, the uncompressed pressure relief joint, and the rotated bearings are shown in Figure 24.

Since excessive pavement pressure was determined to be the cause of the approach slab shoving into the bridge, a full depth joint was placed adjacent to the approach slab. A single 12-inch full depth asphalt joint was placed at the end of the approach slab. The joint was installed in April 2020 by ODOT. A photograph of the completed joint is shown in Figure 27. The photograph was taken in December 2020.

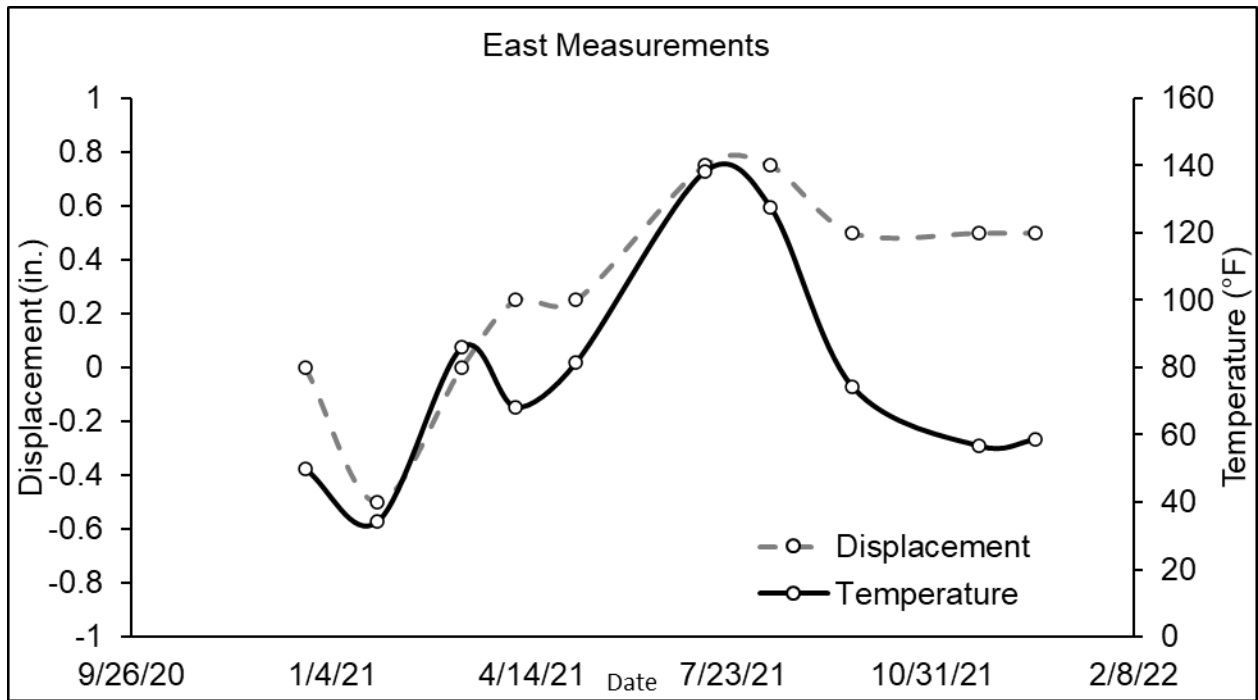
**Figure 30. Shields Boulevard over I-40: Monitoring results - east side**

The displacement as measured at the wingwall and the temperature are shown in Figure 30 and Figure 31 for the east and west sides of the abutment, respectively. The measured movement is relative to the initial measurement which was set to zero.

Throughout the monitoring period the recorded temperature of the pavement ranged from 34.4 °F to 138.2°F. The maximum movement in the direction of the south bridge pier throughout the monitoring period was 0.75 inch for the east side and 0.5 inch

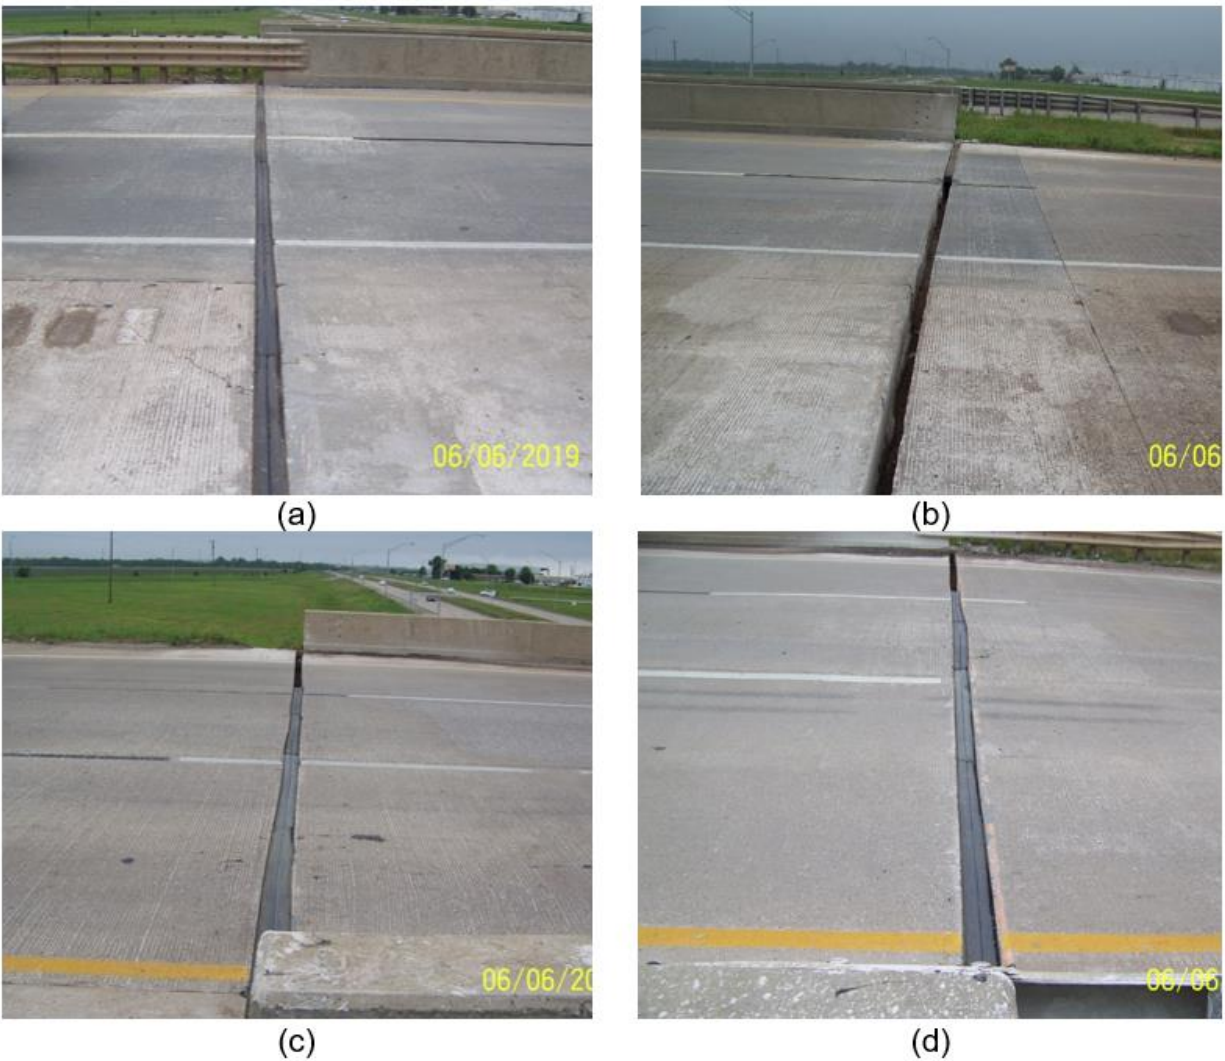
**Figure 35. I-40 over SH-81 Joint Installation: (a) Westbound bridge – east approach, (b) Westbound bridge – west approach, (c) Eastbound bridge – east approach, (d) Eastbound bridge – west approach**

The rigid concrete approach pavement was pushing on the approach slab and bridge deck. The pressure was enough to cause the steel girder ends to touch under

To prevent further damage to the bridge from excessive pavement pressure, four pressure relief joints were installed. One pressure relief joint was installed adjacent to each abutment. The joint was approximately 4 inches wide at the time of installation. The Bridge Expansion Joint System (BEJS) from EMSEAL® was used as the pressure relief joint. The BEJS joint is a compression joint made from foam that is covered in a layer of silicone for the surface exposed to the elements (EMSEAL 2021). The joint is attached to the concrete bridge deck ends using epoxy. A bead of silicone is then used to seal the top edge of the joint to the bridge deck. The BEJS joints used for this project was in 5 feet sticks. Silicone was used to seal the top of the joint at the stick connections. A photograph of the joint used for this project from the EMSEAL product sheet is included in Figure 34.

The pressure relief joints were installed on June 6, 2019. Photographs of the joints during and immediately after the installations are shown in Figure 35. The photographs were provided by ODOT.

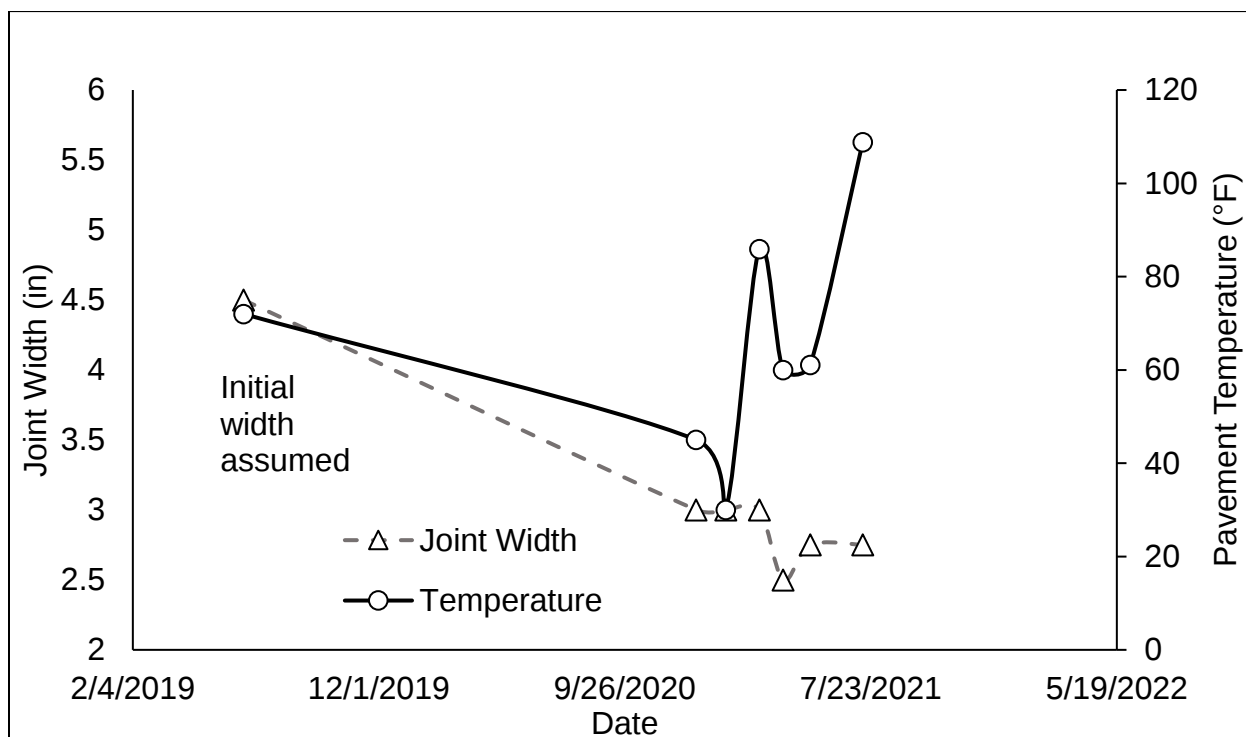
**Figure 37 I-40 over SH-81: Joint width WB-west approach**

The pavement pressure relief joints appear to be functioning correctly. However, the west approach joint on the westbound bridge is currently closing (Figure 37). The joint is currently about half the original width. The expansion joint does not appear to be rebounding for the 2021-2022 cooling season. The temperatures thus far have been mild, the joint may still relax as the temperature decreases for longer periods of time. It is not known why the west approach joint on the westbound bridge closed more than the other joints. There is approximately 3,600 feet of straight rigid pavement west of the bridge before another structure is encountered. In the east direction there is a mile or more of straight rigid pavement before the roadway begins to curve. The presence or absence of joints in the adjacent pavement is not known.

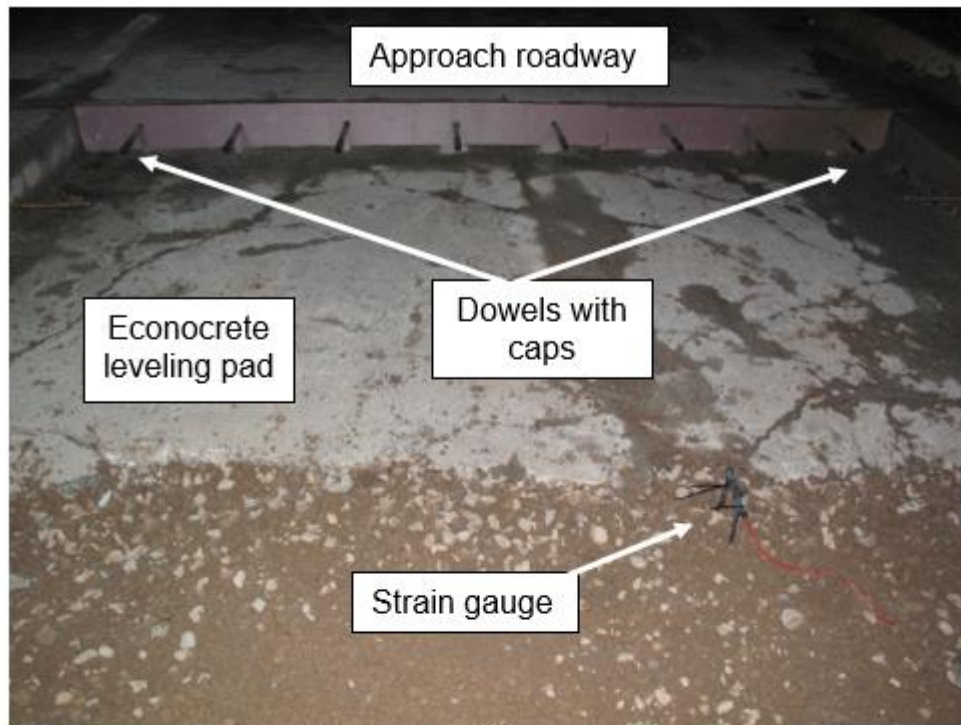
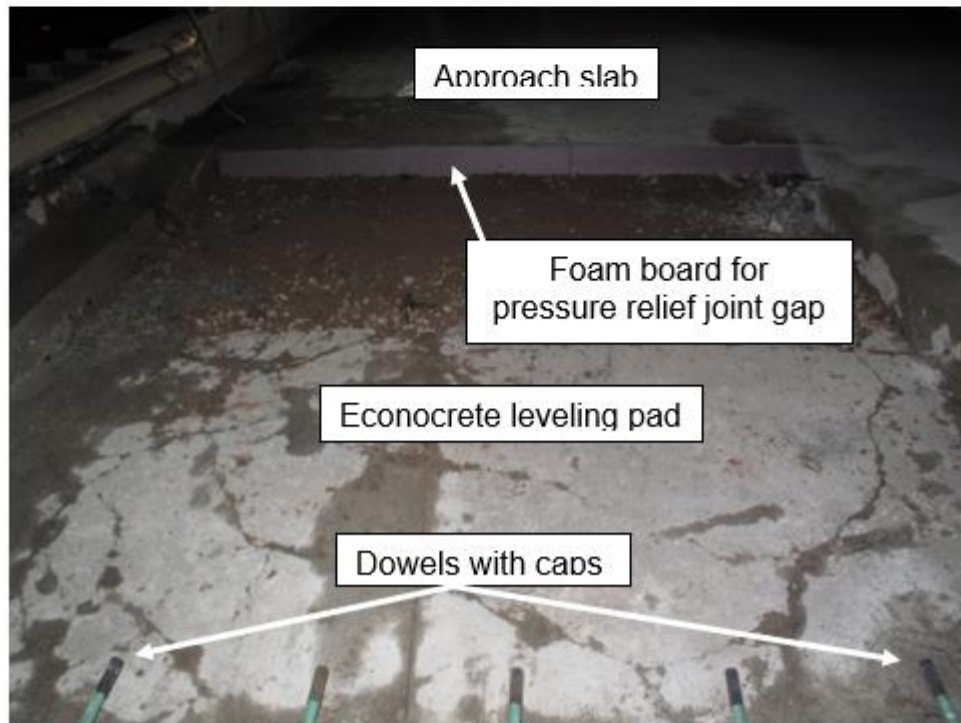
**Figure 46. 19th Street over I-35: Approach roadway replacement (a) facing approach roadway, (b) facing approach slab**

In December 2019 the planned construction started on the east side of the bridge. An additional 30 ft of pavement was replaced in the south driving lane. The additional approach pavement was replaced due to deterioration of the panels. Communication errors caused this initial attempt at the repair to be constructed incorrectly. A gap was not left open for the doweled expansion joint. Instead, a rubber expansion joint material was placed in the gap. Furthermore, the COVID-19 pandemic delayed the installation of the pressure relief joints. This delay caused the gap for pressure relief to close about halfway for the non-doweled joint. The amount of concrete to be sawed off so the joint

could be installed was too thin. The concrete would break rather than cut away from the edge of the panel. This would leave a rough edge to attach the joint to. Since the joint is glued into place a smooth edge is required. For these reasons it was decided to redo the panels.

Prior to the installation of pressure relief joints, approximately 15 feet of the approach pavement was replaced for all lanes on both sides of the bridge. Dowel holes were drilled into the adjacent approach pavement. A gap for the pressure relief joint was left on each side of the new panel. The dowels provided load transfer on the approach roadway side of the new panel. A schematic showing the locations of pressure relief joints is shown in Figure 45.

The east and west side panels were replaced on the nights of September 21, 22, 23, and 24, 2020. A 2-inch gap was left on each side of the new panels for a pressure relief joint to later be installed. The gap was temporarily filled with foam board and sealed with silicone. A representative from OU was onsite during the construction on the nights of September 21 and 24, 2020. A strain gauge was embedded in the concrete of the outside driving lane in each direction on both sides of the bridge for a total of four concrete embedded strain gauges. Photographs showing the construction and placement of the strain gauges are shown in Figure 46. A portion of the new panels are underlain by an existing layer of Econocrete. The Econocrete, shown in Figure 46, was used as a leveling pad when the bridge was originally constructed. Photographs showing the panels completed are shown in Figure 47.

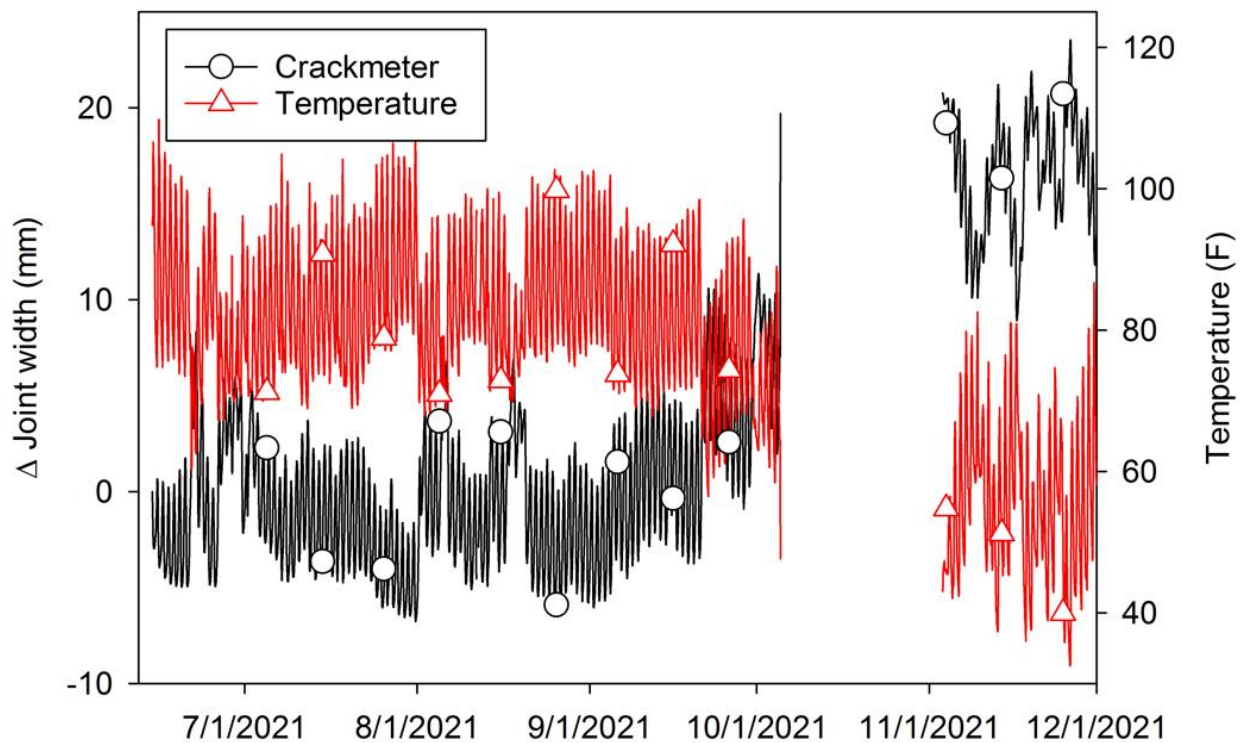
**Figure 58. 19th Street over I-35 pressure relief joint width:  
East approach south non-doweled joint**

The non-doweled pressure relief joints experienced much more movement than the doweled pressure relief joints during the monitoring period. The joints on the east side of the bridge experienced more movement than the west side. This is most notable from the non-doweled joints. The non-doweled joints on the east side experienced about 20 to 25 mm of movement while the west side non-doweled joints only experienced 2 to 4 mm of movement. The daily variations are also greater for the non-doweled joints on both sides of the bridge. The joints appear to be functioning correctly and responding to daily and seasonal temperature changes effectively.

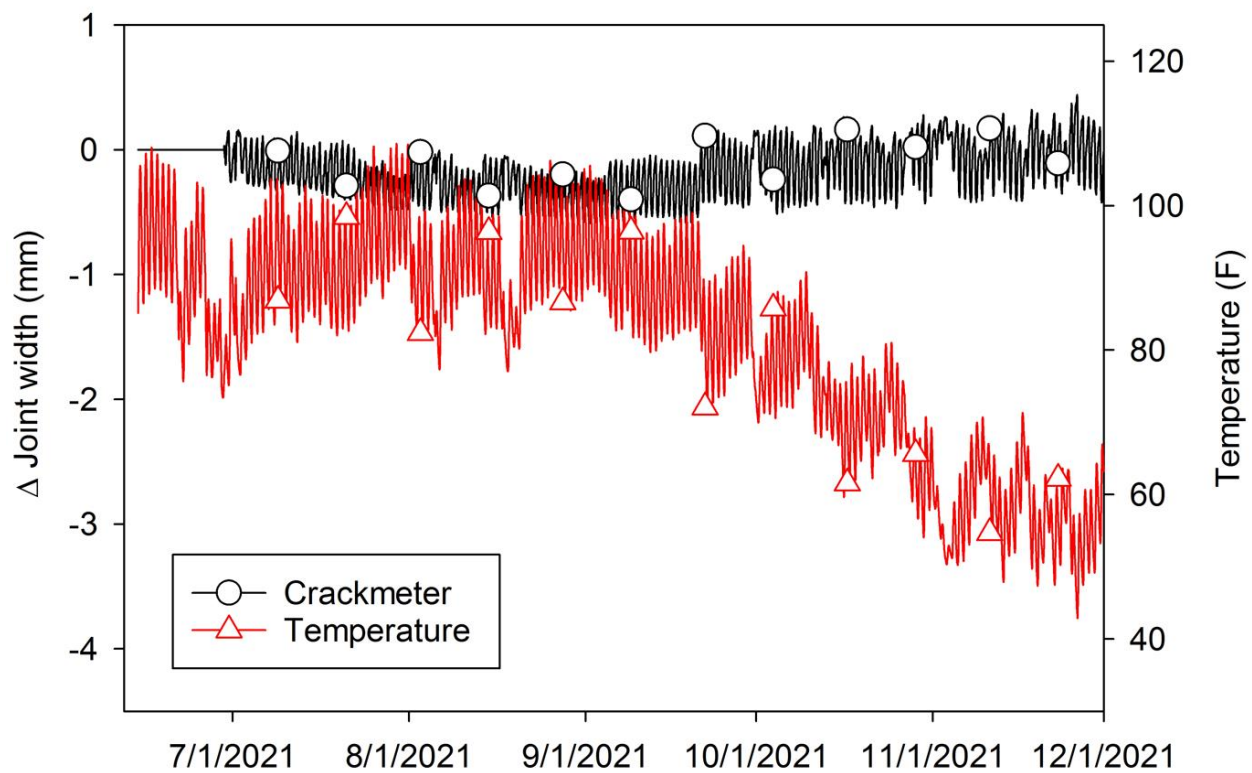
**Figure 65. 19th Street over I-35 pressure relief joint width:  
West approach north doweled joint**

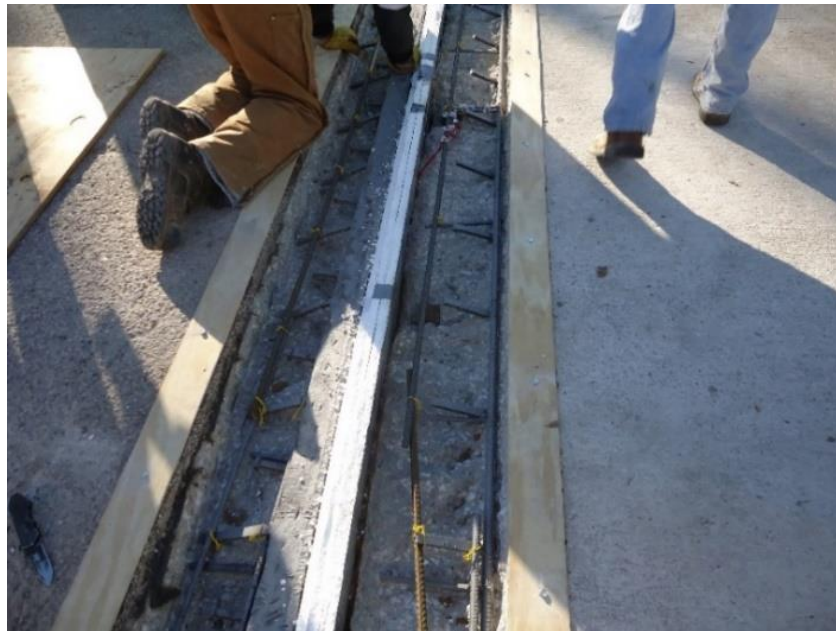
encapsulate the remainder of the older joint. Existing rebar was kept in place and cleaned by sand blasting and a single No. 5 rebar (not epoxy coated) was placed parallel to the joint on each side. The concrete surface was roughened during removal and was sand blasted clean. Figure 70 shows the joint after concrete removal and other preparations, except for placement of the top form. All exposed concrete surfaces were wetted to a damp, surface dry condition immediately before the top form was placed.

**Figure 70. Joint after removal of existing concrete and before placement of the top form**

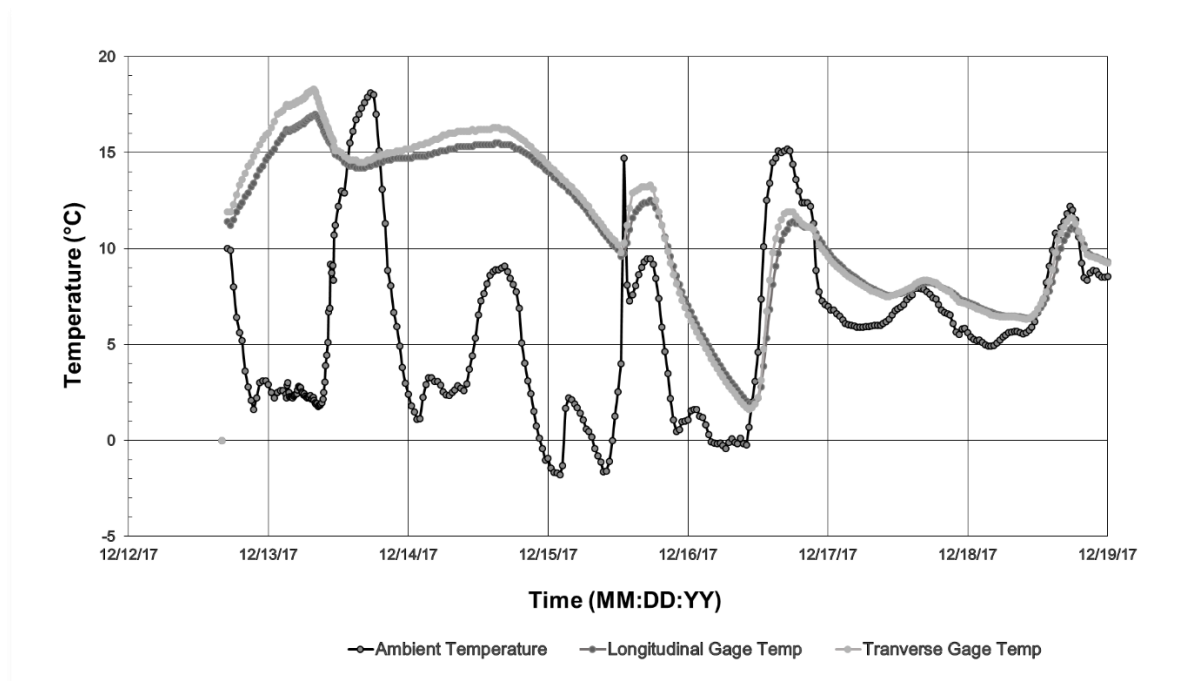
The joint was covered with insulating blankets with the top form still in place and heat lamps were put in place to facilitate heat curing at 3:30 pm, approximately 2.5 hours after completion of the pour. The Geokon datalogger did not function properly due to a bad set of batteries, so manual measurements of the vibrating wire strain gages and associated temperatures were taken for the first 10.5 hours after the start of heat curing. The datalogger batteries were replaced and the gages were hooked to this apparatus at 2:00 am on December 13. Throughout heat curing, the internal concrete temperature slowly increased (shown in Figure 72), but the same 80° to 95° C measured in the lab for a similar joint detail were never observed. Measured temperatures were consistently higher than the ambient temperature, which reached freezing during the night. The heat lamps were turned off at 6:00 am and cylinders were taken back to Fears Structural Engineering Lab for testing. Cylinders were tested at an age of approximately 20 hours including 15 hours of attempted heat curing. Compressive strength test results are presented in Table 1.

**Figure 72. UHPC temperature over the first week after casting**

The compressive strength measured at 20 hours was well below the targeted value of 14,000 psi. Based on the low early age compressive strength and concerns about the time required to achieve strength necessary to reopen the roadway to service, the Division 3 Engineer made the decision to halt the joint replacement after the first section. Traffic control was kept in place to protect the UHPC joint for 3 days at which time the compressive strength was in excess of 11,000 psi, which was still less than the targeted 14,000 psi. However, the location of the joint on the shoulder of the roadway

limits the amount of loading it would receive. The low ambient temperatures at the time of casting were primarily to blame for the slow strength gain.

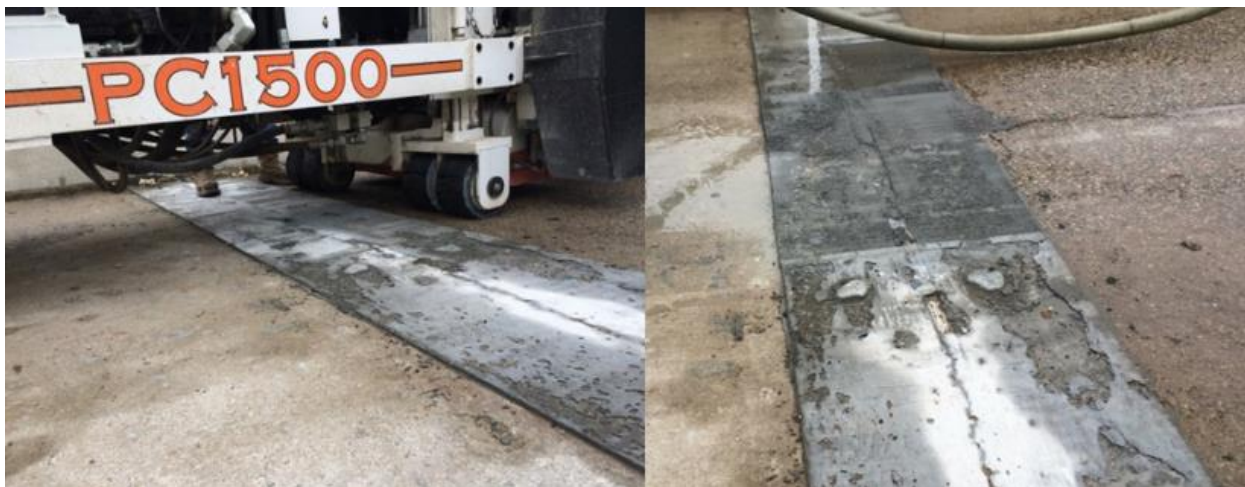
The UHPC used for the joint was cast  $\frac{1}{4}$  inch above the intended finished grade to allow for grinding of the portion containing a high concentration of air bubbles that tends to collect at the top of the material. Manhattan Road & Bridge agreed to provide grinding services in conjunction with another project in the area. Grinding was conducted on December 20, 2017 by a subcontractor to Manhattan, with two representatives of Manhattan present at the time of grinding. The UHPC had a compressive strength of approximately 15,500 psi at the time of grinding, and the machinery operator indicated no problems grinding the material. Photos before and after grinding are shown in Figure 73. The difference in elevation between the two bridge sections did create a problem in grinding the UHPC on both sides of the joint to the same elevation. A decision was made by the research team and ODOT maintenance engineers to match the grade of the higher section to avoid any damage to the bridge deck. The dimensions of the grinding equipment also did not allow for grinding immediately adjacent to the parapet. The difference in ground surfaces can be seen in Figure 73 and the entire section after grinding is shown in Figure 74.

**Figure 73. UHPC joint before (left) and after (right) grinding**

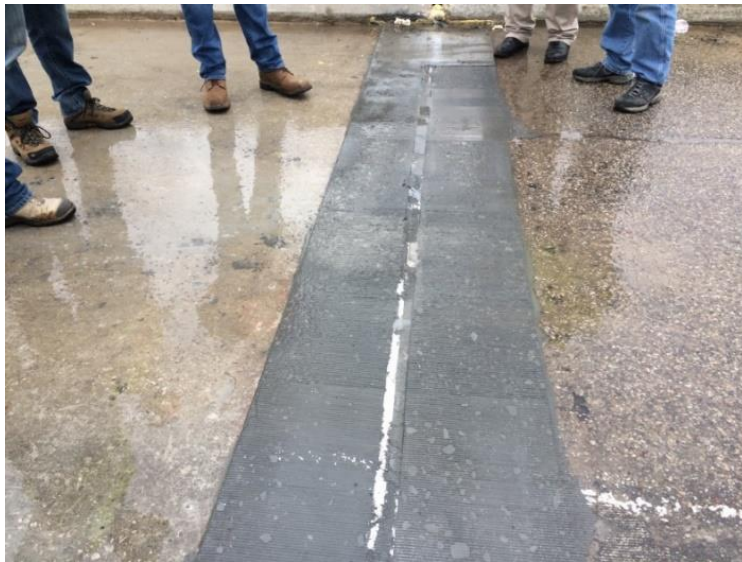
**Figure 74. Entire Joint after grinding**

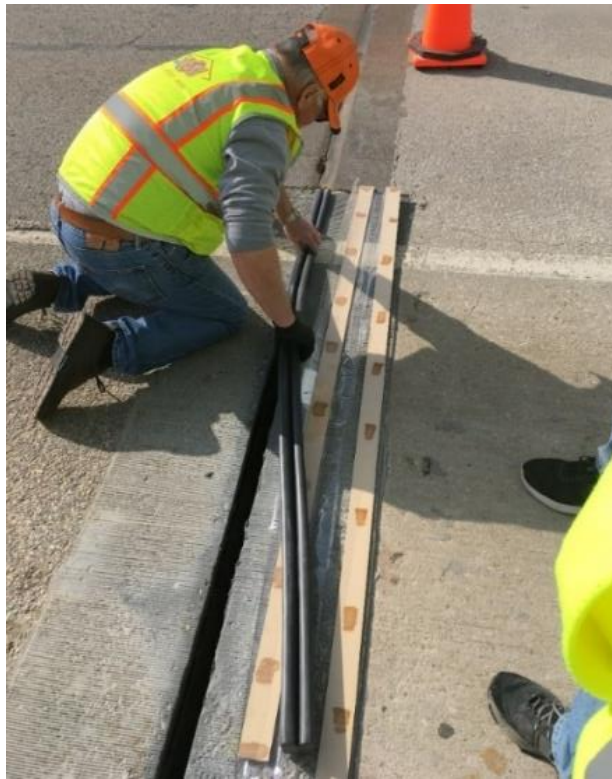
**Figure 75. Installation of BEJS material by SSI Highway Products personnel**

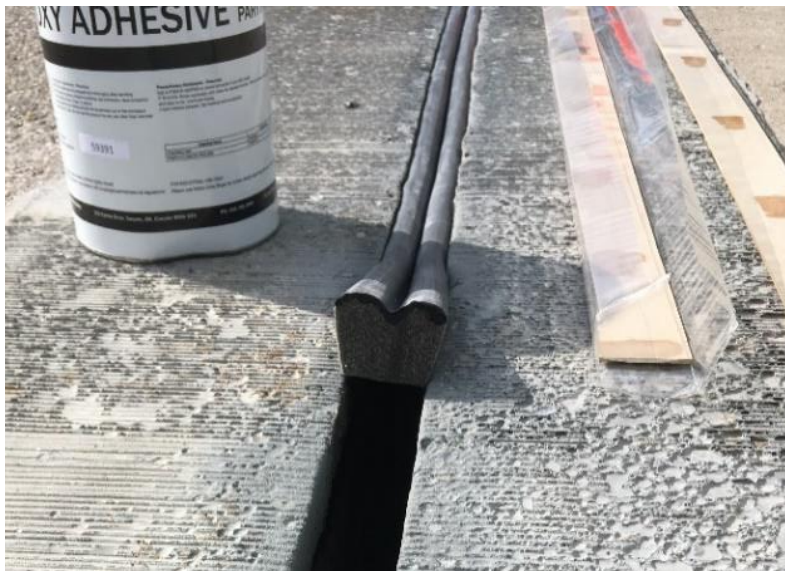
A representative of SSI Highway Products and the Division 3 bridge maintenance crew installed a precompressed EMSEAL BEJS (bridge expansion joint system) joint fill on March 30, 2018. Figure 75 shows placement of the sealant material after each header had been coated with epoxy. Figure 76 shows the end of a section of sealant where a bead of epoxy was applied to connect the next section. Since the original joint opening was wider than the planned 2 inch opening, the new joint headers were formed to produce an opening with a step down from a 2 inch width to a 3 inch width approximately 2 inches from the top of the joint. This prevented the joint material from being installed with the appropriate recess from the top of the joint. It was determined that this should not be a major issue since most of the replacement is on the shoulder area of the bridge but was noted for future installations. The completed joint sealant material is shown in Figure 77.

**Figure 76. End of BEJS stick prepared for splicing**

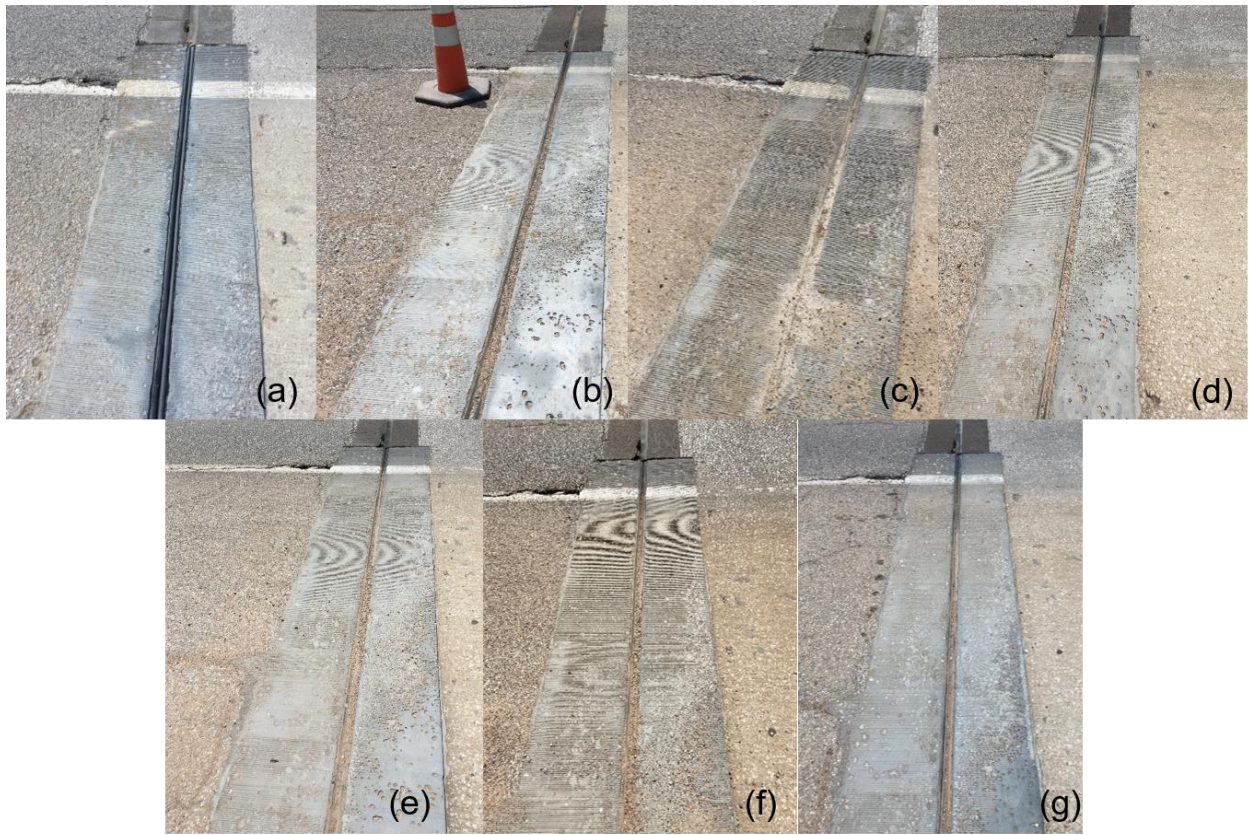
from the matrix, but no deterioration of the UHPC material around these locations was observed. Figure 80 shows photos of the joint over time. It is apparent from these photos that other than being covered with grit and gravel the joint is in very similar condition to when it was placed after almost 4 years of exposure. In September 2021 some cracking and spalling was observed on the SW corner of the joint where the header elevation is higher than the west deck section. Throughout the monitoring period the adjacent elastomeric nosing and poured silicone joint showed visible deterioration.

**Figure 80. Photos of the UHPC joint on the SH-3E bridge over the North Canadian River (a) immediately after BEJS placement, on March 29, 2018 3 months after casting, (b) 7 months after casting, (c) 14 months after casting, (d) 21 months after casting, (e) 29 months after casting, (f) 33 months after casting, and (g) 45 months after casting**

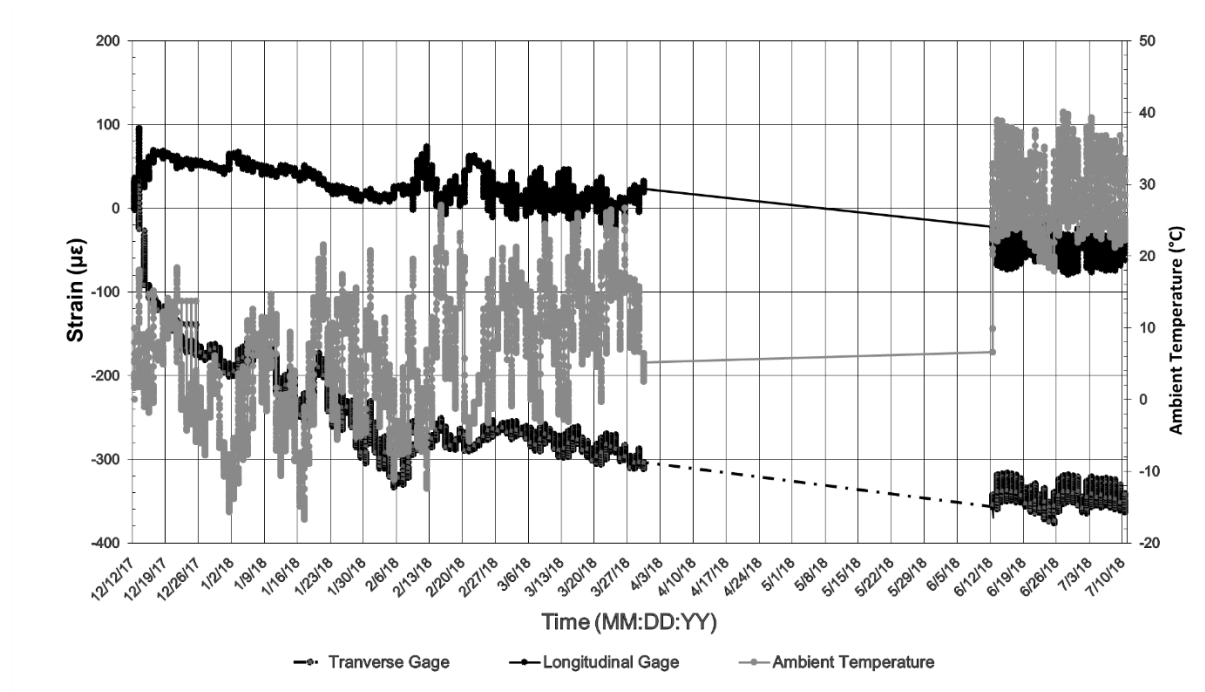
Strain gage data collected over the first seven months after placement shown in Figure 81 indicate that the UHPC showed limited shrinkage in the direction restrained by the deck concrete and more shrinkage in the direction transverse to the joint where one edge was unrestrained. In both cases the measured shrinkage was less than what would be expected for a free condition. The header material appeared to act together with the bridge deck relative to movement caused by changes in ambient temperature.

**Figure 81. Strain measured in the UHPC material for approximately seven months after placement**

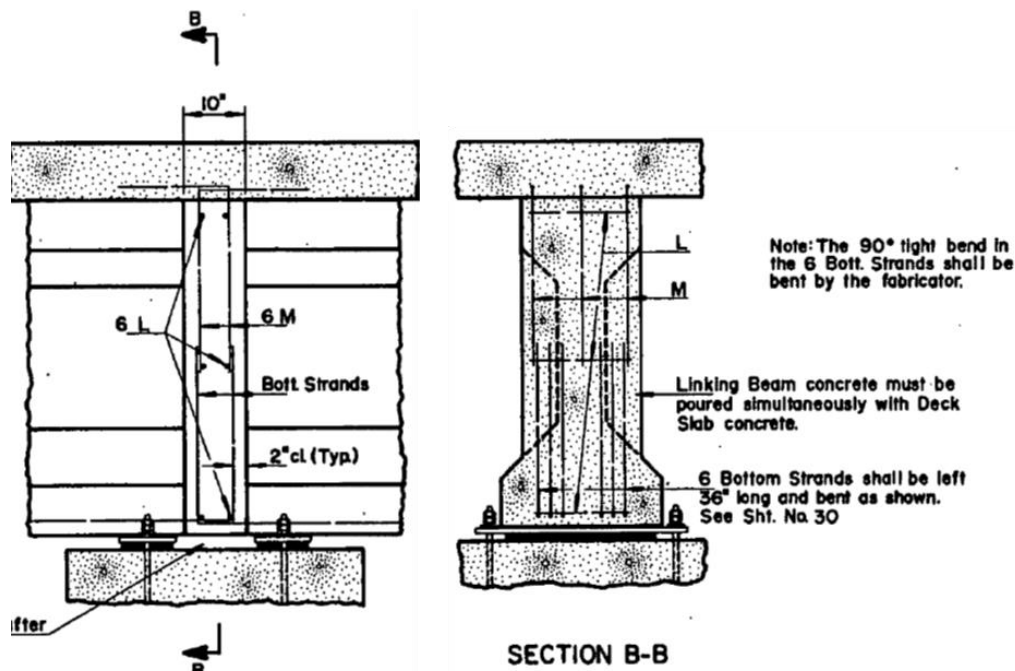
The original details used for the joint construction are shown in Figure 85. To construct the joint, the girders were placed on the pier cap with their ends 10 inches apart. Six prestressing strands at the bottom of the girder extended a length of 3 feet past the girder ends and were bent at a 90° angle approximately 6 inches from the girder face. At the top of the joint, six No. 4 Grade 60 reinforcing bars that were bent to a 90° angle were placed at the top of the joint with the 18 inch leg tied to the bottom deck bars and the 32 inch leg extending down into the joint. Six straight 18 inch long

**Figure 85. U.S. 183/412 over Wolf Creek continuity joint details from original drawings**

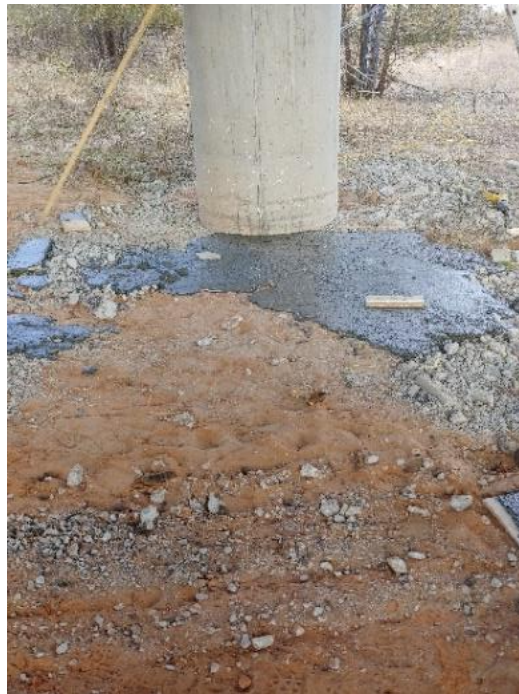
The joints were replaced in two stages to allow for traffic in one lane while the contractor worked on the other half of the bridge. Mobile traffic lights placed at each end of the bridge were used to automatically control traffic. The first stage of replacement was on four joints on the north side of the deck (two on pier 2 and two on pier 3) on November 6, 2019. Immediately after the test batch, a full batch was mixed to start pouring into the continuity joint forms. However, after filling approximately half of the first joint, the forms began to leak around the edges. The leak appeared to be caused by hydrostatic pressure that UHPC creates due to its tremendous flowability. Each joint was more than 5 feet tall which resulted in significant pressure on the bottom of the formwork. The contractor was unable to stop the leak, so the forms were removed, the joint was cleaned out, and the formwork replaced for a second attempt. Even though the material had been in the forms for over an hour, it flowed out of the continuity joint

formwork, off of the pier cap, and formed a puddle on the ground (Figure 93).

**Figure 93. UHPC from failed formwork**

Compressed air and a pressure washer were used immediately to clean the remaining material out of the joint. The forms were rebuilt and braces were wedged between the forms to force the forms against the girders and brace against lateral movement to reduce the chance of leaking. For the exterior girder the braces were supported by lumber directly attached to the deck soffit and to the girder bottom flange. The braced forms are shown in Figure 94.

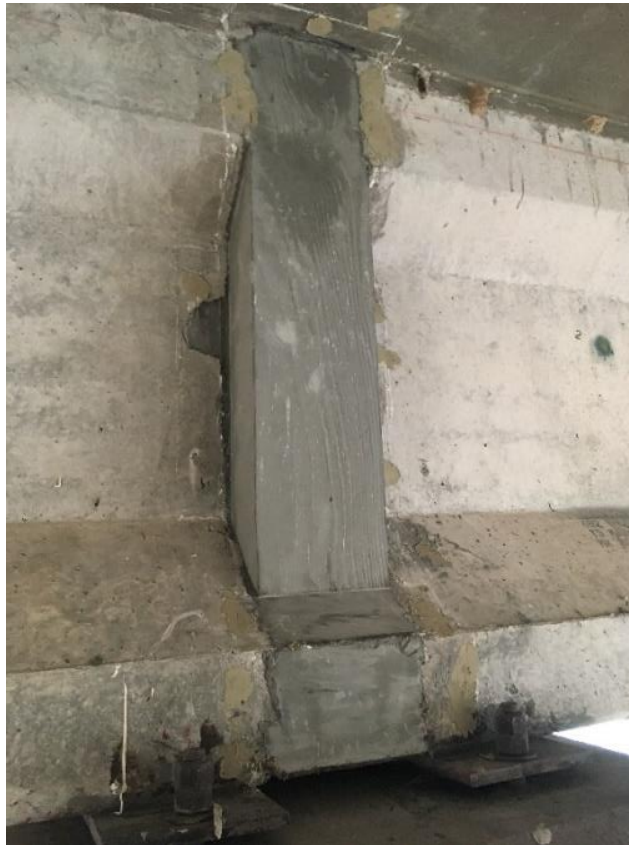
Another issue that occurred during placement was constant settlement of the UHPC in the joints after the initial top-off of the forms. The material was poured into a 2.5 inch hole and the top flange of the girder was 20 inches wide, which left a 90° change in geometry along the bottom of the bridge deck. As the UHPC filling the joint reached the bottom of the bridge deck, air was trapped in the corners of the forms. Due

to its viscosity and slow setting time, the entrapped air took several hours to be released through the fill hole. This delay in air release caused the top of the pour to slowly settle after form top-off, leaving the top surface as much 8 inches below the top of deck in several joints. However, no joint settled below the bottom of the bridge deck, so each continuity joint was filled completely. A completed UHPC continuity joint is shown in Figure 95. Once the wood was removed from around the pour holes on the bridge deck, the contractor manually dug out the voided surface at the top of the UHPC pour then used Rapid Set® Concrete Mix to fill the holes to the top of the deck.

**Figure 95. Completed UHPC continuity joint after form removal**

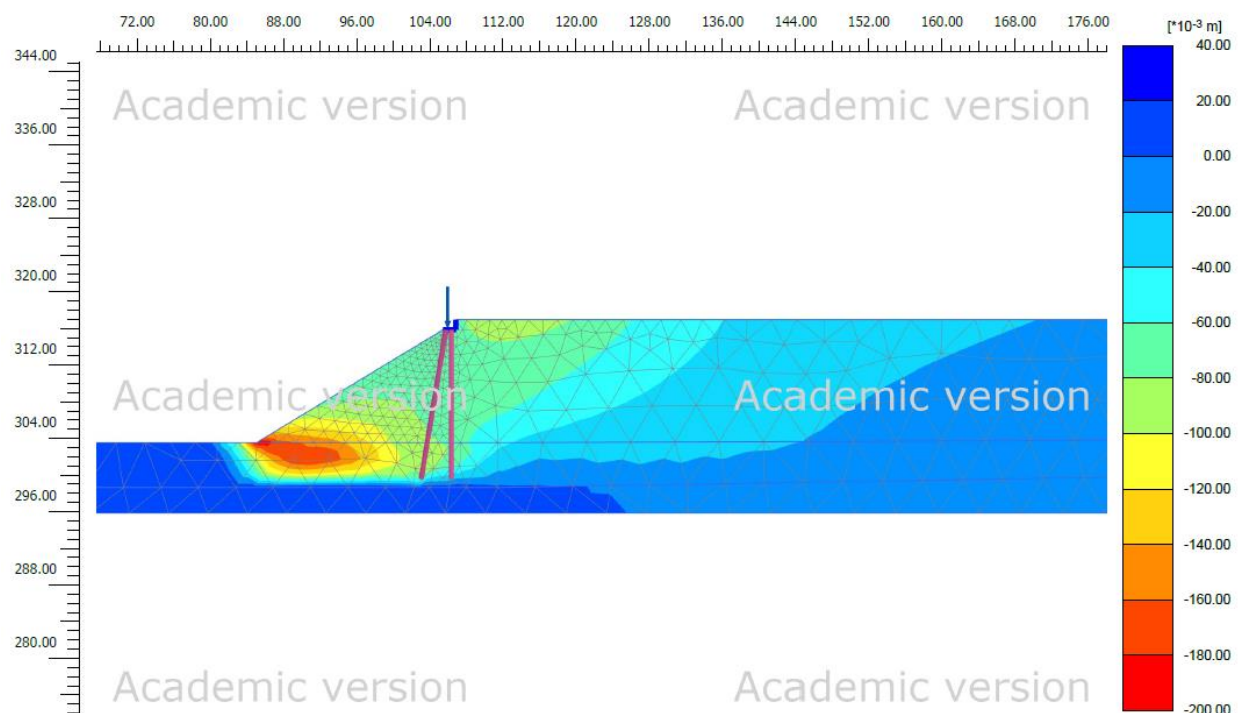
The lateral deformation isochrones at the end of the analysis are shown in Figure 109 and Figure 110 for the east and west embankments, respectively. In both embankments the maximum lateral deformation occurs at the toe of the embankment. The deformation isochrones show that the sloped end of the embankment is essentially carried by the movement in the soft clay layer. The piles were terminated in the soft clay layer according to the as built plans. The piles were likely terminated right on top of the bottom stiff clay layer. This causes the piles and abutment to also be carried along with the embankment. A pinning effect may be realized if the piles are driven into the hard stratum. This lateral movement is suspected to have played a key role in initially closing the bridge expansion joints.

**Figure 109. SH-3 over BNSF Railroad: Lateral deformation isochrones – east embankment**

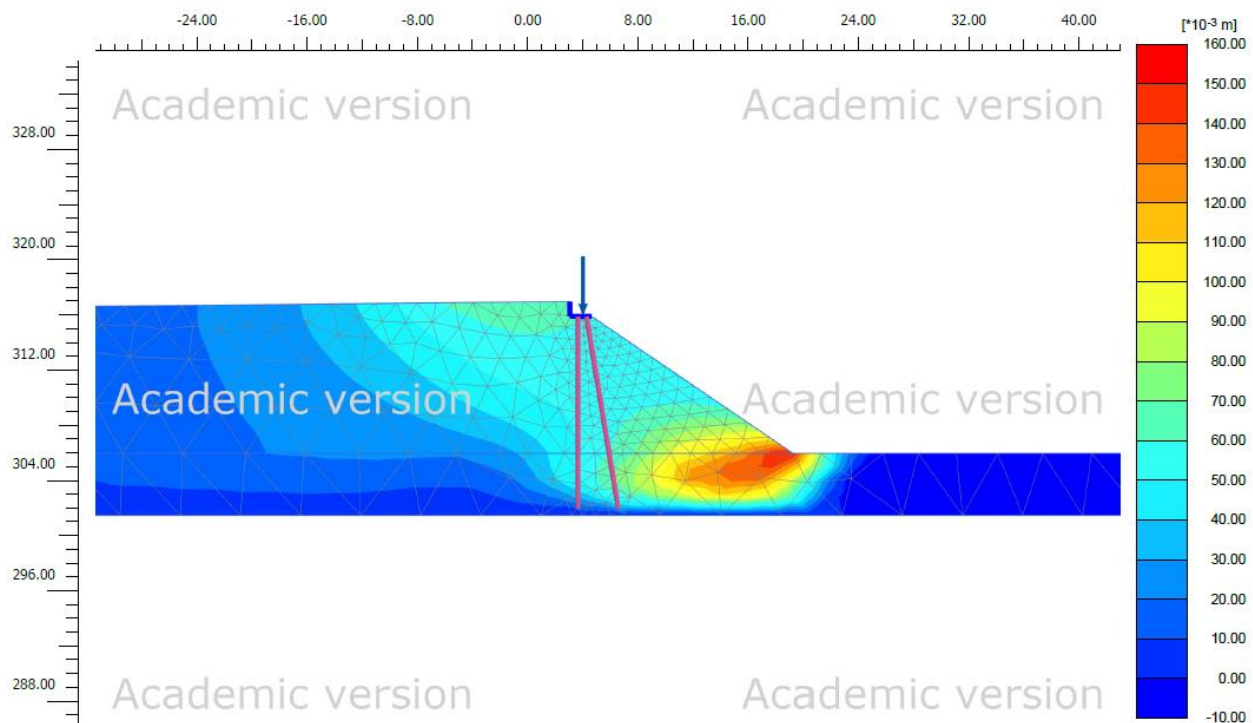
**Figure 110. SH-3 over BNSF Railroad: lateral deformation isochrones – west embankment**

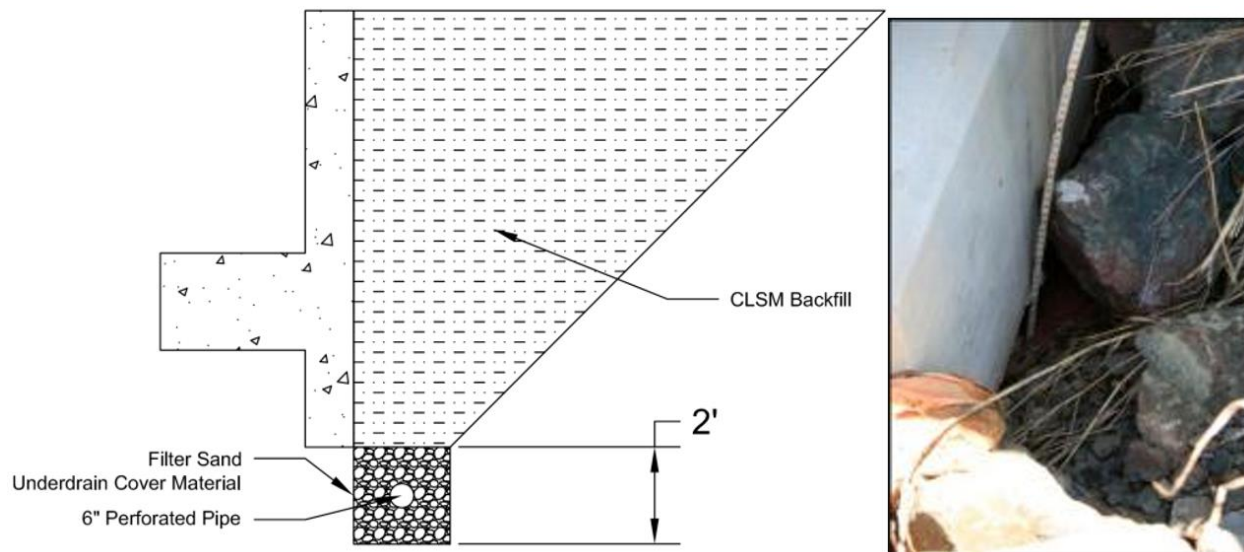
To get a better understanding of the cause of erosion under the abutment, the backfill drainage detail for bridges exhibiting this problem were examined. Figure 113 through Figure 115 show details for three bridge abutment drainage systems associated with erosion under the abutments. While each of these designs have some differences relative to the backfill type and abutment style, they all have a similar underdrain placement at the base of abutment. It is believed that this placement represents an inherent design flaw in these drainage systems, as will be discussed subsequently.

**Figure 113. Underdrain design, after ODOT Proposed Plan for S.H. 3W over Big Creek**

In comparison, it is seen that the details associated with erosion under the abutment in Figure 113 through Figure 115 do not include a measure to prevent water flowing from the underdrain under the abutment. This essentially leads to a short circuit of water from the underdrain under the abutment leading to erosion. The concept is illustrated in Figure 118. The problem is due to differential settlement between the embankment soil and abutment. The abutment is pile supported and not expected to settle much; however, all embankment soils will settle under their own self-weight and from compression of the underlying foundation materials. Even if this settlement is small, it only takes a very small gap to create a short circuit. To prevent this short circuit, a water barrier needs to be included in the design of these drainage systems, such as that suggested by Miller et al. (2013) as shown in Figure 119 and Figure 120 for granular backfill. A similar approach could be used with CLSM backfill.

A water barrier should be placed between the abutment and embankment soils to prevent short circuiting of water from the underdrain through the space between the bottom of the abutment and underlying embankment soils (Figure 118). Some possible details for such a water barrier are shown in Figure 119 and Figure 120. Alternatively, a layer of low permeability clay could be used to create a water barrier, such as shown in Figure 3, which depicts a detail developed by the Kansas DOT.
