**FINAL REPORT ~ FHWA-OK-22-02**

# **A SYSTEMS APPROACH FOR DESIGN, CONSTRUCTION, AND MAINTENANCE OF BRIDGES AND ADJACENT ROADWAYS**

**School of Civil Engineering and Environmental Science (CEES)**  
**The University of Oklahoma**  
**Norman, Oklahoma**

**January 2022**

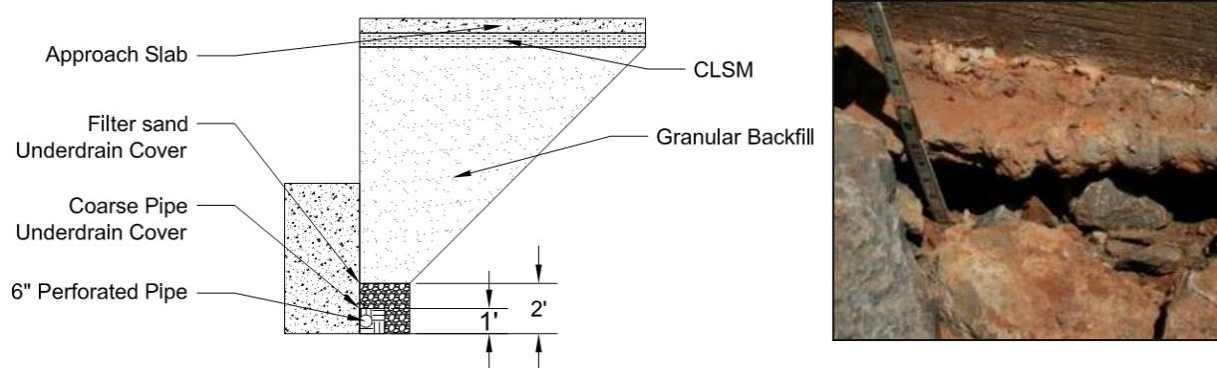
To get a better understanding of the cause of erosion under the abutment, the backfill drainage detail for bridges exhibiting this problem were examined. Figure 113 through Figure 115 show details for three bridge abutment drainage systems associated with erosion under the abutments. While each of these designs have some differences relative to the backfill type and abutment style, they all have a similar underdrain placement at the base of abutment. It is believed that this placement represents an inherent design flaw in these drainage systems, as will be discussed subsequently.

**Figure 114. Underdrain Design, after ODOT Proposed Plan for S.H. 6 over West Elk Creek**

In comparison, it is seen that the details associated with erosion under the abutment in Figure 113 through Figure 115 do not include a measure to prevent water flowing from the underdrain under the abutment. This essentially leads to a short circuit of water from the underdrain under the abutment leading to erosion. The concept is illustrated in Figure 118. The problem is due to differential settlement between the embankment soil and abutment. The abutment is pile supported and not expected to settle much; however, all embankment soils will settle under their own self-weight and from compression of the underlying foundation materials. Even if this settlement is small, it only takes a very small gap to create a short circuit. To prevent this short circuit, a water barrier needs to be included in the design of these drainage systems, such as that suggested by Miller et al. (2013) as shown in Figure 119 and Figure 120 for granular backfill. A similar approach could be used with CLSM backfill.

A water barrier should be placed between the abutment and embankment soils to prevent short circuiting of water from the underdrain through the space between the bottom of the abutment and underlying embankment soils (Figure 118). Some possible details for such a water barrier are shown in Figure 119 and Figure 120. Alternatively, a layer of low permeability clay could be used to create a water barrier, such as shown in Figure 3, which depicts a detail developed by the Kansas DOT.

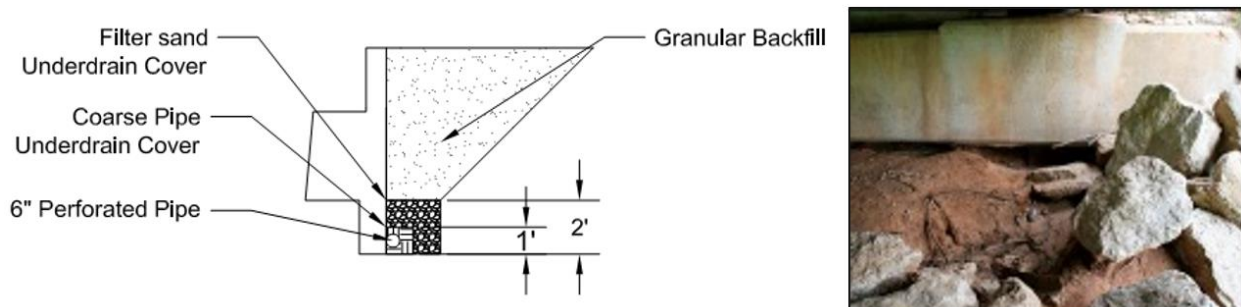
**Figure 115. Underdrain Design, after ODOT Proposed Plan US 177 over Salt Fork, Bridge A**

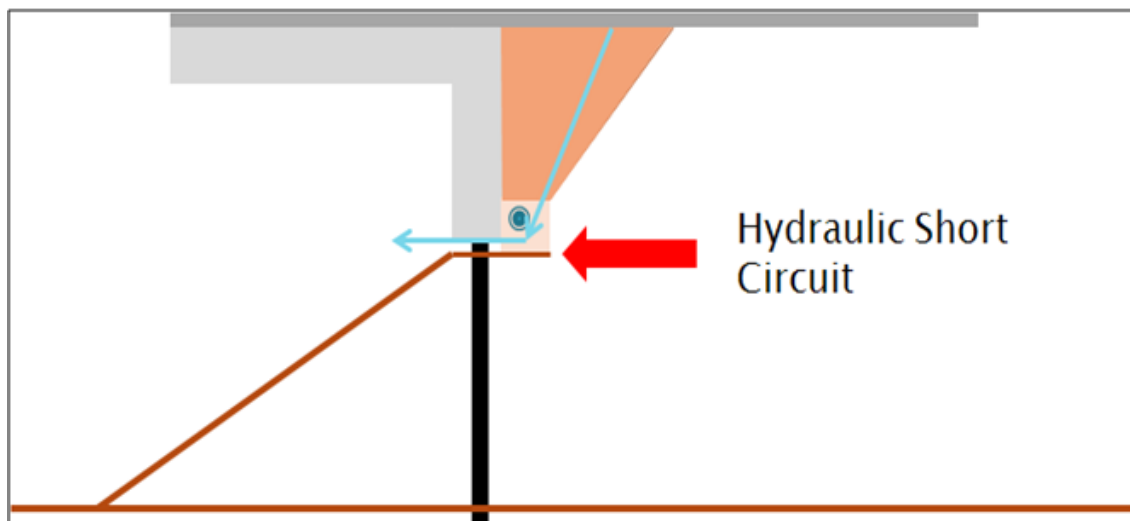
**Figure 118. Schematic Cross-Section View of Hydraulic Short Circuit that Can Develop in the Abutment Drainage System (from Miller et al. 2013)**
