AN INVESTIGATION OF CORROSION
BEHAVIOR OF ALLOY 800

Submitted to the Faculty of the Graduate College
of the Oklahoma State University
in partial fulfillment of the requirement
for the degree of
MASTER OF SCIENCE
May 1991

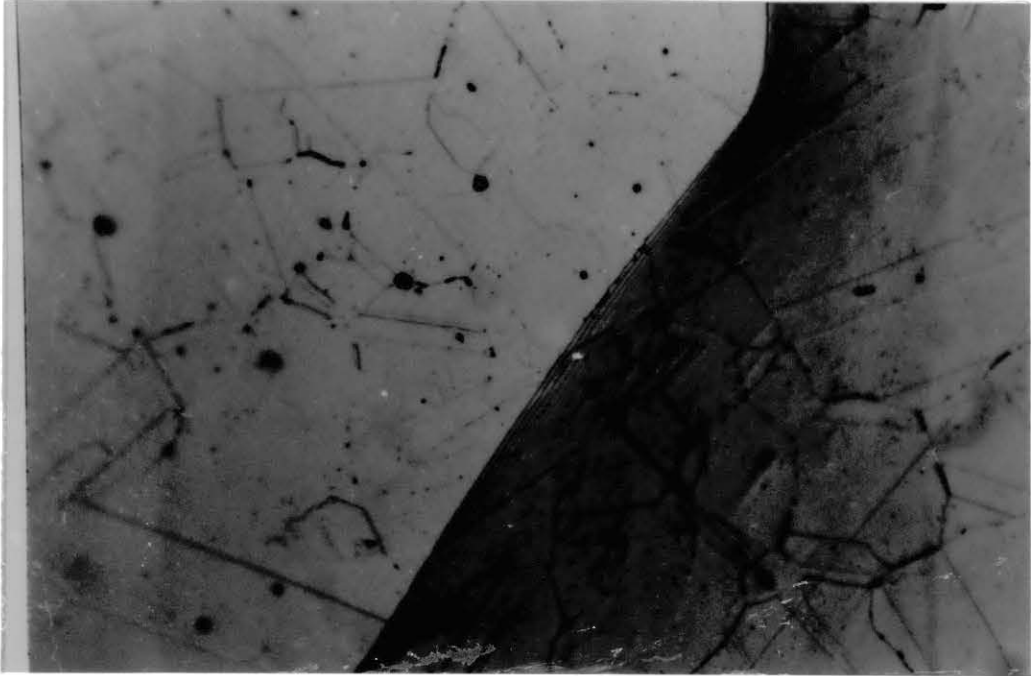
Figure 1. Microstructure of Sensitized Specimen (200 x)

readily visible in the unetched state as small angular inclusions. The phases vary in color from the orange-yellow of the nitride to the grey-lavender tint of the carbide. The nitrides are stable at all temperatures below the melting point and are therefore unaffected by heat treatment. Figures 1 and 2 show the microstructure of alloy 800 in sensitized and unsensitized conditions respectively.

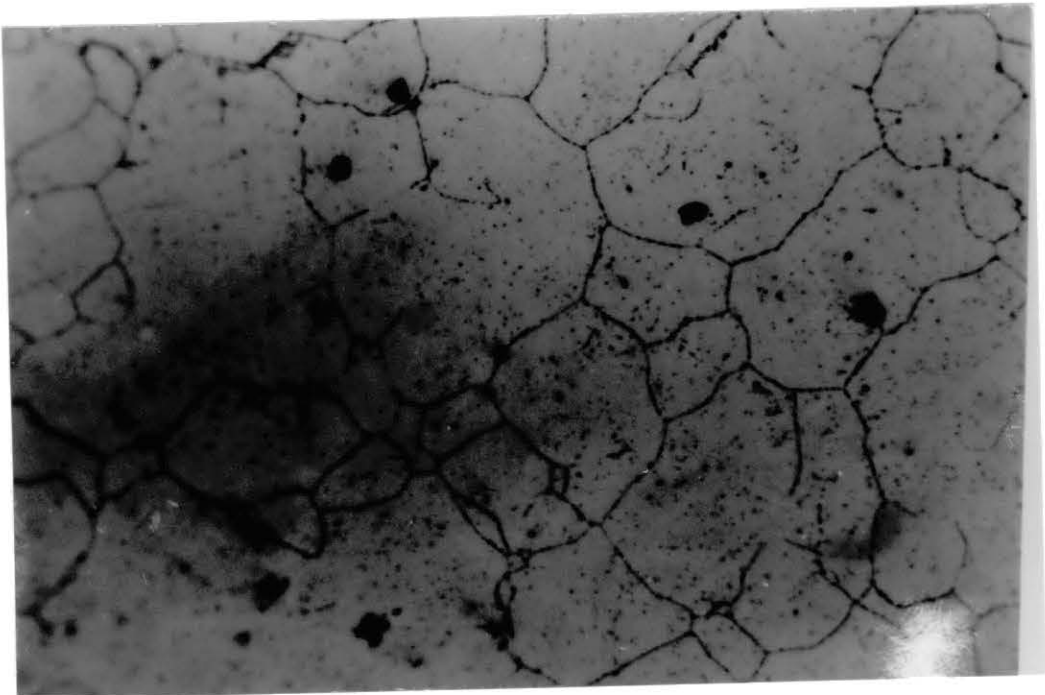
Figure 2. Microstructure of an Unsensitized Specimen

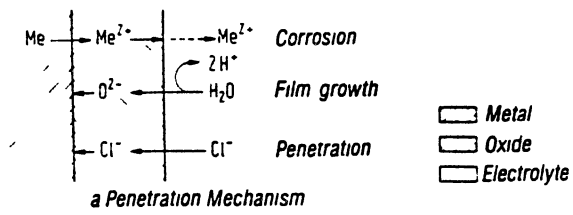
Figure 3. Schematic Sketch of Three Possible Initiation Processes for Pitting : (a) Through Incorporation of Anions into Passive Oxide, (b) Through Island Adsorption of Anions on the Passive Oxide, and (c) Through Tearing of the Passive Oxide [21]

A number of theories have been presented on this topic. According to Evans [22], consider a piece of metal devoid of holes and pits immersed in an aerated sodium chloride solution. If, for any reason the rate of metal dissolution is momentarily high at one particular point, chloride ions will migrate to this point. Since chloride stimulates metal dissolution, this change tends to produce conditions that are favorable to further rapid dissolution at this point. Locally, dissolution may be momentarily high because of a surface scratch, an emerging dislocation, or other defect, or random variations in solution composition. Stagnant conditions and severe cold working increases the chances of pitting. Kaesche [21], is of the opinion that heterogeneous inclusions such as sulfide inclusions in Cr - Ni steels or chromium oxide inclusions in Cr steels, are preferred initiation sites for pitting. Figure 3 shows the possible variations for the pit initiation process, i.e., the formation of the first smallest site for active metal dissolution in the middle of the passive surface, namely the "penetration", the "adsorption", and the "film tearing"

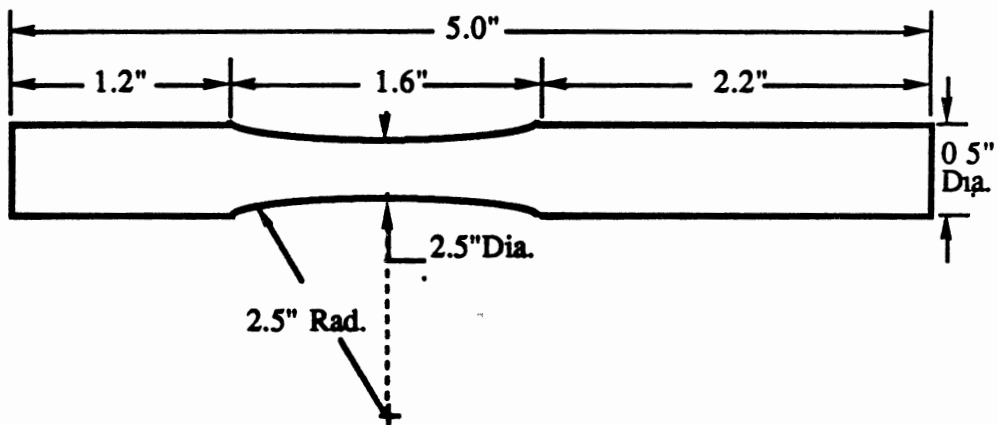
Figure 4. Geometry of the Waisted Specimen Used for the Slow Strain Rate Tests

For the SST study the specimens were machined to a waisted geometry from a hot rolled bar. The minimum diameter was 0.25 inches (6.35 millimeters) Figure 4 shows the geometry of the specimen. The samples were then heat treated, finished to 600 grit, and polished by 0.5 μm alumina powder to get an adequate surface, free from circumferential and longitudinal scratches and grinding marks. The heat treatments are given in Table VIII. It must be noted that vacuum was not maintained.

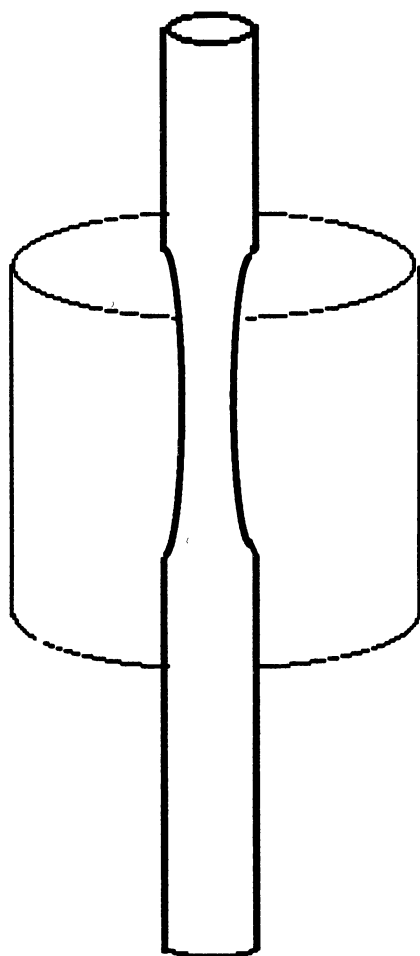
Figure 5. Mounting Arrangement of the Slow Strain Rate Testing Samples

The tests were conducted at room temperature on an MTS machine with 0.4M ferric chloride contained in the solution cell. The arrangement is shown in Figure 5. The experiments were carried out under stroke control which was selected as 20 % of actual 6" stroke. The time of completion of this stroke (ramp rate) varied from 1×10^5 to 5×10^5 s (Table VIII). After failure, the samples were ultrasonically cleaned and dried in air. Later, visual examination, microscopic examination under the zoom microscope (70x), and SEM examination were performed.

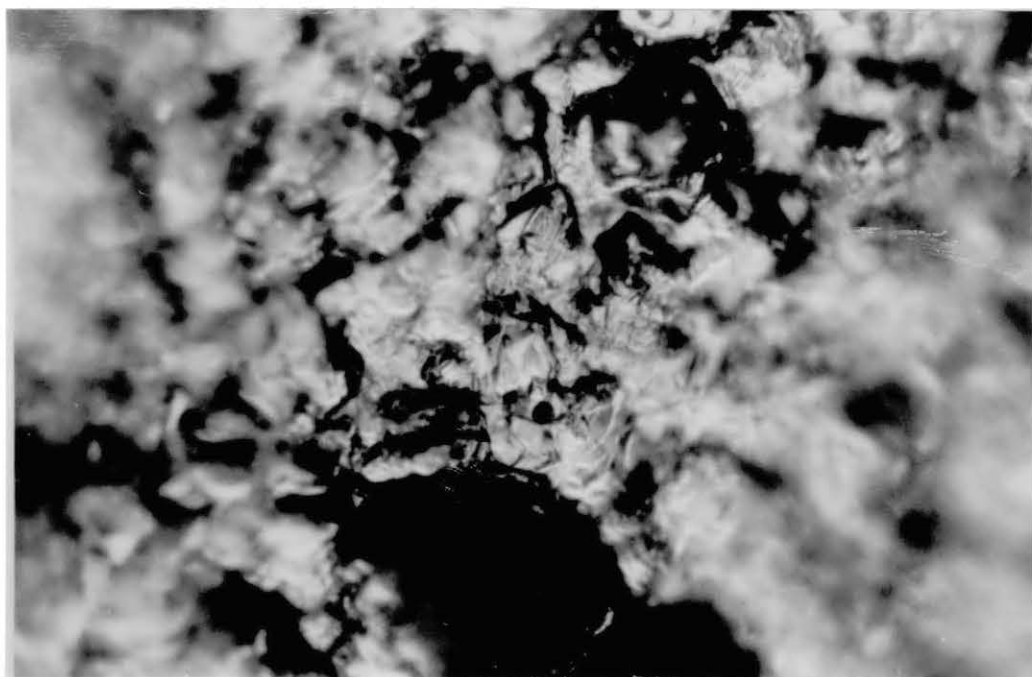
**Figure 7. Crevice Corrosion on a Polished Bottom Face
(200 x)**

The immersion test results in ferric chloride show slight crevice corrosion and pitting with the top oxide film hanging inwards after undercutting, Figure 6. Due to the polished bottom surface, the crevice attack is less as compared to other samples, Figure 7, and thus less crystalline. Crevice corrosion of the unpolished surface is shown in Figures 8 and 9. The severity of the attack is due to the rough surface and the higher concentrations. A closer view of Figure 9 is shown in Figure 10 which is highly crystalline and shiny. Undercutting should also be noted at the edges of the circular rings in Figures 8 and 9. It can be observed in Table III that when crevice corrosion increases the number of pits and/or size of pits on the top face decreases. This fact points out that the top face acts as a cathode as compared to the bottom face which becomes an anode. Thus the bottom face is corroded more due to crevice attack.

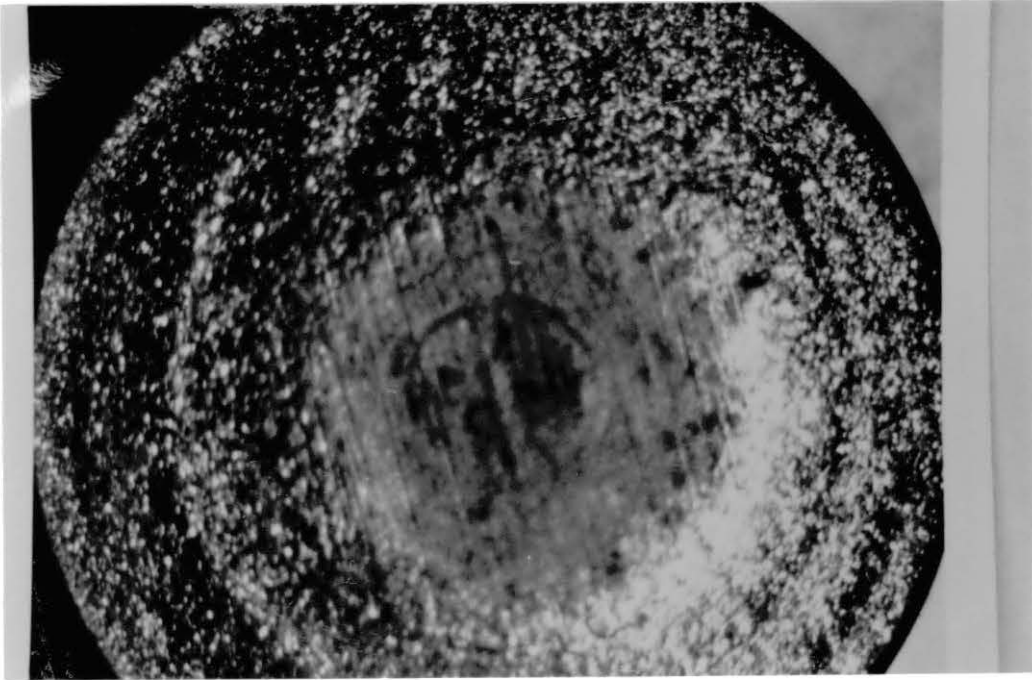
Figure 8. Severe Crevice Corrosion on the Unpolished Bottom Face of the Specimen in 1.11M FeCl_3 . Note the Ring Pattern and Undercutting Along the Periphery

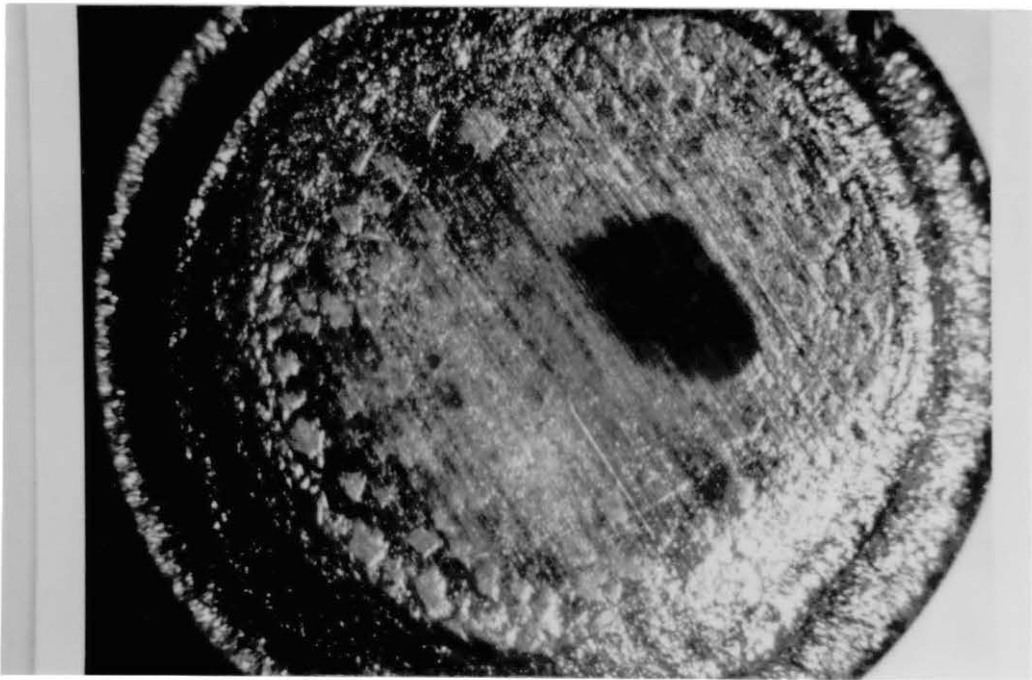
Figure 9. Severity of Crevice Corrosion Has Increased with an Increase in Concentration to 1.85M of FeCl_3 . The Ring Has Become More Deep and Wide

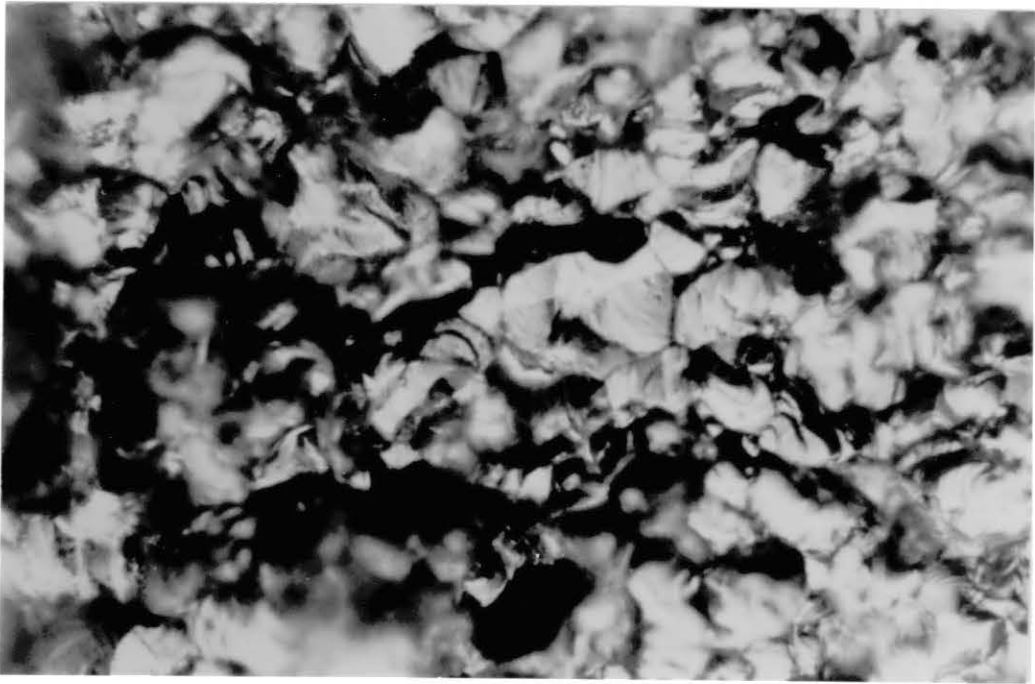
Figure 10. Magnified View of Figure 9 (200 x)

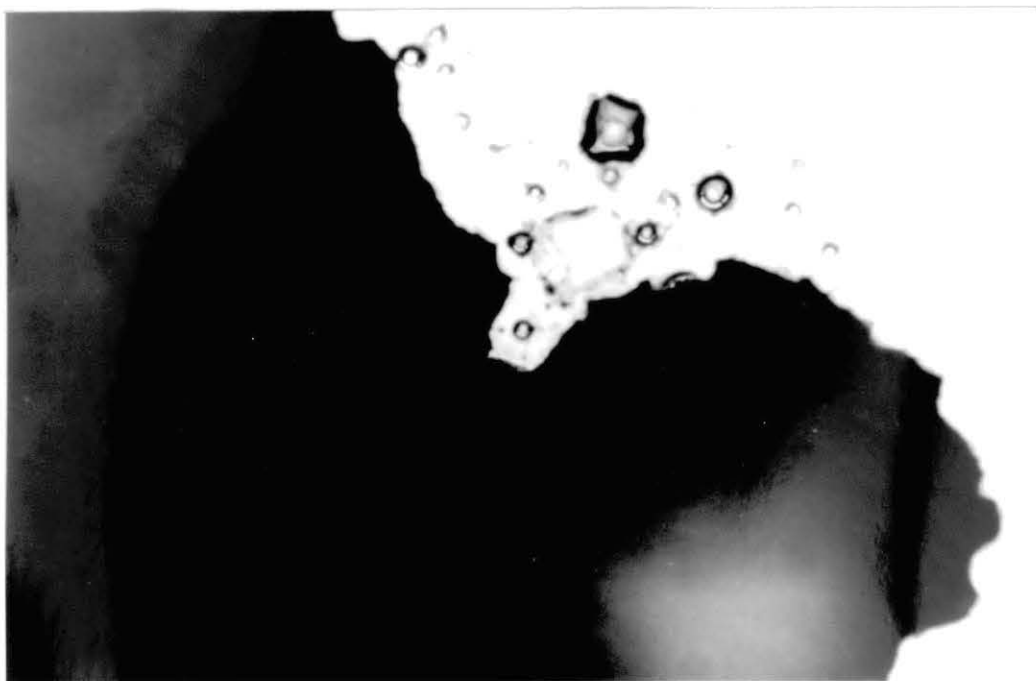
Figure 12. Pit Formed near the Metal/Coating Interface and Penetrated Under the Coating with Increasing Depth and Undercutting thus Causing Crevice Corrosion Beneath the Coating (200 x)

which proved effective, Figure 2. Crevice corrosion under the nail polish was observed when a pit formed near the metal nail polish interface and went under the coating thus causing crevice corrosion, Figures 12 and 13. Alloy 800 is so prone to crevice corrosion in ferric chloride that even vapors and slight crevices are enough to initiate the attack. This was observed when a few samples were tested in 0.4M of ferric chloride by clamping them upside down so that only the top face was immersed. The interface of steel clamp and the specimen served as a crevice for the evaporating solution and it started corroding the sample. On the other hand, galvanic corrosion started between Alloy 800 and the steel clamp which destroyed the ends of the clamp. Even during the slow strain rate tests and fatigue test in 0.4M FeCl_3 the specimens experienced crevice corrosion at the metal-cup interface. Figure 14 shows pitting within the crevice corrosion site.

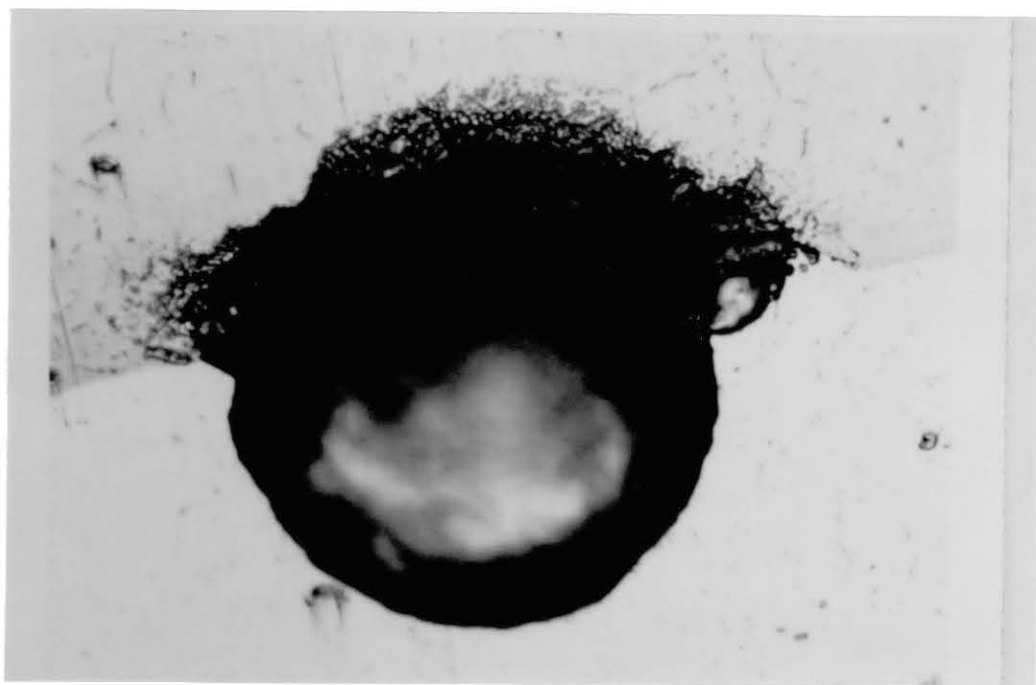
Figure 13. A Pit, Partly Under the Coating, is Initiating Crevice Corrosion (200 x)

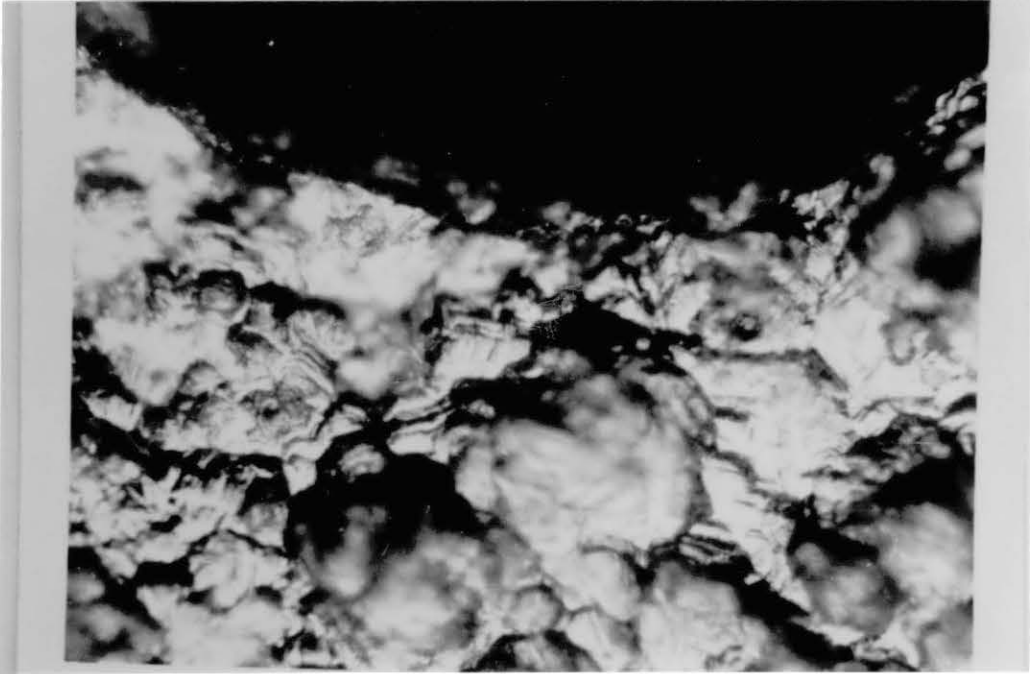
Figure 14. Pit Formation Within a Crevice Corrosion Site
(200 x)

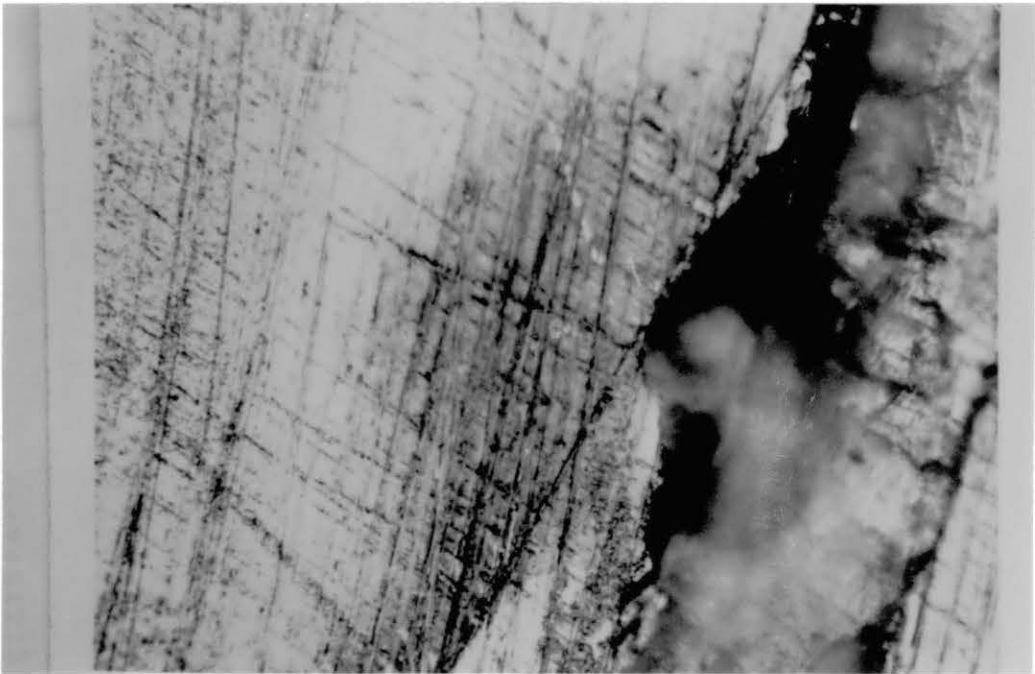
Figure 15. The Scratches Carried 0.6M Cupric Chloride
Underneath the Coating Thus Causing Crevice
Corrosion

Scratches on the surface had to be avoided because when they occurred they served as capillaries to carry the corrodant underneath the coating and hence caused crevice corrosion, Figure 15.

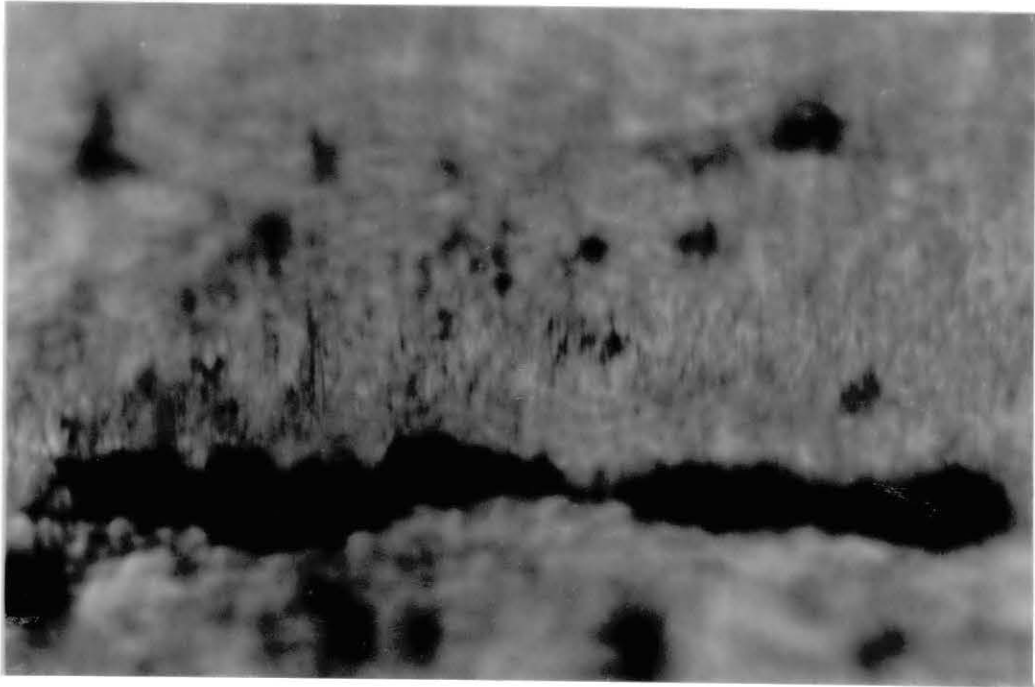
Figure 16. Pits Formed on the Sides of the Specimens are
Following the Pre-working Marks

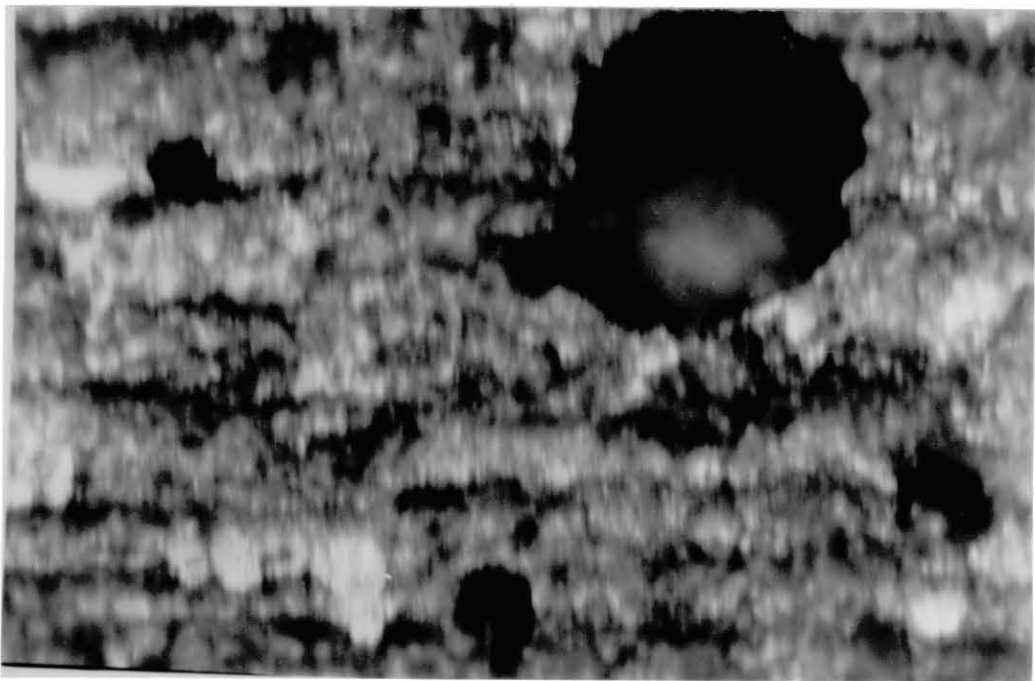
Figure 17. Longitudinal Side Pit Following the Rubbing
marks

The results of pitting test indicate that basically pit initiation is dependent upon surface finish, alloying elements and their composition, and heat treatment including the degree of sensitization and oxide film formation. The scratches on the surface can only be deleterious if there is any residual stress associated with it. Figure 16 and 17 show side pitting, which was caused due to scratch marks formed during hot rolling. These scratches along with residual stresses become a preferential pit site, Figure 16 shows the scratches and a few round pits while Figure 17 shows a longitudinal pit following the scratch. Some pitting results are tabulated in Tables IV and V.

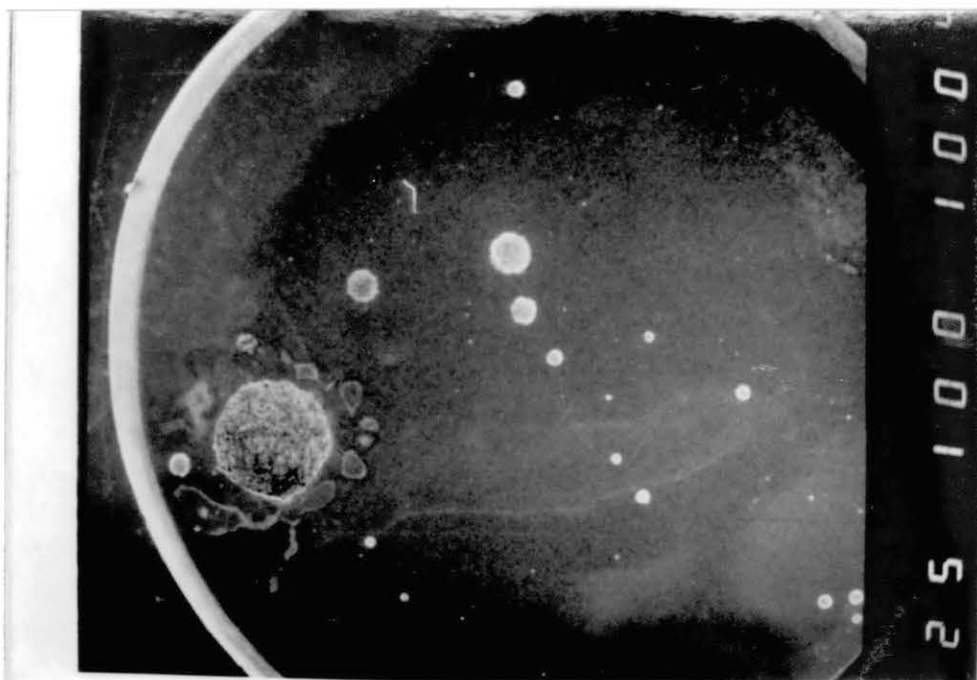
Figure 18. General View of Pits. Note Their Irregularity
in Size and Distribution. This is typical
(10 x)

Figure 18 shows a general view of the pitted surface tested in 0.4M FeCl₃. Figure 19 (is the smallest pit that can be seen in Figure 18. Figure 20 is slightly larger. Notice the shiny particles of titanium nitride. These titanium nitride particles do not corrode themselves rather they behave cathodically thus causing preferential attack on the nearby matrix alloy. Bradshaw [18] in his high temperature study (below 400 C) found out that roughly the number of pits were equal to the number of titanium carbonitride inclusions. The present study does not show one-to-one correspondence.

From the morphology point of view, the interior of the pit is composed of shiny, crystalline facets (Figures 18, 19, 20, 21). The size of the facets change through the depth of the pit in a set pattern. As shown in Figure 22, the facets are finer near the surface but increase in size and become regular in shape when one goes further deep down. Again, at the root the facets gets finer. This pattern looks like a partially open bud, Figure 23. The shape of the pit is a combination of elliptical and horizontal pits [16] as shown in Figure 24 with a common feature of undercutting. Undercutting was severe when the specimen was sensitized. Severe pitting can be seen in Figure 25 where an unsensitized specimen was tested in 1.85M solution of ferric chloride for 24 hours.

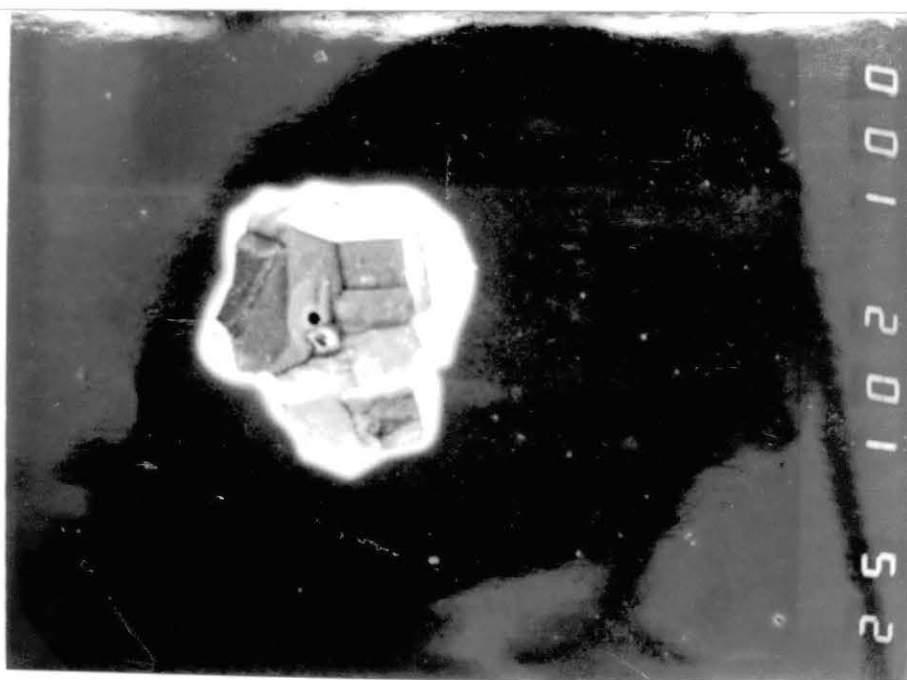
Figure 19. The Top Pit of a Vertical Line of Three at the
Center of Figure 18. It is Faceted and Has an
Irregular Shape (1000 x)

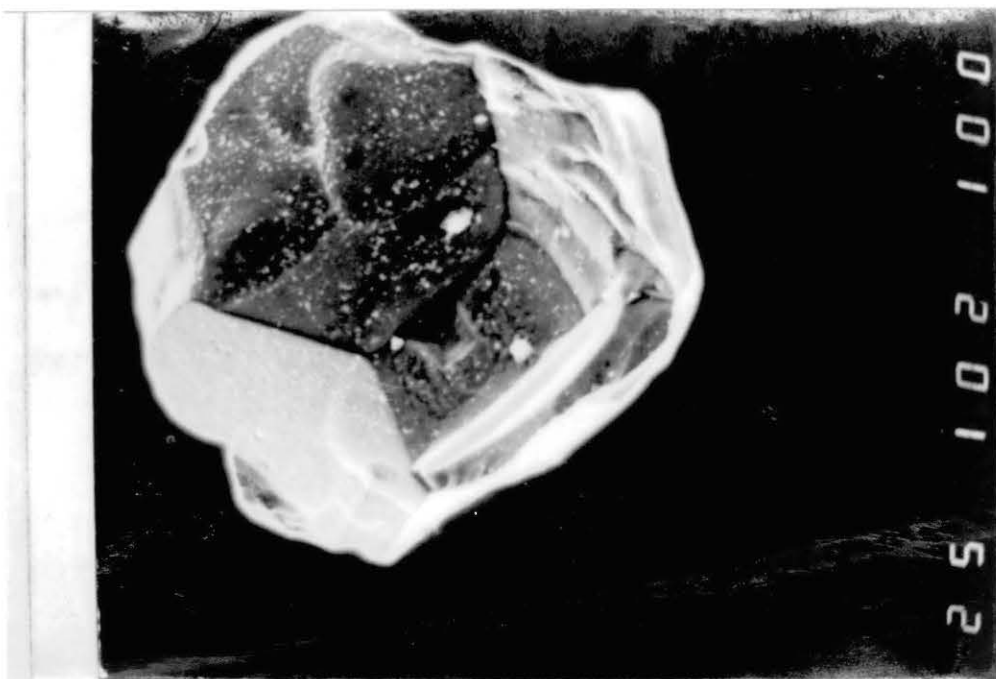
Figure 20. The Middle of the Three Pits Mentioned in Figure 19. Faceted Structure and Shiny Titanium Nitride is Visible. Seen are Precipitate Particles and Corrosion Debris on the Surfaces of the Facets (1000 x)

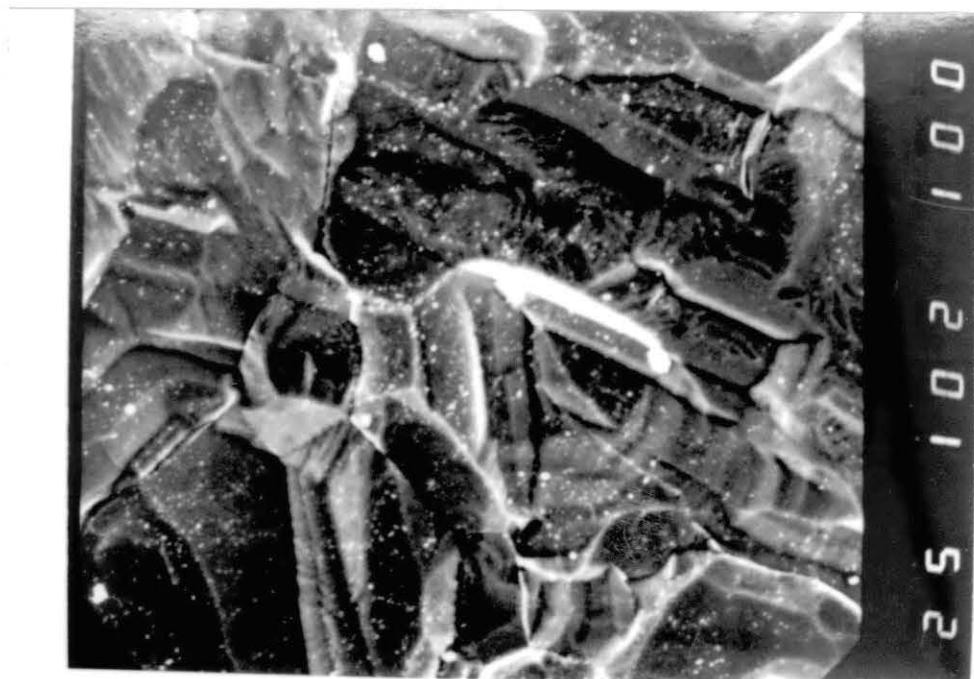
Figure 21. Closer View of a Medium Size Pit of Figure 18. Preferred Crystal Planes are Outlined (1000 x)

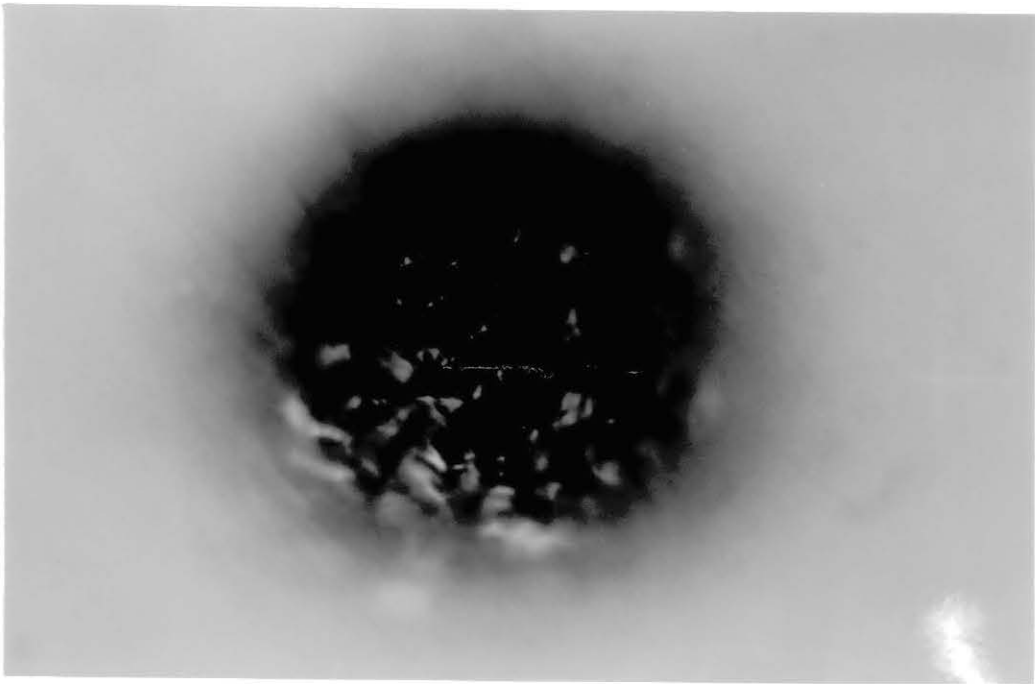
Figure 23. Internal Detail of a Fully Developed Pit. Faceted, Shiny, Crystalline Structure. Features of Figure 22 Can Be Seen (200 x)

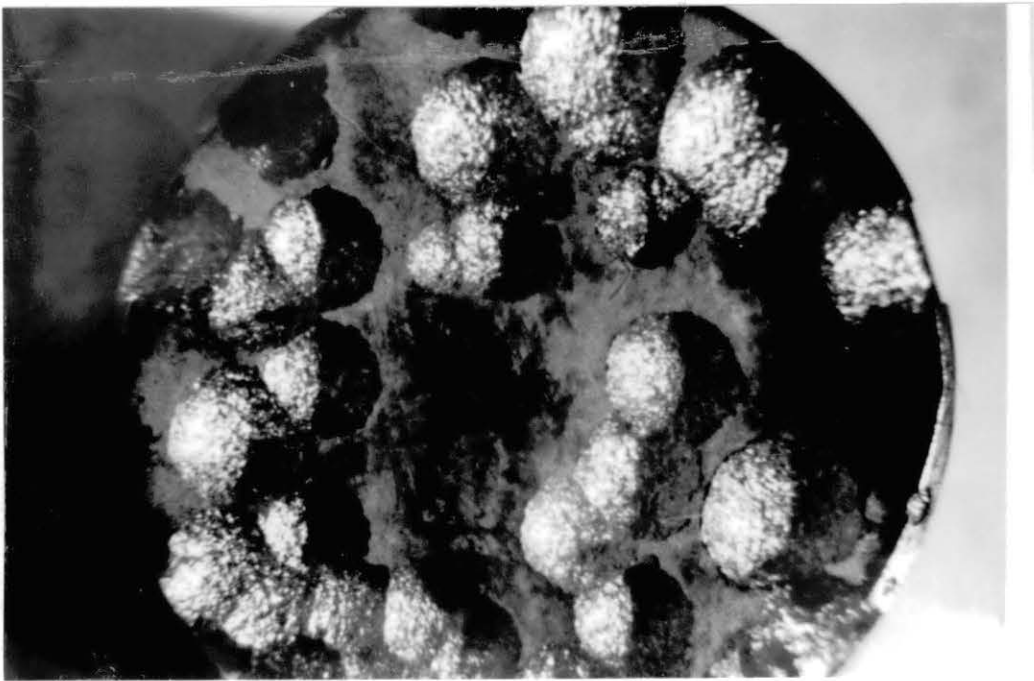
Figure 25. Deep, Broad, and Undercut Pits Formed During a
24h Test in 1.85 (50%) Ferric Chloride

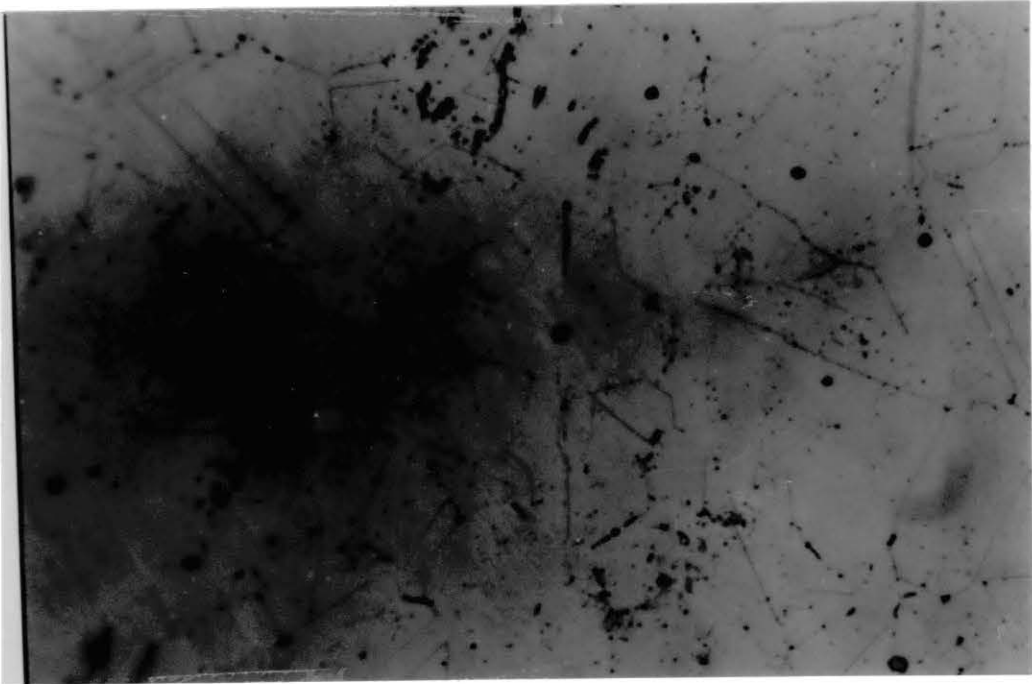
Figure 26. The Black Shiny Particle at the Center is Titanium Nitride which is Serving as a Pit Initiation Site. The Solution Used is 0.4M Ferric Chloride (200 x)

Figure 26, 27, 28, 29, 30 shows the gradual pit growth in Alloy 800. At the center of Figure 26 the shiny black

spot is the titanium nitride particle which is serving as a pit initiation site and hence the matrix around it is corroding. The solution used is 0.4M ferric chloride. In Figure 27 the pit size has slightly increased but the shape is more polygonal than a round one. Figure 28, 29 shows further increase but still irregularity in size. The pit shown in Figure 30 is a full grown round pit. Experimental observations indicate that a full grown pit after achieving a critical depth does not grow deeper, rather it starts widening through undercutting. Sometimes the pits also form clusters as shown in Figure 31.

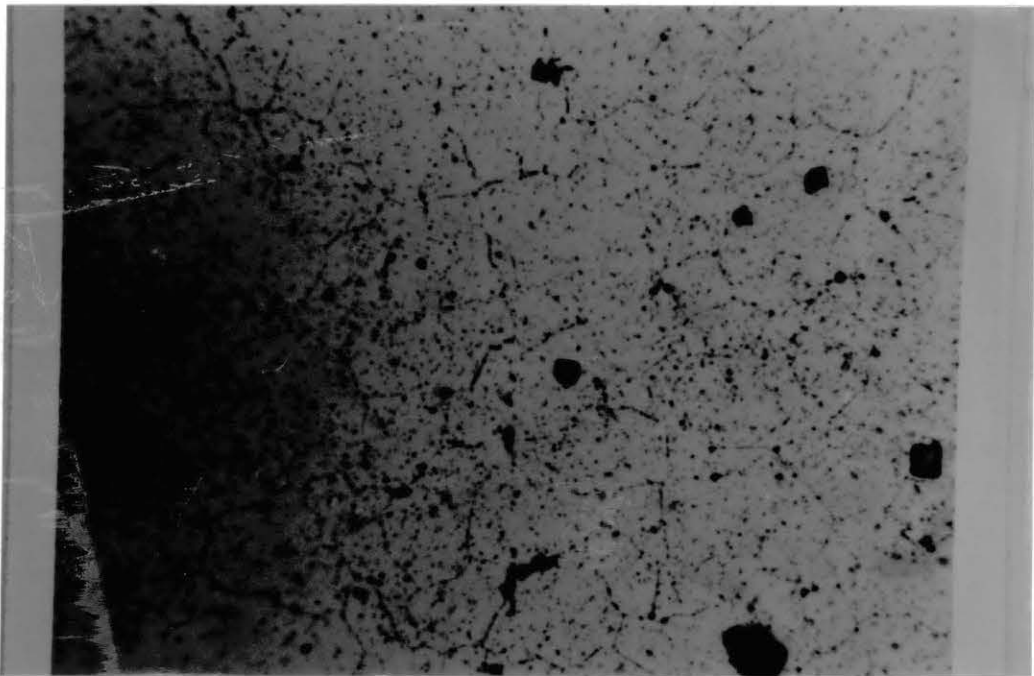
Figure 27. The Pit Has Started Developing and is Polygonal (200 x)

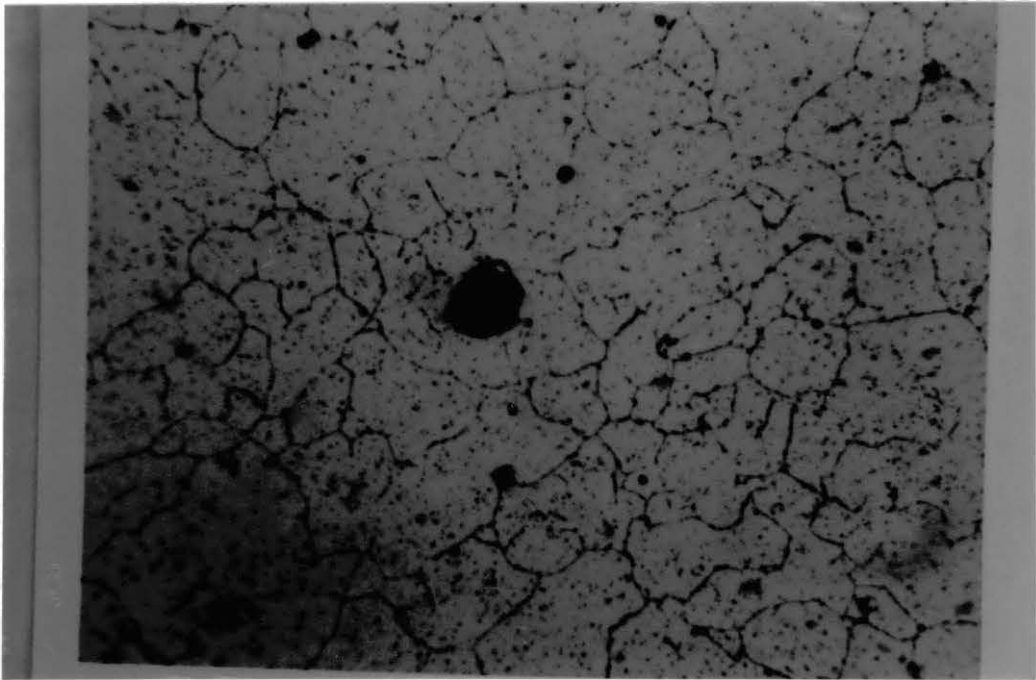
Figure 28. The Size of the Pit Has Increased as Compared to That in Figure 27 But is Irregular in Shape (200 x)

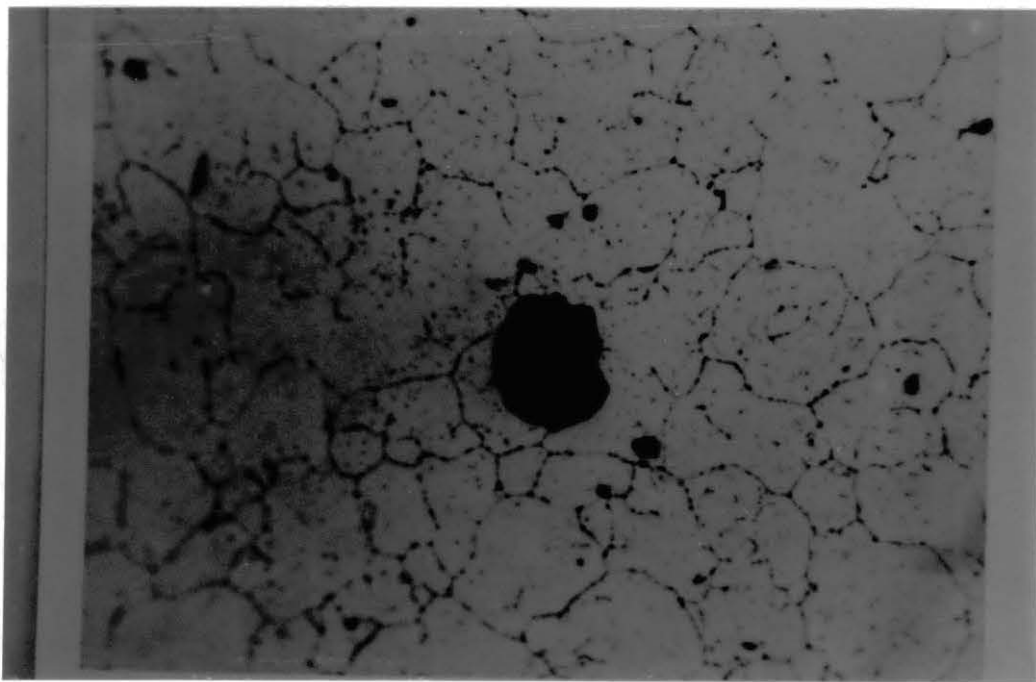
Figure 29. One-half of the Pit Has Become Round While the Other Half is Irregular in Shape (200 x)

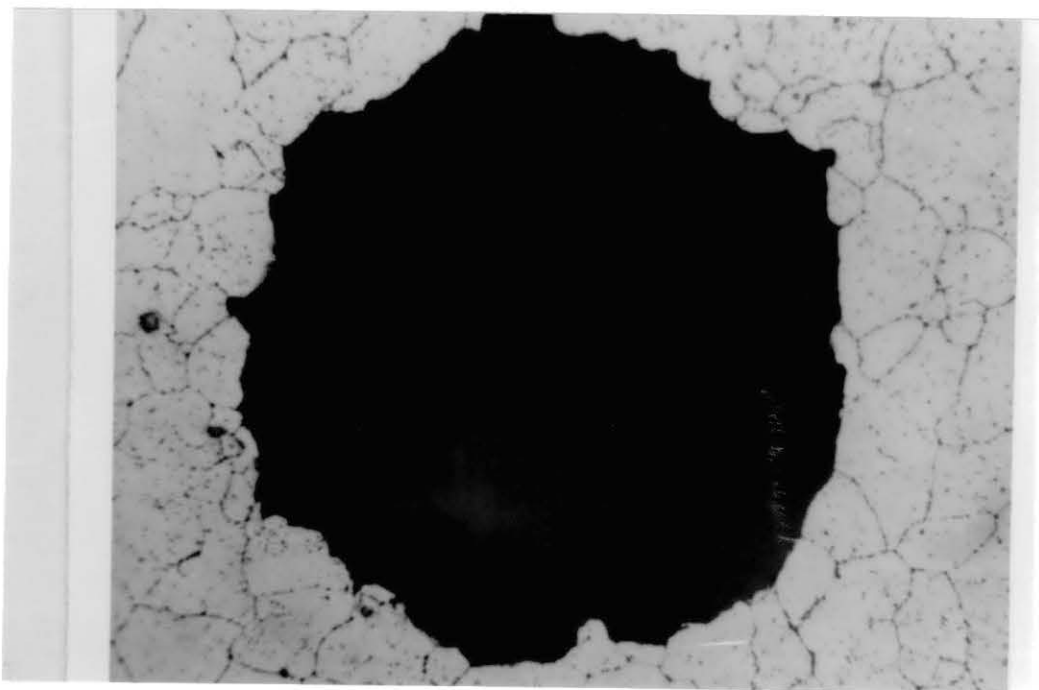
Figure 30. Fully Developed Round Pit (200 x)

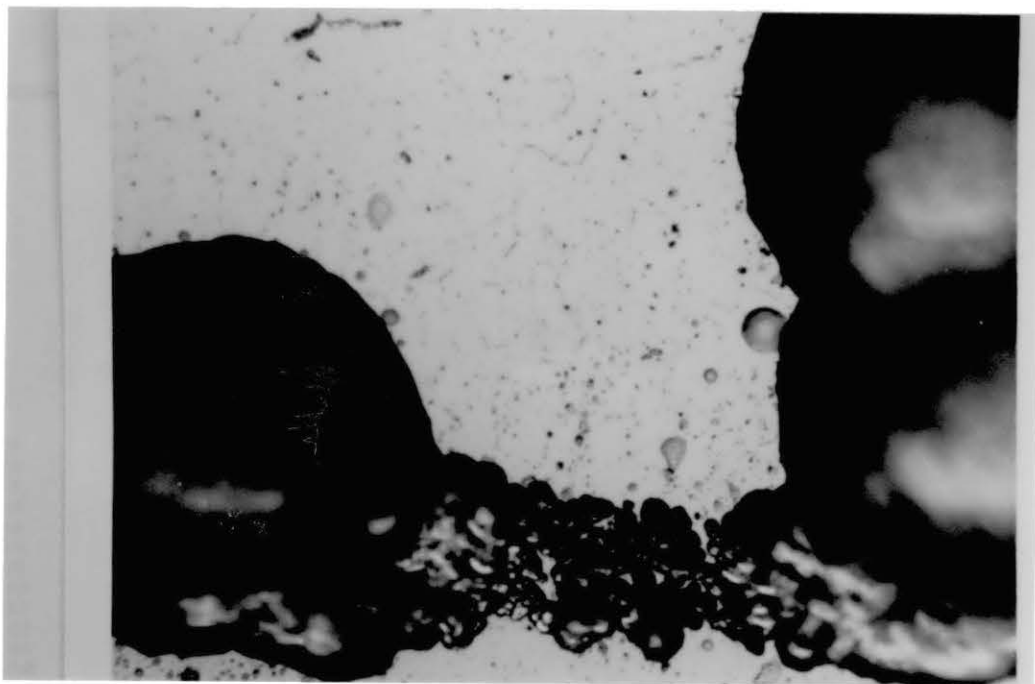
Figure 31. Coalescing Process of Pits Observed in 1.85M
Ferric Chloride in 9 min of Immersion Test
(200 x)

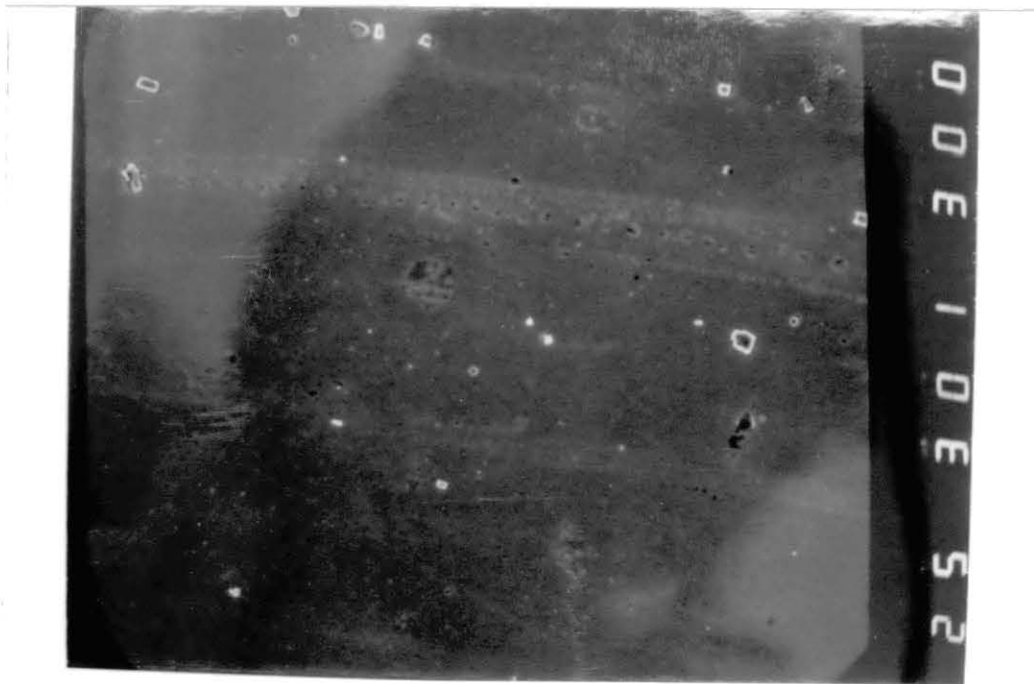
Figure 32. General View of the Pitted Unsensitized Specimen Tested in 20 % Ferric Chloride for 24 h. Scattered Polygonal Pits Can Be Seen where Shiny Particles are Titanium Nitride (300 x)

Heat treatment can affect pit initiation sites, morphology, and number of pits. Table VII shows that the unsensitized (US) specimen has 7 pits, the completely sensitized (IS) one has 557 pits (from $1\mu\text{m}$ - $50\mu\text{m}$), and as received (AR) has 104 pits. In Figure 32, surface of the US specimen is shown. There is some junk as well as titanium nitride particles which are acting cathodically, and hence, corroding the surrounding matrix. This can be seen in Figure 33 which is a 5000 X view of the center-right particle of Figure 32. The black spots are very tiny pits which coalesce to initiate an overall polygonal pit around the inclusion. Compare Figure 34 of the AR sample with Figure 32 of the US sample. It can be seen that the pits on the US sample are very very small. A closer view of the pit adjacent to the twin pits at the center of Figure 34, is shown in figure 35. A faceted, crystalline structure is obvious. Furthermore, there are pits within the pit. The AR sample has greater number of pits, which are well formed and round in shape, irrespective of their size. Undercutting is not significant. IS is suffered severe

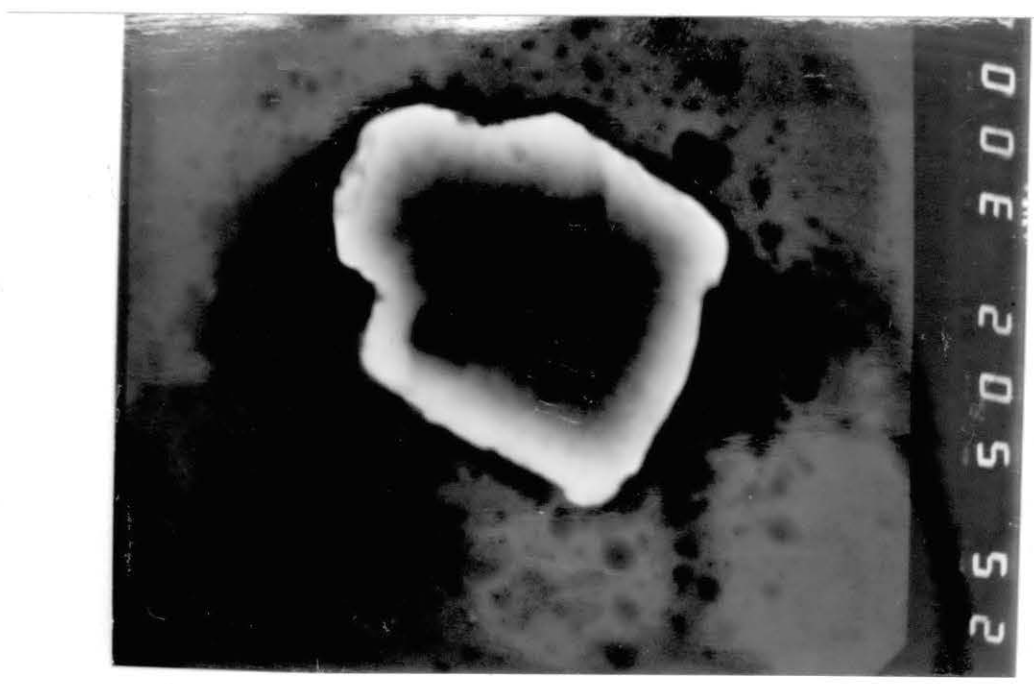
Figure 33. Center-right Particle of Figure 32 (5000 x) Which is Titanium Nitride. Note that the Surrounding Material is Corroding by Pit Formation
