AN INVESTIGATION OF CORROSION
BEHAVIOR OF ALLOY 800

Submitted to the Faculty of the Graduate College
of the Oklahoma State University
in partial fulfillment of the requirement
for the degree of
MASTER OF SCIENCE
May 1991

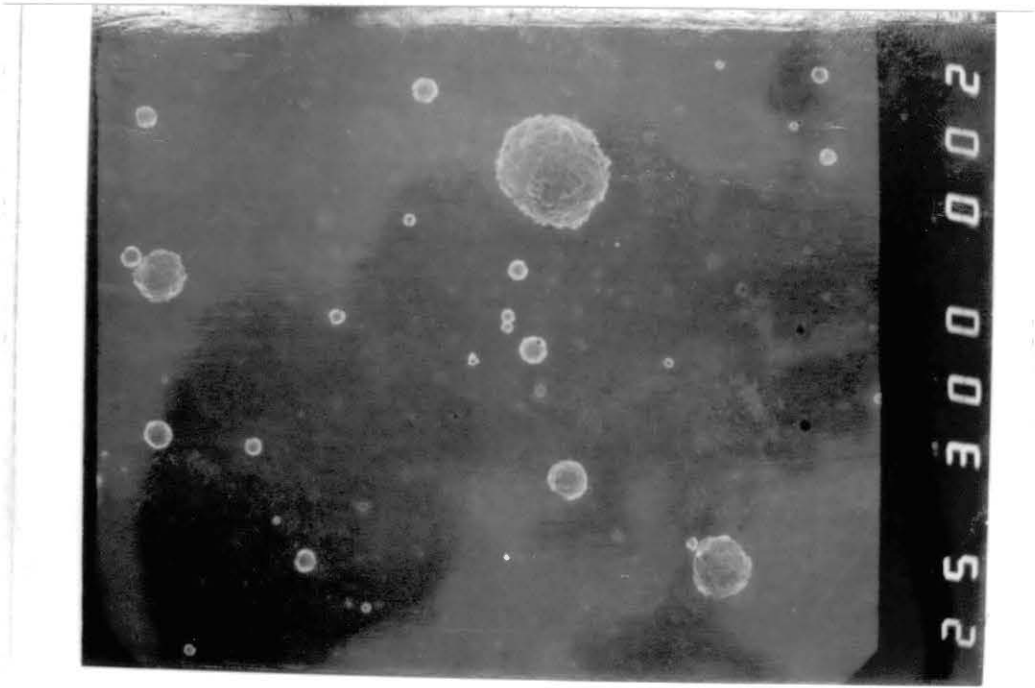
Figure 34. General View of the Partly Sensitized
(As-received) Sample Tested in 20 % Ferric
Chloride for 24 h. The Pits are Well
Formed and Round in Shape (30 x)

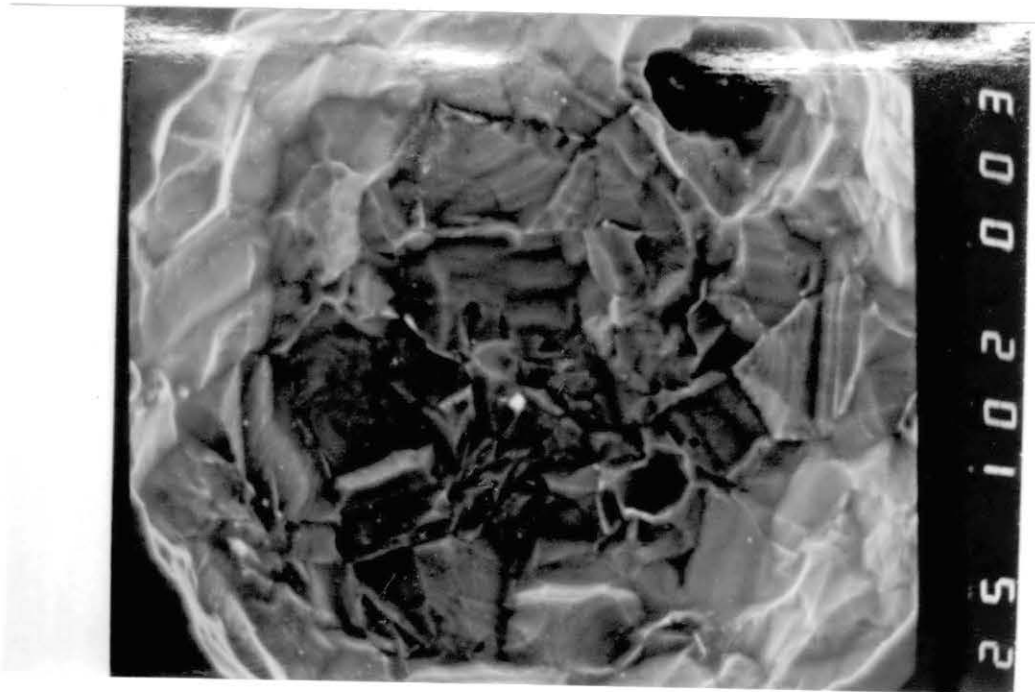
Figure 35. Bigger Pit, Adjacent to the Center Twin Pits of
Figure 34 (1000 x). The Structure is
Faceted and Crystalline With Pits Within the
Pit

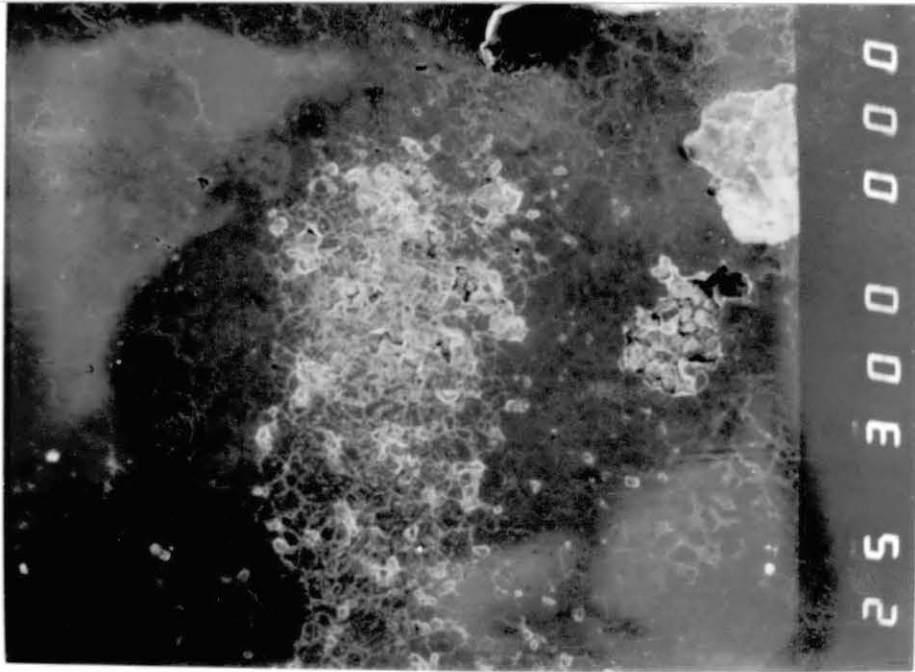
Figure 36. General View of a Portion of the Completely Sensitized Specimen tested in 20 % Ferric Chloride

pitting both, within the matrix and along the grain boundaries. A portion of the specimen is shown in Figure 36. Obviously the attack is intense where the grain size is comparatively smaller. The specimen has the smallest existing pits, $1\mu\text{m}$, as compared to the other two specimens. The pits following the grain boundaries are pointed and angular in shape. A closer view of the upper part of the cluster in Figure 36 is shown in Figure 37. Grain boundaries show extensive corrosion as well as the matrix. An exploded view of the center of Figure 37 can be seen in Figure 38. The intergranular attack is associated with chromium carbide formation. The upper-right matrix of Figure 37 is filled with pits (Figure 39) which are faceted. The initiation sites can be junk, titanium nitride, and titanium carbide particles. A magnificent view of these pyramidal, faceted pits is shown in Figure 40. One large pit on the IS specimen is showing undercutting, Figure 41. The edges have been attacked intergranularly. Figure 42 reveals the pit development process within the central portion of the pit. Figure 43 shows the pitting effect of 1.85M ferric chloride solution on AR sample after 45 minutes. Although it resembles general corrosion, a closer look, (200x) Figure 44, shows that it suffered intergranular pitting along with some pits within the matrix. Figure 45 shows the crystallographic, shiny, faceted structure of the attack. Figure 46 is also an AR sample but tested for 24 h.

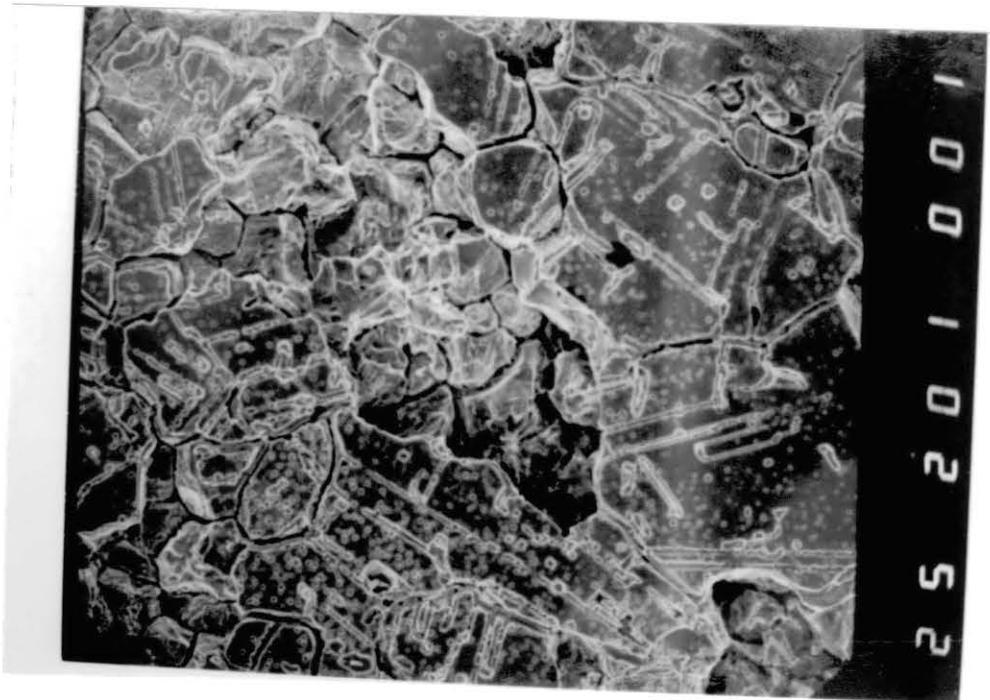
Figure 37. Severe Pitting Along the Grain Boundries and Within the Matrix on the Completely Sensitized Specimen of Figure 36 (200 x). It was Tested in 20 % Ferric Chloride for 24 h

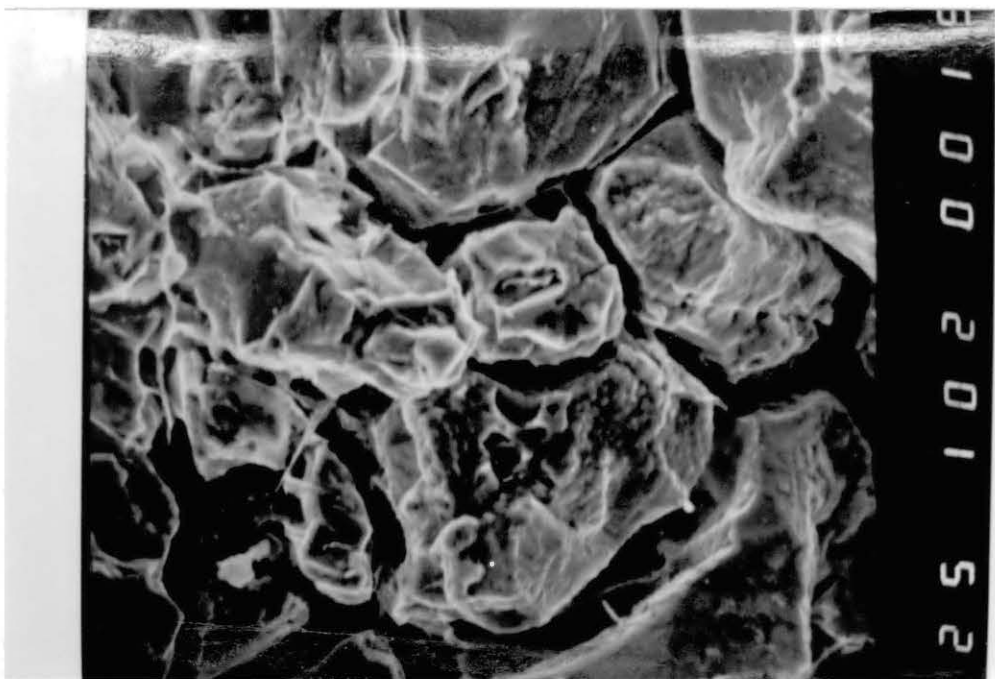
Figure 38. An Exploded View of the Center of Figure 37
(1000 x). Grain Boundaries are Severly
Attacked

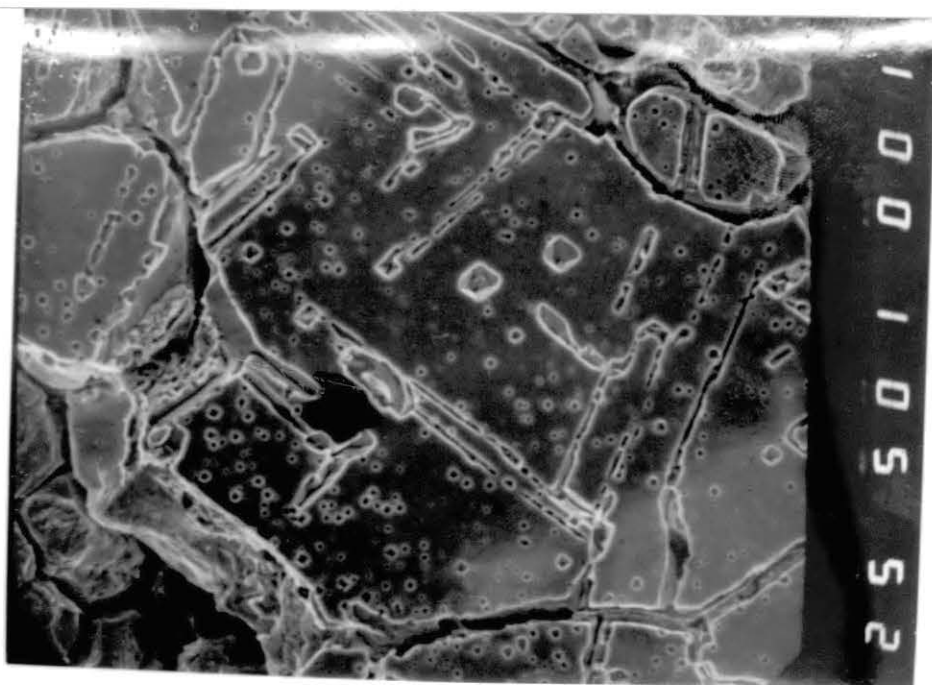
Figure 39. Closer View of the Pitted Upper-Right Matrix of
Figure 37 (500 x)

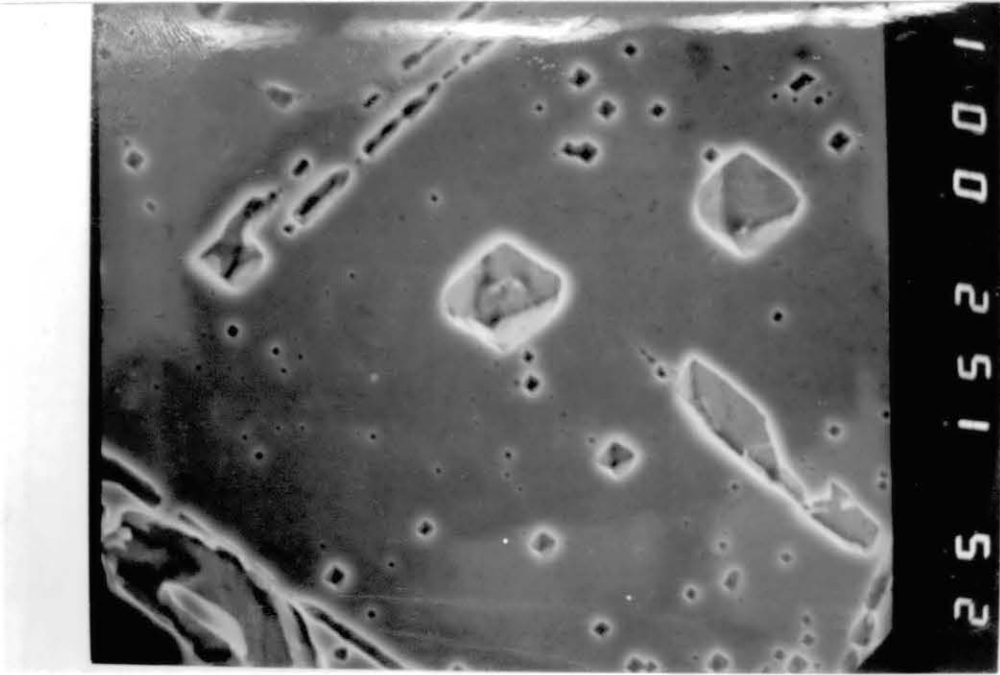
Figure 40. A High Magnification (1500 x) View of Figure 39 Showing intensive Pitting. The Pits are Pyramidical in Shape and Faceted

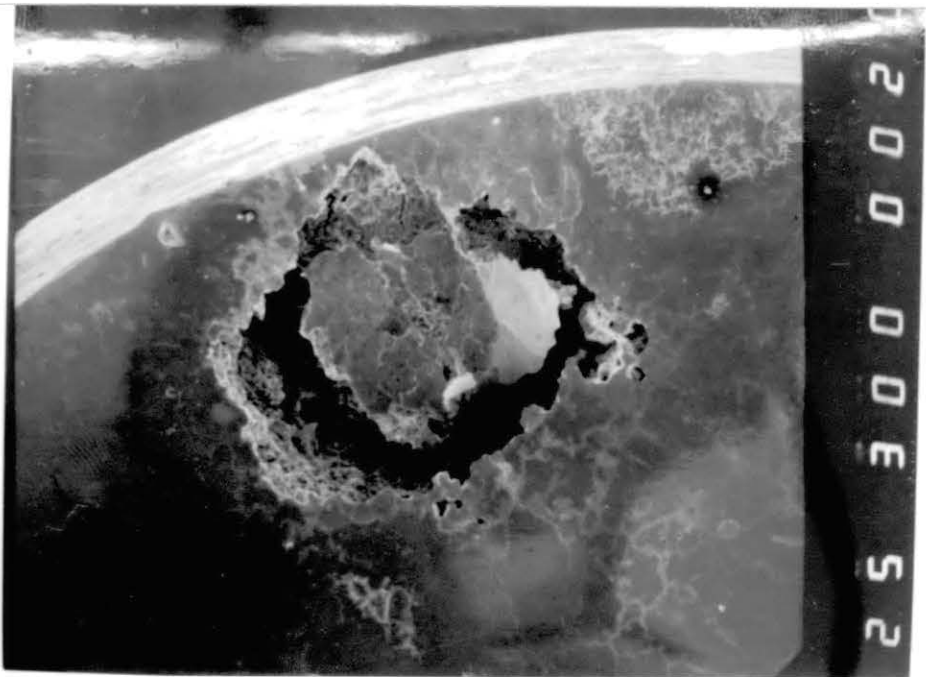
Figure 41. A Large Irregular Pit Formed on the Completely Sensitized Specimen Discussed in the Above Figures. Compare the Size of This Pit (30 x) With Those Shown in Figure 40 at 1500 x

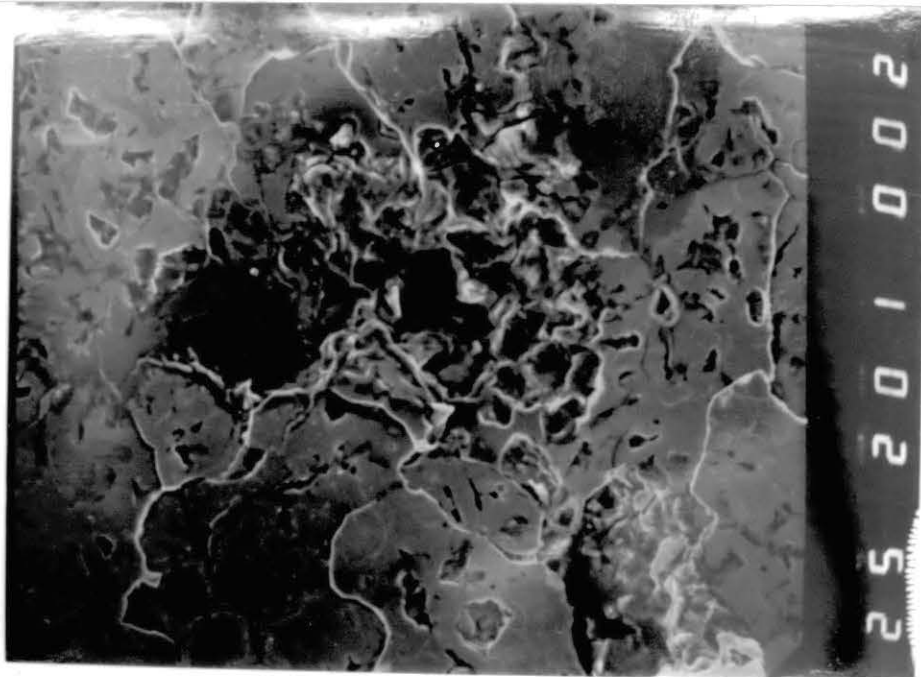
Figure 42. Detail of the Central Flat Surface of the Pit
Shown in Figure 41, Which is Under Severe
Attack (200 x)

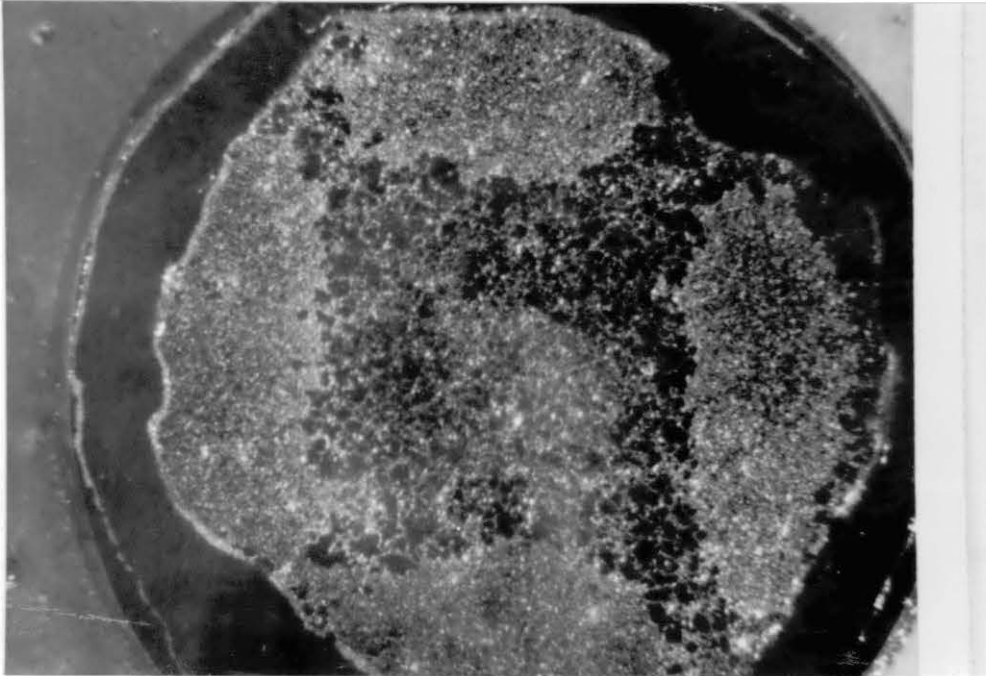
Figure 43. The Pattern of Pitting Attack when the As-received Specimen was Tested for 45 minutes in 1.85M Ferric Chloride. It Looks Like a General Attack but Actually Consists of a Number of Pits Joined Together

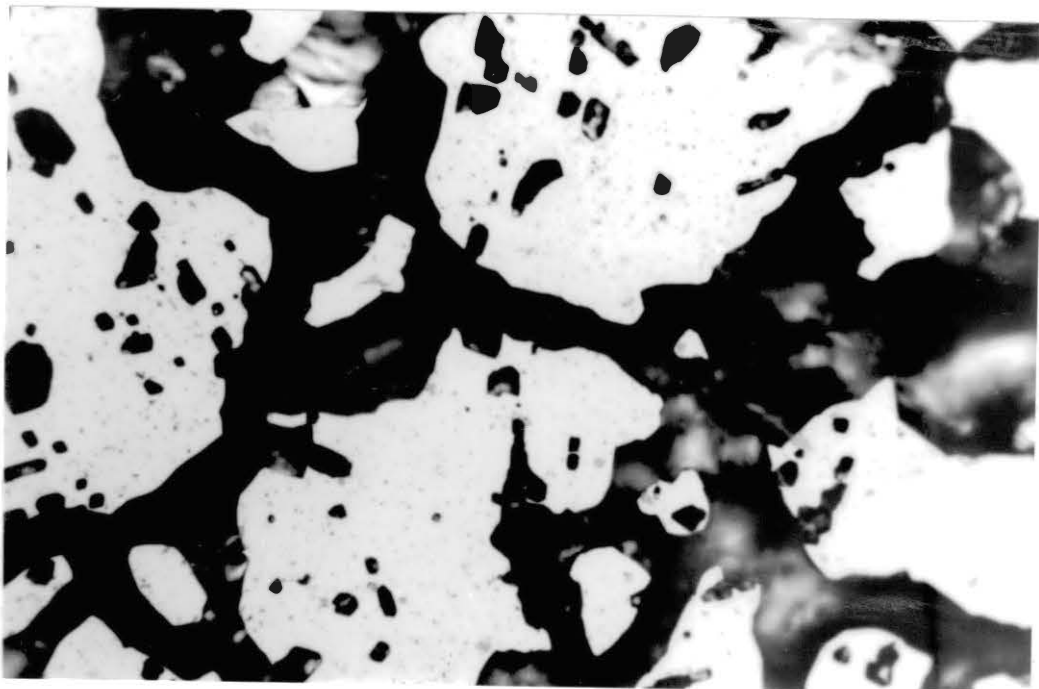
Figure 44. Magnified View of Figure 43. It Shows the Preferential Attack along the Grain Boundaries. This Attack Consist of Many Pits which Have Been Coalesced (200 x). The Attack is Mainly Intergranular With Pits Within the Matrix (200 x)

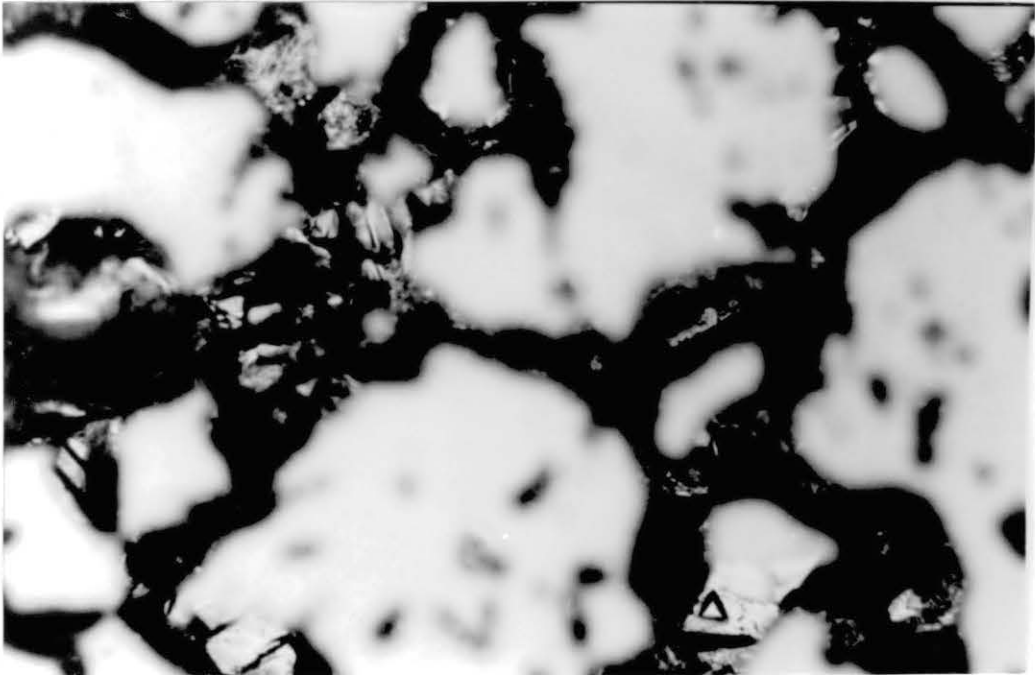
Figure 45. Detail of the Intergranular Attack Showing Crystallographic, Shiny, Faceted Structure Which is Similar to That Found at the Bottom of the Pit (200 x)

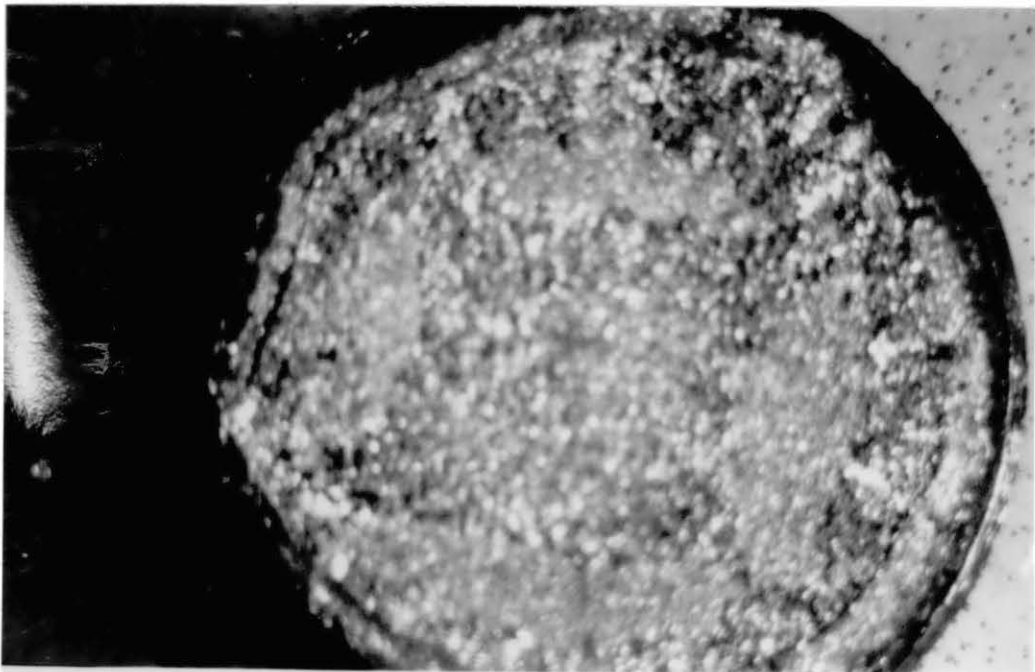
Figure 46. Photograph Taken After 24h Immersion Test in 1.85M Ferric Chloride. Although it Shows a General Corrosion but is Actually the Result of Pit Formation and Coalescence. It Has a Shiny, Crystalline Structure with Undercutting at the Edges (200 x)

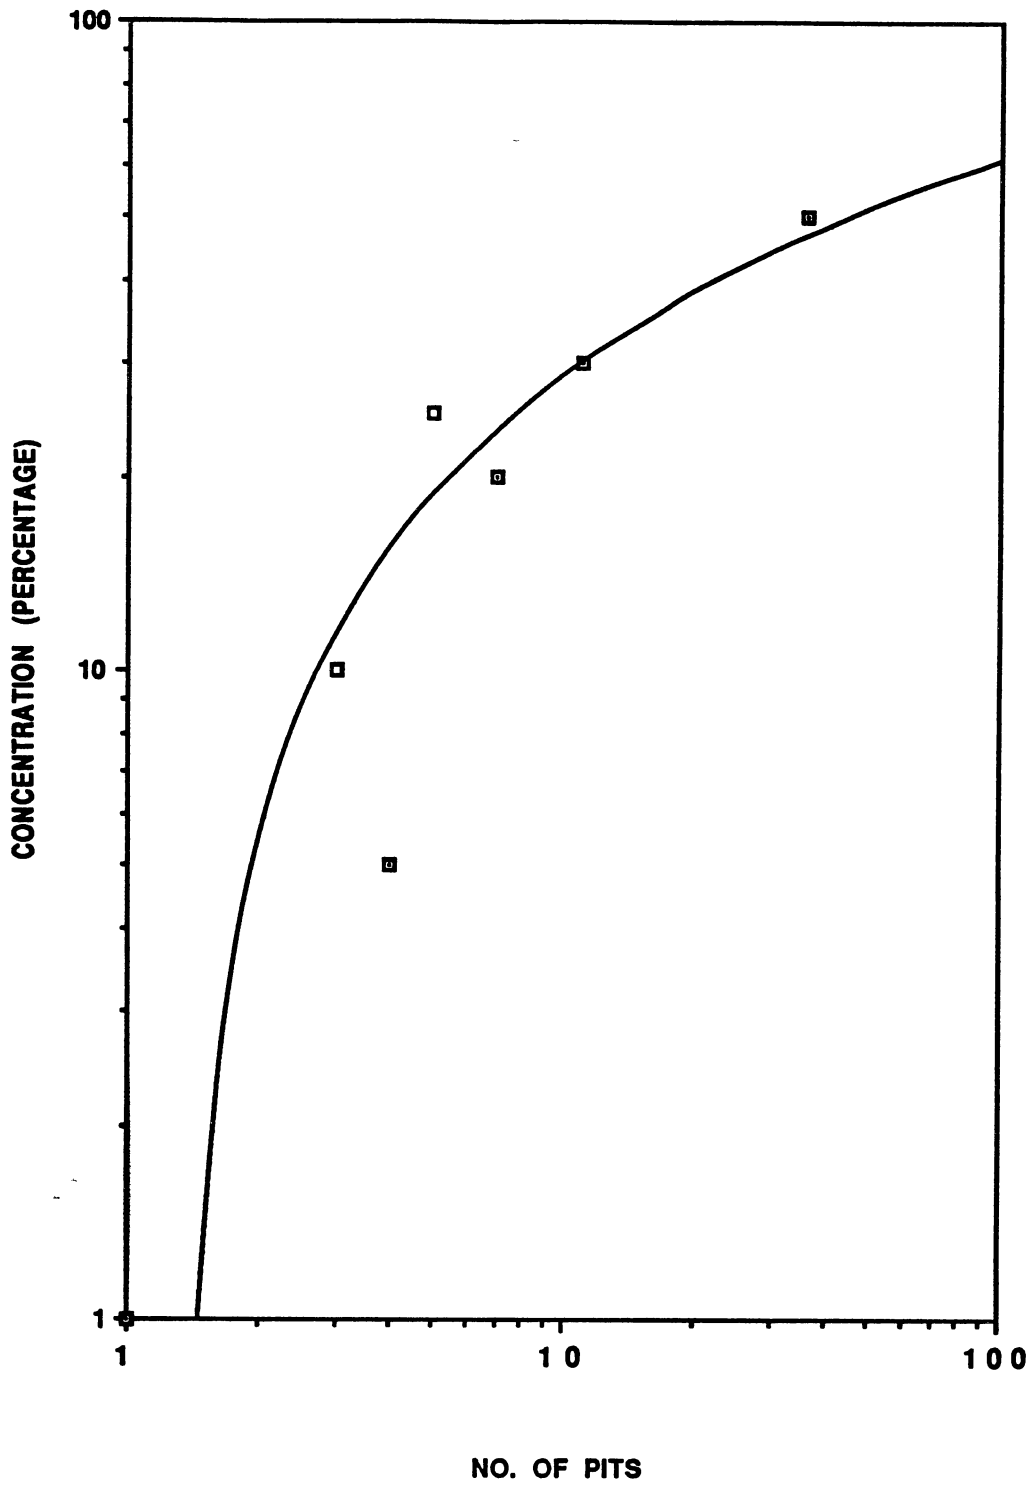
Figure 47. Graph of Concentration vs. Number of Pits

Figure 47 shows a graph of concentration vs. number of pits for unsensitized specimens. It can be seen that from a 0.75M (20%) concentration onwards, the number of pits increases at a decreasing rate. The number of pits observed at this point is 5. From the pitting theory of passive film breakdown and anodic dissolution of the metal, this behavior can be justified because as the number of pits keeps on increasing, the anodic area increases while cathodic area decreases. This change retards the corrosion rate and hence the number of pits. The scatter in the data can be attributed to the degree of crevice corrosion and the quantity/quality of the pits, e.g. pits can be smaller in number but larger in size. The graph (Figure 48) of time vs. number of pits at constant concentration of 10% FeCl_3 gives a linear relationship but with a steeper slope. These specimens were sensitized. Both graphs are related to the tests performed in ferric chloride.

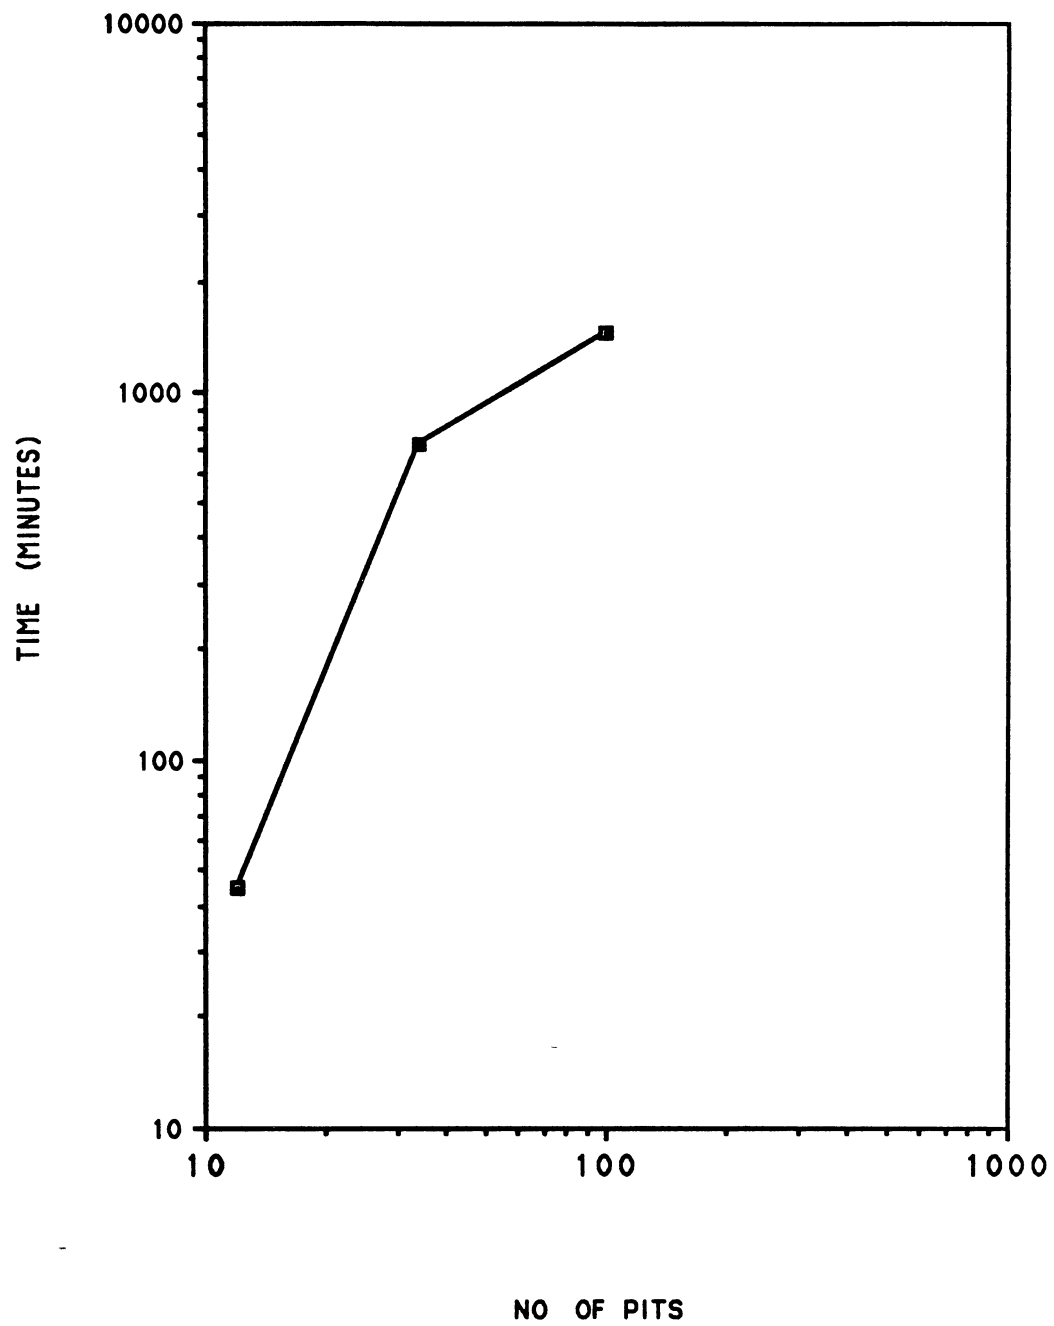
Figure 48. Graph of Time vs. Number of Pits

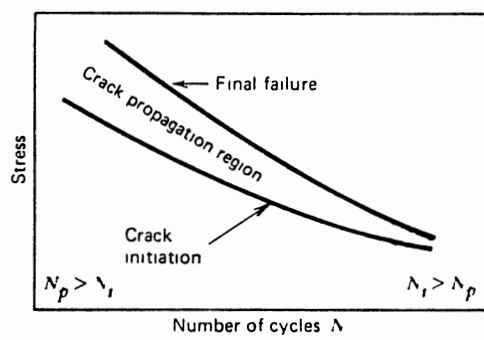
Figure 49. Fatigue Life Depends on Relative Extent of
Initiation and Propagation Stages [38]

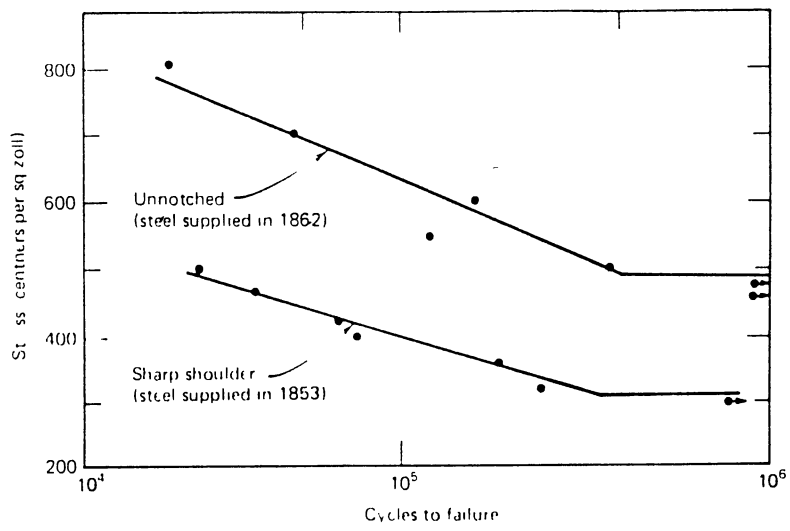
Figure 50. Wohler's S-N Curves for Krupp Axle Steel [38]

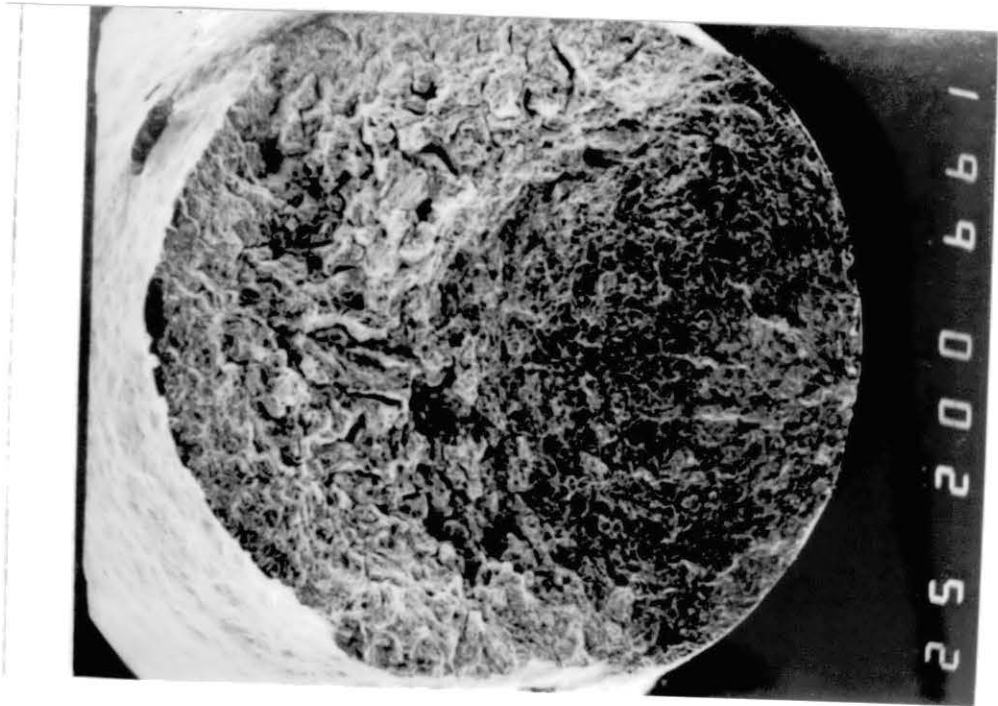
Figure 51. General View. From Right to Left Are Fatigue Zone (50 %) and Overload Zone (50 %) With Secondary Cracking (20 x)

The specimens FFM1, FFM2, and FFM4, were tested at 15 Hz without HCl cleaning. The peak load was calculated at 70% of the tensile strength. The SEM examination of FFM1 is shown in Figure 51. It is a general view composed of fatigue and overload zone. Details of the fracture initiation zone is seen in Figure 52 which seems to be completely transgranular. A closer look in Figure 53 shows tear ridges. Striations are quite prominent. Figure 54 is the general view of FFM2. The fatigue zone is quite smaller than that of FFM1 which is in accordance to the number of cycles sustained. Further details of the fatigue initiation zone are in Figure 55. One more view shows an open transgranular

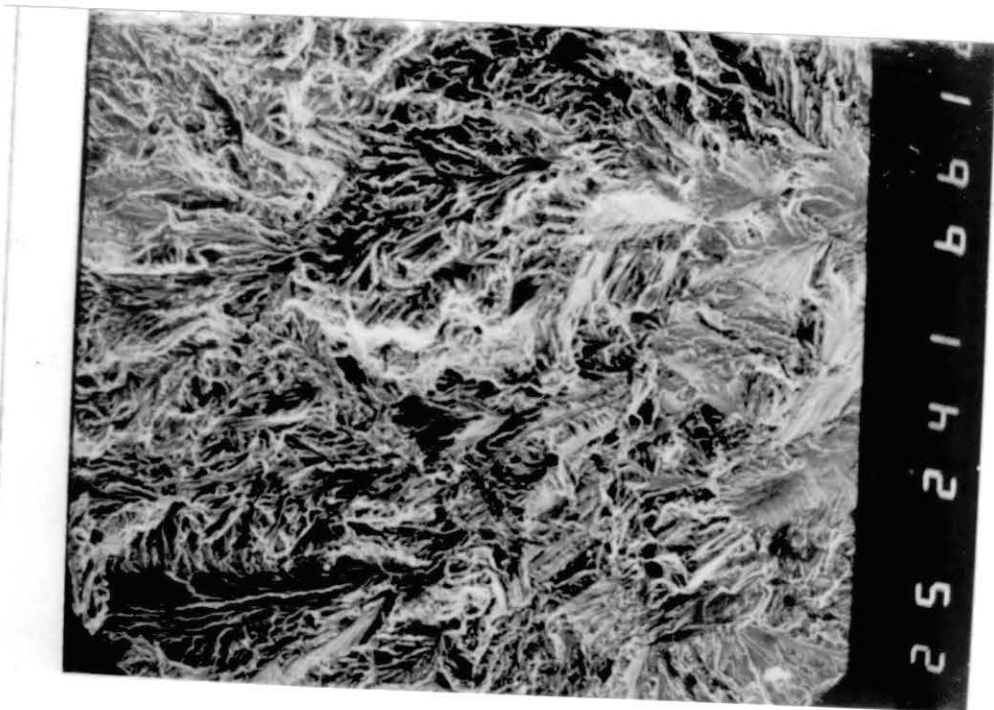
Figure 52. The Center of the Right Hand Side is the Point of Fatigue Zone Initiation. Lines are Radiating Away From That Point. Faceted Transgranular Separation is Visible (240 x)

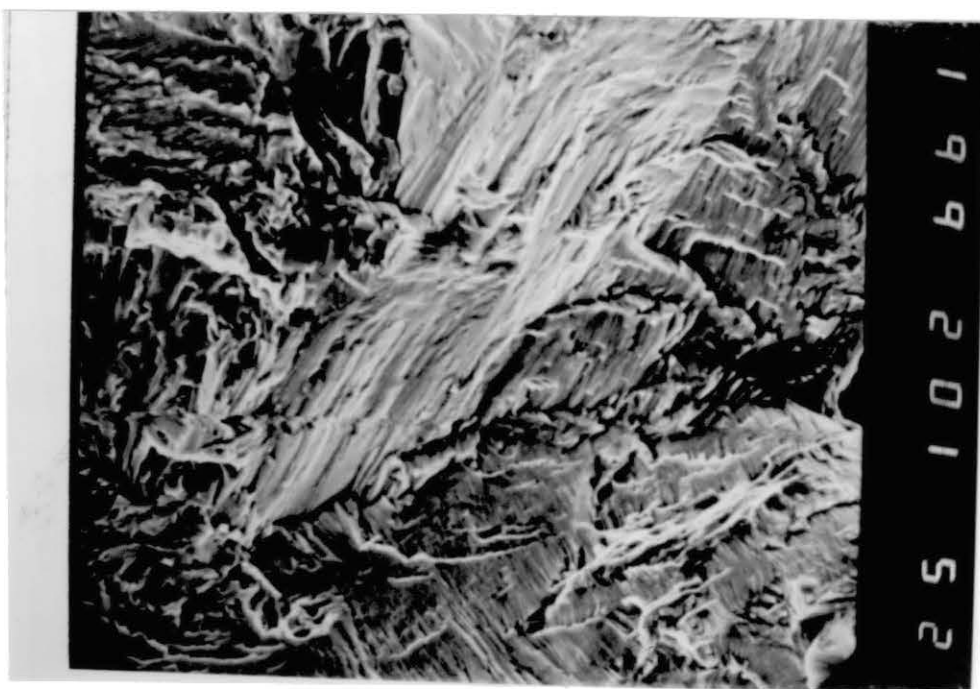
Figure 53. Detail of the Fatigue Initiation Zone Shown in Figure 52. Tear Ridges and Striations Can be Seen (1000 x)

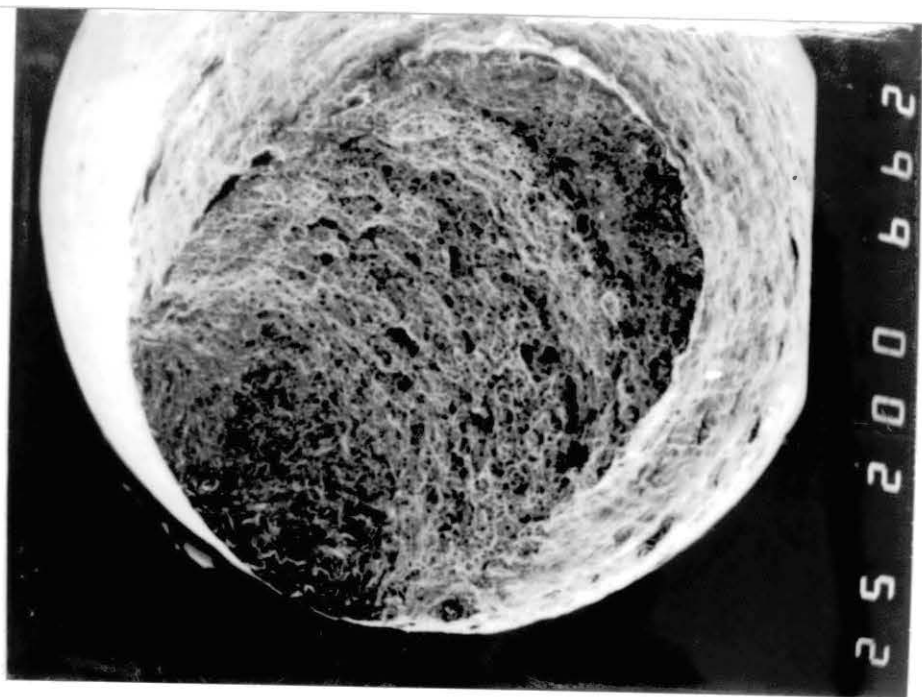
Figure 54. General View Showing Fatigue (Bottom Right) and Overload Zones (Fatigue Zone is Approximately 25 %). Microvoids Can Be Seen in the Overload Zone (20 x)

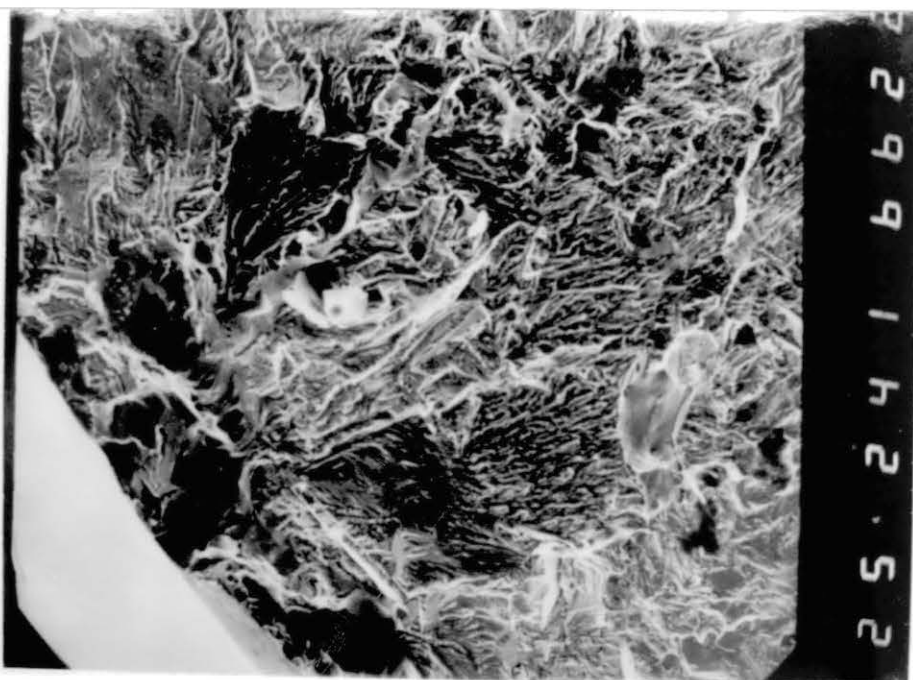
Figure 55. Initiation of Fatigue Zone (Bottom Left). At Origin Can Be Seen Rubbing, a Very Localized IG Zone, Then a Faceted IG Zone that Quickly Becomes More Irregular, Less Planar (240 x)

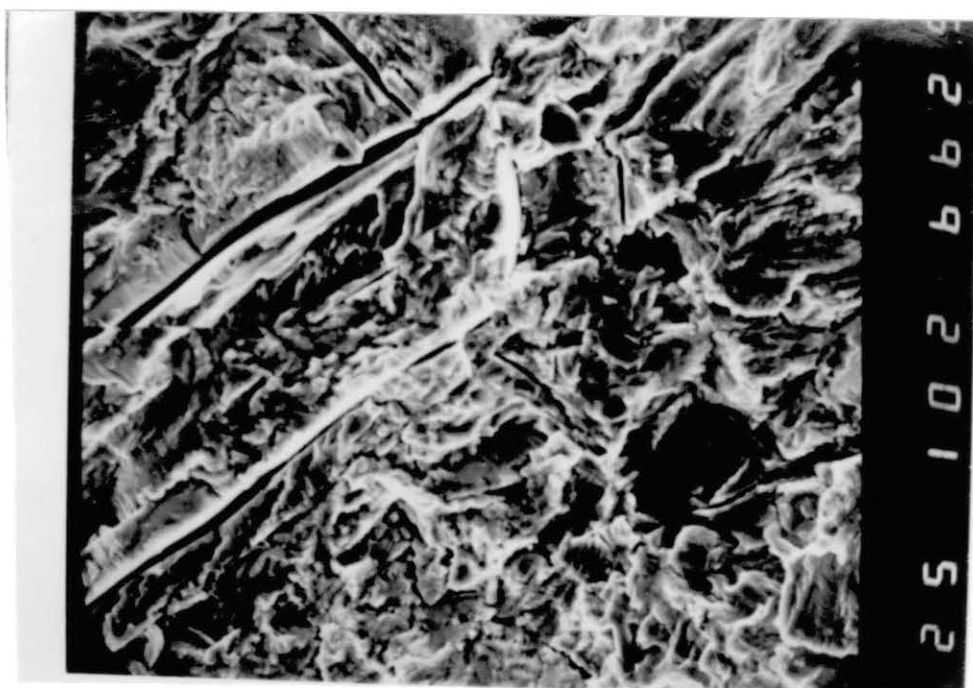
Figure 56. Detail of the Center of Figure 55. Secondary Cracks Can Now Be Seen. They Develop as Major Cracks Grow (1000 x)

crack (Figure 56). Inside detail of the crack can be seen in Figure 57. The detail of the side crack shown in Figure 58 reveals that it has not followed the grinding marks. This specimen fractured off-center. The photographs of these three specimens are quite similar to the ones obtained by Morris, Breedlove, and Valenta [35] [36] in their fatigue test conducted in air. This resemblance is due to the fact that with the oxide film wettability of the surface by mercury is not possible therefore there are very less chances of adsorption hence embrittlement. FFM1 fractured at the upper of meniscus while FFM4 fractured near the shoulder i.e. these fractures were partially in the air environment and mercury didn't play its role.

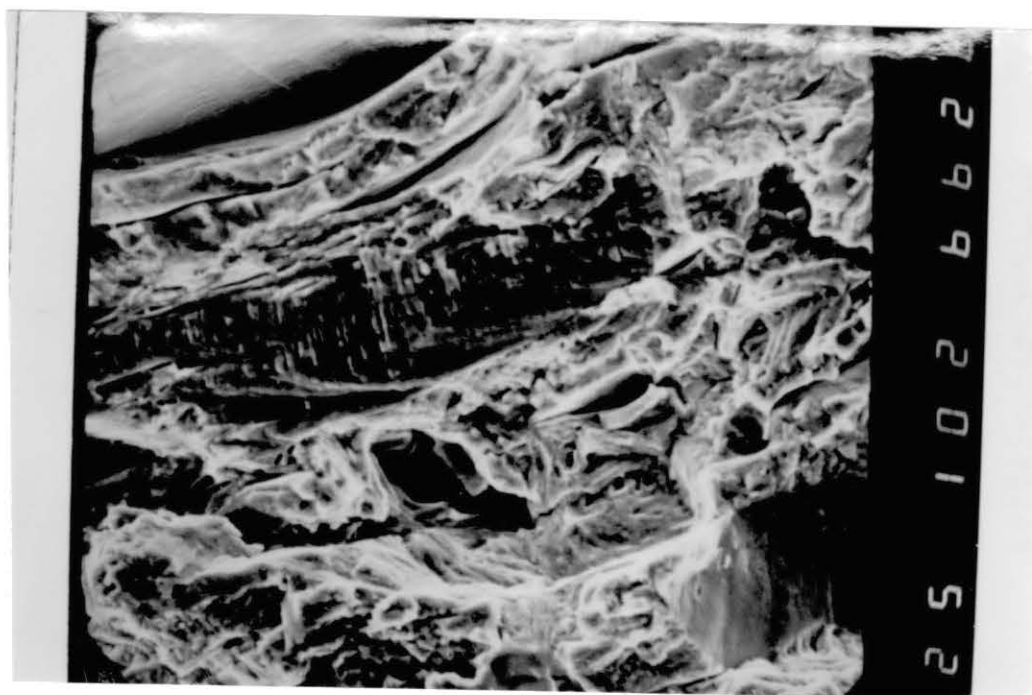
Figure 57. Lower Right Hand Side of Figure 55. Secondary Cracks and Their Internal Details can Be Easily Seen, as Can Striations That are Somewhat Disturbed by Rubbing (1000 x)

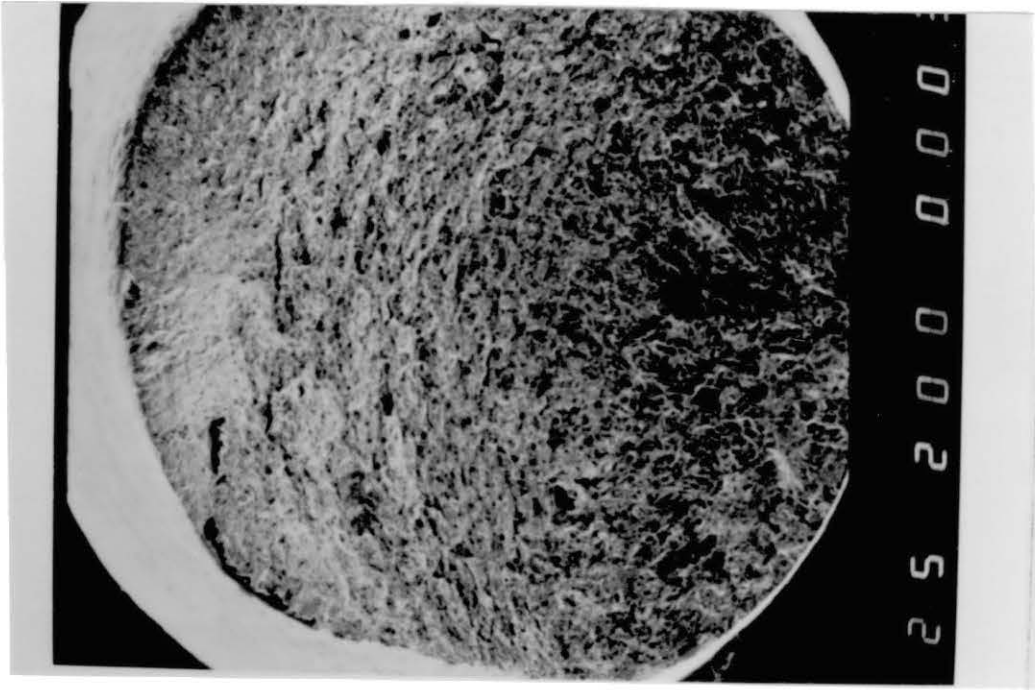
Figure 59. General View of the Fractured Surface. Center of the Right Hand Side is the Fatigue Initiation Zone (20 x)

FFM5 and FFM6 were cleaned by 10% HCl to increase the wettability of mercury. Also, this helps to remove the oxide film. Figure 59 and Figure 60 are the SEM fractographs of the sensitized specimen FFM5. A combination of IG and TG attack is quite visible. Such results were also obtained by Price and Morris [37]. The reasons for an incomplete IG attack could be the lower values of peak load and insufficient oxide cleaning which resulted in lesser wetting; hence IG attack is closer to the edges than the center of the specimen. A magnified view of a portion of Figure 60 is shown in Figure 61, where the attack is IG. Connecting the Figures 60 and 61, one can see that the cracking started intergranularly. Figure 62 shows corrosion in an IG zone. The wart-like appearance is very similar to

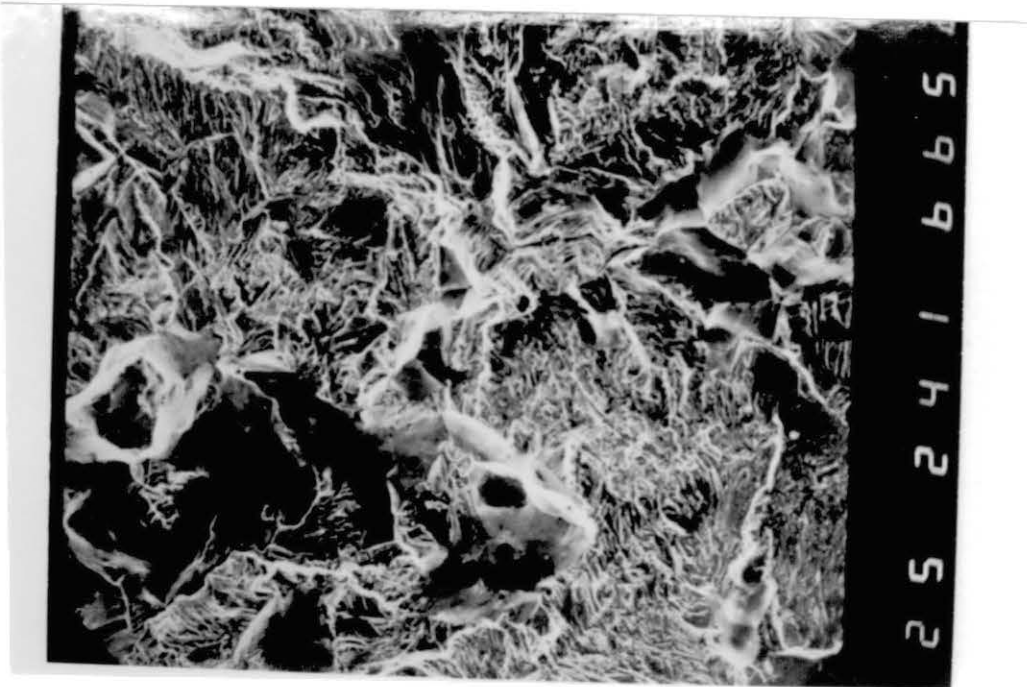
Figure 60. Fatigue Initiation Point. Observe in This Instance Zones of IG Fracture (240 x)

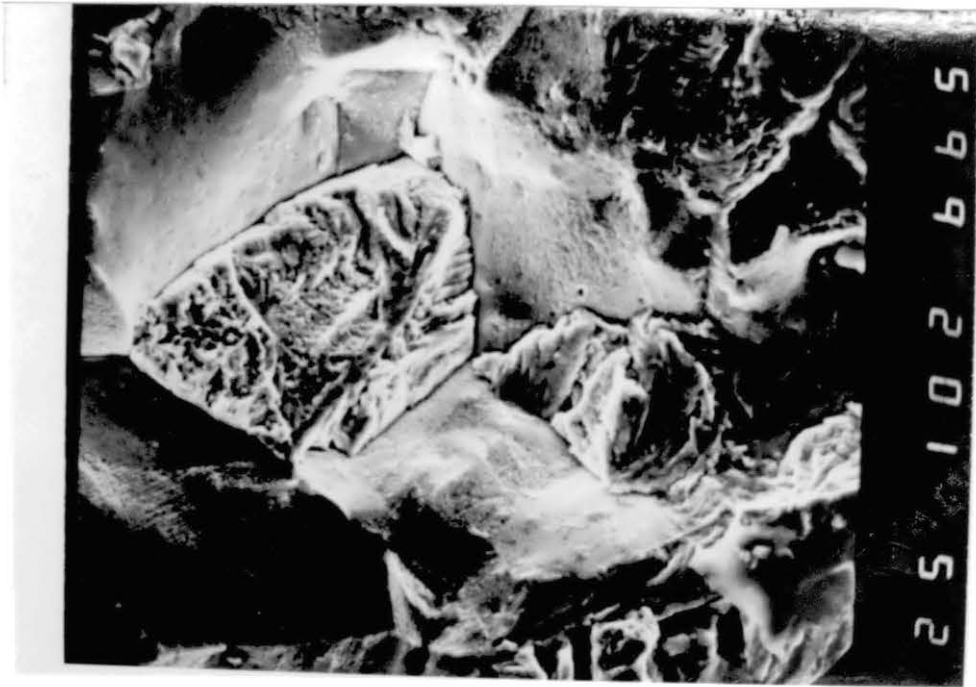
Figure 61. The Upper-right View of Figure 60. Detail of the IG Fracture Zone (1000 x)

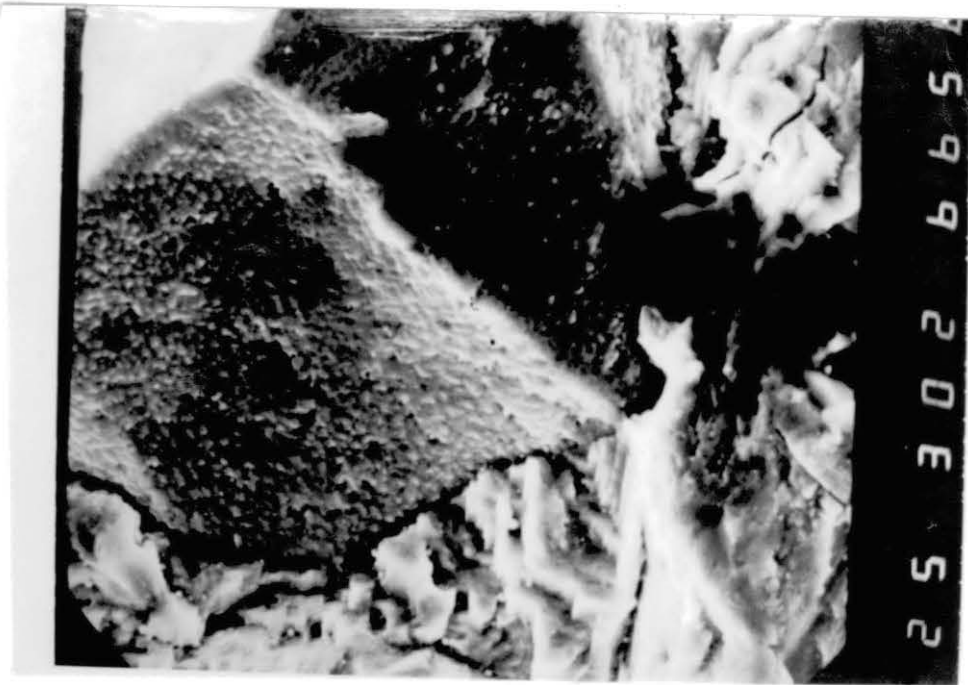
Figure 62. An IG Zone in More Detail Showing Corrosion (3000 x)

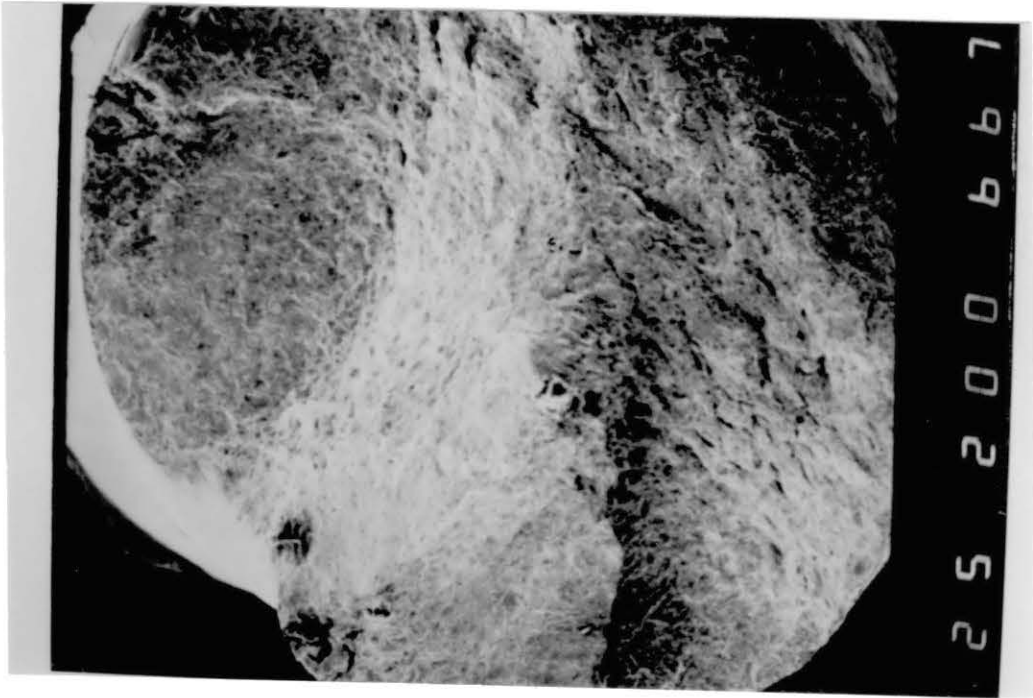
Figure 63. General View. 3 Distinct Fatigue Zones.
Fracture was Brittle. A Big Pit,
Which Served as a Crack Initiation Site,
is Located on the Top-left Side. The
Specimen is Sensitized Hence Undercutting
is Significant. Side Cracking
Can Also Be Seen (20 x)
