AN INVESTIGATION OF CORROSION
BEHAVIOR OF ALLOY 800

Submitted to the Faculty of the Graduate College
of the Oklahoma State University
in partial fulfillment of the requirement
for the degree of
MASTER OF SCIENCE
May 1991

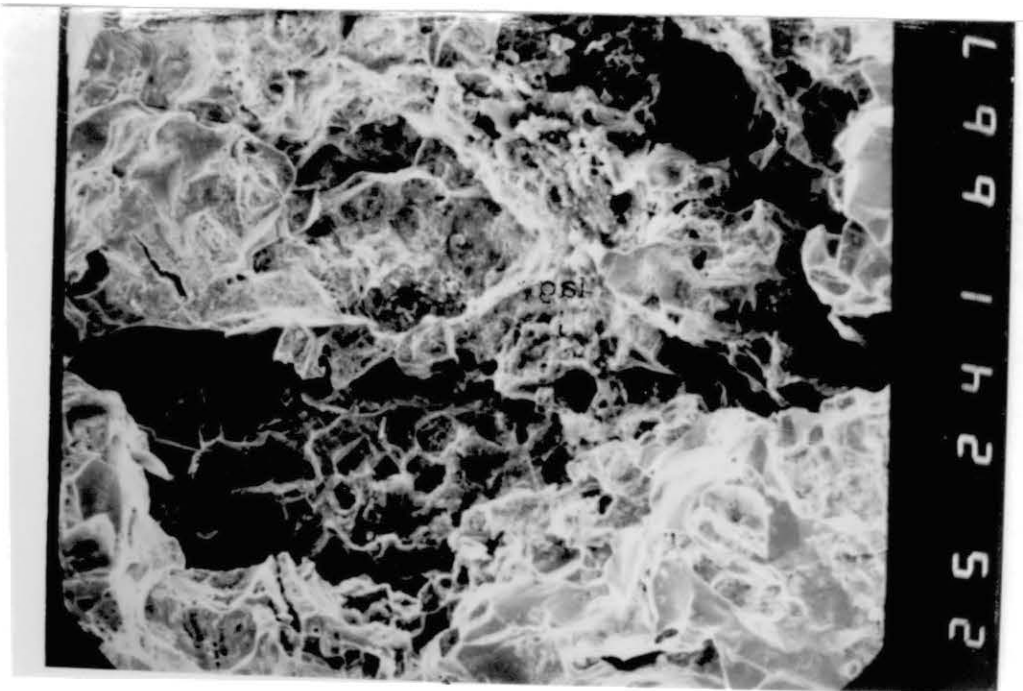
Figure 64. Higher Magnification View of the Pit (240 x).
Faceted Structure, Intergranular Attack, and
Cracks are Visible

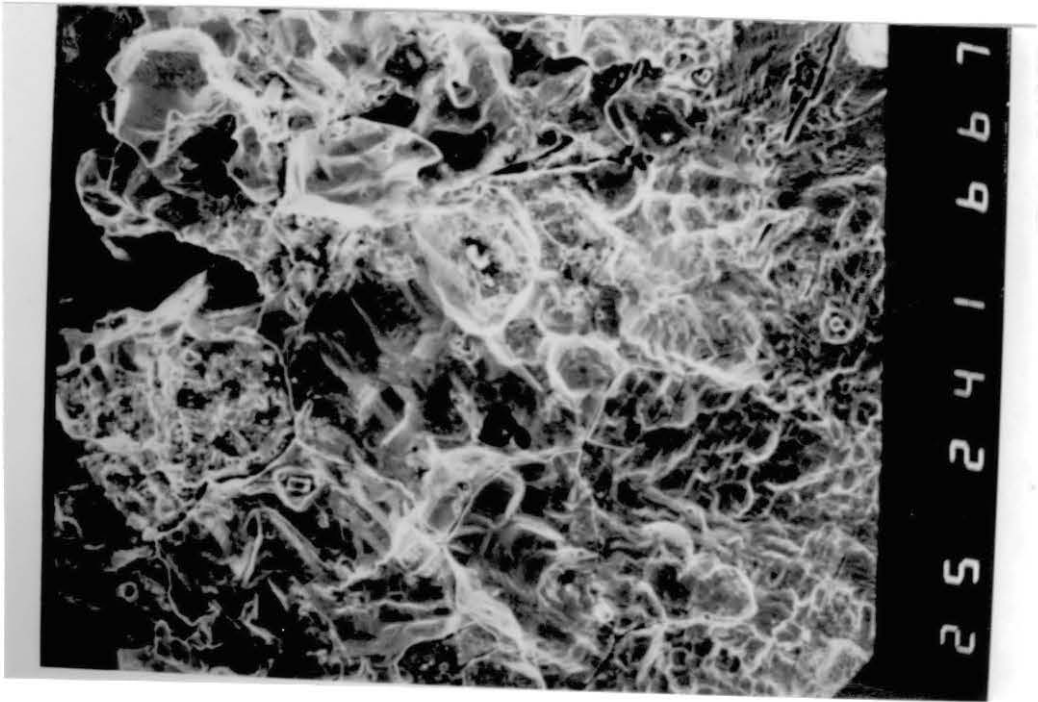
Figure 65. Extreme Right End of Figure 64 Showing the Root/Edge of the Pit. IG Cracking is Apparent

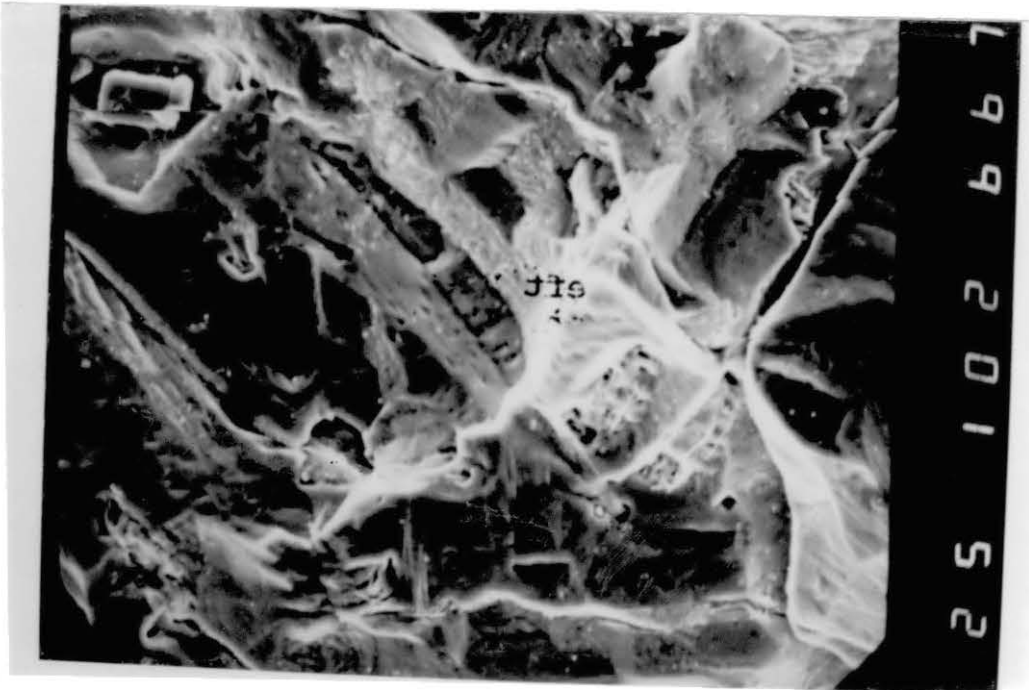
Figure 66. Lower-left View of Figure 65. IG Cracking Can be Seen. There are Some Cavities as if the Particles Have Floated Out. Observe That the Rectangular Particle of Titanium Nitride is Not Corroding Rather it is Acting as a Cathode and the Matrix Around it Corrodes. The faceted structure is Typical of a Pit and Resembles that seen in Figure 22 (1000 x)

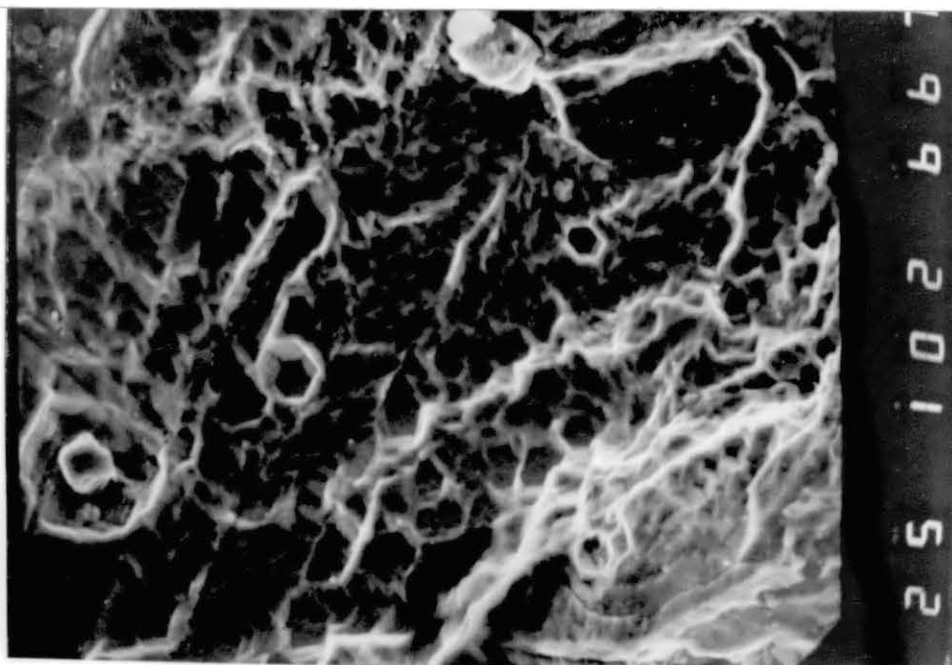
Figure 67. Center of the Extreme Right-end of Figure 65. Corrosion and Intergranular Attack Can Be Seen. Again Observe the Titanium Nitride Particle and the Corroding Matrix (1000 x)

pattern is shown in Figure 67. Apart from this side pit, which initiated the fatigue fracture, there were few more side pits heading towards side cracking. The faceted structure of Figure 58 is typical of a pit and resembles that seen in Figure 21. Note that, in both the cases, preferred crystal planes are outlined. Undercutting of the pit is quite justified by the earlier discussion on pitting results, where it was found that the pits formed on the mechanically polished specimen had a restricted opening, hence the pH inside the pit falls rapidly, thus increasing undercutting.
